Massachusetts Department of Conservation and Recreation

Nantasket Beach Reservation Facilities Utilization Report

Hull, MA

April 2014

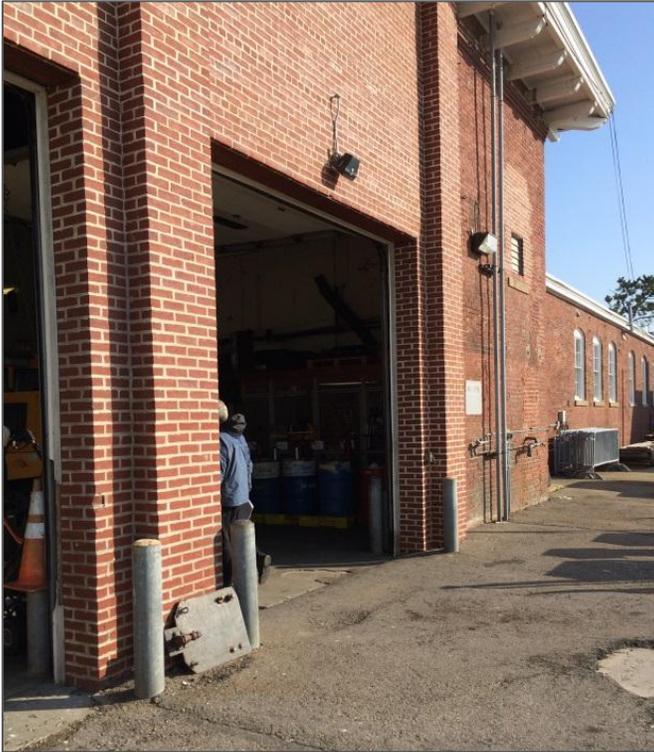
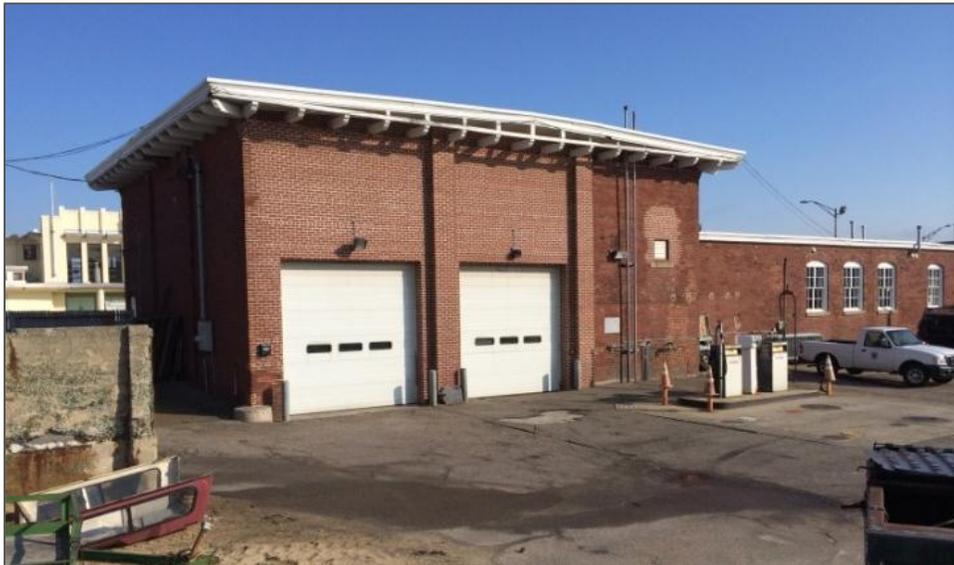
Figure 1: Lower Garage exterior, yard side

The Lower Garage (Figures 1 and 11) has an area of approximately 5,000 square feet and is in overall good condition. Its major use is vehicle and maintenance storage but the facility also provides heated storage and houses the carpentry shop. The building is not prone to flooding, making it ideal for storage of sensitive goods such as toilet paper and waste oil. There are two bathroom facilities and a shower in the building.

All available floor space for vehicles and maintenance storage is used to its fullest extent. There is currently no pedestrian door to access the main part of the garage; only overhead garage doors. This decreases the energy efficiency of the building and causes unnecessary wear and tear to the motorized overhead door equipment.

Figure 11: Lower Garage exterior, yard side

The structure is heated but not insulated. Roof leaking has been reported by on-site staff.

DCR maintenance staff recommends the following repairs:

- Inspection and possible repairs to the roof
- Repair of overhanging eaves
- Re-pointing of all brick work
- Repair or replacement of all windows
- Insulating the structure
- Installation of a pedestrian-sized door to access the building
- Inspection, repair and mitigation of floor drains to ensure proper discharge
- Replacement of the brick arch between the Lower and Upper Garages.

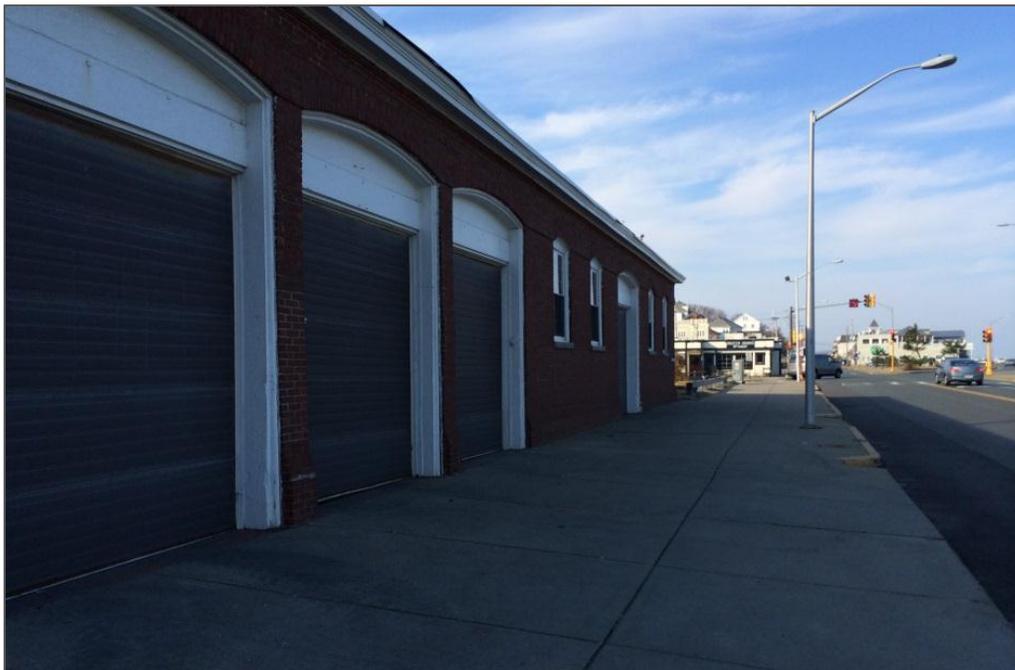
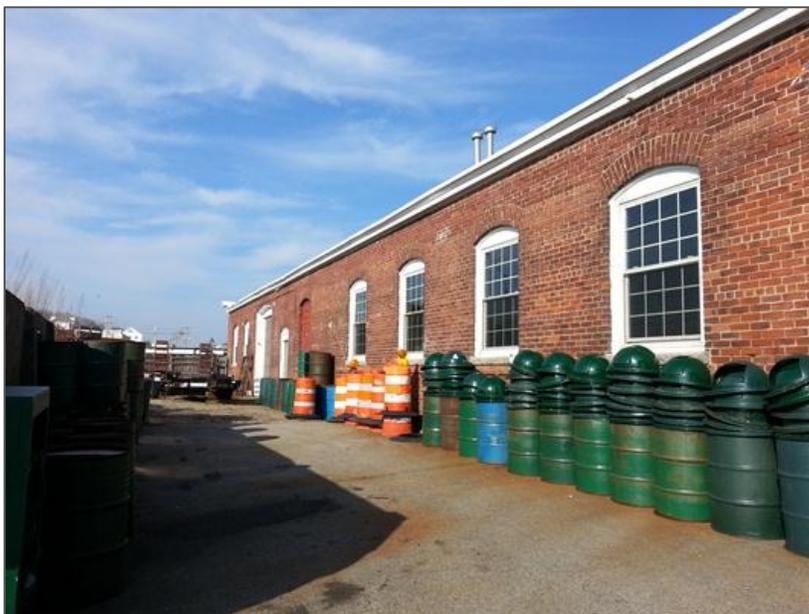
Figure 4: Upper Garage exterior, along Nantasket Avenue

The Upper Garage (Figures 4 and 12) has an area of approximately 2,750 square feet and is in overall good condition. Its major use is vehicle and maintenance storage. Due to current space restrictions, the garage cannot accommodate a truck equipped with a plow and sander. The building is prone to flooding; during large storm events up to 1.5 feet of water may be seen on the floor. This may be due to the overhead doors on the Nantasket Avenue side of the building that do not seal well with the concrete slab floor. There is no bathroom located in this building.

Figure 12: Upper Garage exterior, yard side

Roof leaking has been reported by on-site staff.

DCR maintenance staff recommends the following repairs for the Upper Garage:

- Inspection and possible repairs to the roof
- Repair of eve supports and gutters
- Re-pointing of all brick work
- Inspection, repair and mitigation of floor drains to ensure a proper final discharge.

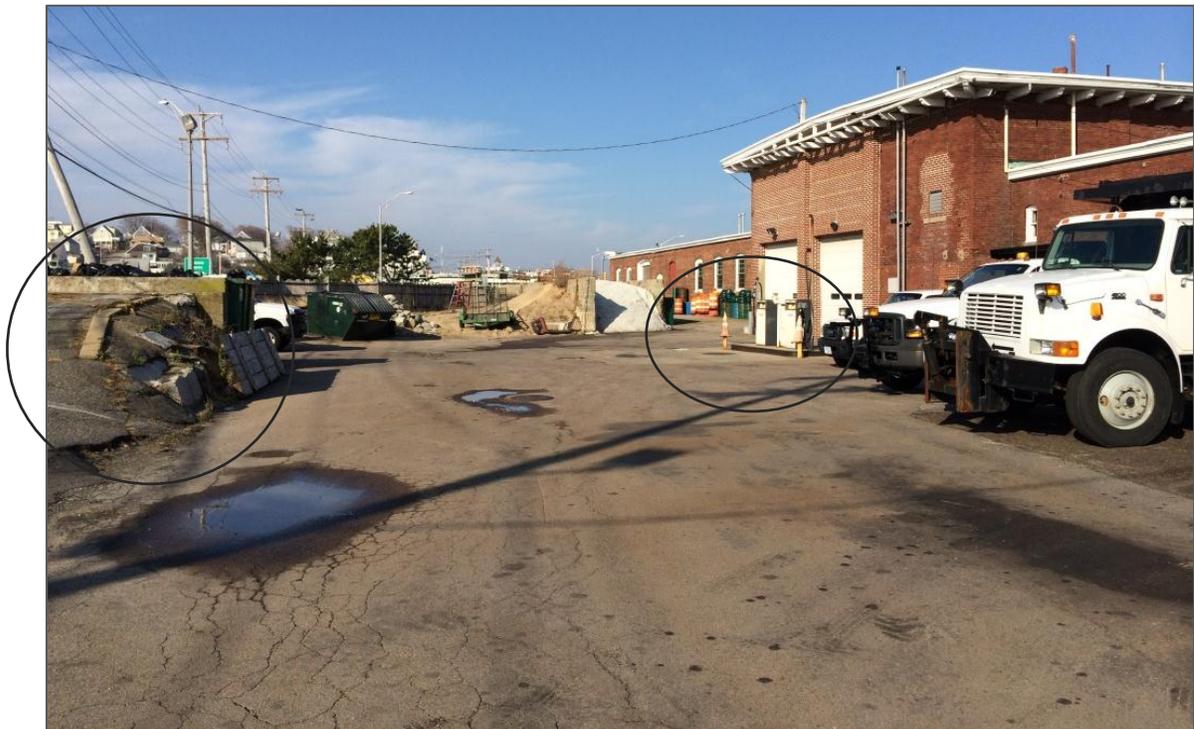
Yard space is also limited for storage and maneuvering. Figure 6 shows the tight circulation area in the yard. Two fuel pumps are located behind the maintenance buildings. Access to these pumps is acceptable but the location of the large trash dumpster has been an issue. Specifically, when a dumpster is being picked up or dropped off, the pumps are within the maneuvering area and in danger of being hit.

Figure 6: Yard area; circled are the dumpster and ramp (left) and the gas pumps (right)

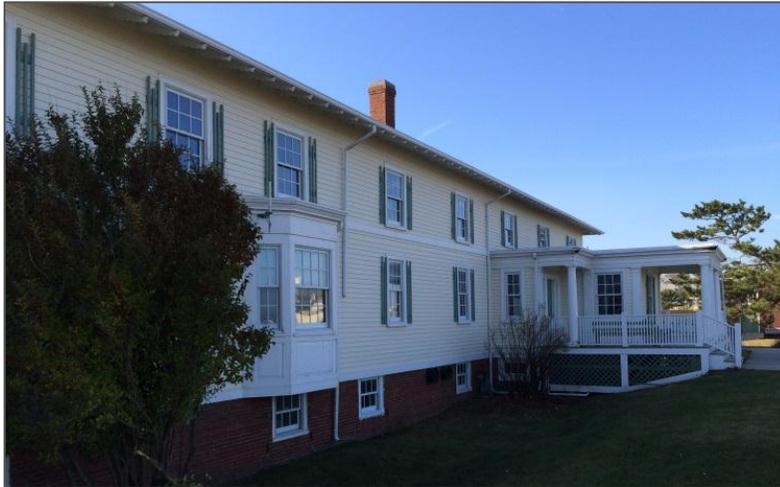
The Dormitory Building (Figure 8) has an area of approximately 9,000 square feet and is in overall poor condition. The main floor is currently used as the DCR operations office building with some space available for dry and hazardous materials storage. The upper floor is largely vacant. During the summer of 2013 parking passes were sold from a folding table in front of the building and paperwork was filed in an office inside the building.

Figure 8: Dormitory Building exterior

Support columns in the basement have been repaired recently after showing severe damage. These repairs were reportedly 'mostly cosmetic' and the structural integrity of the building is still in question.

A visual inspection showed water damage on the walls and ceilings remaining from roof leaks that were recently patched.

The basement of this building experiences severe flooding once every 3 to 5 years. Water is regularly pumped from the basement but during larger storm events infiltration outpaces the removal capacity of the pump. A generator is currently stored in the basement and should be moved as soon as possible to avoid flood damage. The building is heated by a recently purchased gas-fired boiler, installed in the basement.

DCR maintenance staff recommends the following repairs to the Dormitory Building:

- Inspection and possible repairs to the roof
- Assessment of structural integrity of the building
- Inspection and repair of the brick foundation and support columns due to salt damage
- Re-pointing of all brick work
- Extensive gutter and fascia replacement on both porches

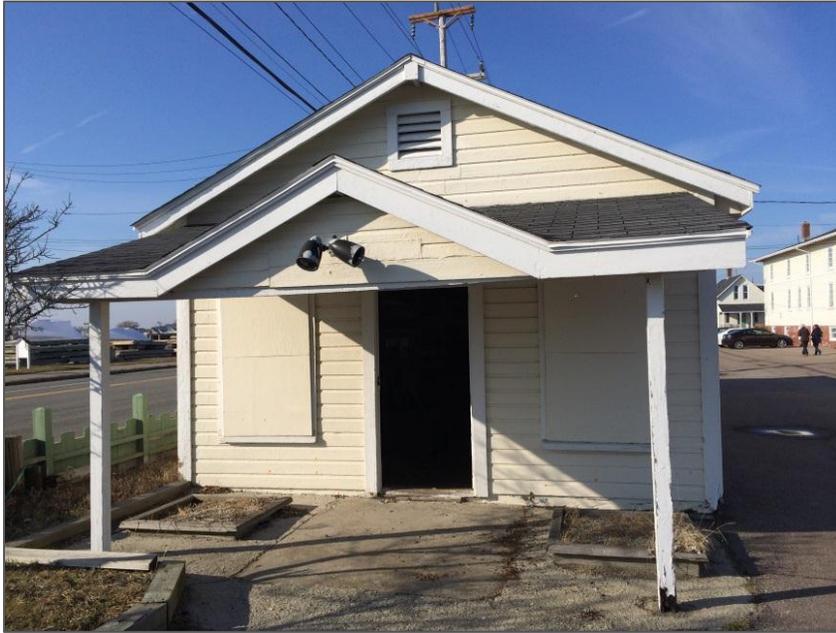
The Laundry Building (Figure 9) has an area of approximately 900 square feet and is in overall adequate condition. It is currently used for dry storage of lumber and is sometimes referred to as the “wood storage room”.

Figure 9: Laundry Building exterior

A visual inspection found the building to be in adequate condition. A 1993 report found the building to contain asbestos and no records of abatement were located as part of the research for this report.

DCR maintenance staff recommends the following repairs to the Laundry Building:

- Asbestos abatement (if not completed previously)
- Inspection and repair of rotten sills
- Replacing of windows

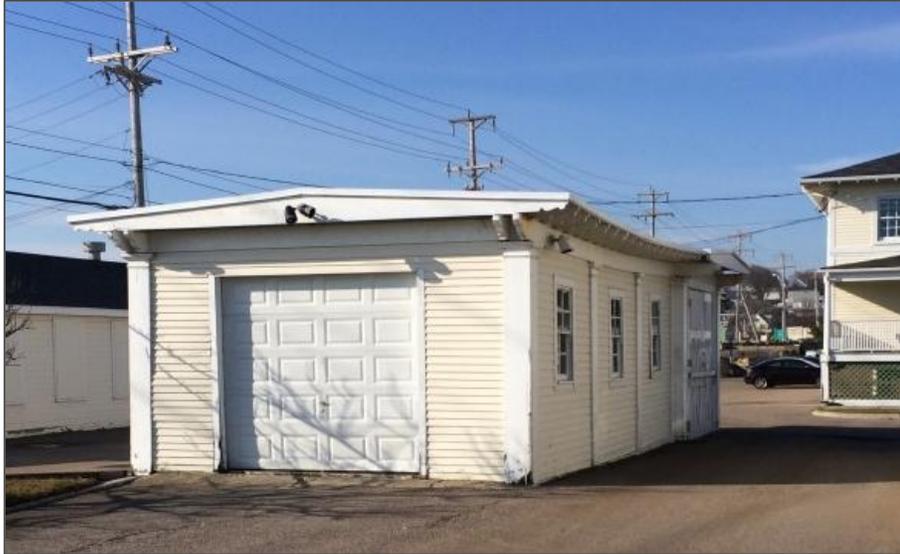
The small wooden garage building (Figure 10) has an area of approximately 1,000 square feet and is in overall poor condition. It is currently used for cold storage of parking supplies such as signs and posts.

Figure 10: Small Garage exterior

It is recommended that the building be demolished or relocated to allow for additional yard space. If historical importance prevents this option, DCR maintenance staff recommends the following repairs:

- Inspection and repair of rotten sills
- Replacement of doors and windows

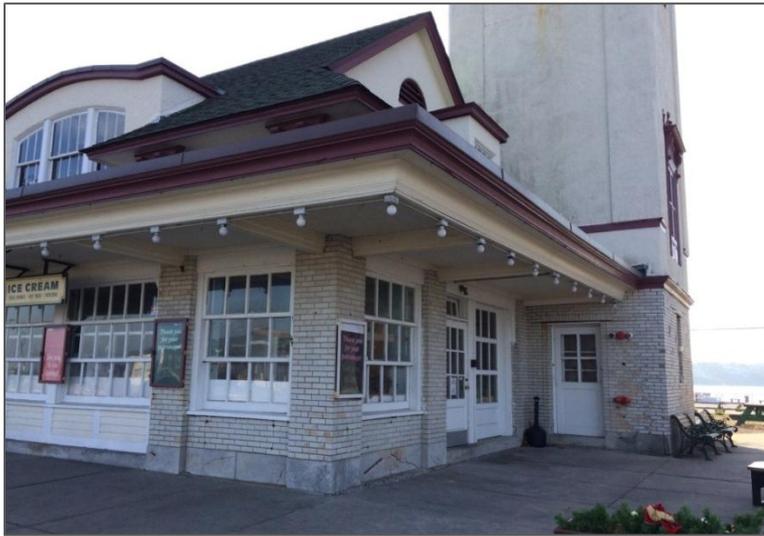
The Clocktower Building (Figure 13) and the adjacent land for the carousel have been leased to the “Friends of Paragon Park”. The long-term lease expires in 2016. The basement currently houses the mechanical equipment for the carousel and a workshop where the carousel horses are maintained. The first floor houses a museum from Paragon Park and an ice cream parlor. The upstairs is used for storage but has no electricity, heat or plumbing.

Figure 13: Clocktower Building exterior

The roof is new but had been damaged for over 10 years causing possible unidentified damage to the ceiling and walls. Lead and asbestos have reportedly been abated throughout the building.

DCR maintenance staff recommends the following repairs for the Clocktower building:

- Testing of the second floor for lead and asbestos
- Complete remodeling of both floors
- Roof repairs
- Possible upgrade of the heating, cooling, and electrical systems.

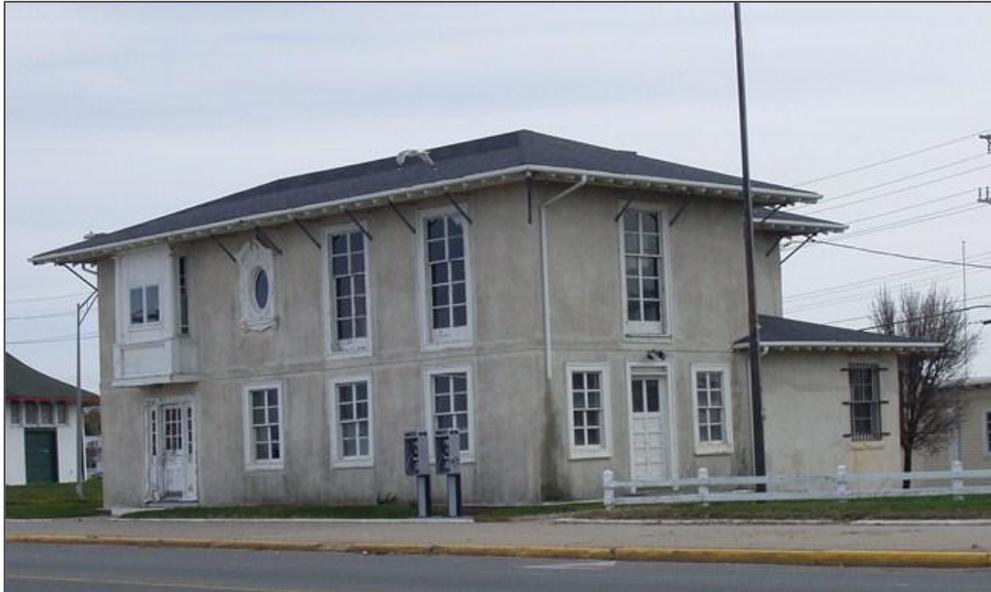
The former Police Station (Figure 14) has an area of approximately 4,000 square feet and is in very poor condition. It is currently vacant and entry is prohibited due to high levels of asbestos. There is no full basement under the building, just a crawl space.

Figure 14: Police Station exterior

A portion of the flooring on the first floor is reportedly unsound. There are visible cracks on the exterior and the paint and plaster are flaking. Overall the roof seems to be water-tight. There is no heat, water, or electricity. Major rehabilitation work would be necessary for this building to be used.

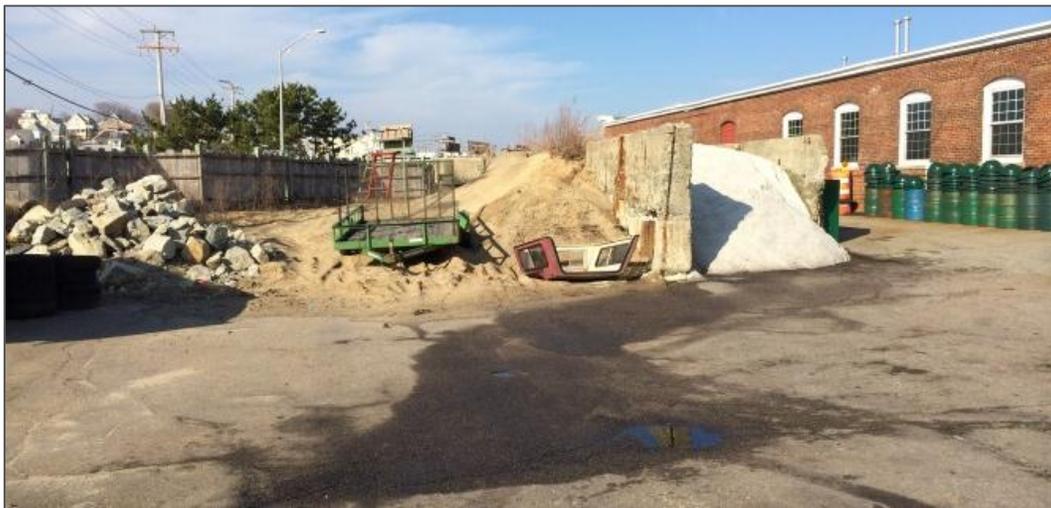
The yard area (Figures 6 and 15) has an area of approximately 25,000 square feet but maneuverability is very limited due to the layout, small buildings, and staff parking. The major use of the yard is maintenance storage. Due to the undersized garages a multitude of items that do not take priority are stored outside. The major assets within the storage yard are:

- A ramp and dumpster which consumes roughly 2,550 square feet
- Two gas pumps
- An uncovered salt bin
- An uncovered storage area for loam, sand, mulch, stone, seaweed and debris (contents vary depending on the season)
- Two underground storage tanks (capacity: 2,300 gallons each; one gasoline, one diesel)
- 30 employee parking spaces

Figure 15: Yard area

DCR maintenance staff recommends the following improvements to the maintenance yard:

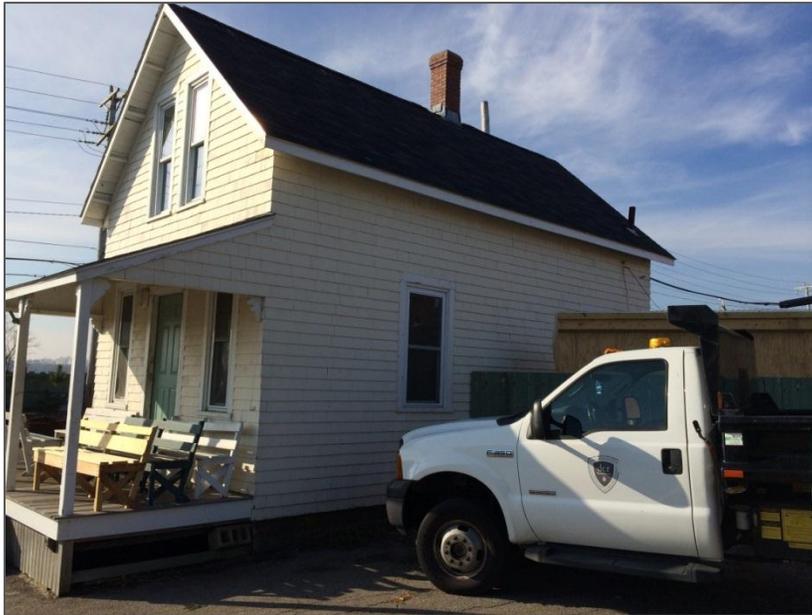
The Boilermaker's House (Figure 17) has an area of approximately 780 square feet and is in overall poor condition. It is currently used as a break room for lifeguards and as office space for the lifeguard supervisor. There is a functioning bathroom in the building.

Figure 17: Boilermaker's House exterior

It is recommended that the building be demolished or relocated to allow for additional yard space and create an opportunity for lifeguards to be situated closer to the beachfront and visitors. If the building is not demolished, DCR maintenance staff recommends the following repairs:

- Inspection and repair of rotten sills
- Inspection and repair of the foundation.
