**-- ANY LAKE DAM --**  
**PHASE I**  
**INSPECTION / EVALUATION REPORT**

Dam Name: Any Lake Dam  
State Dam ID#: 1-1-111-1  
NID #: MA11111  
Owner: MA. Dept. of Conservation and Recreation  
Town: Hinsdale, Massachusetts  
Consultant: Eng Corp, Inc.  
Date of Inspection: November 11, 2008

## EXECUTIVE SUMMARY

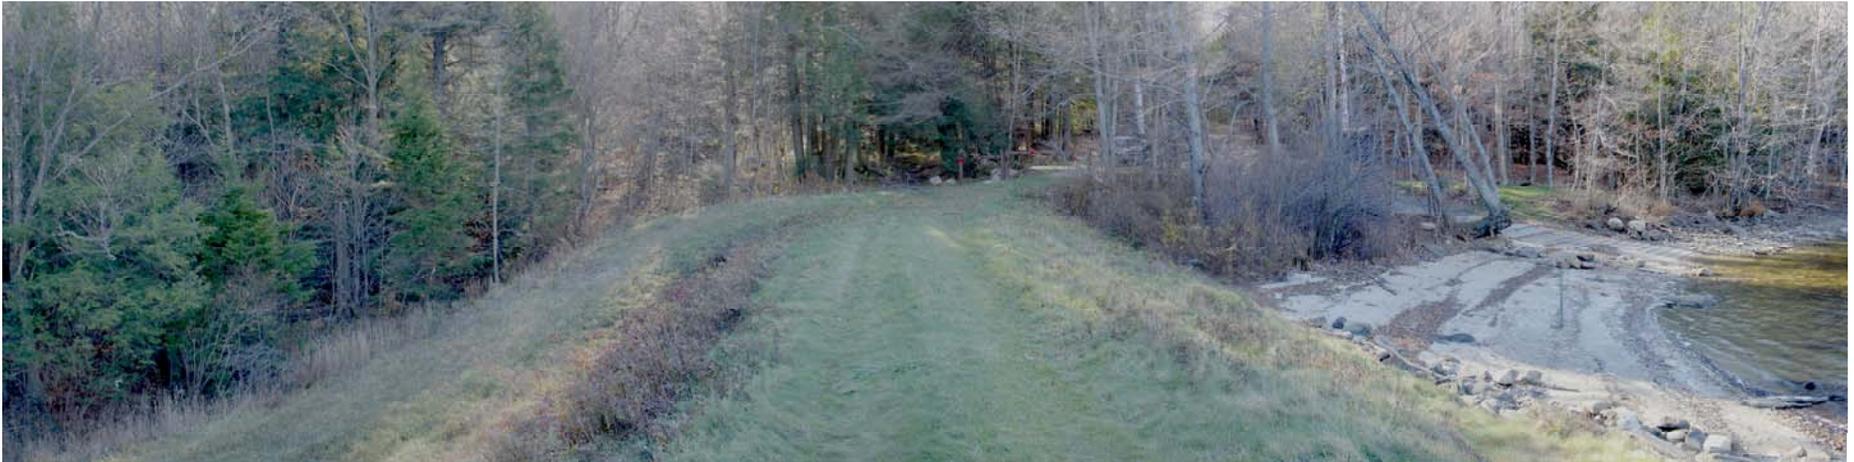
- Brush and several large trees were observed growing on the upstream slope between the right abutment and the embankment. No riprap was observed in this area. See Photograph A1.
  - The embankment slope from the right abutment to about Sta. 10+75 was covered with riprap. The riprap on the lower slope consisted of 6 to 12 inches in diameter cobble and boulder. The upper slope consisted of flat stone riprap 3 to 6 inches

- The downstream embankment slope near the right abutment is heavily wooded with trees and brush. See Photograph A1.
- The right embankment downstream slope is generally covered with grass and low cut brush. See Photographs A4, A5, and A12.
- No seepage was observed on the downstream slope, but wet, soft areas were observed along the embankment toe at the curved section. From about Sta. 6+25 to Sta. 7+25, wetland flagging on the embankment slope may indicate that seepage occurs in this area when the lake level is at normal pool.

Photo A1 – Panorama composite - Right abutment from embankment crest\*

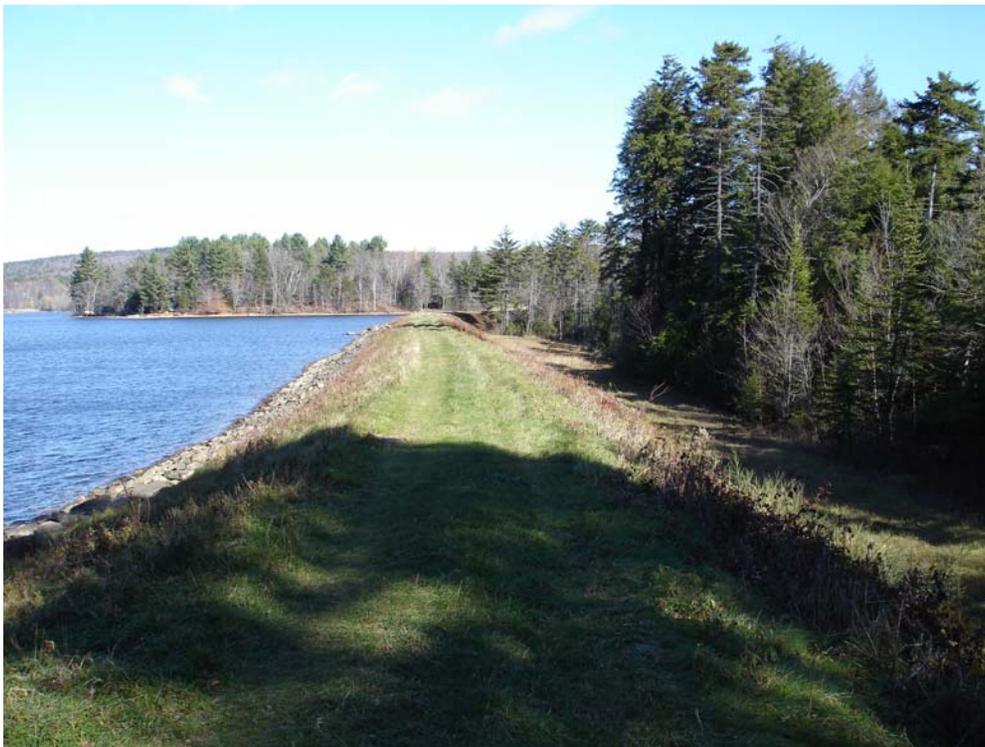
Photo A2 – Embankment from right embankment

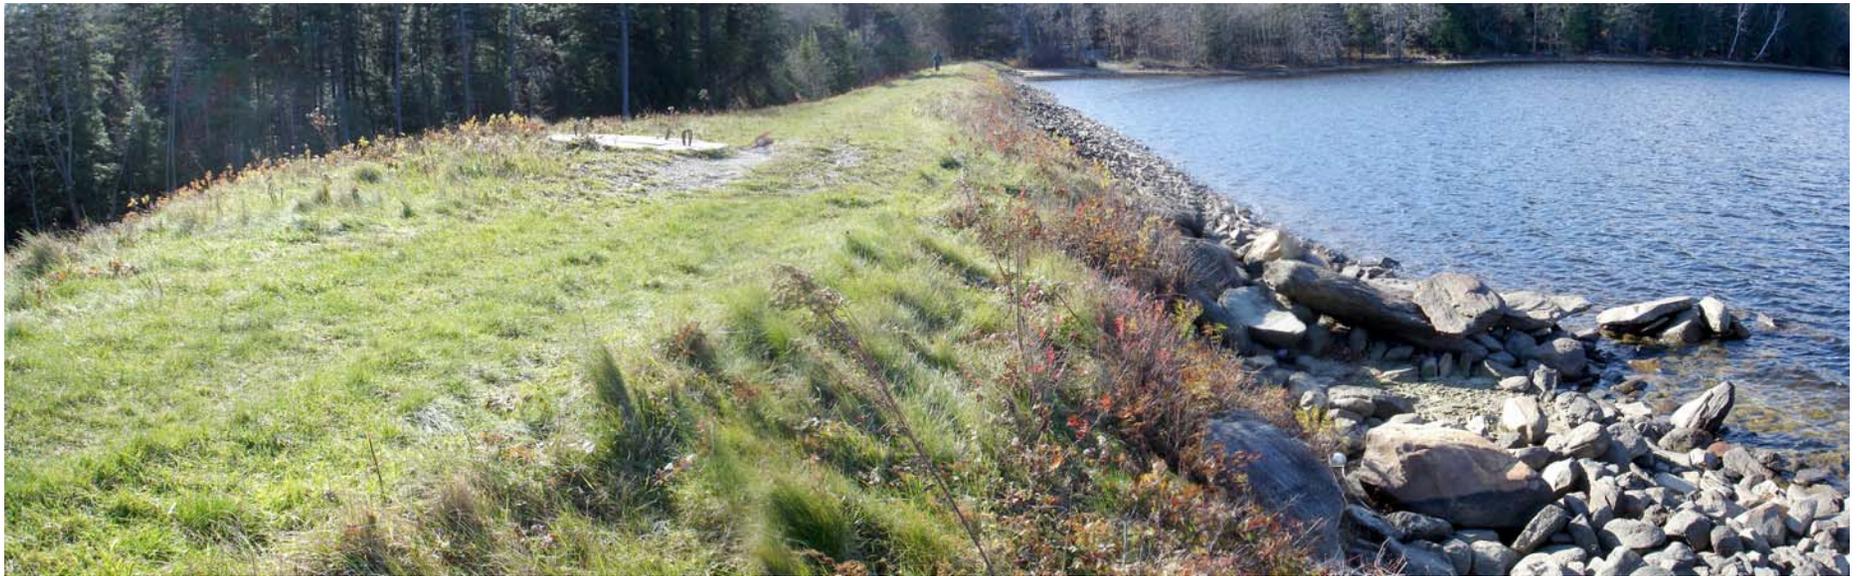
- The butterfly valve at the embankment crest was protected by a locked manhole and was not accessible. See Photograph A3.
- In general, the headwall and concrete wing walls at the downstream end of the outlet pipe appeared to be in good condition and the remaining portions of the original stone masonry outlet structure appeared stable. See Photograph A17.
- The visible portions of the outlet pipe and downstream butterfly valve appeared to be in good condition. The controls for the valve were not accessible and valve was not operated during the inspection.
- The discharge channel for the outlet pipe was lined with riprap near the end of the pipe and no visible signs of channel deterioration were observed.
- Fallen trees blocked the channel downstream of the outlet and may impede flow during periods of significant discharge.

Photo A3 – Panorama composite – Crest and upstream slope from ~Sta. 5+50 toward right abutment\*

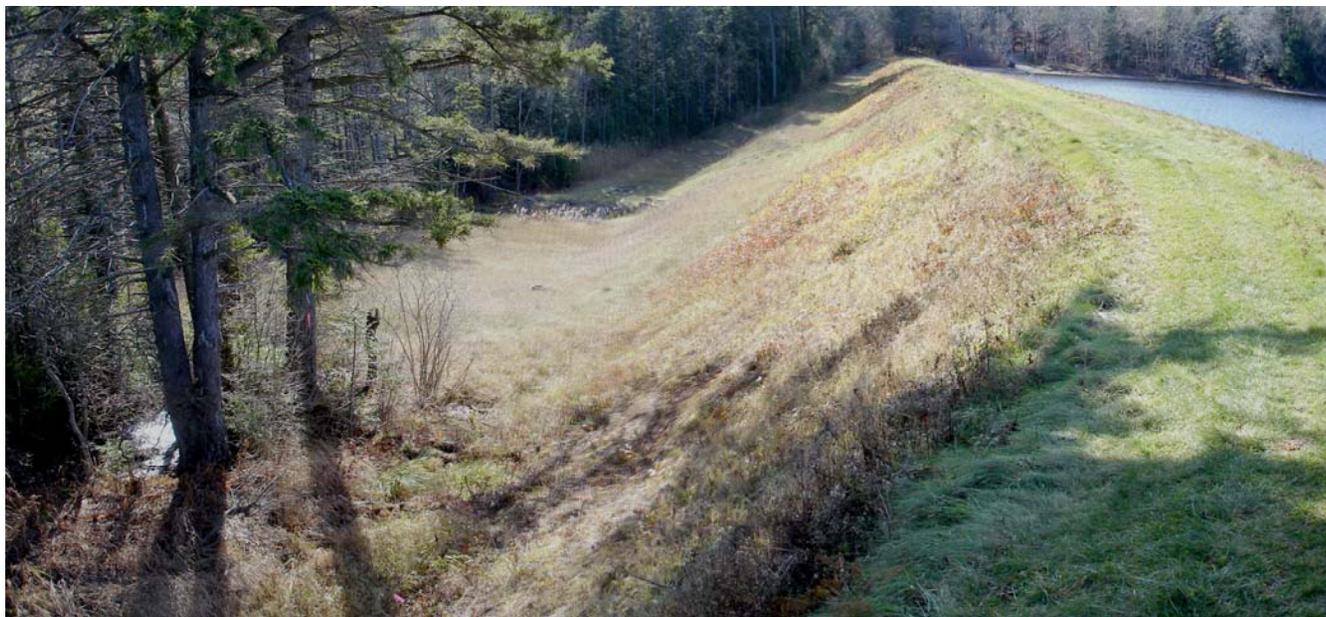
Photo A4 – Panorama composite – Crest and downstream slope from ~Sta. 7+00 toward right abutment\*

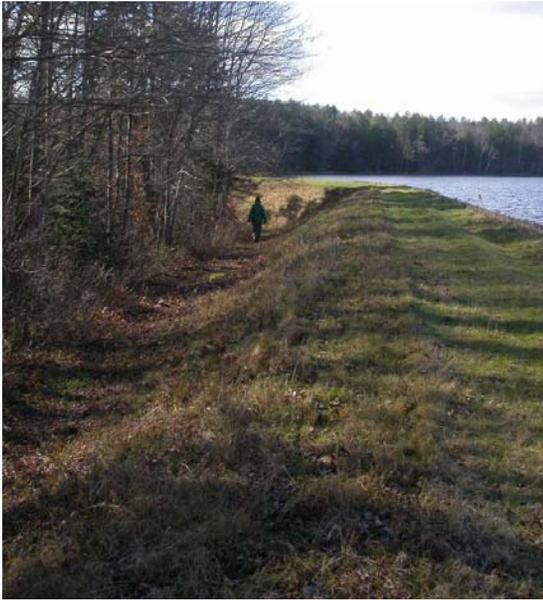
Photo A5 – Crest and upstream slope from ~Sta. 9+00 towards embankment bend

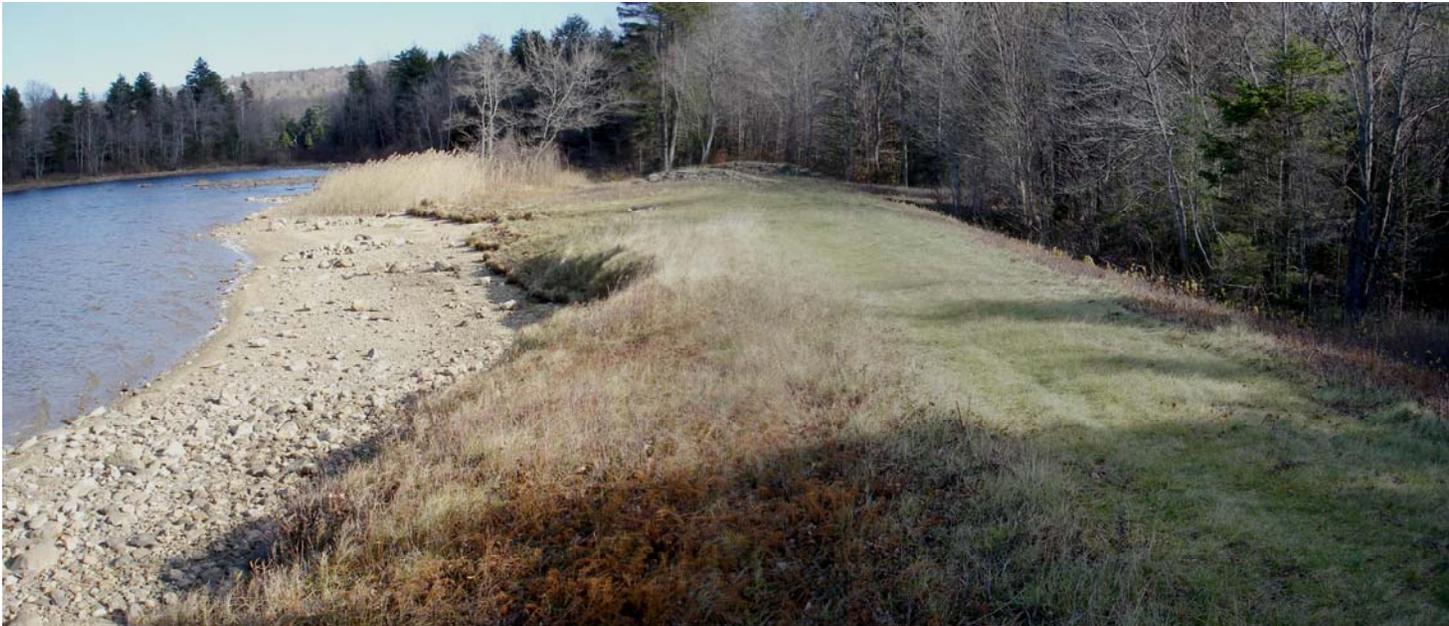
Photo A6 – Panorama composite – Crest and upstream slope from ~Sta. 9+00 toward left abutment\*

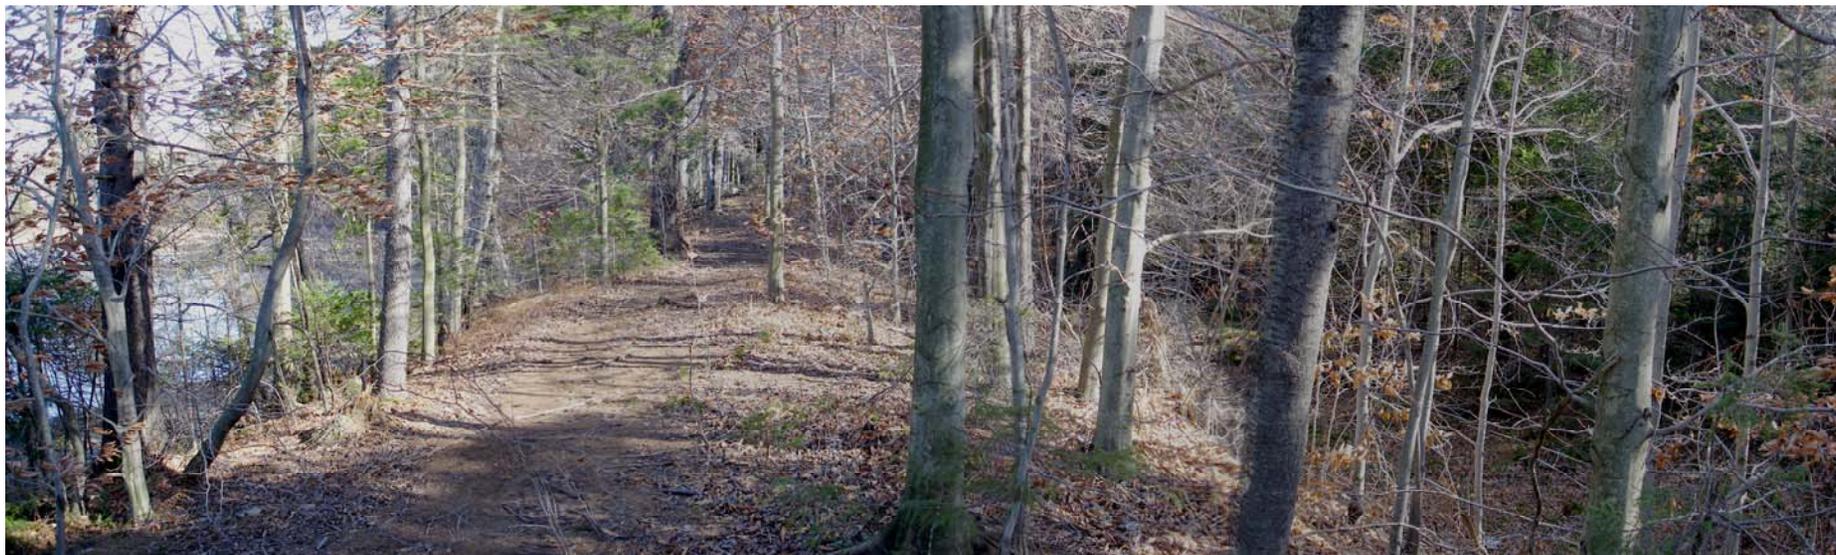
- The riprap on the upstream slope near the low-level outlet consisted of boulders 3 to 5 feet in diameter. An area approximately 8-foot wide was not covered with adequate riprap protection. See Photograph A10.
- From about Sta. 10+75 to the left side of the spillway no riprap was observed. The slope in this area is covered with grass and low cut brush and contains several erosion scarps including a 3-foot high erosion scarp. See Photographs A6 and A11.
- No riprap was observed on the upstream slope of the left embankment, from spillway to the left abutment. This embankment is heavily wooded with trees and brush. The size of the tree growth ranges from several inches to greater than 12 inches in diameter on upstream and downstream slopes. See Photographs A7 and A8.
- Crest

- The left embankment downstream slope is heavily wooded with trees and brush. The size of the tree growth ranges from several inches to greater than 12 inches in diameter on upstream and downstream slopes. See Photographs A7 and A8.
- Several soft and wet areas with standing water were observed along the toe of the right embankment, however, no seepage flow was observed at the time of our inspection with the lake at the winter pool level. Note that previous inspection reports, prepared by others, reported visible seepage flow during normal pool levels.
- The toe drain system was not inspected. The outlet for the toe drains could not be located, but we observed two cleanouts for the toe drains on opposite sides of the low-level outlet channel.

- The downstream toes of the left and right embankments are heavily wooded.
- Wet and soft areas were observed along the embankment toe at the curved section, and along the toe of the right embankment.
- The left embankment downstream slope is heavily wooded with trees and brush. The size of the tree growth ranges from several inches to greater than 12 inches in diameter on upstream and downstream slopes. See Photographs A7 and A8.

Photo A7 – Composite panorama – Left embankment from spillway toward left abutment\*

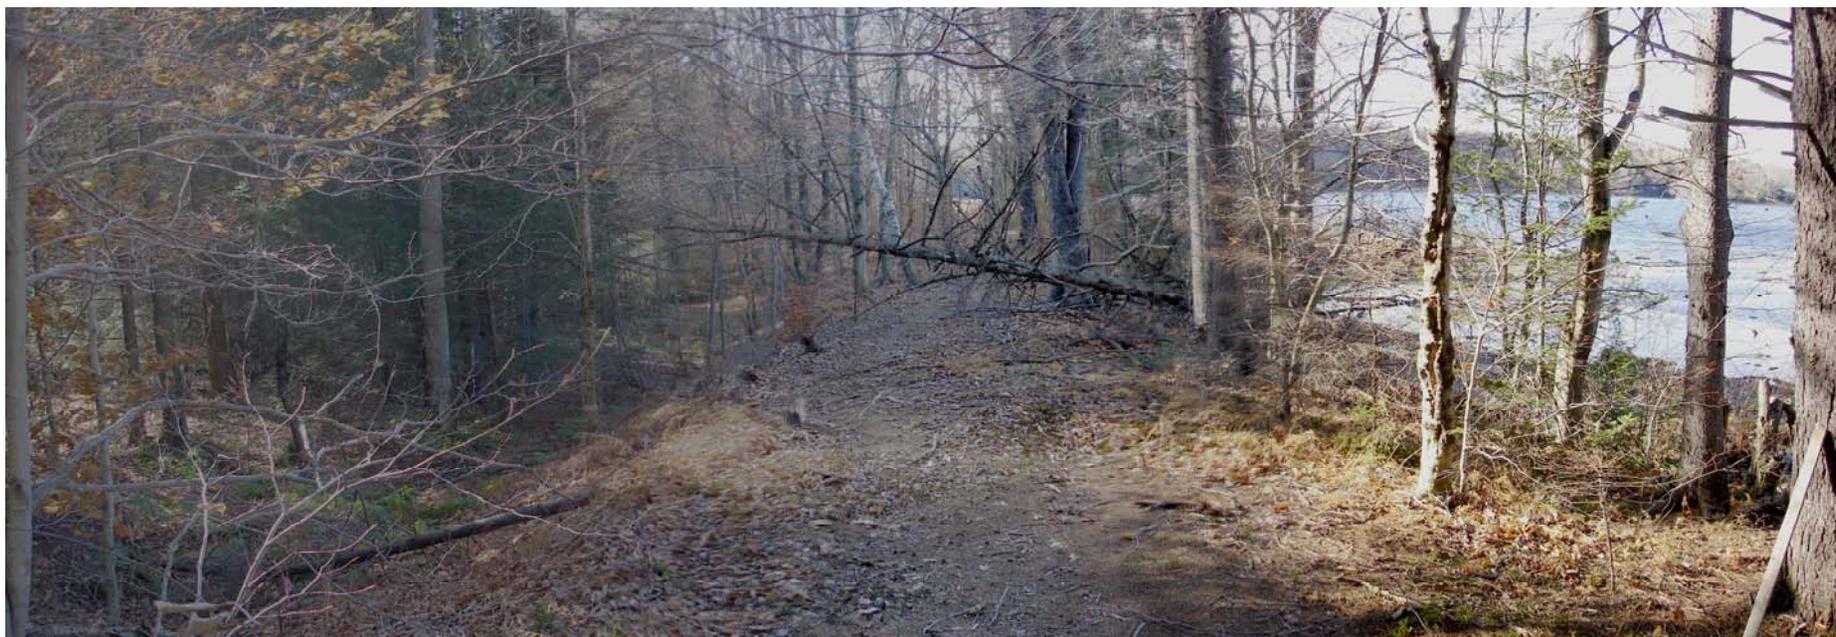
Photo A8 – Composite panorama – Left embankment from left abutment\*

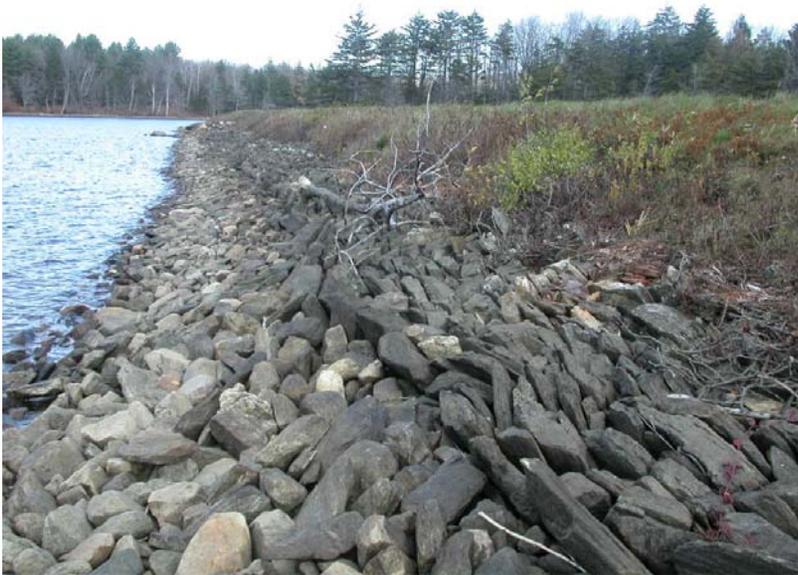
Based on the visual observations made during the inspection, the stability of the upstream and downstream slopes of the embankment are in poor condition. The right embankment upstream slope contained large scarps over most of the length. The downstream slopes are relatively steep at 2H: 1V or steeper. The left embankment contains significant tree growth. Several soft and wet areas with standing water were observed along the toe of the right embankment. A possible slope movement was observed in the bench near the low-level outlet.

Photo A9 – Typical riprap and scarp on upstream slope

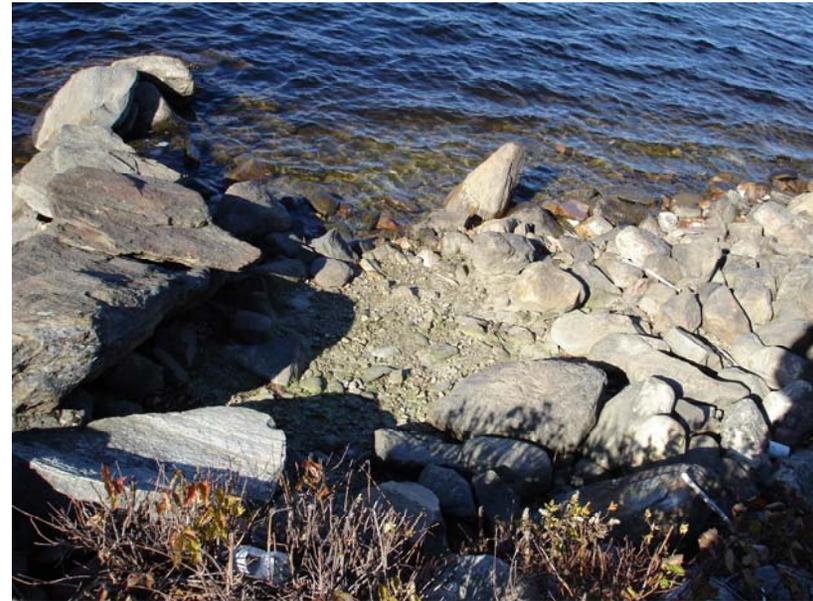
Photo A10 – Upstream slope near low-level outlet

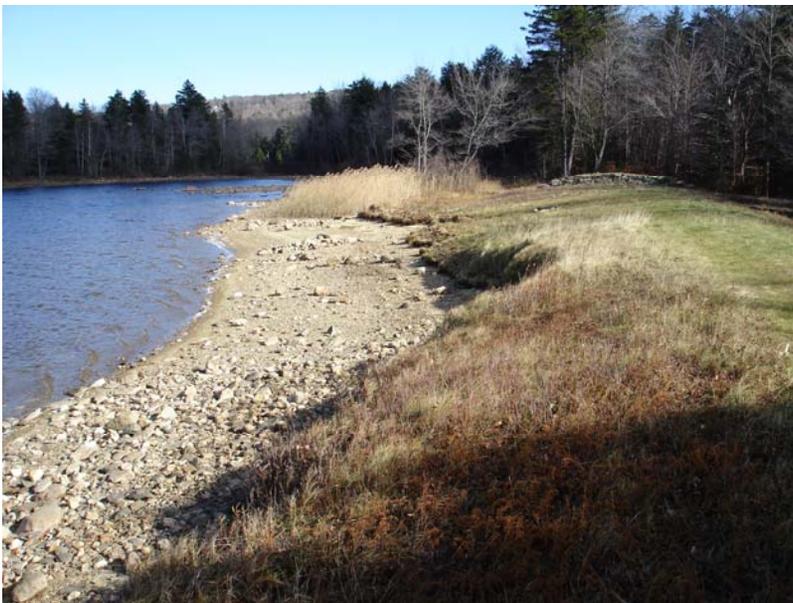
Photo A11 – Upstream slope from ~Sta. 10+75 toward spillway

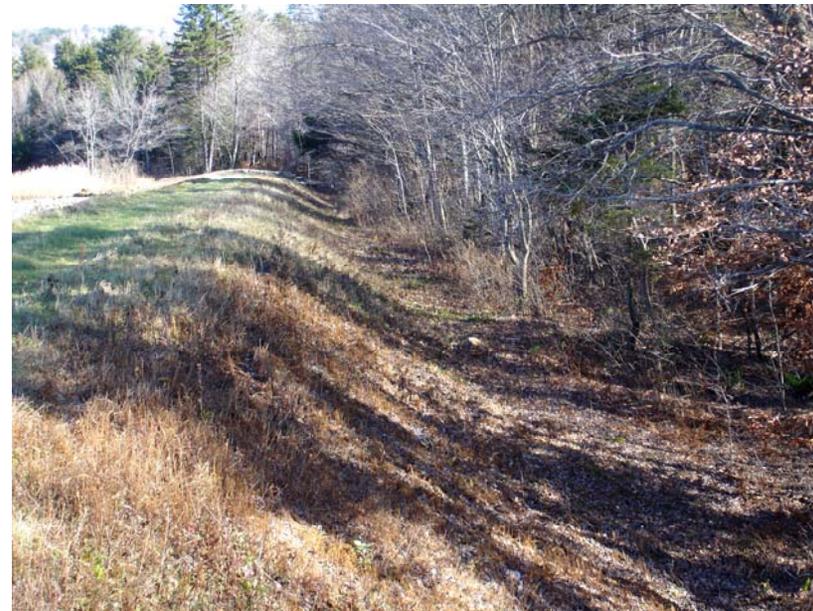
Photo A12 – Downstream slope from ~Sta. 10+75 toward spillway

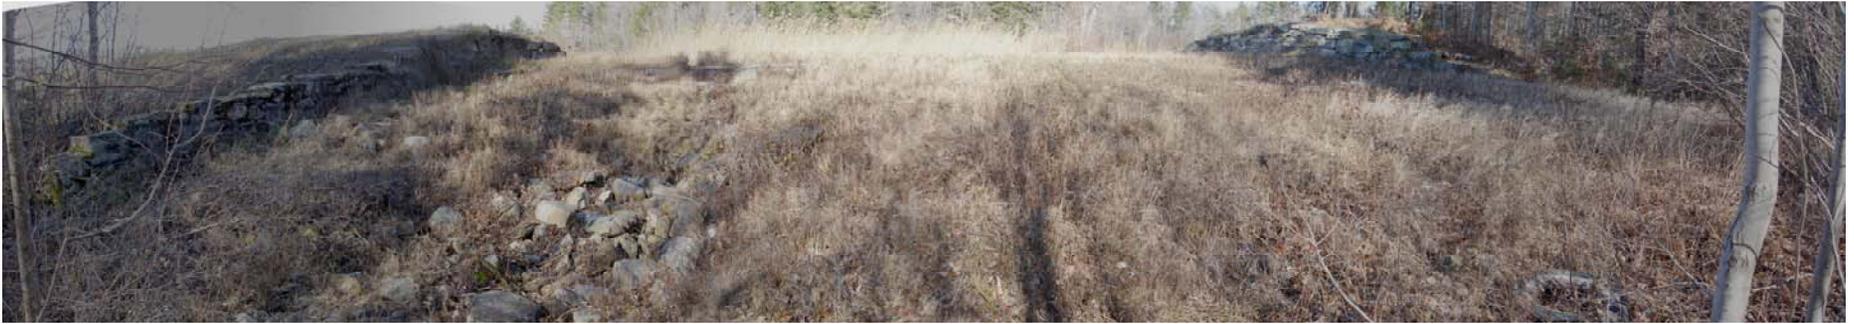
- The spillway approach was covered with reeds and the spillway channel was covered with grass and low cut brush. No riprap or erosion protection was visible in the spillway channel, excluding the stone masonry crest.
- An erosion area was observed in the downstream spillway channel. See Photograph A13.
- The transition from the spillway to the channel is abrupt, relatively narrow, and heavily wooded.
- The stone masonry training walls were generally intact, but the mortar was generally in poor condition or missing. Brush was observed at several locations growing between the masonry training wall joints.

Photo A13 – Composite panorama – Spillway from downstream channel looking upstream\*

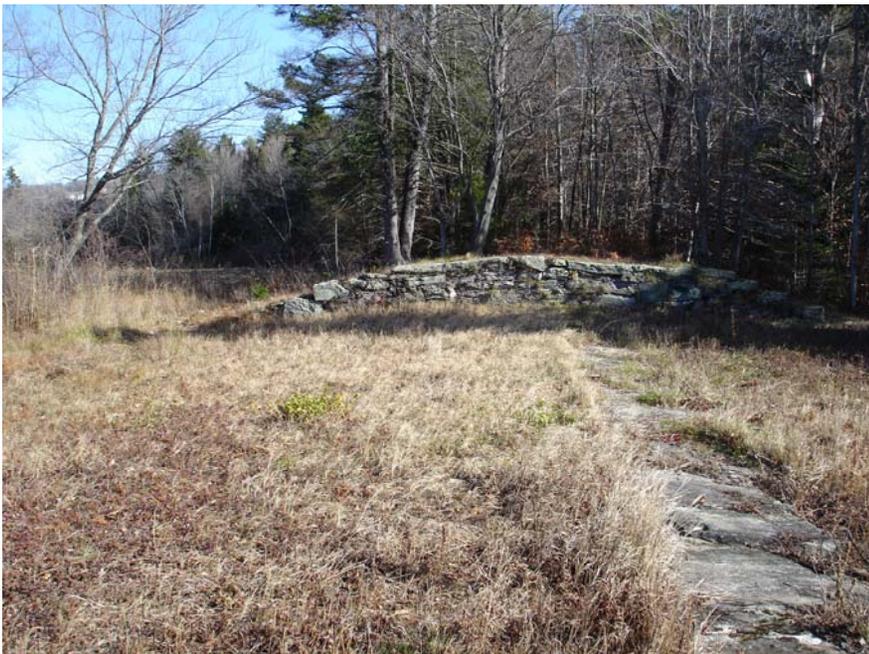
Photo A14 – Spillway from right training wall

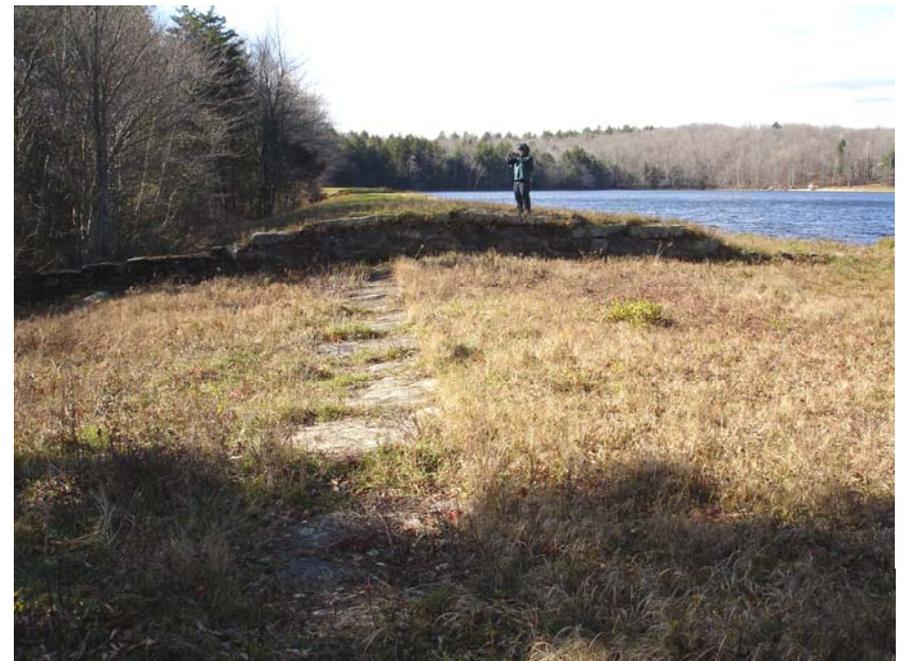
Photo A15 – Spillway from left training wall

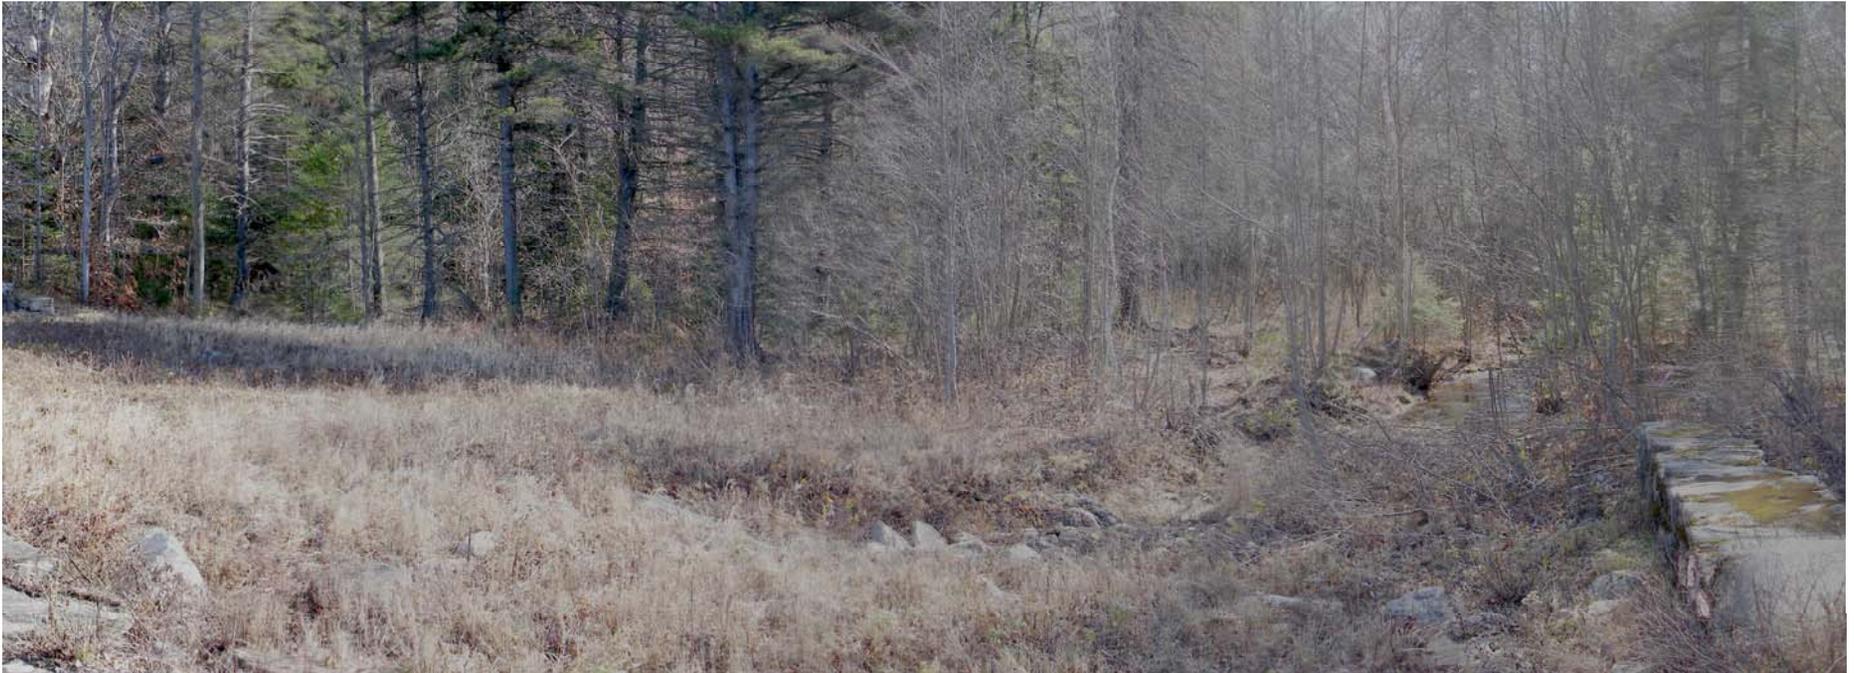
Photo A16 – Downstream end of spillway & spillway channel looking downstream from spillway

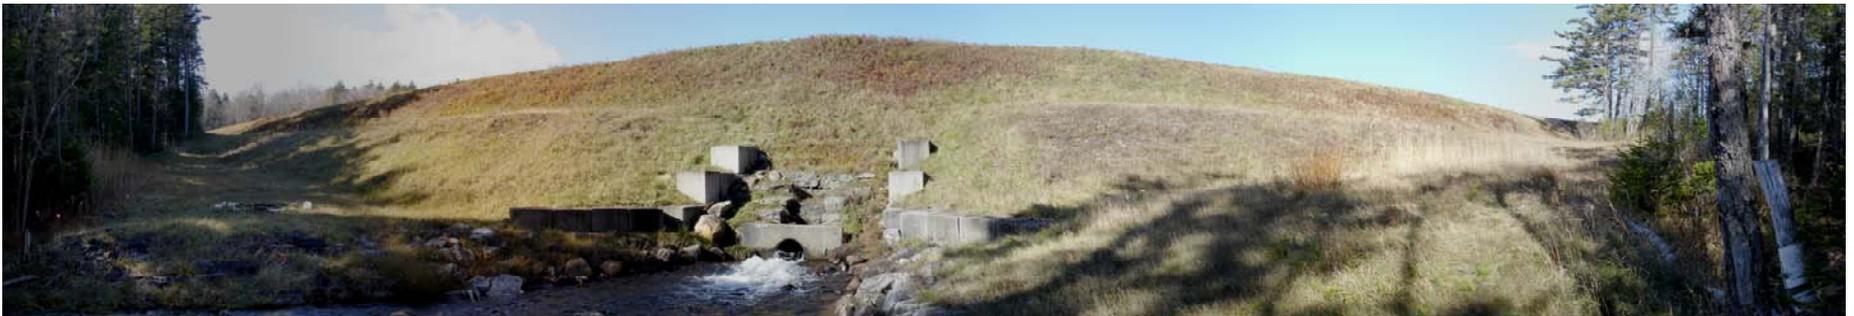
Photo A17 – Panorama composite – Downstream slope and low-level outlet discharge structure\*

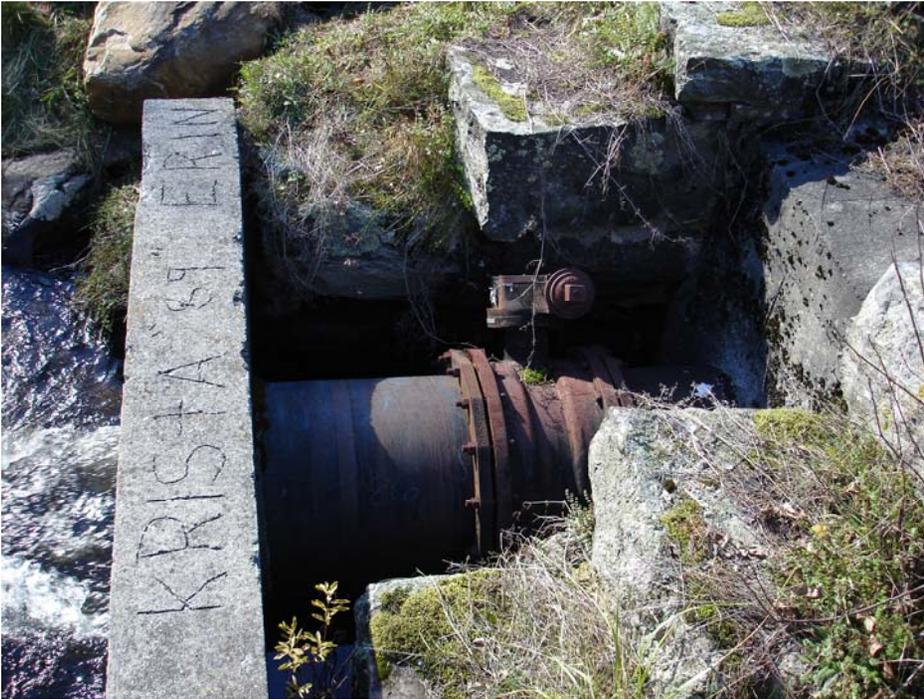
Photo A18 – Low-level outlet downstream control valve
