# Illicit Discharge Detection Report

Permit Year 10 - 2012

At the request of the Massachusetts Department of Conservation and Recreation (DCR), AECOM Environment (AECOM) developed and performed an illicit discharge detection (IDD) program to identify possible illicit discharge sources in urbanized portions of the DCR's stormwater collection system. This project supports the provisions of Minimum Control Measure No. 3 of DCR's NPDES Small MS4 General Permit. This provision mandates the development and implementation of an illicit discharge detection and elimination plan to identify potentially hazardous releases into the stormwater system and establish the means to eliminate these discharges.

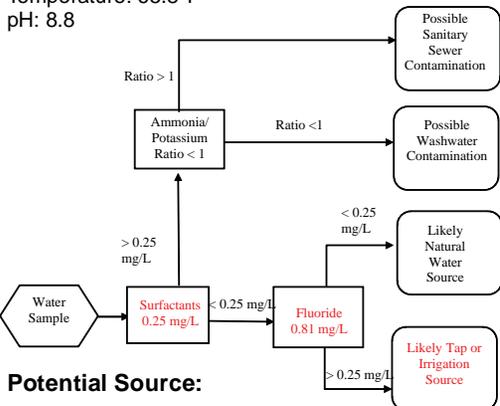
**Figure 3-3**  
 Summary for Feature 467  
 Fellsway, Everett, MA  
 Inspection Date: 09/21/12

Flow was observed in a manhole located on the Fellsway in Everett. The flow was traced upstream to a catch basin located in a residential area. A sample was collected and analytical testing results indicate that the flow is from a tap or irrigation source. Rain occurred during the 48 hours prior to the collection of the sample, therefore a revisit should be conducted to verify results.

Days since last rain event: 2 (0.61" on 09/19/12)  
 Temperature: 65.8°F  
 pH: 8.8

-Tap or Irrigation

Features 467, 12111, 12649, and 23515 were visited within 48 hours of minor rain events. Since the observed flows may have been the result of the precipitation, or the rain may have diluted the chemical signature of an illicit discharge, these features will be revisited in 2013 under dry weather conditions. This follow up visit will confirm the presence or absence of a dry weather flow and provide representative water quality data for the discharge.

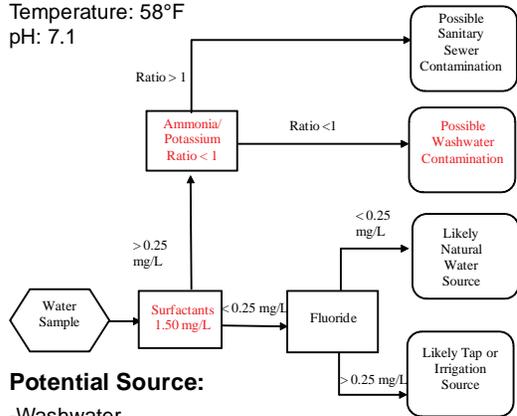
**Figure 3-4**

Summary for Feature 4498  
 Lynnway Road, Revere, MA  
 Inspection Date: 9/11/12

Colorless flow with a moderate sewage smell was observed draining from a hose into catchbasin 4498. The catchbasin was located near an active construction site at a pump house. Two hoses originating from the construction site were placed in the catchbasin. Water was observed dripping out of one hose and there was no flow in the other hose. According to contractors on site the hoses contained groundwater that was being pumped out of the construction site. While sampling the slow trickle from the hose, flow increased to a moderate trickle. Analytical test results suggest that the flow is washwater, not groundwater. There was standing water in catchbasin 4498 and flow was not observed in downstream features.

Days since last rain event: 4 (0.43" on 9/7/12)  
 Temperature: 58°F  
 pH: 7.1

-Washwater

The hose that discharged to feature 4498 was from a temporary construction site at a municipal pump station. The operator of the site reported that the flow was groundwater but test results indicated the presence of surfactants and suggested potential washwater contamination. The site should be revisited to determine if the hose has been removed or confirm that the flow is completely groundwater.

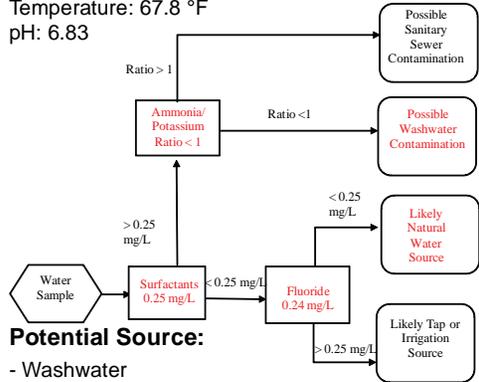
**Figure 3-5**

Summary for Feature 12111  
 Revere Beach Pkwy, Revere, MA  
 Inspection Date: 9/21/12

A steady flow with a sour odor was observed draining through manhole 12111. Manholes upstream of the manhole were off property and could not be checked. The manhole drained to an outfall near a culverted stream that connects to the Belle Isle inlet. Water surrounding the outfall outlet appeared cloudy. The connecting manholes were on the Suffolk Downs horse race track's property and likely receive surface runoff from the track and stable areas. Analytical testing produced inconclusive results. This feature was also visited within 48 hours of a rain event and should be revisited. Upon revisiting this feature, bacteria sampling should be conducted to test for run off containing fecal contamination from Suffolk Downs.

Days since last rain event: 2 (0.61" on 9/19/12)  
 Temperature: 67.8 °F  
 pH: 6.83

- Wastewater
- Natural

3-5	12111	Trickle	None	None	7.2	75.6	0.25	10.00	11.00	0.91	0.25	Washwater	High surfactants, borderline NH <sub>3</sub> /K <sup>+</sup> ratio	Visited within 48 hours of rain, revisit during dry weather
3-6	12649	1/2 Full	None	None	9.8	73.0	0.25	0.00	1.00	0.00	NT	Washwater	High surfactants, low NH <sub>3</sub> /K <sup>+</sup> ratio	Visited within 48 hours of rain, revisit during dry weather
3-7	12660	Trickle	None	None	8.7	59.0	1.00	0.00	4.00	0.00	NT	Washwater	High surfactants, low NH <sub>3</sub> /K <sup>+</sup> ratio	Revisit to collect representative flow sample.
3-8	23515	1/4 Full	None	None	8.2	60.4	0.50	15.00	16.00	0.94	0.00	Washwater	High surfactants, low NH <sub>3</sub> /K <sup>+</sup> ratio	Visited within 48 hours of rain, revisit during dry weather
3-9	36092.1	Trickle	None	None	7.6	50.2	2.20	4.00	215.00	0.02	NT	Washwater	High surfactants, low NH <sub>3</sub> /K <sup>+</sup> ratio	Revisit to determine the source of the flow, investigate areas where auto body shops are located.

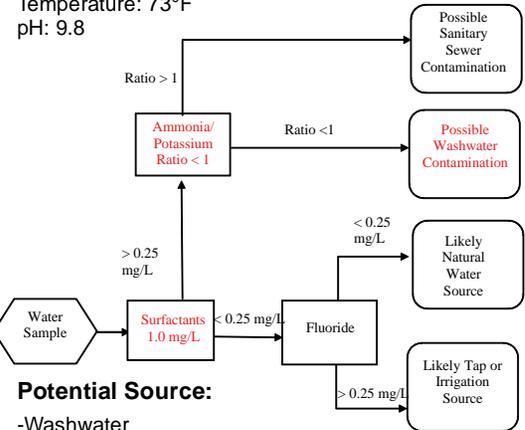
**Figure 3-7**

Summary for Feature 12660  
 Lynnway, Lynn, MA  
 Inspection Date: 10/12/12

Flow from an 18" pipe was observed in a manhole located on the Lynnway in Lynn. There was standing water in the manhole and the water line was near the flowing pipe. The sample that was collected contained standing water as well as the flow entering the manhole. A follow up visit should be conducted to determine whether the analytical results are representative of the flow or of the standing water.

Days since last rain event: 2 (0.14" on 10/10/12)  
 Temperature: 73°F  
 pH: 9.8

-Washwater

Feature 12660 also requires a follow up visit to obtain a representative sample for source determination. This flow was not inspected after a rain event but the discharging pipe was partially submerged in standing water in manhole. The confirmatory investigation should be conducted after an extended period of dry weather when the water level in the manhole is likely to be lower.

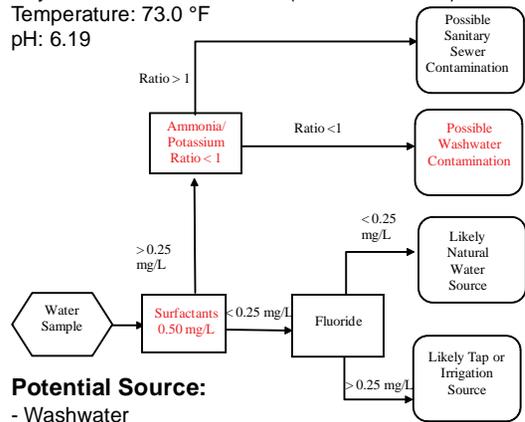
**Figure 3-8**

Summary for Feature 23515  
 Mystic View Road, Everett, MA  
 Inspection Date: 8/30/12

A trickling, oily flow with a strong petroleum odor was observed draining through a series of manholes beginning with manhole 23515. No flow was observed in the connecting catchbasins. The flow continued through the manhole system until reaching an underground detention tank or oil/grit separator. The tank outfalls into the nearby Mystic River, however, no flow was observed at the outfall. The manholes were located near a large stripmall, and Target was the closest potential source. This flow was observed within 48 hours of a rain event and will require a follow up visit.

Days since last rain event: 2 (0.15" on 8/28/12)  
 Temperature: 73.0 °F  
 pH: 6.19

**Potential Source:**  
 - Washwater

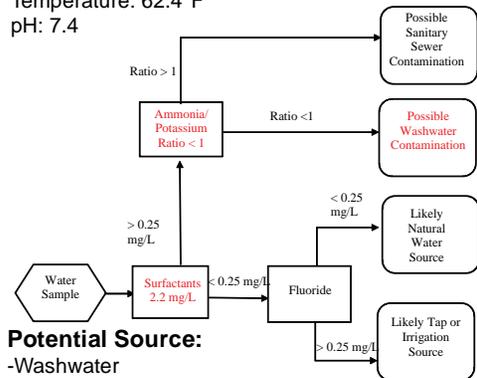
**Figure 3-7**

Summary for Feature 36092.1

Flow was observed in a series of manholes that make up a trunk line along the Lynnway in Lynn. A trickle flow was observed in two manholes upstream of manhole 36092.1 and the field team observed the flow picking up slightly to a steady trickle in manhole 36092.1. A sample was collected and a cloudy color was observed as well as a wastewater odor. The flow was also observed in a downstream manhole but the odor and cloudy color were more apparent at manhole 36092.1. The field team noted that the area is densely settled with commercial businesses including auto body shops that may be contributing washwater to the system. Field investigation produced inconclusive results and this flow will require a follow up visit.

Days since last rain event: 3 (0.16" on 10/20/12)

- Washwater
- Nearby Laundromat

Results from testing the flow at feature 36092.1 suggested potential washwater contamination. The area was densely settled and there were many commercial businesses in the vicinity of the dry weather flow including many auto body shops. A direct connection to any of the businesses in the area could not be determined in the field. Based on inconclusive source determination, and the presence of surfactants (detergents) in the sample, AECOM recommends that a follow-up visit be conducted on this system to further delineate the flow.
