# Spring Pond

Jamaicaway, Boston, MA  
 Inspection Date: 09/05/2013

## IDD Test Results Manhole 37205:

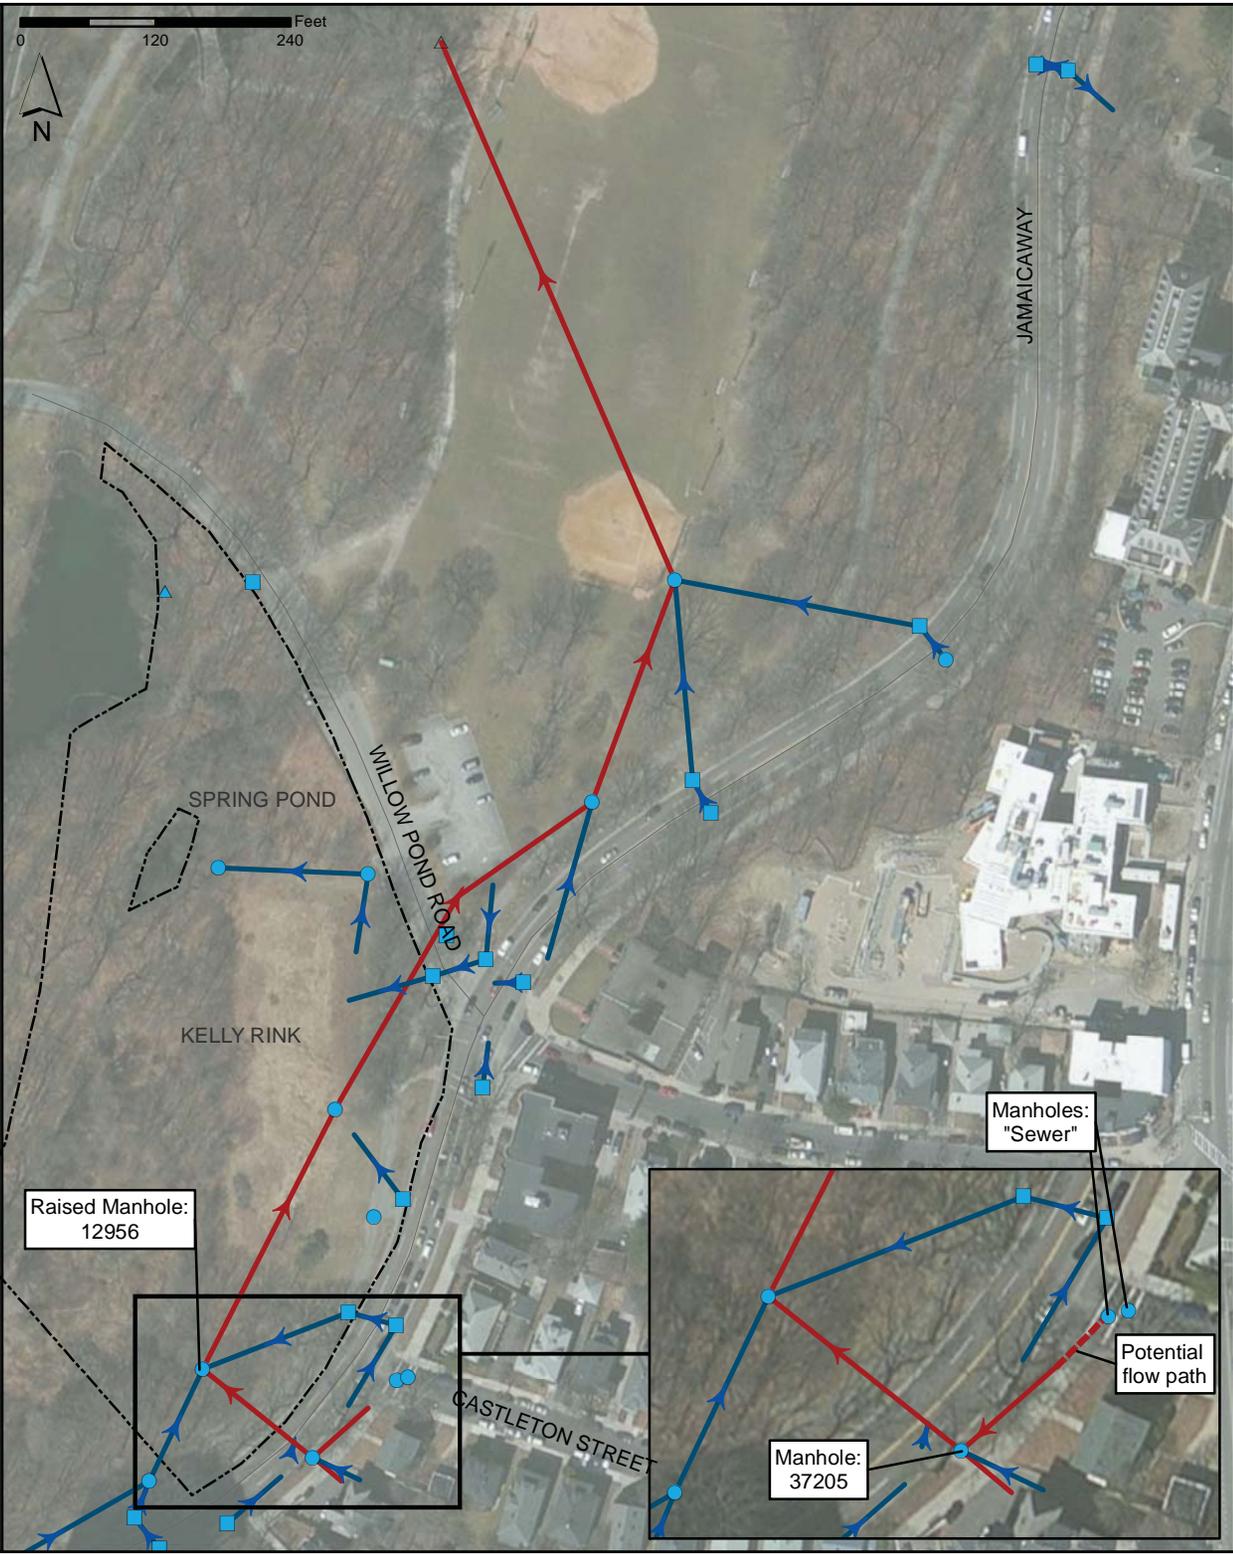
Dry weather flow was investigated in manhole 37205 on Jamaicaaway in Boston. A trickle from a 12" clay pipe that runs underneath the property at 242 Jamaicaaway was observed as well as a more significant flow from an 18" cast iron pipe appearing to originate from the direction of Castleton Street. Further investigation of two manholes on Castleton Street found that the manholes had been sealed under their metal covers with asphalt and were unable to be investigated. The sealed manholes are off of DCR property and were marked with "sewer" covers. Survey results indicated that one or both of the manholes located on Castleton Street may be contributing to the flow observed in manhole 37205 that then flows downstream to raised manhole 12956. This raised manhole has been outfitted with a hinged cover that overflows during some rain events and contributes to erosion and sedimentation issues around Spring Pond. The overflow was documented during a rain event four days before this IDDE survey through photos forwarded to DCR from Mass Fish and Wildlife. Test results performed on the flow from Castleton Street yielded results that indicate possible sanitary sewer contamination. A desktop review of video footage taken in this system displayed results consistent with the findings of this survey.

Note: Red features represent observed dry weather flow path
