**INCIDENT REPORT**

**44 Willowdale Road, Groton, Massachusetts**  
**December 11, 2007**

**Report Issued – September 1, 2009**

**INCIDENT ANALYSIS REPORT  
44 WILLOWDALE AVENUE  
GROTON, MASSACHUSETTS  
DECEMBER 11, 2007 SERVICE RUPTURE AND EXPLOSION**

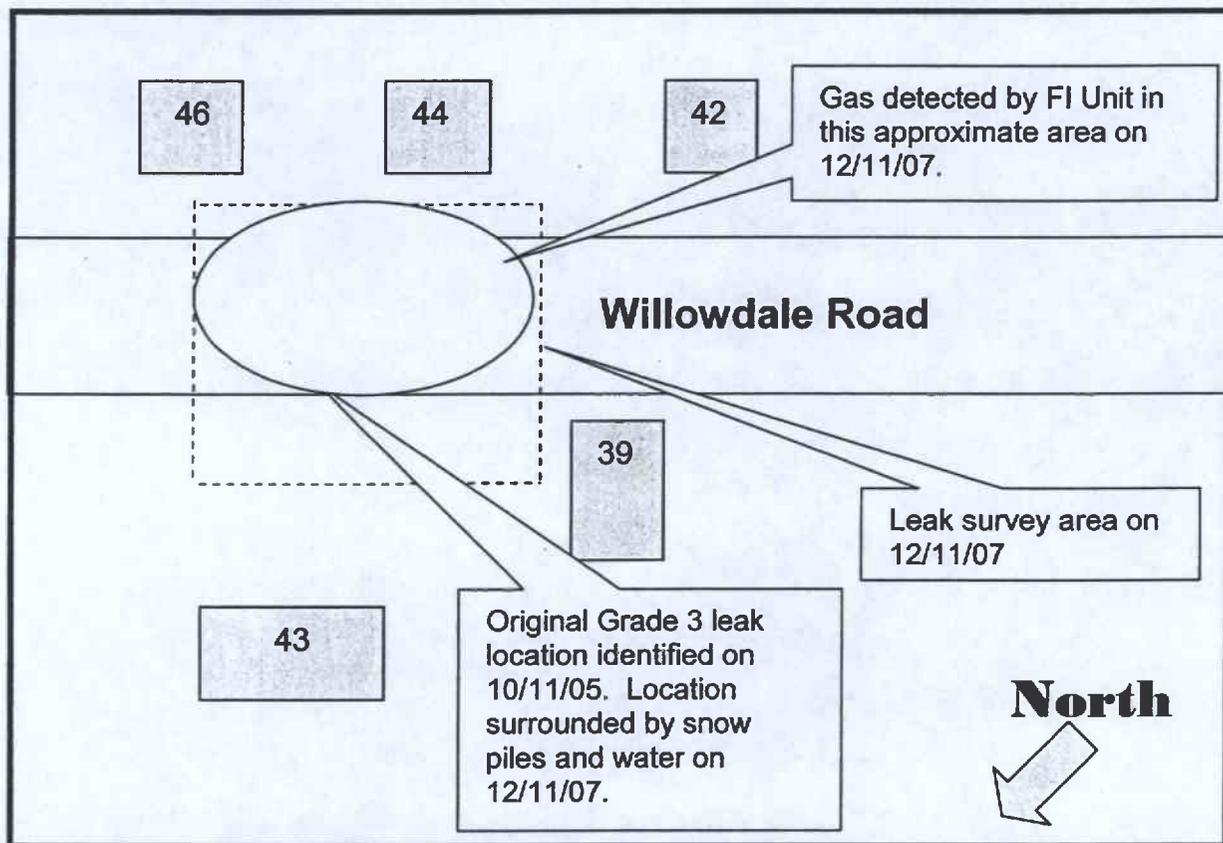
FIGURE 2: Site Schematic

Once on site, Mr. Watson noticed that the reported location of the Grade 3 leak at 43 Willowdale Road was beneath a puddle and surrounded by snow cover (Figure 2). After his Flame Ionization Unit (FI) did not detect gas in the area of the leak noted on the leak investigation report, Mr. Watson walked toward number 43 and the FI continued to register no detection of gas. Mr. Watson then began to walk in a southerly direction into Willowdale Road where his FI began to detect gas at the edge of the lawn at 44 Willowdale Road. Once he was approximately six feet away from the building at 44 Willowdale and still detecting gas with his FI unit, he decided to return to his vehicle to get his Combustible Gas Indicator (CGI) and bang (a/k/a pogo) bar.

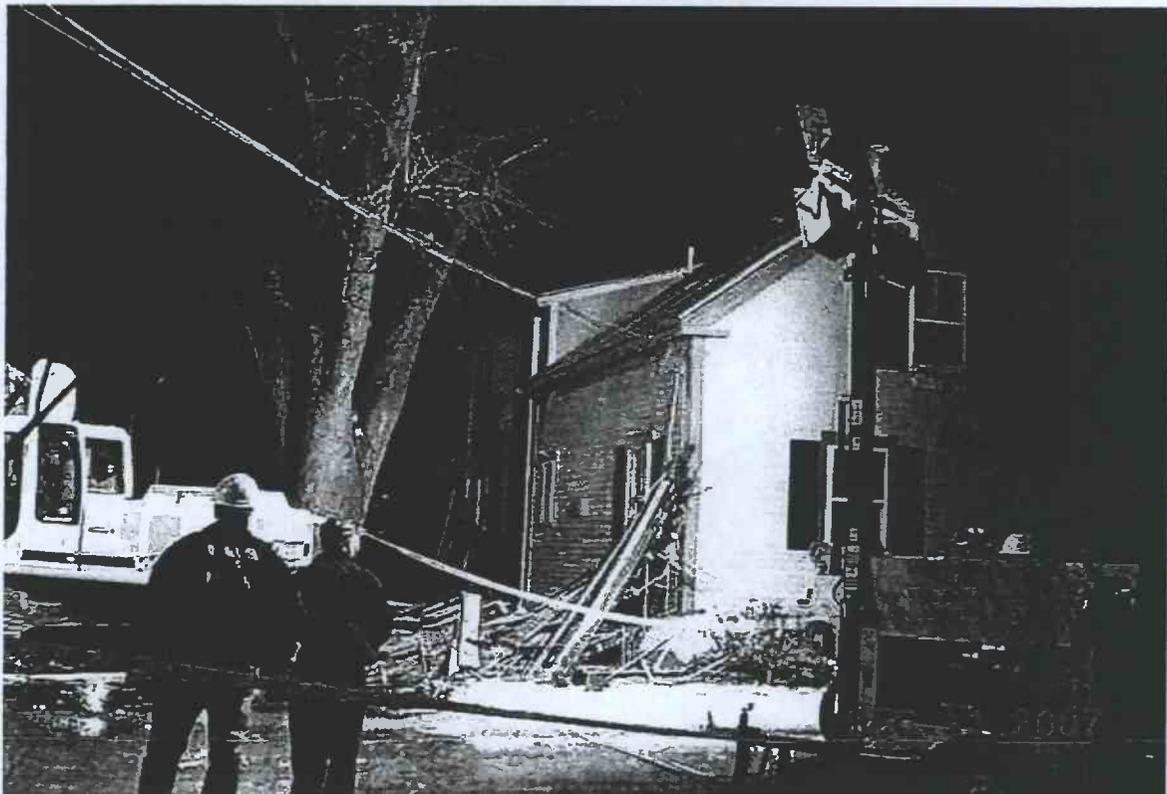
As a result of the explosion, the house at 44 Willowdale Road was destroyed (see photographs, Appendix A) The blast also damaged 42 and 46 Willowdale Road and an automobile parked near the blast. According to National Grid's claims adjusters initial findings assessed damage to the vehicle and all three buildings are estimated at \$262,000.

**Figure A-10. Damage to 46 Willowdale Road.**

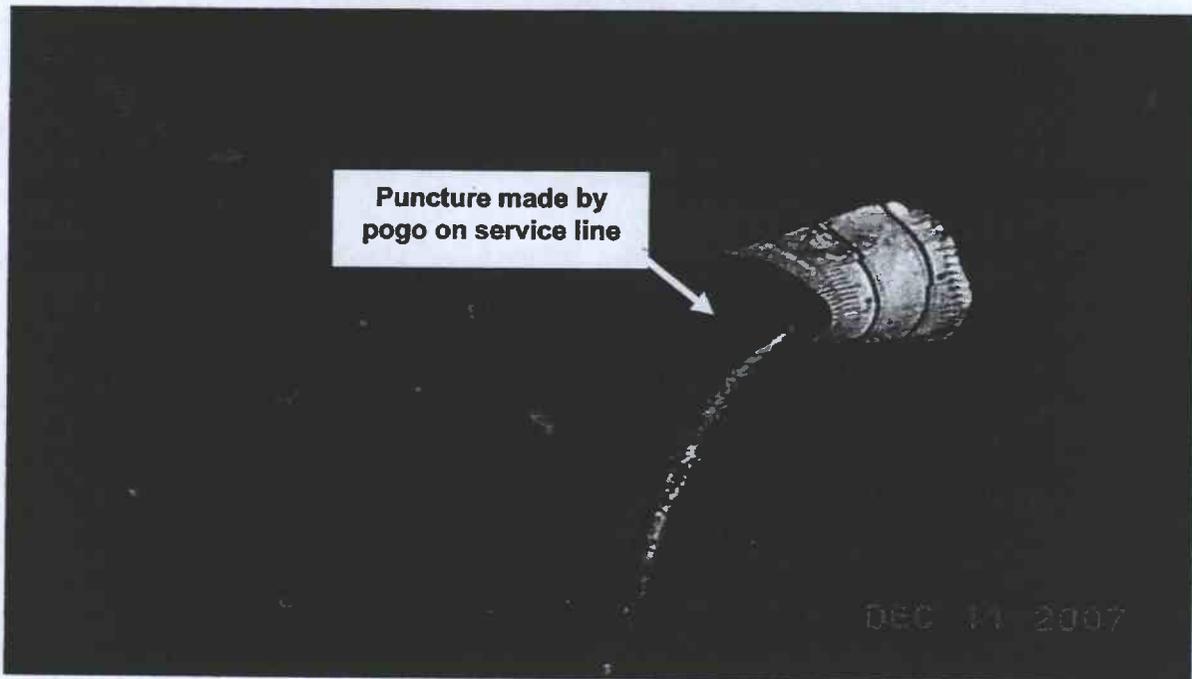
Canto began digging at the service riser working his way back toward the main. While digging, Canto was able to pin point the exact location where Mr. Watson had punctured the service. The crew continued to hand dig until they found the gate valve. After finding the gate valve, the crew was instructed by the Department of Public Utilities (DPU) to shut off the valve. Brett Doehler was then instructed to cut out the plastic service pipe 6" from the valve, along with the connected pipe to the riser and meter. All pipe, fittings, and meter where given to DPU Inspector J. Santi, but were later returned to National Grid for storage.

**Figure A-12. Damage to service line.**

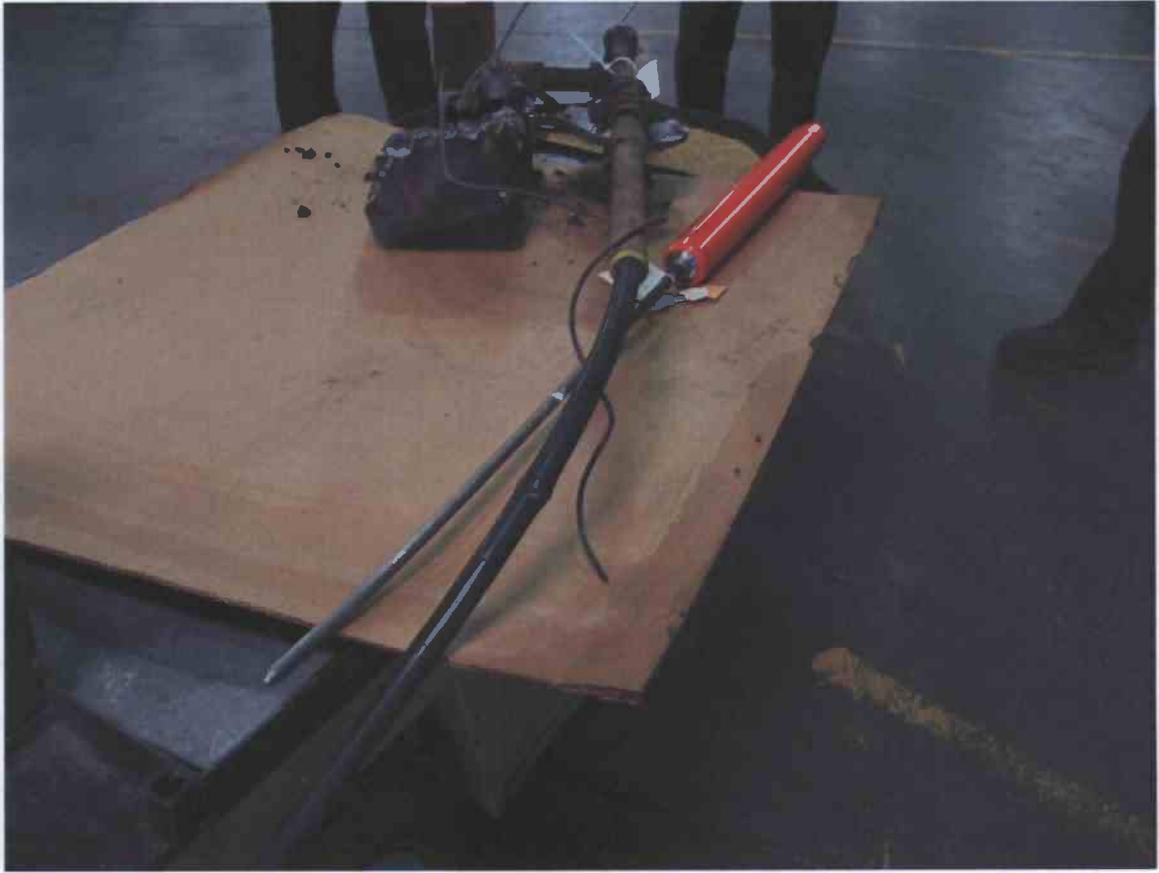
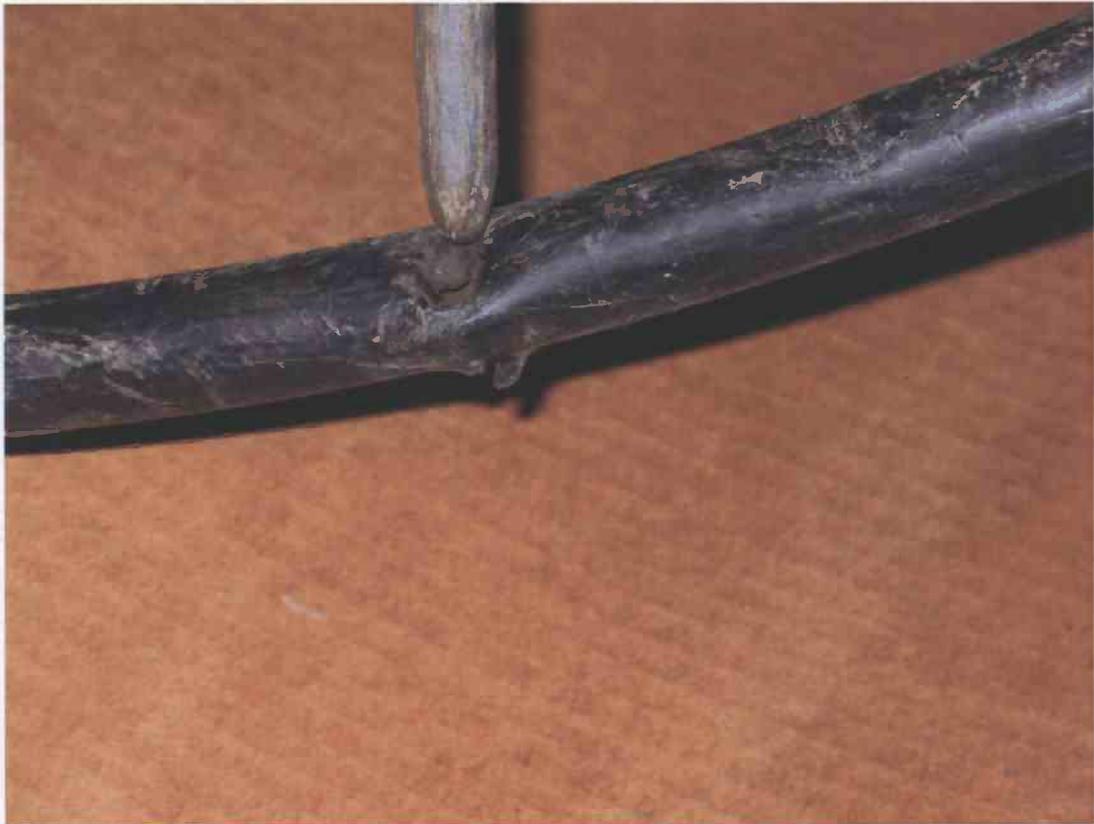
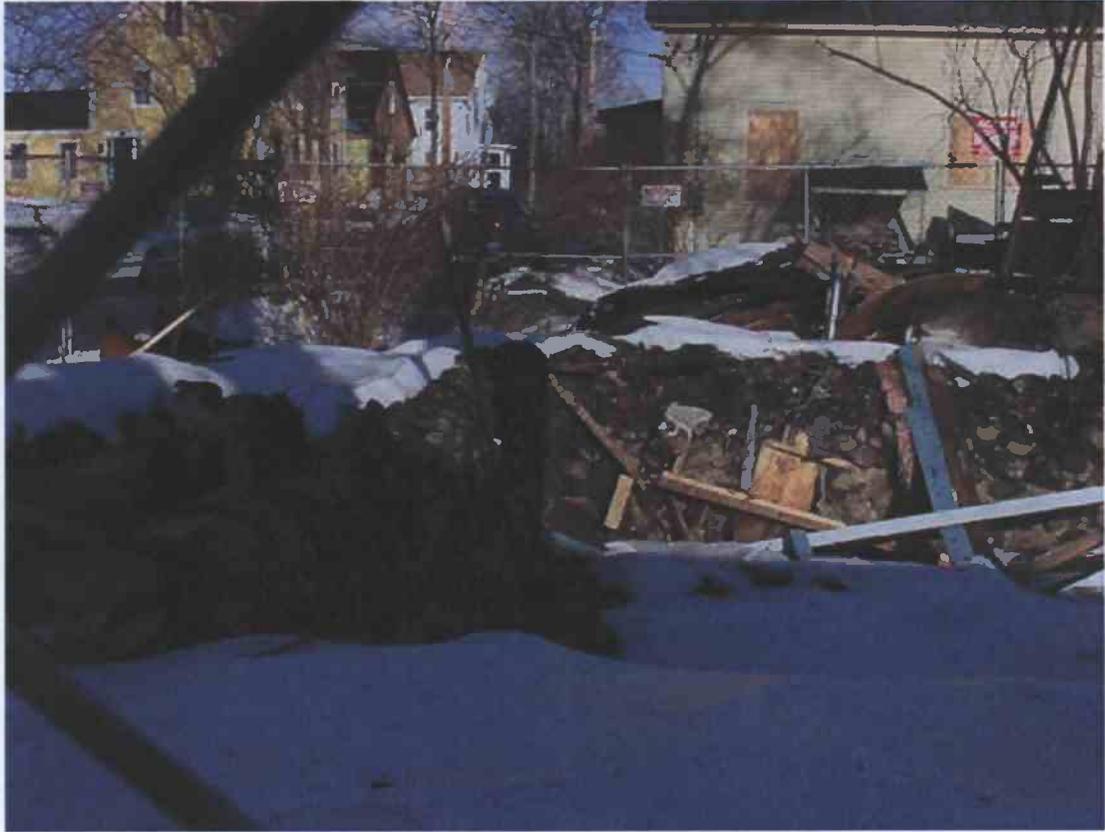
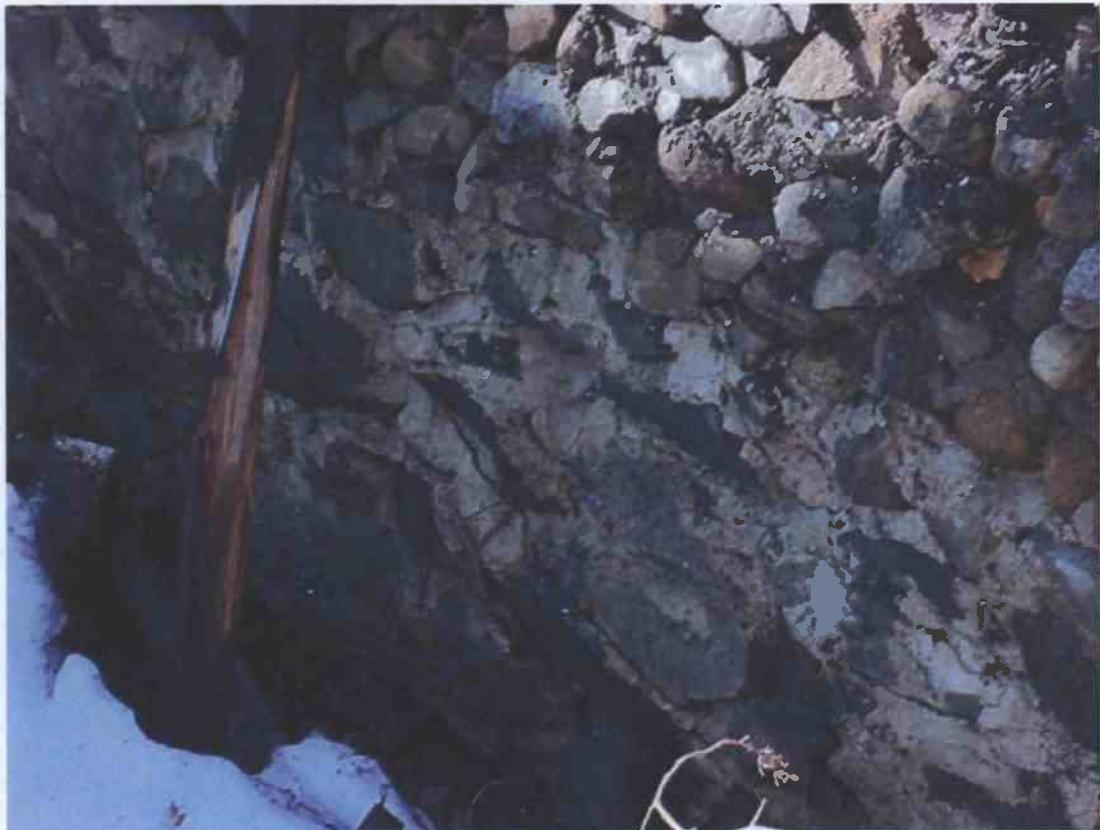
**Photographs of the Operator's Damaged Facilities and the Incident Scene**

The house had been completely destroyed by the explosion and ensuing fire. It collapsed into the foundation. Debris had been blown onto the Road, into adjoining properties and across the Road into a wooded area (Exh. 7). The service riser assembly, gas meter and service regulator were intact, and located in close proximity to the original installation location. The service had been bent over by the debris as it was displaced from the house during the explosion. The meter had been burned as a result of the fire (id.).
