INCIDENT REPORT

Primary Valve Incident
Hildreth Street, Dracut, Massachusetts
April 16, 2009

Gas Company: National Grid

**Root Cause Failure Analysis of 4" Nordstrom Plug Valve –
Pleasant Street and Hildreth Street Dracut, MA**

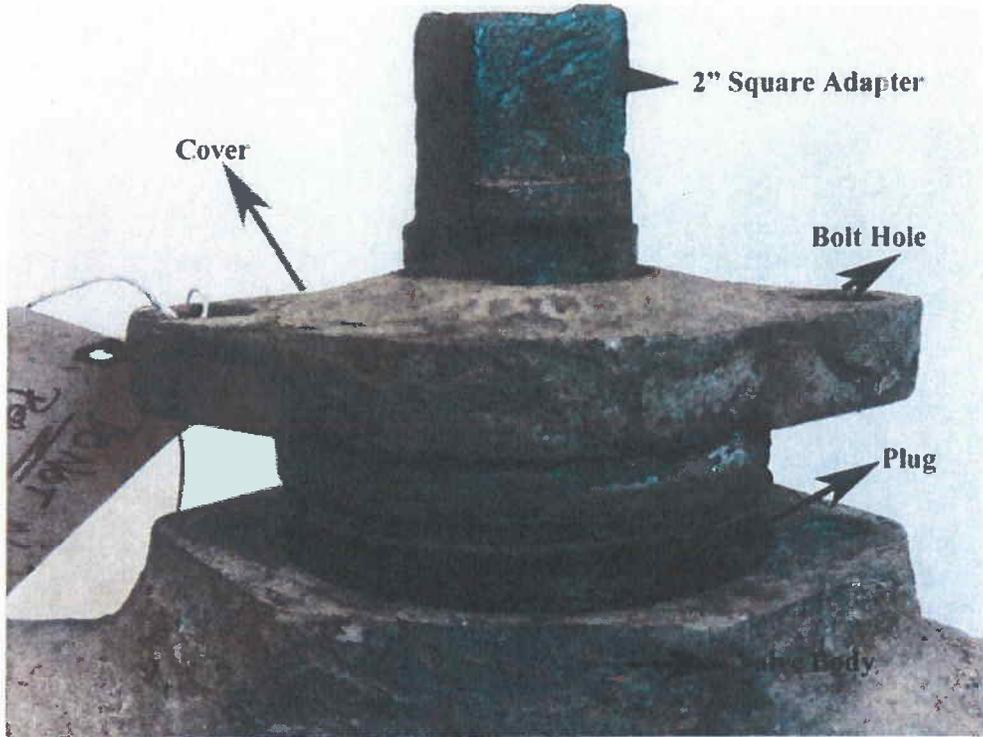
Protocol 1 – Photographs & Visual Inspection: 4" Nordstorm, quarter turn, plug valve, two bolts adjustable cover type, steel body, iron plug, Figure number A 1943 1/2, manufactured in 1953, 200 # Pressure Rating.

4 Inch Nordstrom Plug Valve as Received

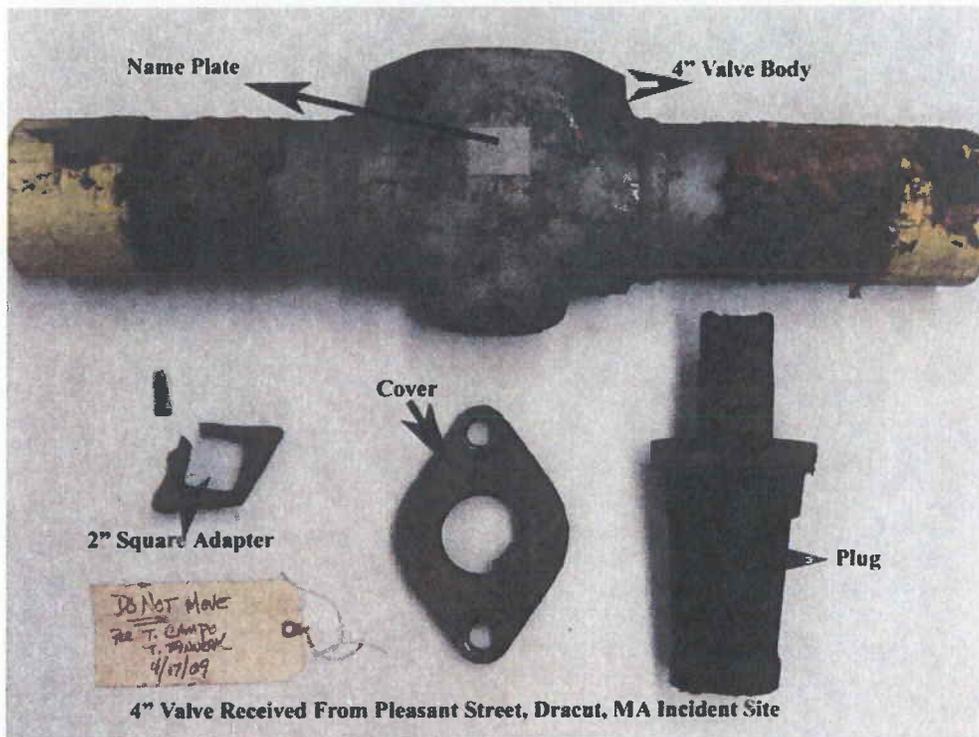
4" Valve Received From Pleasant Street, Dracut, MA Incident Site

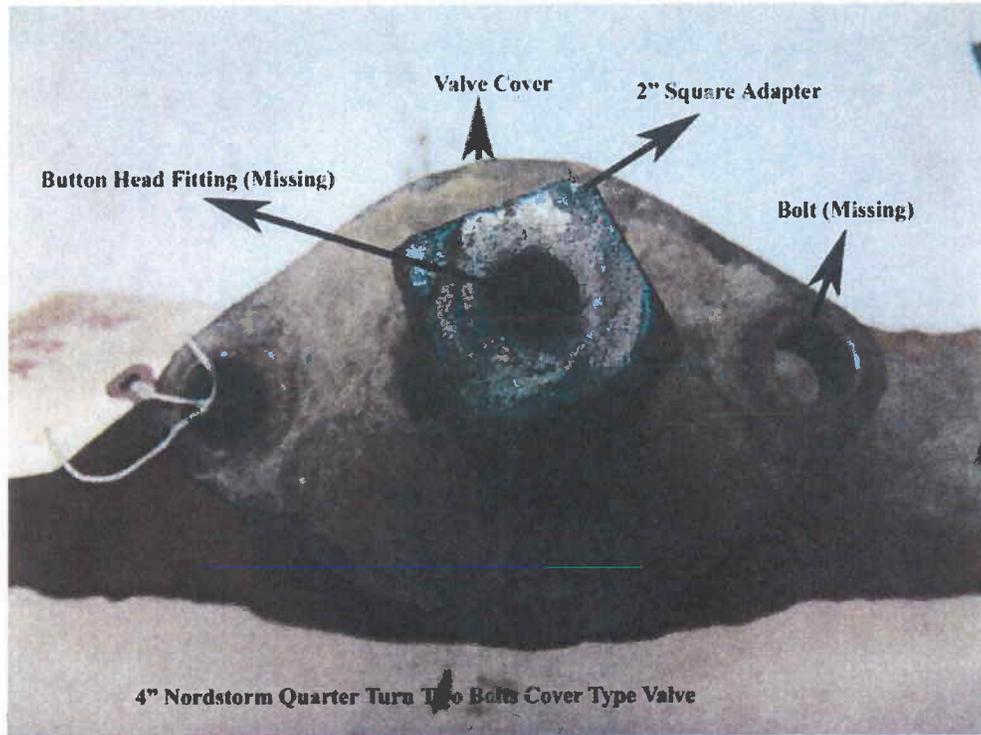
Protocol 2- Inspection of internal parts – There was a mild corrosion noticed between cover and valve body. The hardened sealant and debris were presence between the plug bottom and the valve body. There was no wear on the plug and the groves for the sealant cavities. The valve was disassembled to examine the plug and body for the presence of lubrication sealant or purge compound. There was no evidence of any purge compound or new sealant on any part of plug or body. The bolts & button head fitting were missing.

4" Nordstorm Quarter Turn Two Bolts Cover Type Valve

Missing Bolts & Button Head Fitting

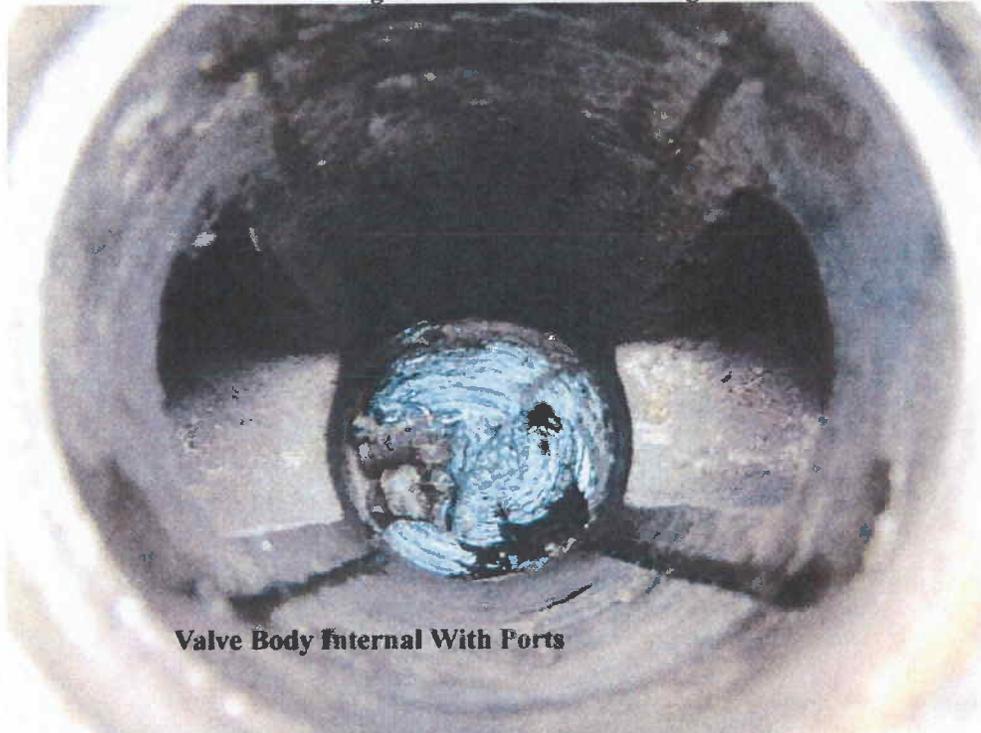
Valve Body Internal With Ports

Hardened Sealant (555) & Debris at Bottom

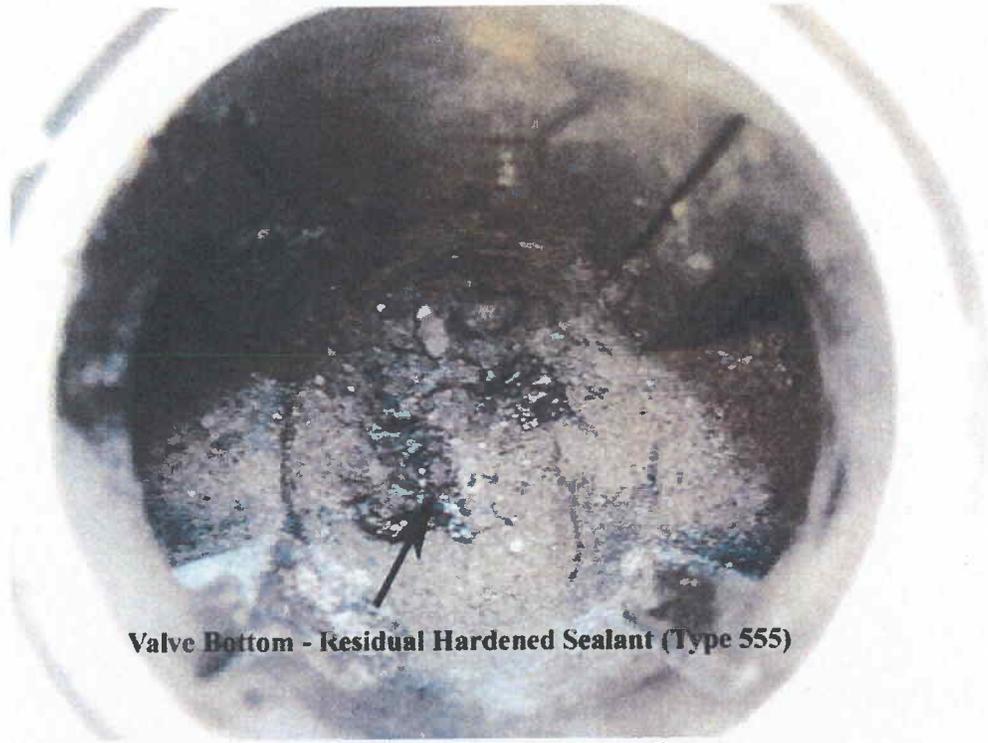
The most likely reason for the failure of the valve to actuate in the field is the sticky grease plus purging compound residue in the grease channels of the body and plug, in addition to hardened dried grease in the well region at the bottom of the valve. Some minor scoring on the plug, if present prior to the incident, would have contributed slightly to elevated starting torque on this valve, but would not have been sufficient to prevent actuation by itself.

Valve Bottom - Residual Hardened Sealant (Type 555)

Hardened 555 Sealant & Debris in Bottom

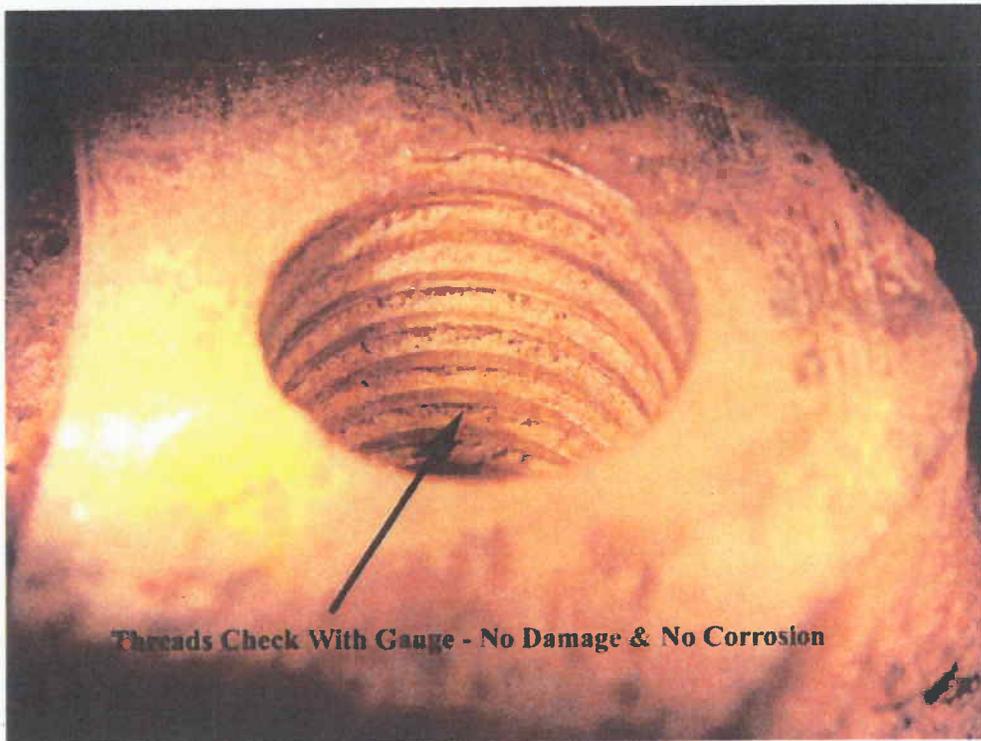
Protocol 3: Inspection of the valve body threads – The threads on the valve cover and body were examined and checked with the gauge for thread damage and corrosion. There was no evidence of the thread damage or corrosion.

Threads Check With Gauge - No Damage & No Corrosion

LH & RH Valve Body Threads

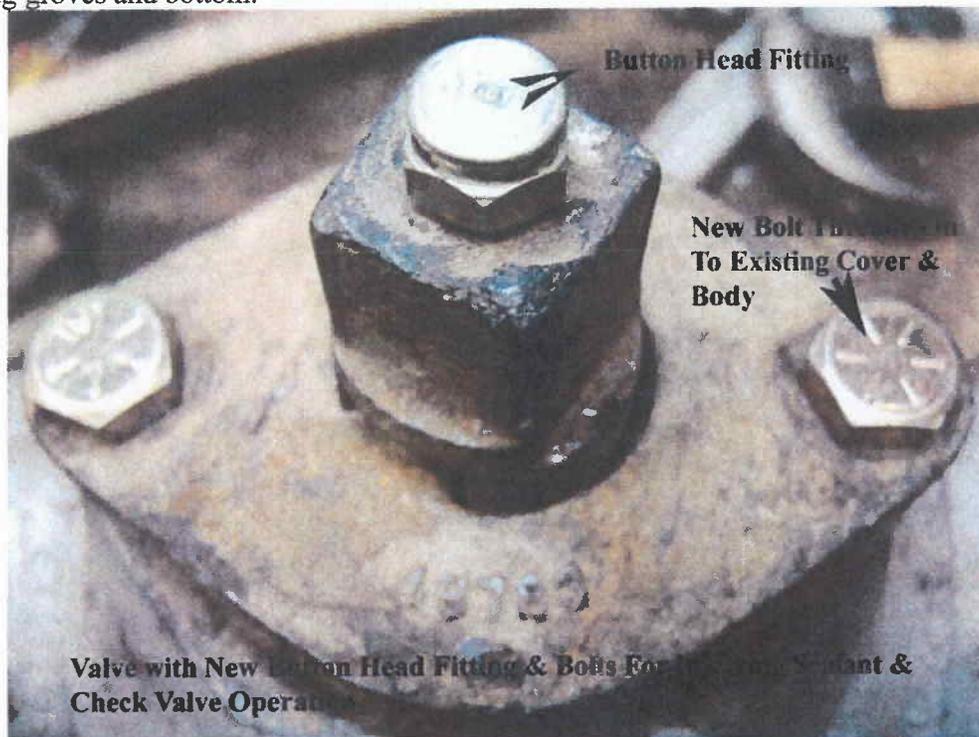
Protocol 4: Lubrication Simulation - The valve was reassembled using new bolts. A new button head fitting was installed and lubricated using Nordstrom 1033 sealant material. After the injection of sealant, valve was operated with the wrench without any difficulty. The valve was disassembled to check the presence of sealant on plug grooves and bottom.

Valve Lubrication with new Button Head
