DEPARTMENT OF PUBLIC UTILITIES

PIPELINE ENGINEERING AND SAFETY DIVISION

INCIDENT REPORT

Webster Street, Needham, Massachusetts

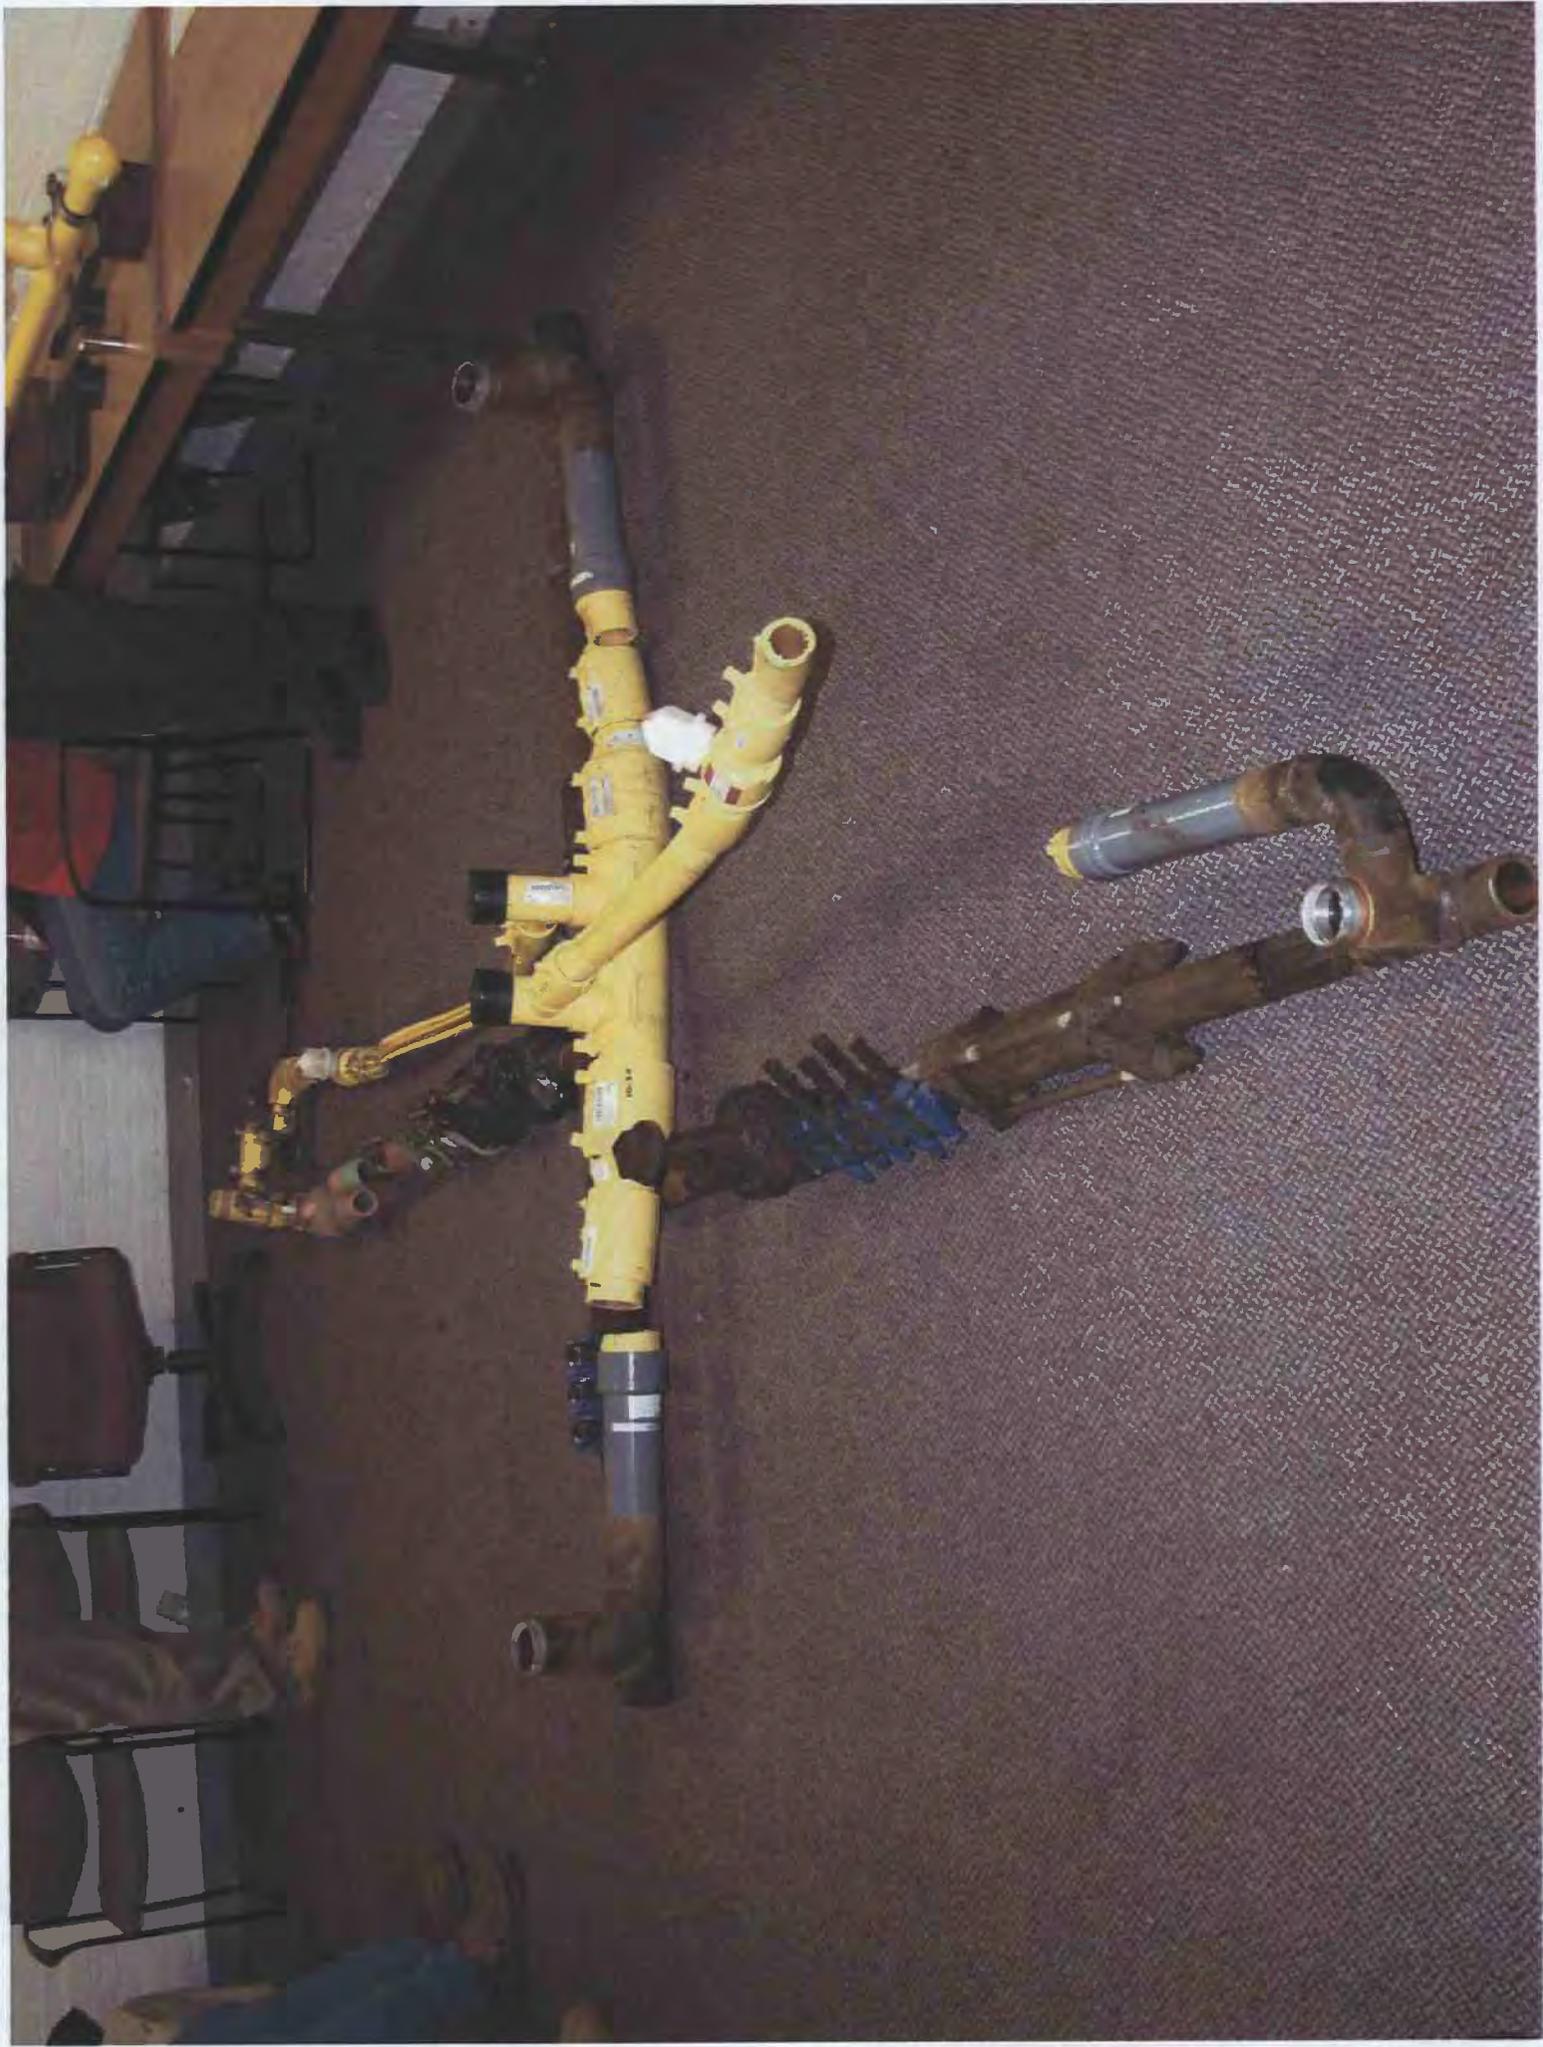
EXHIBIT 7

Photograph of the Existing Mains and the Tie-in Section

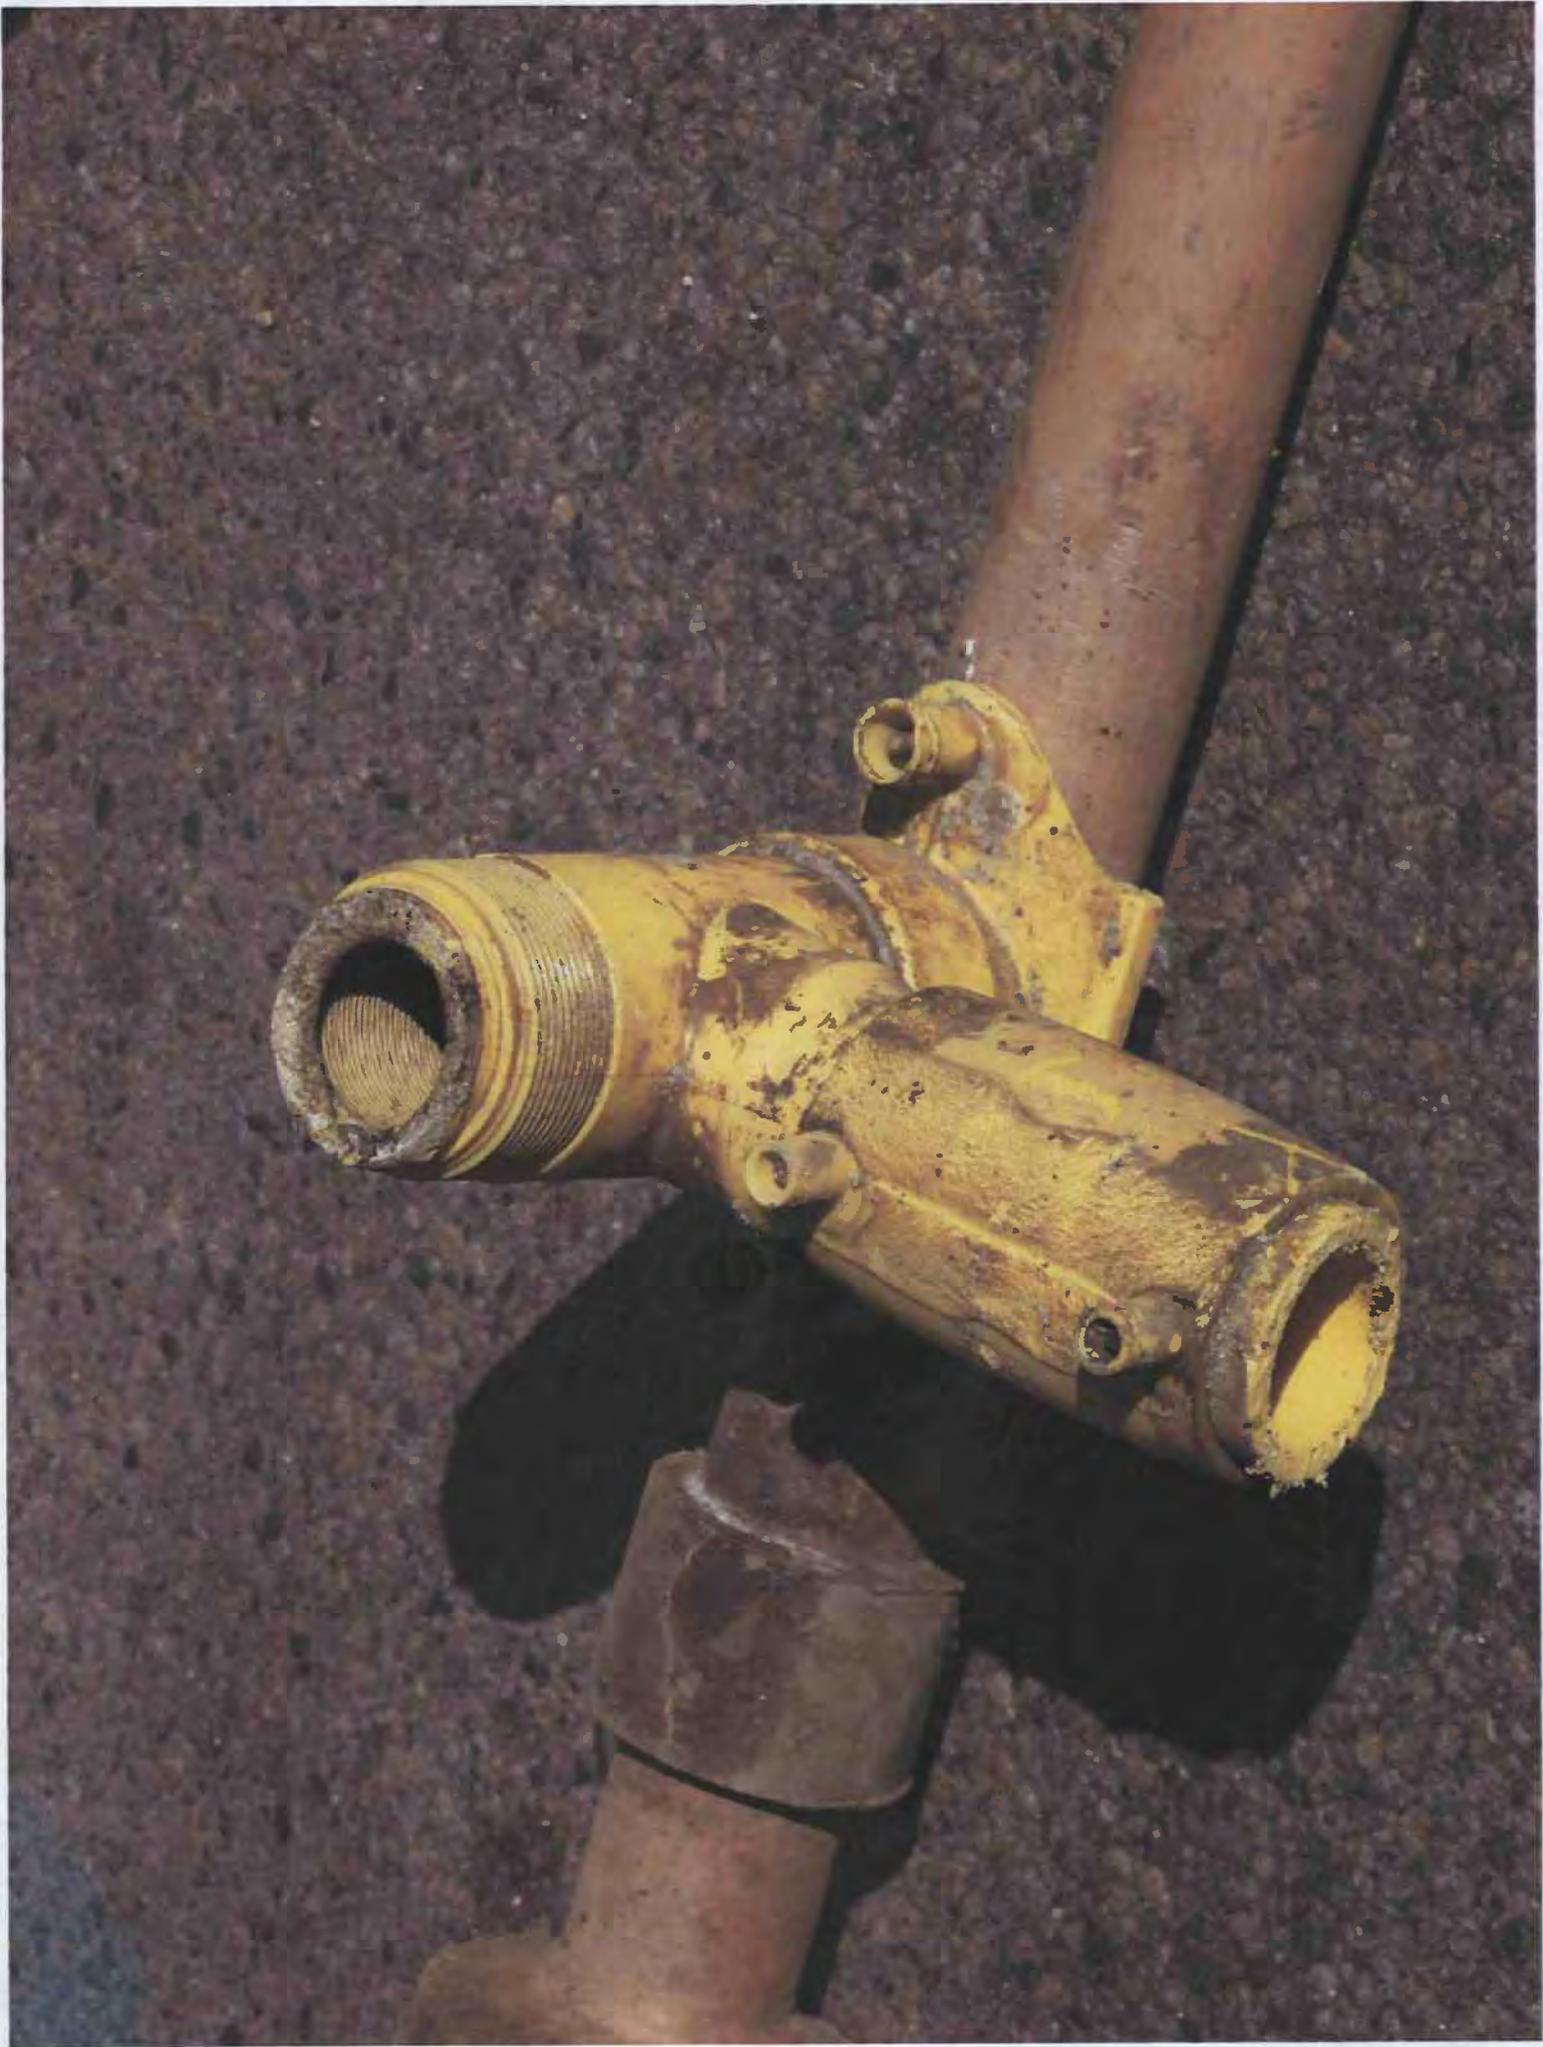
EXHIBIT 8a

Gas Company: NSTAR Gas Company

6. As the employee withdrew the cutter into the body of the HVTT, he heard gas escaping from the tee.
7. The employee stated he observed that the cap was loose and spinning with the tool as he rotated the handle.

10. The cap, handle and cutter were all forced out of the HVTT by the gas pressure.
11. The source of the gas leak was through the open end of the HVTT.

Photograph of the HVTT

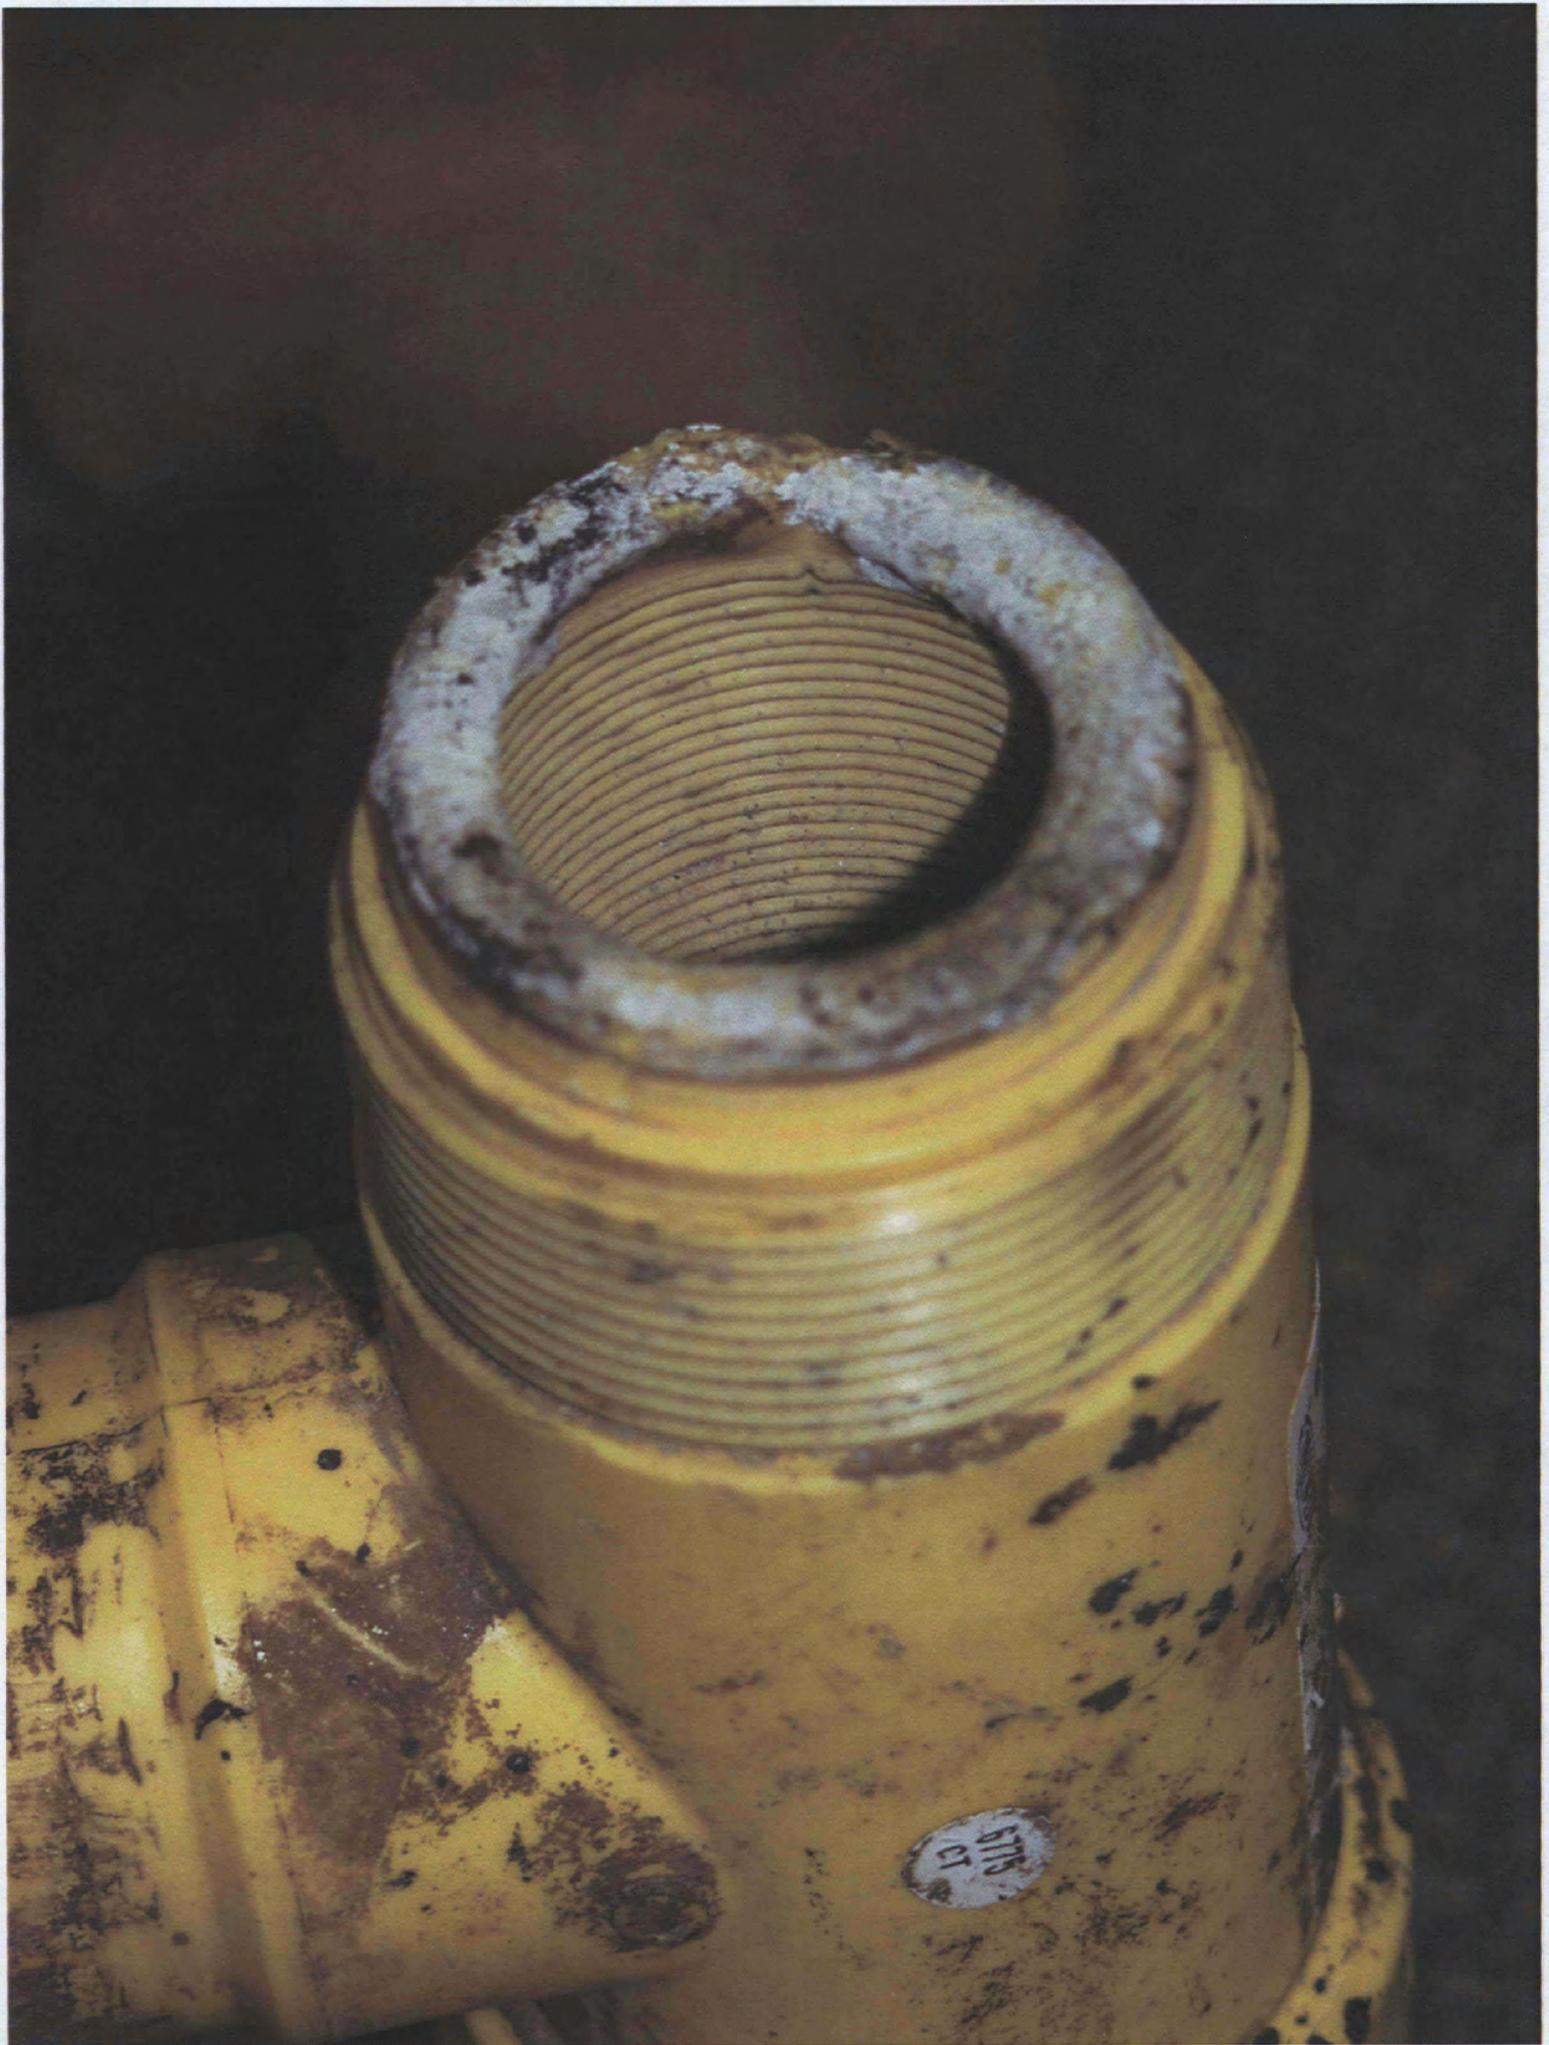
EXHIBIT 8b

Based on the findings from the laboratory testing of exemplar fittings, and the examination of the failed fitting from the incident site, it was likely that during the retraction step in the tapping procedure in the field, the No Blow-By punch tool's cap backed out completely or nearly completely (id.). This allowed the cutter to continue to retract beyond the top of the tee, and become disengaged (id.). This is supported by the evidence that the internal and external threads of the tee from the incident and the internal threads of the tool's cap from the incident were found intact indicating a condition where the cap was not in place and the cutter was free to disengage from the tee allowing the release of gas (id.). It was noted in the laboratory testing the top edge of the exemplar tees were deformed due to the cutter disengaging (id.). After the testing this deformation returned nearly to its original position (id.). The tee from the incident was damaged to heat from the fire and this feature was not identifiable (id.).

Photograph of the HVTT - Closeup

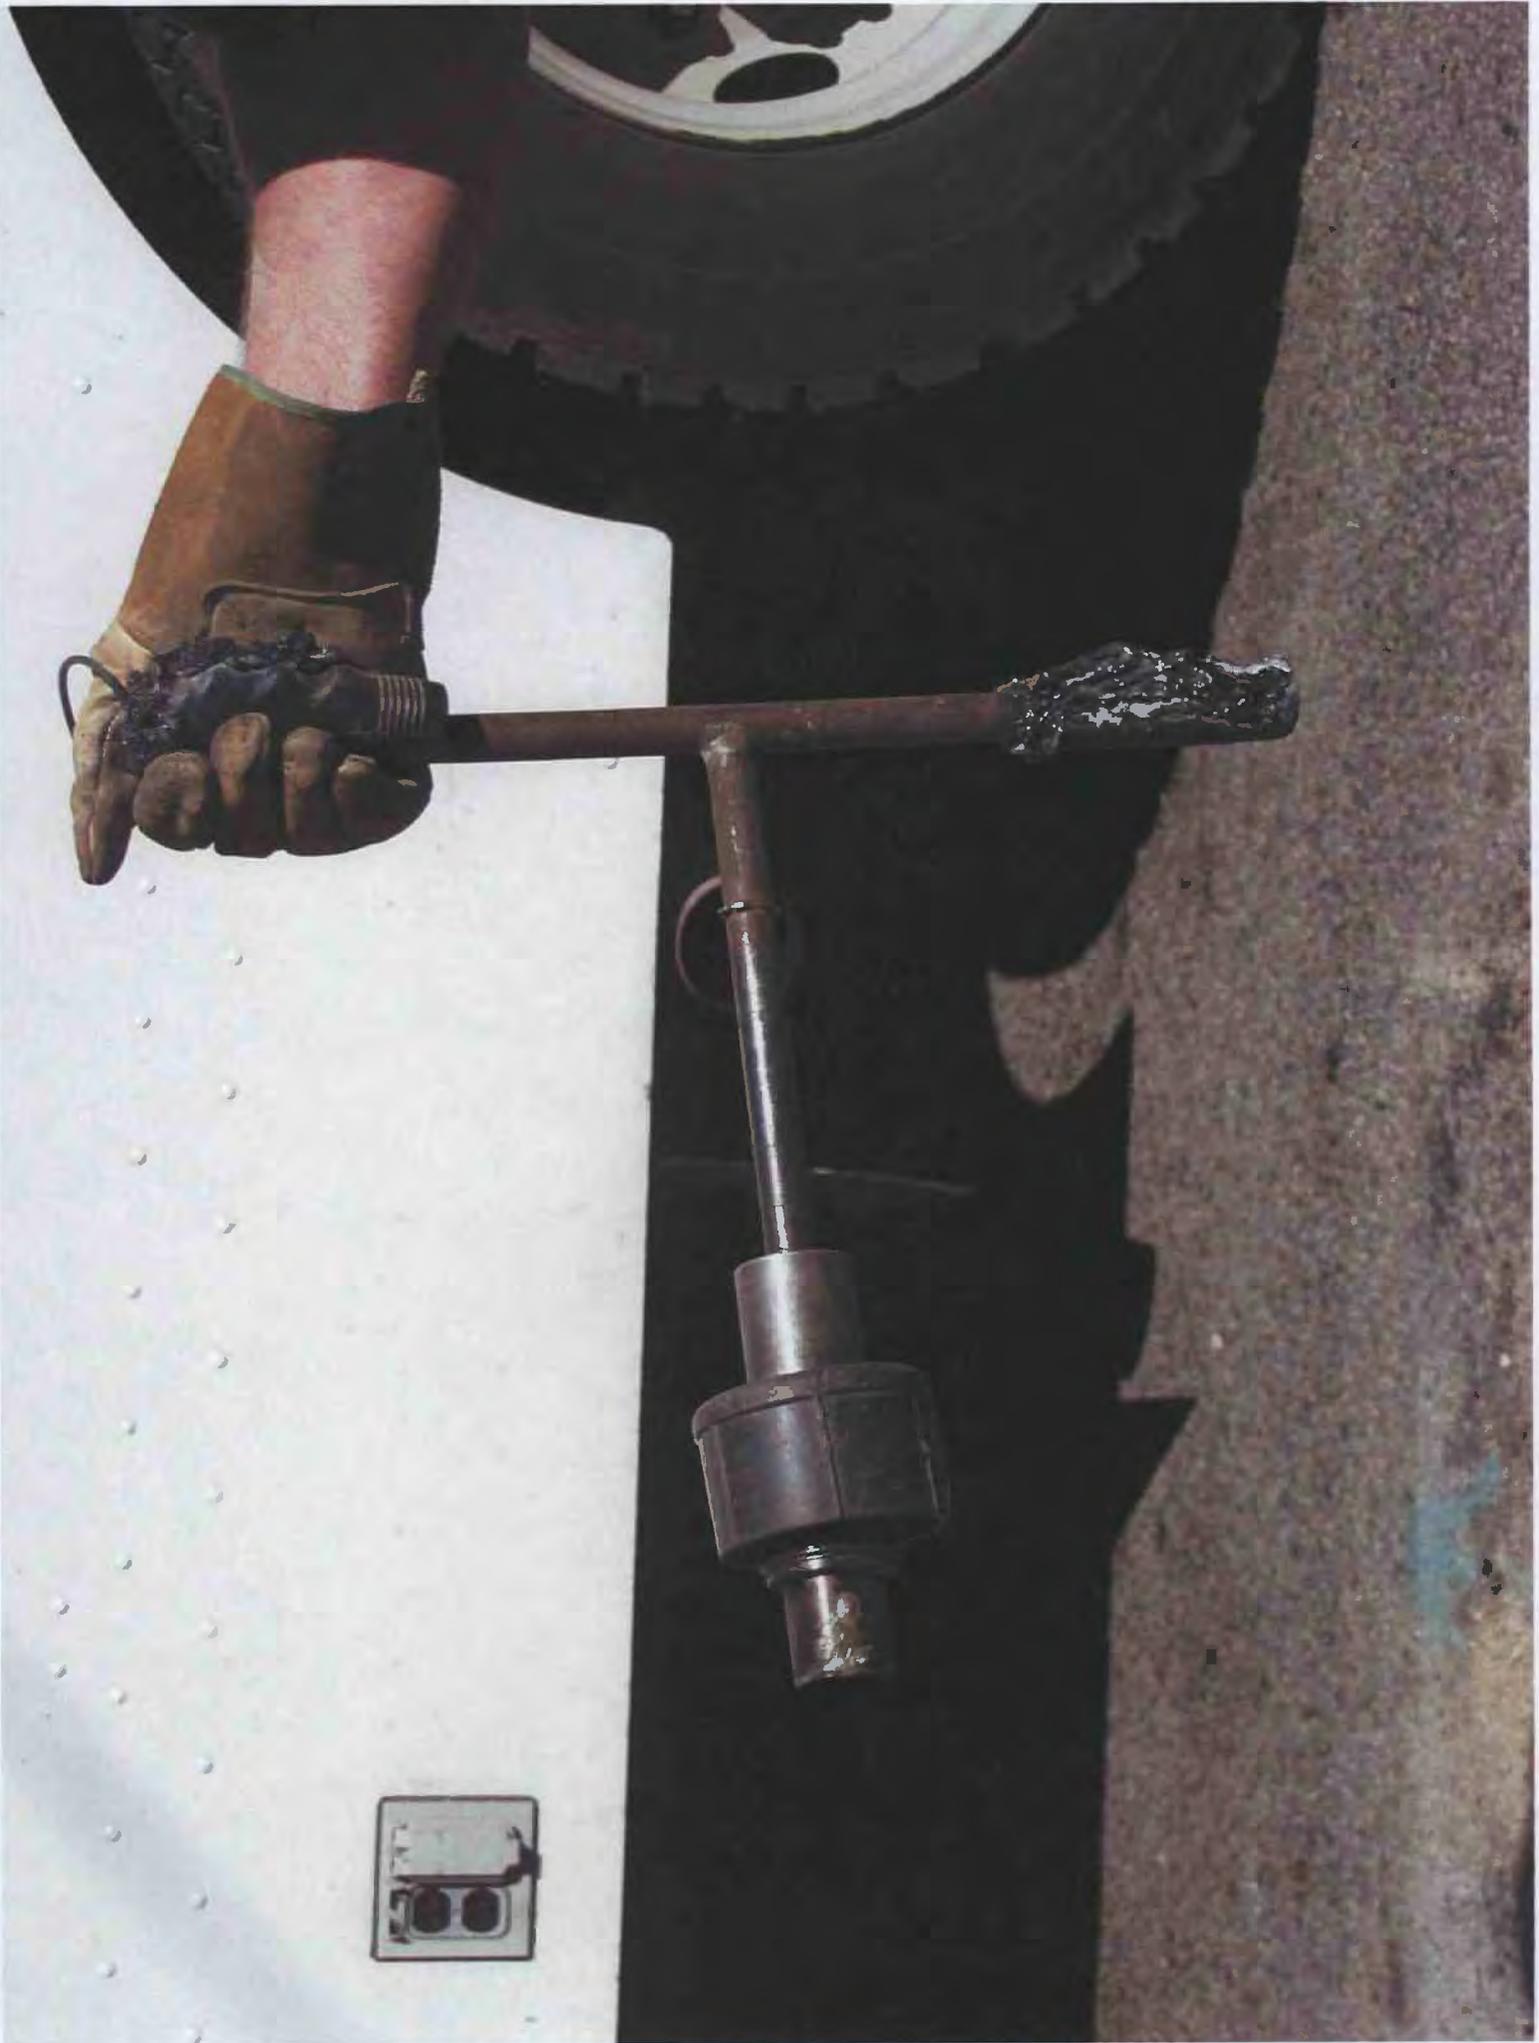
EXHIBIT 9a

It was also noted during the testing that the used corroded No Blow-By tool supplied by NSTAR caused the loosened tool cap to unscrew and become disengaged after 9 ½ full turns of the tool (id. at). The same test performed with the new No blow-By tool did not disengage the tool's cap, and required 39 turns to unscrew the tool's cap only half way (id.).

Photograph of the Tapping Tool

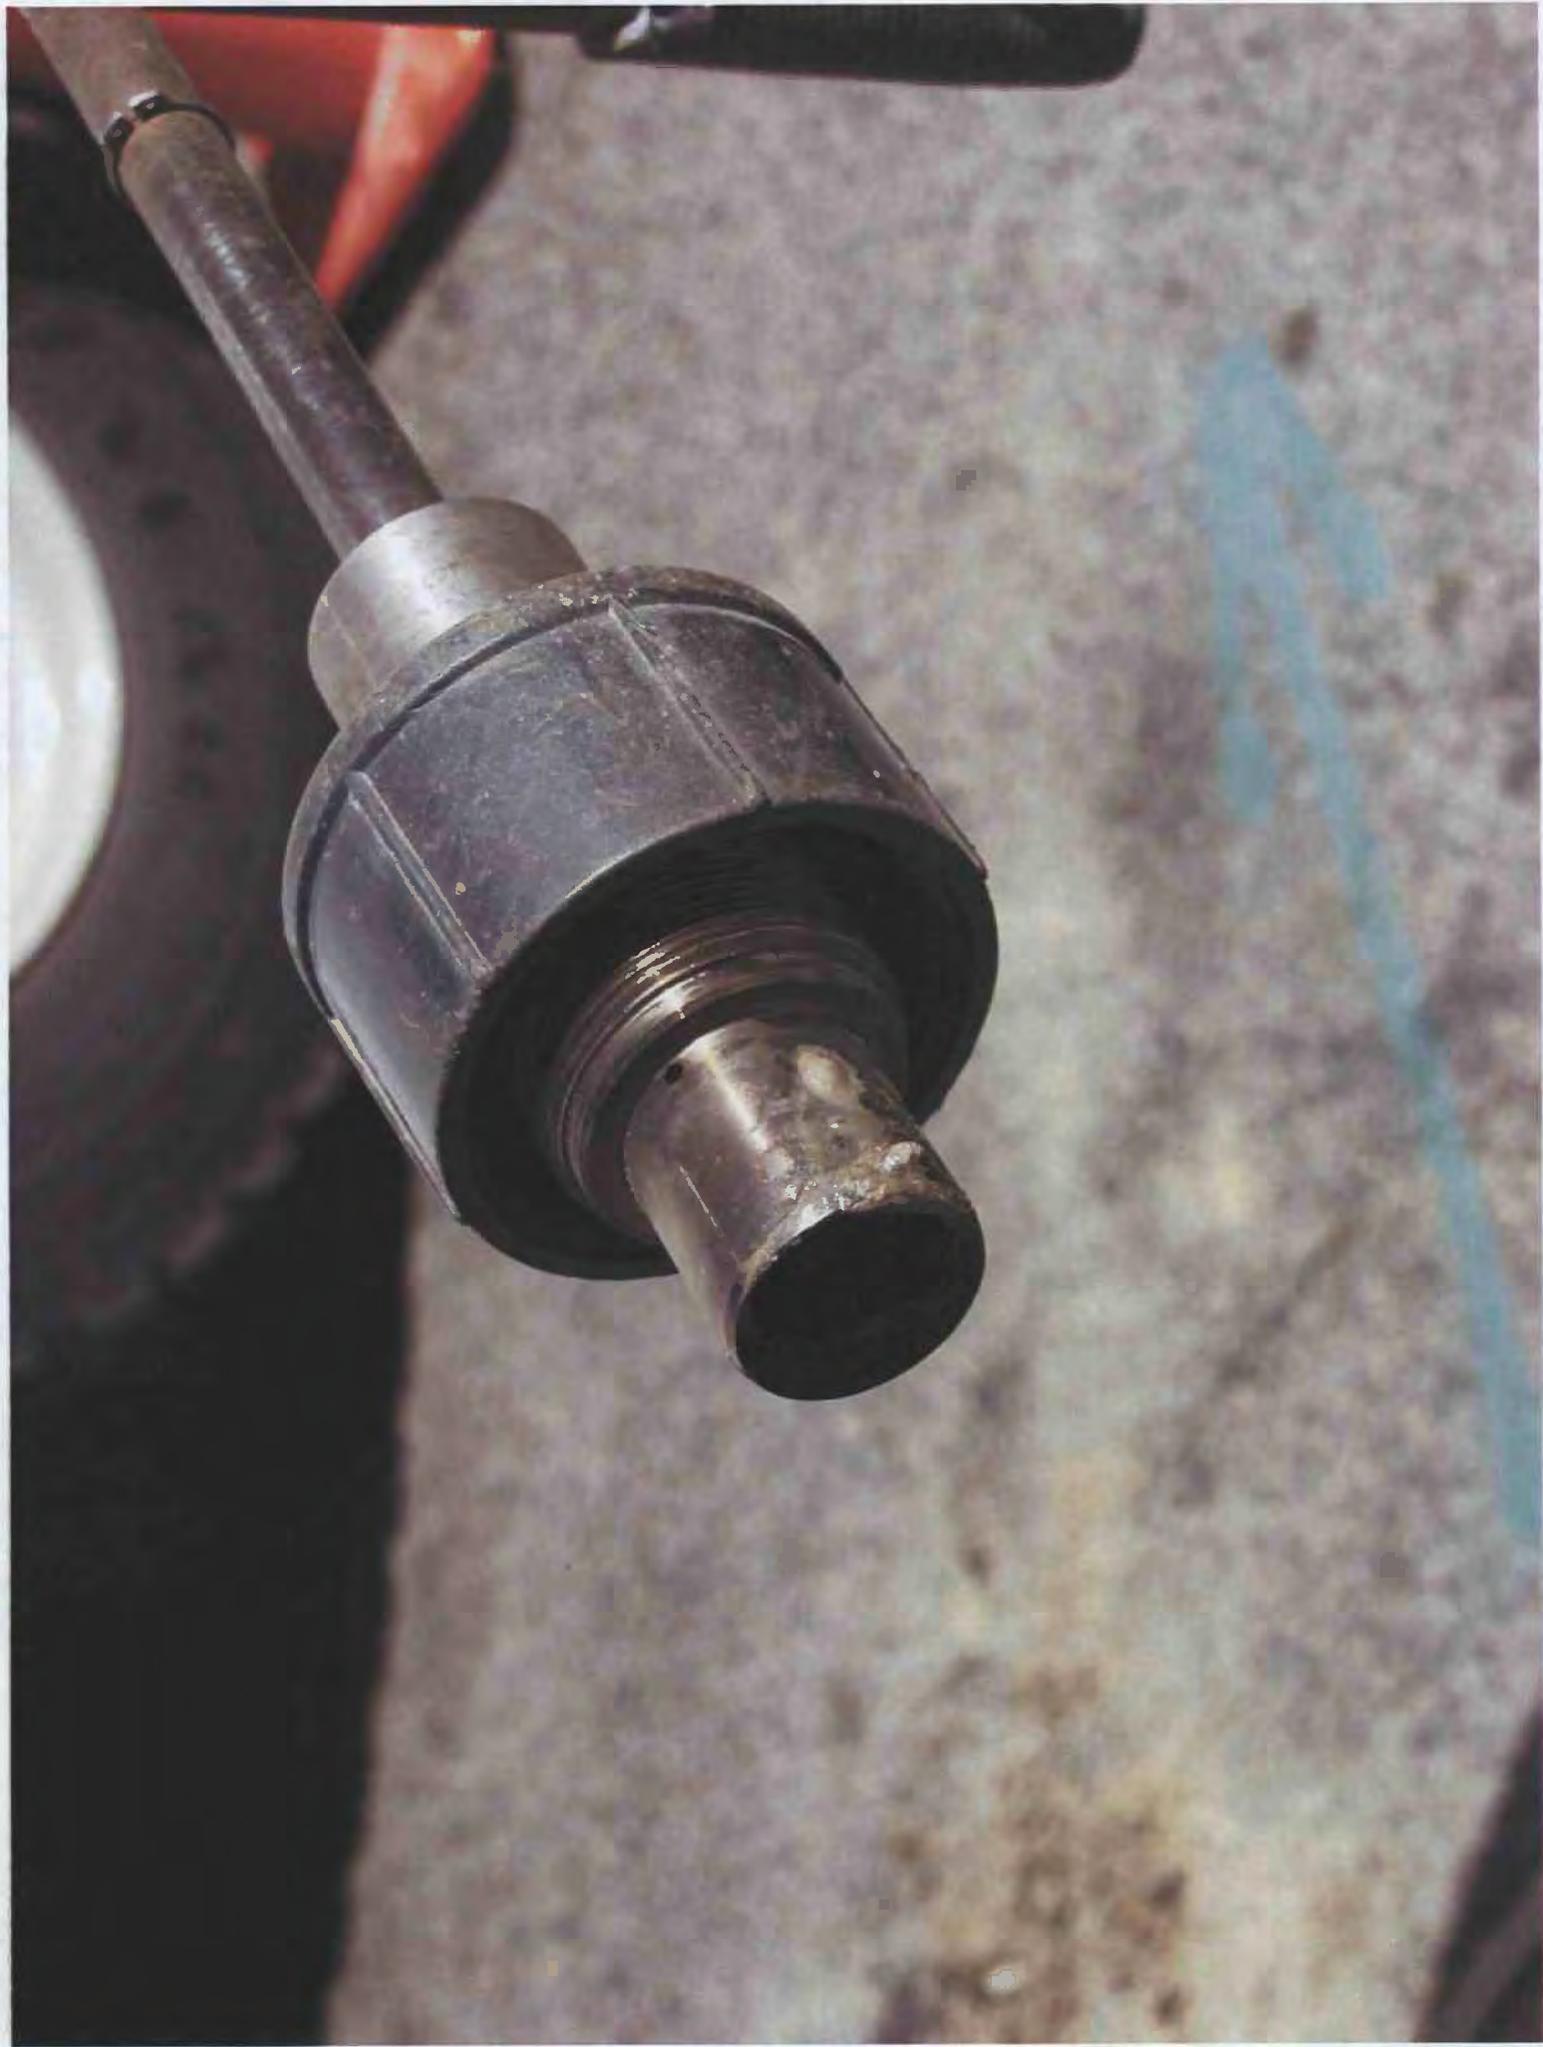
EXHIBIT 9b

- If the tool's cap was loose it became disengaged from the high volume tapping tee and subsequently, the cutter was able to completely thread itself out of the tee during retraction. The torque required for this disengagement of the cutter was on average, 49 ft lbs. This torque is actually less than the torque required for the tapping operation (55 ft lbs). When this test was performed under the 56 psi Nitrogen pressure, no gas leaked until the cutter came out to a point where the pressure pushed it from the tee. These findings indicate an operator may not notice a significant change in torque while retracting the cutter beyond its intended position within the fitting

Photograph of the Tapping Tool Cap and Cutter
