The Commonwealth of Massachusetts
DEPARTMENT OF PUBLIC UTILITIES

PIPELINE ENGINEERING AND SAFETY DIVISION

INCIDENT REPORT

39 Jenny Lind Street, Easton, Massachusetts
September 10, 2007

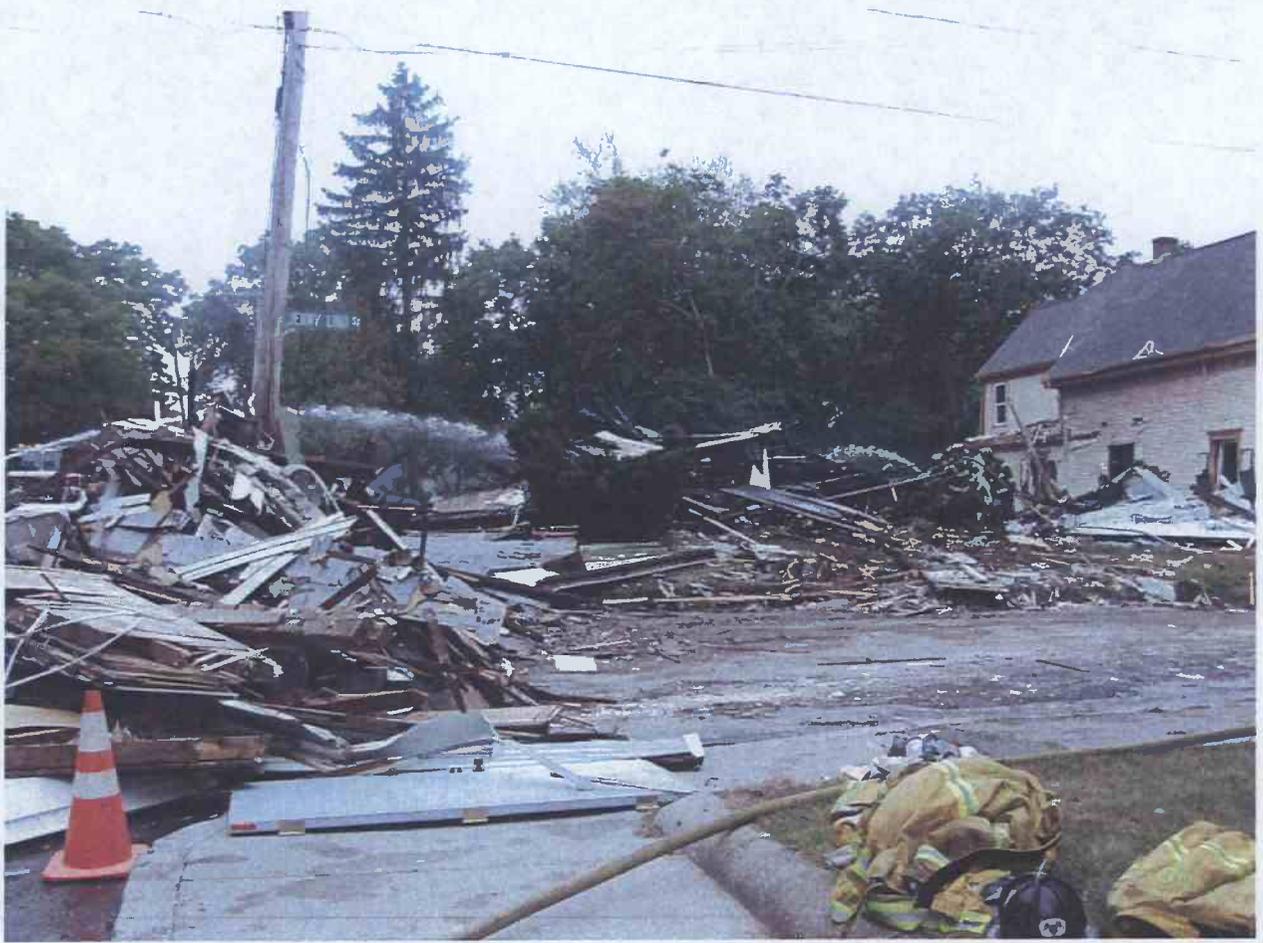
EXHIBIT 5

The Division investigators observed that the house had been completely destroyed. The walls were blown out and the floors and roof collapsed onto the foundation. The house next door, 35 Jenny Lind Street, received substantial damage from the blast and resulting fire.

Photo 39 Jenny Lind Street

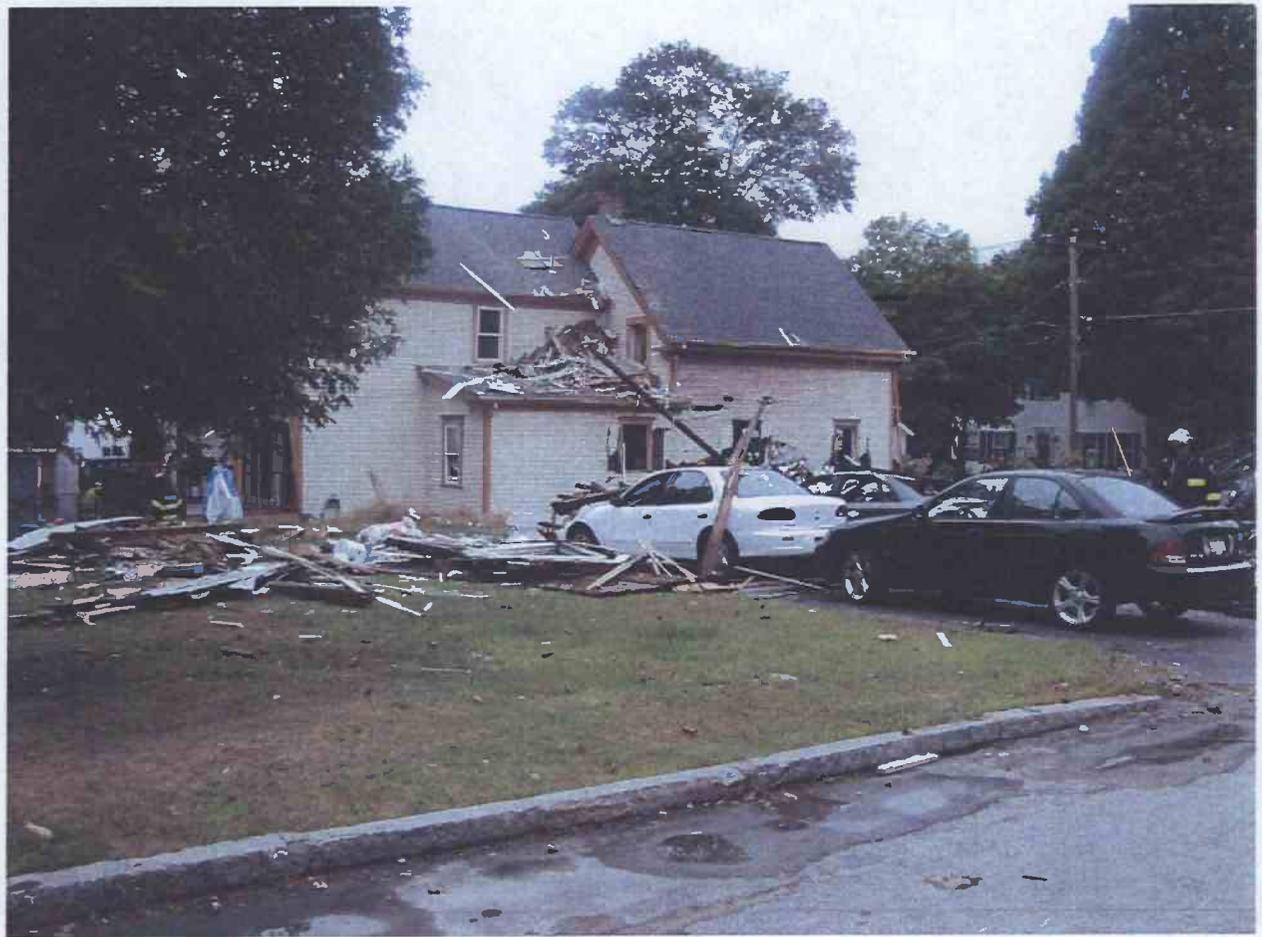
EXHIBIT 6

Photo 35 Jenny Lind Street

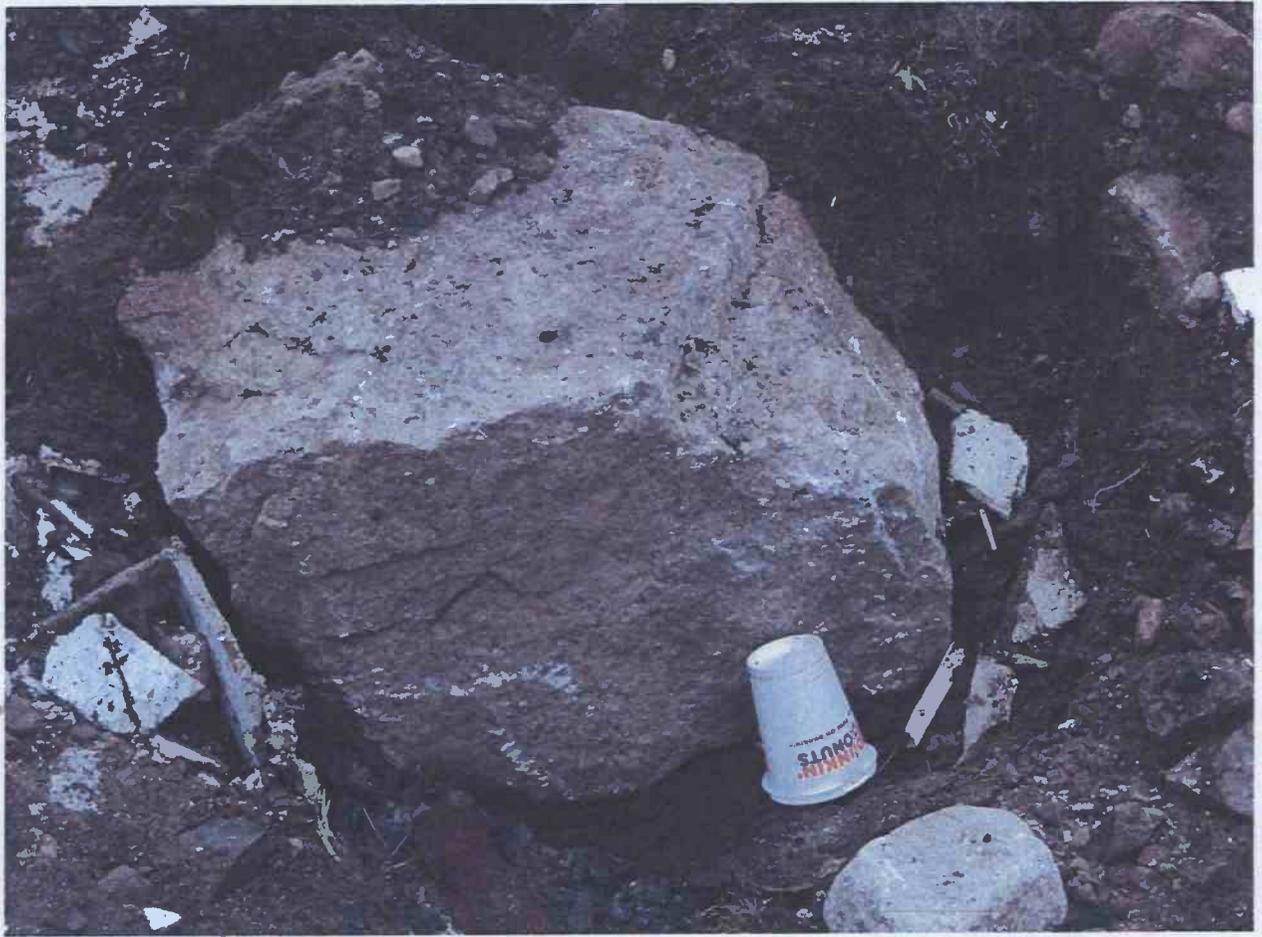
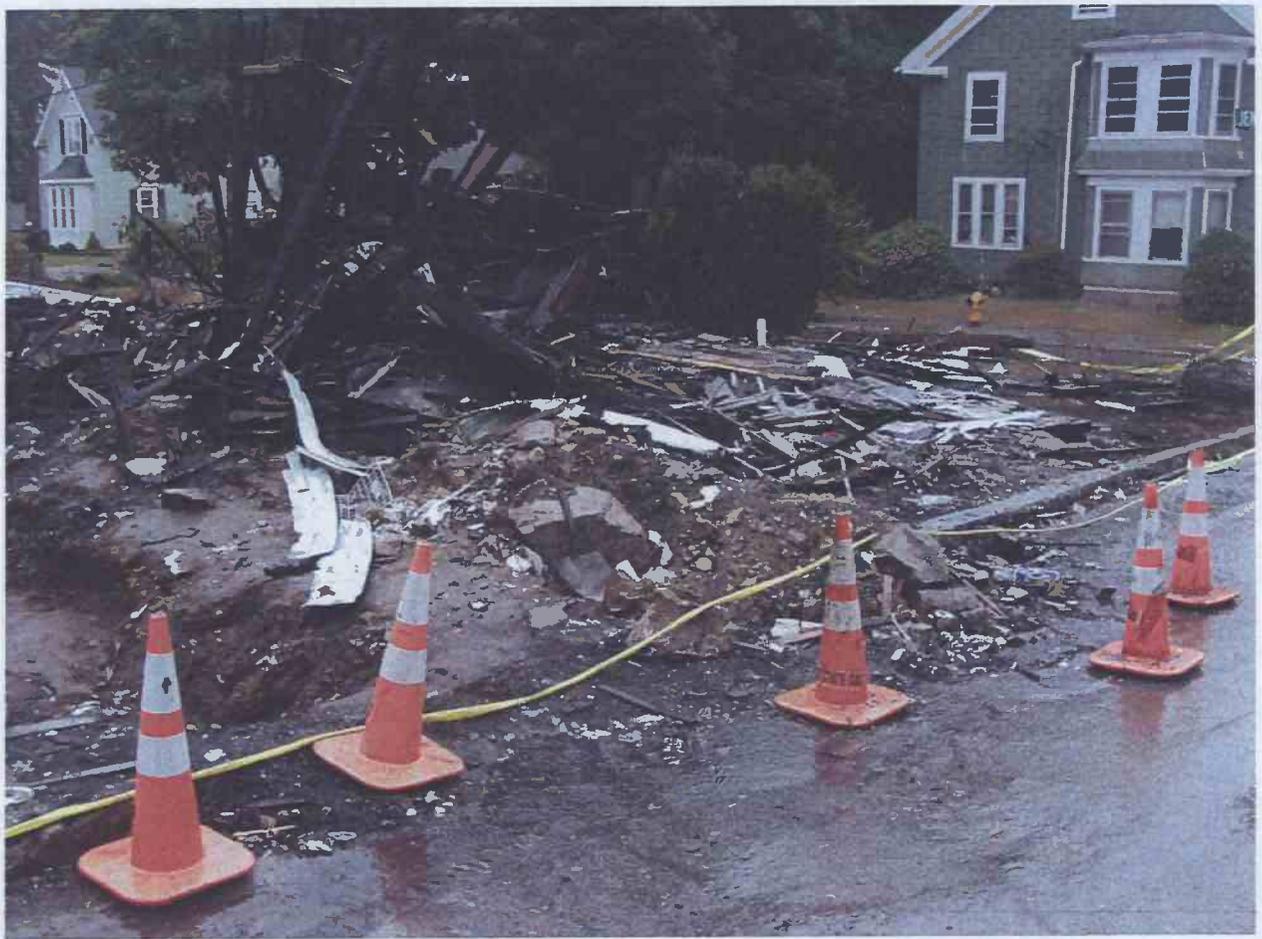
EXHIBIT 7

A backhoe operated by a BSG contractor was replacing the gas service³ line and removed a rock from near the existing gas service line (Exh. 7). The rock contacted the gas service pipe and apparently caused a release of gas inside the basement. The gas was ignited by the gas water heater in the basement (Exh. 2).

- All steel fractures were consistent with ductile overload formed during the house collapse;
- Long longitudinal scrapes along the underside of the bend in the pipe indicate that the rock that was removed from under this bend contacted the pipe in a sliding, dragging motion. Movement against this pipe would translate to movement of the service inside the basement;
- The force was not likely enough to have created enough tensile pulling to fracture the service pipe at the inlet elbow;
- The isolation fitting is most likely the source of the gas;
- Damage to the isolation joint could release gas at high pressure into the basement

Contact of the service pipe with the rock removed from its bend likely caused movement of the service inside the 39 Jenny Lind Street basement. This movement was sufficient to smear the service pipe coating, but not enough to dent or significantly scratch. Therefore, the movement would not likely be sufficient to fracture the service pipe at the elbow, but could be sufficient to cause damage to either the regulator or the polymer part of the isolation fitting adjacent to the high pressure cock . . . Damage to the regulator from the wall contact would have occurred on the vent side, where no gas circulates under normal operating conditions.

The Division agrees with MMR's conclusion that the cause of the release of gas in this Incident is most likely the movement of the service line by the BSG backhoe operator when he removed a rock that contacted the service pipe.

Photos of Rock

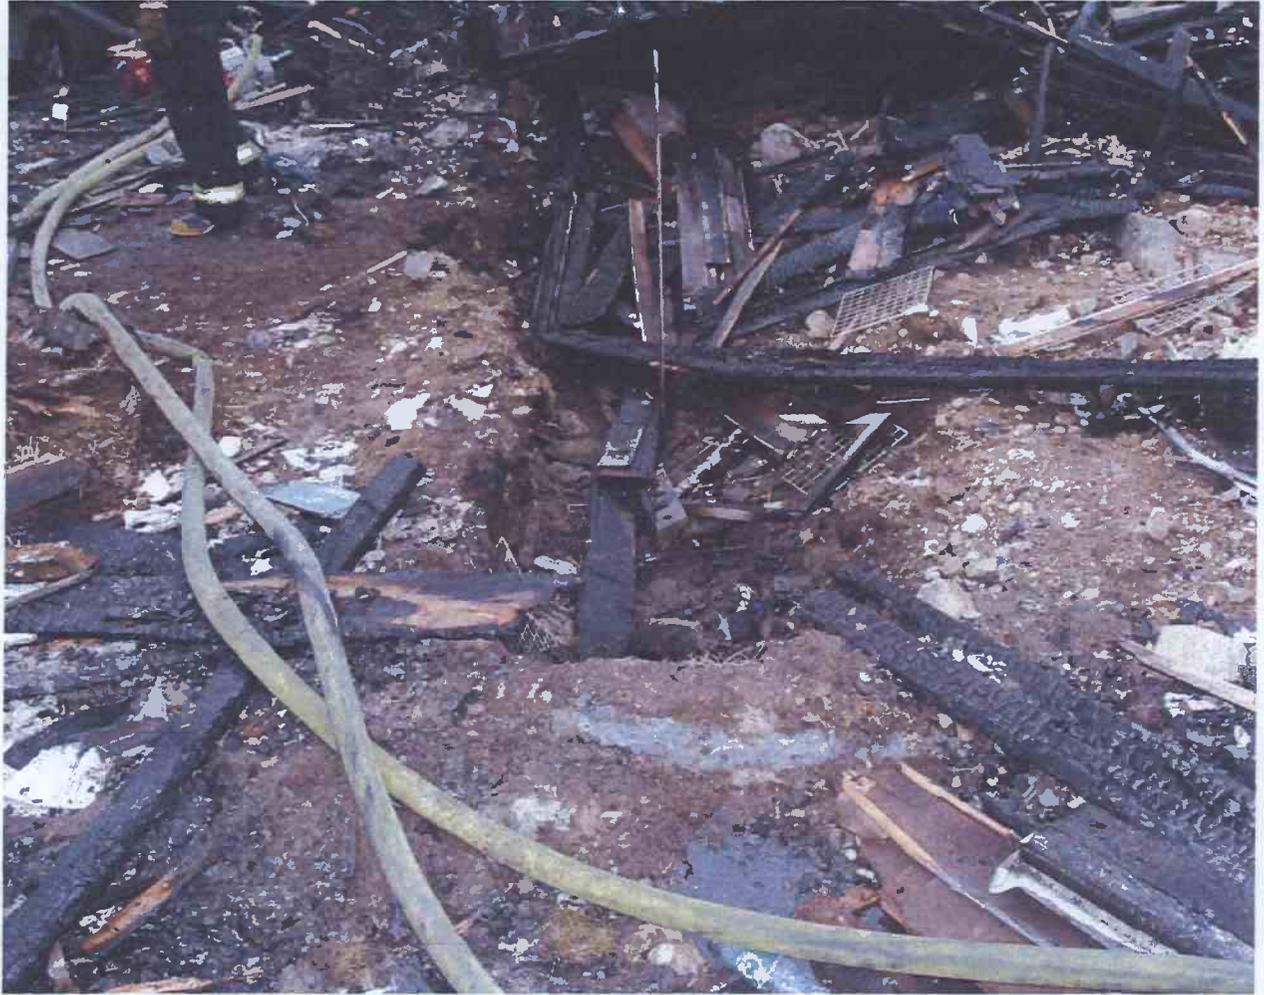
EXHIBIT 16

Photo of Service Line (not exposed)
