COMMONWEALTH OF MASSACHUSETTS

**INCIDENT REPORT**

225 North Avenue, Weston, Massachusetts  
September 12, 2005

Gas Company: KeySpan Energy Delivery New England

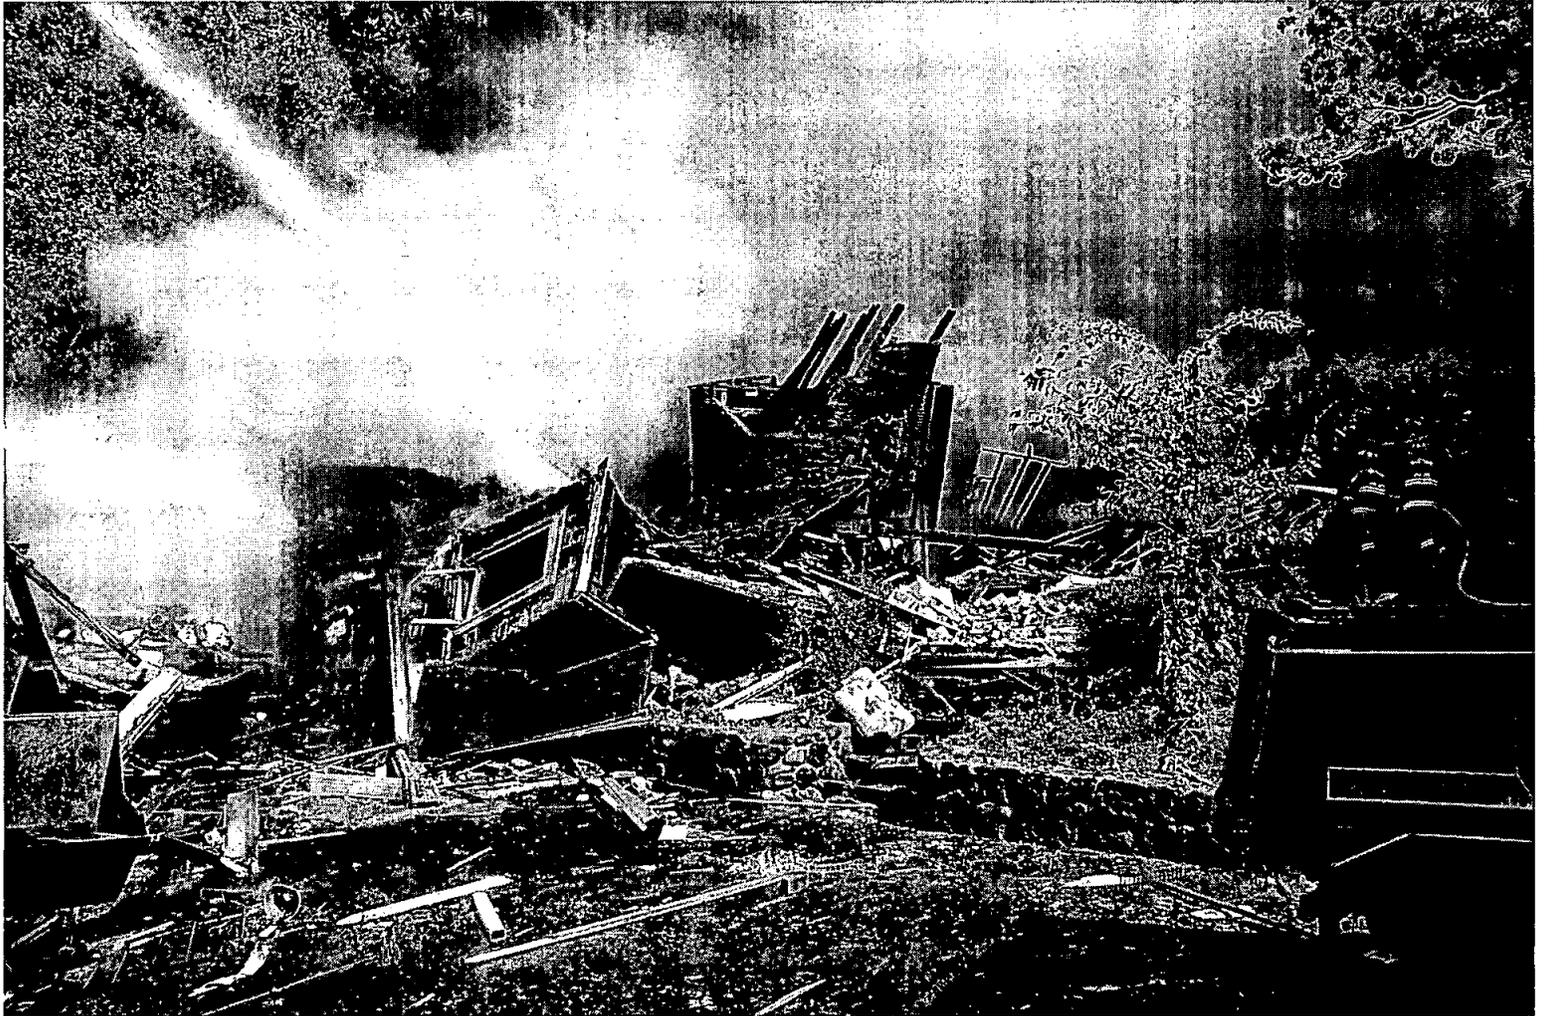
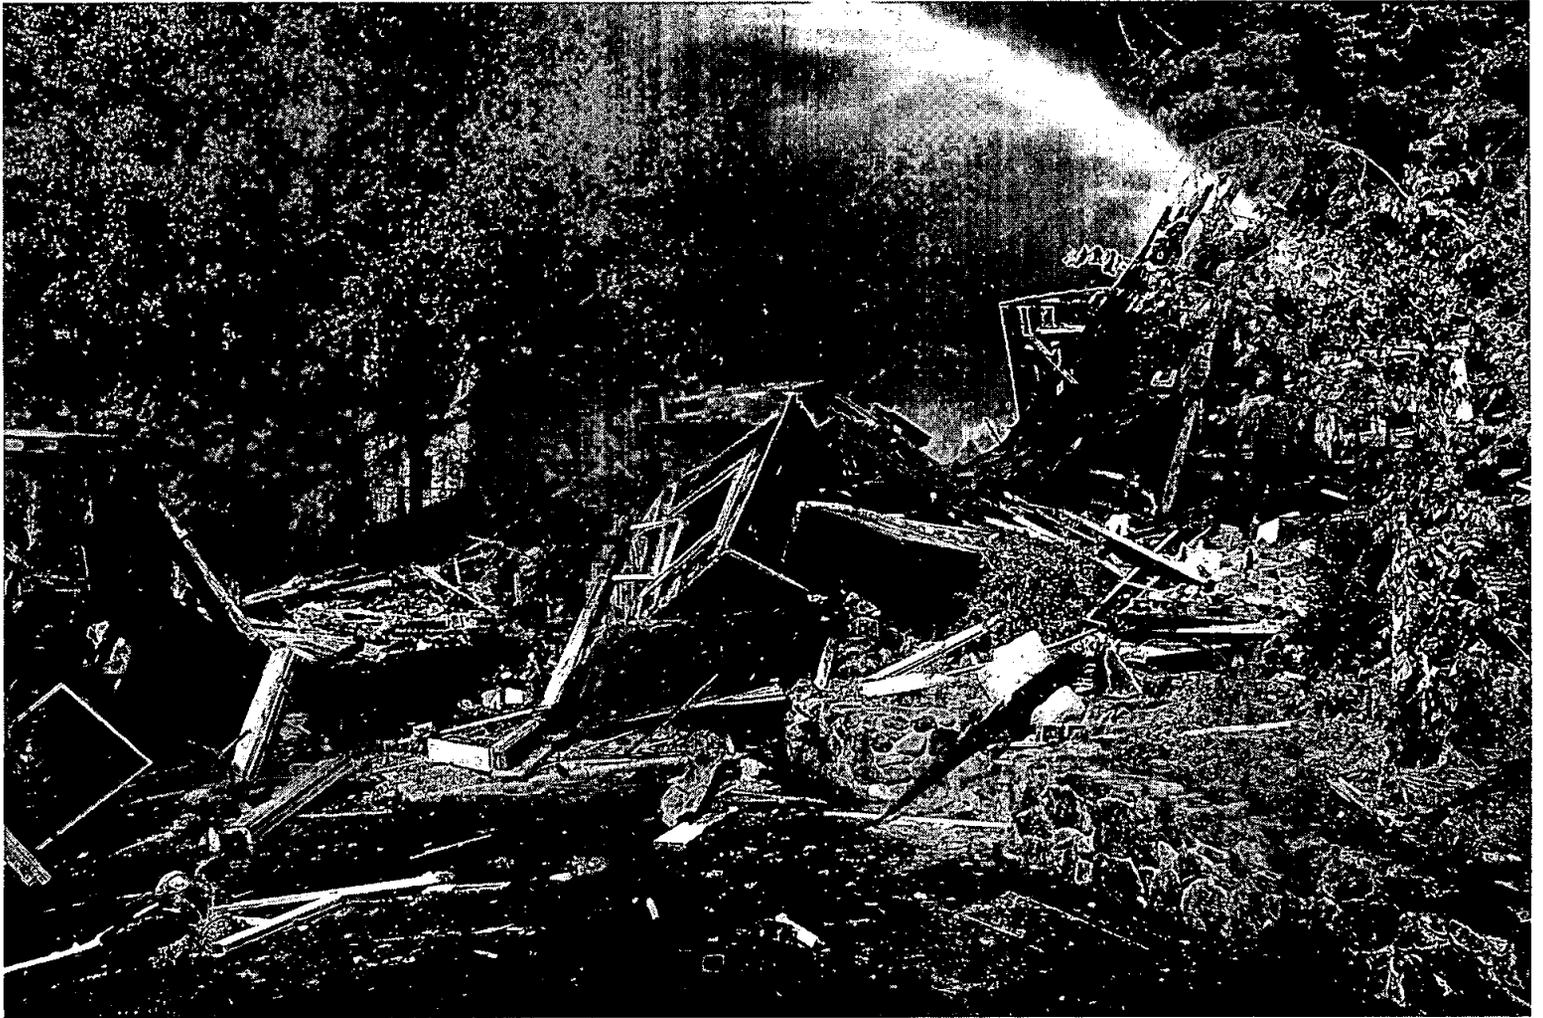
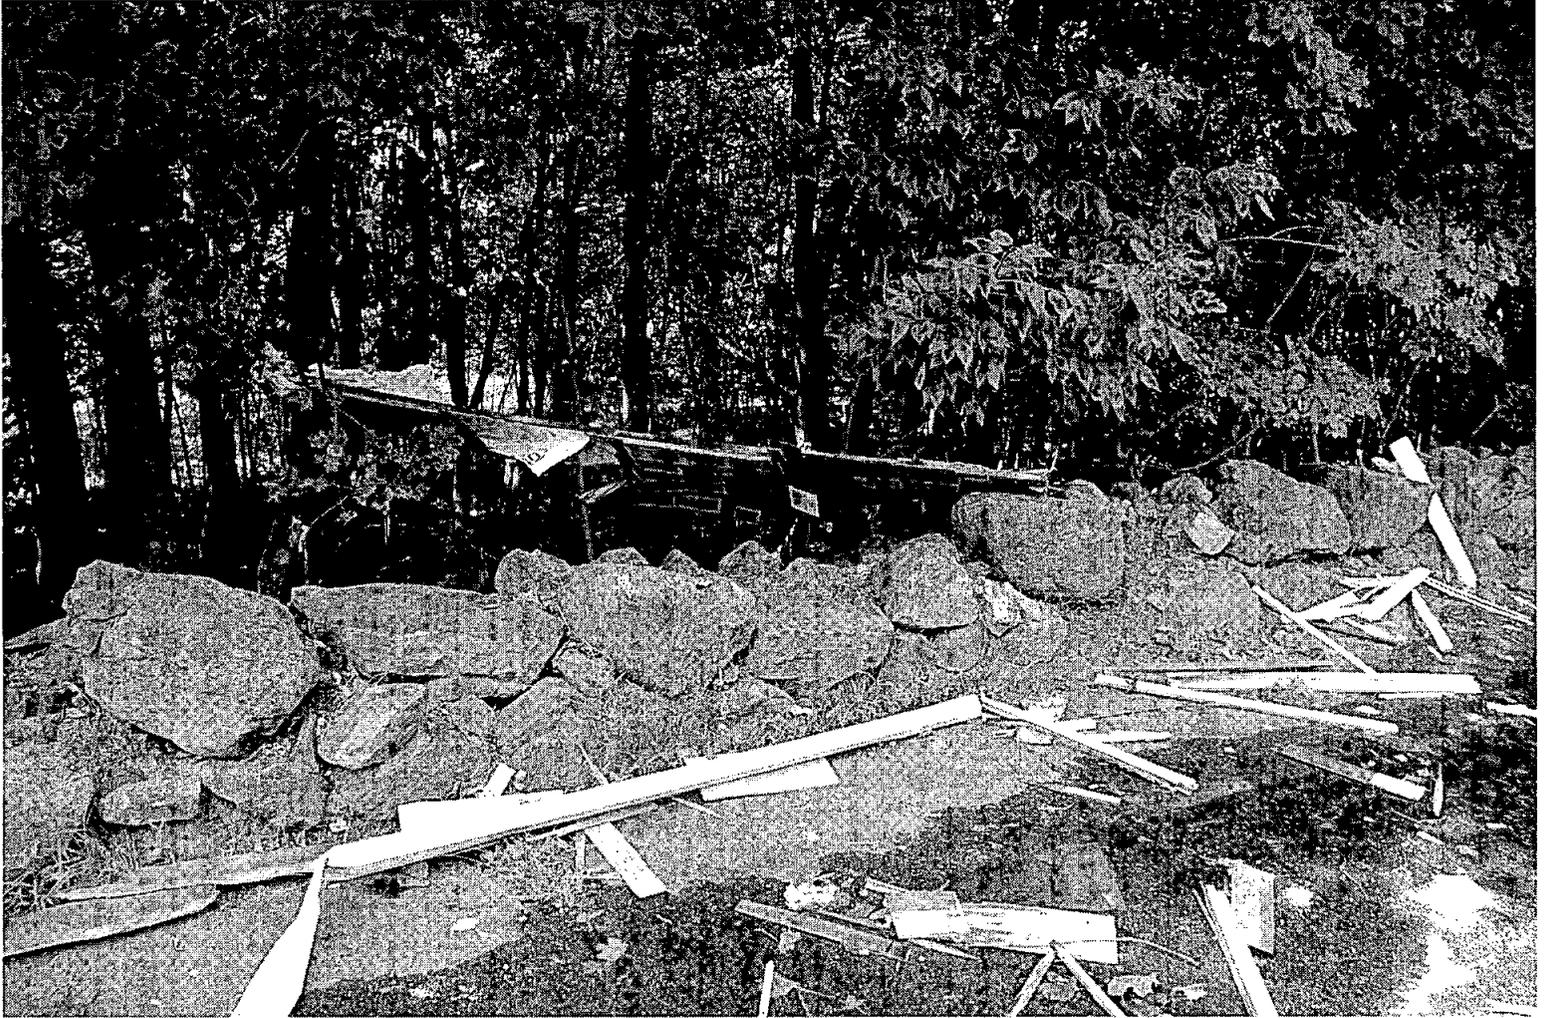
**EXHIBIT 8**

The house had been completely destroyed by the explosion and ensuing fire (Exh. 8). The house had collapsed into the foundation. Debris had been blown across the street into a wooded area (id.). A furnace, washer, dryer, dehumidifier, and water heater were in the basement. In the front of the house, with slight charring of its boom, was a track excavator (Exh. 9). The gas meter was discovered approximately 11 feet from the location of the service riser (Exh. 2). It was discovered under a section of the wall that had been displaced from the foundation during the gas explosion. The meter had been severed from the riser at a point downstream of the meter valve (Exh. 10).

**Photographs of the explosion site**

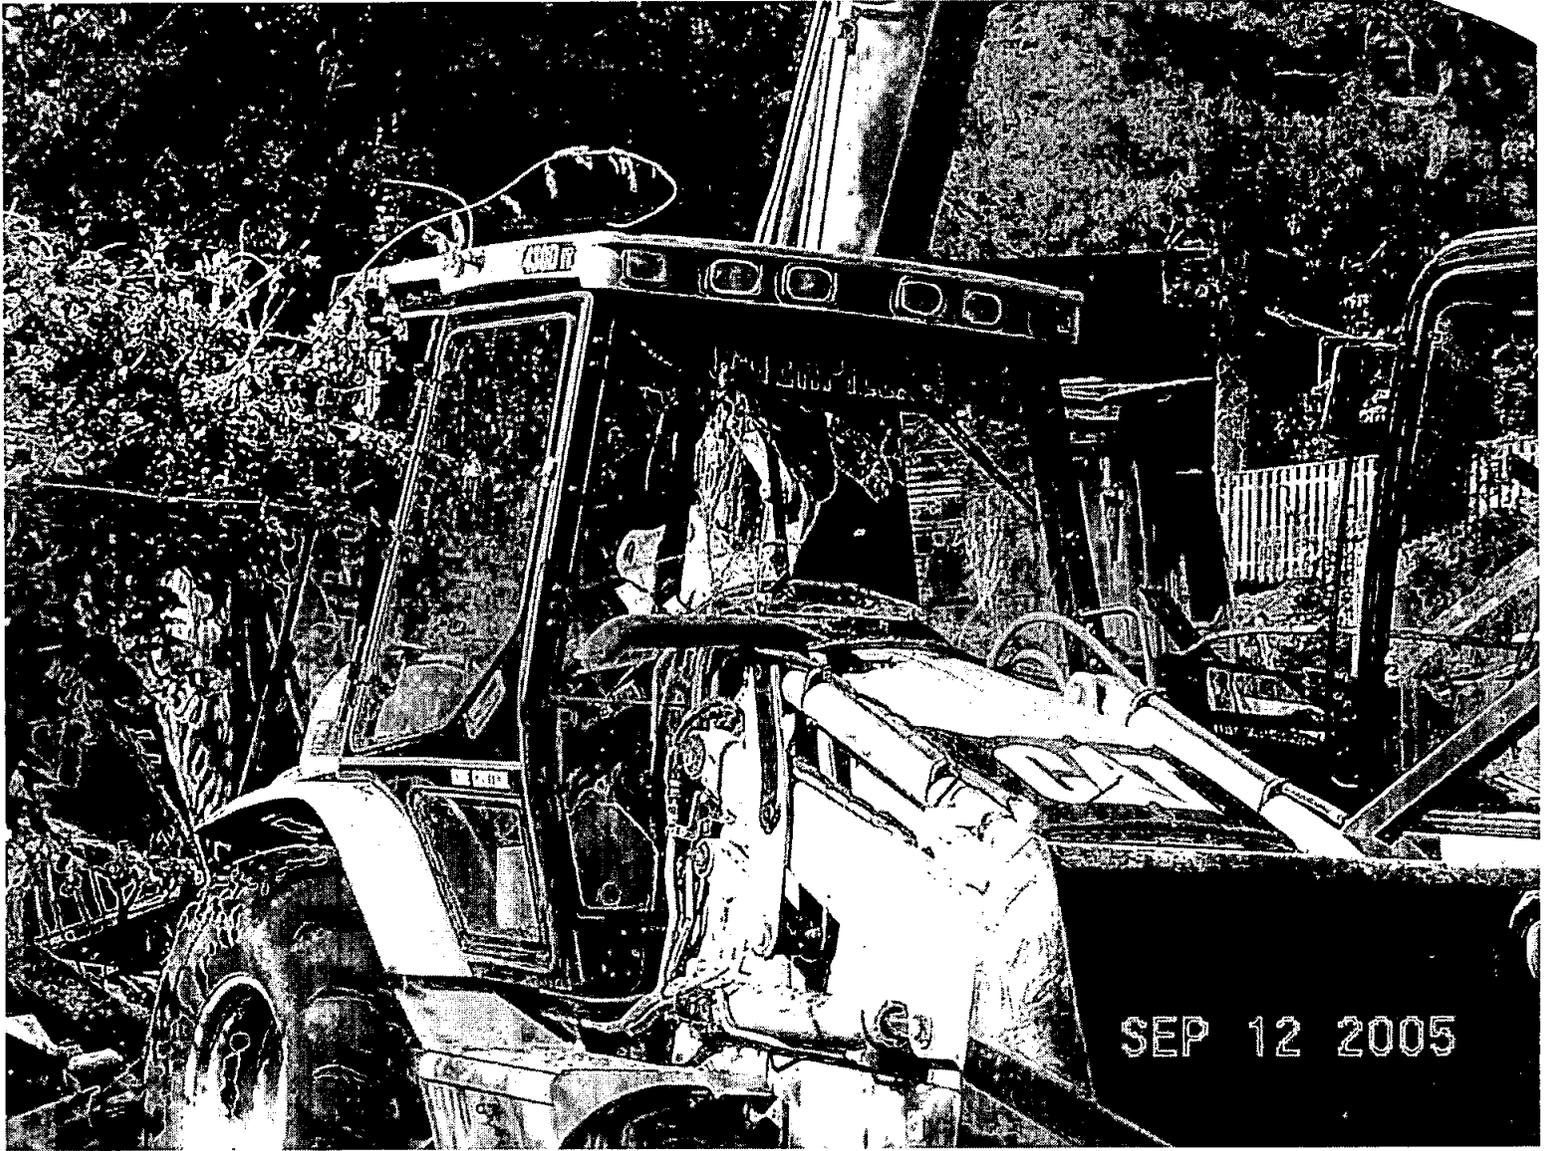
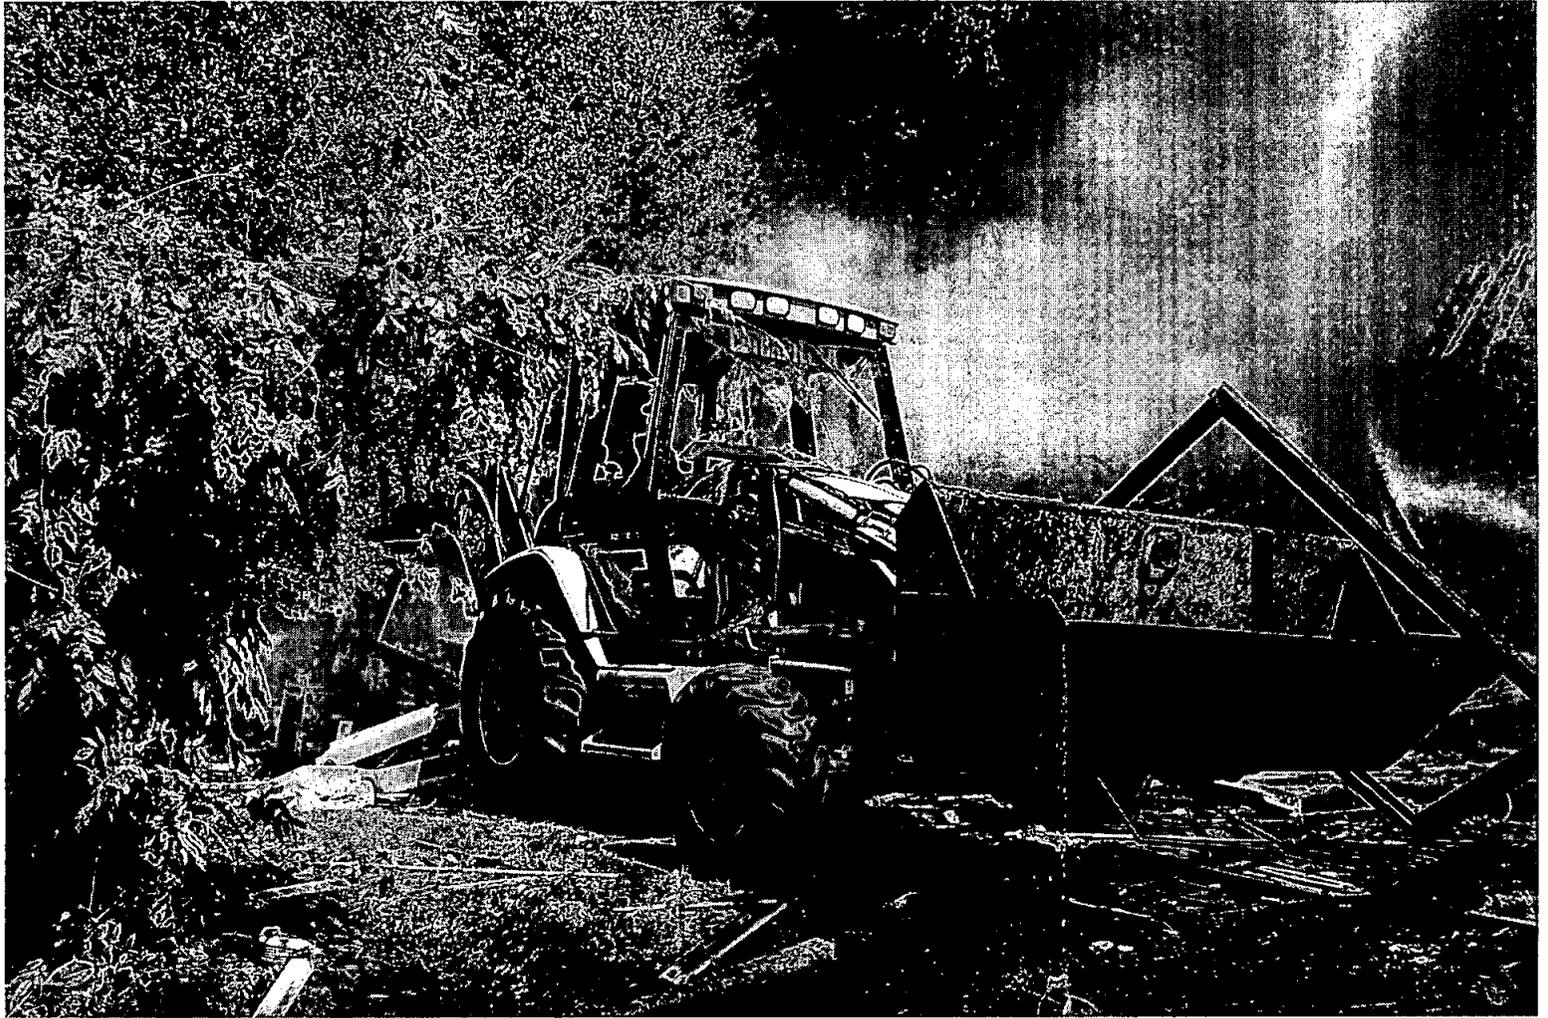
**EXHIBIT 9**

**Photograph of excavator**

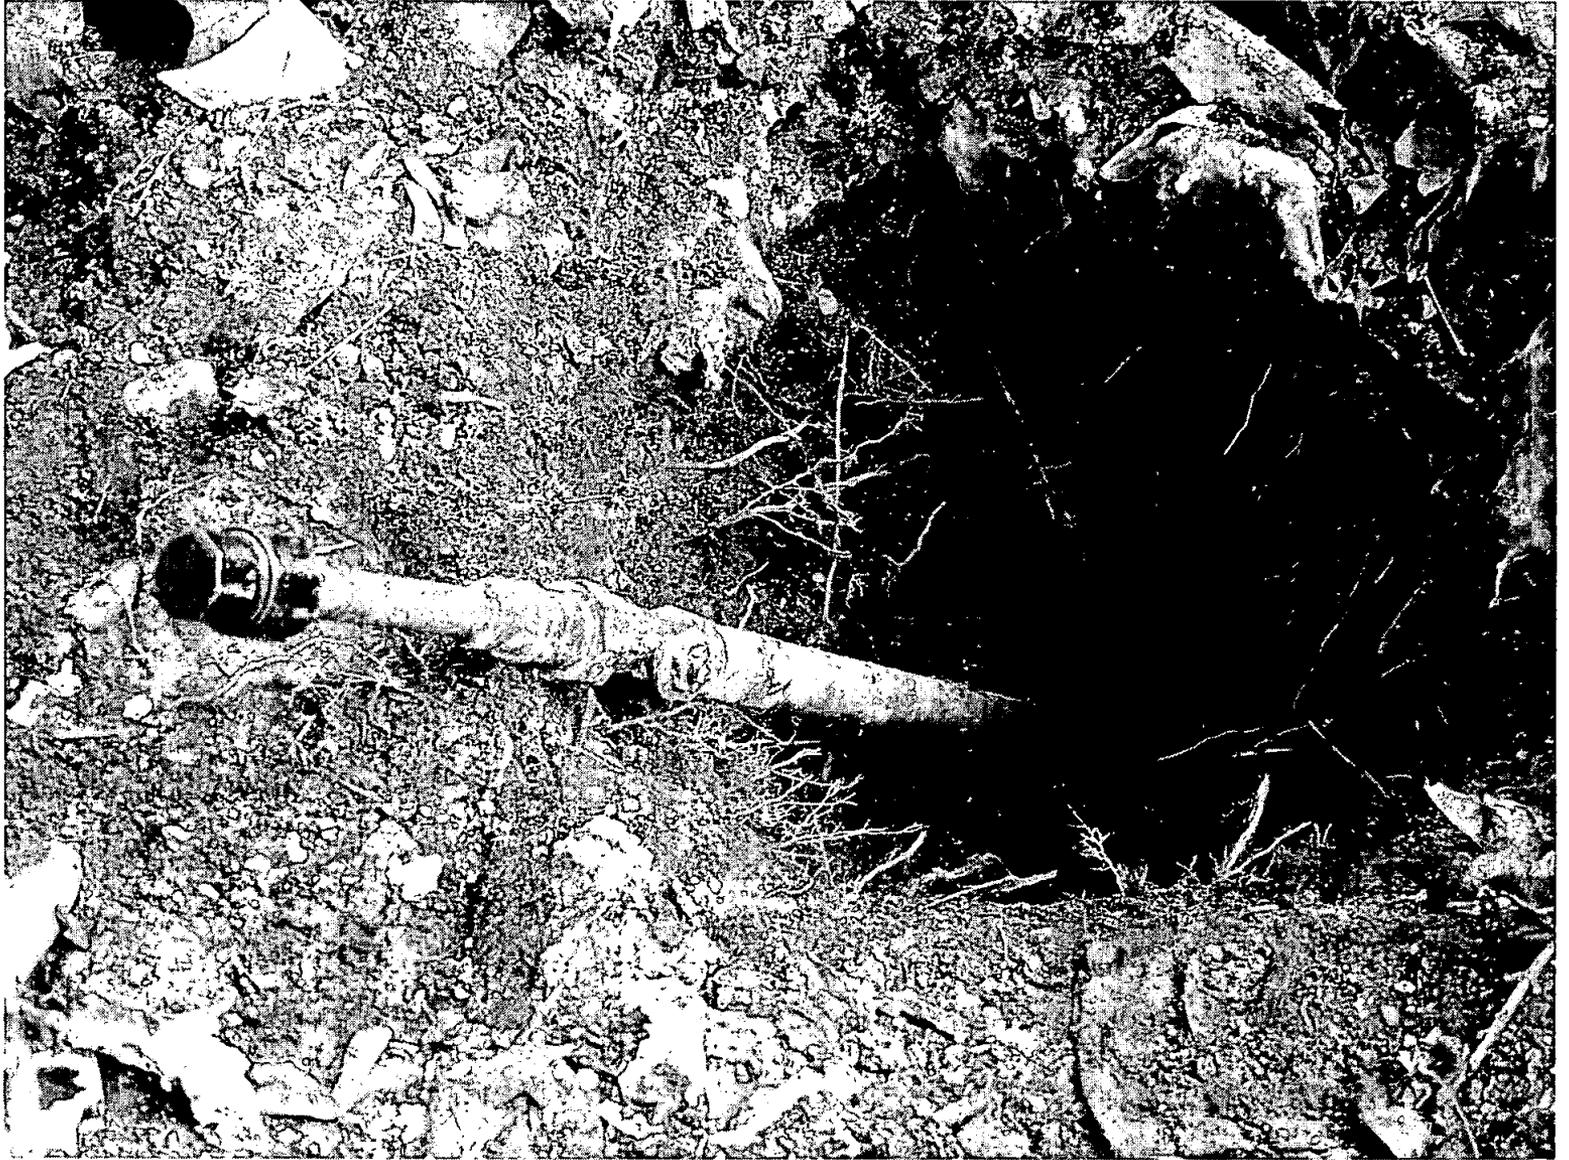
**EXHIBIT 10**

**Photograph of Service Riser**
