INDOOR AIR QUALITY ASSESSMENT

**Ordway Building
Amesbury Senior Center
9 School Street
Amesbury, Massachusetts**

Prepared by:
Massachusetts Department of Public Health
Center for Environmental Health
Emergency Response/Indoor Air Quality Program
April 2007

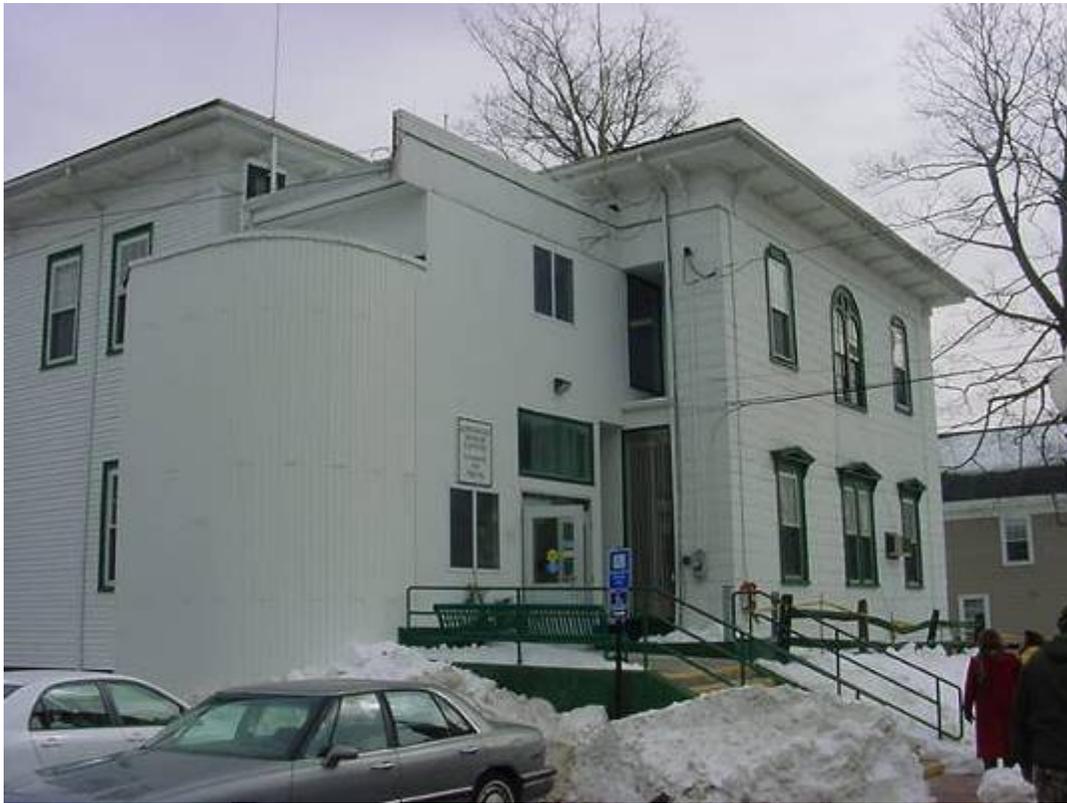
Picture 1

and that remediation be conducted using isolation methods outlined in the US Environmental Protection Agency's document "Mold Remediation in Schools and Commercial Buildings" (SWA, 2005). At the time of the CEH assessment remediation had been completed, which included removal/replacement of mold-contaminated materials; and the installation of new windows in the stairwell and re-siding of portions of the exterior of the building to prevent water penetration (Picture 1).

Front of Ordway Building Showing new Windows and Siding (Front Left) Stairwell

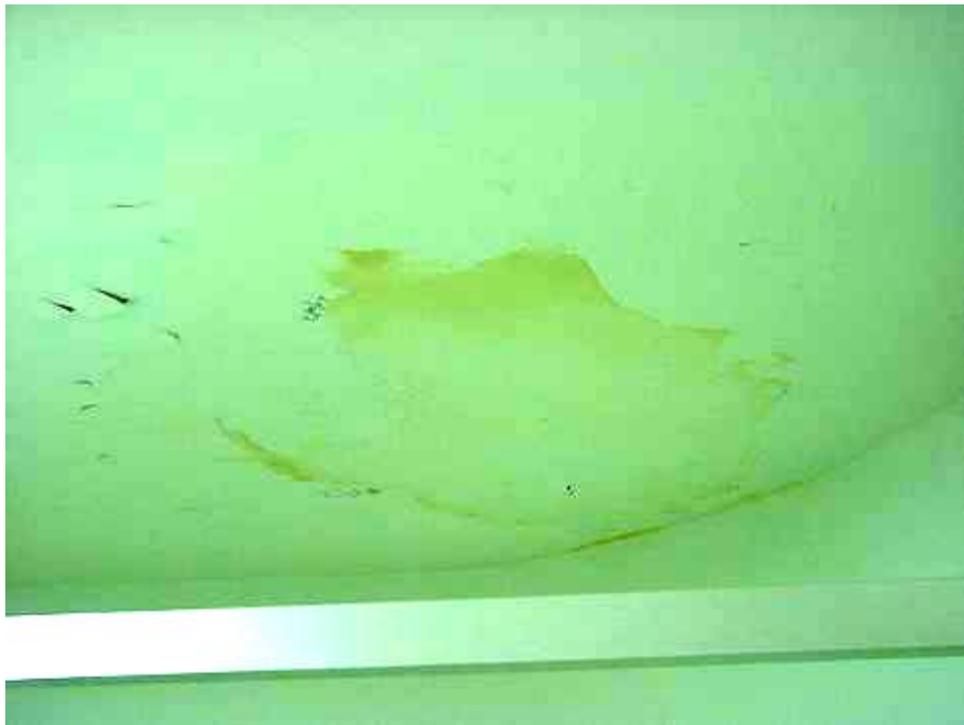
Picture 2

Although no visible mold growth was observed on the second floor, several potential sources of moisture were observed. Most notably, water stained gypsum wallboard (GW) in the men's restroom. The ceiling of the men's room is constructed of GW, which was visibly water damaged, most likely from roof (or possibly plumbing) leaks in the attic (Picture 2).

Water Damaged Gypsum Wallboard Ceiling and Peeling Paint in Second Floor Men's Room

1. Refrain from storing porous materials in the crawlspace.
2. Inspect and discard any water damaged/mold colonized materials in the crawlspace as well as in the second floor stairwell storage closet. Disinfect any non-porous surfaces of microbial growth with a mild detergent or antimicrobial, wipe clean surfaces with soap and water after disinfection.
3. Utilize dehumidifiers in below grade areas to reduce relative humidity as needed. Ensure dehumidifiers are cleaned and maintained as per the manufacture's instruction to prevent microbial growth.
4. Work with a roofing contractor to identify/isolate and repair roof leaks damaging ceilings in the second floor men's restroom. Once leaks are repaired, remove and replace water damaged GW.

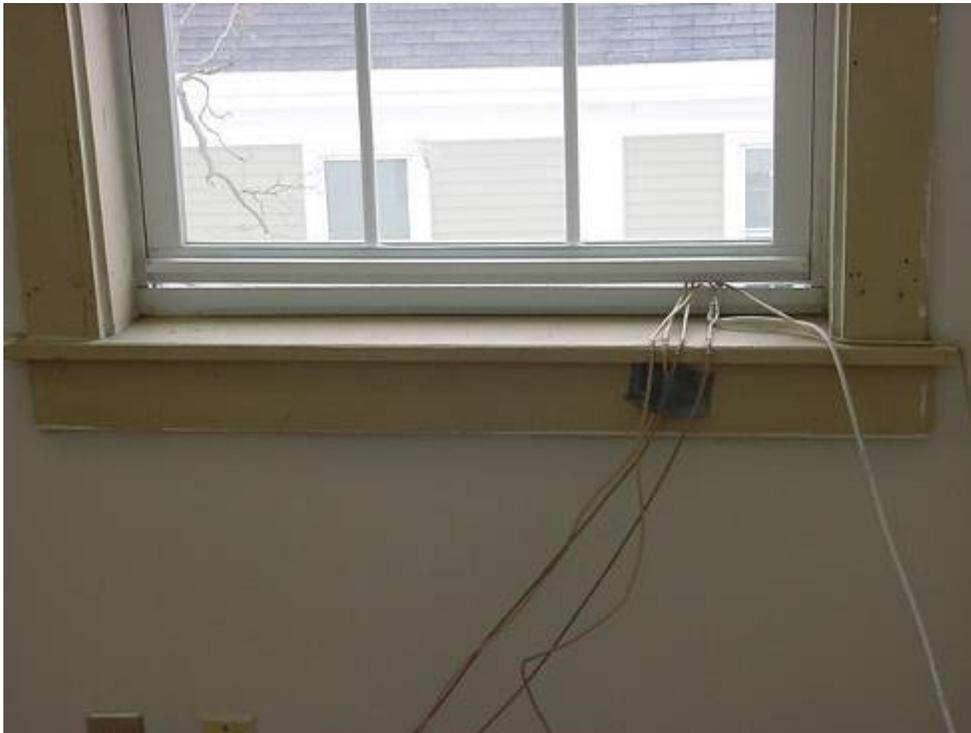
Picture 3

Another potential source of moisture was an open window observed in the former Recreation Director's office. It was reported that staff from this area were relocated to the building directly adjacent to the OB. To maintain communications, phone and other cables are fed through the window across the lawn and into the second floor window of the building next door (Picture 3). Although this configuration appears to be temporary, the windows cannot be shut completely which can provide a source for drafts, moisture and pest entry.

Wires/Cables Fed out Window in Former Recreation Office over to Adjacent Building

16. Seal around windows and plywood plugs, as shown in Picture 10, to eliminate drafts/moisture/pest entry.
 17. As a temporary measure to prevent water penetration/pest entry, seal space from open window in former recreation office with duct tape.

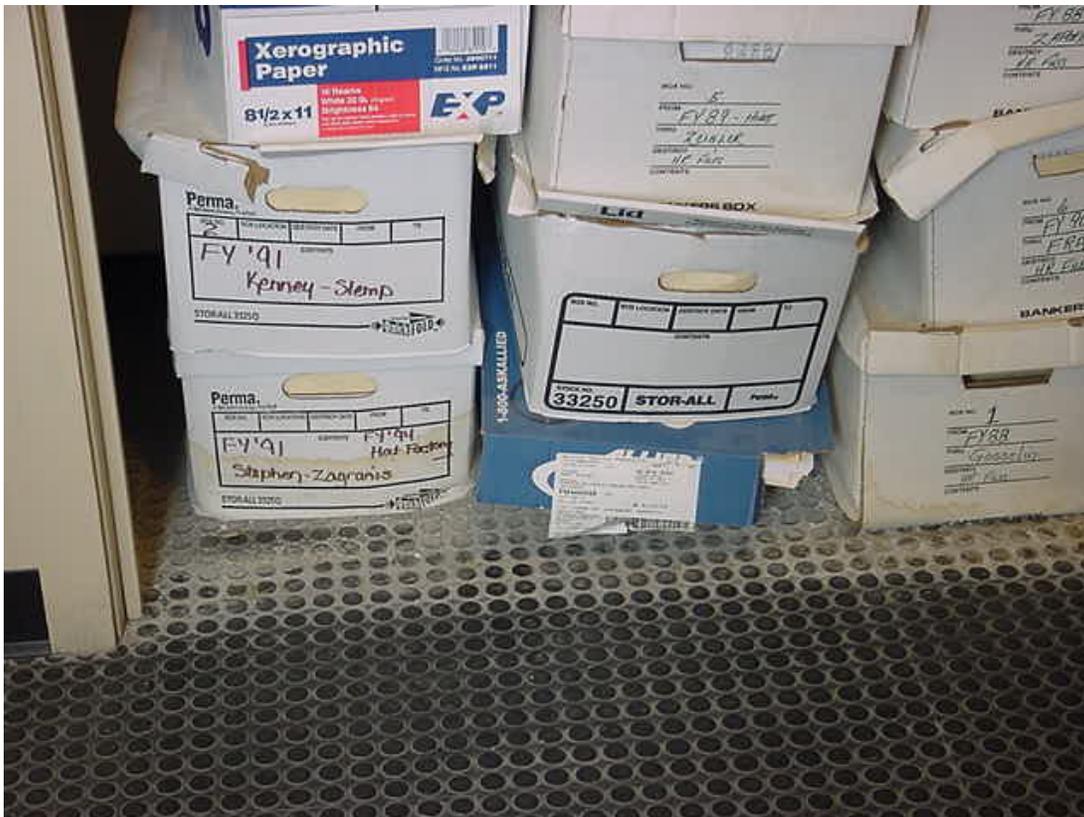
Picture 4

Water damaged boxes were observed stored on the floor in a second floor closet (Picture 4). These boxes and the materials stored therein should be inspected and discarded if moldy.

Water Damaged Boxes in Second Floor Stairwell Storage Closet

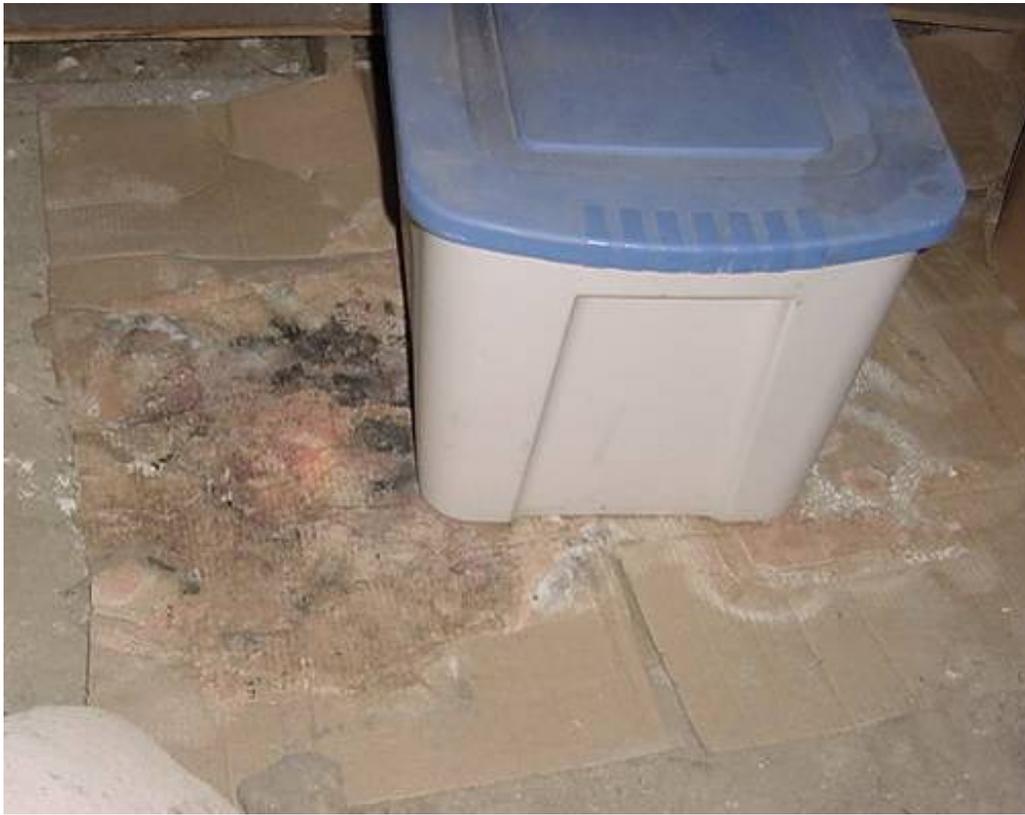
Picture 5

Visible mold growth was observed on porous materials stored in the basement crawlspace adjacent to the EOC (Pictures 5 and 6). The crawlspace is unfinished/unconditioned and is susceptible to elevated moisture conditions (e.g., >70%) during spring/summer months. Therefore is not an ideal space to store materials that are susceptible to mold growth such as paper or cardboard. Missing/damaged mortar around brick was observed in this area from which light could be seen penetrating (Picture 7). Breaches in the building envelope such as this can allow for the introduction of uncontrolled moisture into the crawlspace.

Mold Colonized Cardboard (as Indicated by Dark Stains) in Unfinished Crawlspace

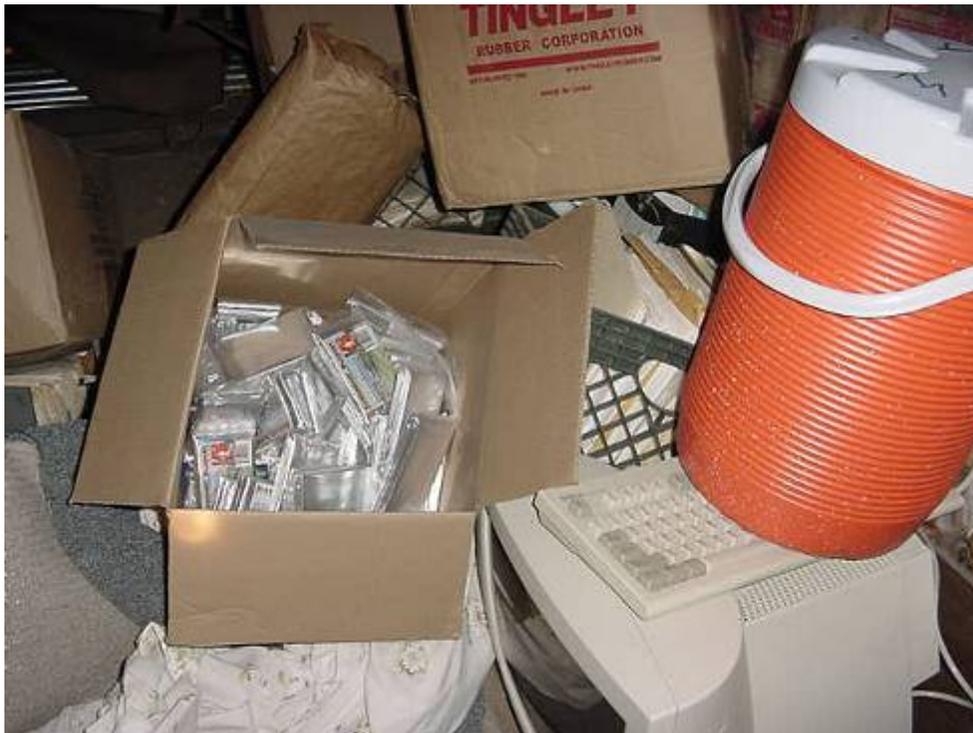
Picture 6

Cardboard Boxes, Paper Bags and Pieces of Carpeting Stored in the Unfinished Crawlspace

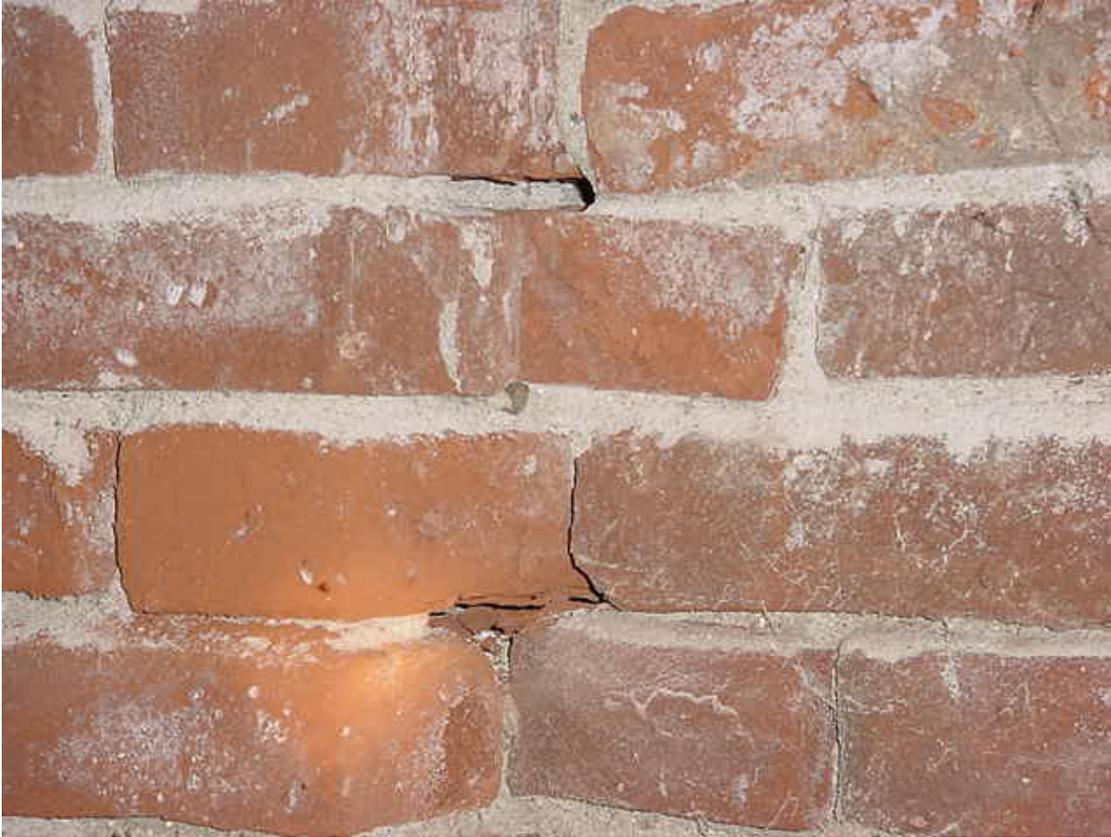
Picture 7

Missing/Damaged Mortar around Bricks through Which Light Could be Seen Penetrating, Picture Taken from Interior of Unfinished Crawlspace

- recommended. Drinking water during the day can help ease some symptoms associated with a dry environment (e.g. throat and sinus irritations).
15. Make any needed repairs to building envelope (e.g., repointing brick foundation) to prevent water infiltration and subsequent water damage.

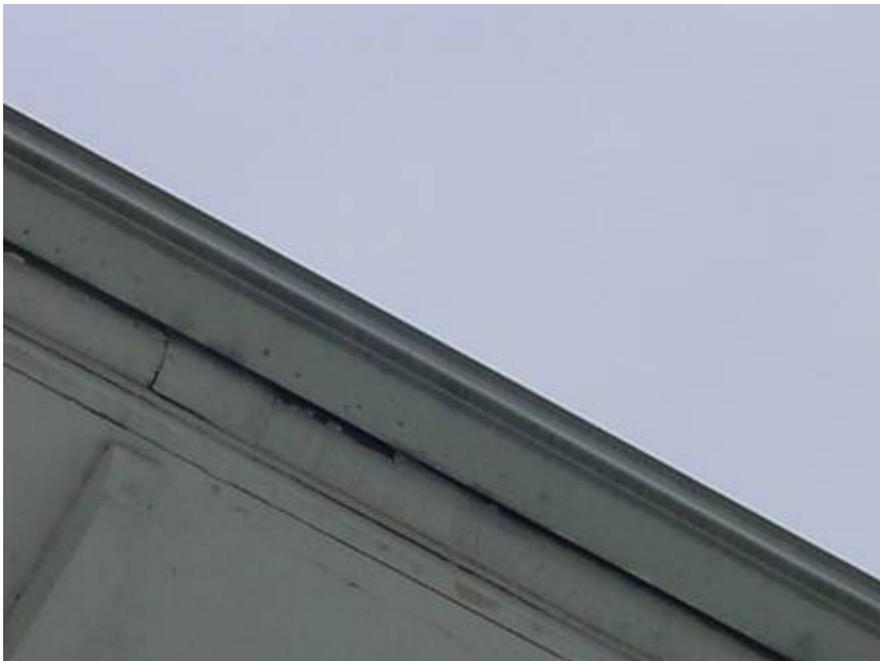
Picture 8

- Damaged/leaking gutters and downspouts (Picture 8),
- Damaged foundation masonry (Picture 9),
- Spaces around plywood plugs that are inserted in place of windows (Picture 10),
- Missing flashing/cladding (Picture 11), and
- Snow drifts against the exterior door (Picture 12), which can also inhibit emergency egress.

Water Dripping From Breaches on Underside of Gutter

18. Repair/replace missing/damaged gutters and downspouts to collect and drain water *away* from the building.
 19. Repair/replace missing flashing/cladding shown in Picture 11.

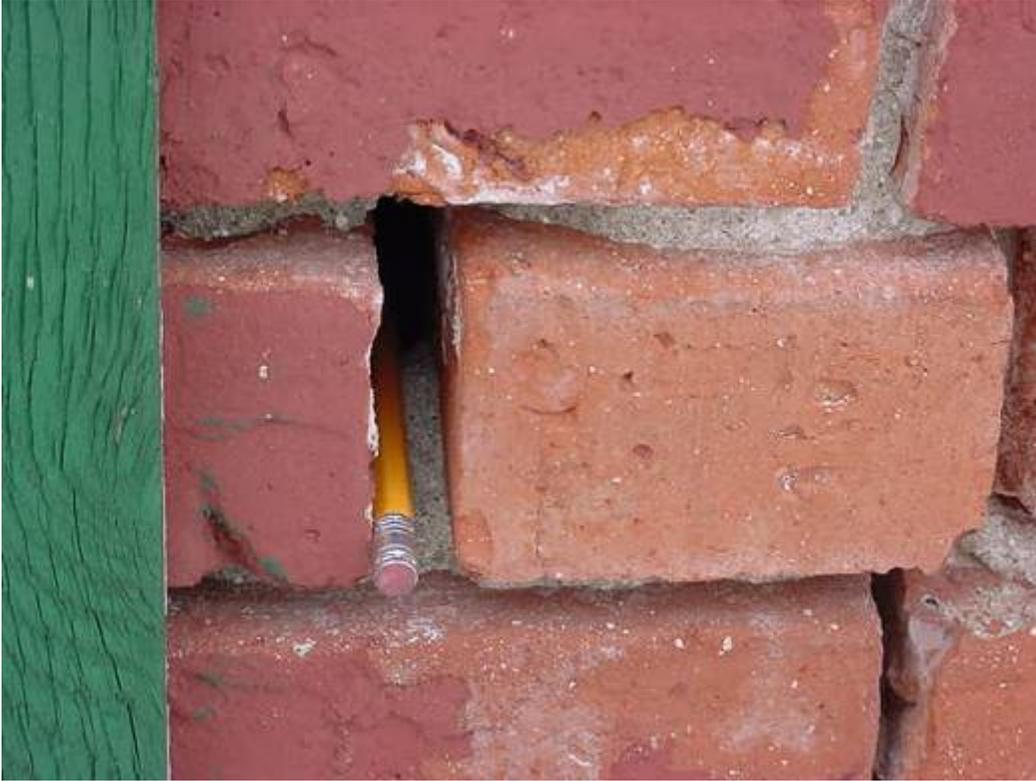
Picture 9

Missing/Damaged Mortar around Exterior Brick, Pencil Inserted by CEH Staff to Show Depth

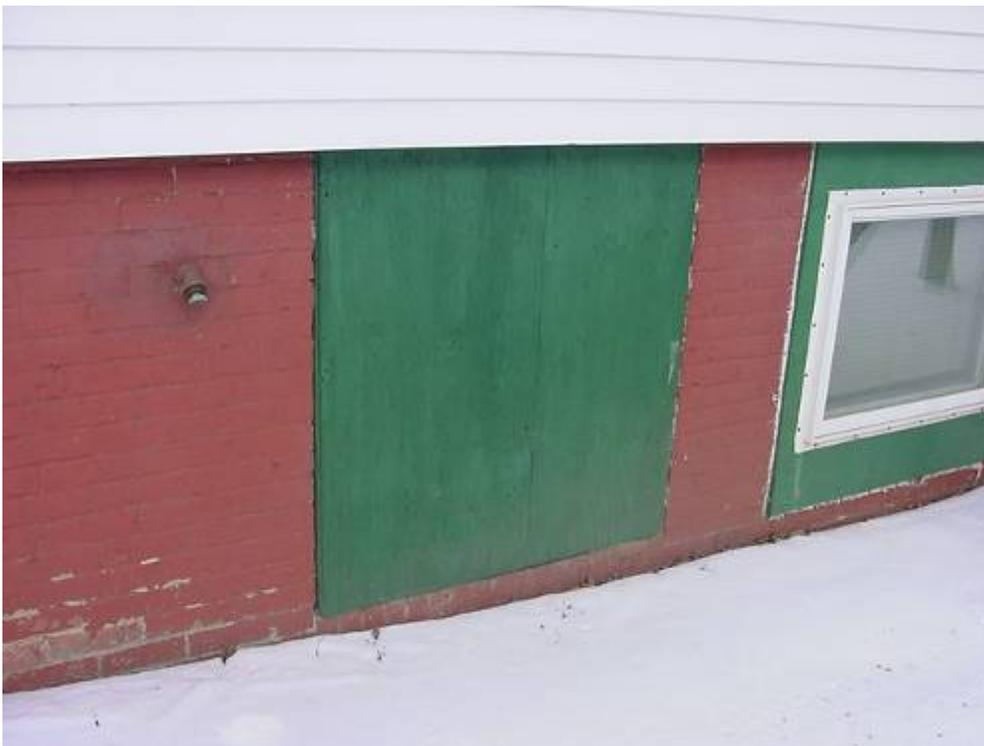
Picture 10

Spaces around Plywood Plugs Inserted in Windows

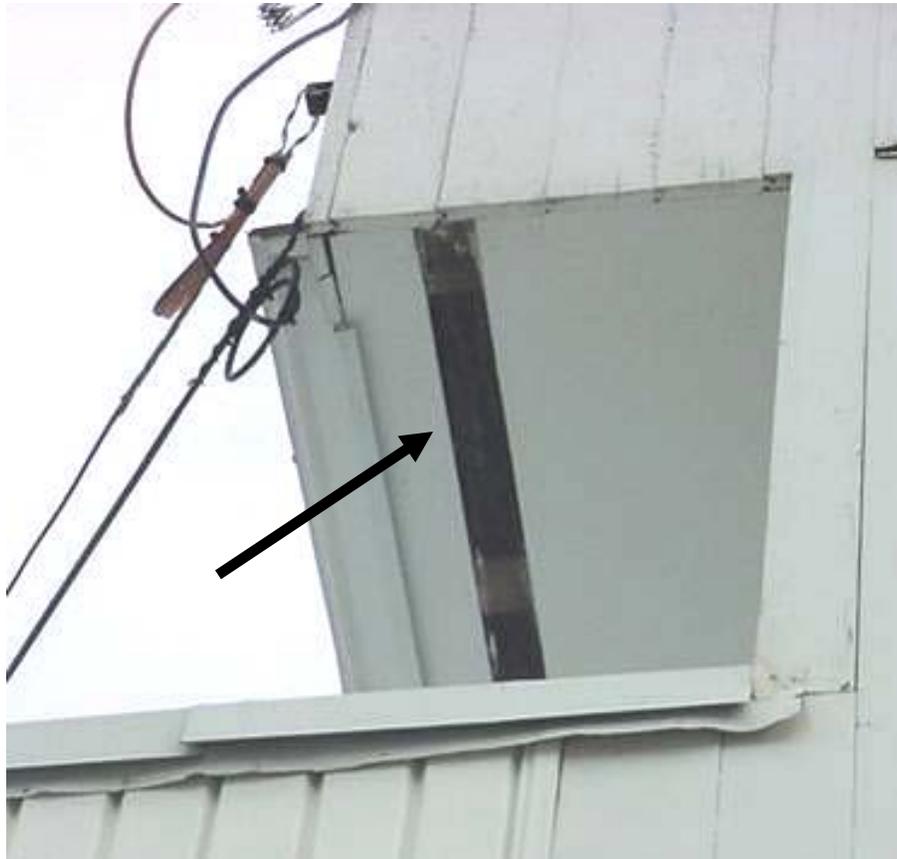
Picture 11

Missing Flashing/Cladding Exposing the Underside of the Building Exterior

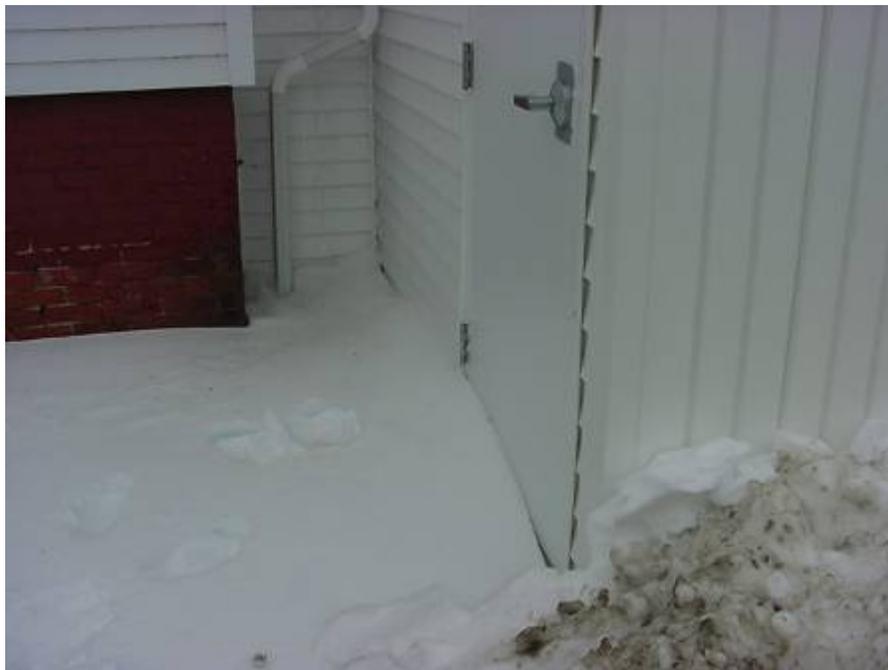
Picture 12

Snow Drift against Exterior Door

6. Ensure exterior doors are free from snow drifts to prevent water damage and to provide egress in the event of an emergency.
7. Install filter media in portable air conditioners and clean cooling fins prior to use.
Disinfect with an appropriate antimicrobial if necessary. If filtration media cannot be acquired consider replacing AC units.

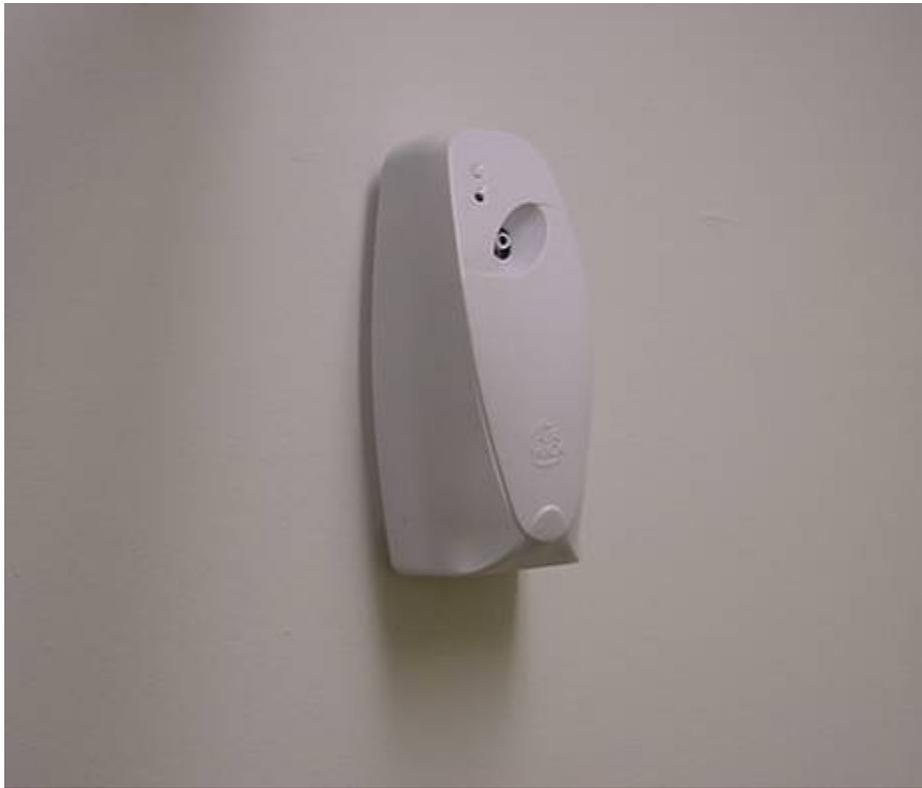
Picture 13

Several other conditions that can affect indoor air quality were noted during the assessment. Mechanical exhaust vents in restrooms on both the first and second floors were not operating at the time of the assessment. Exhaust ventilation is necessary in restrooms to remove moisture and to prevent restroom odors from penetrating into adjacent areas. In addition restrooms had automatic air freshener dispersal units (Picture 13). These products contain chemicals that can be irritating to the eyes, nose and throat of sensitive individuals. Furthermore, air fresheners do not remove materials causing odors, but rather mask odors that may be present in the area.

Automatic Air Freshener Dispenser Unit in Restroom

20. Refrain from using strongly scented materials (e.g., air fresheners).
 21. Consult “Mold Remediation in Schools and Commercial Buildings” published by the US EPA (US EPA, 2001) for further information on mold and/or mold clean up. Copies of this document are available from the US EPA:
http://www.epa.gov/iaq/molds/mold_remediation.html.

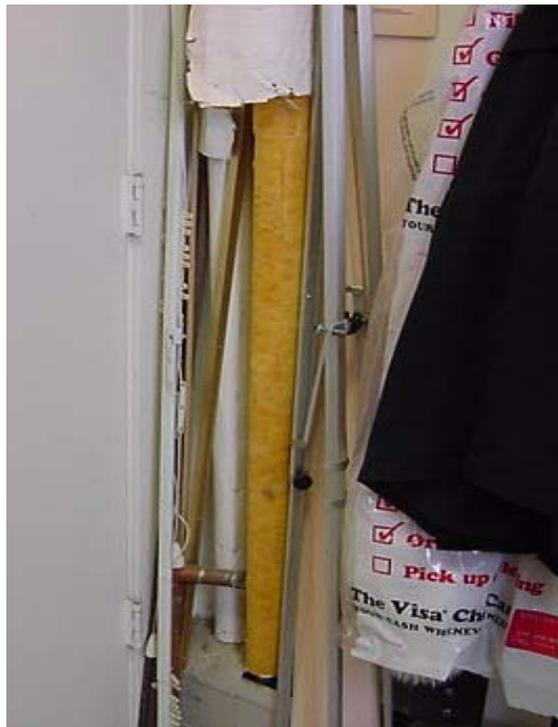
Picture 14

Exposed fiberglass insulation was observed around pipes in the ASC store room (Picture 14) and in the attic. Exposure to fiberglass can serve as a skin and respiratory irritant. In the case of the pipes they should be re-wrapped (Picture 15). To avoid exposure to fiberglass and other accumulated dust and particulates in the attic, the access hatch should be replaced. Open utility holes, missing outlet covers and spaces along floors were observed in several areas throughout the building (Pictures 16 through 18). These breaches can serve as a means for odors, dusts and particulates to migrate between rooms and floors.

Exposed Fiberglass Pipe Insulation in ASC Storage Room

10. Re-wrap exposed fiberglass insulation around pipes in the ASC storeroom.
11. Replace attic access hatch.
12. Use windows as designed to provide air exchange. Care should be taken to ensure windows are properly closed at night and on weekends to avoid the freezing of pipes and potential flooding.

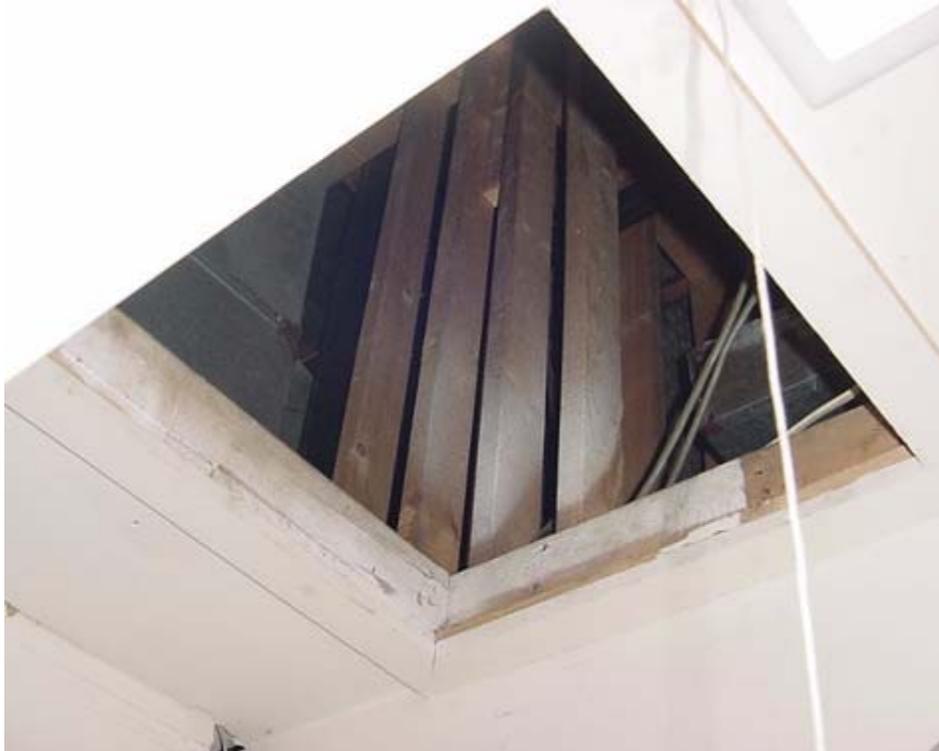
Picture 15

Open Access Hatch to Attic

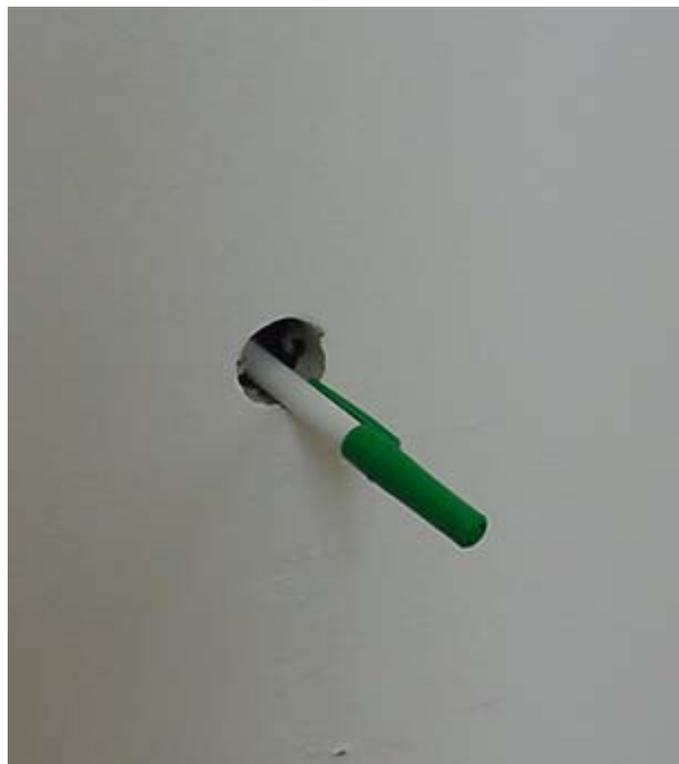
Picture 16

Open Hole in Wall in Second Floor Office, Pen Inserted by CEH Staff to Show Depth

8. Replace water damaged subfloor in recreation room to avoid a tripping/safety hazard.
9. Seal utility holes, spaces around floors and replace missing outlet covers to eliminate paths of odor/particulate migration from wall/floor cavities into occupied areas.

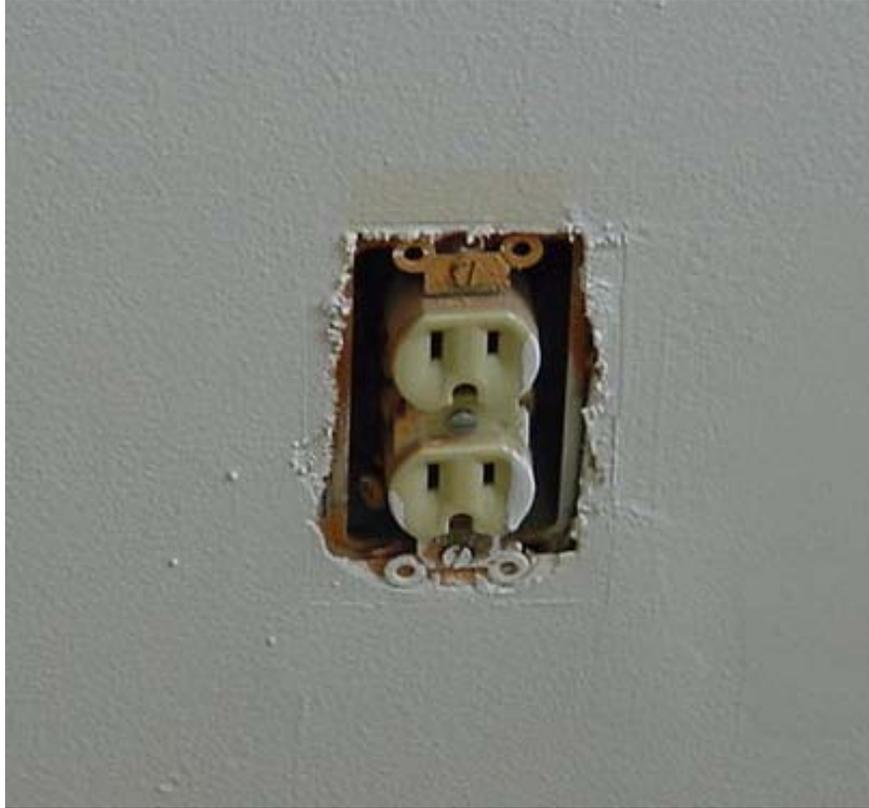
Picture 17

Missing Outlet Cover on Second Floor

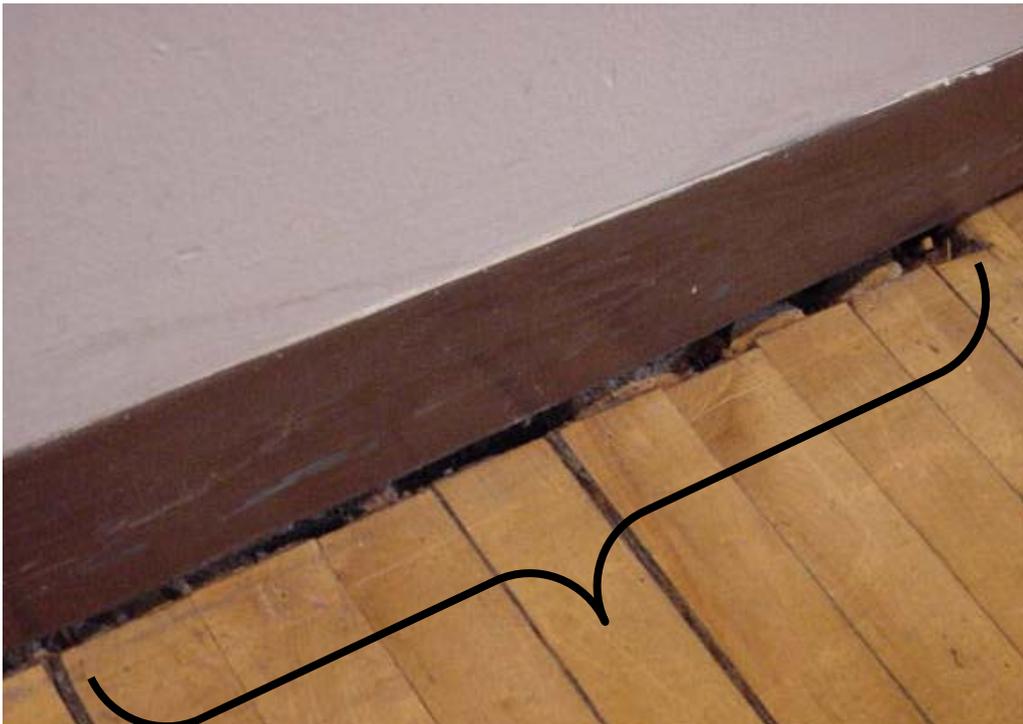
Picture 18

Open Spaces between Floor and Wall (Second Floor)
