INDOOR AIR QUALITY ASSESSMENT

**Ipswich Town Hall
25 Green Street
Ipswich, Massachusetts**

Prepared by:
Massachusetts Department of Public Health
Bureau of Environmental Health
Indoor Air Quality Program
September 2007

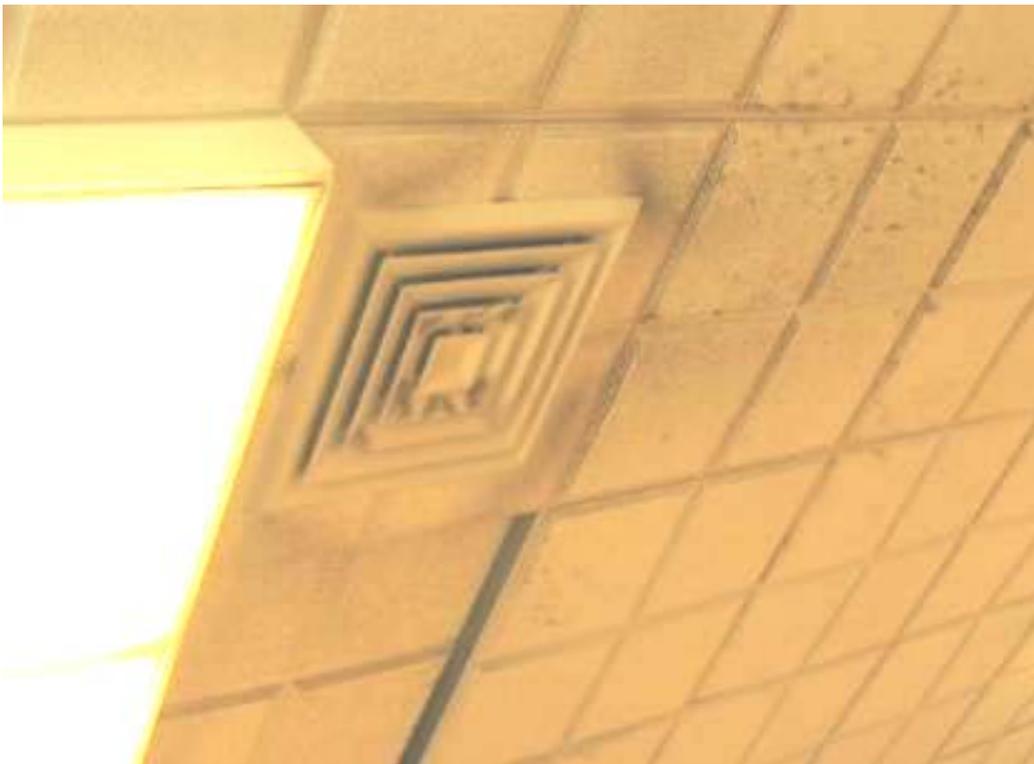
Picture 4

A number of personal fans, supply and return vents and had accumulated dust (Pictures 4 and 25). Accumulated dust and cobwebs were observed in rooms G-12 and G-15. Fans can aerosolize dust and particulates when activated. Settled dust can provide a source of eye and respiratory irritation when re-aerosolized.

Ceiling-Mounted Air Diffuser, Note Dust/Debris on Vent Louvers and on Adjacent Ceiling Tiles

11. Clean personal fans, supply and exhaust vents regularly of accumulated dust. Clean or change soiled ceiling tiles around these vents (e.g., Teen Center).

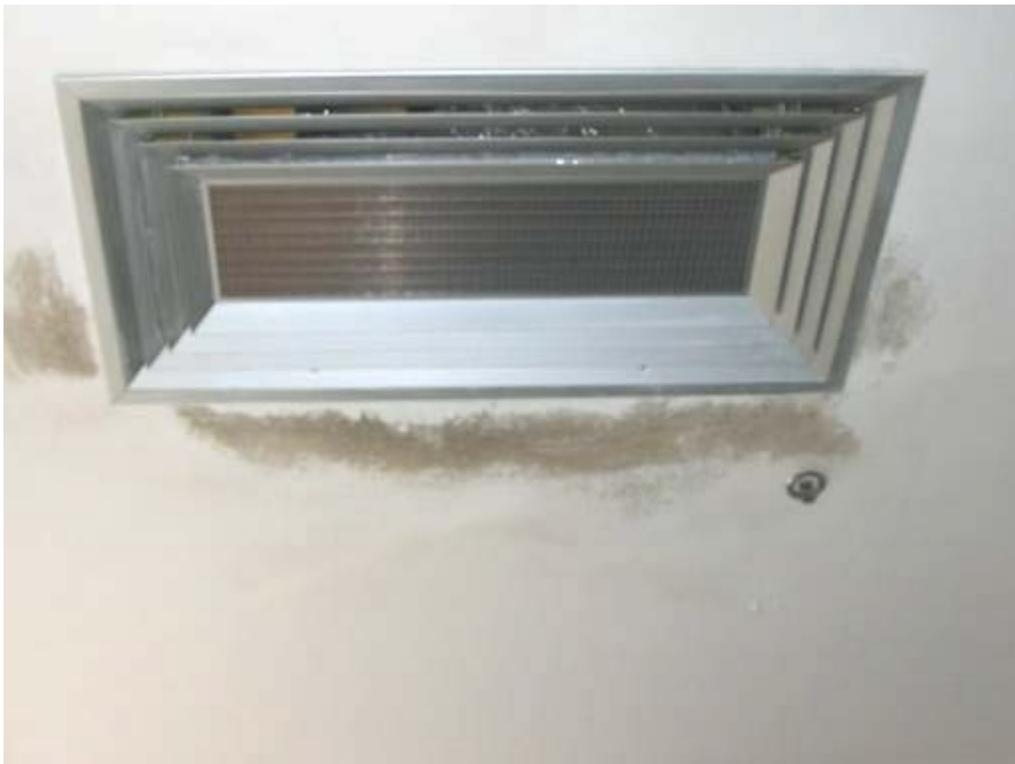
Picture 6

During the assessment, BEH staff observed what appeared to be visible mold growth on the surface of painted ceiling plaster surrounding a metal air diffuser in the computer room of the finance area (Picture 6). Plaster is a non-porous surface constructed of materials that are not likely to be colonized by mold. However, the paint covering the plaster is a carbon-based material that can support mold growth if exposed to moisture for extended periods of time. BEH staff removed a section of the peeling paint from the plaster ceiling. The suspected mold growth appeared to be limited to the surface of the paint.

In order for building materials to support mold growth, a source of moisture is necessary. Should building materials become wet, identifying and eliminating the water source moistening building materials is necessary to control mold growth. According to Mr. Dorr, the source of moisture wetting the ceiling of the computer room was likely condensation generated from heat blowing out of a supply vent and directly against the computer room AC vent, which operates year round (Picture 7). To prevent this reoccurrence, Mr. Dorr sealed the heat vent, which should eliminate the source causing condensation.

The source of moisture resulting in mold growth in the computer room was identified as most likely being condensation. Mitigation measures taken by Mr. Dorr to seal the heat vent so as not to direct hot air onto the air conditioning vent should eliminate the source of moisture, thus preventing further mold growth. In view of the findings at the time of the visit, the following recommendations are made:

Suspected Mold Growth on Painted Ceiling Plaster in Computer Room 216

1. Remove mold-contaminated paint on ceiling of computer room. Mold should be remediated in a manner consistent with recommendations in “Mold Remediation in Schools and Commercial Buildings” published by the US Environmental Protection Agency (US EPA, 2001). Copies of this document can be downloaded from the US EPA website at: http://www.epa.gov/iaq/molds/mold_remediation.html.

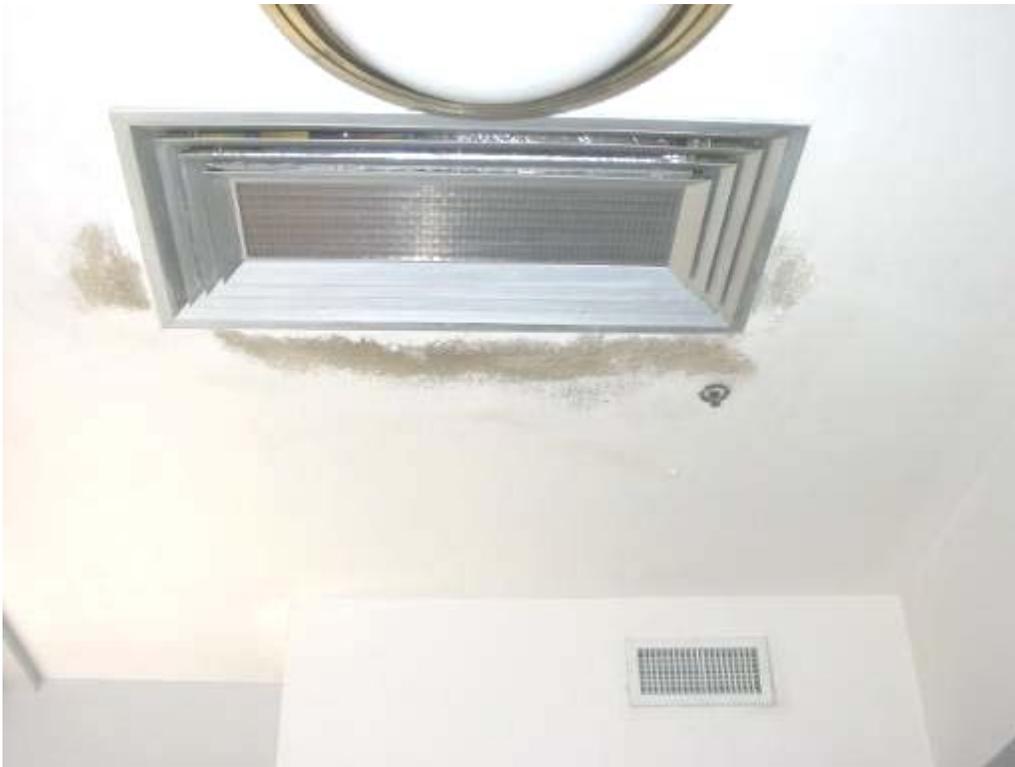
Picture 7

Proximity of Heat Vent (Background) to AC Vent (Foreground/Center)

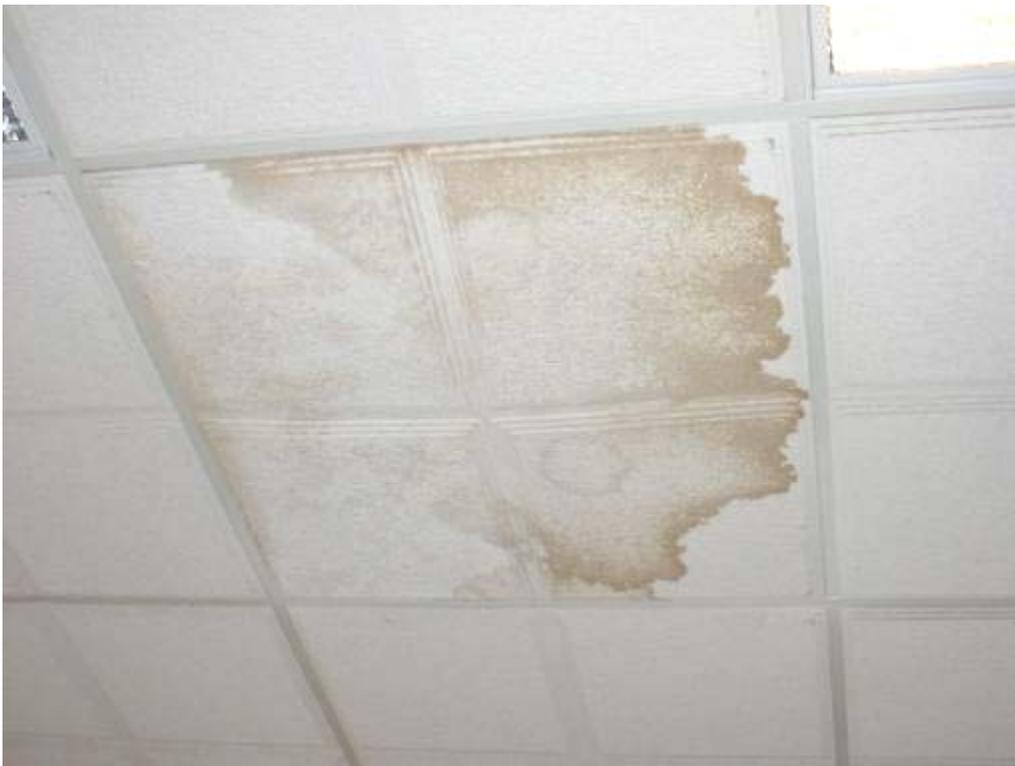
Picture 8

Water-damaged ceiling tiles were observed in a few areas (Picture 8), indicating evidence of historic leaks. Water damaged ceiling tiles can provide a source of mold and should be replaced after a water leak is discovered and repaired.

Water Damaged Ceiling Tiles

2. Replace any remaining water-stained ceiling tiles. Examine the areas above and around these areas for microbial growth.
3. Seal breaches, seams and spaces between sink countertop and backsplash in lunchroom and G-12 to prevent water damage/mold growth.

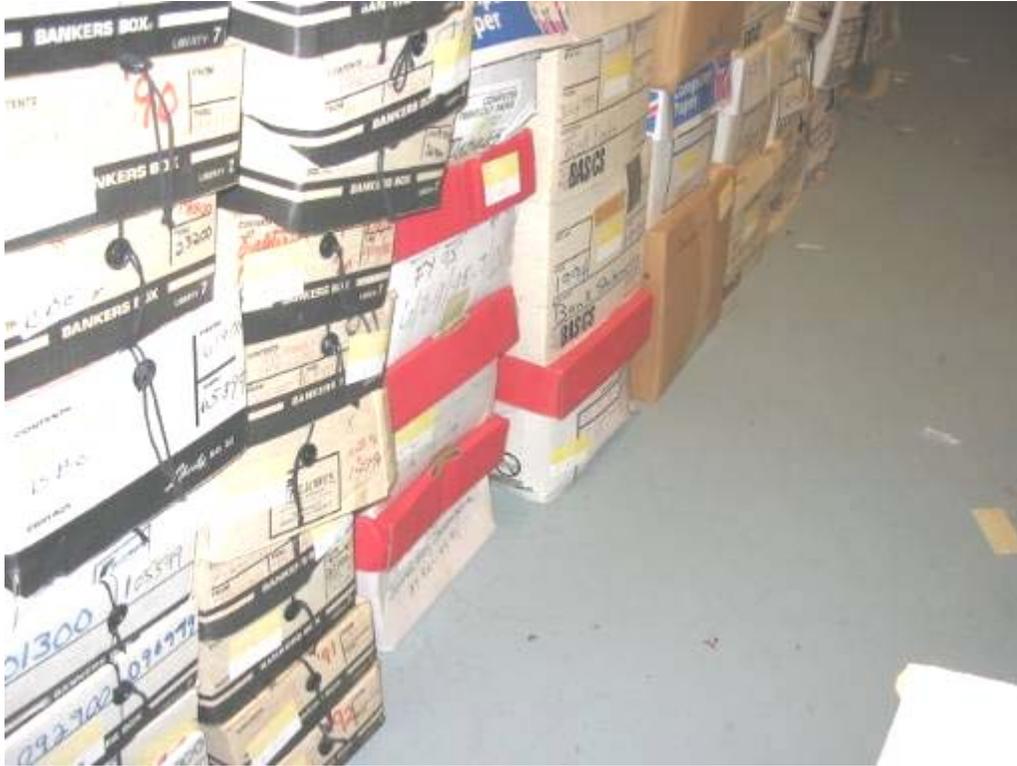
Picture 9

CEH staff observed a number of cardboard boxes and other porous items stored on the floor of basement storage room G-15 (Picture 9). These items should be elevated (e.g., placed on pallets, tables) to prevent moisture/water damage and potential mold growth. Such

Cardboard Boxes Stored Directly on Concrete Floor

6. Seal utility holes in exterior walls to eliminate paths of migration for drafts, moisture and pests into the building.
7. Refrain from storing porous materials (e.g., cardboard boxes) directly on floor of storage rooms. Inspect and discard any water damaged cardboard boxes. Disinfect any areas of

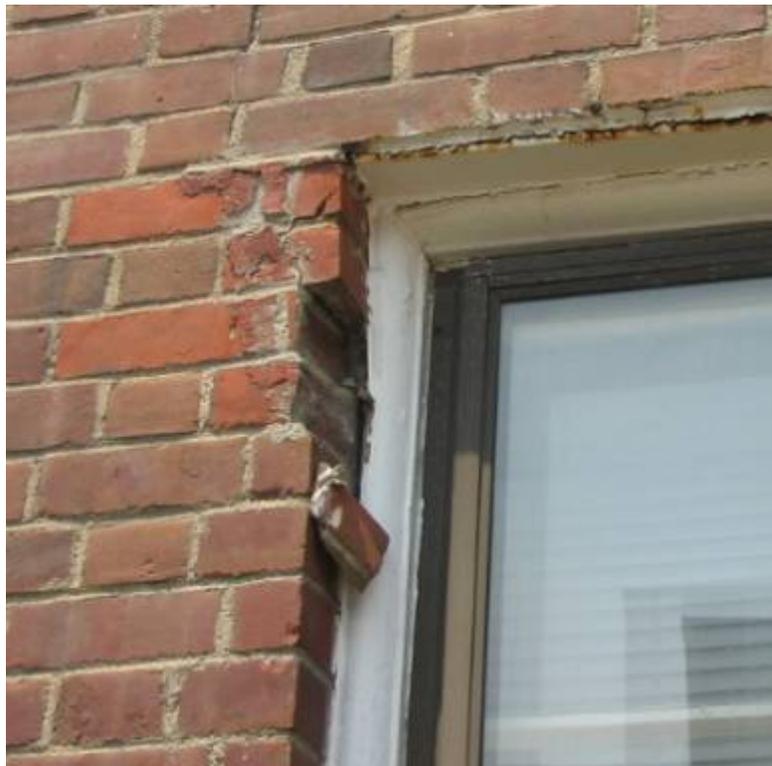
Picture 10

- Missing/damaged mortar and cracks in exterior brick/stone (Pictures 10 through 15);
- Damaged window frames (Picture 16);
- “Bowling” of exterior brick walls (Pictures 17 and 18);
- Open utility holes (Pictures 19 and 20);
- Plant growth in close proximity to air intakes and exterior walls (Pictures 11 and 21);
and
- Clinging plant growth on exterior walls (Picture 22). Clinging plants can cause water damage to brickwork through insertion of tendrils into brick and mortar. Water can penetrate into the brick along the tendrils. Water trapped in brick can subsequently freeze and thaw during the winter. This freezing/thawing action can weaken bricks and mortar, resulting in wall damage.

Damaged Brickwork around Window Frame

1. Consider having exterior walls re-pointed and waterproofed to prevent water intrusion.
2. Contact a structural engineer/building envelope specialist for an examination of the exterior brick work of the building, especially in areas where the exterior wall is “bowing” outwards. This measure should include a full building envelope evaluation.

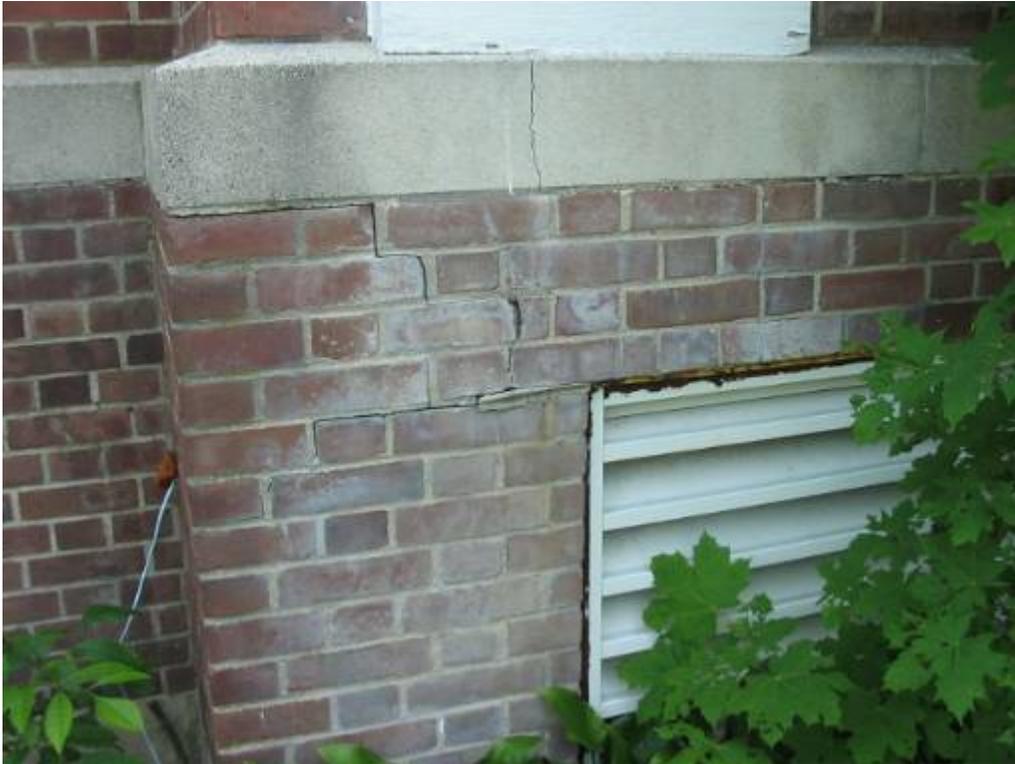
Picture 11

Damaged Brick, Missing/Damaged Mortar, Also Note Plant Growth near Air Intake

4. Remove clinging plants from exterior brick.
5. Trim or relocate plant growth in close proximity to air intakes as needed to prevent the entrainment of mold, pollen and/or particulates into the ventilation system.

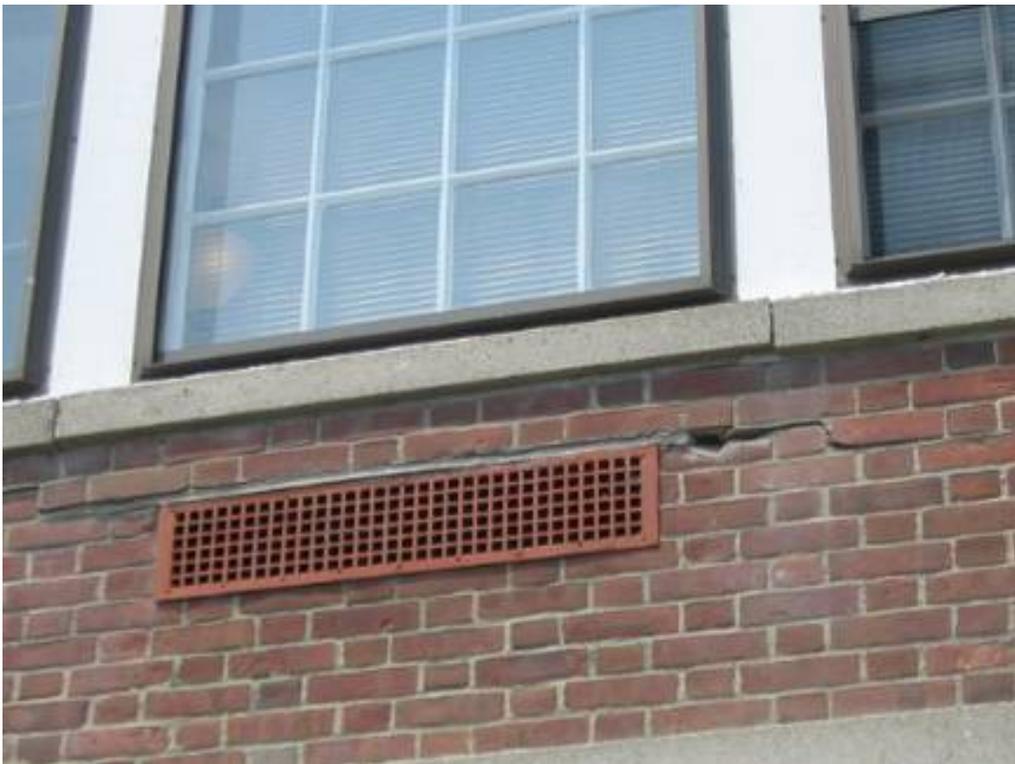
Picture 12

Damaged Brick near (Former) Intake Vent

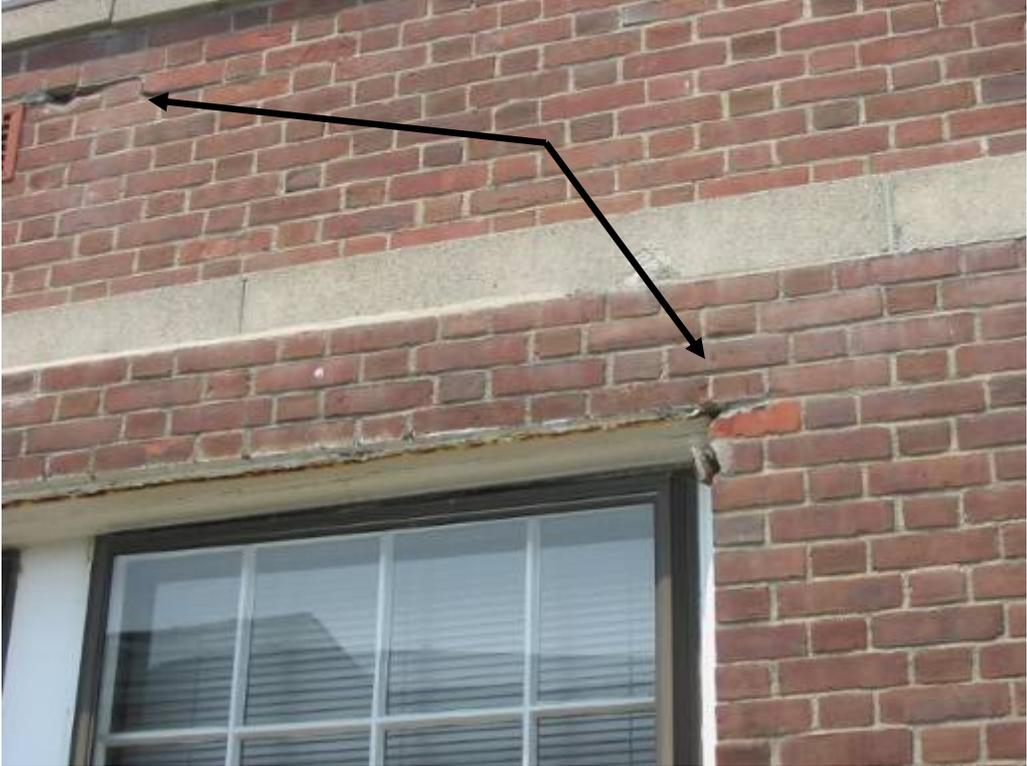
Picture 13

Damaged Brickwork

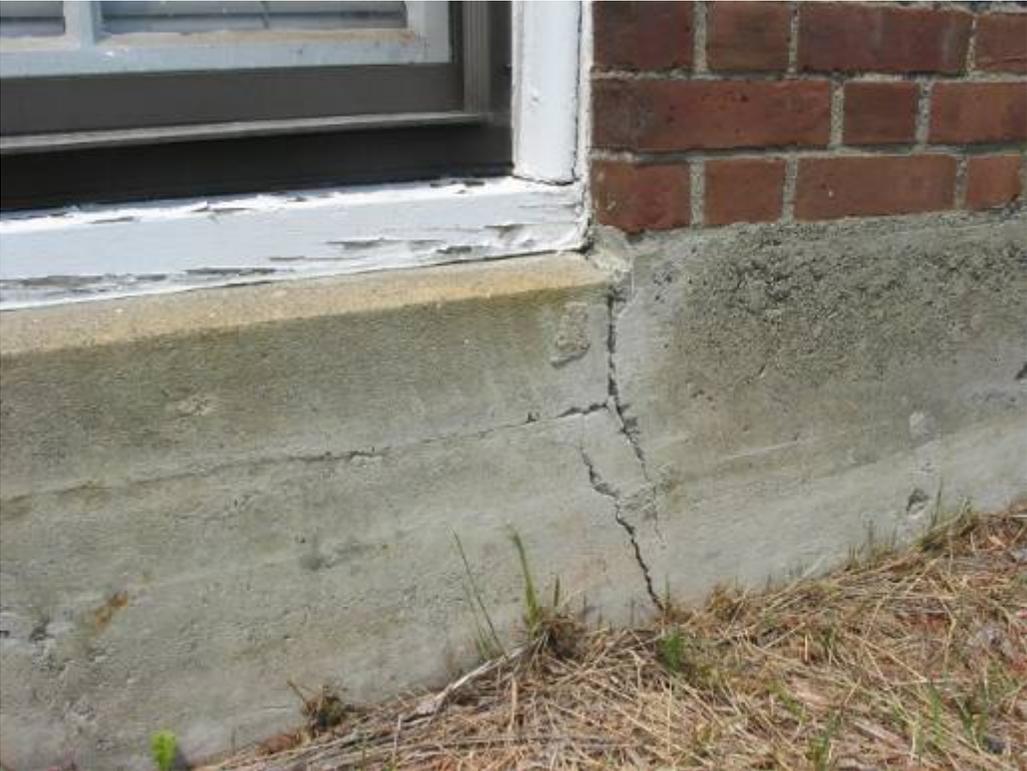
Picture 14

Damaged Cement Foundation

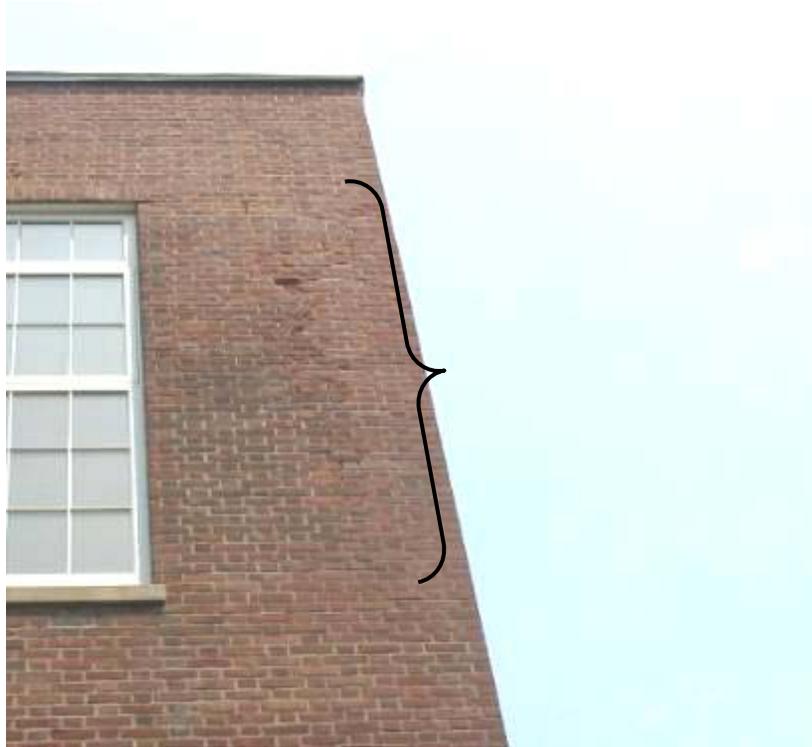
Picture 15

Damaged Brickwork

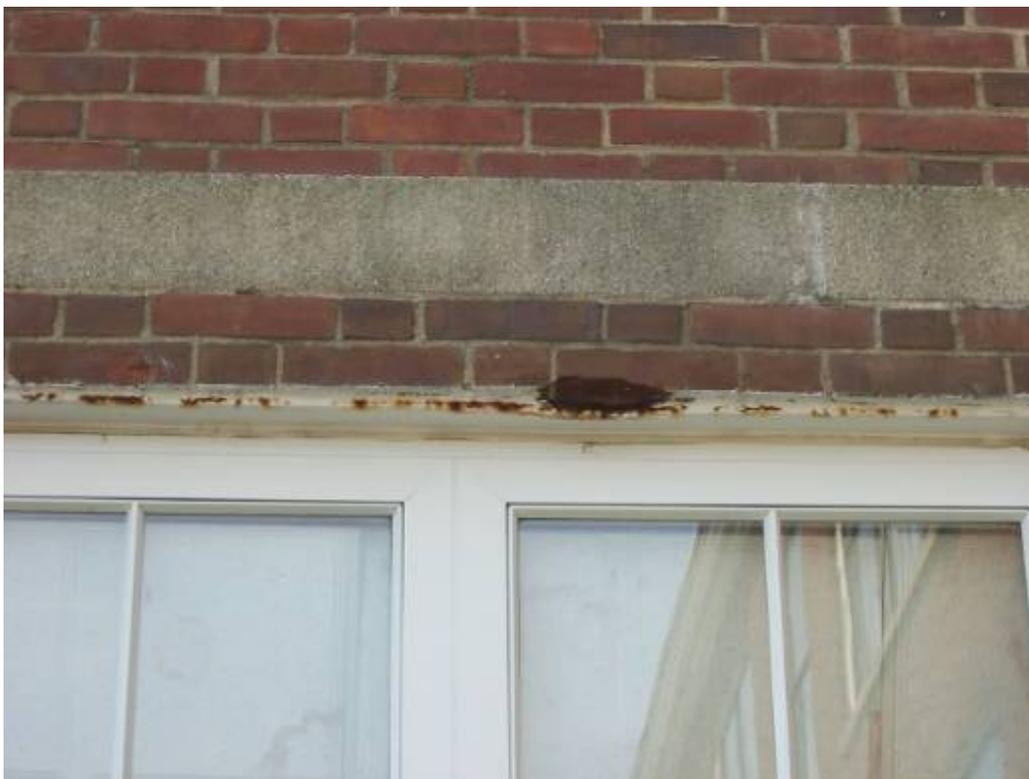
Picture 16

Damaged Brick/Window Frame

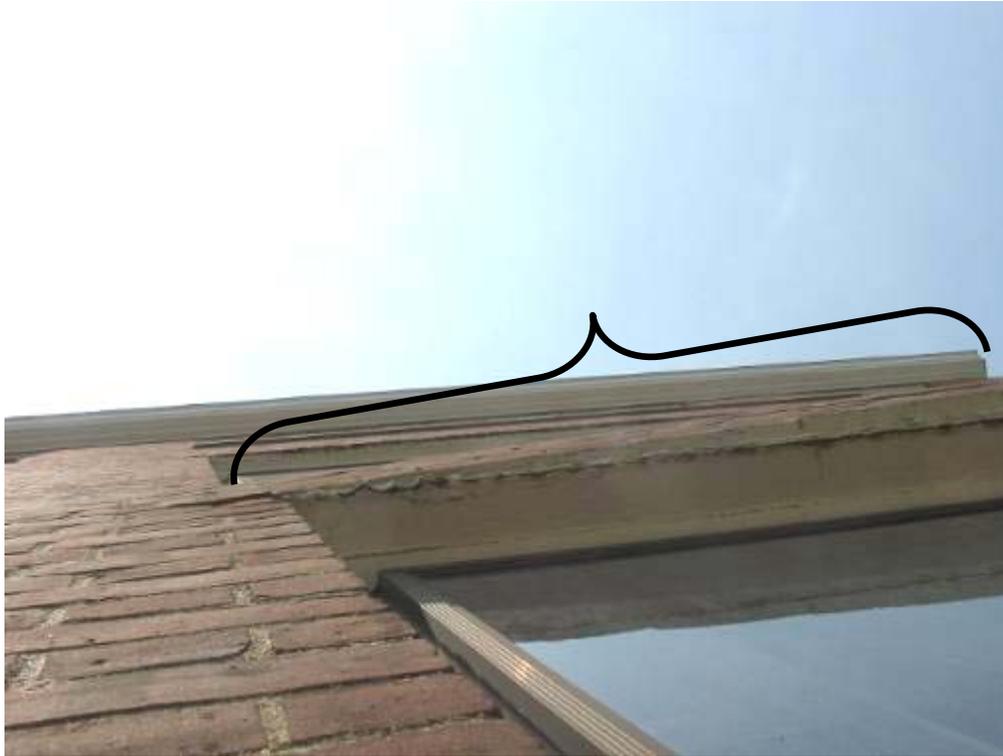
Picture 17

Of particular note is the “bowling” of portions of the exterior wall at the rear of the building, which may raise questions regarding the building's structural integrity. These breaches to the building envelope can allow water to penetrate the building. Repeated water penetration can result in the chronic wetting of building materials and potential microbial growth. In addition, these breaches may also provide a means of egress for pests/rodents into the building.

“Bowling” Exterior Brick Wall

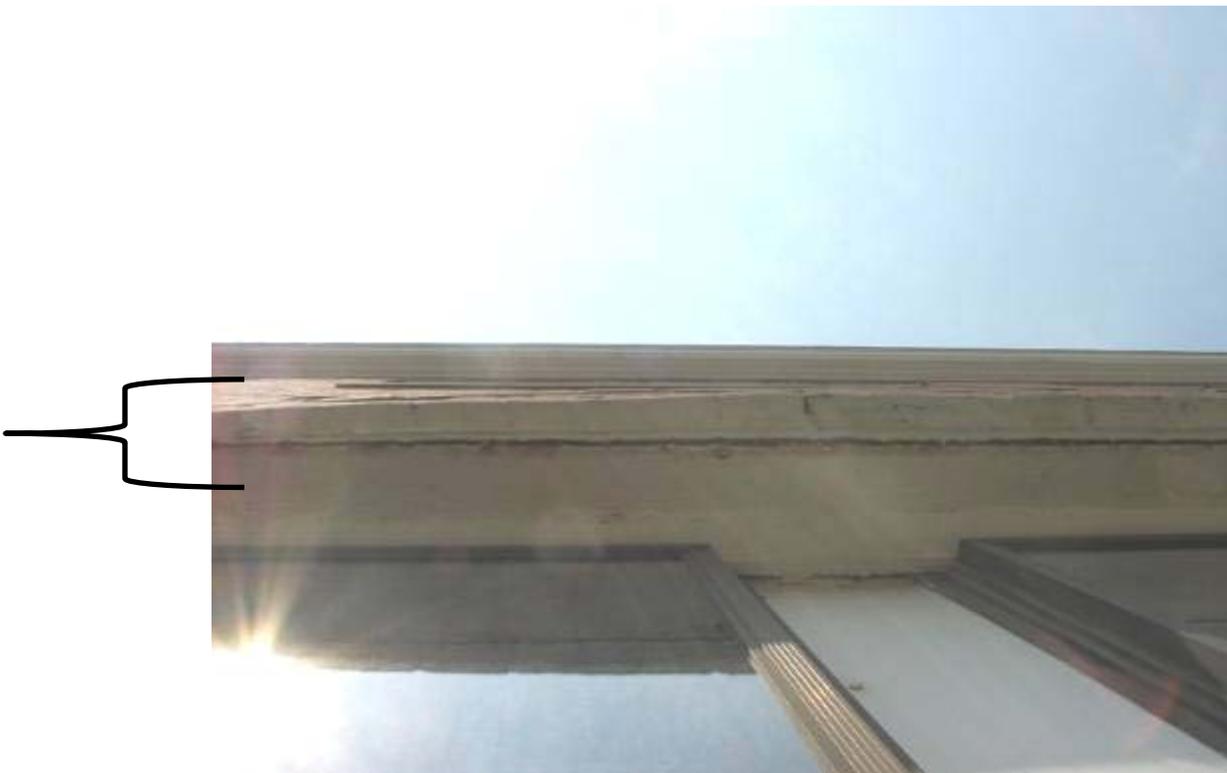
Picture 18

“Bowling” Exterior Brick Wall

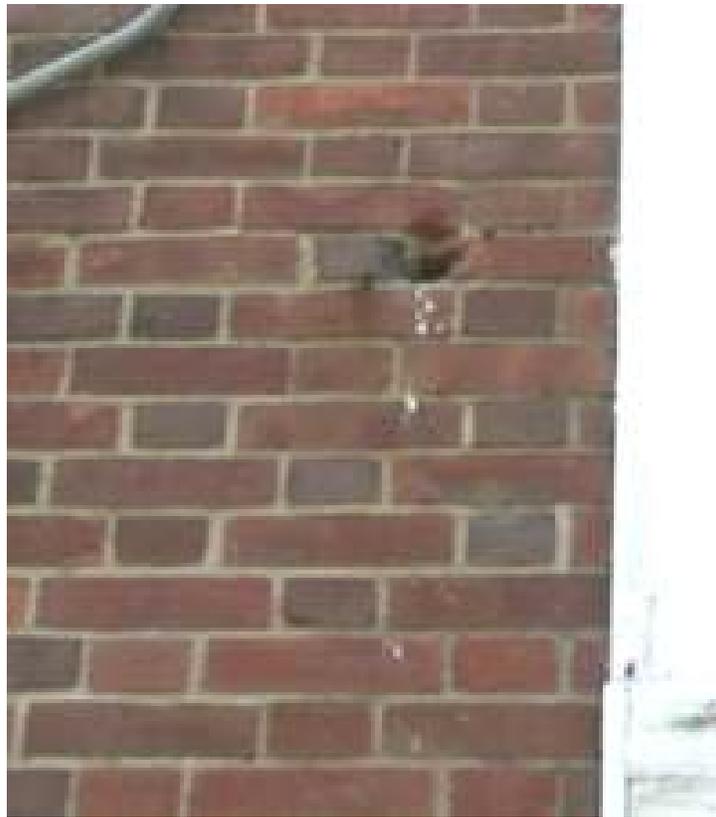
Picture 19

Open Utility Hole, Note Bird Waste (White Material) beneath Hole on Exterior Brick

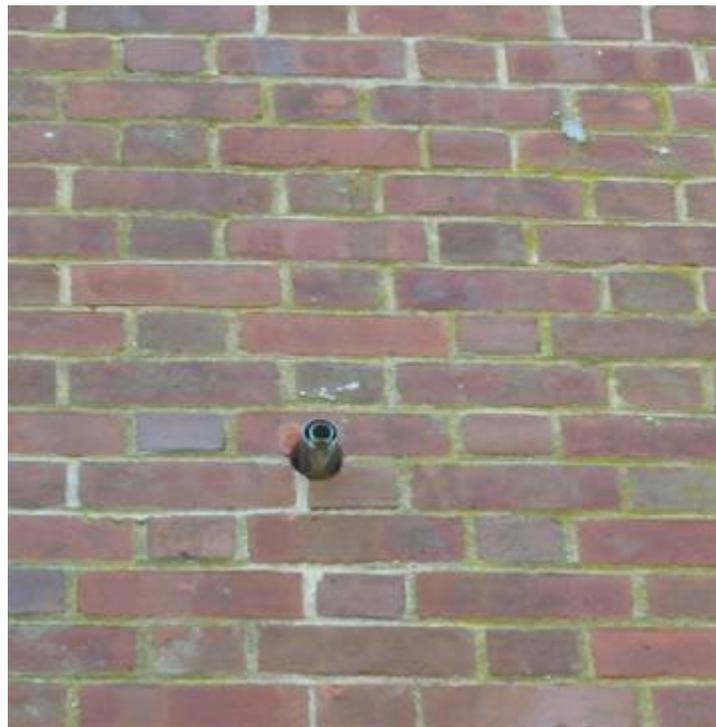
Picture 20

Open Utility Hole

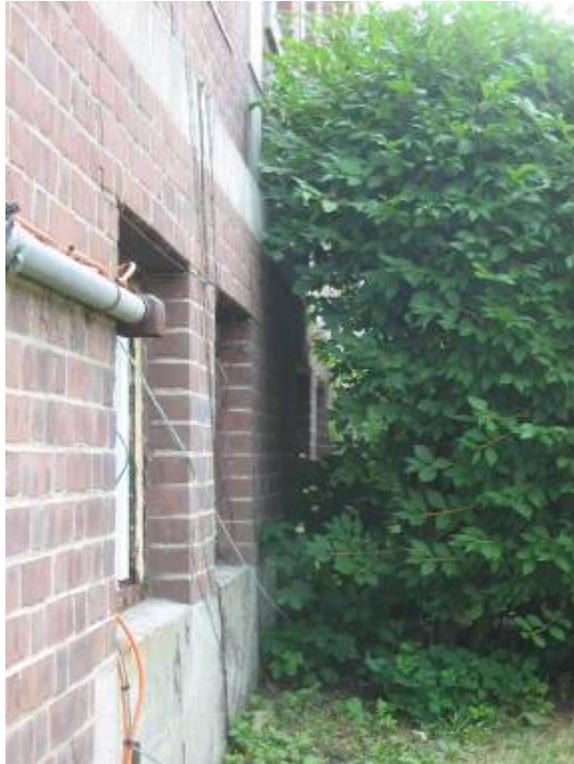
Picture 21

Plant Growth against Exterior Wall

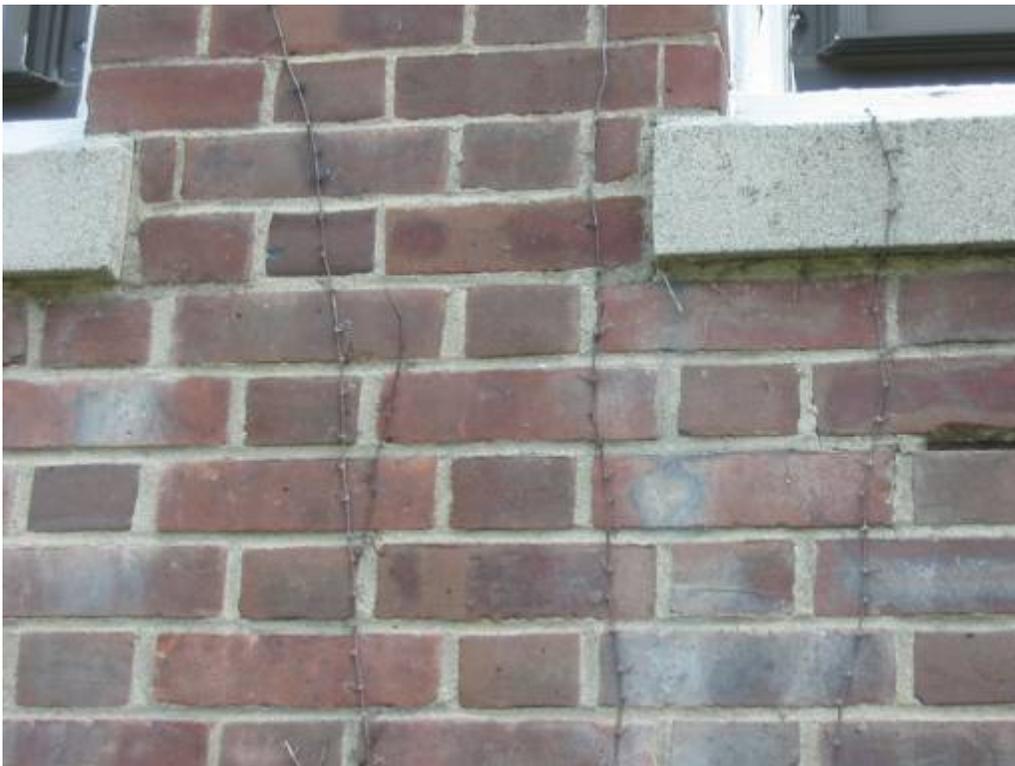
Picture 22

Clinging Plants on Exterior Wall

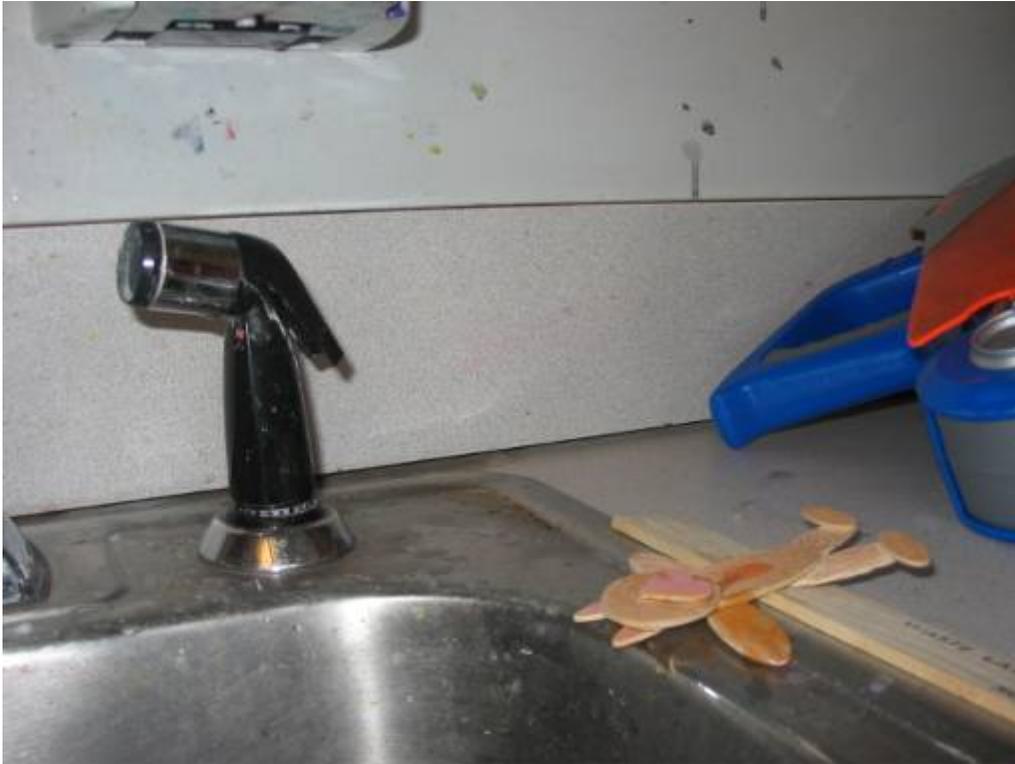
Picture 23

Breaches were observed between the counter and sink backsplashes in the lunchroom and in G-12 (Picture 23). If not watertight, water can penetrate through these seams. Water

penetration and chronic exposure of porous and wood-based materials can cause these materials to swell and show signs of water damage.

Spaces between Sink Countertop and Backsplash

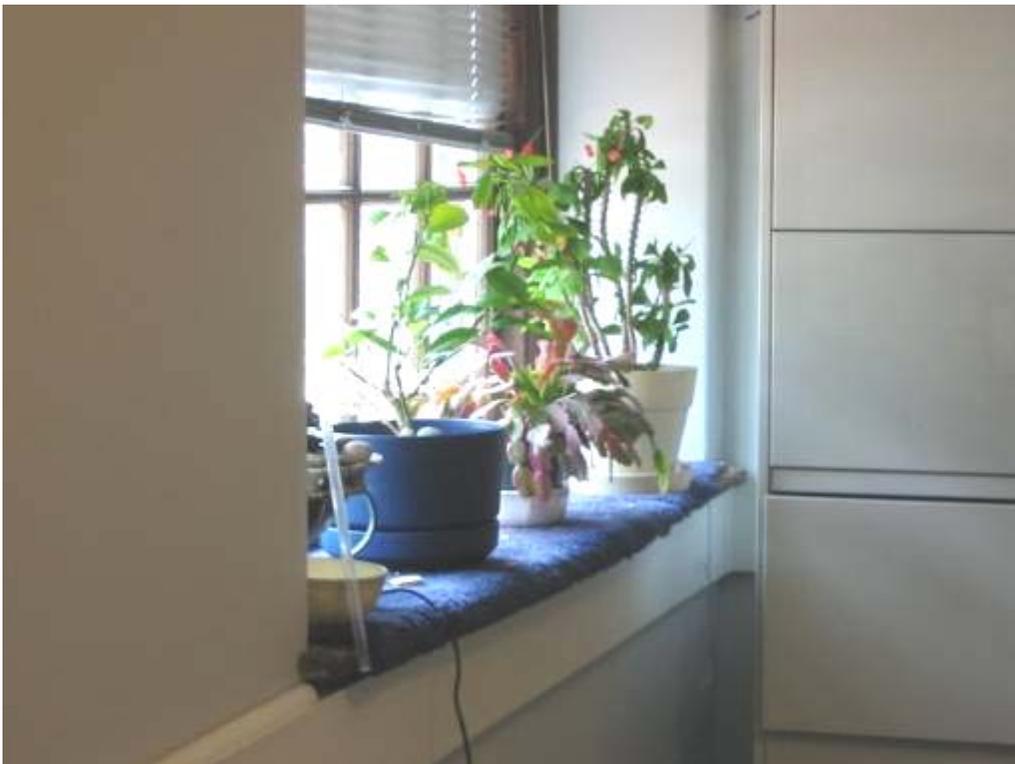
Picture 24

Plants were observed in several areas. In one case plants were placed on top of a section of carpeting, which is a porous material that can absorb moisture (Picture 24). Plants should be properly maintained and equipped with drip pans. Plants should be located away from ventilation sources to prevent aerosolization of dirt, pollen or mold. Plants should not be placed on porous materials, since water damage to porous materials may lead to microbial growth.

Plants on Carpeting

8. Ensure all plants are equipped with drip pans. Examine drip pans for mold growth and disinfect areas of water leaks with an appropriate antimicrobial where necessary.
Remove carpet from beneath plants (Picture 24).

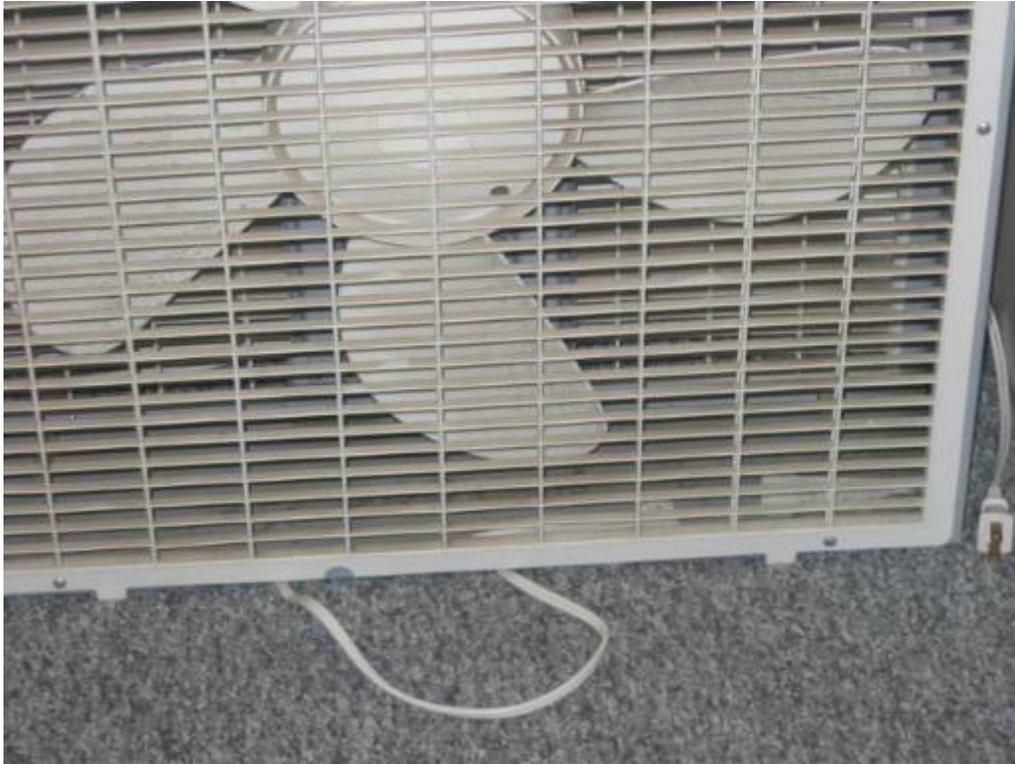
Picture 25

Accumulated Dust on Personal Fan Grates and Blades
