# **INDOOR AIR QUALITY ASSESSMENT**

**Leicester School Department  
Administration Building  
1078 Main Street  
Leicester, Massachusetts**

Prepared by:  
Massachusetts Department of Public Health  
Center for Environmental Health  
Emergency Response/Indoor Air Quality Program  
April 2007

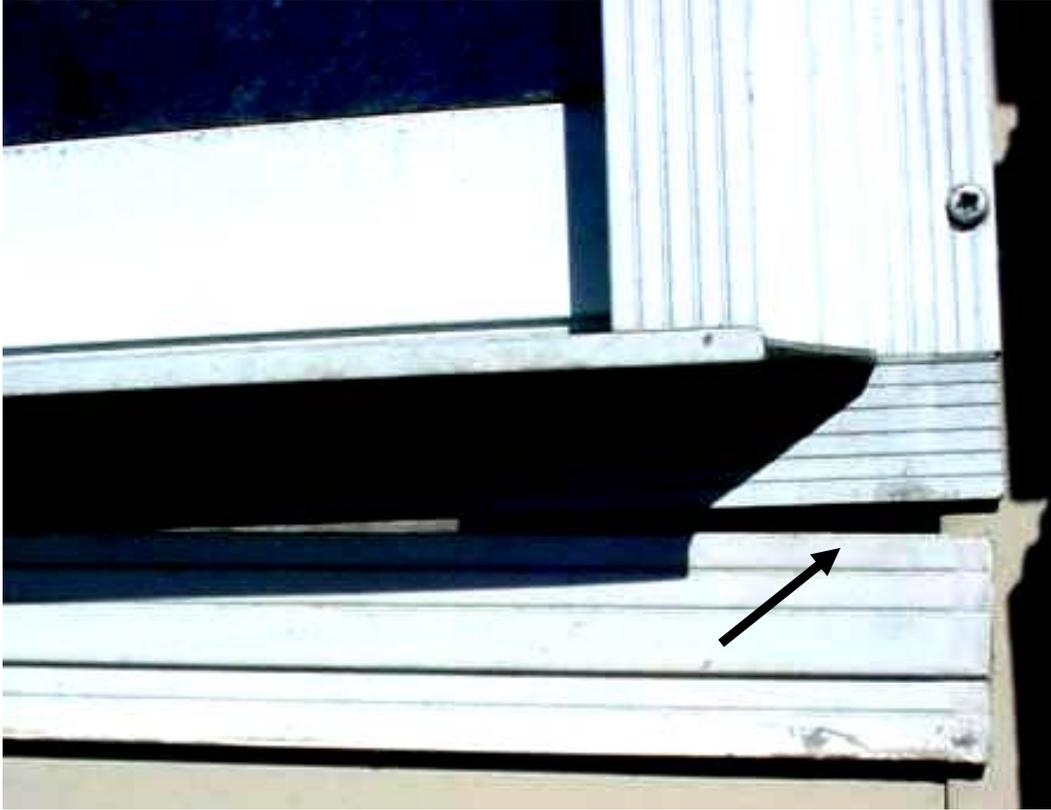
**Picture 1**

- A damaged/missing downspout (Picture 8).
- Missing/damaged mortar and cracks in exterior brick (Pictures 9 through 11).
- Spaces were also noted around flashing and in masonry around windows (Pictures 1, 2 and 11 and 12).
- Open holes in basement wooden window plug (Pictures 13 and 14).

**Exterior View of Spaces around Window Frames**

1. Consider having exterior walls re-pointed and waterproofed to prevent water intrusion. This measure should include a full building envelope evaluation.
2. Repair/replace loose windowpanes throughout the building.

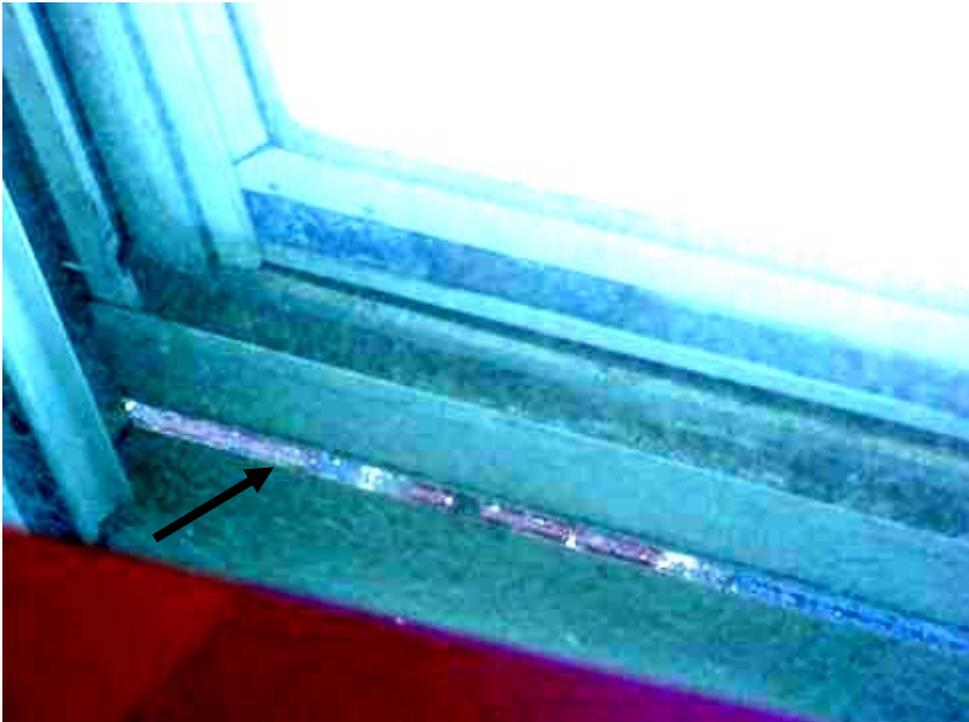
**Picture 2**

**Interior View of Spaces around Window Frames**

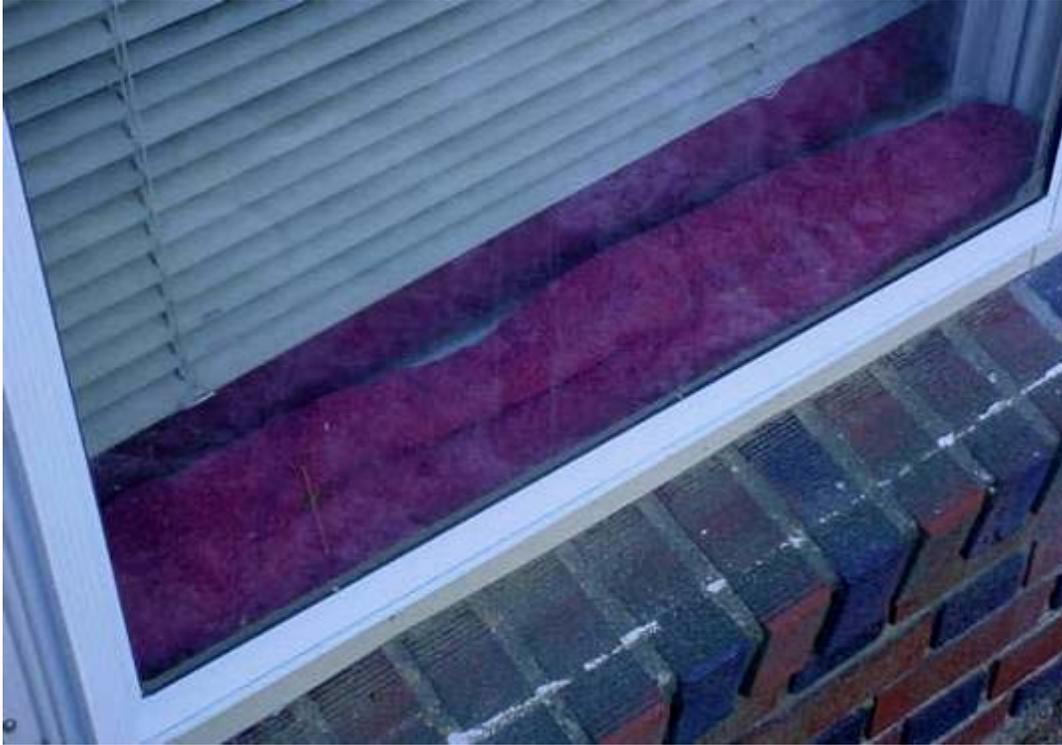
**Picture 3**

**Towels Used to Help Reduce Drafts around Window Frames**

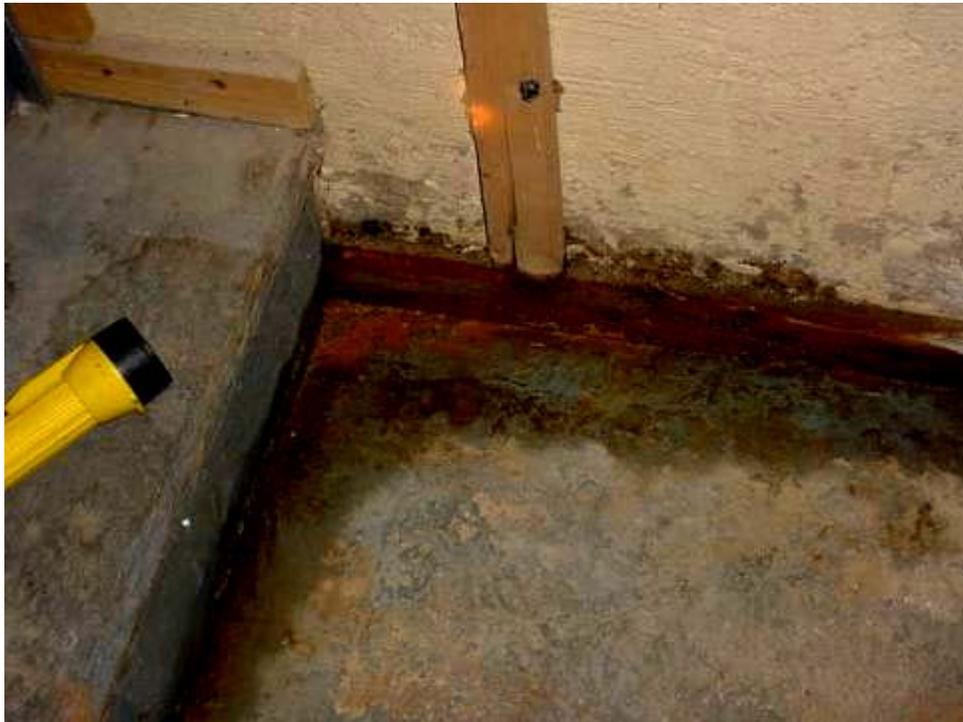
**Picture 4**

appeared to be moistened wooden trim along the floor of the basement and stairs (Pictures 4 through 7).

In an effort to ascertain moisture content of wood trim in the basement moisture readings were taken in materials that appeared to be water damaged. As indicated, moisture content was measured with a Delmhorst Moisture Detector equipped with a Delmhorst Standard Probe. The Delmhorst probe is equipped with three lights that function as visual aids that indicate moisture level. Readings that activate the green light indicate a sufficiently dry or low moisture level, those that activate the yellow light indicate borderline conditions and those that activate the red light indicate elevated moisture content. Moisture readings of wooden trim in several areas were found to have high (i.e., saturated) moisture content (Table 1).

**Moisture Accumulation (Dark Staining) at Landing of Basement Stairwell, Note Bottom of Wooden Stairs had High (i.e., Elevated Moisture Content)**

1. Remediate exposed pipe insulation in basement in conformance with Massachusetts asbestos remediation and hazardous waste disposal laws.
2. Remove water damaged wooden trim from along the base of walls in the basement that are susceptible to water penetration. Clean behind/around these areas with a mild detergent followed by soap and water.

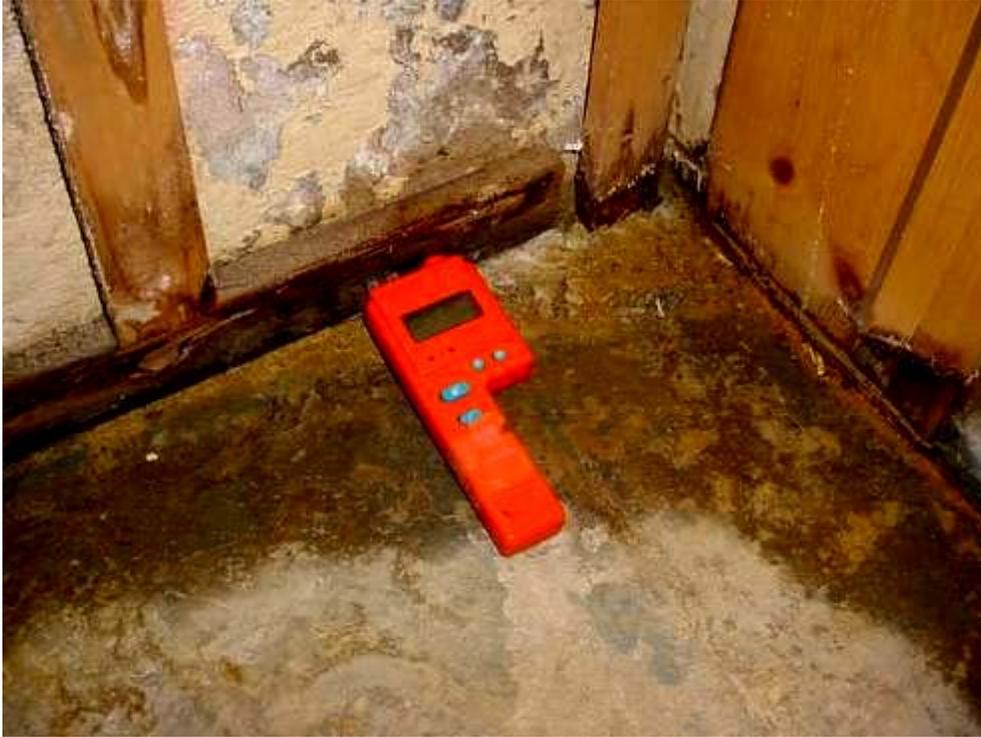
**Picture 5**

**Moisture Accumulation (Dark Staining) at Landing of Basement Stairwell, Note Wooden Trim had High (i.e., Elevated Moisture Content)**

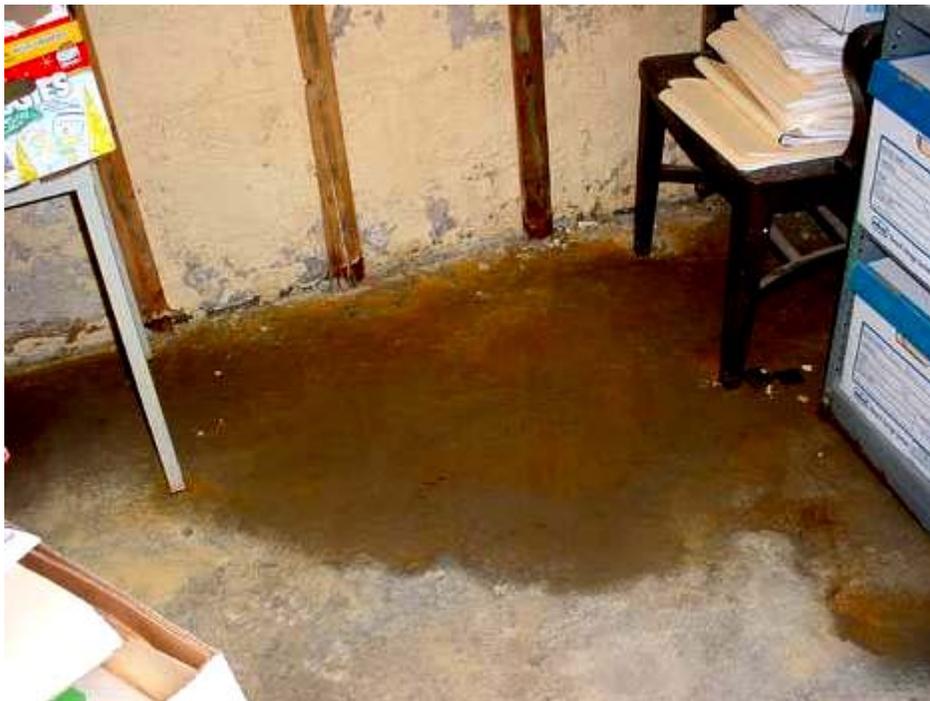
**Picture 6**

**Moisture Accumulation (Dark Staining) in SPED Storage Area, Note Bottom of Wooden Slats had High (i.e., Elevated Moisture Content)**

4. Continue to remove water from basement after heavy rains, employ the use of fans such as the one in Picture 18, (which was found in the basement). Consider using an additional dehumidifier in the SPED storage room.

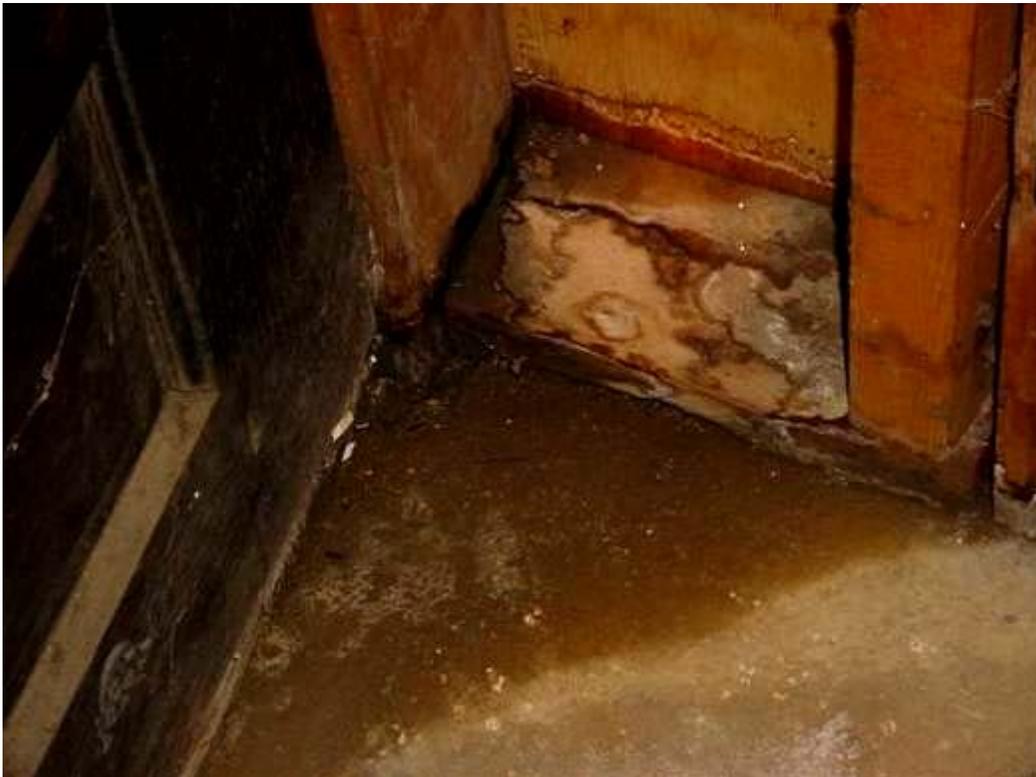
**Picture 7**

**Moisture Accumulation (Dark Staining) near Custodial Closet, Note Wooden Trim along Floor had High (i.e., Elevated Moisture Content)**

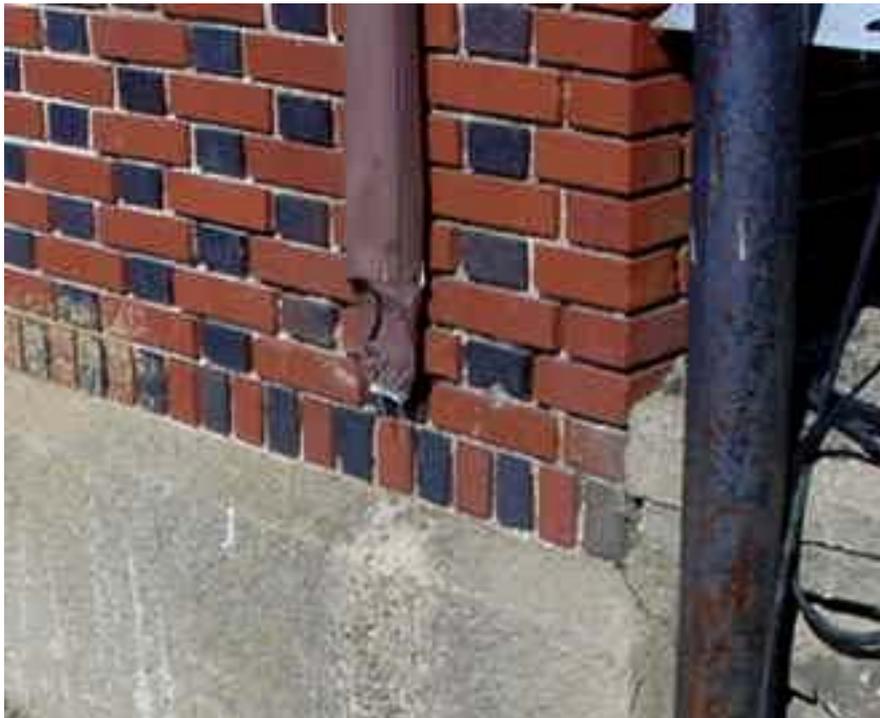
**Picture 8**

**Damaged Downspout and Missing Elbow Extension**

12. Replace missing/damaged elbows to downspouts in a manner to direct rainwater away from the building.
13. Ensure plants have drip pans and are not placed on porous materials (e.g., paper towels/plates). Avoid over-watering of plants and examine drip pans periodically for mold growth. Disinfect with an appropriate antimicrobial where necessary.

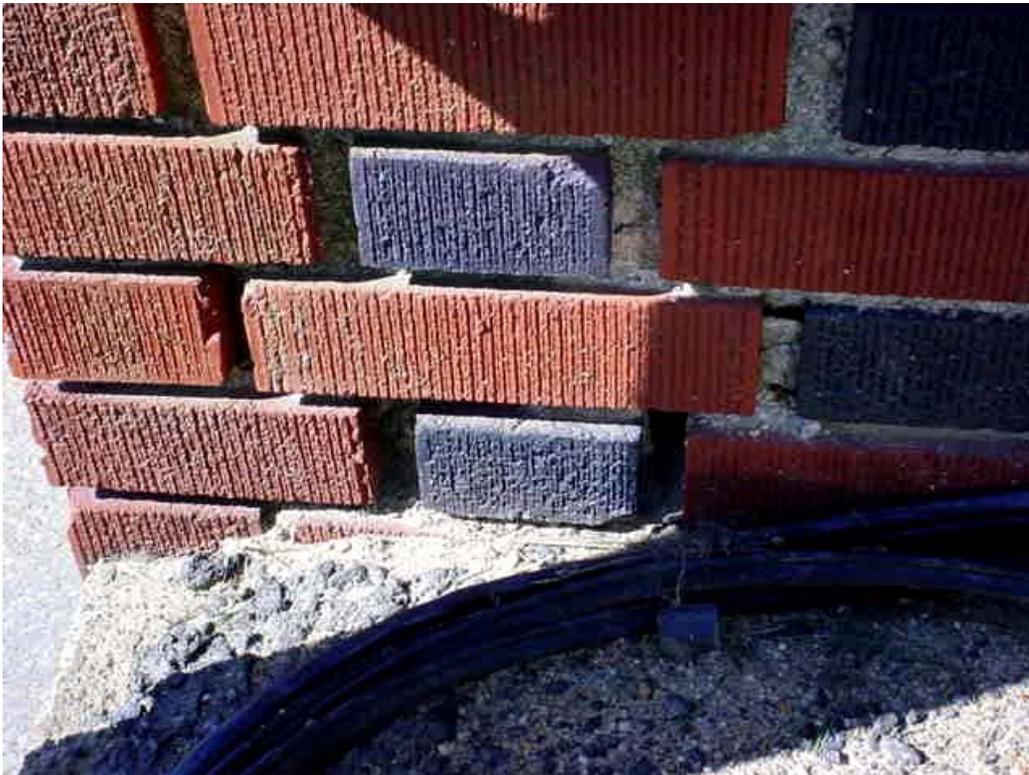
**Picture 9**

Over time, these conditions can undermine the integrity of the building envelope and provide a means of water entry by capillary action into the building through exterior walls, foundation concrete and masonry (Lstiburek & Brennan, 2001). In addition these breaches in the exterior can provide a means of drafts and pest entry into the building.

**Missing/Damaged Mortar around Exterior Brick**

3. Consider consult with an architect, masonry firm or general contractor regarding the integrity of the building envelope, primarily concerning water penetration through exterior walls. Examine the feasibility of repointing brickwork.

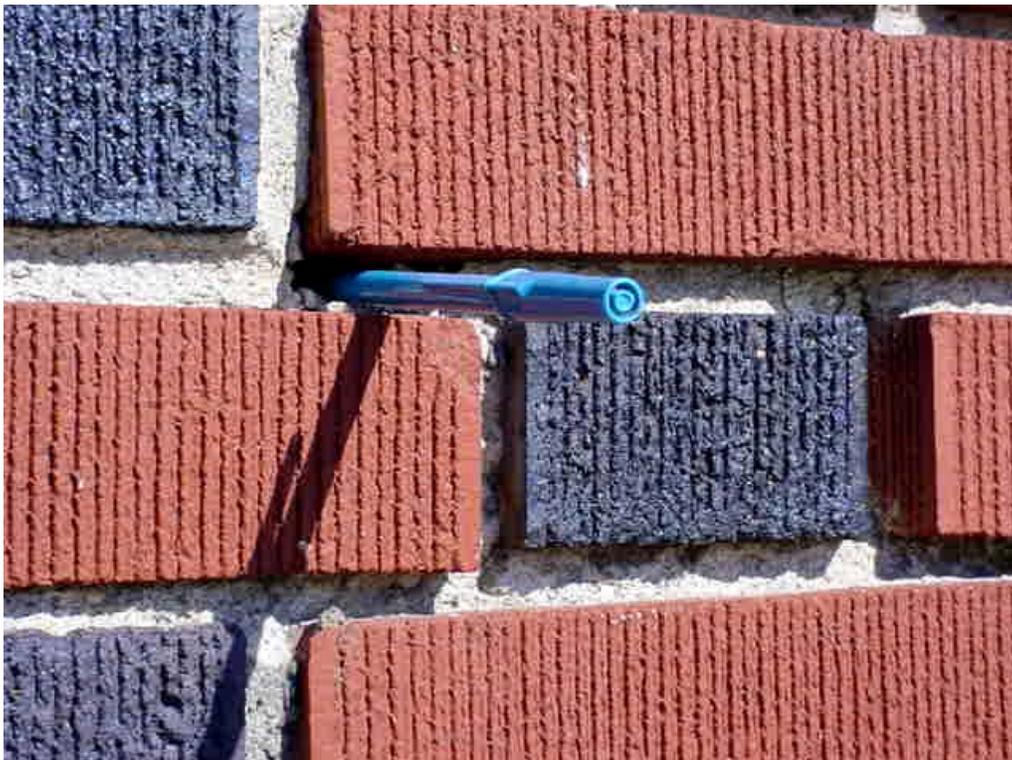
**Picture 10**

**Missing/Damaged Mortar around Exterior Brick, Pen Inserted by CEH Staff to Show Depth**

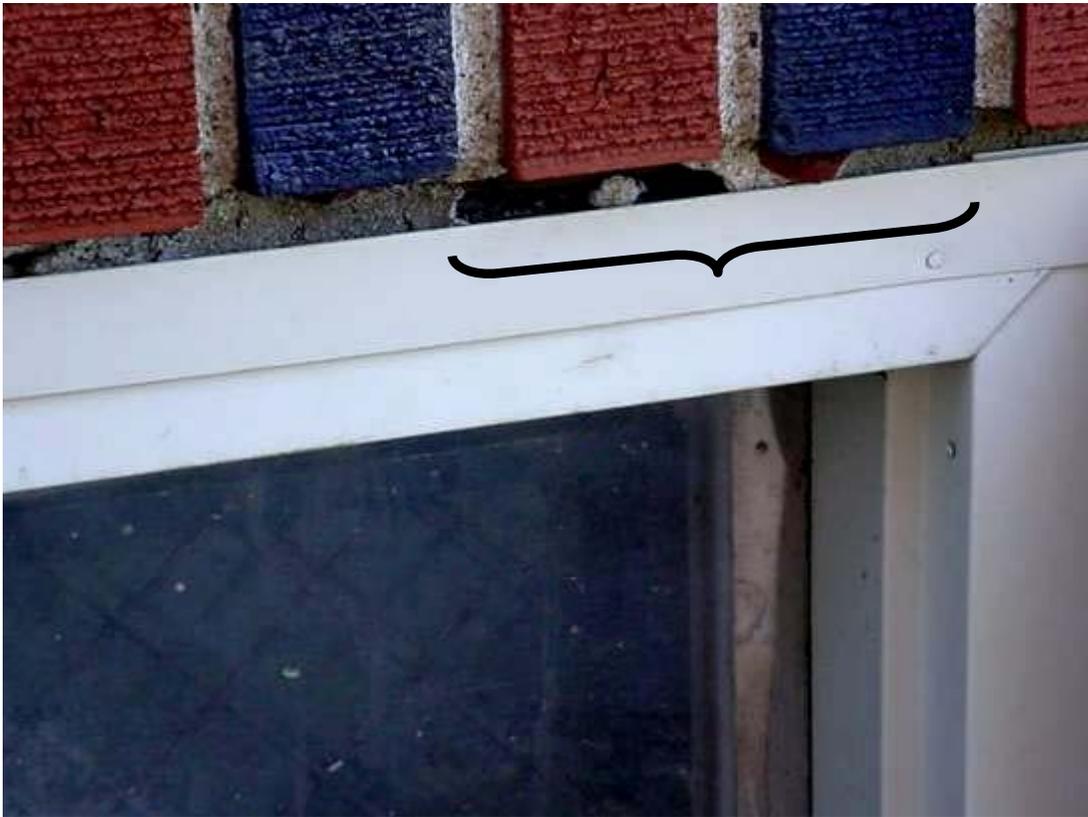
**Picture 11**

**Missing/Damaged Mortar around Exterior Brick/Basement Window Frame**

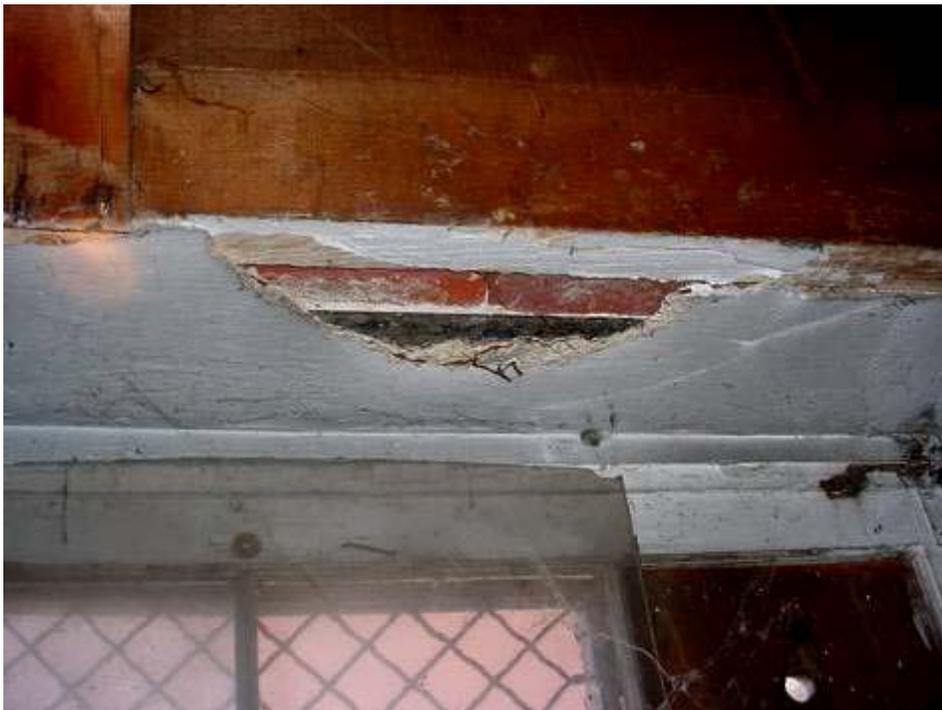
**Picture 12**

**Interior Shot of Damaged Plaster around Basement Window Shown in Preceding Picture**

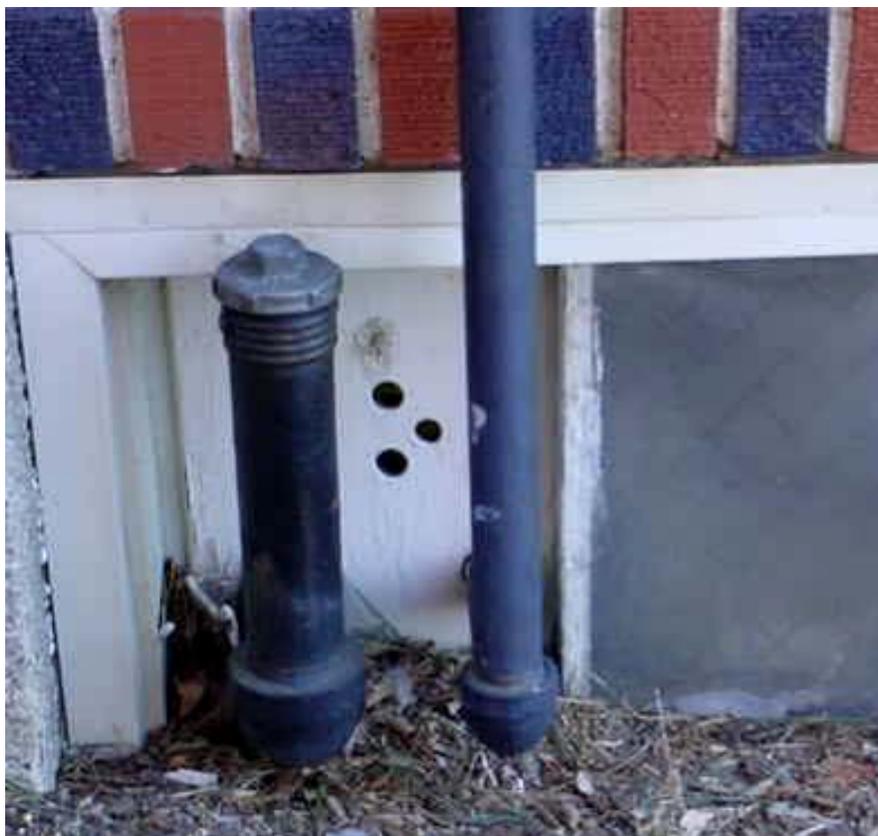
**Picture 13**

**Holes in Plywood Plug for Basement Window**

10. Keep both the basement door and second door at landing shut to prevent the egress of basement odors into occupied areas.
11. Seal holes in basement wooden window plug (Picture 13).

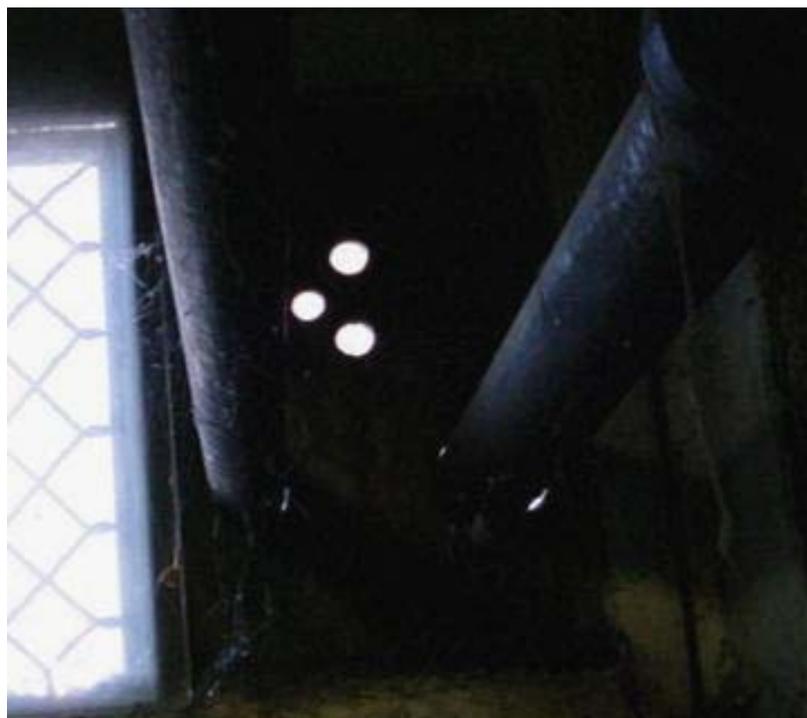
**Picture 14**

**Interior View of Holes in Plywood Plug for Basement Window Shown in Preceding Picture**

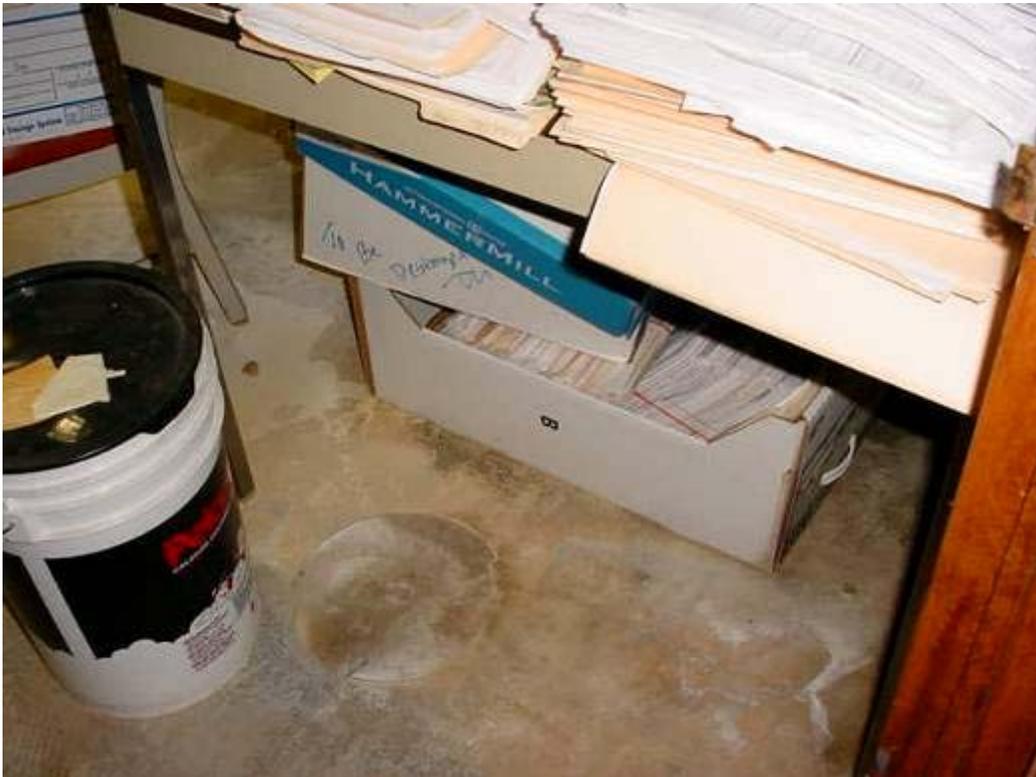
**Picture 15**

As previously mentioned, the basement is not occupied but rather is used for storage. Several areas contained a large number of cardboard boxes, records and other porous items, some located directly on the cement floor (Picture 15). It is important to note that this area is not equipped with mechanical ventilation or air conditioning. One dehumidifier was operating in the basement apparently to help remove moisture. Without mechanical ventilation and/or an adequate means to remove moisture, porous items can be subjected to prolonged periods of elevated moisture (e.g., >70%), which can create conditions conducive to mold growth.

**Cardboard Box Stored Directly on Cement Floor**

5. Do not store cardboard boxes or other porous materials directly on the cement floor. Items should be elevated (e.g., on pallets or shelves).
6. Seal holes in the basement ceilings for pipes and cables to prevent the egress of odors and particulates into occupied areas.

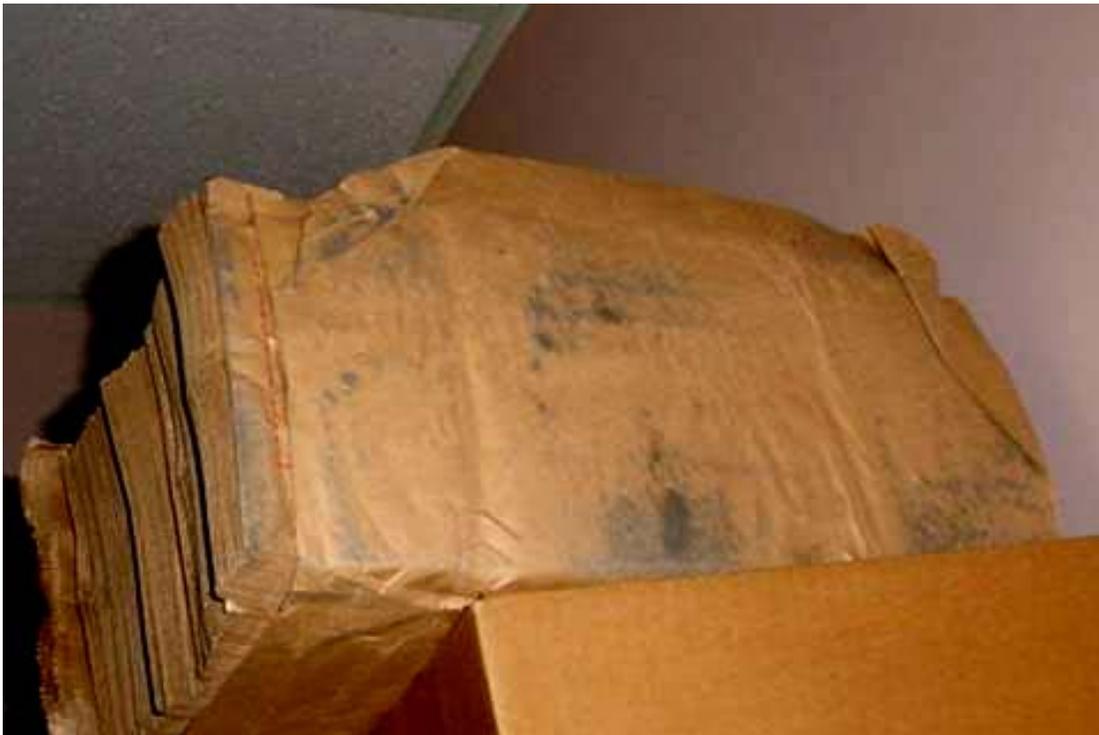
**Picture 16**

A bundle of what appeared to be paper bags colonized with mold was observed in the Food Service Director's office (Picture 16). No signs of water damage or active leaks were reported in this area so it is presumed they became damaged while being stored in another area. These items should be discarded.

**Mold Colonized Paper Products in Food Service Director's Office**

7. Discard moldy paper products in the Food Service Director's office (Picture 16).
8. In order to control the spread of germs frequent hand washing is recommended.

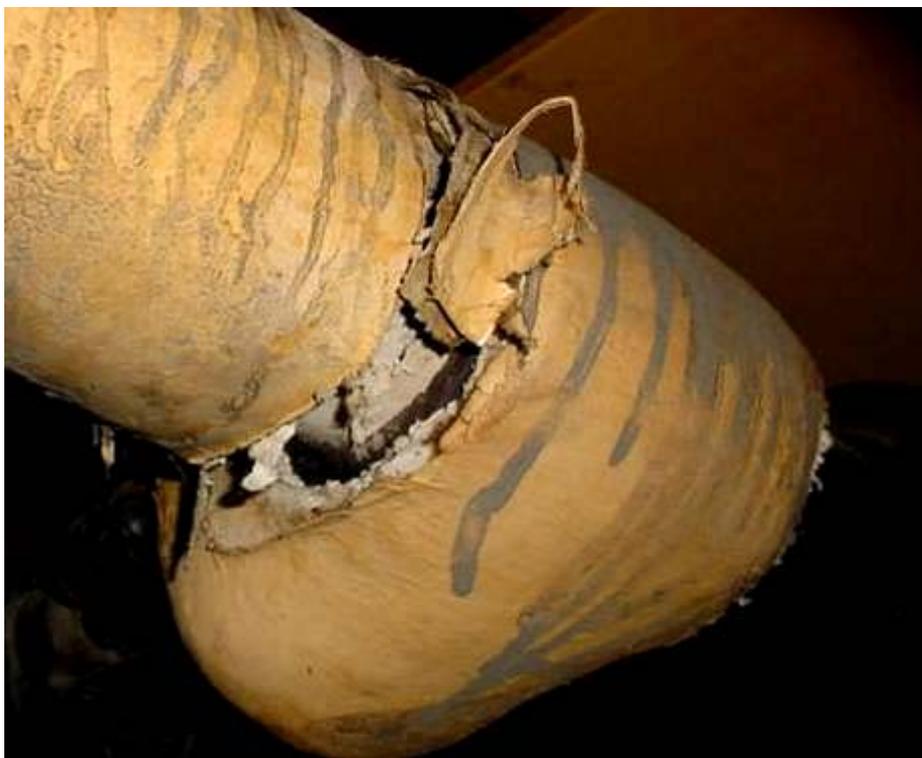
**Picture 17**

Several other conditions that can potentially affect indoor air quality were identified. CEH staff observed exposed pipe insulation in the basement near the oil burner,

which was labeled as asbestos containing material (Picture 17). This finding was reported to Mr. Wicklund upon discovery. CEH staff recommended that the material be encapsulated by a licensed member of the Leicester Public Schools maintenance staff, or a professional remediation firm.

**Exposed Pipe Insulation in Basement**

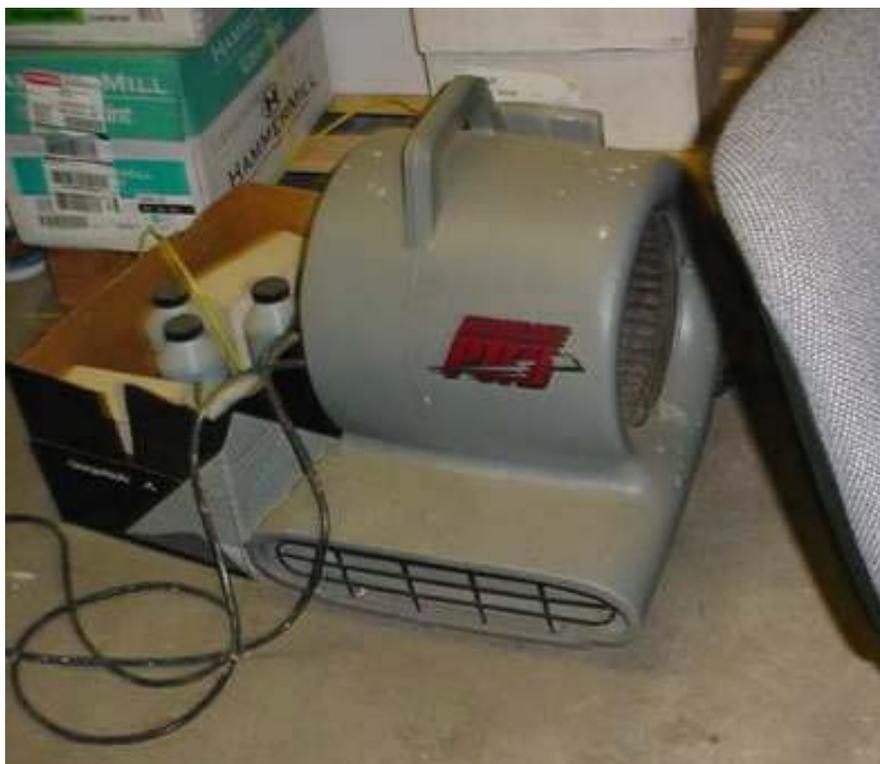
**Picture 18**

**Industrial Floor Fan Found in the Basement**
