INDOOR AIR QUALITY ASSESSMENT

**Department of Transitional Assistance
131 Davidson Street
Lowell, Massachusetts**

Prepared by:
Massachusetts Department of Public Health
Bureau of Environmental Health
Emergency Response/Indoor Air Quality Program
August 2007

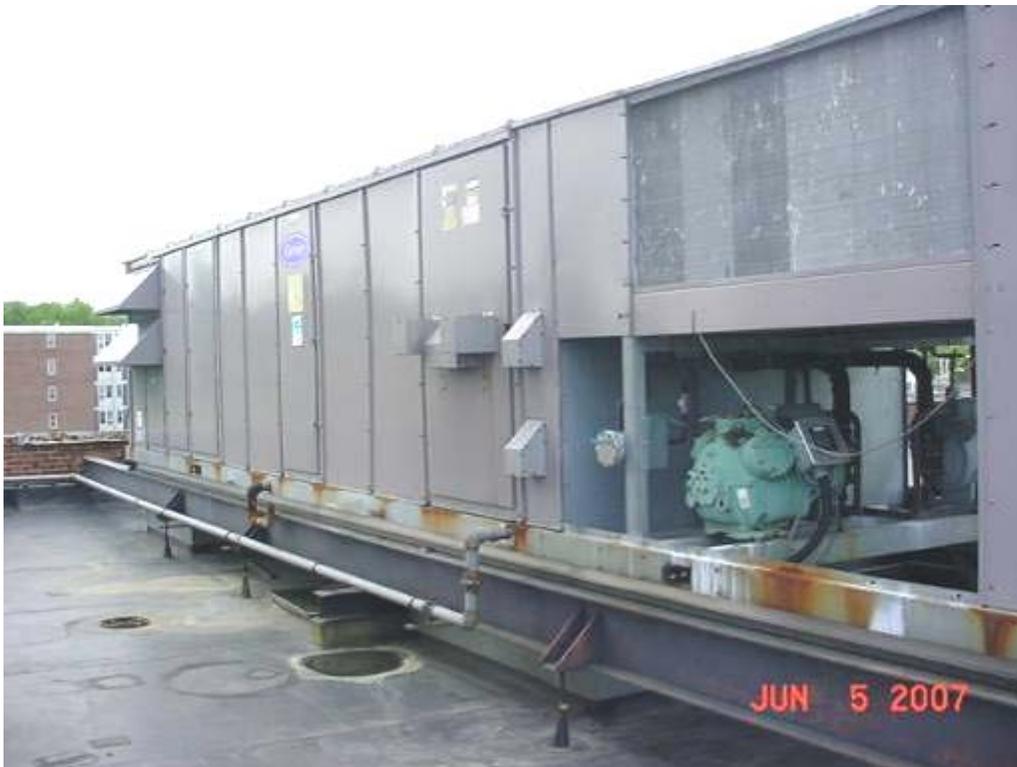
Picture 1

It can be seen from Table 1 that carbon dioxide levels were below 800 parts per million (ppm) in all areas surveyed, indicating adequate air exchange during the assessment. Mechanical ventilation is provided by rooftop air-handling units (AHUs) (Picture 1) equipped with pleated air filters (Picture 2). Fresh air is drawn into the AHUs and delivered to occupied areas via ceiling-

Rooftop AHU

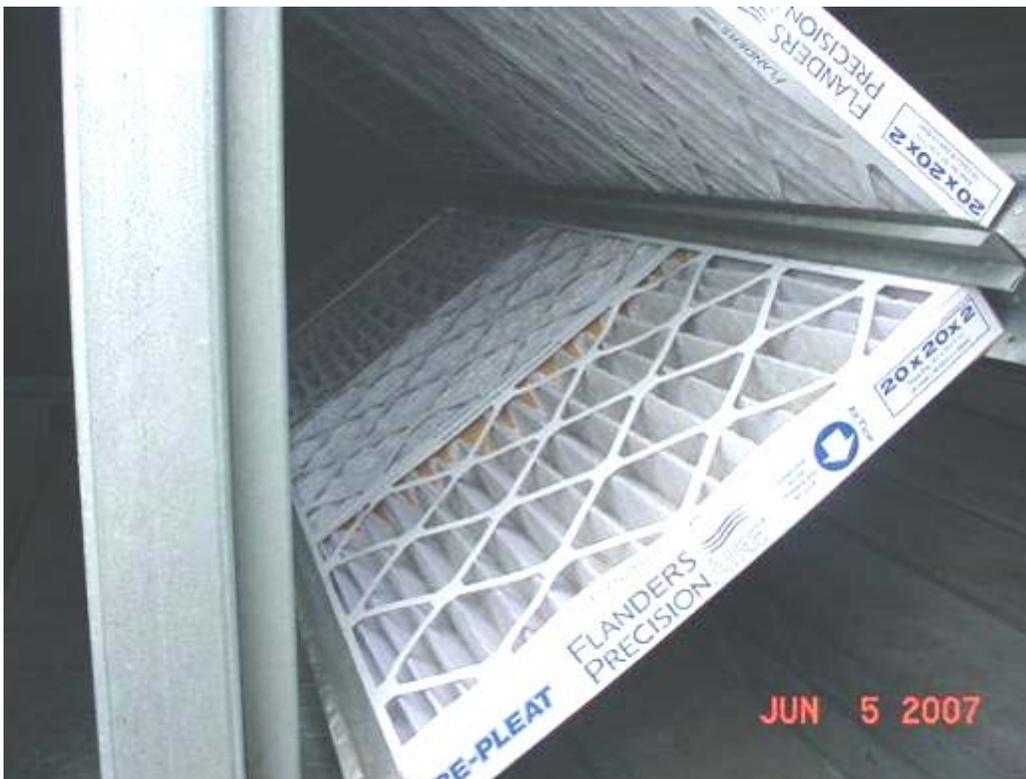
Picture 2

Pleated Air Filters in Rooftop AHUs

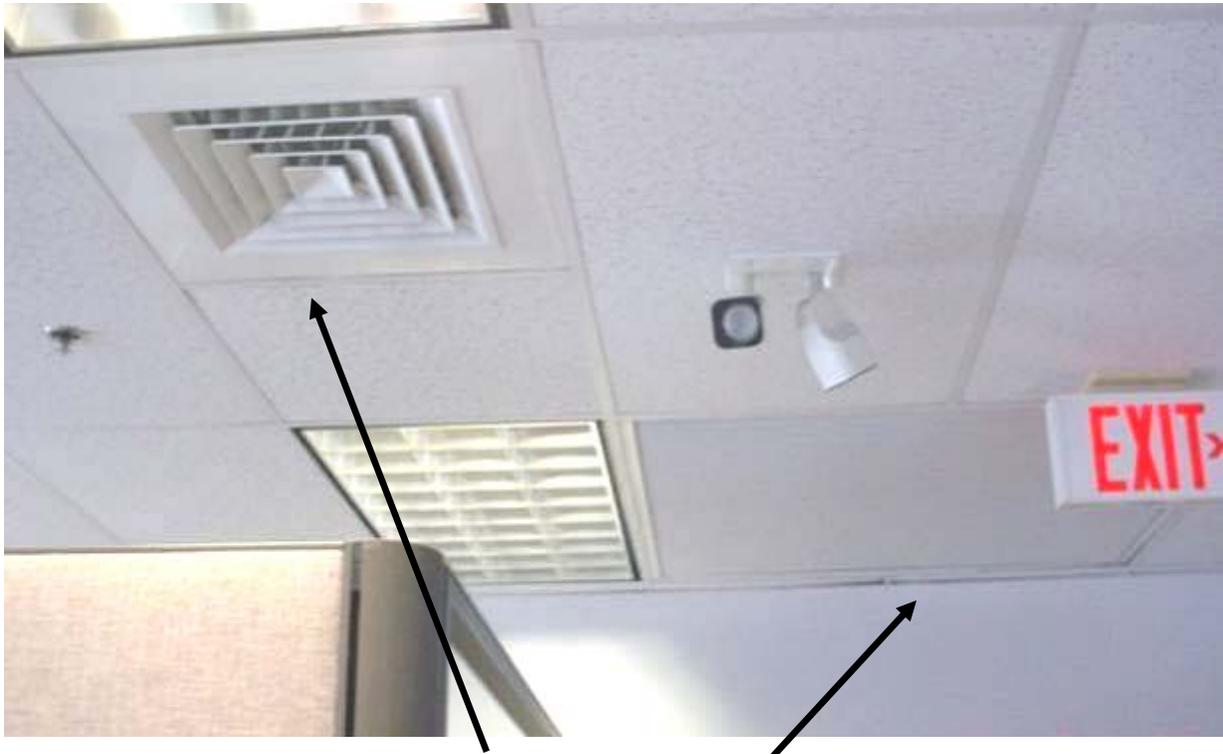
Picture 3

mounted air diffusers (Picture 3) and drawn into ceiling-mounted return vents via ductwork to AHUs (Picture 3).

Supply Air Diffuser and Return Vent

8. Clean air diffusers, return and exhaust vents periodically of accumulated dust.
9. Clean carpeting annually (or semi-annually in soiled high traffic areas) as per the recommendations of the Institute of Inspection, Cleaning and Restoration Certification (IICRC). Copies of the IICRC fact sheet can be downloaded at:
http://www.cleancareseminars.com/carpet_cleaning_faq4.htm (IICRC, 2005)

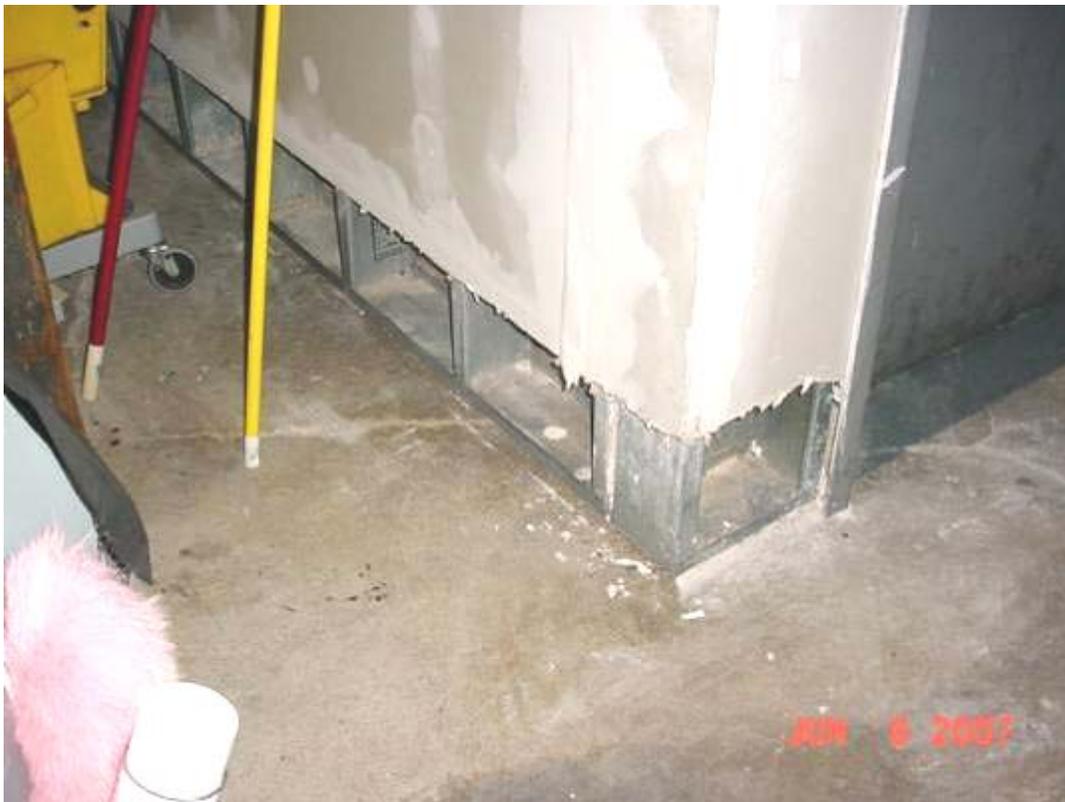
Picture 4

As mentioned previously, the basement has flooded over the past few years, most recently in April 2007. At the time of the assessment remediation of the basement was complete; the basement was dry, water-damaged gypsum wallboard had been removed and dehumidifiers that drain directly into sinks had been installed (Pictures 4 and 5).

Section of Water Damaged GW Removed in Basement

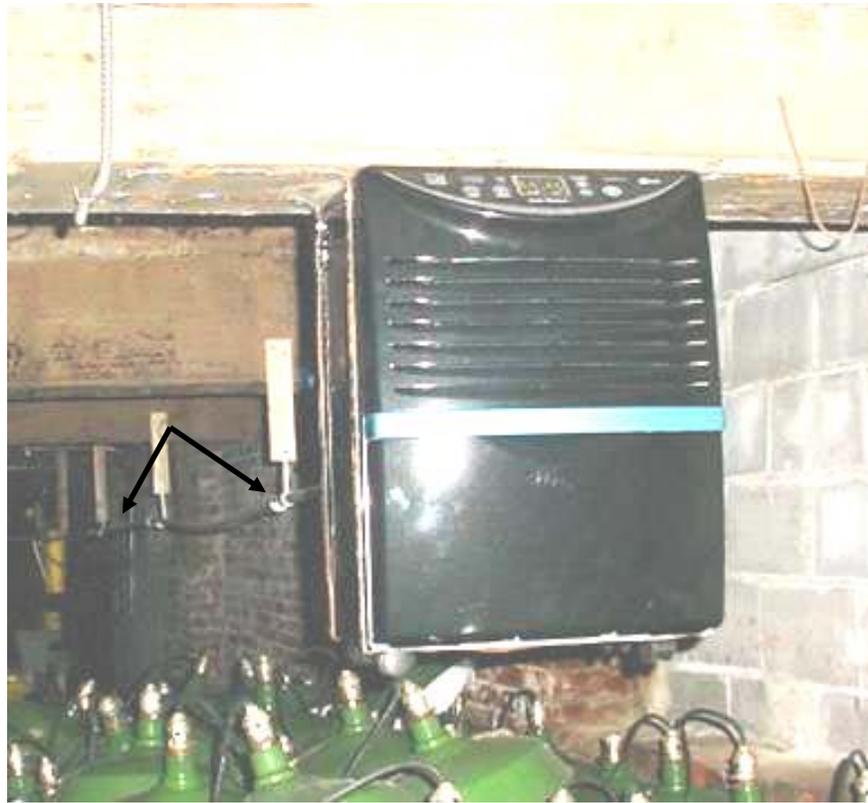
Picture 5

Dehumidifier Installed in Basement, Note Drain Pipe Connected at Rear

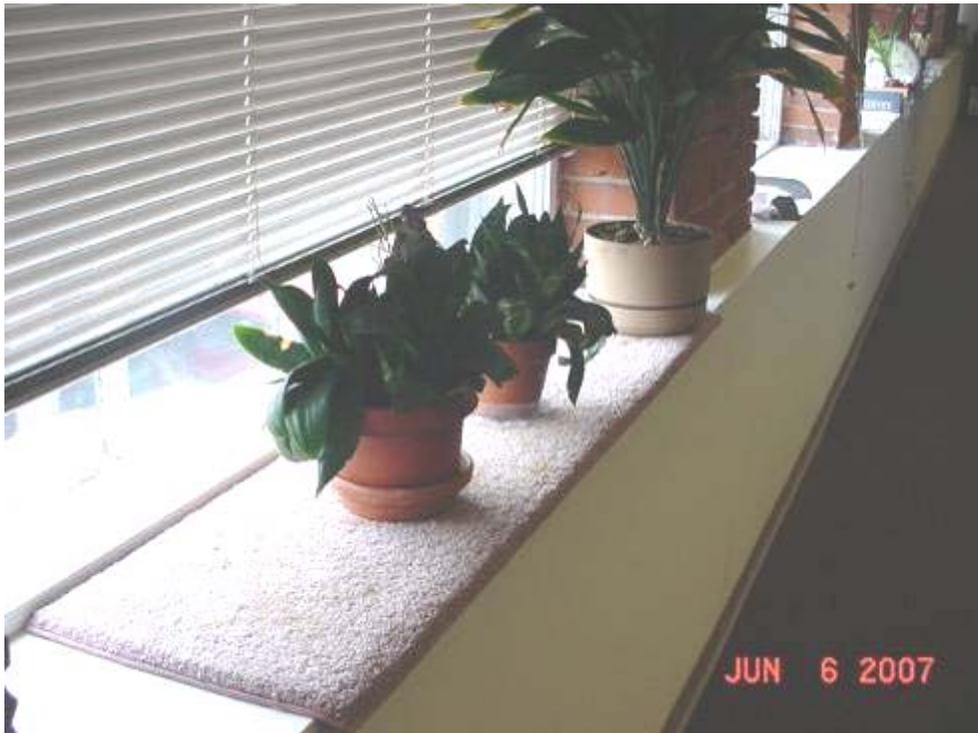
Picture 6

Plants were observed in several areas. In one case plants were placed on top of a section of carpeting, which is a porous material that can absorb moisture (Picture 6). Plants should be properly maintained and equipped with drip pans. Plants should be located away from ventilation sources to prevent aerosolization of dirt, pollen or mold. Plants should not be placed on porous materials, since water damage to porous materials may lead to microbial growth.

Plants Resting on Sections of Carpeting

5. Ensure all plants are equipped with drip pans. Examine drip pans for mold growth and disinfect areas of water leaks with an appropriate antimicrobial where necessary. Remove carpet from beneath plants (Picture 6).

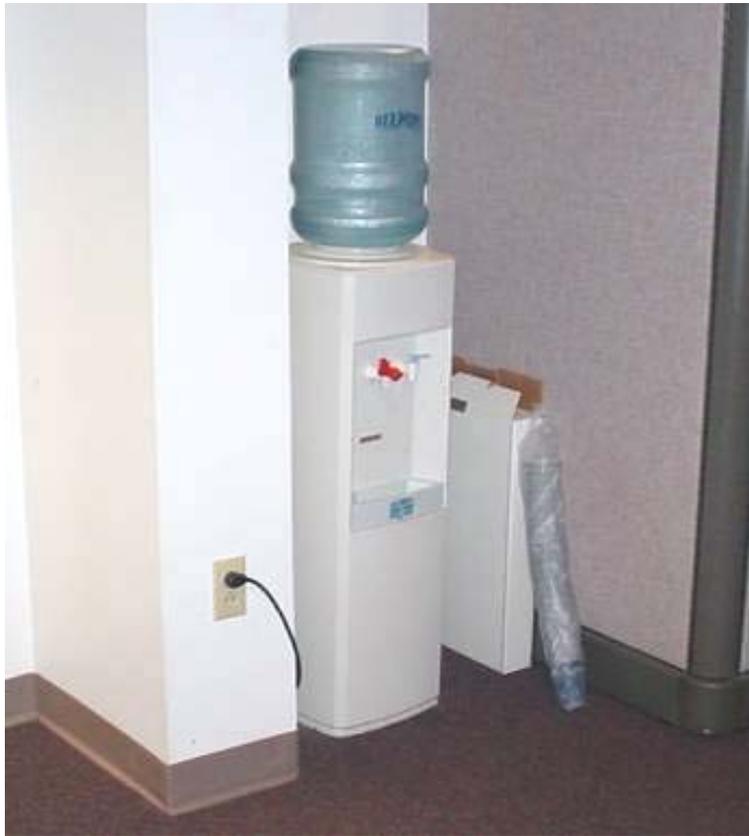
Picture 7

Water coolers and fountains were observed over carpeting (Pictures 7 and 8). Water spillage or overflow of cooler catch basins can result in the wetting of the carpet. In addition, some of the coolers had residue/build-up in the reservoir. These reservoirs are designed to catch excess water during operation and should be emptied/cleaned regularly to prevent microbial and/or bacterial growth.

Water Cooler on Carpeting

6. Relocate or place tile or rubber matting underneath water coolers and water fountains in carpeted areas. Clean and disinfect reservoirs as needed to prevent microbial growth.

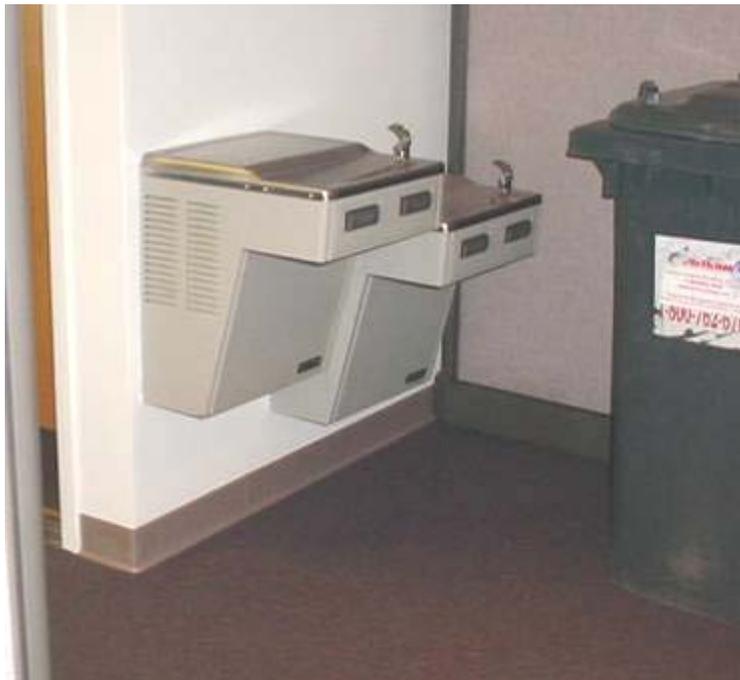
Picture 8

Water Fountain over Carpeting

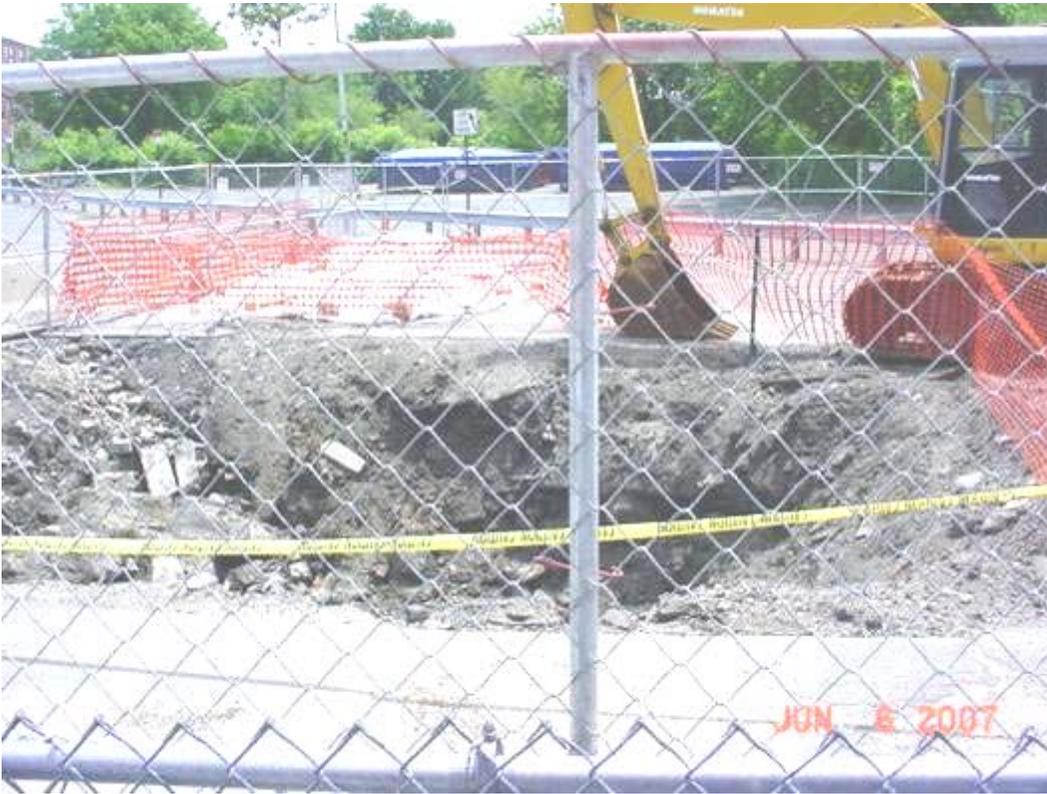
Picture 9

Excavation Site behind DTA

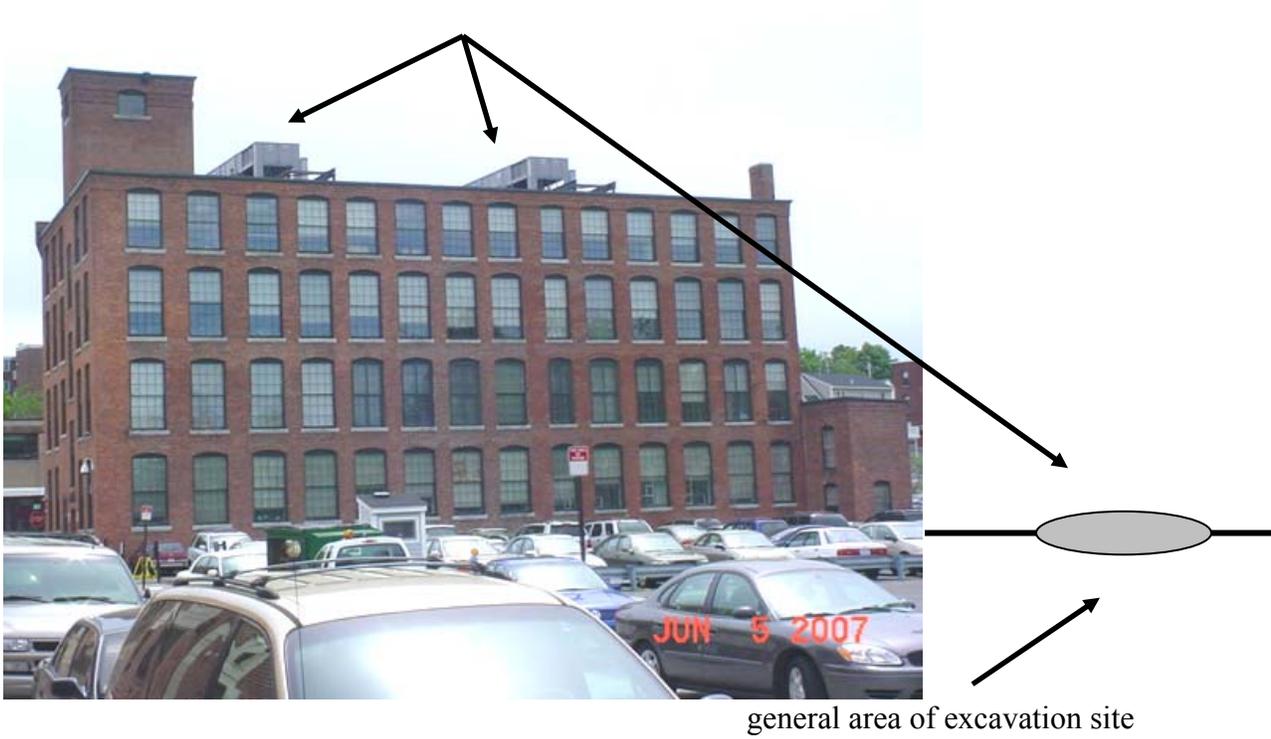
Picture 10

Location of Rooftop AHUs in Relation to Excavation Site

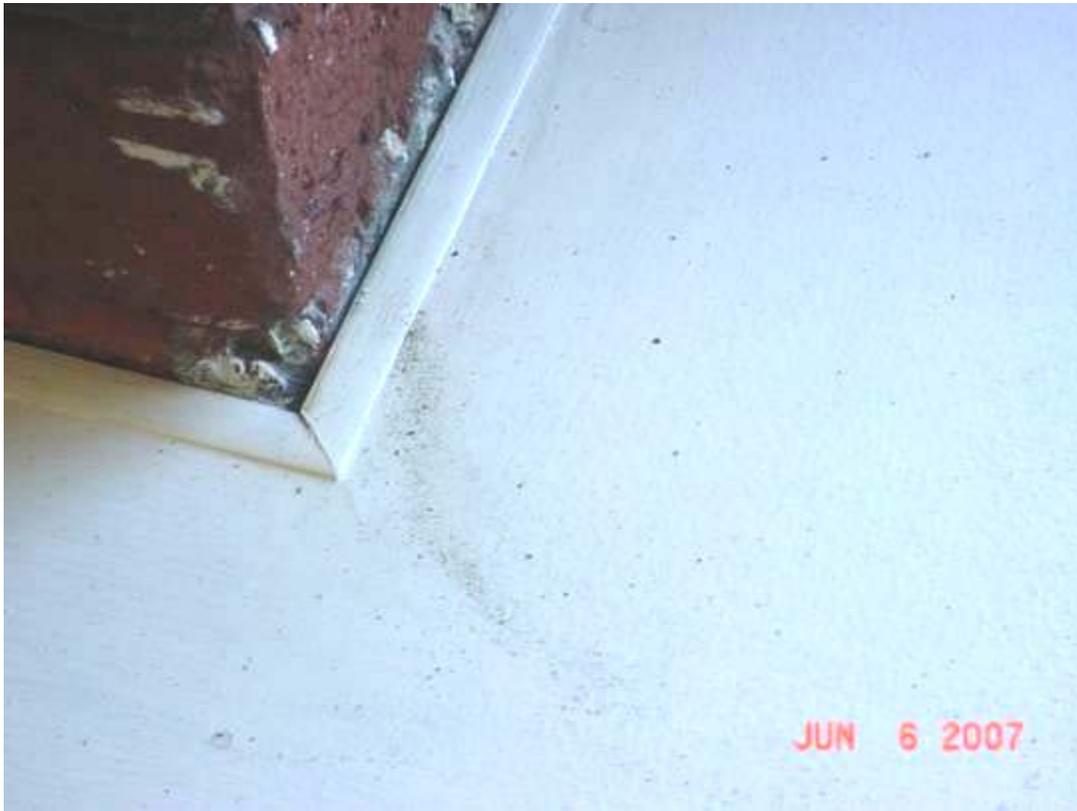
Picture 11

Outdoor PM_{2.5} concentrations at the time of the assessment were measured at 5 µg/m³ (Table 1). PM_{2.5} levels within the DTA ranged from 1 to 5 µg/m³, which were below the NAAQS of 35 µg/m³ (Table 1). Frequently, indoor air levels of particulates can be at higher levels than those measured outdoors. A number of mechanical devices and/or activities that occur indoors can generate particulates during normal operation. Sources of indoor airborne particulate may include but are not limited to particles generated during the operation of fan belts in the HVAC system, cooking and microwave ovens; use of photocopiers, fax machines and computer printing devices, operating an ordinary vacuum cleaner and heavy foot traffic indoors. While some brick dust was observed on windowsills in a few areas, these particles are of a large size and are not likely to become airborne (Picture 11).

Brick Dust on Windowsill

3. Consider increasing cleaning of flat surfaces in close proximity to exposed brick.
4. Ensure leak on 4th floor is repaired and replace any remaining water damaged ceiling tiles.

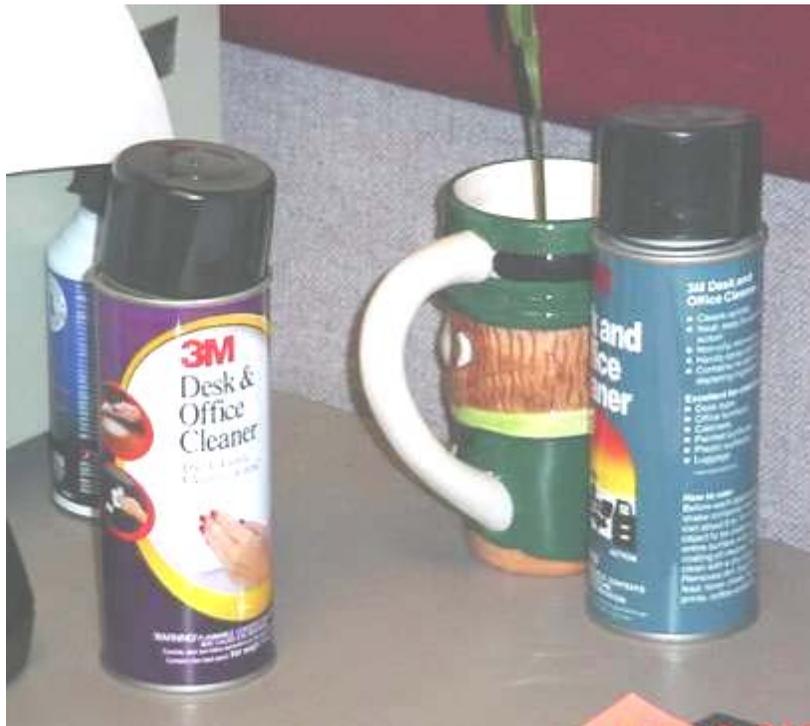
Picture 12

Indoor air concentrations can be greatly impacted by the use of TVOC-containing products. While no measurable TVOC levels were detected in the indoor environment, VOC-containing materials were noted including office cleaners and spray pesticides (Pictures 12 and 13). These materials contain several VOCs (e.g., isopropyl alcohol and monoethanolamine) that can be irritating to the eyes, nose and throat (3M, 2000). Pesticide applicators should be in full compliance with the federal and state rules and regulations that govern pesticide use including posting and notification requirements (333 CMR 13.10). Under no circumstances should untrained personnel apply this material. This product should not be applied prior or during business hours. Under current Massachusetts law (effective November 1, 2001), the principles of integrated pest management (IPM) must be used to remove pests in state buildings (Mass Act, 2000). Pesticide use indoors can introduce chemicals into the indoor environment that can be sources of eye, nose and throat irritation.

Spray Office Cleaners, Note Label Warning: May Cause Eye Irritation

10. Discontinue the use of VOC-containing cleaners. Less irritating materials, (soap and water) may suffice to clean in these areas.
11. Use the principles of integrated pest management (IPM) to rid the building of pests. A copy of the IPM recommendations can be downloaded from the Internet at
http://www.state.ma.us/dfa/pesticides/publications/IPM_kit_for_bldg_mgrs.pdf.

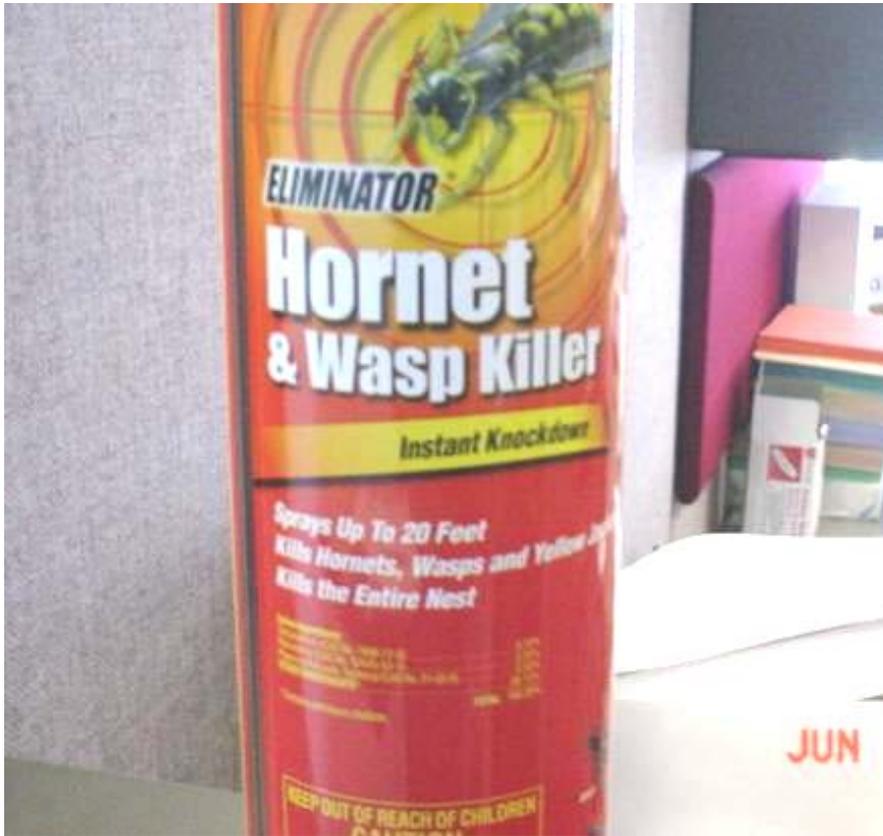
Picture 13

Spray Pesticide in Work Area

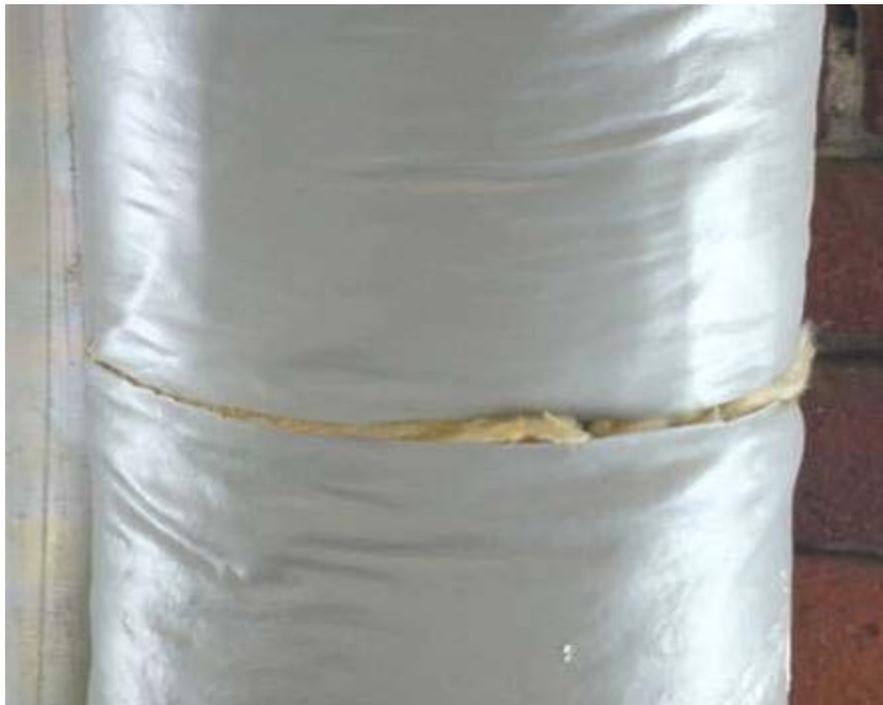
Picture 14

Finally, exposed fiberglass insulation was observed in area 213/214 (Picture 14). Fiberglass insulation can provide a source of skin, eye and respiratory irritation.

Exposed Fiberglass Insulation in Work Area

12. Seal insulation to prevent exposure to fiberglass (Picture 14).
13. For further building-wide evaluations, advice on maintaining public buildings and other related indoor air quality documents, see the MDPH's website at http://mass.gov/dph/indoor_air.

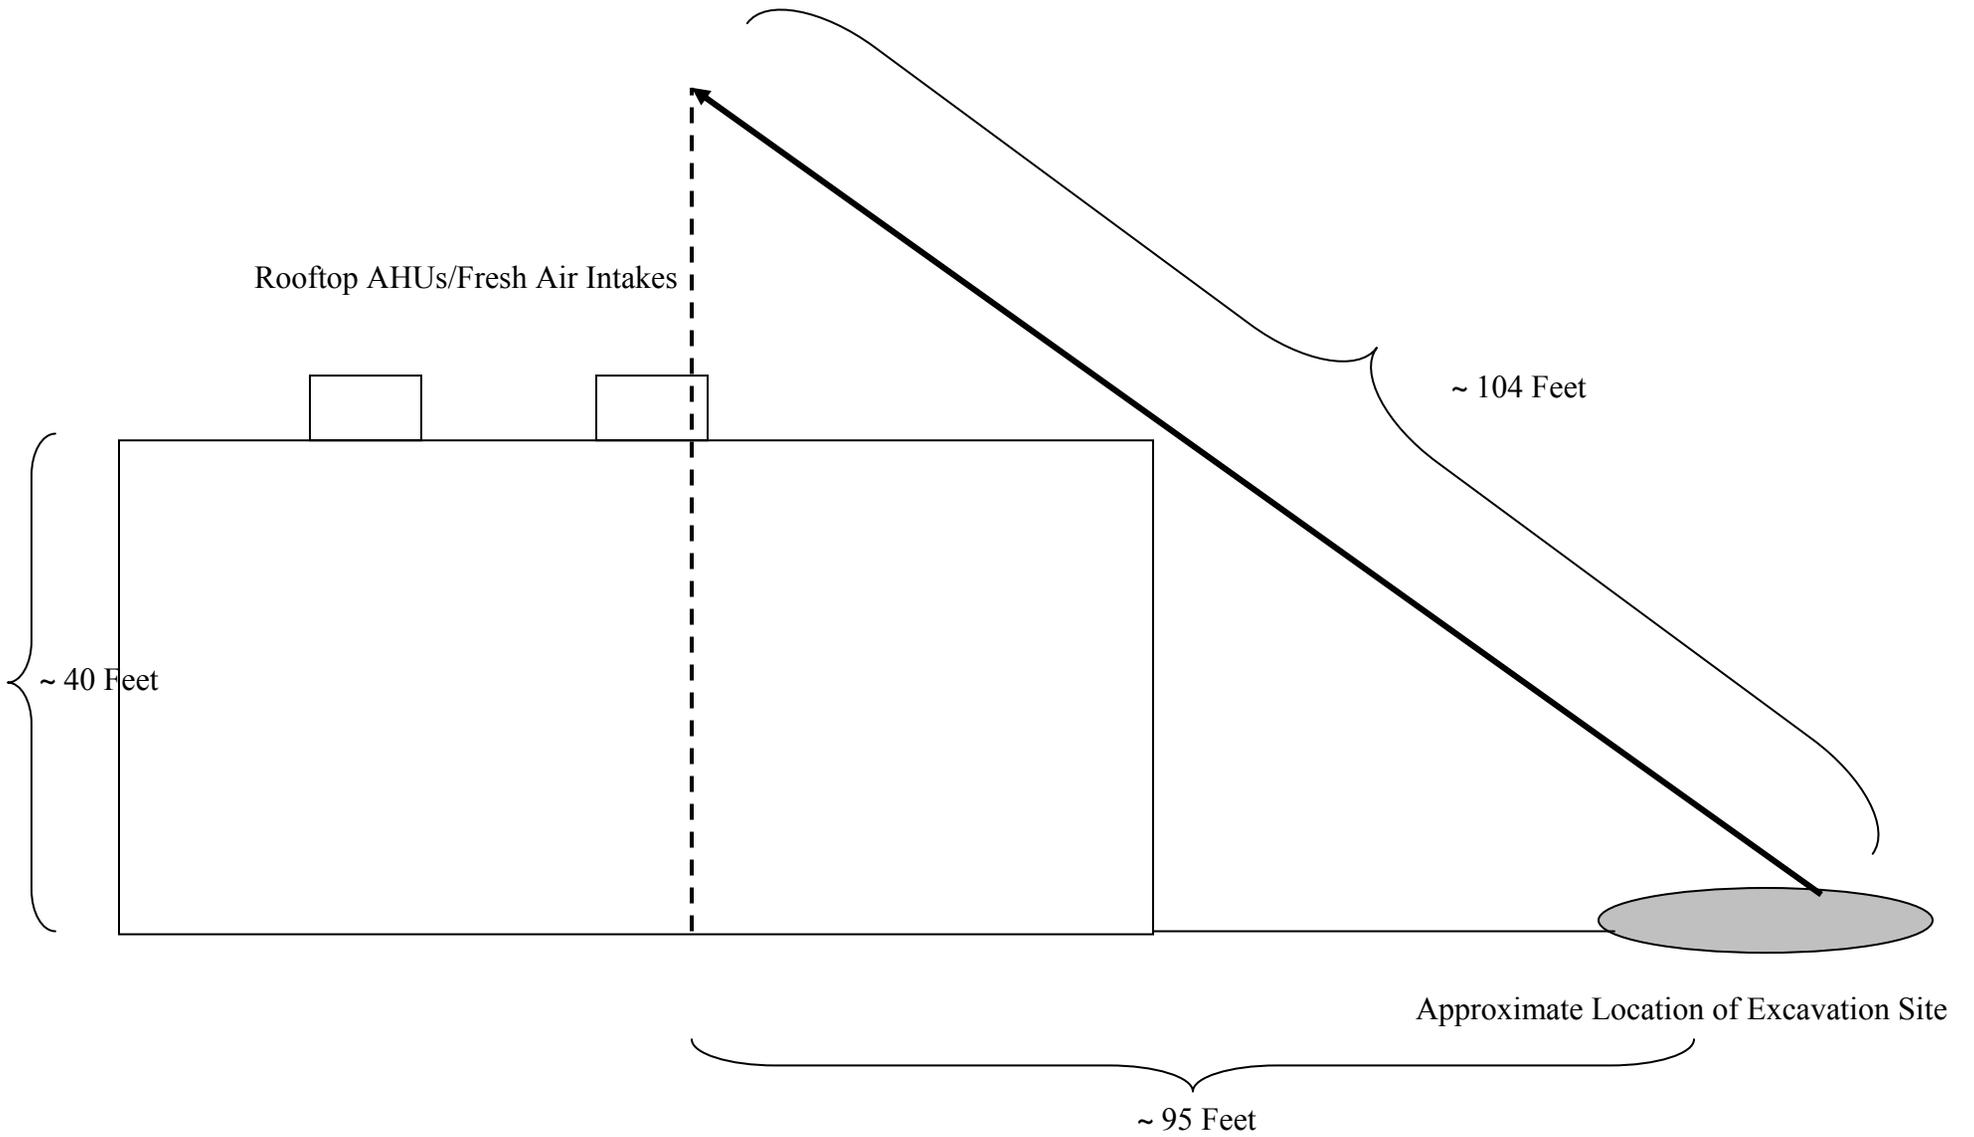
- Windows at the DTA are sealed shut, which prevents both air and pollutants from entering directly into the building.
- The location of AHU fresh air intakes on the roof (i.e., four-stories) would make entrainment of airborne materials generated from the excavation site unlikely ([Figures 1 & 2](#)).
- The AHUs are in the center of the roof outside of a direct pathway to the excavation project approximately 100-feet away ([Figures 1 & 2](#)).

Figure 1
Proximity of Rooftop HVAC Air Intake Vents to Excavation Site behind
DTA Lowell 131 Davidson Street

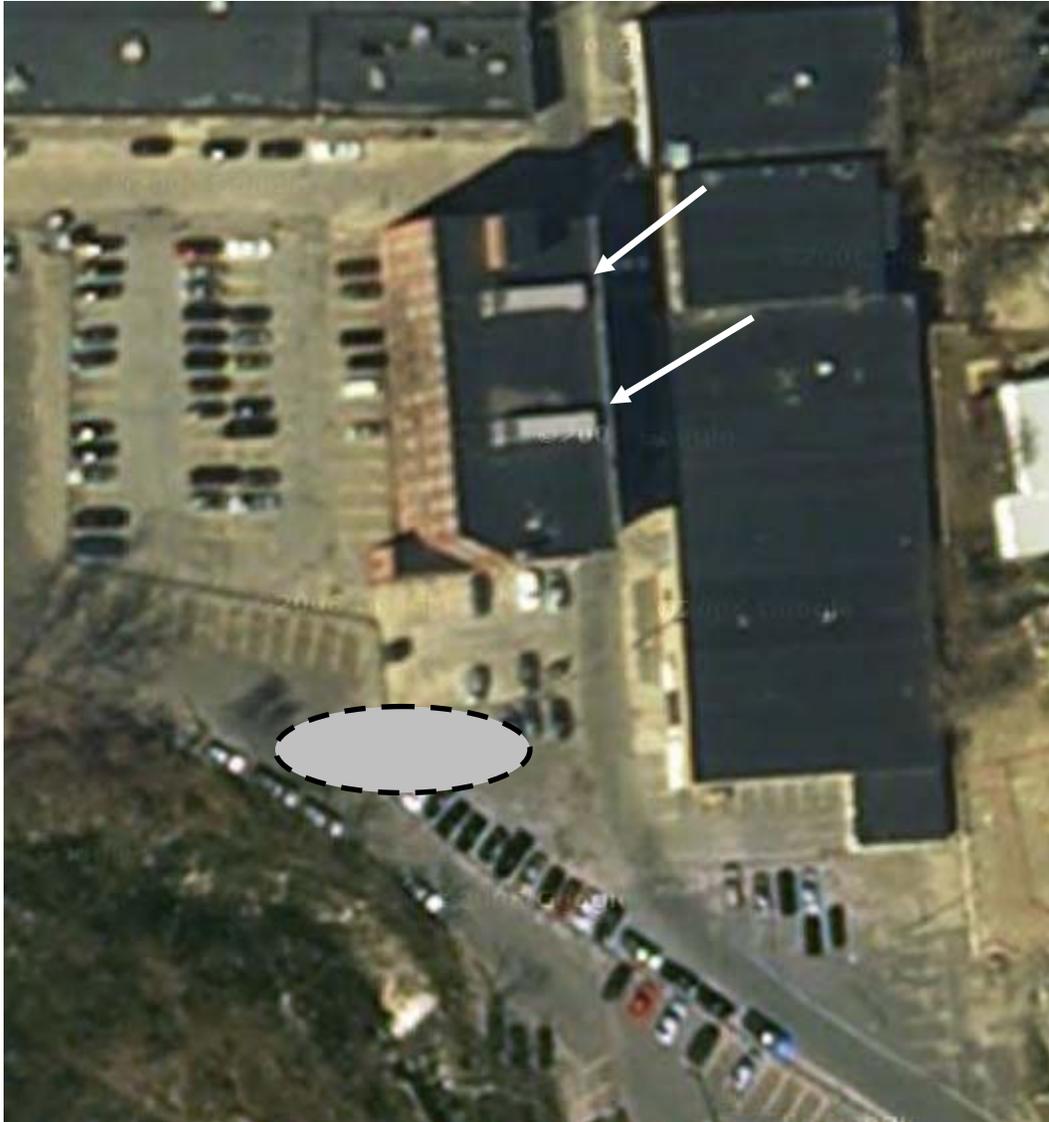
Figure 2

Proximity of Excavation Site behind DTA Offices at 131 Davidson Street

DTA Office Building on Left, Note 2 Rooftop AHUs (small arrows)
Dashed Line Indicates Approximate Proximity of Excavation Site at the Rear of the Building
