INDOOR AIR QUALITY ASSESSMENT

**West Memorial Elementary School
15 Bow Street
Peabody, Massachusetts**

Prepared by:
Massachusetts Department of Public Health
Bureau of Environmental Health
Indoor Air Quality Program
September 2007

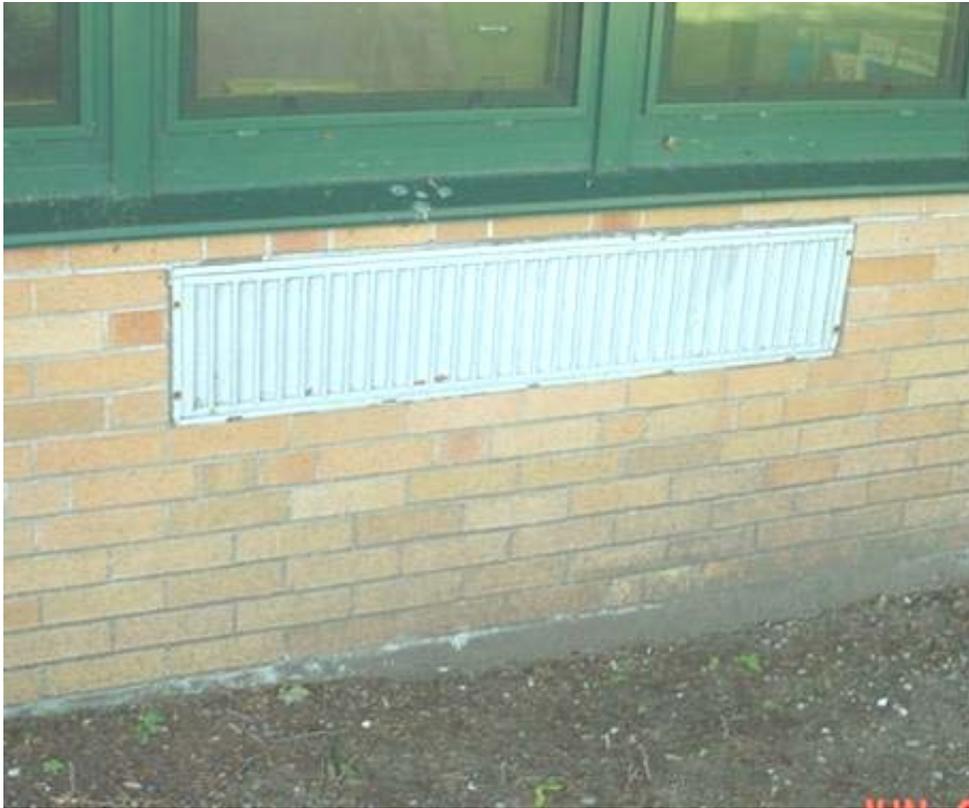
Picture 1

Fresh air to classrooms is supplied by unit ventilators (univents) ([Figure 1](#)). A univent is designed to draw air from outdoors through a fresh air intake located on the exterior wall of the building (Picture 1). Return air is drawn through an air intake located at the base of each unit. Fresh and return air are mixed, filtered, heated and provided to classrooms through an air diffuser located in the top of the unit. The mechanical exhaust ventilation system in classrooms consists of wall-mounted vents ducted to rooftop motors.

Univent Fresh Air Intake

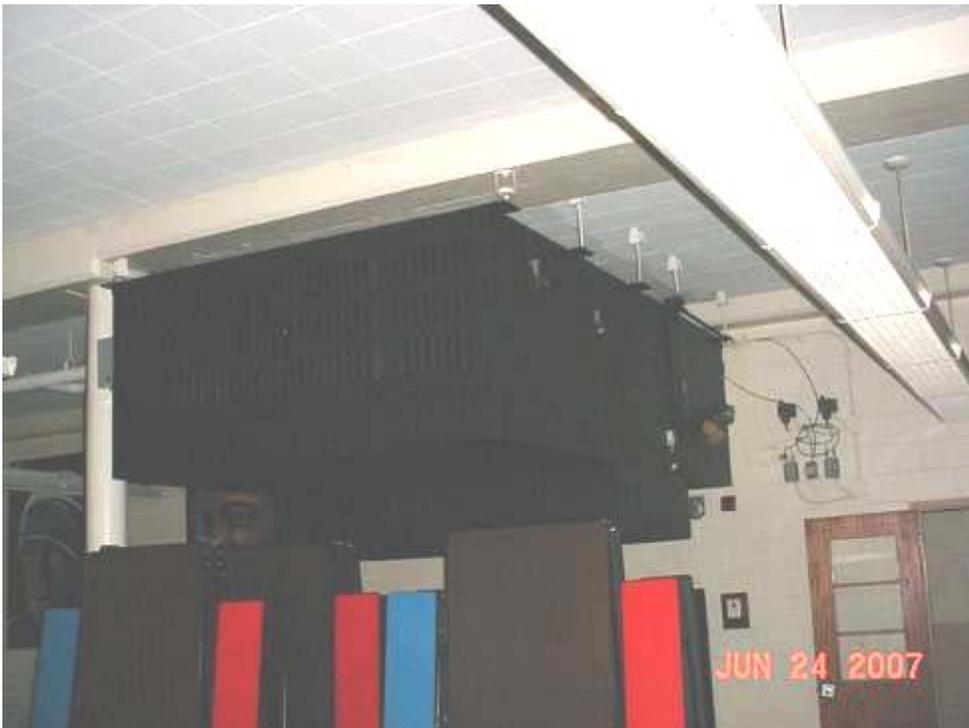
Picture 2

Ventilation in the gymnasium and cafeteria is provided by ceiling-mounted air handling units (AHUs). The AHU in the cafeteria (Picture 2) was not operable at the time of the assessment. Mr. Catone reported that parts were on order to repair this unit. The cafeteria also has openable windows (Picture 3). A local exhaust fan is located opposite the windows (Picture 4). BEH staff suggested that, if the AHU is not repaired prior to the start of the school year, local exhaust fan should be used in combination with openable windows to provide cross ventilation/air exchange.

Ceiling-Mounted AHU in Cafeteria

2. Remove dark-stained section of ceiling plaster in resource room 22-B.
3. Continue with plans to repair AHU in cafeteria. If not repaired prior to the school year, use openable windows in conjunction with local exhaust fan to provide cross ventilation/air exchange.

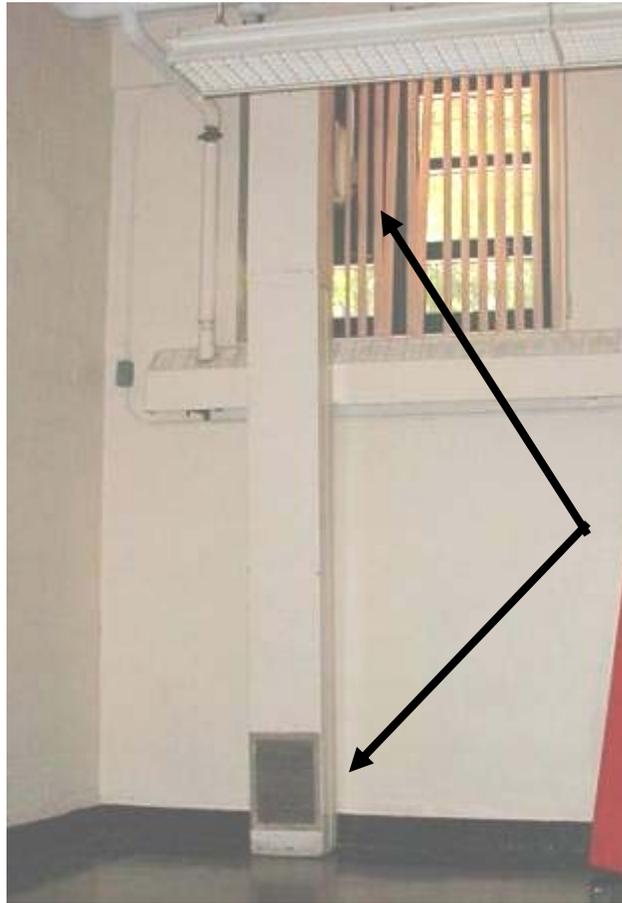
Picture 3

Local Exhaust Fan and Ducted Vent

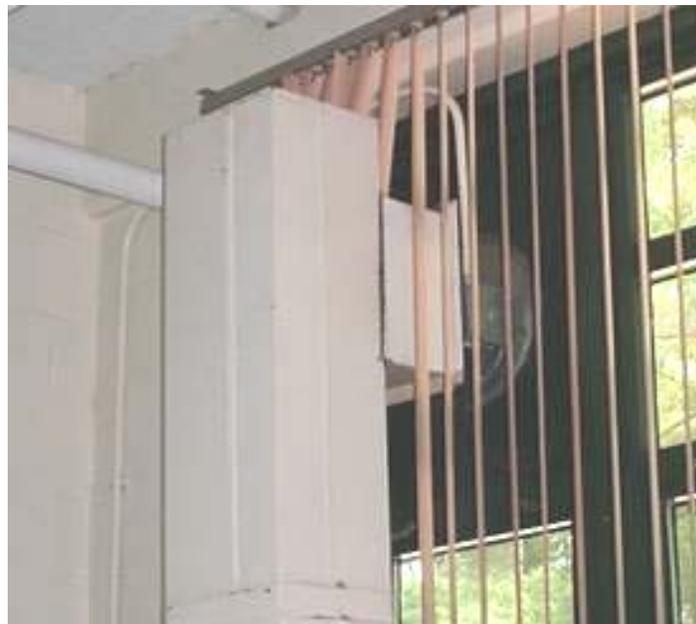
Picture 4

Close-Up of Local Exhaust Fan

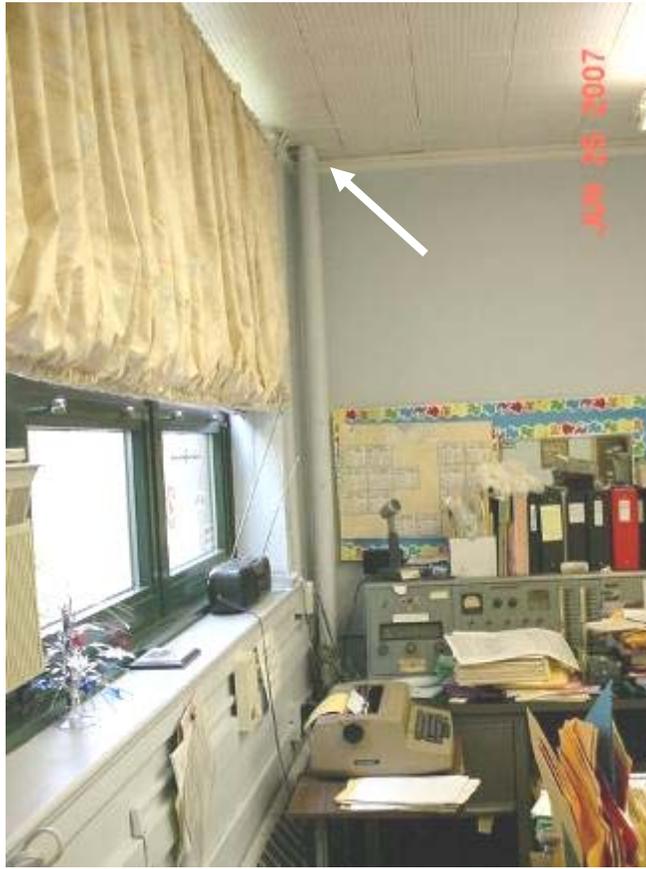
Picture 5

Odors were also reported in the corner of the administrative office near the communications console. BEH observed accumulated dust and cobwebs in this area, as well as an open utility hole in the ceiling above this area (Pictures 5 and 6). Open utility holes can serve as pathways for odors, drafts and particulates to migrate into occupied areas.

**Corner of Administrative Office Where Communications Console is Located,
Arrow Indicates Open Utility Hole**

6. Seal utility hole in ceiling of administrative area.
7. Clean and disinfect corner of administrative area around communications console.
8. Trim tree branches to prevent any from overhanging above the roof. Inspect and clear debris from roof drains regularly.

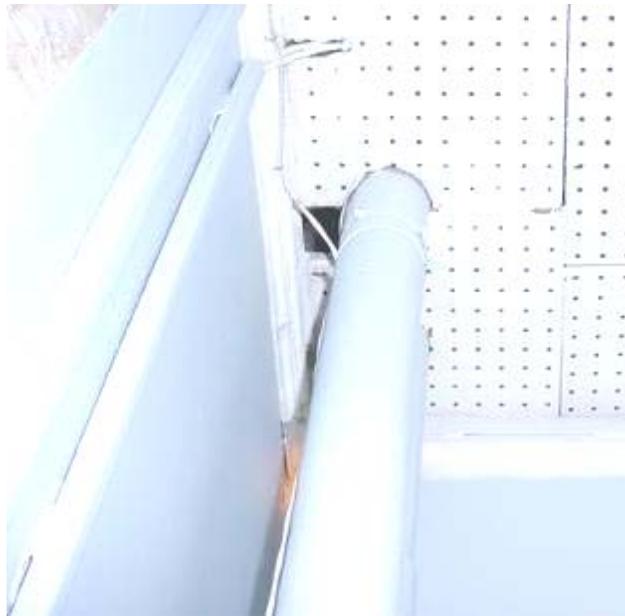
Picture 6

Close-Up of Open Utility Hole above Communications Console in Administrative Office

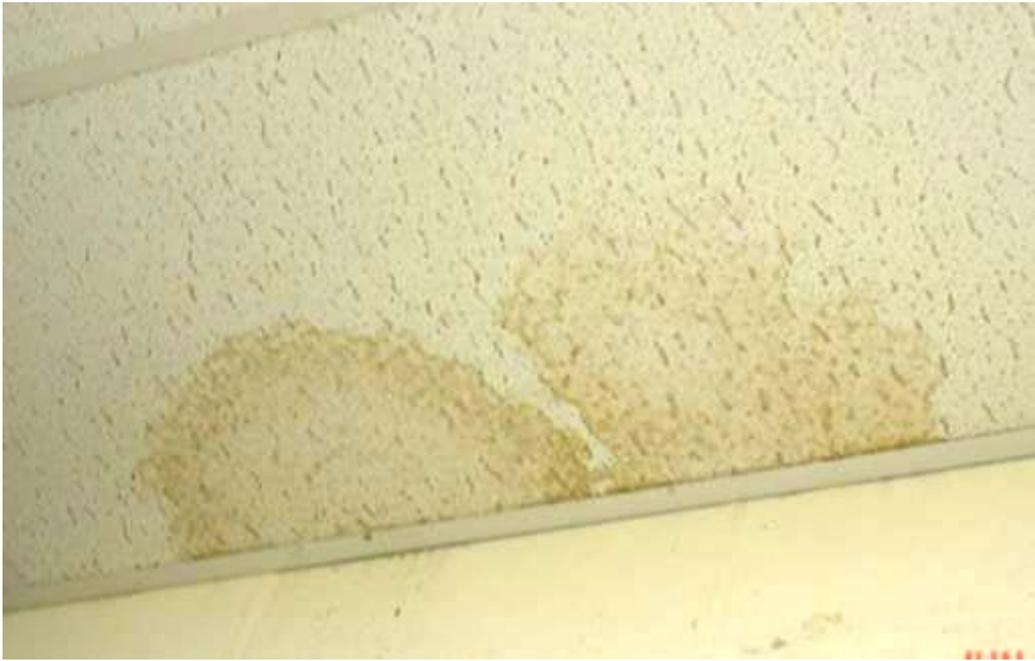
Picture 7

The WES reportedly experiences chronic leaking in the main hallway, possibly around the chimney, that the PPS is actively investigating. Water-damaged ceiling tiles resulting from this leak were observed in resource room 22-B (Picture 7). Water-damaged ceiling tiles can provide a source of mold and should be replaced after a leak is discovered and repaired. BEH staff removed damaged ceiling tiles to observe conditions in the ceiling plenum and noticed a dark staining on the surface of ceiling plaster that may be mold growth (Picture 8).

Water Damaged Ceiling Tiles in Resource Room 22-B

1. Continue to investigate and repair roof leaks. Once leaks are repaired, replace any remaining water-damaged ceiling tiles. Examine the areas above and behind these areas for mold growth. Disinfect areas of water leaks with an appropriate antimicrobial.

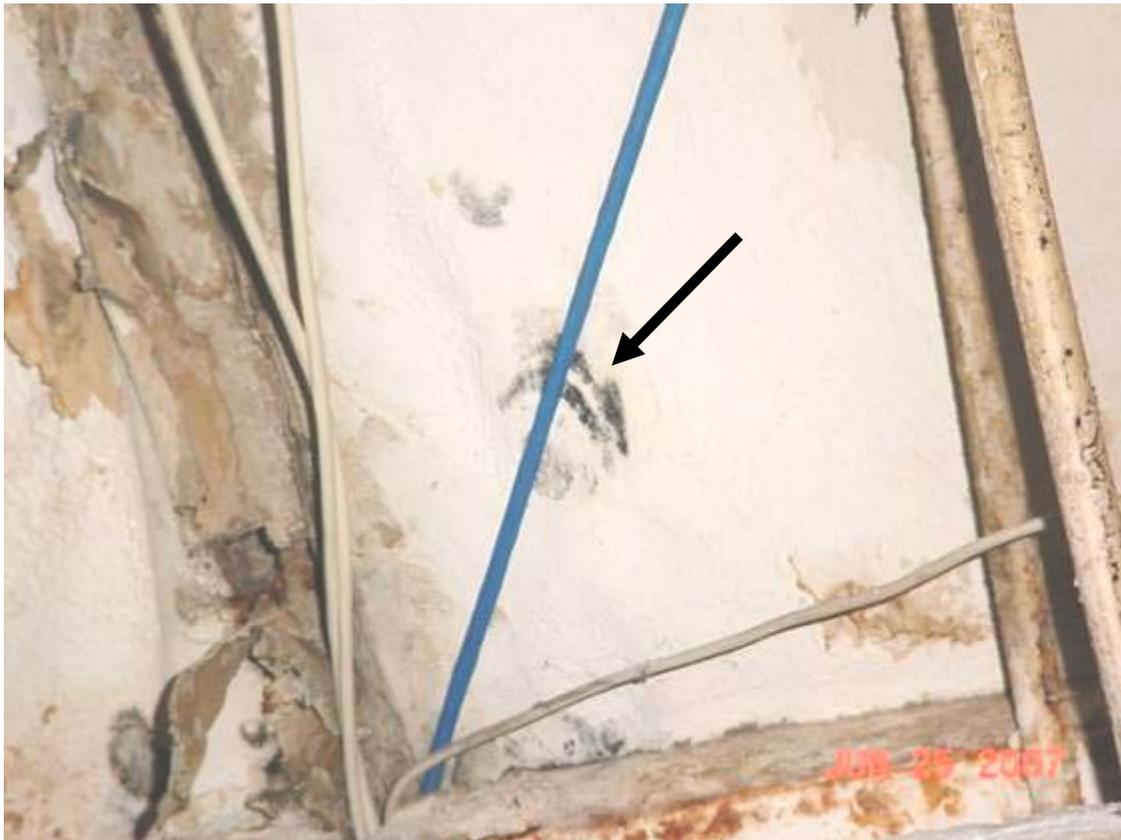
Picture 8

Water Damaged Ceiling Plaster above Ceiling Tile System in Resource Room 22-B, Dark Staining in Center (Arrow) Indicates Possible Mold Growth

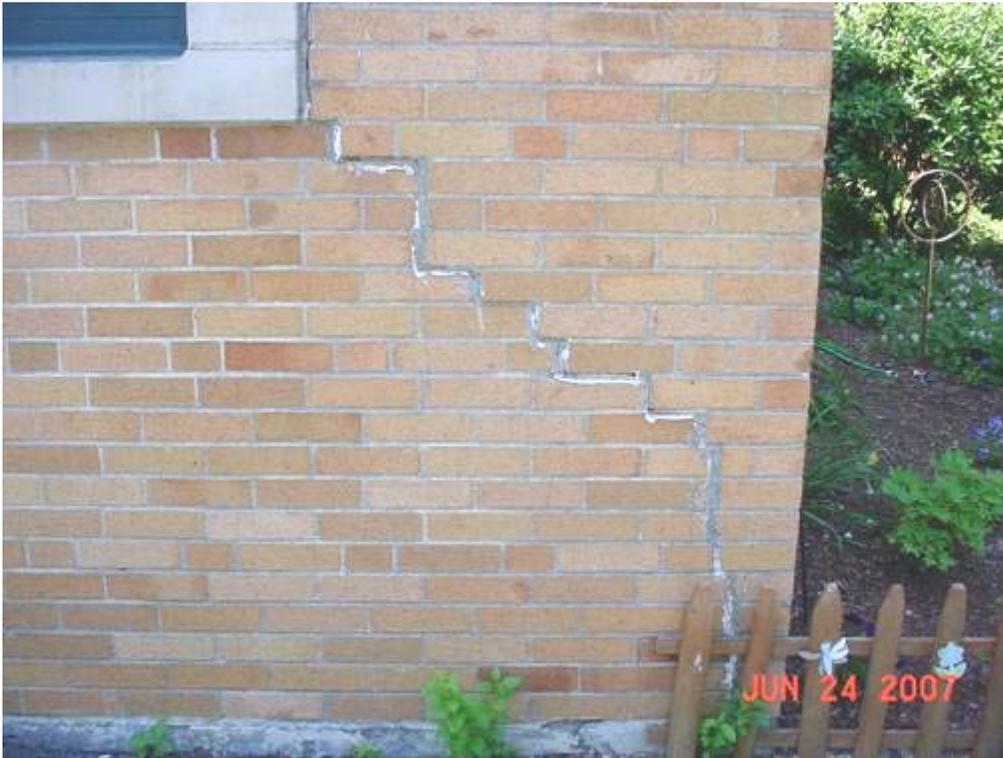
Picture 9

Although some areas of exterior brickwork outside of the Principal's office were reportedly re-pointed, mortar around brick in other areas was observed to be missing/damaged (Pictures 9 to 13). These conditions can undermine the integrity of the building envelope and provide a means of water entry by capillary action into the building through exterior walls, foundation concrete and masonry (Lstiburek & Brennan, 2001).

Crack/Damage to Exterior Brick

9. Repair breaches in the building envelope including, cracks in walls, missing/damaged mortar around exterior brick and open utility holes.
10. For buildings in New England, periods of low relative humidity during the winter are often unavoidable. Therefore, scrupulous cleaning practices should be adopted to minimize common indoor air contaminants whose irritant effects can be enhanced when the relative humidity is low. To control for dusts, a high efficiency particulate arrestance

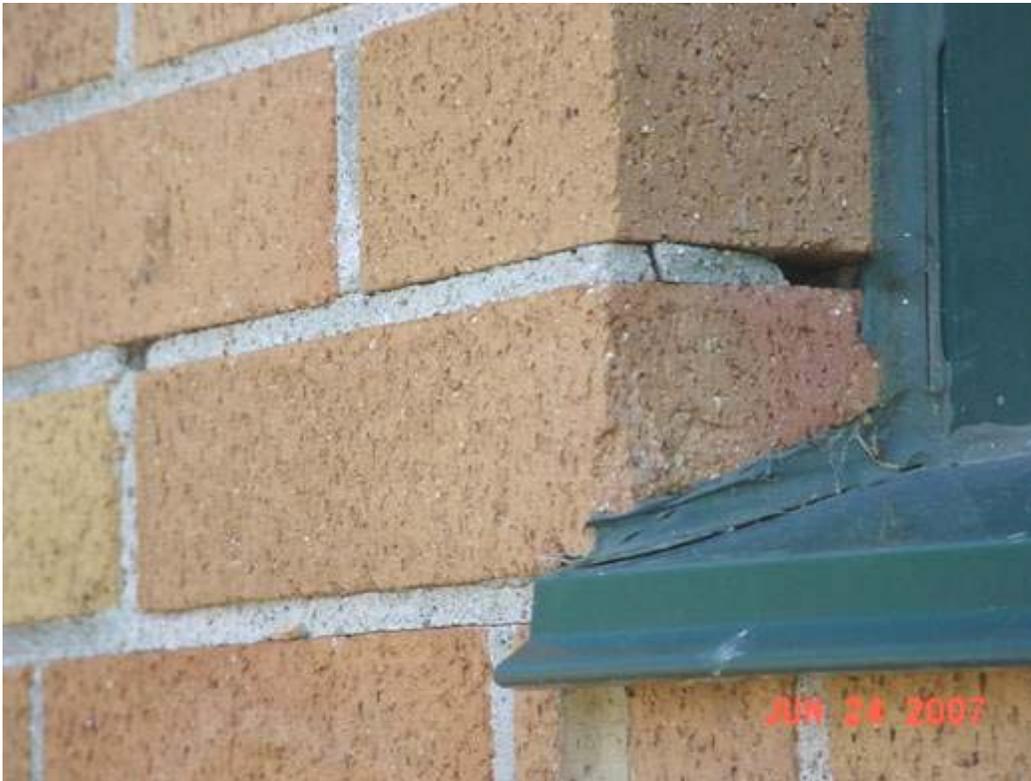
Picture 10

Missing/Damaged Mortar around Brick

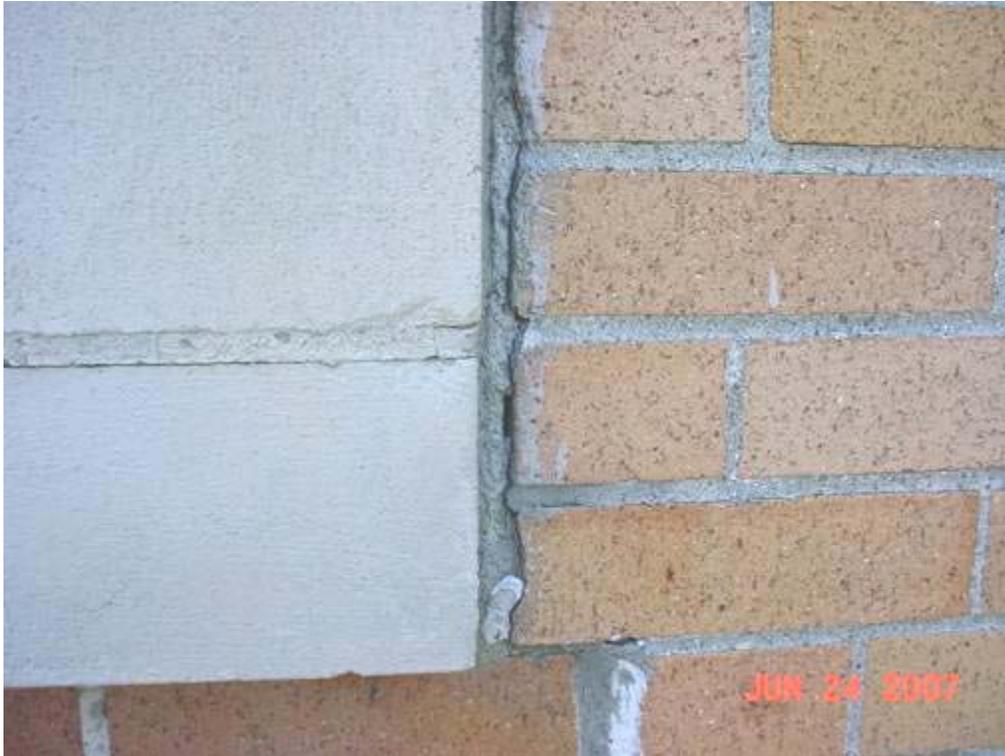
Picture 11

Spaces between Building Materials on Exterior of Building

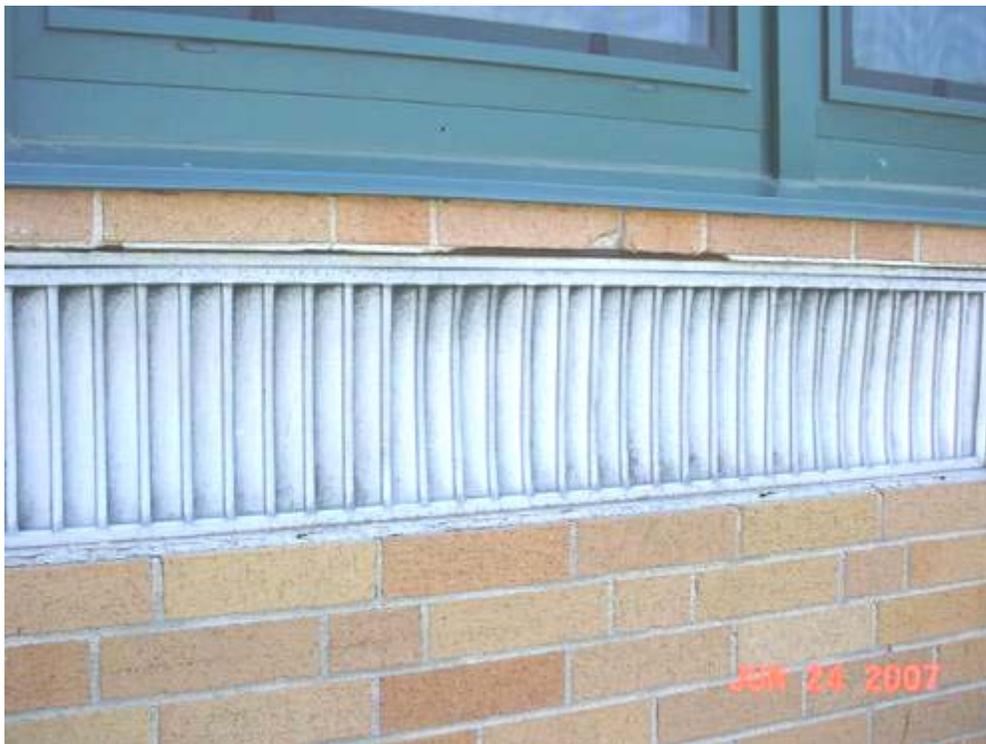
Picture 12

Spaces, Missing/Damaged Sealant around Univent Air Intake

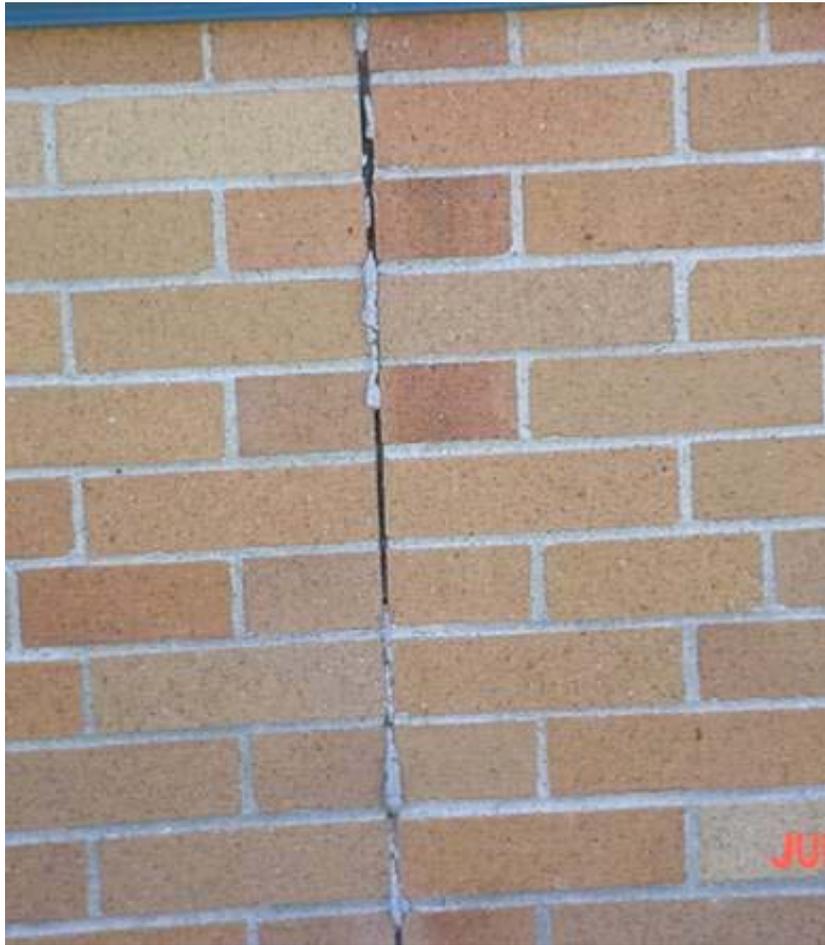
Picture 13

Missing/Damaged Mortar around Brick

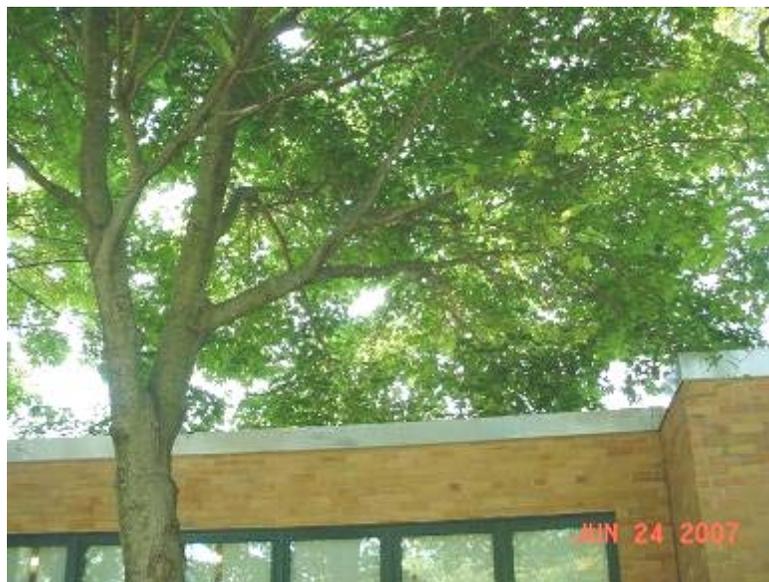
Picture 14

Another source of moisture impinging on the building are trees/branches in close proximity or hanging over the roof of the building (Pictures 14 and 15). Leaves and debris from branches can clog roof drains and accumulate on the roof. Clogged drains, accumulated leaves and debris can hold water on the roof where repeated freezing and thawing during winter months can damage the roof membrane and lead to water penetration.

Branches Overhanging Roof

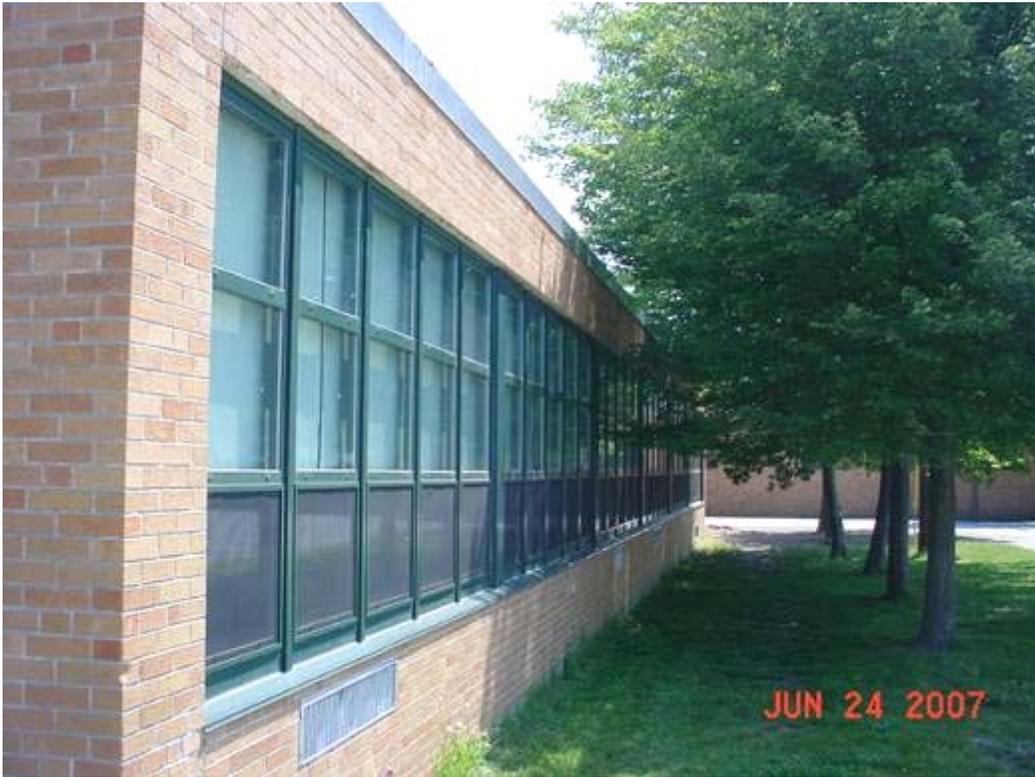
Picture 15

Branches in Close Proximity and over Roof

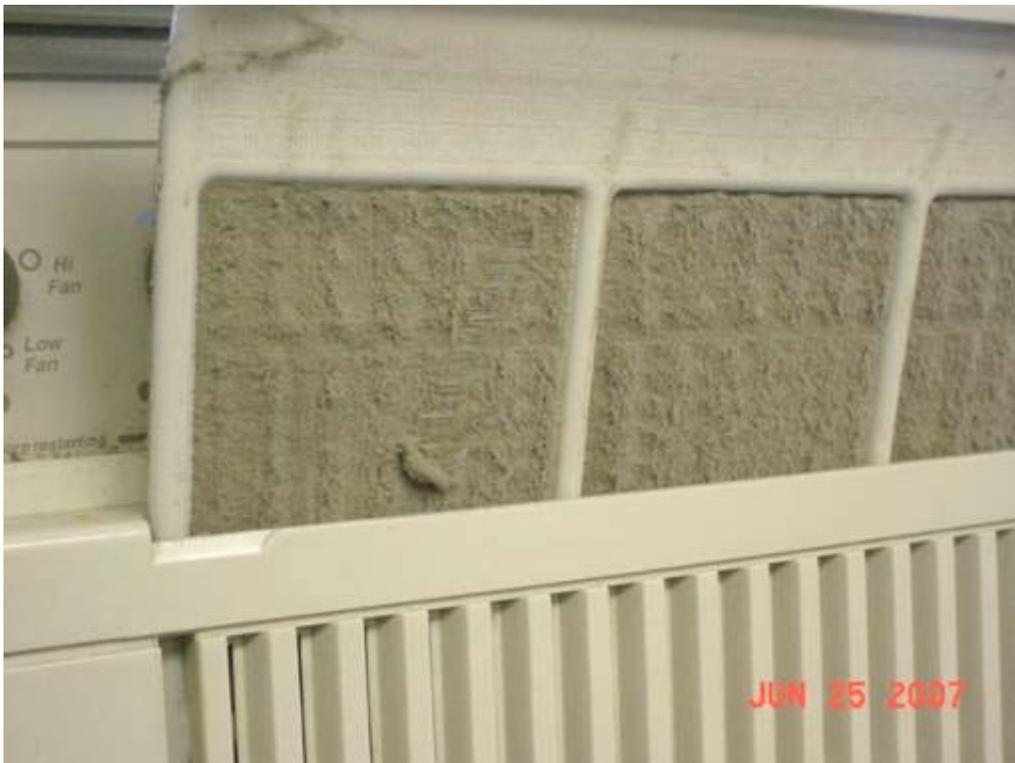
Picture 16

Window-mounted air conditioners are normally equipped with filters, which should be cleaned or changed as per manufacturer's instructions to prevent accumulation and re-aerosolization of dirt, dust and particulate matter. BEH staff examined air conditioning units and observed the filter in the administrative office to be occluded with dust and debris (Picture 16).

AC Air Filter Clogged With Dust and Debris

11. Clean/change filters for portable air conditioners as per the manufacturer's instructions or more frequently if needed.
12. Refer to "Mold Remediation in Schools and Commercial Buildings" published by the US EPA (US EPA, 2001) for further information on mold and/or mold remediation. This document is available at: http://www.epa.gov/iaq/molds/mold_remediation.html.
13. Consider adopting the US EPA (2000) document, "Tools for Schools", to maintain a good indoor air quality environment on the building. This document can be downloaded from the Internet at: <http://www.epa.gov/iaq/schools/index.html>.
14. Refer to resource manuals and other related indoor air quality documents for further building-wide evaluations and advice on maintaining public buildings. These materials are located on the MDPH's website: http://mass.gov/dph/indoor_air.
