INDOOR AIR QUALITY ASSESSMENT

**Department of Revenue
Shetland Park
35 Congress Street
Salem, MA**

Prepared by:
Massachusetts Department of Public Health
Center for Environmental Health
Emergency Response/Indoor Air Quality Program
February 2007

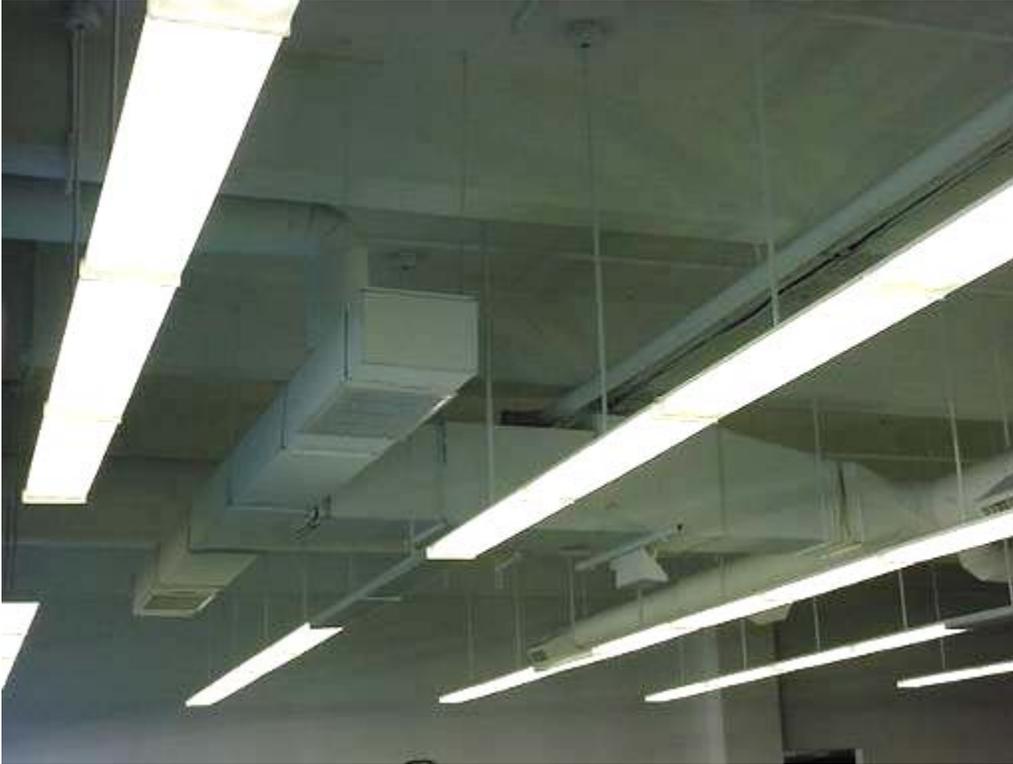
Picture 1

Fresh, heated air is supplied to all areas of the DOR by air-handling units (AHUs) suspended from the ceiling (Picture 1). Fresh air is drawn into the AHUs through air intakes located on the exterior of the building (Picture 2 and 3). Ceiling-mounted air diffusers ducted to the AHUs distribute fresh tempered air to the spaces (Pictures 4 and 5). Return air is drawn into ceiling-mounted vents equipped with pleated air filters (Pictures 6 and 7). Some return air is ducted back to AHUs, where it is mixed with fresh air and redistributed to the office space. Return air can also be exhausted out of the building through exhaust vents located on the exterior of the building (Picture 8). Exhaust vents on the exterior of the building were equipped with wind shields to prevent re-entrainment of exhausted air.

AHU Suspended from the Ceiling

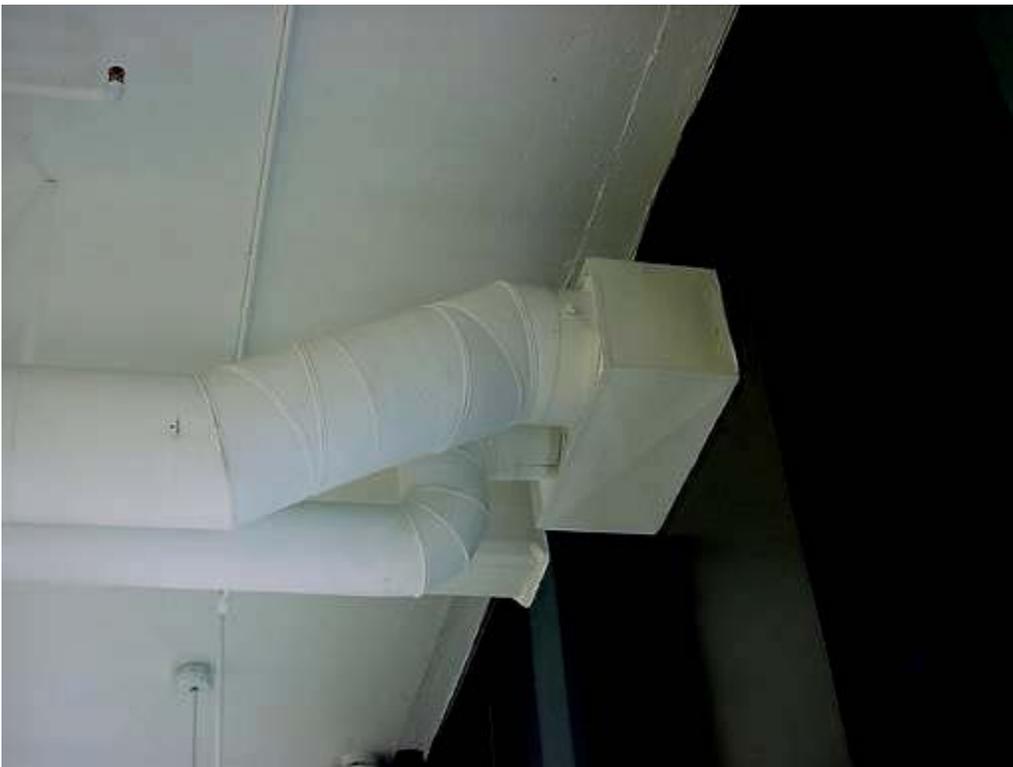
Picture 2

Interior View of Air Intake Ducts/Vent, 3rd Floor DOR

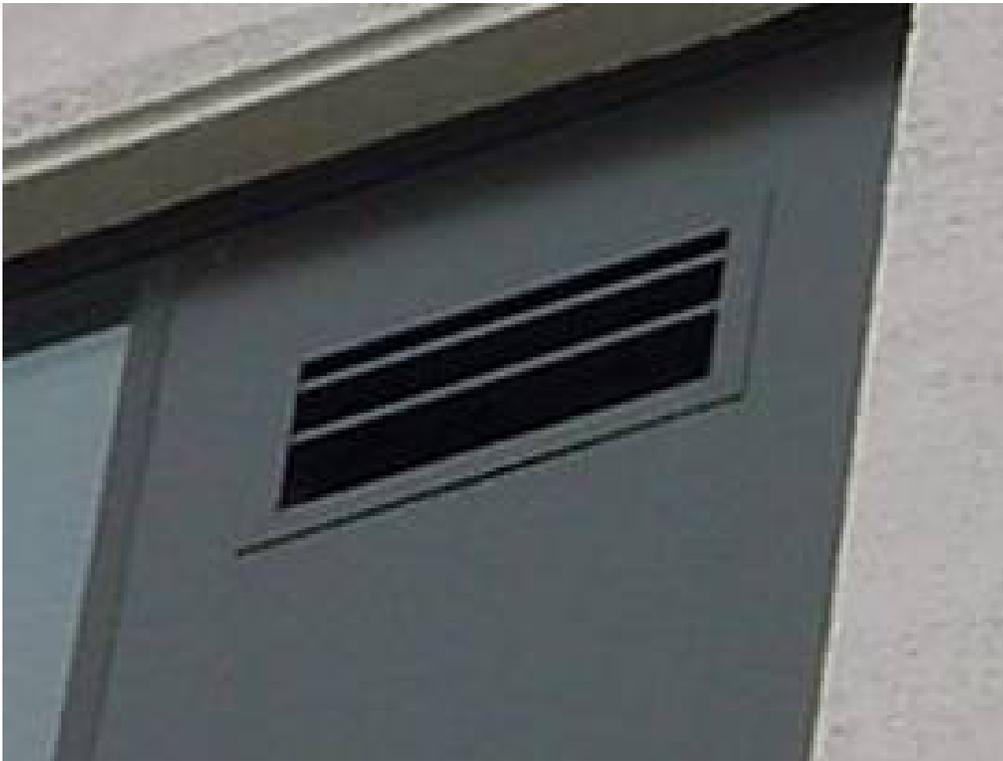
Picture 3

Fresh Air Intake for HVAC System on Exterior of Building

3. Contact the building's HVAC consultant to determine whether the existing fresh air intake system can be adjusted to increase outside air intake.
4. Consider balancing mechanical ventilation systems every five years as per ventilation industrial standards (SMACNA, 1994).

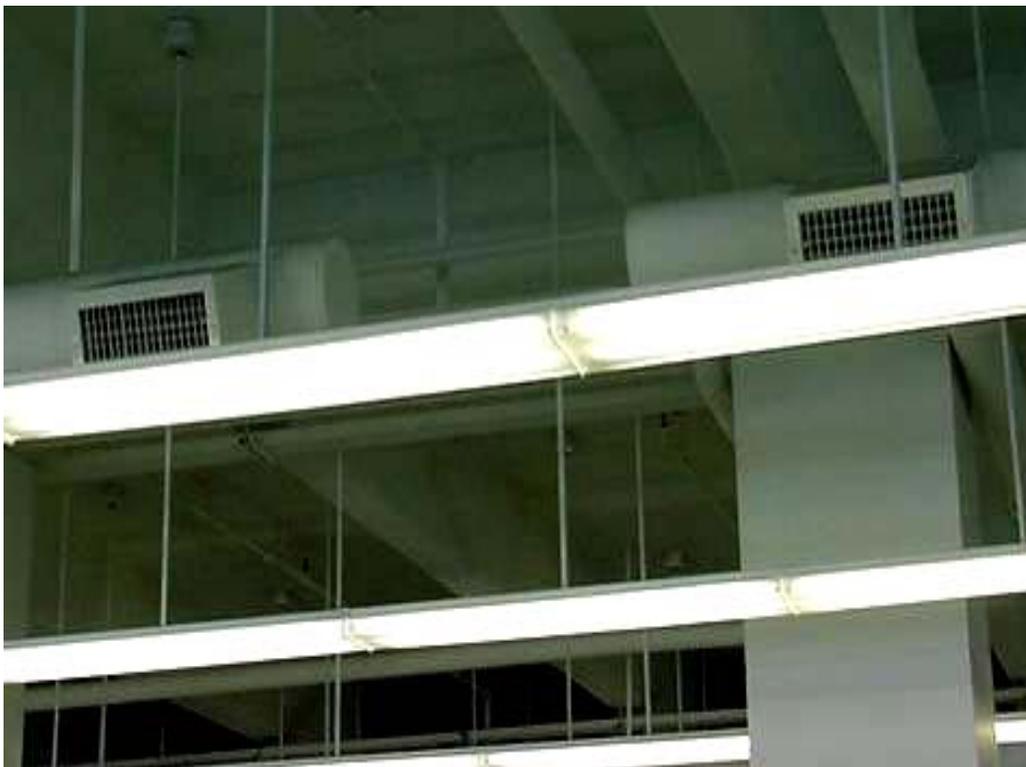
Picture 4

Ducted Air Diffusers in Central Work Areas

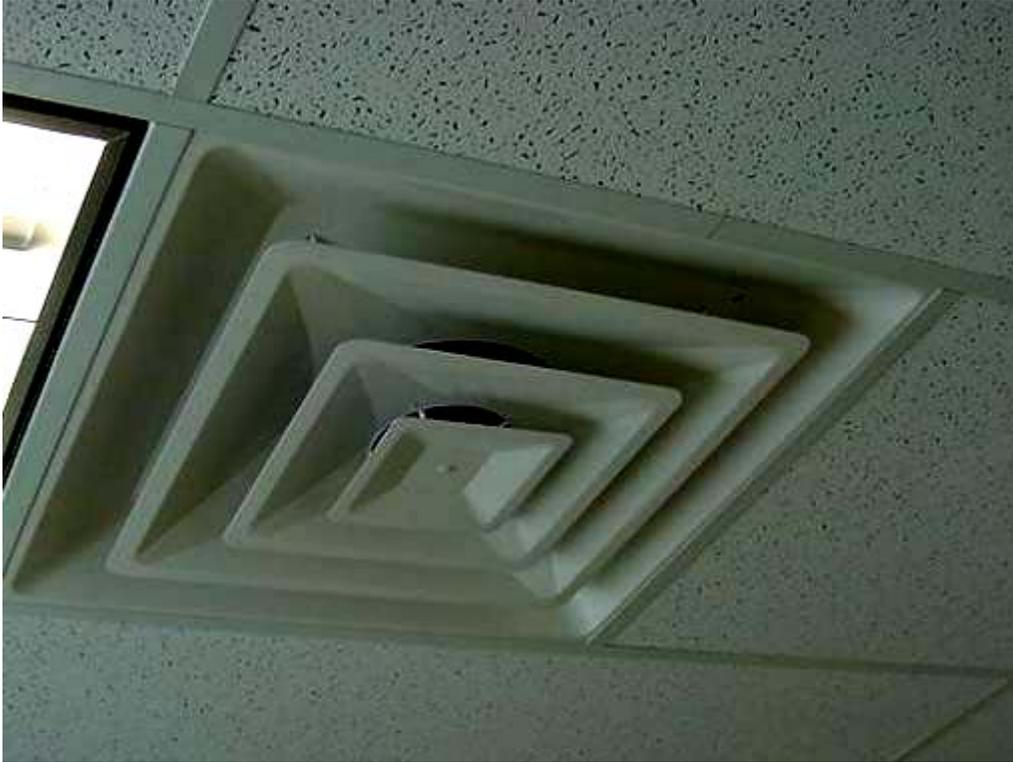
Picture 5

Example of Multi-Directional Air Diffuser in Offices and Common Areas with Dropped Ceilings

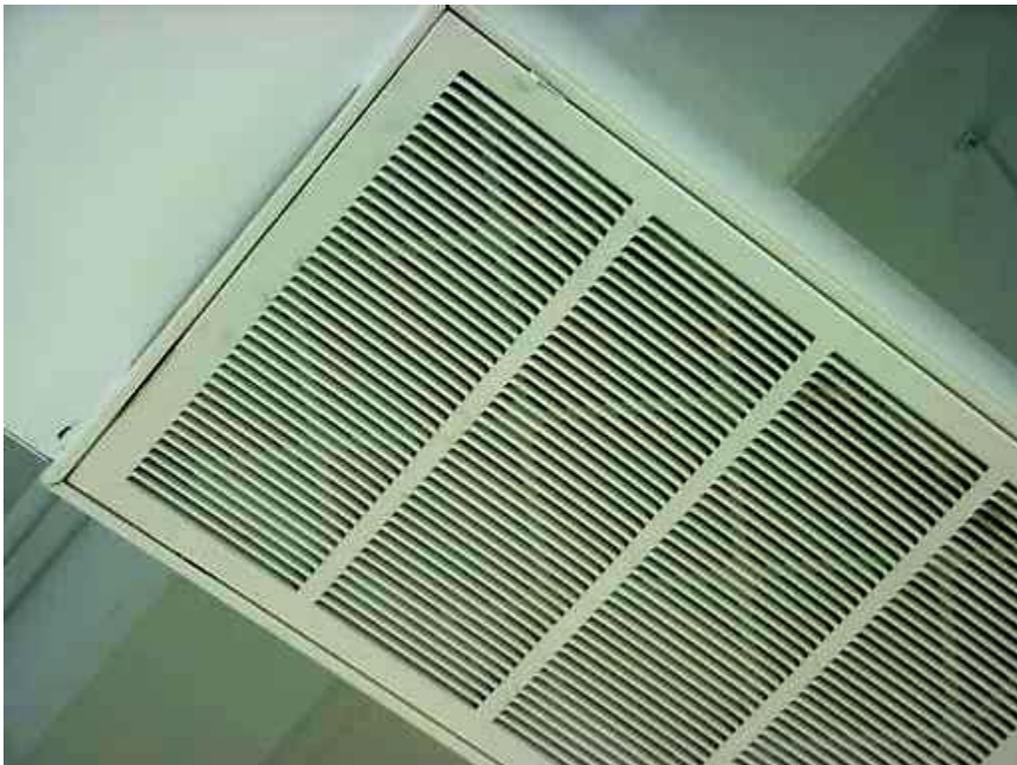
Picture 6

Return Vent with Pleated Air Filter Installed

8. Continue to change HVAC filters on current schedule or more frequently if needed.
9. Clean supply, return and exhaust vents periodically of accumulated dust.

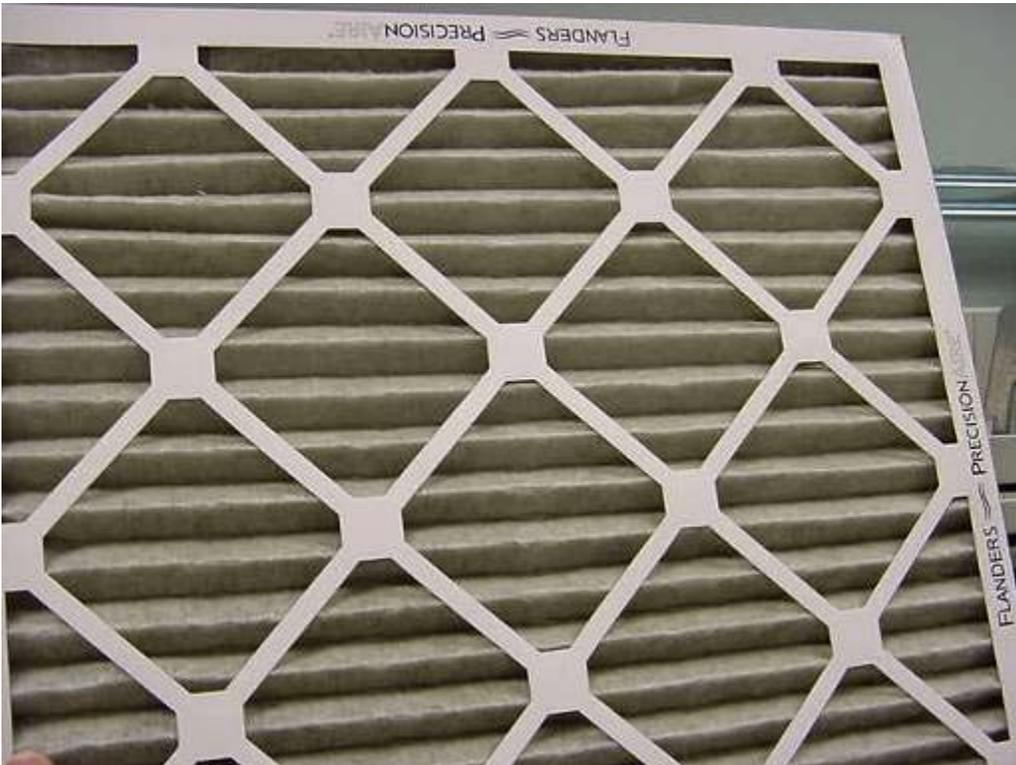
Picture 7

Pleated Air Filter

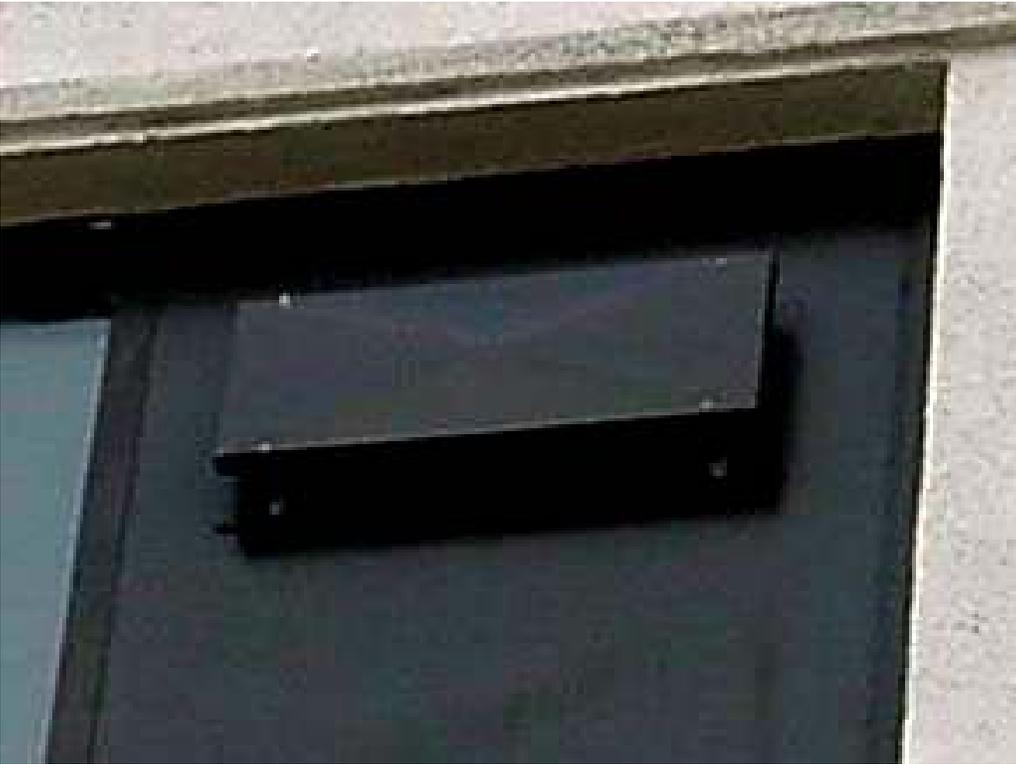
Picture 8

As previously mentioned, the assessment was prompted primarily due to odor concerns. DOR staff had reported an “unusual smell” to DOR management and facilities staff on Thursday January 18, 2007. Some occupants described the odor as “egg salad”. Shetland Management toured the space with DOR staff to investigate, but reportedly no point source of the odor was identified. The windows were opened and the odor reportedly dissipated within several hours. Although the source of odors could not be identified, Shetland management reportedly agreed to clean all the vents and install “wind-shields” on the exhaust vents to prevent potential backdrafting (Picture 8).

Exhaust Vent with Wind Shield Installed to Prevent Backdrafting

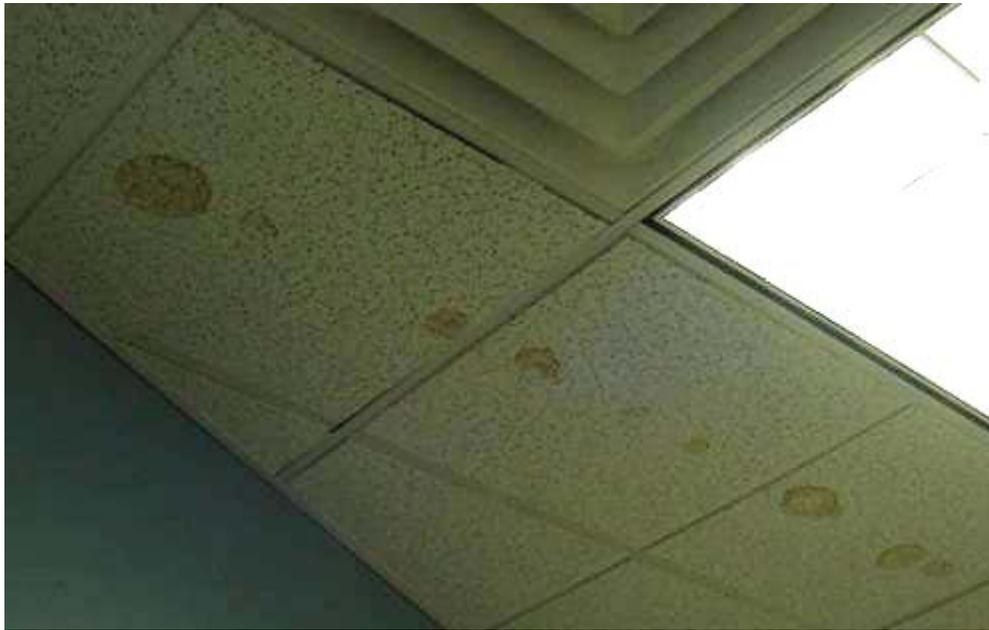
Picture 9

Water-stained ceiling tiles were observed in a few areas (Table 1). A stained tile in the corner of Mr. Auerbach's office reportedly occurred after a recent, heavy, wind-driven rain, indicating an active leak. Several stained tiles in the east wing appeared to be from condensation due to the staining pattern which appears to follow the contour of a horizontal pipe (Picture 9). Water-damaged ceiling tiles can provide a source for mold and should be replaced after a water leak is discovered and repaired.

Water-Stained Ceiling Tiles, like from Pipe Condensation

6. Ensure leaks are repaired and replace water-stained ceiling tiles. Take measures to reduce condensation generation on pipes (e.g., inspect insulation).

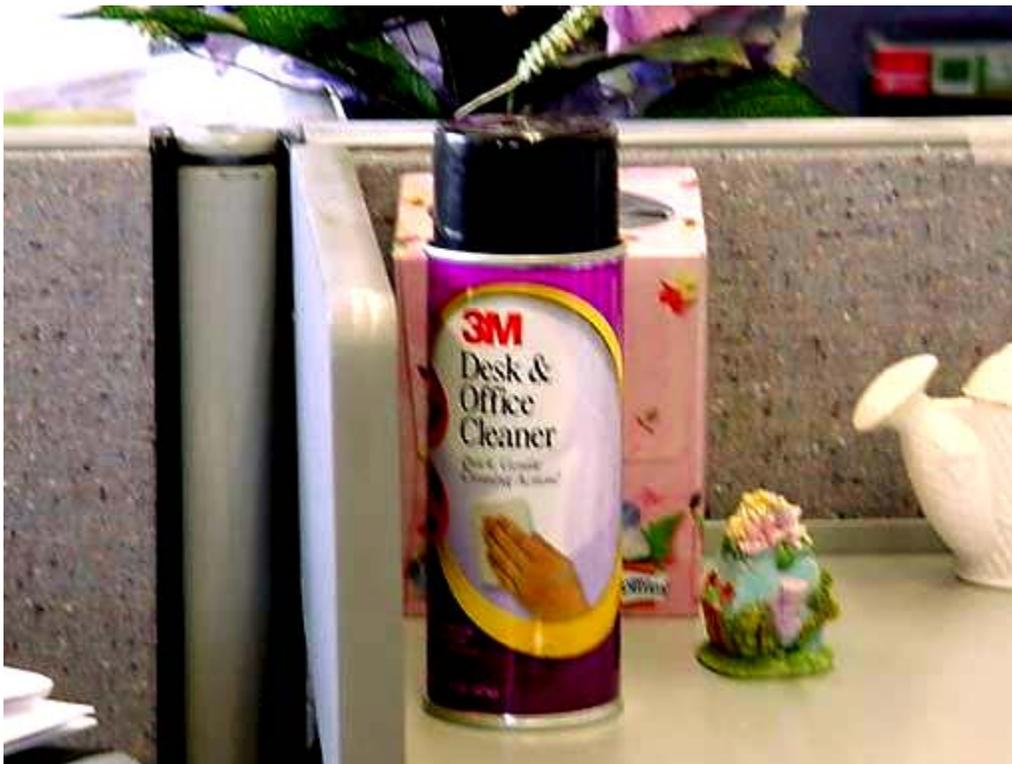
Picture 10

that can be irritating to certain sensitive individuals. In addition, air fresheners do not remove materials causing odors, but rather mask odors, which may be present in the area. VOC-containing cleaning materials were observed to clean personnel work areas (Picture 10). This cleaning agent contains several VOCs (e.g., isopropyl alcohol and monoethanolamine) that can be irritating to the eyes, nose and throat (3M, 2000) (Picture 11).

VOC-Containing Spray Cleaner

10. Refrain from or reduce the use of VOC-containing cleaning materials.
11. Refrain from using air fresheners and deodorizers to prevent exposure to VOCs.

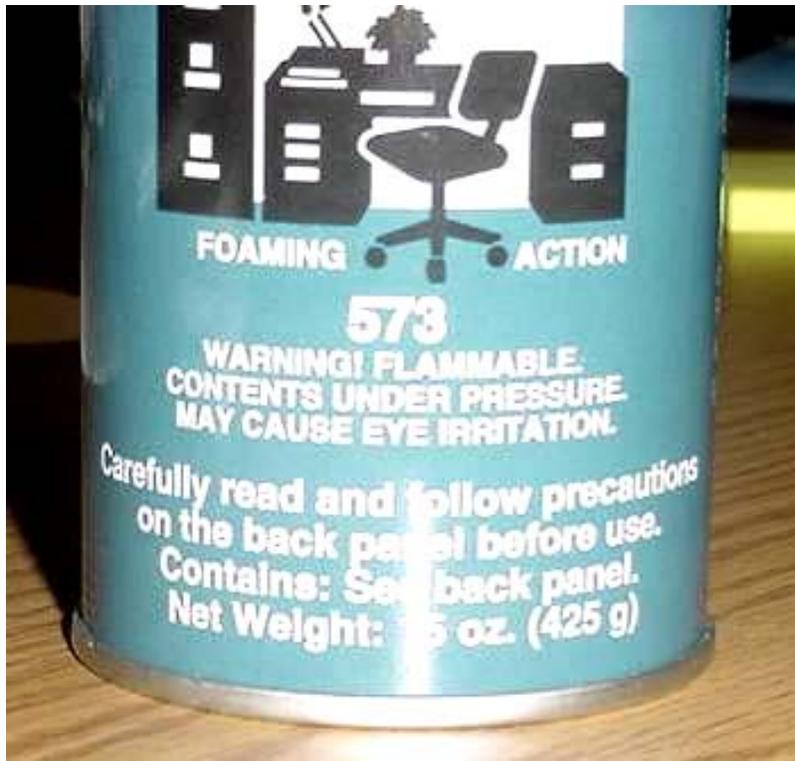
Picture 11

Close-up of Warning Label on Cleaning Material used at DOR

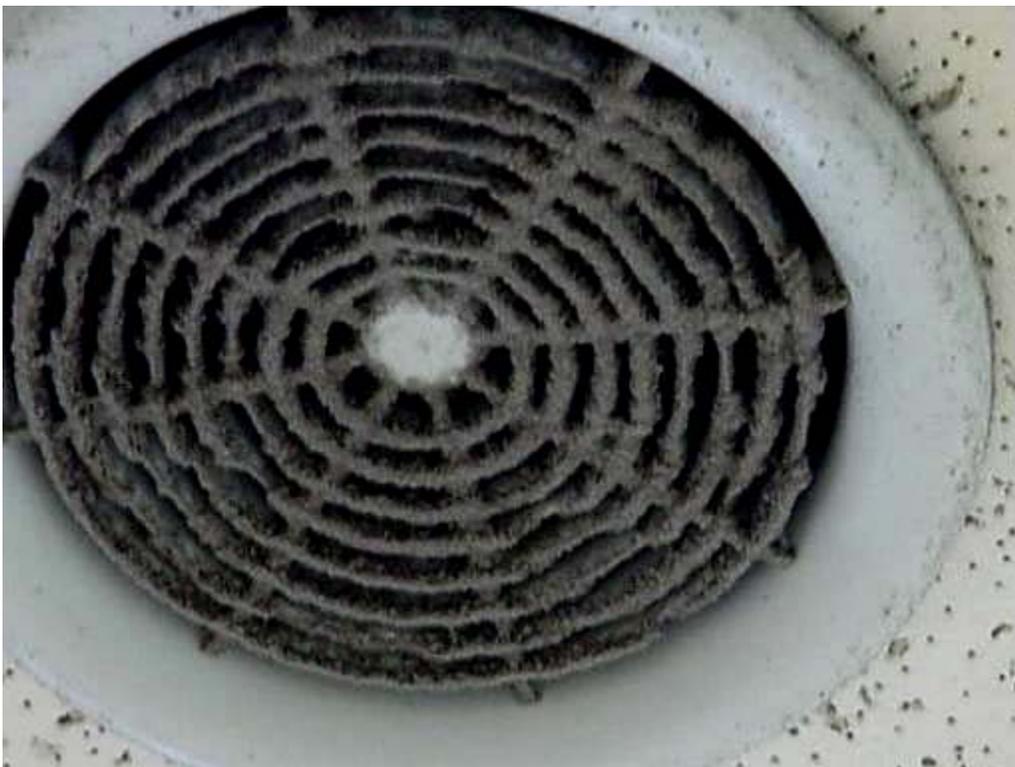
Picture 12

Finally, although supply and return vents in common work areas had been cleaned, exhaust vents in restrooms were observed to be occluded with dust and debris (Picture 12). Picture 13 demonstrates such dust accumulation, which can greatly inhibit airflow.

Dust Accumulation on Restroom Exhaust Vent

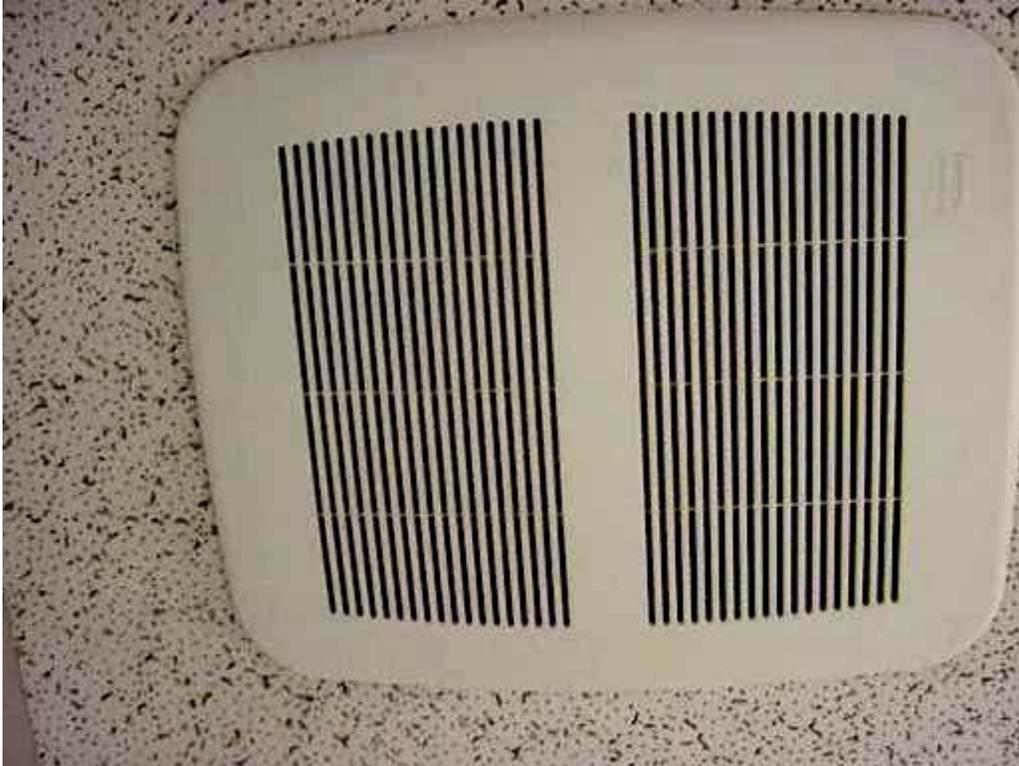
Picture 13

Dust Accumulation on Restroom Exhaust Vent, Note Slots were Obstructed Inhibiting Airflow
