# **INDOOR AIR QUALITY ASSESSMENT**

**Department of Revenue  
Shetland Park  
35 Congress Street  
Salem, MA**

Prepared by:  
Massachusetts Department of Public Health  
Bureau of Environmental Health  
Emergency Response/Indoor Air Quality Program  
June 2007

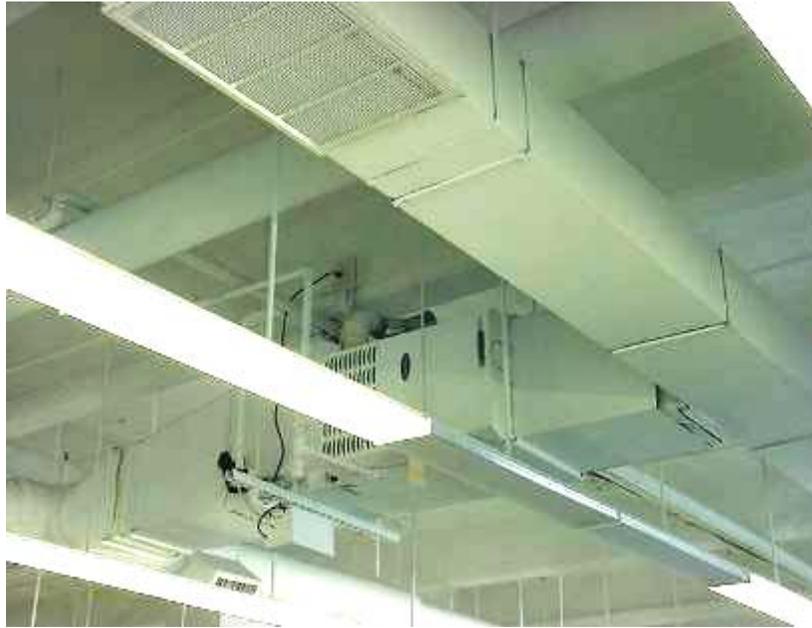
**Picture 1**

Fresh, heated air is supplied to all areas occupied by the DOR by air-handling units (AHUs) suspended from the ceiling (Picture 1). Fresh air is drawn into the AHUs through air intakes located on the exterior of the building (Picture 2). Ceiling-mounted air diffusers ducted to the AHUs distribute fresh tempered air to the occupied areas (Picture 3). Return air is drawn into ceiling-mounted vents (Picture 4). Some return air is ducted back to AHUs, where it is mixed with fresh air and redistributed to the office space. Air is also exhausted out of the building through vents located on the exterior of the building (Picture 5). Exhaust vents on the exterior of the building were equipped with wind shields to prevent re-entrainment of exhausted air.

**Ceiling Mounted AHU**

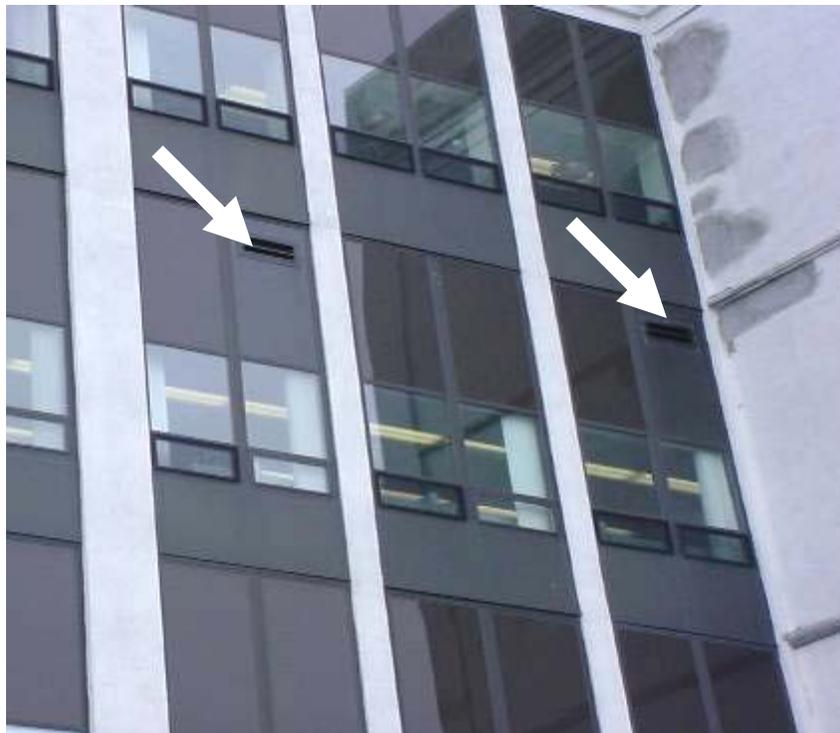
**Picture 2**

**AHU Fresh Air Intake**

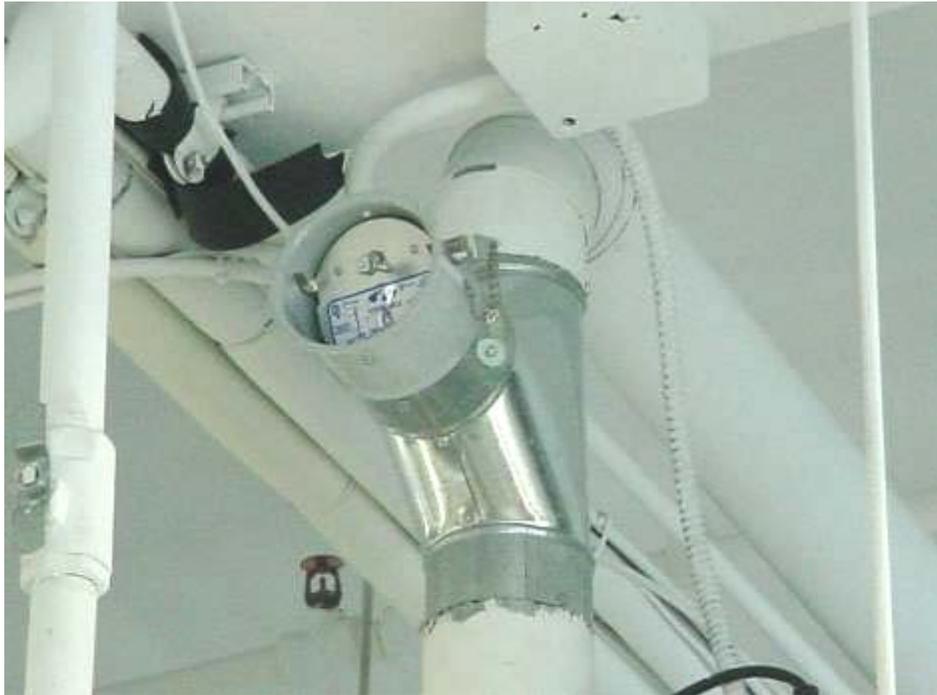
**Picture 7**

Of note is the configuration of the exhaust ventilation. Each ceiling suspended AHU is fueled by natural gas, which allows the AHU to warm the air and subsequently provide it to the occupied space ([Blueprint 1](#)). The exhaust from the firebox is vented into a duct equipped with a flue damper, which is connected to ductwork connected to a power vent ([Blueprint 2](#), Picture 6). The power vent expels the products of combustion through exhaust vents located on the exterior wall of the building. It is not possible to determine whether the power vents are operating when the heating system is operating. Since a major product of combustion is carbon dioxide, previous carbon dioxide measurements conducted in the facility may be reflective of these pollutants venting into the DOR through the flue damper (Picture 7) when/if the power vents are deactivated. The purpose of the flue vents in a system with a mechanical power vent is unclear, since the power vent would aid in drawing products of combustion without the addition of air from the building interior. Typically, installation of this type of AHU furnace does not depict a flue damper on the exhaust vent for this equipment ([Figure 1](#)) (Carrier Corporation, 1994). It is also

unclear from where combustion air for each AHU firebox is drawn. Examination of the blueprints and visual inspection by BEH staff did not indicate a separate duct to provide outside air for the AHUs. Under these circumstances, it must be presumed, unless otherwise demonstrated, that combustion air for the AHUs is drawn from the building's interior. Combustion air should be drawn directly from outdoors to ensure an adequate supply of oxygen exists to support the burning of fuel. Without an adequate oxygen supply, fuel cannot burn cleanly and pollutants and odors of natural gas are produced. These related pollutants/odors can then be drawn into the interior of the building by the operation of the HVAC system, if the power vents are not drawing efficiently and/or are disabled.

**Example of Flue Damper on AHU**

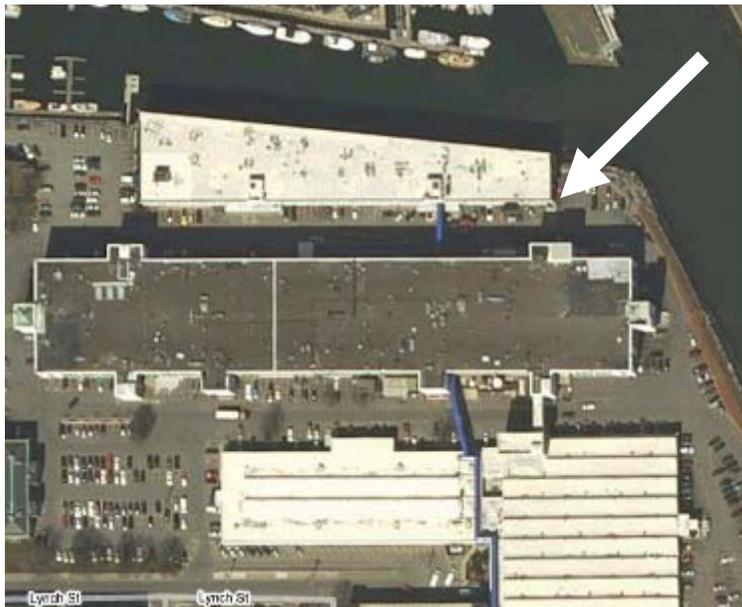
**Picture 8**

Musty odors were detected during the April 25, 2007 assessment and reported several times in the IAQ complaint log during the April 25 to 29, 2007 monitoring period. The DOR office space appears to be experiencing water penetration through the exterior walls and/or window systems. Similar water damage likely occurs when the building is subjected to wind driven rain during nor'easters. The DOR offices are located in the northeast quadrant of the third floor of the building, which would be on the windward side of the structure during nor'easters (Picture 8). The exterior wall system of the DOR office

appears to be solid brick without a curtain wall, which is typical of industrial buildings of this sort. This type of wall system is prone to water penetration through the wall system, which can allow for moistening of carpeting and associated musty odors and/or mold growth.

**Aerial View of DOR Office Building (Arrow Indicates Location of Northeast Wind Impingement on Building)**

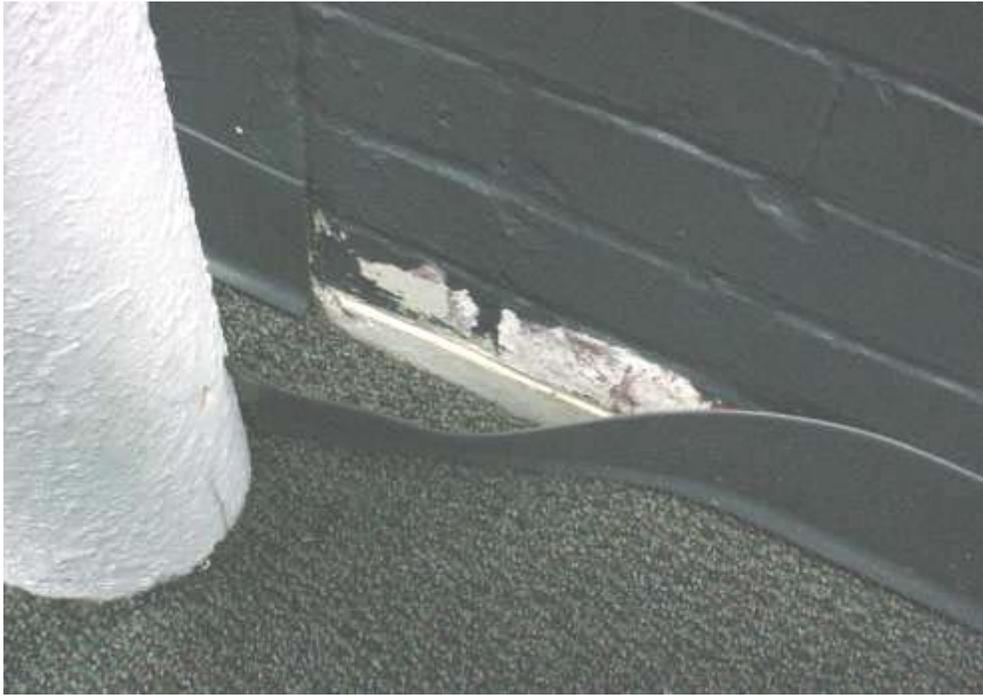
**Picture 9**

Evidence of water penetration was found behind plastic coving on the exterior walls, which had efflorescence build-up (Picture 9). Efflorescence is a salt found in brick and mortar that dissolves in water. When the salt solution migrates to the surface of a wall, the water evaporates, leaving behind a white powder. This powder is not mold growth, but is a sign that water is moving through brickwork. Since the plastic coving is water impermeable, the moisture likely accumulates behind this barrier, which in turn wets the carpeting. In addition, each window has staining on the paint beneath the corners of many window frames, indicating water penetration either through the window frames or through open windows (Pictures 10 and 11). The presence of hogs<sup>1</sup> in several windows indicates an ongoing water penetration problem.

**Efflorescence behind Wall Coving On Exterior Wall**

1. Carpet and coving along all exterior walls should be removed. Carpeting should be removed in a manner consistent with recommendations in “Mold Remediation in Schools and Commercial Buildings” published by the US Environmental Protection Agency (US EPA, 2001). This document is available from the US EPA website: [http://www.epa.gov/iaq/molds/mold\\_remediation.html](http://www.epa.gov/iaq/molds/mold_remediation.html). Replace with a non-porous material (e.g., non-slip surface).

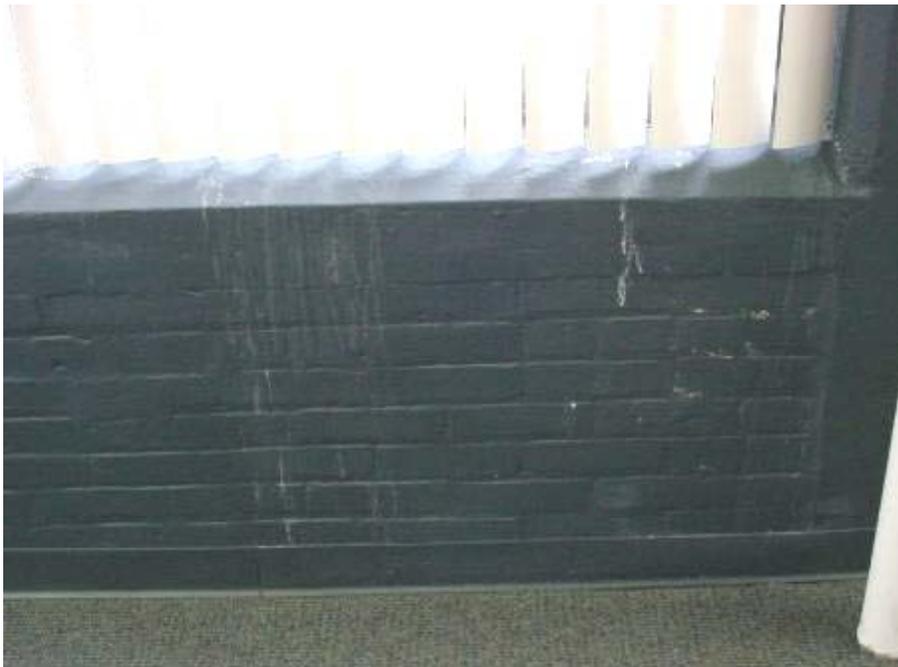
**Picture 10**

**Example of Water Staining Around Windows**

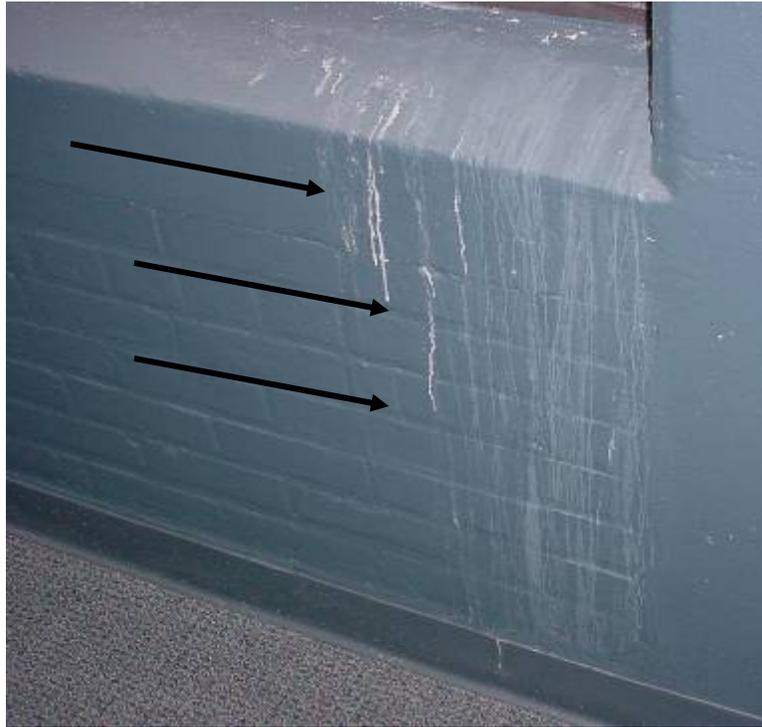
**Picture 11**

**Example of Water Staining Around Windows, Note Efflorescence, Which Likely Indicates Water *behind* the Paint**

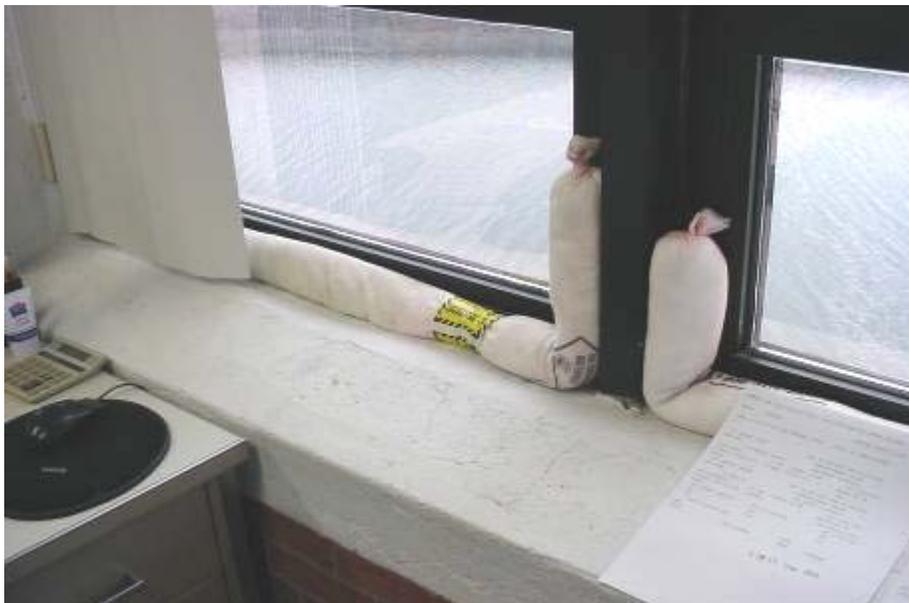
**Picture 12**

<sup>1</sup> A hog is a cloth tube filled with an absorbent material (Picture 11)

**Hogs on Window Sill**

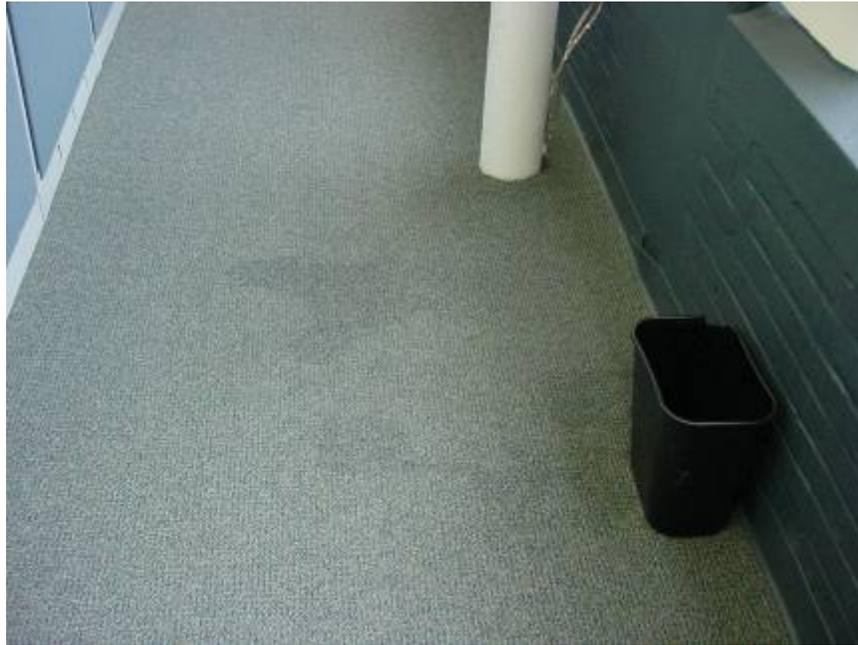
**Picture 13**

During the course of the MDPH assessment, carpet was found moistened in the west section of the office (Pictures 13). The likely source of water moistening the carpet is a leak that appears to originate from ductwork (Picture 14). Prior to the April 25, 2007 visit by BEH staff, the last rainstorm with NNE winds that may have moistened the exterior walls of the DOR office occurred on April 19, 2007 (Weather Underground, 2007), indicating that the carpet was likely wet for at least seven days. Other evidence also suggests that carpets have been moistened during other events. Picture 15 depicts an incident that shows water passing beneath cubicles and possibly moistening floor dividers.

**Moistened Carpet in DOR Office**

In order to properly dry the carpet, temporarily removing the cubicle walls would be recommended. In order to avoid flooding from occupants on the fourth floor, all pipe penetrations in the DOR ceiling and fourth floor should be sealed on both sides of the penetration with a water proof sealant.

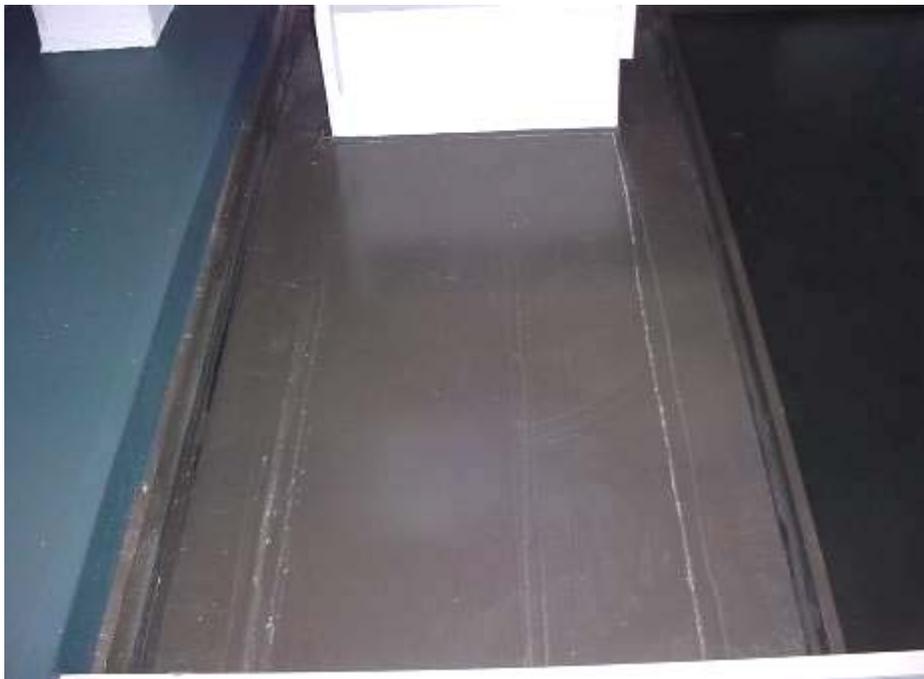
**Picture 14**

**Water Leak Stains from Duct above Stain in Picture 12**

10. Seal open seams around ductwork to prevent leakage and dust/debris accumulation. Clean accumulated dust/debris from these areas.
11. Consider appointing a building liaison (and alternate) to coordinate efforts, facilitate communication and relay building-related concerns between occupants, administration and Shetland Park personnel.

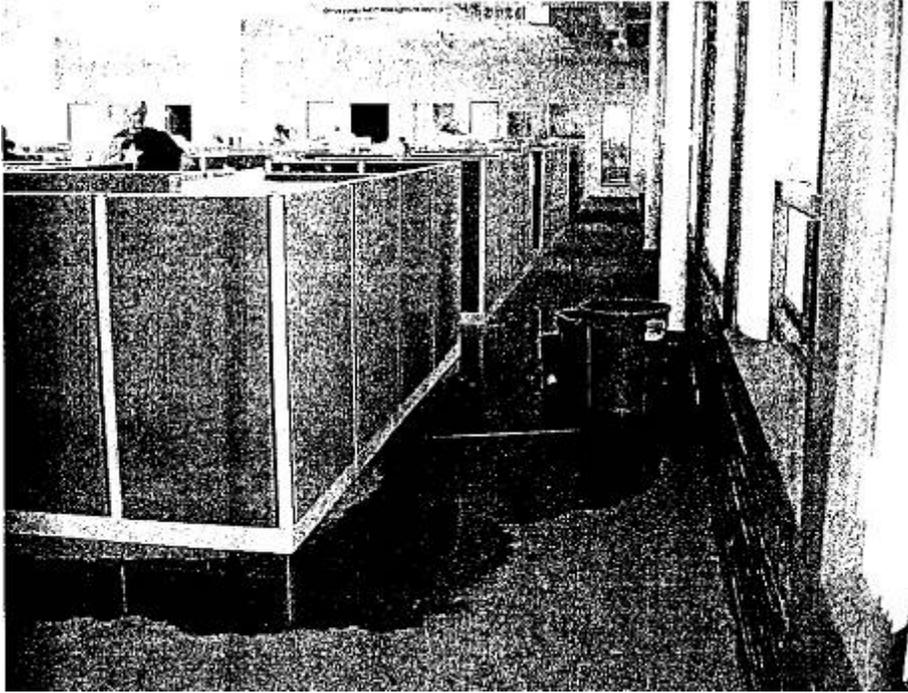
**Picture 15**

**Picture of Flooding in DOR Reportedly Taken by DOR Employee**

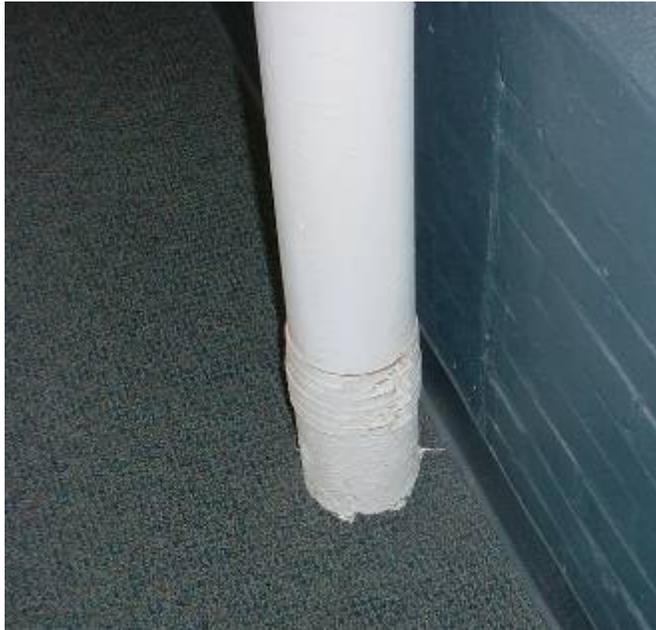
**Picture 16**

space. New drain pipes are held together using a rubber gasket held in place with a screw clamp (a shield strap) (Picture 16). If these pipes are slightly misaligned or damaged, spaces can develop beneath the gasket of the shield strap to allow for drain odors to enter occupied areas.

**New Style of Drain (Shield Strap)**

4. Examine the integrity of all drains present in the DOR space by contacting a licensed plumber to conduct a smoke test. This activity should be conducted during non-business hours, *after* consultation with the Salem Fire Department. If any breaches are found, repair to render pipes water (and air) tight.

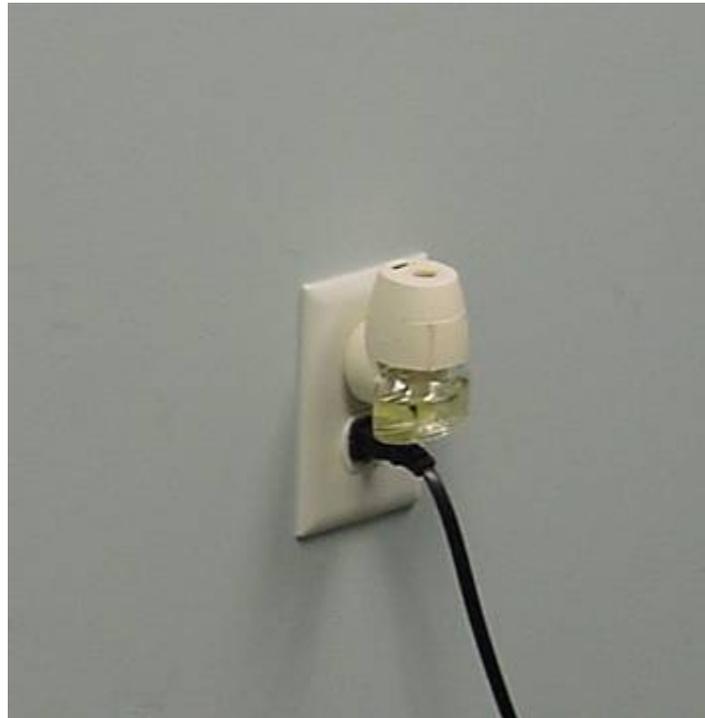
**Picture 17**

**Plug-in Air Freshener**

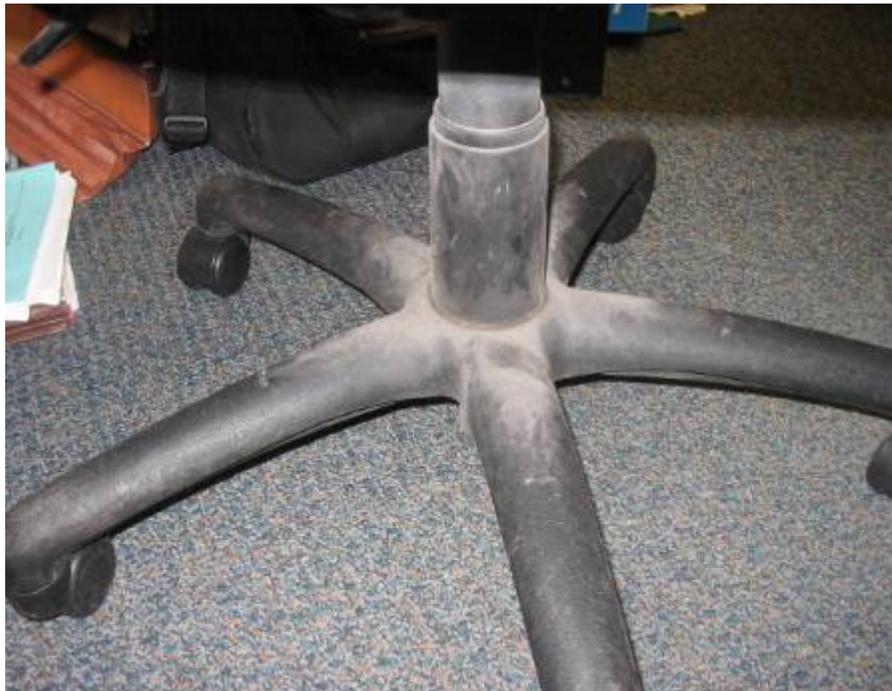
**Picture 18**

Occupants expressed concerns about the accumulation of material on a number of surfaces throughout the DOR space, including vents, ductwork and staining on a pipe that has a history of leaks (Pictures 18 through 22). The direct microscopic analysis method of samples taken from these surfaces was used to provide an assessment of both biological (e.g., mold and spores) as well as non-biological debris (e.g., dust, particulates and fibers). As seen from Table 10, the identity of materials found in four of the five samples taken are

**Tape/Bulk Item Sampled: Chair Leg E. Stephan's Office**

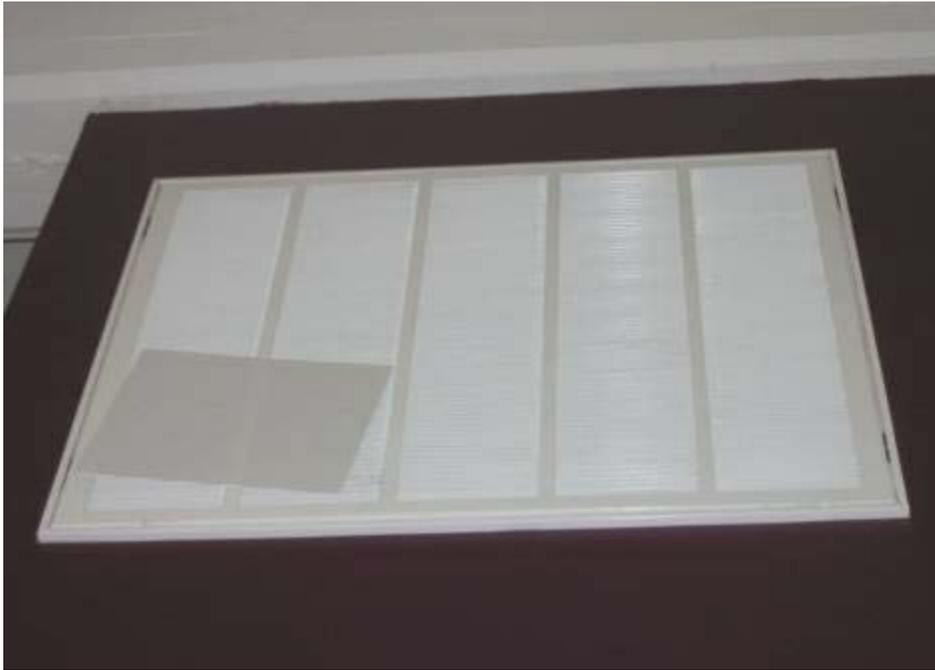
**Picture 19**

**Tape/Bulk Item Sampled: Return Vent above Cravotta Desk, Paper on surface of Vent Indicates Draw of Air *into* the Vent**

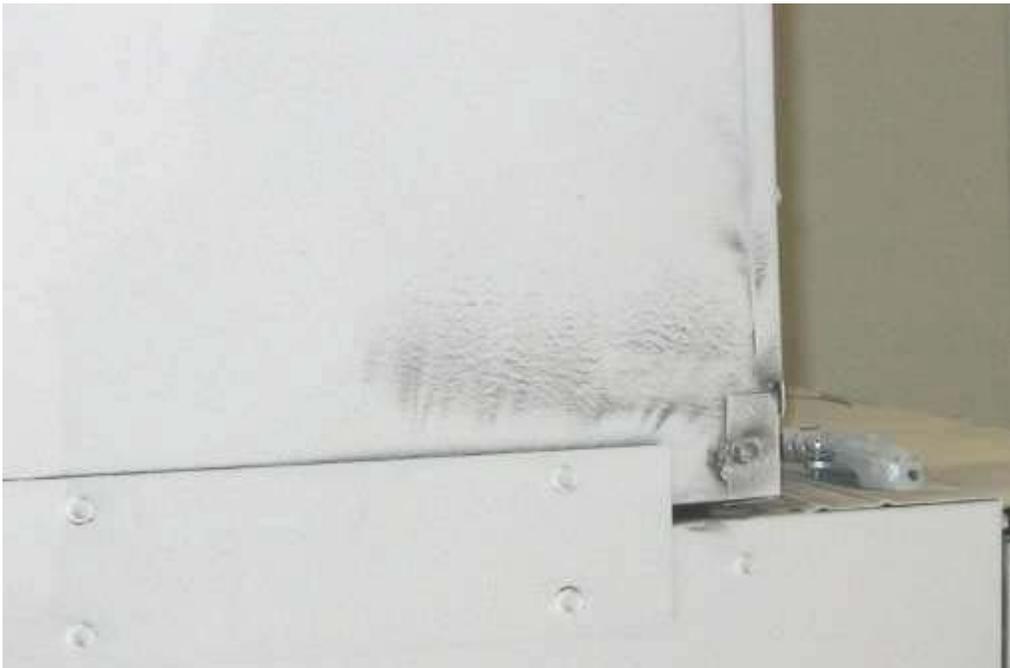
**Picture 20**

**Tape/Bulk Item Sampled: Duct above Deacon Desk**

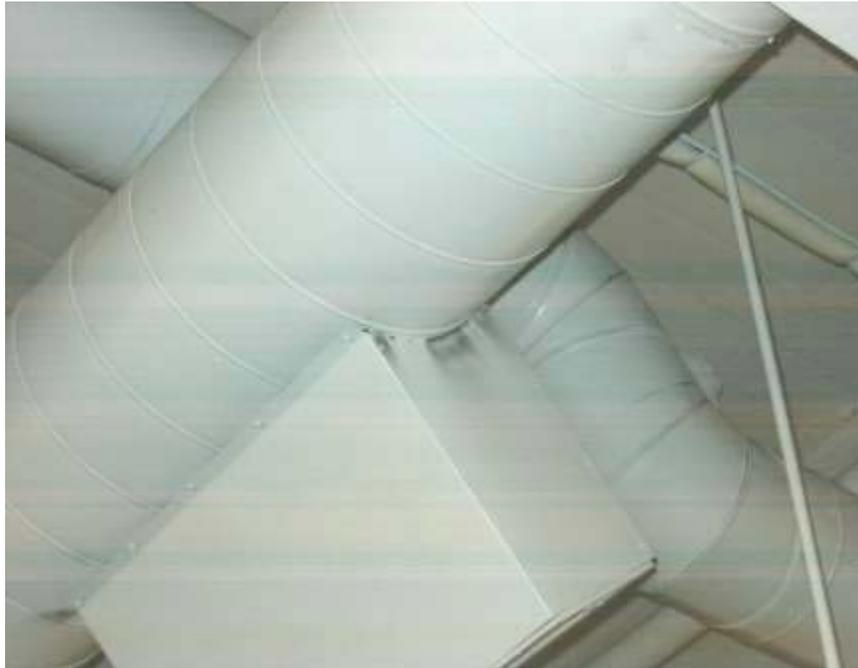
**Picture 21**

**Tape/Bulk Item Sampled: Duct near T. Kneeland Desk**

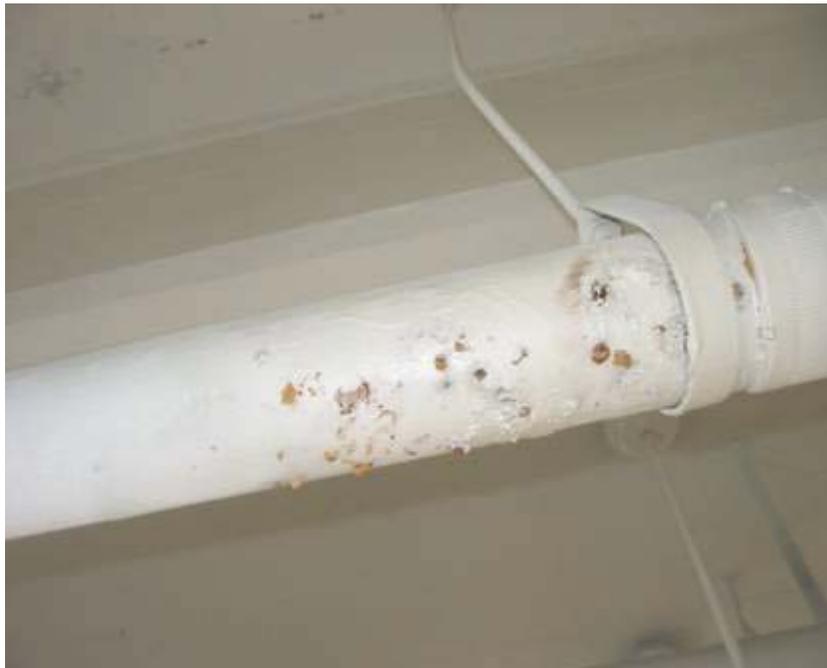
**Picture 22**

materials that can be found in a typical office space (e.g., skin scales, textile fibers, soil-like particles, starch granules and carbon-like particles). The carbon-like particles seen in two of the samples appear to be consistent with diesel exhaust soot (personal conversation with Michael Muilenberg, 2007), the source of which is likely the continuous truck traffic that circles the building during business hours. The likely means for these particles to enter the building is through open windows or entrainment by the HVAC system. Sample 5 was taken in an area with dark staining on the underside of a pipe that occupants thought to be mold growth (Picture 22). The staining was determined to be a rust-like material (Table 10).

**Tape/Bulk Item Sampled: Water Pipe above D. Comfort Desk**

5	Central Wing: Staining on underside of water damaged pipe	None	pollen (1)	No mold spores detected, pollen, abundant rust-like and other colorless (salt-like?) material

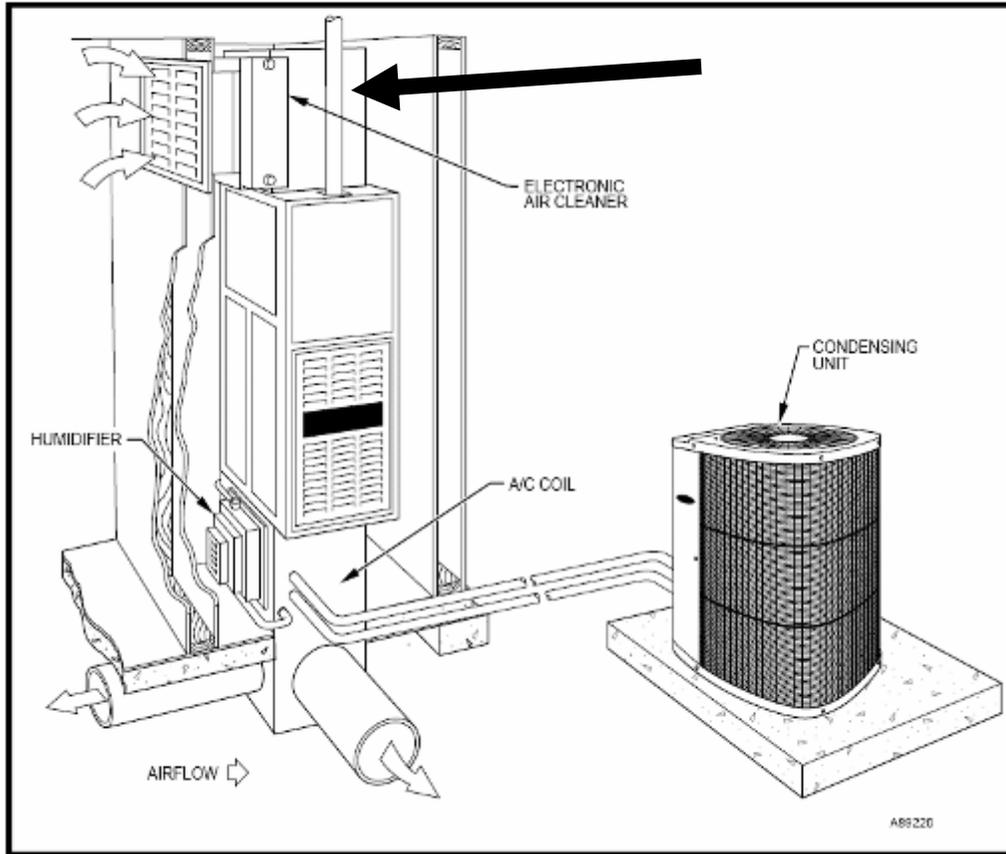
Figure 1

**58ZAV Weathermaker® 8000 Delux High-Efficiency Downflow/Horizontal Gas Furnace, Note absence of flue damper above unit on combustion vent pipe (see arrow in bold) (Carrier Corporation, 1994)**
