# **INDOOR AIR QUALITY ASSESSMENT**

**Saugus High School  
1 Pearce Memorial Drive  
Saugus, MA 01906**

Prepared by:  
Massachusetts Department of Public Health  
Center for Environmental Health  
Emergency Response/Indoor Air Quality Program  
March 2007

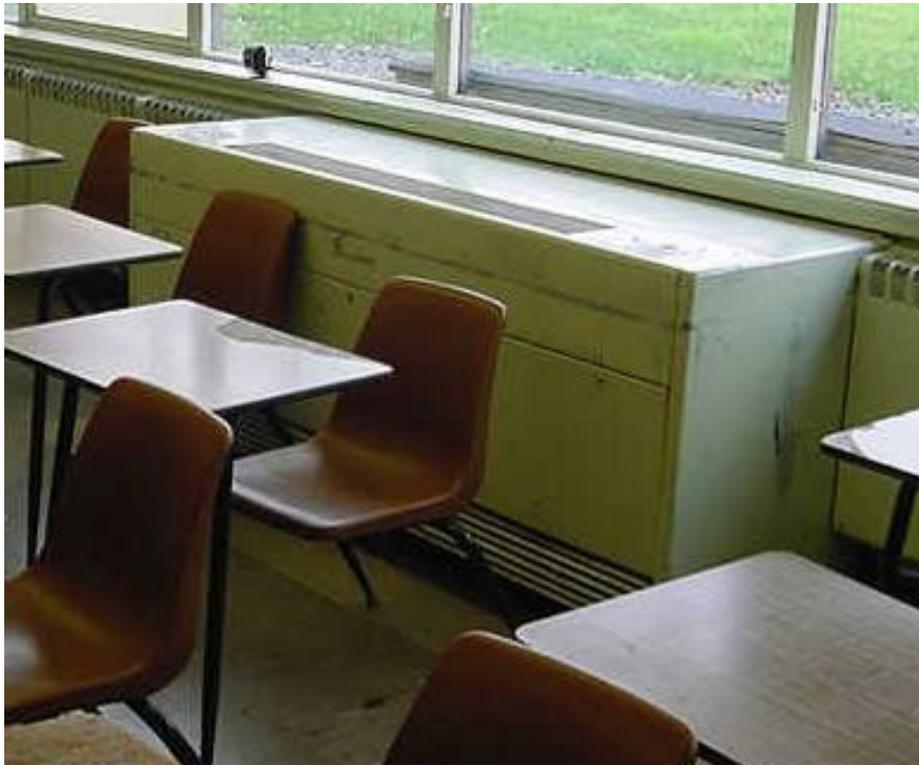
**Picture 1**

Fresh air in classrooms is supplied by unit ventilator (univent) systems (Picture 1). A univent draws air from the outdoors through a fresh air intake located on the exterior wall of the building (Picture 2) and returns air through an air intake located at the base of the unit. Fresh and return air are mixed, filtered, heated and provided to classrooms through an air diffuser located in the top of the unit. Adjustable louvers control the ratio of outside to recirculated air ([Figure 1](#)). Univents are reportedly original equipment (i.e. over

**Classroom Univent 1955 Vintage**

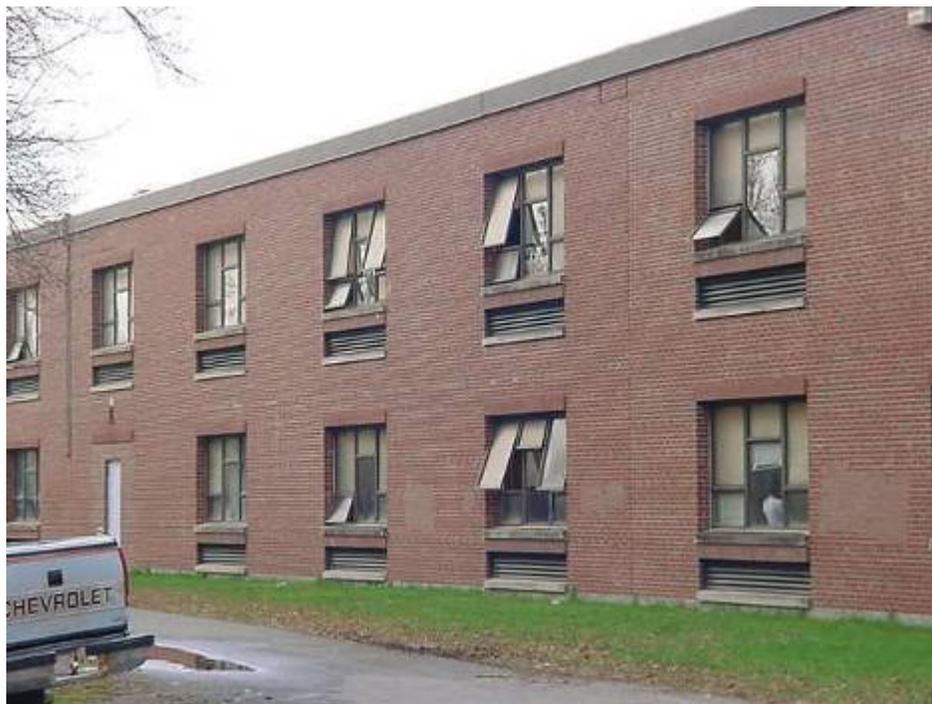
**Picture 2**

**Univent Fresh Air Intakes (below Windows)**

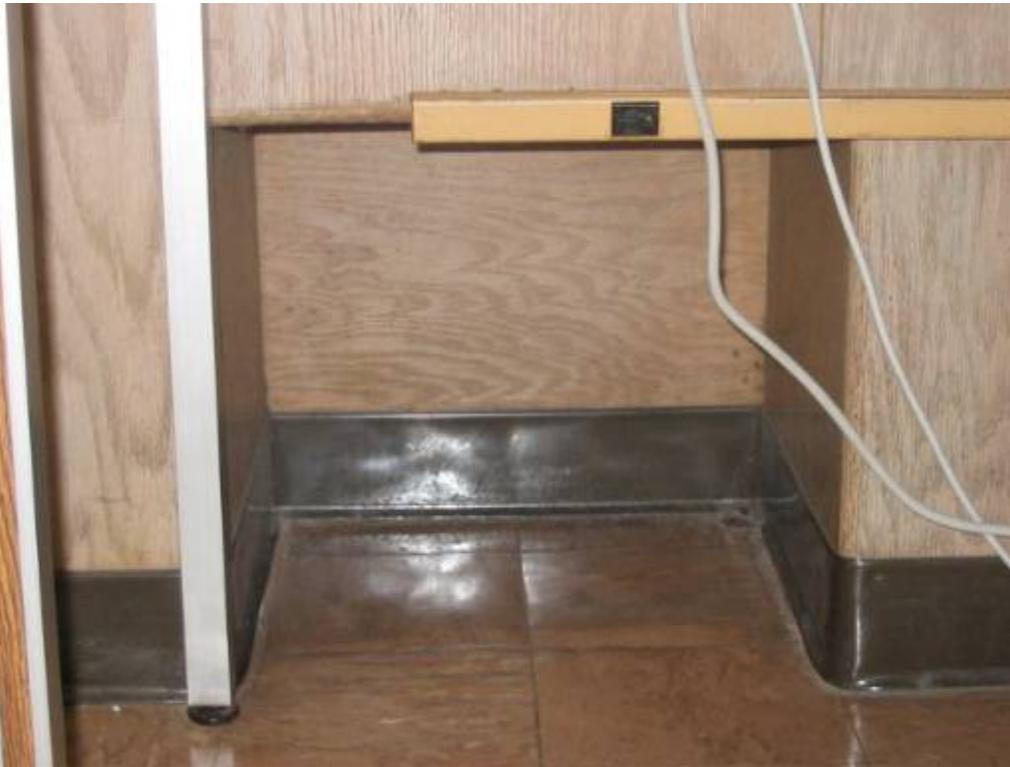
**Picture 3**

Exhaust ventilation in the 1955 building consists of floor level, ungrated “cubby” holes connected to rooftop exhaust fans (Picture 3). The mechanical exhaust ventilation system for classrooms in the 1972 wings consists of ducted, grated wall vents connected to rooftop motors (Picture 4). As with the univents, a number of exhaust vents were either deactivated or drawing weakly (Tables 1 and 2). Tables, chairs, boxes and other items obstructed a number of exhaust vents, preventing draw of air (Picture 4). Some exhaust vents are equipped with pull chains that control a flue that adjusts airflow via the ventilation shaft. At the time of the assessment, a number of these control mechanisms (i.e., pull chains and flues) were closed or in disrepair. Without removal by the exhaust ventilation, normally occurring environmental pollutants can build up, leading to indoor air complaints.

**Cubby Hole Exhaust in 1955 Wing Classroom**

2. Ensure pull chain for classroom exhaust louvers in the 1955 portion of the building are in the "open" position to allow air exchange.
3. Remove obstructions from univents and exhaust vents.

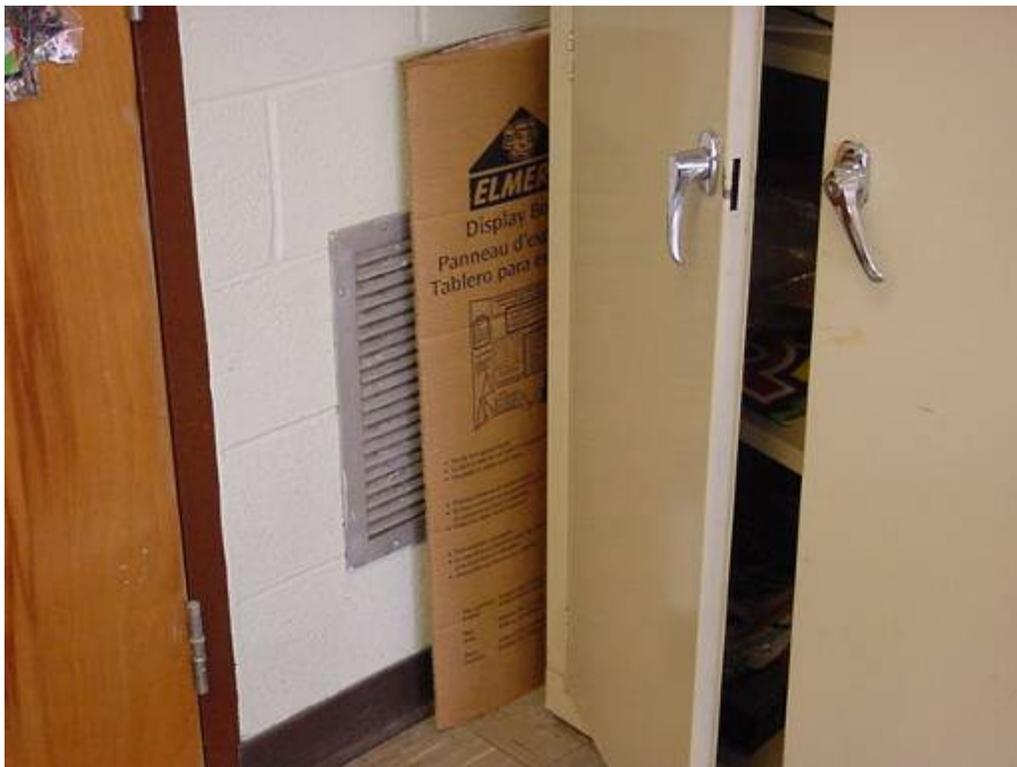
**Picture 4**

**Obstructed Wall-Mounted Exhaust Vent in 1972 Wing Classroom**

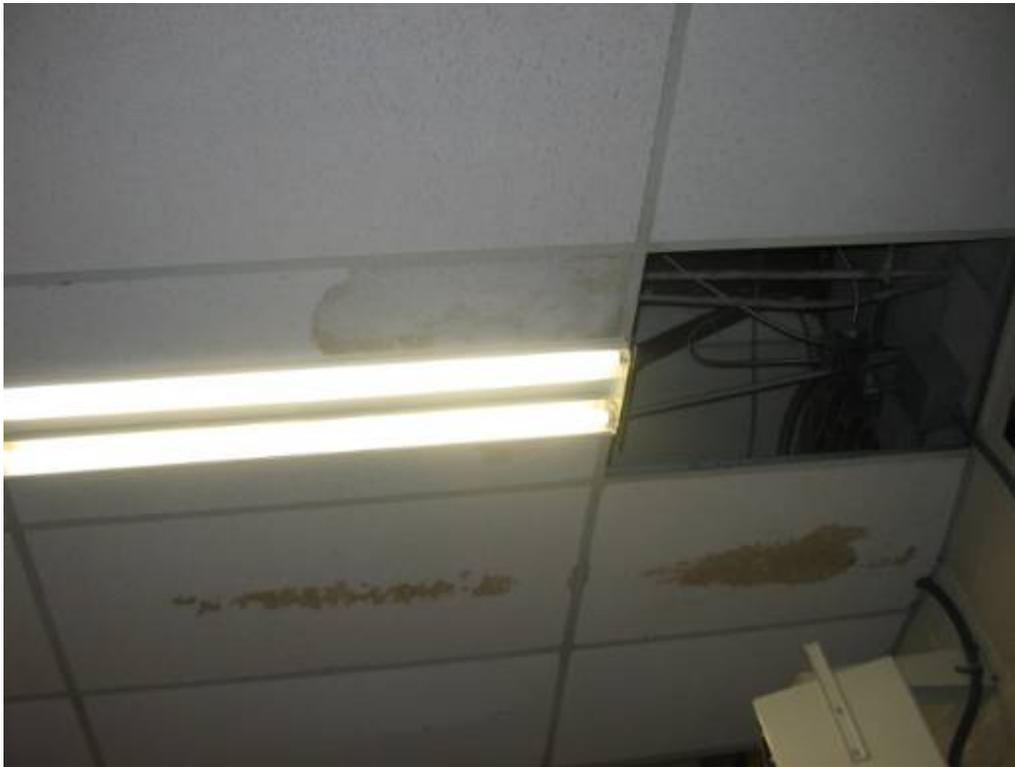
**Picture 5**

The building has had a history of water infiltrating through the roof and window systems, as evidenced by water stained ceilings/tiles and damaged ceilings (Pictures 5 and 6). Porous water-damaged building materials can serve as mold growth media, and should be replaced after a water leak is discovered. As mentioned previously, the roof was replaced nine years ago; however, windows reportedly leak on occasion. A mold-colonized box was found in the storage closet in classroom A 02 (Picture 7). As with other porous materials, cardboard should be discarded once it has become water-damaged and colonized with mold.

**Missing/Water-Stained Ceiling Tiles**

7. Remove/replace water-damaged ceiling tiles. Examine the area above and around these areas for mold growth. Disinfect areas of water leaks with an appropriate antimicrobial or mild detergent.

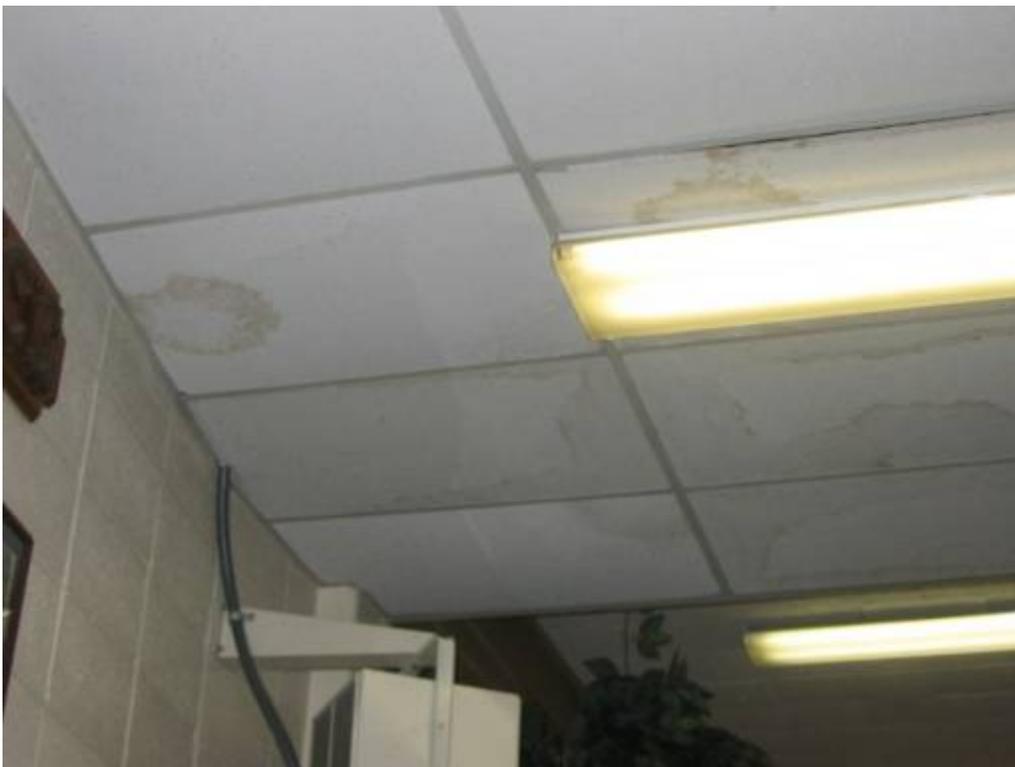
**Picture 6**

**Water-Stained Ceiling Tiles**

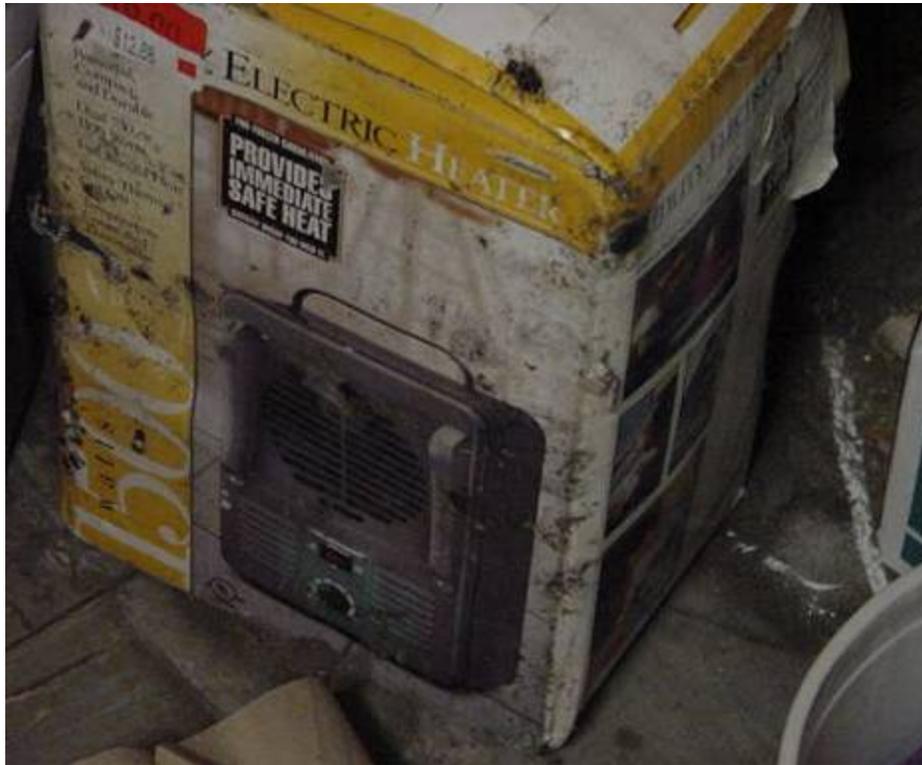
**Picture 7**

**Water Damaged/Mold Colonized with Mold in Storage Closet in Room A 02**

8. Discard mold-contaminated box in classroom A 02. Disinfect area with an appropriate antimicrobial or mild detergent.
9. Repair water-damaged wood/walls \near gymnasium bleachers.

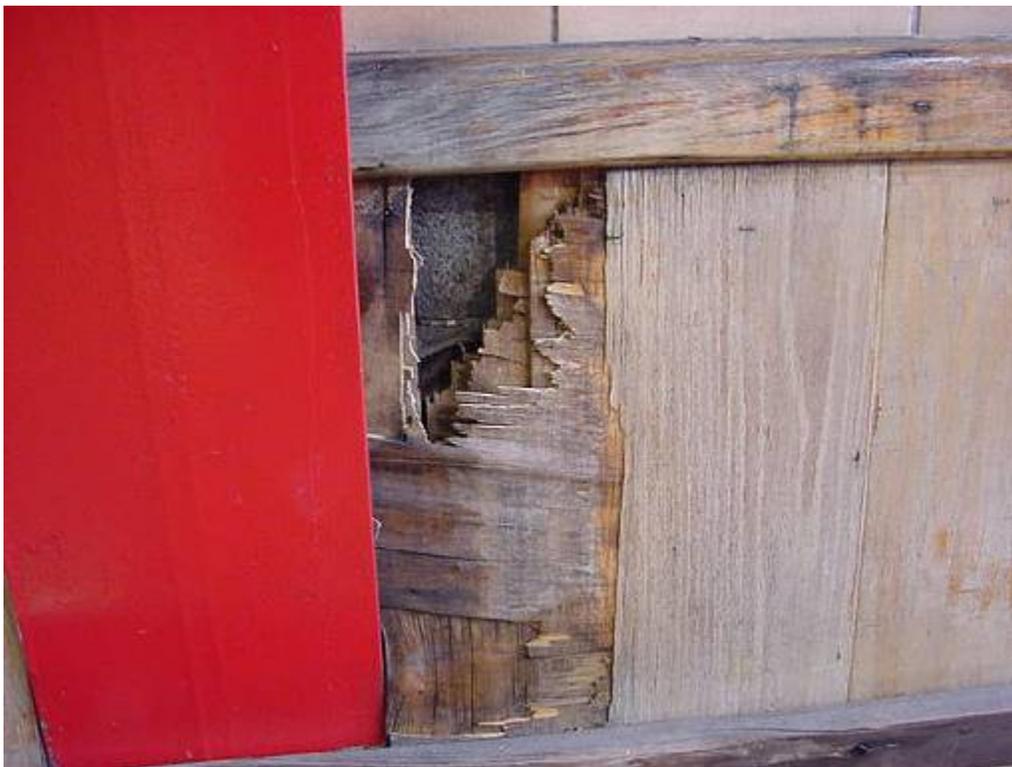
**Picture 8**

Water-damaged wooden walls were observed in the gymnasium (Picture 8). In order for building materials to support mold growth, a source of moisture is necessary. Identification and elimination of water moistening building materials is necessary to control mold growth. In this case, moisture stemmed from a plumbing failure. Building materials with increased moisture content over normal concentrations may indicate the possible presence of mold growth. Identification of the location of materials with

In an effort to ascertain moisture content of the water-damaged wall in the gymnasium, moisture content was measured with a Delmhorst Moisture Detector equipped with a Delmhorst Standard Probe. The Delmhorst probe is equipped with three lights that function as visual aids that indicate moisture level. Readings that activate the green light indicate a sufficiently dry or low moisture level, those that activate the yellow light indicate borderline conditions and those that activate the red light indicate elevated moisture content. No elevated moisture readings were measured during the assessment (Table 1).

**Water Damaged Wood (Wall near Bleachers) in Gymnasium**

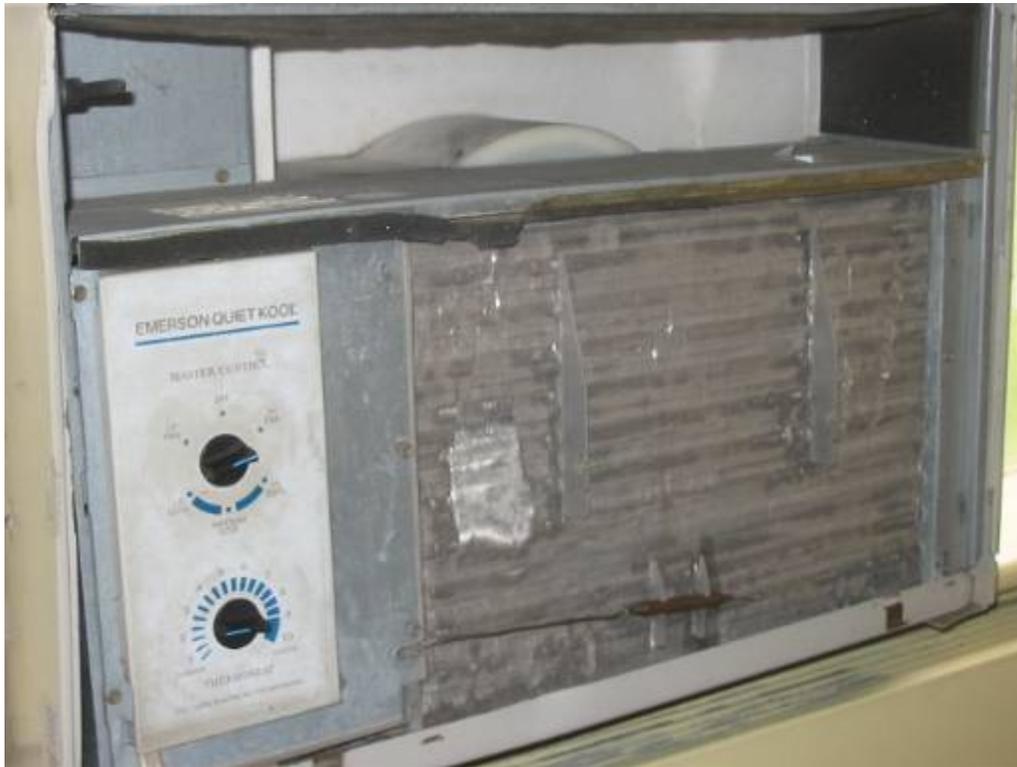
**Picture 9**

Window-mounted air conditioners (ACs) were observed in several areas. These units are normally equipped with filters, which should be cleaned or changed as per manufacturer's instructions to avoid the build-up and re-aerosolization of dirt, dust and particulate matter. Several of the units were missing filters and the cooling fins were occluded with dust and debris (Picture 9), which can provide a mold growth media when moistened.

**Window-Mounted Air Conditioner, Note Filter Missing and Cooling Coils With Accumulated Dust and Debris**

16. Install filter media in portable air conditioners and clean cooling fins prior to use. Disinfect with an appropriate antimicrobial if necessary. If filtration media cannot be acquired consider replacing AC units.

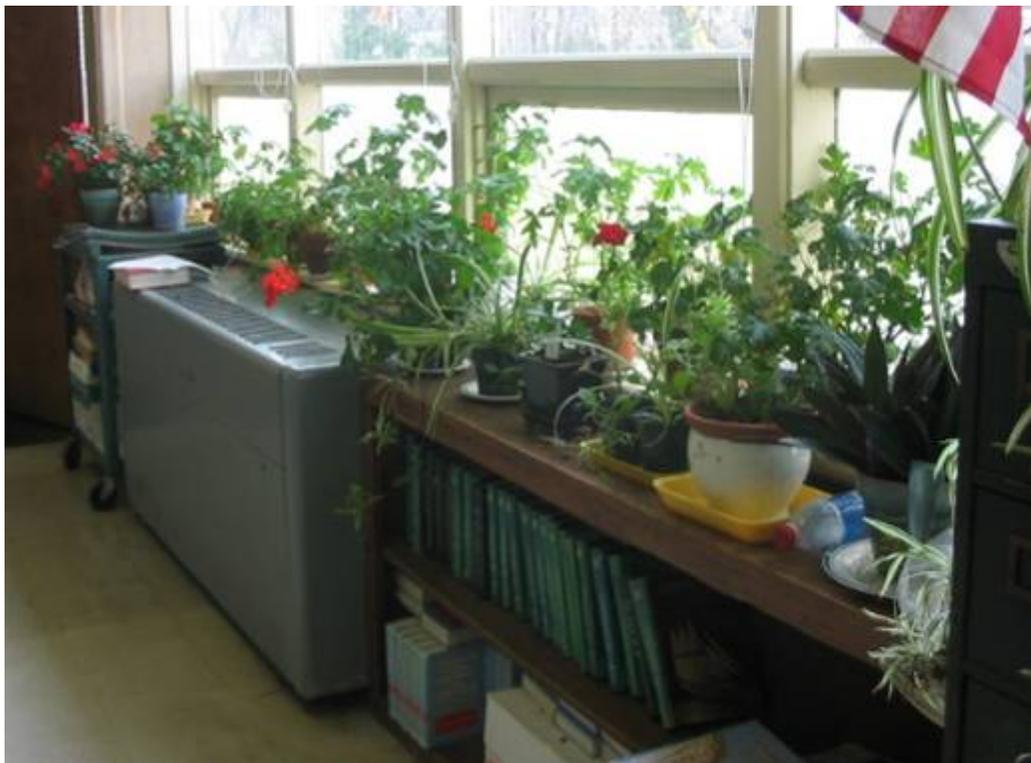
**Picture 10**

A number of classrooms had plants. Moistened plant soil and drip pans can be a source of mold growth. Plants should be equipped with drip pans; the lack of drip pans can lead to water pooling and mold growth on windowsills. Plants are also a source of pollen. Plants should be located away from the air stream of ventilation sources to prevent the aerosolization of mold, pollen or particulate matter throughout the classroom (Picture 10). Plants were also observed on and in close proximity to fresh air intakes, which can draw in pollen, moisture and particulates (Pictures 11 and 12).

**Plants in Classroom and in Close Proximity to Univent Air Diffuser**

15. Remove plants from the air stream of univents and along exterior walls near fresh air intakes.

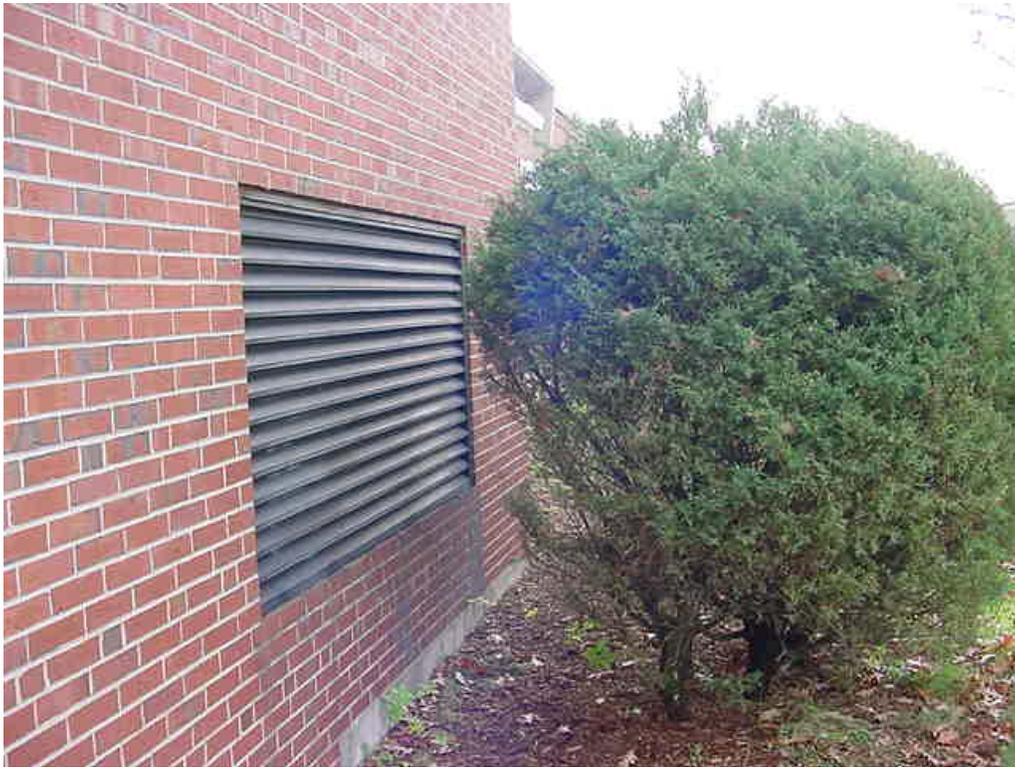
**Picture 11**

**Shrubbery in Close Proximity to Air Intake**

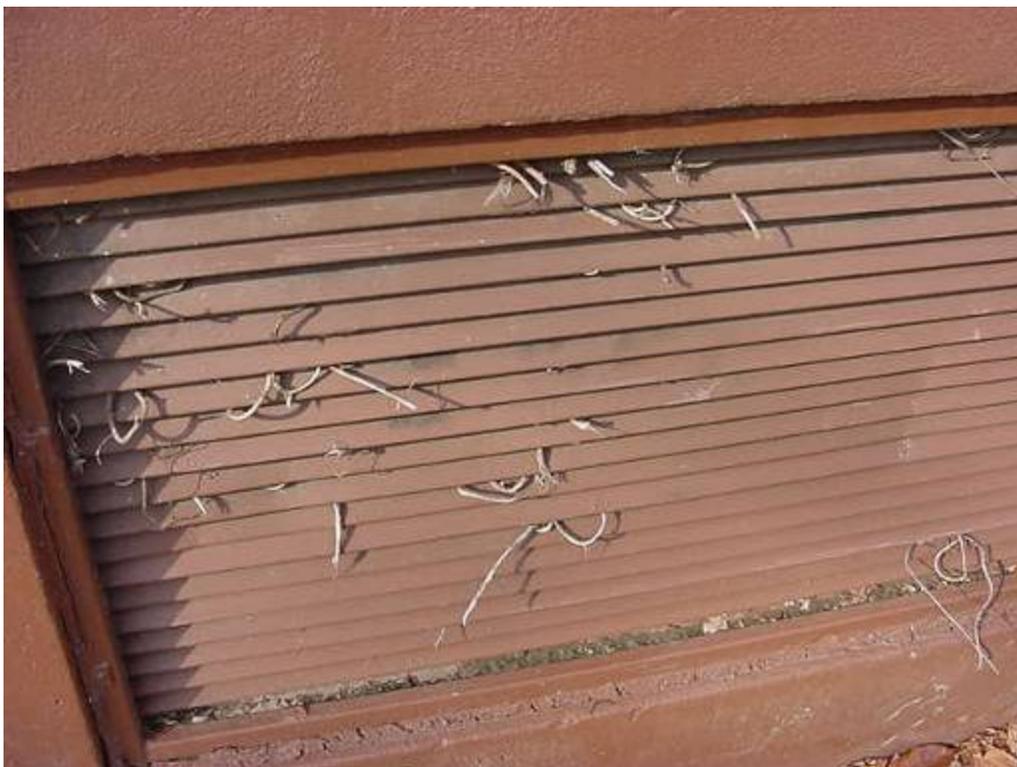
**Picture 12**

**Plant Growth in Univent Air Intakes**

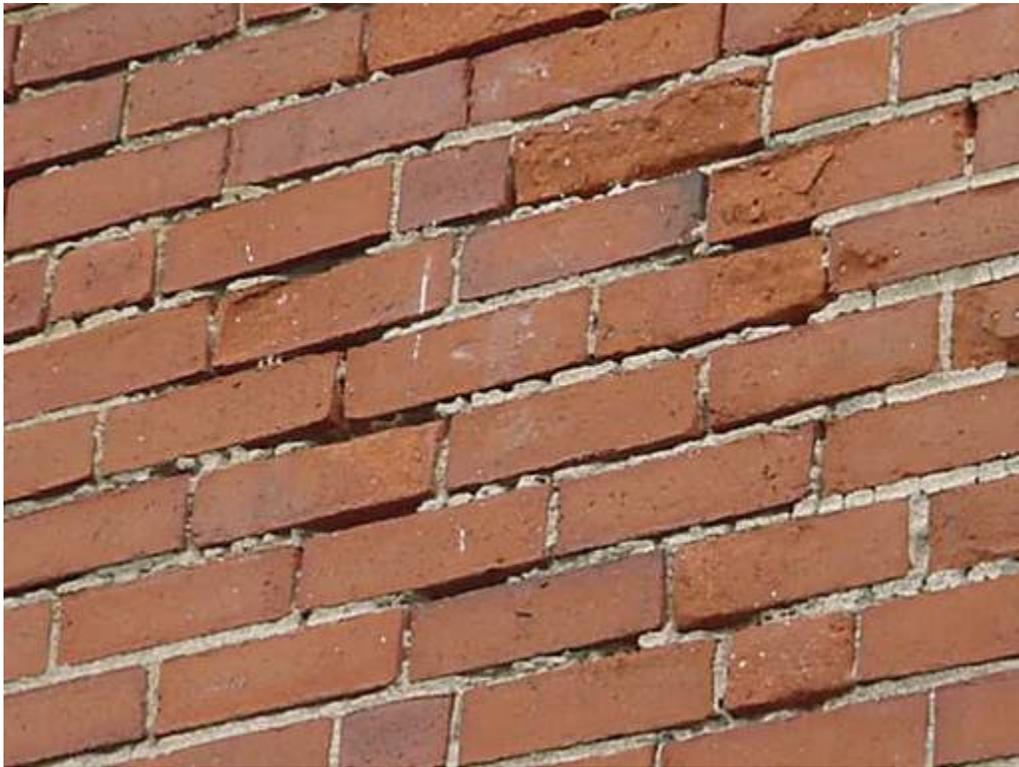
**Picture 13**

- Spaces, missing/damaged mortar around masonry was observed (Picture 13);
- Debris accumulated in gutters (Picture 14);
- Downspouts emptying water against the building (Picture 15);
- Rotted wooden window frames and spaces around exterior doors and wall panels (Pictures 16 and 17); and
- Clogged drains at the rear of the building, resulting in water accumulation (Picture 18).

**Missing/Damaged Mortar around Exterior Brick**

- Repoint missing/damaged mortar around exterior brickwork.
11. Unclog exterior drain at rear of building and inspect regularly for proper drainage.
12. Inspect and clear debris from gutter system on a regular basis.

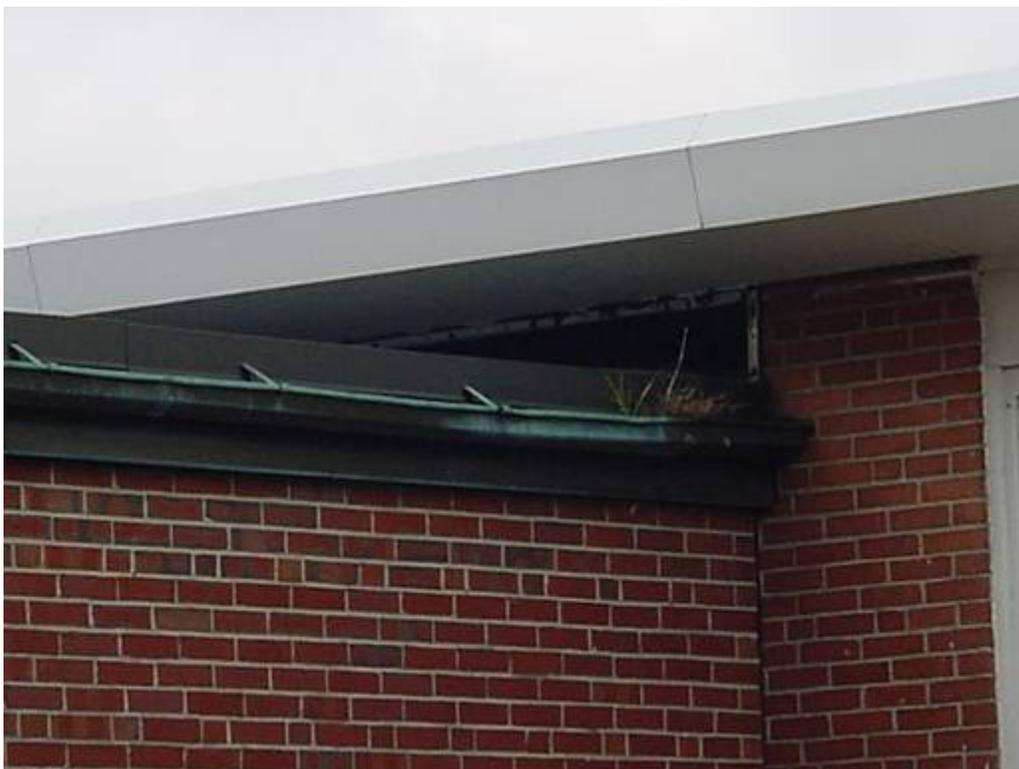
**Picture 14**

**Debris Clogging Gutter**

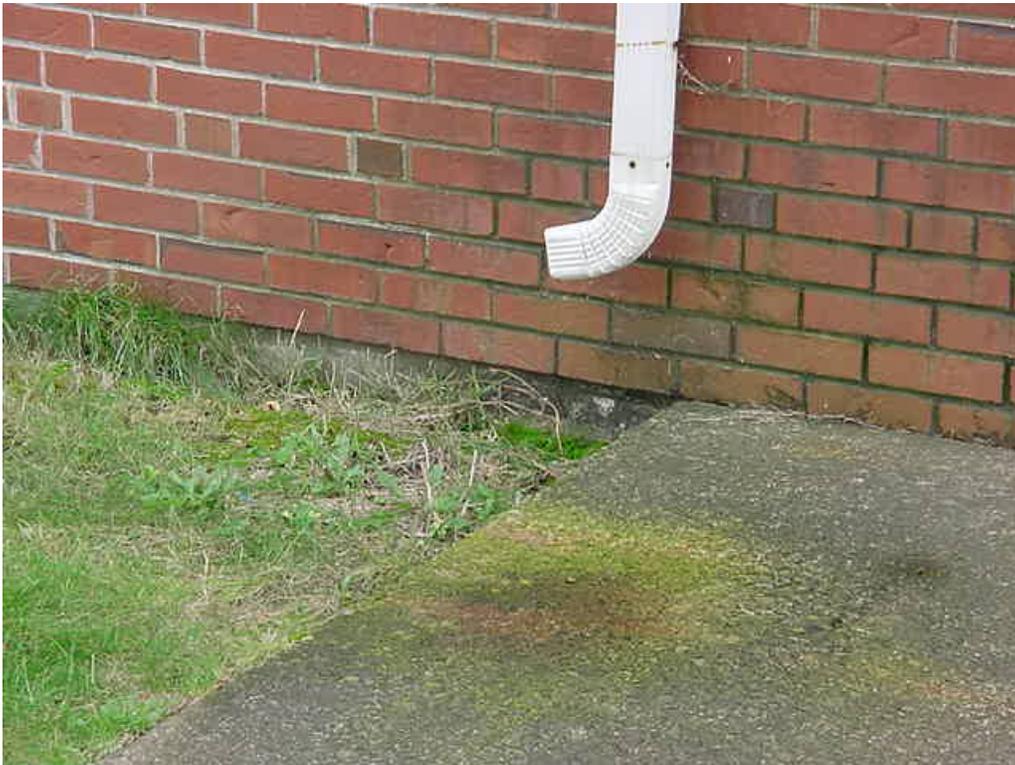
**Picture 15**

**Downspout Emptying Water against the Building**

13. Extend downspouts to drain *away* from the building.
14. Ensure all plants are equipped with drip pans. Examine drip pans periodically for mold growth and disinfect with an appropriate antimicrobial where necessary.

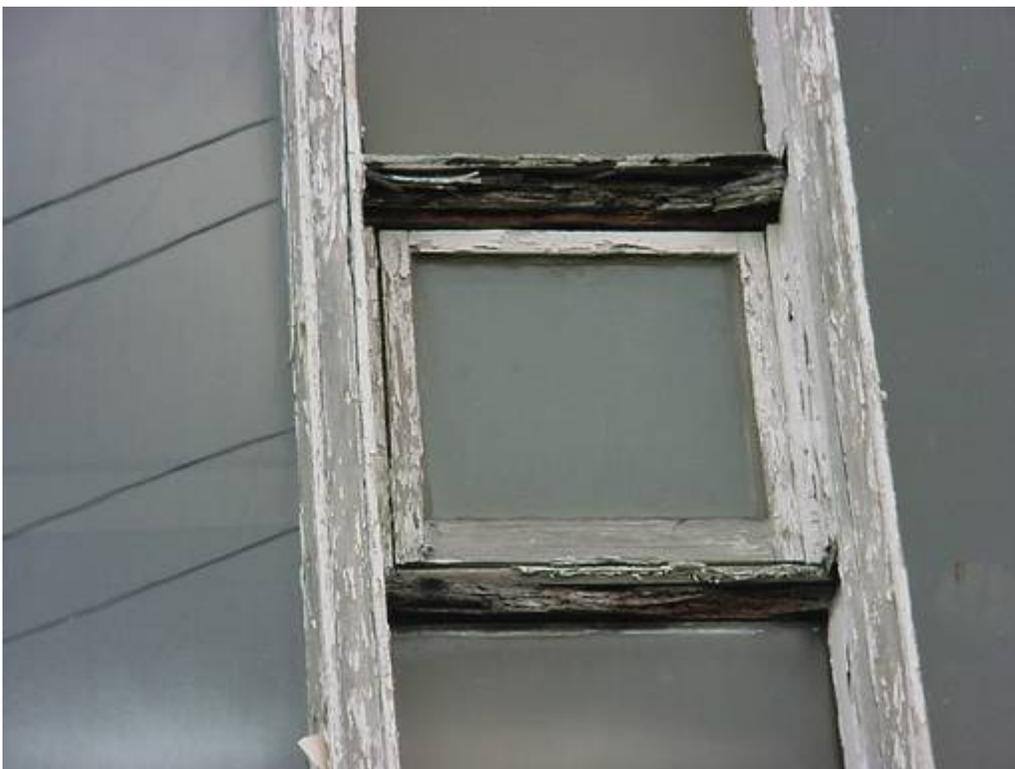
**Picture 16**

**Rotted Wooden Window Frames**

10. Repair breaches in the building envelope:
  - Seal loose/leaking window panes.
  - Repair rotted wooden window frames/sills exterior doors and wall panels.

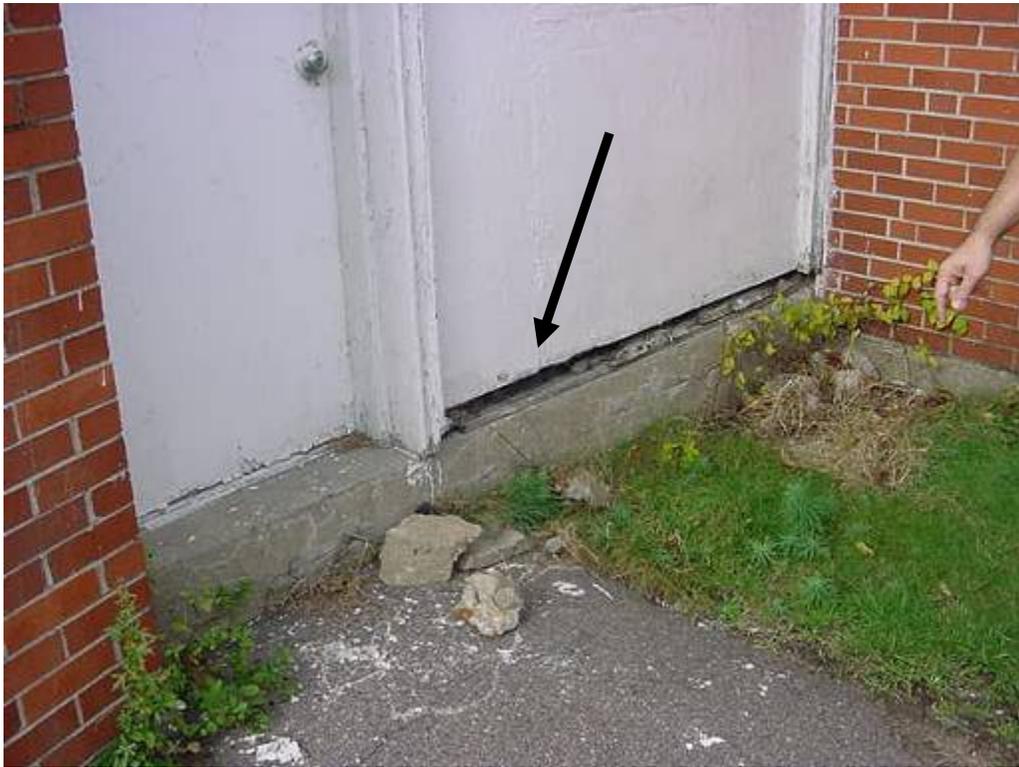
**Picture 17**

**Spaces around Wooden Wall Panels/Door, Note Missing Sealing Compound**

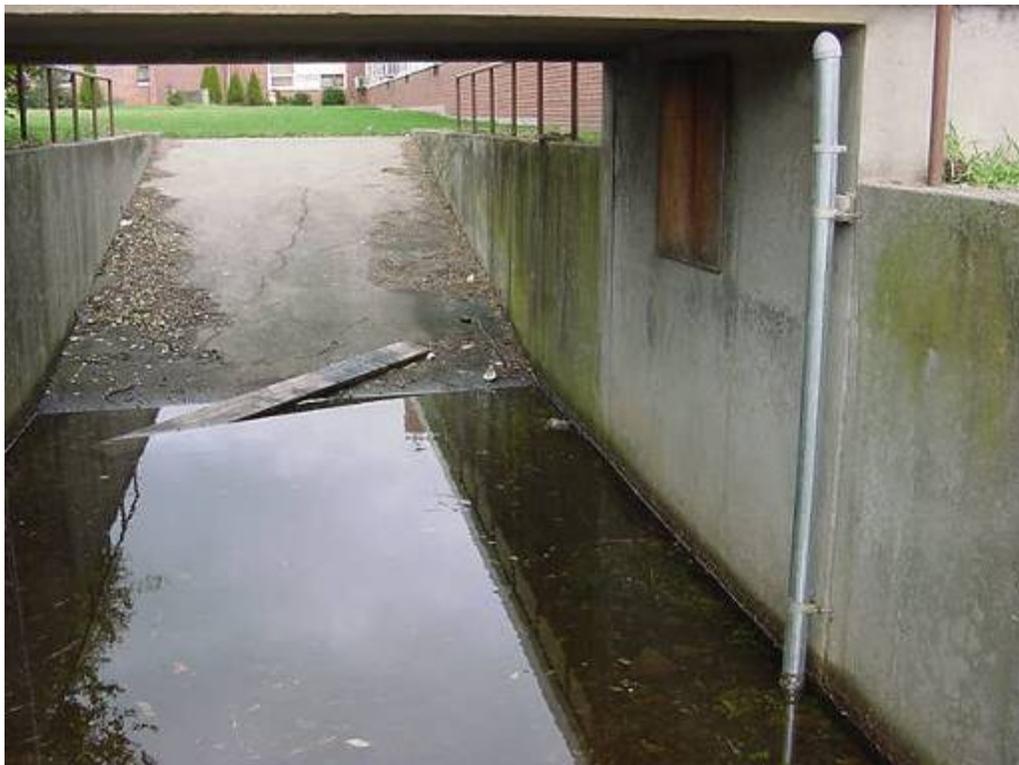
**Picture 18**

**Accumulated Water Pooling at Rear of Building**

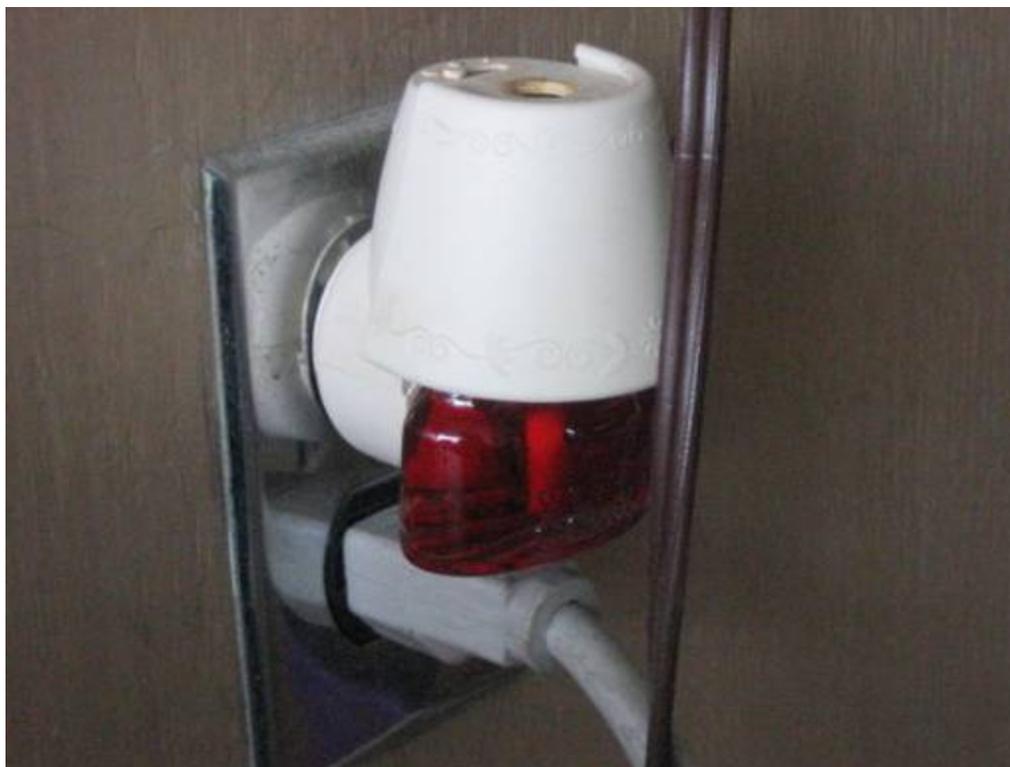
**Picture 19**

A few areas had plug-in air fresheners (Picture 19). These products contain chemicals that can be irritating to the eyes, nose and throat of sensitive individuals. Furthermore, air fresheners do not remove materials causing odors, but rather mask odors that may be present in the area.

**Plug-in Air Freshener in Classroom**

25. Refrain from using strongly scented materials (e.g., air fresheners).
26. Repair damaged vent shown in Picture 20 to eliminate a pathway for pests/rodents into the building.

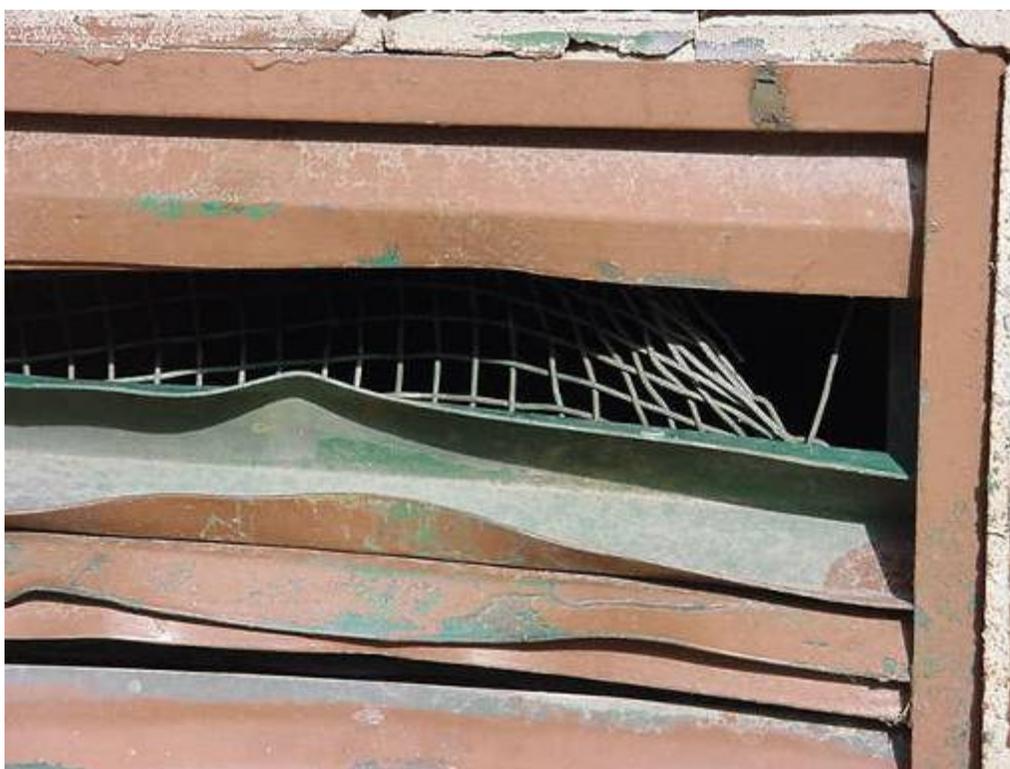
**Picture 20**

Finally, a damaged vent was observed on the exterior of the building (Picture 20). The damaged vent can serve as a pathway for pests/rodents into the building.

**Damaged Vent Exterior/Rear of Building**
