INDOOR AIR QUALITY ASSESSMENT

**Spencer Town Hall
157 Main Street
Spencer, Massachusetts**

Prepared by:
Massachusetts Department of Public Health
Center for Environmental Health
Emergency Response/Indoor Air Quality Program
March 2007

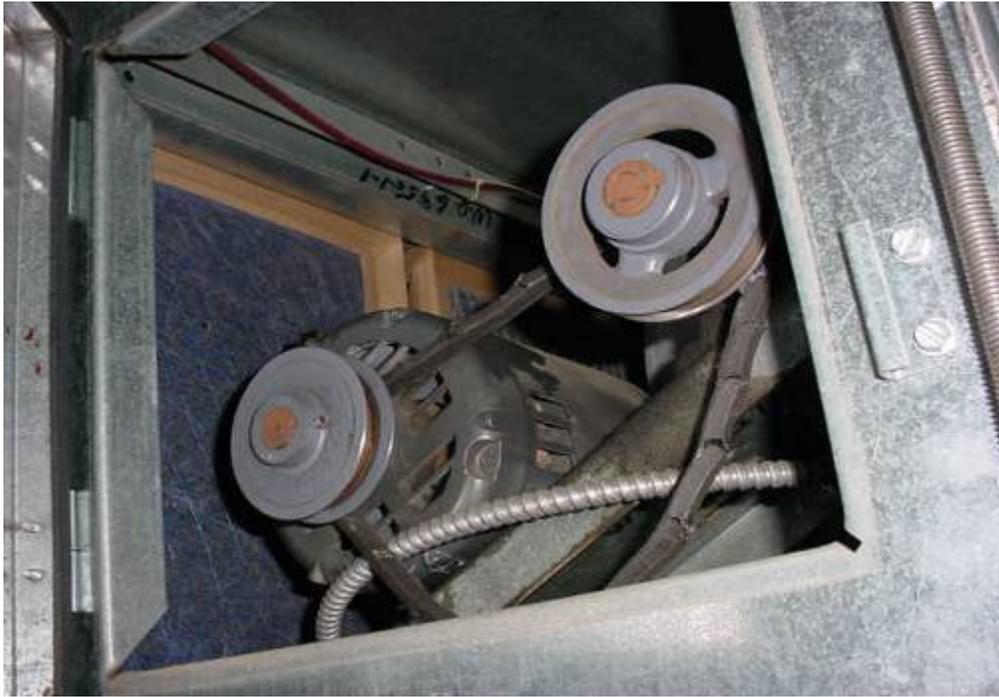
Picture 1

It can be seen from Table 1 that carbon dioxide levels were below 800 parts per million (ppm) in all areas sampled, which indicates adequate air exchange. It is important to note that no general mechanical ventilation systems exist on the first and second floors. Basement offices however, were retrofitted with a mechanical ventilation system. Air is distributed to offices by an air handling unit (AHU) ducted to ceiling or wall-mounted fresh air diffusers. The system was not functioning during the assessment. Examination of the interior of the AHU found the fan motor deactivated and the fan belt disconnected from its flywheels (Picture 1). In this condition, no fresh air is supplied to basement offices.

Fan Motor Deactivated and the Fan Belt Disconnected From its Flywheels

2. Repair the fan belt for the ventilation system. Once repaired, ensure the HVAC system operates appropriately.
3. Change filters in the HVAC system at least twice a year. Ensure that room exists above the ceiling system so that air filters may be slid into place without bending or folding the cardboard frames.

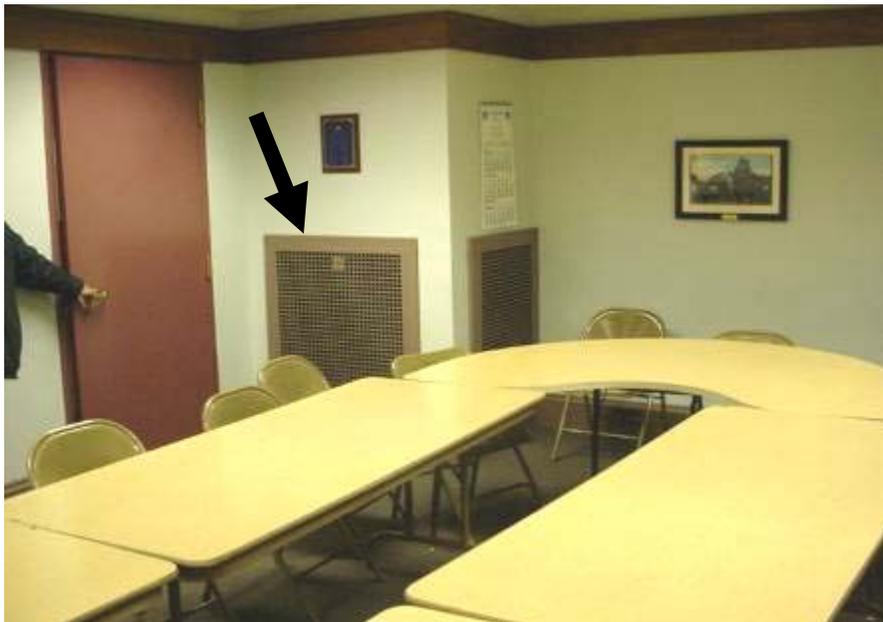
Picture 2

No identifiable mechanical exhaust system could be identified in the basement. A large grill that may have once served as a gravity exhaust air shaft was observed in a basement conference room (Picture 2), but the vent is separated from all other basement areas and cannot provide exhaust ventilation. Without adequate supply and/or exhaust ventilation, normally occurring pollutants or odors can build-up and lead to indoor air quality/comfort complaints.

Possible Gravity Exhaust Air Shaft in Basement Conference Room

2. Consult with a building engineer to provide appropriate exhaust for the basement office HVAC system.
3. Examine the feasibility of providing a mechanical heat source to the women's restroom.

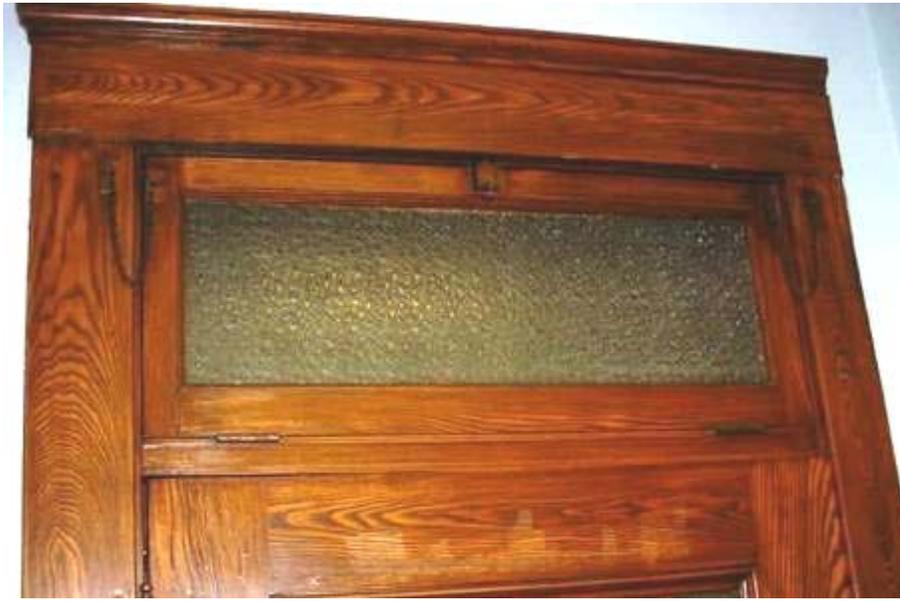
Picture 3

Transom

8. Use windows and transoms to enhance airflow during warm weather if window-mounted air conditioners are not used. Be sure to close at the end of business hours. To aid in the draw of fresh outdoor air in warm weather, use portable fans directing air out windows on the leeward side (opposite the windward side) of the building. Fans positioned in this manner will serve to increase the draw of outdoor air across the first and second floors without interfering with the natural internal airflow pattern of the building.

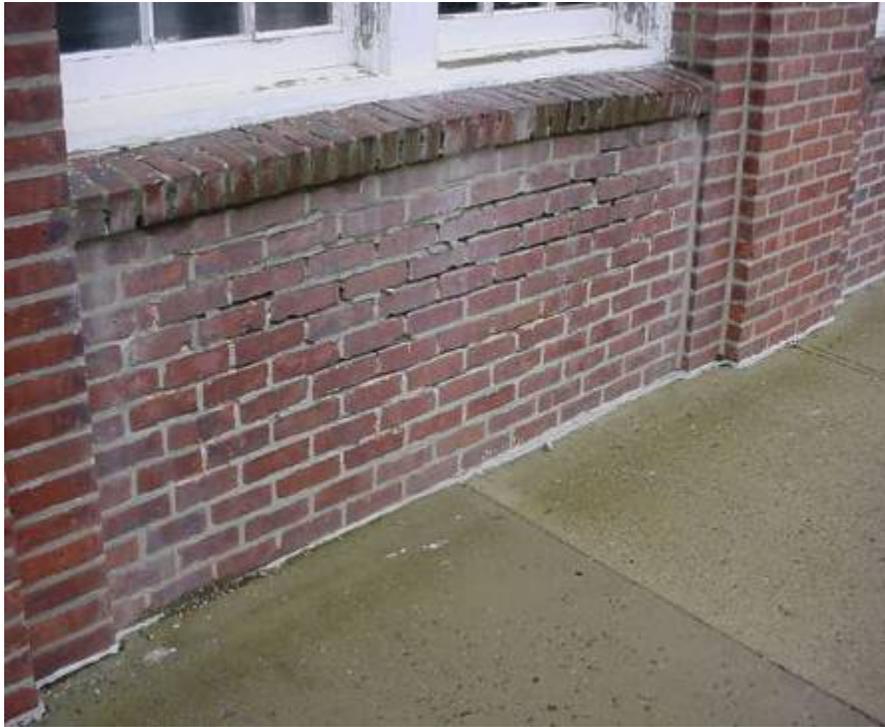
Picture 4

Water damaged carpeting, walls and ceiling tiles was observed in several offices along the western side of the building. The damage is likely related to the deterioration of mortar between brick (Picture 4) as well as dissimilar building materials that make up the exterior walls of the town hall. The wall outside of offices with water damaged carpeting (Picture 5) and ceiling tiles (Picture 6) consists of brick, cement, wood framed windows and wrought iron bars (Pictures 7 and 8). The seams between each of these dissimilar materials have likely failed, resulting in water penetration. The eastern wall of the building was examined, which showed deterioration of the window frames, open seams between the cement, window frames and brick, as well as plants growing from a seam in the window casement (Picture 9). Similar types of breaches would be expected in window seams of the western wall (which could not be examined due to their height). Therefore, when the western wall was subjected to wind-driven rain, water likely entered the interior through these breaches, resulting in the repeated wetting of carpets in ground floor offices, particularly in areas beneath the wrought iron bars on the exterior wall.

Missing/Damaged Mortar around Brick beneath Auditorium Window
Picture 5

1. Consult with a building engineer concerning repointing of the exterior brickwork of the building.

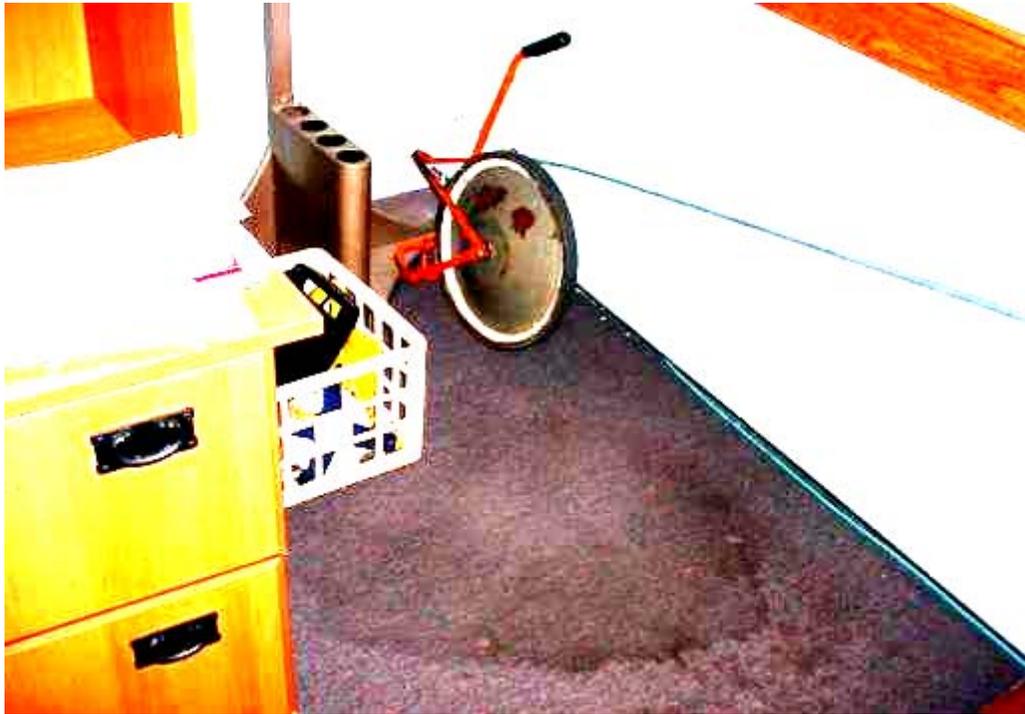
The US Environmental Protection Agency (US EPA) and the American Conference of Governmental Industrial Hygienists (ACGIH) recommends that porous materials be dried with fans and heating within 24 to 48 hours of becoming wet (US EPA, 2001; ACGIH, 1989). If carpeting is not dried within this time frame, mold growth may occur. Since carpeting is porous surfaces; disinfection is likely to be ineffective. Removal of these materials is recommended to prevent exposure of building occupants to mold and other associated pollutants.

Water Damaged Carpet

1. Remove water-damaged materials (e.g., carpeting and ceiling tiles) in a manner consistent with recommendations found in “Mold Remediation in Schools and Commercial Buildings” published by the US Environmental Protection Agency (US EPA, 2001). Consider replacing carpeting with a non-slip, nonporous material (e.g., rubber matting, tile).

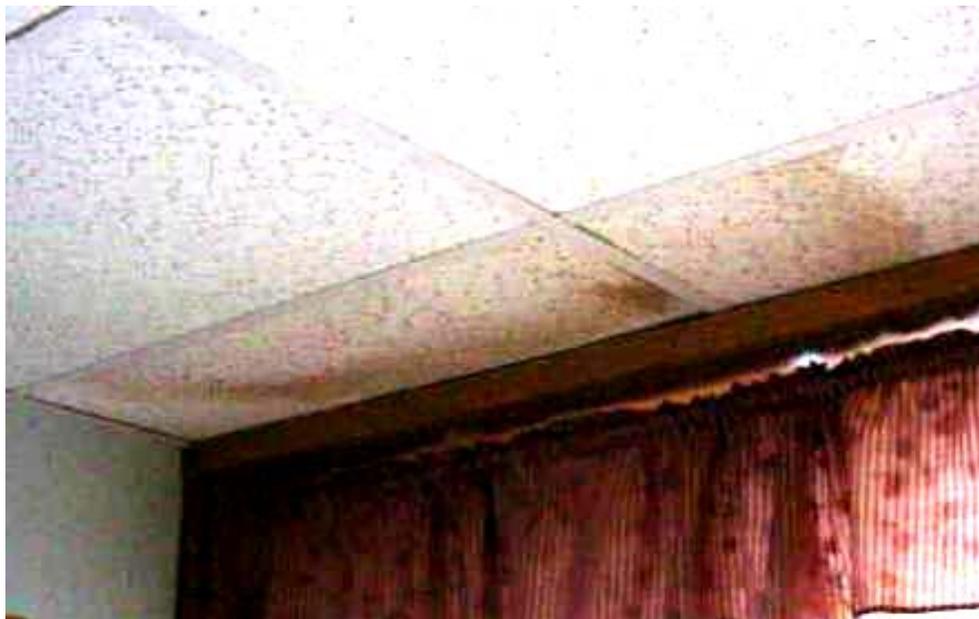
Picture 6

A number of conditions were identified around the exterior of the building that tend to make the building susceptible to water penetration. Offices on the first floor had water damaged ceiling tiles below areas that directly correspond to accumulated debris on the roof.

Water Damaged Ceiling Tiles

5. Remove debris from the flat roofs. Repair the roof membrane as needed.
6. Repair the boiler room door and keep closed. Install weather-stripping and a door sweep of the door in the board of health/inspectional services areas. Keep these doors closed during business hours.

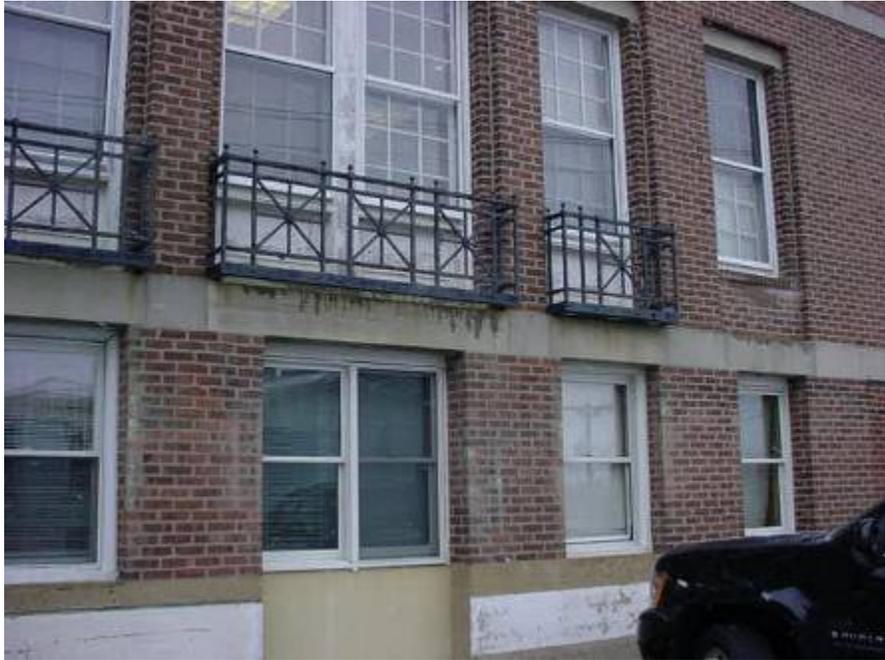
Picture 7

Exterior of the STH (Note Wooden Window Frames, Cement Window Casement with a Flat Sill, Wrought Wire Bars and Wall Brick)

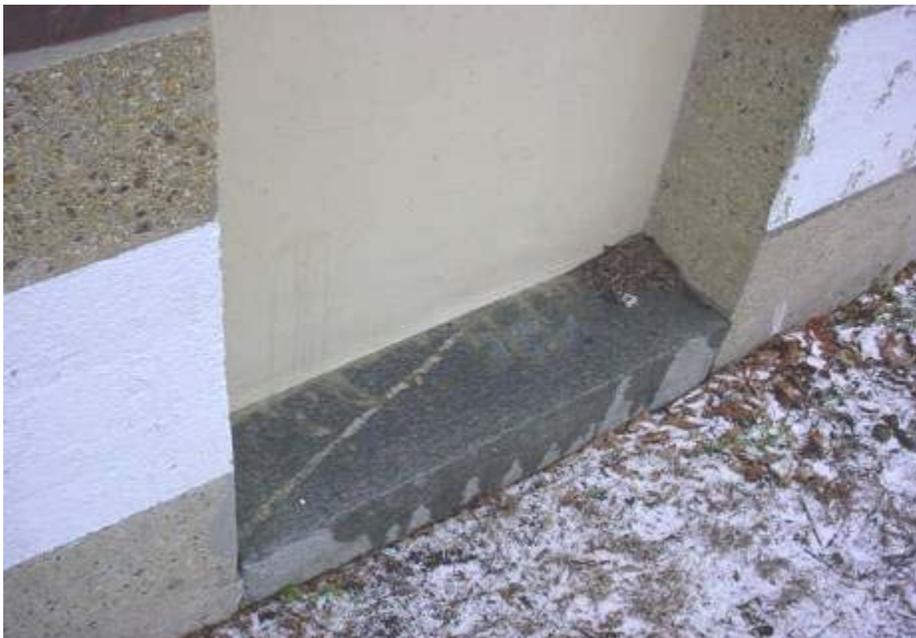
Picture 8

**Close-Up of Flat Window Casement Sill
(Note Moistening of Surface and Debris Accumulation)**

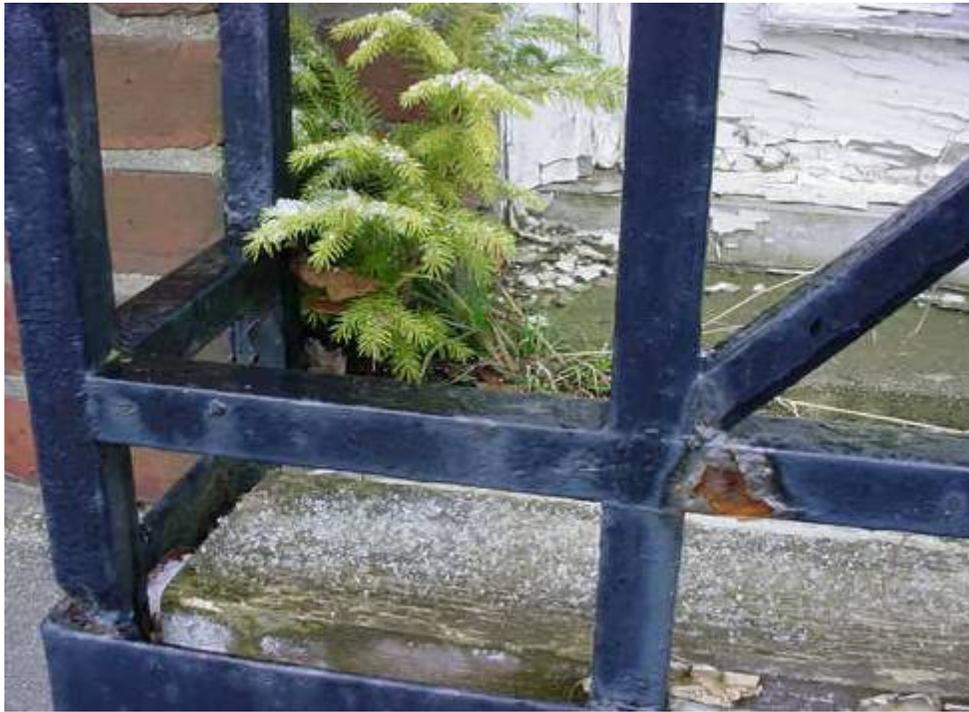
Picture 9

The STH Eastern Wall, Plant Growing from Seam in the Window Casement

4. Remove plants and debris from exterior wall seams. Consult with a building engineer of the best solution to temporality seal leaking seams along the western wall of the building beneath the wrought iron bars until a comprehensive repair solution for the exterior wall system is formulated and implemented.

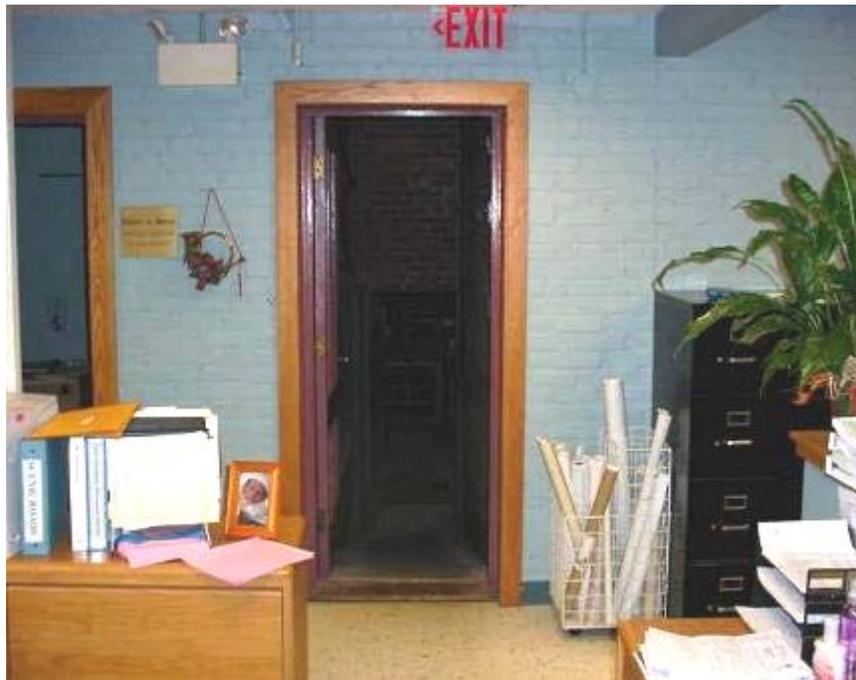
Picture 10

Boiler room odors were detected in the board of health/inspectional services area. The door to the boiler room is located in this area (Picture 10). The fire door to the boiler room was reportedly in disrepair and propped was also open at the time of the assessment (Picture 11). If boiler room doors are left open, the combination of heat/oil vapor can migrate into occupied areas (i.e. the board of health/inspectional services area). Both doors should be kept closed, since oil vapors and particulates related to combustion can be irritating to the eyes, nose and throat.

Door to Boiler Room from the Board of Health/Inspectional Services Area
Picture 11

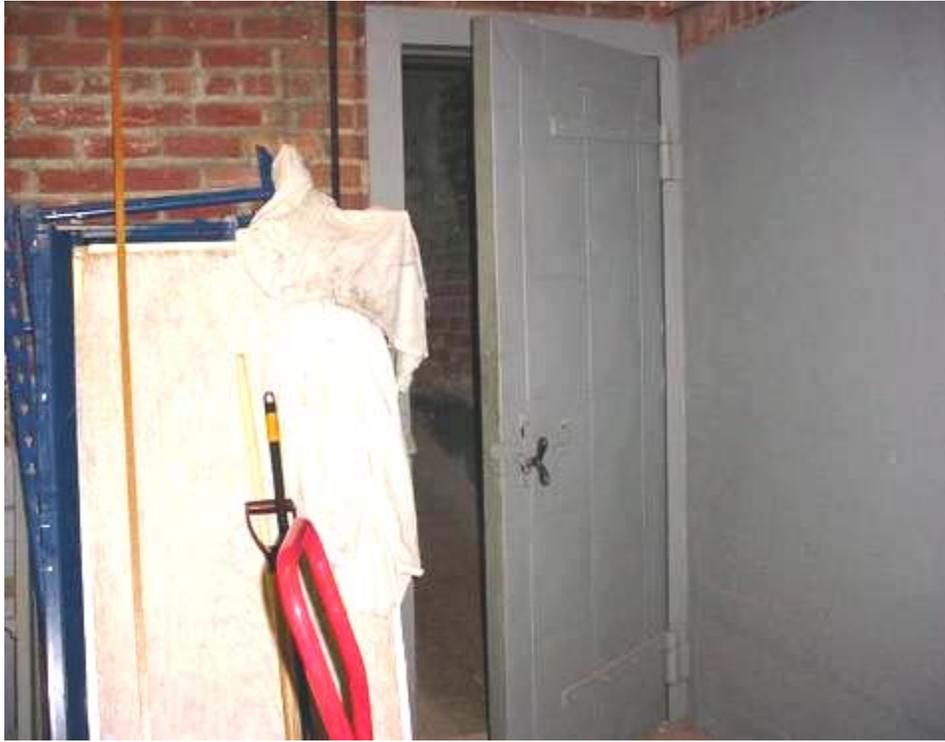
Boiler Room Door Propped Open
