# **INDOOR AIR QUALITY ASSESSMENT**

**North High School  
150 Harrington Way  
Worcester, Massachusetts**

Prepared by:  
Massachusetts Department of Public Health  
Bureau of Environmental Health  
Emergency Response/Indoor Air Quality Program  
August 2007

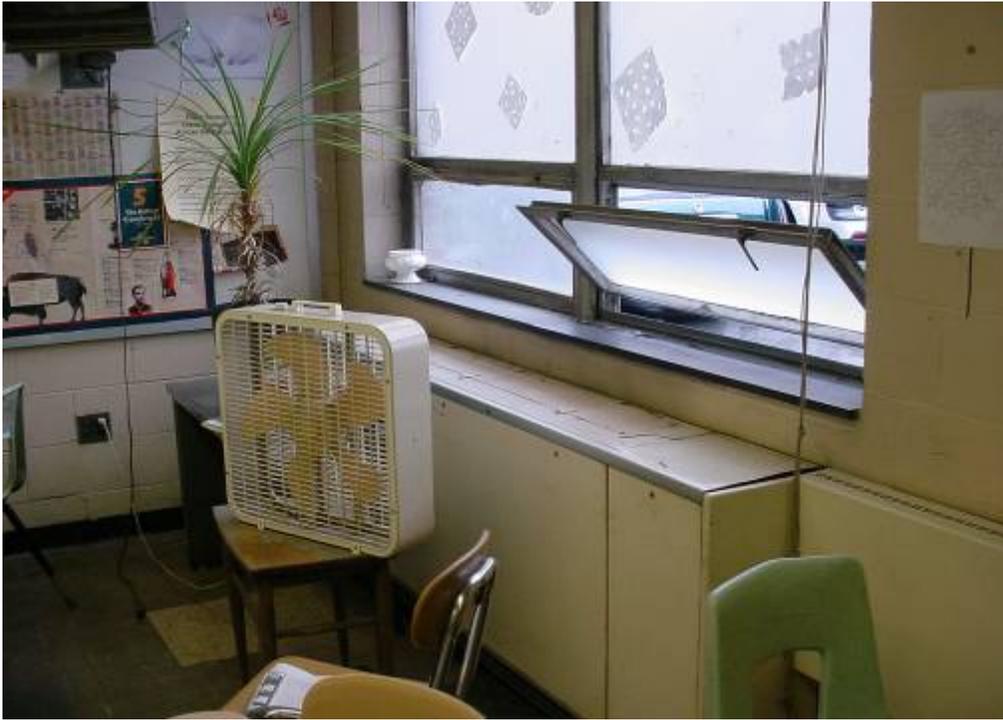
**Picture 1**

Fresh air in classrooms is supplied by unit ventilator (univent) systems ([Figure 1](#)). A univent draws air from the outdoors through a fresh air intake located on the exterior wall of the building and returns air through an air intake located at the base of the unit. Fresh and return air are mixed, filtered, heated and provided to classrooms through an air diffuser located in the top of the unit. Adjustable louvers control the ratio of outside to recirculated air. Univents at the NHS are of two different configurations. Those that appear to be original equipment are located in classrooms with windows ([Picture 1](#)). Windowless classrooms on the ground floor classrooms are fitted with univents of a different configuration ([Picture 2](#)).

**Univent on Upper Floor Classrooms**

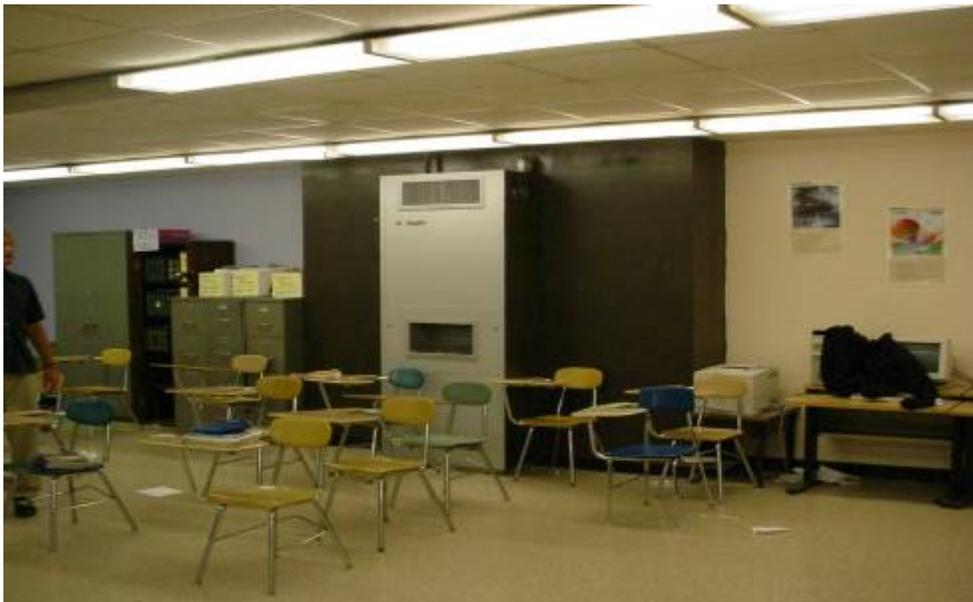
**Picture 2**

**Univent in Ground Level Classrooms**

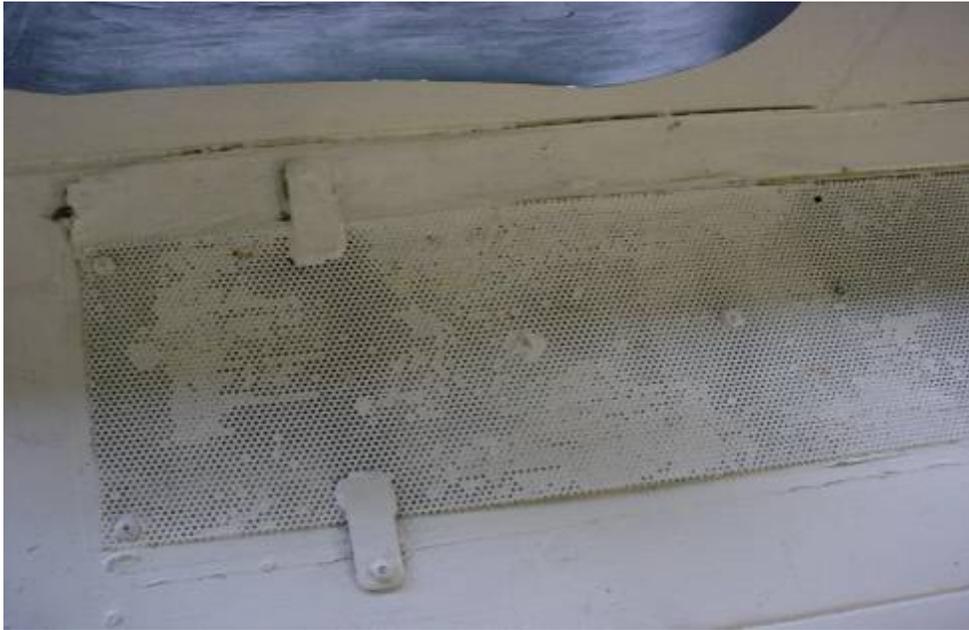
**Picture 3**

Univents were found deactivated in a number of classrooms. In addition, fresh air diffusers from many of the original univents were found damaged. Damaged fresh air diffuser grilles in many classrooms were replaced with a wire mesh that has been repeatedly painted, essentially sealing the mesh ([Picture 3](#)). Univents with these repairs have restricted airflow, since the apertures through which air can pass are smaller than univents with intact fresh air diffuser grilles ([Picture 4](#)). This restriction of airflow can degrade the operation and reduce the life span of motors, fans and fan belts, since univent parts are designed to operate at a lower air pressure (i.e. reduced resistance provided by the original fresh air diffuser

grilles). The decreased function of these univents may lead to an inadequate fresh air supply, as well as premature degradation of calibration of air velocity of univent fresh air intakes.

**Wire Mesh That Is Mostly Painted Shut Used As Fresh Air Diffuser on Old Univents**

1. Examine the feasibility of replacing wire mesh on univents to maximize fresh air distribution. Repair the mechanical exhaust ventilation system and operate during school hours.

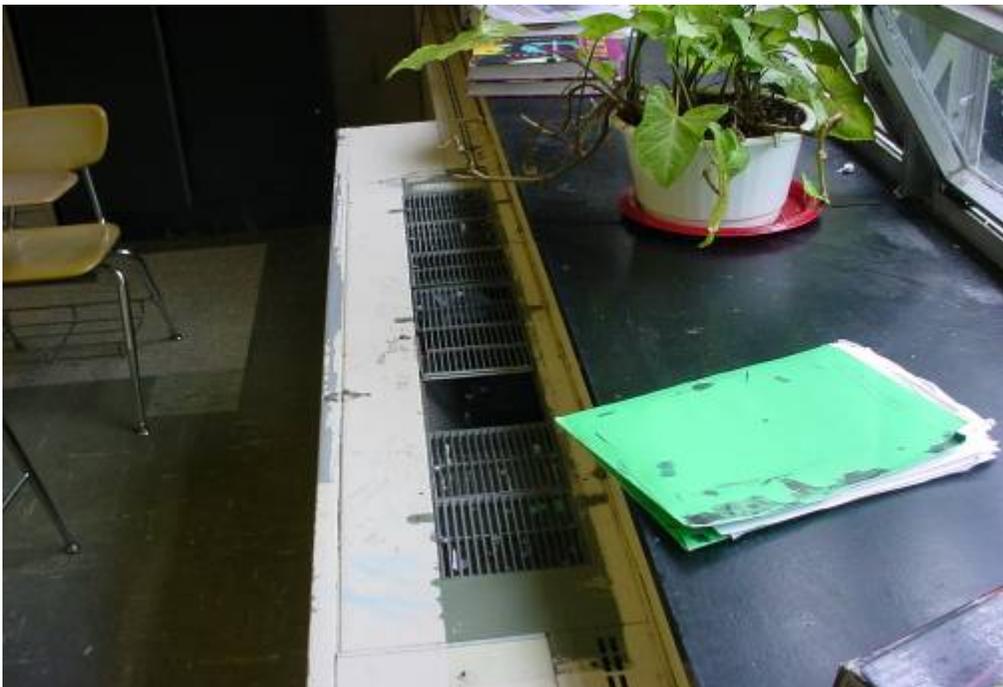
**Picture 4**

**Example of Original Univent Fresh Air Diffusers, Note Size of Opening for Airflow and Compare to Picture 3**

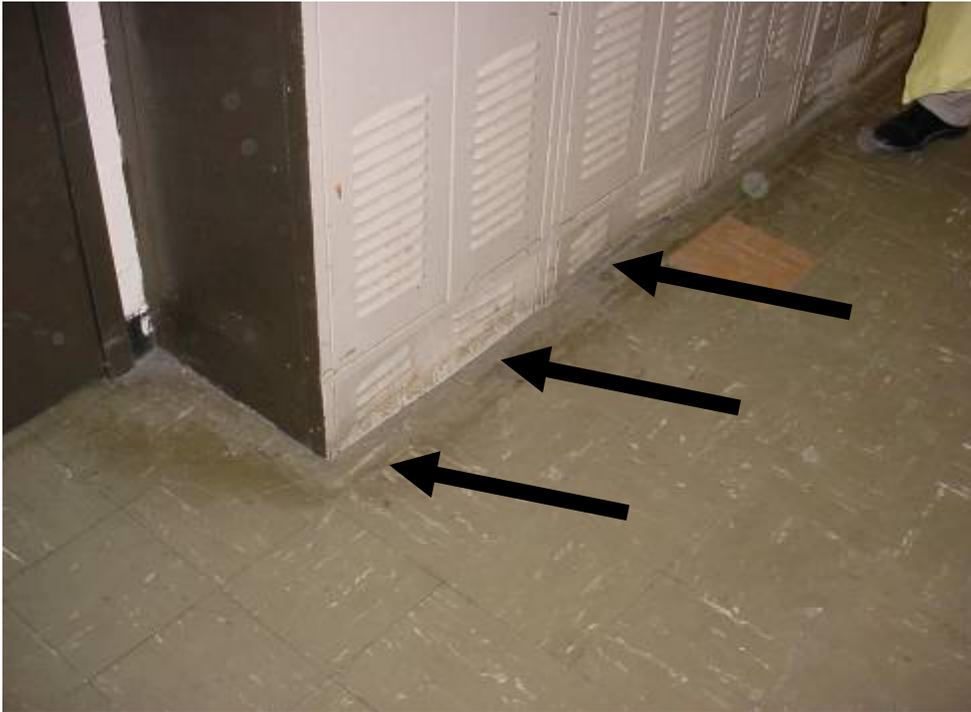
**Picture 5**

In the experience of BEH staff, the configuration of mechanical exhaust ventilation in a majority of classrooms appears unique. Student lockers are located along an interior classroom wall (Picture 5). It appears that air is drawn through openings in these locker doors, as well as through spaces beneath the lockers. Holes present at the rear of the locker walls show a dust accumulation pattern consistent with that often observed when air is drawn into an exhaust duct (Picture 6). As with the univent fresh air diffusers, the original design has been altered through repairs. Sheets of Masonite have been installed below the lockers (Pictures 7). The holes in the Masonite may not be of sufficient number or size to provide adequate exhaust ventilation, thereby limiting the draw of odors from classrooms.

**Student Lockers in Classroom, Arrow Notes Exhaust Vents at Bottom of Locker**

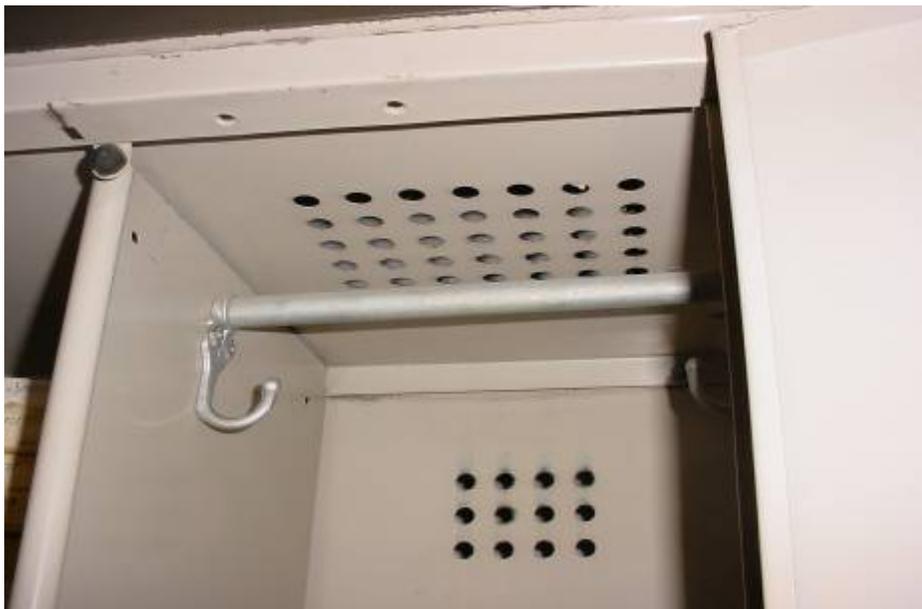
**Picture 6**

**Holes in Rear Wall of Locker, Note Dust Accumulation Typically Seen On Exhaust Vents**

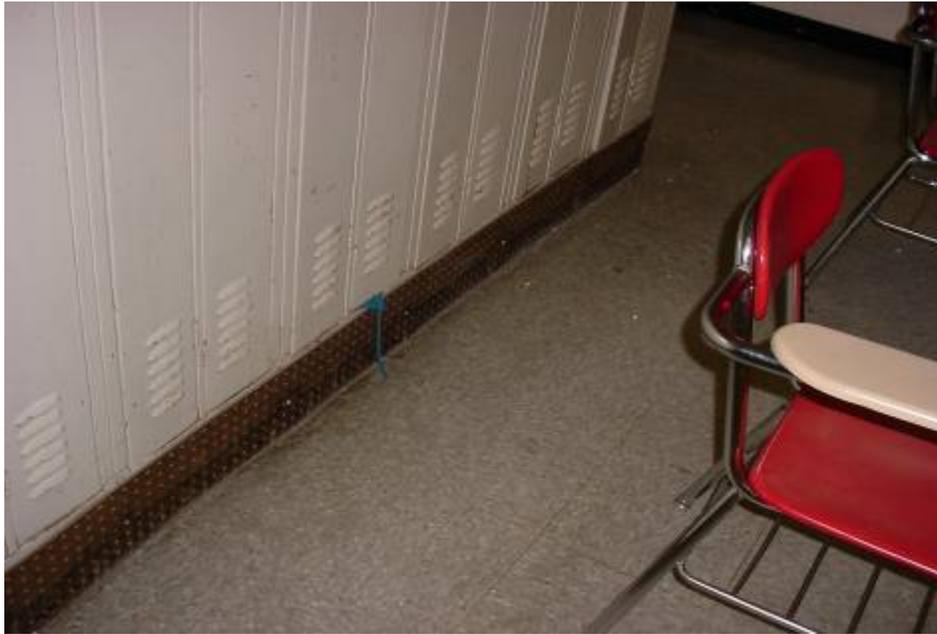
**Picture 7**

**Masonite Installed In Place Of Original Vents**

2. Replace Masonite with a material that will not impede exhaust airflow and is not a source for mold growth.
3. Consult a ventilation engineer to ascertain the best method for increasing fresh air supply to classrooms. Operate all ventilation systems throughout the building (e.g., gym, auditorium, classrooms) continuously during periods of school occupancy independent of thermostat control to maximize air exchange. To increase airflow in classrooms, set univent controls to “high”.

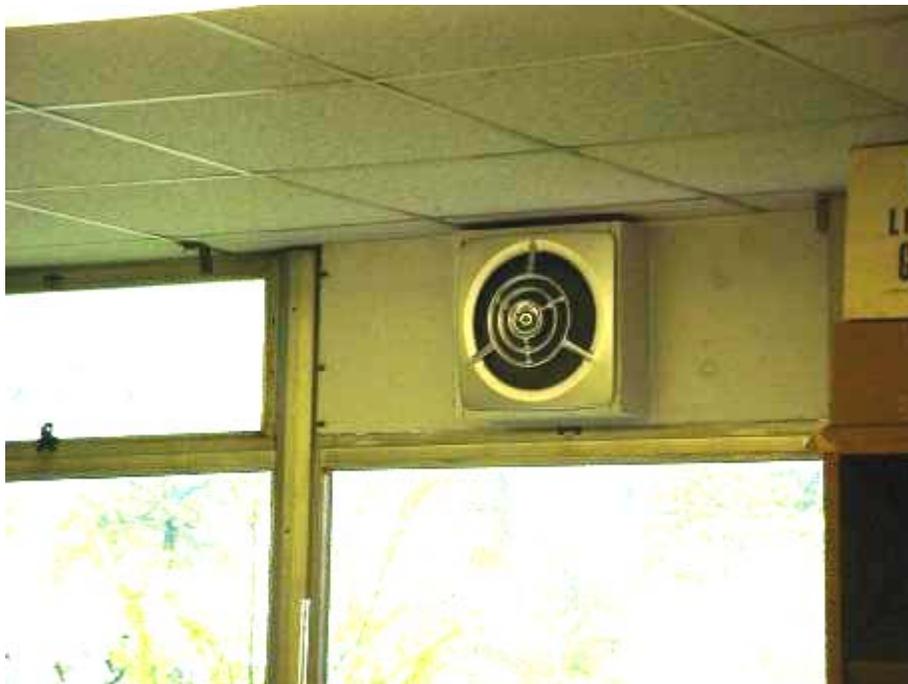
**Picture 8**

Mechanical ventilation in large areas (e.g., gymnasium, the auditorium, and cafeteria) is provided by air-handling units (AHUs) located in mechanical rooms. The chemistry lab has an exhaust fan that is excessively noisy, which limits its use during teaching (Picture 8). Frequently, noise associated with fans is due to excessive fan blade speed.

**Chemistry Lab Exhaust Fan**

6. Repair chemical hoods (i.e. classroom B20) and exhaust ventilation systems for all laboratories and shop activities; use these systems as needed. Chemical hoods should be evaluated annually at minimum to ensure proper draw of air.

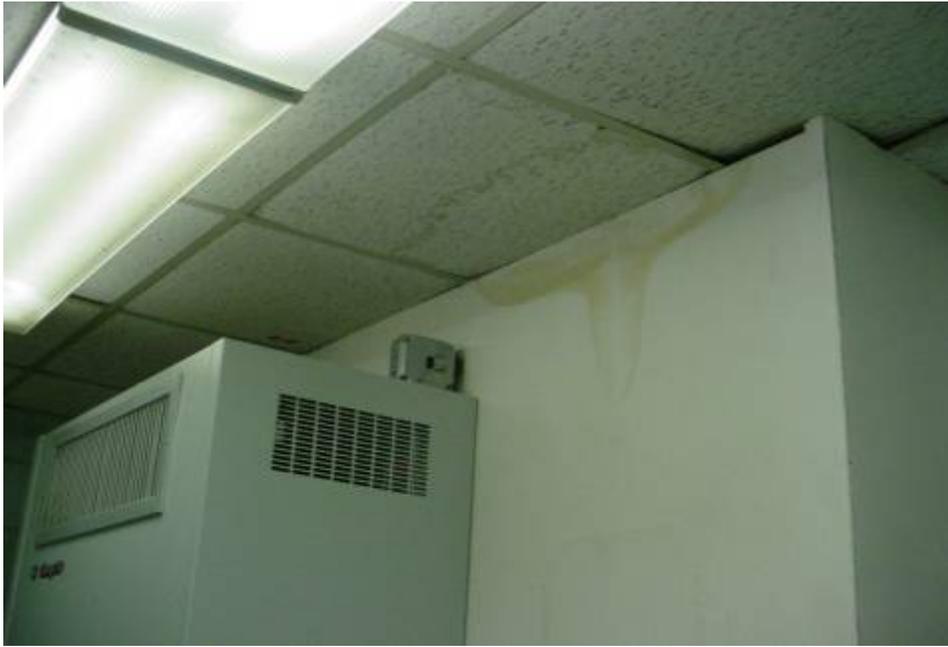
**Picture 9**

The building has experienced water infiltration through the roof in the library. A storeroom with wall-to-wall carpeting had a musty odor. The source is likely historic water leaks that have moistened the carpet. A number of locations contained water-damaged ceiling tiles, which can indicate a leak through the window or univent fresh air intakes vents (Picture 9).

**Water Damage around Univent**

8. Remove water-damaged ceiling tiles in a manner consistent with recommendations found in “Mold Remediation in Schools and Commercial Buildings” published by the US EPA (US EPA, 2001). This document is available from the US EPA website at: [http://www.epa.gov/iaq/molds/mold\\_remediation.html](http://www.epa.gov/iaq/molds/mold_remediation.html).

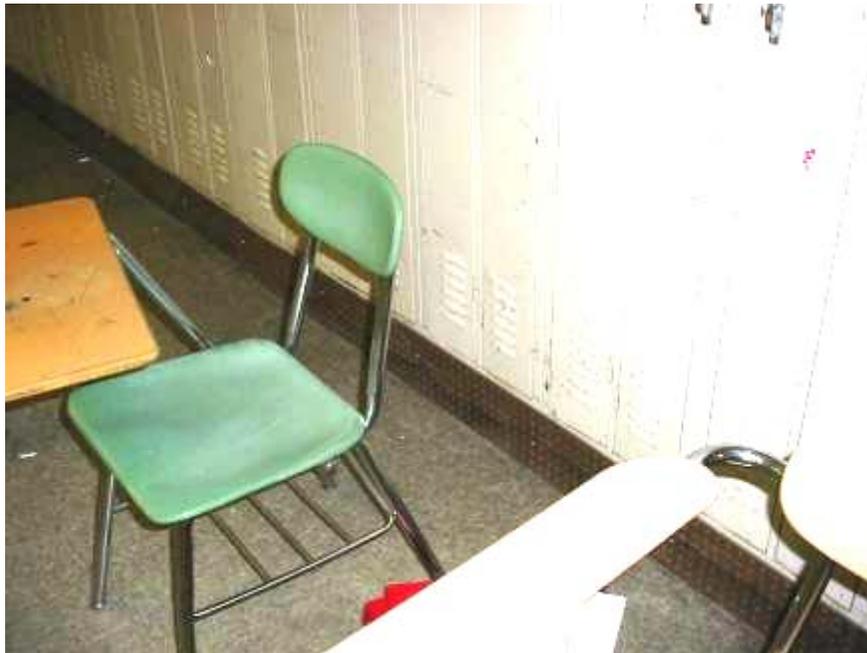
**Picture 10**

The Masonite used to replace damaged exhaust vents, which as discussed are located below student lockers, show signs of water staining (Picture 10). Such staining is likely from wet mopping of classroom floors. Masonite is a material that can support mold growth, particularly if the location is prone to generating condensation during hot, humid weather. Due to the date of construction, it is likely that floors of basement classrooms are prone to condensation, which would likely moisten these materials during hot, humid weather.

**Stain On Masonite**

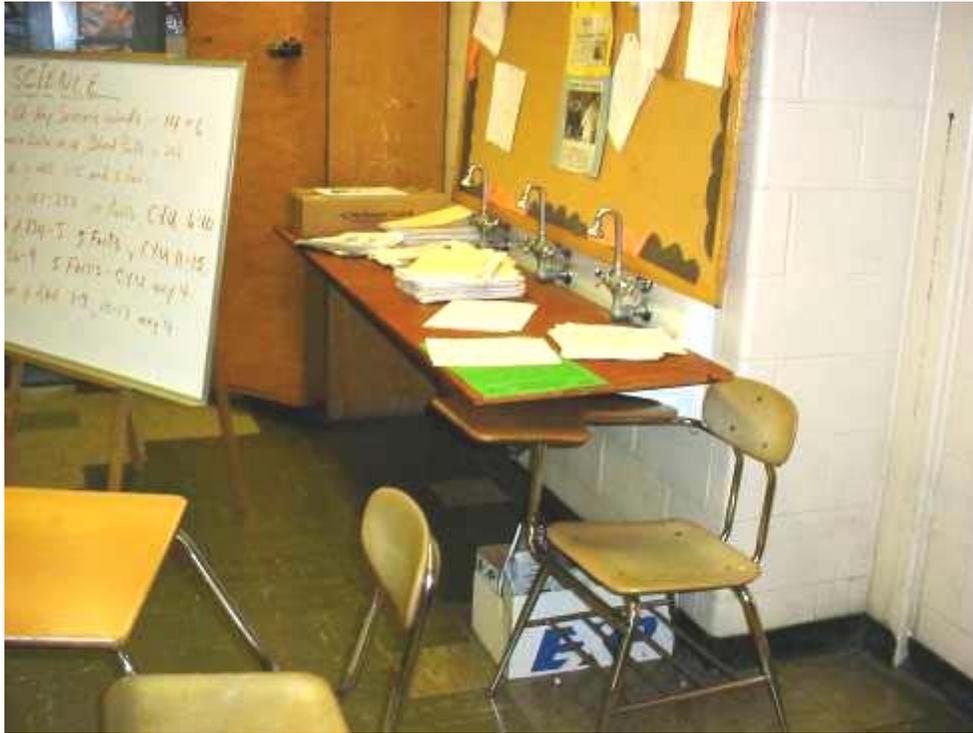
**Picture 11**

- Sinks that do not appear to be in use are located in a number of classrooms (Picture 11). Each sink contains a drain trap, which when filled, prevents odors from emanating from the sink's drain system. Sewer gas (hydrogen sulfide) and other materials in drain systems can be irritating to the eyes, nose and respiratory system. If drain traps are not filled such odors and related health impacts are likely.

**Example of Unused Sink**

9. Ensure all plants are equipped with drip pans. Examine drip pans periodically for mold growth and disinfect with an appropriate antimicrobial where necessary. Remove plants from unvented. Seal all drain on unused sinks. Be sure to shut off water supply to each sink with a sealed drain.
