INDOOR AIR QUALITY ASSESSMENT

**Woods Memorial Library
19 Pleasant Street
Barre, Massachusetts 01005**

Prepared by:
Massachusetts Department of Public Health
Bureau of Environmental Health
Indoor Air Quality Program
November 2008

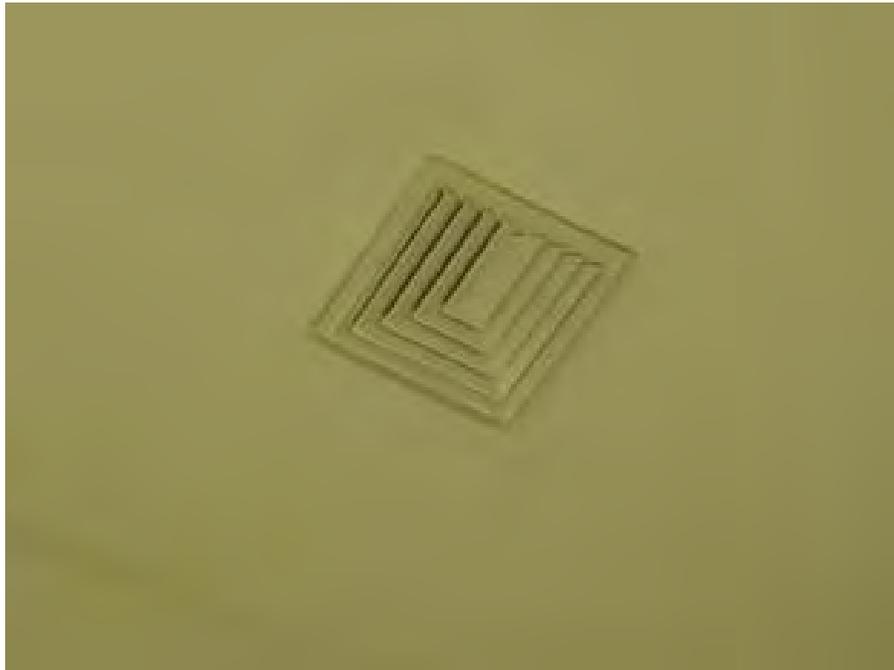
Picture 1

Ceiling-Mounted Air Supply Diffuser

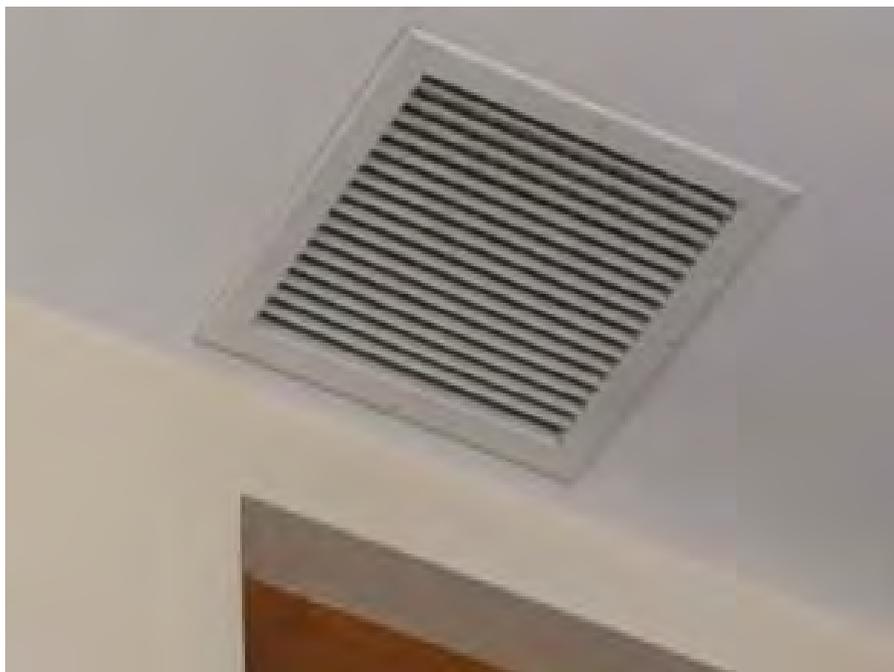
Picture 2

Ceiling-Mounted Exhaust Vent

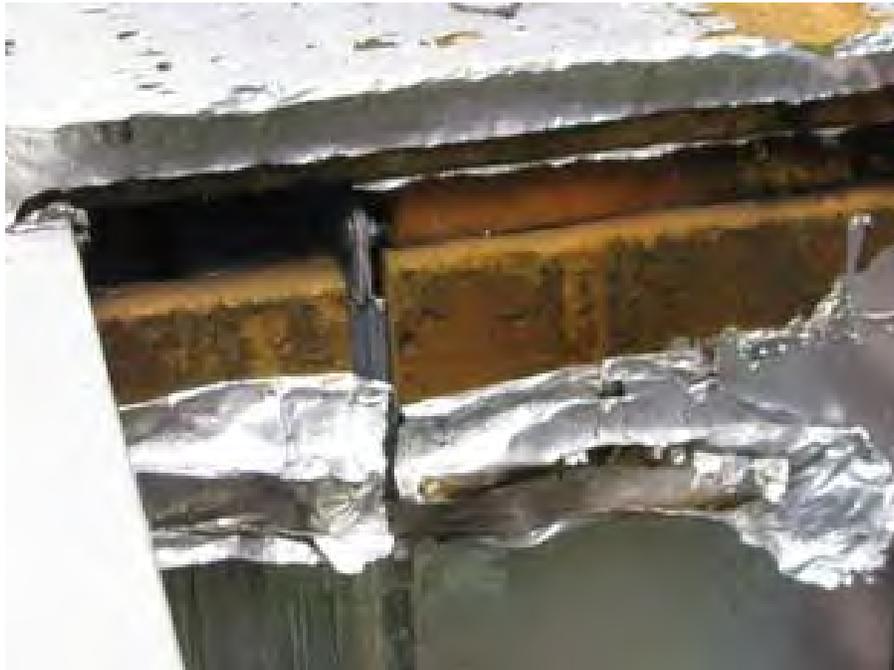
Picture 3

Mechanical ventilation for the library is provided by air-handling units (AHUs) located in an enclosure behind the new building addition. The AHUs draw in outside air through air intakes and distribute it to occupied areas via ceiling-mounted air diffusers (Picture 1). Return air is ducted back to the AHUs via ceiling-mounted exhaust vents (Picture 2). BEH staff found an AHU with its insulation exposed to the outside (Picture 3). This insulation was deteriorating and in disrepair. This condition could allow for water, mold, pests or insulation to enter the AHU.

Deteriorated Insulation on AHUs

1. Trim overgrowth in AHU enclosure. Remove organic debris beneath fresh air intake.
2. Remove and repair or replace deteriorated insulation on AHUs.
3. Locate catch basin in rear parking area and remove debris that has accumulated within it.
Install barriers to prevent sand from being plowed into the storm drain in the future, until such time as long term solution to the drainage problem can be reached.
4. Investigate and determine integrity of roofing system.

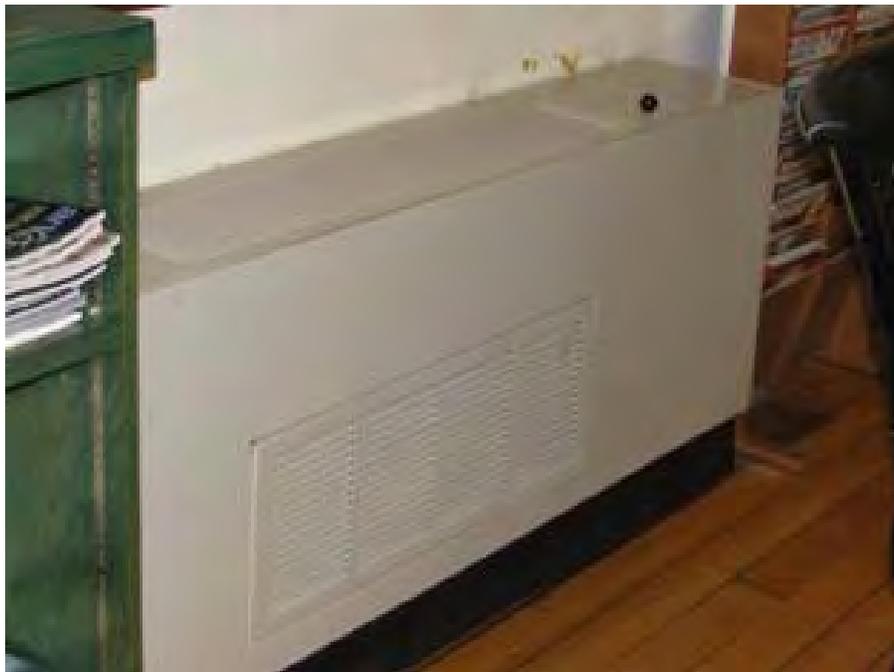
Picture 4

Fresh air is supplied to the reference room, media room and the Acting Director's office by unit ventilator (univent) systems (Picture 4). A univent draws air from the outdoors through a fresh air intake located on the exterior wall (Picture 5) of the building and returns air through an air intake located at the base of the unit ([Figure 1](#)). Fresh and return air are mixed, filtered, heated and provided to rooms through an air diffuser located in the top of the unit.

Unit Ventilator

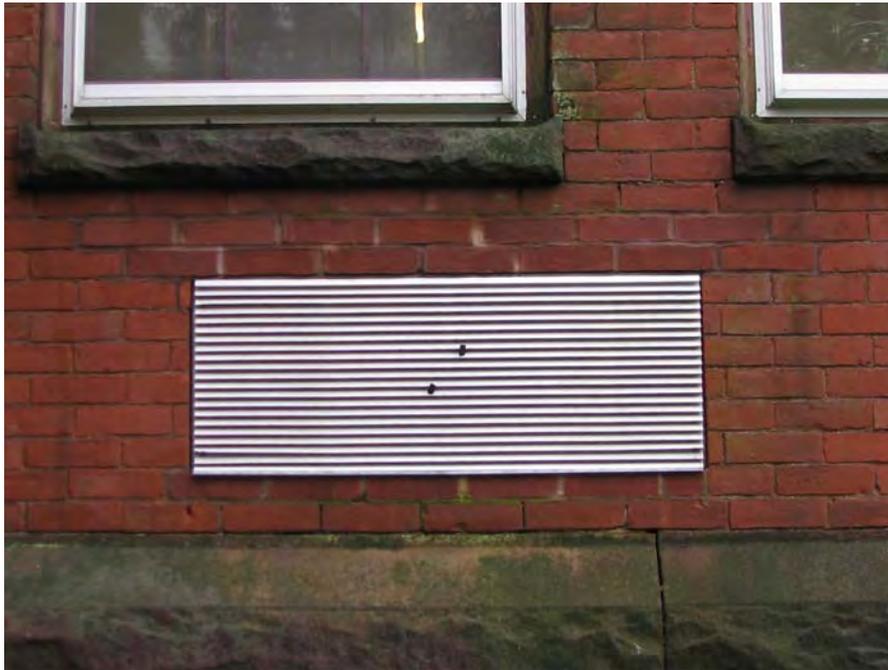
Picture 5

Univent Fresh Air Intake on Exterior Wall

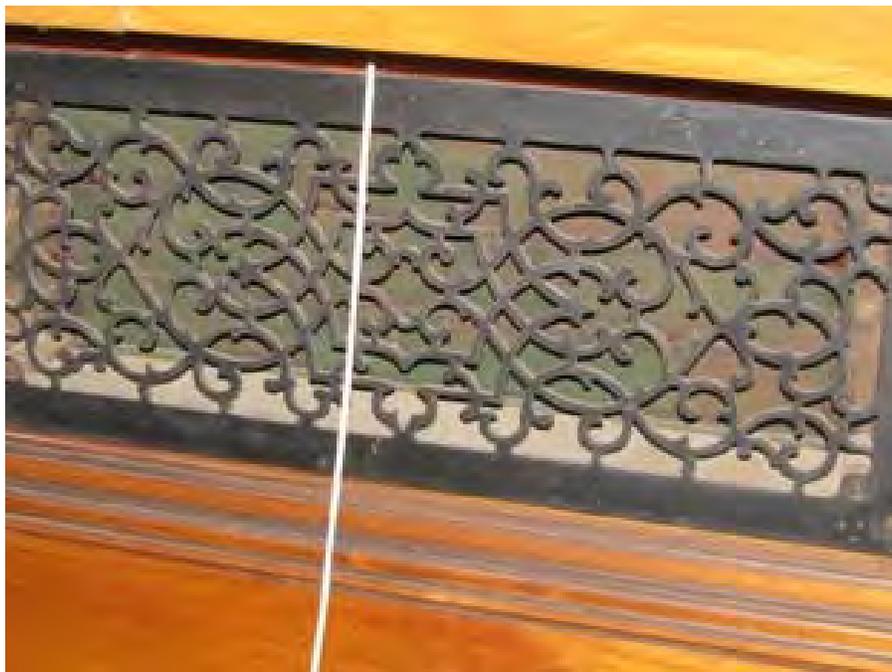
Picture 6

Louvered Vent in Alan Hall

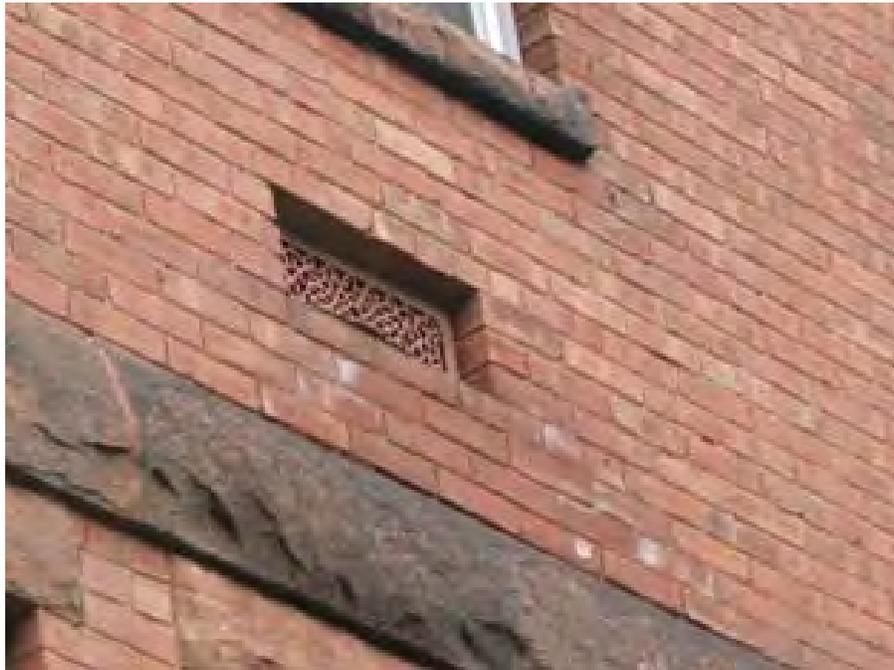
Picture 7

Louvered Vent on Exterior Wall

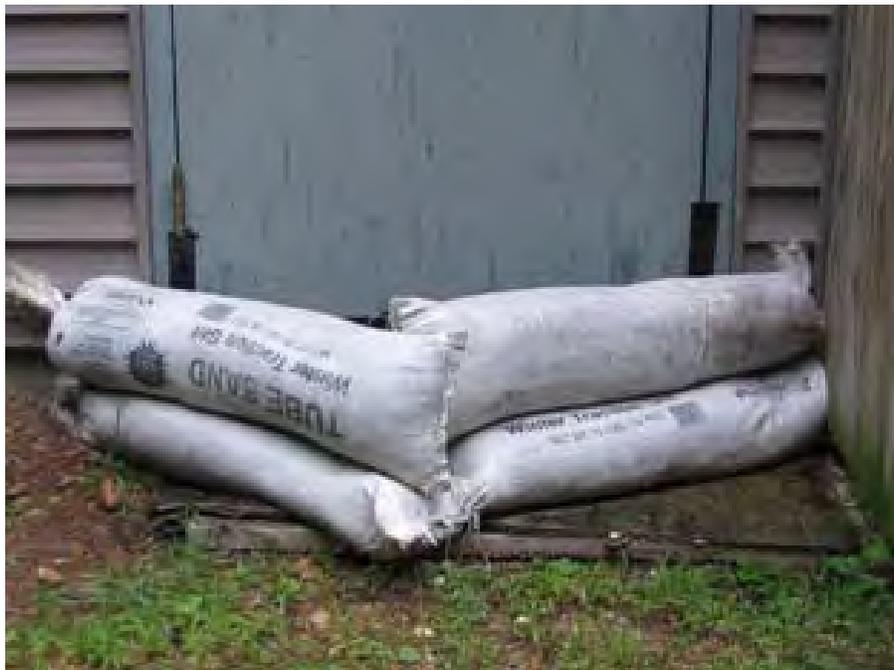
Picture 8

The basement of the WML is sub-grade; therefore, it is prone to flooding during extended/heavy rainfall. BEH staff observed sandbags located at both basement entrances at the time of the assessment (Picture 8). These sandbags are used in the event of a heavy rain.

Sand Bags Used to Prevent Flooding

1. Consider repairing roof if necessary.
2. Consider constructing a concrete dike around the basement entrance of sufficient height to prevent water penetration. Consider enlarging existing berm at top of driveway to prevent street runoff from entering driveway and collecting in rear parking lot.

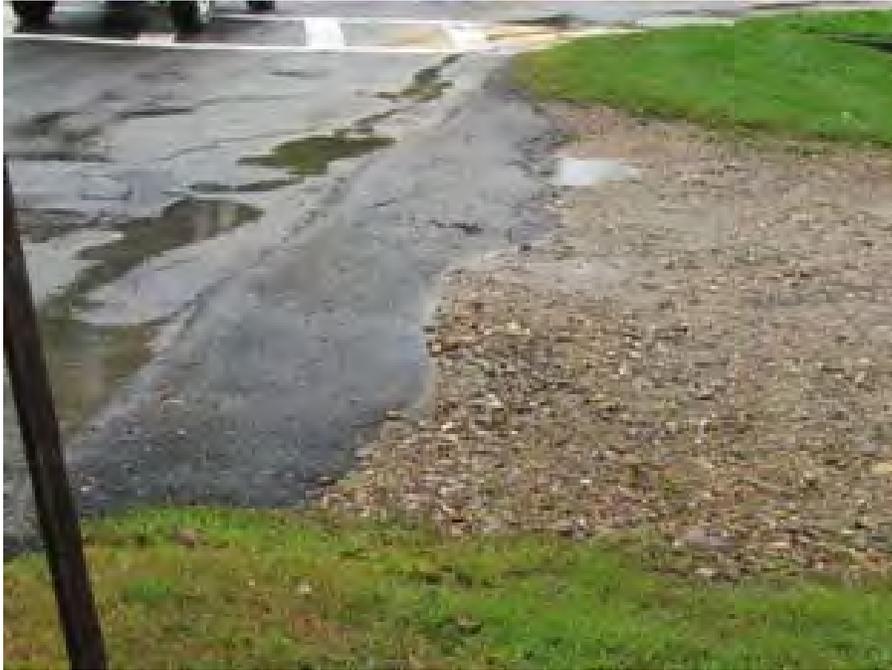
Picture 9

A dirt parking lot in the rear of library borders a wet-land. On the day of the assessment, heavy rain flooded the lower part of the parking lot and the adjacent wet-land. According to WML staff, the majority of the water originates from a culvert located adjacent to the town hall parking lot located on West Street. BEH staff was informed that when the culvert gets blocked with debris, it overflows down the street to the entrance of the parking lot. Although an asphalt berm was installed at the driveway entrance since the last assessment, a significant amount of water accumulated in the parking lot after a relatively short-lived storm on the day of the assessment (Pictures 9 - 11).

Recently Installed Asphalt Berm

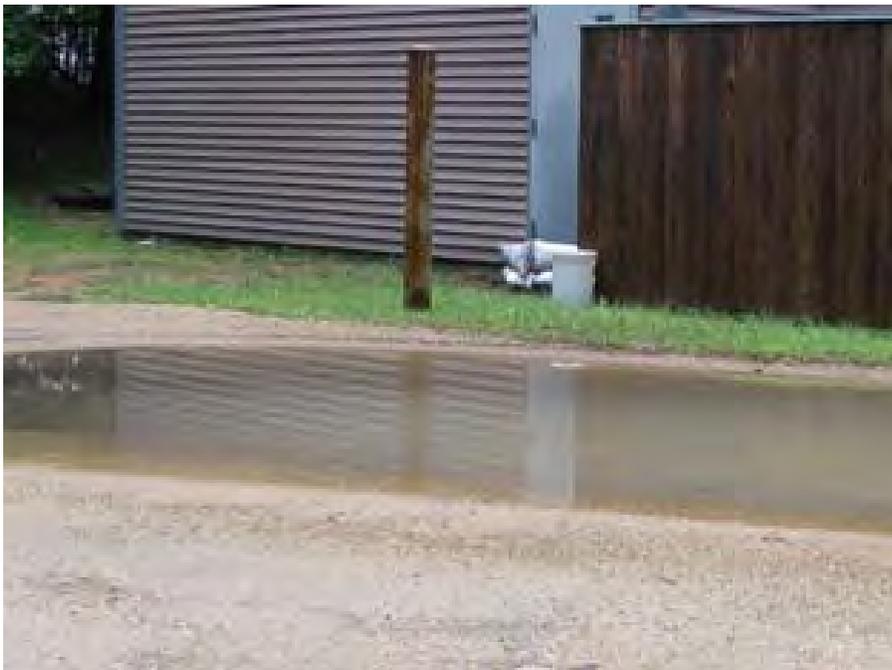
Picture 10

Standing Water in Rear Parking Area Adjacent to Building

3. Consider addressing the drainage issues at the culvert on West Street. Once these issues are resolved, parking lot could be paved and properly sloped to drain away from the building to a functioning catch basin.

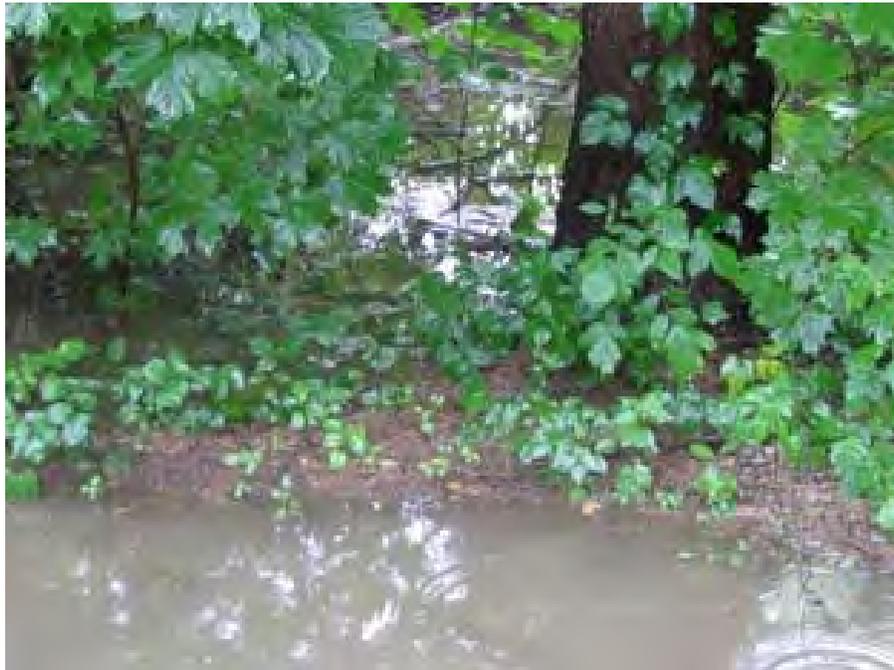
Picture 11

Standing Water in Parking Lot near Wetland

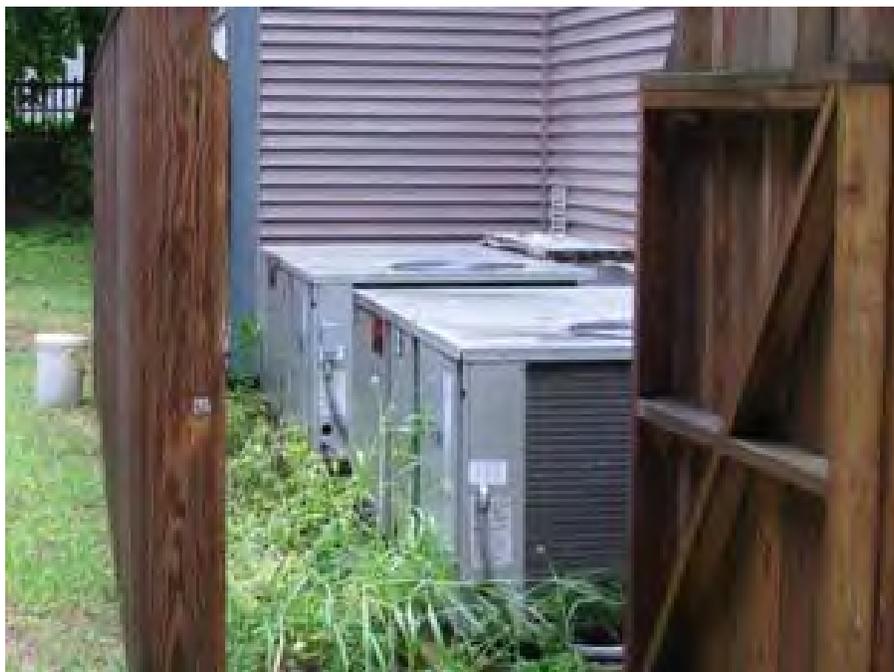
Picture 12

BEH staff found the area surrounding the AHUs overgrown with grass, plants and weeds (Picture 12). An accumulation of organic debris was observed on the concrete slab beneath the fresh air intakes. Plants can serve as sources of mold and pollen, which can be entrained into the

fresh air intakes. Moist organic material can also provide a medium for mold growth.

Weed Growth Surrounding Air Handling Units

Therefore, vegetation should be kept down and regular procedure should be provided for periodic cleanup.

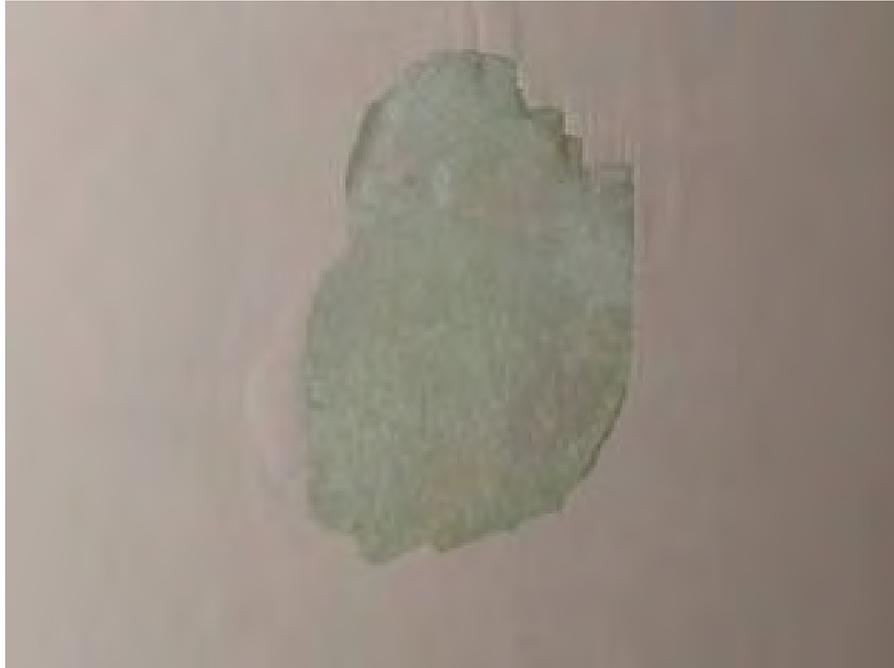
Picture 13

Water damaged ceilings and walls, peeling paint and efflorescence were observed in several areas throughout the library (Pictures 13 and 14). The water damage is most likely the result of water penetration through the building envelope. Efflorescence is a characteristic sign of water damage to masonry (e.g., brick, concrete) and mortar, but it is not mold growth. As moisture penetrates and works its way through mortar and masonry, water-soluble compounds in mortar and masonry dissolve, creating a solution. As the solution moves to the surface of the mortar or masonry, the water evaporates, leaving behind white, powdery mineral deposits.

Efflorescence on Stairway Wall

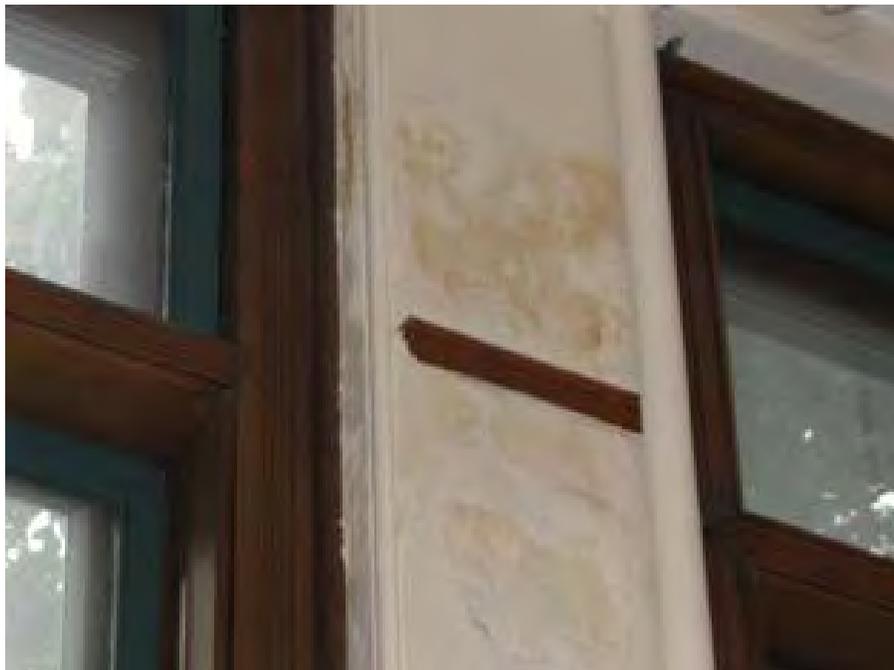
Picture 14

Water Damage on Wall and Window Casing of Media Room

8. Investigate water penetration into media room window, wall and ceiling. Once identified, eliminate pathway of water penetration to the interior of the building.

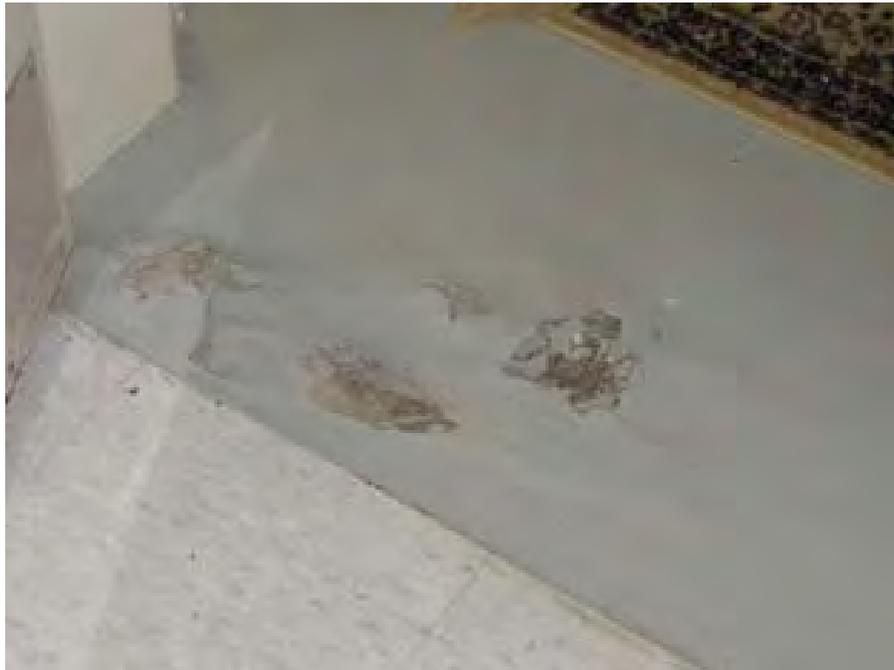
Picture 15

In the children's library, flooring installed to replace carpeting in the main room was in good repair; however, BEH observed portions of the new epoxy/poured floor in the back hallway and storage room in disrepair. These areas exhibit peeling and chipping (Picture 15), which may indicate that some moisture remains in the concrete floor. Dehumidifiers are routinely utilized in these basement areas.

Deteriorating Basement Floor

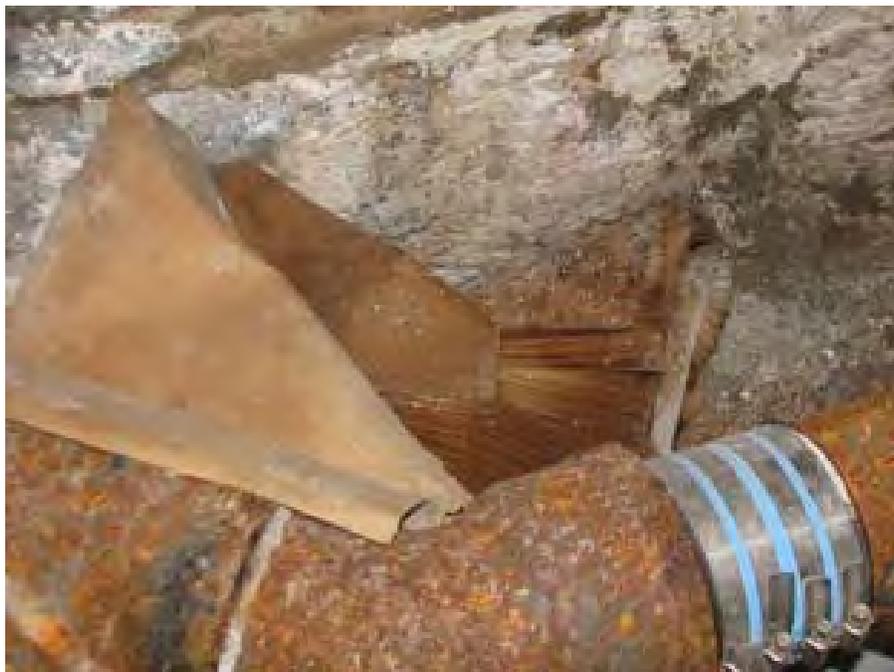
Picture 16

BEH staff found evidence of excess moisture and mold growth in the sprinkler room. Moist cardboard, paper and debris were strewn on the floor. Some cardboard had colonized mold (Picture 16). Oxidation of the cast iron pipes in this room suggests chronic exposure to moisture. In addition, penetration of pipes through walls are not properly sealed (Picture 17). In the multipurpose room, staining from liquid spillage was observed on the carpet.

Moist Cardboard Stored in Sprinkler Room, Note Heavy Oxidation on Pipe

9. Remove extraneous materials from basement storage areas and sprinkler room.
10. Seal all open utility holes with appropriate fire-rated sealant.
11. Remove wick material from weep hole.

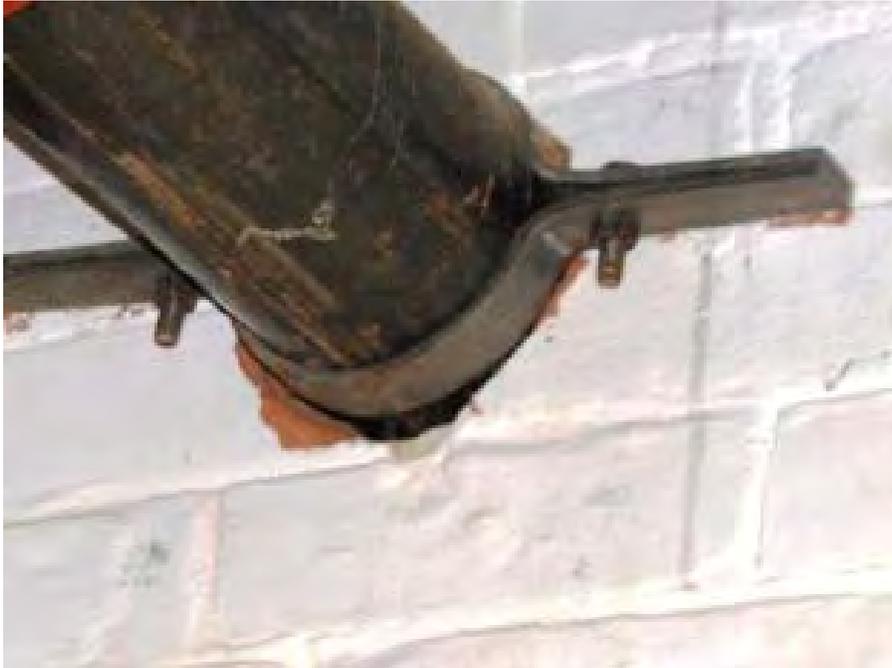
Picture 17

Penetrations of pipes and brackets through ceilings and walls in the sprinkler and boiler rooms are not properly sealed. Open utility holes can provide a means of egress for odors, fumes, dusts and vapors between rooms and floors. These materials can migrate into the air handling units and be distributed to occupied areas. Numerous cans of paint were also observed in close proximity to the burner on the boiler in the basement (Picture 22), which can be a fire/safety hazard.

Penetration of Pipe Through Wall is not Sealed

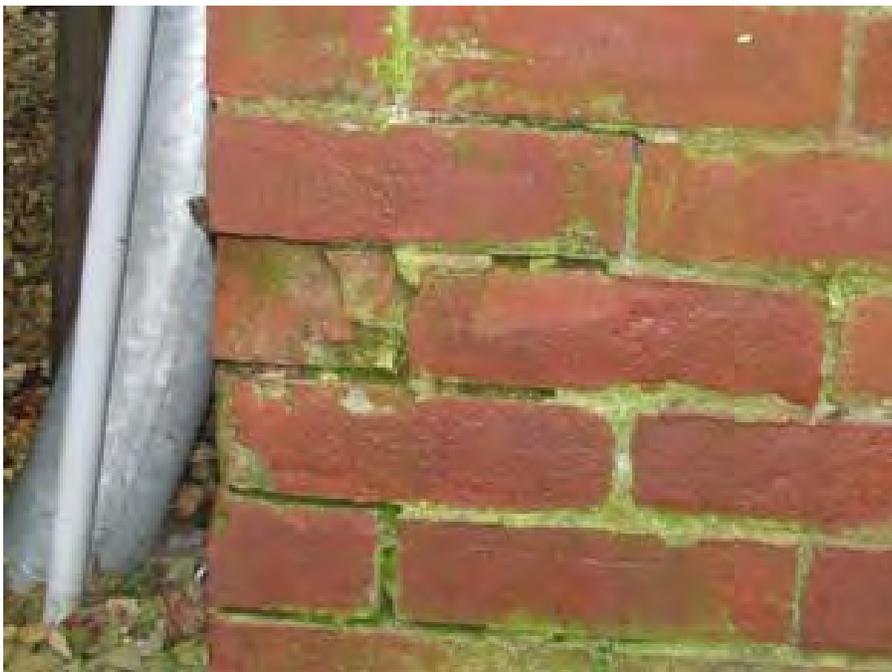
Picture 18

- Damaged/missing exterior brick and mortar (Picture 18);

- One weep hole exhibits a wick; and
- Moss growth was observed on exterior brick and mortar, stairs and windowsills

(Picture 18), indicating heavy/continuous water exposure.

The aforementioned conditions represent potential water penetration sources. Over time, these conditions can undermine the integrity of the building envelope and provide a means of water entry into the building via capillary action through masonry (Lstiburek & Brennan, 2001). In addition, these breaches may provide a means for pests/rodents to enter the building.

Damaged/Missing Brick and Mortar, Note Extensive Moss Growth

6. Repair loose, broken and missing mortar on all areas of the building.
7. Determine if chimney is currently in use. If chimney is currently in use, repair chimney cleanout door and clean soot out of chimney and off of floor. If not, both ends of the chimney should be properly sealed.

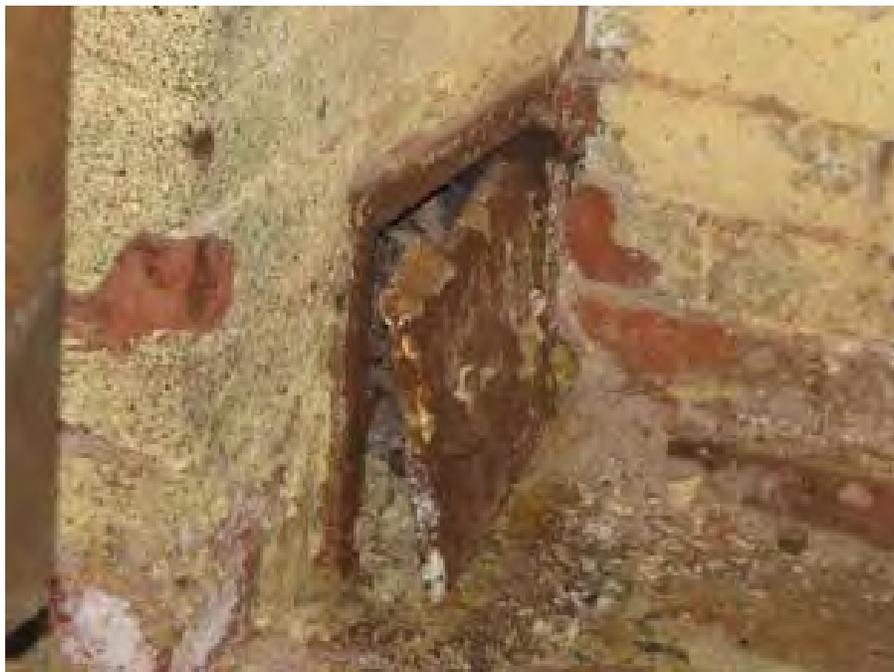
Picture 20

The chimney cleanout door in the boiler room was broken. BEH staff found this door open with accumulated soot pouring out into the room (Picture 20). If the chimney is in use in its present condition, it could pose a potential threat of carbon monoxide accumulation/exposure, and should be repaired. If the chimney is no longer in use, both ends of the chimney should be sealed. Additionally, the exhaust duct exiting the boiler exhibits oxidation (Picture 21).

Broken Chimney Door with Soot Accumulation

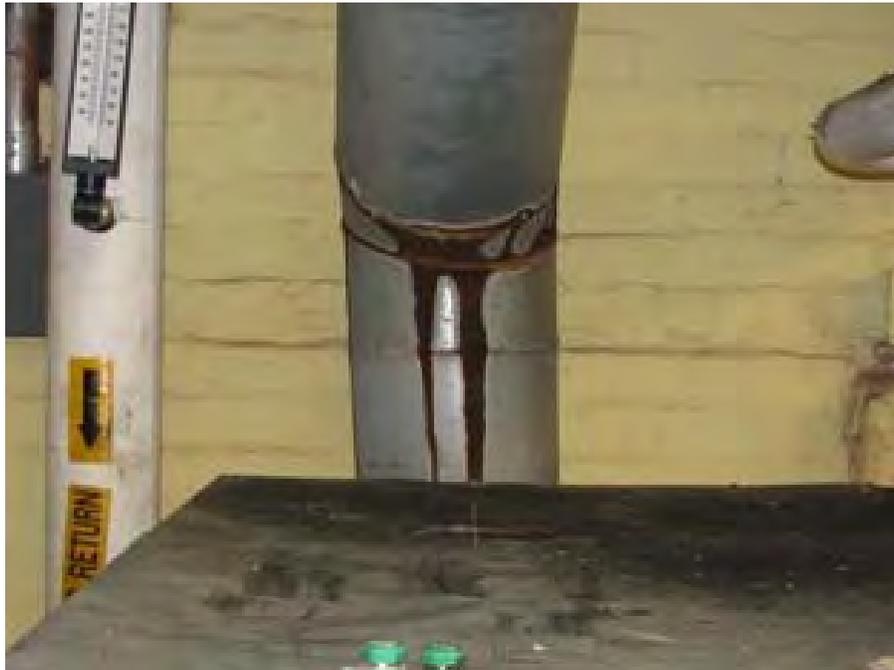
Picture 21

Oxidized Exhaust Duct on Boiler

18. Consult a heating systems professional to inspect the heating system components and associated ducts annually for structural integrity and proper functioning.

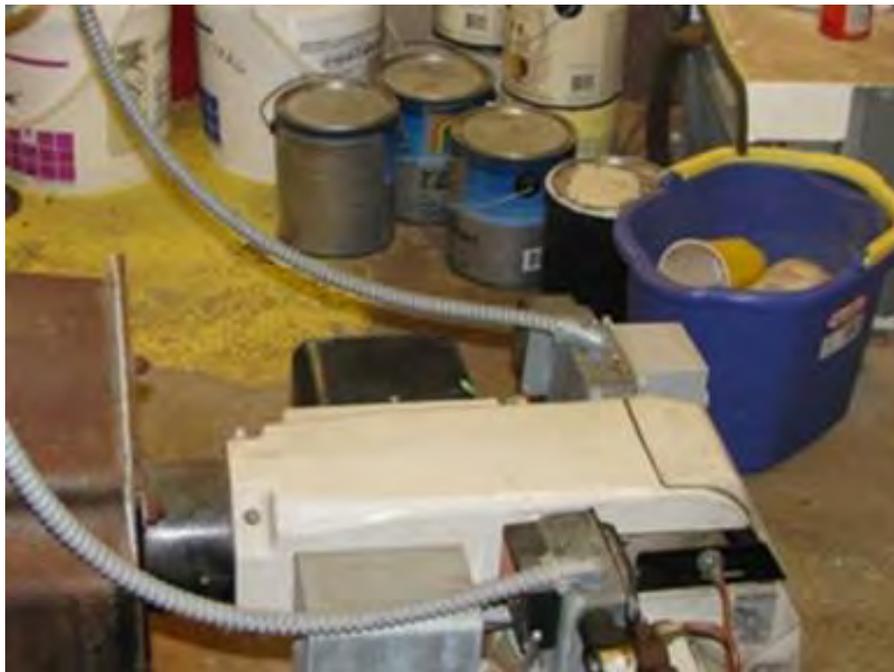
Picture 22

Paint Cans Stored Near Boiler
