INDOOR AIR QUALITY ASSESSMENT

**Gloucester High School
32 Leslie O. Johnson Rd
Gloucester, MA 01930**

Prepared by:
Massachusetts Department of Public Health
Bureau of Environmental Health
Indoor Air Quality Program
August 2008

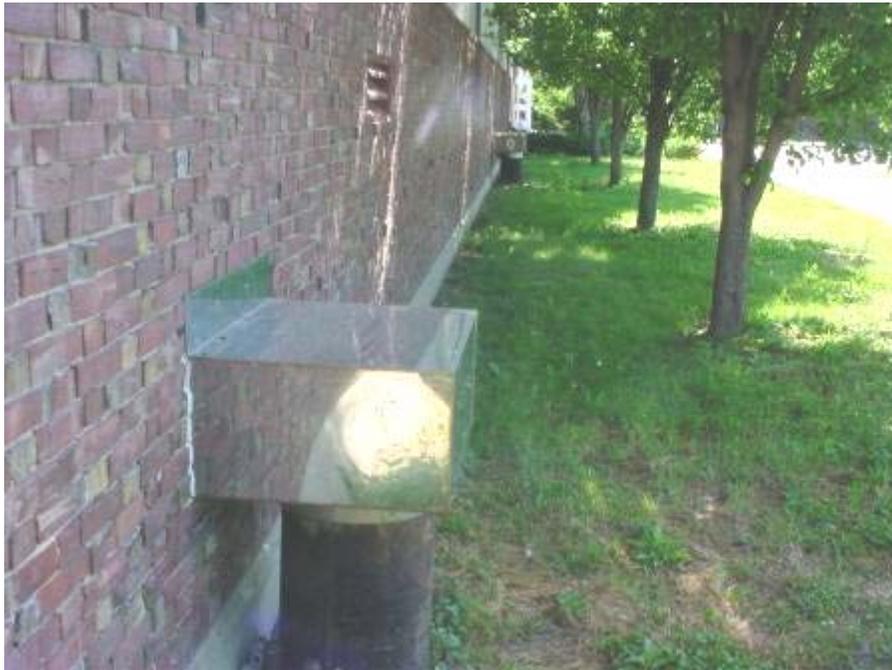
Picture 1

The GHS was originally constructed in 1940. In 1996, the building underwent extensive renovations, which included the construction of a field house and other additions, as well as replacement of the heating, ventilating, and air conditioning (HVAC) system. The main GHS complex is a three-story structure consisting of a main building with the science wing connected to the west side of the building and the field house connected to the east side. A freestanding vocational building is situated to the north of the main GHS complex ([Map 1](#)). Windows are openable throughout the building. A crawlspace exists beneath the main building complex. A second crawlspace that is situated under the footprint of the science wing appears to be separate from the main crawlspace. A mechanical ventilation system that exhausts air from the crawlspaces was retro-fitted (Picture 1).

Crawlspace exhausted via motorized fan

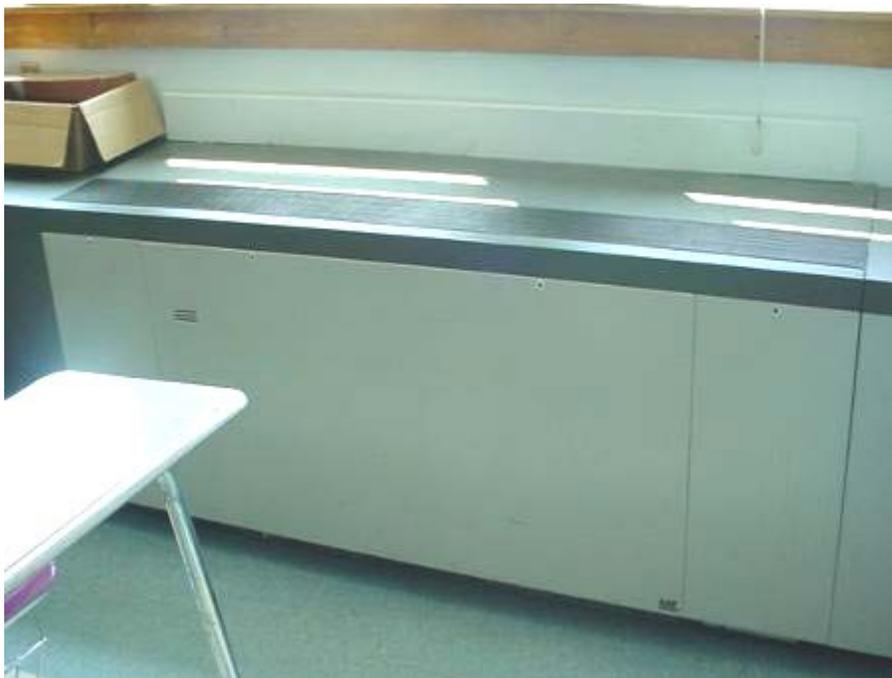
Picture 2

Classroom univent

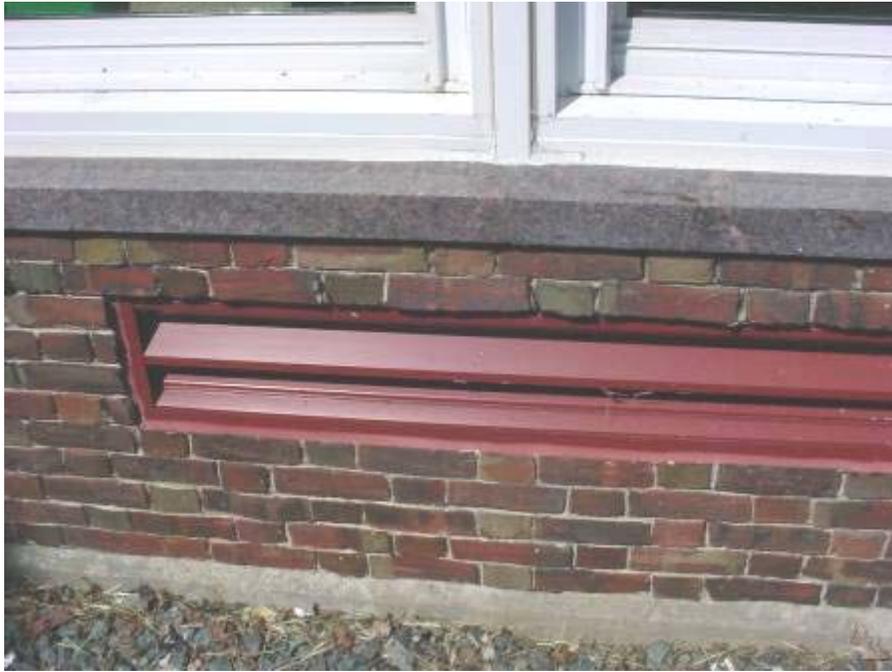
Picture 3

Univent fresh air intake

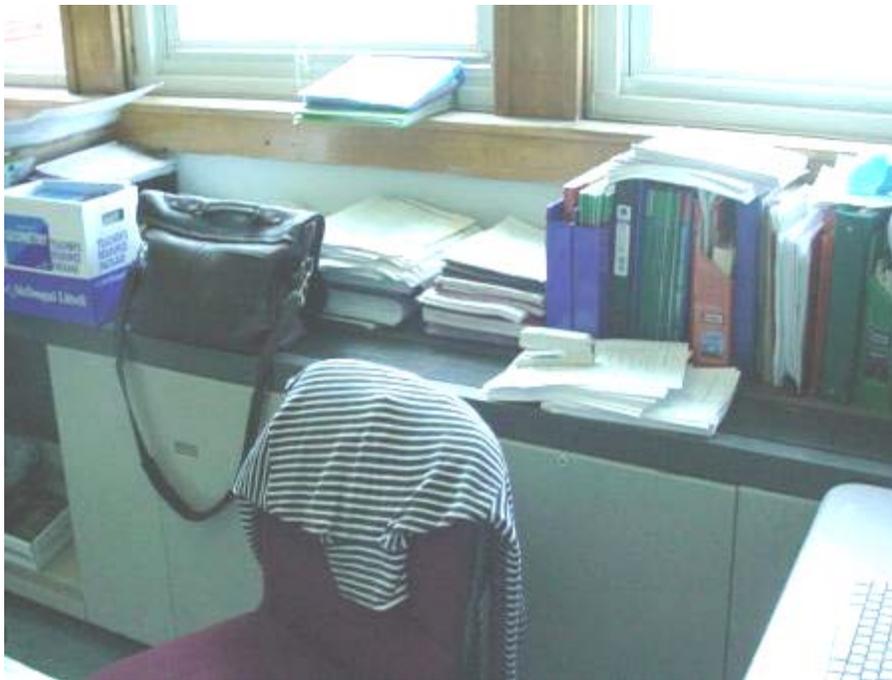
Picture 4

Items placed on top of univent

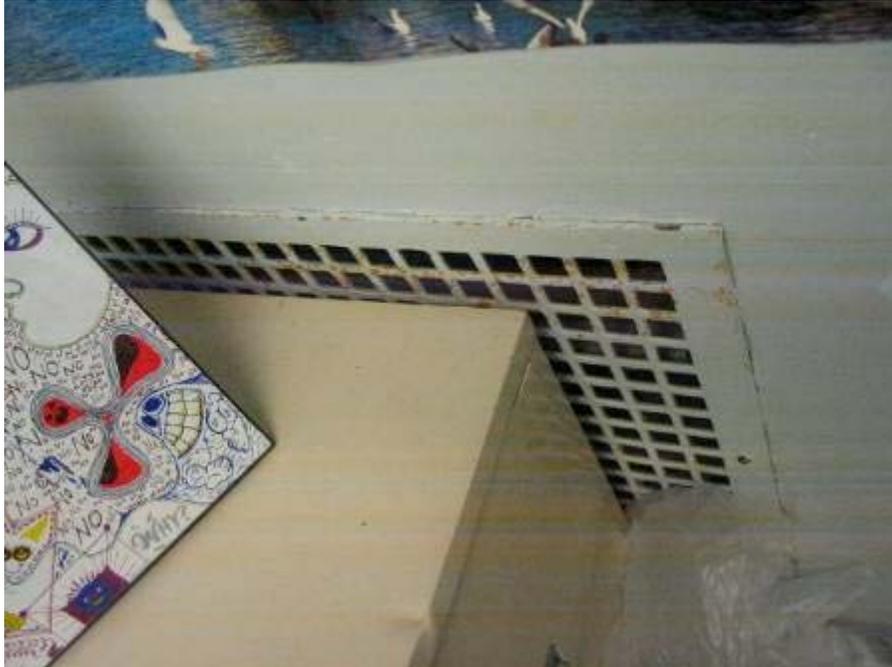
Picture 5

Exhaust vent blocked by cabinet

6. Restore exhaust ventilation in classrooms and common areas; make repairs as necessary.
7. Remove all blockages from univents and exhaust vents/cubbies to ensure adequate airflow.

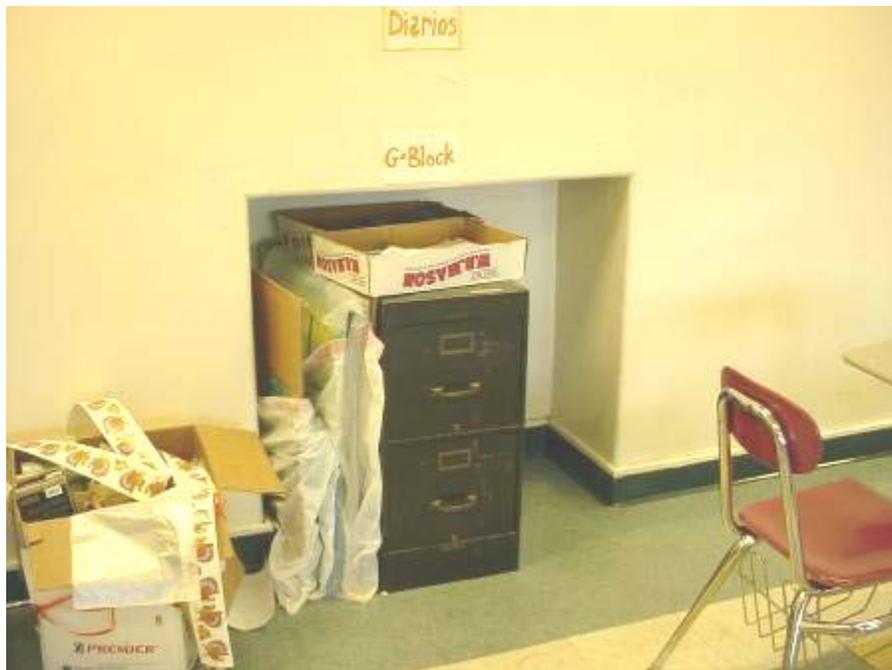
Picture 6

File cabinet and items stored in cubby exhaust

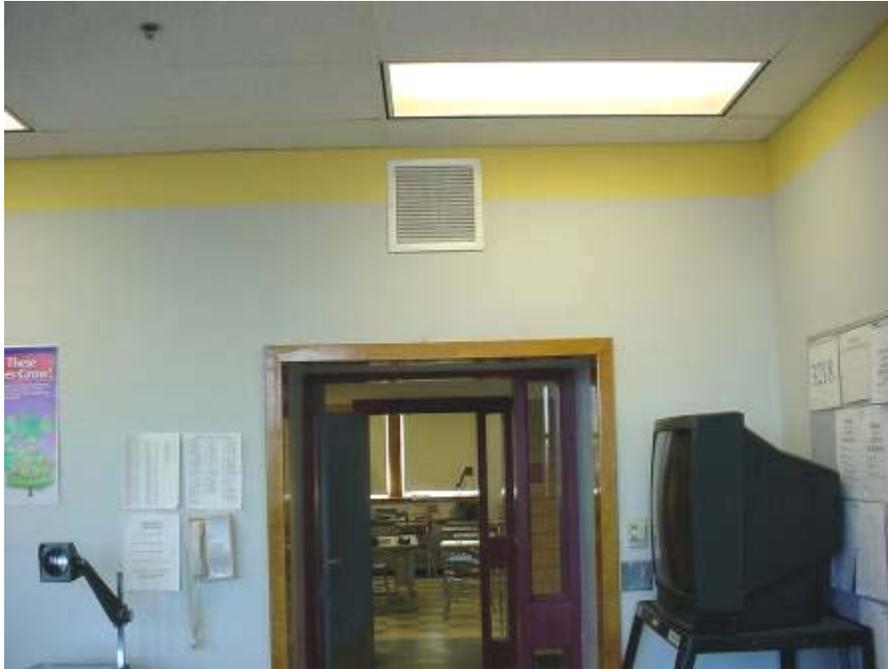
Picture 7

Exhaust vent located above hallway door

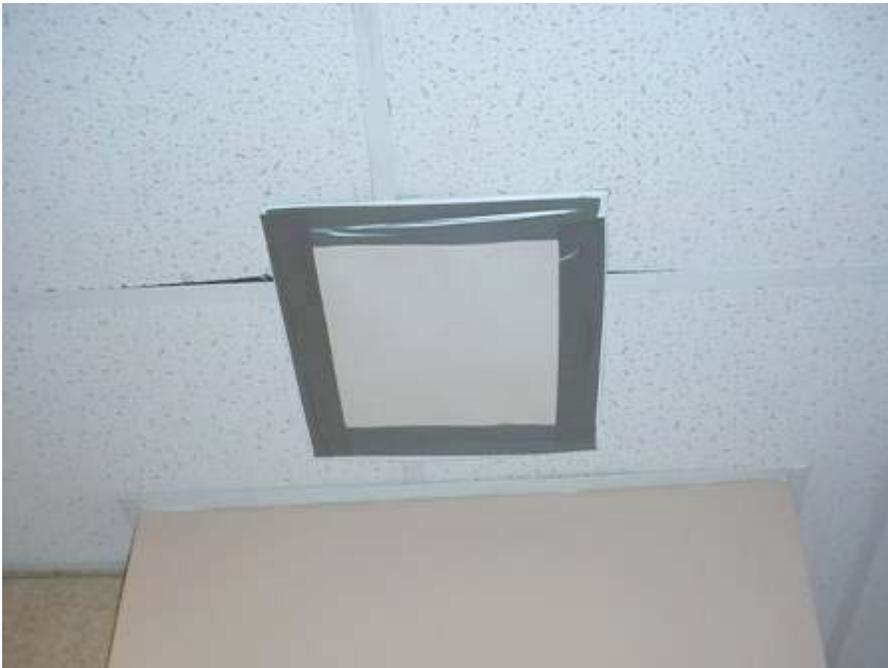
Picture 8

Supply vent sealed/blocked with duct tape and manila folder

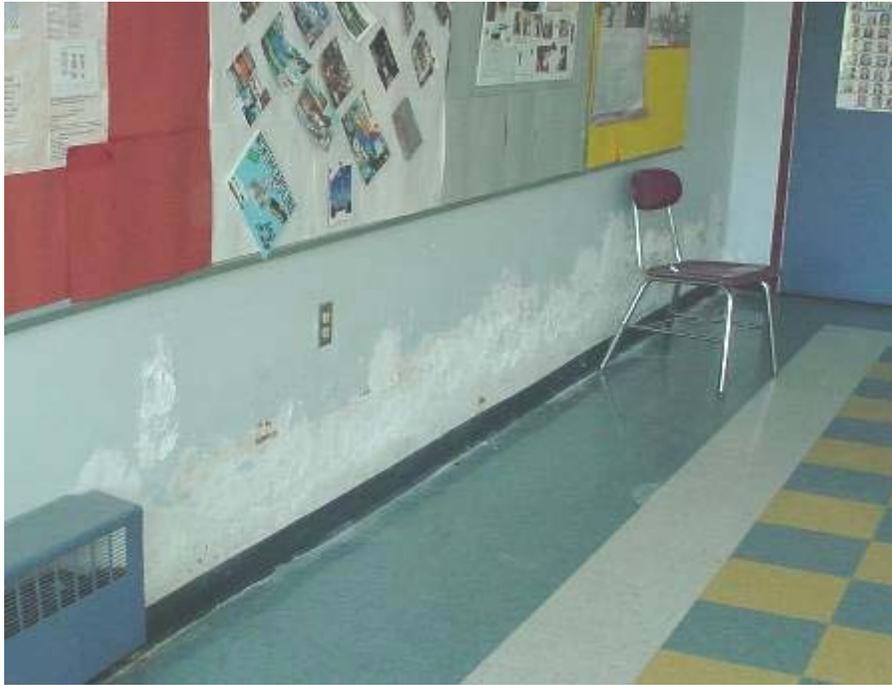
Picture 9

During the BEH assessments, staff observed conditions indicating water penetration in the building. Of note is the condition of the gypsum wallboard (GW) observed in the day care center during the May 30, 2007 assessment. The day care is located on the ground floor in the southeast corner of the science wing and showed signs of repeated water damage (Picture 9). BEH staff examined the exterior wall and window system corresponding to this wall and observed the following conditions that indicate that the source of water damaging the GW is most likely moisture through the window system.

Damaged GW in the day care center

17. Inspect exhaust vent near room 1218 and seal to prevent water infiltration.
18. Remove/replace water-damaged GW from the day care centers and science wing hallway ground floor.

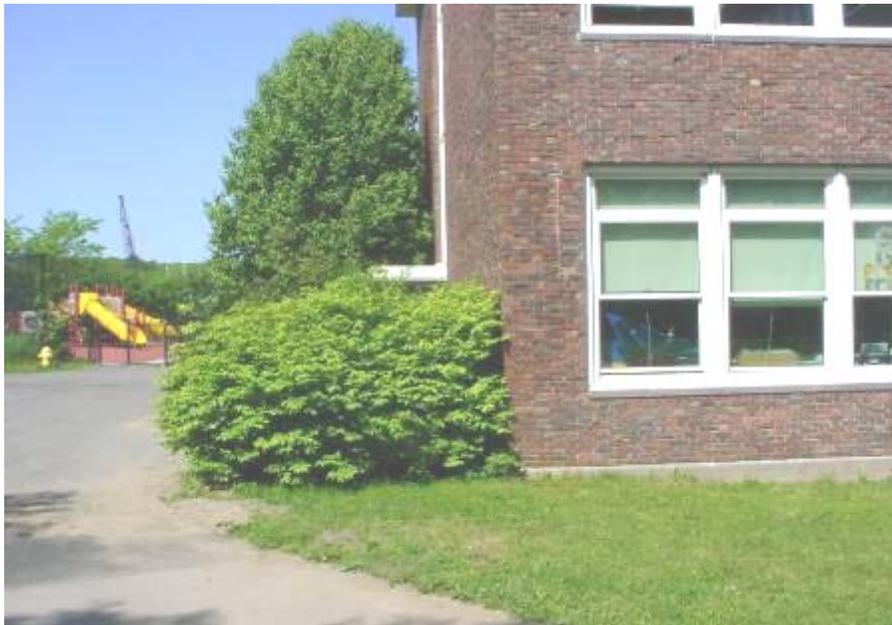
Picture 10

- No flashing exists in or around the window to direct water away from the window frame.
- Spaces between the exterior wall and the window sills and frames appear to be sealed with a caulking material that was damaged or missing.

As a result of aforementioned conditions, rain, particularly wind-driven rain from the southwest, can penetrate through the window system and chronically moisten GW. Evidence of water penetration through the window system was also observed in other areas of the GHS (Tables 1 and 2).

Window sills installed with minimal outward pitch

3. Examine and repair window systems to prevent water infiltration.
4. Consider re-seating the window sills in the east wall of the science wing to create a slope to allow for water to pour away from the sill. Each window frame should have window drip caps to prevent water penetration. Given the type of driven wet weather experienced in the greater Gloucester area, each windowsill should be flashed to direct water away from the window frame.

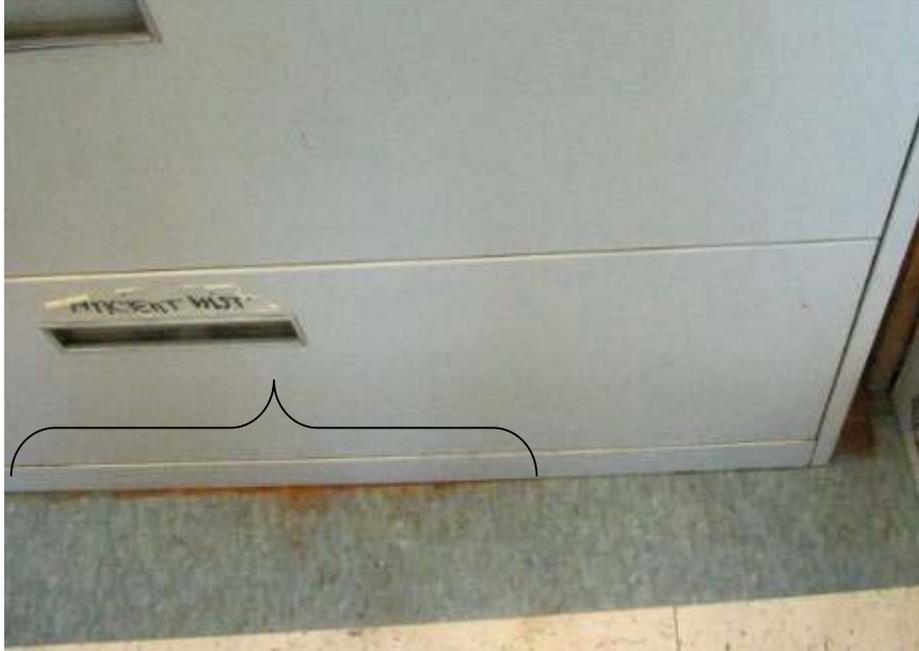
Picture 11

BEH staff observed rust stains around a file cabinet in classroom 1218 during the May 30, 2008 assessment (Picture 11). The classroom occupant reported that these stains were related to repeated water penetration from the exhaust vent. Water penetration through the exhaust vent duct work is an indication that the exhaust fan is no longer functioning and/or a breach in the roof membrane.

File cabinet blocked exhaust vent; rust staining along bottom/front of cabinet from water penetration through exhaust vent

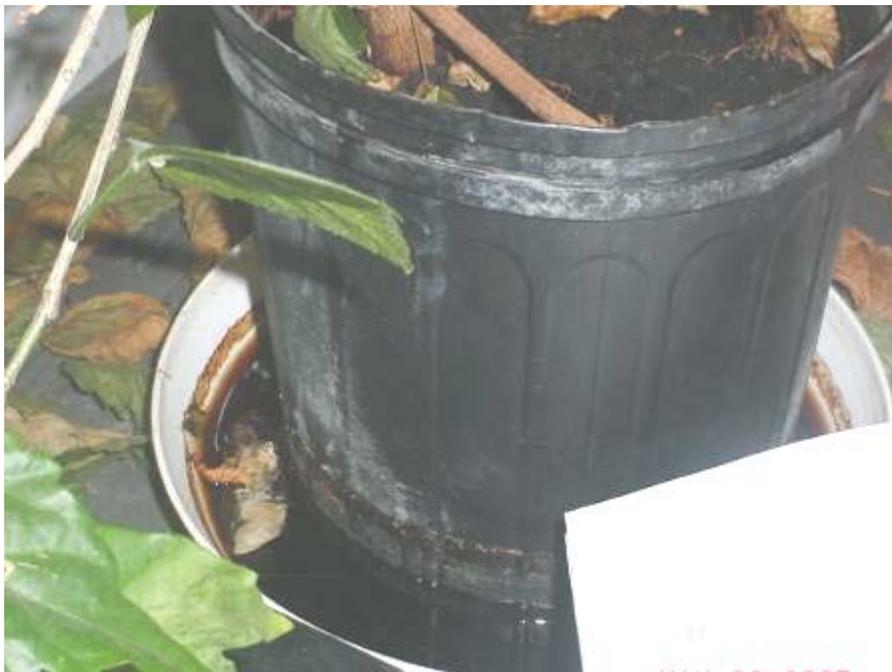
Picture 12

Several classrooms had a number of plants. Standing water was also noted in drip pans (Picture 12). Moistened plant soil and drip pans can be a source of mold growth. Plants should be equipped with drip pans; the lack of drip pans can lead to water pooling and mold growth on windowsills. Plants are also a source of pollen. Plants should be located away from the air

Standing water in drip pan

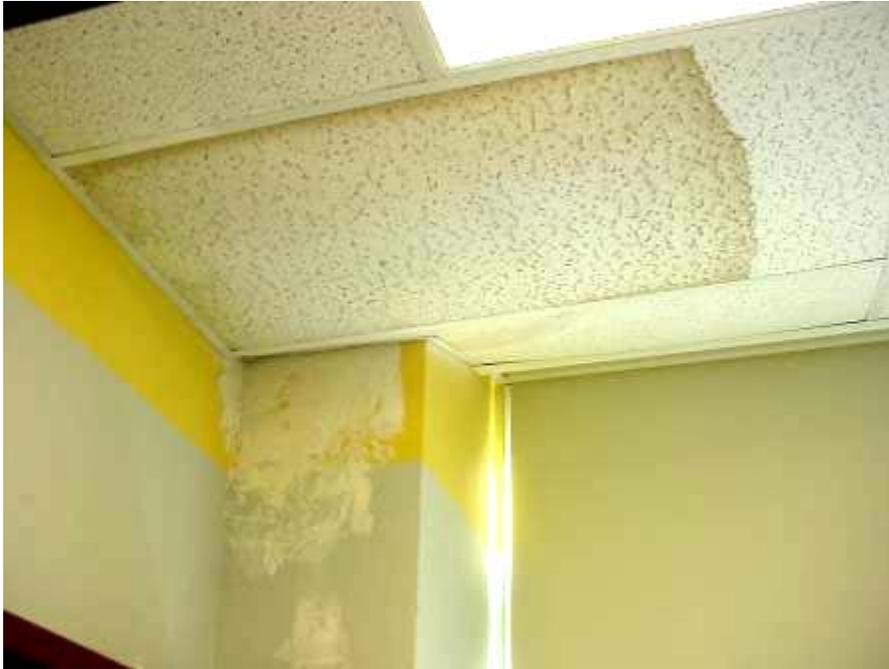
Picture 13

A number of classrooms had water-damaged/missing ceiling tiles which can indicate roof or plumbing leaks (Picture 13; Tables 1 and 2). Water-damaged ceiling tiles can provide a source for mold growth and should be replaced after a water leak is discovered and repaired.

Water-damaged ceiling tile and GW

15. Seal the hole in the exterior wall outside room 1205.
16. Ensure leaks are repaired and remove/replace water damaged ceiling tiles. Examine the areas above and around for mold growth. Disinfect areas of water leaks with an appropriate antimicrobial.

21. Replace missing/damaged ceiling tiles.

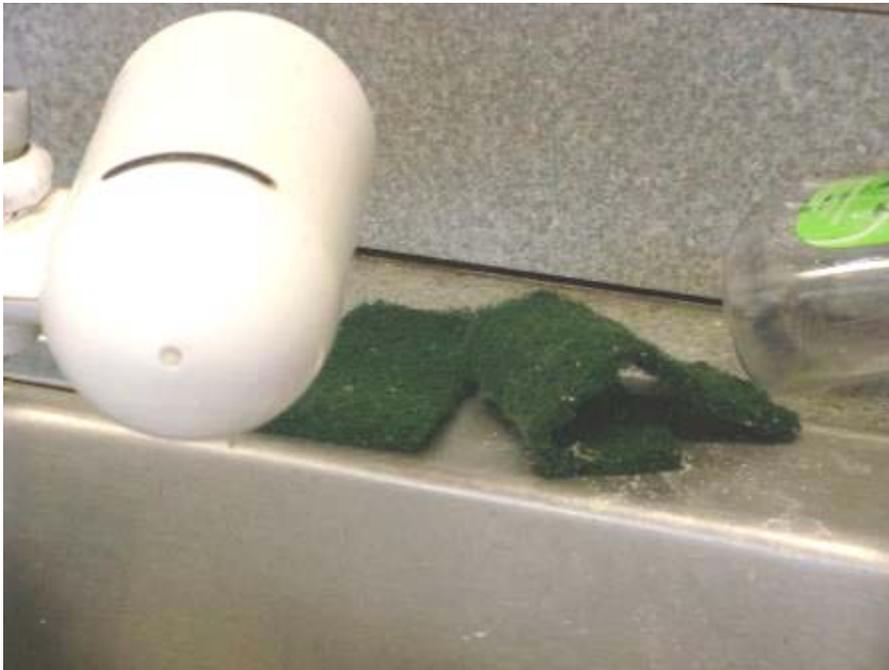
Picture 14

Breaches were observed between the counter and sink backsplashes in some classrooms (Tables 1 and 2). If not watertight, water can penetrate through these seams. Improper drainage or sink overflow can lead to water penetration into the countertop, cabinet interior and areas behind cabinets. Water penetration and chronic exposure of porous and wood-based materials can cause these materials to swell and show signs of water damage (Picture 14), which can subsequently lead to mold growth.

Breach between sink countertop and backsplash

20. Seal areas around sinks to prevent water damage to the interior of cabinets and adjacent wallboard. Inspect wallboard for water damage and mold growth, repair/replace as necessary. Disinfect areas with an appropriate antimicrobial, as needed.

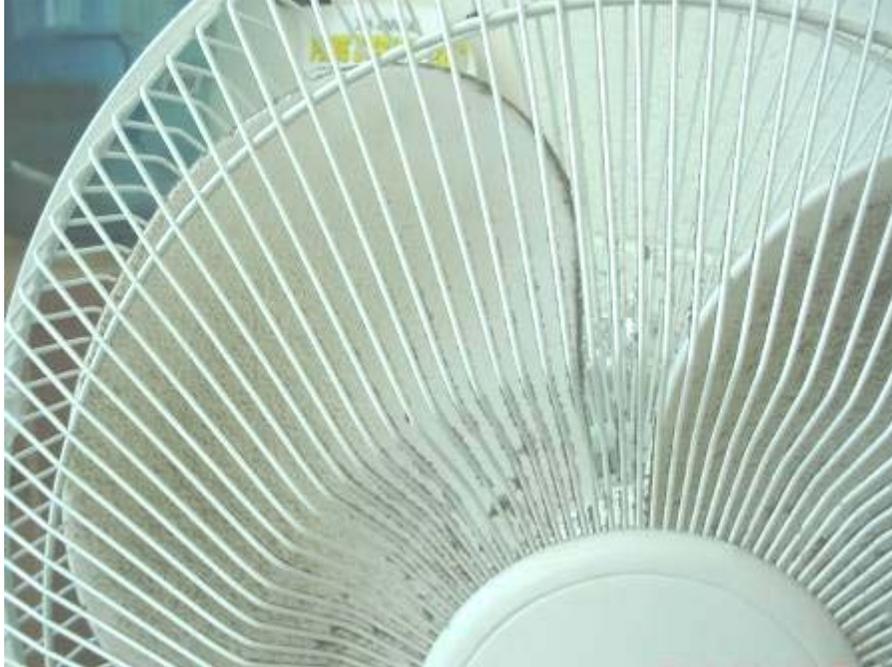
Picture 15

Several personal fans and return/exhaust vents were occluded with dust and debris (Pictures 15 and 16). Similarly, debris was observed in univent diffusers (Picture 17). Dust can be a source for eye and respiratory irritation. Re-activated univents personal fans can serve to distribute dust. If exhaust vents are not functioning, backdrafting can occur and aerosolize dust particles.

Fan blades/cage occluded with dust

26. Clean personal fans, univent air diffusers, return vents and exhaust vents periodically of accumulated dust.
27. Replace latex-based tennis balls with latex-free tennis balls or alternative glides.

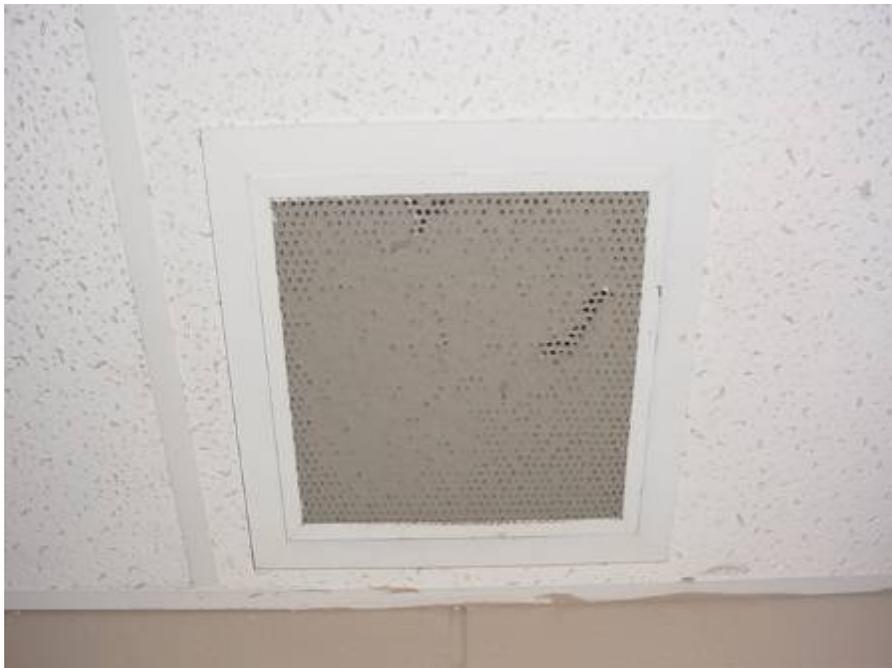
Picture 16

Exhaust vent occluded with dust

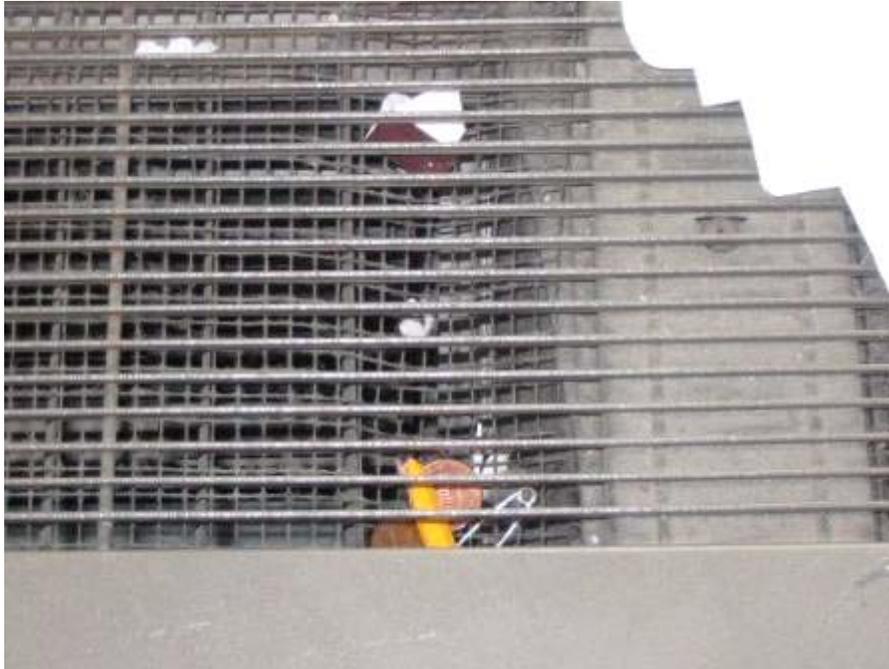
Picture 17

Debris in univalent diffuser

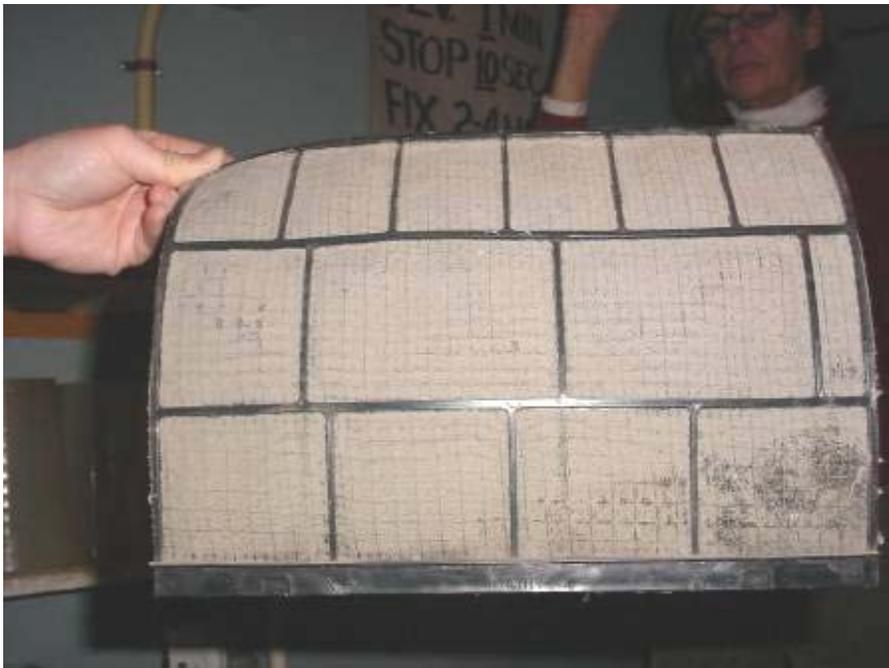
Picture 18

Window or wall-mounted air conditioners are located in a number of areas throughout the school. These units are equipped with filters. BEH staff observed the conditions of several filters and noted they were occluded with dust/debris (Picture 18). Filters should be cleaned or changed as per manufacturer's instructions to avoid the build-up and re-aerosolization of dirt, dust and particulate matter.

Air-conditioning filter occluded with dust/debris

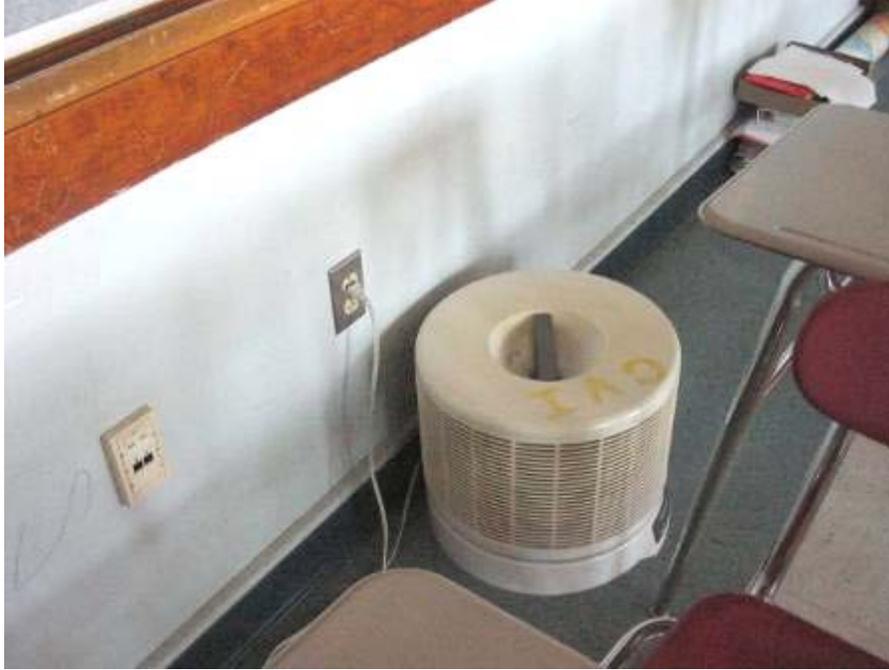
Picture 19

High efficiency particulate air (HEPA) purifiers were observed on the floor in several locations (Picture 19). Air purifiers should be placed within the breathing zone rather than at floor level. In addition, this equipment is normally equipped with filters that should be cleaned or changed as per manufacturer's instructions to prevent build up and re-aerosolization of dirt, dust and particulate matter.

HEPA filtered air purifier placed on the floor

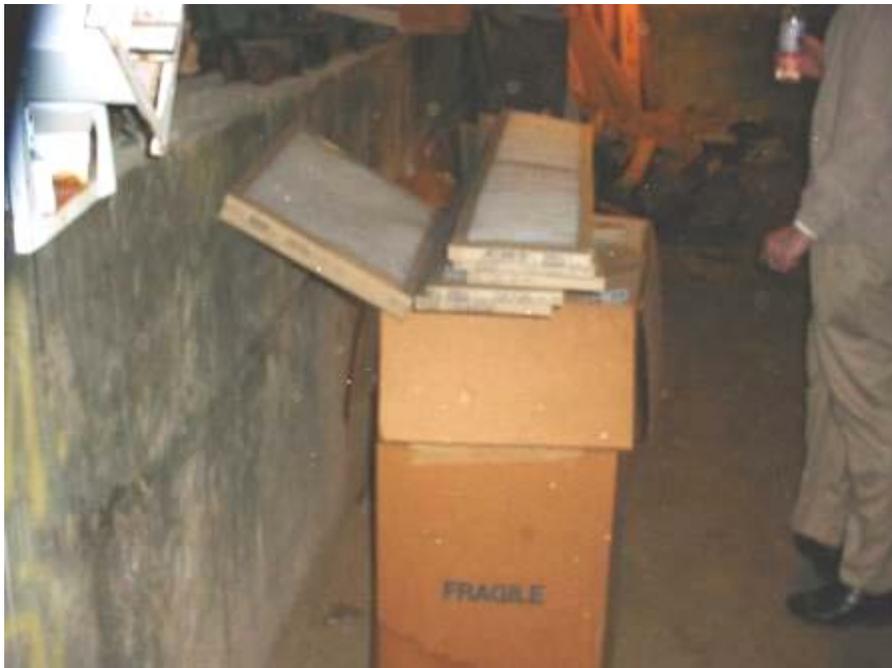
Picture 20

Open boxes of univent filters where found stored in the crawlspace

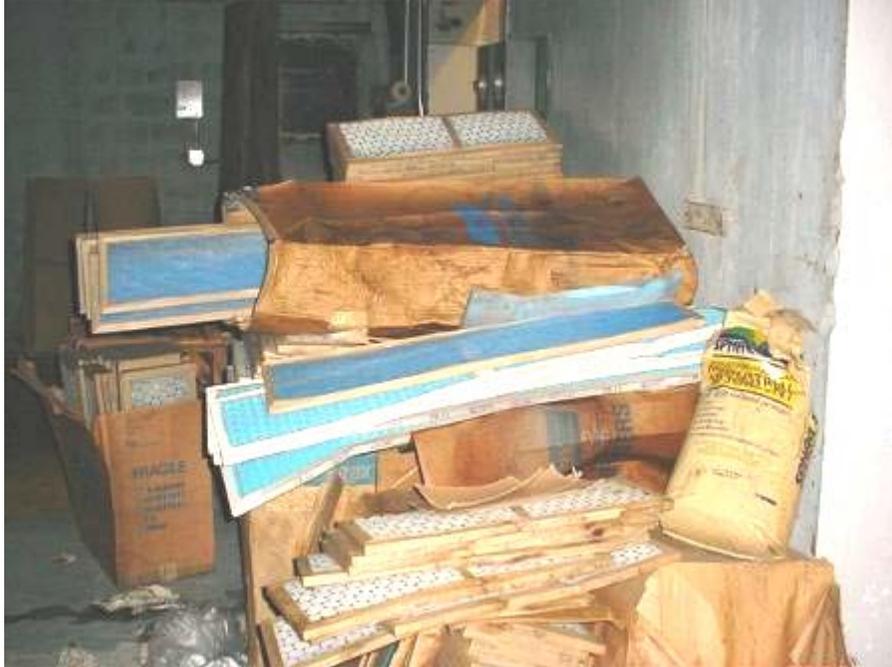
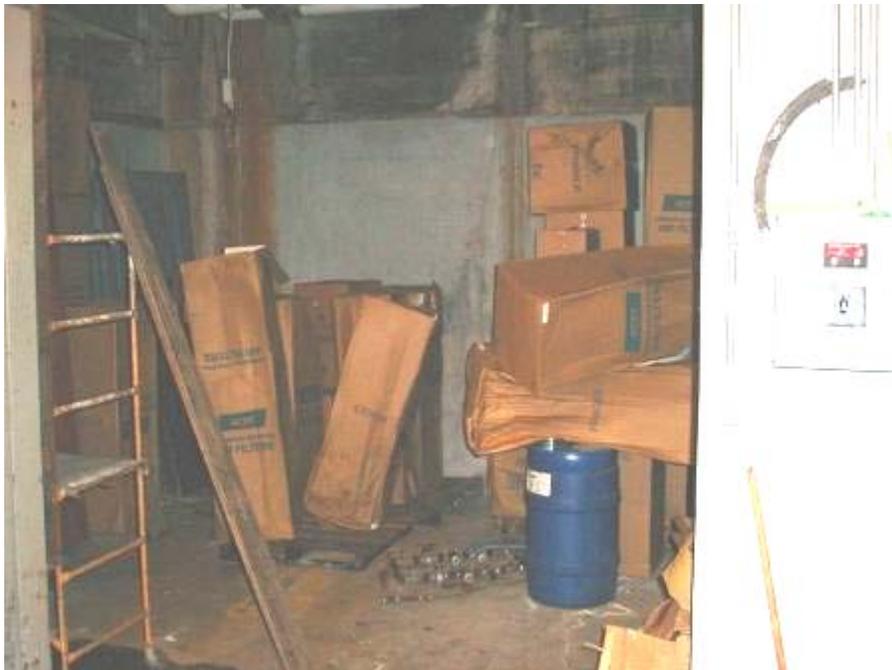
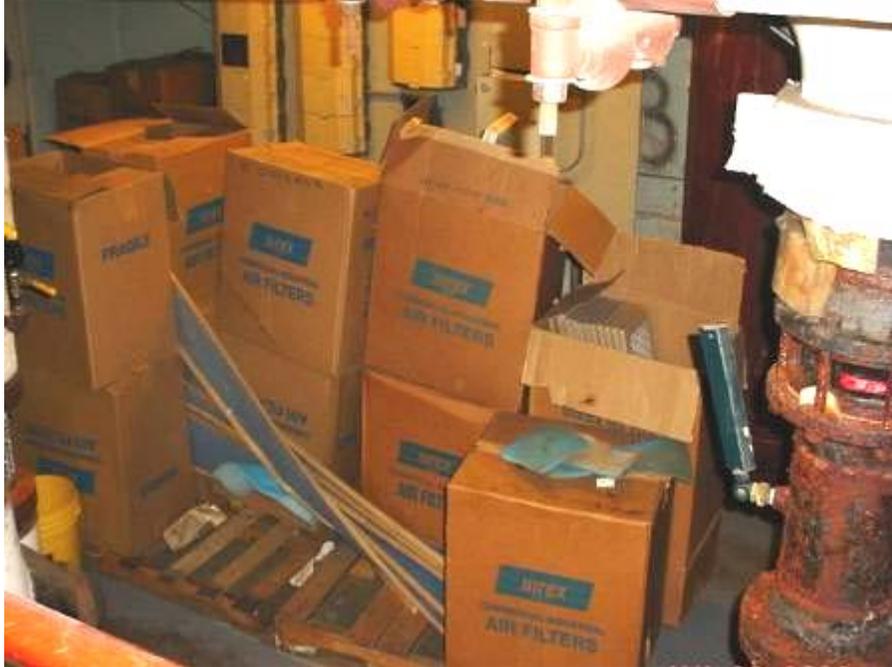
Univent filter storage

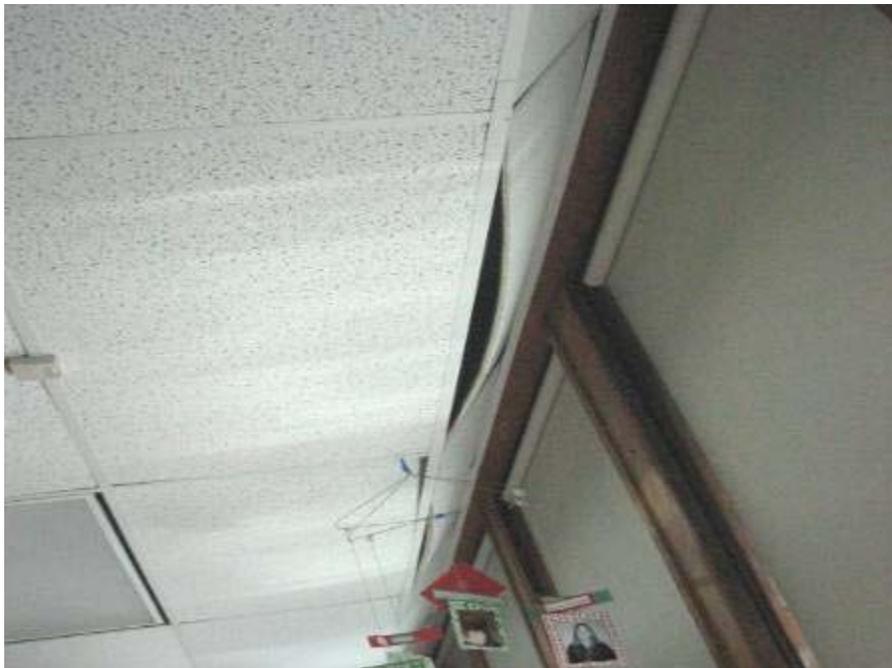
Picture 24

Missing/ajar ceiling tiles were observed in classrooms throughout the GHS (Picture 24). Missing/ajar ceiling tiles can provide pathways for materials (e.g., odors, dust, particulates) to migrate into occupied areas. Missing tiles should be replaced to maintain the integrity of the suspended ceiling tile system. Ceiling tiles should be flush with ceiling system to prevent such movement. Occupants should also refrain from hanging items from the ceiling tile systems to prevent potential pathways for materials into occupied areas.

Ajar ceiling tiles

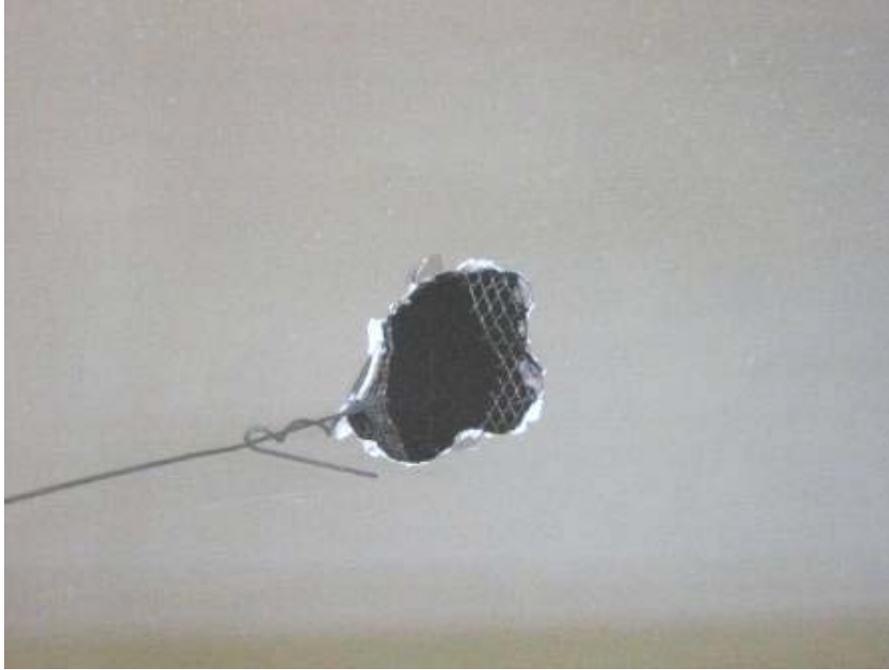
Picture 25

Similarly, utility holes were observed in a number of classrooms (Picture 25). Utility holes can also serve as pathways for odors/materials to migrate from floor/wall cavities into occupied areas and should be sealed.

Utility hole

22. Seal utility holes in classroom walls/floors.
23. Conduct a complete inventory of pottery glazes to ensure that all lead-containing glazes have been removed/replaced by lead-free products.

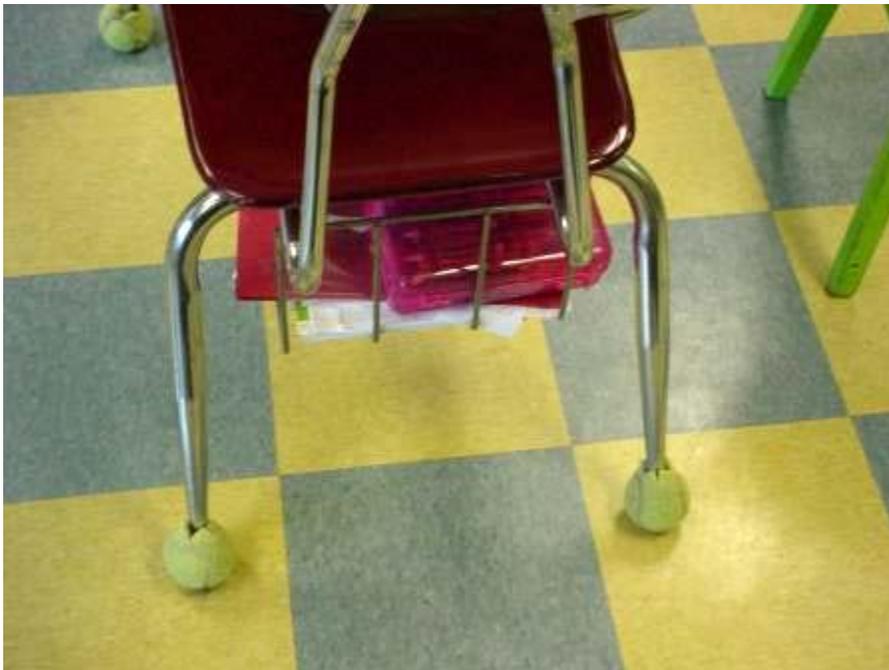
Picture 26

Lastly, BEH staff observed tennis balls that had been sliced open and placed on chair legs, in an effort to reduce noise from sliding chairs (Picture 26). Tennis balls are made of a number of materials that are a source of respiratory irritants. Constant wearing of tennis balls can produce fibers and off gas VOCs. Tennis balls are made with a natural rubber latex bladder, which becomes abraded when used as a chair leg pad. Use of tennis balls in this manner may introduce latex dust into the school environment. Some individuals are highly allergic to latex (e.g., spina bifida patients) (SBAA, 2001). It is recommended that the use of materials containing latex be limited in buildings to reduce the likelihood of symptoms in sensitive individuals (NIOSH, 1997). A question and answer sheet concerning latex allergy is attached as

Tennis balls on chair legs

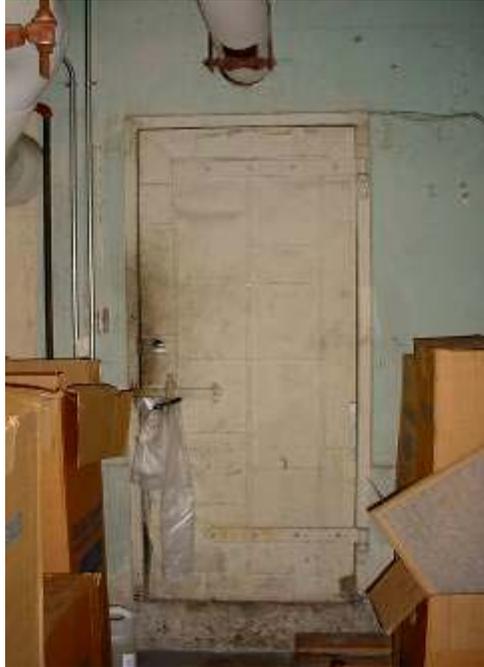
Picture 27

Main building crawlspace access door in boiler room

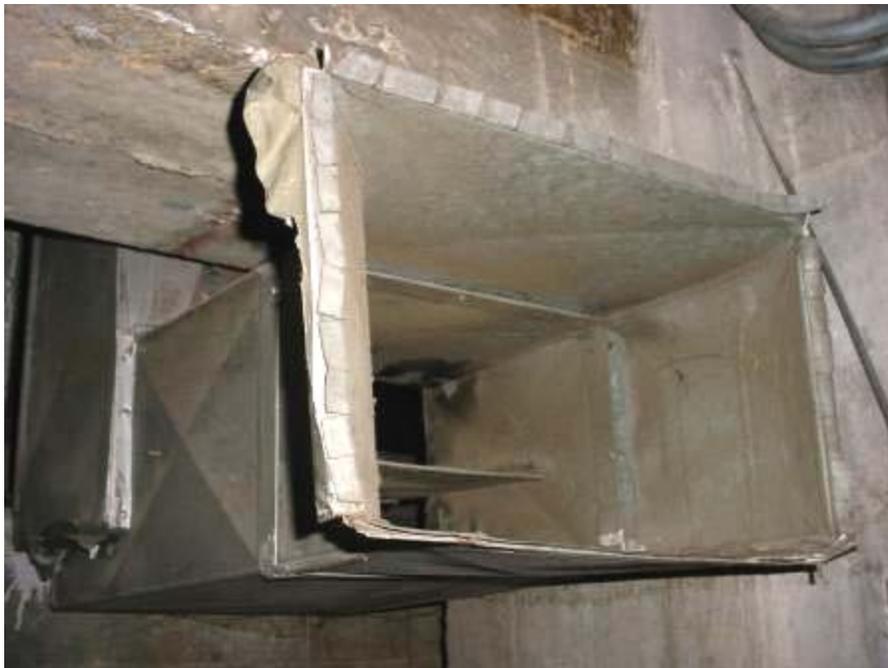
Picture 28

BEH staff also found ventilation ducts beneath the auditorium that were open to the crawlspace (Picture 28) and, in one instance, sealed with cardboard that had become dislodged (Picture 29). In addition, BEH staff examined univent interiors and observed spaces around heating and electrical conduits, (such as in Room 1205) (Picture 30). Breaches in the floor of univent cabinets can serve as pathways for crawlspace air to enter first floor classrooms.

Open duct in crawlspace beneath auditorium

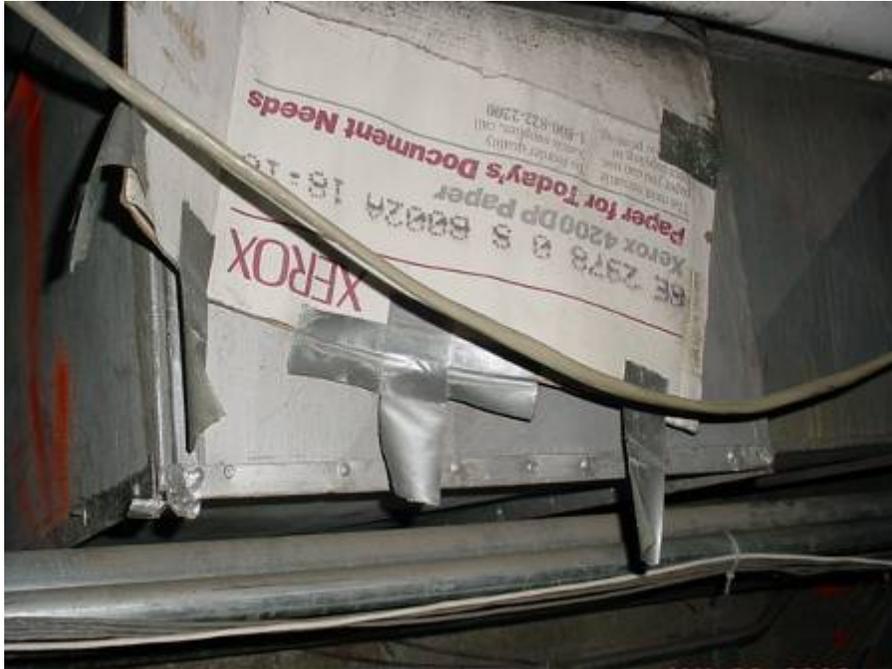
Picture 29

Cardboard used to seal duct in crawlspace beneath library

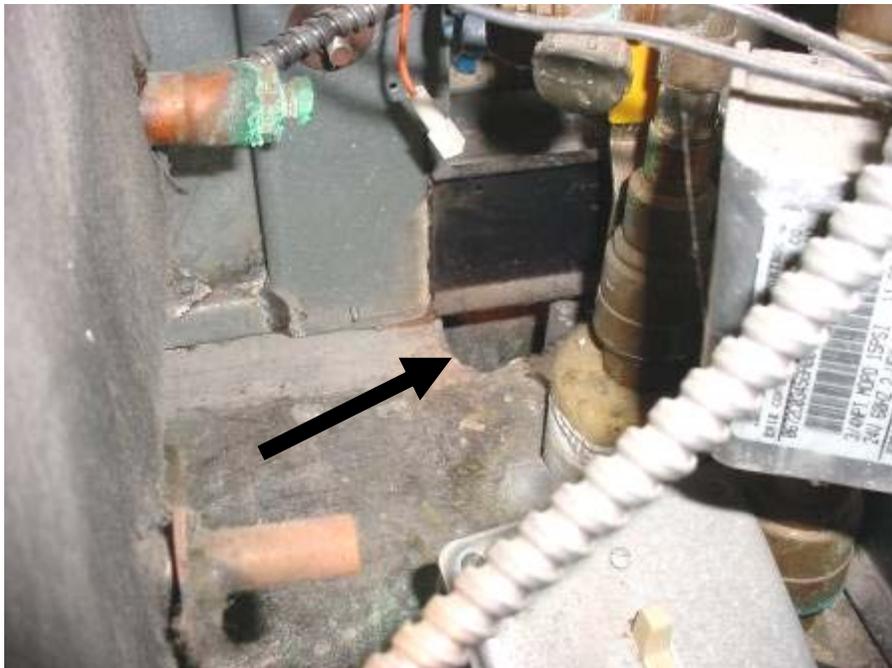
Picture 30

Of note is classroom 1205, where room occupants reported odors. BEH staff found aforementioned spaces in the floor of the univent cabinet through which the heating pipe and

electrical conduit pass (Picture 30). In this condition, crawlspace air is likely being drawn into the classroom via the univent. BEH staff also identified an opening in the exterior wall of GHS beneath Room 1205 (Picture 35). This opening may have been for a water spigot, which was likely removed during the renovations. Since the exterior wall of Room 1205 is facing southwest, it is likely that air is forced into this area of the crawlspace during windy conditions, which can then stir up dust and other pollutants to be captured by the univent through the hole in the floor. A number of abandoned pipes were found open in the crawlspace (Pictures 36 and 37). These open pipes can serve as a means for crawlspace pollutants into occupied areas. Dust, dirt and other particles commonly found in crawlspaces can serve as irritants to the eyes, nose and respiratory system.

Hole in floor of room 1205 univent

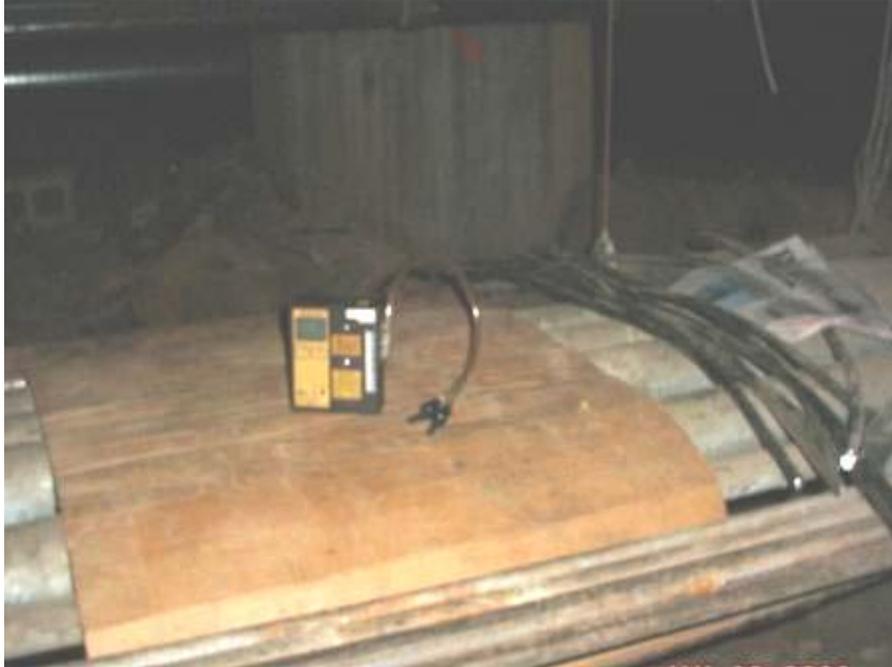
Picture 31

Rotometer in crawlspace beneath main hallway

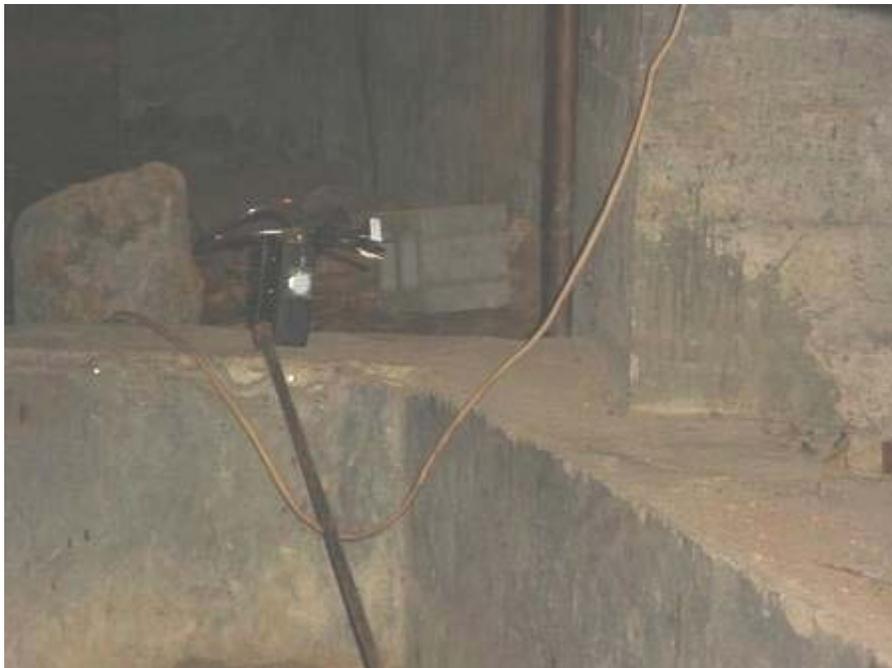
Picture 32

Rotometer near lowest point of crawlspace, main building

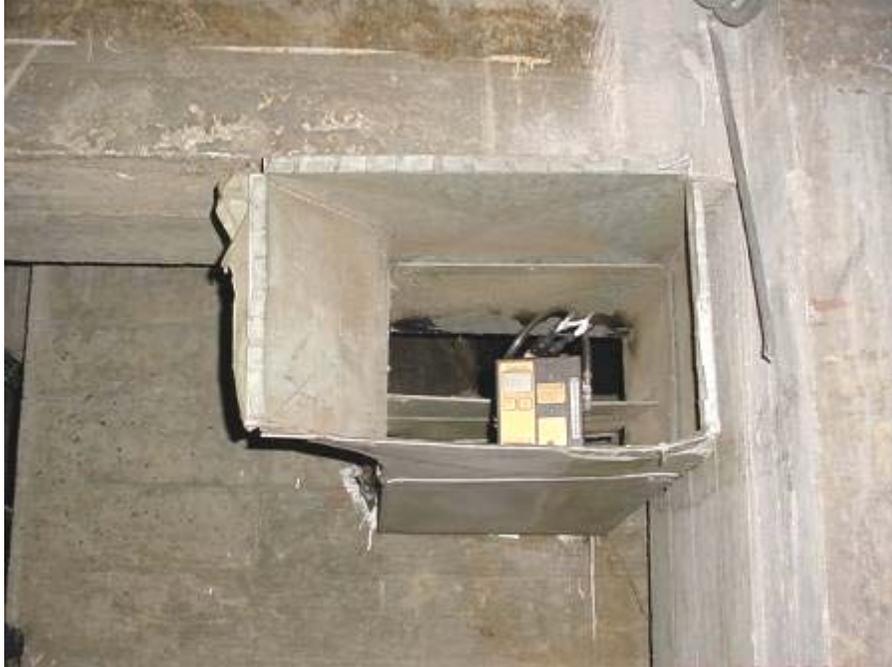
Picture 33

Rotometer in duct in crawlspace beneath auditorium

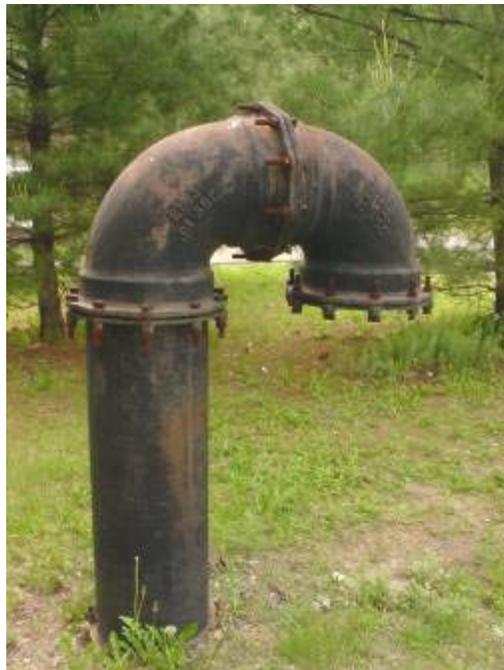
Picture 34

Crawlspace exhaust vent terminus
