INDOOR AIR QUALITY ASSESSMENT

**Gloucester High School
32 Leslie O. Johnson Rd
Gloucester, MA 01930**

Prepared by:
Massachusetts Department of Public Health
Bureau of Environmental Health
Indoor Air Quality Program
August 2008

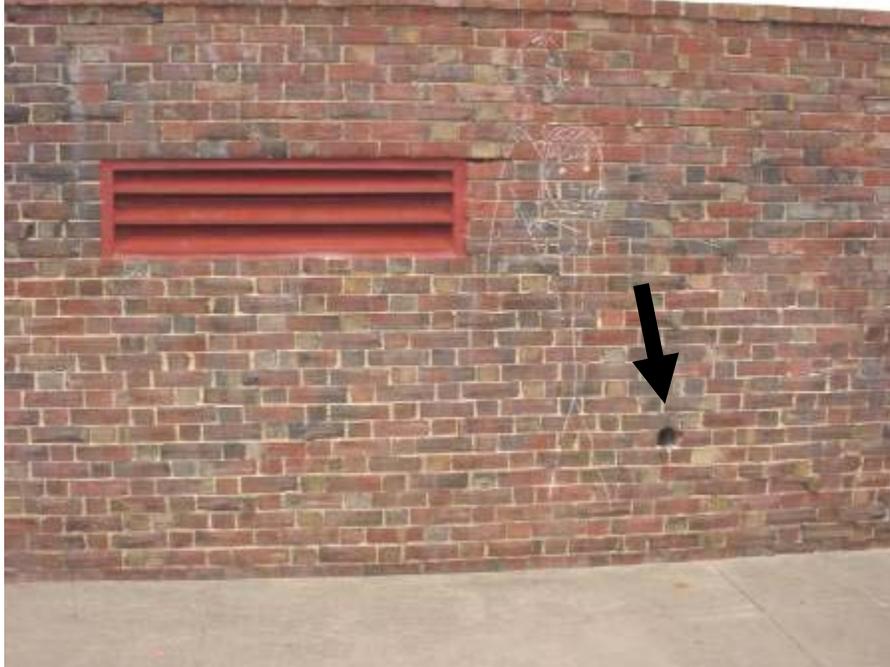
Picture 35

electrical conduit pass (Picture 30). In this condition, crawlspace air is likely being drawn into the classroom via the univent. BEH staff also identified an opening in the exterior wall of GHS beneath Room 1205 (Picture 35). This opening may have been for a water spigot, which was likely removed during the renovations. Since the exterior wall of Room 1205 is facing southwest, it is likely that air is forced into this area of the crawlspace during windy conditions, which can then stir up dust and other pollutants to be captured by the univent through the hole in the floor. A number of abandoned pipes were found open in the crawlspace (Pictures 36 and 37). These open pipes can serve as a means for crawlspace pollutants into occupied areas. Dust, dirt and other particles commonly found in crawlspaces can serve as irritants to the eyes, nose and respiratory system.

Open hole in exterior wall outside room 1205

15. Seal the hole in the exterior wall outside room 1205.
16. Ensure leaks are repaired and remove/replace water damaged ceiling tiles. Examine the areas above and around for mold growth. Disinfect areas of water leaks with an appropriate antimicrobial.

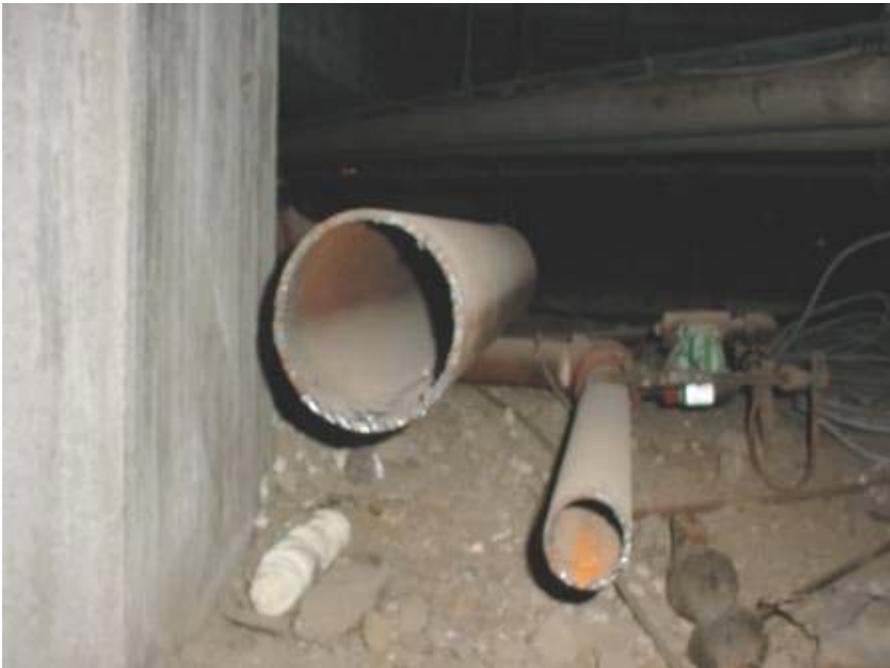
Picture 36

Open pipe in crawlspace

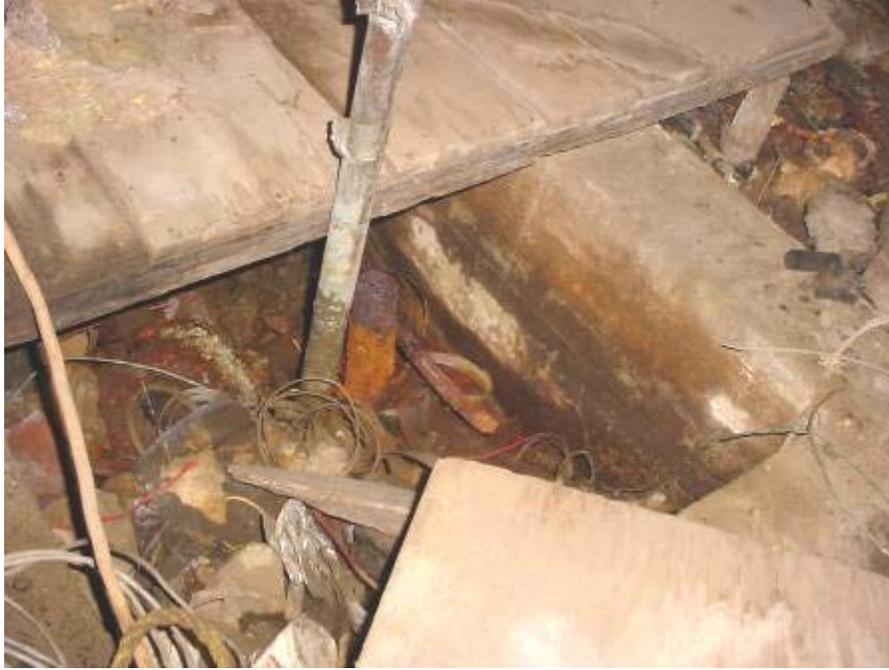
Picture 37

Open pipe in crawlspace

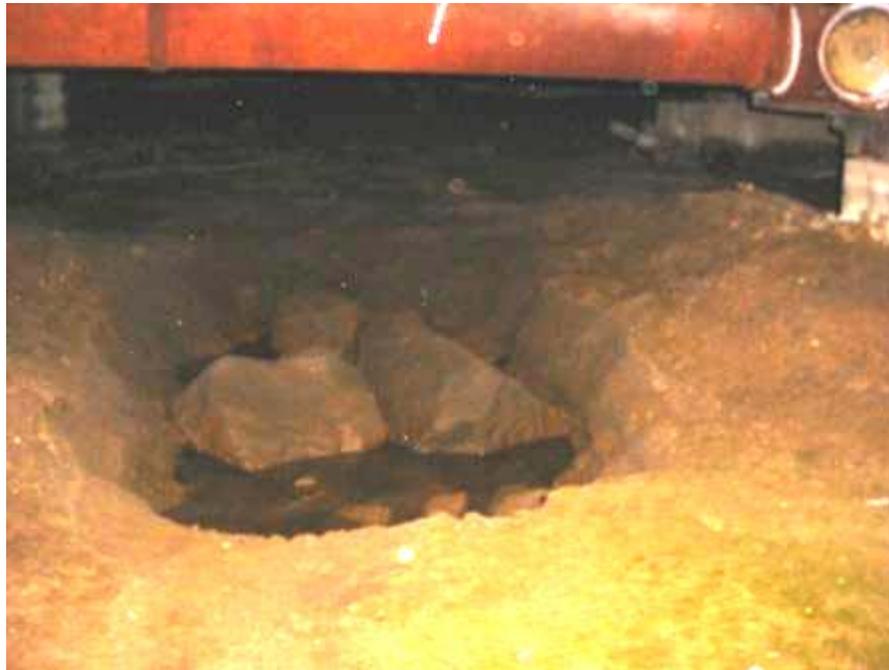
Picture 38

The crawlspace of the science wing is separate from the main building and appears to be subject to chronic water infiltration, as evidenced by the existence of pooling water (Picture 38). The likely source of water infiltration is along the north and west walls due to the topography surrounding the science wing. A substantial rock outcropping/hillock is located along the north and west walls of the science wing (Map 1). In addition, a tarmac driveway exists uphill to the northeast of the science wing. The outcropping/hillock tends to direct rainwater toward the science wing, as evidenced by marshy ground along the west wall of the science wing (Picture 39). The driveway directs runoff to the rear of the building (Picture 40), which under certain circumstances can enter the building through the rear door and floods a significant portion of the first floor. Sand deposition on the floor of the science wing north stairwell floor (Picture 41) and water damage to hallway walls confirm this observation. Of note is the apparent lack of a

Pool of water in crawlspace beneath science wing

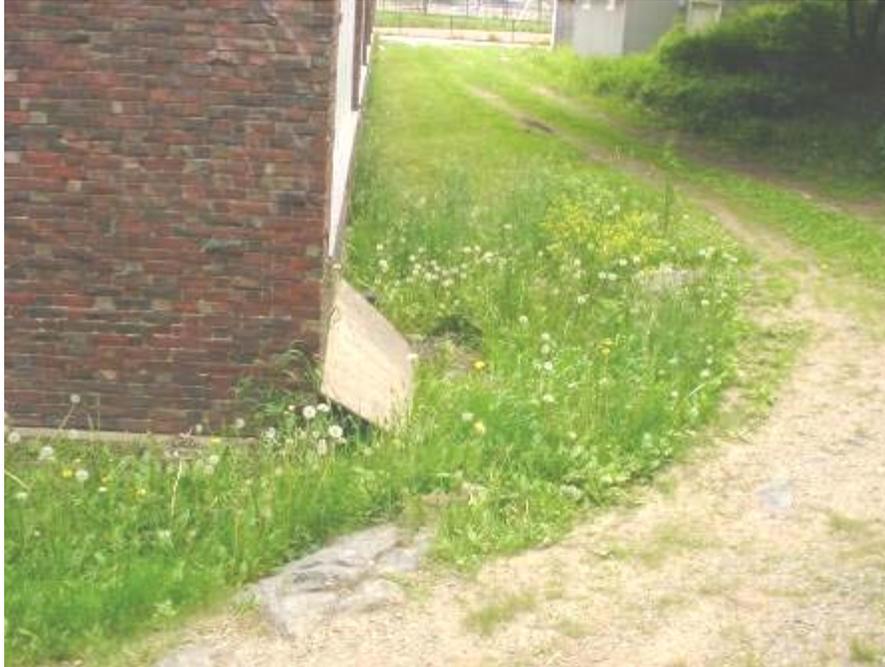
Picture 39

Marshy ground along the west wall of the science wing

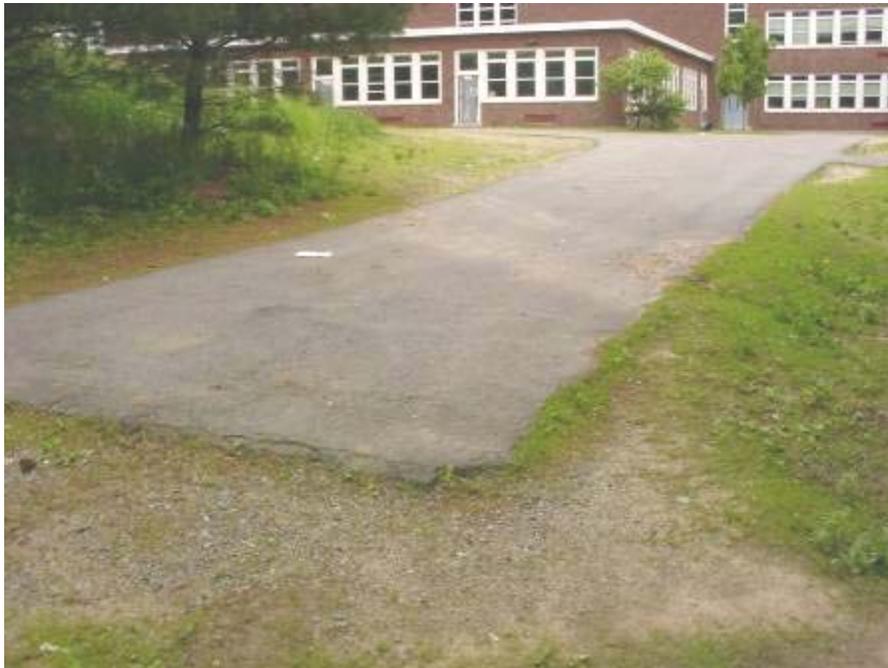
Picture 40

Driveway behind science wing sloped toward rear door

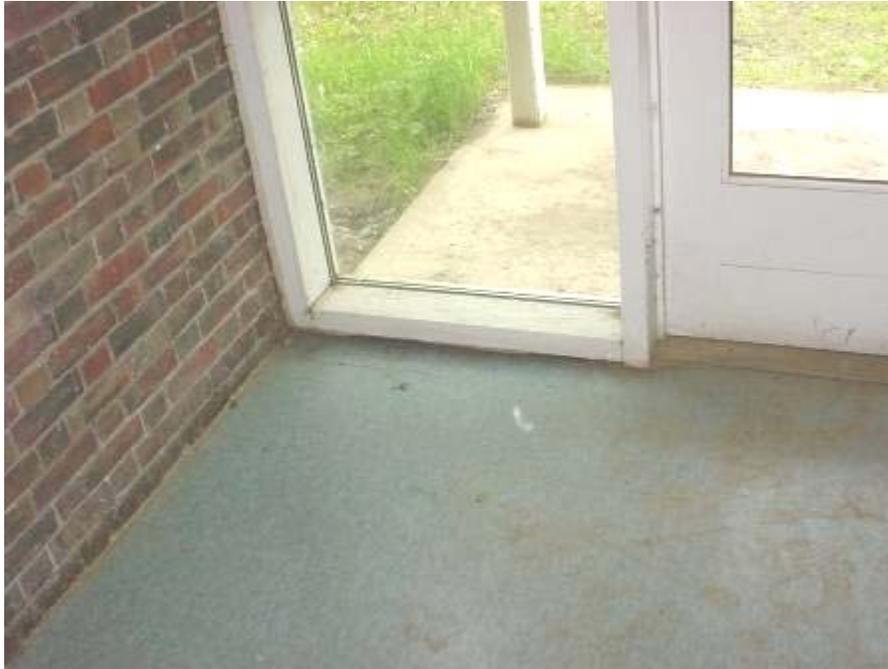
Picture 41

Sand deposition in north staircase floor of science wing

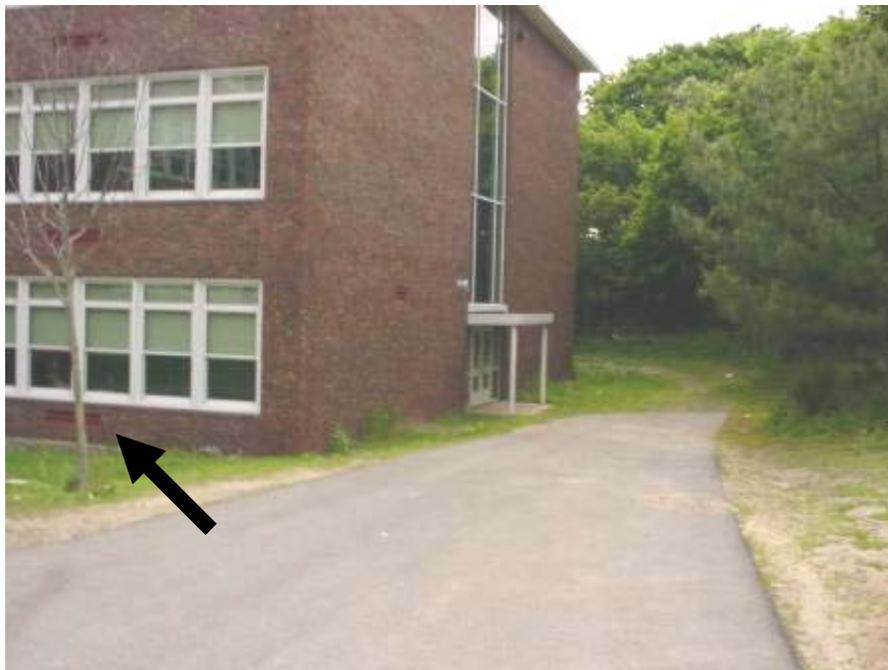
Picture 42

foundation drain system around the north or west wall of the science wing. The ground of the east wall of the science wing is lined with crushed rock (Picture 42), which can indicate the existence of a French drain, which would redirect water away from the foundation wall. No such structure could be identified for both the north and west walls of the science wing.

**Crawlspace exhaust vent termini occluded with debris,
Note no crushed rock at rear of building**

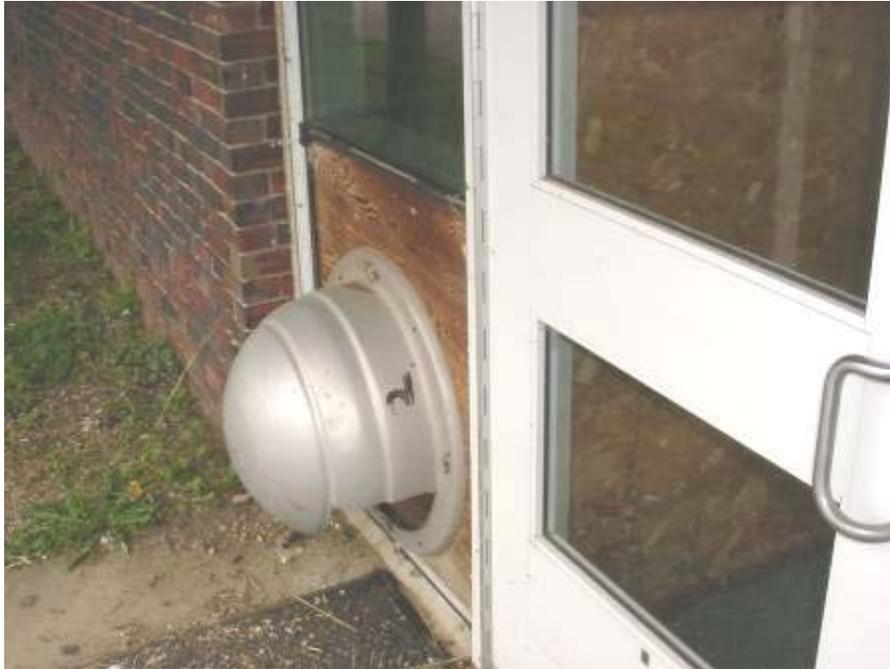
Picture 43

Science wing crawlspace exhaust fan

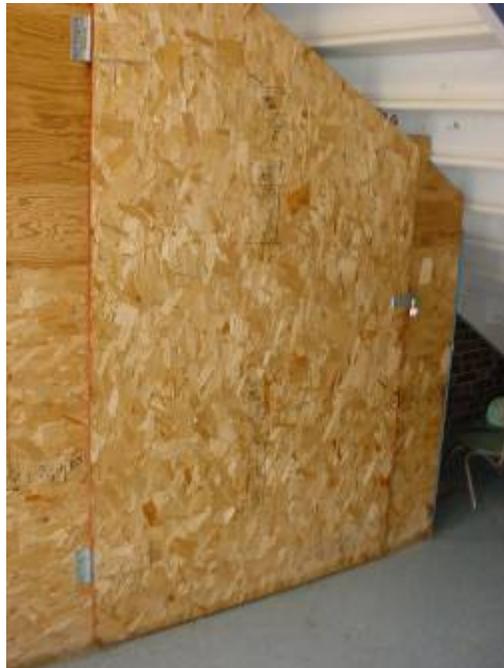
Picture 44

Plywood barrier beneath the science wing south stairwell

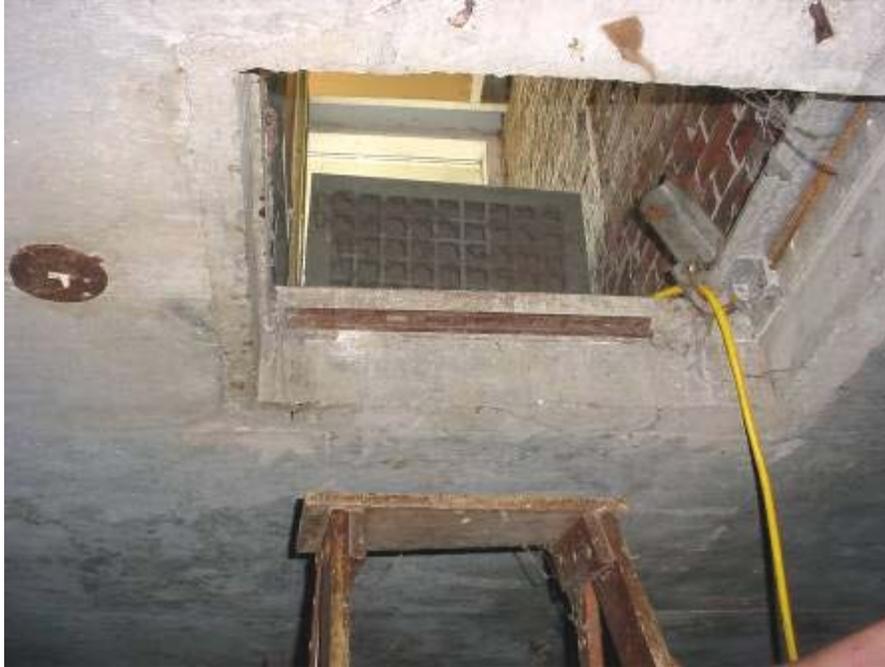
Picture 45

Crawlspace air is drawn through open hatch, into space behind the plywood wall in Picture 24, Note debris accumulation on grill of vent

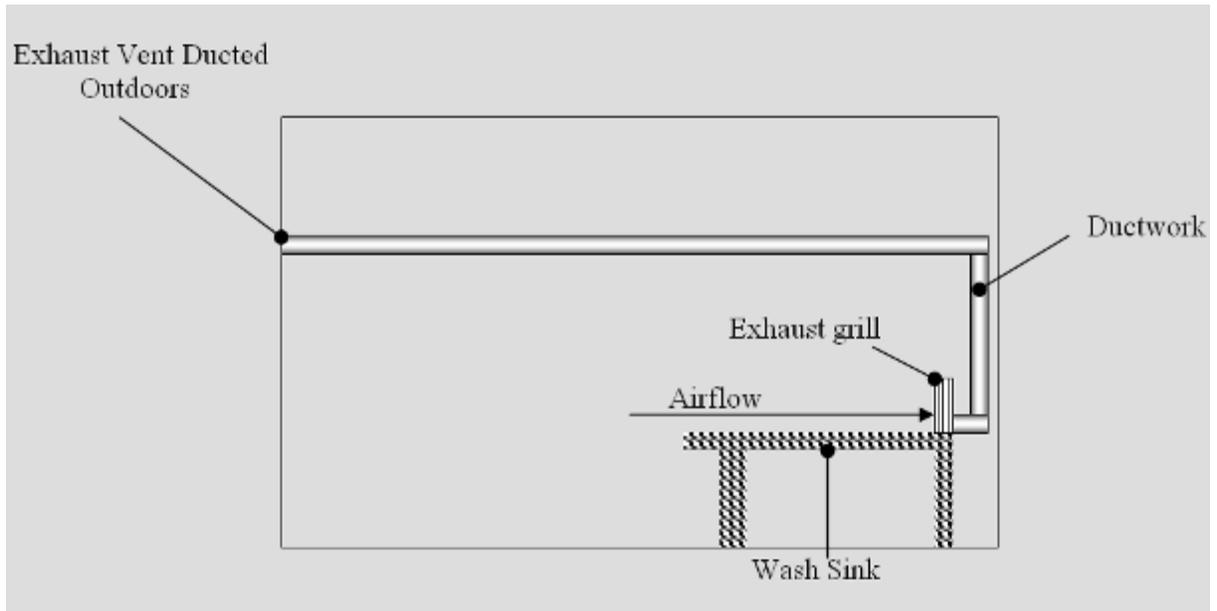
Figure 2

The odor of photograph developing chemicals was noted in the classroom outside the darkroom. A number of photographic chemicals were observed in the darkroom, an area with either non-functional or poorly functioning exhaust ventilation. In addition, local exhaust vents should be located at the level of the wash sink and developing pans to draw odors away from

Suggested Reconfiguration of Dark Room Exhaust Ventilation

4. Improve ventilation to remove photography developing chemical odors from building; examine and make repairs/adjustments to the ventilation system as necessary. An automatic rather than a manually operated ventilation system should be considered.
