INDOOR AIR QUALITY ASSESSMENT

**Ventress Memorial Library
Library Plaza
Marshfield, Massachusetts**

Prepared by:
Massachusetts Department of Public Health
Bureau of Environmental Health
Indoor Air Quality Program
June 2008

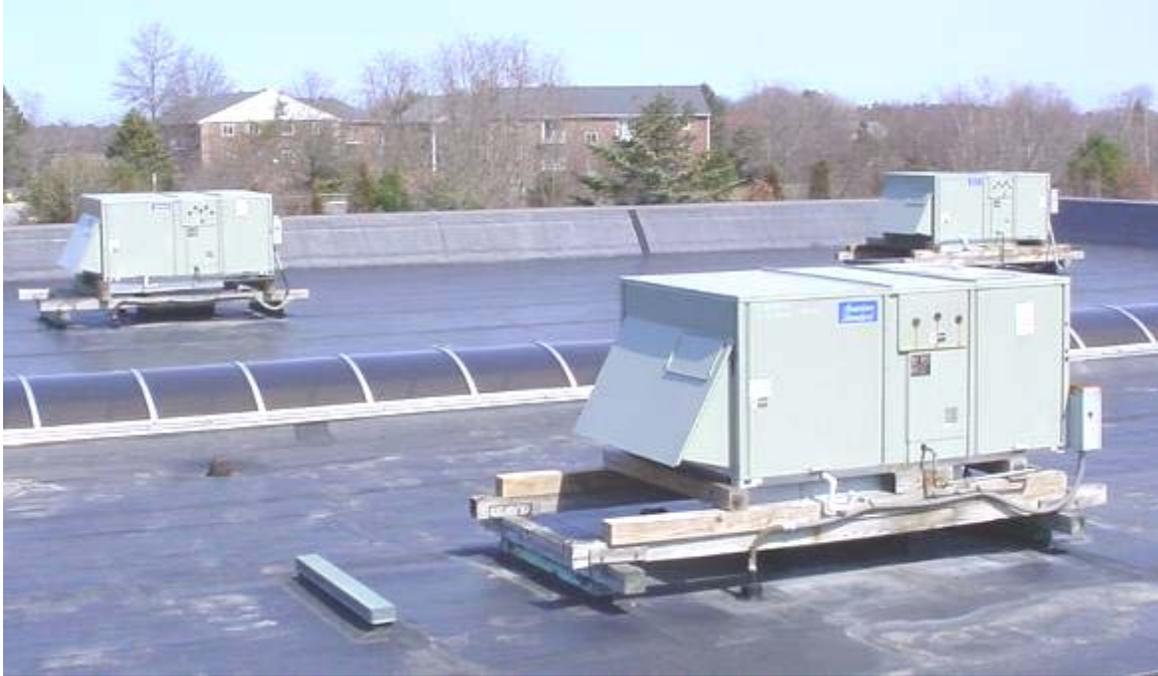
Picture 1

It can be seen from Table 1 that carbon dioxide levels were below 800 parts per million (ppm) in all areas surveyed, indicating adequate air exchange at the time of the assessment. Mechanical ventilation is provided by air handling units (AHUs) located on the roof (Picture 1). Outside air is heated or cooled and distributed to occupied areas via ceiling-mounted air diffusers (Picture 2); the supply vent in the meeting room was missing its diffuser (Picture 3). Return air is drawn into ceiling-mounted vents and ducted back to the AHUs (Picture 4). Thermostats control each AHU, which were set to the fan “auto” setting which deactivates the HVAC system

Rooftop AHUs

1. Continue with plans for roof replacement.
2. Operate the HVAC system continuously in the fan “on” mode during periods of occupancy to maximize air exchange.

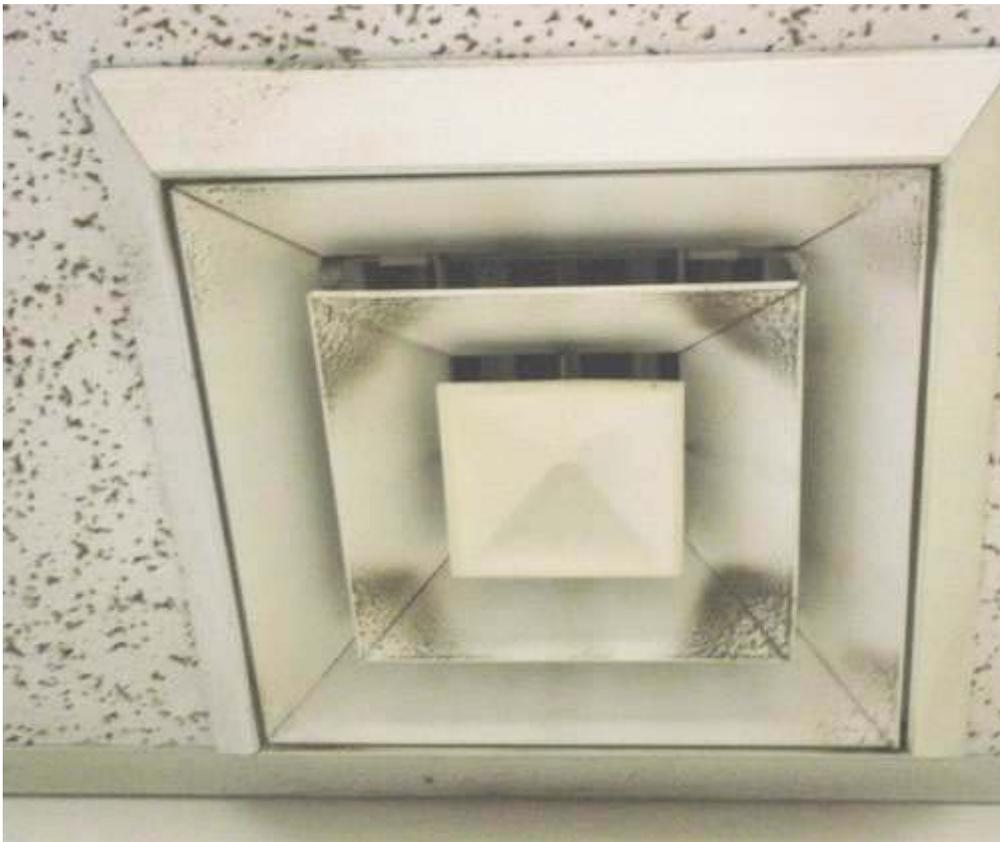
Picture 2

Finally, a number of supply diffusers, return vents and adjacent ceiling tiles were observed to have accumulated dust/debris (Pictures 2, 4, & 24). Dusts can provide a source of eye and respiratory irritation and provide a source of mold growth, especially if moistened repeatedly.

Supply Diffuser, Note Dust/Debris Accumulation on Surface of Louvers

17. Clean air diffusers, exhaust, return vents and adjacent ceiling tiles periodically of accumulated dust. If soiled ceiling tiles cannot be cleaned, replace.

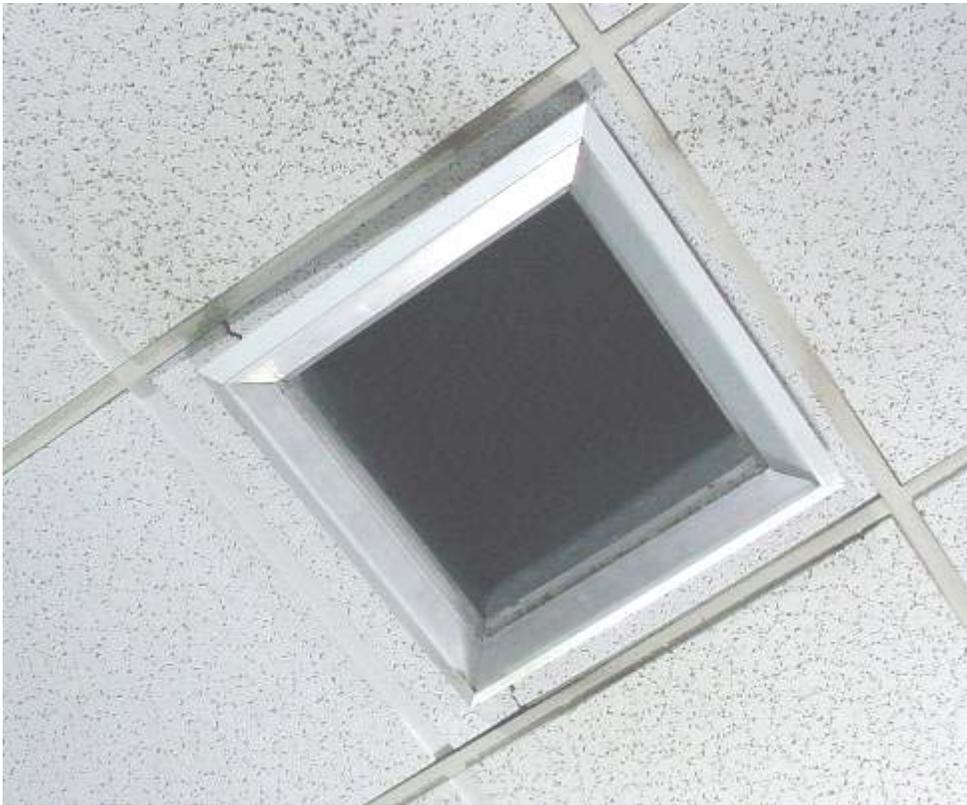
Picture 3

Supply Vent Missing Diffuser in Meeting Room

3. Consult the buildings’ heating, ventilation and air conditioning (HVAC) vendor concerning temperature control issues in the conference room.
4. Replace missing supply diffuser in meeting room.

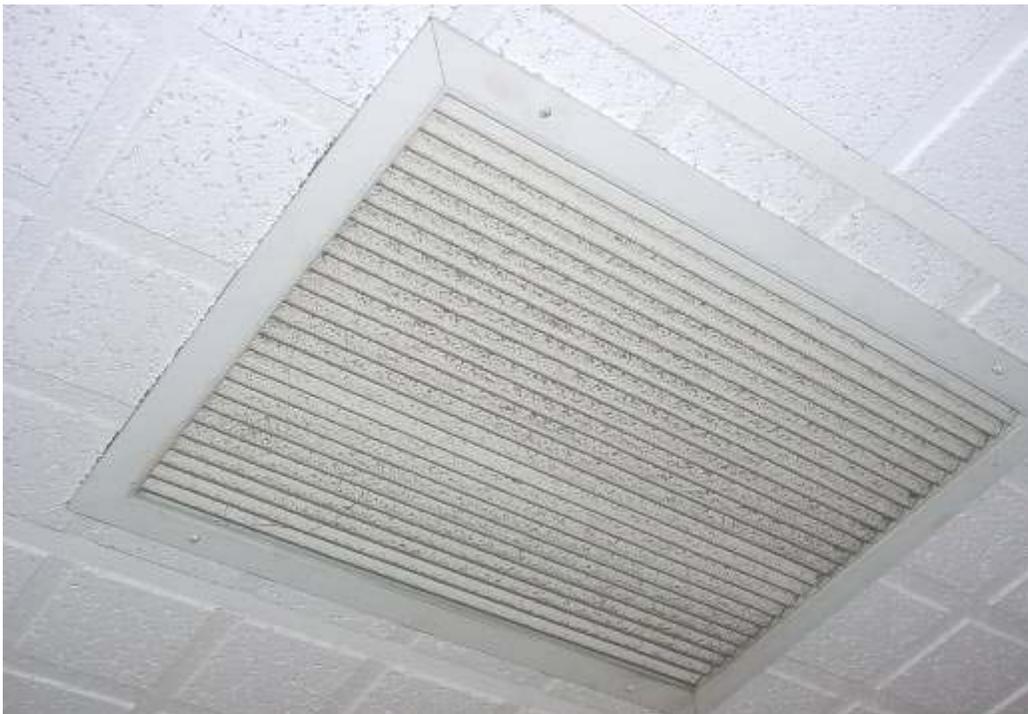
Picture 4

Return Vent, Note Dust/Debris Accumulation on Surface of Louvers

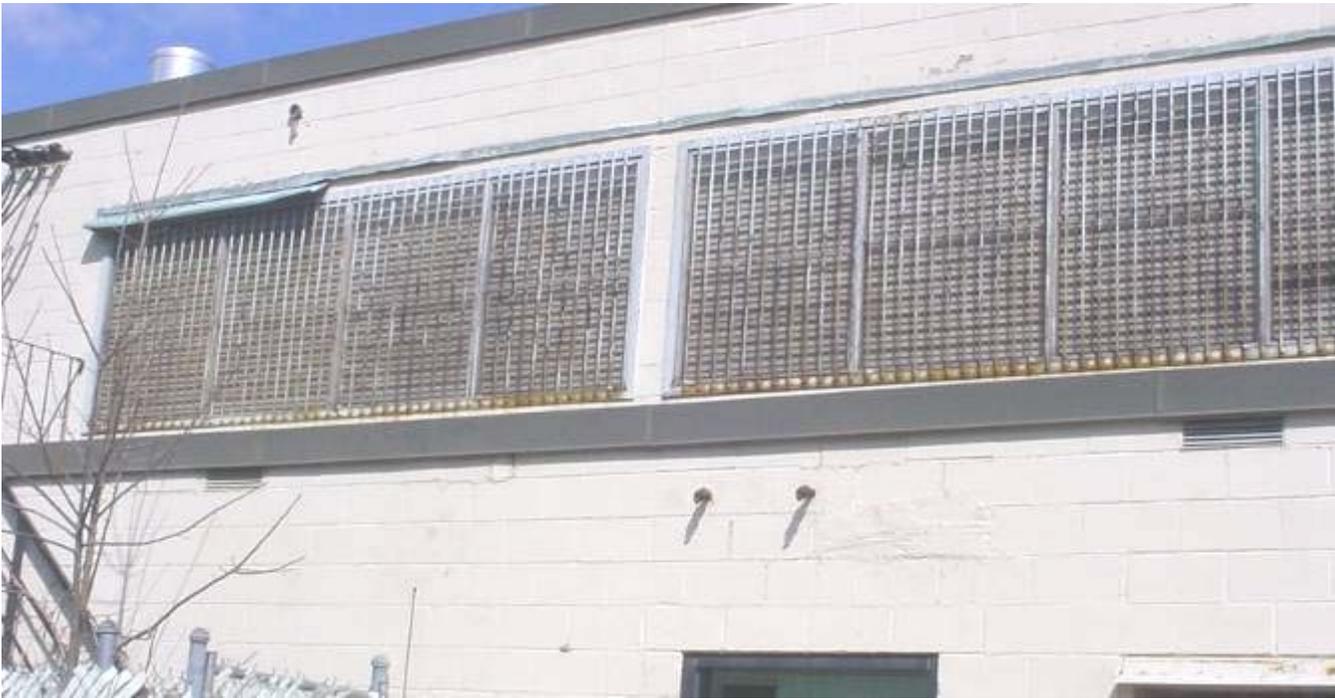
Picture 5

Passive Attic Vents

5. Reseal passive attic vents to prevent drafts, water penetration and pest entry.
6. Consider adopting a balancing schedule of every 5 years for all mechanical ventilation systems, as recommended by ventilation industrial standards (SMACNA, 1994).

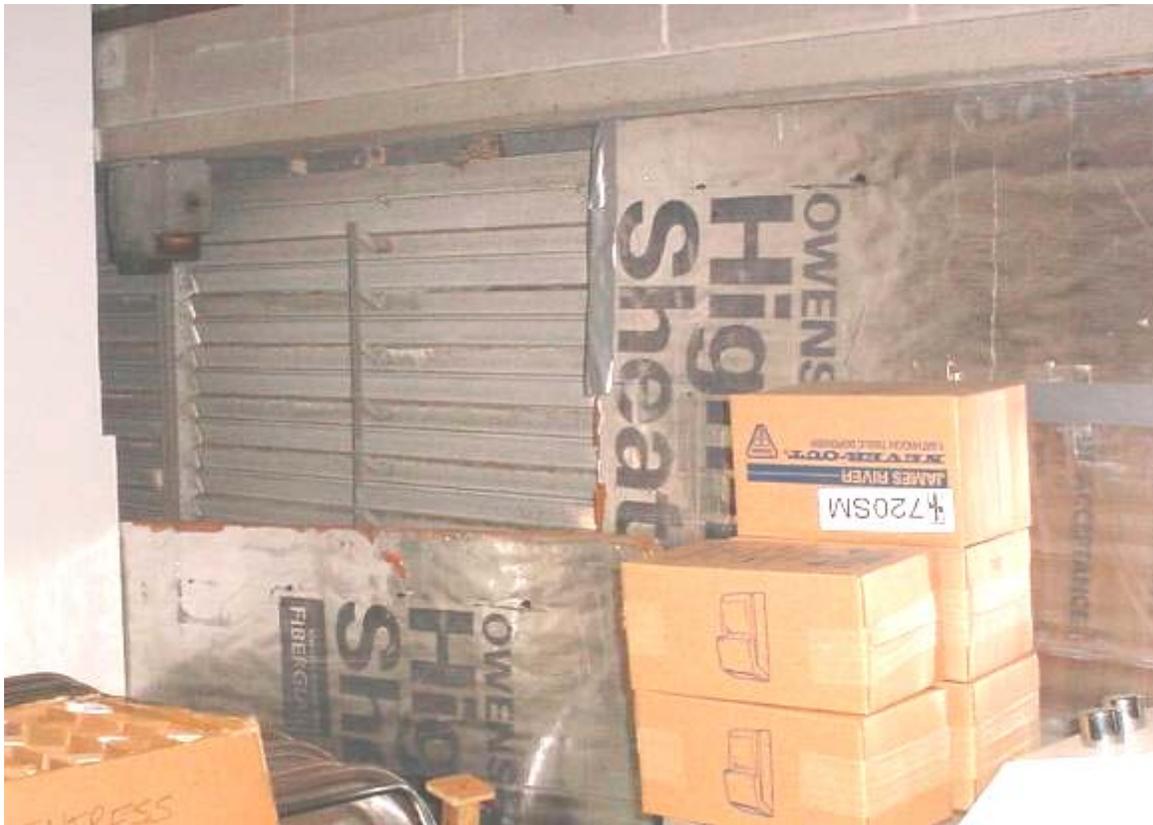
Picture 6

Temperature measurements ranged from 71° F to 77° F, which were within the MDPH recommended comfort guidelines on the day of the assessment (Table 1). The MDPH recommends that indoor air temperatures be maintained in a range of 70° F to 78° F in order to provide for the comfort of building occupants. Temperature control complaints (excessive heat) were reported in the conference room. In many cases concerning indoor air quality, fluctuations of temperature in occupied spaces are typically experienced, even in a building with an adequate fresh air supply. In an effort to seal drafts in the attic, insulation boards were installed over large passive vents that served to ventilate the former supermarket (Pictures 5 and 6). However several of the insulation boards have subsequently fallen off, allowing the uncontrolled introduction of un-tempered outside air.

Passive Attic Vents Sealed with Insulation Boards, Note Missing Board Top/Left

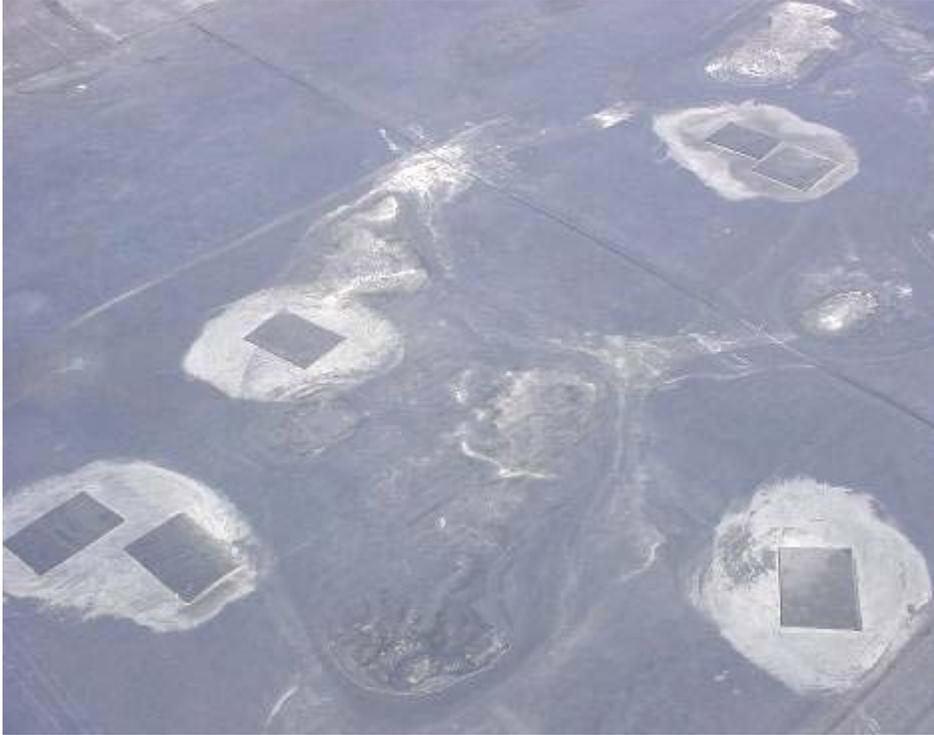
Picture 7

As previously discussed, the VML has a history of chronic roof leaks. Ms. Riboldi, reported that the town of Marshfield was currently accepting bids to have the roof replaced, with work was tentatively scheduled for the end of April 2008. In the interim, attempts reportedly continue to be made to temporarily repair the roof by patching (Pictures 7 through 9). MDPH staff examined the roof and found the roof surface to be rippled and bulging in various areas. These defects can eventually result in further damage to the roof membrane and create breaches in the building envelope enhancing water penetration into the building. Note: Ms. Riboldi reported that the administrative office has had no further leaks since roof repairs were implemented.

Numerous Patches Observed on Roof

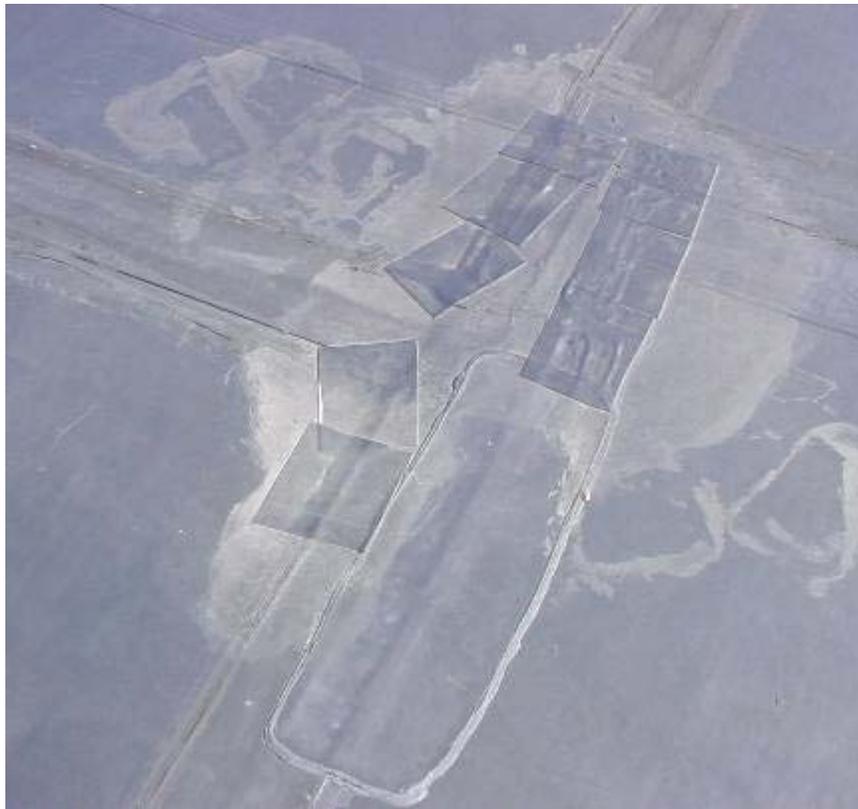
Picture 8

Numerous Patches Observed on Roof

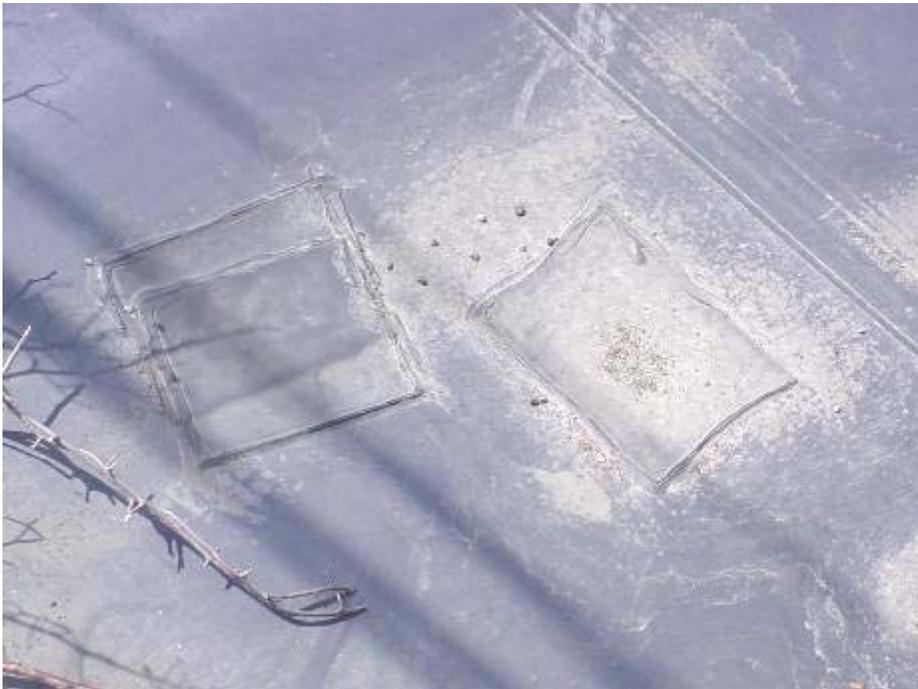
Picture 9

Patches Observed on Roof

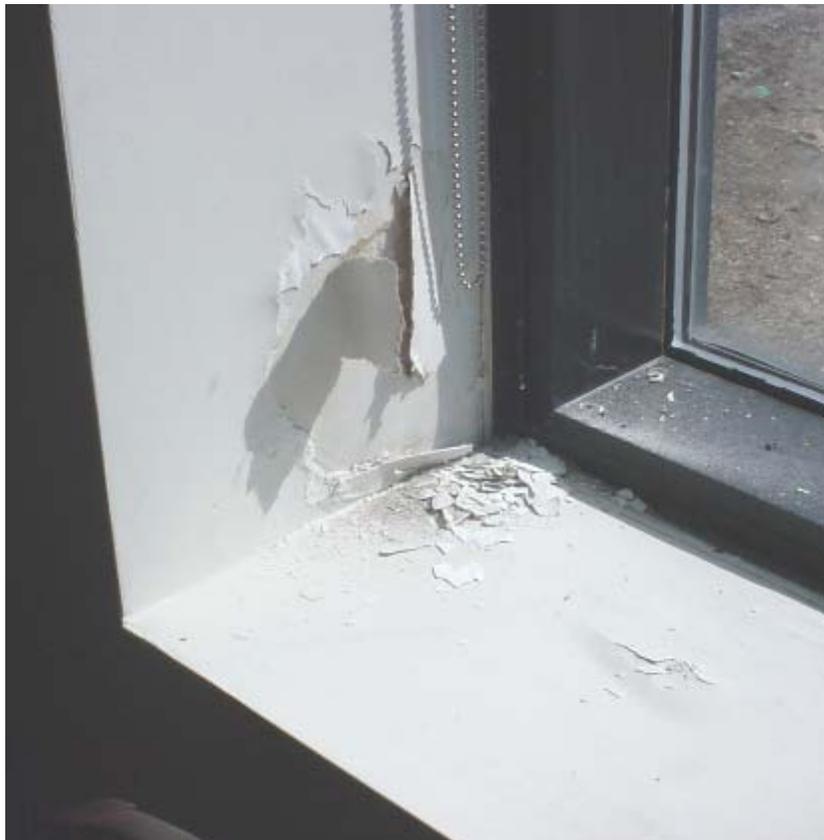
Picture 10

Of note was water damaged plaster and efflorescence along the window in the history room (Pictures 10 and 11) and meeting room (Pictures 12 through 14). Efflorescence is a characteristic sign of water damage, but it is not mold growth. As moisture penetrates and works its way through porous building materials (e.g., brick, plaster, cement), water-soluble compounds in the material dissolves, creating a solution. As this solution moves to the surface of the material, the water evaporates, leaving behind white, powdery mineral deposits. This condition indicates that moisture is penetrating through the building envelope in this area, most likely through the exterior wall around window frames.

Water Damaged Wall Plaster around Window Frame in the History Room

8. Make repairs to failing/damaged caulking around windows particularly in the history and meeting rooms.
9. Once repairs are made, repair water damaged plaster in history and meeting room.

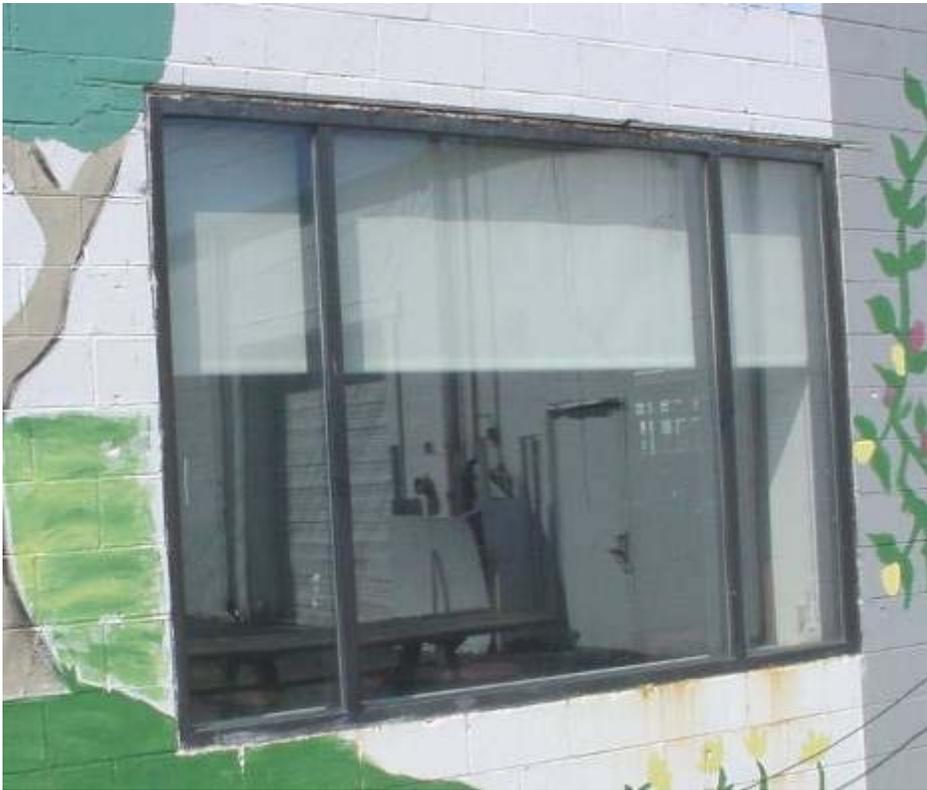
Picture 11

Exterior View of History Room Window System

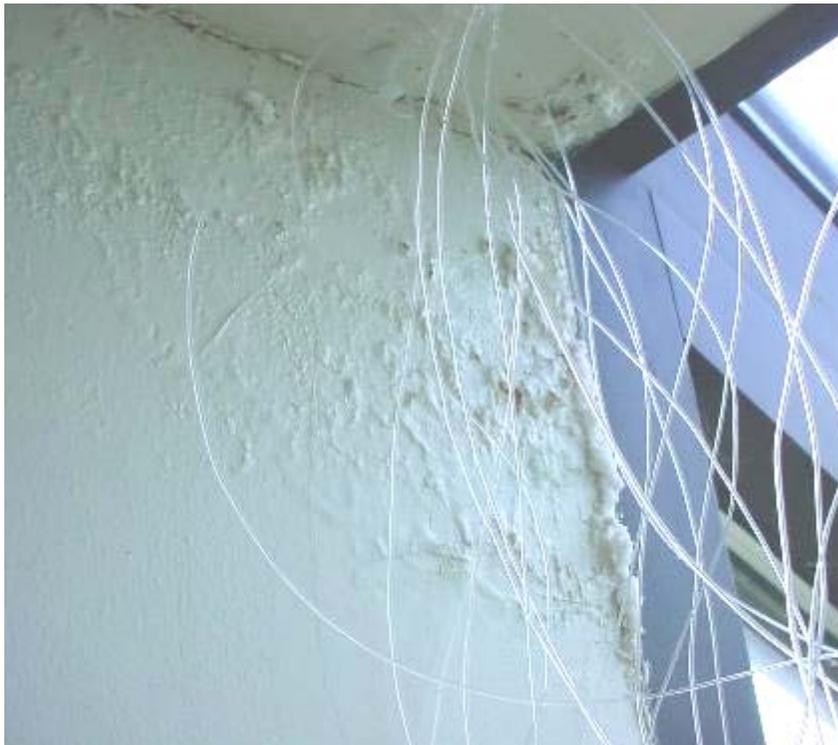
Picture 12

Water Damaged Wall Plaster/Efflorescence around Window Frame in the Meeting Room

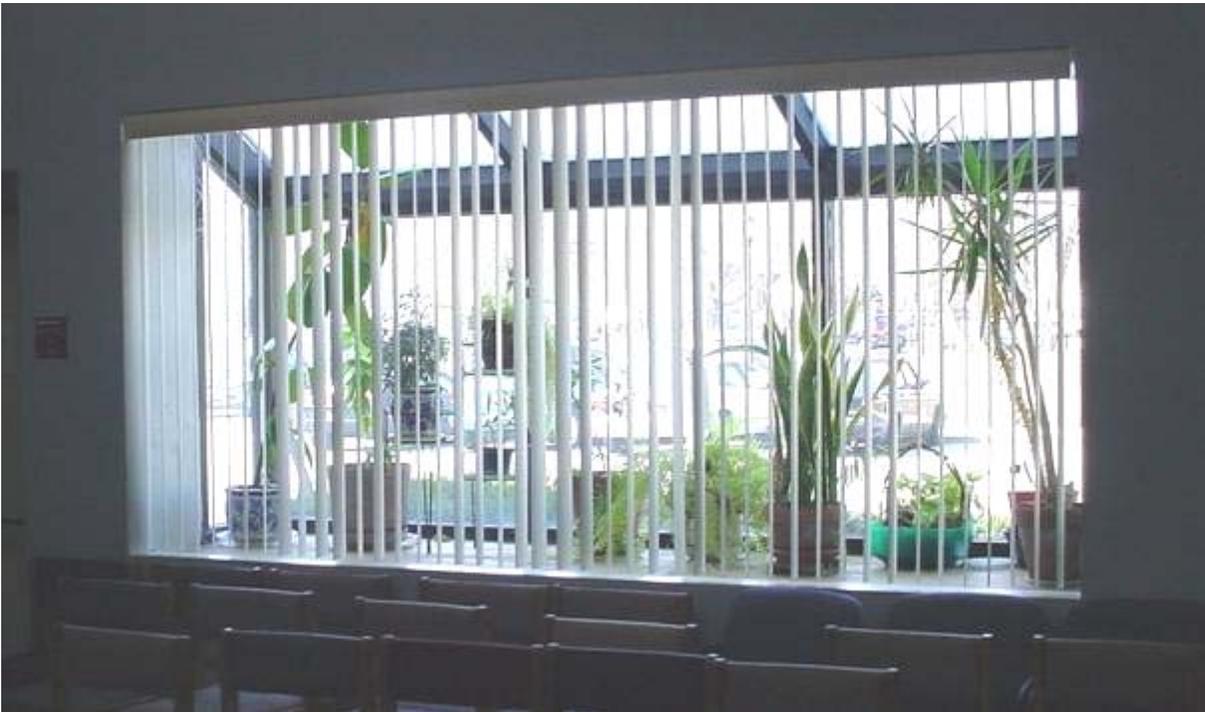
Picture 13

Interior View of Window System in Meeting Room

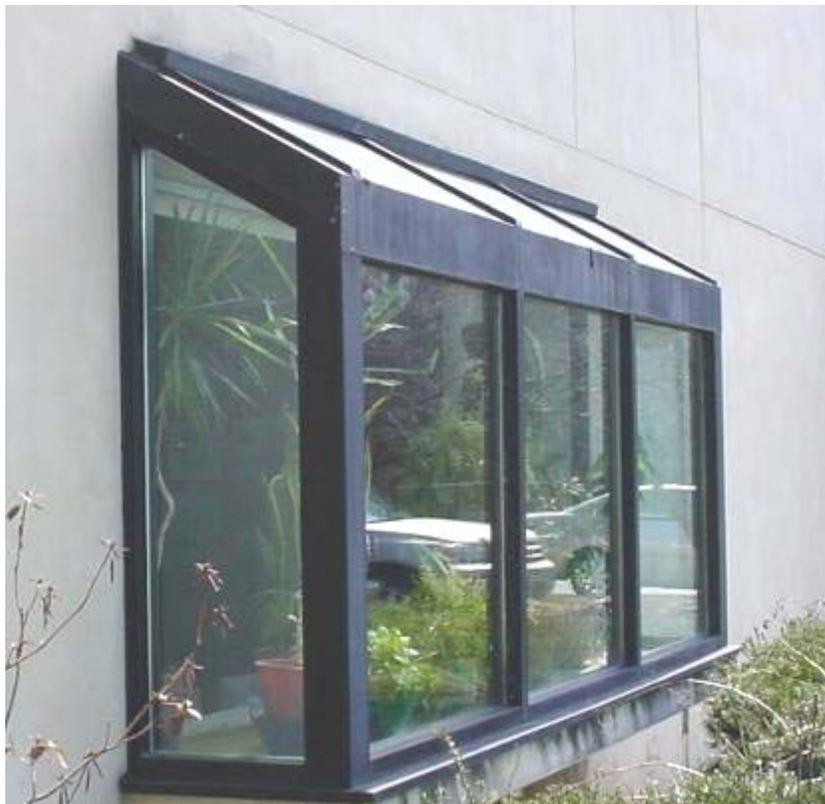
Picture 14

Exterior View of Window System in Meeting Room

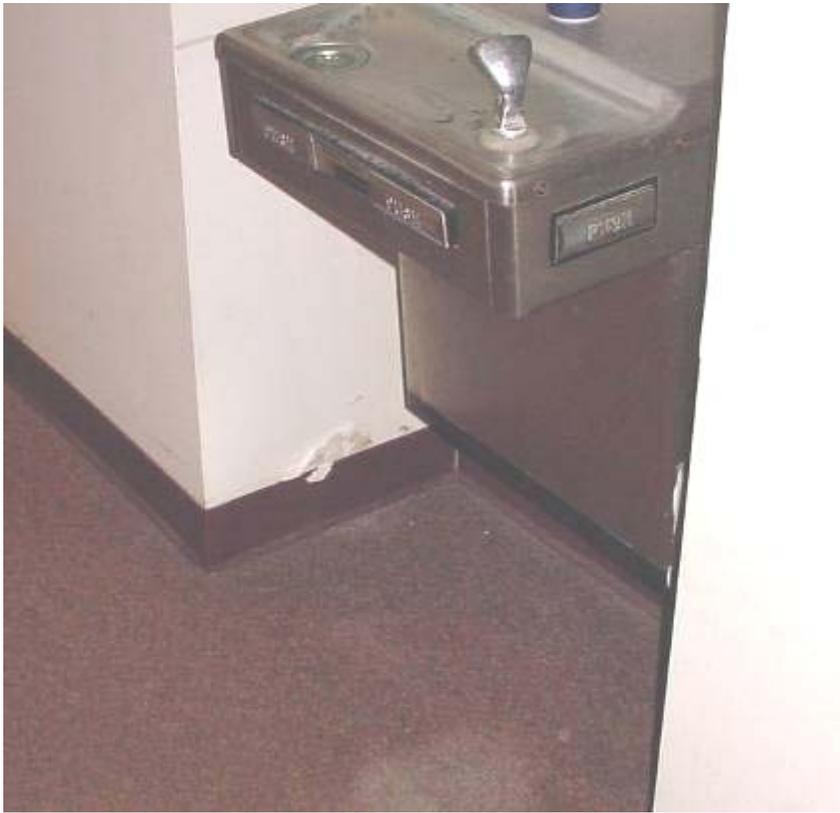
Picture 15

Water stained carpeting and gypsum wallboard (GW) was observed beneath and adjacent to the water fountain in the restroom hallway (Picture 15). Carpeting and GW are porous materials that can provide a medium for mold growth if wetted repeatedly.

Water Stained Carpeting and GW beneath/adjacent to Water Fountain

10. Place tile or rubber matting underneath water fountains in carpeted areas to prevent water damage/mold growth to carpeting. Inspect carpeted area below water cooler for mold and remove if colonized. Repair water damaged wallboard.

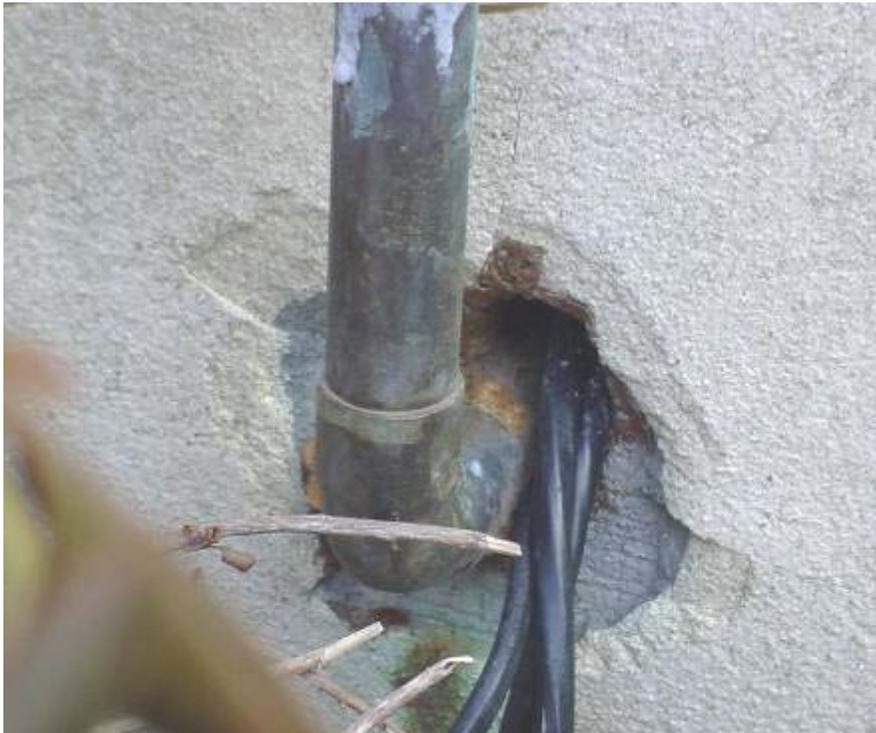
Picture 16

- Spaces around a utility hole along the front of the building (Picture 16);
- Damaged/corroded metal frames around exterior doors and missing sealant around door frames (Picture 17);
- Failing/damaged caulking around windows (Pictures 18 and 19);
- Missing/damaged sealant between expansion joints (Pictures 20 and 21);
- Lack of gutters/downspouts, which causes the sloped roof to direct water against the base of the building causing staining and moss growth (Pictures 22 and 23). Moss

Spaces around Utility at near Front Entrance of Building

14. Consider installing drainage system (e.g., gutters/downspouts) to prevent the impact of back-splashing rainwater on the exterior of the building.
15. Seal any breaches around exterior utility holes and spaces under/around exterior doors to prevent water penetration, drafts and pest entry.

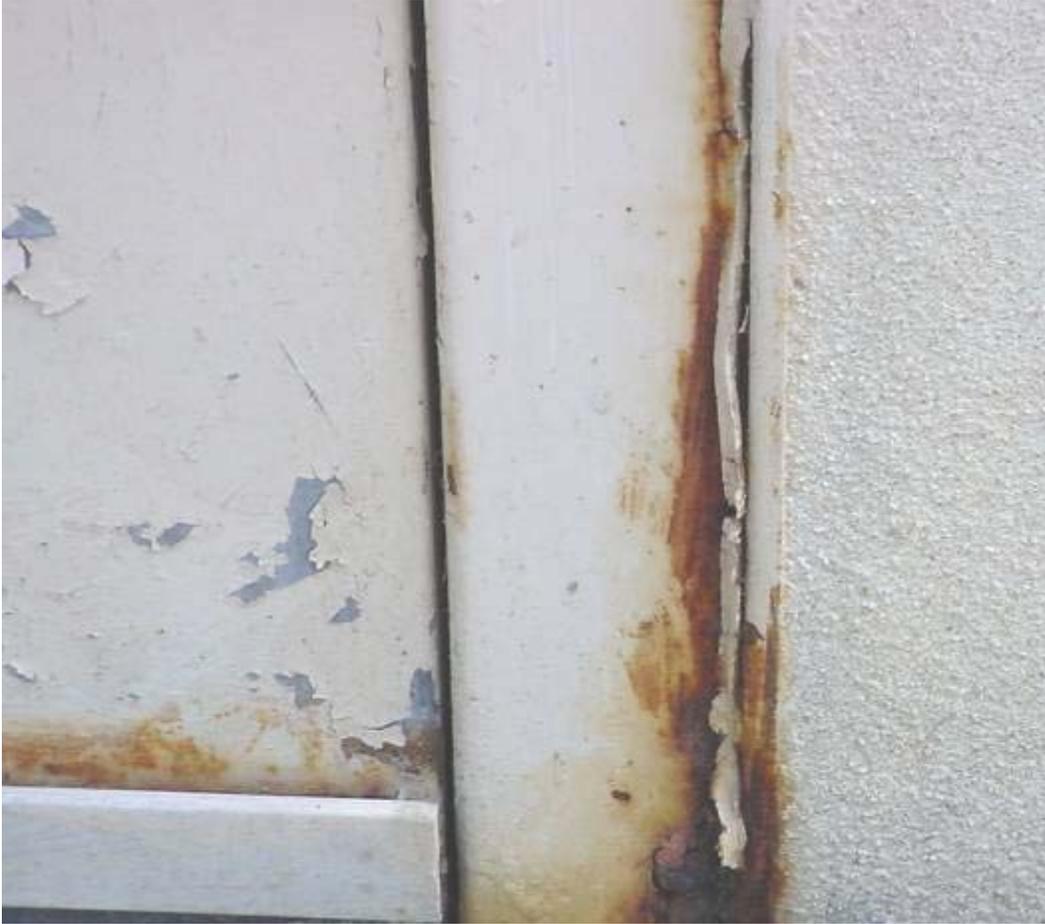
Picture 17

Damaged/Corroded Metal Frame around Door, Noted Missing/Damaged Sealant along Right Side of Frame

11. Make repairs to failing/damaged sealant around exterior door frames.
12. Repair or replace corroded/damaged exterior doors as necessary.
13. Make repairs to failing/damaged sealant in expansion joints/wall panels.

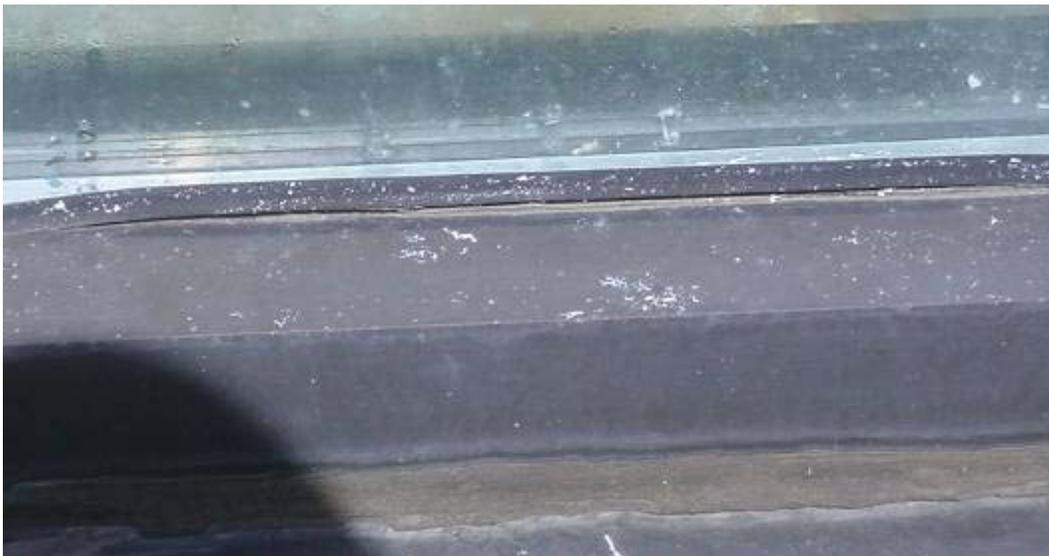
Picture 18

Failing Strip Caulking along Meting Room Window

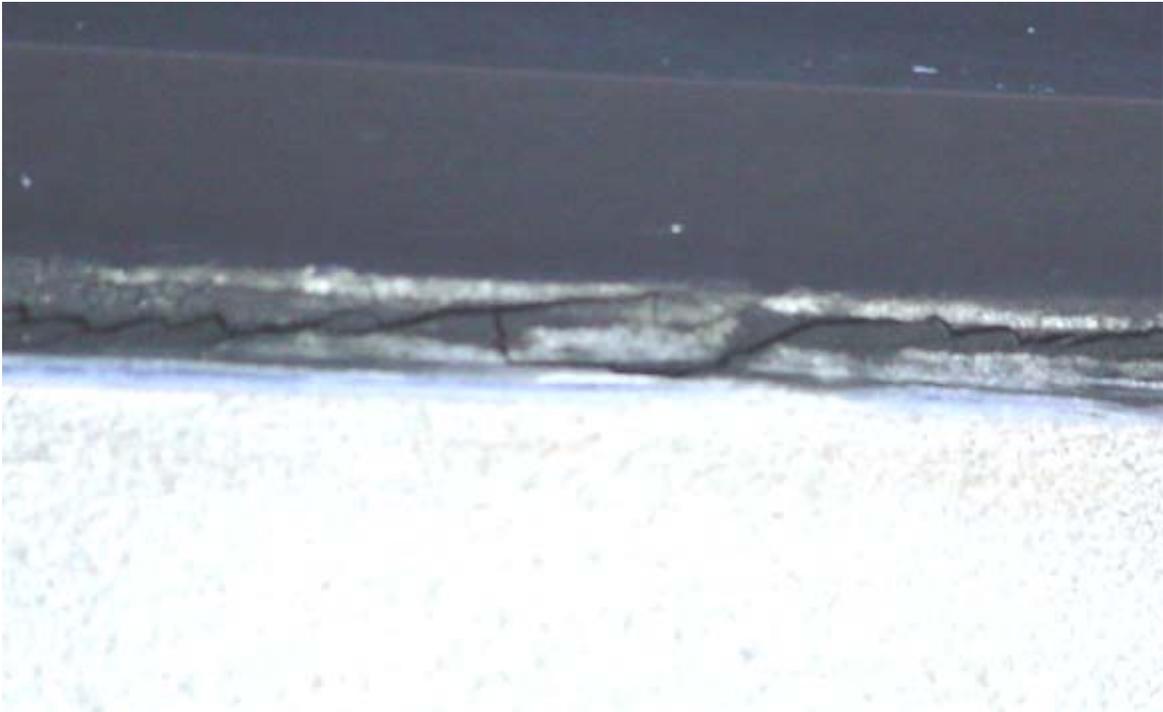
Picture 19

Cracked/Damaged Caulking along Meeting Room Window

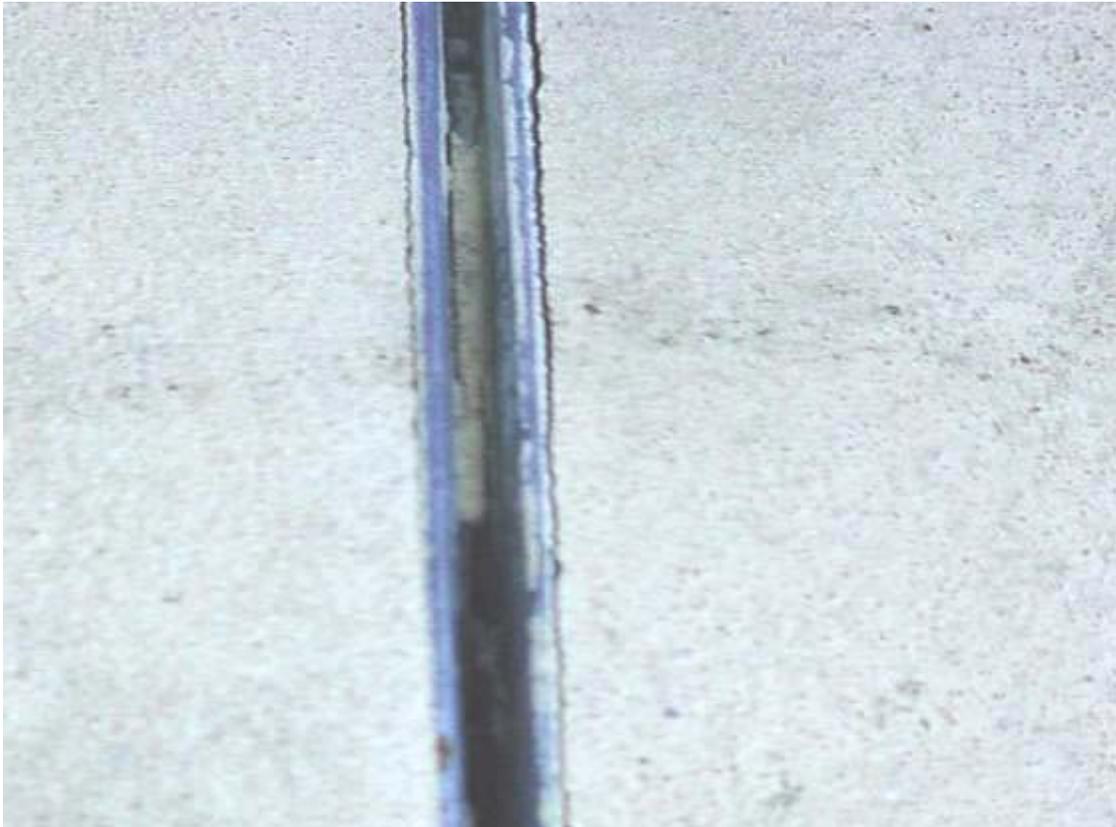
Picture 20

Missing/Damaged Sealant along Expansion Joint/Exterior Wall Panels

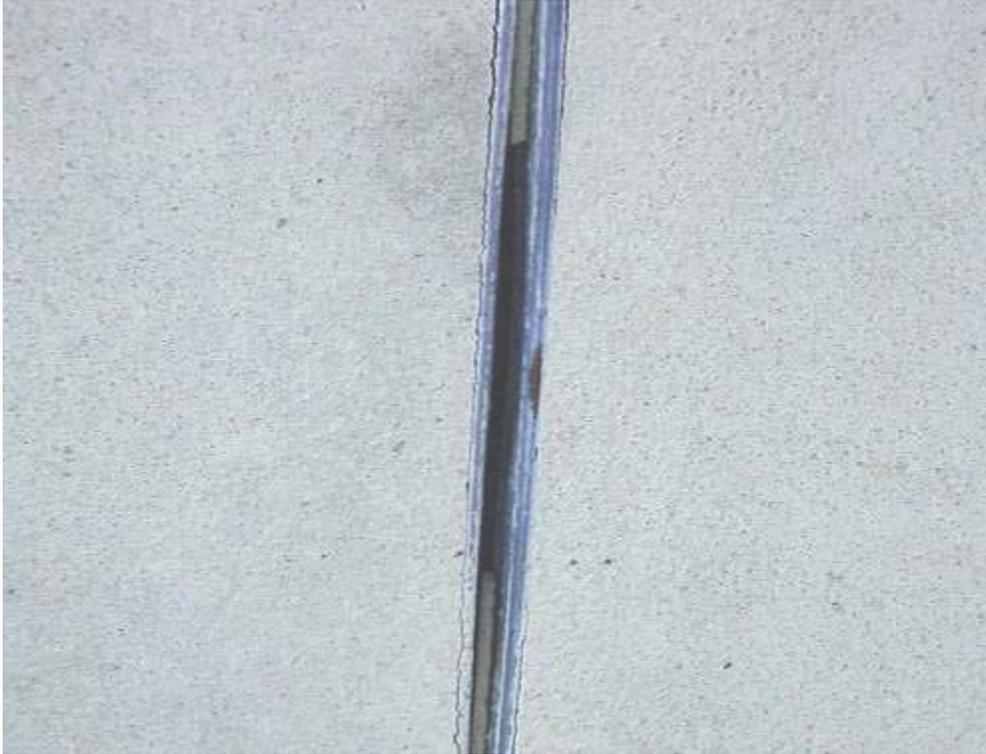
Picture 21

Missing/Damaged Sealant along Expansion Joint/Exterior Wall Panels

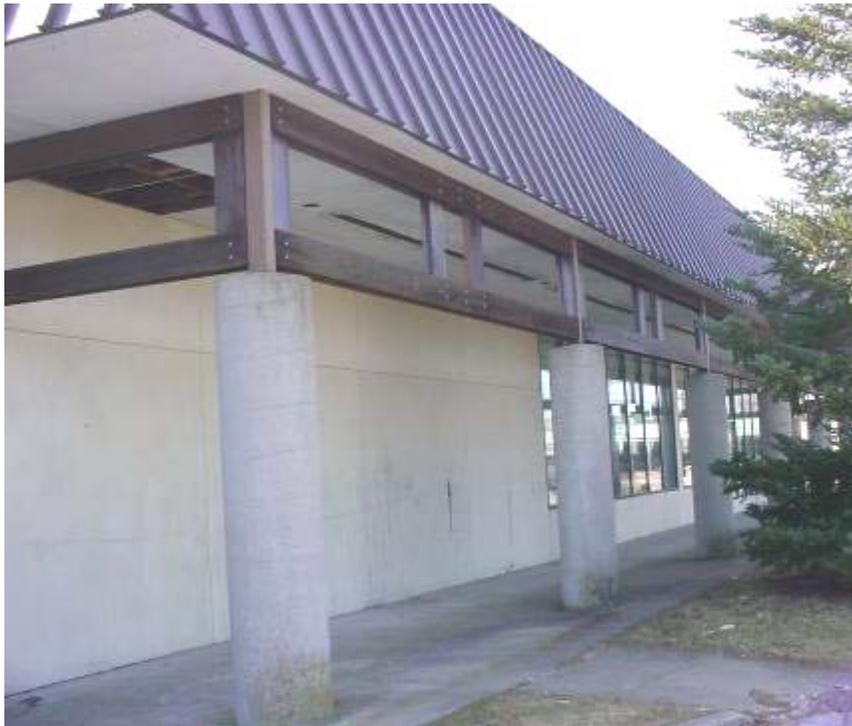
Picture 22

growth is a sign of heavy/continuous water exposure, which can result in damage to the structural integrity the building.

Lack of Gutters/Downspouts, Note Staining/Moss Growth on Apron/Columns

Due to Water Accumulation and Splashback

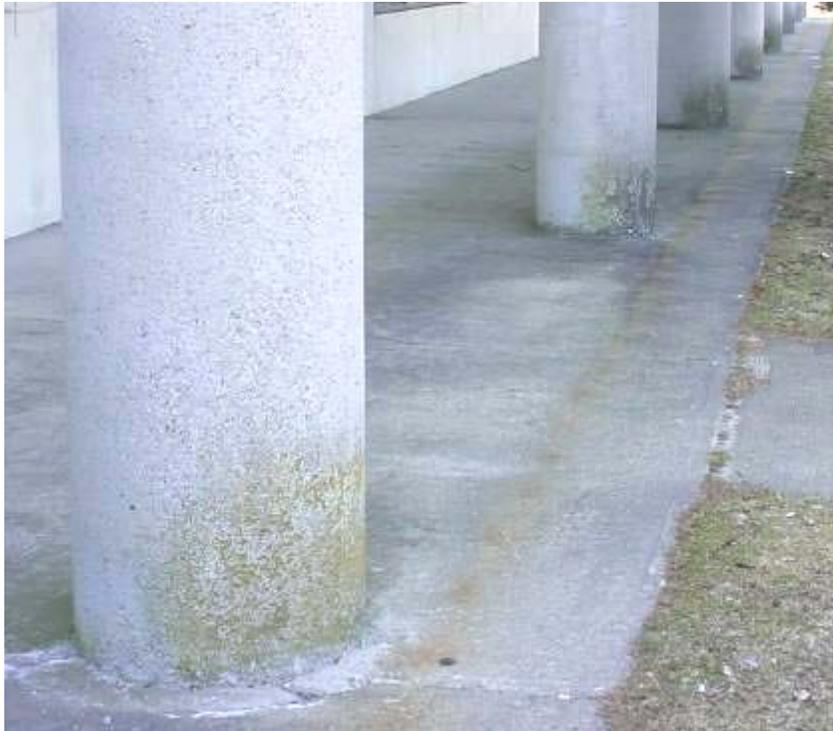
Picture 23

**Close-Up of Staining/Moss Growth on Apron/Columns
Due to Water Accumulation and Splashback**

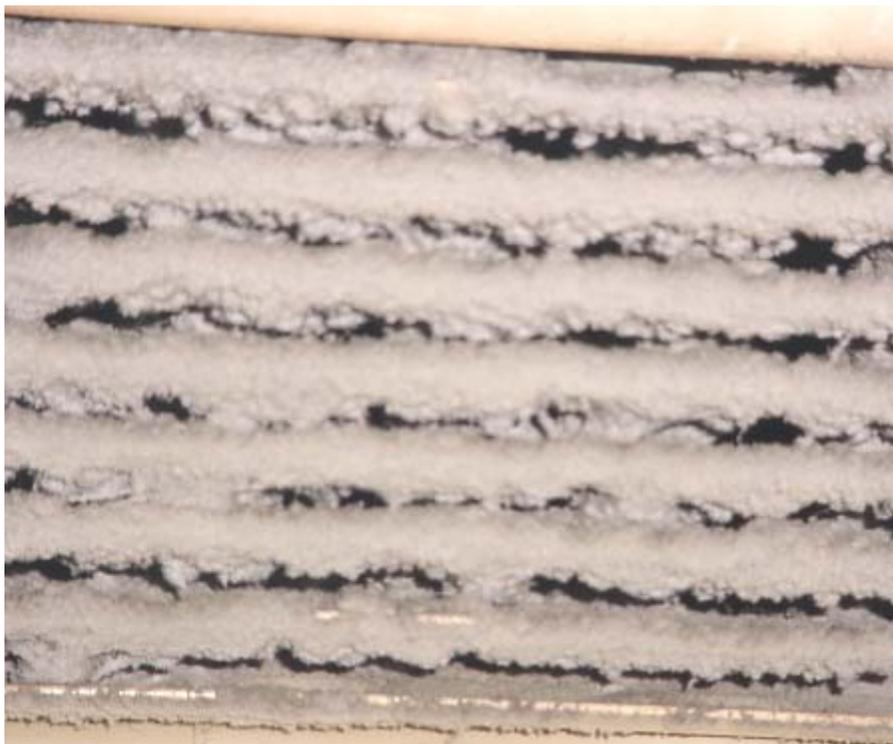
Picture 24

Close-Up of Accumulated Dust/Debris on Exhaust Vent in Restroom
