**INDOOR AIR QUALITY ASSESSMENT
OF
PROPOSED SCHOOL SITE FOR
NEWMAN ELEMENTARY SCHOOL**

**Saint Patrick's School
44 Central Avenue
Natick, Massachusetts**

Prepared by:
Massachusetts Department of Public Health
Bureau of Environmental Health
Indoor Air Quality Program
August 2008

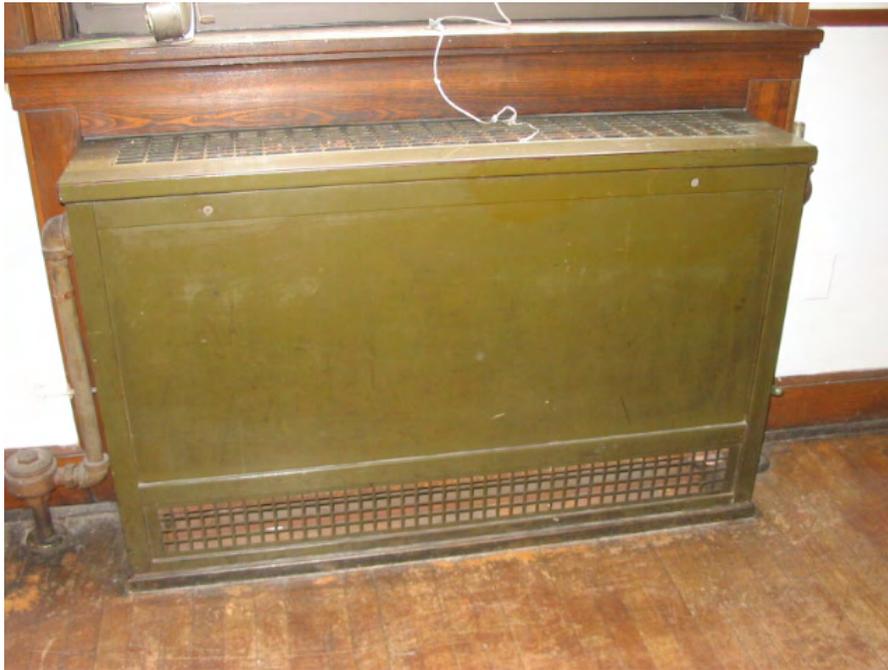
Picture 1

Classrooms in each wing of the school complex are equipped with unit ventilators (univents) that serve as the heating, ventilating, and air conditioning (HVAC) systems. The original building has fresh air provided by Sturtevant univents (Picture 1). The univents appear to be original equipment, installed when the wing was built¹. These univents draw fresh air from the exterior of the building through air intakes (Picture 2). The louvers that control the percentage of fresh air to room return air are set by hand using a lever that exists on the exterior of the cabinets of the unit ventilator (Picture 3). Sturtevant univents do not have any means to filter air. Lack of filtration would lead to univent fresh air intakes capturing and distributing normally occurring outdoor air pollutants (i.e., airborne mold particles and pollen) into classrooms. In addition, some fresh air intakes for the original building appear to be bricked over (Picture 4), eliminating the ability for these units to draw fresh air. Exhaust ventilation in this older section of the building is provided by vents located at floor level (Picture 5). These vents were found to be sealed at the time of assessment (Picture 6). BEH staff could not determine the functionality of the exhaust system at the time of the visit.

Sturtevant Univent in Original Building

1. Contact a ventilation engineer to determine whether the Sturtevant ventilation equipment can be cleaned and repaired. If this system cannot be made clean and functional, the older section of the school will not have functional mechanical ventilation system. The ventilation engineer should also determine whether the exhaust ventilation system is functional.

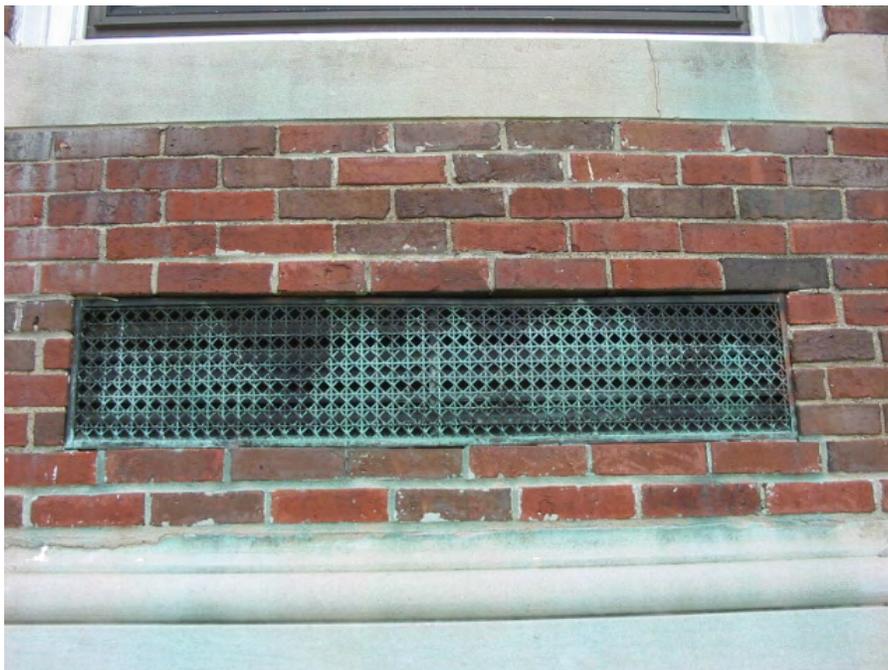
Picture 2

Fresh Air Intake

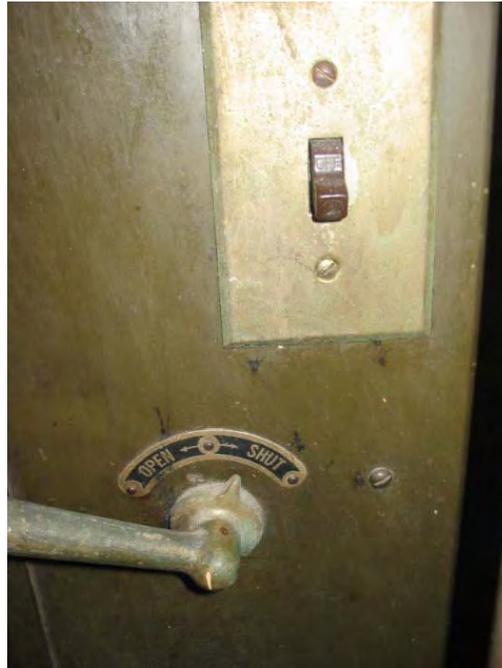
Picture 3

Lever That Set Univent Louver, Note Open-Shut Label

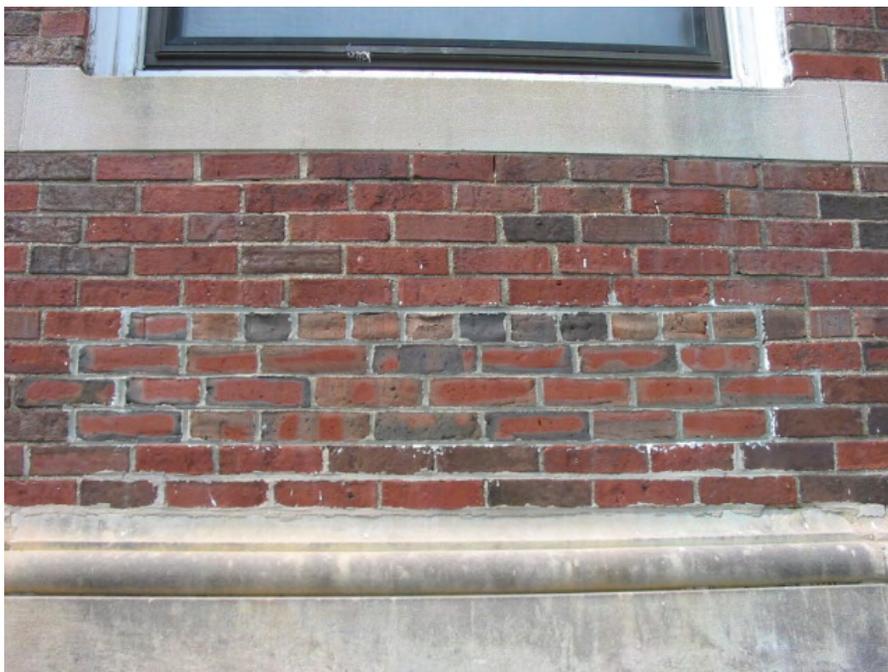
Picture 4

Bricked In Fresh Air Intake

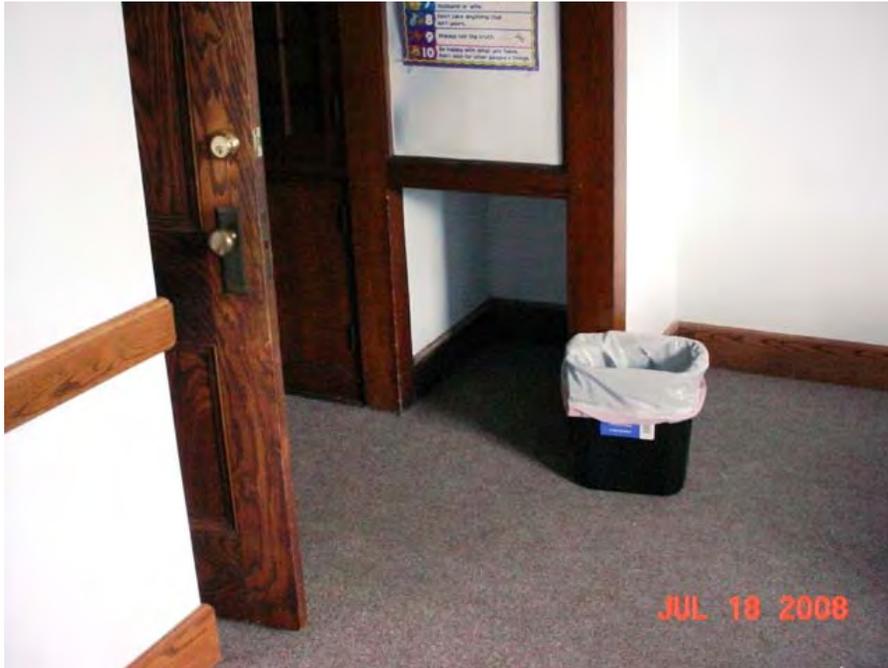
Picture 5

Exhaust Vent in Original Building

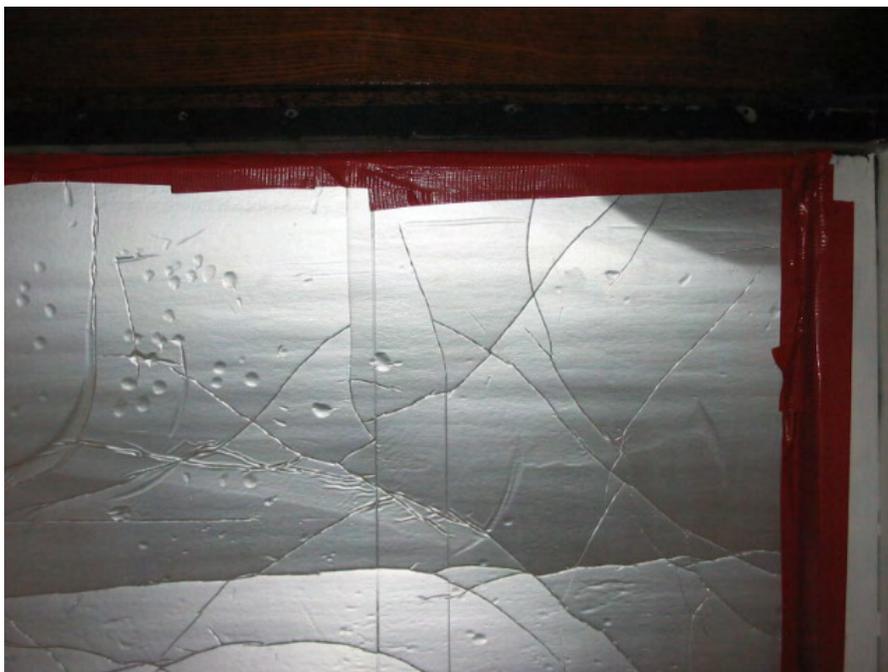
Picture 6

Sealed Exhaust Vent in Original Building

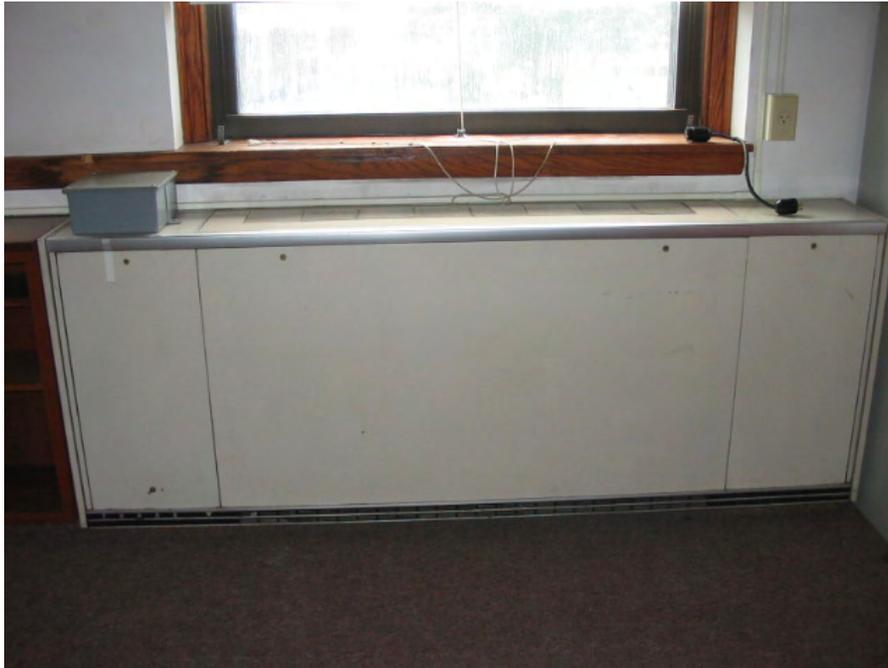
Picture 7

Univents in the newer edition appear to be modern (Picture 7). In some cases, univent fresh air intakes appeared to be sealed (Picture 8). Exhaust ventilation is located in the ceiling of closets (Picture 9). All exhaust vents were sealed at the time of assessment; thus the functionality could not be determined.

Univent in Newer Wing

2. Determine whether univents in both wings can be outfitted with appropriate filters.
3. The floor of Room 5 needs to be mechanically dried. This room should be examined for musty odors and be remediated as needed once dried. It is also recommended that the floor be refinished in order to seal any cracks and/or crevices that exist in the floor material after floor is appropriately dried.

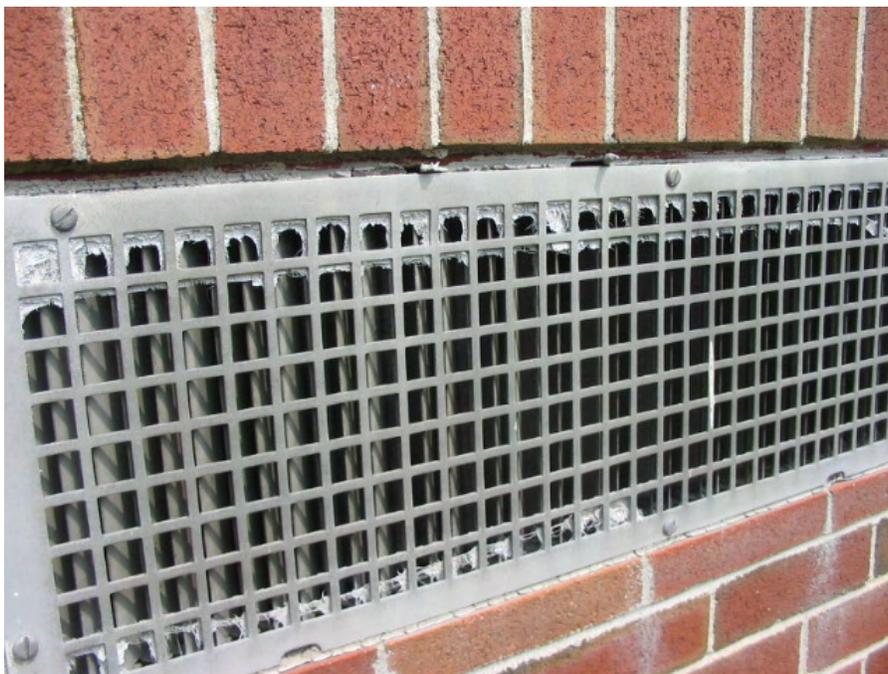
Picture 8

Remnants of Materials Used To Seal Univent Fresh Air Intakes

To maximize air exchange, the MDPH recommends that both supply and exhaust ventilation operate continuously during periods of school occupancy. In order to have proper ventilation with a univent and exhaust system, the systems must be balanced to provide an adequate amount of fresh air to the interior of a room while removing stale air from the room. It is recommended that existing ventilation systems be re-balanced every five years to ensure adequate air systems function (SMACNA, 1994). Prior to occupancy of this building, it would be recommended that the ventilation system in all wings be re-balanced. Based on the configuration, age and condition of the ventilation systems in both wings, re-balancing will be very difficult to achieve.

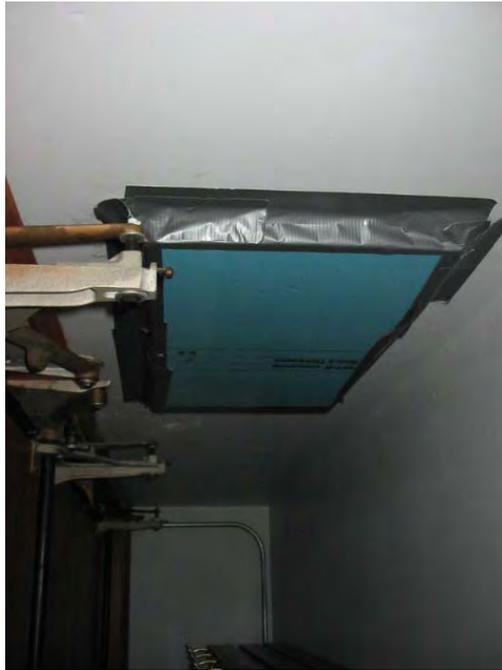
Picture 9

Sealed Exhaust Vents in Classroom Closets

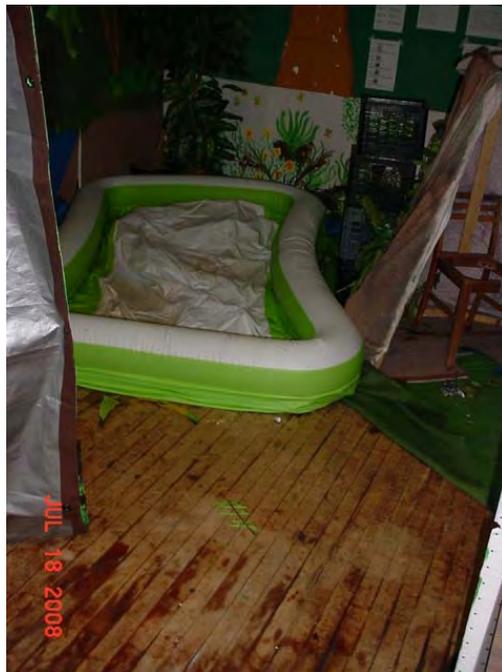
Picture 10

As mentioned previously, the building was being used for the summer camp at the time of assessment. In room 5, BEH observed the maple tongue-in-groove flooring to be chronically moistened from an inflatable pool placed directly on the floor in this room (Picture 10). While maple flooring is resistant to mold colonization, the chronic moistening can cause the floorboards to swell and become uneven. In addition, moisture can accumulate in sub-flooring. Prior to any reuse of this classroom, steps should be taken to dry the floor thoroughly.

Inflatable Pool in Room 5, Note Water Damage to Maple Floor

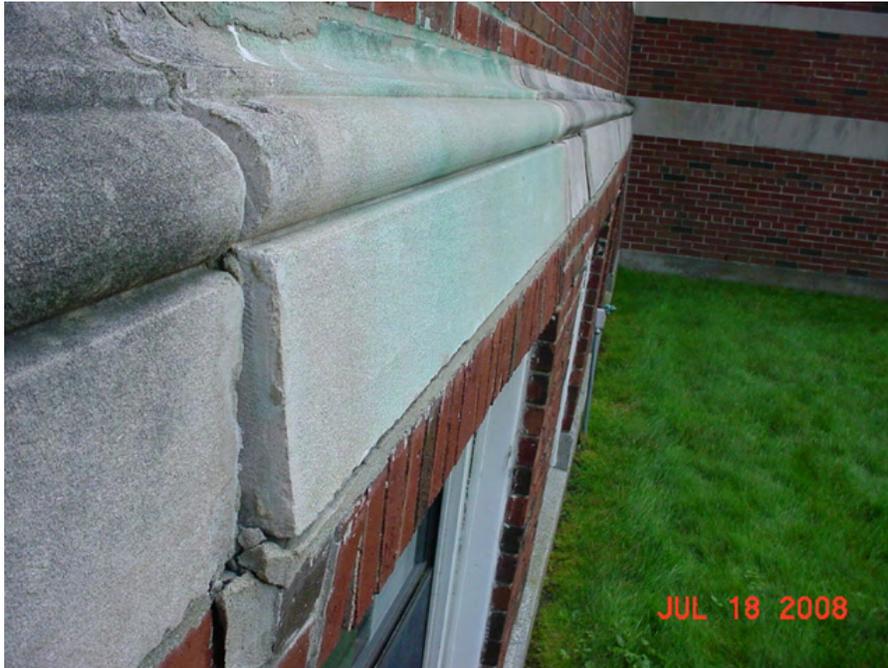
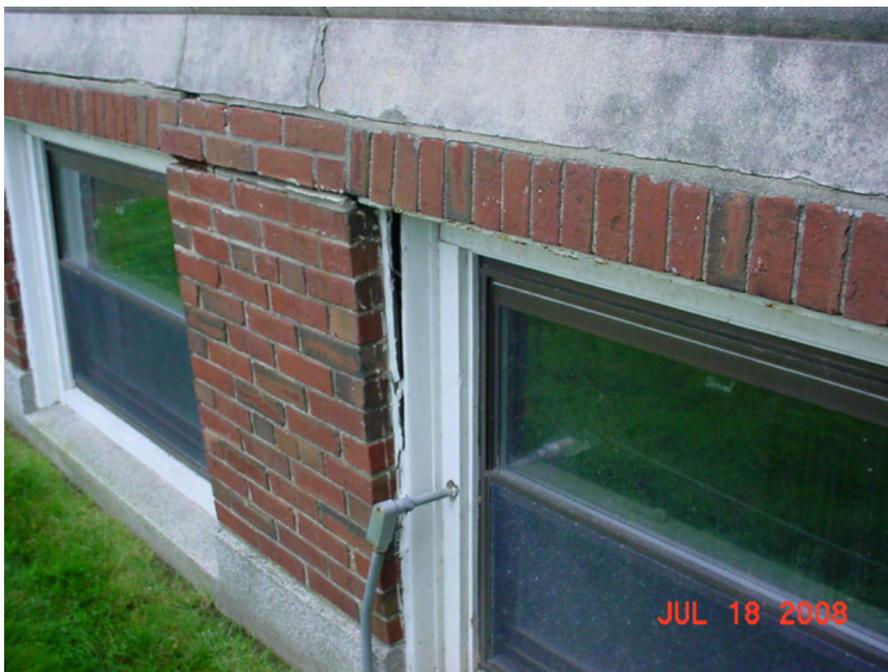
The exterior wall to the right of the main, front entrance appears to be buckling outwards (Pictures 11 and 12). With the exterior wall in this state, wind driven rain from a northeasterly direction would likely penetrate through the exterior wall and into the building interior. Water penetration can result in damage to interior walls.

Buckling Wall In Front Of Building

4. All cracks crevices and holes in the exterior walls of the building need to be repaired in order to prevent further water damage.
5. Carpeting with musty odors should be removed, particularly in the function room. Prior to any carpet removal it is recommended that all floor tile be examined by a licensed asbestos inspector.

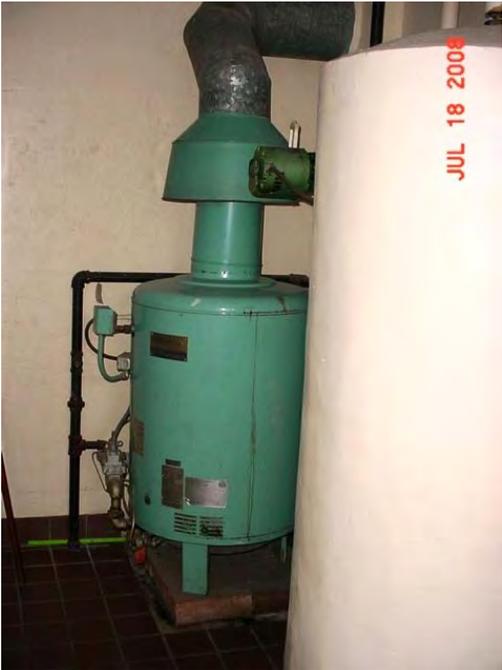
Picture 13

The kitchen area contains a gas fired water heater (Picture 13). No carbon monoxide detectors could be identified in or around the location of this water heater. Since it is located in an occupied space of the building, the water heater should likely be connected to a power vent in

order to ensure that products of combustion are vented from the building in an appropriate manner. If not, products of combustion of gas will not be vented from the kitchen area as needed.

Gas-Fired Water Heater

6. Consideration should be given to installing the power vent on the exhaust vent for the water heater.
7. Carbon monoxide detectors should be installed in the basement due to the presence of the gas-fired water heater.
