INDOOR AIR QUALITY ASSESSMENT

**The Ralph J. Froio Senior Center
330 North Street
Pittsfield, Massachusetts 01201**

Prepared by:
Massachusetts Department of Public Health
Bureau of Environmental Health
Indoor Air Quality Program
October 2008

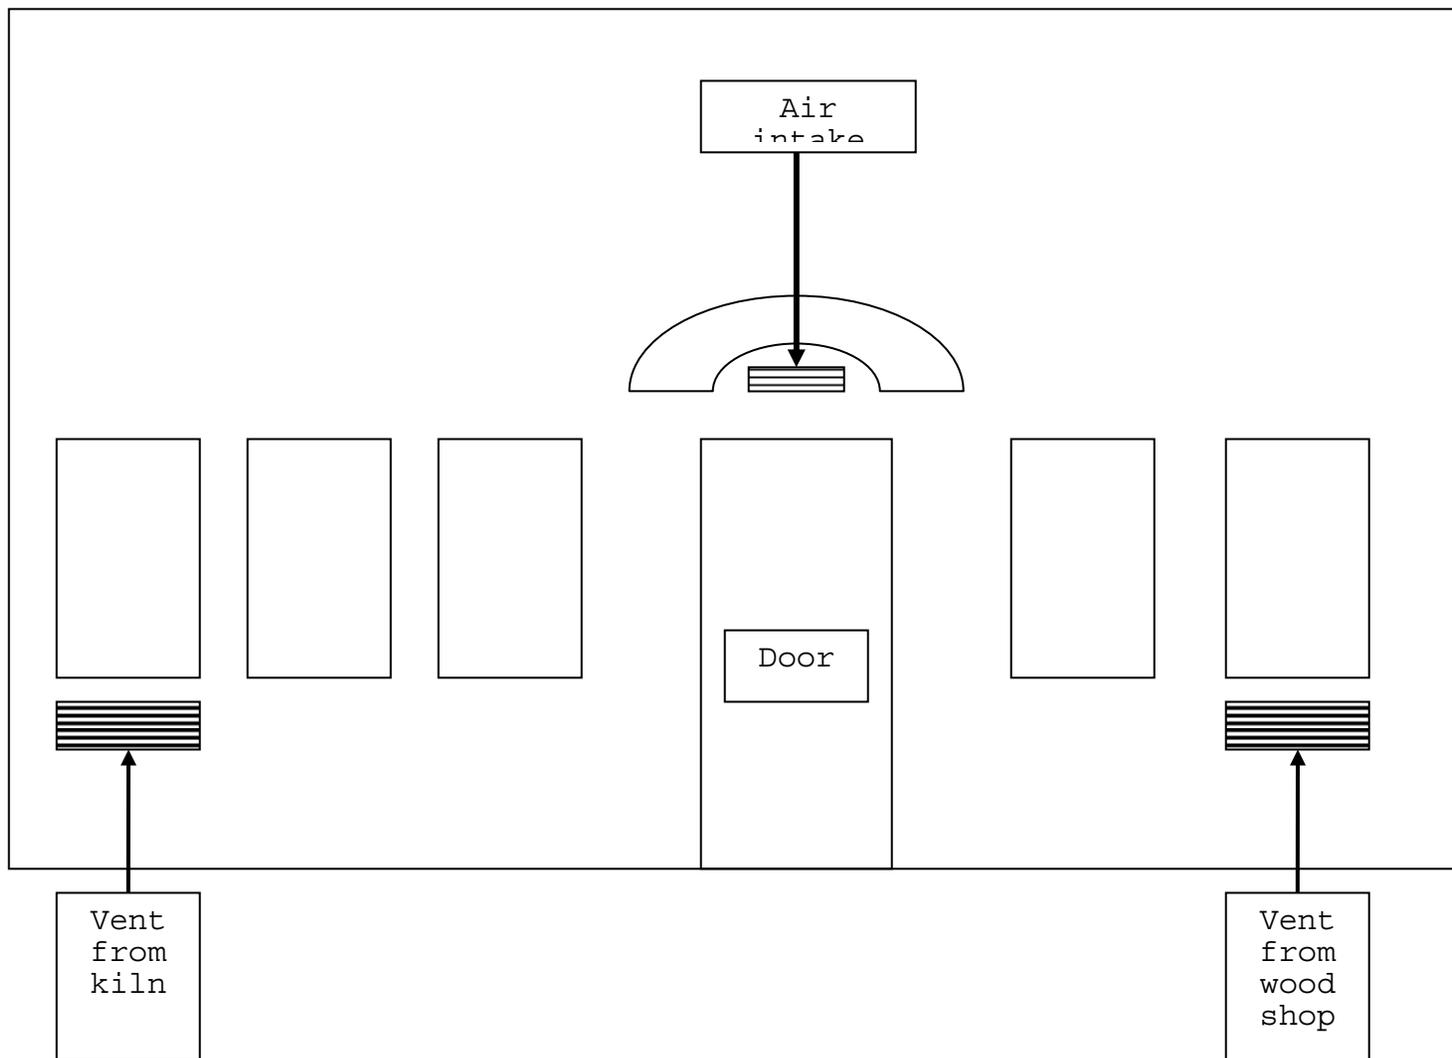
Ralph J. Froio Senior Center
Figure 1
Location of Exhaust Vents to Fresh Air Intake under Awning

The exhaust vents for the wood shop and the kiln in the ceramics room are located beneath the sills of first floor windows on either side of the building entrance (Pictures 15 and 16). As previously mentioned, the AHU fresh air intake is located above the entrance door and below an awning that protects the entrance to the building (Figure 1). Under certain wind and weather conditions, exhaust air from the kiln and wood shop can accumulate under the awning and become entrained in the fresh air intake.

1. Consider either eliminating awning over air intake or replacing with an impervious material.
2. Consider ducting exhaust from kiln and woodshop away from fresh air intake.

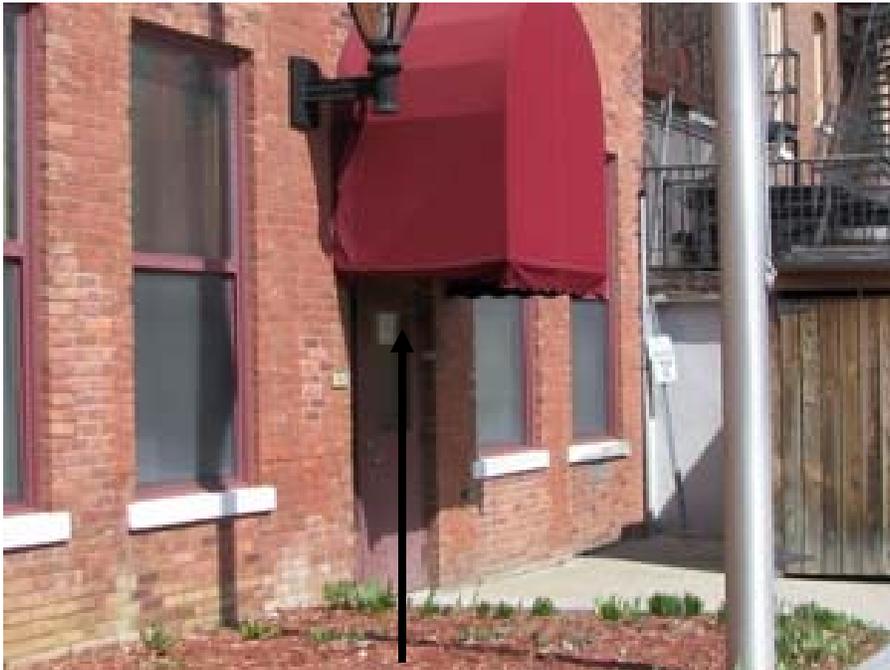
Picture 3

As previously mentioned, the AHU fresh air intake for the basement and first floor is the under the awning over the entrance. The awning is made of a canvas-like material that is water permeable. When wet, the awning may remain so for extended periods of hot and humid weather, which may result in mold growth on its surface. Mold spores can then be drawn into the fresh air intake and distributed through the building.

Air intake is located beneath awning above entrance door

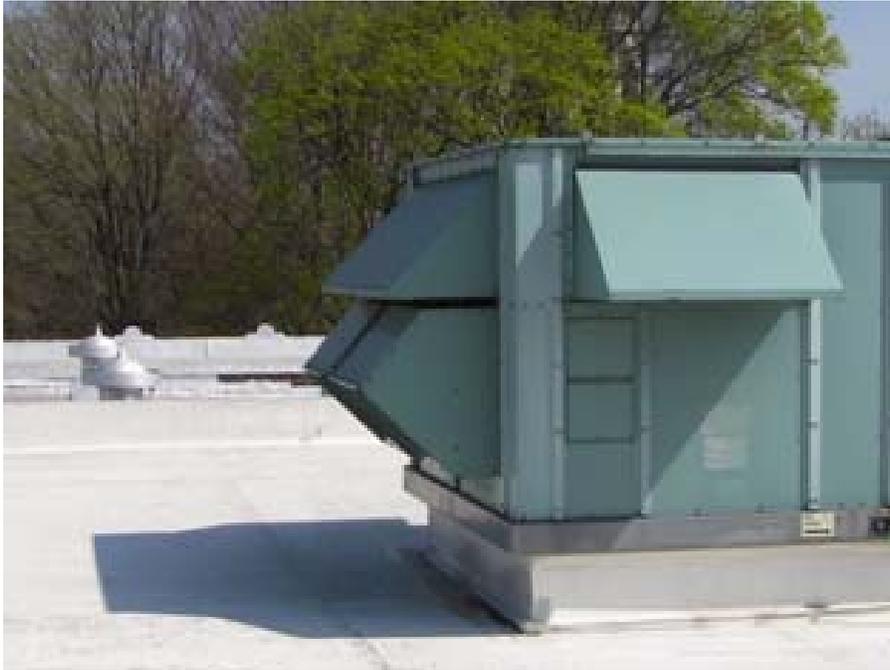
Picture 5

found that this unit lacks an exhaust (Picture 5), which was confirmed by maintenance staff. Screens on the air intake were damaged, which can allow for materials to be drawn into the AHU and may result in damage to the heating coils and fan system (Picture 6). BEH staff found several air diffusers on the second and third floors deactivated at the time of the assessment. It was reported to BEH staff, that the rooftop AHU is controlled by a computer system.

Rooftop AHU

1. Continue to implement corrective actions listed in the ATC report.
2. Contact an HVAC engineering firm to evaluate AHUs for exhaust capabilities, and to maximize the operation of the building's HVAC system. Evaluate existing ductwork system for proper installation and function. In addition, the AHUs should be evaluated for their ability to provide adequate fresh air as well as their ability to remove contaminants from the building. For the rooftop AHU, ensure computerized aspects of AHU are performing in accordance with original design.

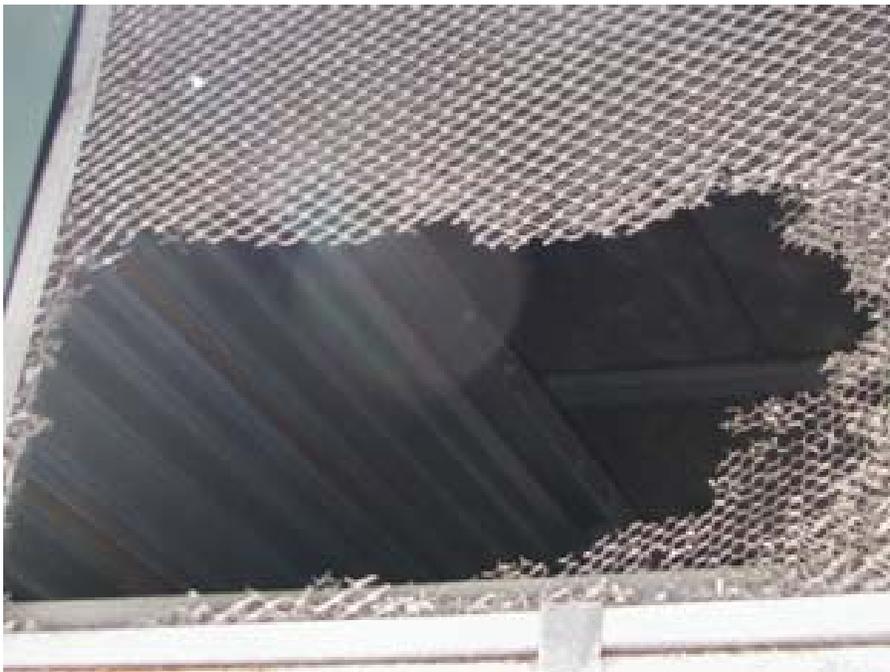
Picture 6

One of several damaged air intake screens on AHU

3. Replace screens on rooftop air handling unit.
4. Consider adopting a balancing schedule of every 5 years for the mechanical ventilation systems, as recommended by ventilation industrial standards (SMANCA, 1994).

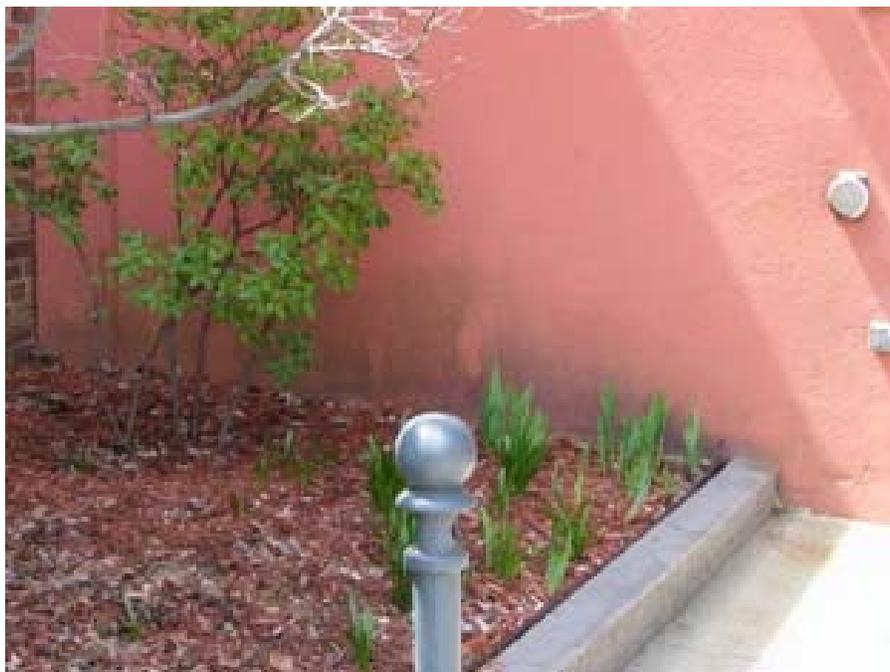
Picture 8

Rainwater is drained from the roof by means of a scupper. Scuppers collect water from the roof and drain it through the building's parapet to the exterior of the building. The RFSC does not supplement its scupper with a gutter/downspout; therefore, water empties against the exterior of the building and pools on the ground at the base of the building. As a result, surface discoloration and possible mold colonization were observed on the exterior brick at the base of the building (Pictures 7 and 8). Further, discoloration of the exterior brick was noted around the scupper (Picture 9).

Discolorization, possible mold colonization at base of building below scupper

9. Install gutters/downspouts to direct rainwater from the roof away from the building.
10. Repair missing/damaged exterior brick and mortar.
11. Shrubbery/trees should be cut in a manner to maintain a space of five feet from the building.

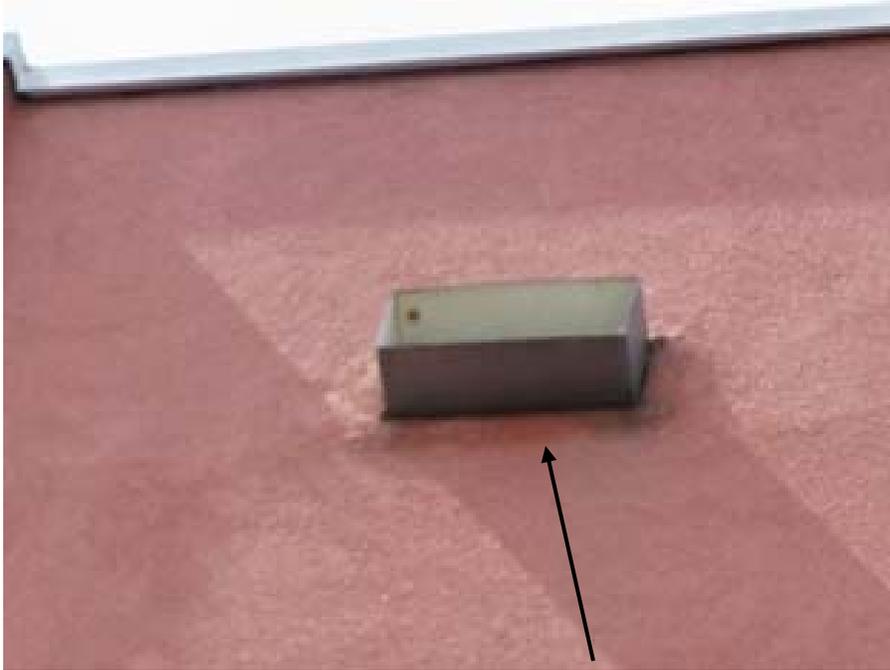
Picture 9

Discoloration of exterior wall around scupper

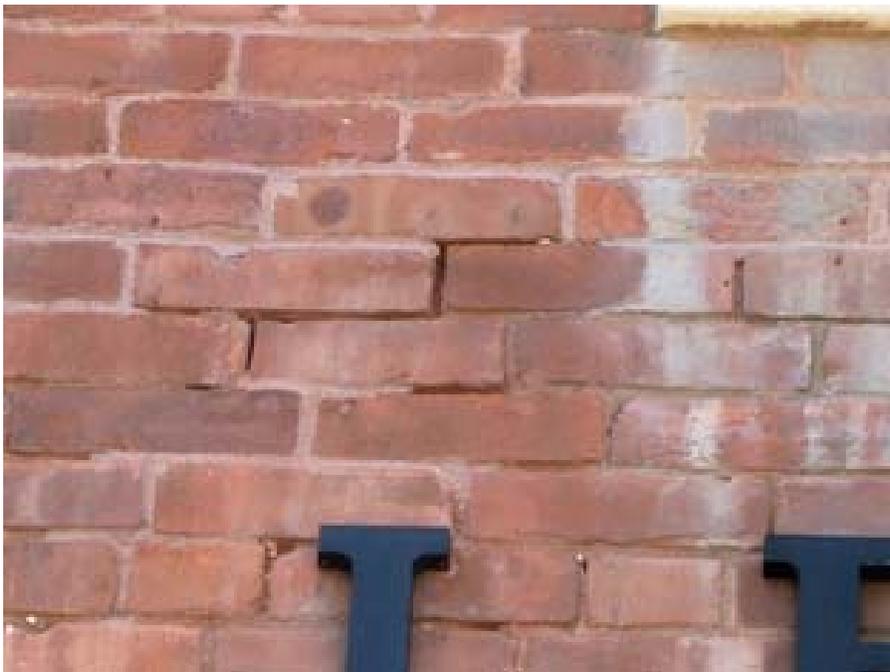
Picture 10

- missing/damaged exterior brick and mortar (Picture 10);
- shrubbery/trees growing in close proximity to the building, which can hold moisture against the building;
- missing/damaged sealant on the walkway to the building entrance (Picture 11); and

The aforementioned conditions represent potential water penetration sources. Over time, these conditions can undermine the integrity of the building envelope and provide a means of water entry into the building via capillary action through foundation concrete and masonry (Lstiburek & Brennan, 2001). The freezing and thawing action of water during the winter months can create cracks and fissures in the foundation. In addition, they can serve as pathways for insects, rodents and other pests into the building.

Missing/damaged brick and mortar

3. Consider installing mechanical exhaust ventilation to increase air exchange and remove environmental pollutants.
4. Consider having exterior walls re-pointed and waterproofed to prevent water intrusion. This measure should include a full building envelope evaluation.

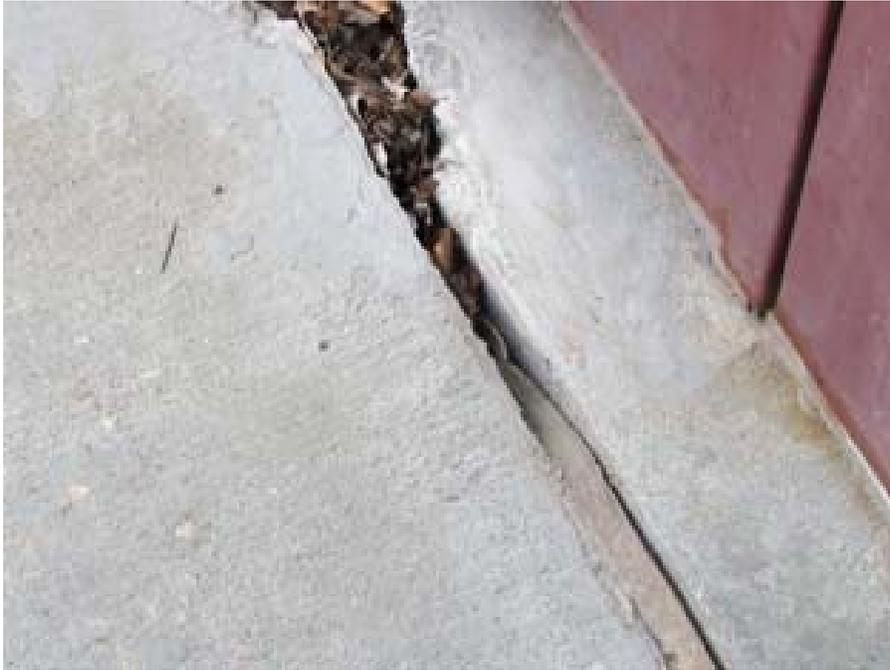
Picture 11

**Sealant missing/damaged near entrance door
Note accumulation of organic debris in crevice**

12. Replace sealant on sidewalk and eliminate open spaces along the base of the building and sidewalk.
13. Consider elimination of dry erase boards, or alternatively, utilize dry erase markers and dry erase cleaners that emit fewer VOCs.

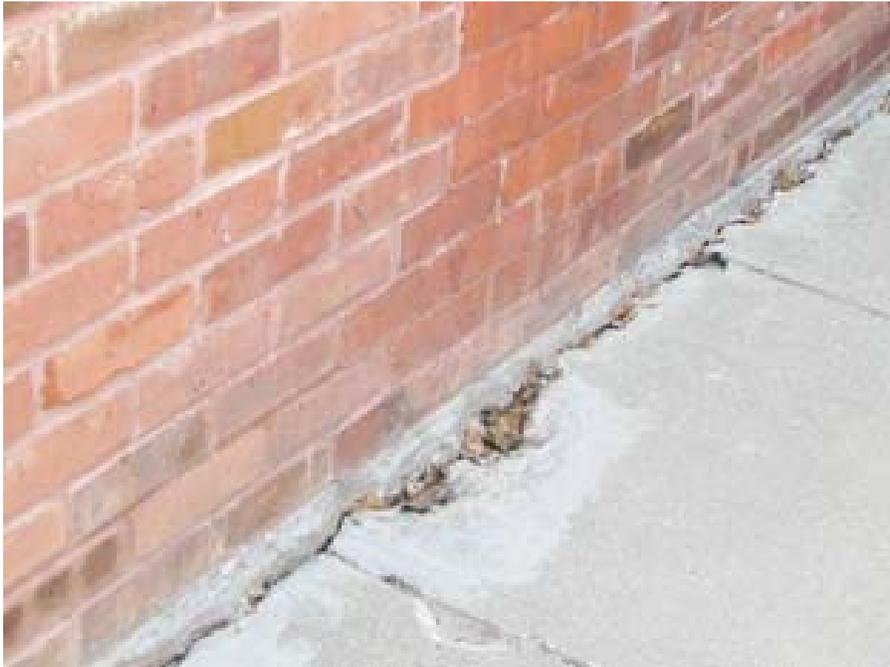
Picture 12

- open spaces along the base of the building and sidewalk, which can allow for water to pool against the foundation (Picture 12).

Open spaces along the base of the building and sidewalk

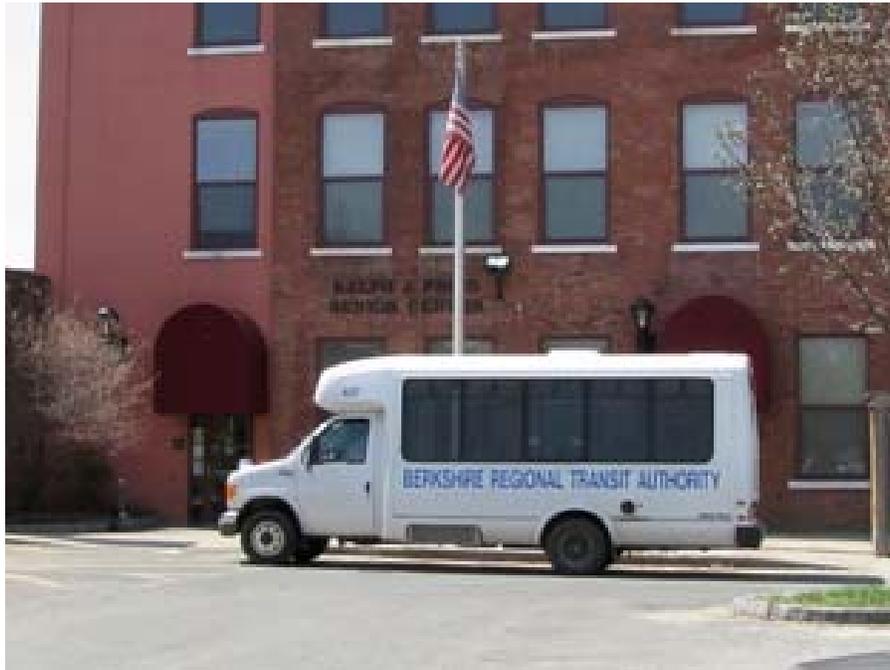
Picture 13

BEH staff observed FRSC transportation vehicles parked near the building entrance, above which is located the fresh air intake for the AHU (Picture 13). At the time of the assessment, the vehicles were not operating; however, there is potential for carbon monoxide to become entrained (drawn into) the air intake when this equipment *is* operated. The opening of windows allows for unfiltered air to enter the building environment carrying with it exhaust emissions as well as airborne dirt, dust and particulates. Thus, opening windows along this area of the building should be done with caution.

Transportation vehicle parked in front of air intake

17. Eliminate idling of vehicles in front of the air intake.
18. Pour water into the floor drains at least twice a week to prevent dry traps and maintain the integrity of the seal.

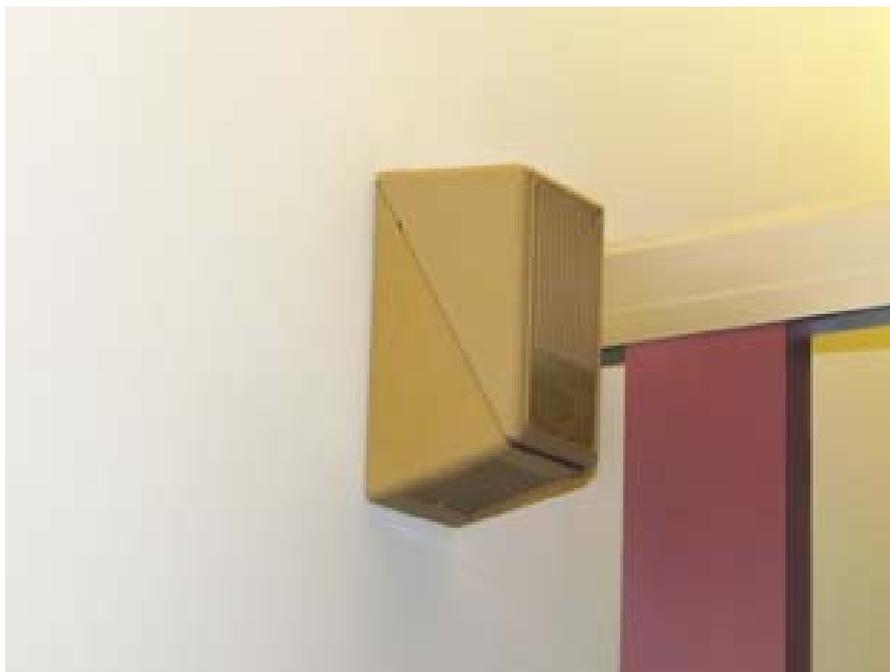
Picture 14

Both the men's and women's restrooms on the third floor had elevated TVOC concentrations; 2.8 and 3.4 ppm, respectively (Table 1). In these restrooms, BEH staff found air fresheners and deodorizing materials (Picture 14). These air fresheners and deodorizers were emitting very strong chemical odors. The strength of the odors could have been due, in part, to the deactivated exhaust vents. Therefore, the ability to remove and reduce bathroom odors, moisture and chemical odors was not available in these rooms at the time of the assessment. Air deodorizers contain chemicals that can be irritating to the eyes, nose and throat of sensitive individuals. Many air fresheners contain 1,4-dichlorobenzene, a VOC which may cause reductions in lung function (NIH, 2006). Furthermore, deodorizing agents do not remove materials causing odors, but rather mask odors that may be present in the area.

Wall mounted deodorizer

14. Refrain from the use of air fresheners/deodorizers in the building.

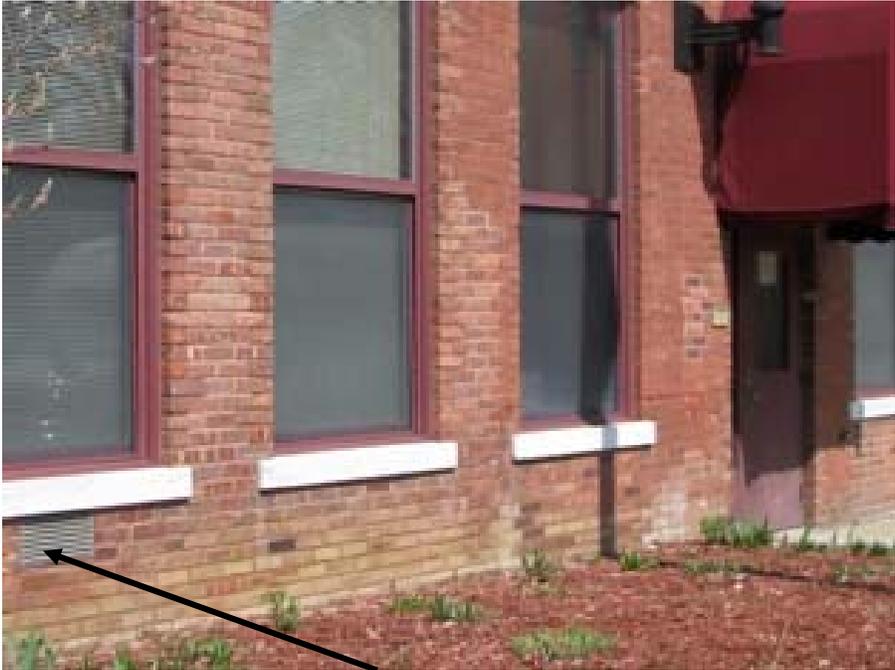
Picture 15

Exhaust vent from kiln

19. Repair/replace dust collection hoses in wood shop.
20. Operate local exhaust systems in the wood shop and ceramics room during hours of occupancy.
21. Ensure first floor windows adjacent to exhaust vents for kiln and wood shop remain closed when exhaust is operating.

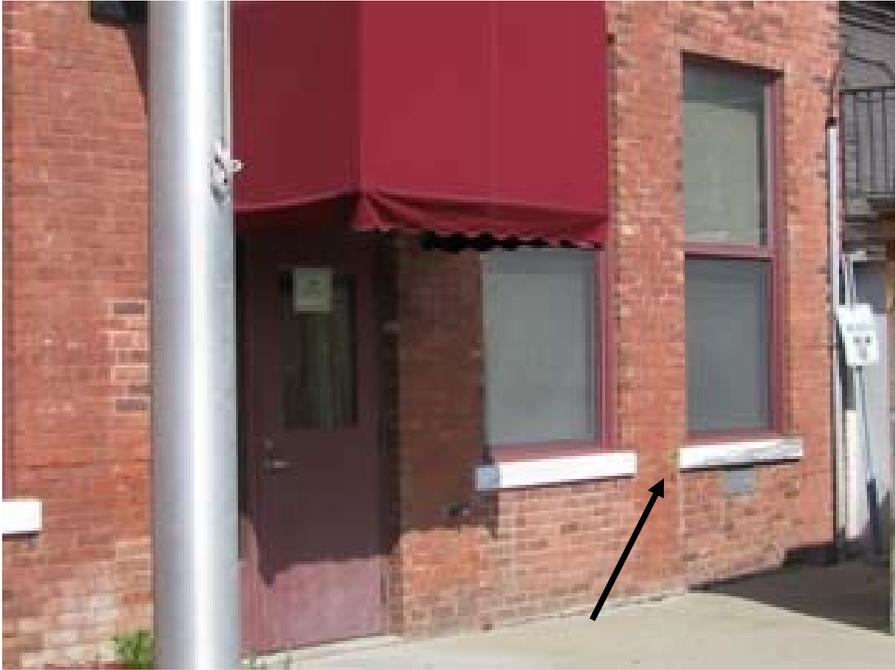
Picture 16

Exhaust vent from wood shop

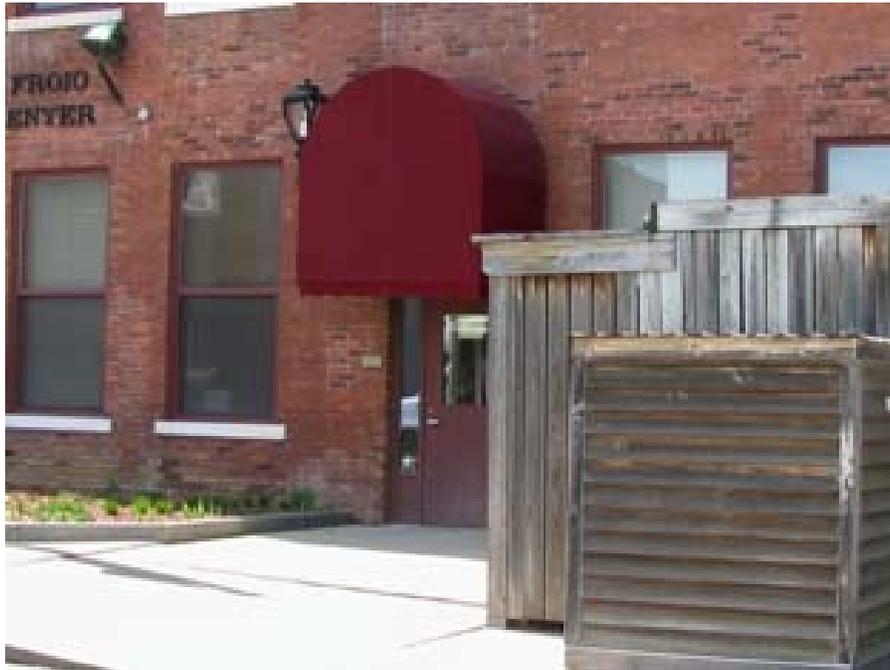
Picture 17

The dumpster is in close proximity to the fresh air intake (Picture 17). Although no odors were noted at the time of the assessment, the potential exists for odors from the dumpster to be entrained by the AHU fresh air intake.

Wooden enclosure surrounding dumpster near fresh air intake

22. Consider relocation of dumpsters.
23. Ensure exhaust ventilation is utilized in kitchen when meals are being prepared.
24. Refer to resource manual and other related indoor air quality documents located on the MDPH's website for further building-wide evaluations and advice on maintaining public buildings. These documents are available at: http://mass.gov/dph/indoor_air.

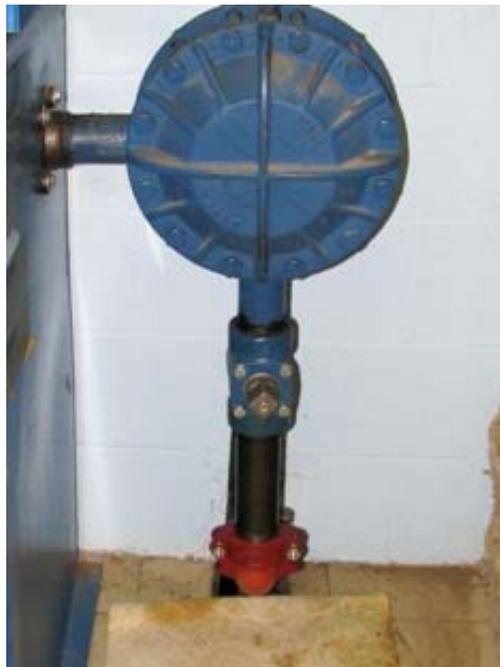
Picture 18

In the mechanical room for the elevator, a leak of hydraulic fluid was noted (Pictures 18 and 19). It could not be determined how long this leak was present. Hydraulic fluid contains chemicals that may be irritating to the eyes and respiratory system.

Saturated absorbent pad located below hydraulic fluid leak in mechanical room of elevator

15. Avoid over-watering plants and examine drip pans periodically for mold growth. Disinfect with an appropriate antimicrobial where necessary.
16. Repair hydraulic leak in elevator's mechanical room. Clean dried spillage from the floor as well.

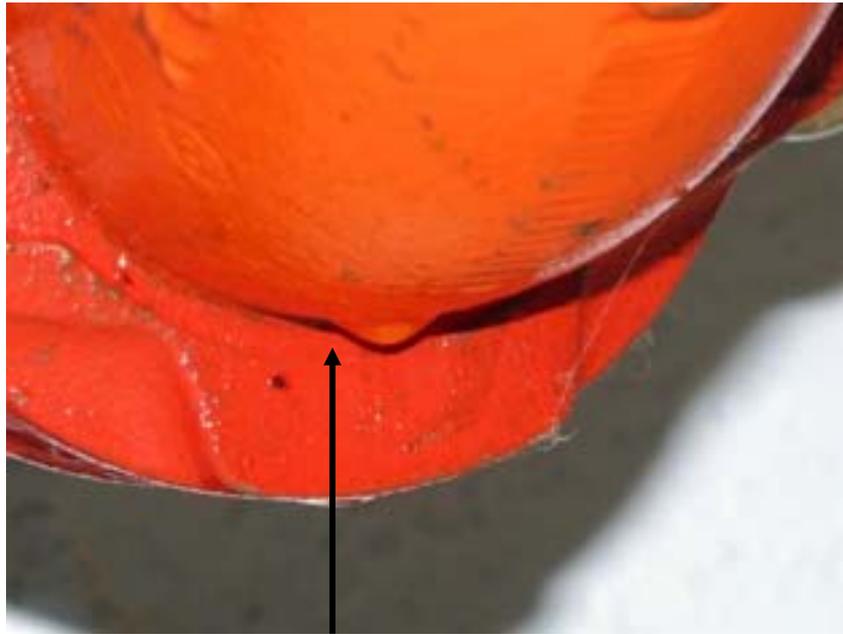
Picture 19

Leaking hydraulic fluid
