# **INDOOR AIR QUALITY ASSESSMENT**

**Shelburne Senior Center  
7 Main Street  
Shelburne Falls, Massachusetts 01370**

Prepared by:  
Massachusetts Department of Public Health  
Bureau of Environmental Health  
Indoor Air Quality Program  
October 2008

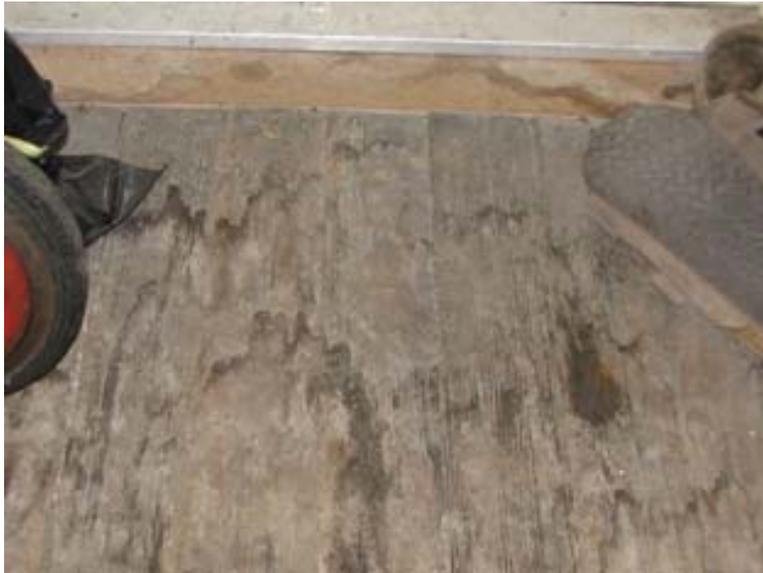
**Picture 1**

The basement of the SSC exhibited the effects of chronic dampness. The wooden landing at the top of the basement stairs exhibited signs of moisture (Picture 1). Water stains were also evident adjacent to the exterior door's threshold. BEH was informed that the Director did store his boots on this landing throughout the winter. The exterior door at the top of these stairs did not appear weathertight as daylight was visible from the landing.

**Water damaged landing at top of basement stairs**

27. Repair rotted threshold on south side of the building.
  28. Exterior door to the basement should be made weather-tight.
  29. Investigate origin of vents on exterior of the building wall.

30. Eliminate storage of wet items such as boots on basement stairway landing.
  31. For buildings in New England, periods of low relative humidity during the winter are often unavoidable. Therefore, scrupulous cleaning practices should be adopted to

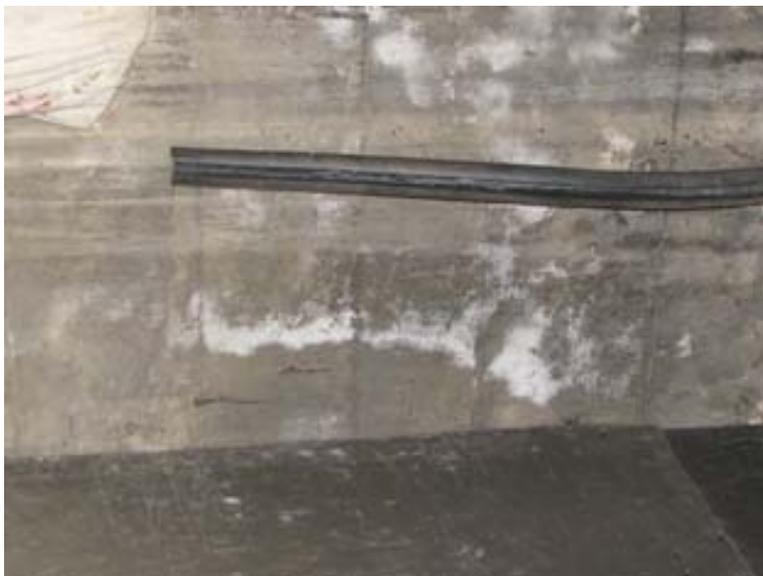
**Picture 2**

The basement walls in the boiler room exhibited numerous areas of efflorescence (Picture 2). Efflorescence is a characteristic sign of water damage to cement, but it is not mold growth. As moisture penetrates and works its way through seams in the cement, water-soluble compounds in the cement dissolve, creating a solution. As this solution moves to the surface of the cement, the water evaporates, leaving behind white, powdery mineral deposits.

**Efflorescence on basement wall**

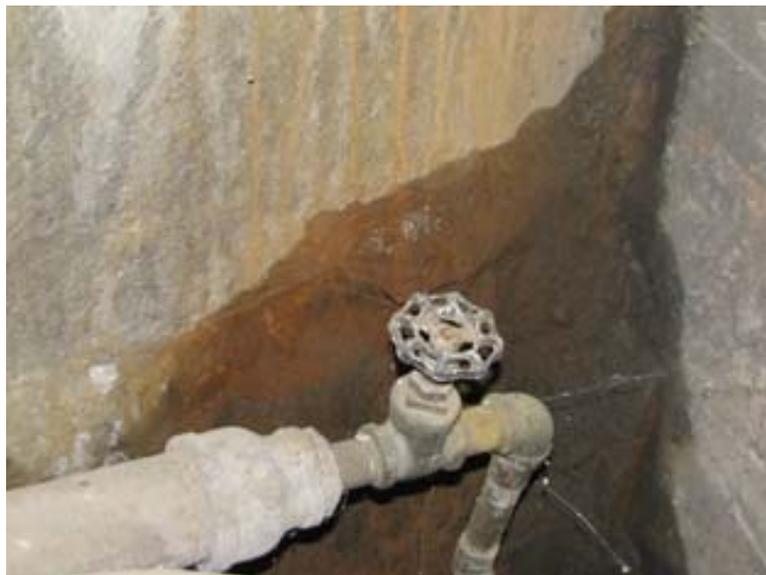
**Picture 3**

The corner of the wall near the entrance to the crawlspace was moist. An old glass pitcher was placed beneath a water line in the same area (Pictures 3 and 4). No appreciable amount of water was observed in the pitcher at the time of the assessment.

**Moist stone wall in boiler room**

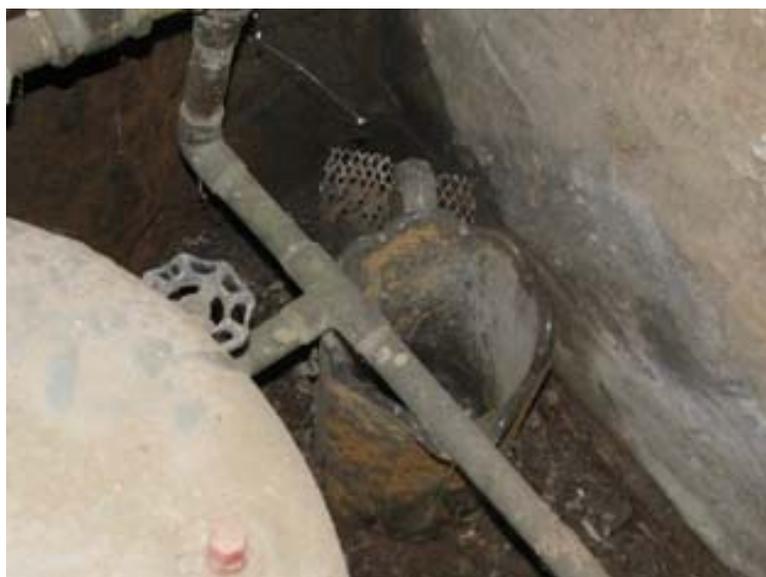
**Picture 4**

**Glass pitcher positioned below water line**

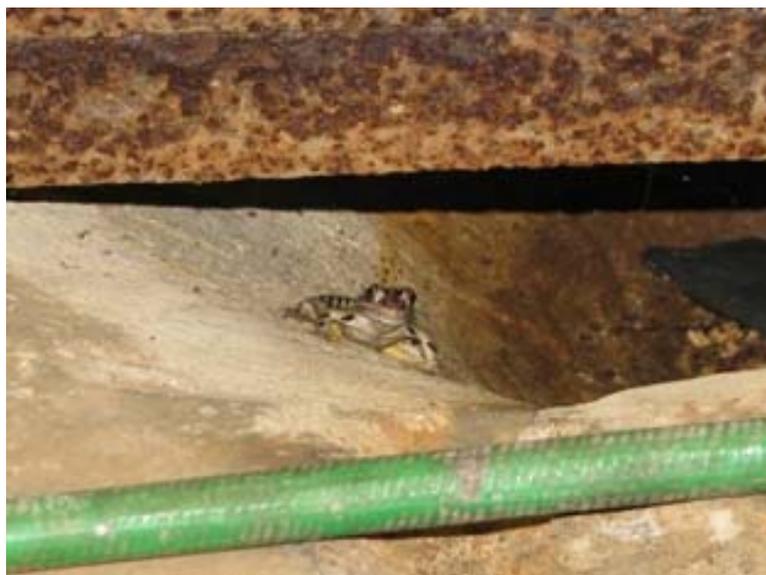
**Picture 5**

materials capable of supporting mold growth were stored on the floor of the boiler room. Additionally, a frog was noted near the floor drain in the boiler room indicating moist conditions may be present in the room (Picture 5). Many metal components within the boiler room, including pipes and ducts, exhibited substantial oxidation, indicating that moist conditions are or have been a regular occurrence in this room.

**Frog in boiler room**

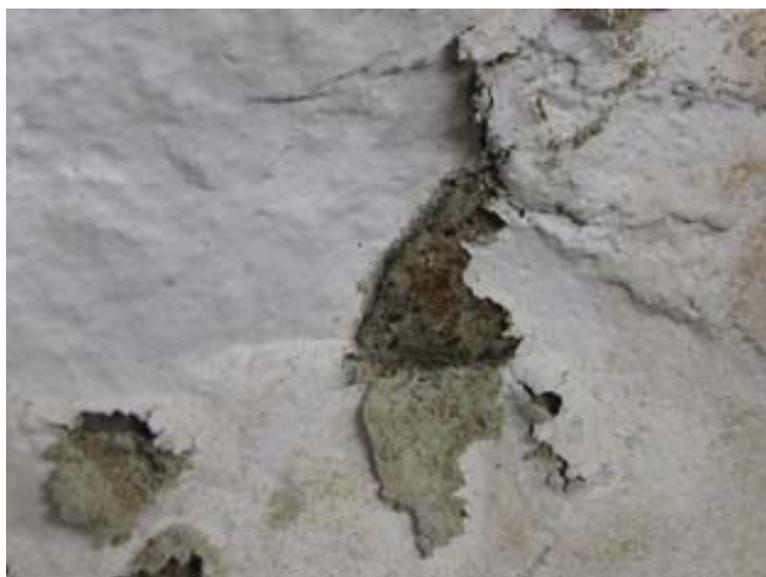
**Picture 6**

In the basement storage room, the stone wall adjacent to the crawlspace exhibits peeling paint and discoloration from water intrusion (Picture 6). The gypsum wallboard (GW) in this area was heavily colonized with mold (Picture 7). Wooden shelves utilized for storage of cardboard boxes exhibited moisture in the areas that had contact with the floor. The GW at floor level beneath these shelving units exhibited mold colonization as well. Additionally, a soft-sided cooler in the storage room demonstrated heavy mold colonization (Picture 8). Of note is a white powdery material (e.g., efflorescence) on the floor of the storage area. This condition indicates that moisture is migrating through the foundation floor in this area.

**Peeling paint on stone in basement storage room**

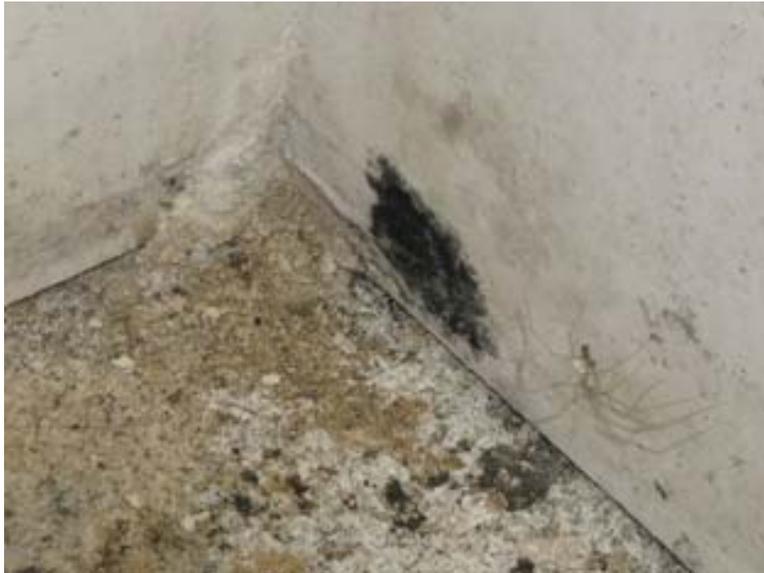
**Picture 7**

**Mold colonization on storage room walls**

5. Remove water damaged/mold colonized materials (carpeting in activity room and gypsum wallboard (GW) and any affected insulation in the basement storage areas as well as the wallboard in the boiler room), after consultation with asbestos inspector (See short term recommendation # 4). This measure will remove actively growing mold colonies that may be present. Remove mold contaminated materials in a manner consistent with recommendations found in “Mold Remediation in Schools and Commercial Buildings” published by the US Environmental Protection Agency (US EPA, 2001). Copies of this document can be downloaded from the US EPA website at: [http://www.epa.gov/iaq/molds/mold\\_remediation.html](http://www.epa.gov/iaq/molds/mold_remediation.html).

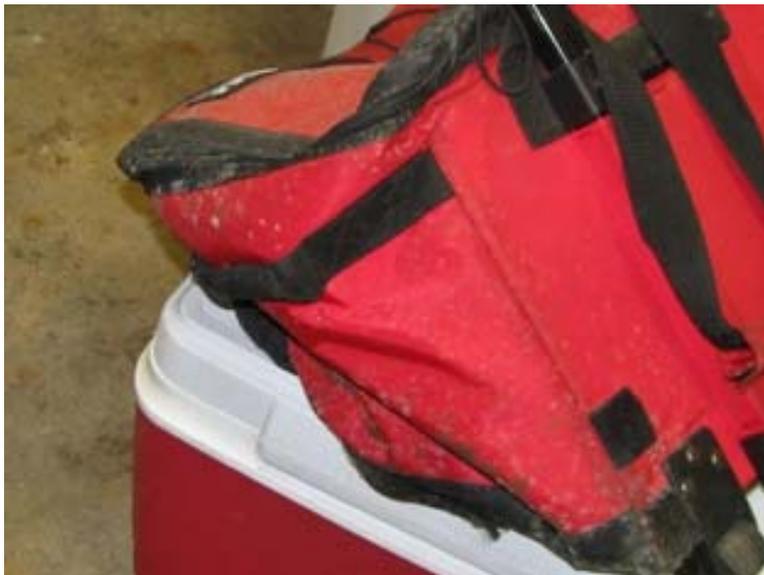
**Picture 8**

**Mold colonization on items stored in basement**

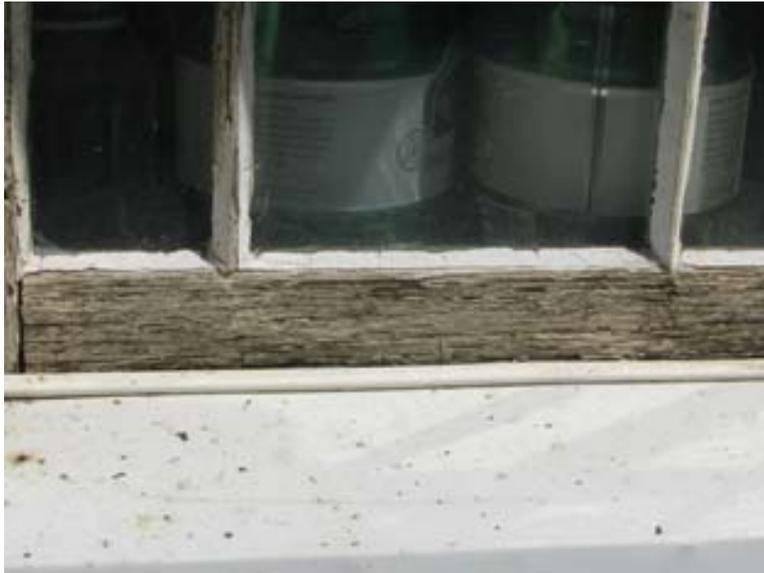
**Picture 9**

**Moisture damaged window rail**

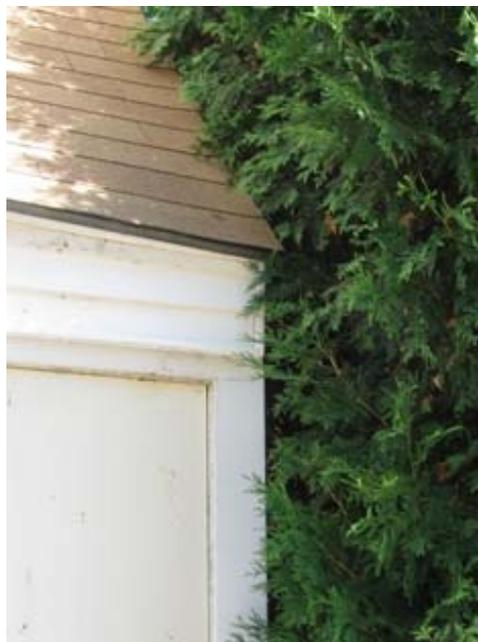
**Picture 10**

- Lawn appears to slope toward the foundation on the north side of the building.
- Shrubbery was observed growing against the building in some areas (Picture 10). The growth of roots against exterior walls can bring moisture in contact with the foundation. Plant roots can eventually penetrate, leading to cracks and/or fissures in the sublevel foundation.

**Shrubbery growing against building**

16. Cut shrubbery in a manner to maintain a space of 5 feet from the building. If possible, improve the grading of the ground away from the foundation at a rate of 6 inches per every 10 feet (Lstiburek & Brennan, 2001). Reduce shaded area on the north side of the building by removing/trimming large trees.

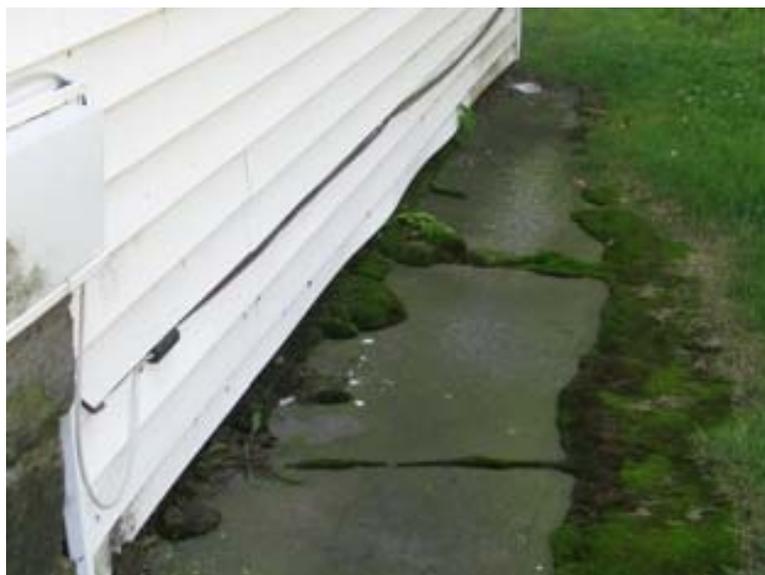
**Picture 11**

- Moss was observed growing on the apron and foundation on the north side of the building (Picture 11).

The presence of moss is indicative of repeated water exposure. The two main requirements of a moss are sufficient moisture and accessible nutrients. The north side of the SSC is well shaded by large trees, which allows the area to stay moist and is conducive to moss growth. Additionally, the shade and moist conditions on the north side of the SSC may be contributing to possible mold growth on the vinyl siding (Picture 12). Since this area is beneath and adjacent to the air conditioners that serve the SSC, the siding should be periodically cleaned as necessary to prevent mold and particulates from entering the building. Additionally, air conditioners are normally equipped with filters, which should be cleaned or changed as per manufacturer's instructions to avoid the build-up and re-aerosolization of dirt, dust and particulate matter.

**Moss growth on lawn, apron and stone foundation**

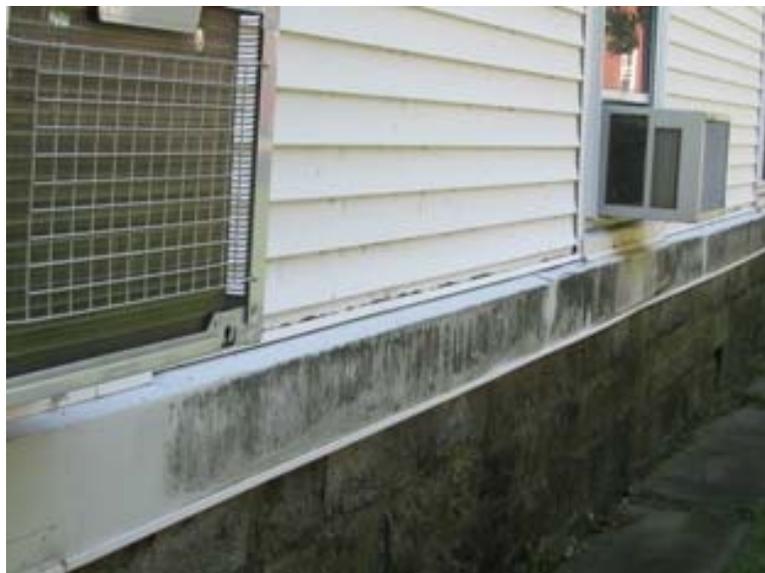
**Picture 12**

**Accumulation of debris and probable mold growth on siding**

25. Clean ceiling fans and personal fans to eliminate the potential of re-distributing dust in the building.
  26. Wash dirt and mold formation off the siding on the north side of building.

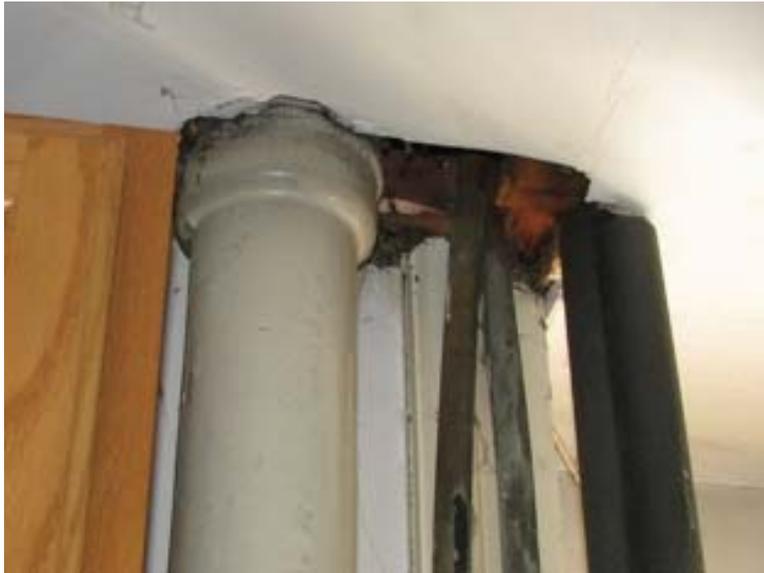
**Picture 13**

Other conditions that can affect indoor air quality were observed during the assessment. Numerous open utility holes were observed in floors, walls and ceilings on the first floor as well as the basement (Picture 13). Open utility holes can provide a means of egress for odors, fumes, dusts and vapors as well as rodents between rooms and floors.

**Open penetration into the ceiling of the kitchen**

6. During removal of building materials use local exhaust ventilation and isolation techniques to control remediation pollutants.
7. Seal any utility holes and other potential pathways to eliminate pollutant paths of migration from the basement/crawlspace to the first floor. Ensure tightness by monitoring for light penetration and drafts.

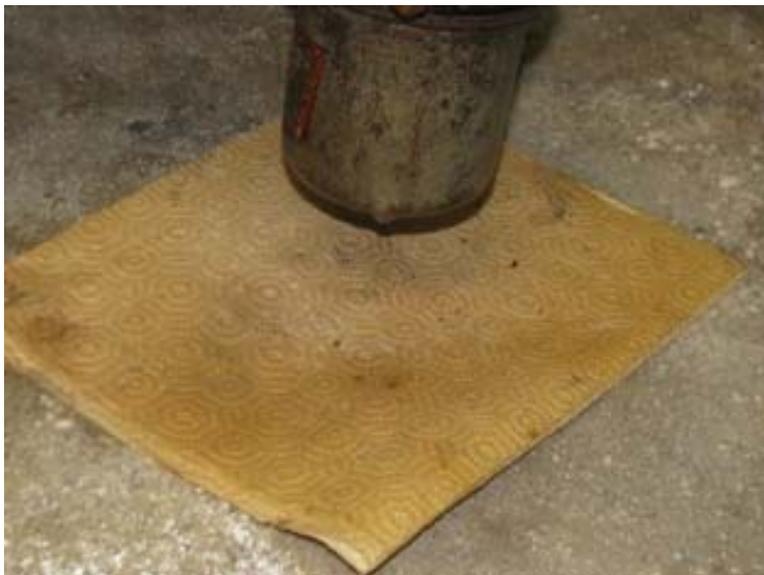
**Picture 14**

The odor of fuel oil was present upon entering the basement stairwell. A stained absorbent pad was positioned beneath the oil filter during the assessment (Picture 14). These odors can be distributed throughout the building through open penetrations as well. The large number of open utility holes in the basement would allow the odors to easily migrate to the first floor. Health effects from exposure to fuel oils vary depending upon the type of fuel vapors one is exposed to, however, such fuel vapors should not be present in a typical indoor environment. The following steps should be employed to remedy the occurrence of fuel oil vapors entering the office space:

**Absorbent pad beneath fuel oil filter**

- The source of fuel odor in the basement must be immediately identified and remedied.
- All of the open utility holes in the basement and crawlspace must be properly sealed.

- appropriate placement of a carbon monoxide detector, and install one as directed for the protection of the occupants in the SSC.
21. Identify and eliminate the source of fuel odor in the basement.

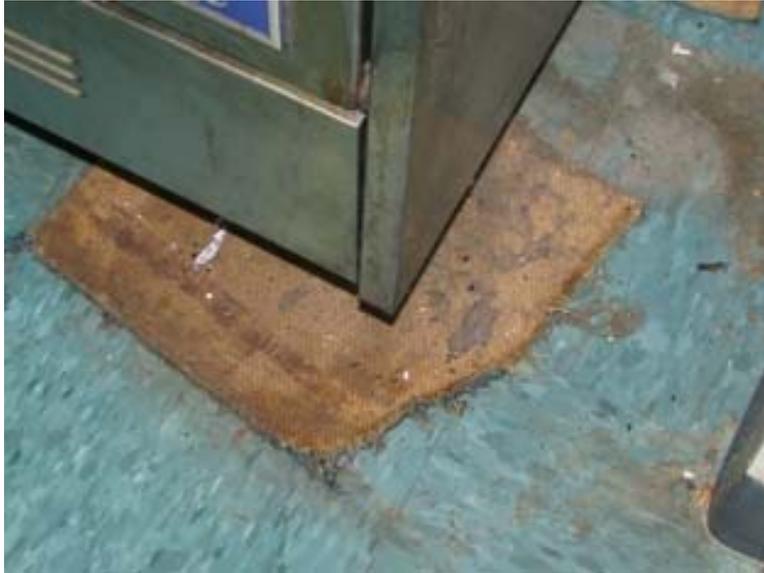
**Picture 15**

In the kitchen, the floor and wall adjacent to the stove as well as some of the carpet beneath the stove exhibit organic accumulation, which may attract rodents (Picture 15). Rodent infestation results from easy access to food and water in a building. Rodent infestation can result in indoor air quality related symptoms due to materials in their wastes. Mouse urine contains a protein that is a known sensitizer (US EPA, 1992). In order to prevent a rodent infestation, and subsequent exposure to allergens, reduction/elimination of pathways/food sources that may attract rodents is necessary. In addition, windows to the crawlspace are open with the exception of metal bars (Picture 16). This condition may allow insects and rodents easy access to the building. Installing screens in the windows would eliminate these points of entry.

**Organic accumulation on floor of kitchen**

23. Store and dispose of fluorescent light bulbs in accordance with DEP guidelines.
  24. Remove organic debris from floor and walls adjacent to stove. Remove carpet squares from beneath stove.

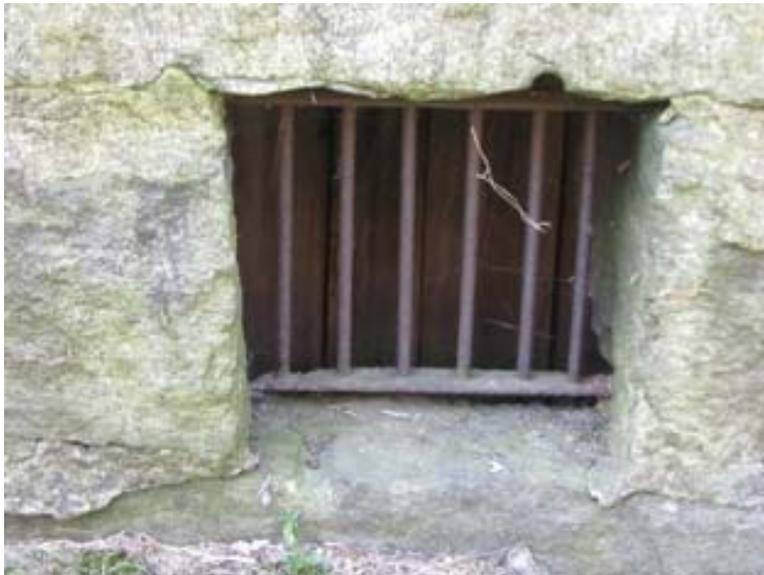
**Picture 16**

**Metal bars on crawlspace window (note: no screening)**

11. Repair hole at rear gable end of building.
12. Repair siding as well as broken storm windows and broken panes of glass and deteriorated glazing. Consider installing screening in crawlspace windows to prevent entry of pests into the building.

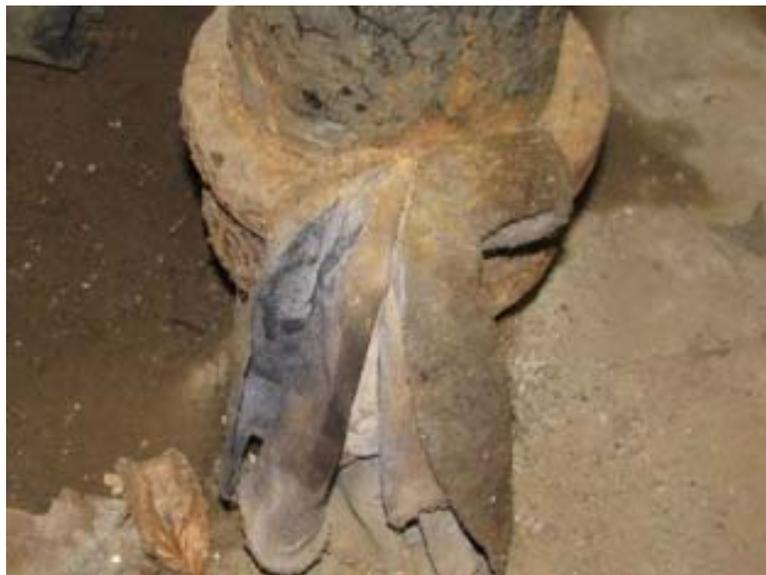
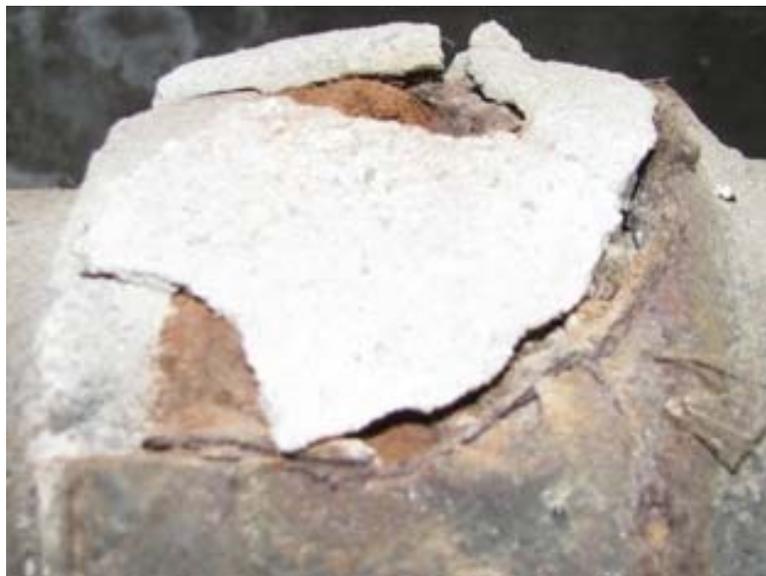
A basement sewer line is deteriorated. At a joint close to the floor, it appears as if a cloth has been placed between two pipes. At the top of the same line was an apparent repair to a hole in the line that has now failed (Pictures 17 and 18). This deteriorated condition may allow sewer gas to enter the basement. Exposure to sewer gas causes nuisance odors and may be an irritant to susceptible individuals.

**Sewer line in boiler room**

**Old, crumbling repair to sewer line**

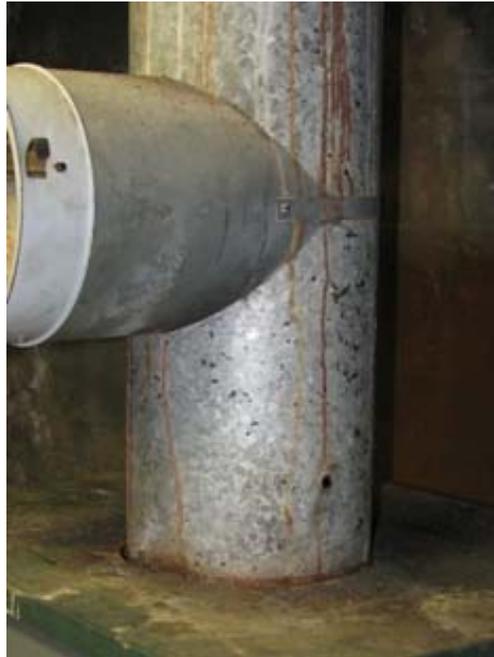
**Picture 19**

BEH staff observed a hole in the exhaust ductwork to the boiler system (Picture 19). If breaches are present in the ductwork, exhaust emissions such as carbon monoxide can be released into the indoor environment. Exhaust ducts are heavily corroded and exhibit evidence of consistent presence of water on the interior of the duct. The junction of the boiler exhaust duct with a rusted metal duct is stuffed with insulation (Pictures 20 and 21). This condition may also allow carbon monoxide to be released into the basement. During the assessment, it appeared that the make up air vent for this room had been sealed. Boilers require oxygen from air to support combustion. If the make up air vents are closed, the boiler will draw air from the interior of the building. This condition may deprive the boiler of an adequate air supply that can result in incomplete combustion. Incomplete combustion can result in an increased production of *carbon monoxide* from the boiler. In order to avoid this condition, the makeup air vent should be opened to allow for an adequate supply of oxygen to the boiler.

**Hole in boiler duct**

22. Contact an HVAC engineering firm to evaluate the entire heating system, including the heavily rusted ducts, the apparent moisture in the ducts, holes in ducts, the junction of the boiler duct to the rusted metal outlet, and whether the seal of this connection is adequate. Make repairs to the system to prevent the escape of exhaust emissions into the building. Additionally, the specialist should also determine whether adequate draw of exhaust is occurring due to the length of the line from the boiler exhaust duct to the chimney. Once system is in good repair, have boiler inspected annually or as per the manufacturer's instructions to ensure continued proper operation.

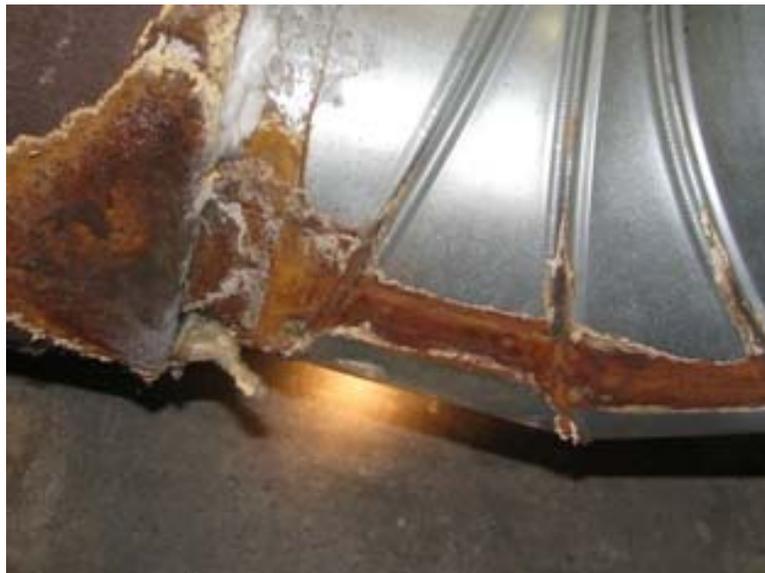
**Picture 20**

**Heavy oxidation of exhaust duct  
Note evidence of water leakage as well as protruding insulation**

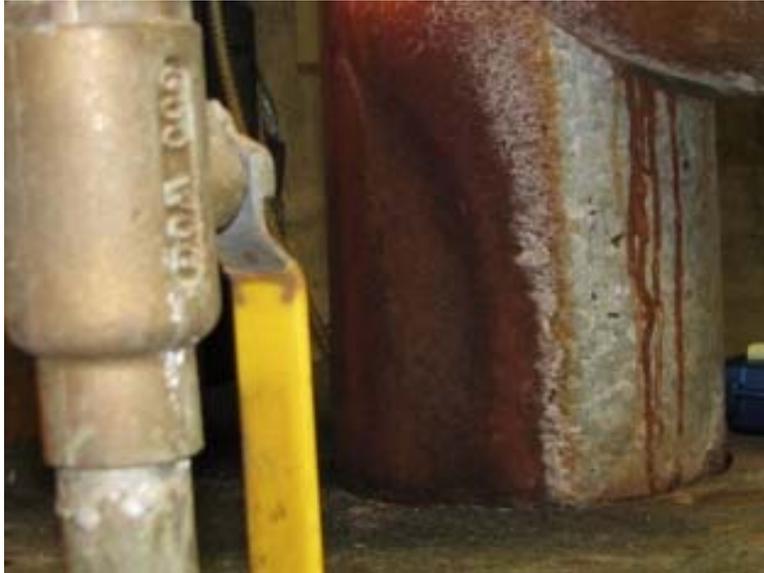
**Picture 21**

**Heavy oxidation of boiler duct**
