INDOOR AIR QUALITY ASSESSMENT

**Shelburne Senior Center
7 Main Street
Shelburne Falls, Massachusetts 01370**

Prepared by:
Massachusetts Department of Public Health
Bureau of Environmental Health
Indoor Air Quality Program
October 2008

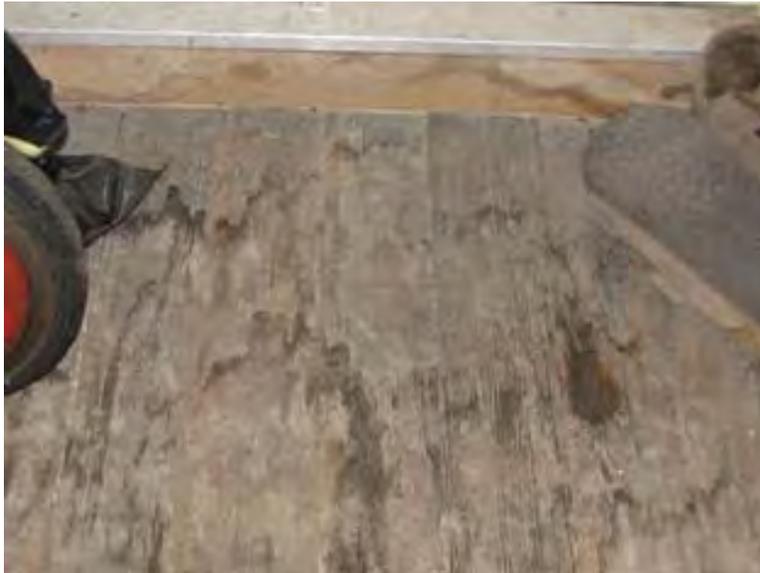
Picture 1

The basement of the SSC exhibited the effects of chronic dampness. The wooden landing at the top of the basement stairs exhibited signs of moisture (Picture 1). Water stains were also evident adjacent to the exterior door's threshold. BEH was informed that the Director did store his boots on this landing throughout the winter. The exterior door at the top of these stairs did not appear weathertight as daylight was visible from the landing.

Water damaged landing at top of basement stairs

27. Repair rotted threshold on south side of the building.
 28. Exterior door to the basement should be made weather-tight.
 29. Investigate origin of vents on exterior of the building wall.

30. Eliminate storage of wet items such as boots on basement stairway landing.
 31. For buildings in New England, periods of low relative humidity during the winter are often unavoidable. Therefore, scrupulous cleaning practices should be adopted to

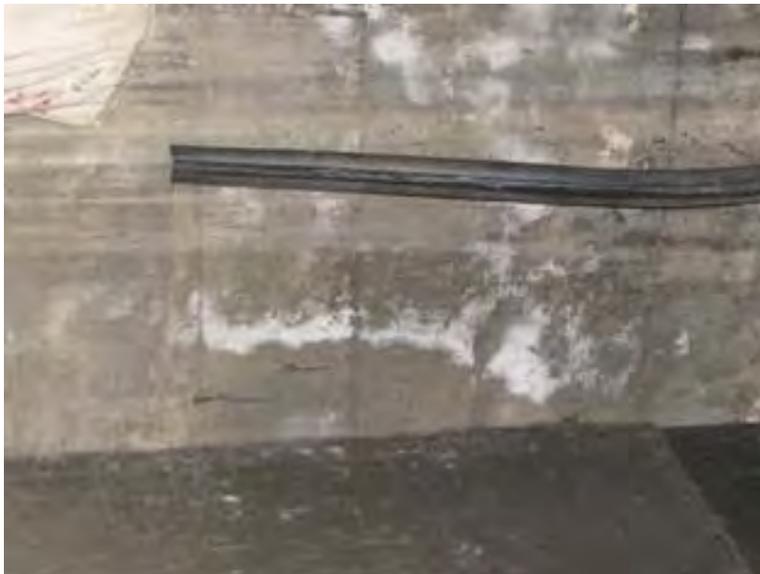
Picture 2

The basement walls in the boiler room exhibited numerous areas of efflorescence (Picture 2). Efflorescence is a characteristic sign of water damage to cement, but it is not mold growth. As moisture penetrates and works its way through seams in the cement, water-soluble compounds in the cement dissolve, creating a solution. As this solution moves to the surface of the cement, the water evaporates, leaving behind white, powdery mineral deposits.

Efflorescence on basement wall

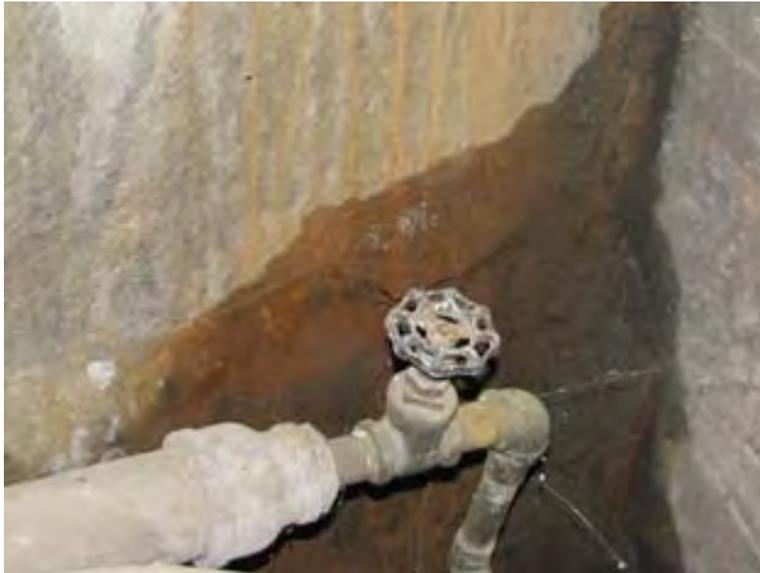
Picture 3

The corner of the wall near the entrance to the crawlspace was moist. An old glass pitcher was placed beneath a water line in the same area (Pictures 3 and 4). No appreciable amount of water was observed in the pitcher at the time of the assessment.

Moist stone wall in boiler room

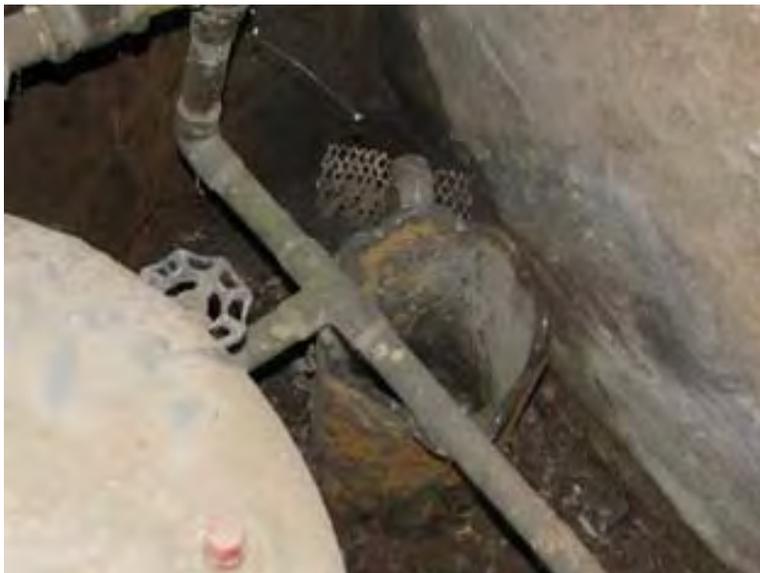
Picture 4

Glass pitcher positioned below water line

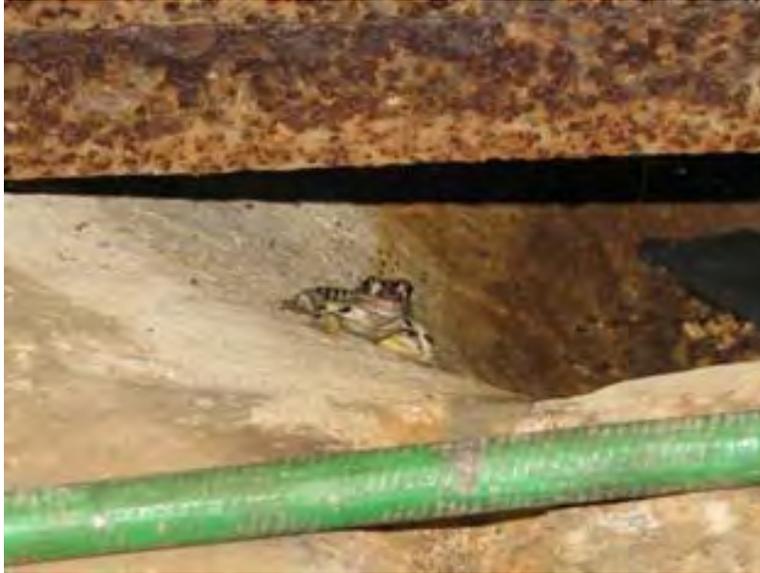
Picture 5

materials capable of supporting mold growth were stored on the floor of the boiler room. Additionally, a frog was noted near the floor drain in the boiler room indicating moist conditions may be present in the room (Picture 5). Many metal components within the boiler room, including pipes and ducts, exhibited substantial oxidation, indicating that moist conditions are or have been a regular occurrence in this room.

Frog in boiler room

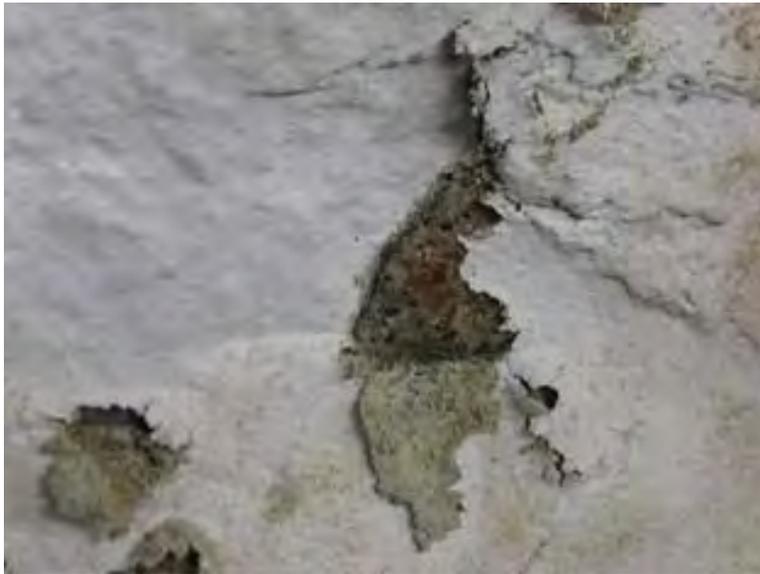
Picture 6

In the basement storage room, the stone wall adjacent to the crawlspace exhibits peeling paint and discoloration from water intrusion (Picture 6). The gypsum wallboard (GW) in this area was heavily colonized with mold (Picture 7). Wooden shelves utilized for storage of cardboard boxes exhibited moisture in the areas that had contact with the floor. The GW at floor level beneath these shelving units exhibited mold colonization as well. Additionally, a soft-sided cooler in the storage room demonstrated heavy mold colonization (Picture 8). Of note is a white powdery material (e.g., efflorescence) on the floor of the storage area. This condition indicates that moisture is migrating through the foundation floor in this area.

Peeling paint on stone in basement storage room

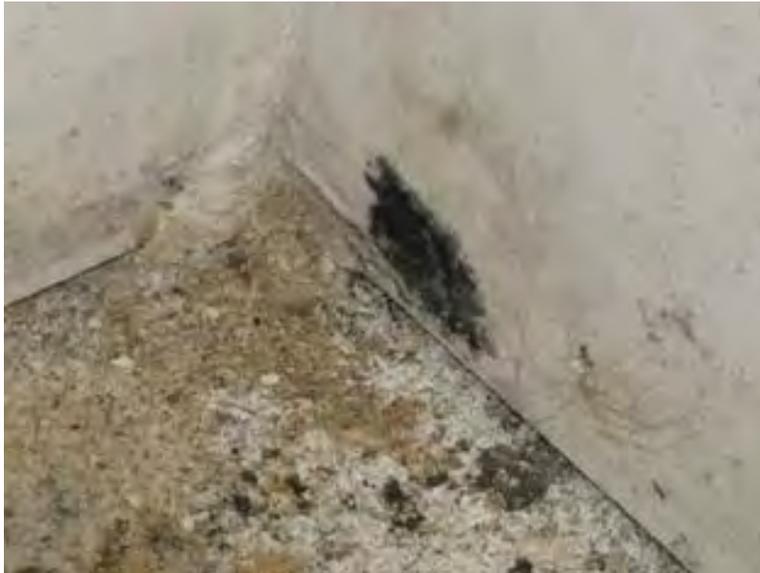
Picture 7

Mold colonization on storage room walls

5. Remove water damaged/mold colonized materials (carpeting in activity room and gypsum wallboard (GW) and any affected insulation in the basement storage areas as well as the wallboard in the boiler room), after consultation with asbestos inspector (See short term recommendation # 4). This measure will remove actively growing mold colonies that may be present. Remove mold contaminated materials in a manner consistent with recommendations found in “Mold Remediation in Schools and Commercial Buildings” published by the US Environmental Protection Agency (US EPA, 2001). Copies of this document can be downloaded from the US EPA website at: http://www.epa.gov/mold/mold_remediation.html.

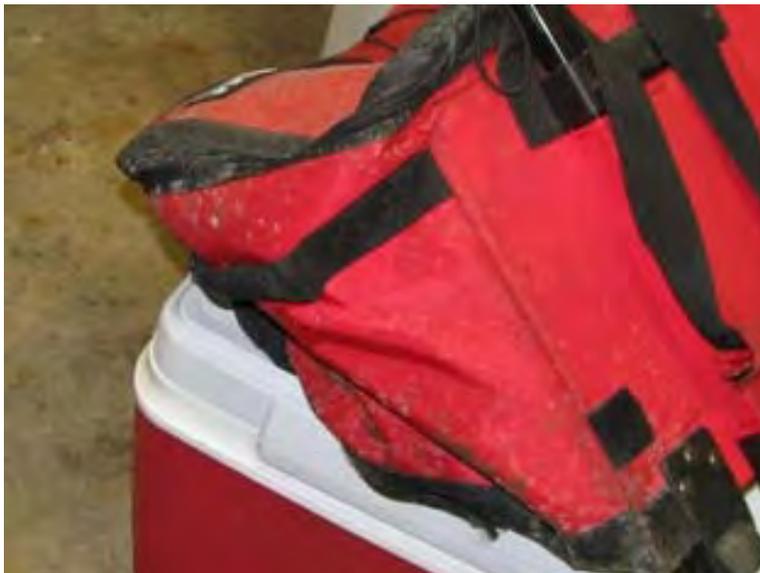
Picture 8

Mold colonization on items stored in basement

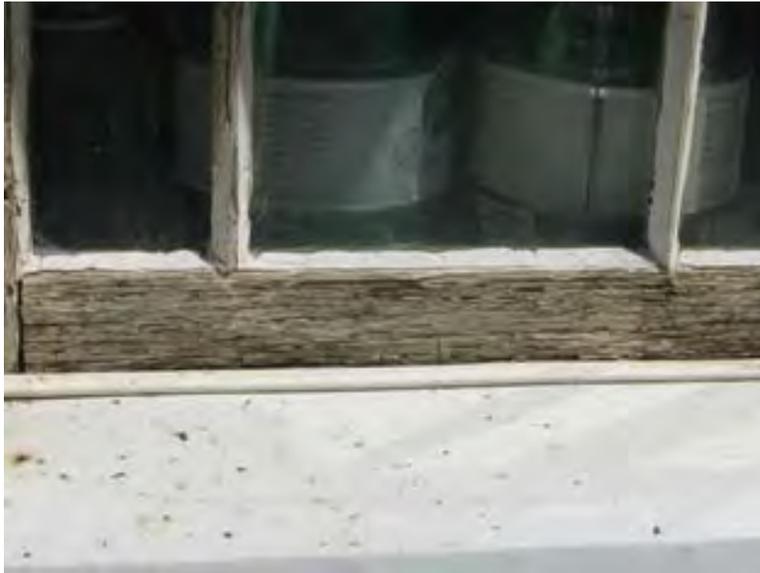
Picture 9

Moisture damaged window rail

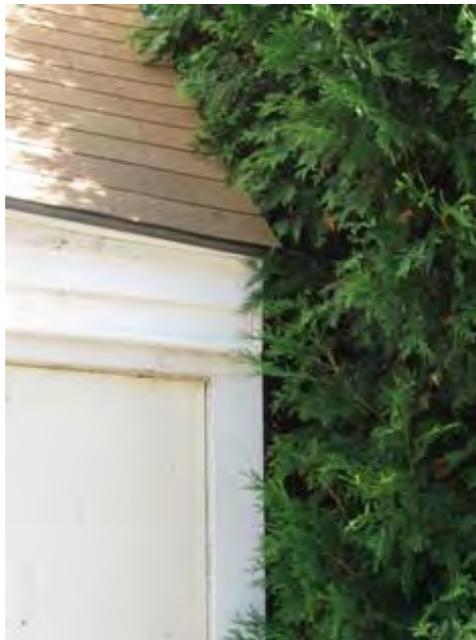
Picture 10

- Lawn appears to slope toward the foundation on the north side of the building.
- Shrubbery was observed growing against the building in some areas (Picture 10). The growth of roots against exterior walls can bring moisture in contact with the foundation. Plant roots can eventually penetrate, leading to cracks and/or fissures in the sublevel foundation.

Shrubbery growing against building

16. Cut shrubbery in a manner to maintain a space of 5 feet from the building. If possible, improve the grading of the ground away from the foundation at a rate of 6 inches per every 10 feet (Lstiburek & Brennan, 2001). Reduce shaded area on the north side of the building by removing/trimming large trees.

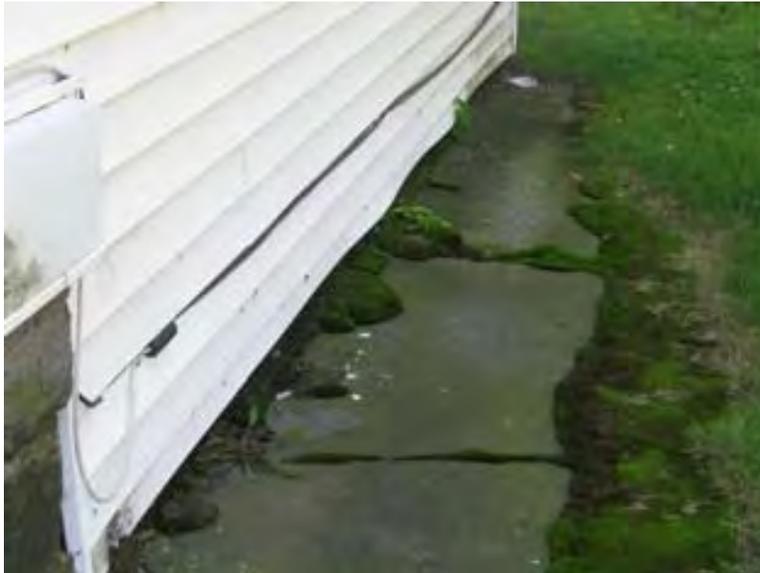
Picture 11

- Moss was observed growing on the apron and foundation on the north side of the building (Picture 11).

The presence of moss is indicative of repeated water exposure. The two main requirements of a moss are sufficient moisture and accessible nutrients. The north side of the SSC is well shaded by large trees, which allows the area to stay moist and is conducive to moss growth. Additionally, the shade and moist conditions on the north side of the SSC may be contributing to possible mold growth on the vinyl siding (Picture 12). Since this area is beneath and adjacent to the air conditioners that serve the SSC, the siding should be periodically cleaned as necessary to prevent mold and particulates from entering the building. Additionally, air conditioners are normally equipped with filters, which should be cleaned or changed as per manufacturer's instructions to avoid the build-up and re-aerosolization of dirt, dust and particulate matter.

Moss growth on lawn, apron and stone foundation

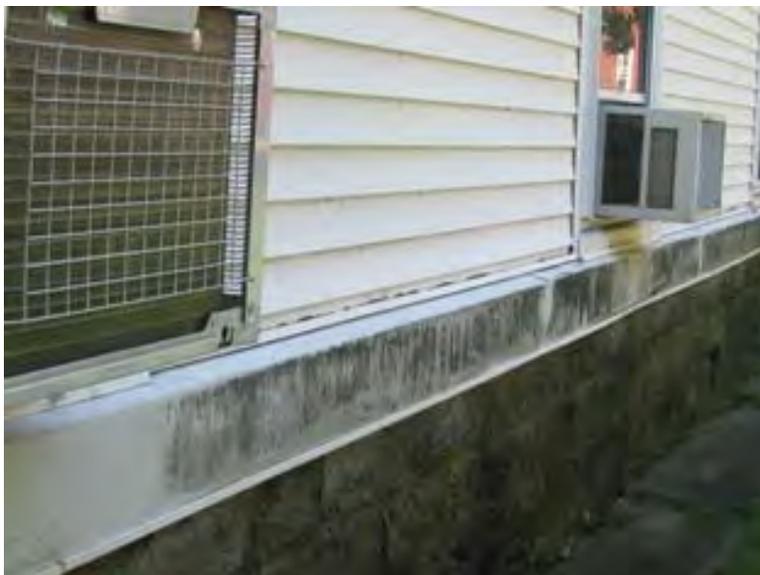
Picture 12

Accumulation of debris and probable mold growth on siding

25. Clean ceiling fans and personal fans to eliminate the potential of re-distributing dust in the building.
 26. Wash dirt and mold formation off the siding on the north side of building.

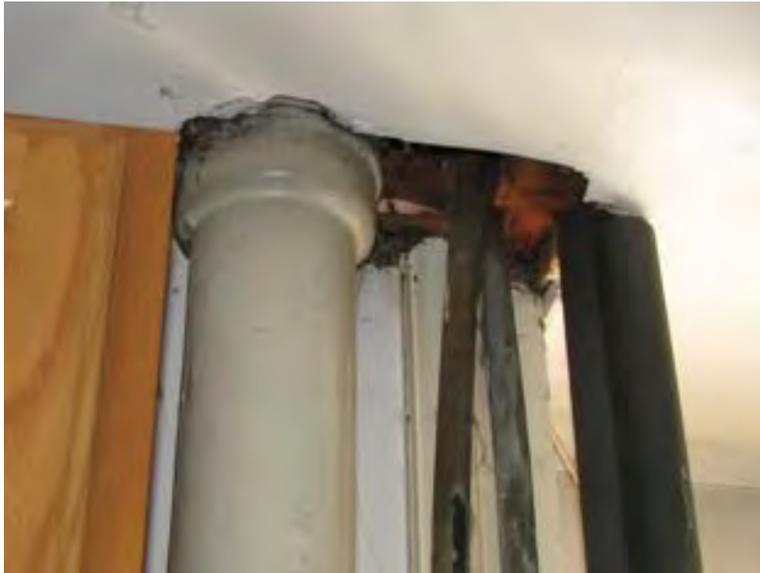
Picture 13

Other conditions that can affect indoor air quality were observed during the assessment. Numerous open utility holes were observed in floors, walls and ceilings on the first floor as well as the basement (Picture 13). Open utility holes can provide a means of egress for odors, fumes, dusts and vapors as well as rodents between rooms and floors.

Open penetration into the ceiling of the kitchen

6. During removal of building materials use local exhaust ventilation and isolation techniques to control remediation pollutants.
7. Seal any utility holes and other potential pathways to eliminate pollutant paths of migration from the basement/crawlspace to the first floor. Ensure tightness by monitoring for light penetration and drafts.

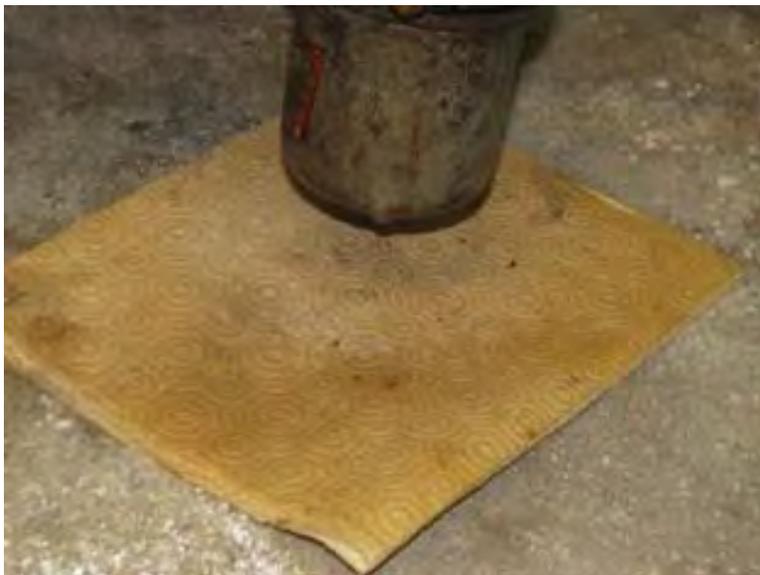
Picture 14

The odor of fuel oil was present upon entering the basement stairwell. A stained absorbent pad was positioned beneath the oil filter during the assessment (Picture 14). These odors can be distributed throughout the building through open penetrations as well. The large number of open utility holes in the basement would allow the odors to easily migrate to the first floor. Health effects from exposure to fuel oils vary depending upon the type of fuel vapors one is exposed to, however, such fuel vapors should not be present in a typical indoor environment. The following steps should be employed to remedy the occurrence of fuel oil vapors entering the office space:

Absorbent pad beneath fuel oil filter

- The source of fuel odor in the basement must be immediately identified and remedied.
- All of the open utility holes in the basement and crawlspace must be properly sealed.

- appropriate placement of a carbon monoxide detector, and install one as directed for the protection of the occupants in the SSC.
21. Identify and eliminate the source of fuel odor in the basement.

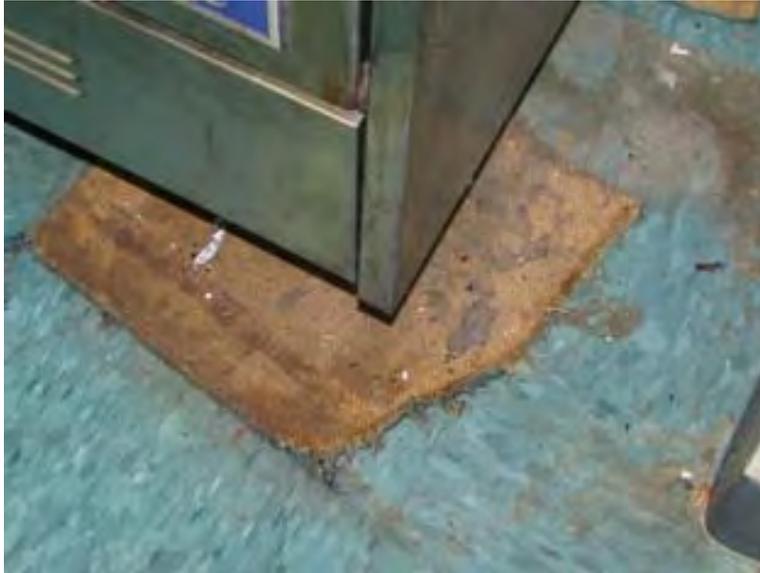
Picture 15

In the kitchen, the floor and wall adjacent to the stove as well as some of the carpet beneath the stove exhibit organic accumulation, which may attract rodents (Picture 15). Rodent infestation results from easy access to food and water in a building. Rodent infestation can result in indoor air quality related symptoms due to materials in their wastes. Mouse urine contains a protein that is a known sensitizer (US EPA, 1992). In order to prevent a rodent infestation, and subsequent exposure to allergens, reduction/elimination of pathways/food sources that may attract rodents is necessary. In addition, windows to the crawlspace are open with the exception of metal bars (Picture 16). This condition may allow insects and rodents easy access to the building. Installing screens in the windows would eliminate these points of entry.

Organic accumulation on floor of kitchen

23. Store and dispose of fluorescent light bulbs in accordance with DEP guidelines.
 24. Remove organic debris from floor and walls adjacent to stove. Remove carpet squares from beneath stove.

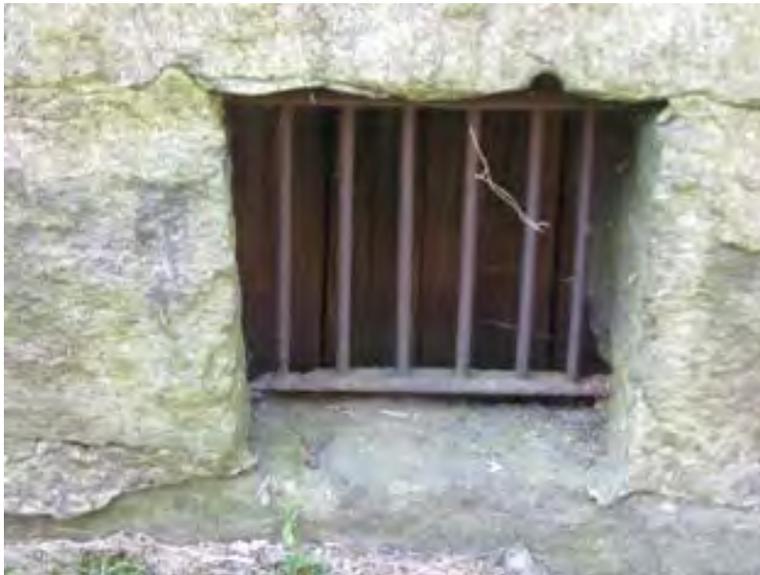
Picture 16

Metal bars on crawlspace window (note: no screening)

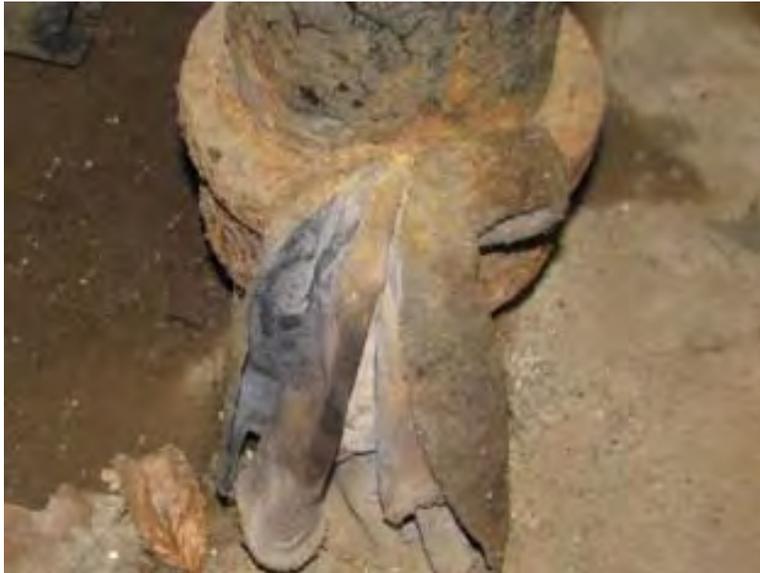
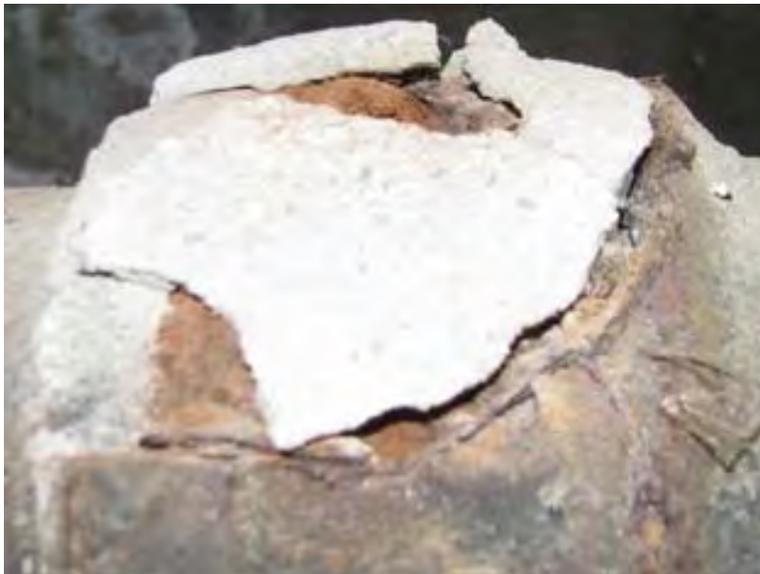
A basement sewer line is deteriorated. At a joint close to the floor, it appears as if a cloth has been placed between two pipes. At the top of the same line was an apparent repair to a hole in the line that has now failed (Pictures 17 and 18). This deteriorated condition may allow sewer gas to enter the basement. Exposure to sewer gas causes nuisance odors and may be an irritant to susceptible individuals.

Sewer line in boiler room

Old, crumbling repair to sewer line

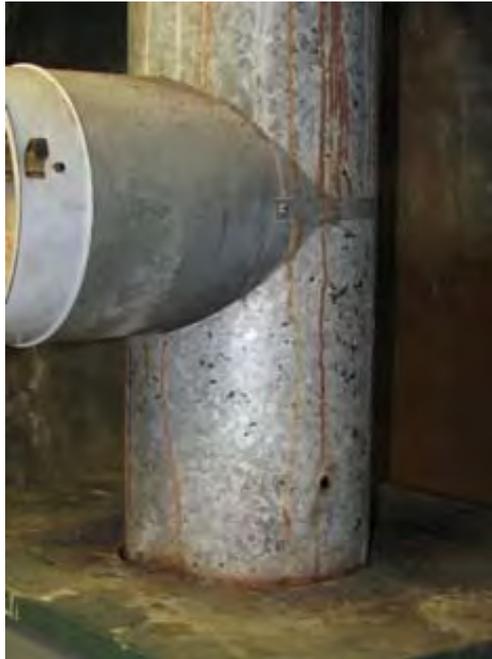
Picture 19

BEH staff observed a hole in the exhaust ductwork to the boiler system (Picture 19). If breaches are present in the ductwork, exhaust emissions such as carbon monoxide can be released into the indoor environment. Exhaust ducts are heavily corroded and exhibit evidence of consistent presence of water on the interior of the duct. The junction of the boiler exhaust duct with a rusted metal duct is stuffed with insulation (Pictures 20 and 21). This condition may also allow carbon monoxide to be released into the basement. During the assessment, it appeared that the make up air vent for this room had been sealed. Boilers require oxygen from air to support combustion. If the make up air vents are closed, the boiler will draw air from the interior of the building. This condition may deprive the boiler of an adequate air supply that can result in incomplete combustion. Incomplete combustion can result in an increased production of *carbon monoxide* from the boiler. In order to avoid this condition, the makeup air vent should be opened to allow for an adequate supply of oxygen to the boiler.

Hole in boiler duct

22. Contact an HVAC engineering firm to evaluate the entire heating system, including the heavily rusted ducts, the apparent moisture in the ducts, holes in ducts, the junction of the boiler duct to the rusted metal outlet, and whether the seal of this connection is adequate. Make repairs to the system to prevent the escape of exhaust emissions into the building. Additionally, the specialist should also determine whether adequate draw of exhaust is occurring due to the length of the line from the boiler exhaust duct to the chimney. Once system is in good repair, have boiler inspected annually or as per the manufacturer's instructions to ensure continued proper operation.

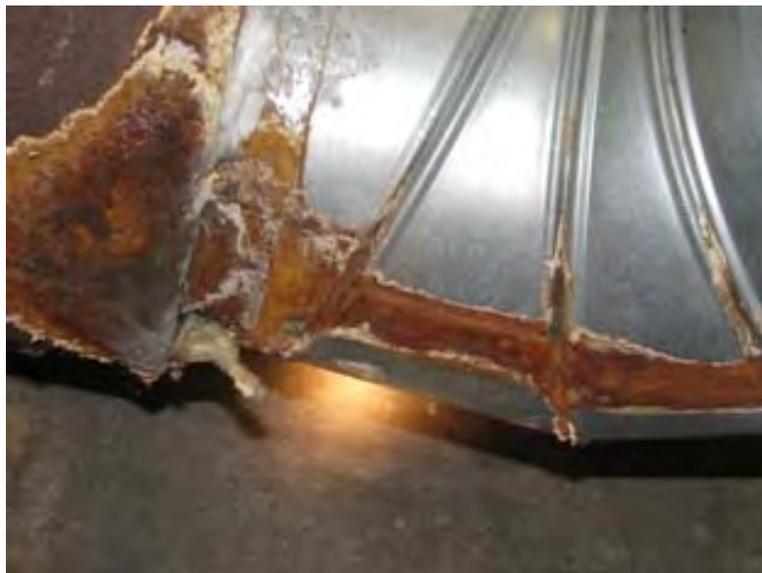
Picture 20

**Heavy oxidation of exhaust duct
Note evidence of water leakage as well as protruding insulation**

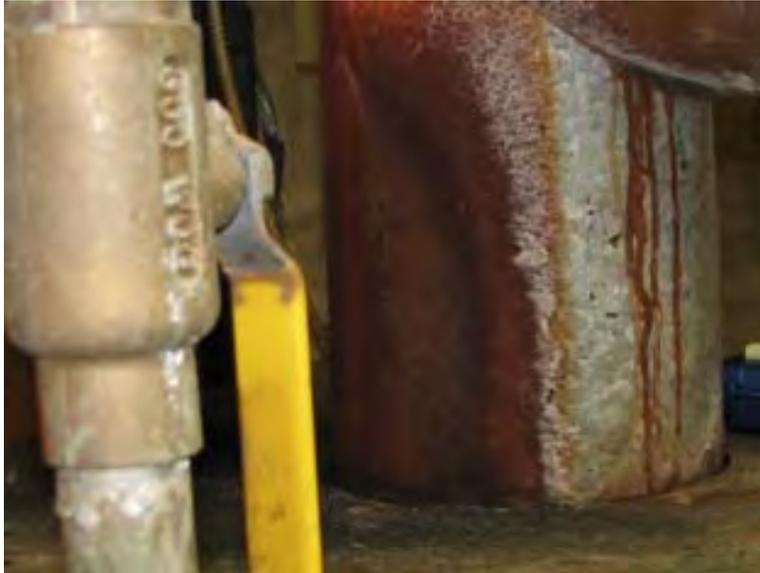
Picture 21

Heavy oxidation of boiler duct
