# **INDOOR AIR QUALITY ASSESSMENT**

**Massachusetts Department of Transitional Assistance  
79 North Street  
Southbridge, Massachusetts 01550**

Prepared by:  
Massachusetts Department of Public Health  
Bureau of Environmental Health  
Indoor Air Quality Program  
July 2008

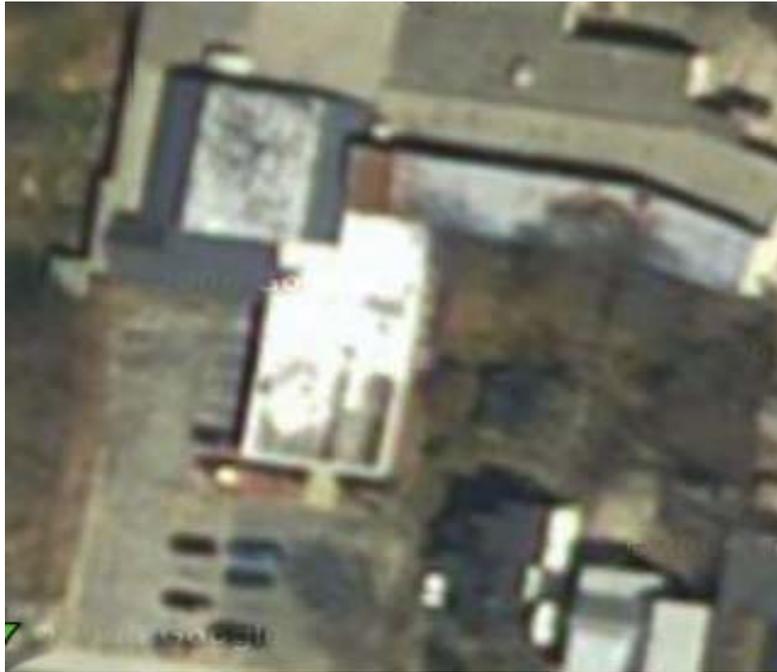
**Picture 1**

The DTA offices are located in a complex of interconnected buildings; namely a one-story brick building built on a slab connected at the rear to a cinderblock building (Picture 1) by an interior ramped corridor. The contrasting building materials and varying roof lines indicate that some sections of the rear building were likely built at different times (Picture 2). The front (brick) building houses administrative personnel for the DTA. The DTA space consists of workstations, offices and common areas. The rear (cinderblock) building contains offices, cubicles and meeting rooms. The second floor of this building is used for storage by the DTA. The Massachusetts Department of Mental Retardation (DMR) also occupies the building.

**Aerial View of Building and Parking Lot**

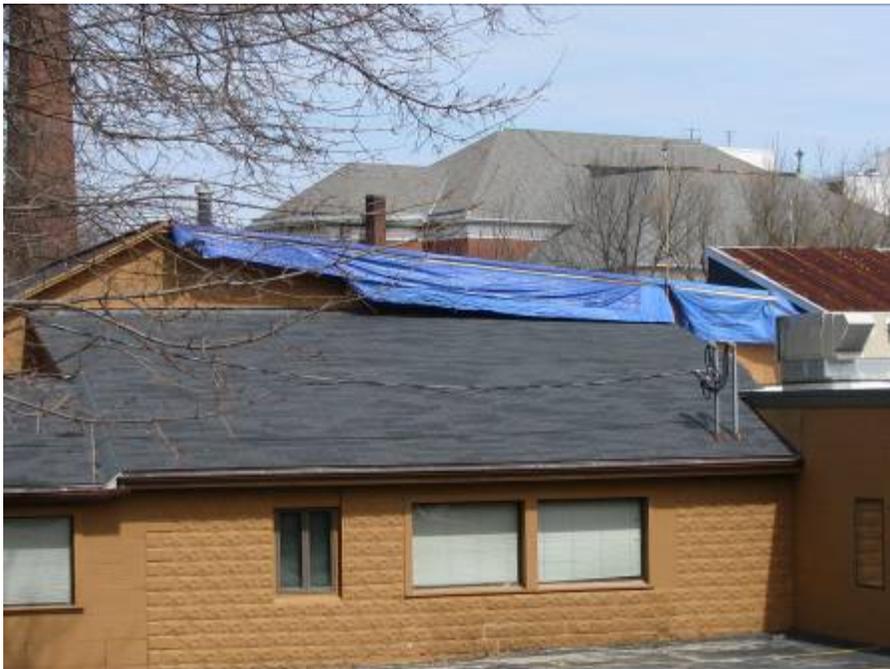
**Picture 2**

Active roof leaks were reported at the DTA. In an effort to prevent these leaks, two large tarps were secured to the rear portion of the building (Pictures 2 and 13). BEH staff observed water-damaged gypsum wallboard in a second floor storage area. Mold growth was found on an area on the wall (Picture 14).

**Differing Building Materials and Roof Line, Note Large Tarp on Rear of Building,**

1. Continue with plans for roof replacement to prevent further leaks into the building. Until roof can be replaced, continue to patch roof leaks as needed.
2. Contact an HVAC engineering firm for an assessment of the ventilation system (e.g., controls, air intake louvers, thermostats). Any abandoned heating system components should be removed or properly sealed at both ends.
3. Set thermostat controls to fan "on" to operate ventilation system in the building continuously during periods of occupancy.
4. Inspect exhaust motors and belts for proper function. Repair and replace as necessary.

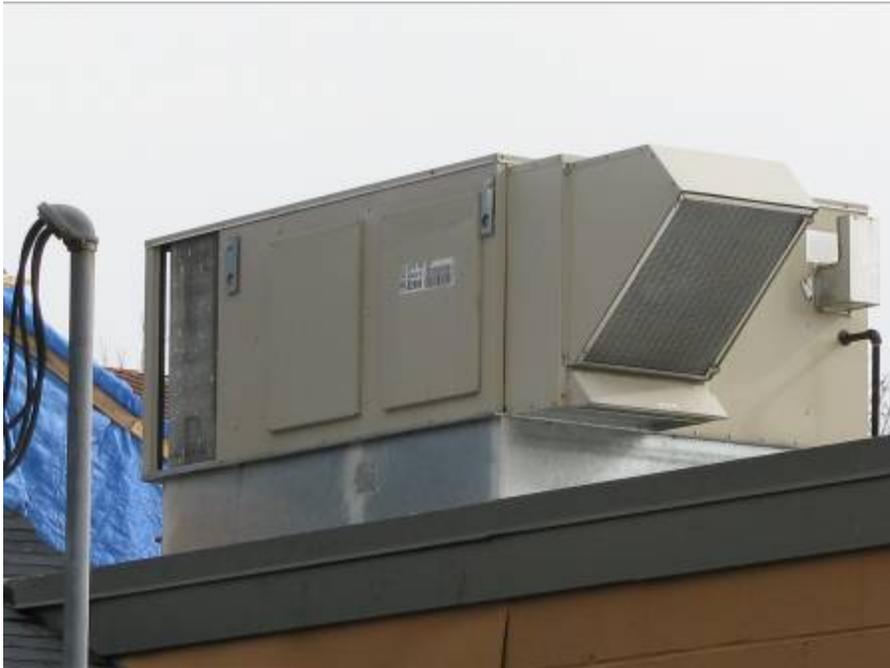
**Picture 3**

**Roof Top Air Handling Unit**

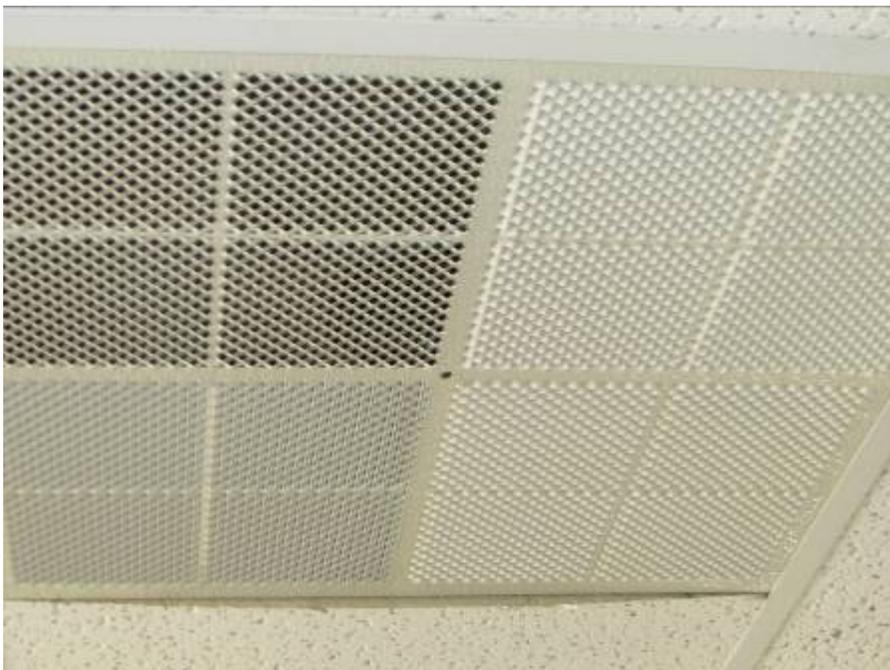
**Picture 4**

Different types of air diffusers and vents were observed throughout the building (Pictures 4 through 8). Several diffusers and vents appeared to be installed more recently than others. The different configuration of vents lead BEH staff to believe that the HVAC system may be zoned separately or that portions of it may no longer be in operation.

**Air Diffuser**

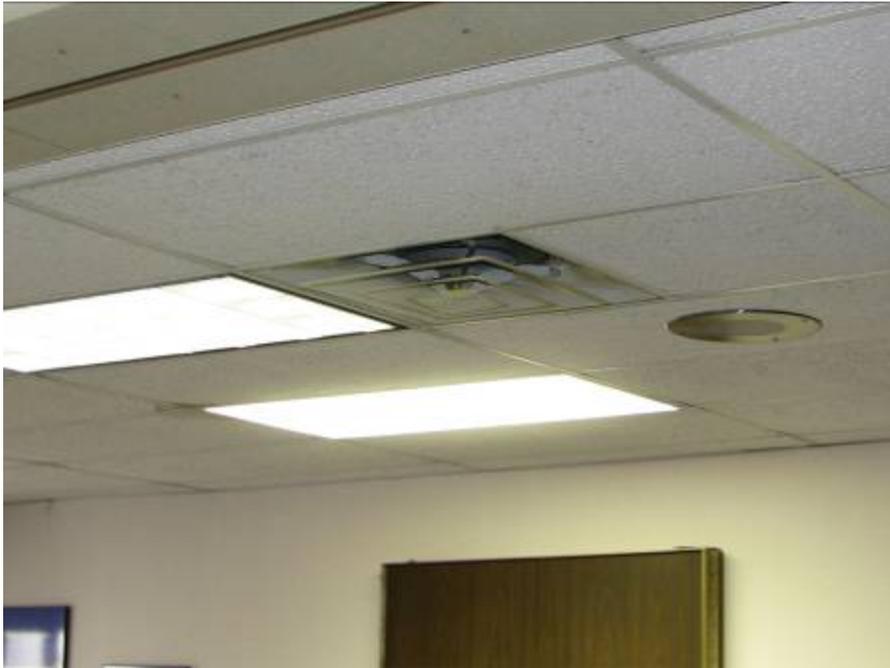
**Picture 5**

**Air Diffuser**

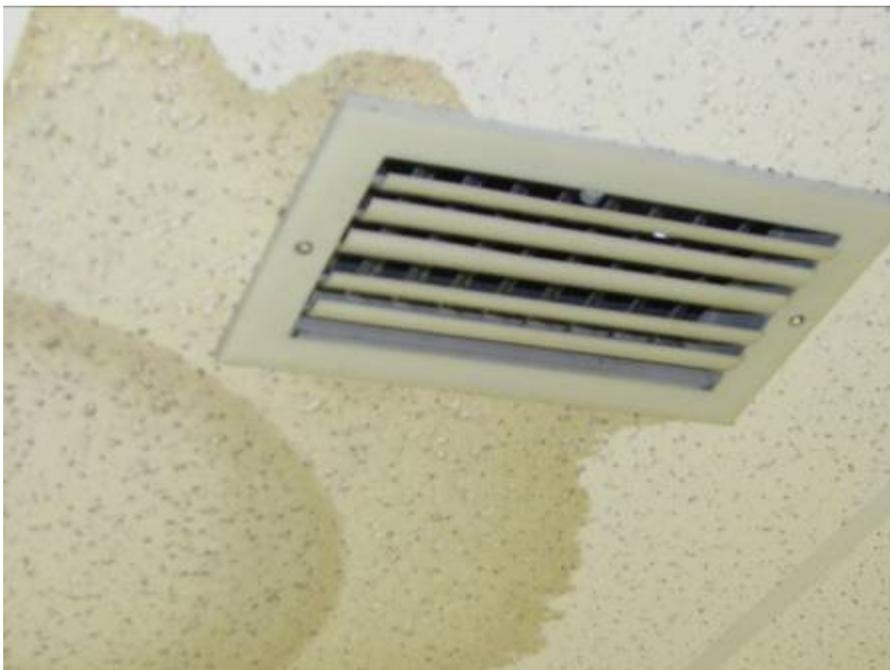
**Picture 6**

**Ceiling Vent, Note Water Damaged Ceiling Tiles**

11. Replace water damaged ceiling tiles. Examine the area above and around these areas for mold growth. Disinfect areas of water leaks with an appropriate antimicrobial.

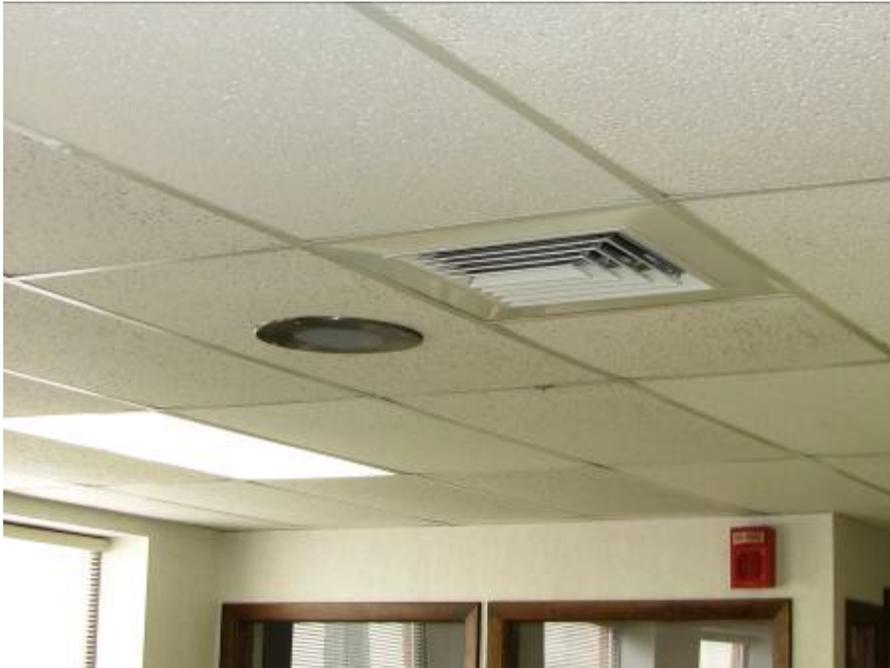
**Picture 7**

**Air Diffuser**

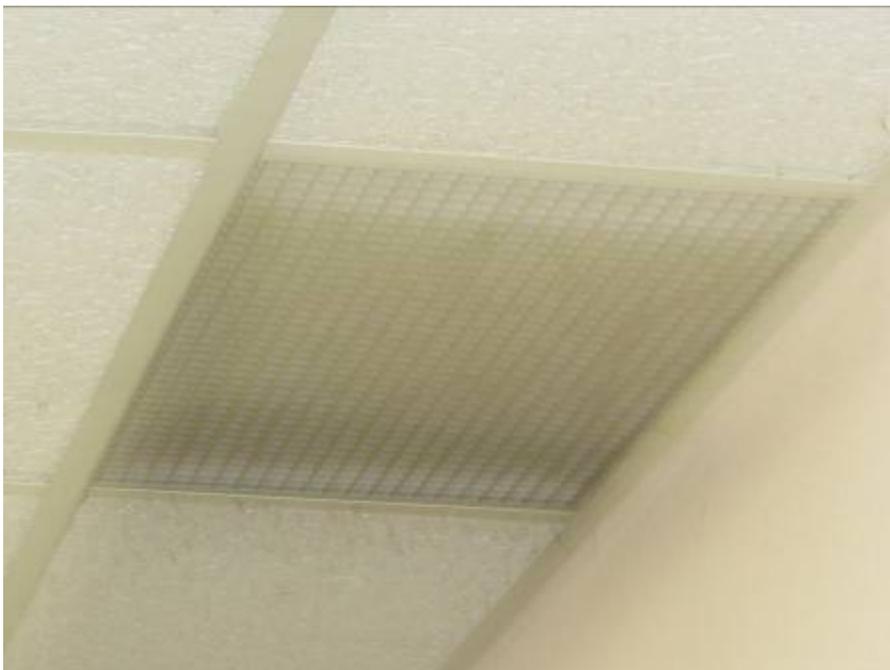
**Picture 8**

**Exhaust Vent**

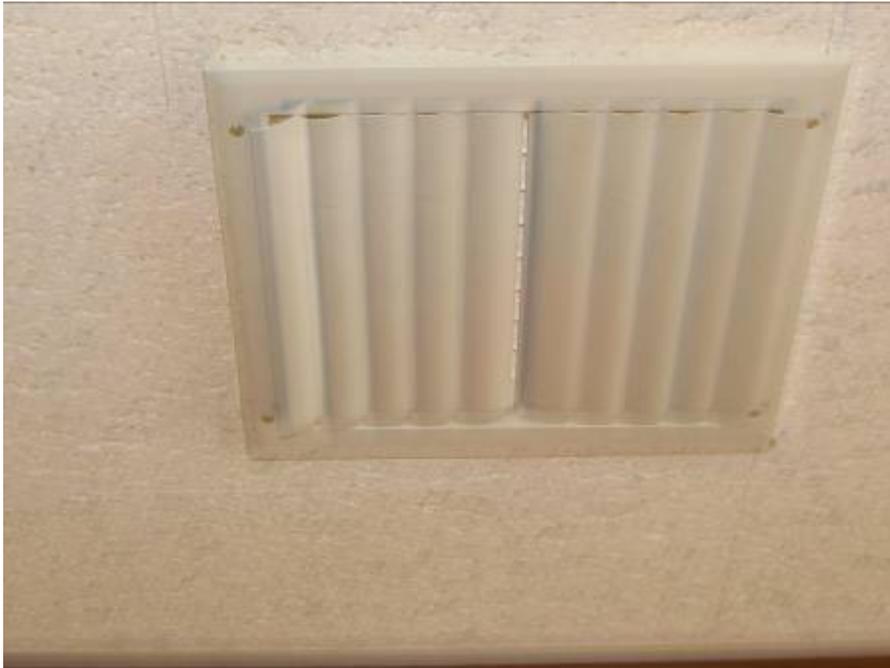
**Picture 9**

Numerous air diffusers in the offices were closed (Picture 9). Many exhaust vents throughout the building had cobwebs on them, indicating minimal air movement (Picture 10). If exhaust vents are not functioning, backdrafting can occur, which can re-aerosolize accumulated dust particles. Several exhaust vents in the administrative wing were located behind office doors (Picture 11). The location of these return vents can limit exhaust efficiency. When doors are open, these vents are blocked. Further, the vents will tend to draw air from both the hallway and the office. Around the perimeter of the large shared office space were a number of small offices. To create airflow, these offices had passive vents in each door (Picture 12).

**Closed Ceiling Vent**

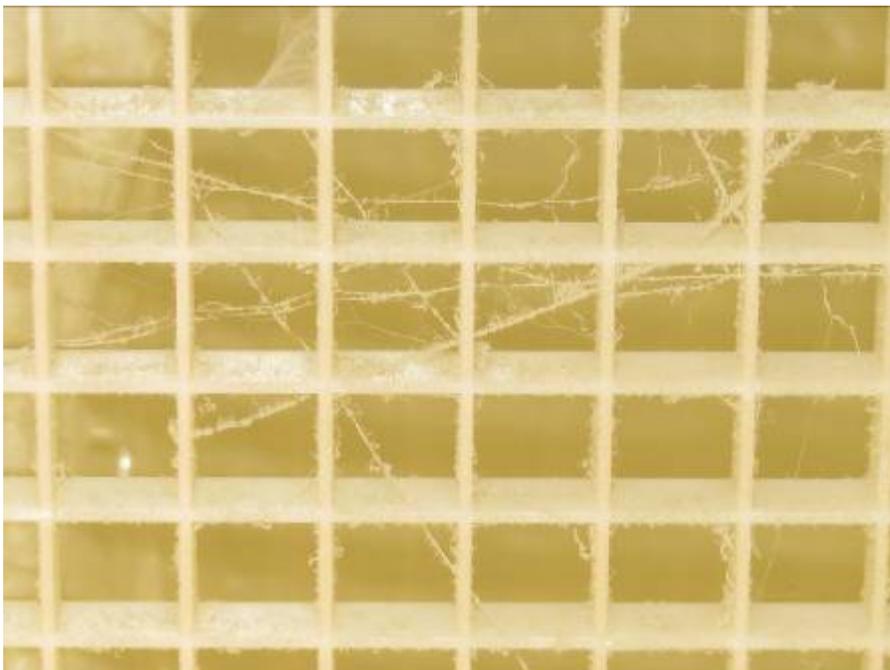
**Picture 10**

**Cobwebs on Exhaust Vent**

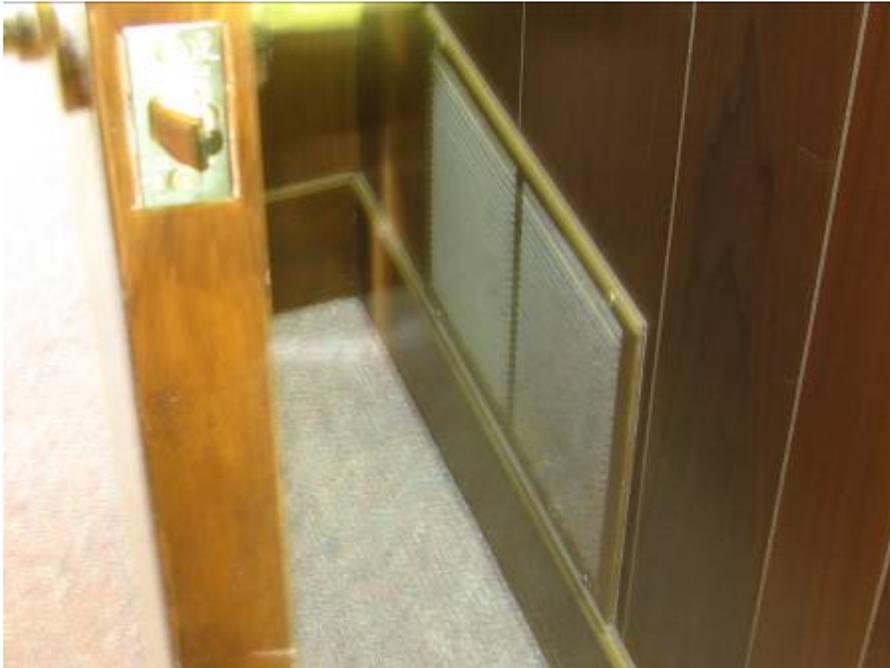
**Picture 11**

**Vent Located Behind Door in Administration Wing**

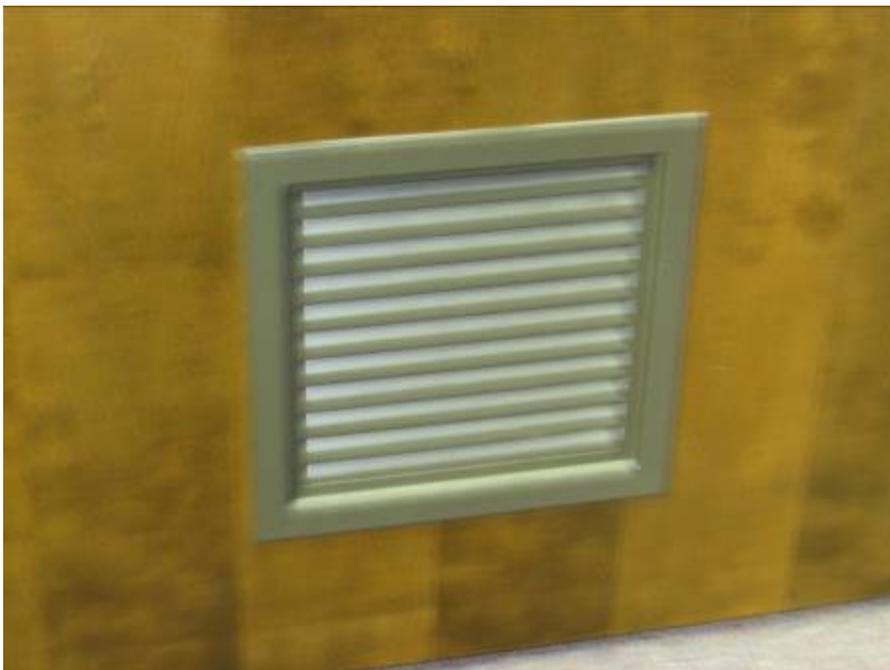
**Picture 12**

**Passive Vent in Office Door**

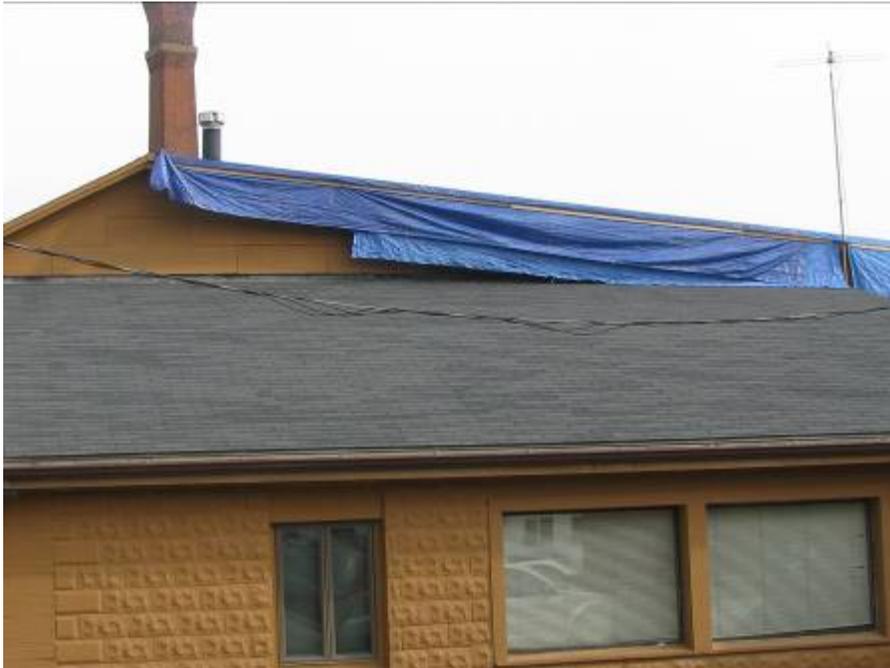
**Picture 13**

**Note Tarp on Rear Roof**

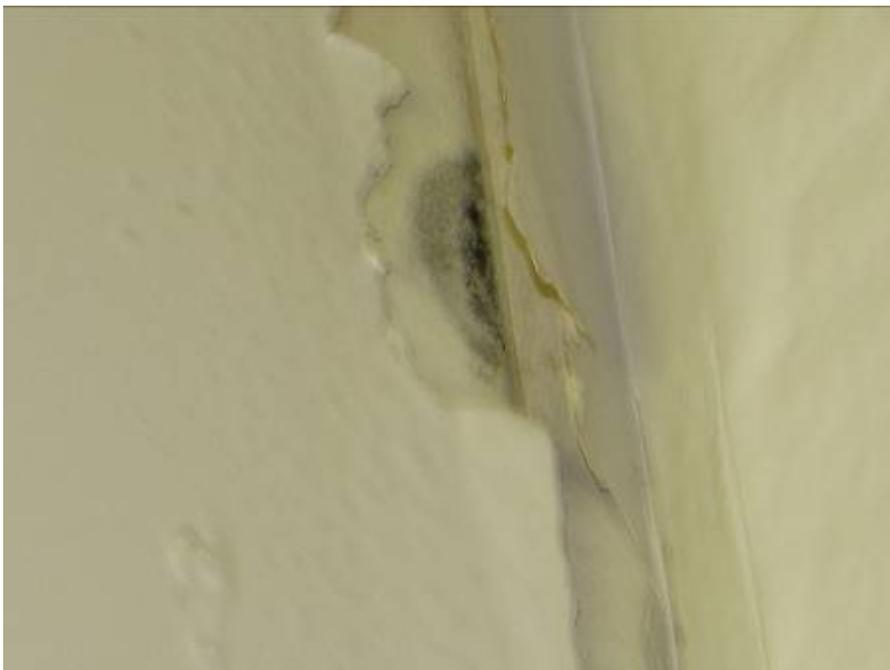
**Picture 14**

**Water Damage and Mold Formation on Wall Of Upstairs Storage Area**

10. Remove/replace water-damaged/mold colonized gypsum wallboard and other porous materials.

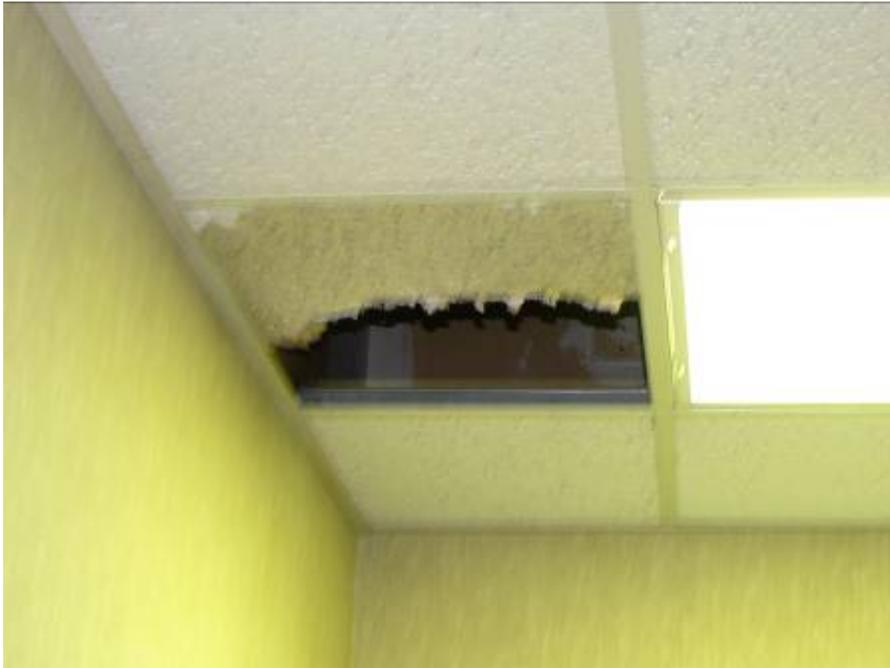
**Picture 15**

The ceiling tile system was damaged in several areas throughout the building. BEH staff found ceiling tiles broken, missing or water-damaged (Pictures 15-18). Water damaged ceiling tiles can indicate sources of water penetration and provide a source of mold. Ceiling tiles should be replaced after a water leak is discovered and repaired.

**Broken, Water-damaged Ceiling Tile**

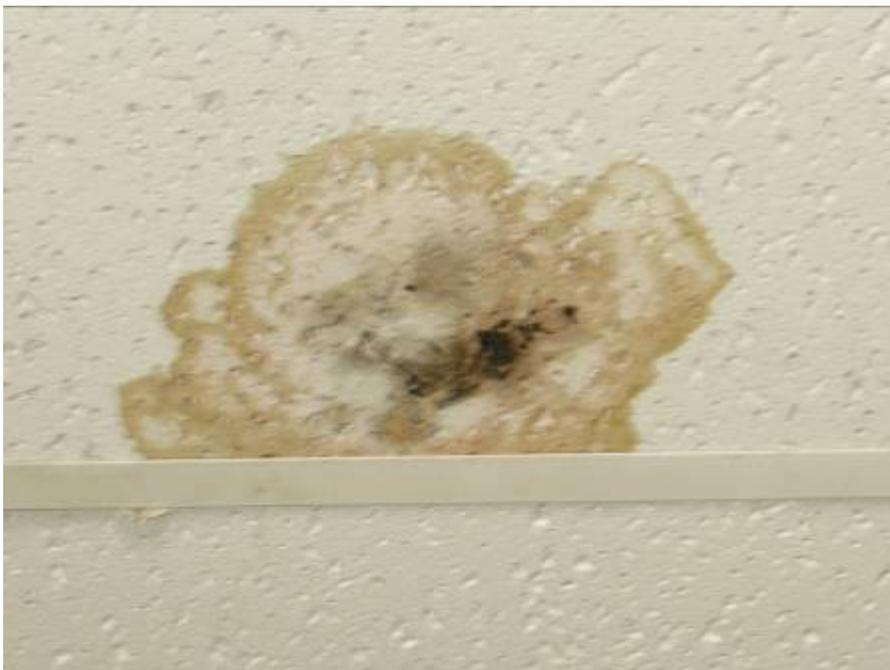
**Picture 16**

**Mold Growth on Ceiling Tile**

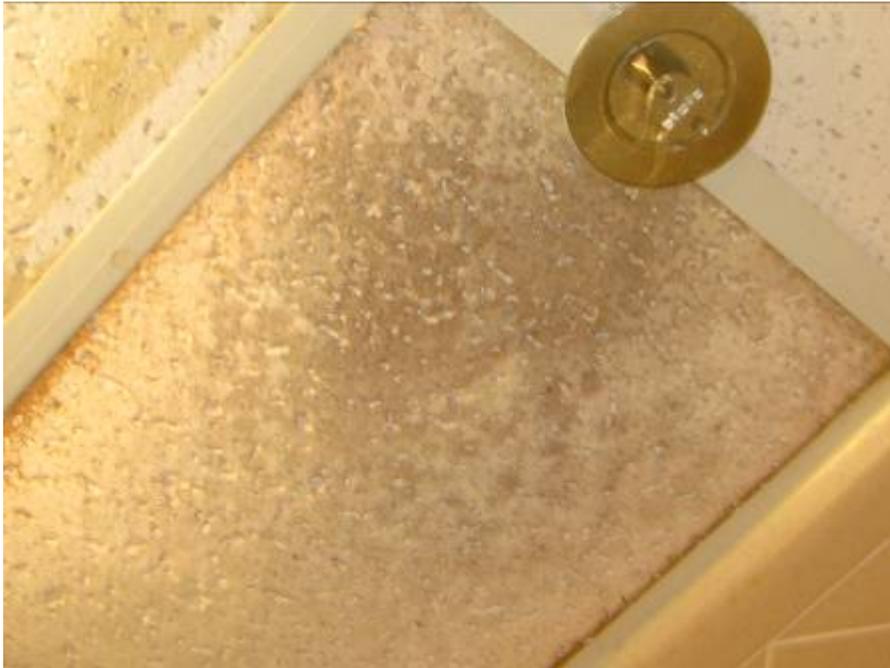
**Picture 17**

**Significant Water-damage on Ceiling Tile**

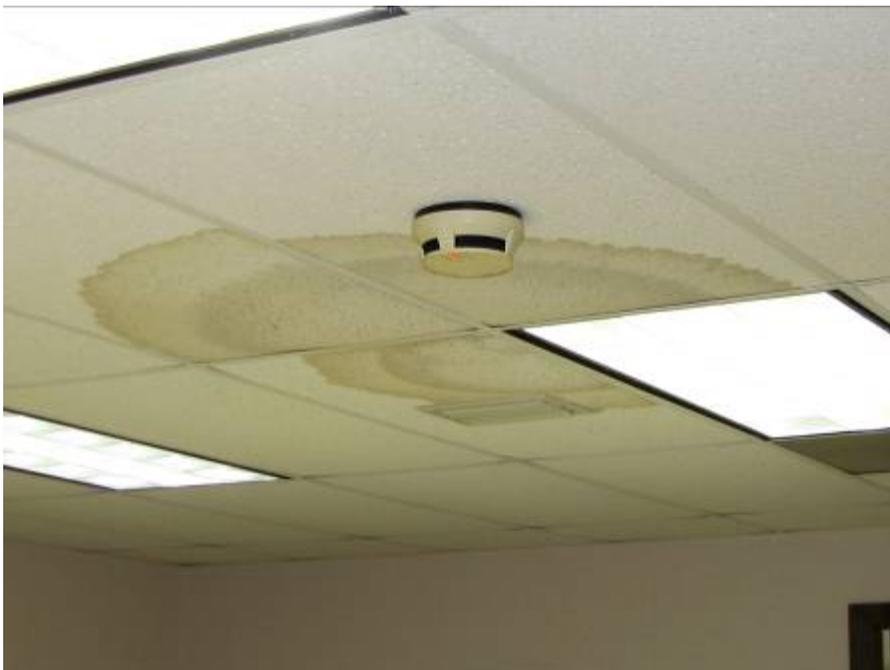
**Picture 18**

**Water-damaged Ceiling Tiles**

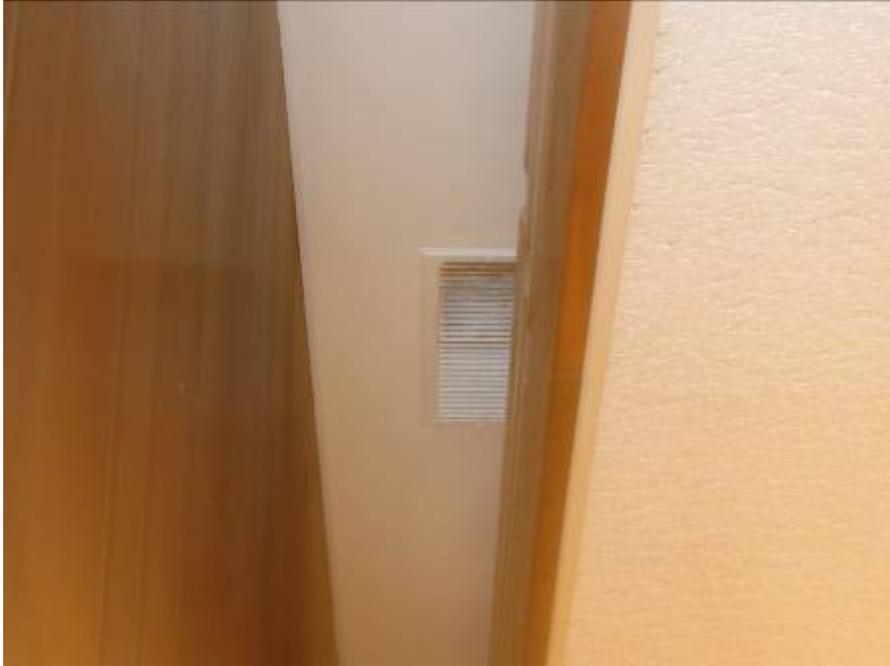
**Picture 19**

In the administration wing of the building, some of the offices had a wood framed suspended ceiling located approximately one foot below a plywood ceiling (Picture 19). The plywood ceiling in the Program Director's office exhibited evidence of water damage (Picture 20).

**Plywood Ceiling Above Framed Suspended Ceiling**

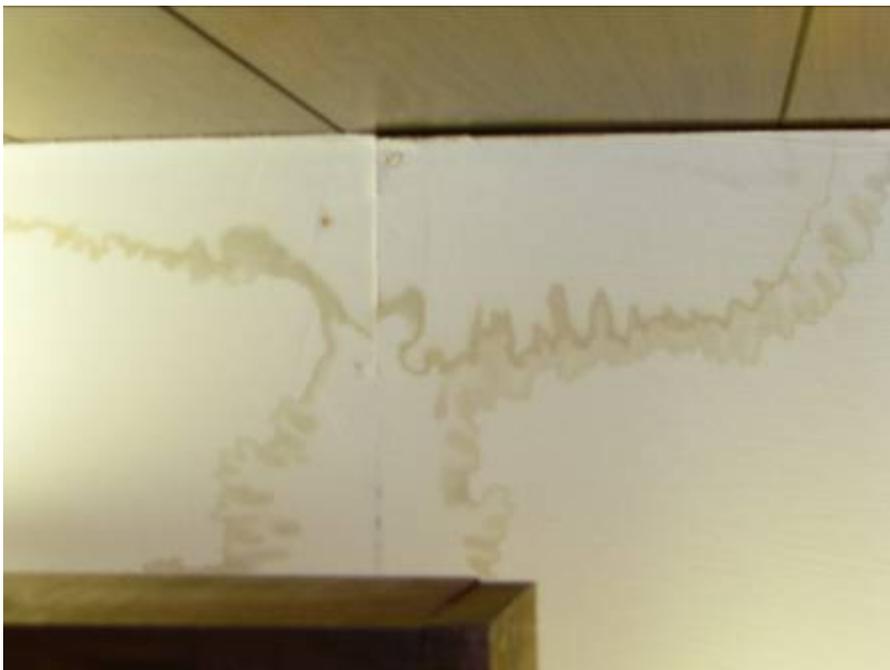
**Picture 20**

**Water Damage to Plywood Ceiling in Program Director's Office**

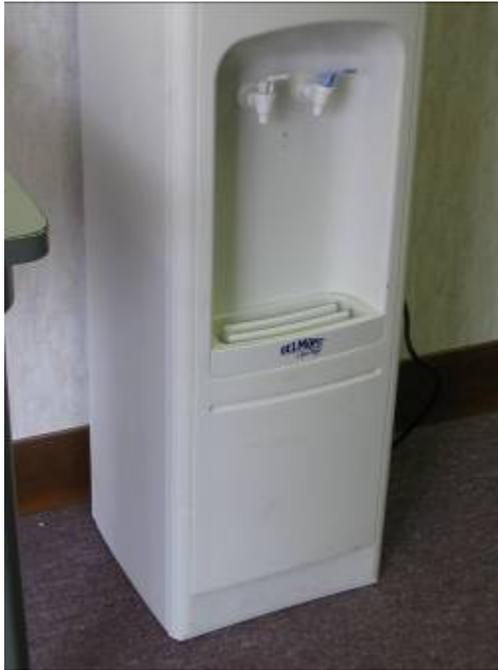
**Picture 21**

A water cooler and a water fountain were located over carpeted areas (Pictures 21 and 22). Overflow of water coolers/water fountains or spills that often occur around these water sources can moisten carpeting. It is also important that the catch basin of water coolers be

**Water Cooler Located On Carpet**

12. Remove water damaged carpet within the building, particularly in cubicle 129.
13. Provide nonabsorbent mats beneath cooler/bubbler to prevent water damage to carpeted areas.

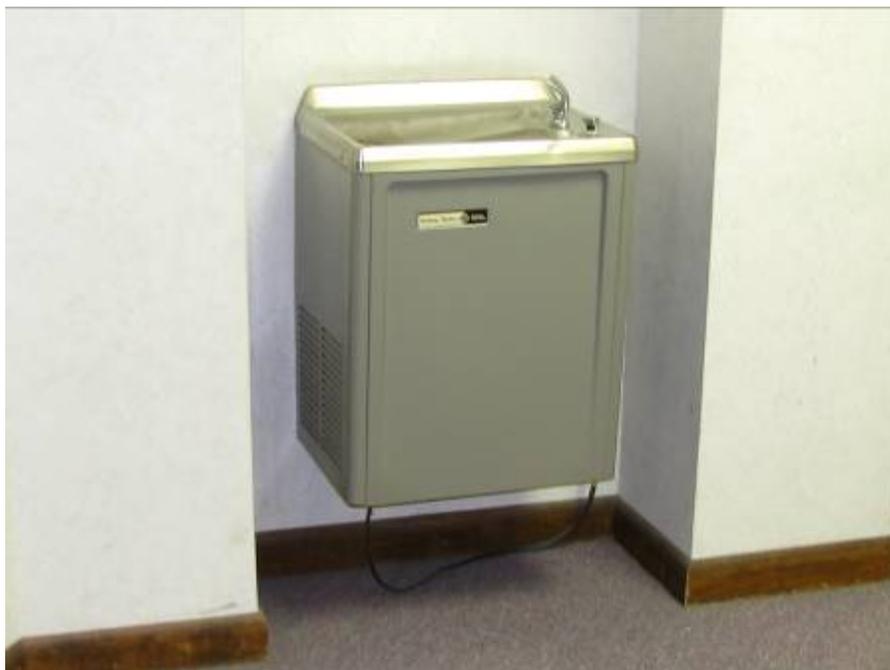
**Picture 22**

**Water Fountain Located Above Carpeting**

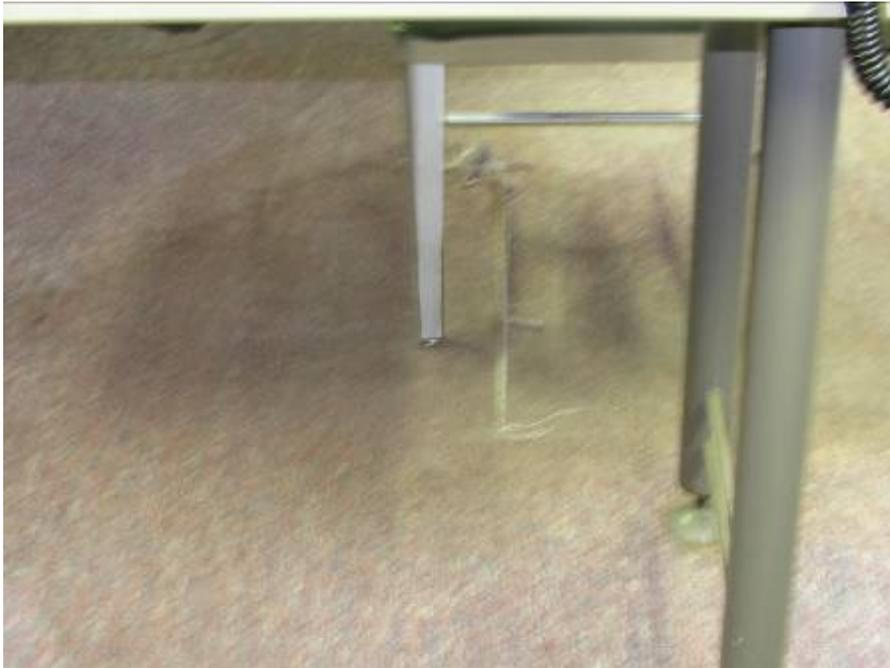
**Picture 23**

The carpet in cubicle 129 was water damaged (Picture 23). The US Environmental Protection Agency (US EPA) and the American Conference of Governmental Industrial Hygienists (ACGIH) recommends that porous materials be dried with fans and heating within 24 to 48 hours of becoming wet (ACGIH, 1989; US EPA, 2001). If not dried within this timeframe, mold growth may occur. Once mold has colonized porous materials, they are difficult to clean and should be removed/discarded.

**Water Damaged Carpet**

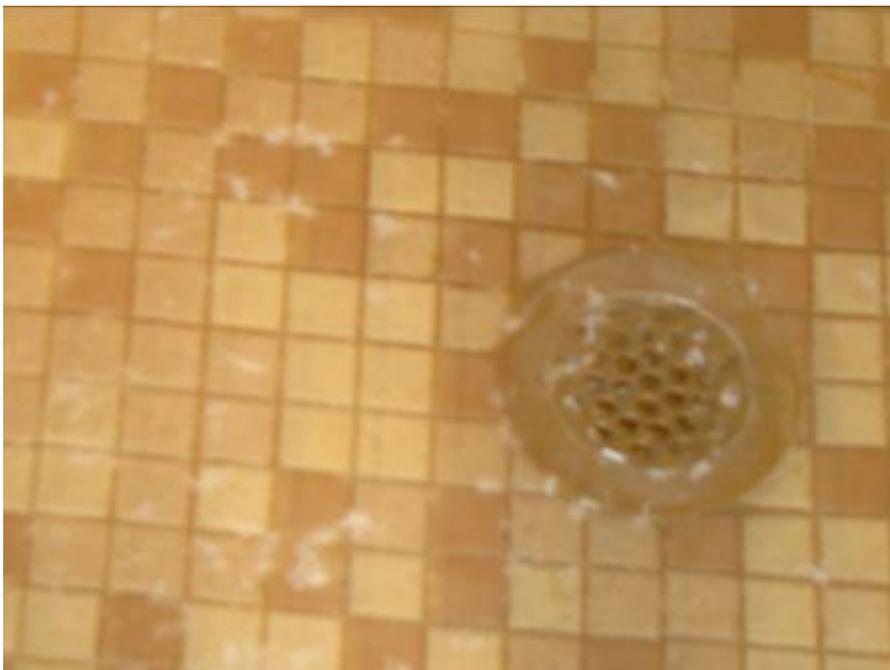
**Picture 24**

It was reported to BEH staff that the two bathrooms in the administration wing had been closed due to a sewer backup. In the bathroom located off the main hallway, evidence of the backup was still visible in the shower, where disintegrated toilet tissue was observed near the shower drain (Picture 24). A vanity in the bathroom was water damaged due to the water/sewage exposure (Picture 25). Biological hazards that may be found in sewage or wastewater include bacteria, fungi, parasites and viruses (CPWR, 2004). In general, it is recommended that absorbent materials (gypsum wallboard, insulation, carpeting, manufactured wood products, fabrics, books, cardboard, etc.) be discarded once in contact with sewage (IICRC, 1999). Flooring and sub flooring (such as wood and tile) should be evaluated, cleaned, disinfected, dried and sealed when appropriate (IICRC, 1999).

**Evidence of Sewer Backup in Shower Area of Bathroom**

14. Contact a licensed plumber to repair the plumbing system in administrative wing.
15. All components of the bathroom (shower, floor and wall tiles) that experienced the sewage backup should be cleaned and properly sanitized once the repairs are made.

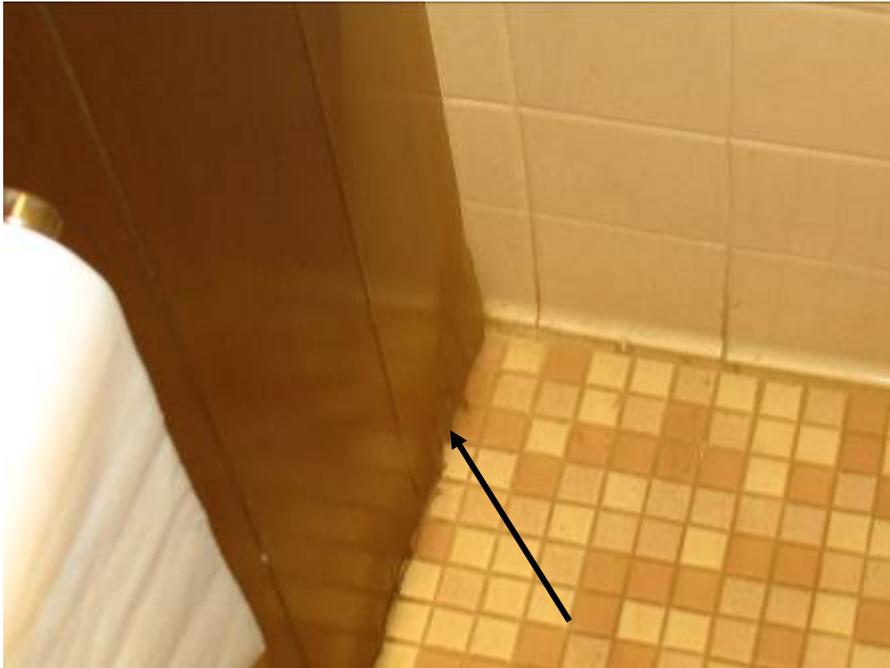
**Picture 25**

**Vanity Exhibits Evidence Of Chronic Moisture Damage.**

16. Vanity that exhibited evidence of chronic water damage should be replaced. If water damaged gypsum wallboard is observed behind the vanity, it should be removed three feet above the observed water mark, to ensure that no moisture is retained in the wall.

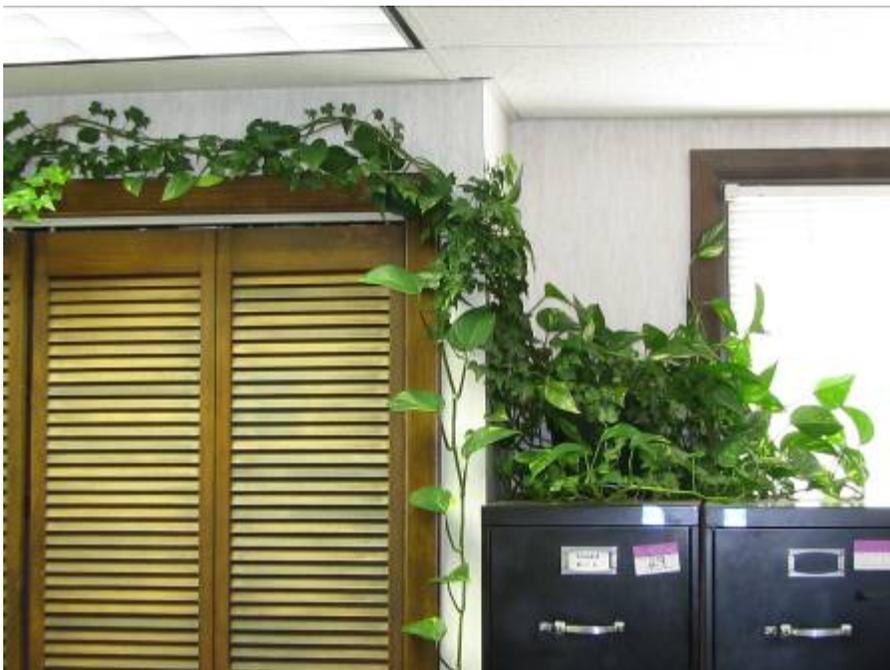
**Picture 26**

Plants were observed in several areas of the building (Picture 26). Plants, soil and drip pans can serve as sources of mold growth and should be properly maintained. Over-watering of plants should be avoided and drip pans should be inspected periodically for mold growth. In addition, flowering plants can be a source of pollen. Therefore, plants should be located away

**Plants In Office**

17. Ensure plants have drip pans. Examine drip pans periodically for mold growth and disinfect with an appropriate antimicrobial where necessary.
18. Trim shrubbery/plants back approximately 5-feet to prevent water impingement on exterior brick.

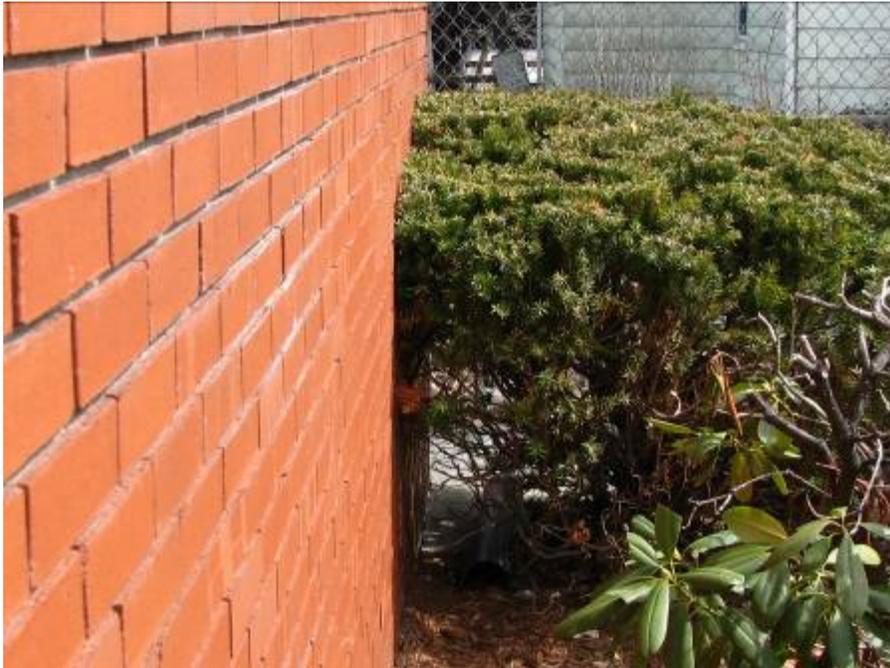
**Picture 27**

Shrubbery was growing in close proximity to the building (Picture 27). Plants/shrubbery in close contact with brick can hold moisture against the building. Repeated freezing and thawing of water during winter months can create cracks and fissures in the foundation leading to damage and subsequent water penetration. Over time, this process can undermine the integrity of the building envelope and provide a means of water entry into the building via capillary action through exterior walls, foundation concrete and masonry (Lstiburek & Brennan, 2001).

**Shrubbery against Building**

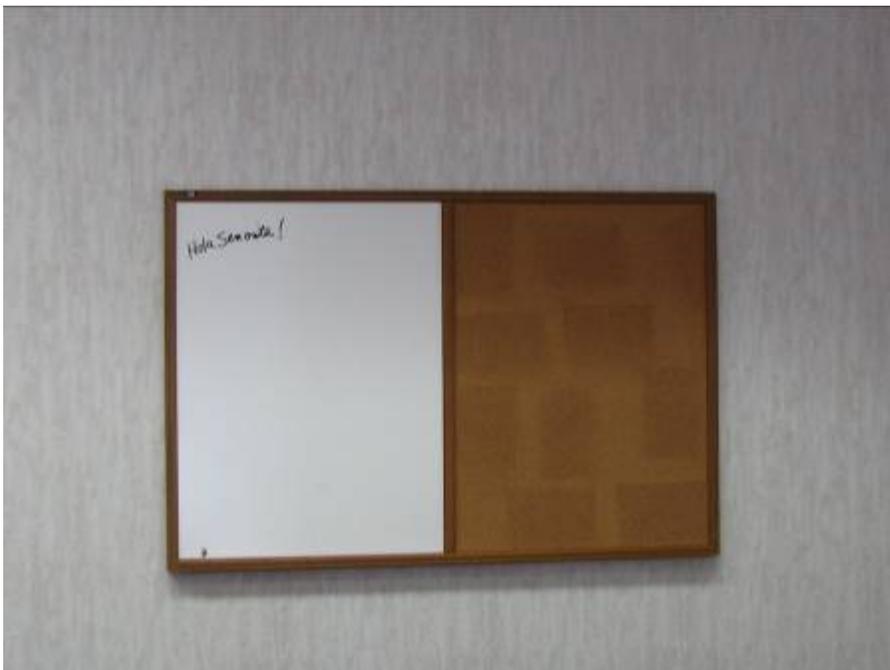
**Picture 28**

Dry erase boards and related materials were observed in the administrative wing (Picture 28). Materials such as dry erase markers and dry erase board cleaners may contain VOCs, such as methyl isobutyl ketone, n-butyl acetate and butyl-cellusolve (Sanford, 1999), which can be irritating to the eyes, nose and throat.

**Dry Erase Board**

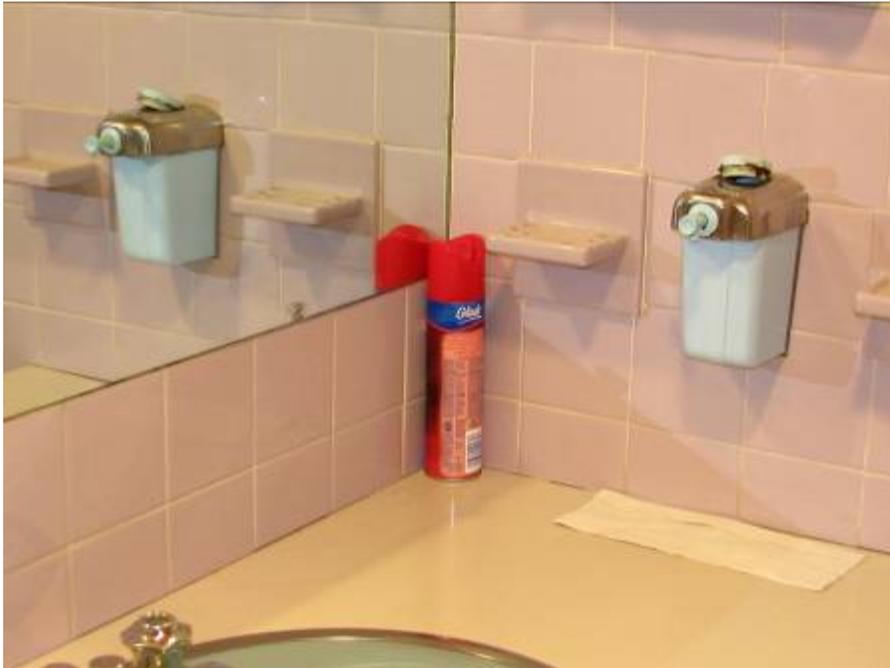
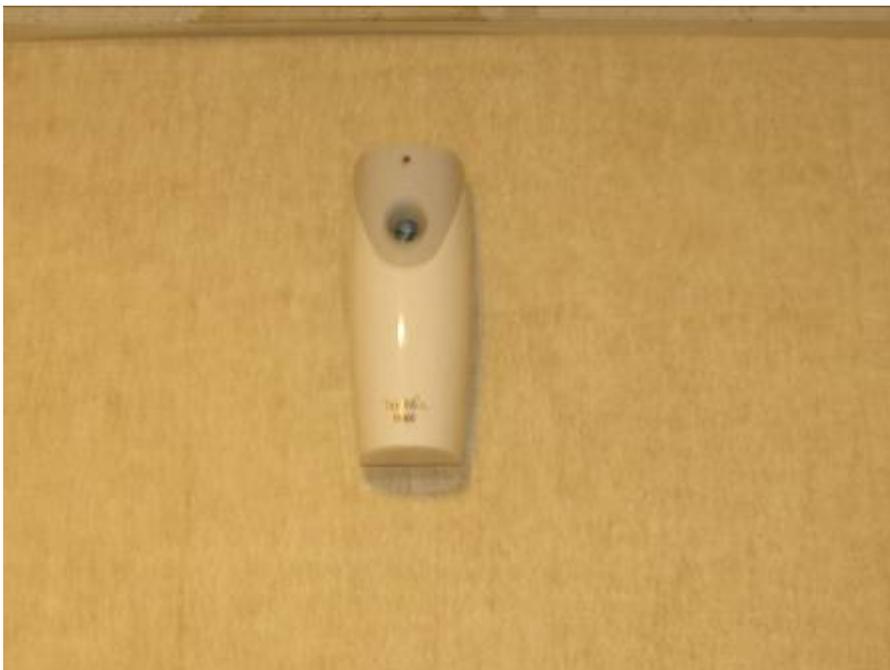
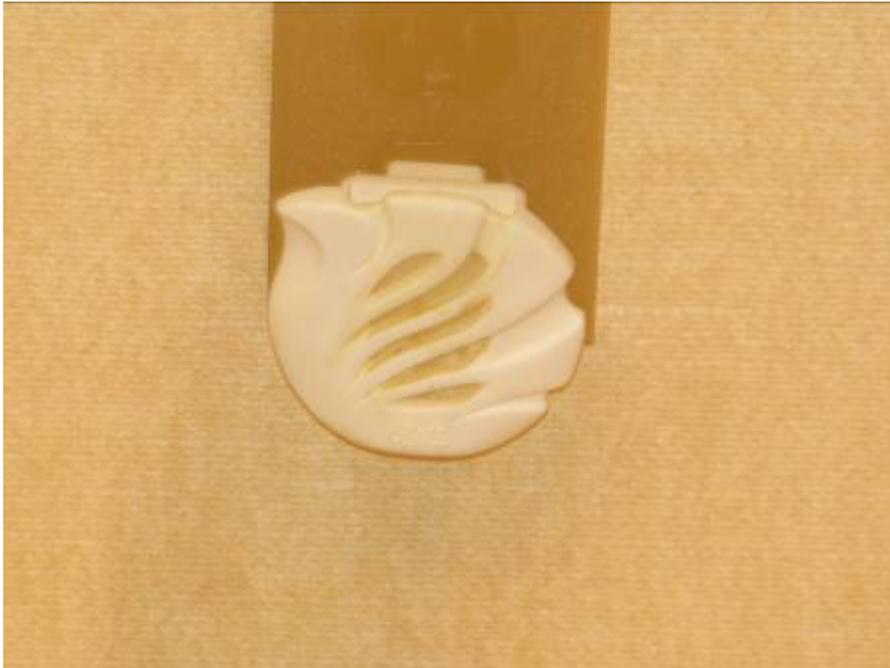
Air fresheners and deodorizing materials were observed in several areas (Pictures 29 through 31). Air deodorizers contain chemicals that can be irritating to the eyes, nose and throat of sensitive individuals. Many air fresheners contain 1,4-dichlorobenzene, a VOC which may cause reductions in lung function (NIH, 2006). Furthermore, deodorizing agents do not remove materials causing odors, but rather mask odors that may be present in the area.

**Air Freshener**

**Plug In Air Freshener**

19. Refrain from using air fresheners and deodorizers to prevent exposure to VOCs.
20. Remediate damaged floor tiles in conformance with Massachusetts asbestos remediation and hazardous waste disposal laws.

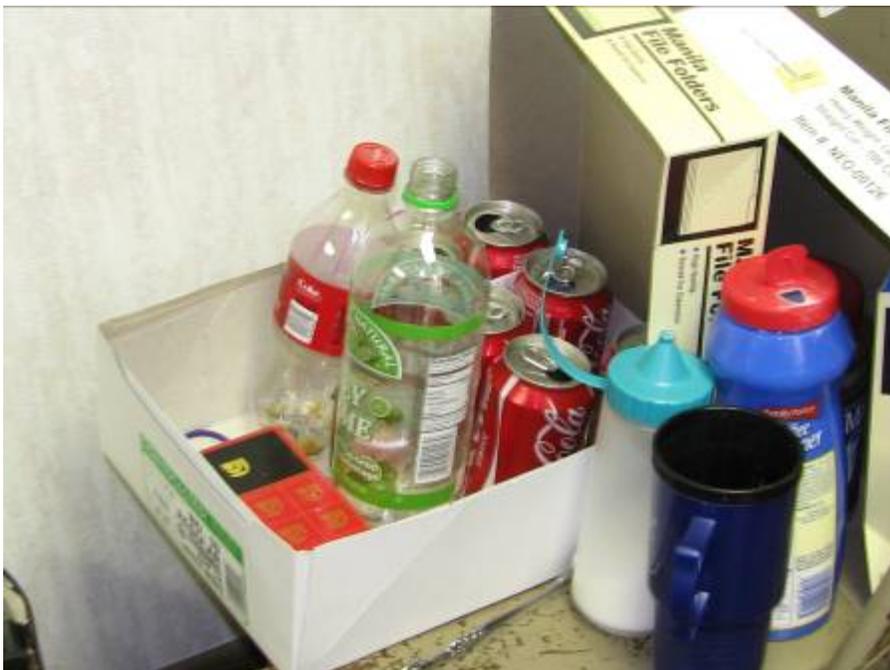
**Picture 32**

Other conditions that can affect indoor air quality were observed during the assessment. Empty food/beverage containers were noted in the building (Picture 32). If not properly stored, food can create conditions that attract pests, such as ants. The reduction/elimination of pathways/food sources that may attract these pests should be the first step taken to prevent or eliminate an infestation.

**Empty Food and Beverage Containers**

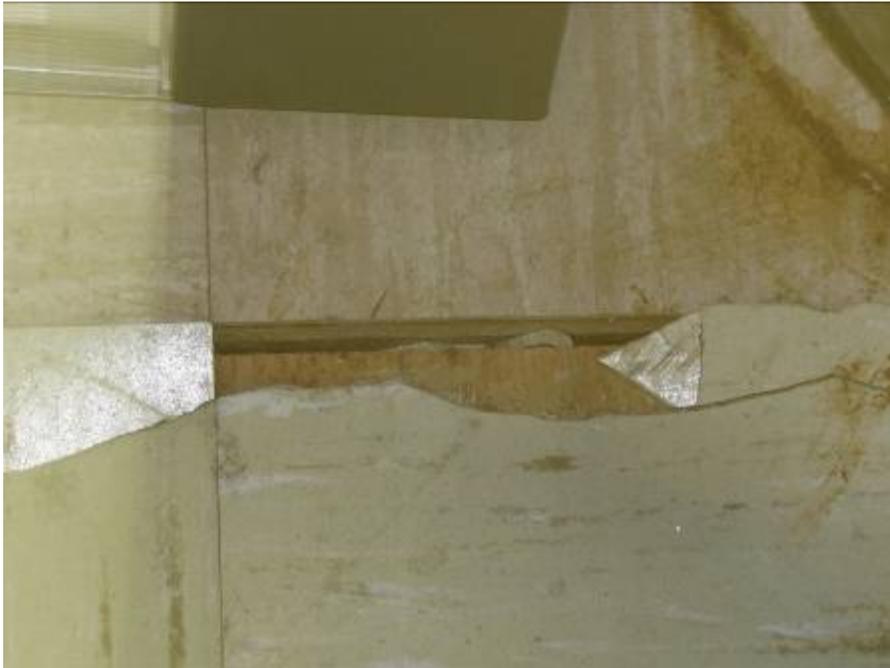
**Picture 33**

BEH observed floor tiles cracked and in disrepair near the storage room (Picture 33). Given the building's age, these tiles may contain asbestos. Repeated grinding of small pieces of tile could release asbestos into the indoor environment. Floor tiles should be in tact regardless of the tile composition. Cracked and broken tiles lose their ability to provide a surface that is impervious to water, exposing the subfloor beneath it to water damage. Where asbestos-containing materials are found damaged, these materials should be removed or remediated in a manner consistent with Massachusetts asbestos remediation laws (MDLI, 1993).

**Cracked and Broken Floor Tiles**
