ODOR INVESTIGATION/INDOOR AIR QUALITY ASSESSMENT

**Major Edwards Elementary School
70 Crescent Street
West Boylston, Massachusetts**

Prepared by:
Massachusetts Department of Public Health
Bureau of Environmental Health
Indoor Air Quality Program
February 2008

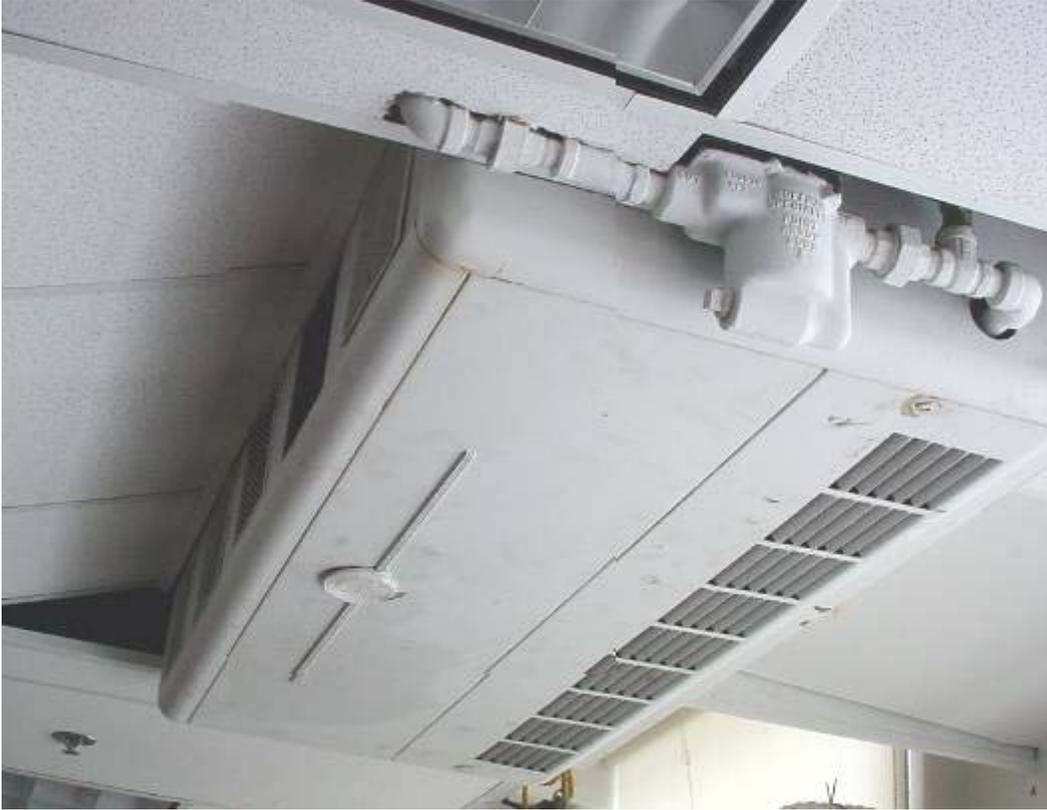
Picture 1

Fresh air in basement classrooms is supplied by ceiling-mounted unit ventilator (univent) systems (Picture 1). A univent draws air from outdoors through a fresh air intake located on the exterior wall of the building (Picture 2) and returns air through an air intake located at the base of the unit ([Figure 1](#)). Fresh and return air are mixed, filtered, heated and provided to classrooms through an air diffuser located in the top of the unit. Mechanical exhaust ventilation is provided by wall-mounted vents (Picture 3) powered by rooftop motors. Univents are reportedly original equipment from the 1950's. Univents of this age can be difficult to maintain because replacement parts are often unavailable. The univent in the music room was extremely loud and in need of repair. The univent in the life skills room was reportedly deactivated due to lack of heat control (i.e., overheating).

Ceiling-Mounted Univent (1950s Vintage) in Classroom

6. Seal open utility holes/breaches in exterior walls (Picture 12).
7. Examine each univent for function, replace parts and make repairs as necessary. Survey classrooms for univent function to ascertain if an adequate air supply exists for each room; an increase of fresh air intake may be necessary. Operate univents while classrooms are occupied.

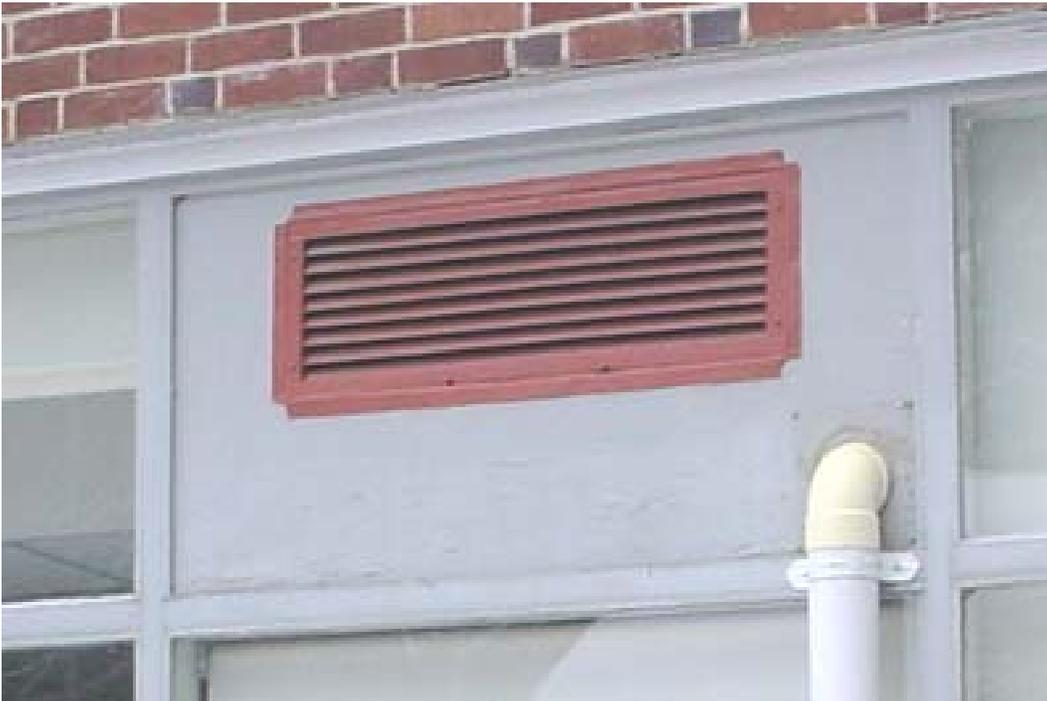
Picture 2

Univent Fresh Air Intake Vent

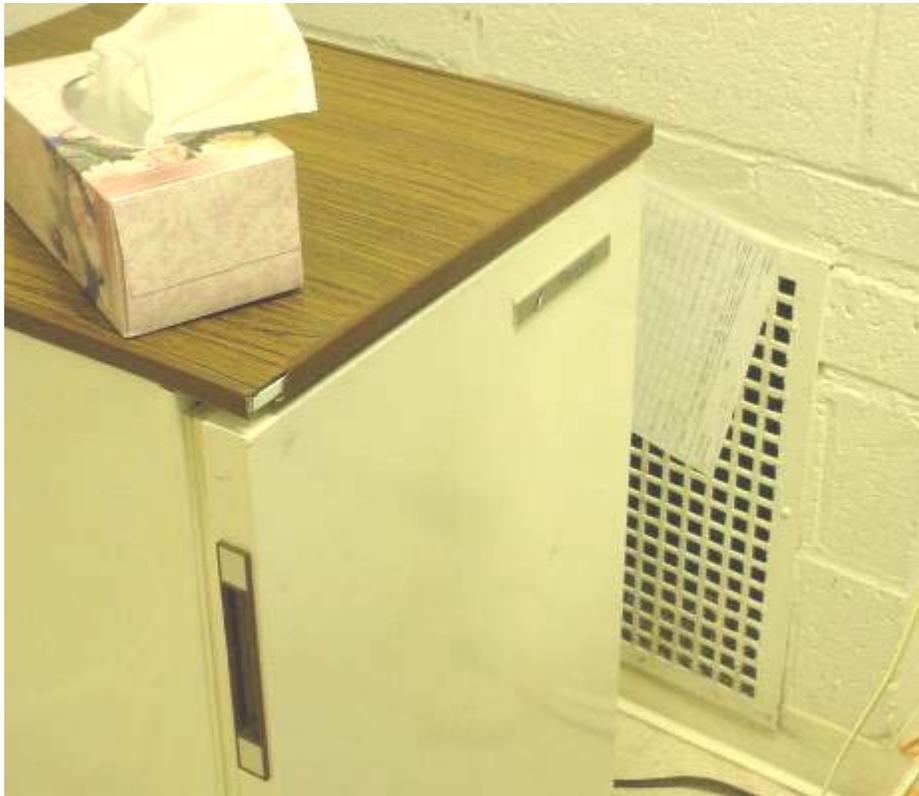
Picture 3

Also having a negative effect on air exchange was the subdivision of basement classrooms. A large room in the basement was subdivided, which placed the univent in the music room and the exhaust vent in the OT room (Picture 3). This subdivision essentially places the music room under positive pressure and the OT room under negative pressure. It is common practice to adjust mechanical ventilation systems so that classrooms will be slightly *pressurized*. Areas that are *depressurized* can draw air/odors from surrounding areas, which may account for the odor complaints in the OT room.

Wall-Mounted Exhaust Vent in OT Room, Suspended Paper Indicates Draw of Air

11. Work with HVAC firm to examine methods to provide mechanical supply ventilation to the OT room and exhaust ventilation to the music room. As noted in the report, classrooms should be slightly *pressurized* to avoid the entrainment of odors/particulates from adjacent areas.

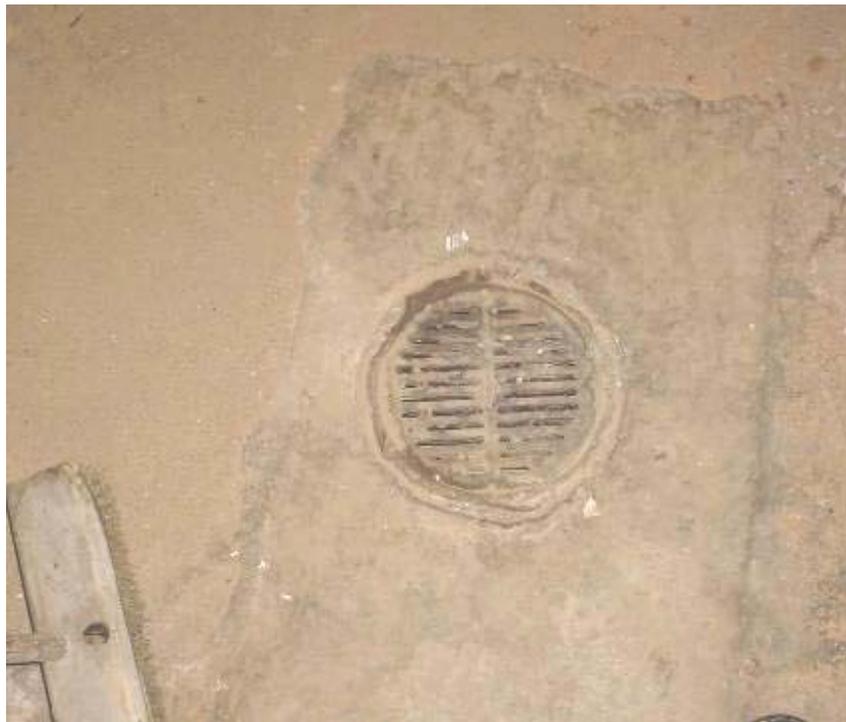
Picture 4

- Floor drains in the boiler room (Picture 4) and a clogged drain in an exterior stairwell outside the OT room (Picture 5). Drains are usually designed with traps in order to prevent sewer odors/gases from penetrating into occupied spaces. When water enters

a drain, the trap fills and forms a watertight seal. Without a periodic input of water (e.g., every other day), traps can dry, breaking the watertight seal. Without a watertight seal, odors or other material can travel up the drain and enter the occupied space.

Floor Drain Located in Boiler Room

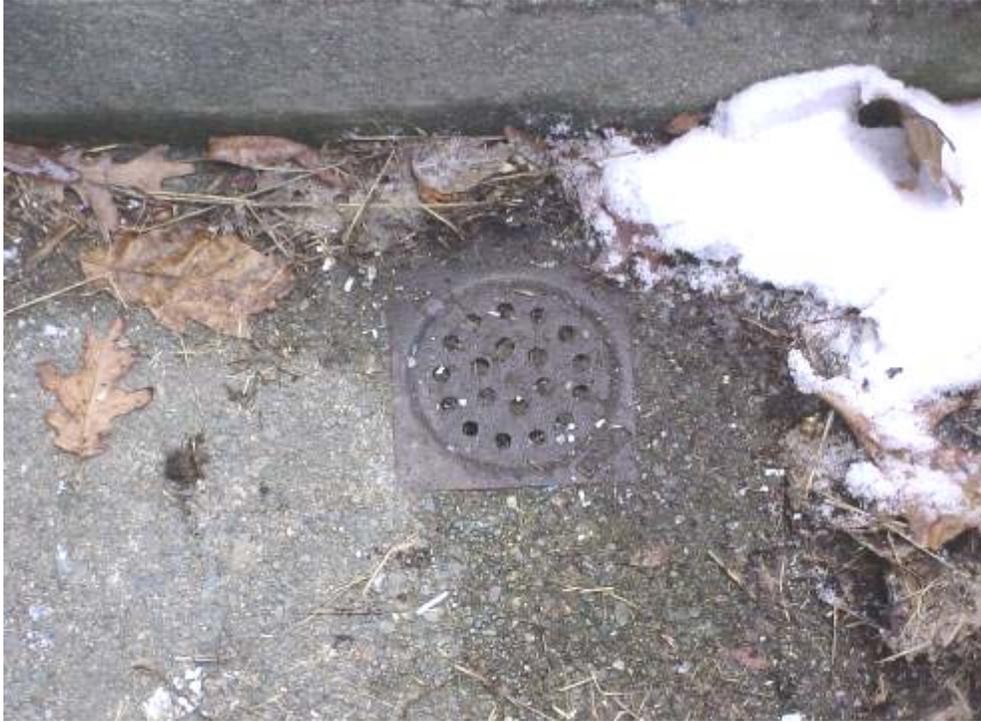
Picture 5

Clogged Exterior Stairwell Drain outside of OT Room

1. Continue with plans to seal abandoned pipe chase way beneath floor of OT room (as well as in any other occupied areas of the basement).
2. Seal or remove open pipes to decommissioned heating system in the basement.
3. Ensure drain at bottom of exterior stairwell outside of basement classrooms is clear and draining properly. Inspect/maintain on a regular basis.

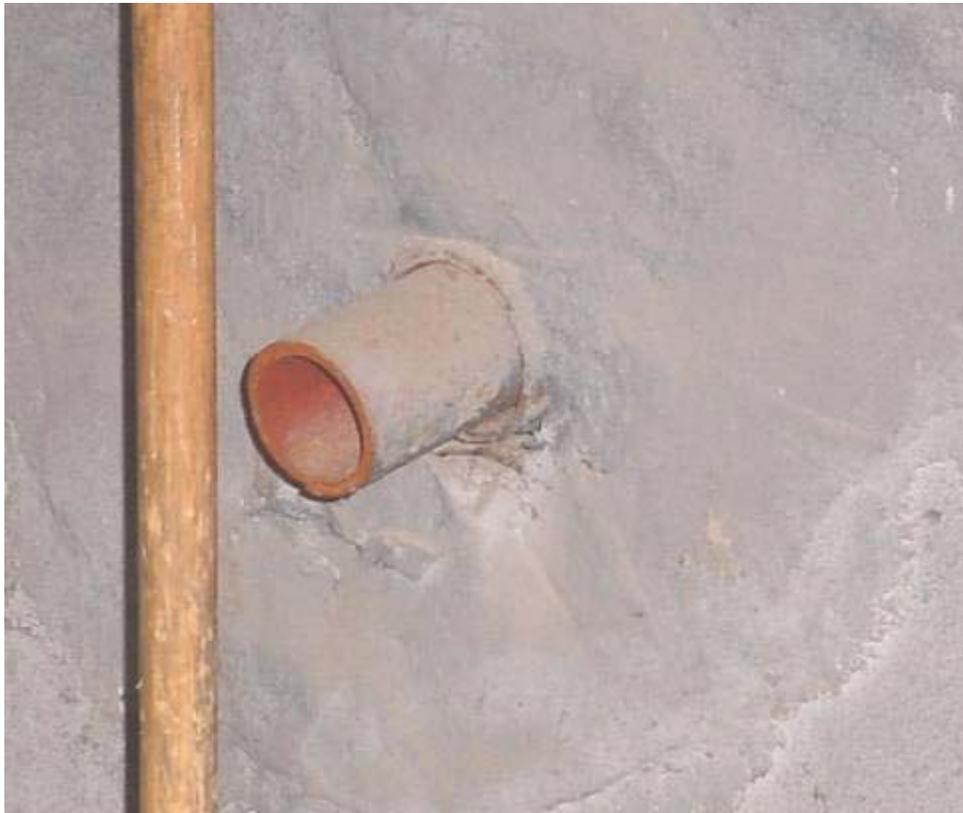
Picture 6

- Open utility pipes in the boiler room and a decommissioned heating system in the basement hallway (Pictures 6 and 7);
- Spaces in the basement boy's restroom wall around sink pipes (Picture 8);
- An abandoned chase way for pipes beneath the floor of the OT room (Picture 9); and
- Spaces beneath exterior doors to the emergency generator room (off the boiler room) (Pictures 10 and 11) and rear exterior wall (Picture 12), which could provide access to pests/rodents into the building.

Open Pipe in Boiler Room to Abandoned Heating System in Basement Hallway

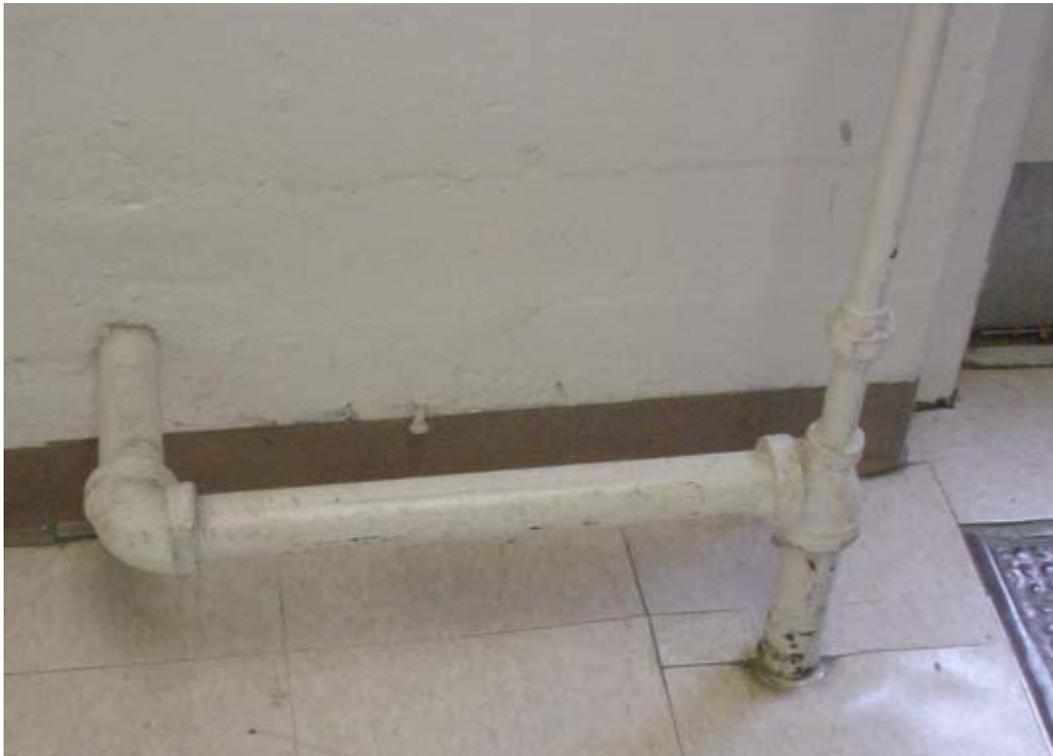
Picture 7

Pipes in Basement Hallway to Abandoned Heating System

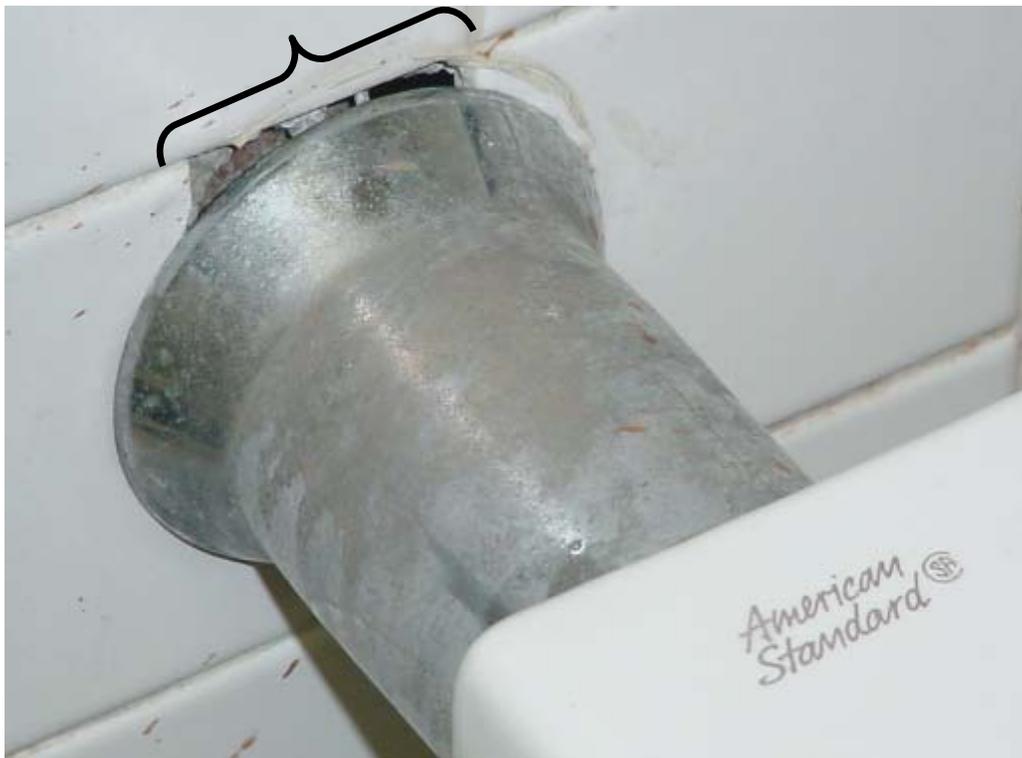
Picture 8

Spaces around Pipes in Basement Restroom Where Drafts were Detected

4. Seal around pipes/wall in basement restroom.
5. Take measures to tighten exterior doors (e.g., weather-stripping) to the emergency generator room to prevent pest/rodent entry. Ensure tightness of doors by monitoring for light penetration and drafts around doorframes.

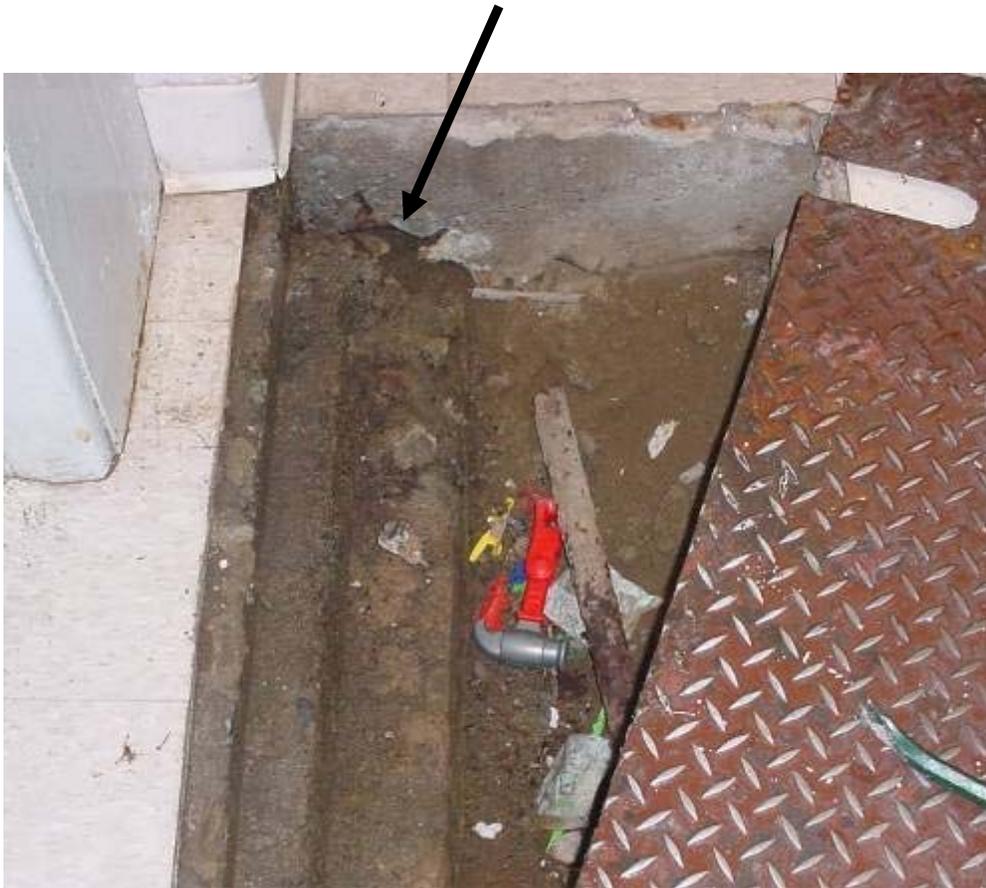
Picture 9

Of particular interest was the abandoned chase way located beneath a metal floor plate in the OT room. Although no unusual odors were detected during the assessment, significant airflow was detected around the access plate indicating a potential pathway for drafts/odors to migrate into the OT room. Since the OT room is *depressurized*, (due to the subdivision of the room putting the supply vent in one room and exhaust in the other), it would tend to entrain (draw-in) odors from adjacent areas including the chase way beneath the floor. Mr. Watson suggested sealing the abandoned chase way with cement; BEH staff agreed that this may eliminate a potential (and most likely) source/pathway of odors/drafts into the OT room.

Chaseway beneath Metal Floor Panel in OT Room, Arrow Indicates Open Utility Hole for Pipe Passage

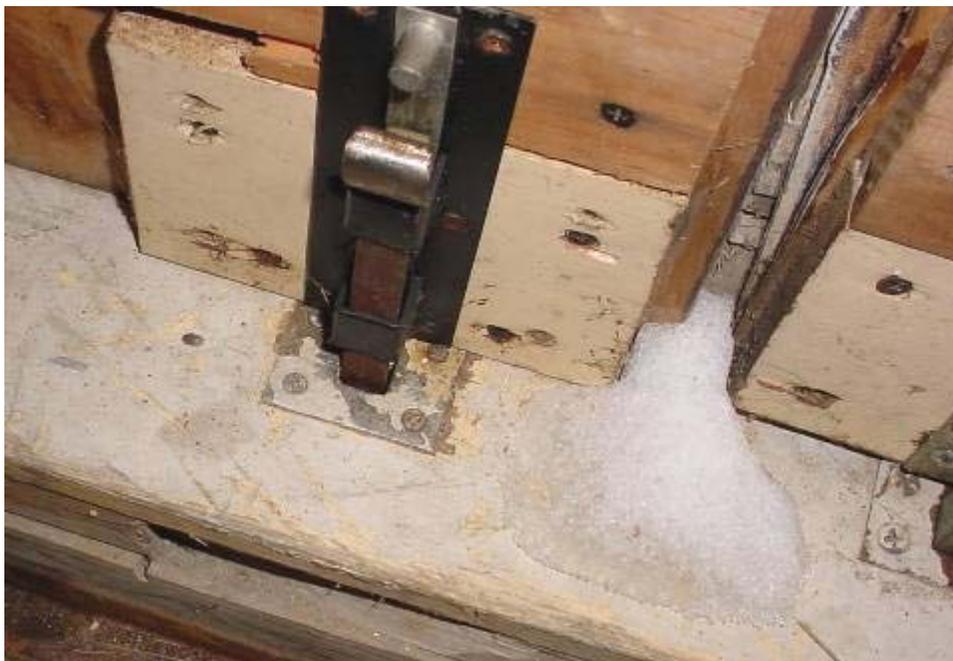
Picture 10

Spaces around Emergency Generator Room, Note Snow Penetration

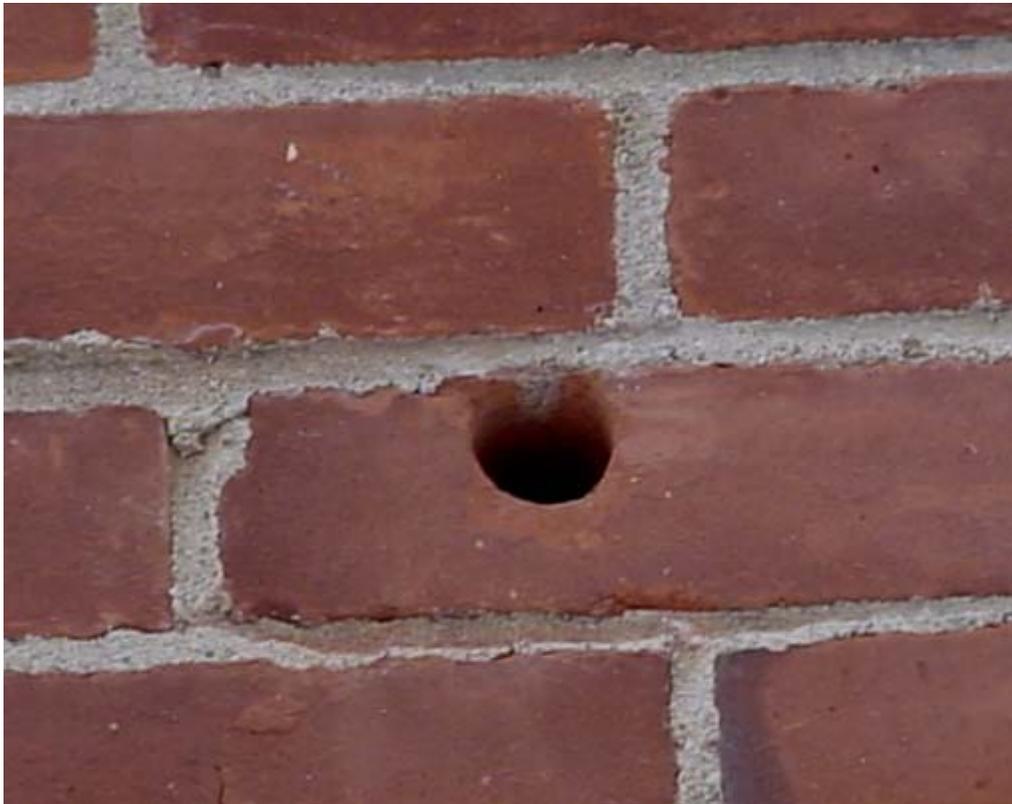
Picture 12

Open Utility Hole in Rear Exterior Wall

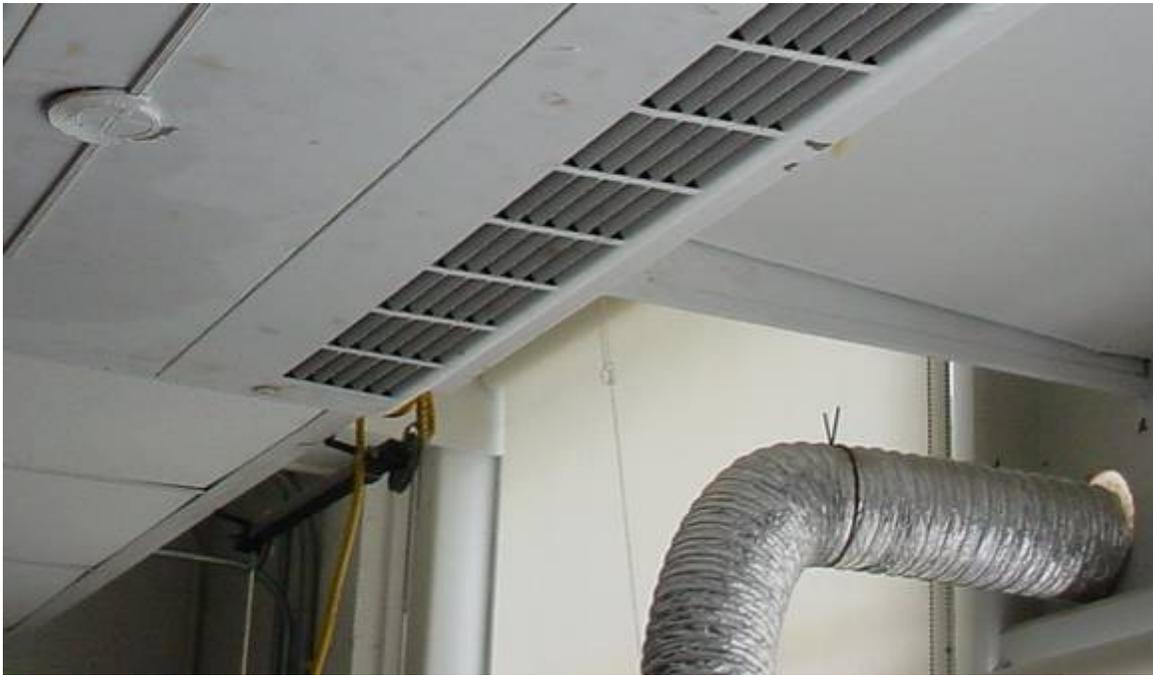
Picture 13

Finally, the art room has a kiln equipped with local exhaust ventilation (Picture 13). Pottery kilns can produce carbon monoxide and sulfur dioxide, which can cause respiratory symptoms in exposed individuals (McCann, 1985). The terminus of the exhaust vent releases kiln exhaust approximately 4-feet below the unvented fresh air intake (Picture 14). The building code requires that pollutant sources must be ten feet away from and two feet above fresh air intakes (BOCA, 1993, SBBRS, 1997). An extension several feet above the fresh air intake may be needed to prevent entrainment of kiln exhaust.

Art Room Univent and Local Exhaust Duct Exiting Exterior Wall

20. Extend local exhaust vent pipe for kiln in close proximity to univent air intake several feet above the fresh air intake to prevent entrainment. The building code requires that pollutant sources must be ten feet away from and two feet above fresh air intakes (BOCA, 1993; SBBRS, 1997).
21. Consider adopting the US EPA (2000) document, “Tools for Schools”, as an instrument for maintaining a good indoor air quality environment in the building. This document is available at: <http://www.epa.gov/iaq/schools/index.html>.
22. Refer to resource manual and other related indoor air quality documents located on the MDPH’s website for further building-wide evaluations and advice on maintaining public buildings. These documents are available at: <http://www.state.ma.us/dph/MDPH/iaq/iaqhome.htm>.

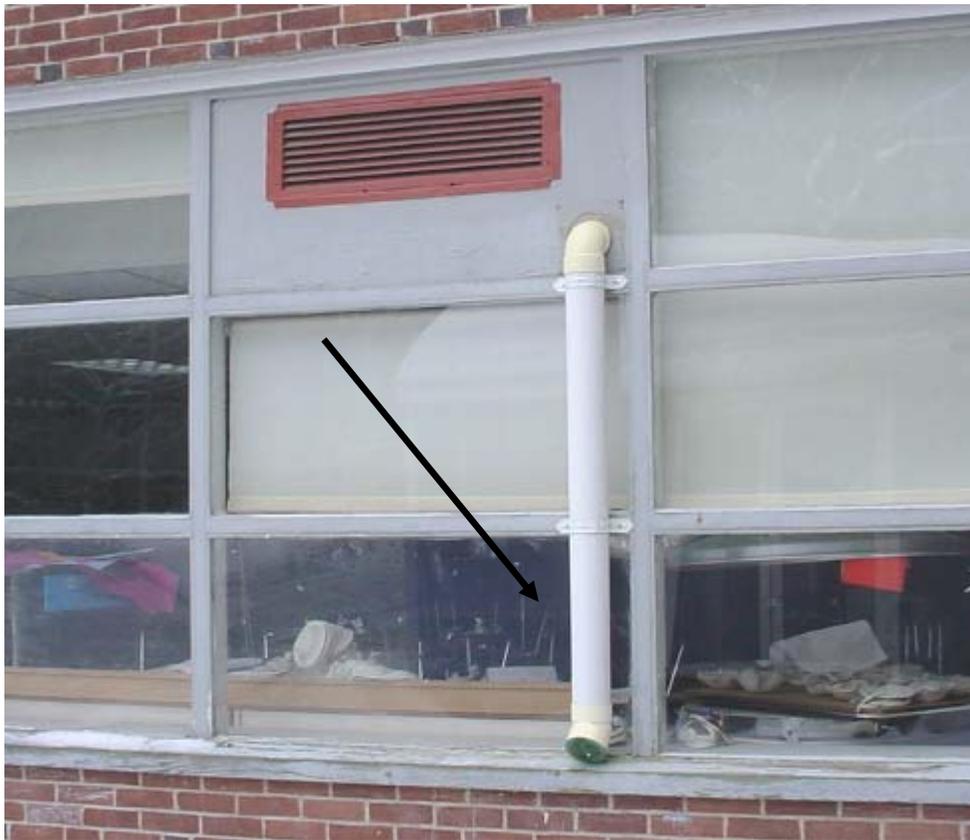
Picture 14

Art Room Univent Air Intake, Note Proximity to Local Kiln Exhaust

(as Indicated by Arrow)
