# **INDOOR AIR QUALITY ASSESSMENT**

**Massachusetts Department of Revenue  
40 Southbridge Street  
Worcester, Massachusetts 01608**

Prepared by:  
Massachusetts Department of Public Health  
Bureau of Environmental Health  
Indoor Air Quality Program  
August 2008

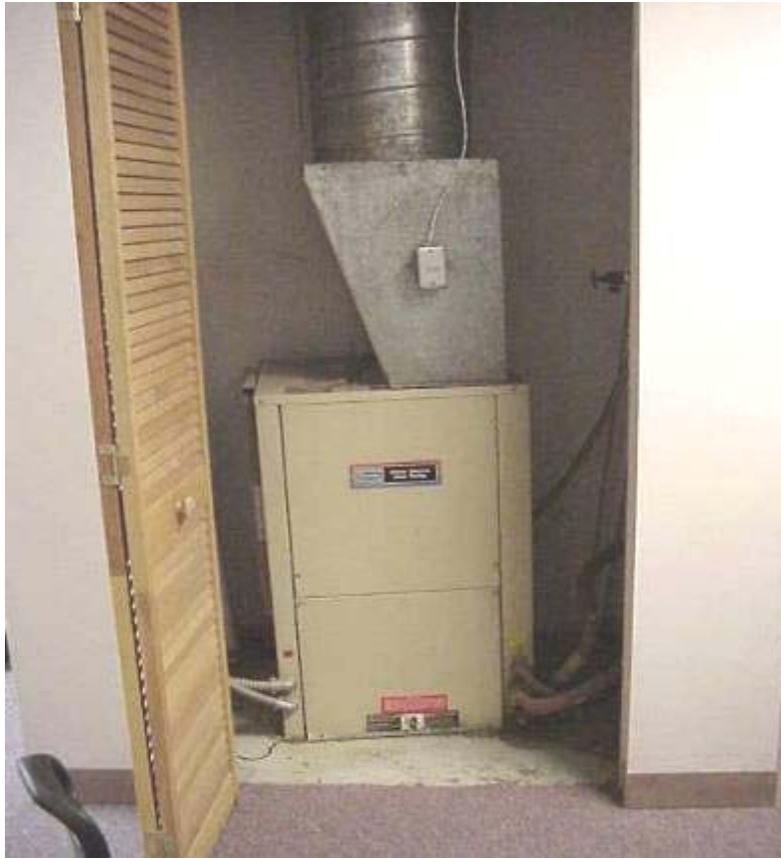
**Picture 1**

Ventilation is provided by a heating, ventilation and air conditioning (HVAC) system. The design of the HVAC system uses air handling units (AHUs) located in closets on each floor to provide heat and chilled air (Picture 1). Air is distributed from each AHU by ducted ceiling-mounted air diffusers. This system does not have ducted return vents. In this configuration, air is drawn back to the AHU closets from office space and hallways through passive vents located in closet doors (Picture 2), ceilings and/or walls. Once air is drawn through the passive vents into the AHU closet, it is pulled through a filter affixed to an opening in the AHU cabinet back

**AHU Closet, Note Louvered Door, Which Serves as the Transfer Air Vent For the AHU.**

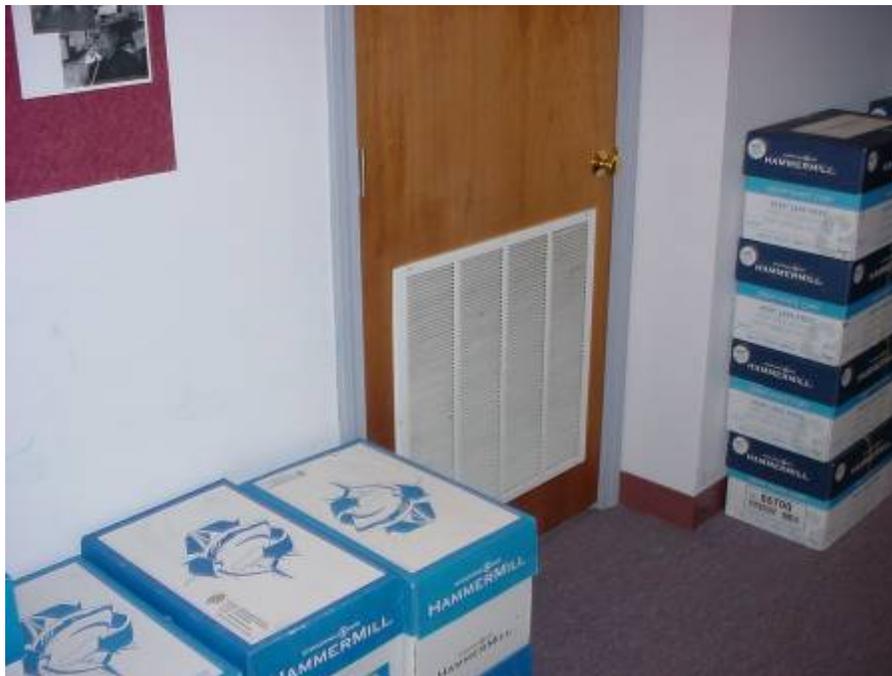
**Picture 2**

**Passive Vent (Transfer Air Vent) for AHU Closet, 4<sup>th</sup> Floor Reception**

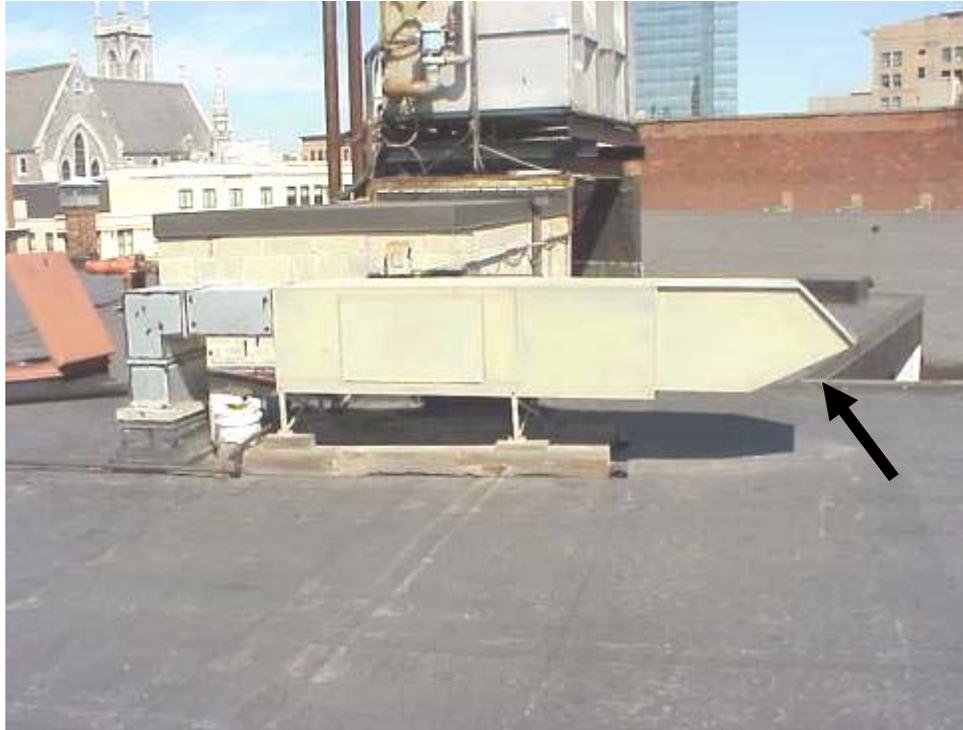
**Picture 3**

**Rooftop Fresh Air Intake AHU, Note Chilled Water Tower in Rear**

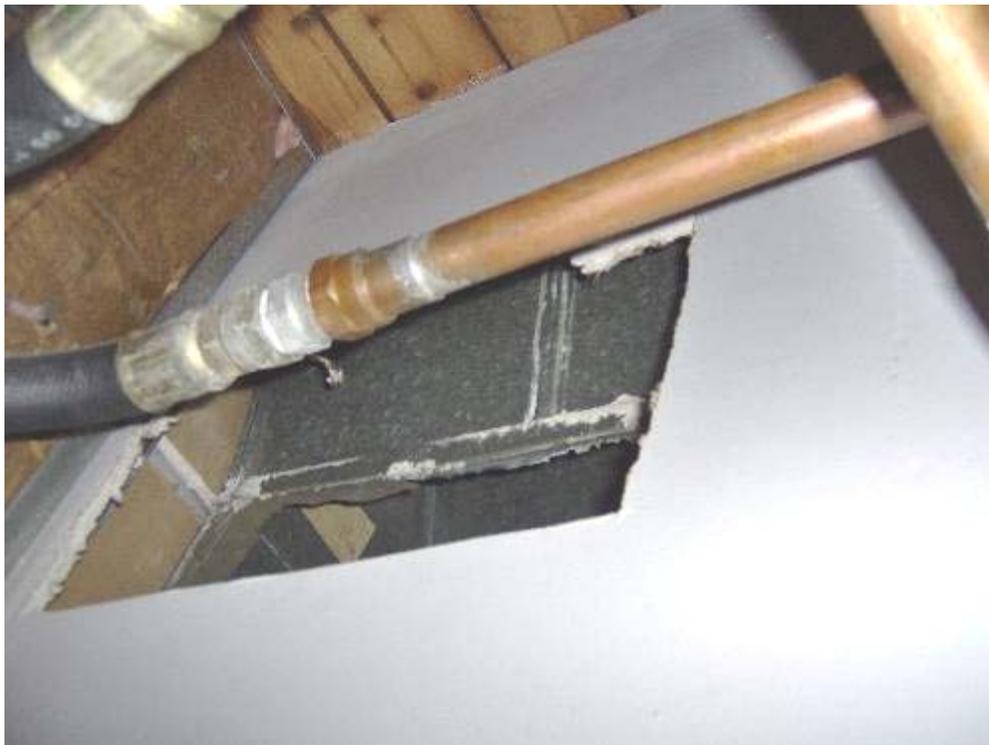
**Picture 4**

- The fresh air supply on the fifth floor has a hole in a wall that opens into a ceiling plenum near the elevator (Picture 4). This ceiling plenum also contains an AHU that distributes conditioned air to the main workspace on the fifth floor. Two other AHUs exist on the floor, however neither of these units has a separate fresh air supply. Therefore, these two AHUs only recirculate air.

**Fresh Air Supply Vent in a Plenum on 5<sup>th</sup> Floor**

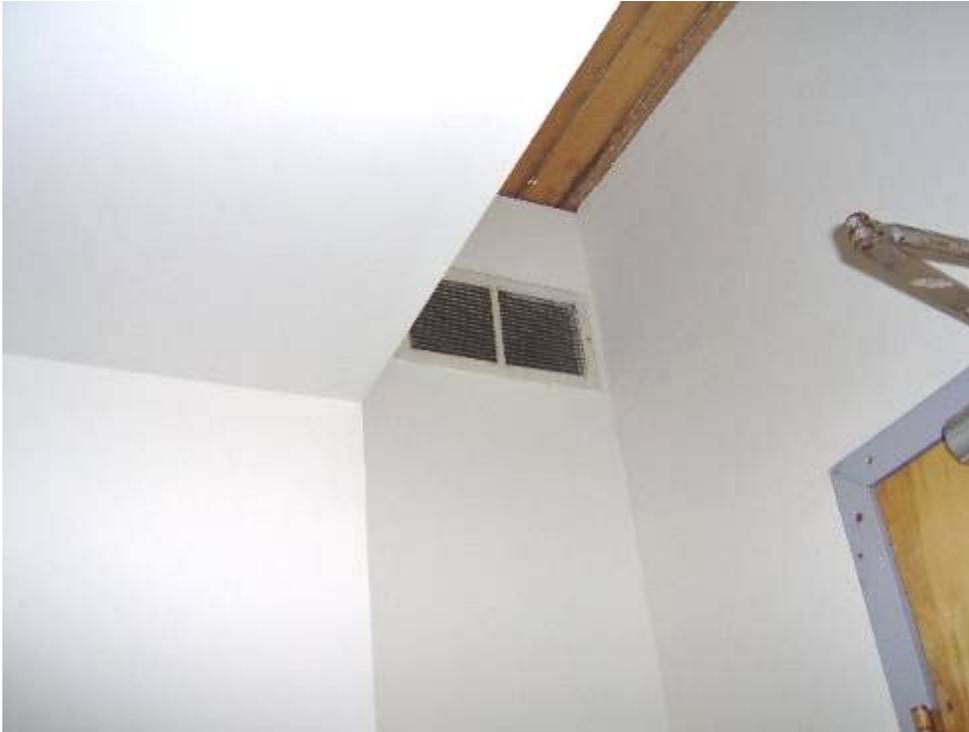
**Picture 5**

- The fresh air supply for the fourth floor is a vent that is located in the elevator hall lobby outside of the main public entrance to the DOR office (Picture 5). Due to the configuration of the ventilation system on this floor, the only area that likely receives fresh air is the elevator lobby because AHUs on this floor are located behind security doors. Fresh air from this vent cannot infiltrate into these areas and is likely drawn into the elevator shaft. Therefore, AHUs on the fourth floor only recirculate air.

**Fresh Air Supply Vent in a Plenum on the 4<sup>th</sup> Floor**

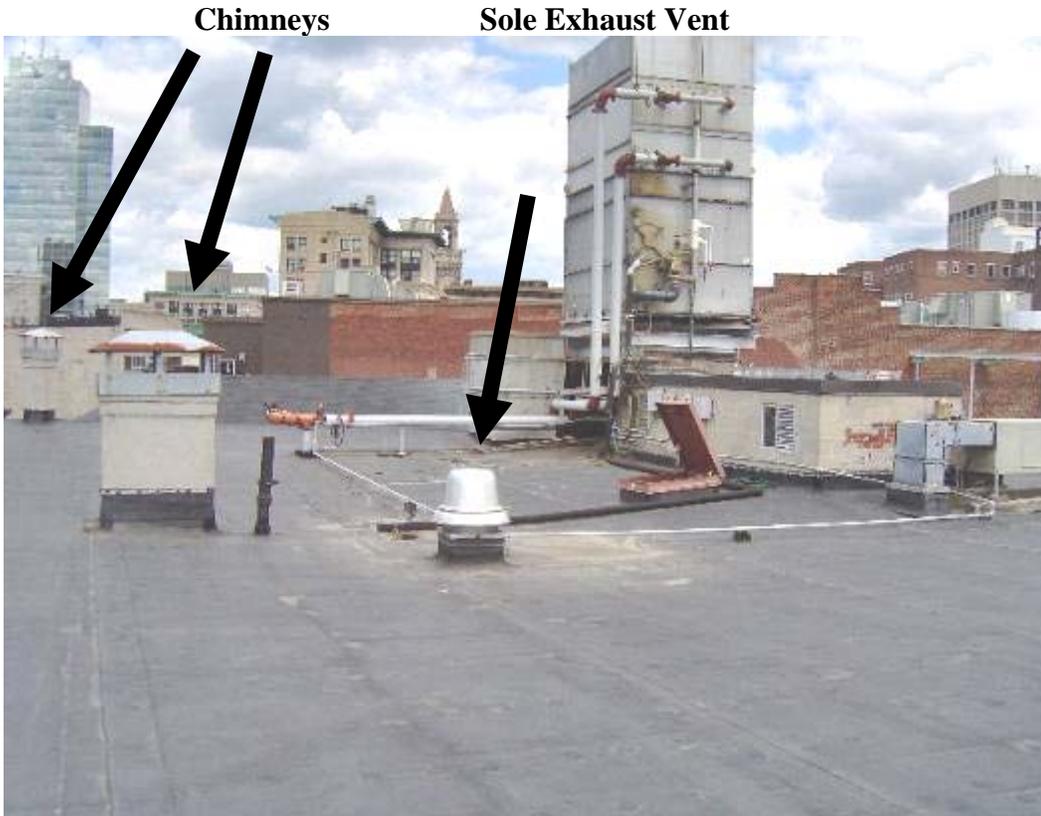
**Picture 6**

The exhaust system for the DOR offices appears to be provided solely by the restroom exhaust vents. A single exhaust vent terminus exists on the roof (Picture 6). This particular exhaust vent is likely connected to restrooms in the DOR space. In the experience of IAQ staff, it is a typical design to use the restroom exhaust vents as the sole source of exhaust air for a building that has been renovated from one use into office space. No other exhaust ventilation system could be identified by IAQ staff. Grilles seen in the suspended ceiling are most likely return air vents for each AHU closet or are installed to provide a place for heated air to rise out of the occupied space. Also of note was that restroom doors did not appear to be undercut in order to readily allow for transfer air to be drawn from the occupied space into the rest rooms. If restroom vents are not operational during business hours and/or do not have an undercut (or passive door vent) to allow for air to be drawn from occupied spaces into the restroom, the various floors of the DOR do not have a viable means to mechanically remove air. In this condition, normally occurring pollutants can build up and lead to indoor air/comfort complaints.

**Exhaust Vent on the Roof**

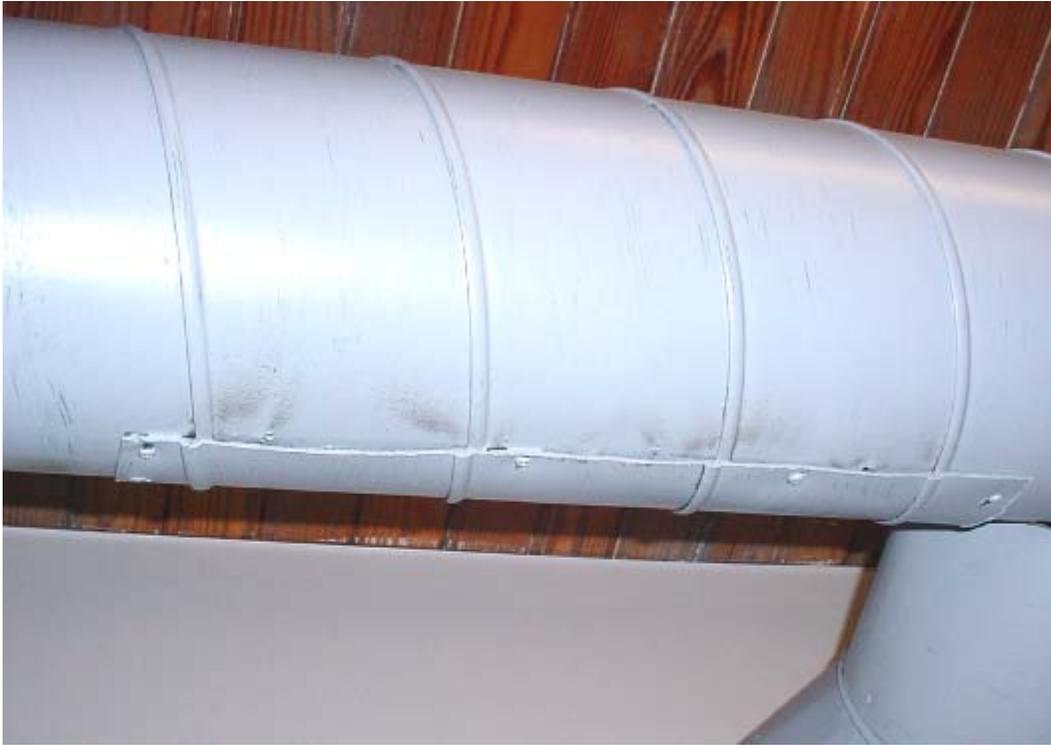
**Picture 7**

In addition, breaches in ductwork, around vents and directly from heat pumps were observed. In several cases, air was detected escaping from these breaches (Pictures 7 and 8). Compromised integrity of ductwork and holes in AHU closet walls (Picture 9) may reduce the efficiency of the system to heat/cool and distribute air, which may account for some of the difficulty controlling temperature.

**Leaking Ductwork, Note Dust "Corona" Patterns from Metal Patch**

5. Inspect heat pumps and all HVAC system ductwork thoroughly and seal breaches throughout the DOR space. In particular, leaking air from the kitchen heat pump on the 3<sup>rd</sup> floor should be addressed.

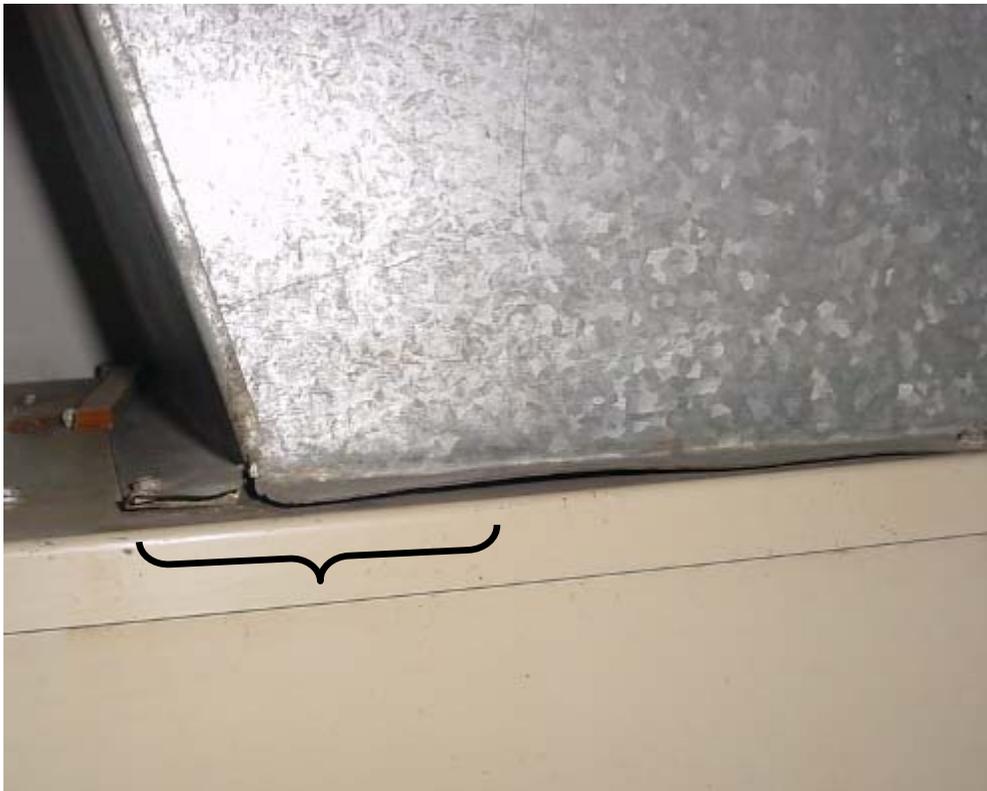
**Picture 8**

**Breach between Ductwork/Heat Pump with Conditioned Air Escaping**

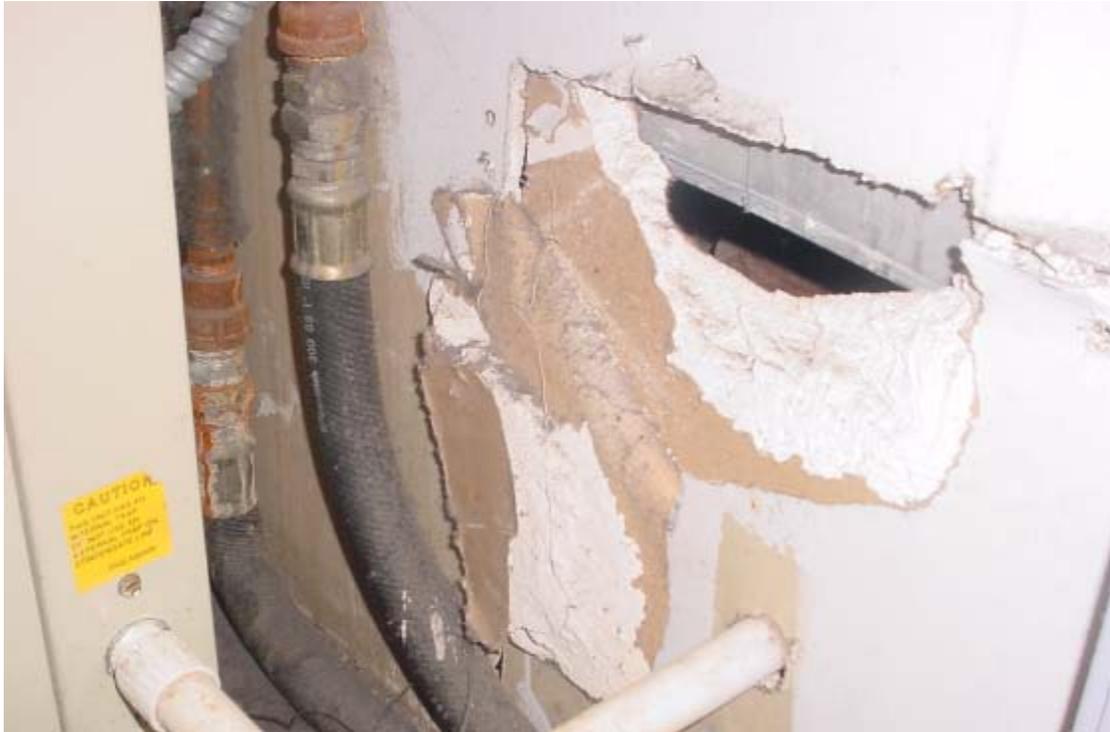
**Picture 9**

**Hole in Wall of Heat Pump Closet, 4th Floor DOR Reception Area**

4. Seal breaches/holes in heat pump rooms to prevent the draw of pollutants, odors and particulates from wall cavities or adjacent areas into the mechanical ventilation system.

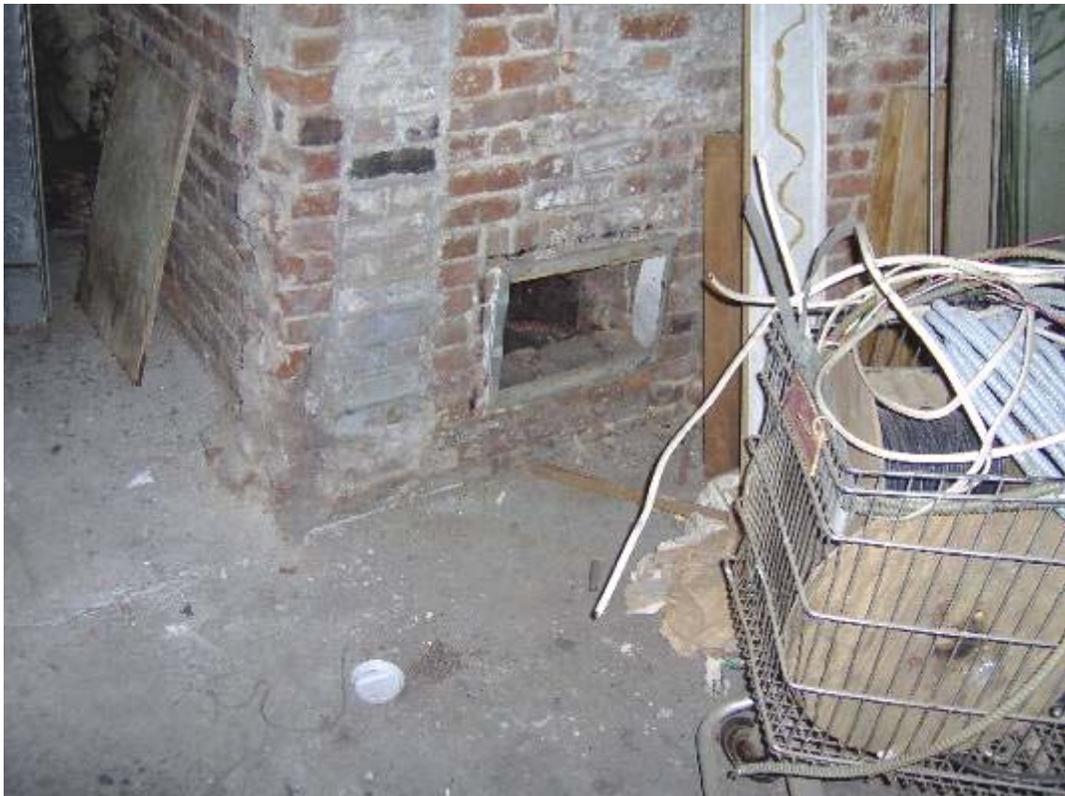
**Picture 10**

Other conditions that can affect indoor air quality were observed during the assessment. During the initial investigation of the building evacuation, IAQ staff noted that chimneys, that are original to the building, pass through the DOR offices. Each of these chimneys terminated at roof level and do not appear to be abandoned (Picture 6). In one instance, heated air was detected rising out of the chimney. Each of these chimneys had cracks, missing mortar and/or other defects which could allow for air/heat/pollutants to migrate into occupied space. Of note was a chimney clean-out that was found open in the basement area (Picture 10), immediately adjacent to the furnaces that were the source of carbon monoxide (as determined by the WFD).

**A Chimney Cleanout Door in Basement**

If these chimneys are not in use, they should be appropriately abandoned by sealing the openings on the roof and in the basement.

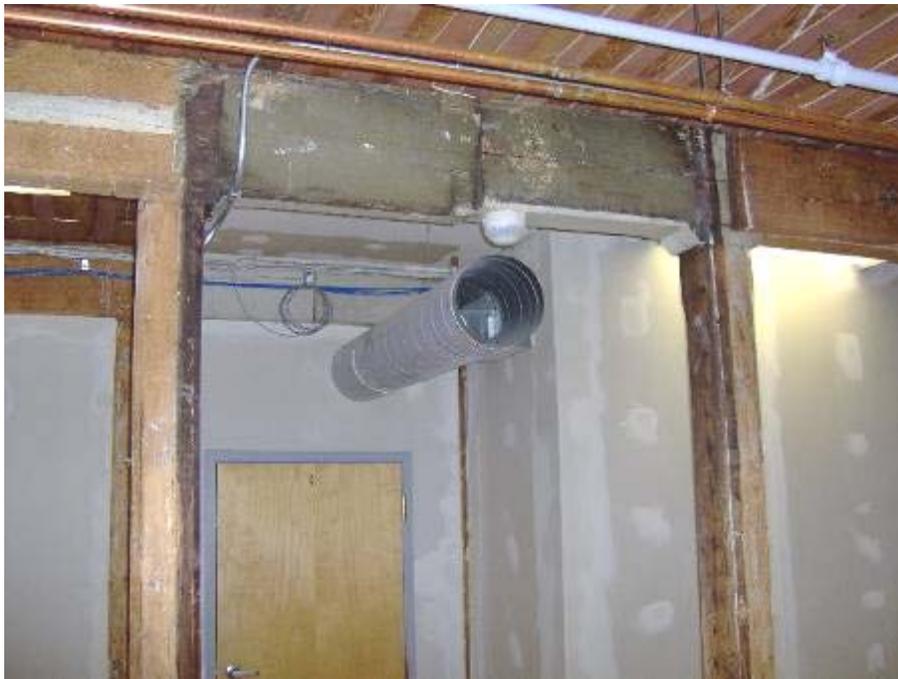
**Picture 11**

Areas on the third floor were found to be undergoing renovation while the building is occupied. Of note was a duct in the DOR office that was open on the renovation side of the floor (Picture 11). In addition, the door leading from the occupied space to the renovation side of the floor was not sealed (Picture 12). In this condition, pollutants generated during the renovation project can readily enter adjacent space. Exposure to these pollutants can result in irritations to the eyes, nose, and respiratory system. For that reason such pollutants should be properly contained and vented from the building during occupied hours.

**Open Duct in DOR Space, Note Lack of Covering for Vent Opening**

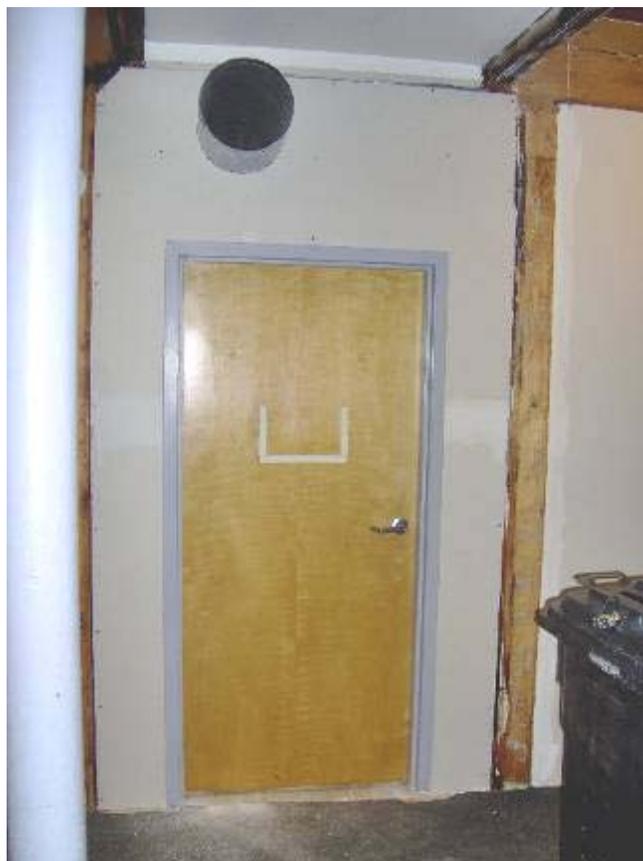
**Picture 12**

**Door Leading to Renovated Area from DOR Space, Note Lack of Barriers on Door**

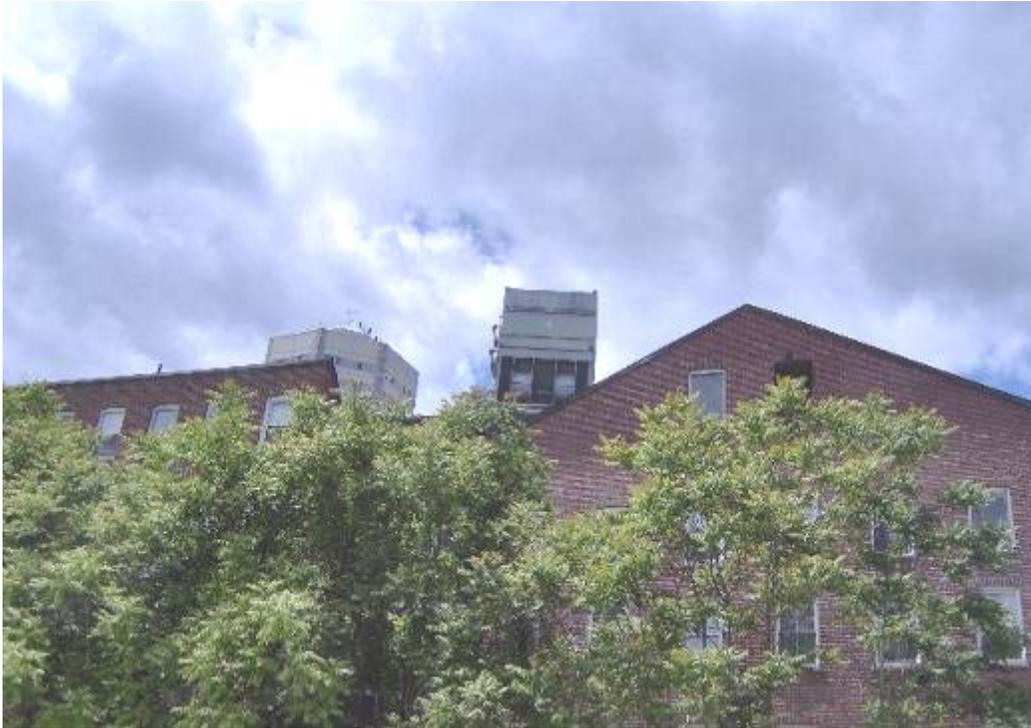
**Picture 13**

During the course of this evaluation, IAQ a staff noted water droplets impacting on ground areas behind the building. This moisture appeared to be coming from the rooftop chiller for the HVAC system (Picture 13), which appeared to be leaking water from its cabinet onto a

**Rooftop Chiller for HVAC System**

11. Repair the rooftop chiller to maximize efficiency and reduce opportunities for moisture intrusions.
12. Store fluorescent bulbs in a secured fashion or remove/recycle if expired.

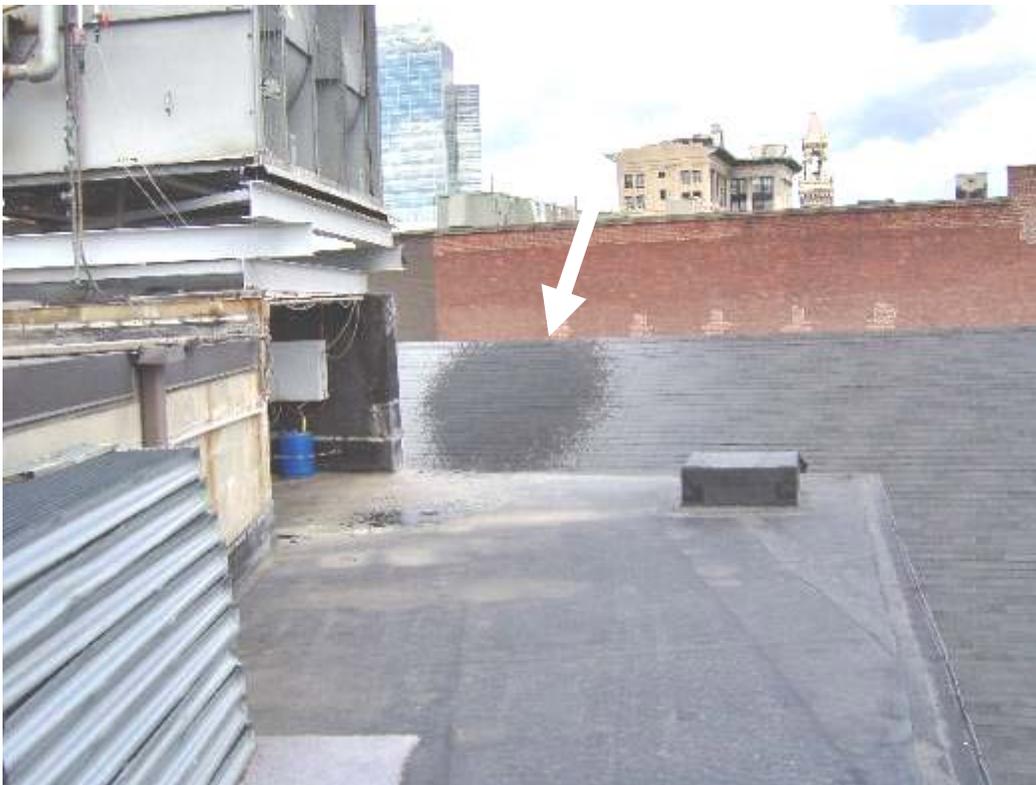
**Picture 14**

peaked section of the roof (Picture 14) as well as on to the ground below. A chiller system that is losing water is likely affecting the efficiency of such a unit to provide adequate cooling.

**Moisture from Chiller Wetting Roof Shingles**

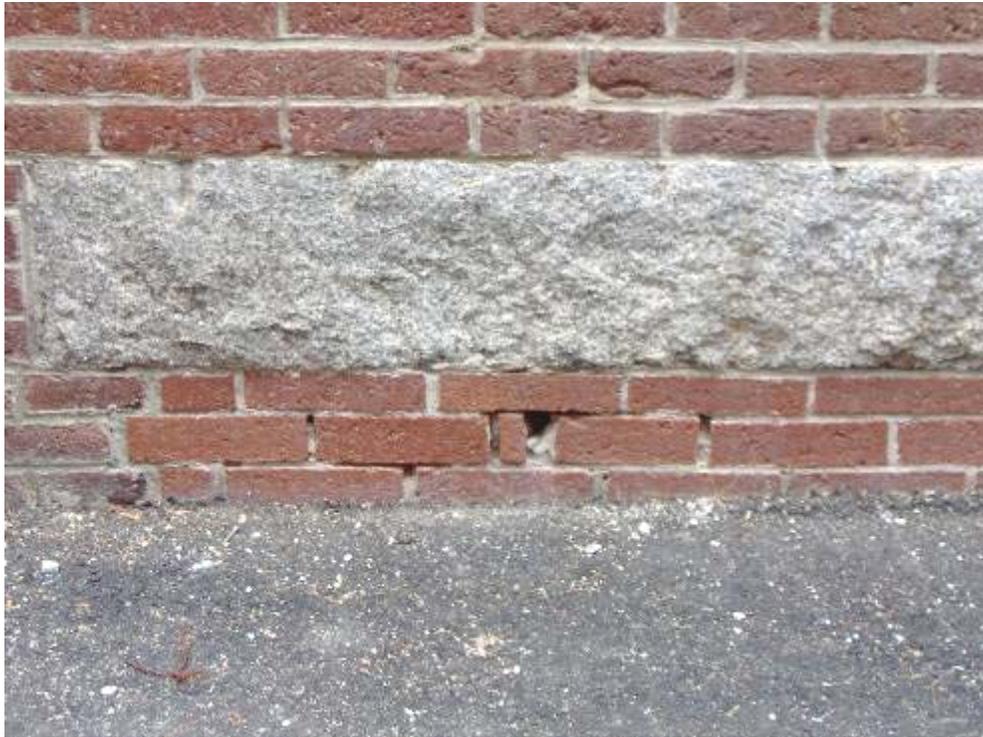
**Picture 15**

Holes in damaged exterior brick were observed around the foundation of the building (Picture 15). These breaches can serve as a pathway for rodents and other pests to enter the building. It is recommended that such a means of the ingress be sealed to control pest infestation.

**Missing/Damaged Mortar/Brick Exterior Wall/Foundation**

8. Seal spaces around utility holes and breaches in walls/floors and ceilings with an appropriate fire-rated sealant.
9. Seal holes/breaches in exterior brick/foundation.

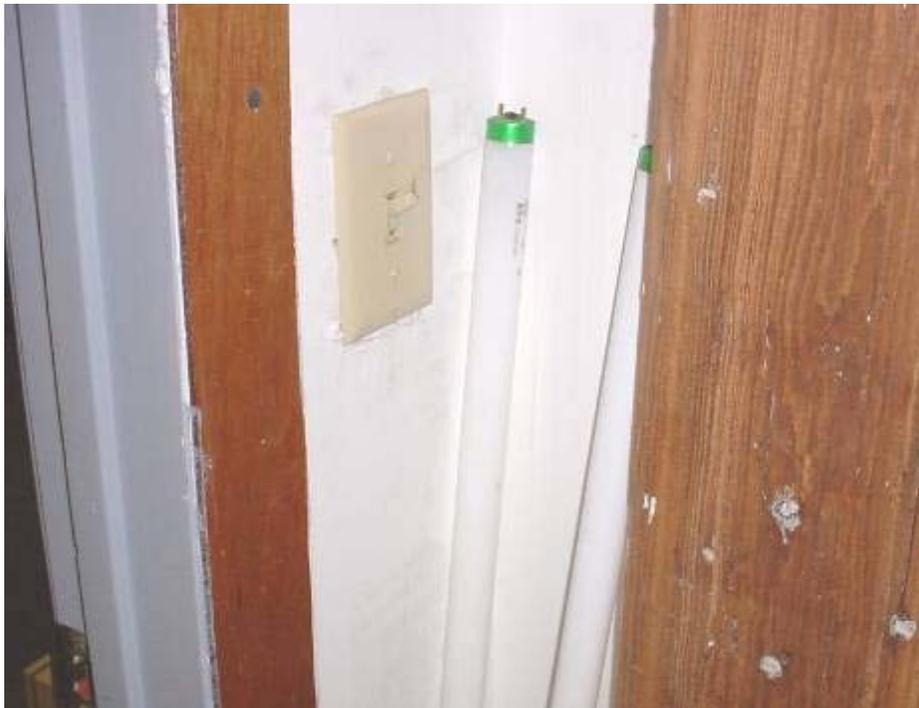
**Picture 16**

Finally, several fluorescent light bulbs were found leaning against the wall, unsecured in the 2<sup>nd</sup> floor heat pump room (Picture 16). Fluorescent bulbs should be stored in a secured fashion or removed/recycled if expired. Breakage of glass can cause injuries and may release mercury and/or other hazardous compounds.

**Fluorescent Light Bulbs Leaning Against Wall in 2<sup>nd</sup> Floor Heat Pump Room**
