INDOOR AIR QUALITY ASSESSMENT

**Massachusetts Department of Revenue
60 Perseverance Way
Hyannis, Massachusetts**

Prepared by:
Massachusetts Department of Public Health
Bureau of Environmental Health
Indoor Air Quality Program
September 2009

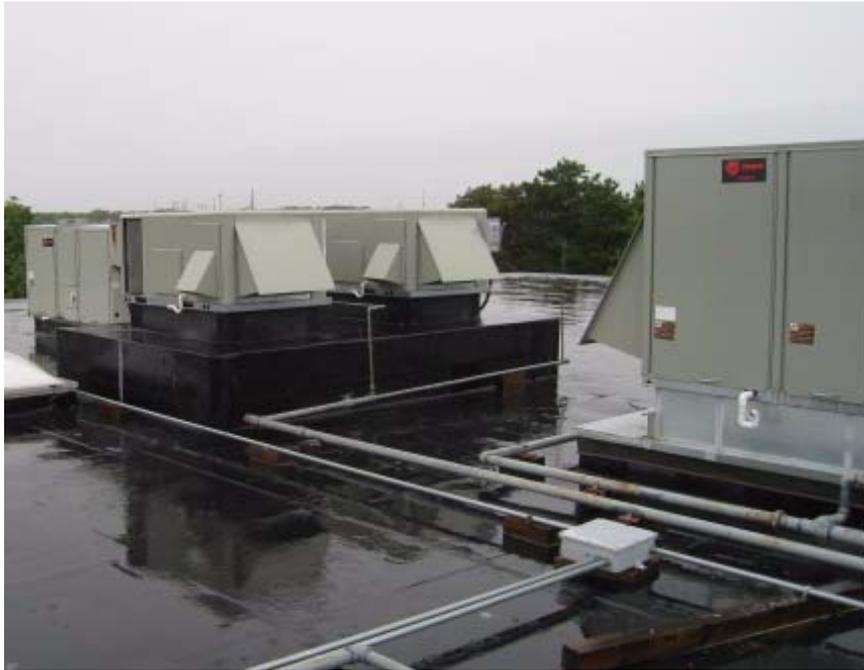
Picture 1

It can be seen from Table 1 that carbon dioxide levels were below 800 parts per million (ppm) in all areas surveyed, with one exception, indicating adequate air exchange throughout the building the day of the assessment. Mechanical ventilation is provided by rooftop air-handling units (AHUs) (Picture 1). Fresh air is drawn into the AHUs and delivered to occupied areas via ceiling-mounted air diffusers (Picture 2). Return air is drawn into ceiling-mounted vents and ducted back to the AHUs (Picture 3).

Rooftop AHUs

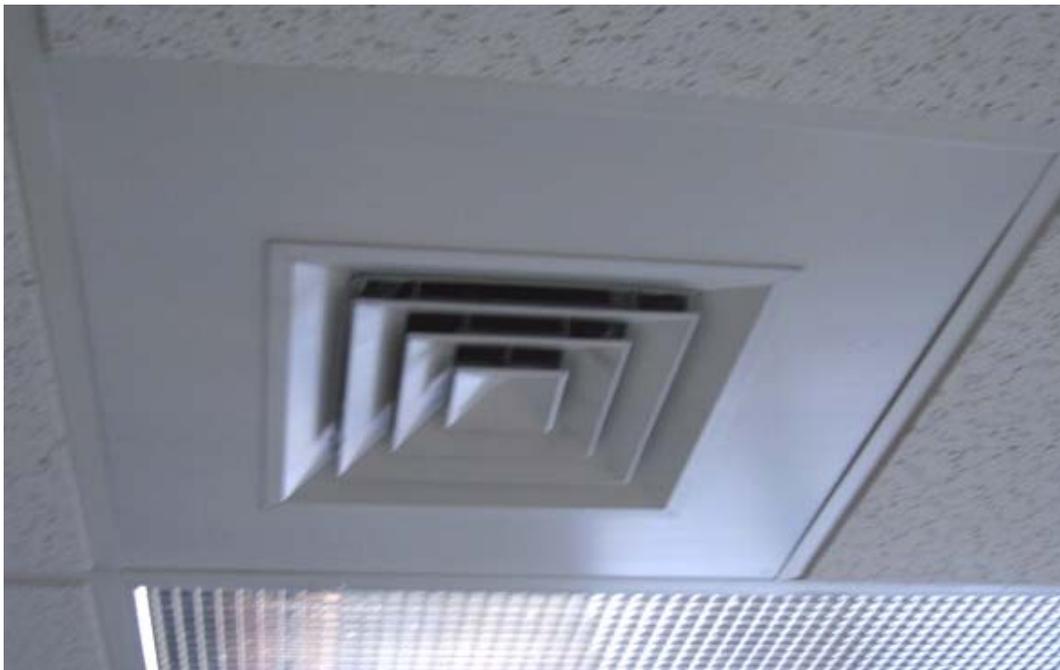
Picture 2

Ceiling-Mounted Air Diffuser

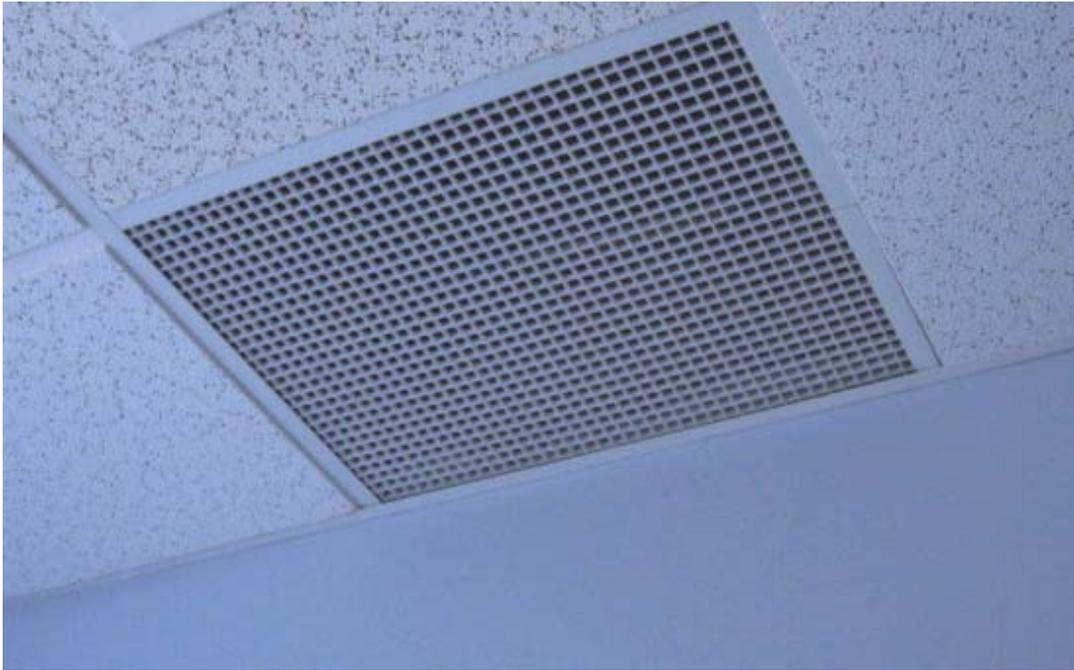
Picture 3

Ceiling-Mounted Return Grill

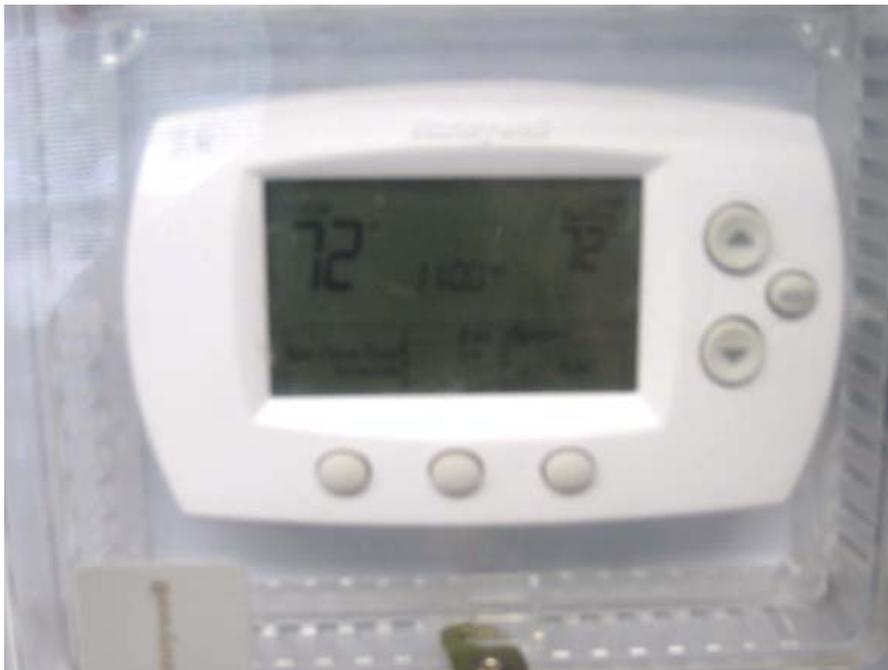
Picture 4

Digital wall-mounted thermostats control the heating, ventilating and air conditioning (HVAC) system (Picture 4). Thermostats have fan settings of “on” and “automatic”. At the time of the MDPH assessment, the thermostats were set to the fan “auto” setting. The “automatic” setting on the thermostat activates the HVAC system at a preset temperature. Once the preset temperature is reached, the HVAC system is deactivated, whereas the fan “on” setting provides *continuous* airflow, which is recommended by the MDPH.

Digital Wall Thermostat

1. Set thermostat controls in the fan "on" position to provide continuous air exchange during periods of occupancy.
2. Consult with an HVAC engineer to ascertain the most appropriate method to improve comfort in the interview rooms. Options may include the relocation of supply vents outside the rooms and the installation of passive door vents to allow air exchange.

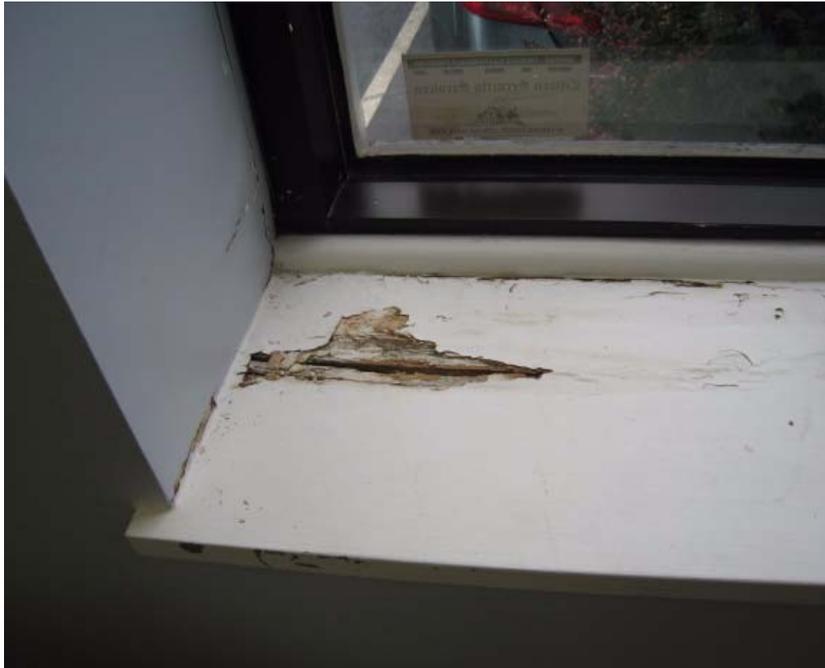
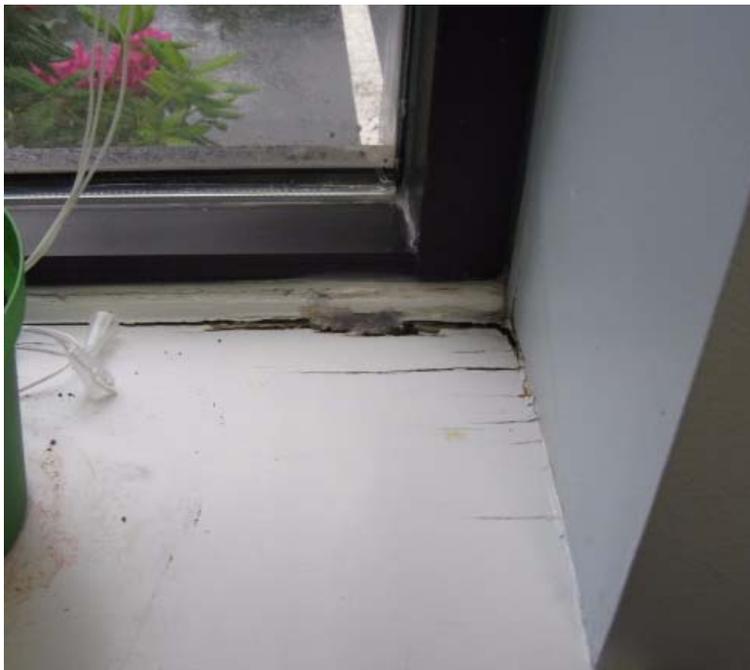
potential mold growth resulting from water damaged building materials. The main source of water penetration was reportedly through window systems (Pictures 5 and 6). According to Mr. Gomes, building management has repeatedly attempted to make repairs to window systems to prevent further water penetration. At the time of the assessment, the majority of water damaged building materials (e.g., gypsum wallboard) had been replaced/repared and refinished. Building occupants reported that water penetration had either ceased or was only occurring periodically in some areas, particularly during heavy wind/rain patterns.

Water Damaged Wooden Window Sill

5. Continue working with building management to identify and address window leaks.
6. Replace water damaged wooden windowsills.

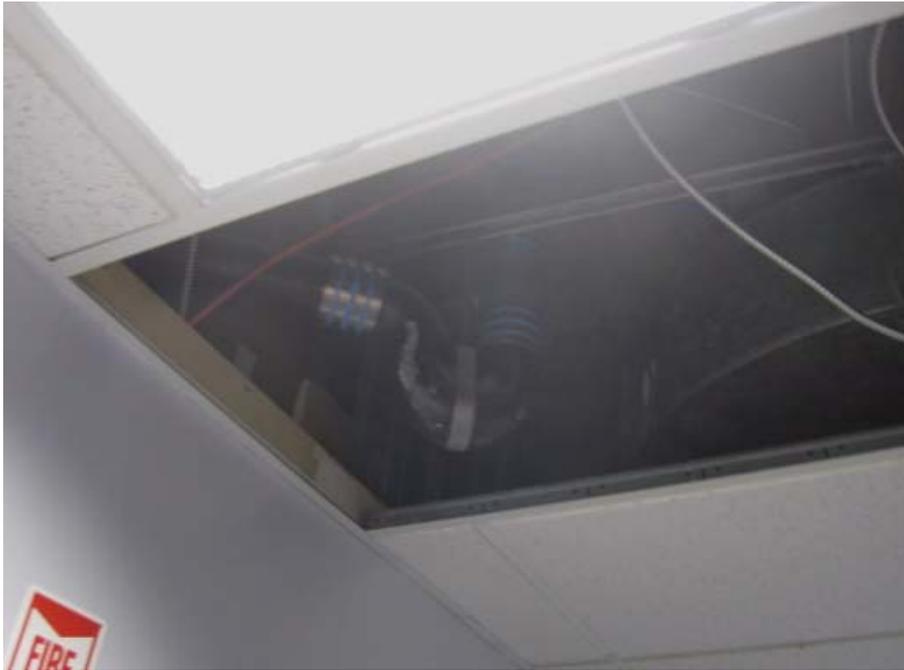
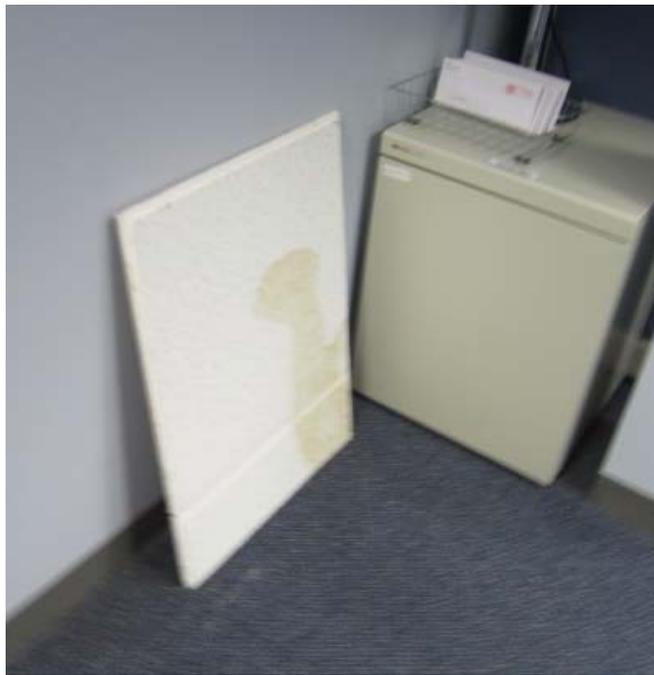
In the main work area opposite the reception desk, a water stained ceiling tile had been removed to fix a plumbing/drainage leak (Pictures 7 and 8). Water damaged ceiling tiles can provide a source of mold and should be replaced after a water leak is discovered and repaired.

Ceiling Tile Removed to Fix Plumbing/Drainage Leak

Water Stained Ceiling Tile Removed to Fix Plumbing/Drainage Leak

7. Replace water-damaged ceiling tiles. Examine above and around these areas for microbial growth. Disinfect areas of water leaks with an appropriate antimicrobial as needed.

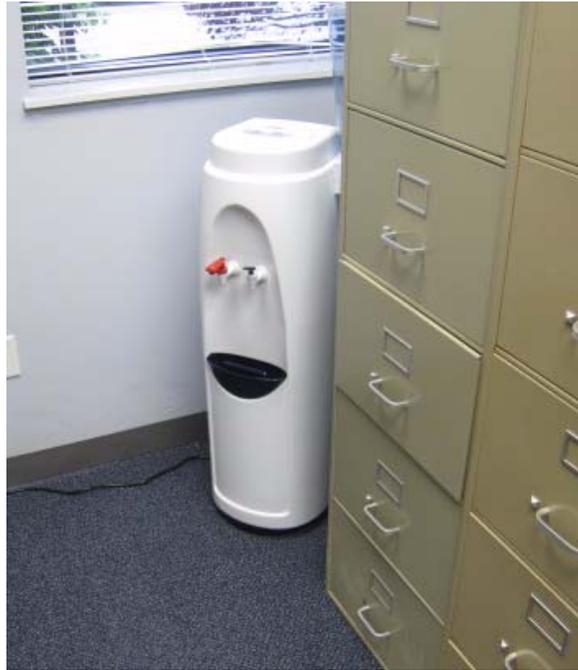
Picture 9

A water cooler was located over carpeting (Picture 9). Water spillage or overflow of cooler catch basins can result in the wetting of the carpet. In addition, some of the coolers had residue/build-up in the reservoir. These reservoirs are designed to catch excess water during operation and should be emptied/cleaned regularly to prevent microbial and/or bacterial growth.

Water Cooler on Carpeting

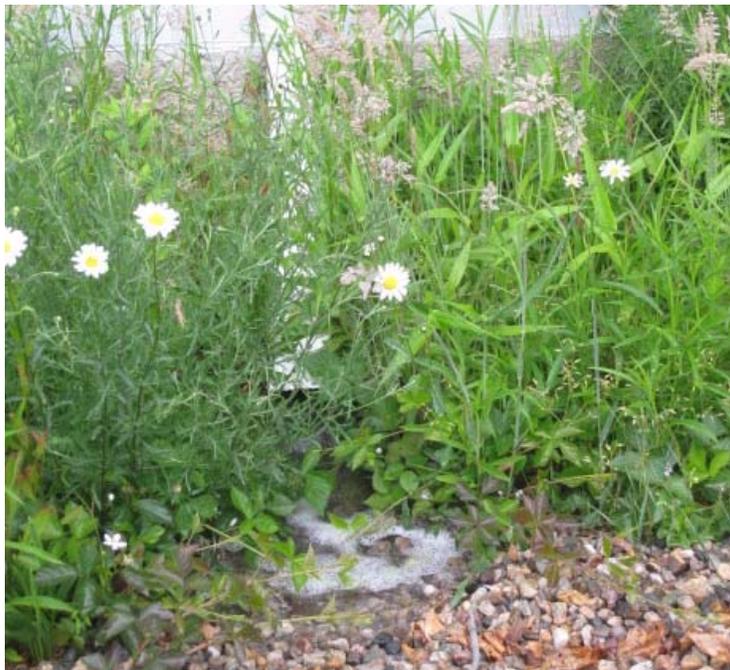
Picture 10

clogged/damaged downspouts/elbow extensions and/or poor drainage around the building (Pictures 10 through 12). Over time these conditions can undermine the integrity of the building envelope and provide a means of water entry by capillary action into the building through exterior walls, foundation concrete and masonry (Lstiburek & Brennan, 2001).

Downspout Missing Elbow Extension Note Water Pooling against Exterior Wall

8. Inspect downspouts and elbows for proper drainage. Consider regarding outside perimeter of building to draw water away from the building.
9. Avoid over watering of plants. Ensure flat surfaces around plants are free of potting soil and other plant debris. Examine drip pans periodically for mold growth and disinfect with an appropriate antimicrobial where necessary.

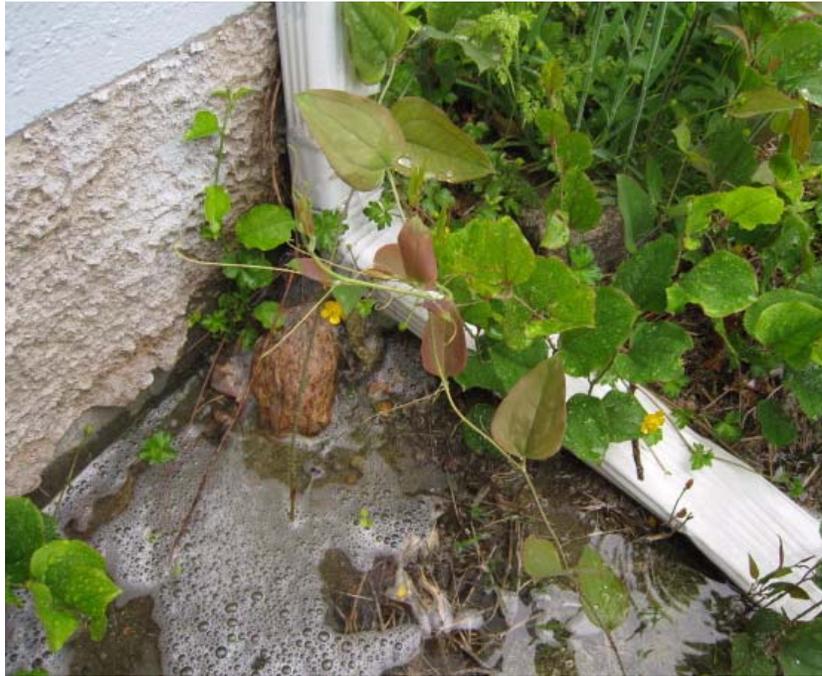
Picture 11

Clogged/Damaged Downspout/Elbow Extension Emptying Water against Exterior Wall

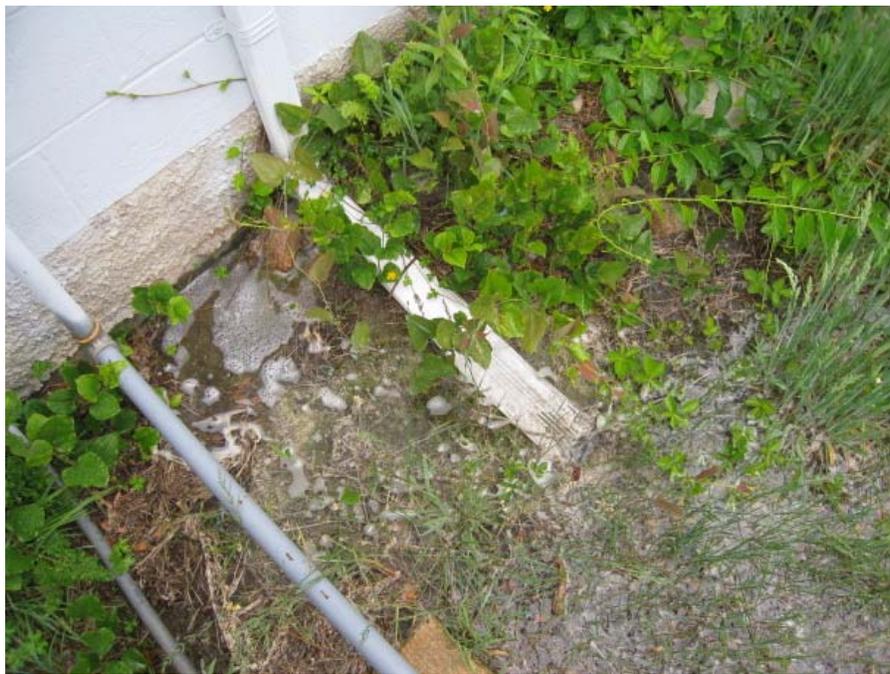
Picture 12

Water Pooling against Exterior Wall

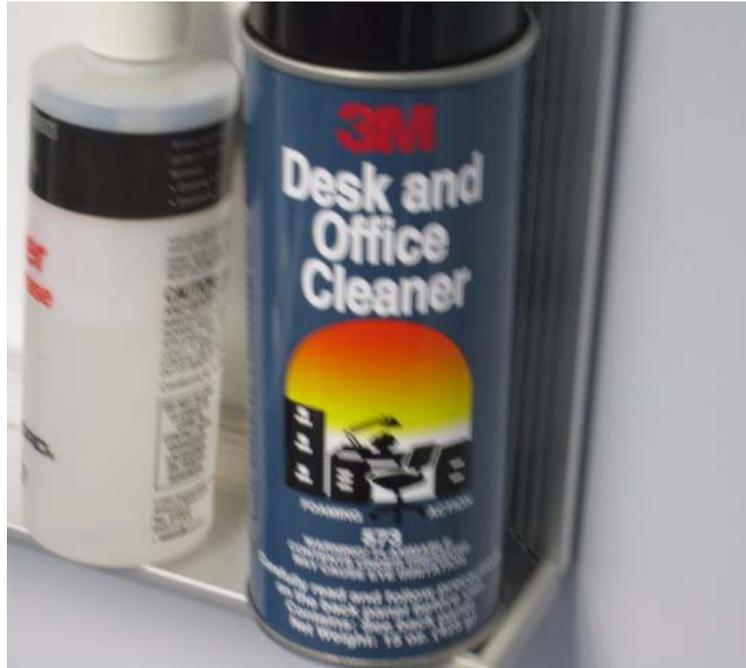
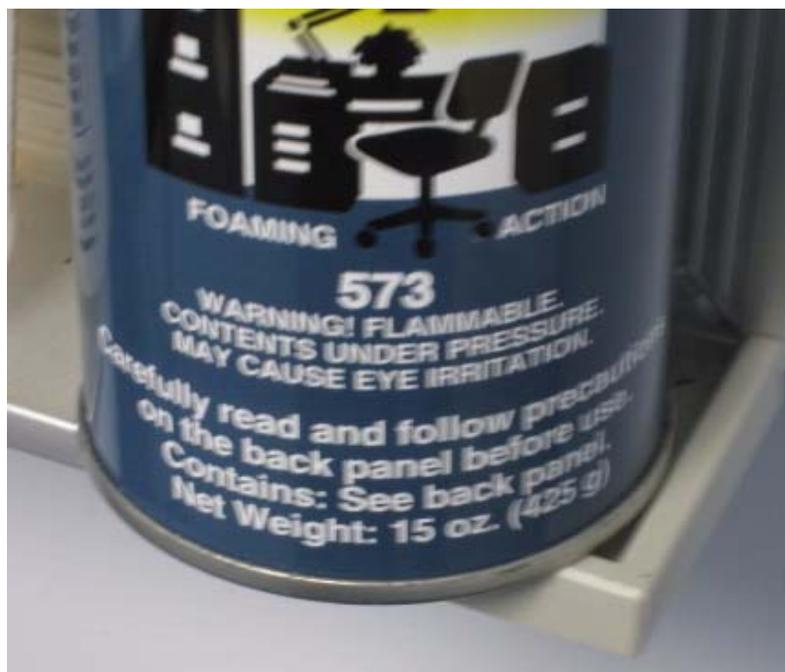
Some areas contained dry erase boards and related materials. Materials such as dry erase markers and dry erase board cleaners may contain VOCs, such as methyl isobutyl ketone, n-butyl acetate and butyl-cellusolve (Sanford, 1999), which can be irritating to the eyes, nose and throat. Lastly, VOC-containing cleaning materials were observed (Pictures 13 and 14) in some personal work areas. These materials contain several VOCs (e.g., isopropyl alcohol and monoethanolamine) that can be irritating to the eyes, nose and throat (3M, 2000).

VOC-Containing Office Cleaner

Close-Up of Label in Preceding Picture, Note Flammable/Causes Eye Irritation

10. Discontinue the use of VOC-containing cleaners. Less irritating materials, (soap and water) may suffice to clean in these areas.
11. Ensure that restroom local exhaust vents are ducted to the outdoors to remove odors and excess moisture.

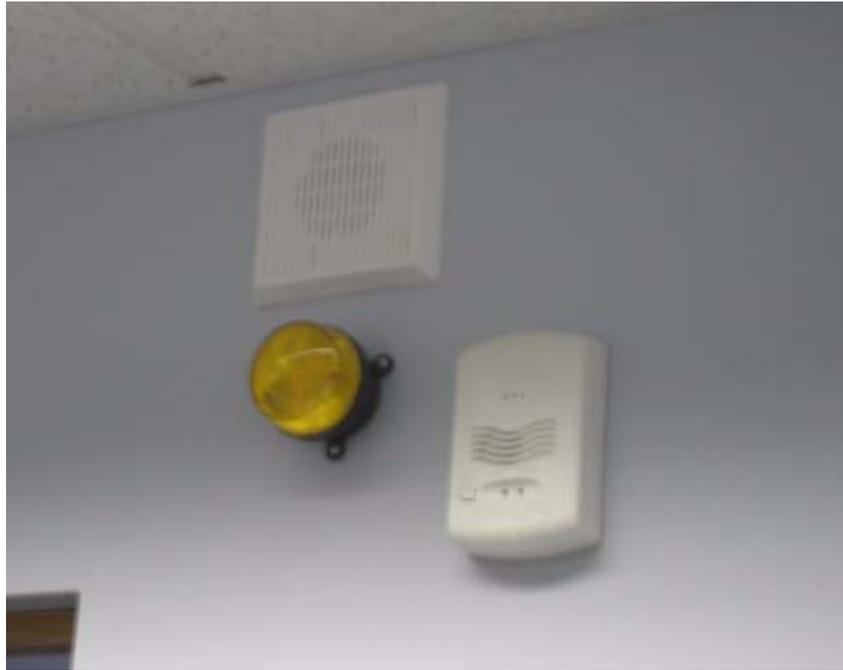
Picture 15

As a proactive measure, wall-mounted carbon monoxide detectors were installed in the building (Picture 15). Carbon monoxide detectors have a varying shelf-life depending on make and model. To ensure proper working order carbon monoxide monitors should be tested and replaced as per the manufacture's instructions.

Wall-Mounted Carbon Monoxide Detector

12. Test carbon monoxide detectors to ensure proper working order and replace as per the manufacture's recommendations.
13. Refer to resource manuals and other related indoor air quality documents for further building-wide evaluations and advice on maintaining public buildings. Copies of these materials are located on the MDPH's website: <http://mass.gov/dph/iaq>.

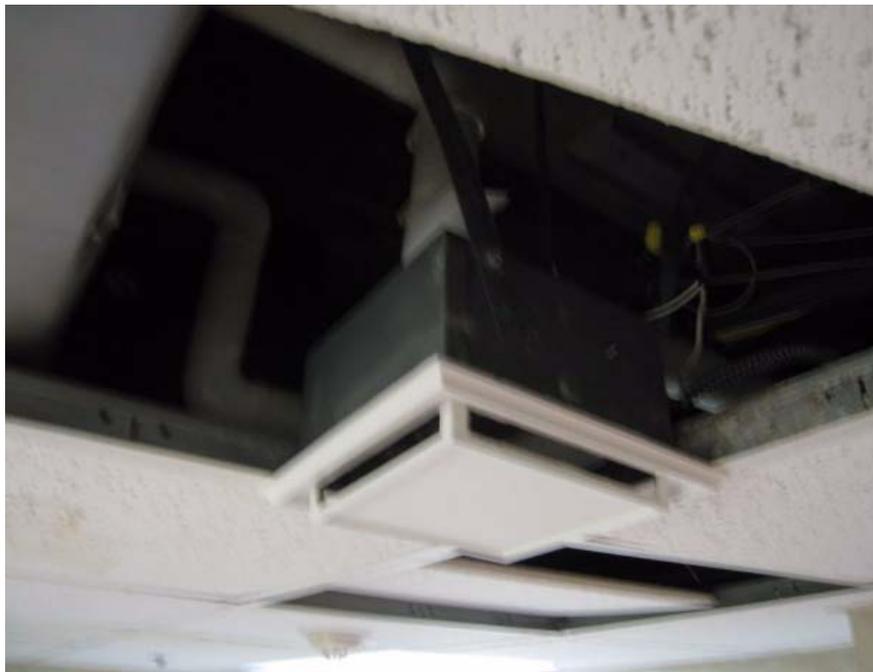
Picture 16

Restroom exhaust is provided by ceiling-mounted vents that are designed to remove odors and excess moisture. BEH staff examined the vents in the men's room and determined that it was not ducted to the outside of the building (Picture 16). Exhaust ventilation is necessary

in restrooms to remove moisture and to prevent restroom odors from penetrating into adjacent areas. Local exhaust vents in the women's restroom appeared to be ducted to the outside.

Unducted Local Exhaust Vent in Men's Restroom
