INDOOR AIR QUALITY ASSESSMENT

**Belchertown Emergency Medical Services
9 East Walnut Street
Belchertown, Massachusetts**

Prepared by:
Massachusetts Department of Public Health
Bureau of Environmental Health
Indoor Air Quality Program
December 2009

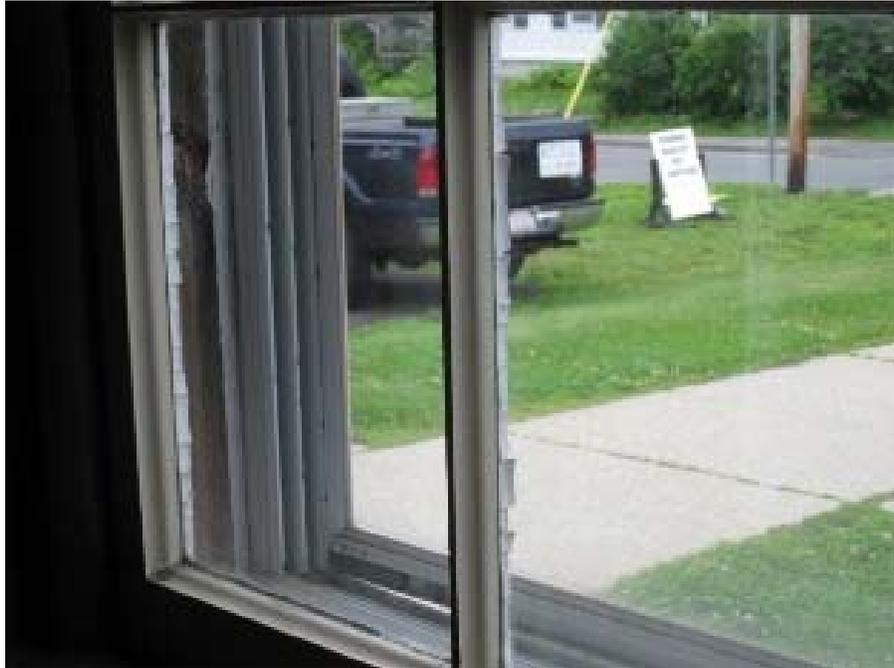
Picture 1

Several potential sources of moisture, water damage and/or mold growth were observed during the assessment. Broken/missing window glazing was observed throughout the building ([Pictures 1](#) and 2). Gaps were also evident around window-mounted air conditioners. Nonfunctioning ventilation equipment used for the former jail cells was still in place and was open to the outdoor environment ([Picture 3](#)). All of these conditions may allow hot, moist air into the BEMS, which can potentially lead to the generation of condensation in the building, in addition to reducing air conditioning efficiency.

Deteriorated Glazing

1. Repair broken panes of glass and deteriorated glazing in windows. Be advised that tightening up the building envelope by repairing/replacing windows without a subsequent increase in ventilation may result in an increase in carbon dioxide levels within the BEMS. (Please refer to long term recommendation # 1).
2. Seal gaps surrounding window-mounted air conditioners.
3. Remove old ventilation equipment in former jail cells and properly seal opening.
4. Change filters for air conditioners as per the manufacturer's instructions or more frequently if needed.

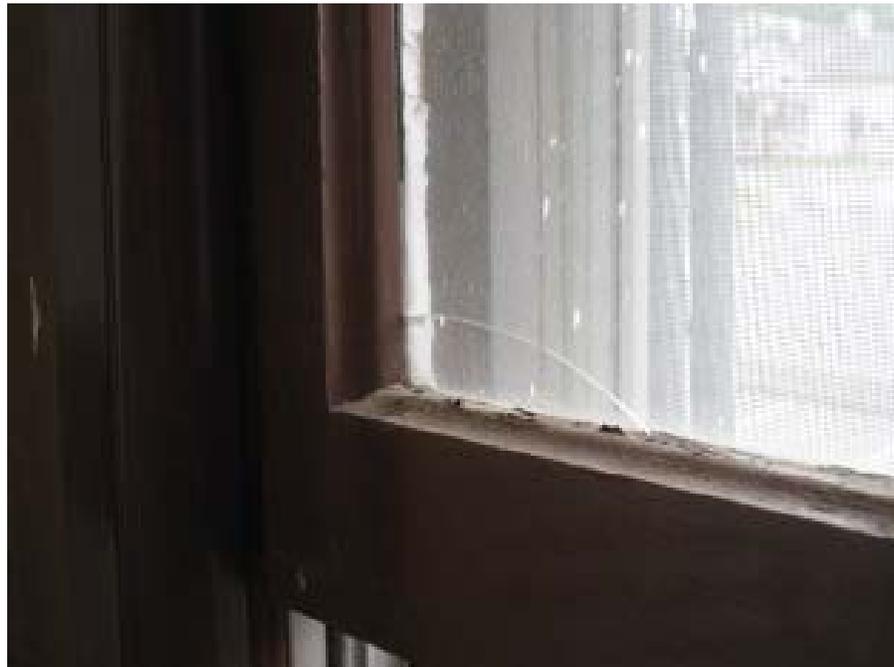
Picture 2

Broken Pane of Glass

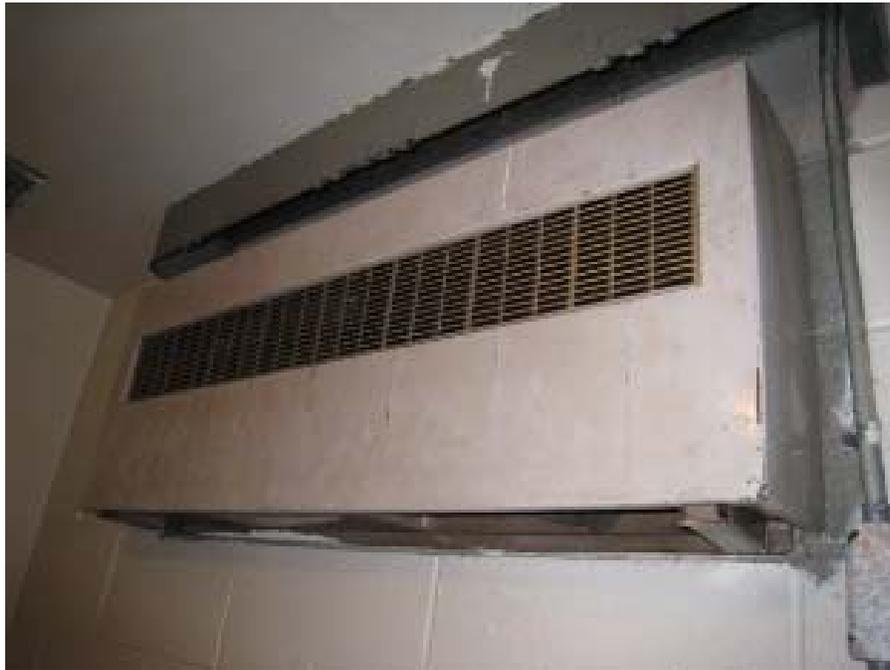
Picture 3

The ventilation system at BEMS does not appear to be designed to provide either mechanical fresh air supply or exhaust ventilation. Fresh air is currently supplied by openable windows. With a lack of fresh air supply and/or exhaust ventilation, normally occurring indoor environmental pollutants can accumulate and lead to air quality/comfort complaints. The former cell block had a exhaust ventilation system, which was not in use. Restrooms have an exhaust vent system.

Nonfunctioning Ventilation Unit in Former Jail Cell

1. Consider contacting an HVAC engineering firm to design and install an appropriately sized ventilation system.
2. Consider installing replacement windows.
3. Consider installing kitchen and bathroom vents that terminate on the outside of the building.

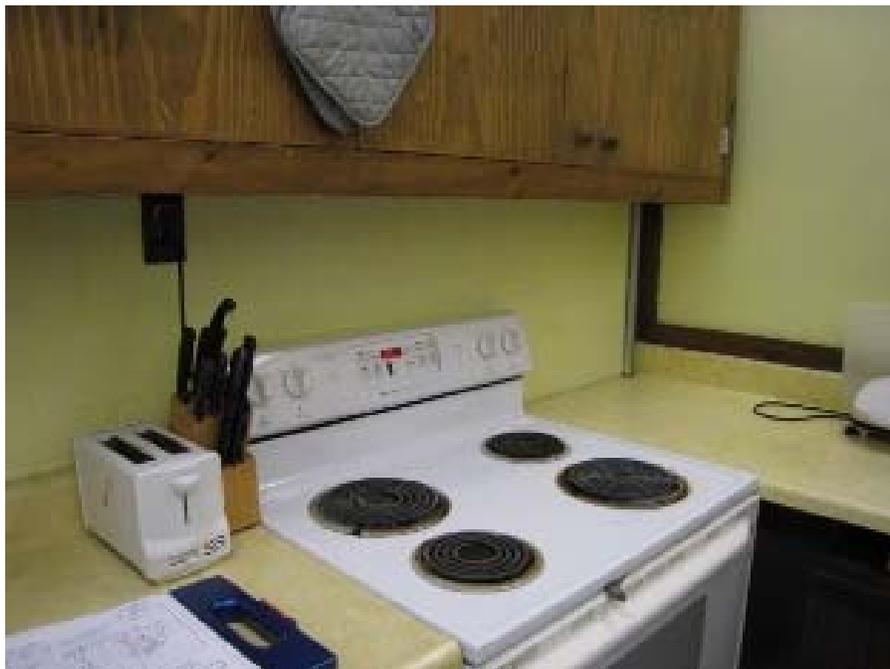
Picture 4

The bathroom vent appeared to terminate in the attic space. This was confirmed by Ms. Metcalf. The kitchen lacked an exhaust fan above the stove ([Picture 4](#)). Both of these conditions will allow moisture and odors to remain within the interior of the BEMS.

Exhaust Fan Lacking Above Stove

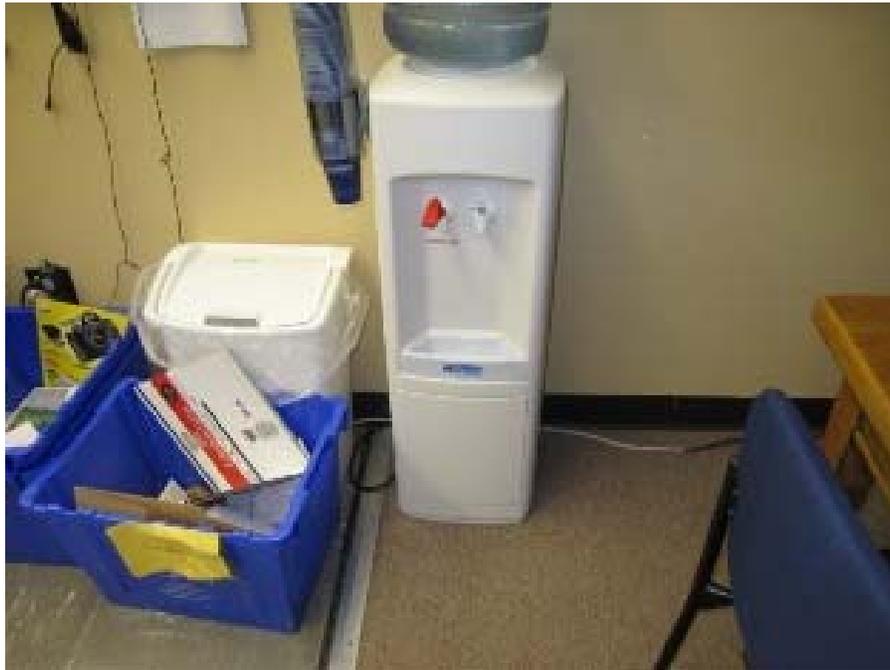
Picture 5

A water cooler was located over a carpeted area ([Picture 5](#)). Overflow of the water basin or spills that occur often can moisten carpeting, which can lead to mold growth. It is important that the catch basin of a water cooler be cleaned regularly as stagnant water can be a source of odors, and materials (i.e., dust) collected in the water can provide a medium for mold growth.

Water Cooler Located on Carpet

6. Relocate water cooler onto a surface that is impervious to water or provide a mat beneath it that is impervious to water. Clean catch basin on a regular basis.

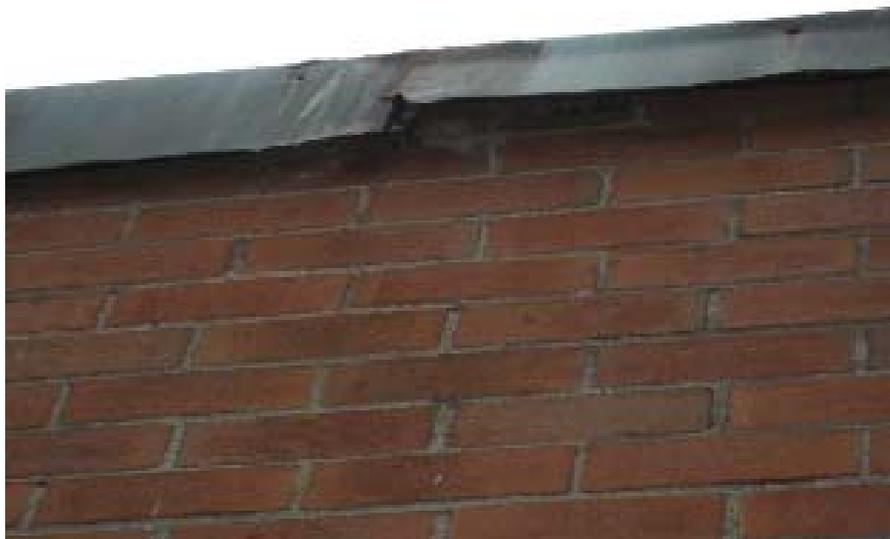
Picture 6

- Flashing at the edge of the roof was in disrepair ([Picture 6](#)).
- Gaps were observed between window casings and exterior window sills ([Picture 7](#)).

Flashing At Edge of Roof in Disrepair

9. Repair flashing at edge of roof. Examine roof for damaged areas and repair.
10. Develop routine maintenance schedule for roof drains/gutters to eliminate possibility of ice dams in the future.

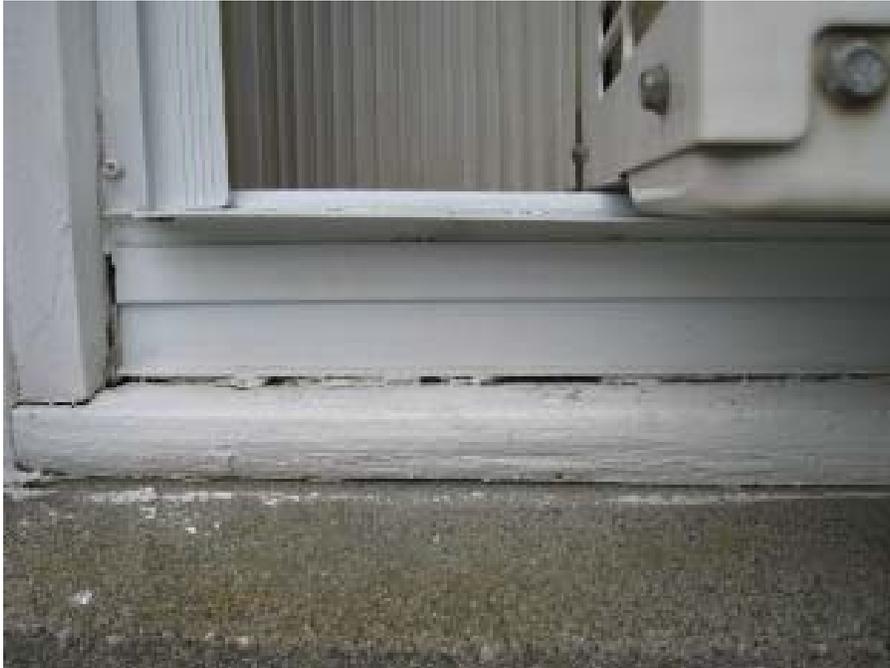
Picture 7

Gaps between Window Casing and Exterior Sill

11. Seal gaps between window casings and exterior sills.
12. Repair sealant at top of window casings.
13. Repair holes in masonry. Re-point masonry where necessary.

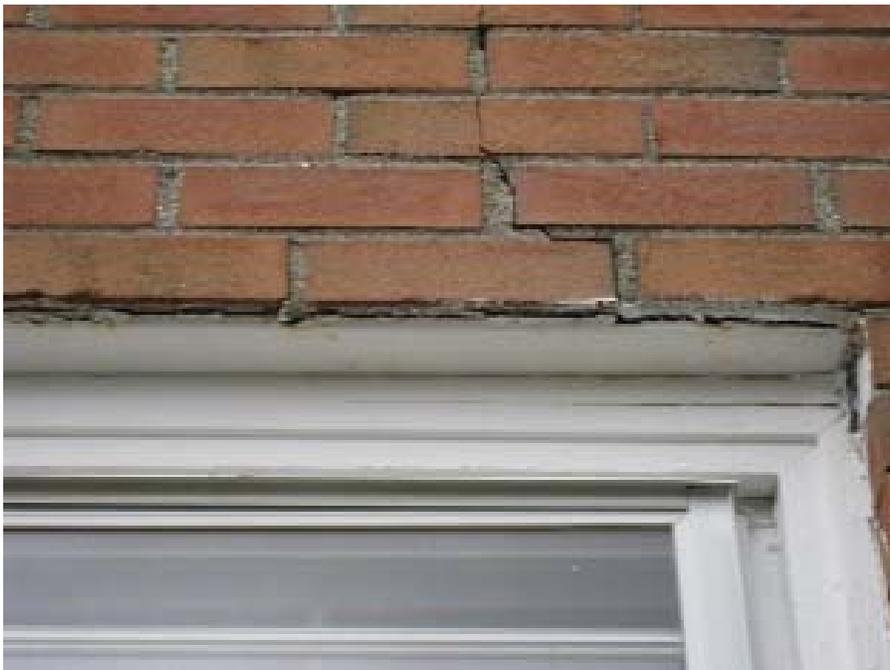
Picture 8

- Sealant at the top of windows was deteriorated/missing ([Picture 8](#)).
- Window glazing was deteriorated and missing in some areas.
- Holes were observed in masonry ([Picture 9](#)). Some exterior walls exhibited cracked and/or bulging brick and mortar ([Pictures 10](#) and [11](#)). The bulging surfaces of brick and mortar were observed on both the east and west sides of the building, which may be an indication of a structural issue. The local building commissioner should be consulted to evaluate the building's structural integrity.

**Sealant at Top of Window is Deteriorated
Note Cracked, Broken Masonry**

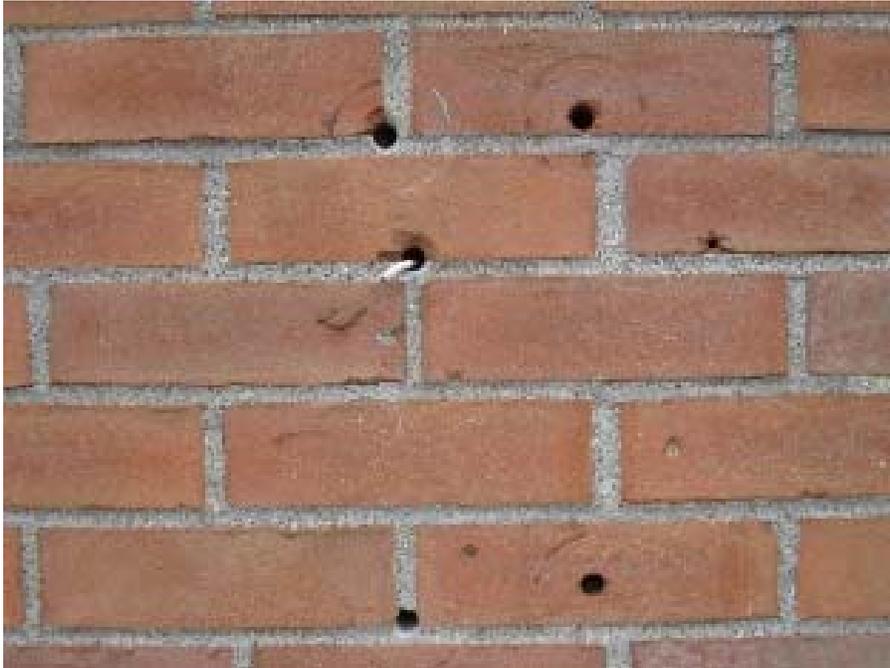
Picture 9

Holes in Brick

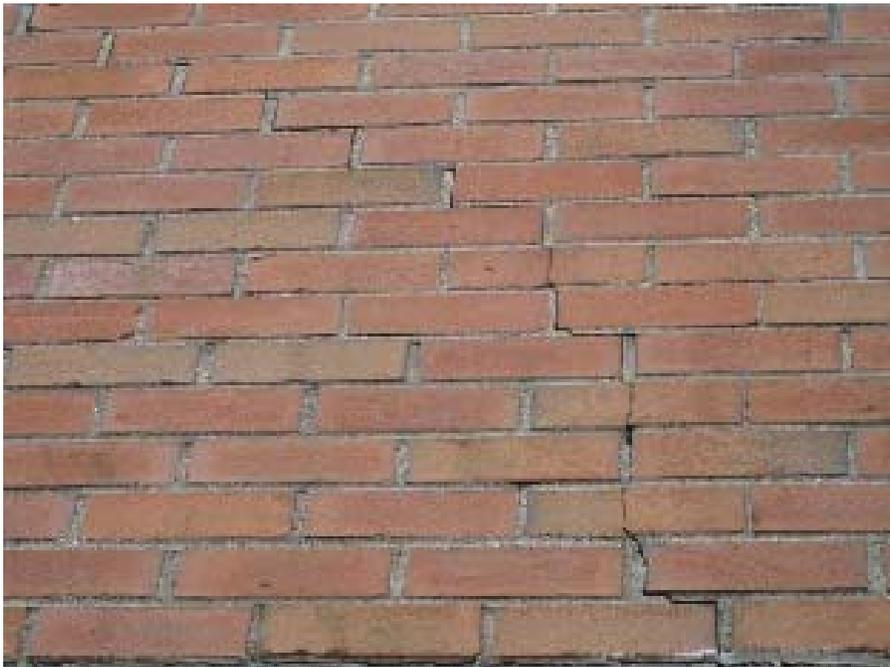
Picture 10

Cracks in Brick and Mortar

14. Contact local building inspector to request an evaluation of the structural integrity of the building envelope.
15. Remove debris from blocked weep holes.

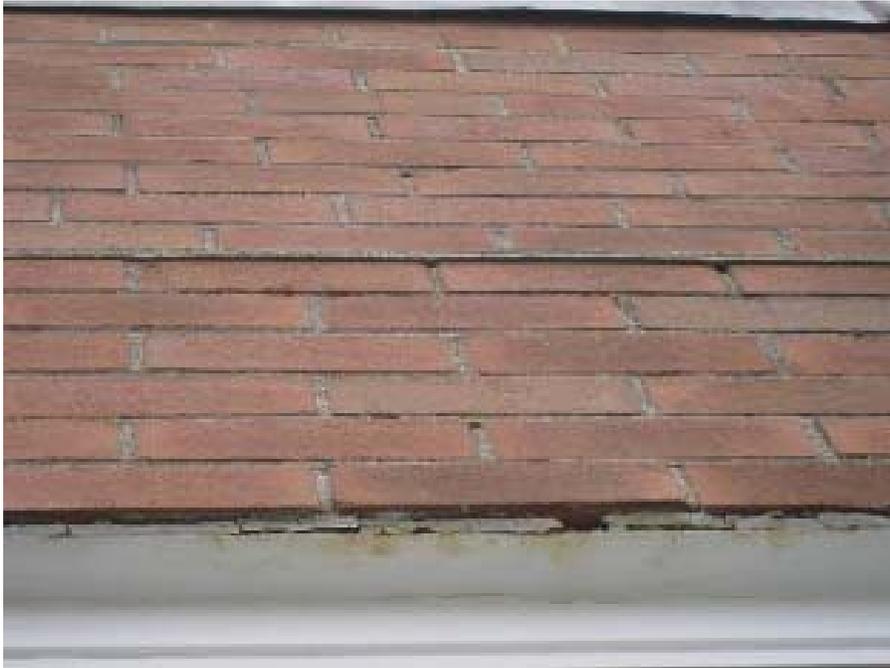
Picture 11

Cracked, Broken and Bulging Mortar

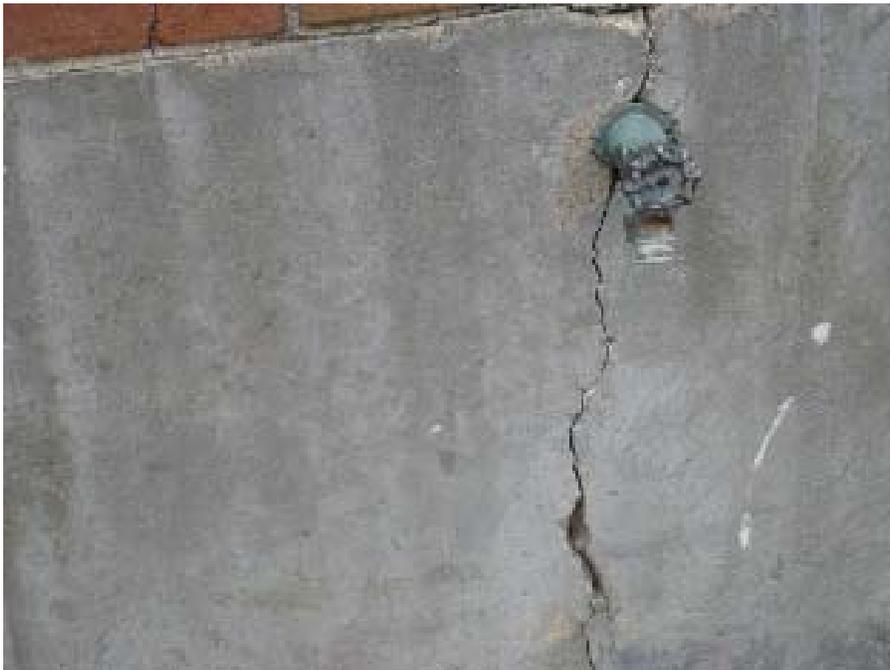
Picture 12

- Cracks were evident on the exterior foundation ([Picture 12](#)).
- A section of the sweep below the front door was missing.
- Wood mulch was observed at the front of the building ([Picture 13](#)). One characteristic of mulch is that it is able to hold moisture in soil, which if in contact with the foundation may result in water vapor penetration through cracks and fissures in the building envelop.

Crack in Foundation

16. Repair cracks in concrete foundation.
17. Repair gap at base of front door.
18. Consider removing mulch from front of building.

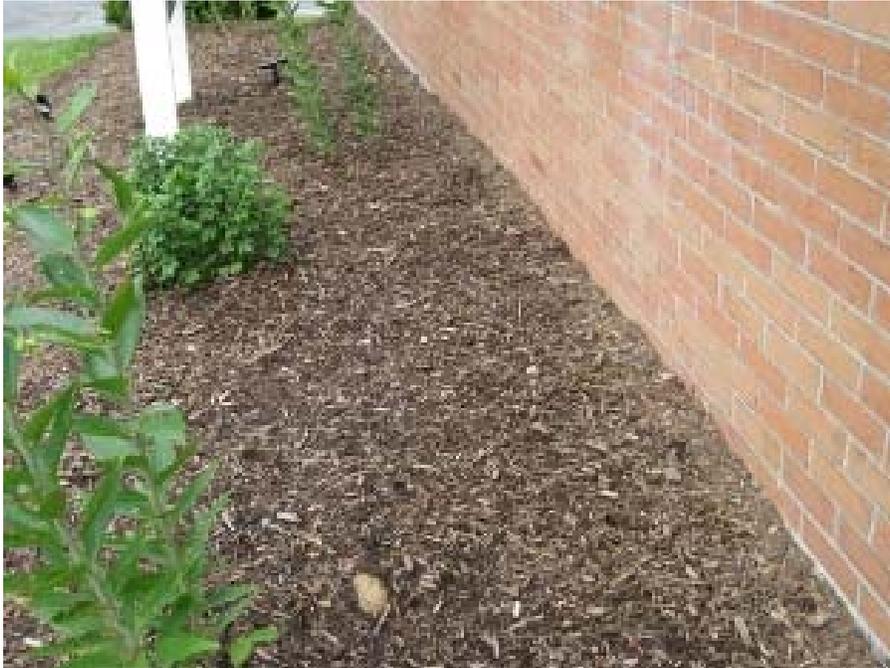
Picture 13

Wood Mulch at Front of Building

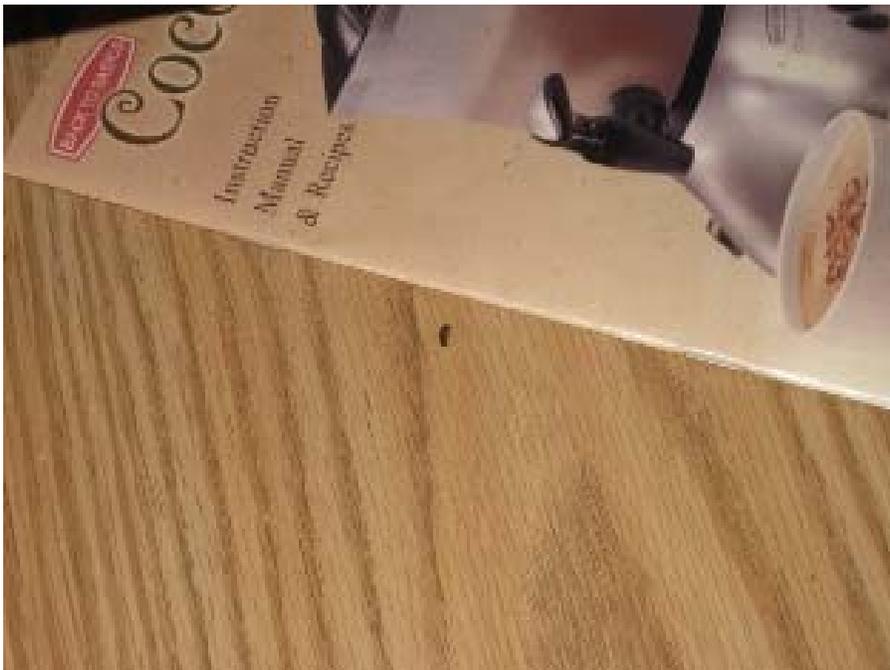
Picture 14

Rodent droppings were observed in the kitchen (Picture 14). To penetrate the exterior of a building, rodents require a minimal breach of ¼ inch (MDF, 1996). The gap observed beneath the front door would be sufficient to allow rodents to enter the building. Rodent

Rodent Droppings

1. removal of the rodents;
2. cleaning of waste products from the interior of the building; and
3. reduction/elimination of pathways/food sources that are attracting rodents.

- a. Holes as small as ¼” are enough space for rodents to enter an area. Examine each room and the exterior walls of the BEMS office for means of rodent egress and seal. If doors do not seal at the bottom, install a weather strip as a barrier to rodents.
 - b. Reduce harborages (e.g. discarded equipment and cardboard boxes) where rodents may reside (MDFA, 1996).
 - c. Regularly clean crumbs and other food residues from oven, toaster, coffee pot and other small appliances used in the kitchen.
 - d. To the extent possible, avoid eating at workstations. In areas where food is consumed, periodic vacuuming to remove crumbs is recommended.
 - e. Store food in tightly closed containers.
23. Replace ill-fitting ceiling tiles.
 24. Seal all open utility holes throughout the building.

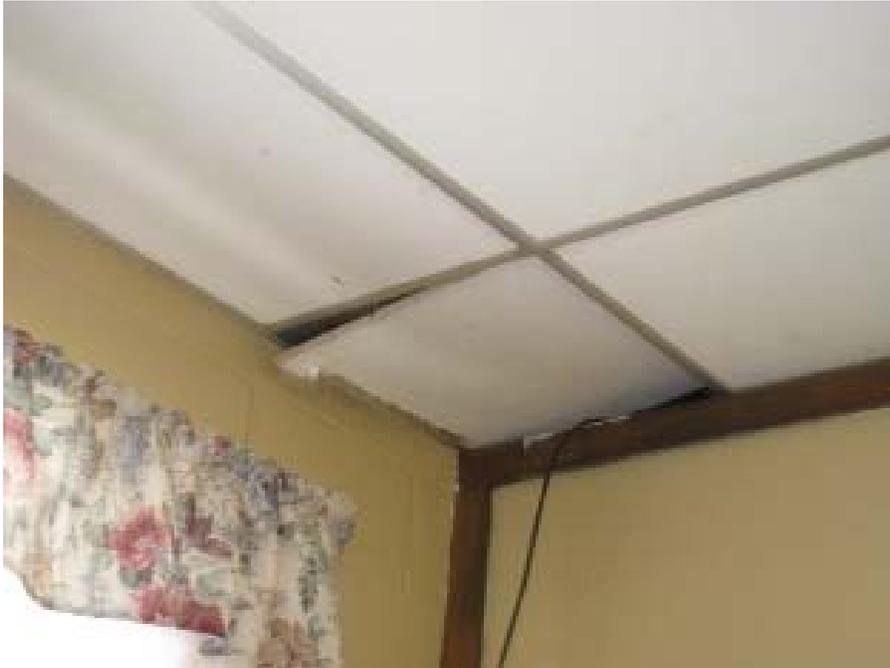
Picture 15

Some ceiling tiles were ill-fitting and buckled ([Picture 15](#)). Open utility holes were observed in several areas ([Picture 16](#)). These conditions can allow dust, vapors, odors and particulates to enter occupied rooms. Open utility holes also provide rodents with pathways to travel throughout the building.

Ajar Ceiling Tile

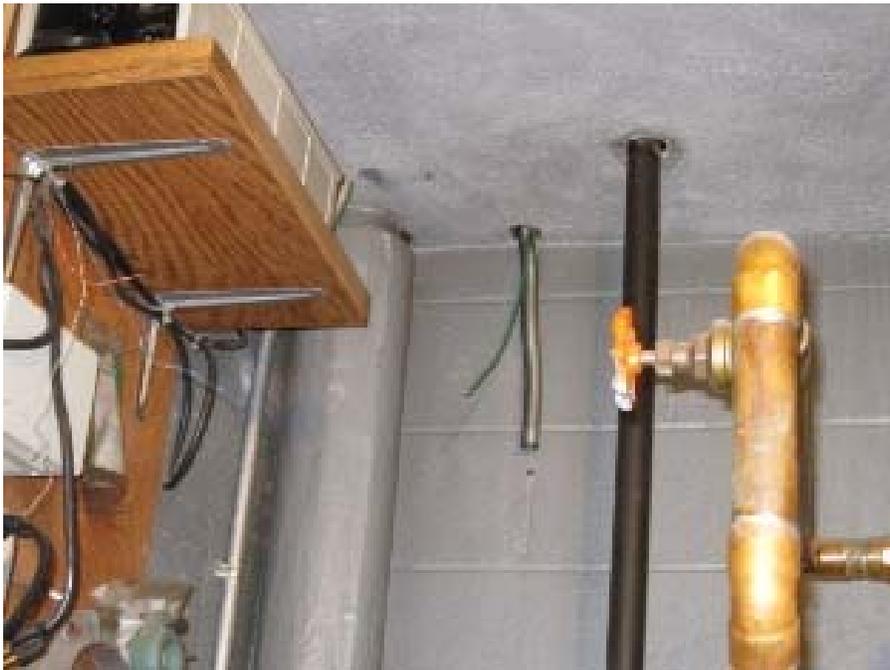
Picture 16

Open Utility Holes

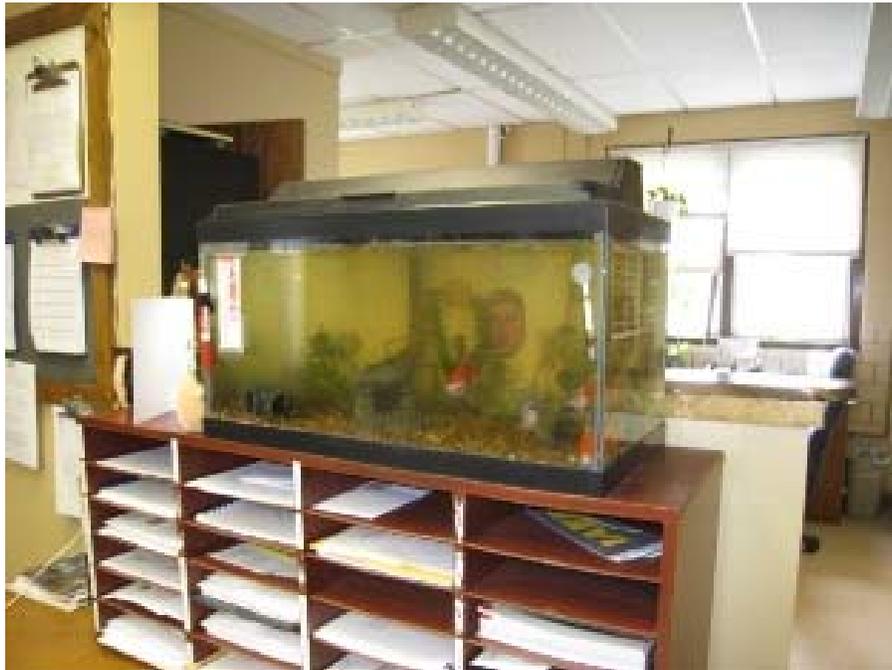
Picture 17

The aquarium in the day room was observed to contain algae growth ([Picture 17](#)). Aquariums should be properly maintained to prevent microbial/algae growth, which can emit unpleasant odors.

Algae Growth in Aquarium

26. Pour water into floor drain twice a week (or as needed) to maintain an airtight seal.
27. Clean and maintain aquarium to prevent algae growth and associated odors.
