# **INDOOR AIR QUALITY ASSESSMENT**

**Belmont Hill School  
Morse Hall  
350 Prospect Street  
Belmont, Massachusetts 02478**

Prepared by:  
Massachusetts Department of Public Health  
Bureau of Environmental Health  
Indoor Air Quality Program  
April 2009

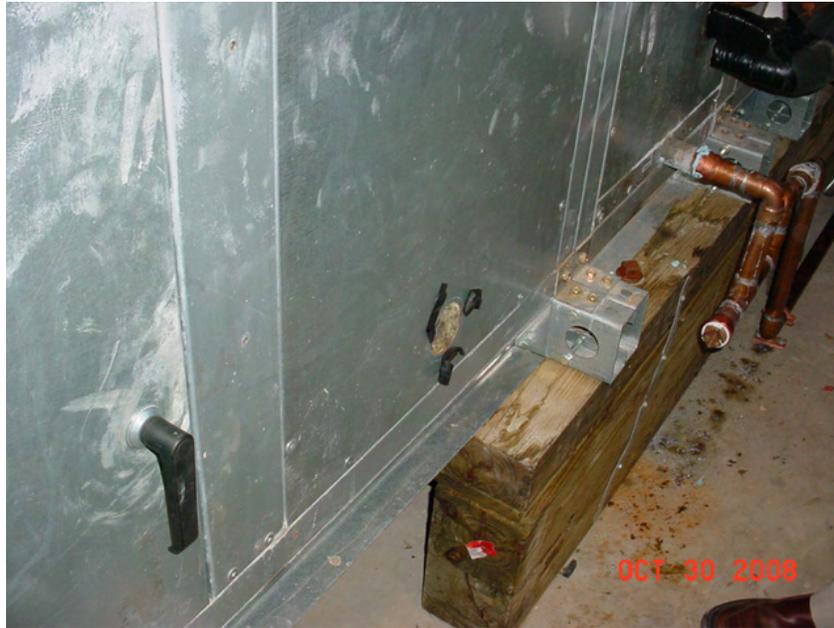
**Picture 1**

and/or cool the air, then distribute it to occupied areas via ceiling/wall-mounted air diffusers. Exhaust air is returned back to the AHUs via ceiling/wall-mounted return vents. An AHU in the attic provides mechanical ventilation to the second floor (Picture 1). The other AHU is in the basement, where the furnace for the building is located (Picture 2).

**Attic AHU**

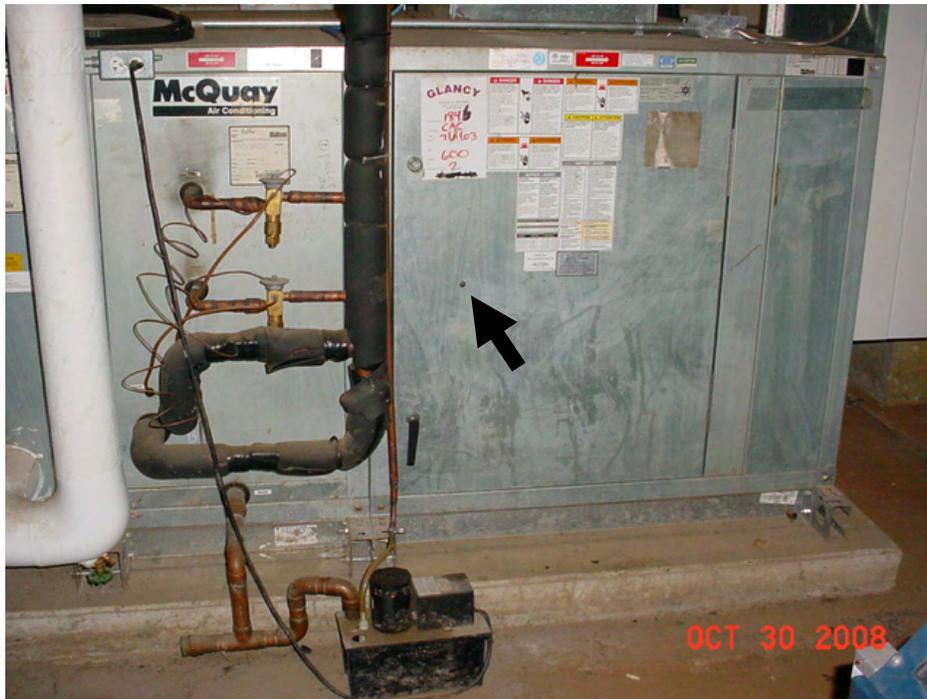
**Picture 2**

**Basement AHU, Note Hole in Door**

1. Seal all holes in AHU cabinets in the basement and attic.
2. Repair the connection of the furnace to its flue to render this junction airtight.
3. Repair the connection of the chimney to the flue to render this junction airtight.

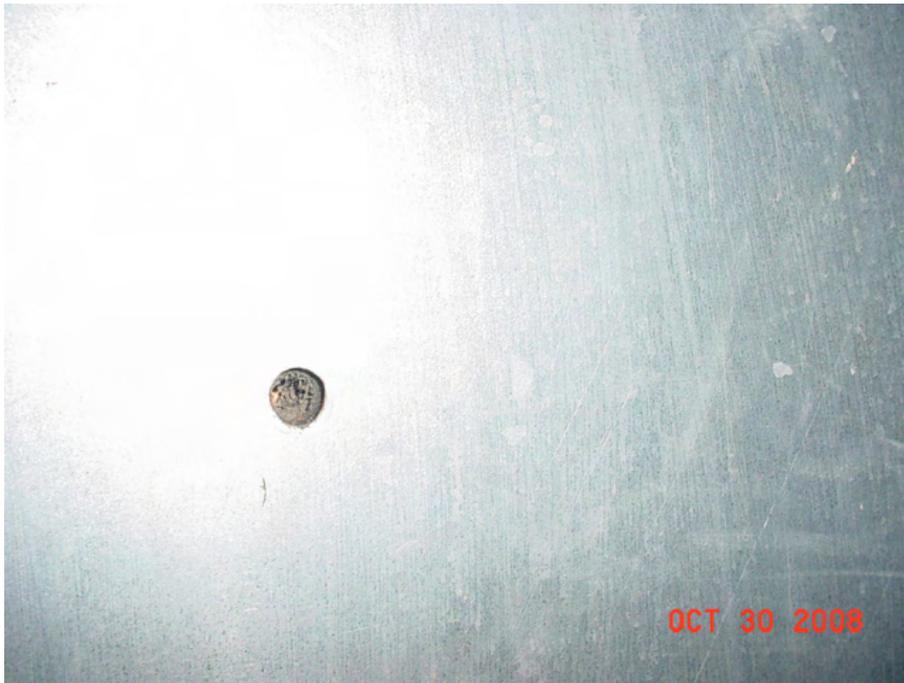
**Picture 3**

The basement AHU was found to have a hole in its casing that was drawing air from the basement mechanical room (Pictures 3 and 4). The basement AHU is also equipped with high efficiency particle arrestance (HEPA) filters (Picture 5). It is likely that the presence of the HEPA filters is increasing the draw of basement air into the AHU through breaches/holes in the cabinet since HEPA filters require significant energy expenditure to draw air through the filter. Removing the HEPA filters and installing appropriate pleated air filters require a decrease in fan speed, which should reduce the draw of odors via cabinet breaches.

In this configuration, the basement AHU is likely to draw air through the hole in Picture 3 rather than through the HEPA filter, since the hole is the path of least resistance for air to enter the cabinet. Any odors/pollutants in the basement will then be drawn into the AHU via this hole, which would then be distributed to occupied areas via the ductwork. Since a number of odor sources exist in the basement, this AHU cabinet hole must be sealed. The following odor sources were noted in the basement mechanical room:

**Close-Up of Hole in Door of Basement AHU**

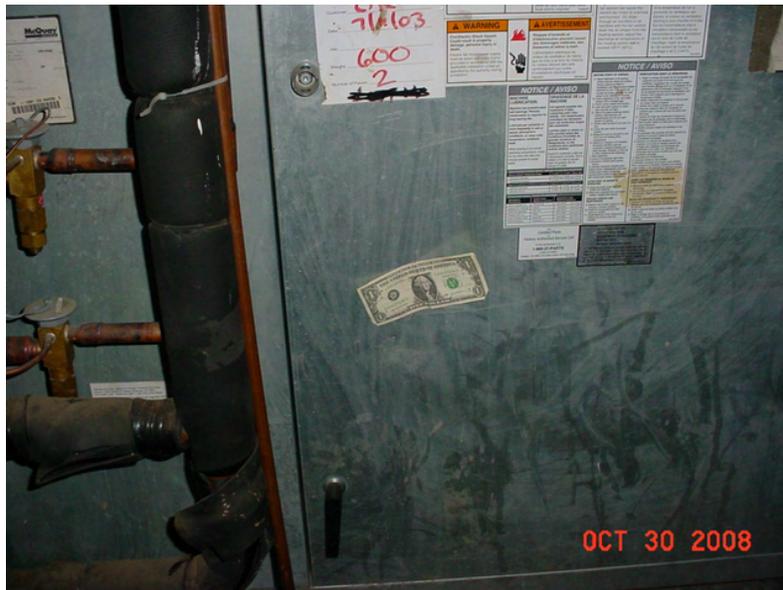
**Picture 4**

**Draw Of Air of Hole in Door by Basement AHU Fan Strong Enough to Hold Dollar Bill in Place**

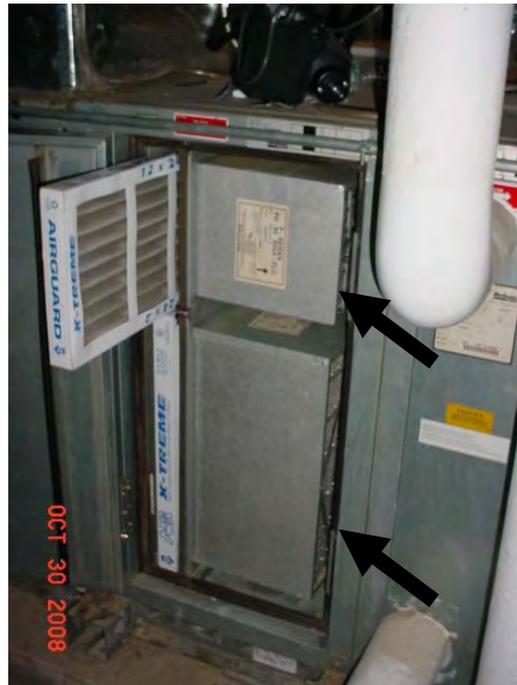
**Picture 5**

**HEPA Filters Installed In Basement AHU**

4. Remove HEPA filter banks from the AHU and replace with an appropriate pleated filter.  
Consult a ventilation engineers concerning filter selection and adjusting the fan speed of the basement AHU.
5. Seal all flue joints with an appropriate, fire rated sealant.
6. Seal all open pipes in the foundation wall.

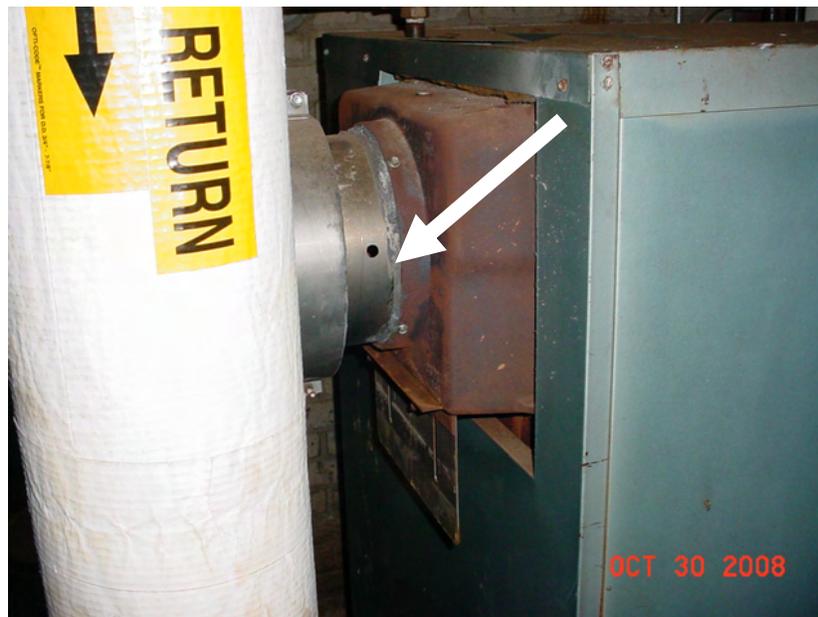
**Picture 6**

- A breach in the furnace connection to the flue was noted in a location opposite the hole in the AHU (Picture 6). When the furnace was operating, a stream of air was noted emanating from this breach. The furnace combusts natural gas as its fuel. Since natural gas is odorless, a material containing sulfur called mercaptan is added to provide a odor in order to indentify gas leaks (Hess Corp., 2006). The odors reported by BHS staff were described as sulfur-like, which would be consistent with the odor of combusted gas.
- A breach between the flue and the chimney connection was also noted (Picture 7).
- Seams also exist in the flue pipe (Picture 8).
- Two unsealed pipes in the foundation wall were also identified (Pictures 9 and 10). These pipes may be connected to the school sewer system, which may also be a source of sulfurous odor.

The combination of the furnace flue breach with the breach of the AHU cabinet drawing air from the basement mechanical room are the most likely source of sulfur odor on the first floor. While a similar opening was found in the attic AHU (Pictures 11 and 12), no source of odor could be located.

**Hole in Furnace Flue**

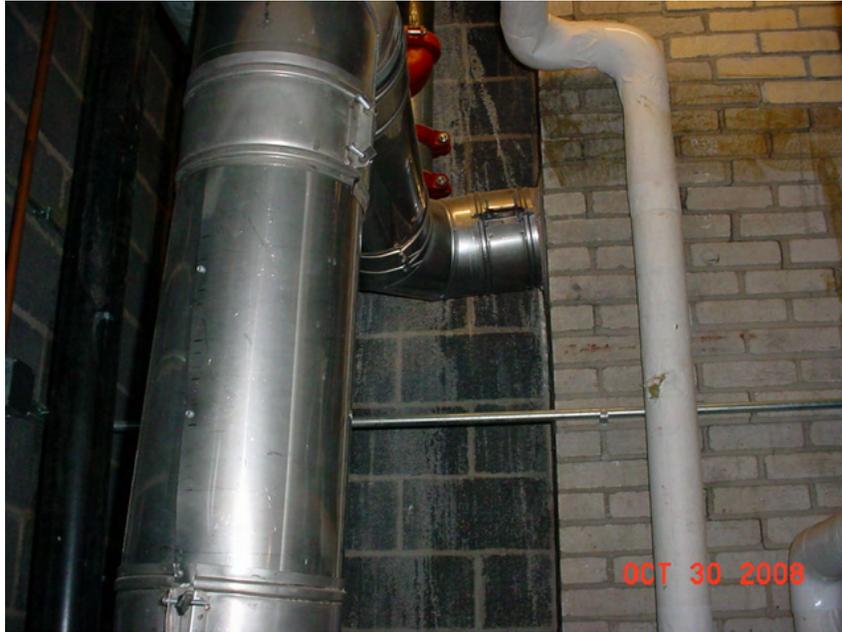
**Picture 7**

**Breach in Flue/Chimney Connection, Note Flue Is Not Flush With Chimney**

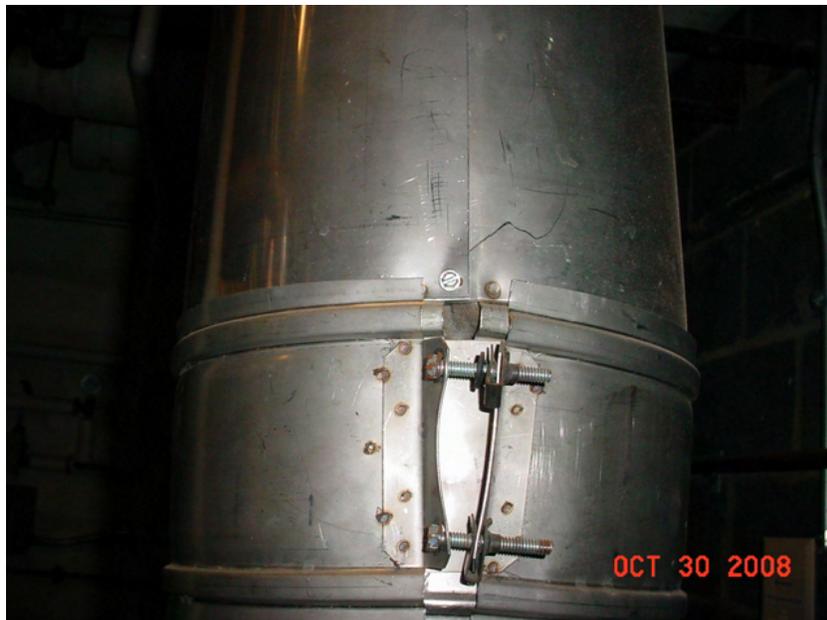
**Picture 8**

**Unsealed Flue Seams**

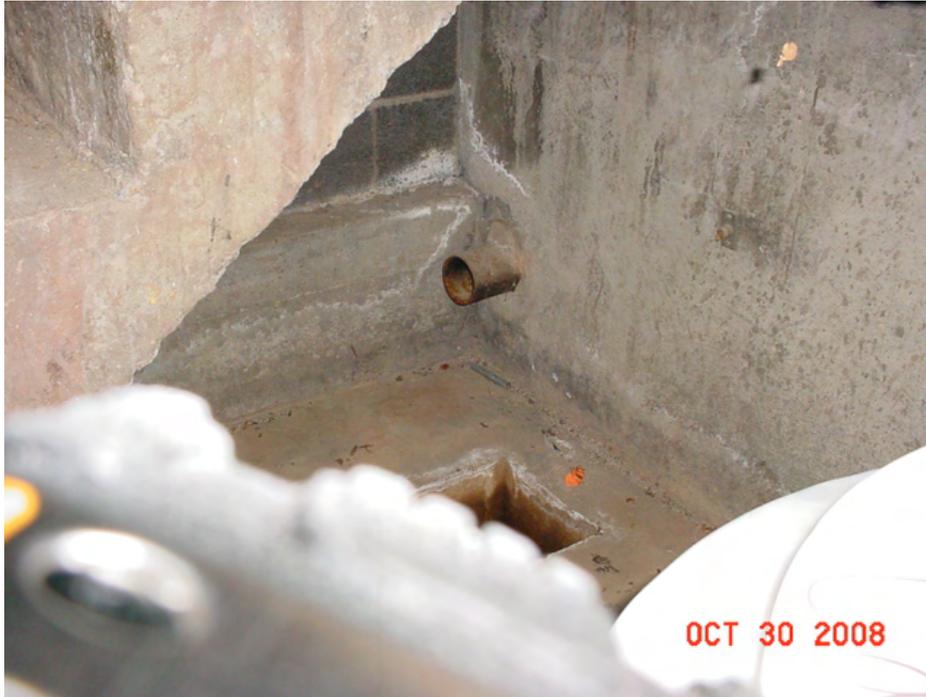
**Picture 9**

**Open Pipe beneath Mechanical Room Stairs**

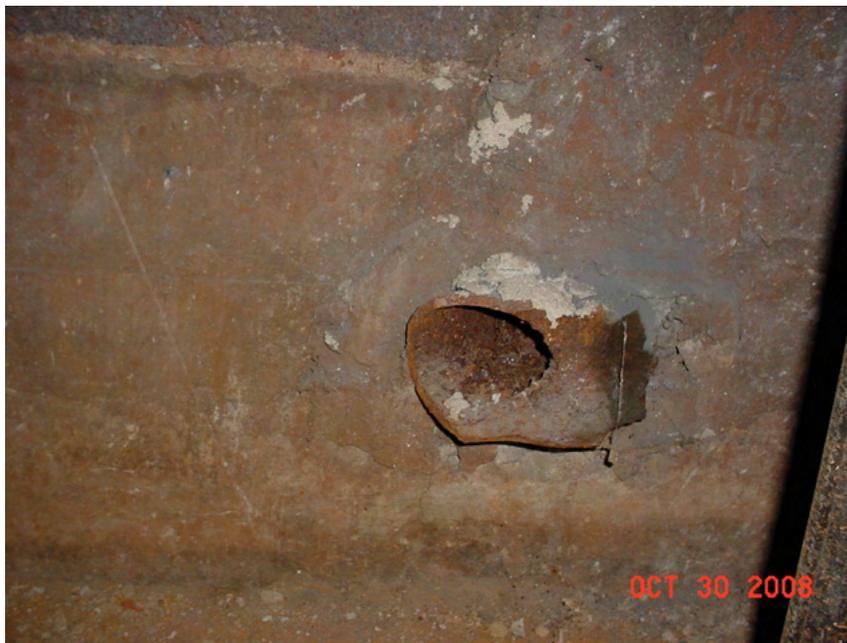
**Picture 10**

**Unsealed Pipe in Foundation Wall**

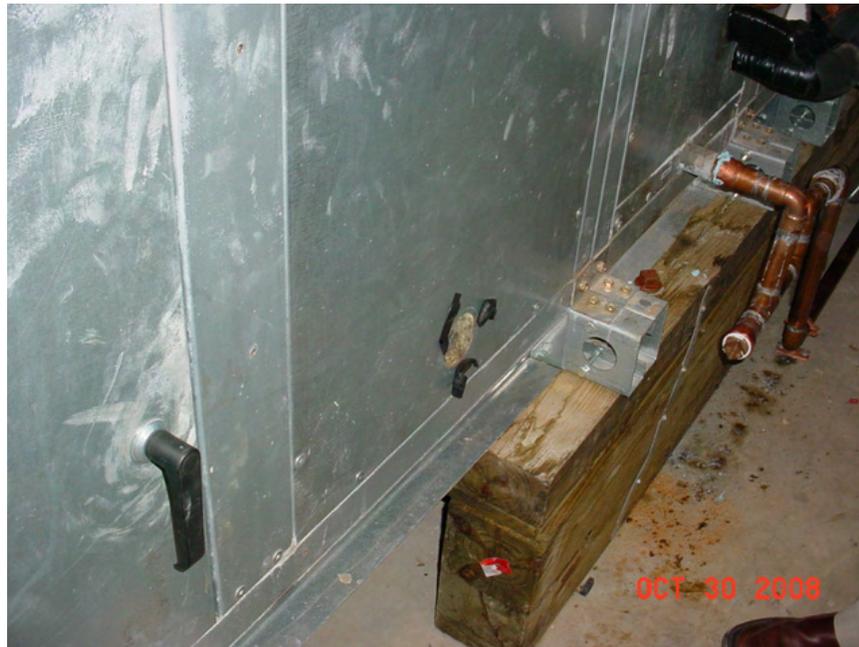
**Picture 11**

**Hole in Cabinet of Attic AHU**

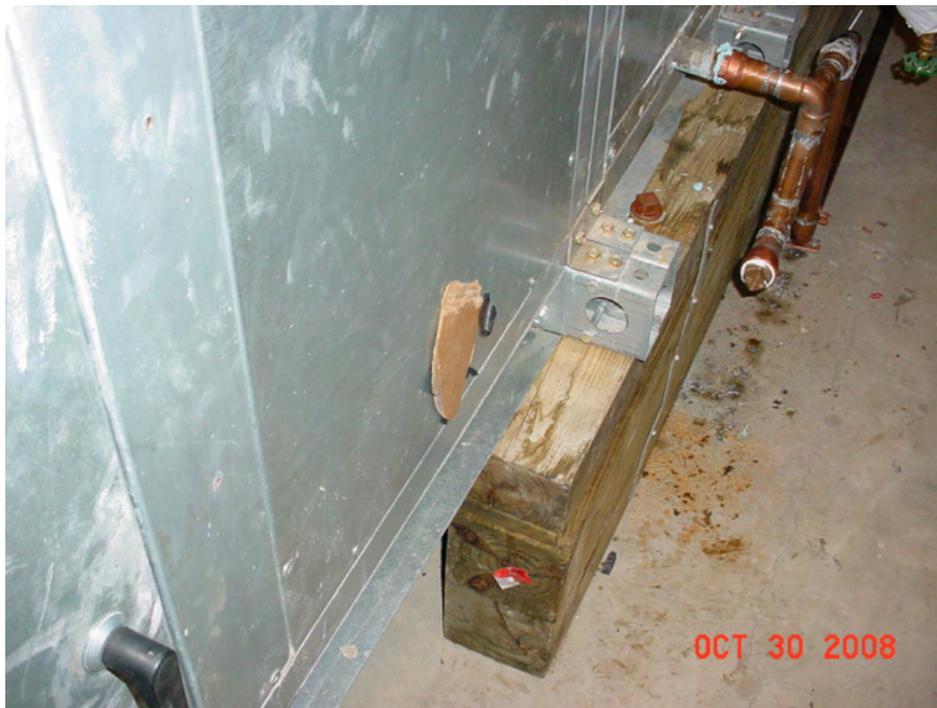
**Picture 12**

**Hole in Cabinet of Attic AHU Seal with Cardboard and Electrical Tape**
