INDOOR AIR QUALITY ASSESSMENT

**Massachusetts Department of Transitional Assistance
Dudley Square Office
2201 Washington Street
Roxbury, Massachusetts 02119**

Prepared by:
Massachusetts Department of Public Health
Bureau of Environmental Health
Indoor Air Quality Program
October 2009

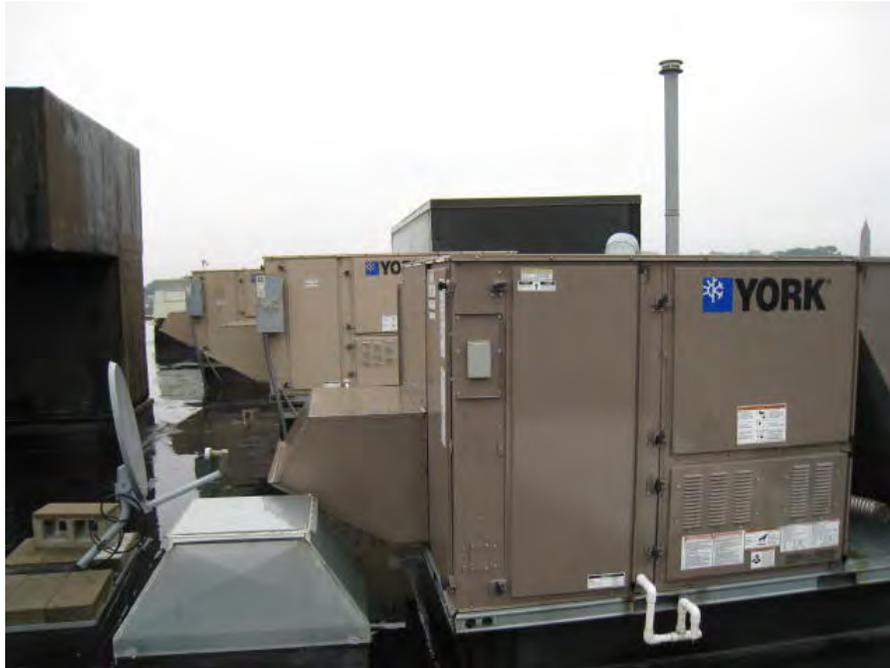
Picture 1

The heating, ventilating and air conditioning (HVAC) system consists of rooftop air handling units (AHUs), which draw outside air through air intakes and distribute it to occupied areas via ceiling-mounted air diffusers (Pictures 1 and 2). Return air is drawn through grates and ducted back to the rooftop AHUs (Picture 3). At the time of assessment, the AHU servicing the ground floor was reportedly turned off. All other AHUs were reportedly operating.

Rooftop Air Handling Units

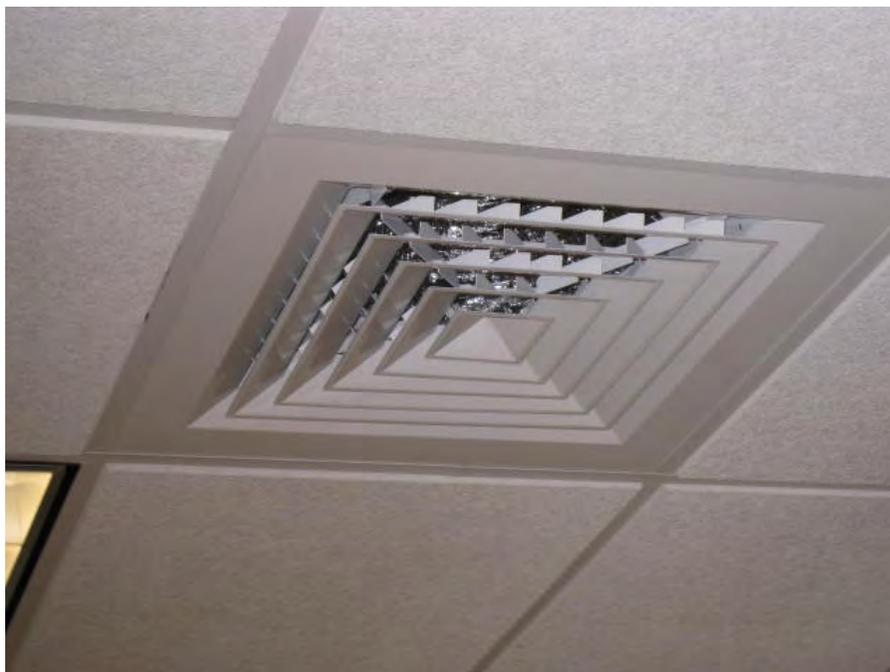
Picture 2

Supply Air Diffusers

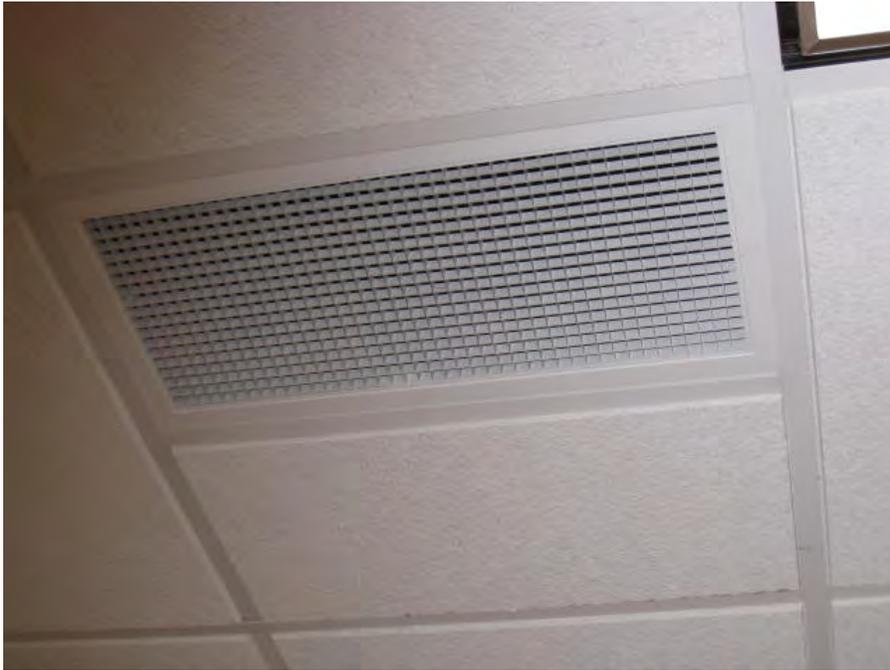
Picture 3

Return Air Grate

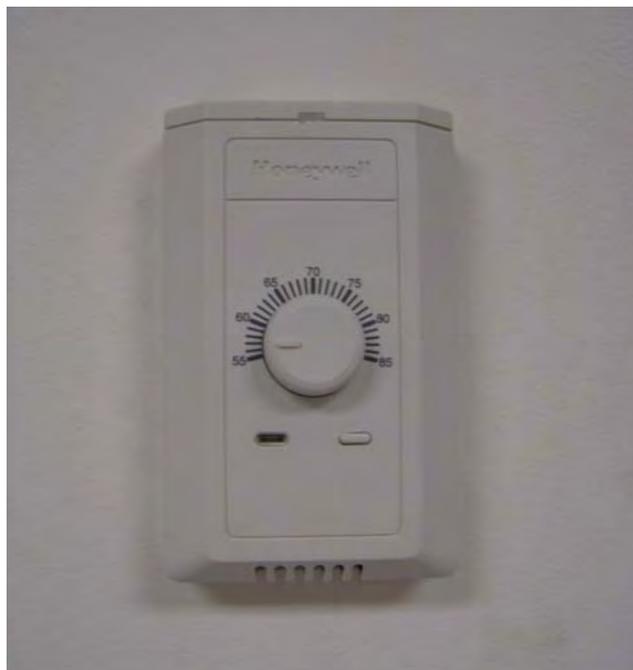
Picture 4

HVAC Thermostat

1. Operate HVAC system throughout the building *continuously* during periods of occupancy. Set thermostat for AHUs to the fan “on” setting in order to provide continuous airflow throughout the office space.
2. Increase fresh air supply to the VAV boxes.

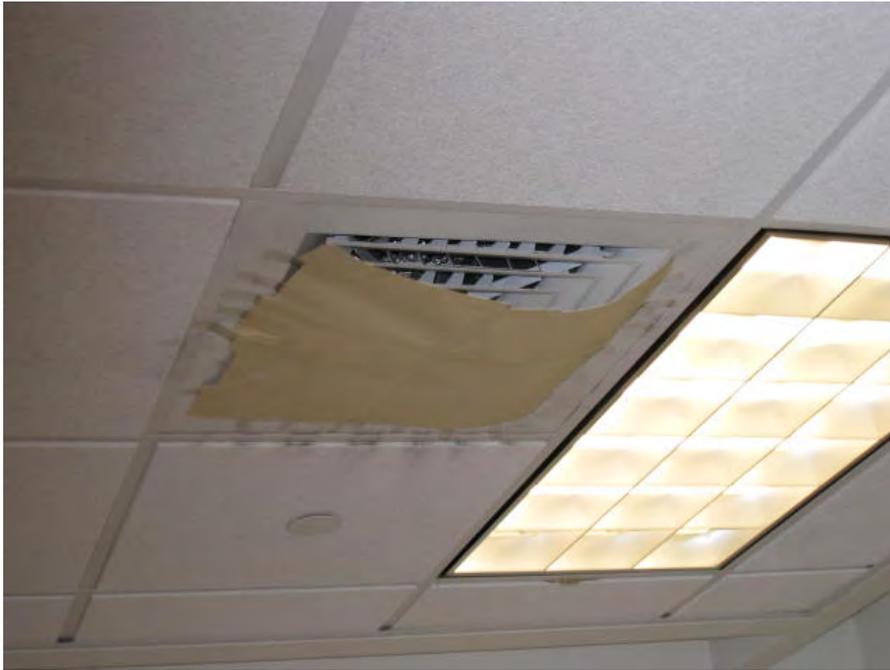
Picture 5

Interferences with airflow were observed in the form of modifications to HVAC components. In several areas, supply diffusers were covered by cardboard/paper and tape

(Picture 5). This alteration can create an imbalance in the system, resulting in uneven heating/cooling conditions leading to occupant discomfort.

Supply Air Diffuser Covered by Cardboard

3. Consider adding air diffusers and return grates to the ground floor office space to improve air circulation.
4. Remove obstructions from air diffusers.

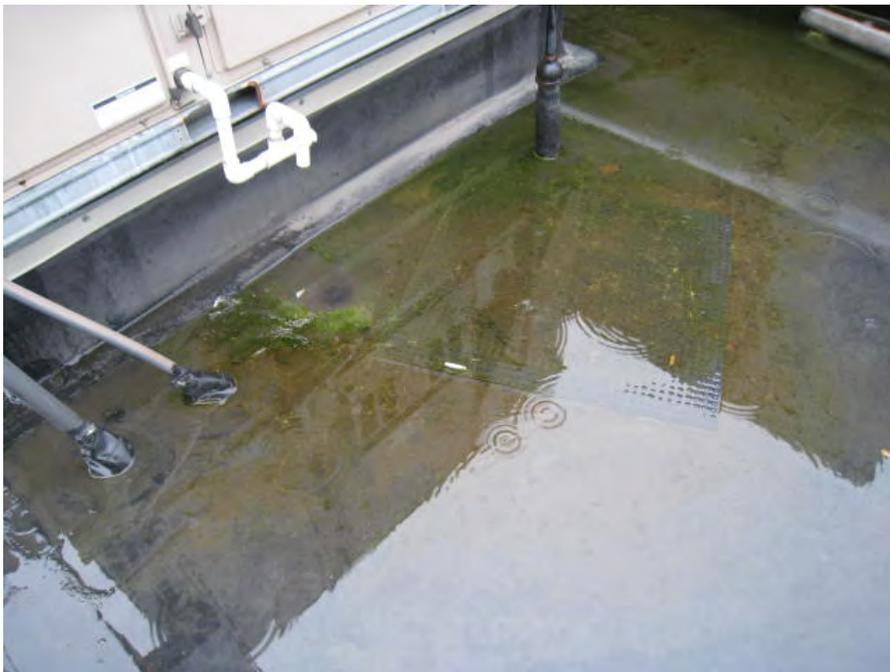
Picture 6

During a roof examination, BEH staff found water pooling around the AHUs (Pictures 6 and 7). Pooling water is an indication of inadequate draining. Debris was observed in some roof drains, preventing proper drainage. In addition, the roof was not graded in a manner that aided drainage (i.e. drain at highest point) in some areas. Freezing and thawing of pooling water during winter months can damage the roof, causing leaks and subsequent water penetration to the interior of the building. Pooling water can also become stagnant, which can lead to mold and bacterial growth or serve as a breeding ground for mosquitoes.

Pooling Water on Roof around Air Handling Units

11. Remove debris from roof drains to ensure proper drainage. Take additional measures to prevent water from pooling on the roof.
12. Consider having exterior walls re-pointed and waterproofed to prevent water intrusion. This measure should include a full building envelope evaluation.

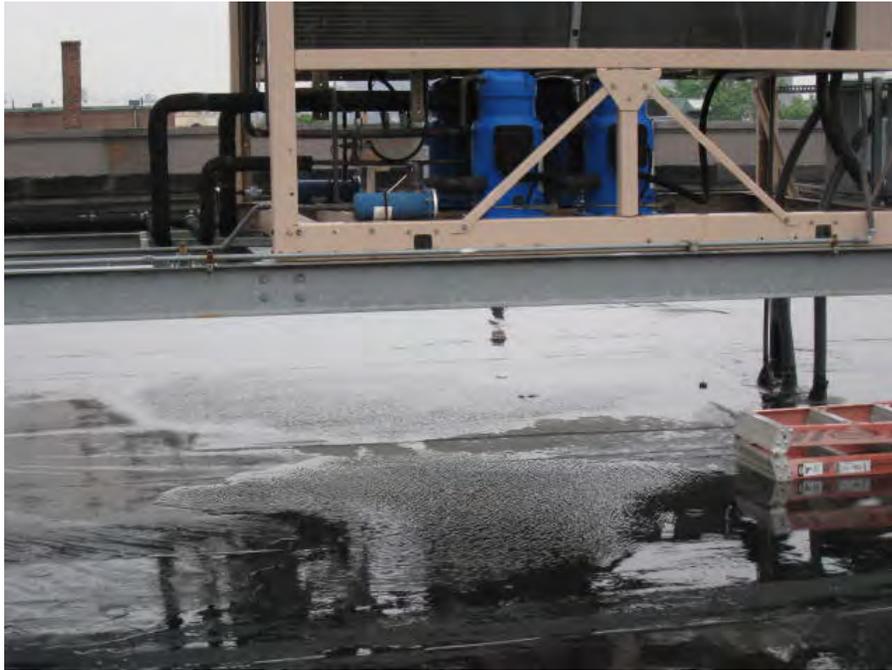
Picture 7

Pooling on the Roof

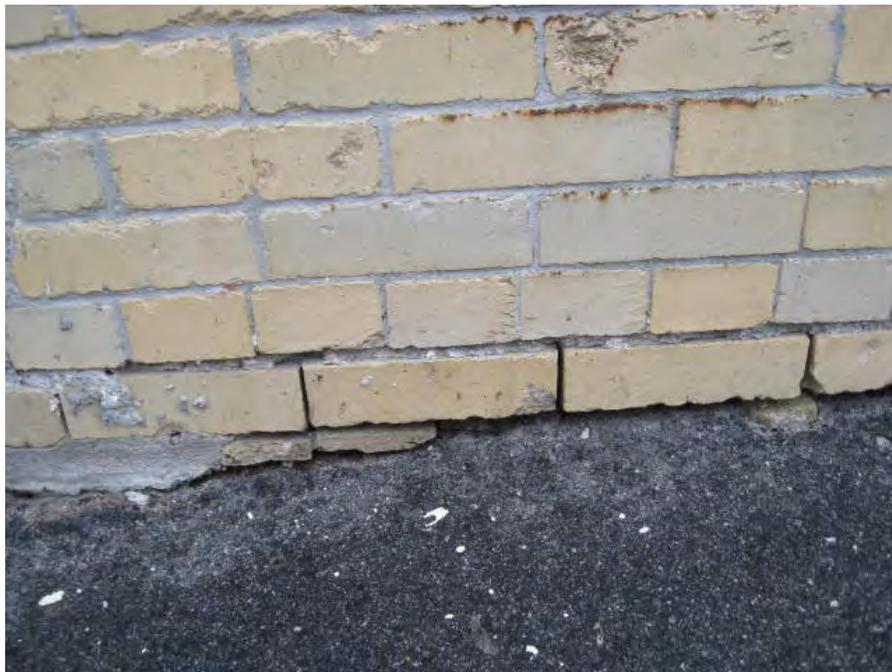
Picture 8

- Exterior brick and mortar was damaged and/or missing (Pictures 8 and 9); and
- Efflorescence¹ on interior brick (Picture 10).

These conditions indicate that water has penetrated through the building envelope. Moisture laden air can infiltrate through breaches and condense on building materials. A heavy and/or continuous water exposure to the building exterior can undermine the integrity of the building envelope and provide a means of water entry into the building via capillary action through foundation concrete and masonry (Lstiburek & Brennan, 2001).

Damaged Exterior Brick and Mortar

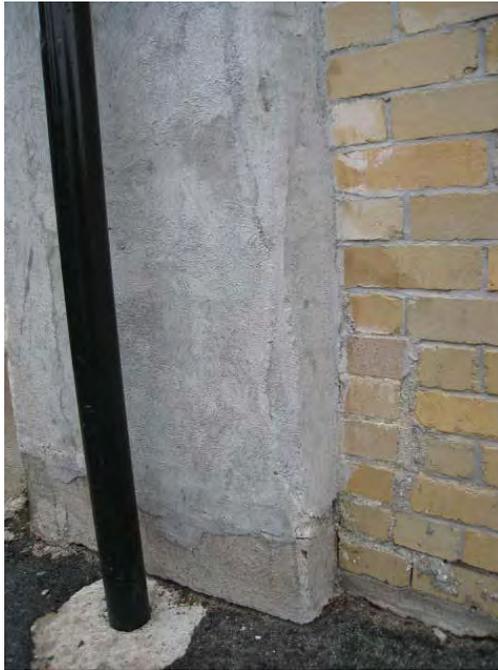
Picture 9

Damaged Exterior Brick and Mortar

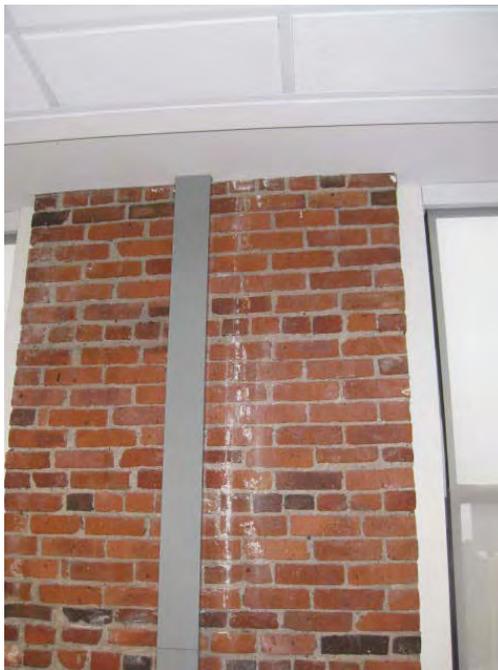
Picture 10

Efflorescence on Interior Brick

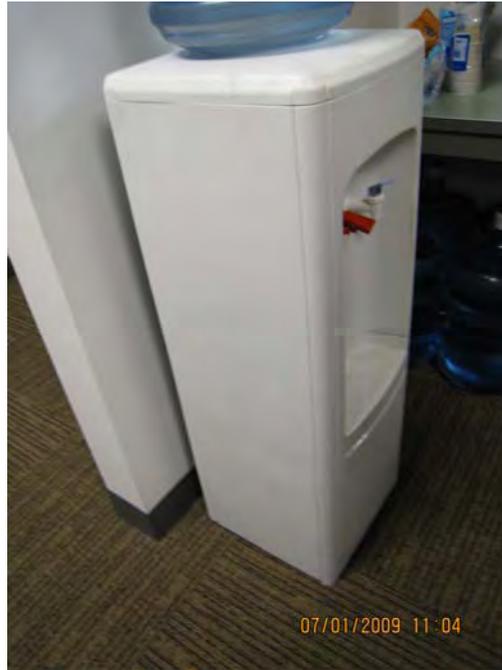
Picture 11

Water coolers were located over carpet in several areas (Picture 11). Overflow of the water basin or spills that often occur can moisten carpeting, which can lead to mold growth. It is

also important that the catch basins of water coolers be cleaned regularly as stagnant water can be a source of odors, and materials (i.e., dust) collected in the water can provide a medium for mold growth.

Water Cooler on Carpet

14. Provide nonabsorbent mats beneath water coolers to prevent water damage to carpeting.
15. Ensure plants have drip pans. Examine drip pans periodically for mold growth and disinfect with an appropriate antimicrobial where necessary. Move plants away from the air stream of ventilation sources.

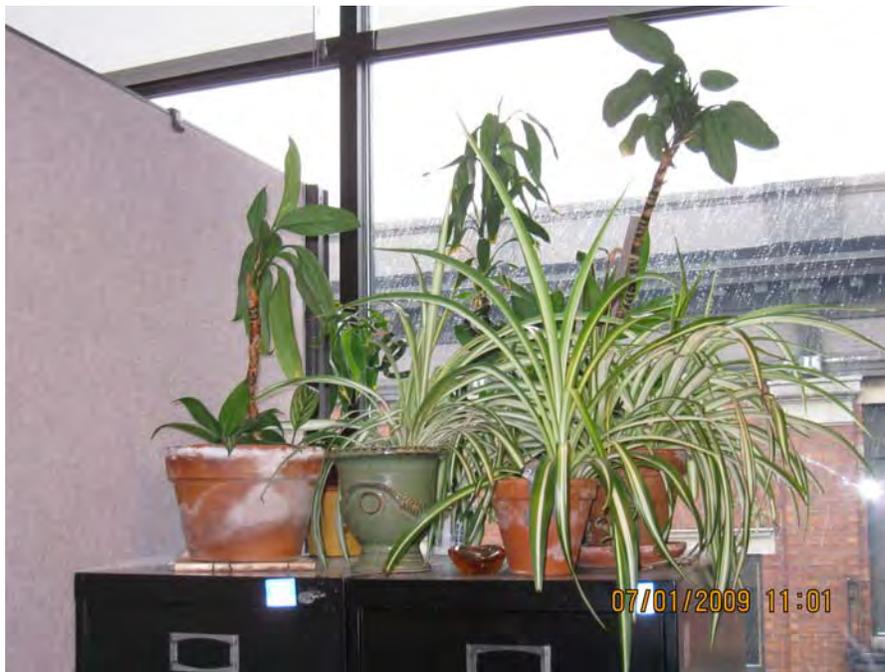
Picture 12

Several areas had a number of plants (Picture 12). Plants can be a source of pollen and mold, which can serve as respiratory irritants for some sensitive individuals. Plants should be properly maintained and equipped with drip pans to prevent water damage to porous building materials, which can lead to mold growth. Plants should also be located away from ventilation sources to prevent the aerosolization of dirt, pollen or mold.

Plants in the Office Space

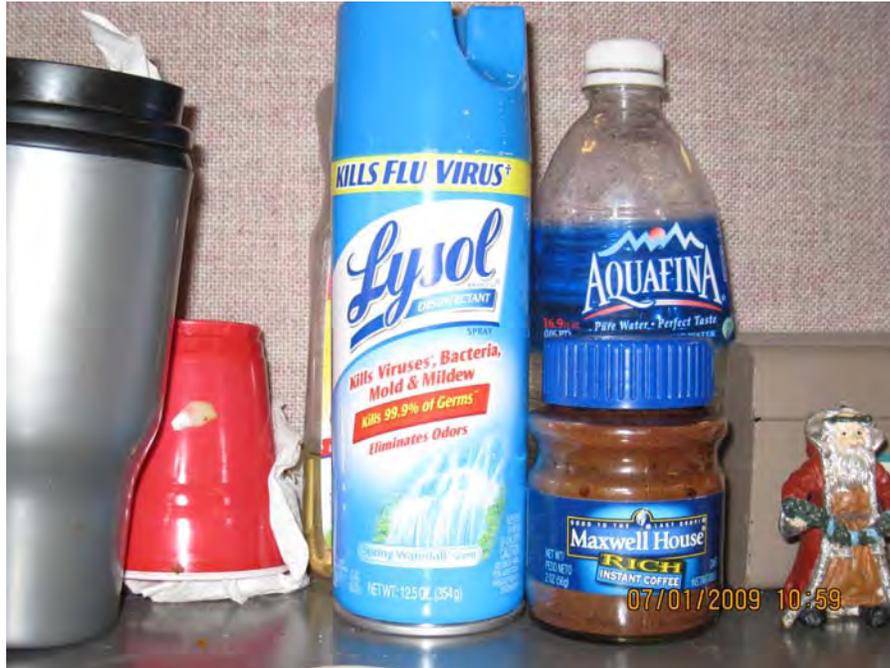
Picture 13

Cleaning products were observed in areas throughout the building (Picture 13). Cleaning products contain VOCs and other chemicals that can be irritating to the eyes, nose and throat of sensitive individuals. These products should be properly labeled and stored with a Material Safety Data Sheet (MSDS) at a central location.

Cleaning Products

16. Store cleaning products properly with a MSDS at a central location.
17. Refrain from using air fresheners or other air deodorizers to prevent exposure to VOCs.

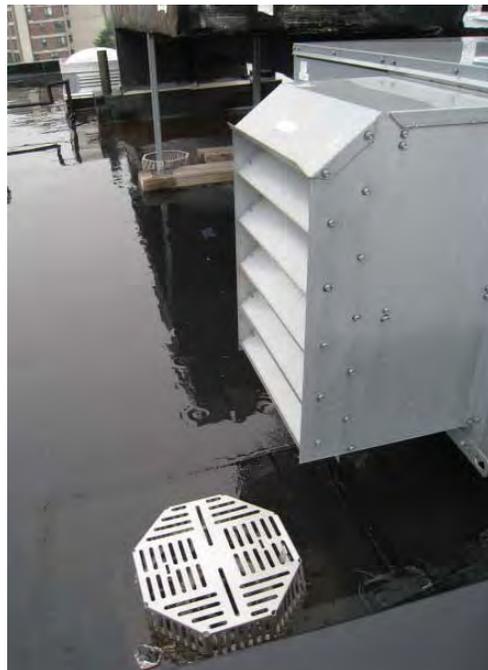
Picture 14

BEH staff examined the AHUs on the roof. BEH noted an a roof drain for the ground floor AHU (Picture 14). In this condition, the intake can draw in odors from the drain and/or moisture-laden air and introduce them into the indoor environment. Office staff from the ground floor have reported sewer-like odors, which they attributed to the AHU. At the time of assessment, building maintenance was considering installing a rubber flapper to prevent odors from escaping the roof drain and becoming entrained in the system. If odors from the drain

AHU Intake Above Roof Drain

continue to be detected in the office space, it may be necessary to duct the roof drain up and away from the air intake. An alternate solution would relocate the fresh air supply to the opposite side of the AHU or duct the fresh air supply outwards and away from the drain (Picture 15). It should also be noted that the fiberglass insulation on the AHU duct was damaged and exposed (Picture 16). The integrity of the insulation is compromised by repeated exposure to water and holes by which the original wrap was fastened around the duct. The insulation must be replaced and the duct re-wrapped to allow for proper insulation of the ductwork.

5. Determine whether the installation of a rubber flapper on the roof drains is sufficient to prevent odor entrainment in the AHUs. If odors persist, relocate (or re-duct) the fresh air intake for the ground floor AHU to the opposite side, away from the roof drain.

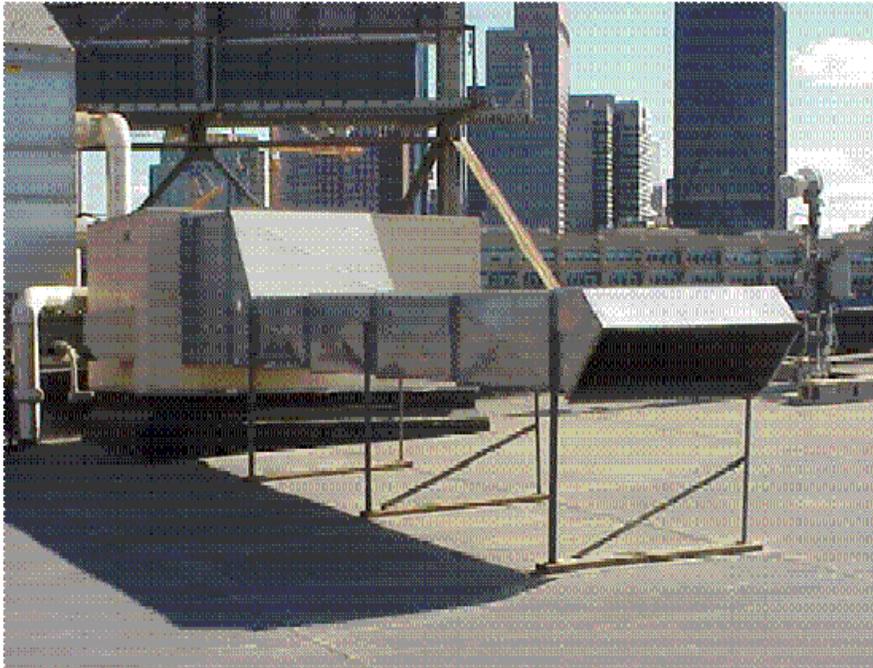
Picture 15

Example of Fresh Air Supply ducted outwards, 239 Causeway St, Boston, MA

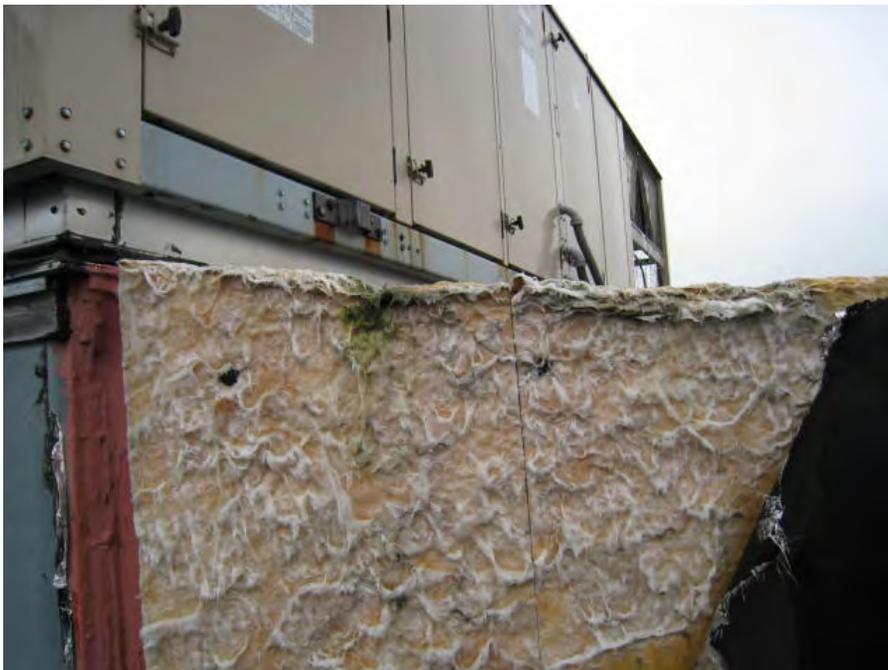
Picture 16

Fiberglass Insulation Damaged and Exposed

10. Replace damaged ductwork insulation and rewrap appropriately to prevent future damage to insulation.

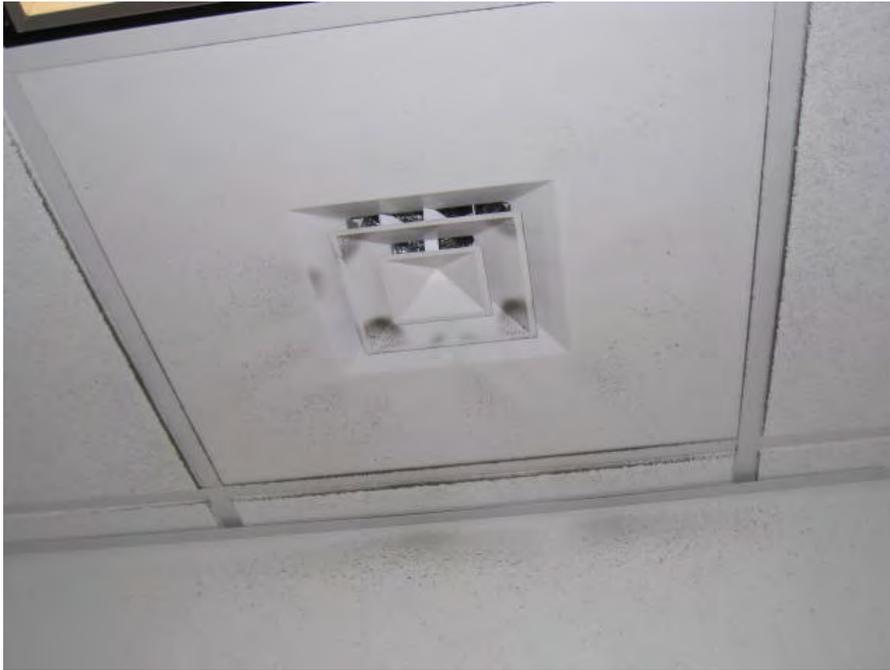
Picture 17

Lastly, a number of supply air diffusers, exhaust vents and personal fans in several areas were observed to have accumulated dust/debris (Picture 17). Re-activated supply vents/fans can aerosolize dust accumulated on fan blades/housing. If exhaust vents are not functioning, backdrafting can occur, which can re-aerosolize dust particles.

Dirt and Dust on Air Diffuser

20. Clean accumulated dust and debris periodically from air diffusers, return grates and blades of personal fans.
21. Refer to resource manual and other related indoor air quality documents located on the MDPH's website for further building-wide evaluations and advice on maintaining public buildings. These documents are available at: <http://mass.gov/dph/iaq>.
