# **INDOOR AIR QUALITY ASSESSMENT**

**Colrain Central Elementary School  
Jacksonville Road  
Colrain, Massachusetts**

Prepared by:  
Massachusetts Department of Public Health  
Bureau of Environmental Health  
Indoor Air Quality Program  
September 2009

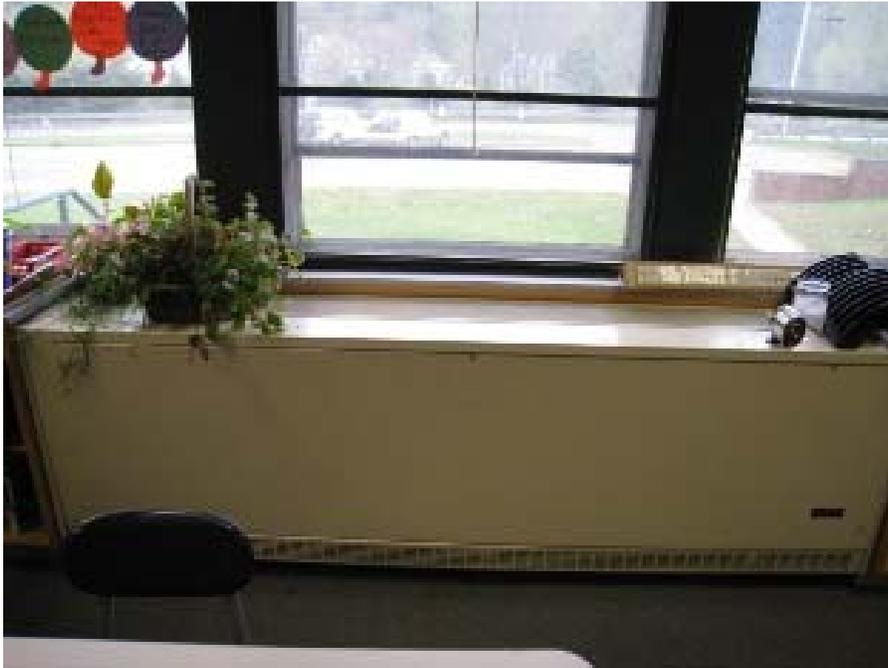
**Picture 1**

Fresh and return air are mixed, filtered, heated and provided to classrooms through an air diffuser located in the top of the unit (Picture 1).

**Unit Ventilator (Univent) in Classrooms  
Note Plant on Univent**

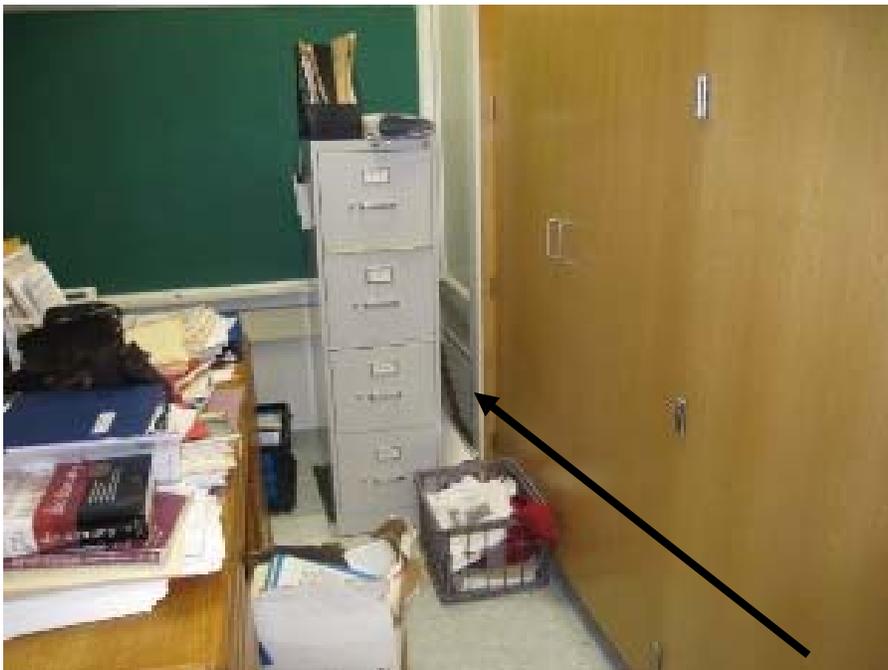
**Picture 2**

Classrooms are provided with wall mounted, ducted exhaust vents (Picture 2). Ceiling mounted air handling units (AHUs) provide ventilation to the gym, cafeteria, kitchen, staff areas, administration and nurse's office, library and a few classrooms. AHUs are reportedly serviced annually and univents are serviced twice a year. Heat is provided by two boilers. BEH staff was informed that the boilers were shut down for the season approximately two weeks prior to the assessment.

The exhaust vents in numerous classrooms were blocked by furniture and file cabinets. Likewise, some univents were blocked by paper, sheets of plastic, and an accumulation of materials. These conditions impede the ventilation system from operating properly. A plant was observed on top of a univent. This condition can cause aerosolization of mold, pollen and particulate matter.

**Wall Mounted Exhaust Vent  
Note Vent is Obstructed by File Cabinet, Papers**

5. Consider removing obstructions from univents and in front of exhaust vents in classrooms. Move plants away from ventilation system.
6. Repair/replace broken window.

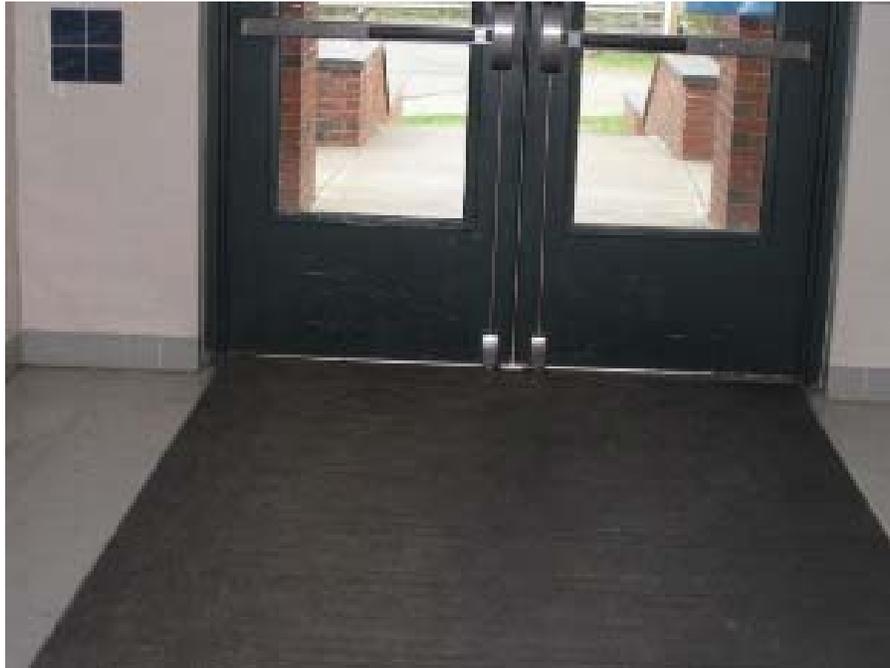
**Picture 3**

- Exterior doors exhibited large gaps (Picture 3).
- Sealant on exterior windows was in disrepair (Picture 4).
- Sealant at base of building was deteriorated and missing in some areas, leaving sizable gaps between wall and walkway (Picture 5).
- Broken window was sealed with plywood.
- Peeling paint was observed on numerous exterior surfaces. This condition allows building components to come into direct contact with moisture.
- Bottom of several door casings exhibited rotted wood (Picture 6).
- Efflorescence<sup>1</sup> was observed on the exterior of the building (Picture 7).

**Gaps Below Exterior Doors**

18. Continue to maintain aquarium to prevent microbial/algae growth.
19. Seal gaps in doors and any breaches in the building envelope that allow unconditioned air and insects to enter the interior of the building.

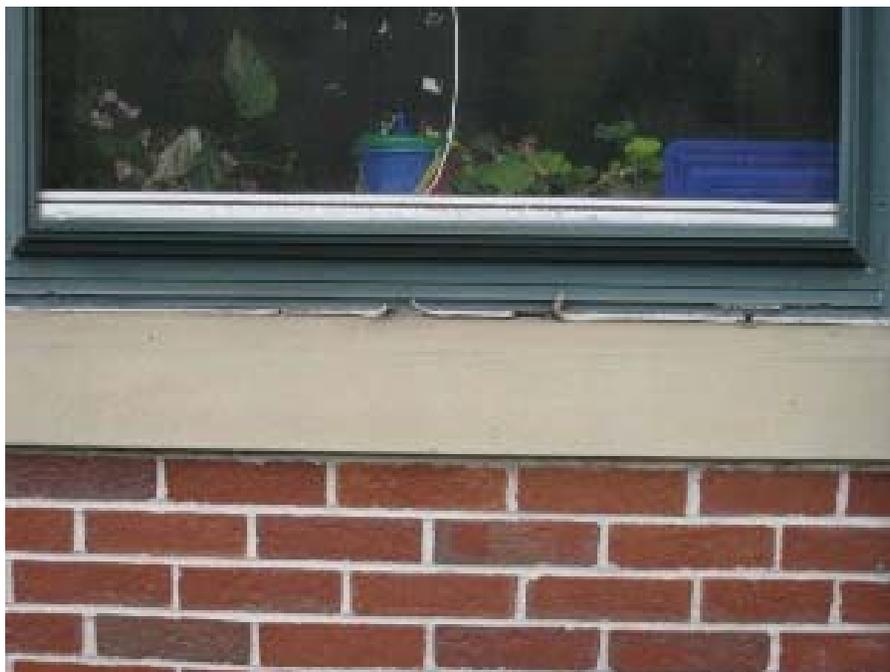
**Picture 4**

**Window Sealant in Disrepair**

10. Routinely maintain drain near basement door.
11. Repair/Replace sealant on exterior of the building
12. Remove plants from crevices at base of building.

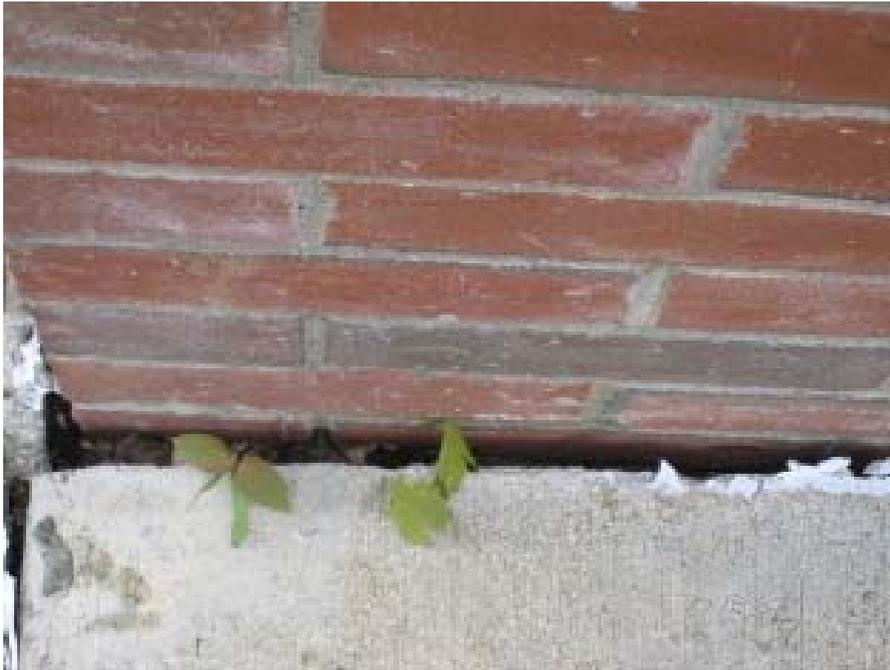
**Picture 5**

**Gap Adjacent to Building Due to Deteriorated Sealant  
Note Plant Growth Adjacent to Masonry**

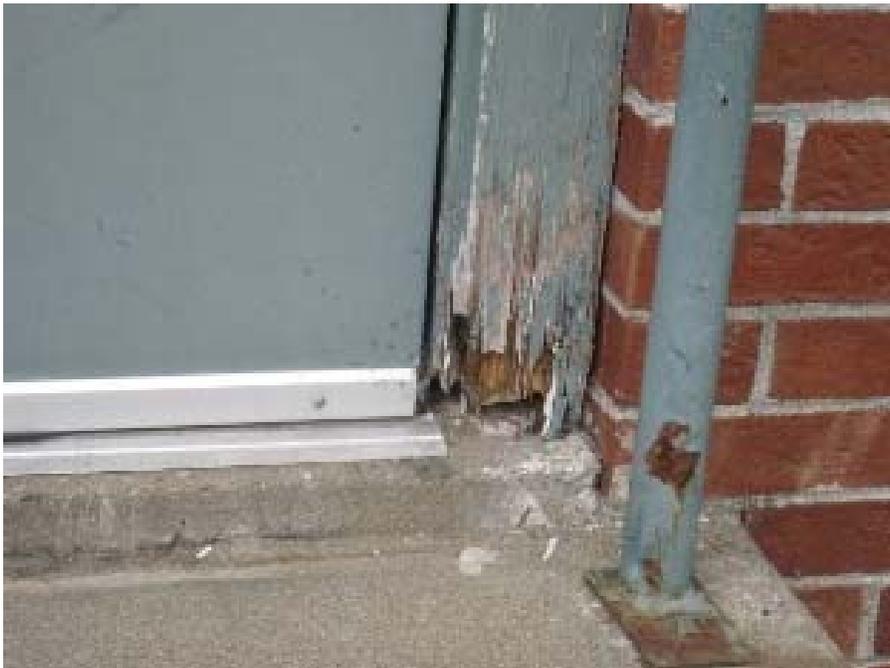
**Picture 6**

**Rotted Door Casing**

8. Repair/replace rotted exterior door casings.
9. Design and install gutter and downspout system to collect rain and deposit it away from the building.

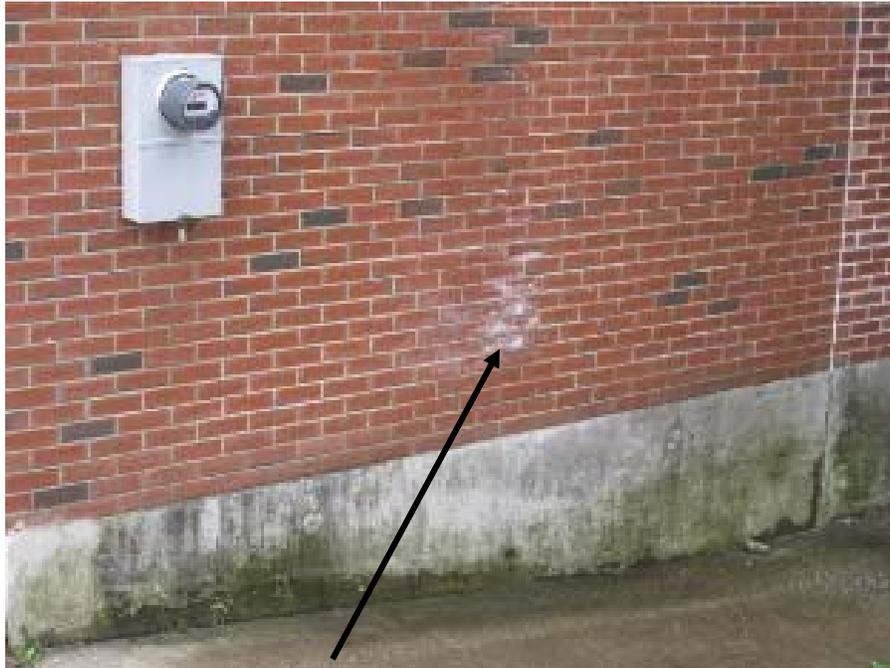
**Picture 7**

<sup>1</sup> Efflorescence is a characteristic sign of water damage to building materials, but it is not mold growth. As moisture penetrates and works its way through building materials (e.g., plaster, mortar, brick), water-soluble compounds dissolve, creating a solution. As this solution moves to the surface, the water evaporates, leaving behind white, powdery mineral deposits.

**Efflorescence on Brick Wall  
Note Discoloration and Moss Growth on Concrete**

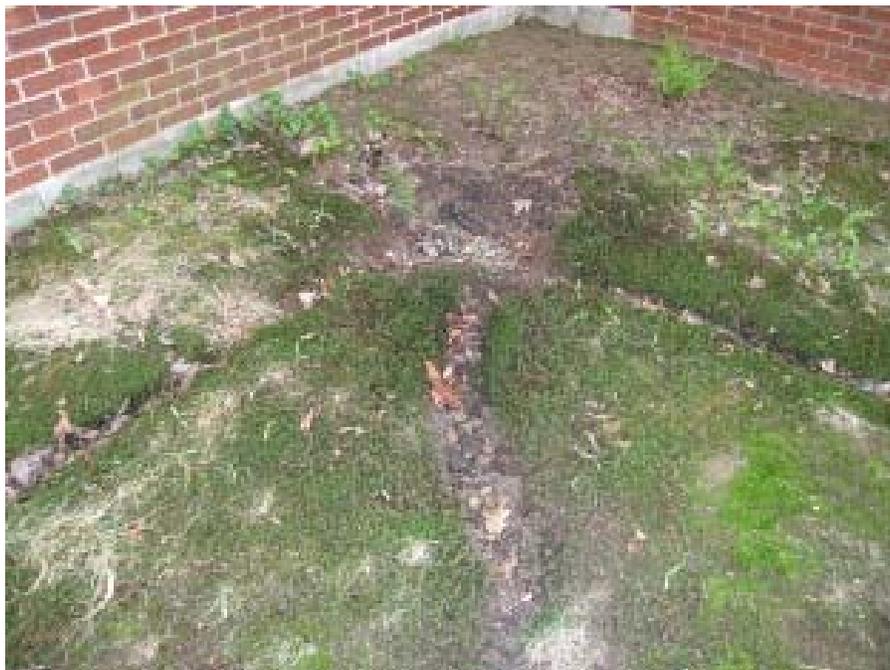
**Picture 8**

**Depressions Created Where Water Drains Off Roof**

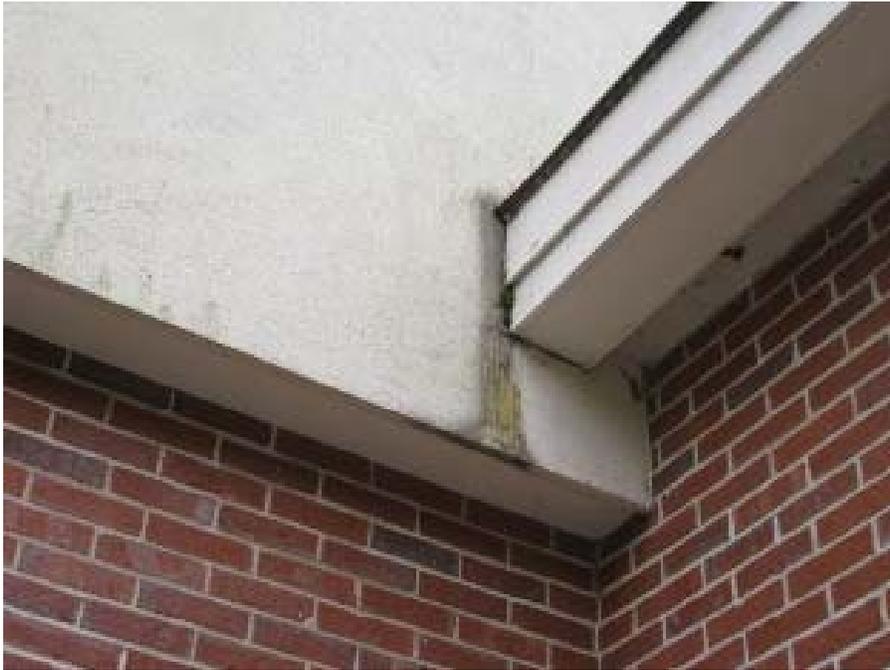
**Picture 9**

- The slope of the earth where the original building meets the addition creates a convergence of moisture moving toward the basement door.
- CCES lacks gutters to collect and disperse rain water away from the base of the building. As a result, troughs have been created close to the base of the building by water deposition, which in turn, allow water to pool, creating saturated conditions adjacent to the building's foundation (Picture 8). This was particularly evident in areas where roofs converged. In addition, water is deposited against exterior walls, which has caused deterioration of the wall surface, as seen in Picture 9.

**Water Damaged Exterior Wall**

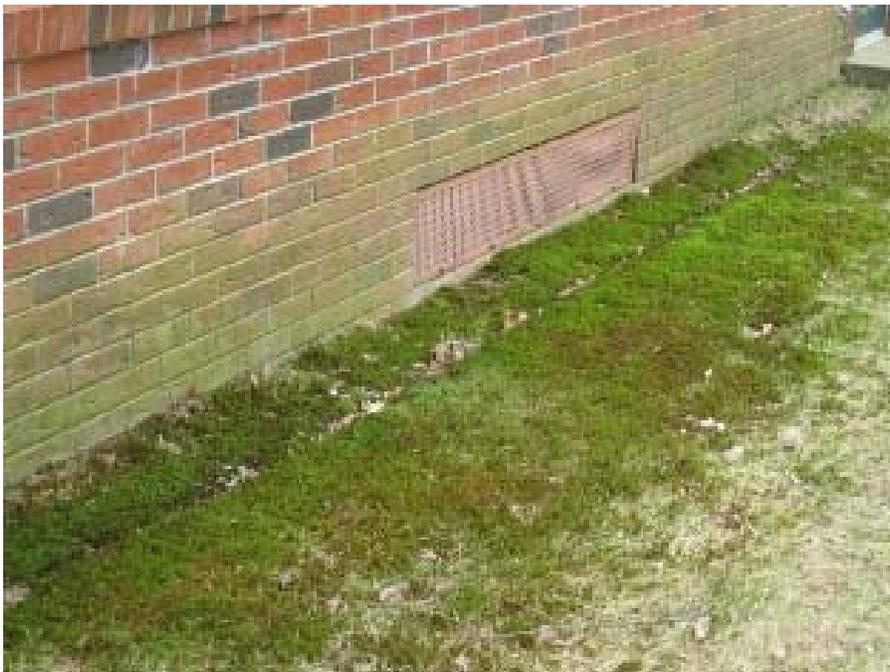
**Picture 10**

- Saturated conditions have allowed moss to proliferate on the grounds surrounding the building as well as on the building itself (Pictures 10, 11). The presence of moss on the brick and mortar shown in Picture 10 and the heavy moss accumulation on the roof in Picture 11 are indicative of repeated water exposure. The two main requirements of a moss are sufficient moisture and accessible nutrients.

**Moss Growth On Ground and Masonry**

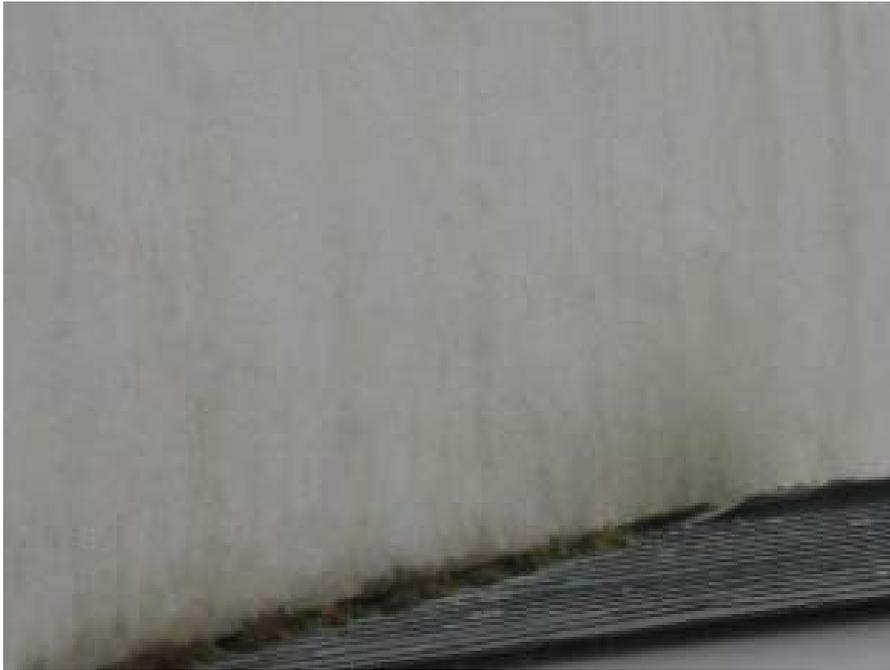
**Picture 11**

**Moss Growth At Juncture of Wall and Asphalt Shingles on Roof**

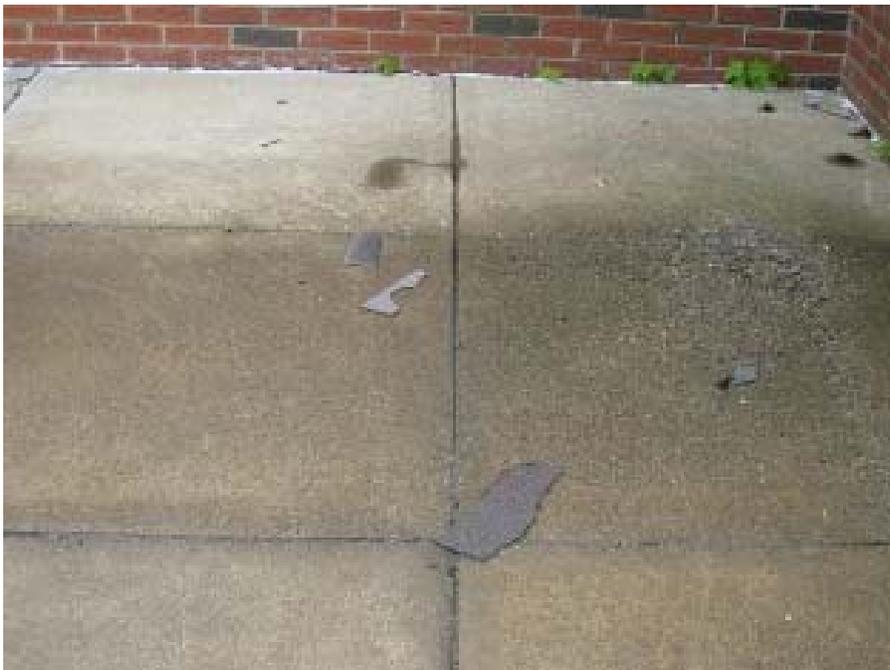
**Picture 12**

- Pieces of asphalt shingles were observed on the sidewalk on the east side of the building (Picture 12). This condition may indicate that in addition to the roof leakage reportedly due to ice dams, there may be some shingles in disrepair that are contributing to the moisture problem. Roofing should be examined for areas of disrepair.

**Portions of Asphalt Shingles on Sidewalk**

13. Inspect asphalt shingles for deterioration and repair/replace as necessary.
14. Repair crevices in pavement.

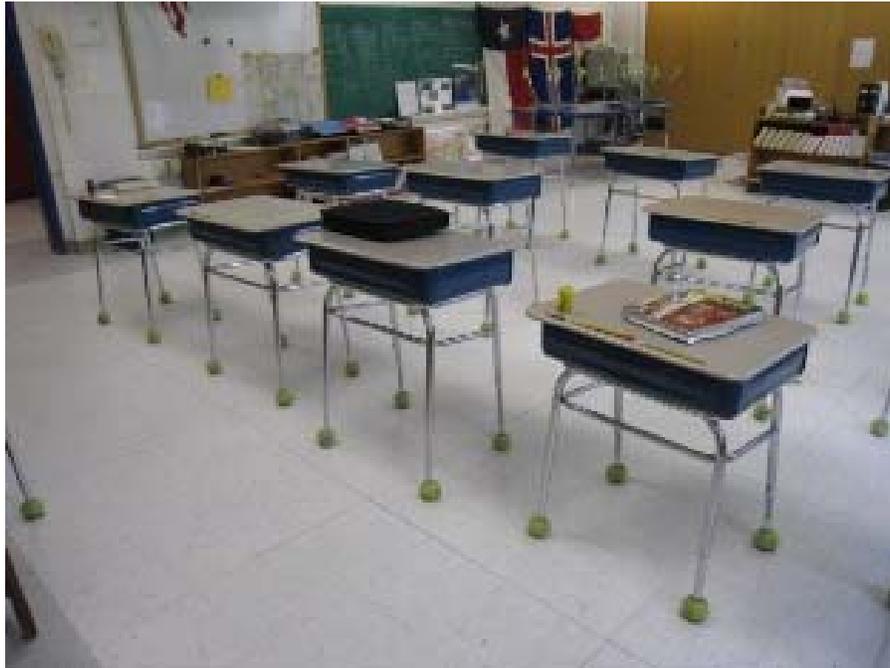
**Picture 13**

In an effort to reduce noise from sliding chairs and desks, tennis balls were sliced open and placed on desk and chair legs (Picture 13). Tennis balls are made of a number of materials that are a source of respiratory irritants. Constant wearing of tennis balls can produce fibers and off-gas VOCs. Tennis balls are made with a natural rubber latex bladder, which becomes abraded when used as a chair leg pad. Use of tennis balls in this manner may introduce latex

dust into the school environment. Some individuals are highly allergic to latex (e.g. spina bifida patients) (SBAA, 2001). It is recommended that the use of materials containing latex be limited in buildings to reduce the likelihood of symptoms in sensitive individuals (NIOSH, 1997). A question and answer sheet concerning latex allergy is attached as [Appendix B](#) (NIOSH, 1998).

**Latex Tennis Balls on Legs of Desks**

20. Evaluate condition of window caulking material throughout the building. If in poor condition, repair or replace.
21. Discontinue use of tennis balls on classroom desks and chairs.

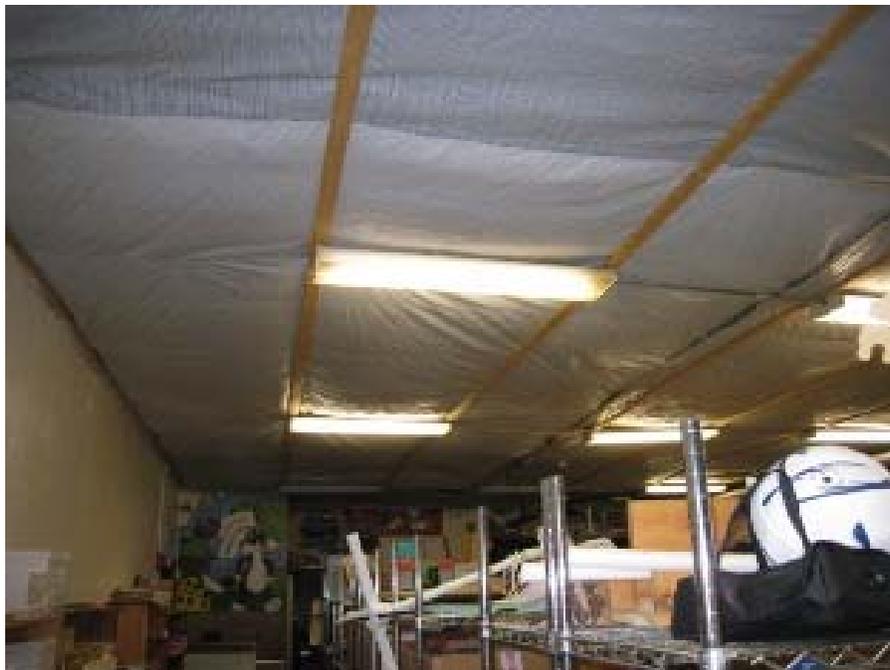
**Picture 14**

The ceiling of the basement area, now used for storage, has been constructed by using plastic sheeting held in place with wood strapping (Picture 14). Missing ceiling tiles were observed in some areas of the basement and one classroom had buckled ceiling tiles. In addition, open utility holes were observed in walls of basement (Picture 15). These conditions can provide a means of egress for odors, fumes, dusts and vapors between rooms and floors. In addition, these materials can migrate into the air handling chambers of unit ventilators and be distributed to occupied areas.

**Basement Ceiling**

1. Consider replacing windows in the original building.
2. Consider installing a suspended ceiling in basement.
3. Consider constructing an apron adjacent to the building that will be less pervious to water. Where feasible, improve the grading of the ground away from the foundation to eliminate saturation of soils adjacent to the exterior wall.

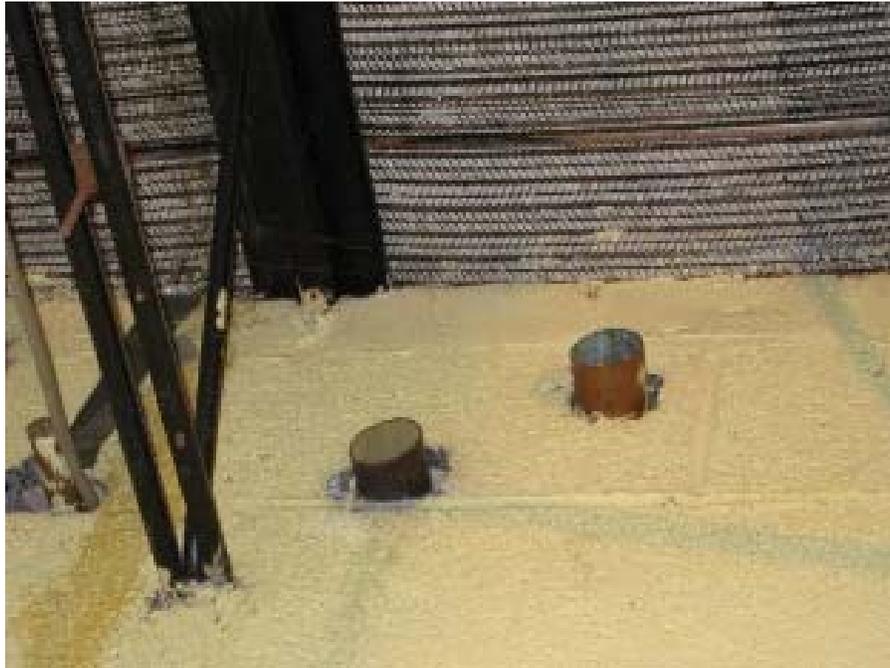
**Picture 15**

**Open Utility Holes**

15. Install a carbon monoxide detector in kitchen.
16. Seal open utility holes throughout building.
17. Consider providing plants with drip pans and avoid over-watering. Examine drip pans periodically for mold growth. Disinfect with an appropriate antimicrobial where necessary. Discontinue practice of resting planters on cloth. Remove and dispose of plant fragments as they drop off plants.

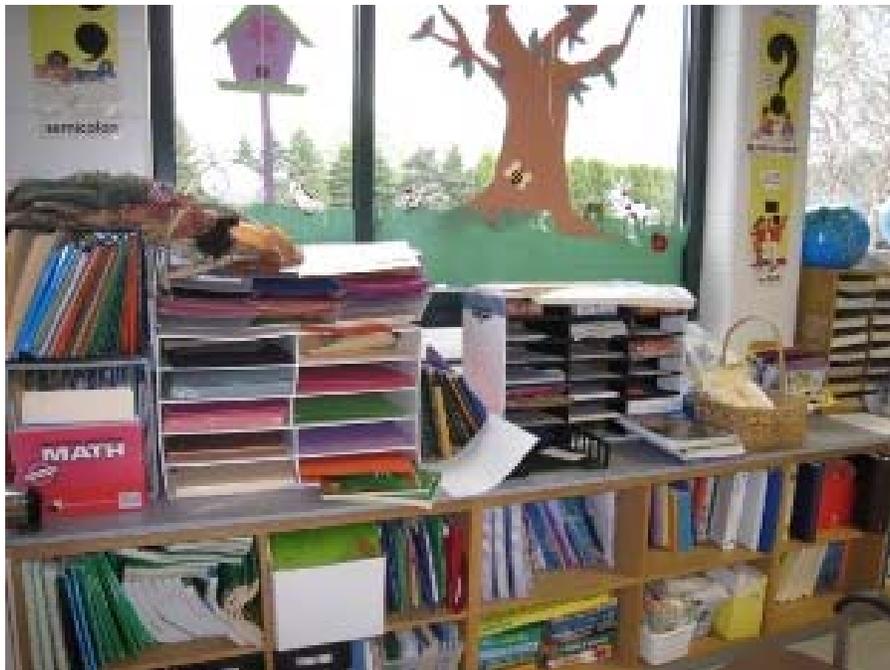
**Picture 16**

In one classroom, items were observed on the counters and bookcases (Picture 16). In addition to blocking access to the windows, the large number of items stored in the classroom provides a source for dusts to accumulate. These items (e.g., papers, folders, boxes) make it difficult for custodial staff to clean. Items should be relocated and/or be cleaned periodically to avoid excessive dust build up. In addition, these materials can accumulate on flat surfaces (e.g.,

**Accumulation of Materials Stored in Classroom  
Note Materials Obstruct Access to Windows**

26. Relocate or consider reducing the amount of materials stored in classrooms to allow for more thorough cleaning of classrooms. Clean items regularly with a wet cloth or sponge to prevent excessive dust build-up. Arrange materials to allow access to windows.

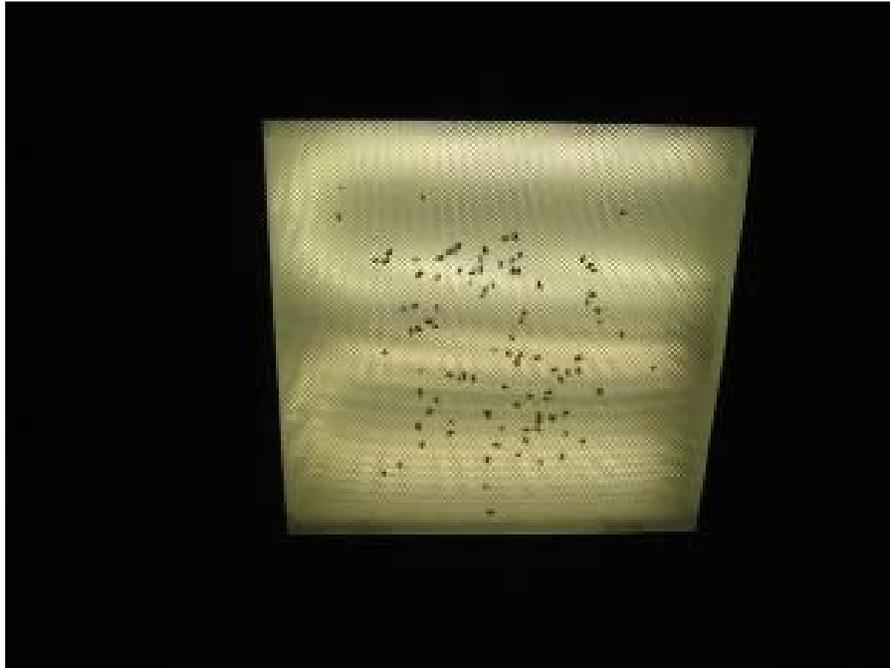
**Picture 17**

Numerous dead flies were observed within a light fixture in Room 9 (Picture 17). As they decay, parts of these insects can become dried out and aerosolized and may serve as a source of allergenic material for certain sensitive individuals. Breaches or gaps in the building envelope in this area of CCES must be identified and remedied in order to eliminate this condition.

**Dead Flies on Light Fixture**

| Location/<br>Room | Occupants<br>in Room | Temp<br>(°F) | Relative<br>Humidity<br>(%) | Carbon<br>Dioxide<br>(ppm) | Carbon<br>Monoxide<br>(ppm) | PM2.5<br>(µg/m3) | Windows<br>Openable | Ventilation | | Remarks |
|---|---|---|---|---|---|---|---|---|---|--|
| Room 9<br>(bathroom) | | | | | | | N | N | Y | DC, Flies observed above light fixture |

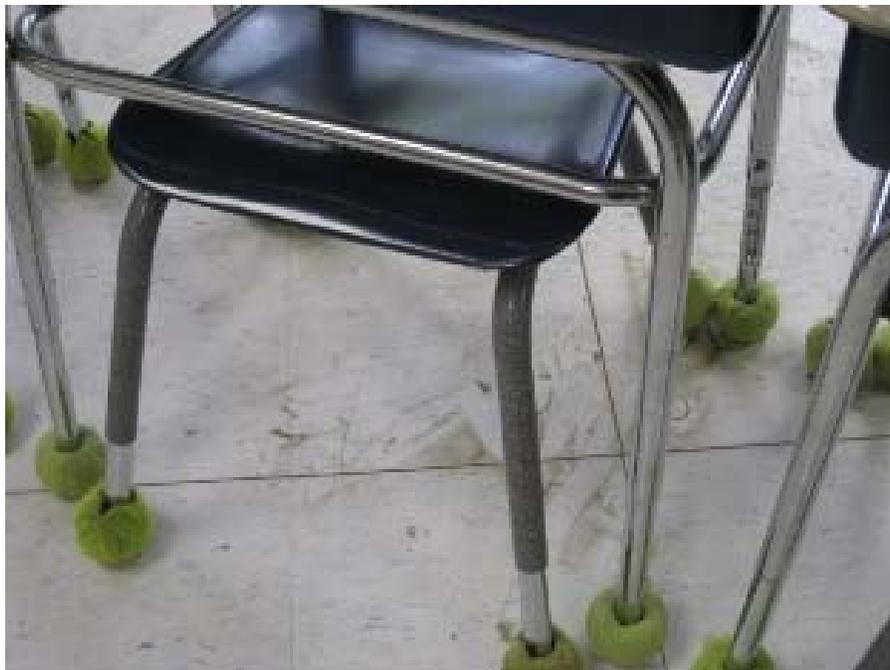
**Picture 18**

**Soil Accumulation on Classroom Floor**

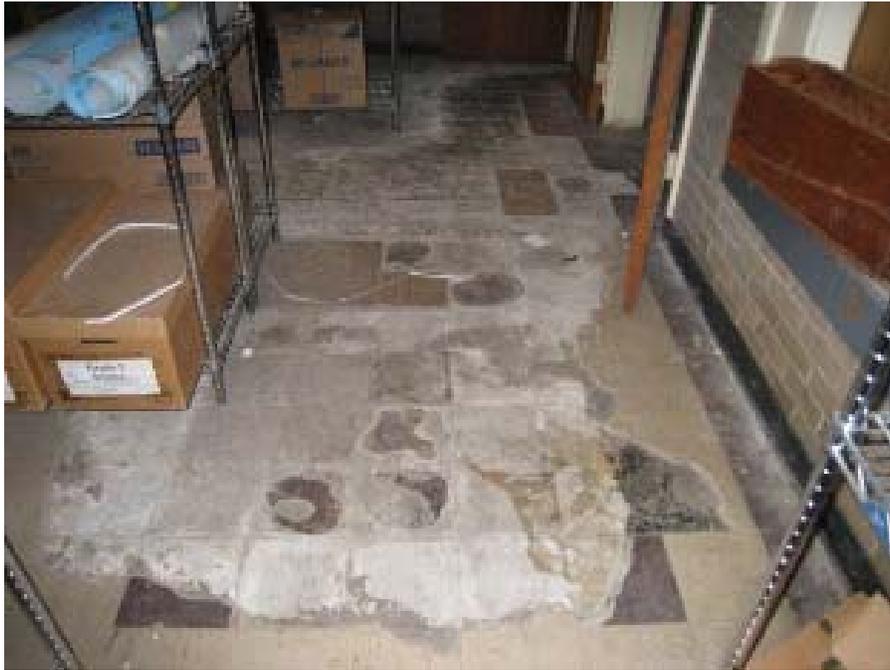
**Picture 19**

In the basement, numerous floor tiles were in disrepair (Picture 19). These tiles may contain asbestos and if so, should be remediated in conformance with all applicable Massachusetts asbestos abatement and hazardous materials disposal laws.

**Basement Floor Tiles in Disrepair**

| Location/<br>Room | Occupants<br>in Room | Temp<br>(°F) | Relative<br>Humidity<br>(%) | Carbon<br>Dioxide<br>(ppm) | Carbon<br>Monoxide<br>(ppm) | PM2.5<br>(µg/m3) | Windows<br>Openable | Ventilation | | Remarks |
|--|---|---|---|---|---|---|---|---|---|--|
| (1952<br>Section of<br>Building)<br>Basement | 0 | 70 | 41 | 609 | ND | - | N | ? | ? | Old cafeteria, floor tiles in very poor repair |

22. Periodically clean dry erase boards and trays. Consider using dry erase markers that emit fewer VOCs.
23. Discontinue use of deodorizing materials.
24. Determine composition of basement floor tiles. If they contain asbestos, remediate in accordance with state and federal asbestos removal and hazardous materials disposal regulations.
