**INDOOR AIR QUALITY ASSESSMENT
OF
PROPOSED SCHOOL SITE FOR
NEWMAN ELEMENTARY SCHOOL**

**Saint Mary's School
420 High Street
Dedham, Massachusetts**

Prepared by:
Massachusetts Department of Public Health
Bureau of Environmental Health
Indoor Air Quality Program
August 2008

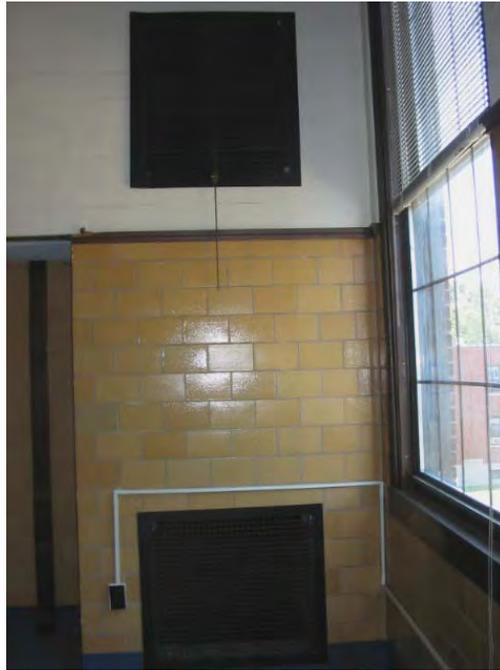
Picture 1

Each wing of the school complex is serviced by a different type of heating, ventilating, and air conditioning (HVAC) system. Ventilation is provided to each room in the 1935 wing via a large vent located near the ceiling (Picture 1) and connected to an air-handling unit (AHU) located in the basement (Picture 2). Fresh air for the AHU is drawn through air intakes located at ground level on north side of the building (Picture 3). This type of ventilation system does not have the capacity for filtering outdoor air, which would allow normally occurring outdoor pollutants (i.e., airborne mold particles and pollen) to be drawn into the ventilation system and distributed to classrooms.

Exhaust ventilation in 1935 wing classrooms is provided by wall or cubby exhaust systems (Picture 1), which are connected via ductwork to rooftop exhaust (Picture 5). Whether the exhaust system on the roof was motorized could not be determined, since the roof of the 1935 wing could not be accessed during the assessment. Frequently, ventilation systems of this age and design do not incorporate rooftop fans, but rely on the fresh air system to pressurize the building. Air forced into the exhaust system would move up vertical air shafts and exit through the rooftop vent system. The efficacy of this system could not be determined during the course of this assessment.

Supply (top) and Exhaust (bottom) Vents in 1935 wing classrooms

2. Contact a ventilation engineer to determine whether the exhaust ventilation system in the 1935 wing is functional.
3. Determine whether or not the each HVAC system in both wings can be outfitted with appropriate filters.

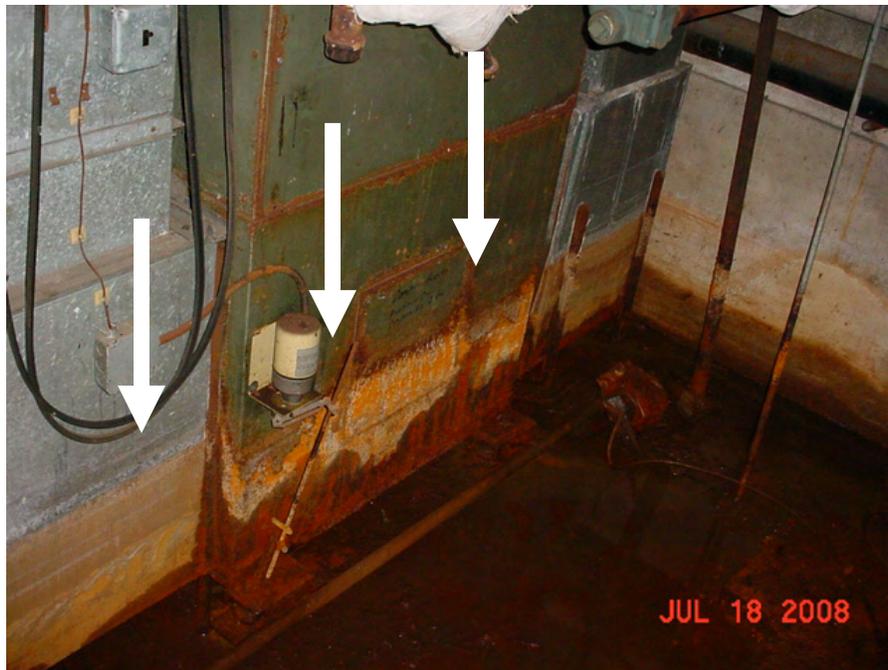
Picture 2

Of note is the condition of the ductwork connected to the AHU for the 1935 wing. It appears that the AHU and its ductwork have been repeatedly exposed to water, as demonstrated by the water staining on the exterior of the ductwork and AHU casing (Picture 2). Repeated exposure to water can cause damage/deterioration of ductwork and AHU casing, likely resulting in water penetration to AHU equipment. Repeated water-damaged has likely created conditions for mold growth within the AHU equipment, which could then distribute mold particles/odors to classrooms connected to the system. At minimum, an extensive cleaning of this system would be required prior to any use of this equipment. It is, however, most likely that this equipment would need to be replaced.

As mentioned previously, the mechanical room housing the 1935 wing's HVAC system is subject to water damage. This condition is likely the result of the basement area being located directly below a grass area adjacent to a driveway. It is likely that water runoff and melting ice impinges against the foundation wall and then passes through the concrete into the basement.

Base of the AHU That Is Located In the Basement, Note High Water Mark On Duct and AHU Cabinet

1. Contact a ventilation engineer to determine whether the ventilation equipment in the 1935 wing can be cleaned and repaired to prevent further water damage and possible distribution of microbial growth within ventilation equipment into classrooms. If this system cannot be made clean and functional, the 1935 wing does not have a functional mechanical ventilation system.

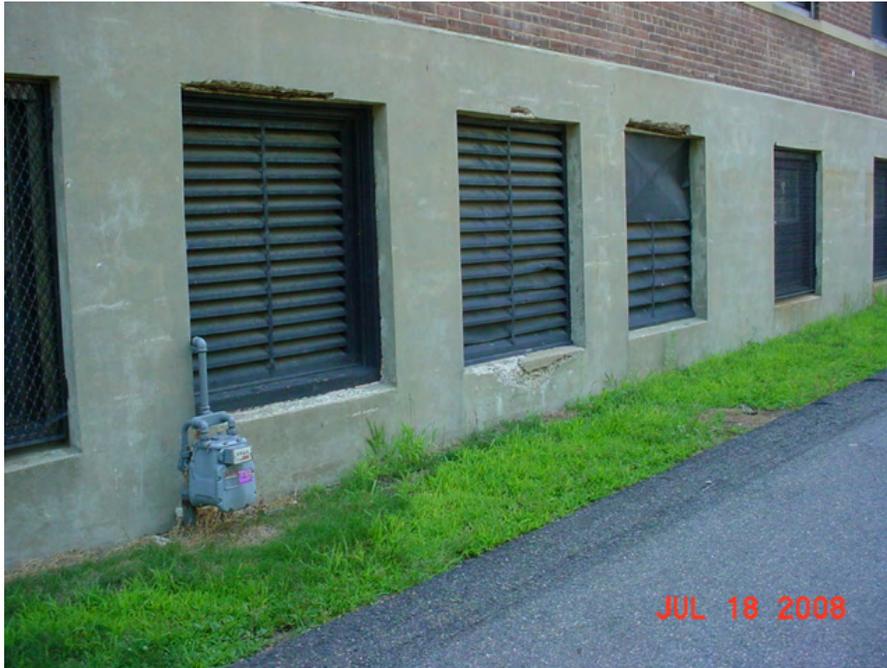
Picture 3

Fresh Air Intakes for AHU

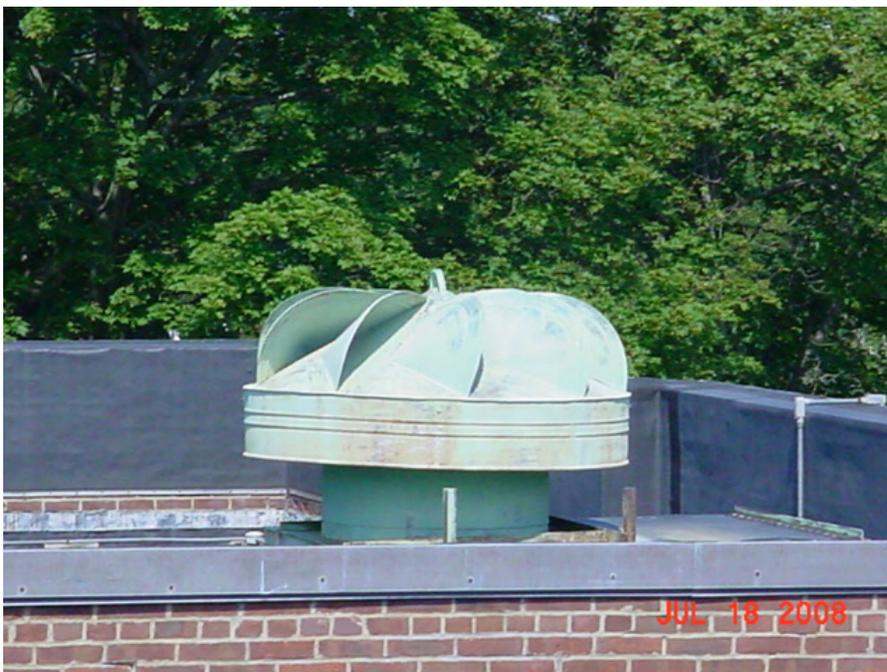
Picture 4

Rooftop Exhaust, 1935 Building

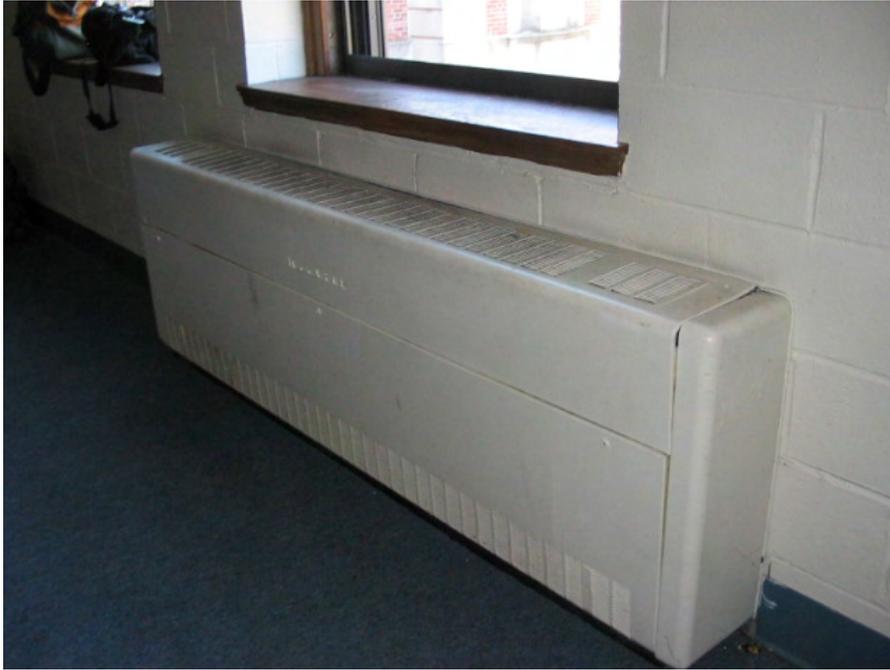
Picture 5

Fresh air is supplied to classrooms in the 1957 wing unit ventilators (univents) (Picture 5). The univents appear to be original equipment (i.e., installed when the wing was built)¹. These univents do not have any means to filter air, allowing normally occurring outdoor air pollutants (i.e., airborne mold particles and pollen) to be distributed into classrooms. Exhaust ventilation in these classrooms is provided by vents that are located in the ceiling of classroom closets (Picture 6). In this configuration, when closet doors are closed, stored materials will block the free flow of air to the exhaust vents.

Univent

To maximize air exchange, the MDPH recommends that both supply and exhaust ventilation operate continuously during periods of school occupancy. In order to have proper ventilation with a univent and exhaust system, the systems must be balanced to provide an adequate amount of fresh air to the interior of a room while removing stale air from the room. It is recommended that existing ventilation systems be re-balanced every five years to ensure adequate air systems function (SMACNA, 1994). Prior to occupancy of this building, it would be recommended that the ventilation system in all wings be re-balanced. Based on the

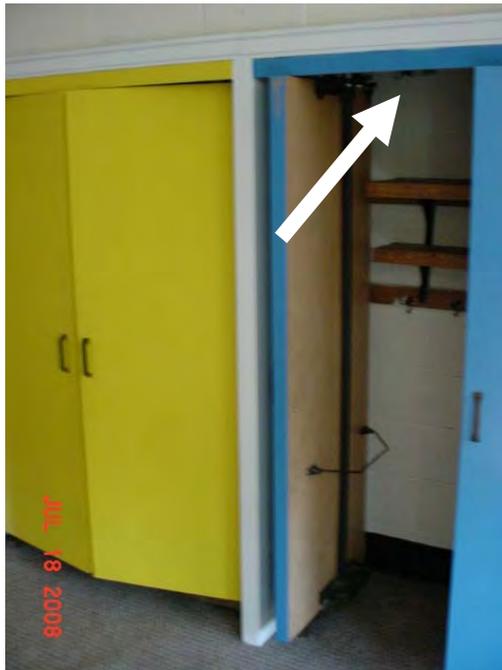
Picture 6

Exhaust Vents in Classroom Closet

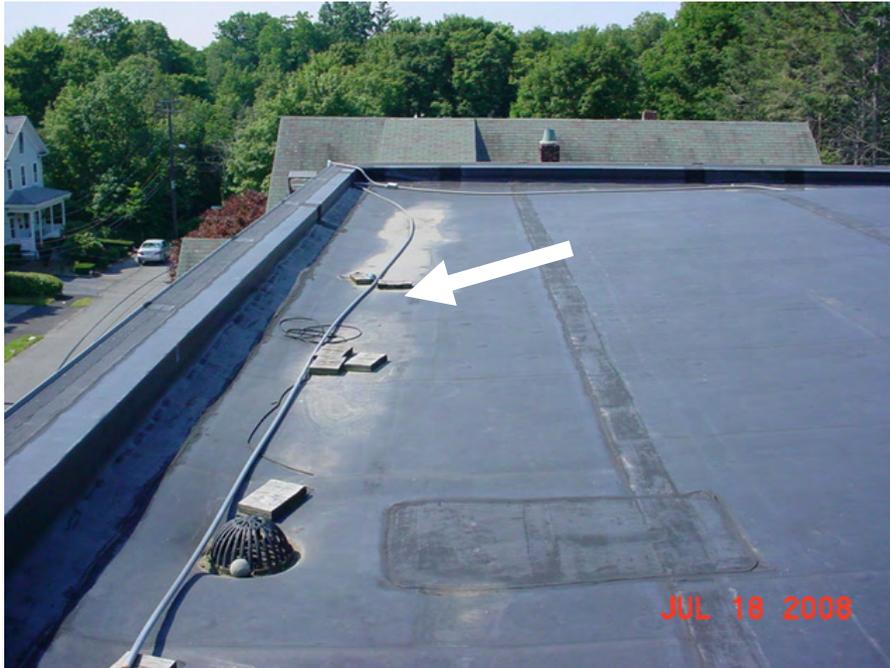
Picture 7

Water-damaged ceiling/wall plaster was noted in several classrooms located on the top floor of each wing. In the case of the 1957 wing, this water penetration is likely due to accumulation of rainwater in low lying roof areas (Picture 7). As this pooling water freezes and thaws, the roof membrane can become damaged, allowing moisture to pass through into the ceilings. These ceilings are made of plaster, which resists mold growth.

Low Lying Area on Roof, Note Debris Accumulation, Which Roughly Corresponds To Location of Ceiling Plaster Damage in the Top Floor Classrooms

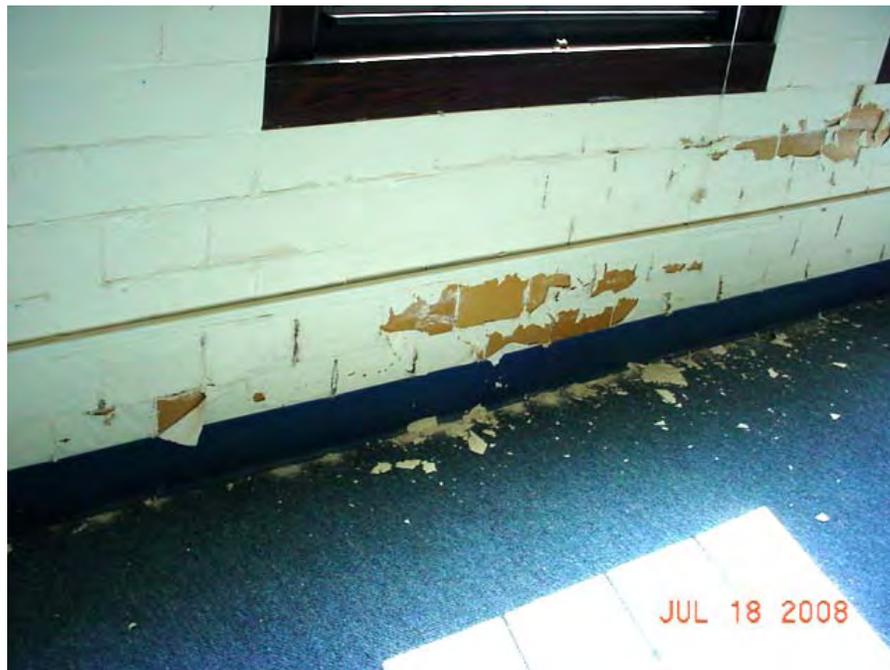
Picture 8

Peeling paint was observed in a classroom in the 1935 wing (Picture 8). The surface below the paint appears to be similar to the stone block walls found in the hallways. Moisture accumulation below the surface of the paint most likely caused it to peel; however, the materials to which the paint was applied are not likely to support mold growth.

Peeling Paint on Stone Classroom Wall

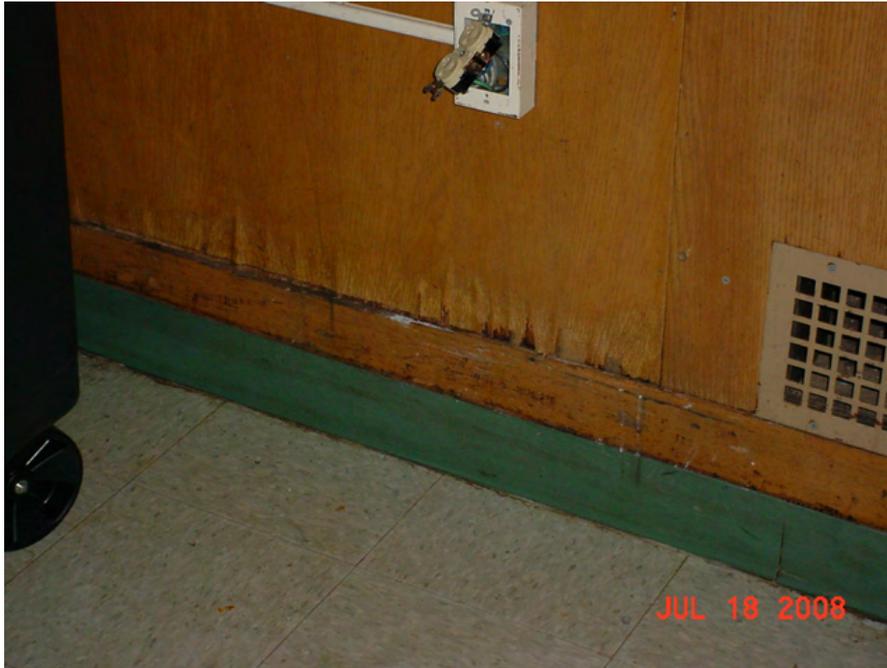
Picture 9

As indicated by Mr. Bergeron, Needham town officials who visited the school reported musty odors in the cafeteria area. The walls of this area are covered with wood-paneling, which appears to have begun splaying in two areas along the exterior wall. Wall-paneling is a material that can support mold growth if exposed repeatedly to water. One potential source of water in this area is leaking steam pipes, as suggested by a note written on a panel displaying significant delamination (Pictures 9 and 10). Another possible source resulting in water penetration to this area may be the lack of functional drainage around the foundation of the building. The cafeteria

Delaminating Wood Panel

6. Remove carpeting with musty odors. Prior to any carpet removal, contact a licensed asbestos inspector to examine all floor tiles.
7. Remove all water-damaged wood paneling in the cafeteria area. The source of water damaging the cafeteria wall paneling should be identified and repaired.

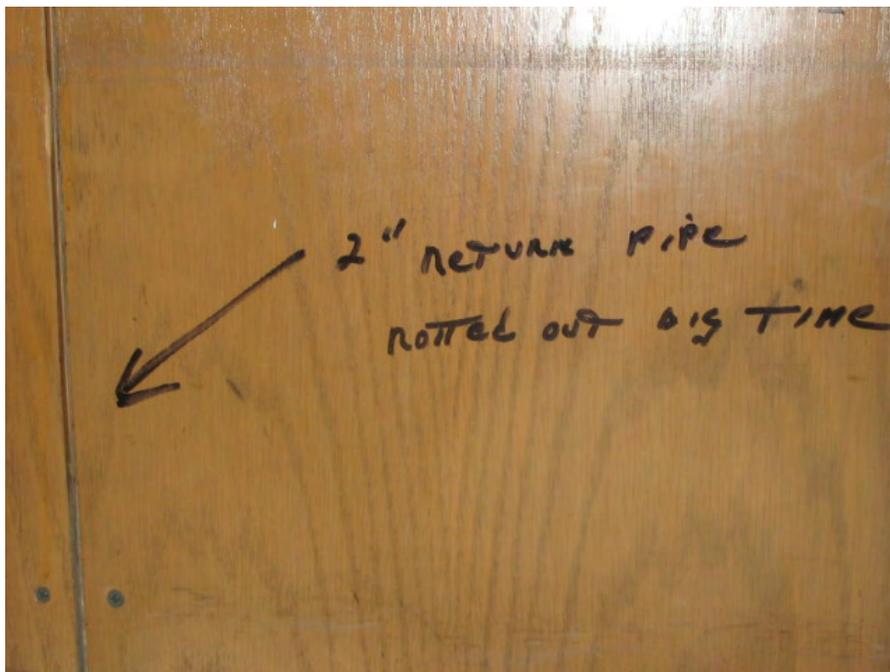
Picture 10

**Handwritten Note on Delaminating Panel,
Note Reads "2" Return Pipe Rotted Out Big Time"**

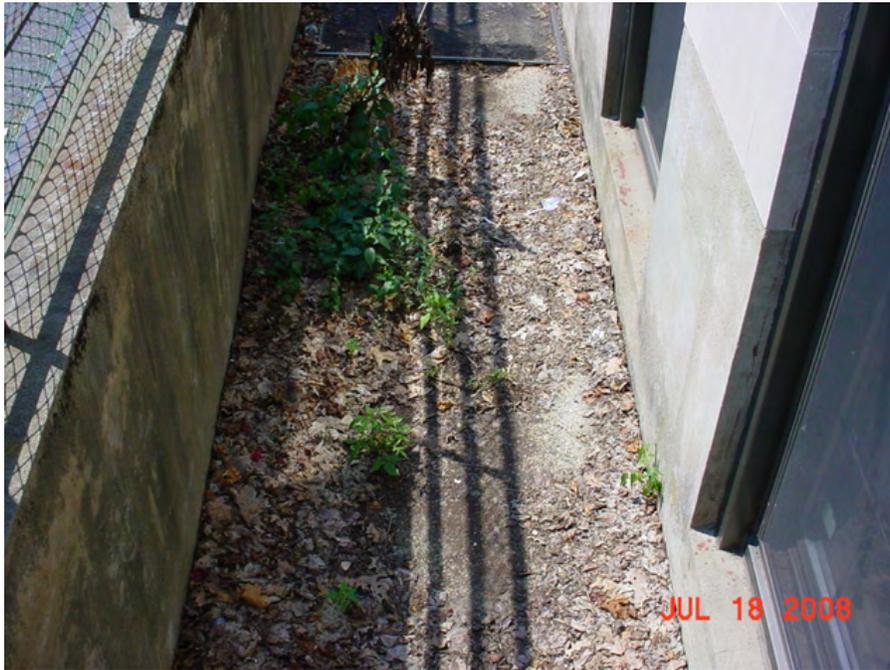
Picture 11

area appears to be flanked on its north and south walls by large cement lined pits (Picture 11). In locations where drains were most likely located in these pits, large plants were found growing (Pictures 12 and 13). If not properly drained, water will accumulate in these areas and then penetrate through the foundation wall and into the cafeteria area.

Example Cement Lined Pit outside Cafeteria

4. Clean and restore all drains around the exterior walls of the building.
5. Repair all cracks crevices and holes in the exterior walls of the to prevent further water damage.

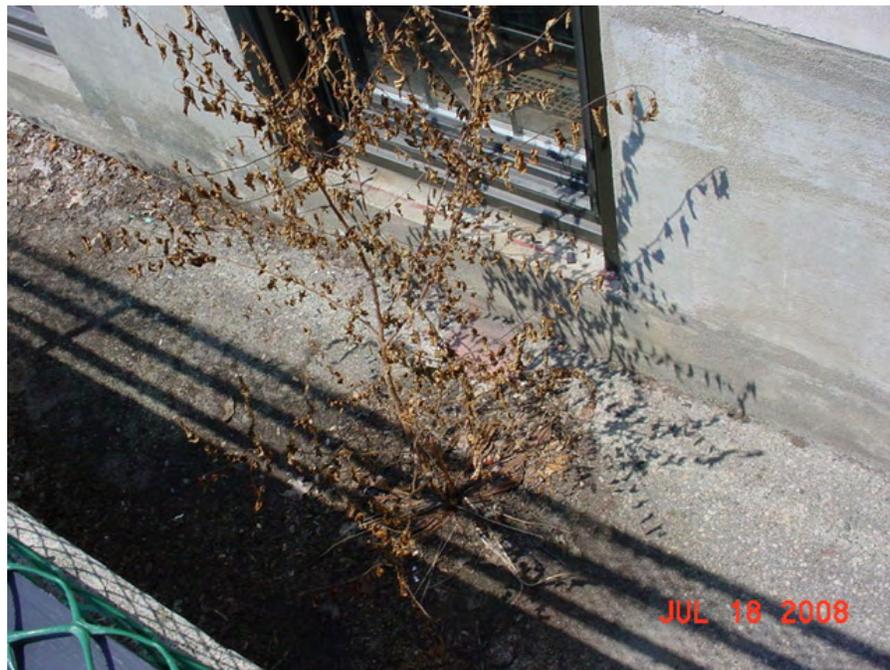
Picture 12

Plant Growing From Likely Location of Drain, South Exterior Wall of Cafeteria

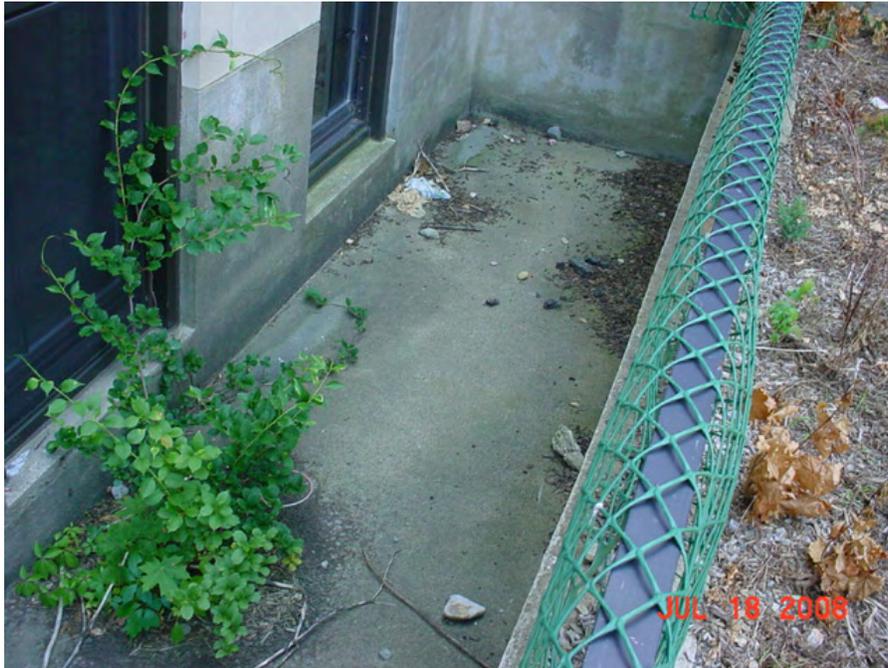
Picture 13

Plant Growing From Likely Location of Drain, North Exterior Wall of Cafeteria

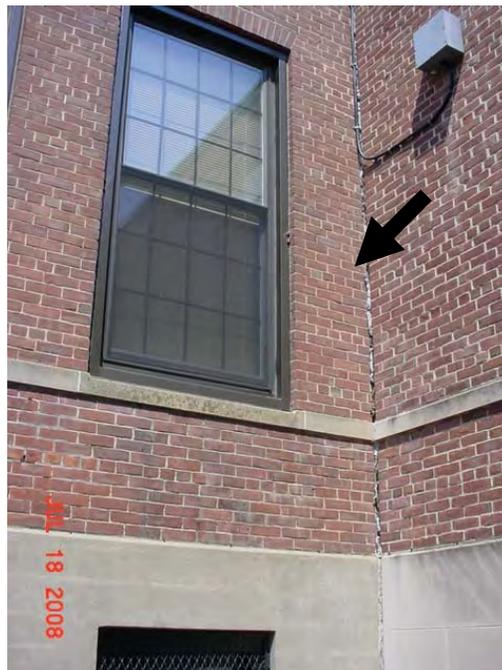
Picture 14

The exterior wall of the building had a number of areas displaying either water-damaged mortar or damaged sealants (Picture 14). Damaged mortar and joint seals can lead to water penetration into the interior of the building.

Damage Seam Sealant, Rear of Building

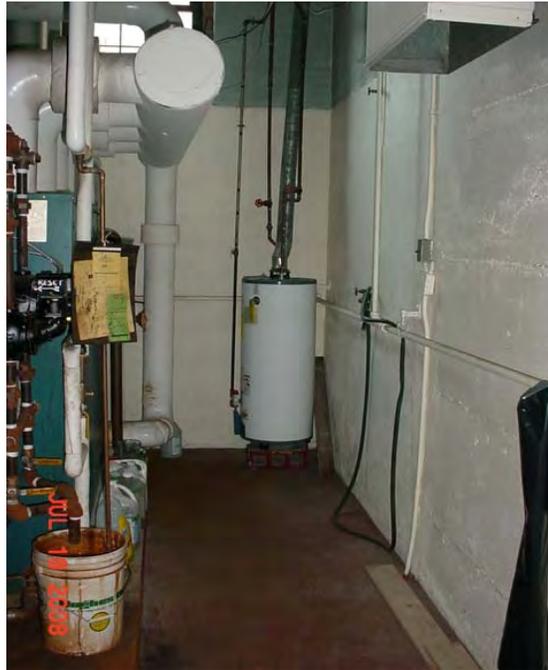
Picture 15

The boiler room contains a gas-fired water heater (Picture 15). Exhaust pipes for the water heater runs upwards to a 90° turn, which then runs parallel (Picture 16) to the floor until it makes a second 90° turn before connecting to the chimney (Picture 17). A water heater exhaust vent that runs parallel to the floor and of this length should likely be connected to a power vent in order to ensure that products of combustion are vented from the building appropriately. If not, products of combustion of gas, such as carbon monoxide, will not be vented from the boiler room as needed. Under these conditions, pollutants will likely accumulate and penetrate into the kitchen and/or the teen center since the doors to this building are used to pass between the basement areas of each wing.

Water Heater in Boiler Room

8. Consider installing a power vent on the exhaust vent for the water heater

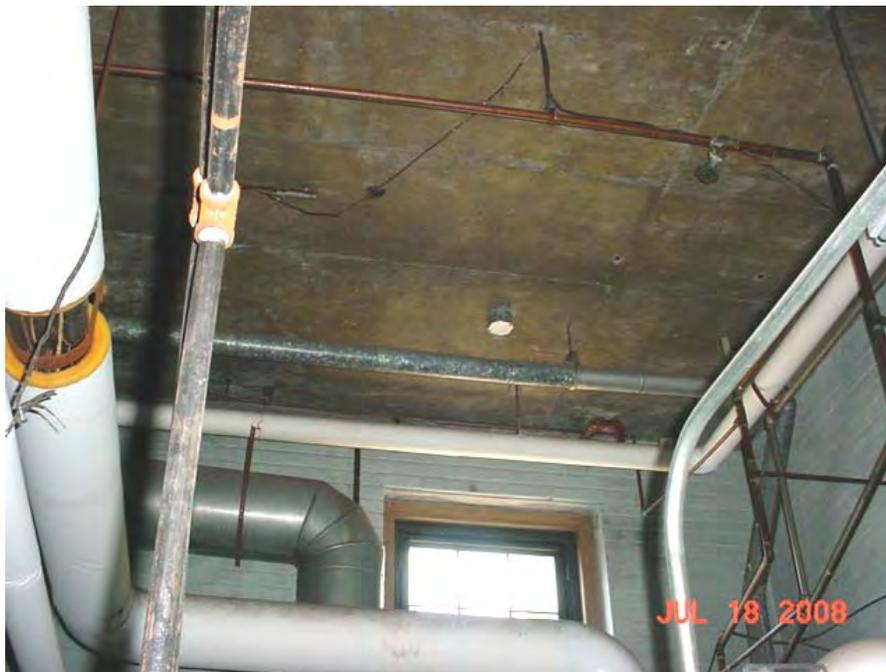
Picture 16

Water Heater Exhaust Pipe Parallel to the Floor, Note Bend in Exhaust Pipe

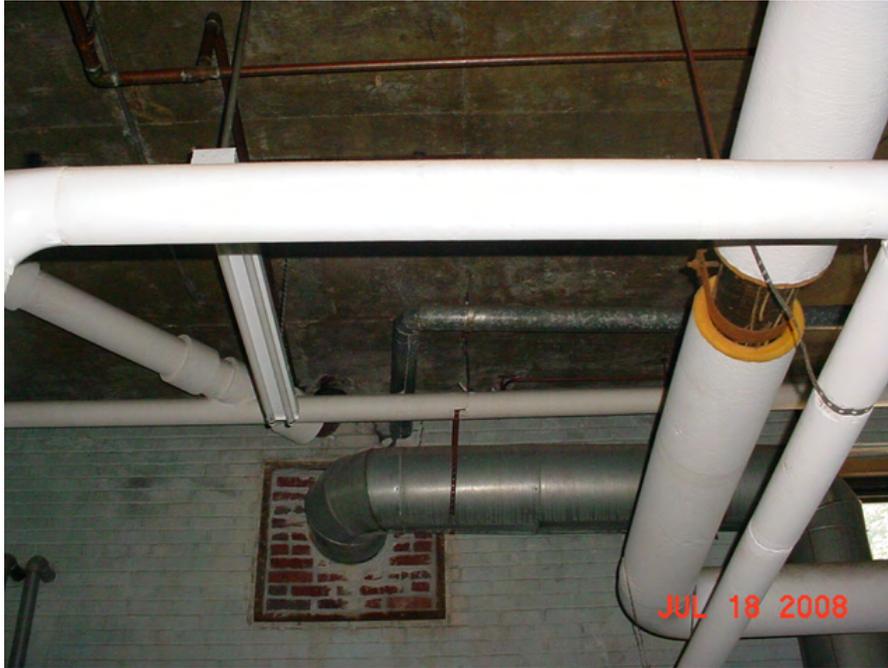
Picture 17

Water Heater Exhaust Pipe Connected Into the Main Chimney, Note Lack of Power Vent

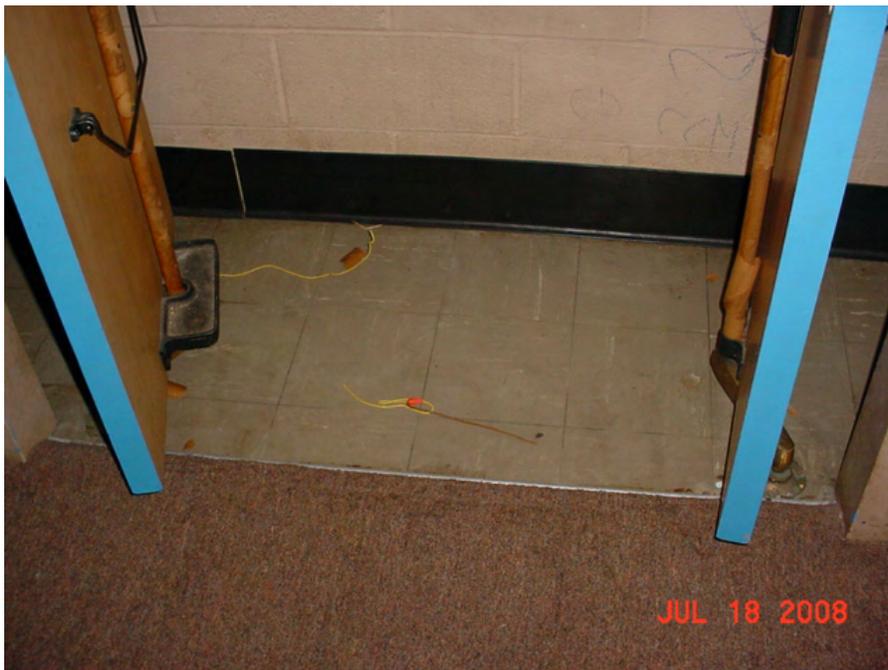
Picture 18

Wall-to-wall carpeting was observed in many classrooms throughout the building. It appears that this wall-to-wall carpeting was installed over an original tile floor (Picture 18). Frequently, these types of tiles will contain asbestos. The composition of the floor tiles (i.e. asbestos containing) should be determined prior to any removal of carpeting. Where asbestos-containing materials are found damaged, these materials should be removed or remediated in a manner consistent with Massachusetts asbestos remediation laws (MDLI, 1993).

Carpet Installed On Floor Tile
