INDOOR AIR QUALITY ASSESSMENT

**Memorial Middle School
615 Rollstone Street
Fitchburg, Massachusetts**

Prepared by:
Massachusetts Department of Public Health
Bureau of Environmental Health
Indoor Air Quality Program
September 2009

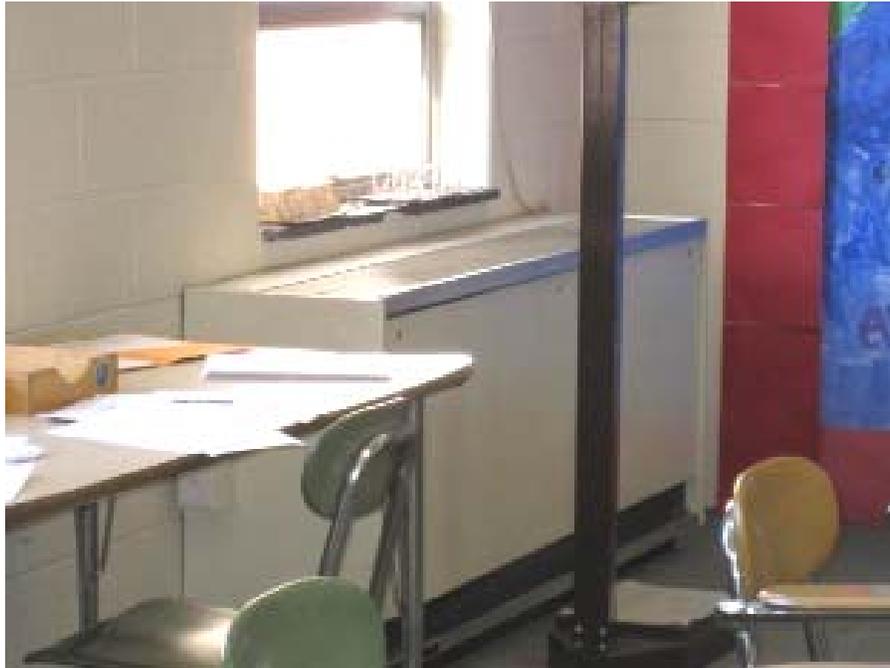
Picture 1

Fresh air is supplied to classrooms by unit ventilator (univent) systems (Picture 1). A univent draws air from the outdoors through a fresh air intake located on the exterior wall of the

Unit Ventilator

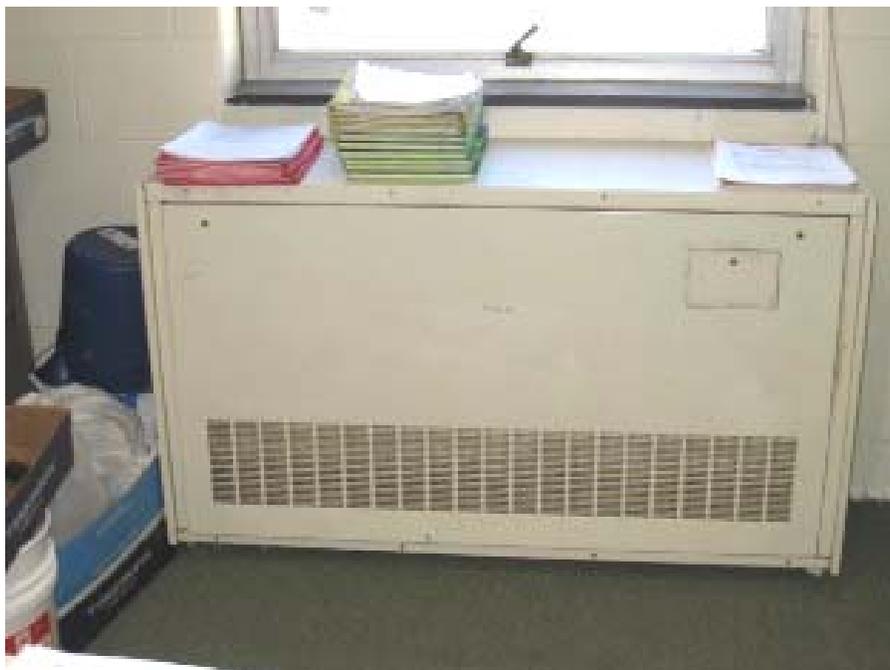
Picture 2

Unit Exhaust Ventilator

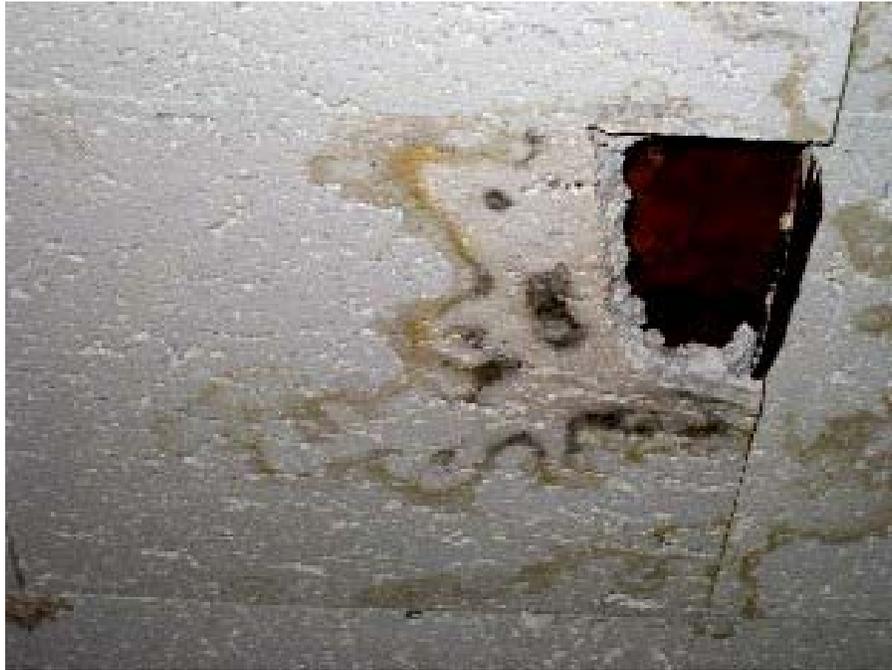
Picture 3

Several potential sources of water damage and/or mold growth were observed during the assessment. Active roof leaks were observed in the form of water damaged building materials. Water damaged, broken, stained and (in some cases) mold colonized ceiling tiles were observed throughout the school (Picture 3). Of note is a white powdery material (i.e., efflorescence) noted on the ceiling in a storage area, which indicates water penetration (Picture 4). Efflorescence is a characteristic sign of water intrusion but it is not mold growth. As moisture works its way through the building envelope, water-soluble compounds dissolve, creating a solution. As this solution moves to the surface of the ceiling, the water evaporates, leaving behind white, powdery mineral deposits. Evidence of water exposure was also observed on walls of classrooms and in the auditorium (Pictures 5 through 7).

Water Damaged and Mold Colonized Ceiling Tile

9. Ensure roof leaks are repaired and replace water damaged, missing and ill-fitting ceiling tiles. Examine the area above and around these areas for mold growth. Disinfect areas of water leaks with an appropriate antimicrobial.

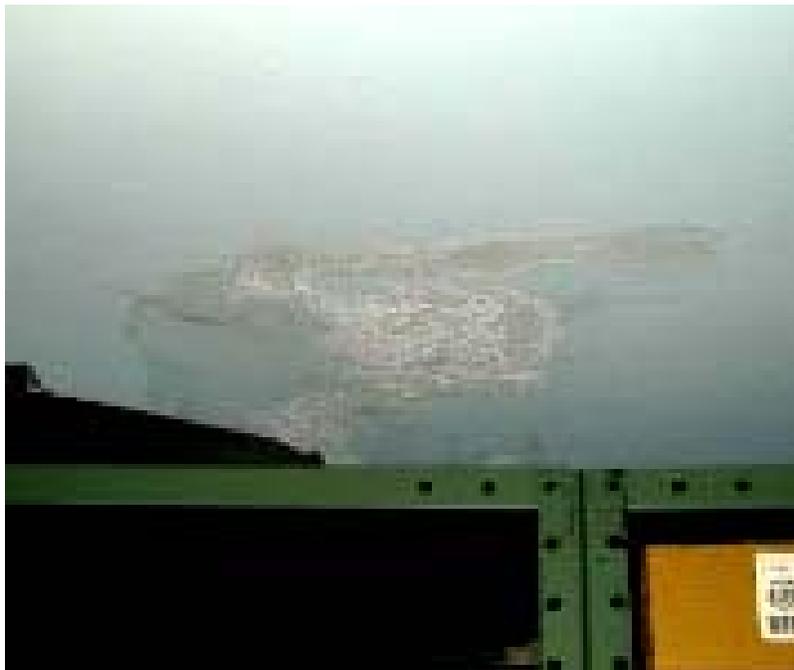
Picture 4

Efflorescence on Storage Room Ceiling

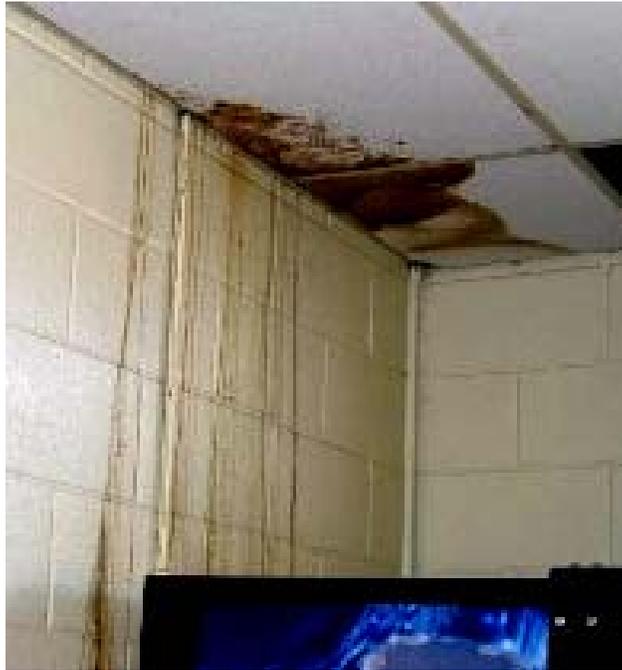
Picture 5

Water Damaged Ceiling Tiles and Water Stains on Wall

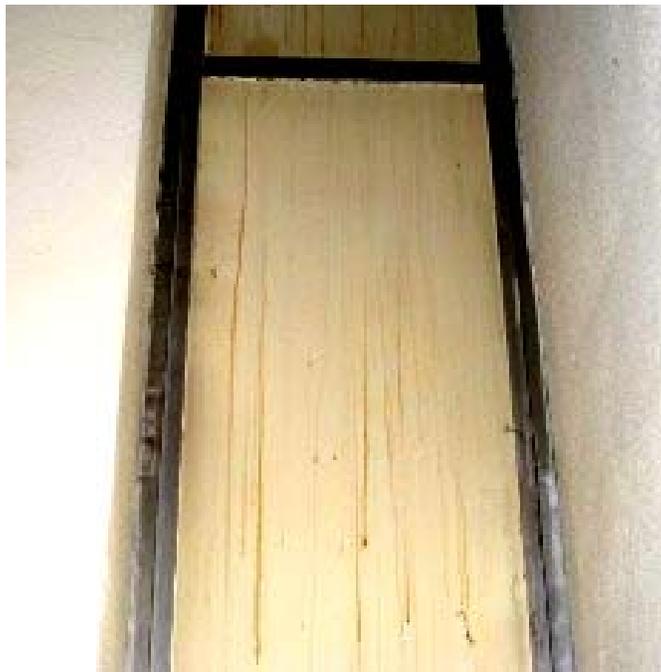
Picture 6

Evidence of Water Infiltration in Auditorium

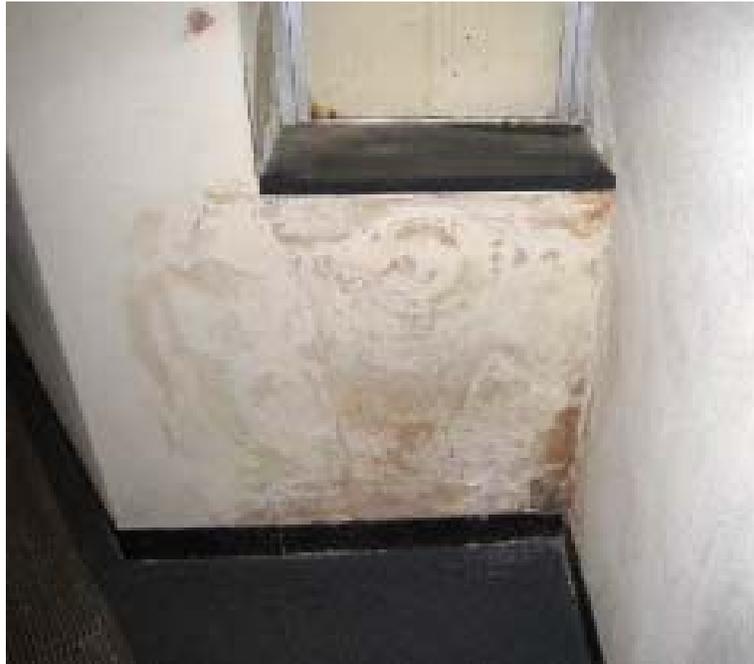
Picture 7

Efflorescence and Water Stains

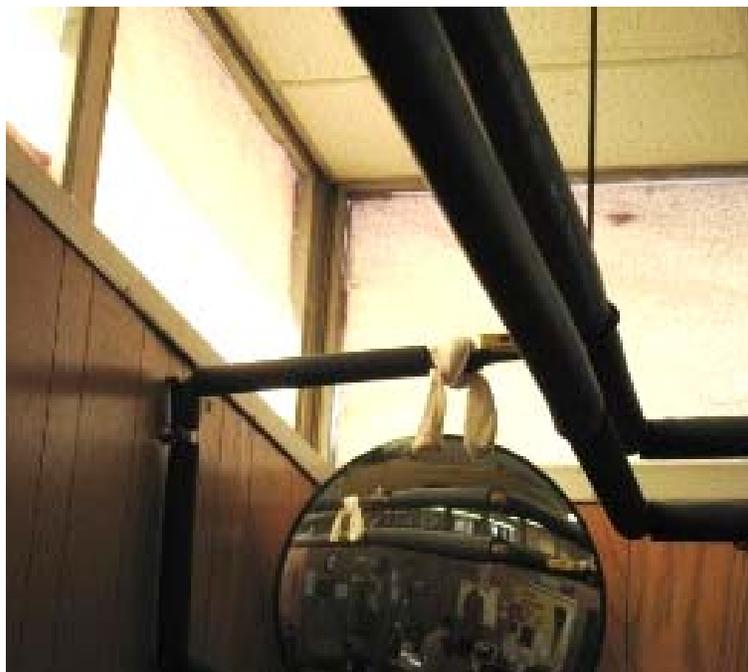
Picture 8

Water distribution lines for the boiler's heating system exhibited some valve joints that were wrapped with cloth, indicating potentially active leaks in the office over carpeted areas (Picture 8). The seals on the sink in room 120 are in disrepair, which may allow water to escape from the sink basin. Additionally, the left portion of the sink has been repaired with a piece of wood. Wood is not impervious to water and could support mold growth and eventually deteriorate (Pictures 9 & 10).

Cloth Wrapped Around Valve Joint

11. Investigate valve joints wrapped in cloth and if plumbing leaks are found, repair in accordance with Massachusetts Plumbing Code.
12. Repair any defective seals on sinks. If wood must be utilized as the edge of a sink, ensure a waterproof seal is maintained on the wood to reduce exposure to moisture.

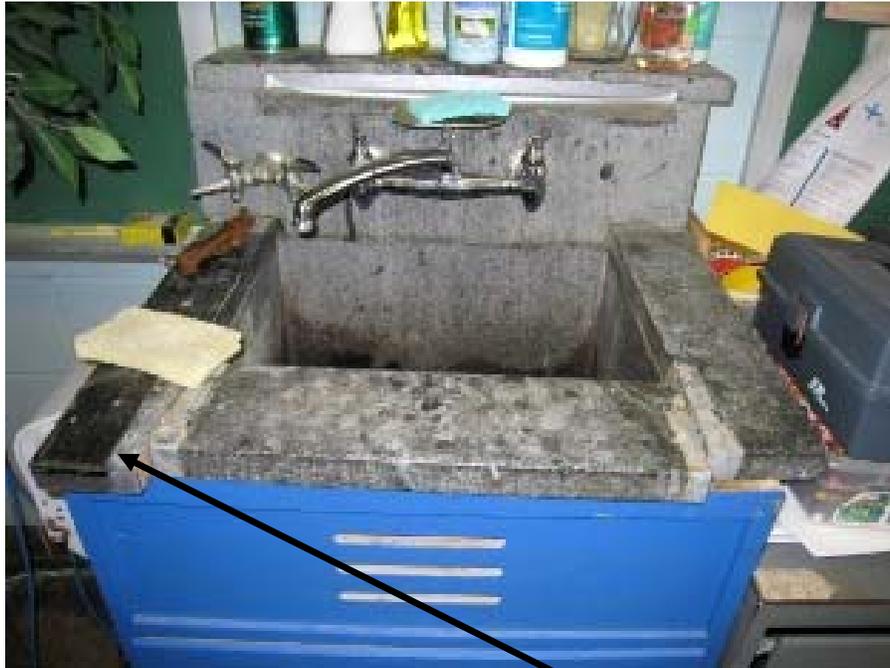
Picture 9

**Portion of Sink Top Made of Wood
Note Edges of Sink are not Secure**

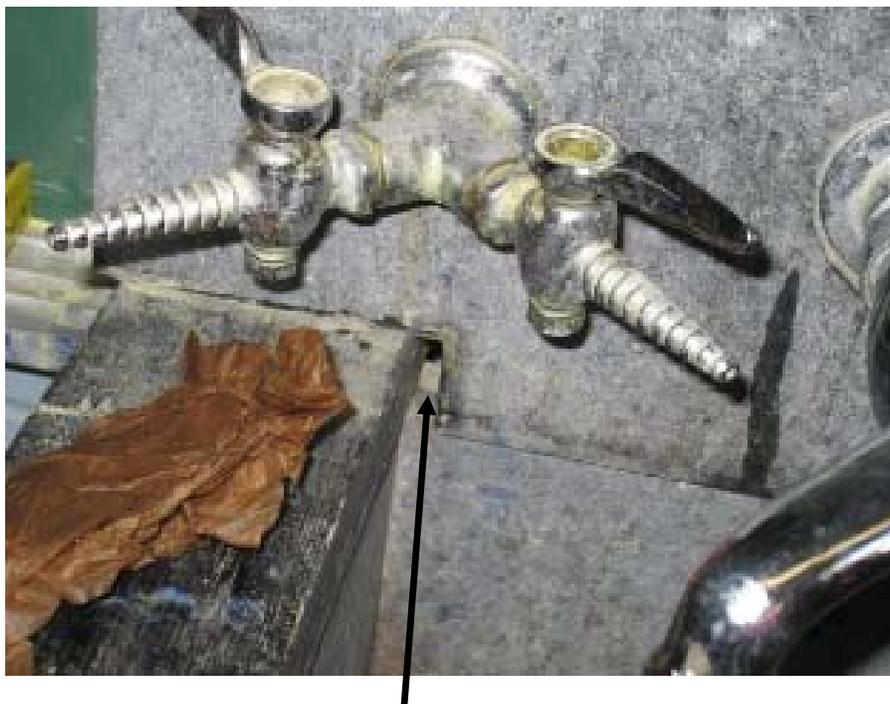
Picture 10

Sealant is Lacking on Portions of Sink

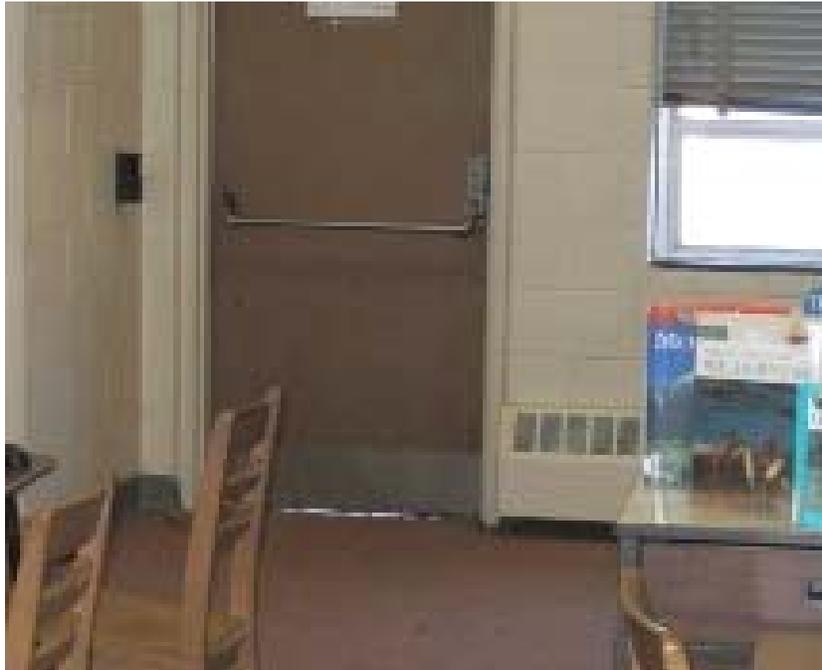
Picture 11

- Exterior doors exhibit gaps (Picture 11).
- The sealant around the perimeter façade of the building was failing (Picture 12), which can allow moisture, drafts as well as pests into the building. In fact, the soffit already exhibits evidence of water penetration (Picture 13).

Exterior Door Exhibits Gap

25. Eliminate gaps on all exterior doors by installing weather-stripping or door sweeps.
26. Repair failing/missing sealant on the perimeter façade of the building. Where visible, remove nesting materials.

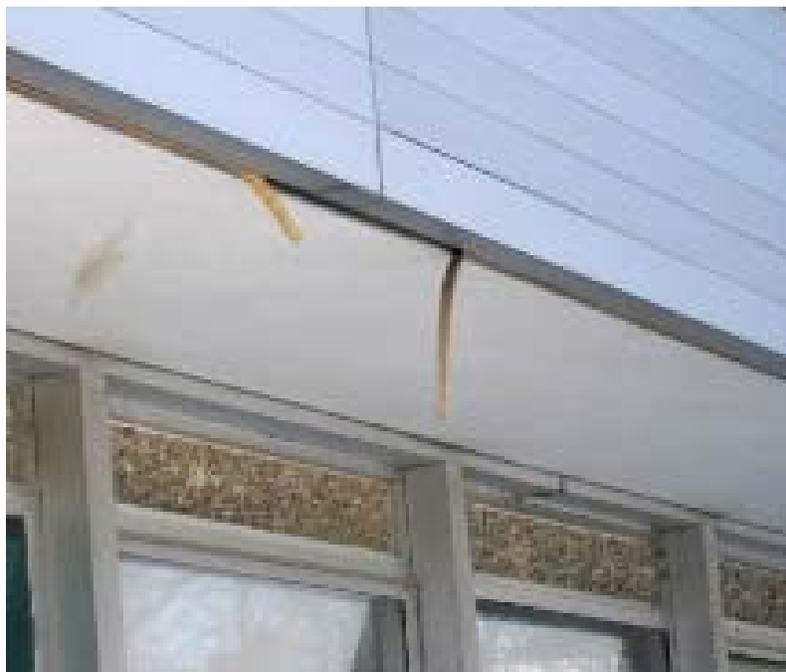
Picture 12

Sealant on Exterior Façade in Disrepair

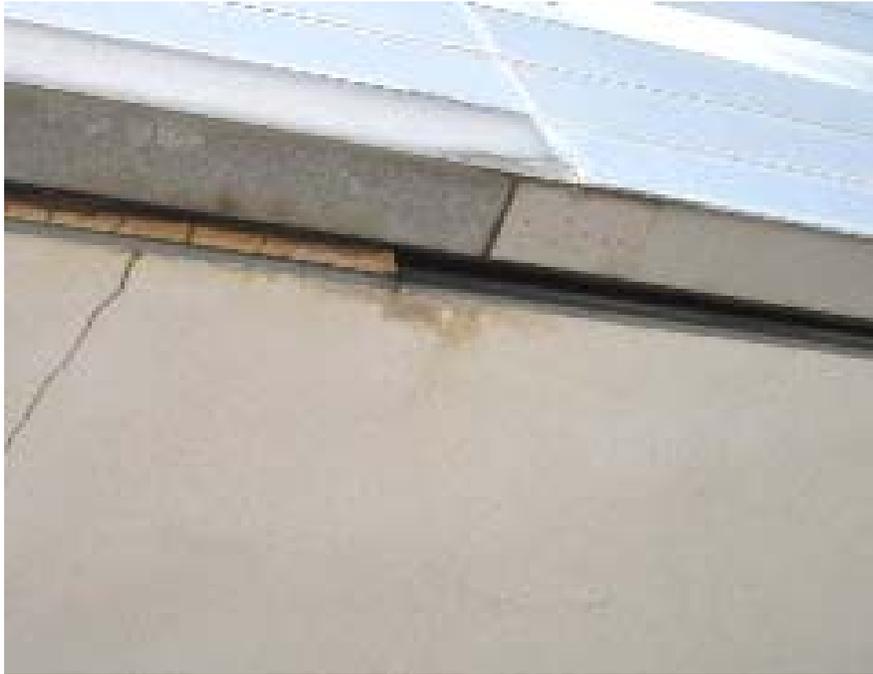
Picture 13

Missing Sealant, Note Water Damaged Soffit

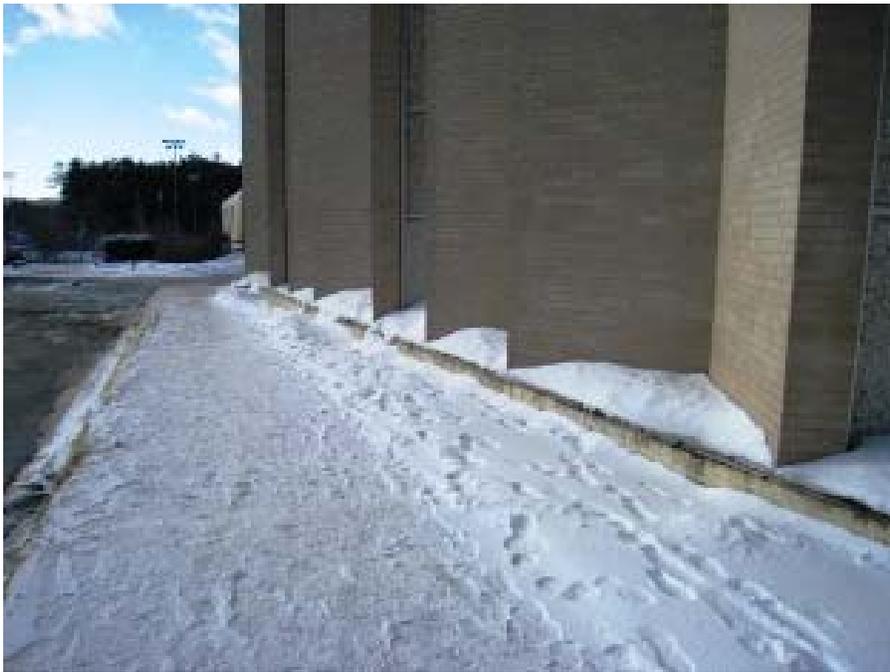
Picture 14

- The configuration of the exterior auditorium wall provides numerous corners in which snow and ice can accumulate during the winter months. It may also inhibit access to sun and wind, preventing these areas from drying as quickly as the exterior walls on the rest of the building. In addition, the sealant surrounding the decorative pebble-board in this area is deteriorated and missing in some areas, and is therefore allowing water to penetrate the building envelope (Pictures 14 & 15).

Snow Accumulation on Exterior of Auditorium

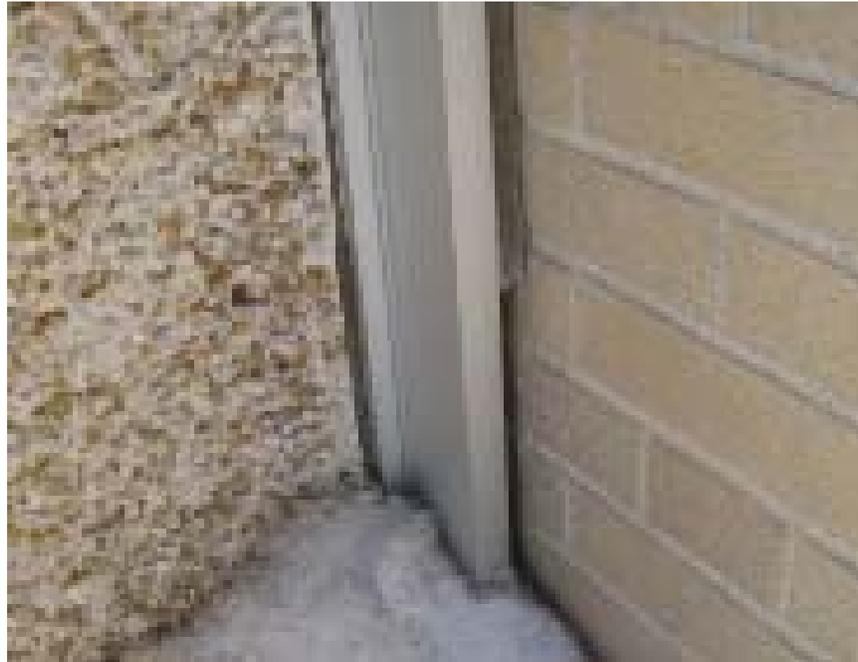
Picture 15

Missing Sealant Adjacent To Masonry

27. Repair missing sealant on pebble-board on the exterior of building.
28. Remove remaining wicks from weep holes in masonry.
29. Repair/Replace portable classroom window frames.

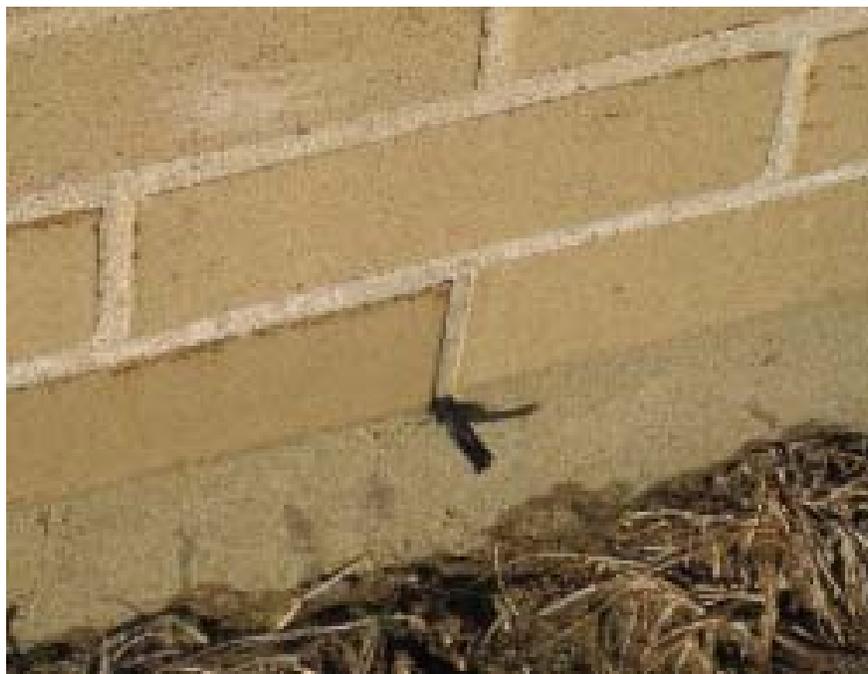
Picture 16

- Some weep holes exhibit wicks that were not functioning as intended (Picture 16). Wicks were originally installed to enhance water movement from the drainage plane. Over time, sediment accumulation turns the wick into a stopper, which prevents water drainage from the exterior wall system. “[Use of] ropes or tubes for weep [hole]s” is not recommended (Nelson, 1999). Without appropriate drainage, moisture can build up

inside the wall's drainage plane, resulting in increased water/moisture problems in the exterior wall.

Wick Protruding From Weep Hole in Masonry

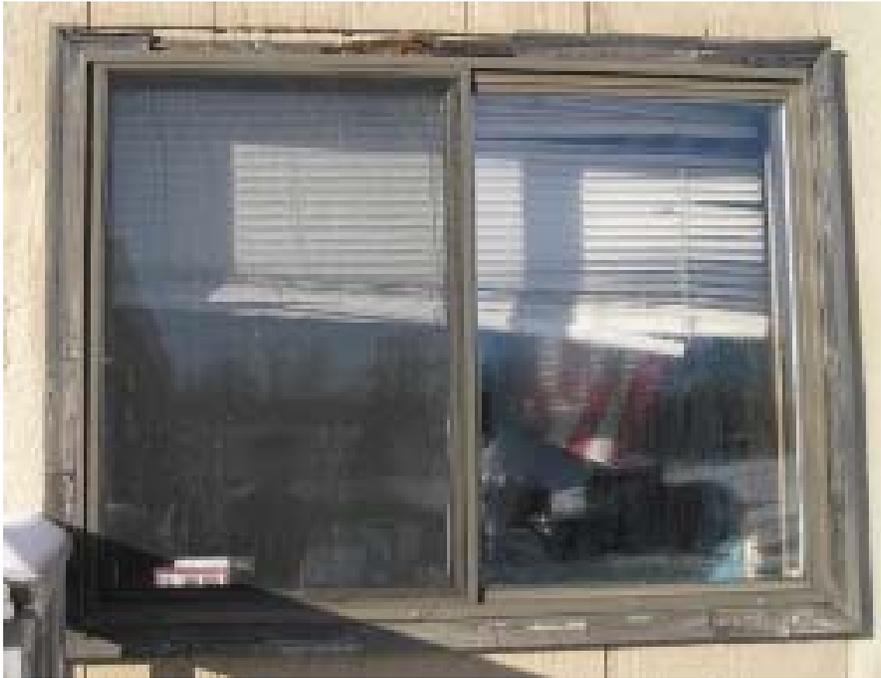
Picture 17

- Window casings exhibit water damaged/rotted components (Picture 17).
- Downspouts are missing in several areas, allowing water and ice to accumulate against the building (Picture 18).
- Snow was piled up against the portable classroom walls, causing moisture to have prolonged contact with the exterior building envelope.

Deteriorated Window Casing Portable Classrooms

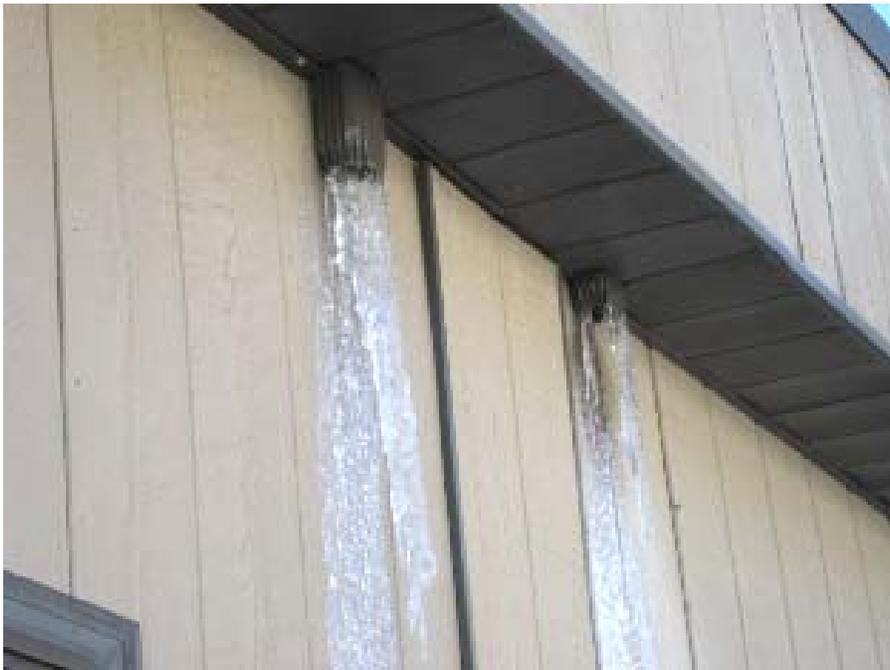
Picture 18

Missing Downspouts on Exterior of Portable Classrooms

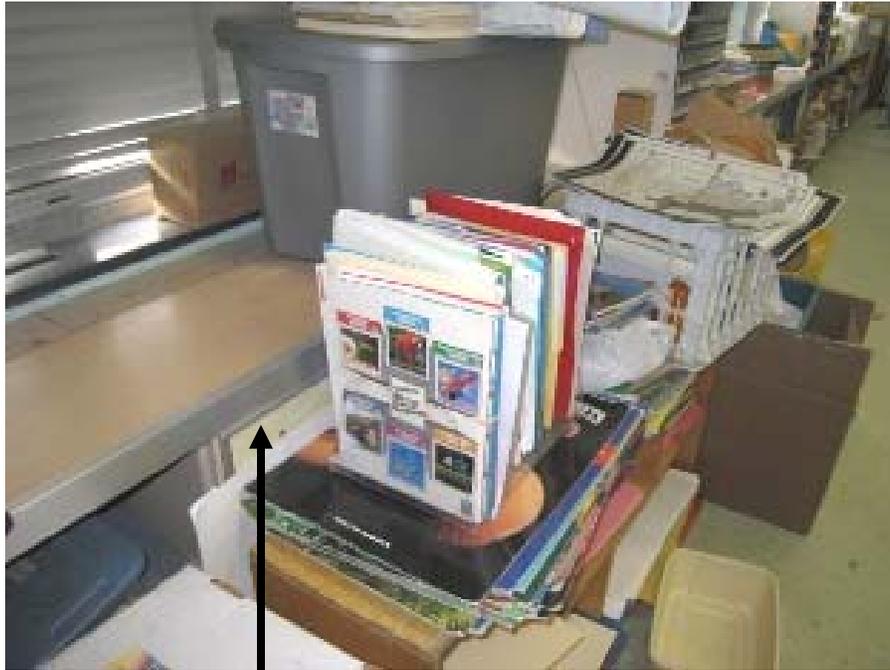
Picture 19

Other conditions that can affect indoor air quality were observed during the assessment. Numerous unit ventilators and exhausts were blocked by furniture, bookcases, posters and accumulated paper (Picture 19). Interior of the unit ventilators examined revealed accumulated dust and debris. In addition, the utility holes for univent plumbing were not sealed, which can draw unconditioned air, particulates and odors into the univent to subsequently be dispersed throughout the classroom.

Univent Exhaust Blocked by Bookcase

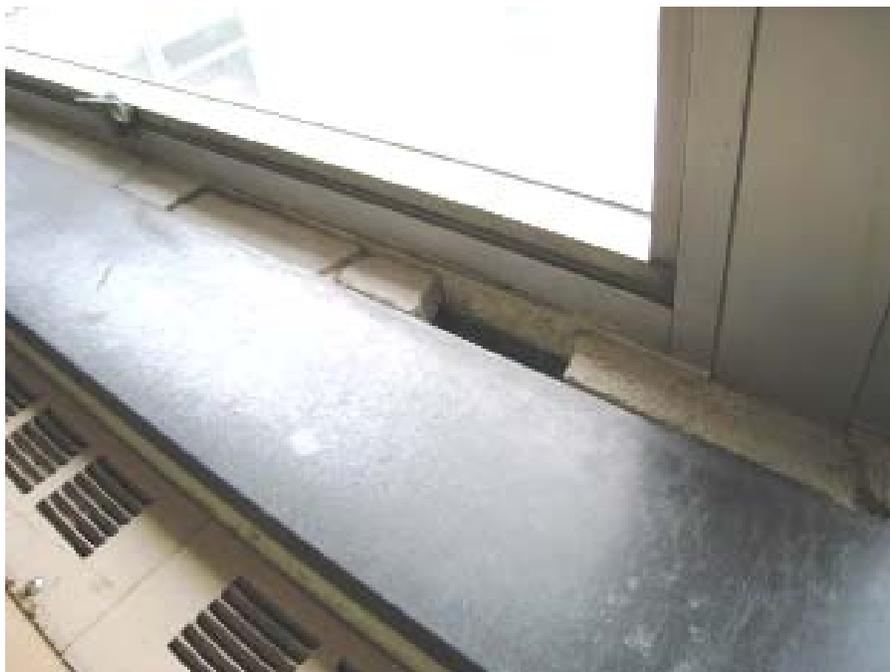
In several classrooms, cracked, broken and missing sections of what appeared to be concrete were observed adjacent to window frames exposing a large breach into the wall cavity (Picture 20). This condition allows unconditioned air to enter the classroom. The temperature of the air in one of these crevices was measured at 45°F on the day of the assessment. In addition to allowing unconditioned air to enter the space, these conditions may also allow odors, dusts and particulates to enter the room from the interior wall space and become distributed by the unit ventilator throughout the classroom.

Deteriorated Surface Adjacent to Window and Interior Sill

16. Repair broken surfaces adjacent to windows as seen in Picture 20 in classrooms and library.
17. Remediate peeling paint in girls' bathroom and if applicable in accordance with state lead laws.

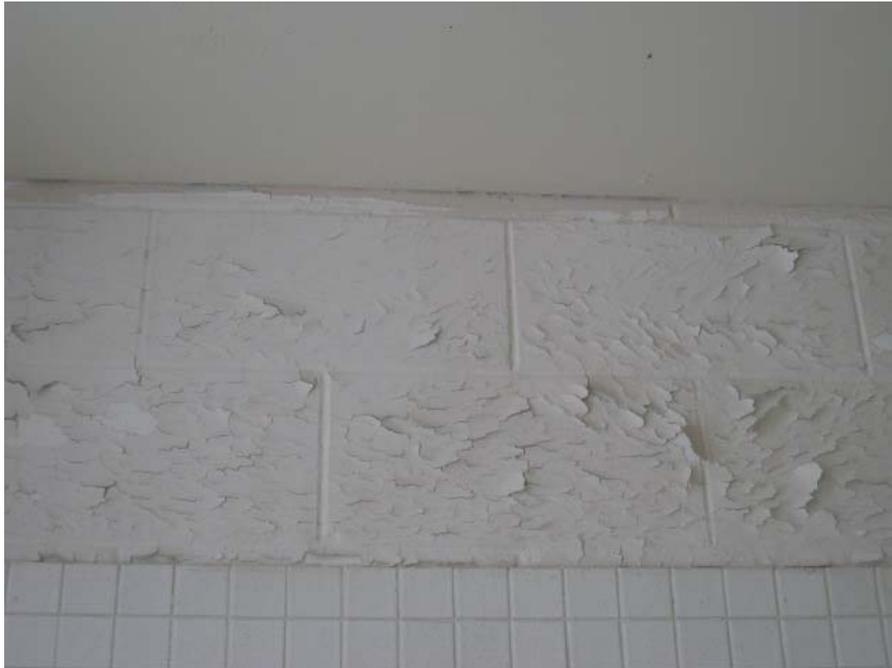
Picture 21

A moderate to heavy amount of peeling paint was observed on the bathroom walls (Picture 21). If the surface was painted with lead based paint, care must be taken to prepare and repaint the wall surface in compliance with state lead paint laws (105 CMR 460.000).

Peeling Paint in Bathroom

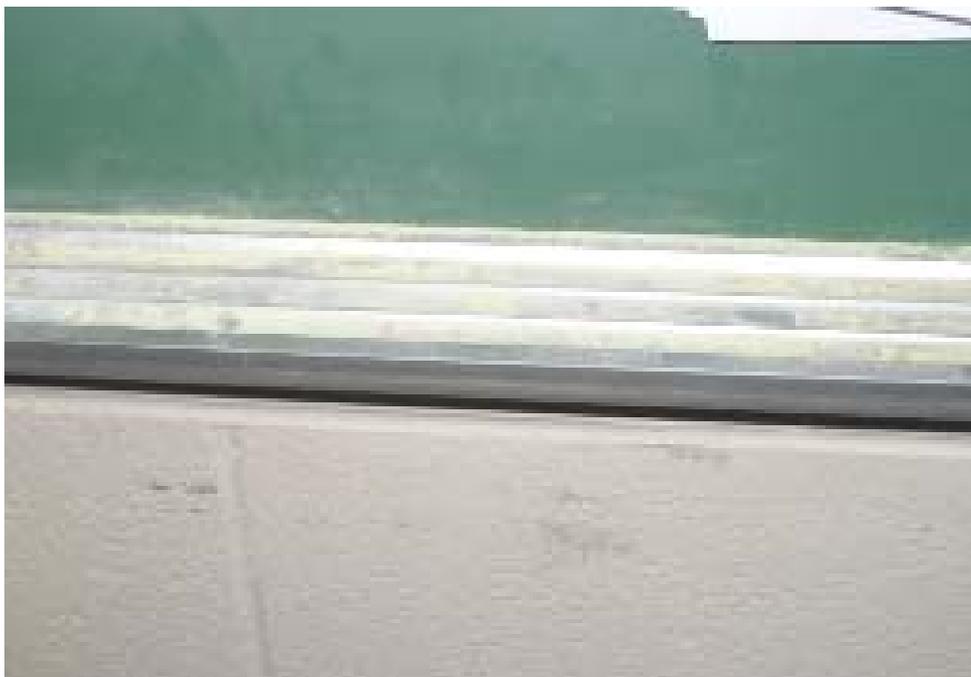
Picture 22

Accumulated chalk dust was noted in several classrooms (Picture 22). Chalk dust is a fine particulate, which can become easily aerosolized and serve as a source of eye and respiratory irritation.

Accumulated Chalk Dust

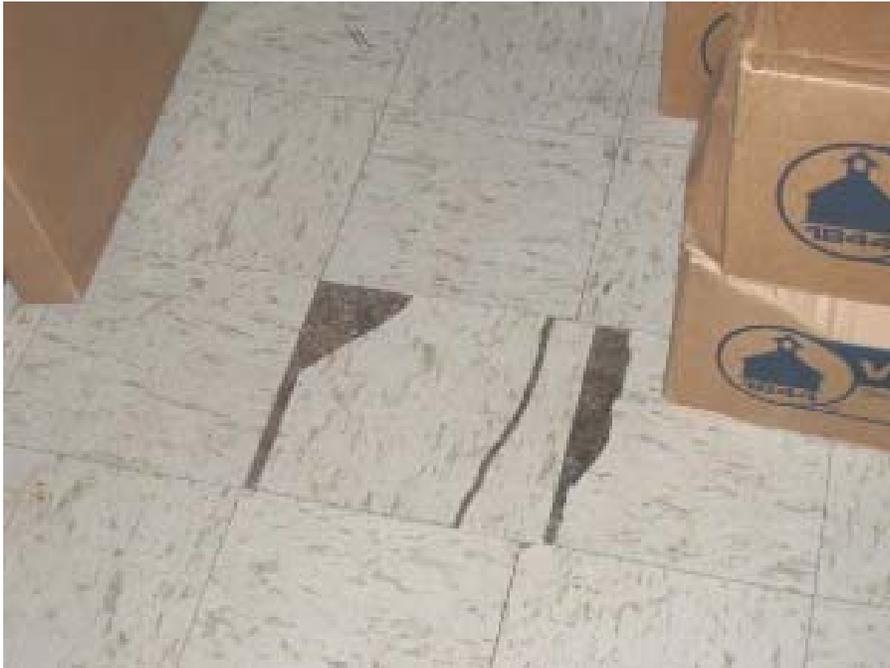
Picture 23

A number of areas throughout the school exhibited worn, cracked or broken floor tiles (Picture 23). These floor tiles may contain asbestos. Intact asbestos-containing materials do not pose a health hazard. If damaged, asbestos-containing materials can be rendered friable and become aerosolized. Friable asbestos is a chronic (long-term) health hazard, but will not produce acute (short-term) health effects (e.g., headaches) typically associated with buildings believed to have indoor air quality problems. Where asbestos-containing materials are found damaged, these materials should be removed or remediated in a manner consistent with Massachusetts asbestos remediation laws (MDLI, 1993).

Cracked, Broken Floor Tiles

15. Determine whether floor tiles in question contain asbestos. If so, remediate damaged floor tiles in conformance with Massachusetts asbestos remediation and hazardous waste disposal laws.

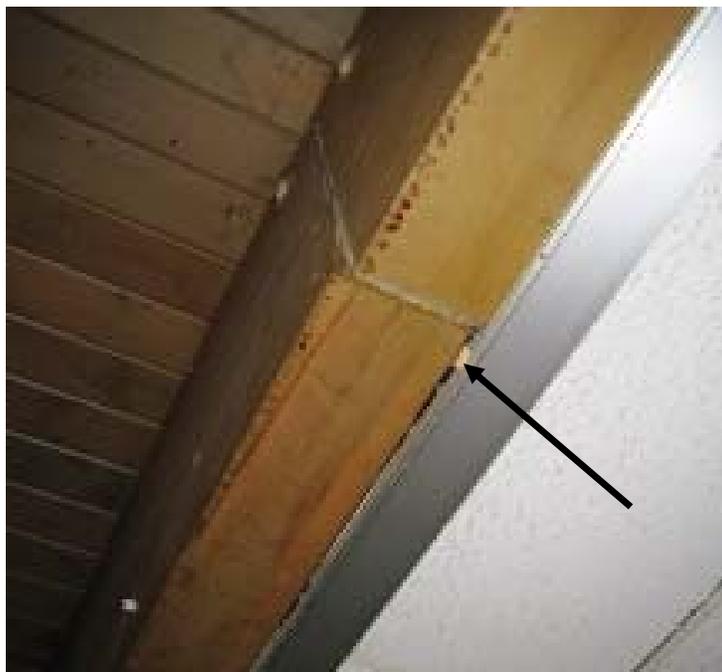
Picture 24

A wooden beam in the hallway appears to have shifted over time (Picture 24). This condition should be examined by a structural engineer to determine its integrity.

Wooden Beam Appears to Have Shifted

1. Consider establishing a schedule for replacement of carpets based on IICRC recommendations.
2. Considering the age, physical deterioration and availability of parts of the HVAC system, an evaluation by an HVAC engineering firm is strongly recommended for proper operation and/or repair/replacement of the ventilation systems.
3. Consider consulting a structural engineer regarding the integrity of the beam in Picture 23.

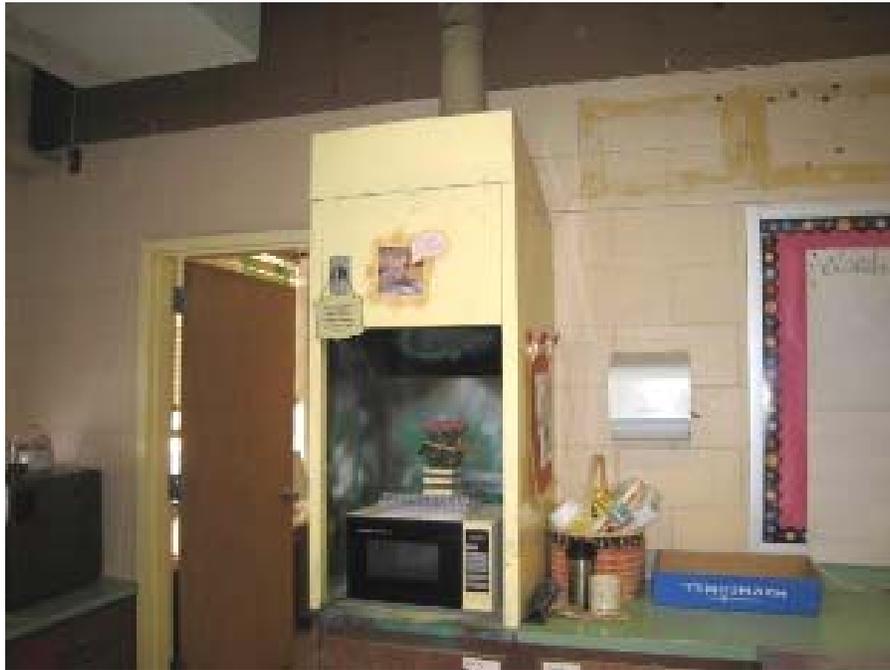
Picture 25

Finally, a former exhaust hood located in a classroom is currently being utilized for storage of a microwave oven. Unless the hood is equipped with a baffle or backflow prevention device, unconditioned air may be entering the classroom by means of the hood (Picture 25). This condition may cause dusts and particulates to aerosolize as the air enters the classroom.

Old Ventilation Hood Housing Microwave Oven

33. Examine the former exhaust hood to determine whether a baffle exists to prevent unconditioned air from back-drafting into the classroom. If none is found, consider sealing both ends of the hood.
