INDOOR AIR QUALITY ASSESSMENT

**Reingold Elementary School
70 Reingold Avenue
Fitchburg, Massachusetts**

Prepared by:
Massachusetts Department of Public Health
Bureau of Environmental Health
Indoor Air Quality Program
September 2009

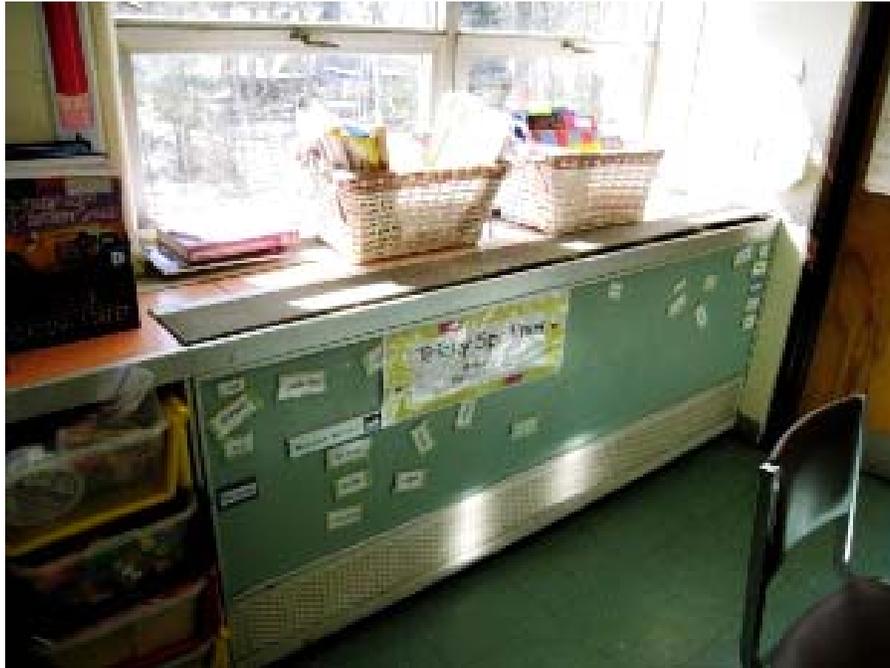
Picture 1

Fresh air in most classrooms is supplied by wall or ceiling mounted unit ventilator (univent) systems (Picture 1). A univent draws air from the outdoors through a fresh air intake located on the exterior wall of the building and returns air through an air intake located at the base of the unit. Fresh and return air are mixed, filtered, heated and provided to classrooms through an air diffuser located in the top of the unit ([Figure 1](#)).

Both univents and univent exhaust systems appear to have been installed at the time the building was constructed in the late 1960’s, which makes them approximately 40 years old. Mechanical ventilation units of this age can be difficult to maintain because replacement parts are often unavailable.

Unit Ventilator Circa Late 1960's

5. Contract with a ventilation engineer to inspect AHUs, UVs as well as unit exhaust ventilators for proper function. Repair or replace components as necessary to ensure adequate air supply and exhaust capability throughout the school’s classrooms, offices and common areas.

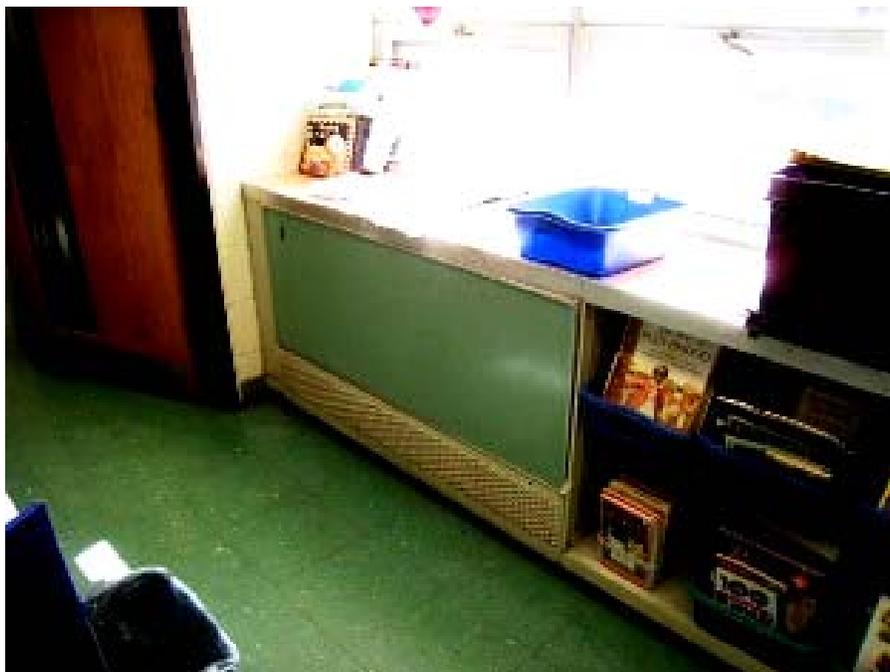
Picture 2

Classroom exhaust ventilation is provided by unit exhaust ventilators (Picture 2). A unit exhaust ventilator appears similar to a univent, but removes air from the classroom and exhausts it out of the building. Many univents and exhausts were deactivated/not-functioning during the assessment. In addition, a number of both univent and exhaust units were obstructed by furniture, bookcases, paper and supplies (Pictures 3 & 4). Without proper supply and exhaust

Unit Exhaust Ventilator Circa Late 1960's

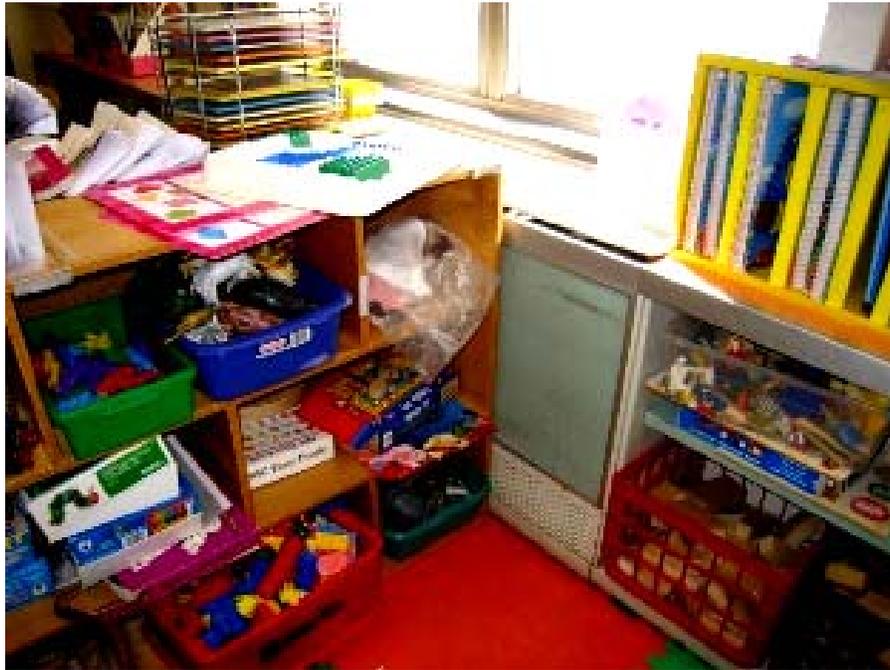
Picture 3

Unit Ventilator Obstructed by Bookcase and Classroom Supplies

ventilation, environmental pollutants can build up in the indoor environment and lead to indoor air quality complaints. In order for univents and exhausts to function as designed, air diffusers, intakes/vents must remain free of obstructions. Importantly, these units must remain “on” and be allowed to operate while rooms are occupied.

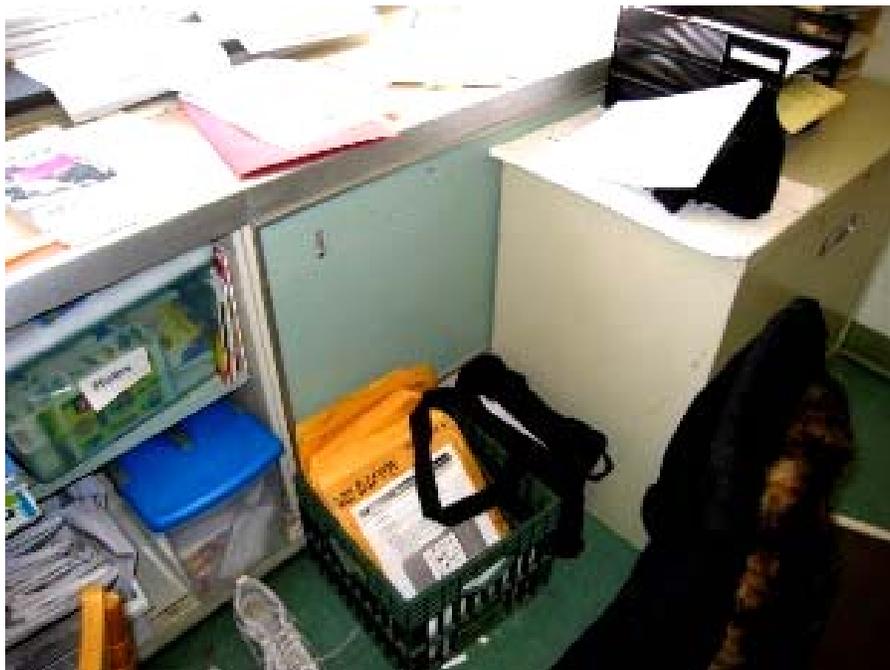
Picture 4

Exhaust Obstructed by Filing Cabinet and Other Items

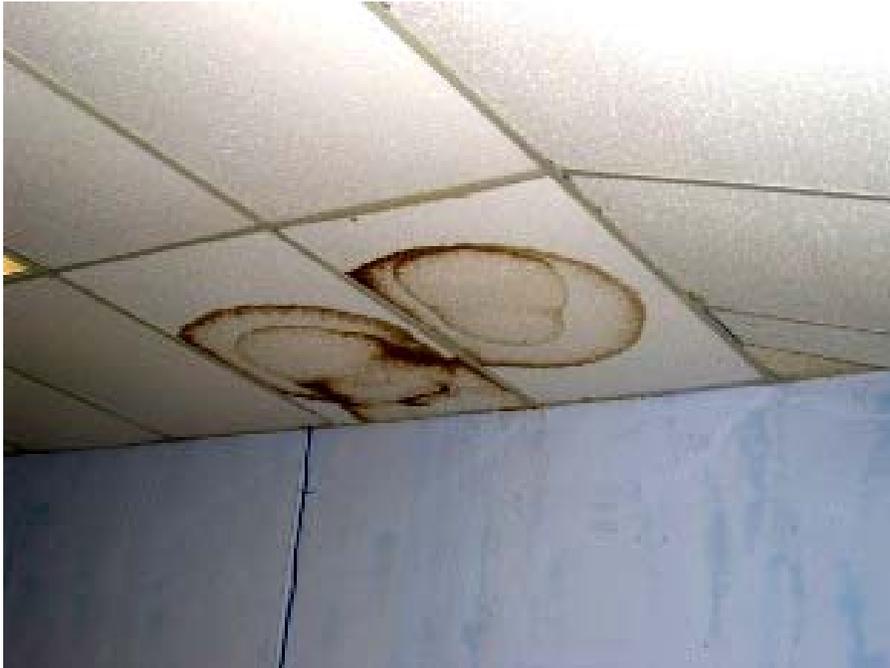
Picture 5

Several potential sources of water damage and/or mold growth were observed during the assessment. Water damaged ceiling tiles were observed in classrooms as well as in hallways on both levels of RES and in the portable classroom (Table 1/Picture 5). Water-damaged ceiling tiles can provide a source of mold growth and should be replaced after a water leak is discovered and repaired.

Water Damaged Ceiling Tiles

8. Restore exhaust ventilation in restrooms to remove odors and moisture, make repairs as necessary.
9. Ensure leaks are repaired and replace water damaged ceiling tiles. Examine the area above and around these areas for mold growth. Disinfect areas of water leaks with an appropriate antimicrobial.

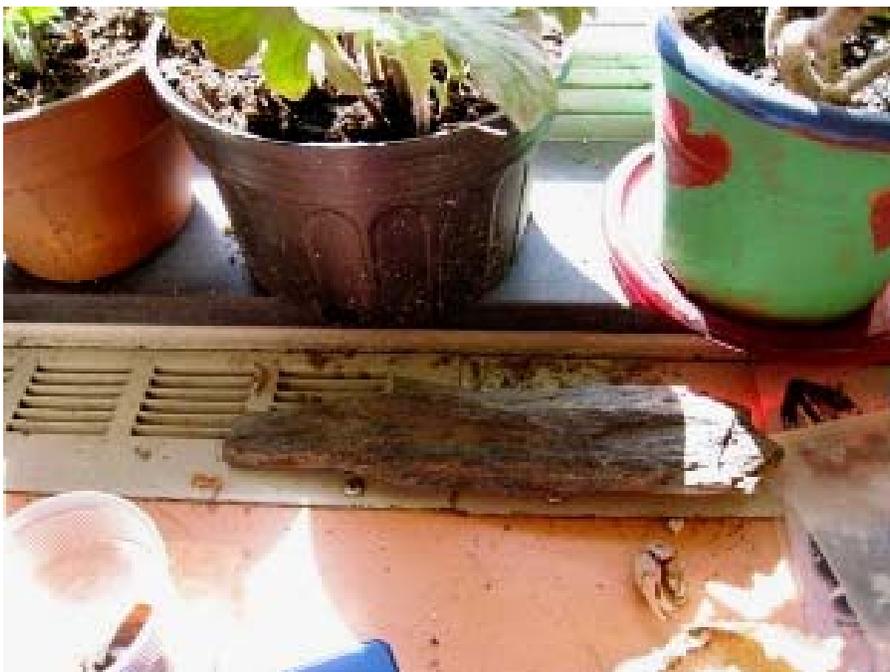
Picture 6

Plant soil and drip pans can serve as a source of mold growth. A number of plants were observed without drip pans (Picture 6). Plants should be properly maintained and be equipped with drip pans. Plants should also be located away from the air stream of mechanical ventilation to prevent aerosolization of dirt, pollen or mold. Additionally, the counter surface adjacent to some of the plants exhibited soil accumulation.

**Plants on Window Sill
Note Soil Accumulation**

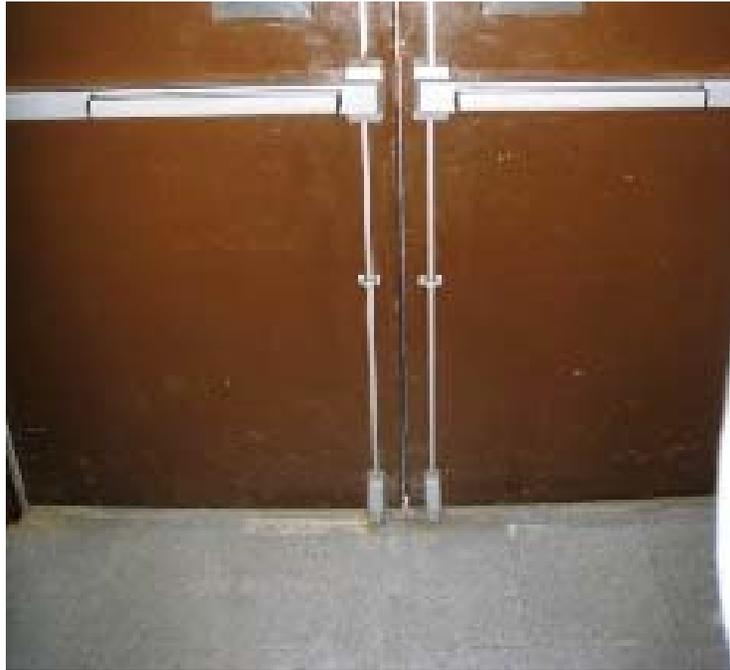
Picture 7

- Exterior doors near portable classroom exhibited gaps to the outdoors (Picture 7). The interior side of the door revealed buckled floor tiles, likely due to water penetration.

**Gap in Exterior Door
Note buckled Floor Tiles**

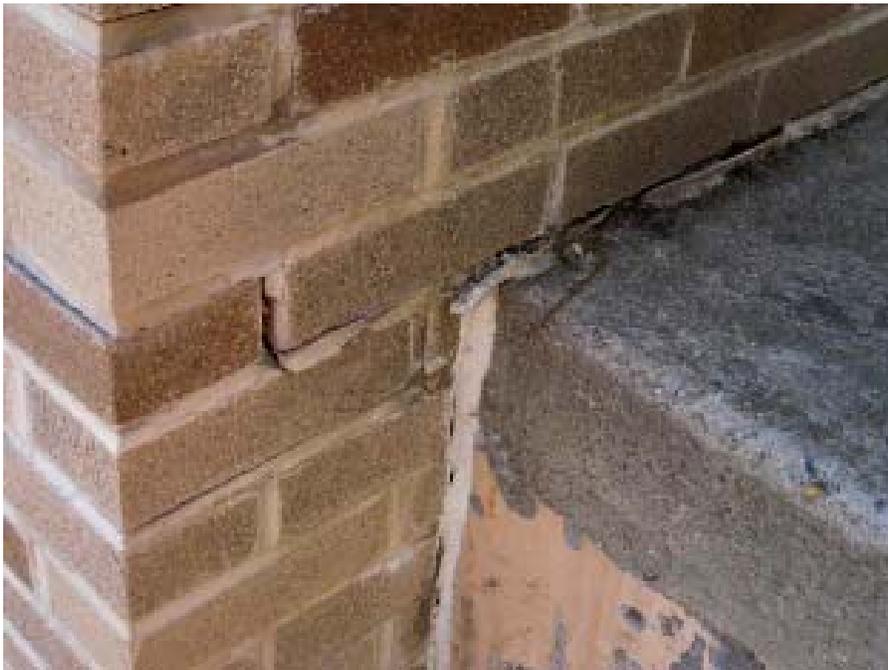
Picture 8

- Mortar was cracked and missing around exterior brick (Picture 8).
- Sealant was observed to have deteriorated (Picture 8).
- Moss was also observed at the base of the building (Picture 9). The presence of moss on exterior brick is indicative of repeated water exposure. “The two main requirements of moss are sufficient moisture and accessible nutrients. For example, the moist environment of a rooftop shaded by trees is just fine for mosses, [which] prefer to colonize shingles above the eaves, on detritus that builds up in the eaves' troughs or other depressions. Mosses will be at their best in the winter when there is plenty of water, little light, and low temperatures” (OSU, 2000).

Cracked, Missing Mortar and Deteriorated Sealant

26. Repair or replace deteriorated sealant on the exterior of the building.
27. All plants in contact with the foundation or walls of the RES should be either trimmed or removed. Cut shrubbery in a manner to maintain a space of five feet from the building.

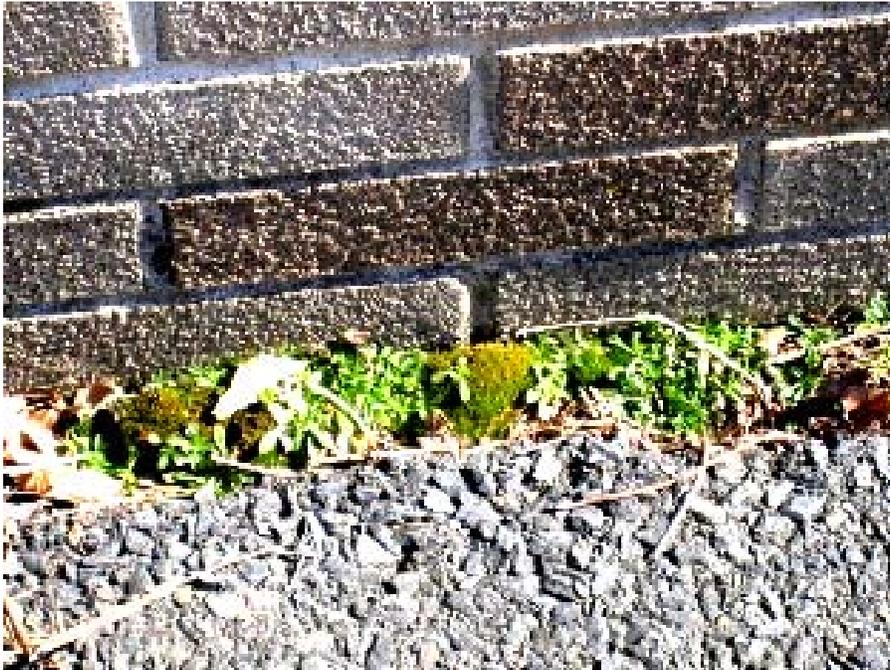
Picture 9

Moss and Plant Growth at Base of Building

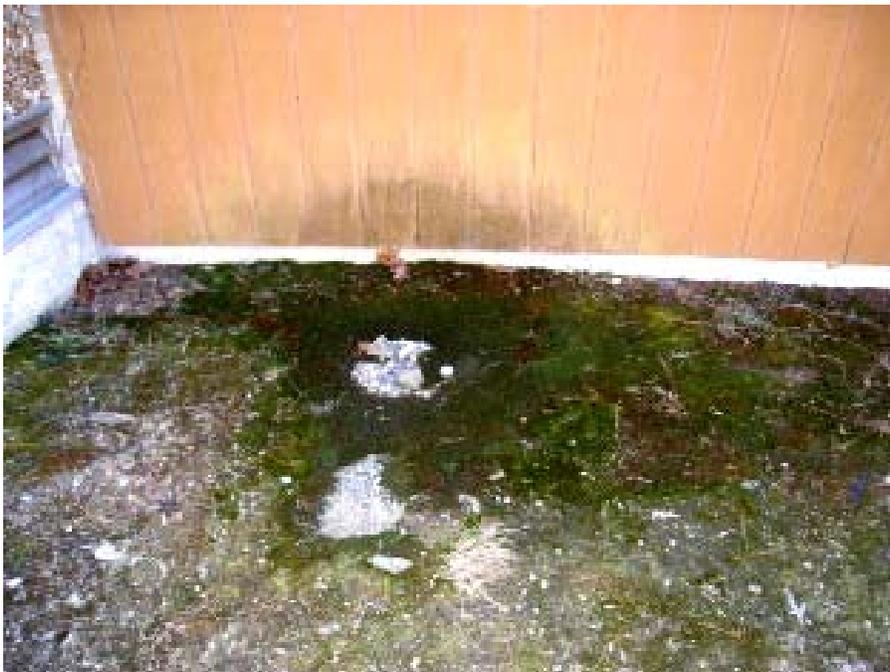
Picture 10

- Warped, water damaged vertical siding was observed on the portable classroom. Moss was observed on portions of siding as well (Picture 10). Additionally, the foundation of the portable classroom was damaged.

Vertical Siding Subject to Moisture/Staining/Moss Growth

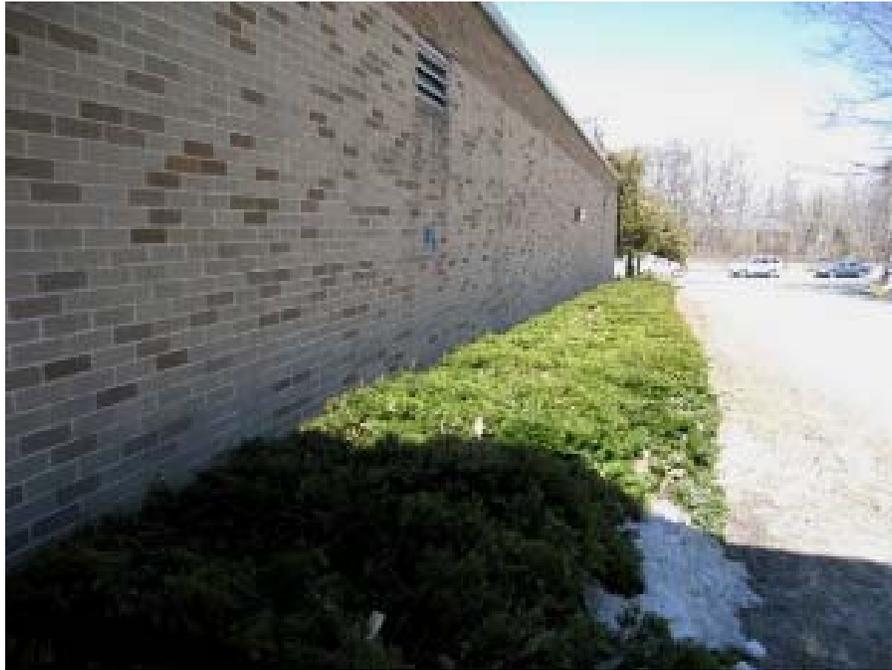
Picture 11

- Trees, shrubs and plants were observed to be growing in close proximity to the building (Pictures 11 & 12). The growth of roots against exterior walls can bring moisture in contact with the foundation. Plant roots can eventually penetrate, leading to cracks and/or fissures in the sublevel foundation.

Plants Adjacent to Building

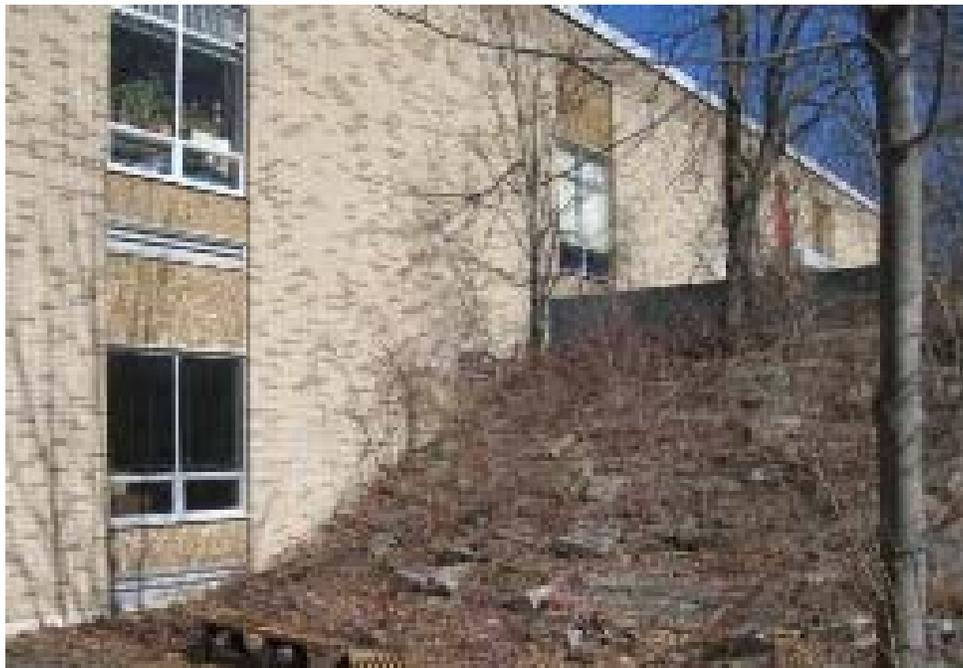
Picture 12

Brush Adjacent to Building

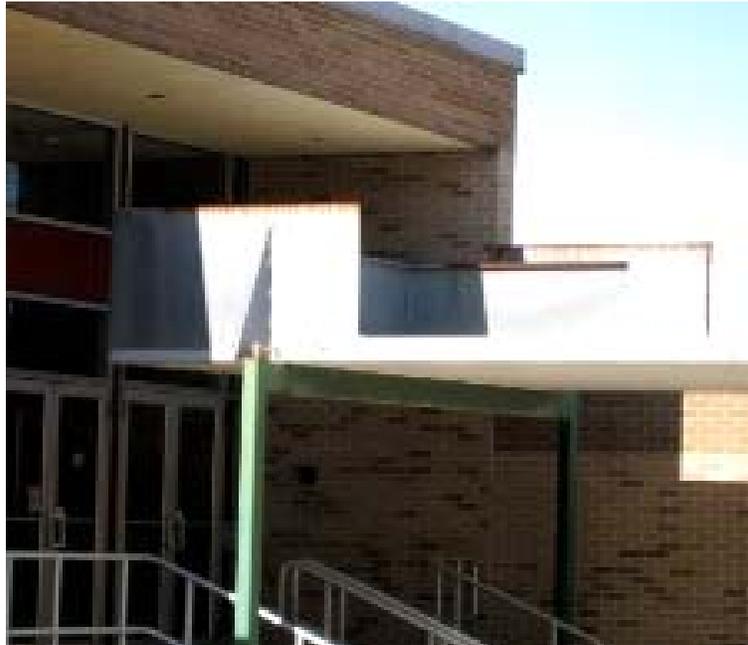
Picture 13

- One portion of the roof observed above the front stairway had a temporary drainage system designed out of sheet metal, which was likely installed to eliminate rainwater from pouring onto individuals as they walk up the stairway to enter the school (Picture 13). A well-designed gutter and downspout system would provide more protection and would also be likely to deposit the rainwater further away from the building.

Temporary Drainage System above Stairway

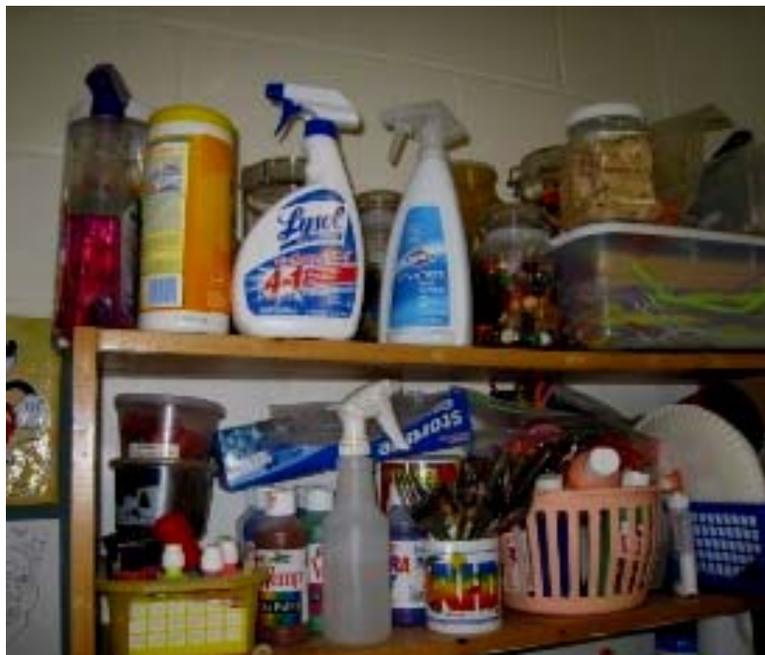
Picture 14

Air fresheners, reed diffusers, deodorizing materials and cleaning products were observed in several areas, some within reach of children (Picture 14). Air deodorizers contain chemicals that can be irritating to the eyes, nose and throat of sensitive individuals. Many air fresheners contain 1,4-dichlorobenzene, a VOC which may cause reductions in lung function (NIH, 2006). Furthermore, deodorizing agents do not remove materials causing odors, but rather mask odors that may be present in the area. Cleaning products and an unlabeled spray bottle containing a clear liquid was also observed during the assessment. All products should be stored in properly labeled containers and out of the reach of children. Additionally, Material Safety Data Sheets (MSDS) for all cleaning products used within RES must be stored in a central location and must be accessible to all individuals during periods of building operations in the event of an emergency as required by the Massachusetts Right-To-Know Act (MGL, 1983).

**Numerous Cleaning Product Stored in Classroom
Note Unlabeled Spray Bottle**

20. Eliminate air fresheners and reed diffusers.
21. Replace latex-based tennis balls with latex-free tennis balls or alternative “glides”.
22. Professionally clean upholstered furniture annually or more frequently as needed.

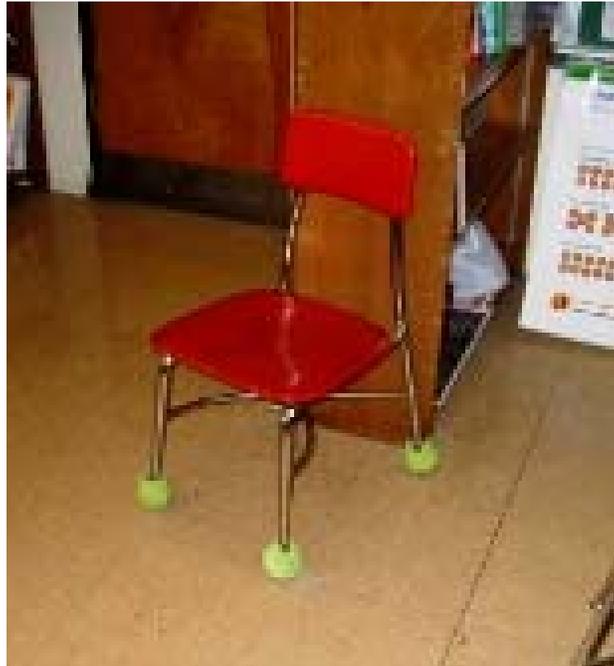
Picture 15

In an effort to reduce noise from sliding chairs and tables, tennis balls were sliced open and placed on chair legs in some classrooms (Picture 15). Tennis balls are made of a number of materials that are a source of respiratory irritants. Constant wearing of tennis balls can produce fibers and off-gas VOCs. Tennis balls are made with a natural rubber latex bladder, which becomes abraded when used as a chair leg pad. Use of tennis balls in this manner may introduce latex dust into the school environment. Some individuals are highly allergic to latex (e.g. spina bifida patients) (SBAA, 2001). It is recommended that the use of materials containing latex be limited in buildings to reduce the likelihood of symptoms in sensitive individuals (NIOSH, 1997). A question and answer sheet concerning latex allergy is attached as [Appendix B](#) (NIOSH, 1998).

Tennis Balls on Chair Legs

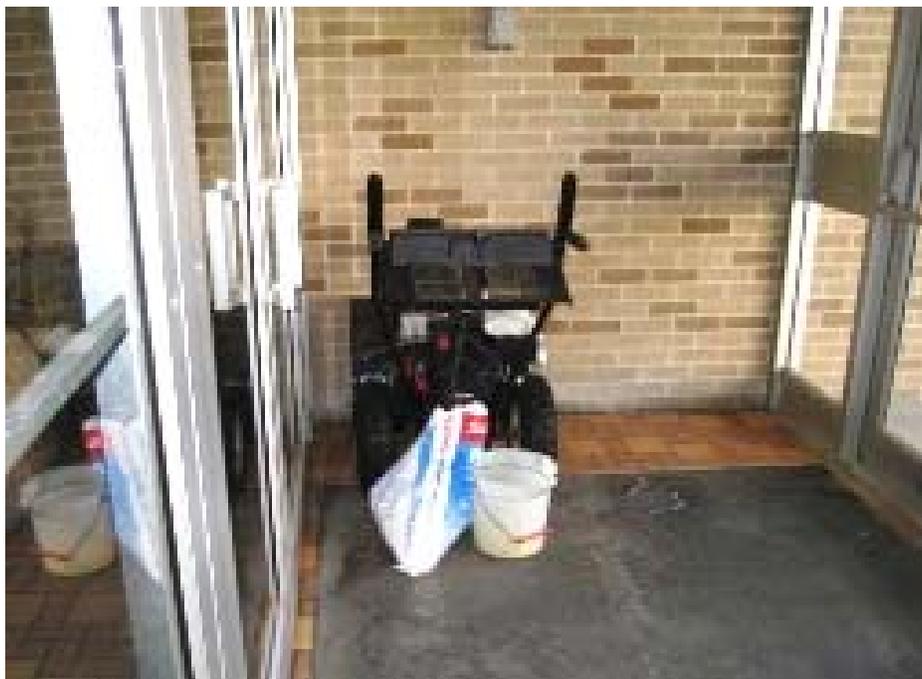
Picture 16

A snow-blower was observed stored in the front foyer of the main entrance (Picture 16). Odors and off-gassing of VOCs from gasoline can have an adverse effect on indoor air quality. In addition, storing gas-powered equipment indoors may be a fire hazard.

Snow-Blower Stored in Foyer

13. Eliminate sources of food from within classrooms.
14. Discontinue practice of storing snow blower within the building.
15. Clean personal fans, air diffusers, exhaust, return vents and adjacent ceiling tiles periodically of accumulated dust. If soiled ceiling tiles cannot be cleaned, they should be replaced.

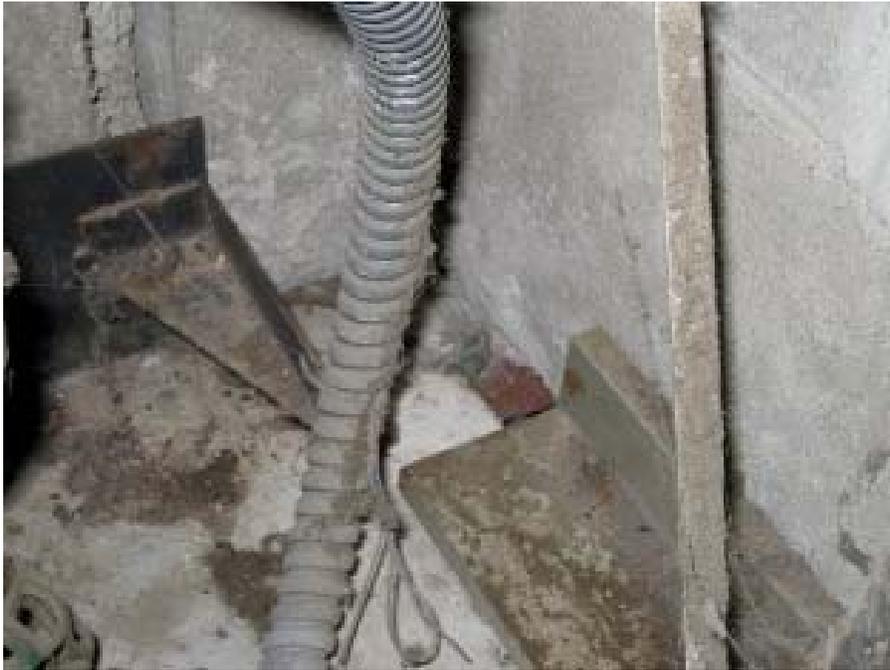
Picture 17

Other conditions that can affect indoor air quality were observed during the assessment. A number of unit ventilators were opened and examined during the assessment. Dust/debris accumulation was observed on the interior of these units. Spaces around pipes were noted within all univent cabinet interiors surveyed. Additionally, a large hole was observed in the floor of one of the units. Open spaces around pipes and within these cabinets can serve as pathways for dust, dirt, odors and other pollutants to move from the floor/wall cavities into occupied areas during the operation of univents (Picture 17).

Hole at Wall/Floor Junction into Wall Cavity

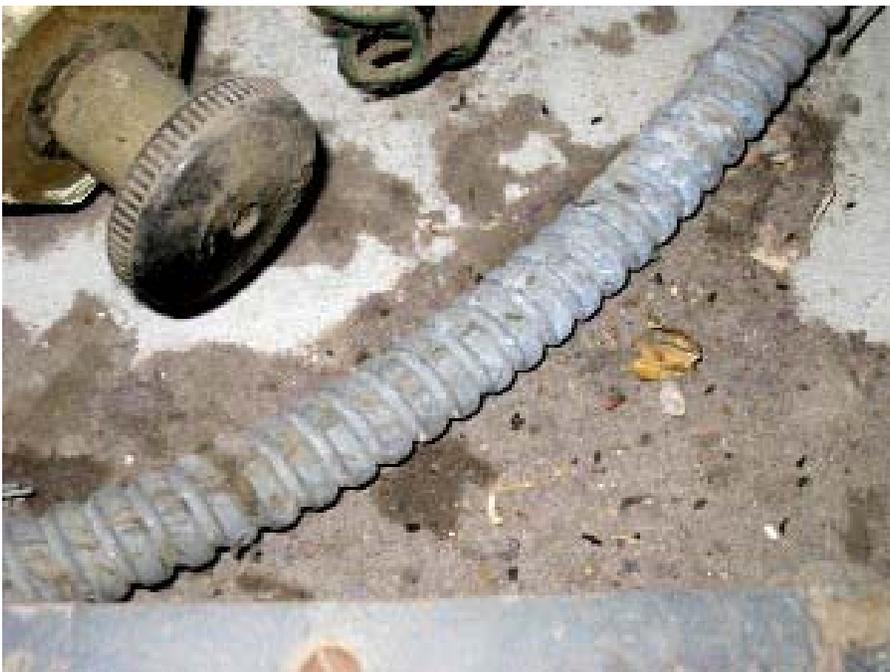
Picture 18

Of note was an accumulation of rodent droppings within some univents (Picture 18). To penetrate the exterior of a building, rodents require a minimal breach of ¼ inch (MDFA, 1996). As previously mentioned, spaces on exterior doors, on masonry, as well as spaces within the univent cabinets themselves were noted during the assessment, each of which would be sufficient to allow rodents to enter and travel within the building. Rodent infestation results from easy access to food and water in a building. Evidence of food sources included numerous food products stored in classrooms (Picture 19). In addition, many classrooms contain refrigerators, microwaves and numerous small appliances (Picture 20). Rodent infestation can result in indoor air quality related symptoms due to materials in their wastes. Mouse urine contains a protein that is a known sensitizer (US EPA, 1992). A three-step approach is necessary to eliminate rodent infestation:

Rodent Droppings (as Indicated by Dark Spots) on Floor of Unit Ventilator

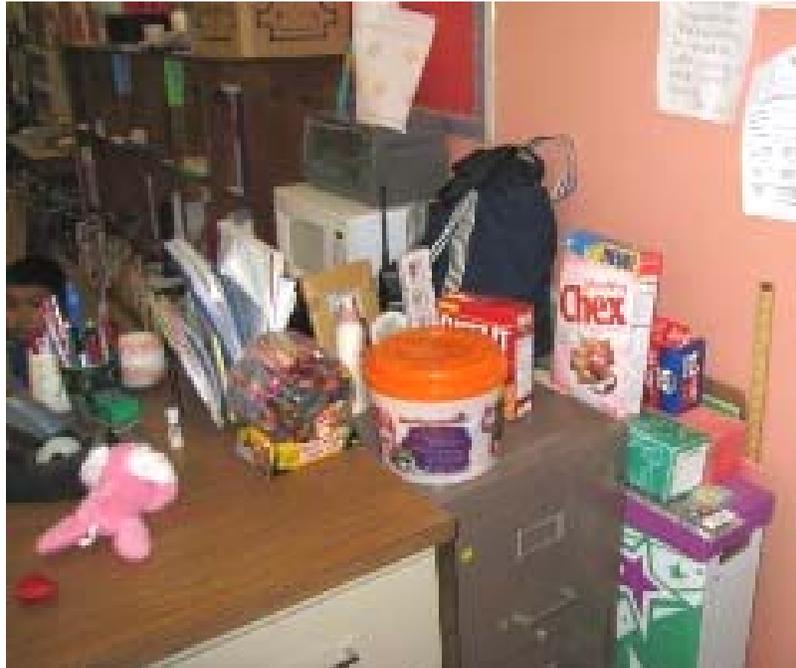
Picture 19

Food Products Stored in Classroom

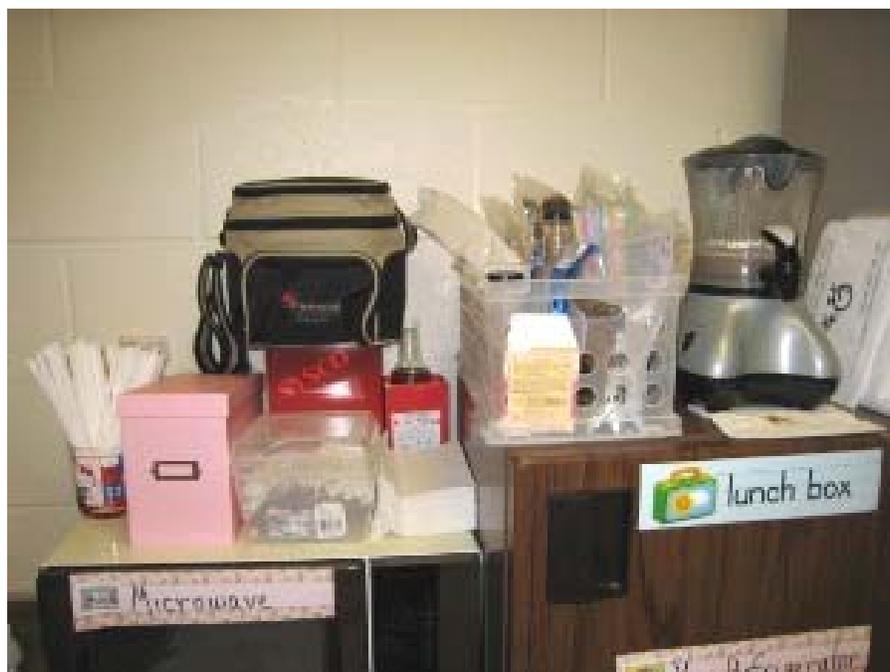
Picture 20

Small Appliances in Classroom

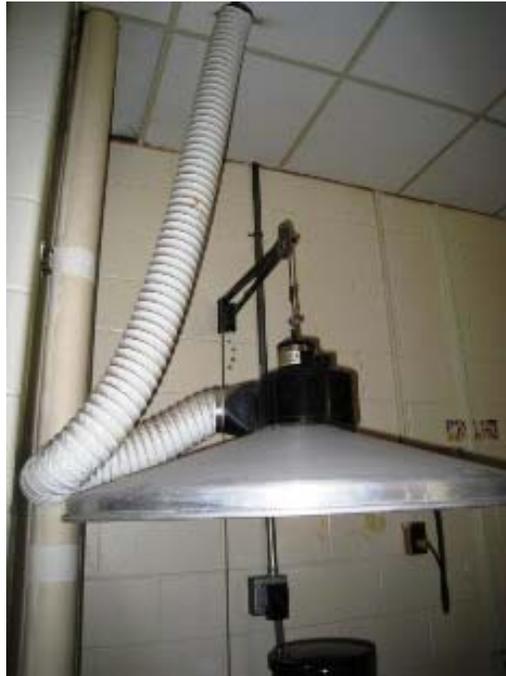
Picture 21

A kiln was observed in the art room. BEH was informed that the kiln was not currently in use. A ribbed plastic hose commonly utilized for dryer vents was being utilized as a duct for the kiln vent (Picture 21). These hoses puncture easily and may not be as temperature resistant as the duct materials frequently in use today. Prior to its use, it was recommended that the kiln be fitted with an appropriately constructed, fire resistant, dedicated exhaust system.

Plastic Vent Hose for Kiln

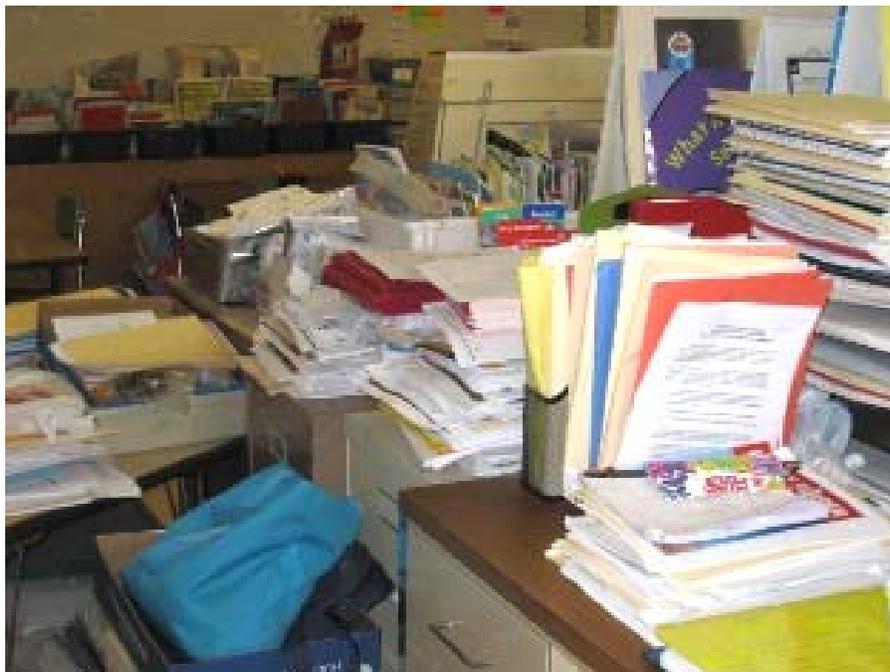
Picture 22

In several classrooms, items were observed on the floor, windowsills, tabletops, counters, bookcases and desks (Picture 22). Clutter was also observed in the hallways between classrooms in some areas as well. Some of these storage areas actually blocked exterior doors meant to be used as a second means of egress (Picture 23). In addition to posing a fire hazard, the large number of items stored in classrooms and hallways provides a source for dusts to accumulate. Once dusts accumulate, they can be subsequently re-aerosolized causing further irritation. These items (e.g., papers, folders, boxes) also make it difficult for custodial staff to clean. Items should be relocated and/or be cleaned periodically to avoid excessive dust build up.

Paper and Accumulation Materials in Classroom

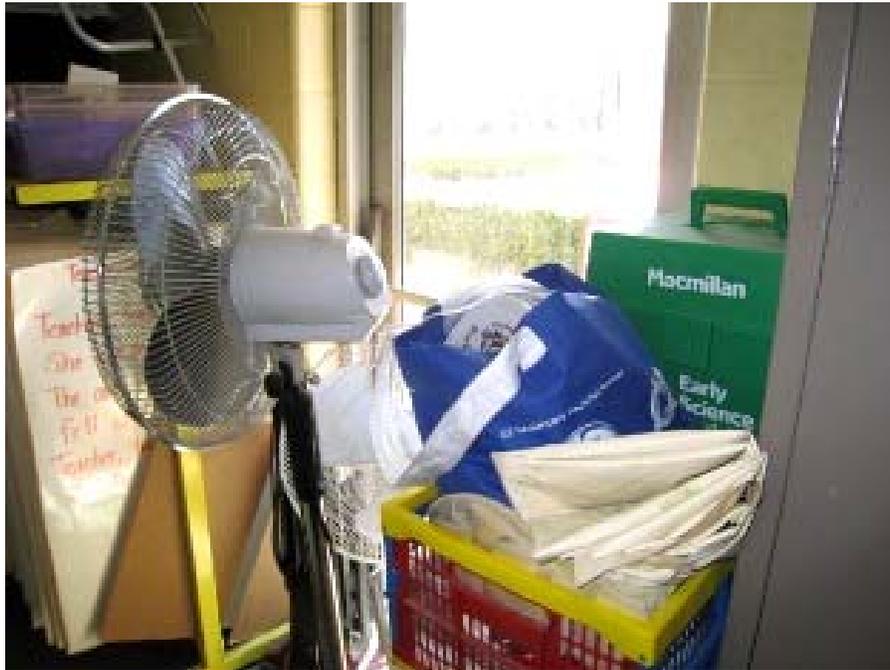
Picture 23

**Clutter Stored in Hallway between Classrooms
Note Obstructed Exterior Door**
