# **INDOOR AIR QUALITY ASSESSMENT**

**Marblehead High School  
2 Humphrey Street  
Marblehead, Massachusetts**

Prepared by:  
Massachusetts Department of Public Health  
Bureau of Environmental Health  
Indoor Air Quality Program  
September 2009

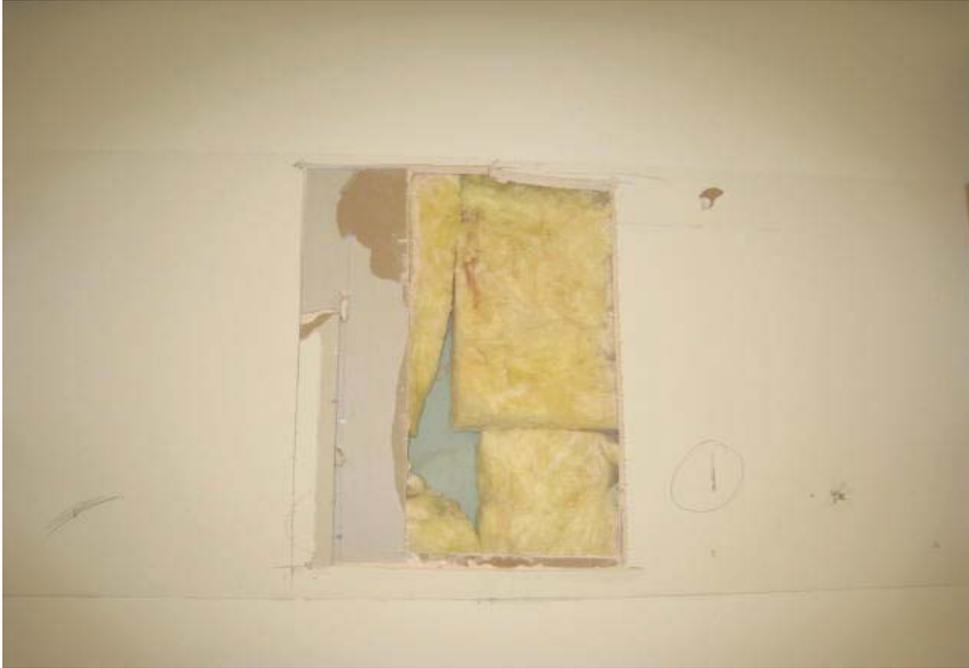
**Picture 1**

As mentioned, room B-215 became water damaged as a result of a roof leak in October of 2008. The leak caused water damage and moistening of walls and insulation (Picture 1). At the time of the DPH assessment, historic water damage from an air conditioning leak in 2006 in

In an effort to determine moisture content of water-damaged ceiling materials in room B-215, moisture content was measured with a Delmhorst Moisture Detector equipped with a Delmhorst Standard Probe. The Delmhorst probe is equipped with three lights that function as visual aids that indicate moisture level. Readings that activate the green light indicate a sufficiently dry or low moisture level, those that activate the yellow light indicate borderline conditions, and those that activate the red light indicate elevated moisture content. No elevated moisture readings were measured in the remaining insulation or in the wall behind the insulation during the assessment. Nor were any mold growth or associated odors detected.

**Insulation in Room B-215**

1. Ensure leaks are repaired and replace any remaining water damaged materials (e.g., ceiling tiles, insulation).
2. Continue to monitor both Room B-215 and the AHU in the adjacent hallway for prompt action if leaks recur.
3. If leaks recur in the AHU, the unit should be examined by an HVAC engineering firm for proper function.
4. Consult “Mold Remediation in Schools and Commercial Buildings” published by the U.S. Environmental Protection Agency (U.S. EPA, 2001) for more information on mold.

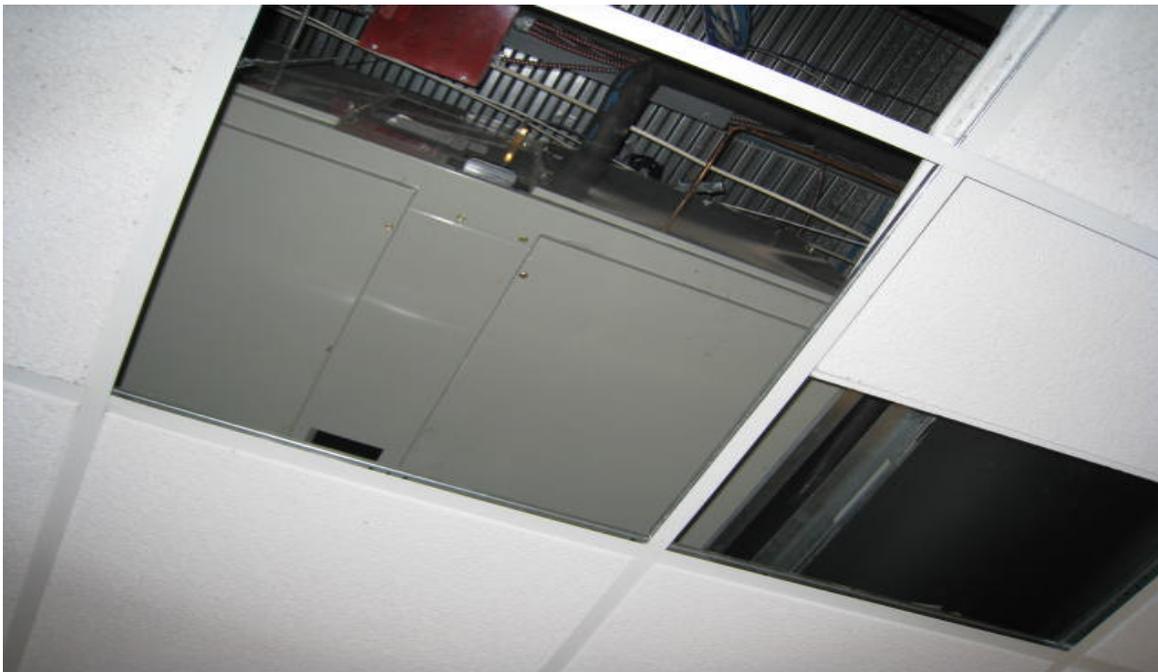
**Picture 2**

the plenum of the adjacent hallway that houses an air handling unit (AHU) was also evaluated (Picture 2). The AHU leak resulted in the moistening of insulation surrounding the unit and adjacent pipes (Pictures 2 and 3). In addition, water stains were seen emanating down the wall from the plenum area (Picture 4). This area was reportedly disinfected with an appropriate anti-microbial and the insulation dried.

**Hallway AHU Adjacent to Room B-215**

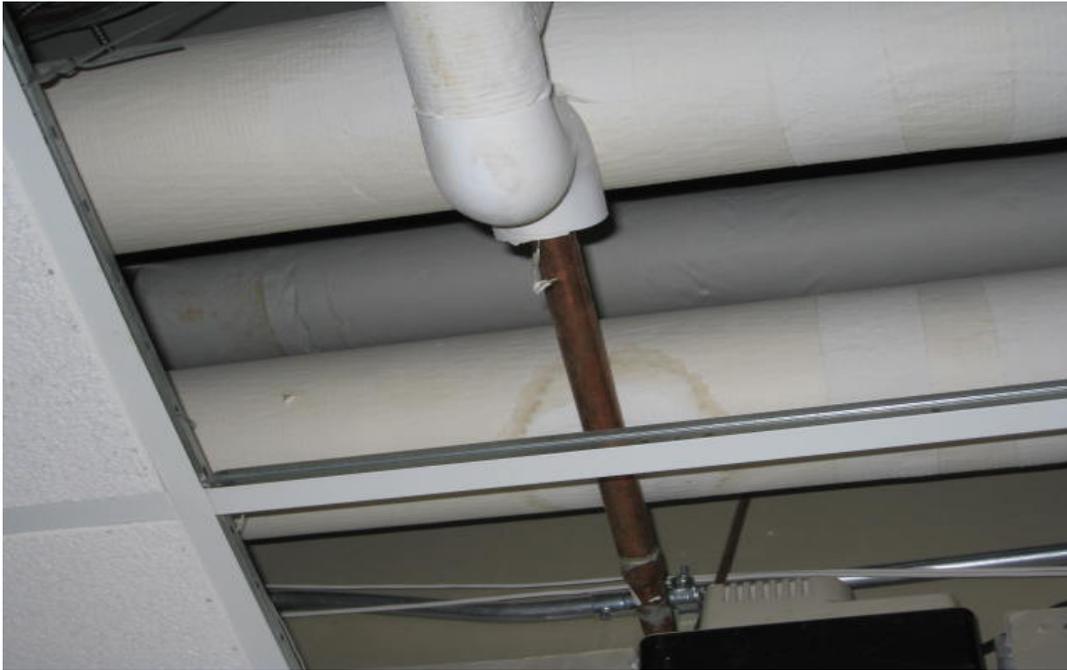
**Picture 3**

**Plenum above Hallway AHU (note water staining on pipe)**

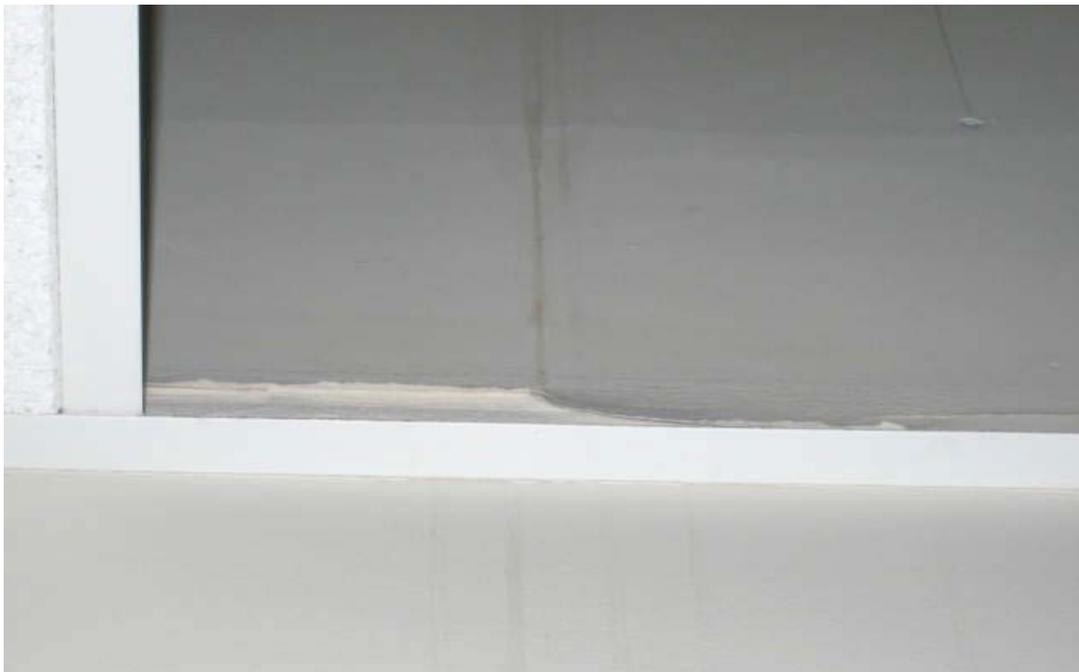
**Picture 4**

**Plenum in room B-215 (note water stains)**
