Mold/Water Damage Investigation

**Memorial Elementary School
12 Walnut Street
Milford, Massachusetts**

Prepared by:
Massachusetts Department of Public Health
Bureau of Environmental Health
Indoor Air Quality Program
October 2009

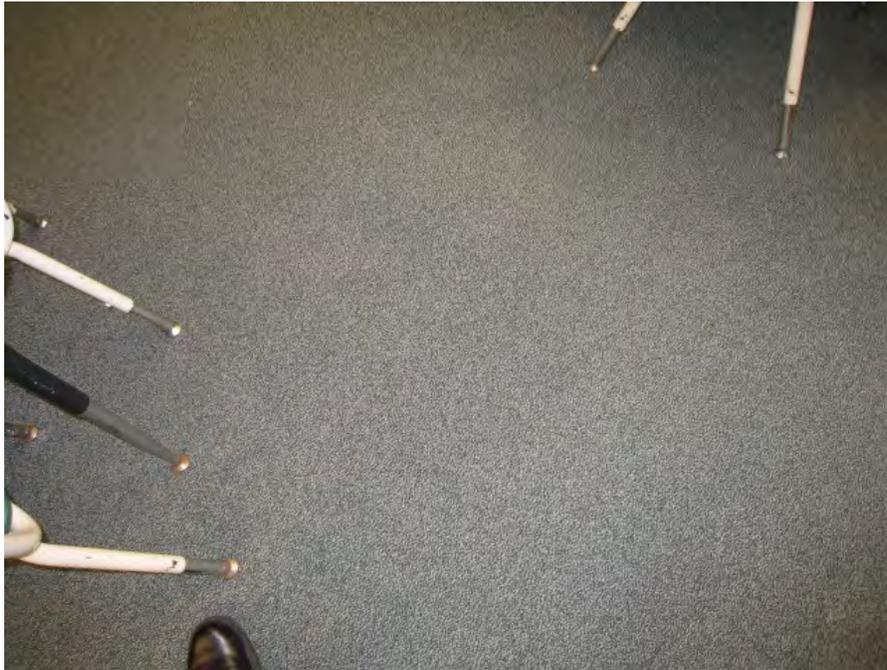
Picture 1

As previously mentioned, the assessment was prompted by concerns of mold growth observed by school staff on several surfaces in classroom 30. Shortly after its discovery, the mold was reportedly removed/cleaned from the carpeting (Picture 1) and other surfaces by MPS

maintenance staff using bleach and water. BEH staff did not observe/detect visible mold or associated odors on these surfaces at the time of the assessment.

Carpeting in Classroom 30, No Visible Mold/Moisture Damage

2. Consideration should be given to replacing carpeting with a non-porous flooring surface during the next school vacation.
3. Remove the exhaust vent and examine whether wall cavity surface of the GW is mold colonized. If mold colonized, remove in a manner consistent with recommendations made in “Mold Remediation in Schools and Commercial Buildings” published by the US Environmental Protection Agency (US EPA, 2001). This document can be downloaded from the US EPA website at: http://www.epa.gov/mold/mold_remediation.html.

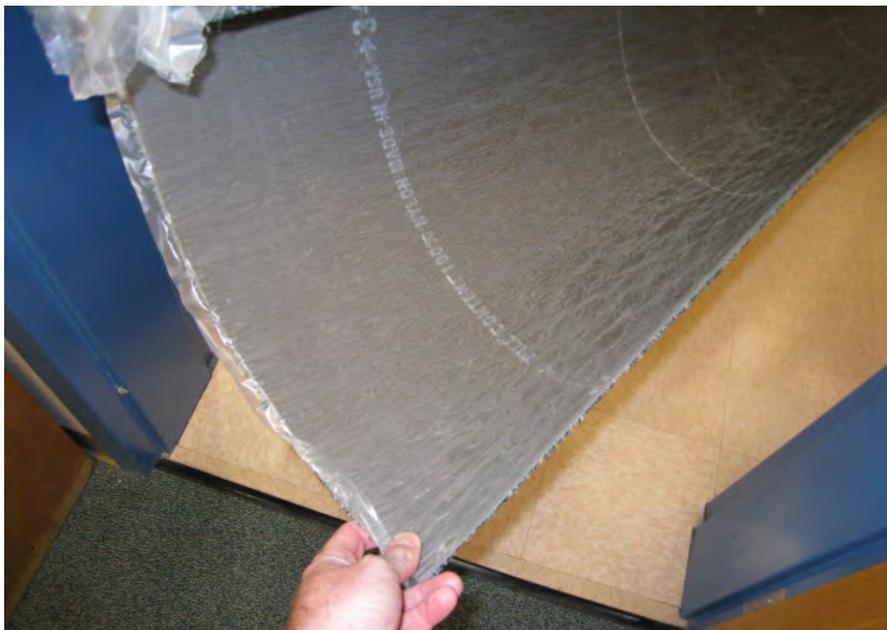
Picture 2

BEH staff obtained a sample of the carpeting and noted that the backing of the carpet was made of an impermeable plastic/vinyl material (Picture 2). The impermeable plastic/vinyl material prevents moisture (i.e., from the top) to move downwards; similarly, water could not penetrate from the slab through to the carpet. Carpeting at the MES was thin (approximately 1/2-inch thick) and adhered directly on slab with no carpet pad. Often times, when carpeting gets

wet (e.g., a flooding event), attempts to dry are successful; however the padding can retain moisture, grow mold and give off unpleasant odors. The carpet in the MES has a water-impervious backing that is adhered directly to the floor slab. Any mold growth, if present, would be limited to the pile above the backing and could be readily cleaned using a high temperature, steam/water extracting cleaning process. Since this carpeting has been repeatedly subjected to mold growth, BEH staff recommends that the carpeting be replaced with a non-porous material since this floor appears to be prone to condensation which will wet the carpet pile, producing future mold growth. Until the carpeting is replaced, BEH staff recommends regular vacuuming with a high efficiency particulate arrestance (HEPA) filter equipped vacuum cleaner, which filters out 99.97% of fine particles 0.3 micrometers (μm) in diameter that can exacerbate asthma and allergy symptoms (US EPA, 2001).

Impermeable Plastic/Vinyl Backing of Carpeting Sample Similar to that Installed in Classroom 30

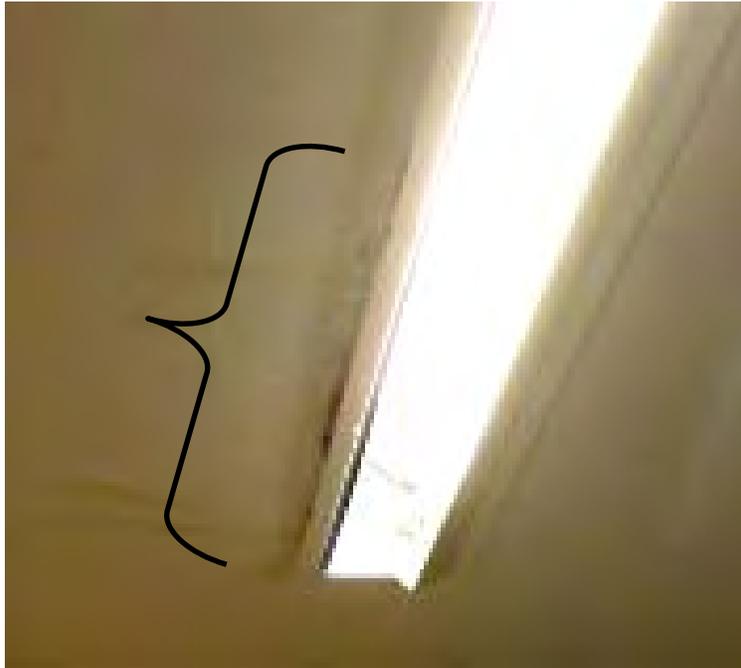
Picture 3

Some visible mold was observed on the surface of the GW ceiling around a metal light fixture and a return vent (Pictures 3 and 4). As with the carpeting, these surfaces appear to be chronically prone to condensation generation, which may likely require some removal of GW and insulation around the exhaust ductwork. As an interim measure, BEH staff recommended sealing the vent and removing the mold by cleaning, followed by vacuuming the surface of the GW as well as surfaces around and below these areas, with a HEPA filtered vacuum cleaner. As discussed, the HVAC system had been deactivated overnight during periods of elevated relative humidity. When warm, moist air passes over a surface that is colder than the air; condensation can collect on the cool surface of the metal fixtures. Over time, water droplets can form, and lead to mold growth on porous materials (i.e., GW).

Light Mold Growth on Surface of GW along Metal Light Fixture in Classroom 30

1. Ensure mold is cleaned from the metal light fixture. An examination of the GW surface in the ceiling plenum side is advised to ascertain whether mold colonization exists. This examination would likely require removal of the light fixture and removal of some GW.

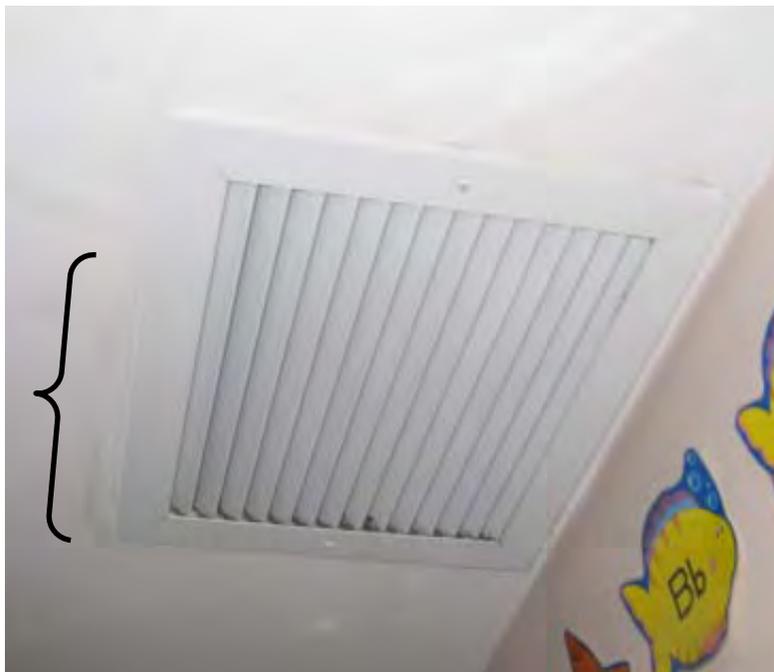
Picture 4

Light Mold Growth on Surface of GW along Metal Return Vent in Classroom 30

4. Consideration should be given to extending the ductwork so that the exhaust vent is not in direct contact with the ceiling GW. Consideration should also be given to installing an insulation material between the exhaust vent duct and the ceiling GW.
