INDOOR AIR QUALITY ASSESSMENT

**George H. Dunbar Elementary School
338 Dartmouth Street
New Bedford, Massachusetts 02740**

Prepared by:
Massachusetts Department of Public Health
Bureau of Environmental Health
Indoor Air Quality Program
March 2009

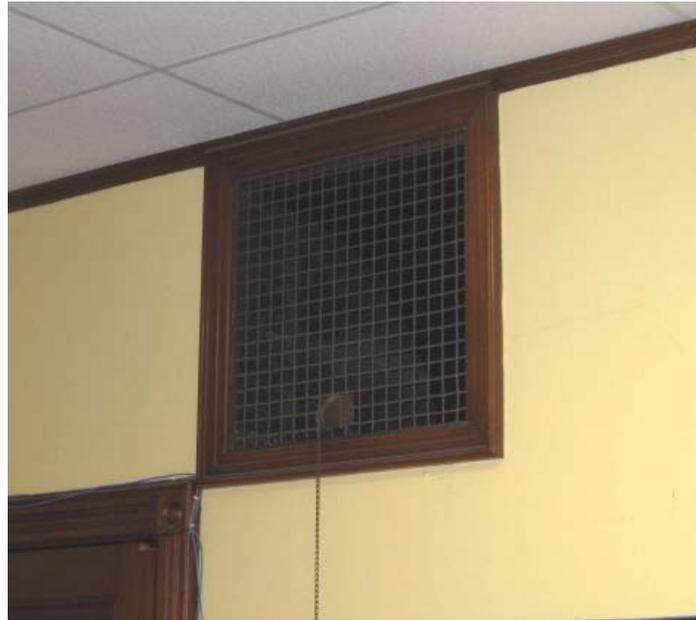
Picture 1

Originally, ventilation was provided by a series of louvered vents. Each classroom has an approximately 3' x 3' grated air vent in the center of an interior wall near the ceiling (Picture 1) which is connected by a ventilation shaft to a vault-like "air-mixing" room in the basement (Picture 2). A corresponding 3' x 3' vent exists in each room (Picture 3) near the floor that is

connected to an exhaust ventilation shaft that runs from the roof to the basement. Classrooms were constructed around these shafts to provide exhaust ventilation. The draw of air into these vents is controlled by a draw chain pulley system. The chains of the pulley system were designed to set the flue in the ventilation shaft at a desired angle to adjust fresh air intake (Pictures 1 and 4).

Natural Gravity Supply Vent near Classroom Ceiling, Note Pull Chain for Adjustable Flue

2. Examine the feasibility of restoring the original gravity feed ventilation system. This may entail repair or replacement of heating elements located in ventilation shafts; repair of broken or missing warm air and cool air pulley chain/louver door systems to provide ventilation in this building as designed; repair of the hinged-pulley system and/or installation of openable windows in basement area to provide fresh air to classrooms. If restoration is not an option, consideration should be given to installing a mechanical ventilation system in the original building.

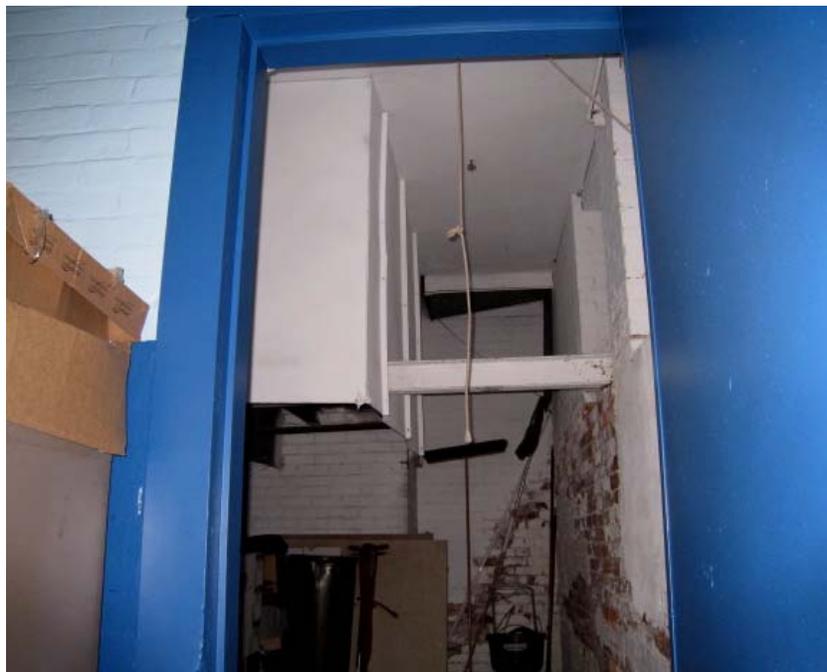
Picture 2

“Air-Mixing Room” in Basement

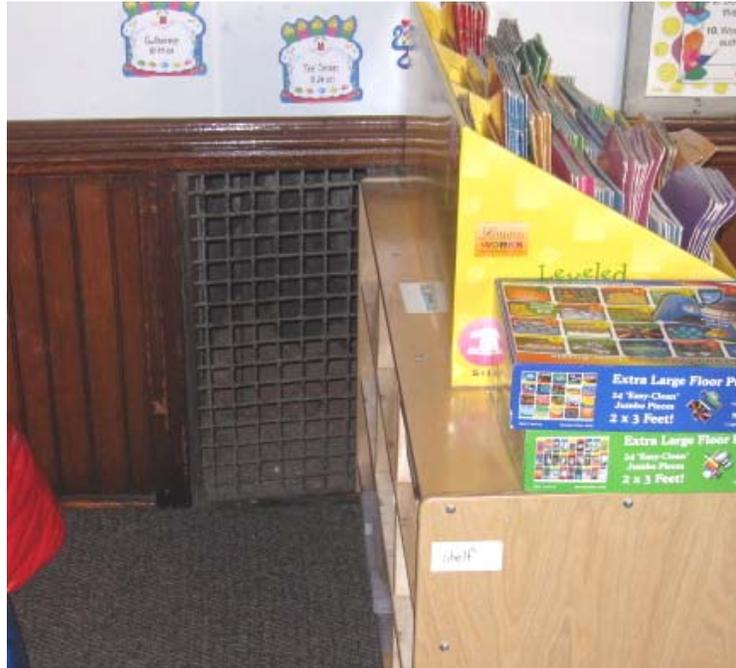
Picture 3

As mentioned previously, this ventilation system has been abandoned. Without a functional ventilation system, normally occurring environmental pollutants can build up. If this system is not to be restored, care should be taken to ensure ventilation shafts are rendered airtight in classrooms, in basement air-mixing rooms and at the top of abandoned chimney/ventilation stacks to prevent the egress of pests, dirt, dust and drafts into occupied areas.

Natural Gravity Exhaust Vent near Classroom Floor

2. Seal abandoned supply and exhaust vents in classrooms on the roof and in the basement to prevent drafts and the egress of odors, dust and particulate matter into occupied areas.

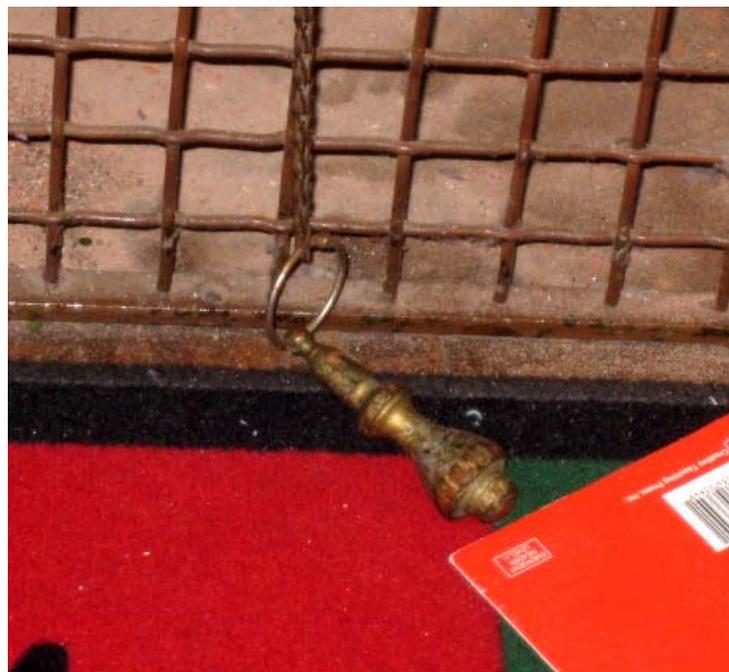
Picture 4

Pull Chain for Adjustable Flue

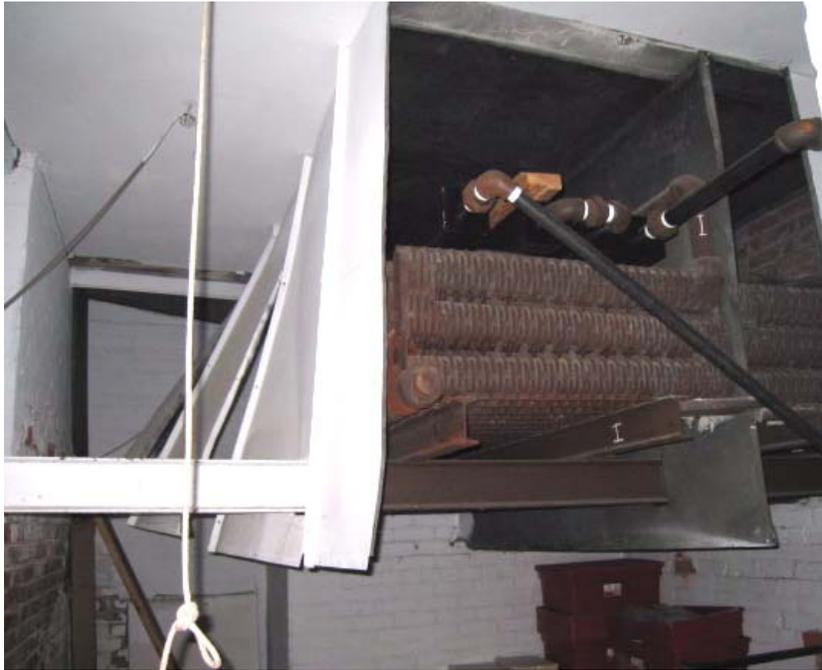
Picture 5

Air movement is provided by the stack effect. Heating elements located in the base of the ventilation shaft warm the air, which rises up the ventilation shafts (Picture 5). As the heated air rises, negative pressure is created, which draws cold air from the enclosed air-mixing room in the basement into the heating elements/ventilation shaft. This system was designed to draw in outside air from windows in the air-mixing room. The percentage of fresh air is controlled by a hinged window-pulley system (Pictures 6 and 7).

Ventilation Shaft with Heating Element/Radiator in Basement “Air-Mixing Room”

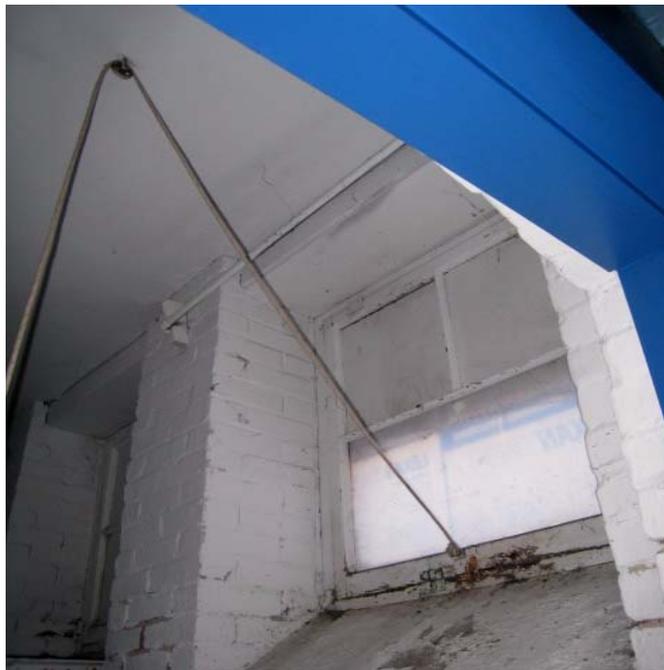
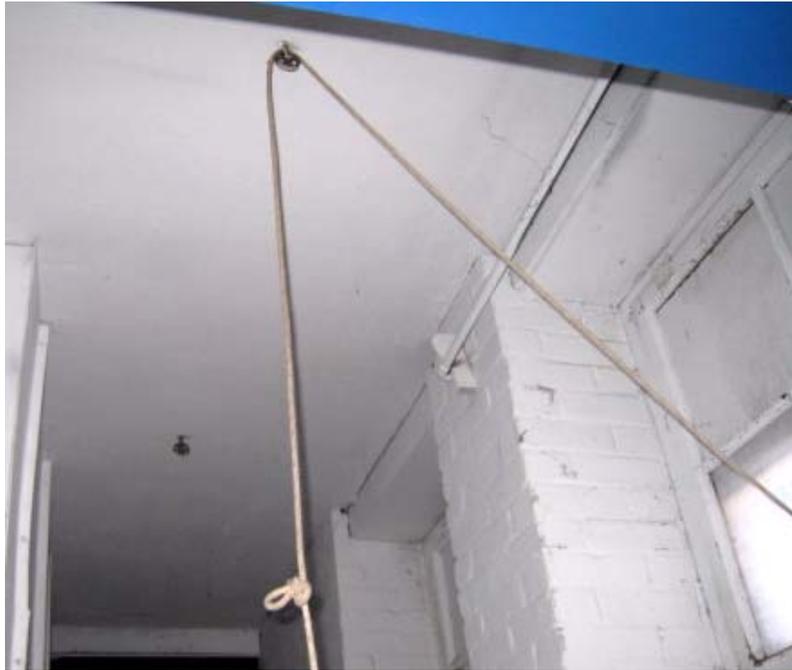
Basement Window in “Air Mixing Room” with Rope & Pulley System

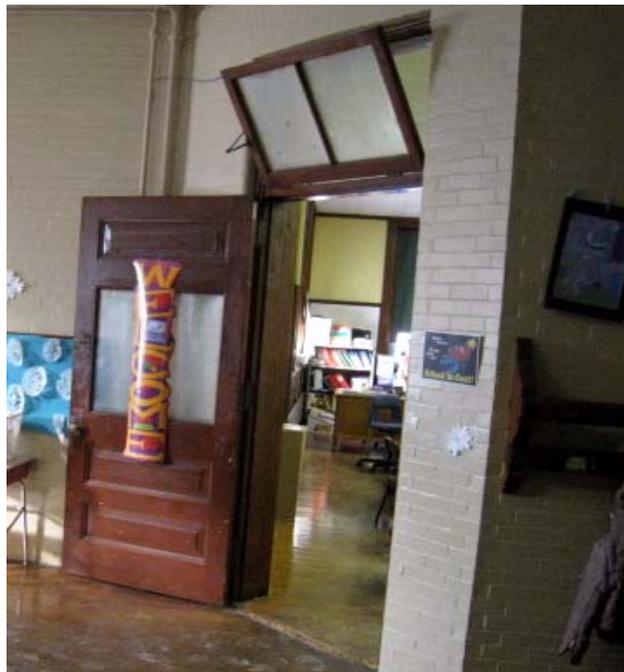
Picture 8

Currently, ventilation in the school is controlled by the use of openable windows in classrooms. Classrooms were originally configured in a manner to use cross-ventilation to provide comfort for building occupants. The building is equipped with windows on opposing exterior walls. In addition, the building has hinged windows located above the hallway doors. This hinged window (called a transom) (Picture 8) enables classroom occupants to close the hallway door while maintaining a pathway for airflow. The design allows for airflow to enter an open window, pass through a classroom and subsequently pass through the open transom.

Transom Open over Classroom Door

1. Regulate airflow in classrooms using windows and transoms (for cross-ventilation) to control for comfort. Care should be taken to ensure windows are properly closed at night and weekends to avoid the freezing of pipes and potential flooding. Contact the window manufacturer concerning proper operation/maintenance of window systems.

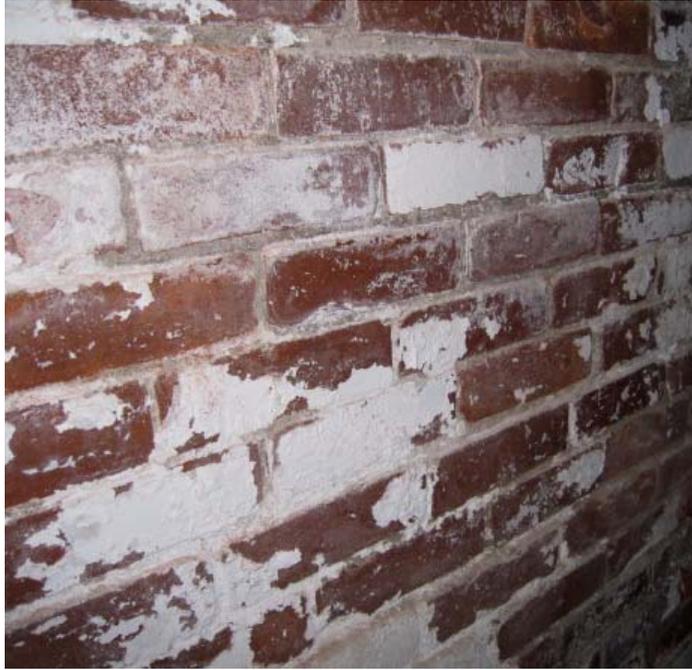
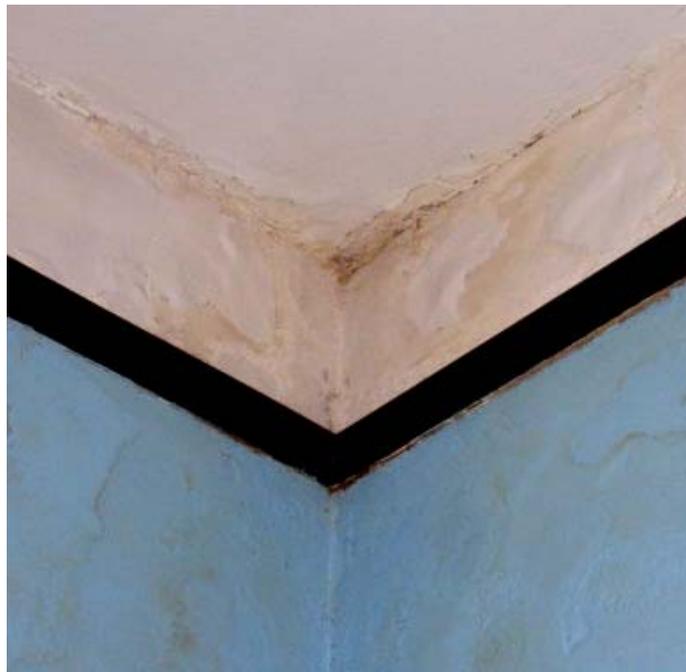
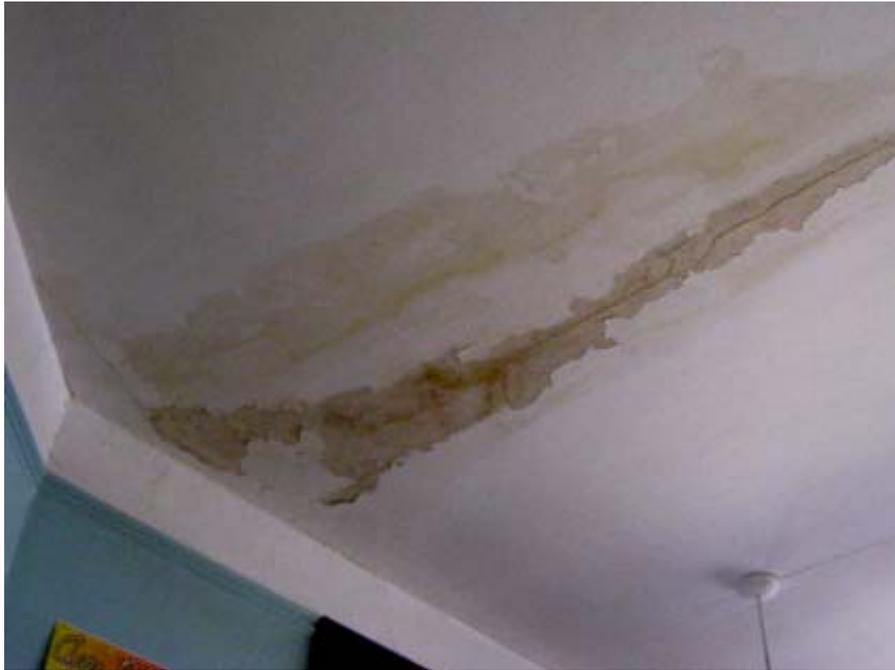
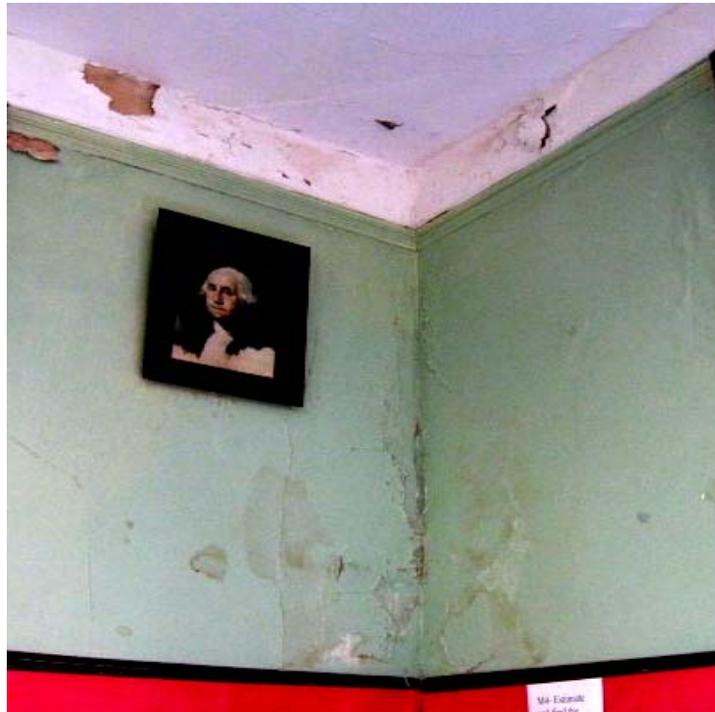
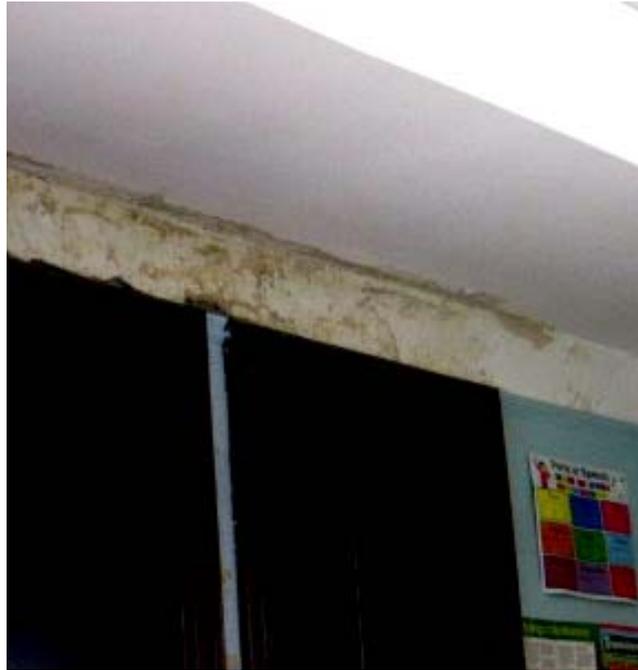
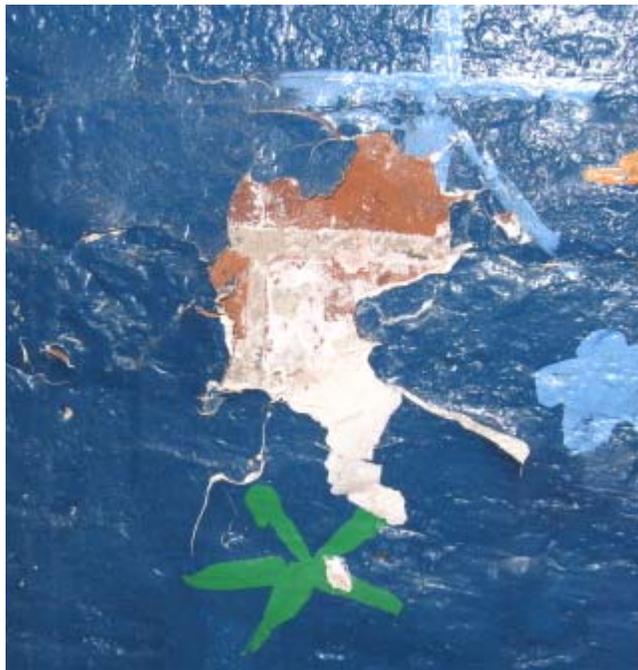
Water damaged wall plaster, peeling paint and efflorescence were observed in a number of areas throughout the building, most notably on the top floor (Pictures 9 through 14).

Efflorescence is a characteristic sign of water damage to brick and mortar, but it is not mold growth. As moisture penetrates and works its way through mortar, brick or plaster, water-soluble compounds dissolve, creating a solution. As the solution moves to the surface of the material, the water evaporates, leaving behind white, powdery mineral deposits. In one case, wooden slats were affixed to the ceiling to prevent falling plaster (Picture 15). Water damage is most likely the result of water penetration through the building envelope (roof and exterior brick), as evidenced by numerous buckets and tarps in the attic to catch leaks through the original slate roof (Pictures 16 through 19). Another obvious source of water penetration was through a broken skylight (Picture 20).

Efflorescence (i.e., Mineral Deposits) on Interior Brick

Water Damaged Ceiling/Wall Plaster and Efflorescence

Water Damaged Ceiling Plaster and Efflorescence

Efflorescence and Peeling Paint in the Basement

6. Consider having exterior brick foundation re-pointed and waterproofed to prevent further water intrusion. Repair/replace water damaged interior plaster. Examine surrounding non-porous areas for mold growth and disinfect with an appropriate antimicrobial if necessary.

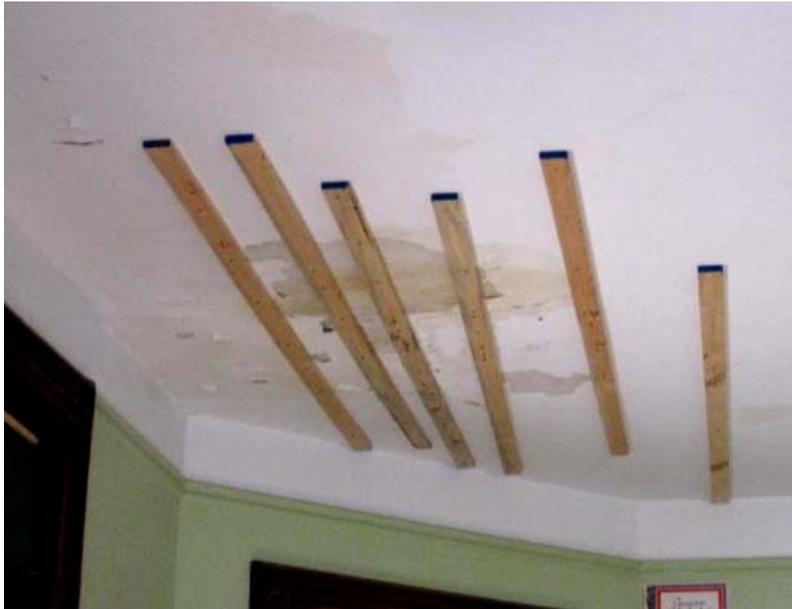
Picture 15

Water Damaged Ceiling Plaster, Note Wooden Slats to Prevent Falling

4. Replace or make repairs to original slate roof. Once roof is repaired, repair/replace any remaining water-damaged building materials. Examine above and around these areas for microbial growth. Disinfect areas of water leaks with an appropriate antimicrobial.

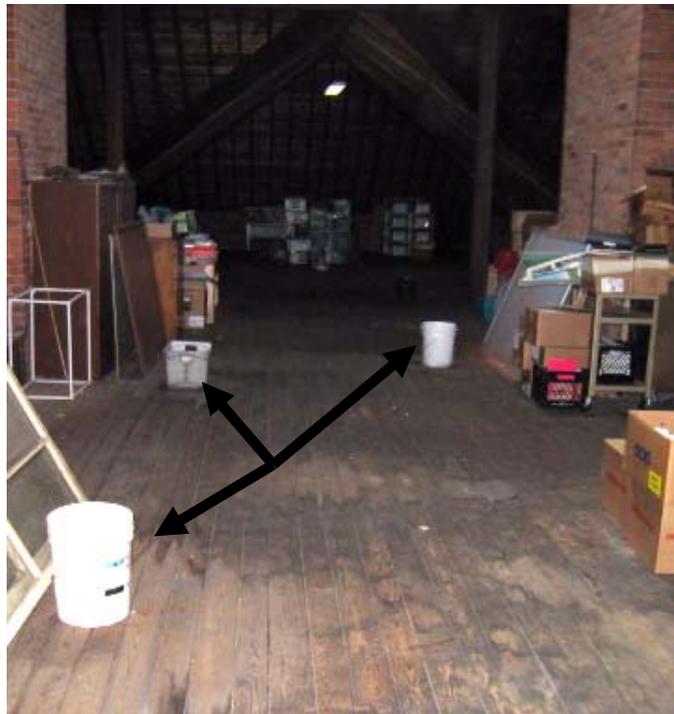
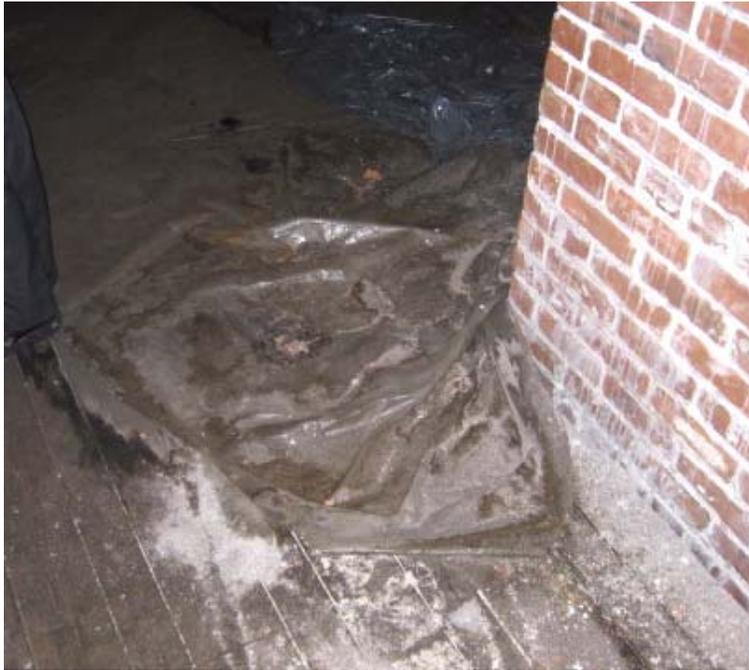
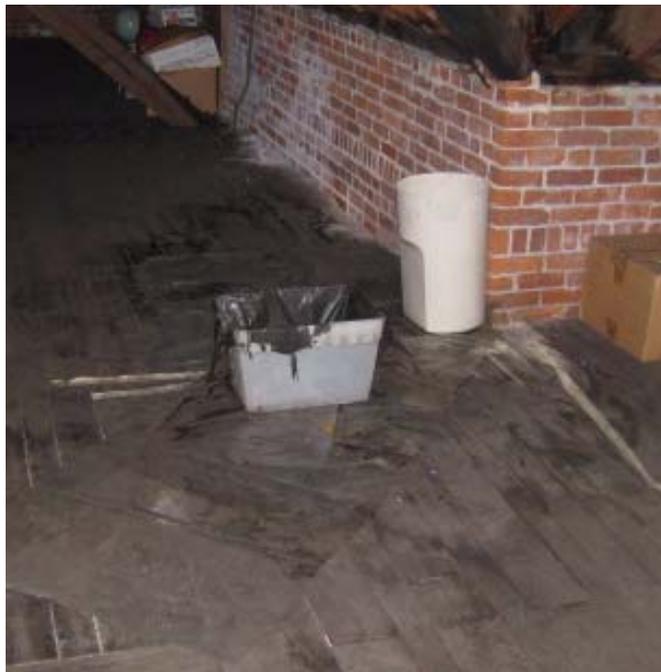
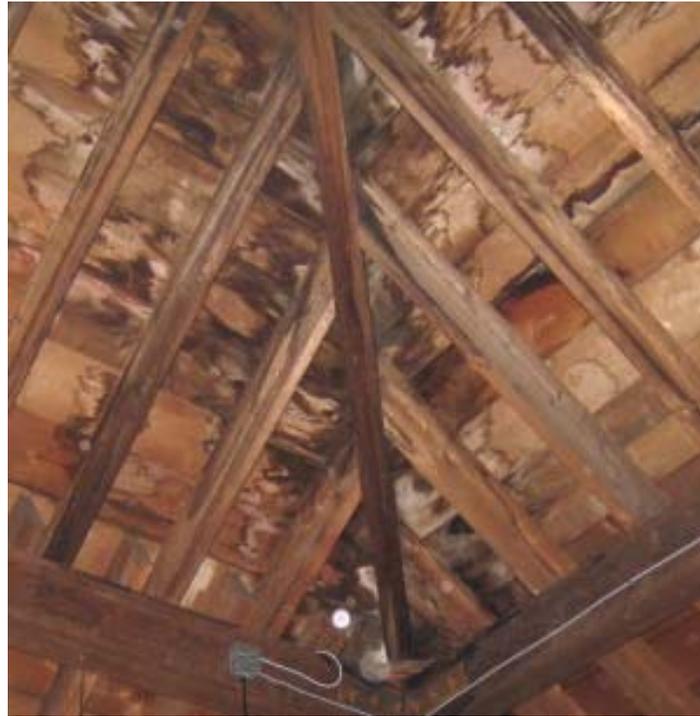
Buckets/Containers in Attic to Catch Rainwater, Note Water Stained Wooden Floor

Plastic/Tarp on Attic Floor to Catch Rainwater

Plastic Tarp/Containers on Attic Floor to Catch Rainwater

Water Damaged Attic Ceiling Due to Leaks

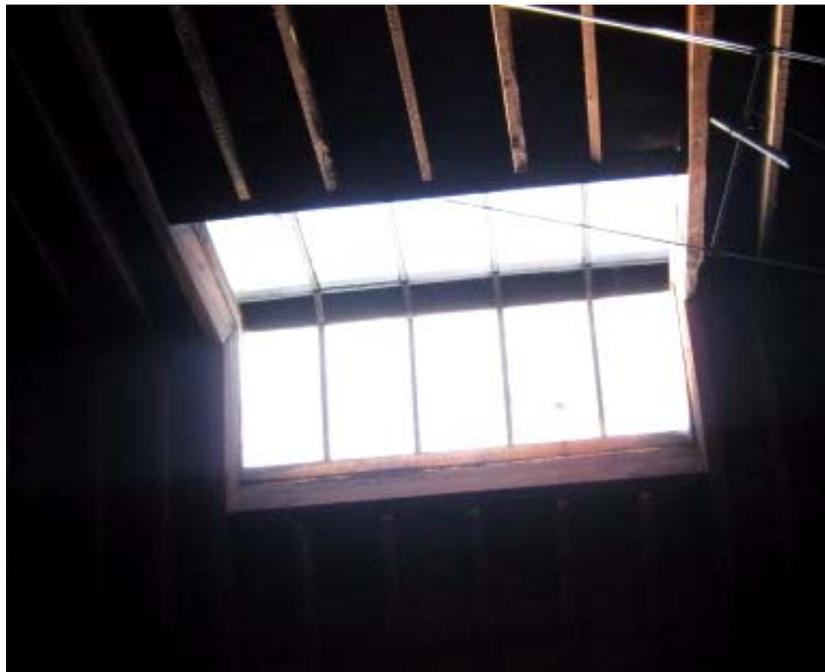
Picture 20

Broken (Glass) Skylight in Attic

7. Repair/replace missing/damaged sections of gutter/downspout system to direct water away from the foundation of the building.
8. Repair or seal leaking skylight in attic.

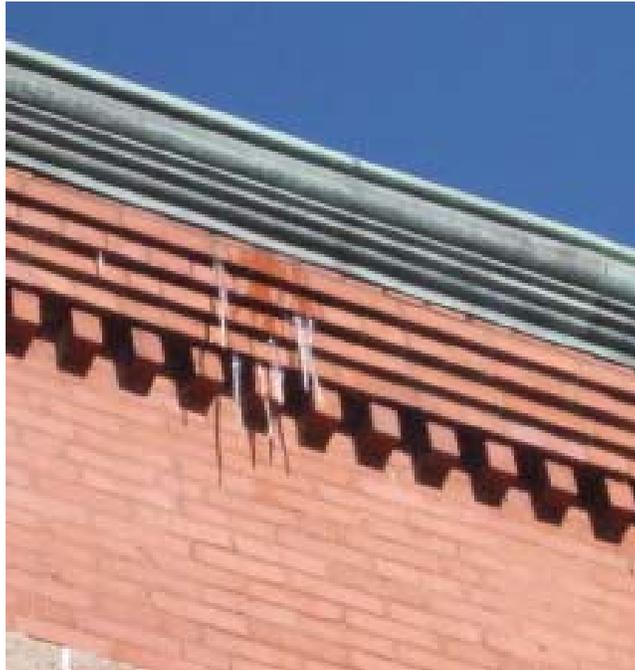
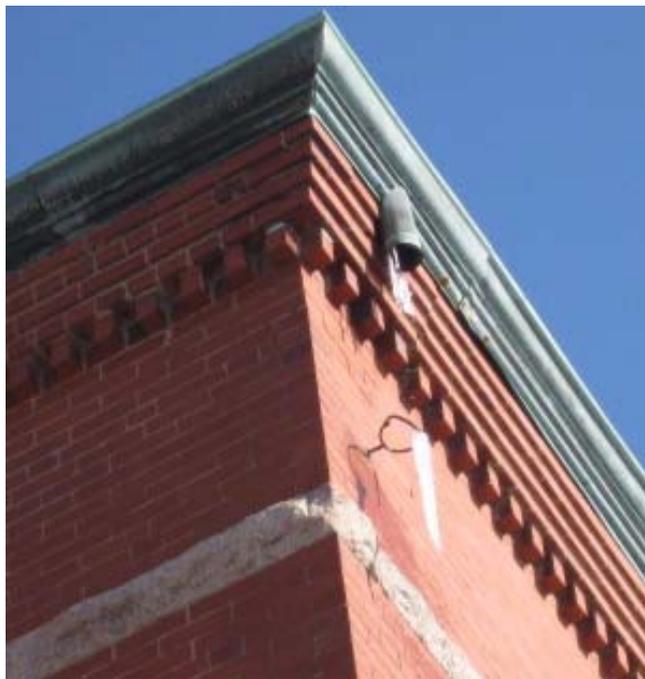
Other potential moisture sources were noted around the exterior of the building, including damaged gutters/downspouts (Pictures 21 and 22); and missing/damaged mortar and exterior brick (Pictures 23 through 26). These conditions represent potential moisture penetration sources. Over time, these conditions can undermine the integrity of the building envelope and provide a means of water entry into the building via capillary action through foundation concrete and masonry (Lstiburek & Brennan, 2001). The freezing and thawing of water during winter months can lead to further damage and subsequent water penetration into the

Icicles Forming Indicating Leak/Damaged Gutter System

Missing/Damaged Downspout

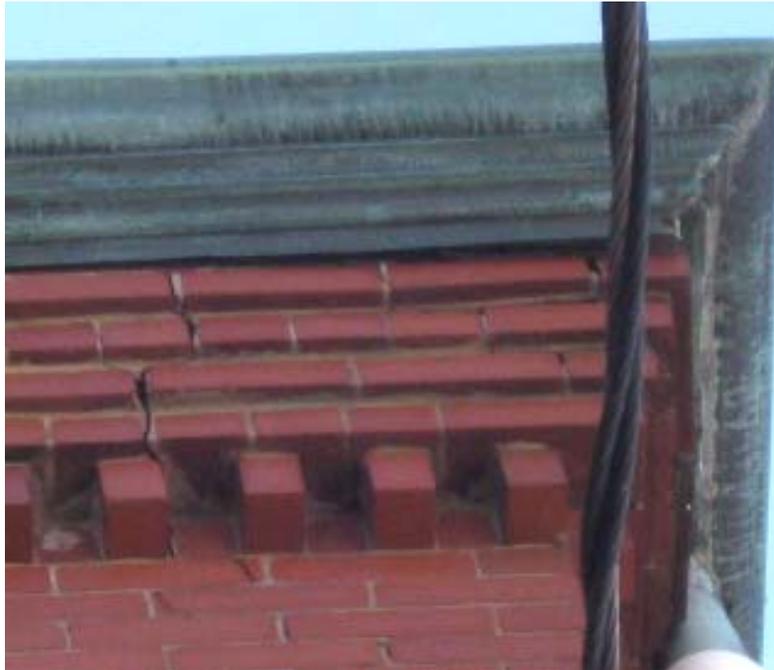
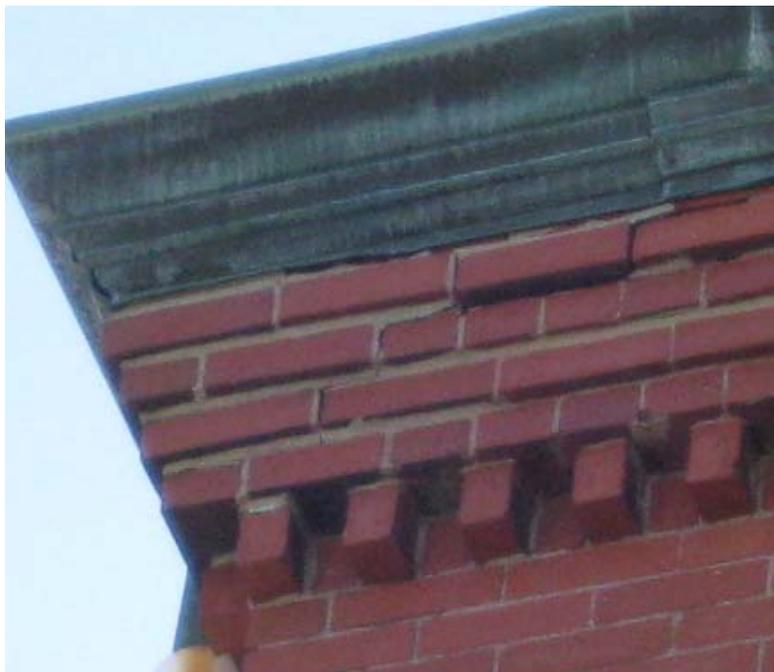
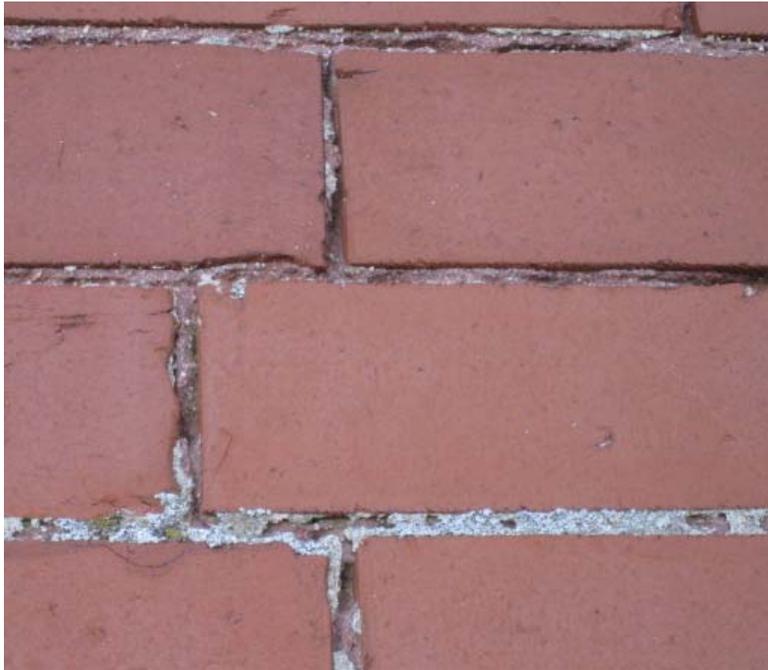
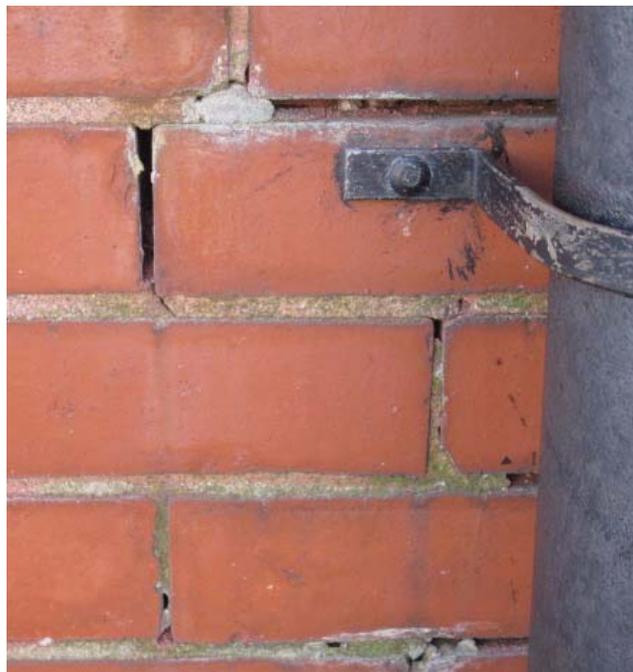
interior of the building. In addition, these breaches may provide a means for pests/rodents into the building.

Missing/Damaged Mortar/Exterior Brick

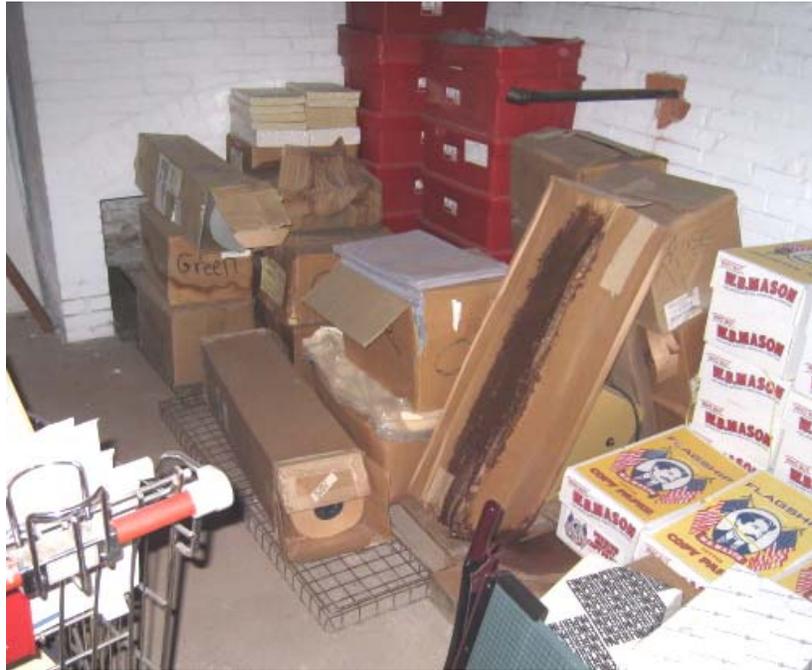
Picture 27

Water damaged/mold colonized cardboard boxes and paper was observed in the air-mixing room near the girl's restroom (Picture 27). The US Environmental Protection Agency (US EPA) and the American Conference of Governmental Industrial Hygienists (ACGIH) recommend that porous materials be dried with fans and heating within 24 to 48 hours of becoming wet (US EPA, 2001; ACGIH, 1989). If not dried within this time frame, mold growth may occur. Once mold has colonized porous materials, they are difficult to clean and should be removed/discarded.

Water Damaged/Mold Colonized Cardboard Boxes and Paper in Basement “Air-Mixing” Room (near Girl’s Restroom)

9. Discard water damaged/mold-colonized boxes in air-mixing room near girl's restroom (Picture 27).
10. Relocate or consider reducing the amount of materials stored in classrooms to allow for more thorough cleaning of classrooms. Clean items regularly with a wet cloth or sponge to prevent excessive dust build-up.

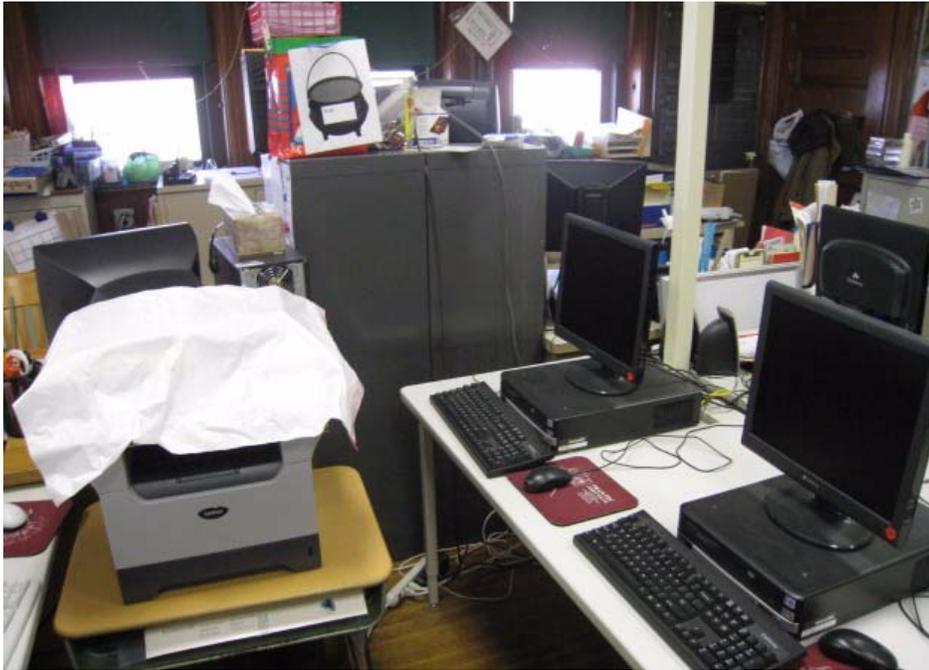
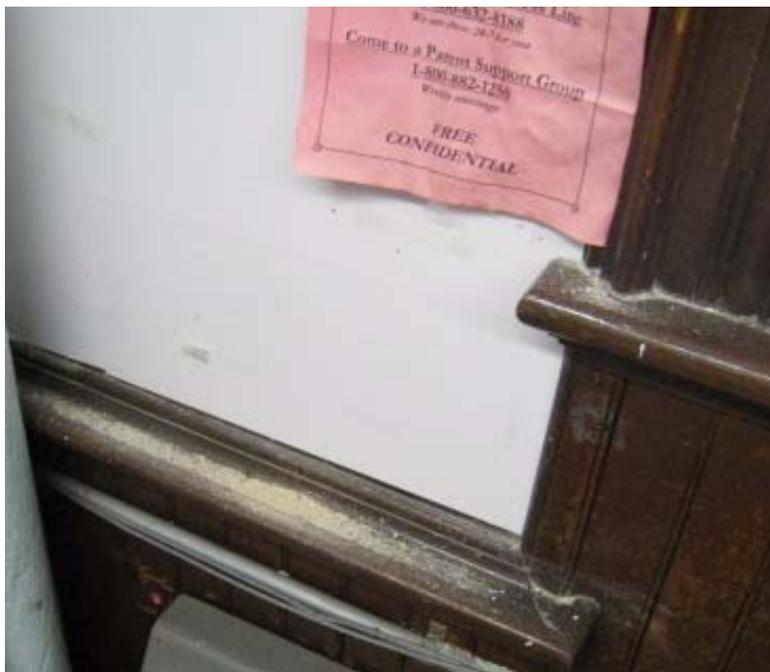
Other conditions that can affect indoor air quality were observed during the assessment. In several classrooms, items were observed on windowsills, tabletops, counters, bookcases and desks. The large number of items stored in classrooms provides a source for dusts to accumulate. These items (e.g., papers, folders, boxes) make it difficult for custodial staff to clean. Items should be relocated and/or be cleaned periodically to avoid excessive dust build up. In addition, these materials can accumulate on flat surfaces (e.g., desktops, shelving and carpets) in occupied areas and subsequently be re-aerosolized causing further irritation (Pictures 29 and 30).

Accumulated Items in Classroom

Dust/Debris on Flat Surfaces in Classroom 1

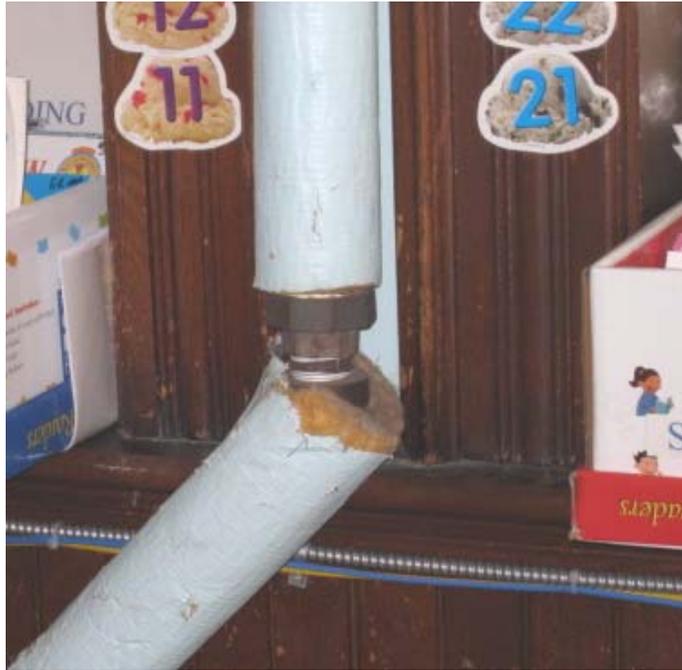
Picture 31

Window-mounted air conditioners (ACs) were observed in a few areas. These units are normally equipped with filters, which should be cleaned or changed as per manufacturer's instructions to avoid the build-up and re-aerosolization of dirt, dust and particulate matter. Exposed fiberglass pipe insulation was observed in classroom 3 (Picture 31). Fiberglass insulation can provide a source of skin, eye and respiratory irritation.

Exposed Fiberglass Insulation around Pipes in Classroom 3

13. Wrap exposed fiberglass pipe insulation in classroom 3 and in any other areas.
14. Replace latex-based tennis balls with latex-free tennis balls or glides.

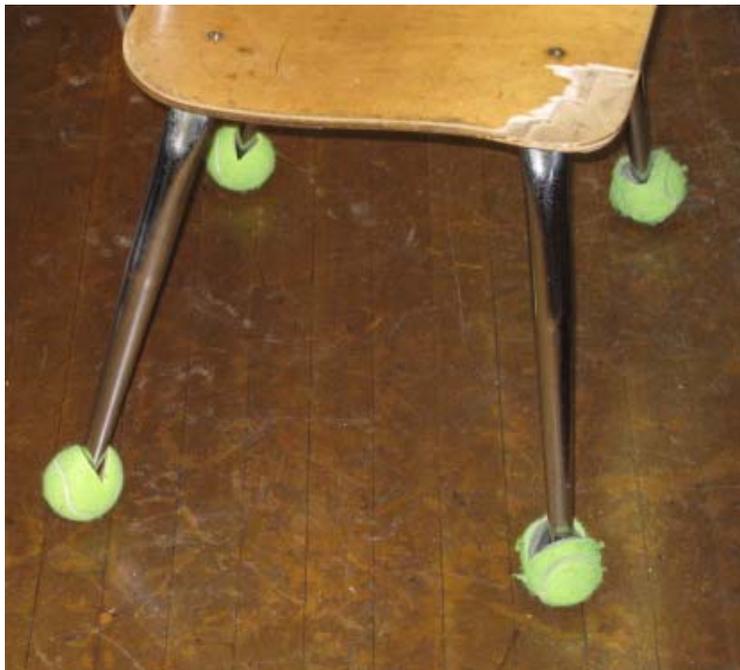
Picture 32

Finally, in an effort to prevent scratching from sliding tables, tennis balls had been sliced open and placed on the table legs (Picture 32). Tennis balls are made of a number of materials that are a source of respiratory irritants. Constant wearing of tennis balls can produce fibers and cause TVOCs to off-gas. Tennis balls are made with a natural rubber latex bladder, which becomes abraded when used as a chair leg pad. Use of tennis balls in this manner may introduce latex dust into the school environment. Some individuals are highly allergic to latex (e.g., spina bifida patients) (SBAA, 2001). It is recommended that the use of materials containing latex be limited in buildings to reduce the likelihood of symptoms in sensitive individuals (NIOSH, 1997).

Tennis Balls on Chair Legs
