INDOOR AIR QUALITY ASSESSMENT

**Pittsfield City Hall
70 Allen Street
Pittsfield, MA 01201**

Prepared by:
Massachusetts Department of Public Health
Bureau of Environmental Health
Indoor Air Quality Program
December 2009

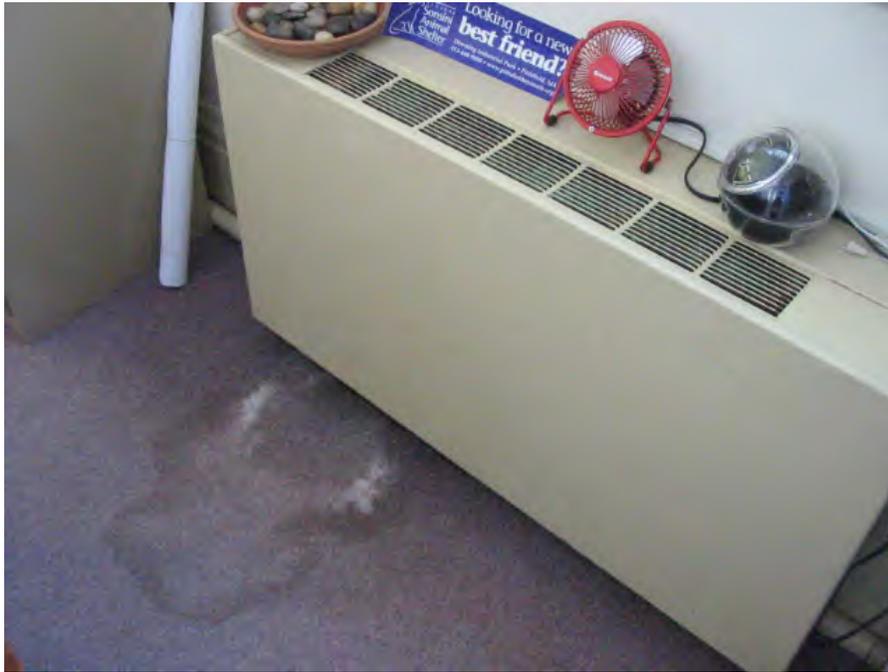
Picture 3

Fan coil units (FCUs) below the windows in each room facilitate airflow and temperature control (Pictures 3 and 4). FCUs do not provide fresh air to rooms; rather, they re-circulate air and provide heating and/or cooling. A FCU draws air from the room through an intake located at the base of the unit. Air passes through the filter, is conditioned by the coils, and then distributed

Fan Coil Unit, Note Water Damaged Carpet

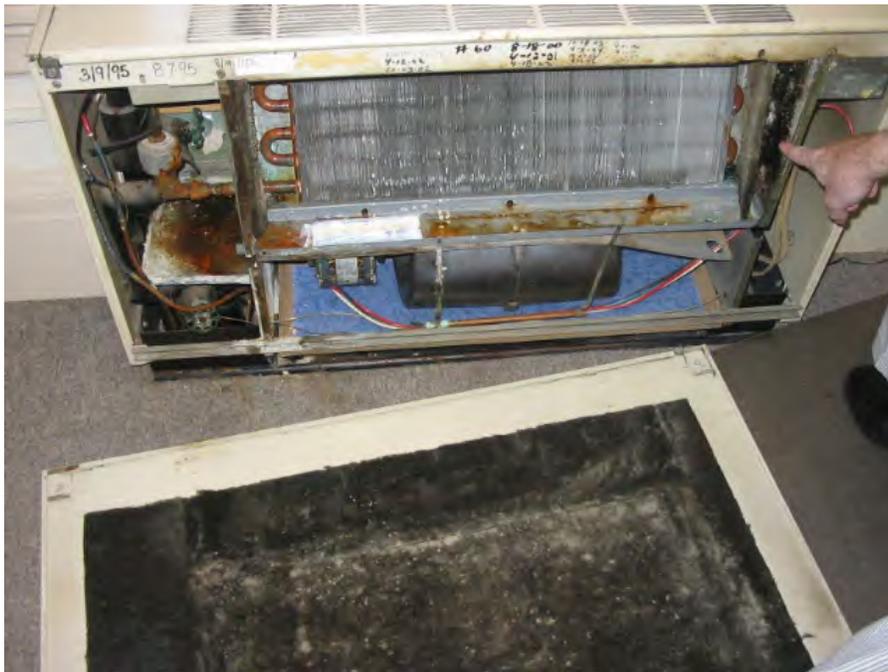
Picture 4

BEH staff performed a visual inspection of building materials for water damage and/or microbial growth. Several PCH employees reported to BEH staff that musty odors emanate from the FCUs when activated; therefore, BEH staff examined the interior of several units (Pictures 4 and 13).

Fan Coil Unit, Front Panel Removed

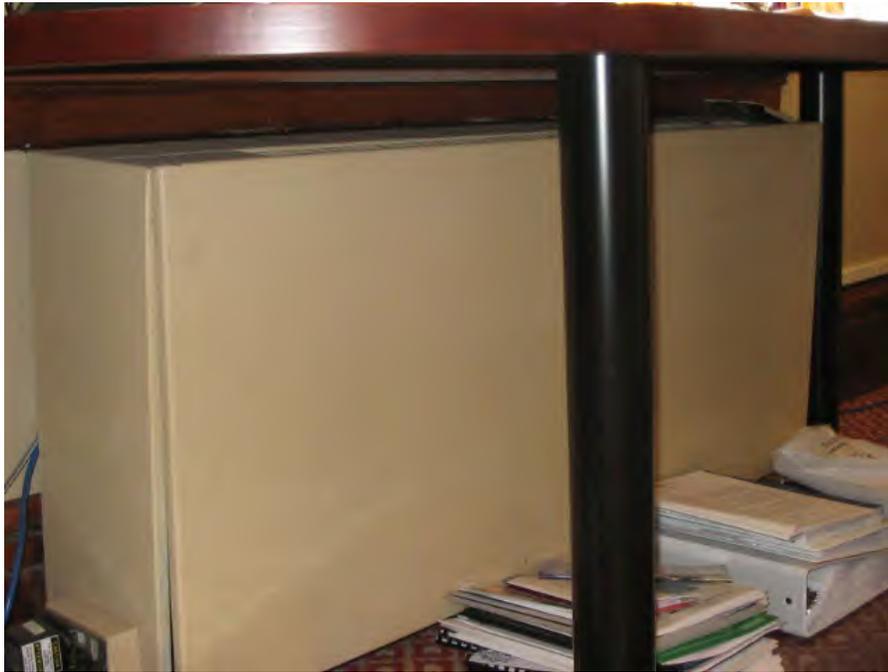
Picture 5

to the room through an air diffuser atop the unit ([Figure 3](#)). In a number of areas, FCUs were found obstructed by furniture, books and other stored materials (Picture 5). In order for FCUs to facilitate airflow as designed, air intakes and diffusers must remain free of obstructions. Importantly, these units must be allowed to operate while rooms are occupied to provide adequate air exchange.

Fan Coil Unit Air Diffuser Blocked by Table and Return Blocked by Books

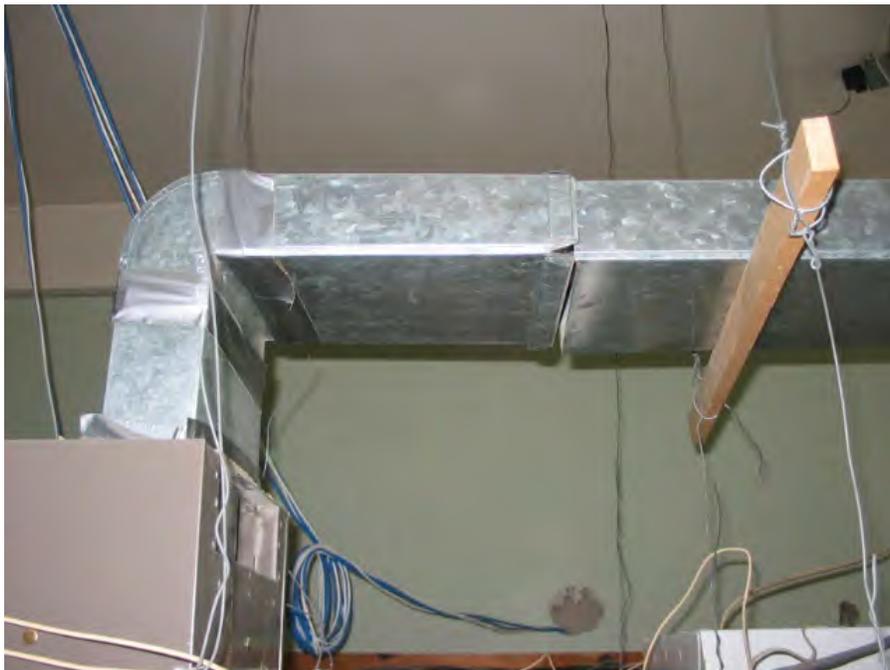
Picture 8

BEH staff noted a mechanical exhaust system in the Assessor's office. Ductwork observed in the ceiling was in disrepair; it was not sealed properly and had holes (Picture 8). Further, the ductwork appeared to terminate within the ceiling plenum near the window (Picture 9). It is likely that this duct was not reconnected to an exterior wall vent when the window system was replaced in 1995. This is problematic for several reasons: 1) it can pressurize the ceiling plenum, forcing any accumulated dust, debris, fiberglass fibers, etc. into occupied areas; 2) the ceiling plenum is designed to be depressurized to provide exhaust ventilation; and 3) it interferes with the proper balance of the system, creating uneven heating/cooling conditions in other areas and decreasing overall comfort in the building.

Exhaust Ductwork in Assessor's Office

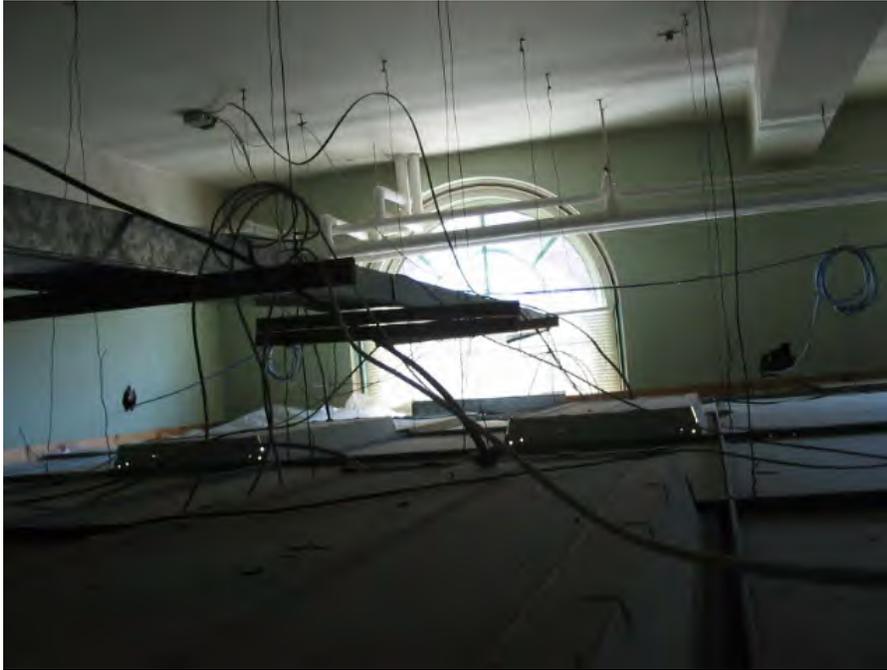
Picture 9

Ductwork Terminates inside Ceiling Plenum at Window

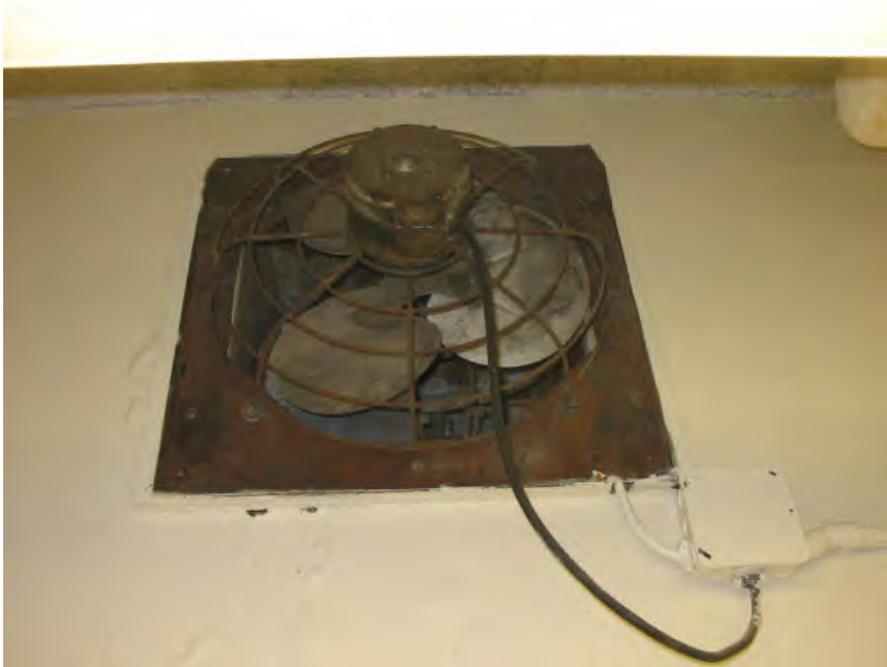
Picture 10

BEH staff also found a deactivated fan in the exterior wall of basement room 03, which exhausts air outside at the base of the back stairs of the PCH (Picture 10). The fan was sealed on the outside with glass. In addition, tape was observed on the switch, indicating that the fan was not operating (Pictures 11 and 12).

Fan on Exterior Wall in Basement Room 03

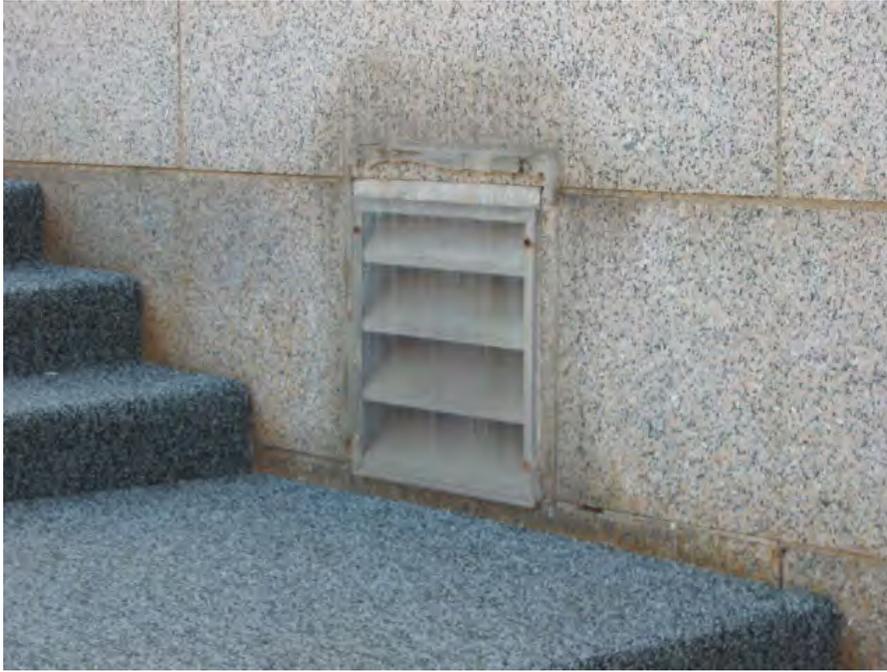
Picture 11

Fan on Exterior Wall Sealed

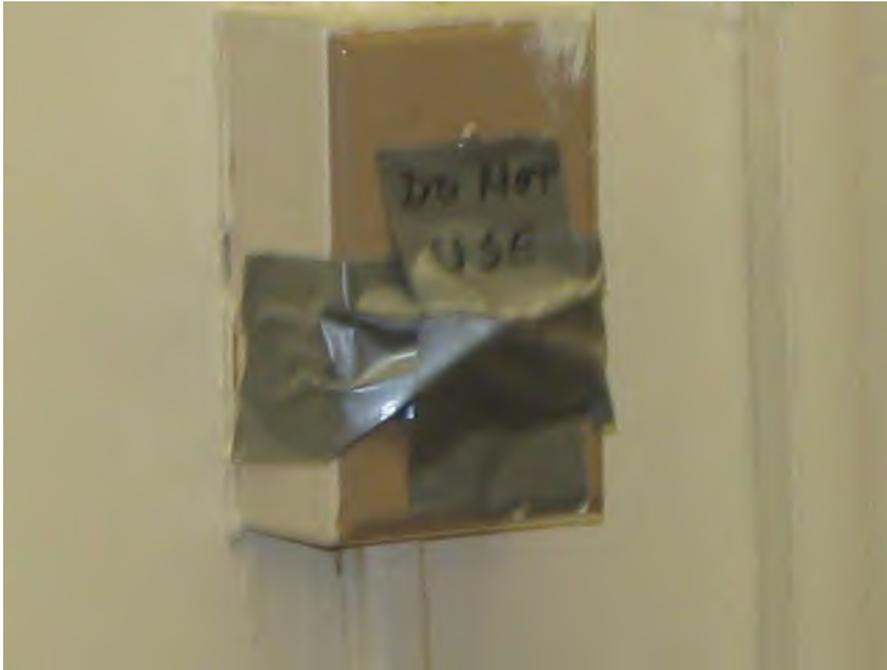
Picture 12

Fan Switch Covered with Duct-tape

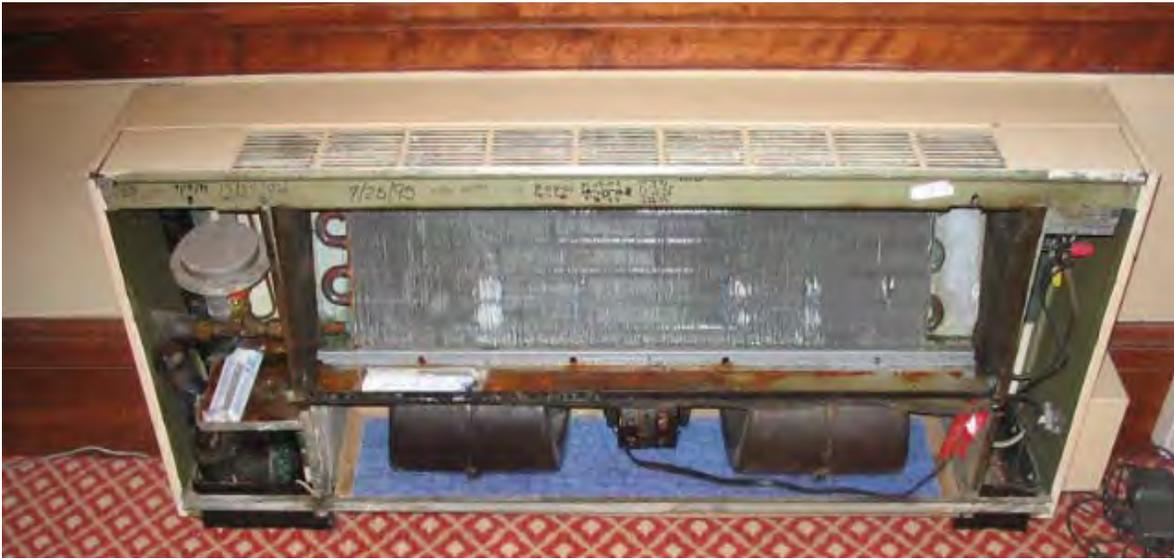
Picture 13

As mentioned previously, BEH staff found an antimicrobial agent (StaClean® Antimicrobial) in drip pans examined (Pictures 13 to 15). The StaClean® Antimicrobial product contains an organic ammonium chloride compound, alkyl dimethyl benzyl ammonium chloride, which is an alkaline chemical (Appendix B; State Chemical, 2007). As condensation contacts the StaClean® Antimicrobial tablet surface, a solution of organic ammonium chloride compound is formed in water. This solution likely becomes aerosolized during FCU operation if standing water remains in drip pans. This solution may also stain carpeting as water overflows from leaking drip pans. Exposure to this product may cause irritation to the eyes, skin and respiratory tract (State Chemical, 2007).

Interior of Fan Coil Unit

2. Remove antimicrobial tablets from all FCU drip pans.
3. The building was designed to use windows to provide fresh air. Since no mechanical ventilation is available in most offices, the opening of windows is recommended to temper room temperature and provide fresh air during the *heating season only*. Opening windows during hot weather during summer months will introduce moisture into the building, resulting in condensation generation on chilled water pipes during operation of the chiller.

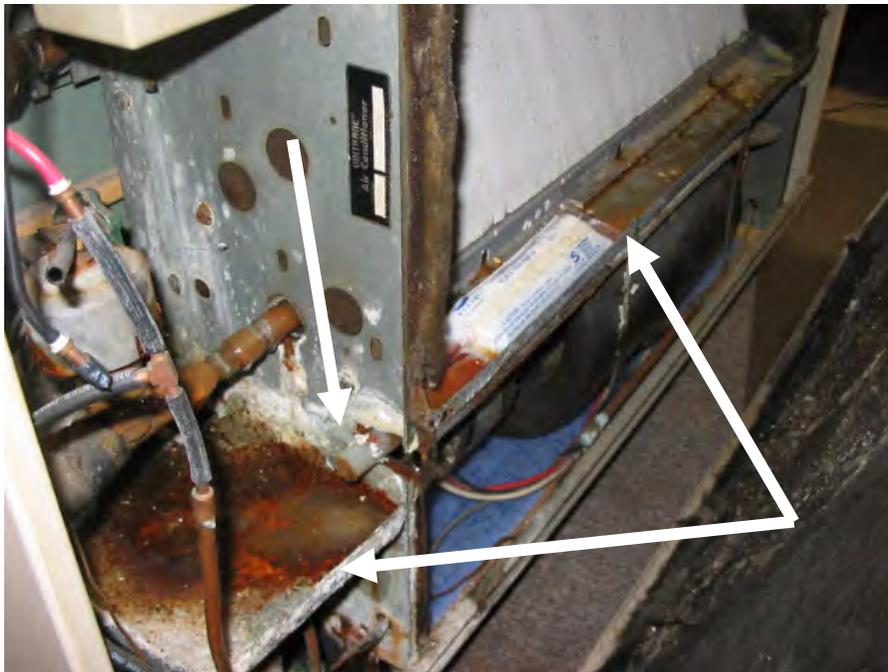
Picture 14

When a FCU operates in the cooling mode, drip pans collect and drain the condensation that accumulates on the coils. A drip pan below the coils directs the water through a drain pipe to an auxiliary drain pan (Picture 14). Over time, drip pans can collect debris and deteriorate as a result of oxidation (i.e. rusting). Drip pans should be cleaned to prevent accumulation of debris, and ensure proper drainage. Drip pans should also be maintained to prevent deterioration and ensure integrity of the drip pans.

**Fan Coil Unit Drip Pans Connected by Drain Pipe
Note Antimicrobial Tablets in Drip Pan**

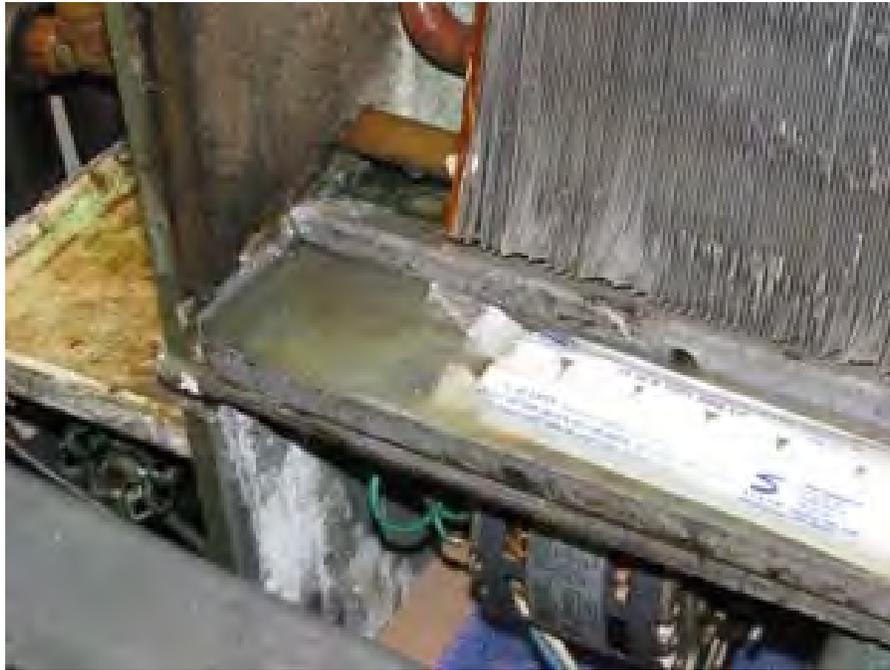
Picture 15

BEH staff observed drip pans and found accumulated debris that can serve as a source of microbial growth and suggests that the units have not been routinely cleaned and maintained (Pictures 15 and 16). BEH staff noted a FCU that did not have a drain pipe. As a replacement, a piece of aluminum foil was sculpted to bridge the drip pans (Picture 17). In an effort to control microbial growth, an antimicrobial agent was placed in the drip pans of each FCU throughout the PCH (Pictures 13 to 15). This antimicrobial agent is discussed further in the “Volatile Organic Compounds” section of this report.

Accumulated Debris in Drip Pan, Note Antimicrobial in Drip Pan

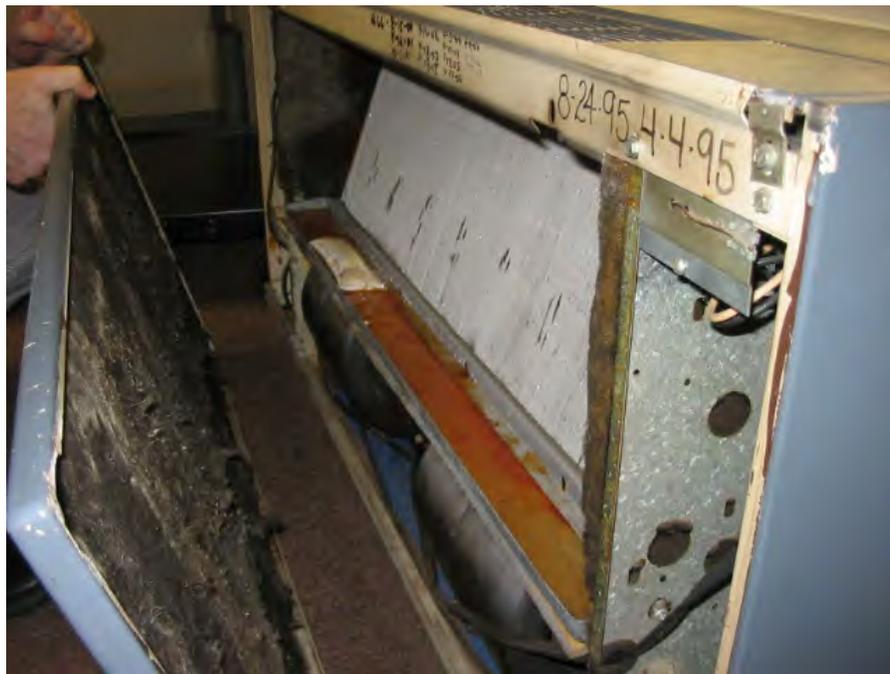
Picture 16

Accumulated Debris in Drip Pan

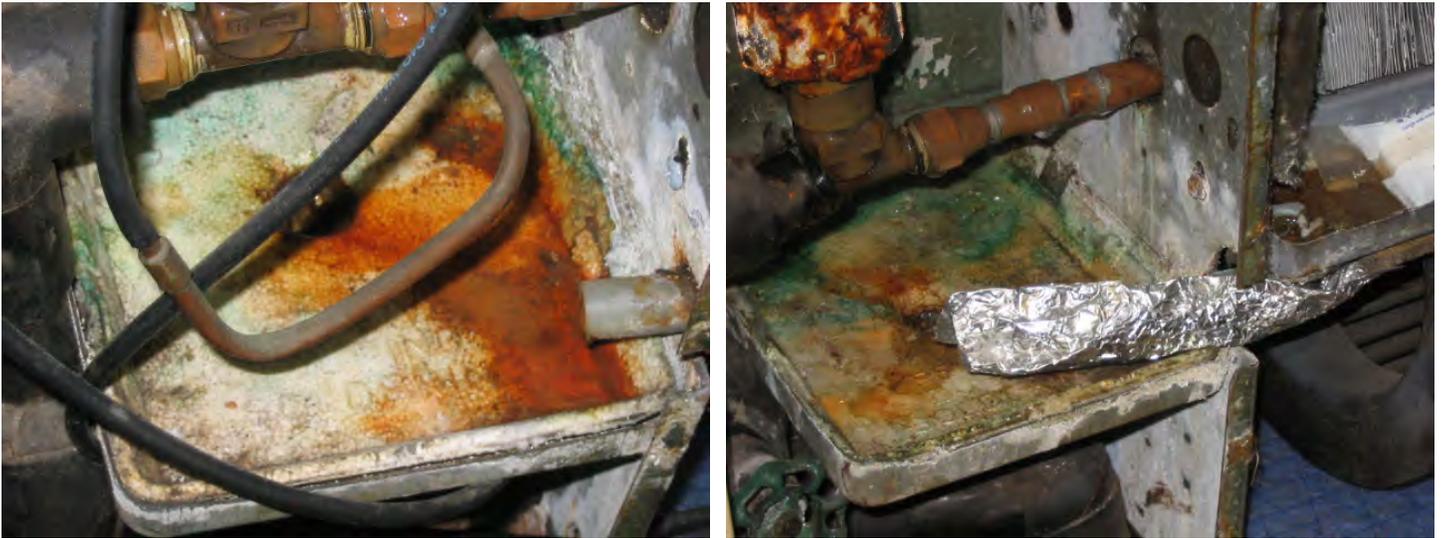
Picture 17

**Aluminum Foil Sculpted as Drain Pipe
Note Intact Drain Pipe on Left**

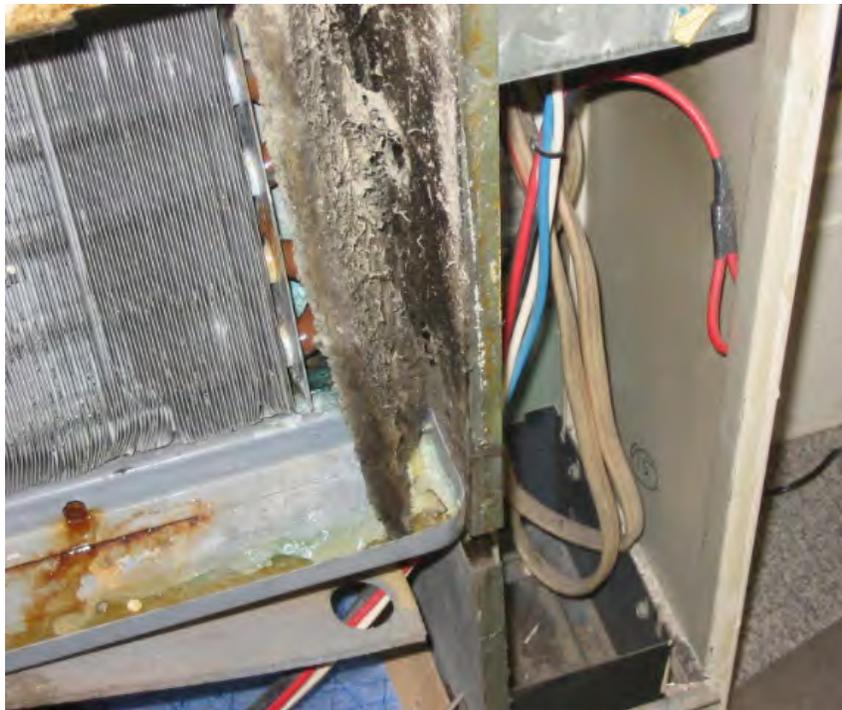
Picture 18

Insulation within the FCUs was found damaged and deteriorated. In this condition, condensation can form on the metal housing of the unit (Picture 18). BEH staff also found water-stained carpet around a FCU indicating that the unit is not properly draining water (Picture 3). Water damaged carpet can serve as mold growth media. Porous building materials can result in microbial growth. Several areas in the PCH had water-damaged ceiling tiles which can

Damaged Insulation within Fan Coil Unit

2. An evaluation of FCUs should be done to ascertain whether this HVAC system component can be repaired to prevent condensation generation. If not repairable, consideration should be given to replacing FCUs.
3. Consider providing mechanical ventilation for all offices and rooms in PCH. Examine the feasibility of using the abandoned exhaust system as fresh air ductwork. Return air ventilation may be done with ducting or by using the interior hallways as a plenum return system.
4. Examine the feasibility of installing local exhaust ventilation for photocopiers or move to a well-ventilated area.
5. Inspect woodwork in close proximity to sub-flooring for mold growth or water damage. If mold contaminated, remove in accordance with recommendations in the US Environmental Protection Agency's Mold Remediation in Schools and Commercial Buildings guide (US EPA, 2001).

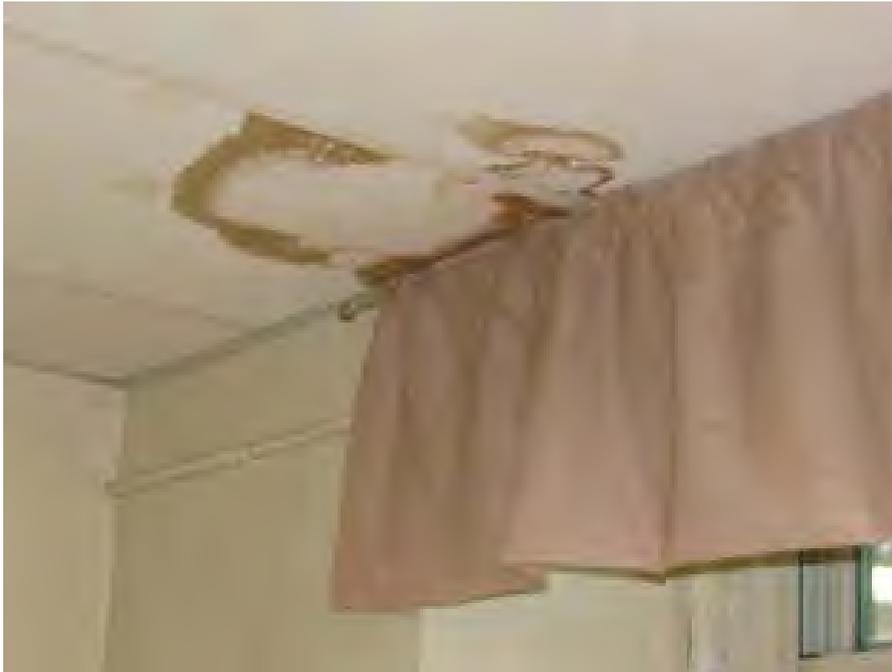
Picture 19

indicate leaks from either the roof or plumbing system (Picture 19). Water-damaged ceiling tiles can provide a source of mold and should be replaced after a water leak is discovered and repaired.

Water-Damaged Ceiling Tiles

14. Remove/replace water damaged ceiling tiles. Examine the areas above and around for mold growth. Disinfect areas of water leaks with an appropriate antimicrobial.

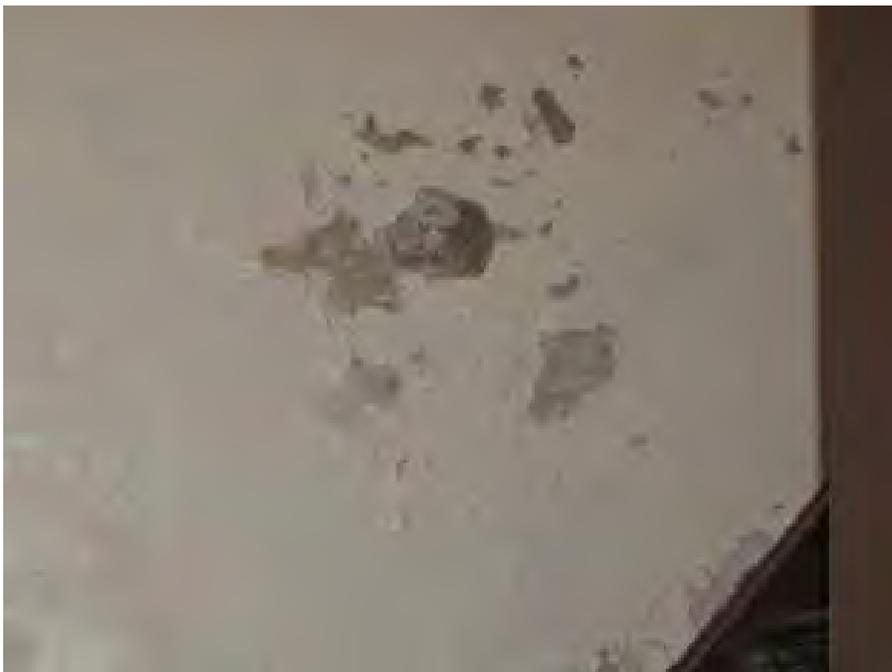
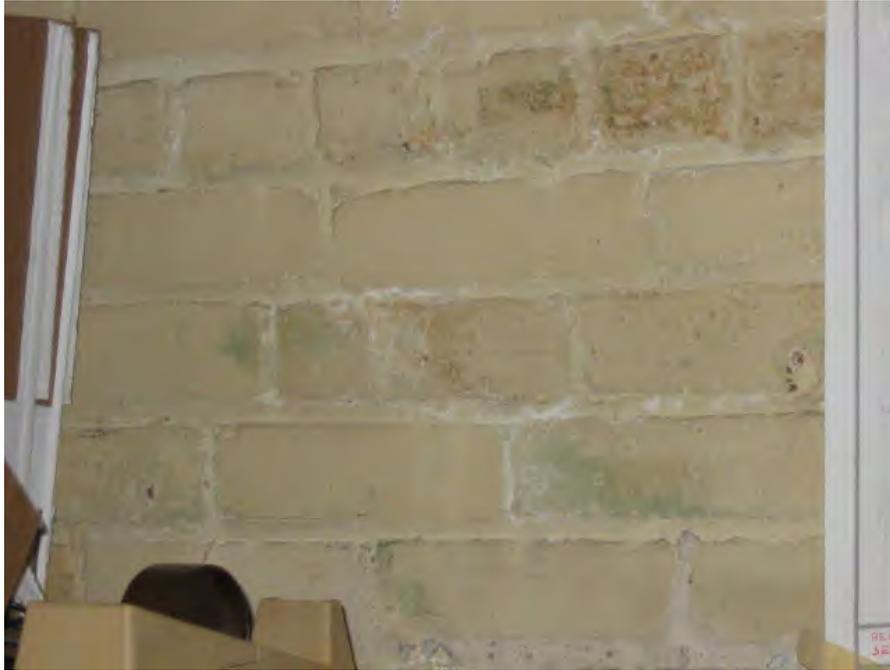
Water-damaged plaster, peeling paint and efflorescence was noted in a few areas (Pictures 20 and 21). Efflorescence is a characteristic sign of water damage, but it is not mold growth. As moisture penetrates and works its way through porous building materials (e.g., brick, plaster, cement), water-soluble compounds in the material dissolves, creating a solution. As this solution moves to the surface of the material, the water evaporates, leaving behind white, powdery mineral deposits. This condition indicates that moisture is penetrating through the building envelope in this area. The area should be cleaned, sealed, re-painted and monitored for further damage. If evidence of water penetration recurs, an evaluation of the building envelope/exterior should be conducted for possible sources of water penetration.

Peeling Paint and Efflorescence on Wall

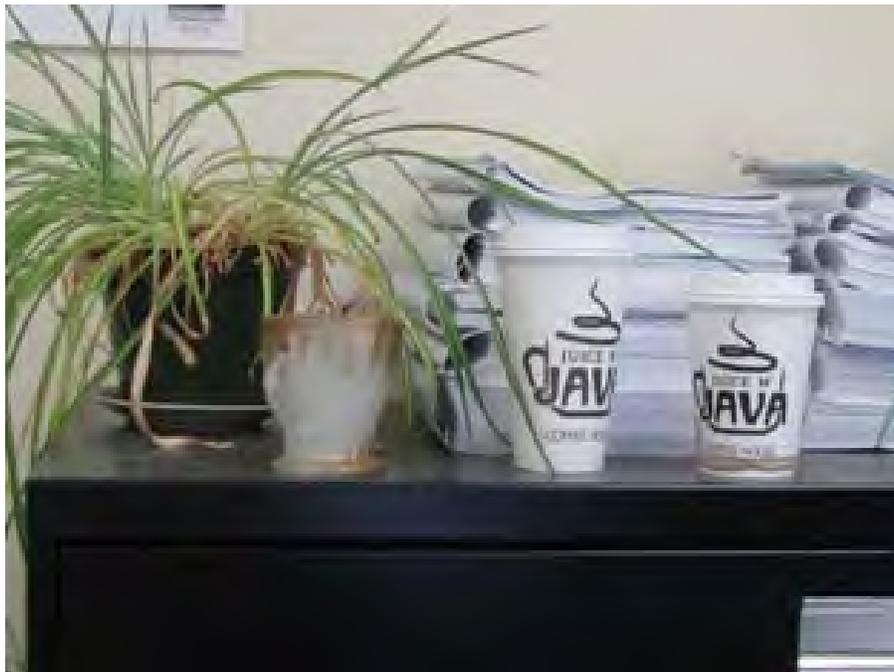
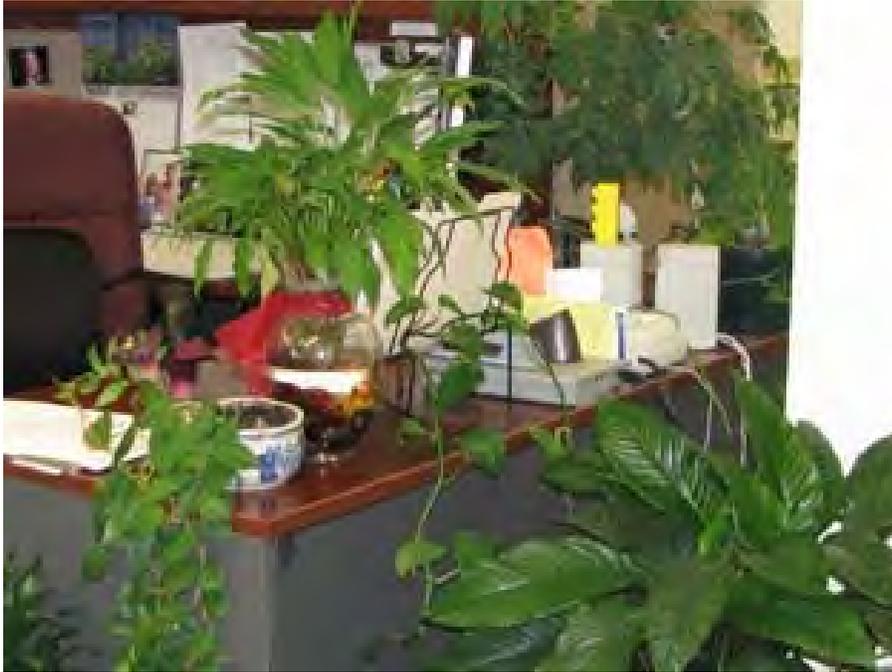
Plants were observed in a number of rooms, many without drip pans (Pictures 22 and 23). Plants, soil, and drip pans can serve as sources for mold growth and should be properly maintained. Over-watering of plants should be avoided and drip pans should be inspected periodically for mold growth. In addition, flowering plants can be a source of pollen. Therefore, plants should be located away from the air stream of ventilation sources to prevent aerosolization of mold, pollen and particulate matter.

Plants on Cabinet

Plants on Desk and Floor

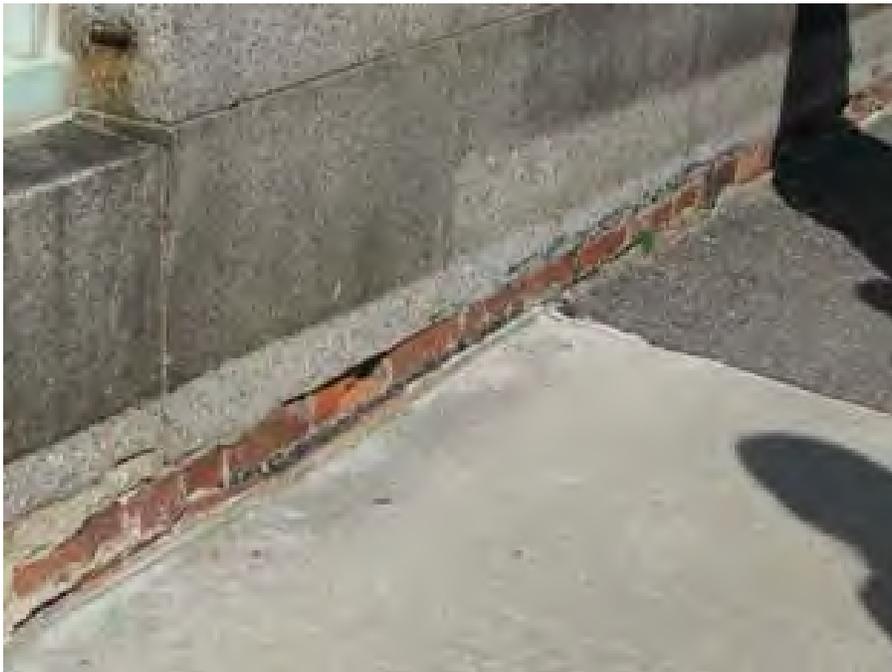
Picture 24

- Missing/damaged exterior brick and mortar (Picture 24). Breaches in the building envelope represent potential pathways for air and moisture to enter the building. Over time, this condition can undermine the integrity of the building envelope and provide a means of water entry into the building via capillary action through foundation concrete and masonry (Lstiburek and Brennan, 2001). In addition, these breaches may provide a means of egress for pests/rodents into the building.

Damaged Exterior Brick and Mortar

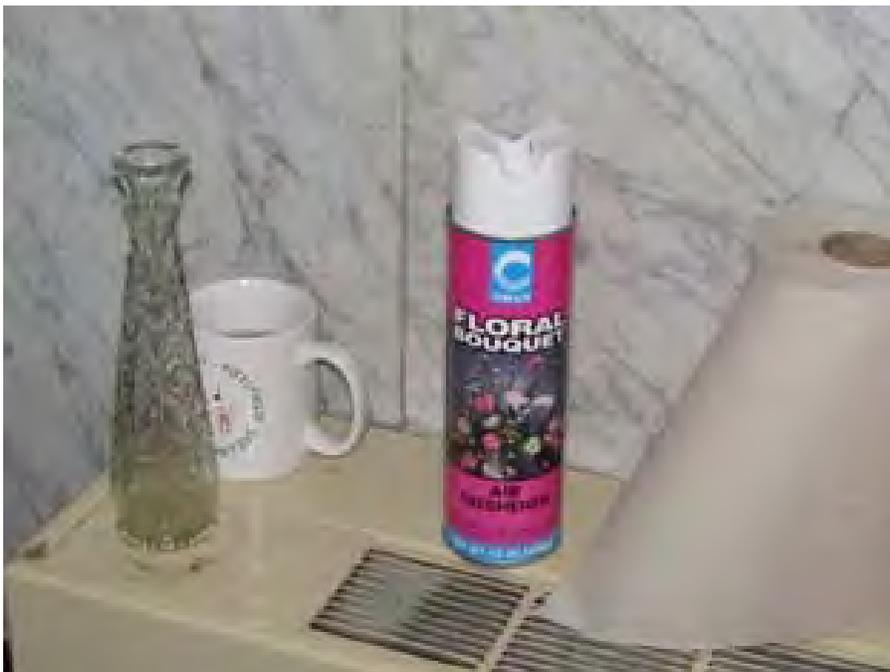
Picture 28

Air fresheners and deodorizers were observed in several areas (Picture 28). Air deodorizers contain chemicals that can be irritating to the eyes, nose and throat of sensitive individuals. Many air fresheners contain 1,4-dichlorobenzene, a VOC which may cause reductions in lung function (NIH, 2006). Deodorizing agents do not remove materials causing odors, but rather mask odors that may be present in the area.

Air Freshener

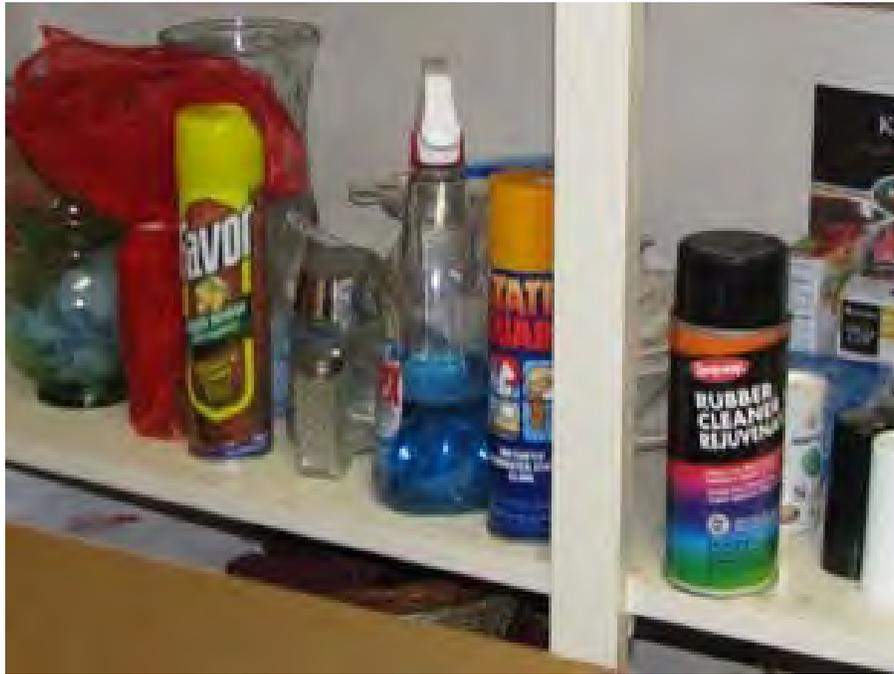
Picture 29

Cleaning products were found in several offices (Picture 29). Cleaning products contain VOCs and other chemicals that can be irritating to the eyes, nose and throat of sensitive individuals. Material safety data sheets (MSDS') should be obtained for each chemical utilized at PCH and stored/posted in a central location within the facility.

Cleaning Products

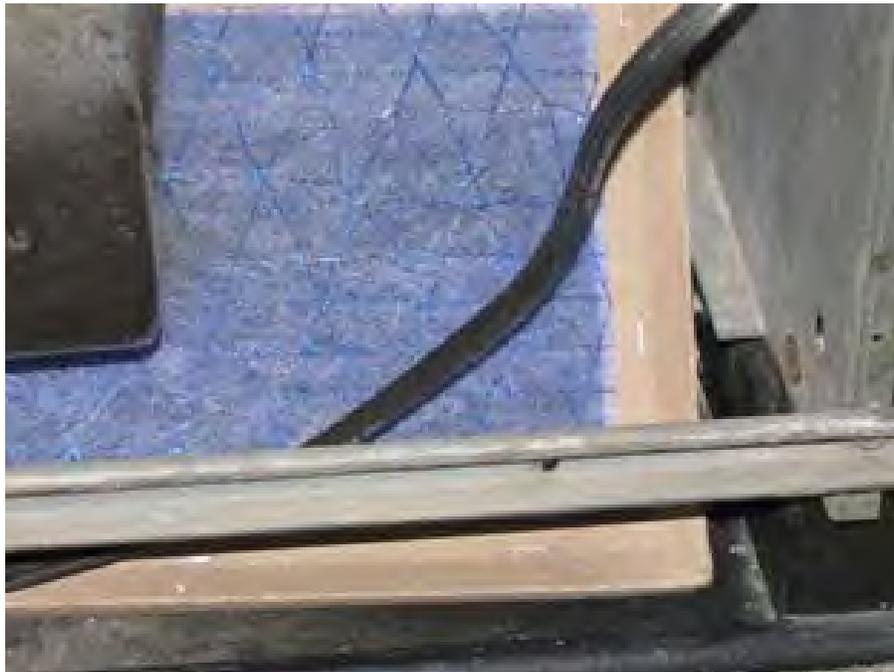
Picture 30

BEH staff noted the filters for the FCUs had spaces around them (Picture 30). Without filters in place, spaces around filters can allow for unfiltered air to bypass the filters and be distributed to occupied areas the by units.

Space around Filters where Unfiltered Air can bypass
