INDOOR AIR QUALITY ASSESSMENT

**Massachusetts Rehabilitation Commission
6 Clinton Avenue
Pittsfield, Massachusetts 01201**

Prepared by:
Massachusetts Department of Public Health
Bureau of Environmental Health
Indoor Air Quality Program
November 2009

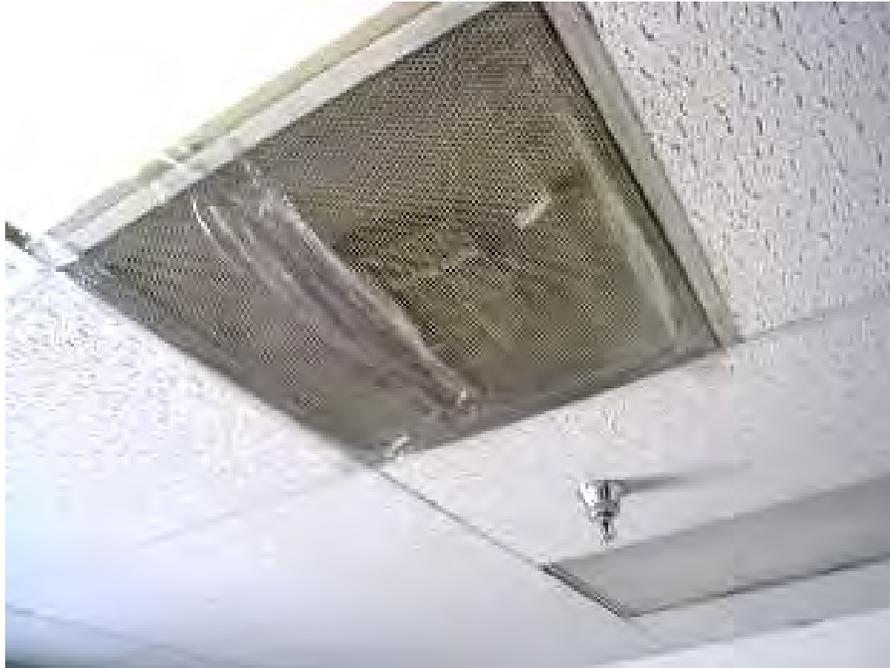
Picture 1

As can be seen in Picture 1, MRC occupants have attempted to adjust the airflow within their space by obstructing the air diffuser in an effort to reduce the volume of air entering the room. This alteration can create an imbalance in the system, resulting in uneven heating/cooling conditions leading to comfort complaints.

Fresh Air Diffuser, Note Diffuser is Obstructed

1. Operate the HVAC system continuously during periods of occupancy to maximize air exchange.
2. Remove obstructions from air diffusers. To improve thermal comfort/temperature control, it is highly recommended that MRC staff work in conjunction with building

management and their HVAC vendor to examine the configuration of floor space and the placement of diffusers/vents/thermostats.

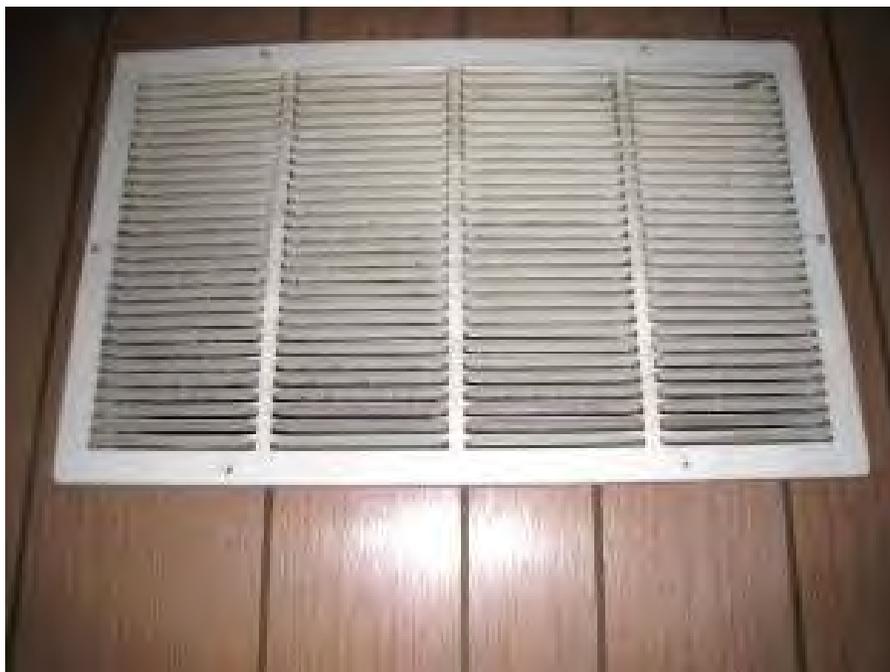
Picture 2

Return Vent

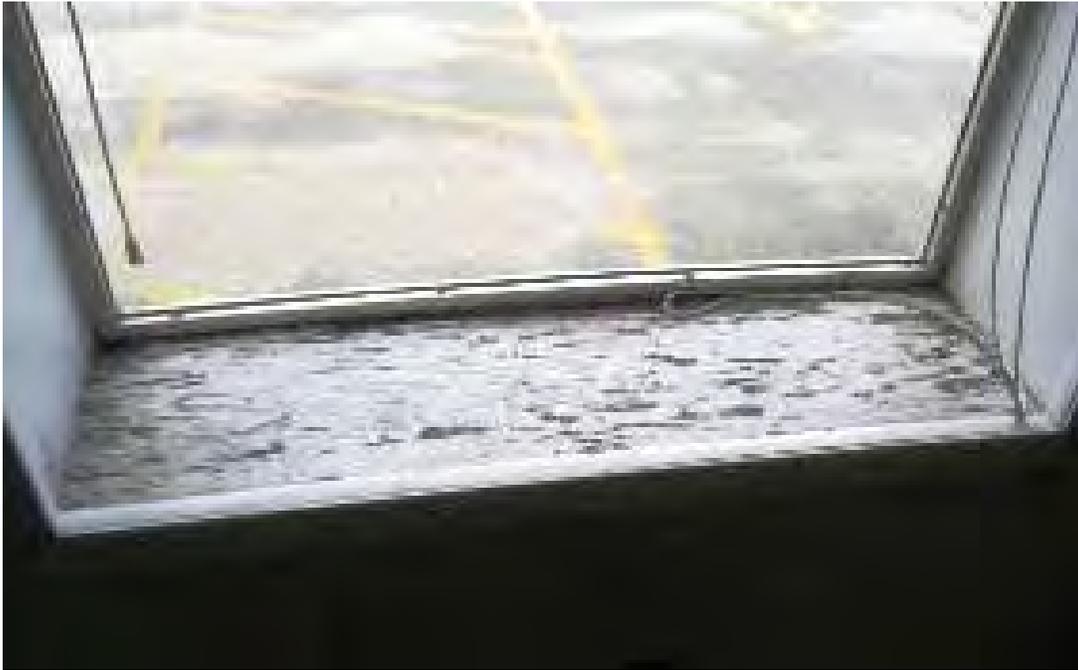
Picture 3

Water Damaged Window Sill

7. Consider replacement of window system in the MRC office. During the replacement process, ensure all water damaged materials, (e.g., window sills, casings,) are replaced. Investigate materials adjacent to the windows, including insulation and gypsum wall board, and remove any additional materials that appear to have been water damaged.

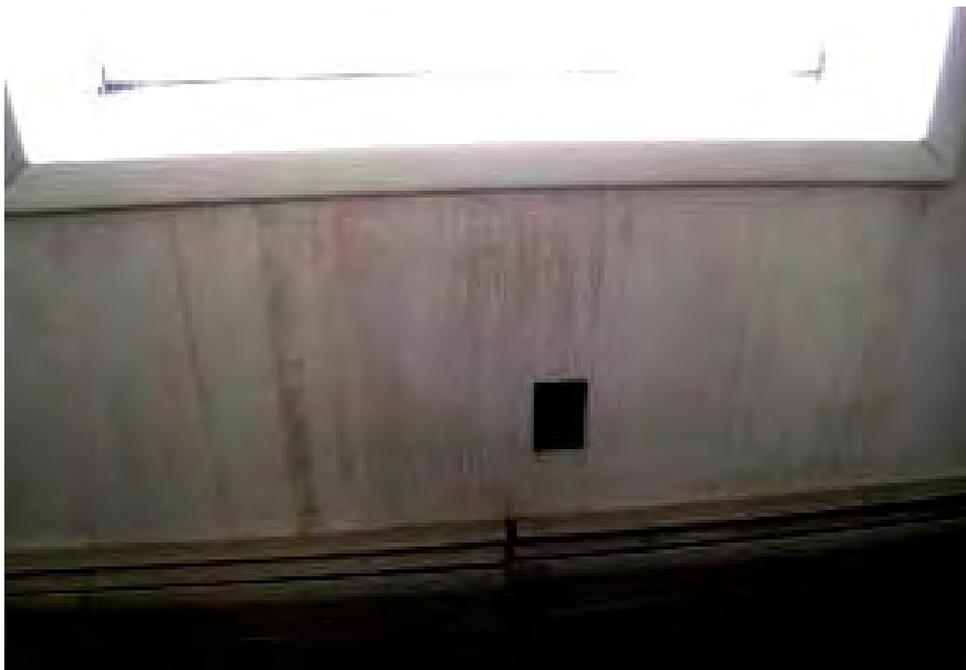
Picture 4

Water Stains on Wall

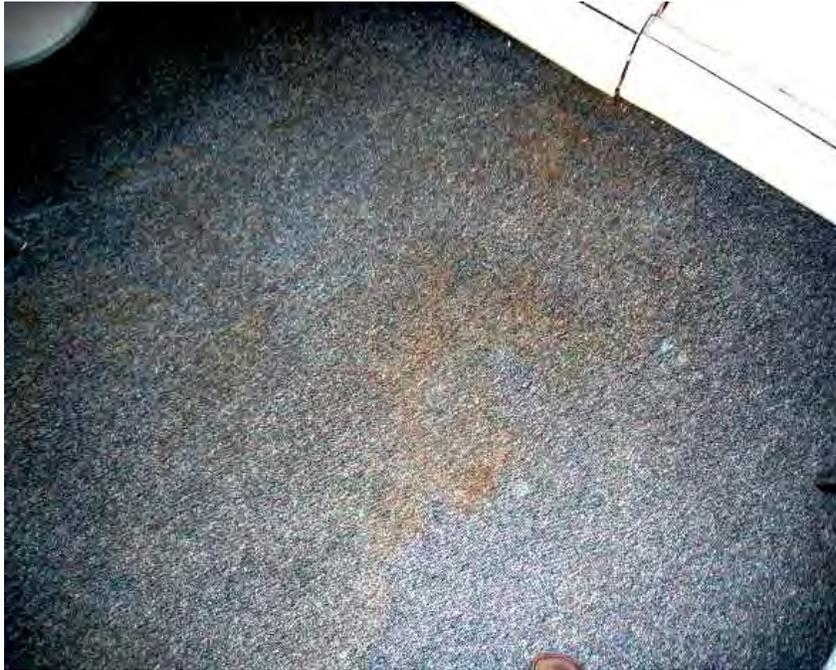
Picture 5

Water Stained Carpet

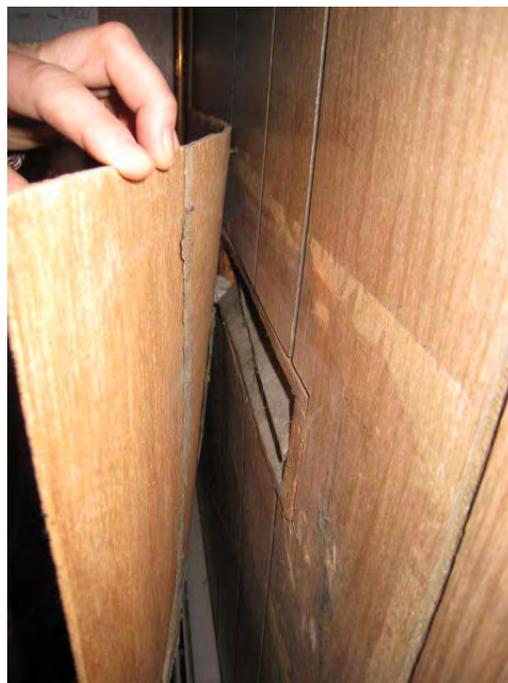
Picture 6

Abandoned Mail Slot Covered by Paneling

9. Remove and properly seal abandoned mail slot.
10. Repair and replace damaged and/or missing exterior brick and mortar. Consider having exterior walls re-pointed and waterproofed to prevent water intrusion. This measure should include a full building envelope evaluation.

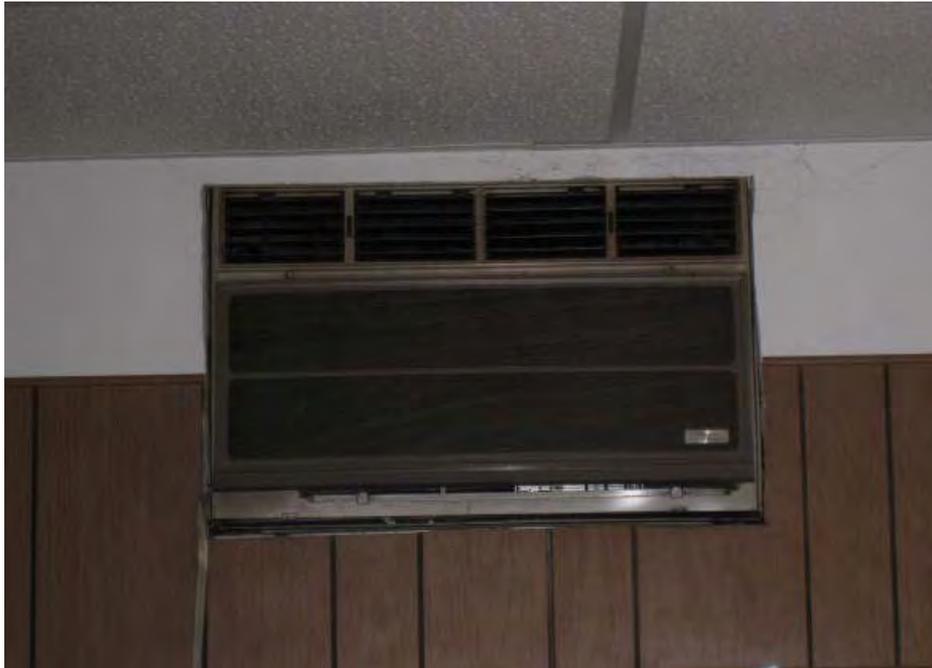
Picture 7

Wall-Mounted Air Conditioner with Gaps around it

8. Seal gaps around the wall mounted AC.

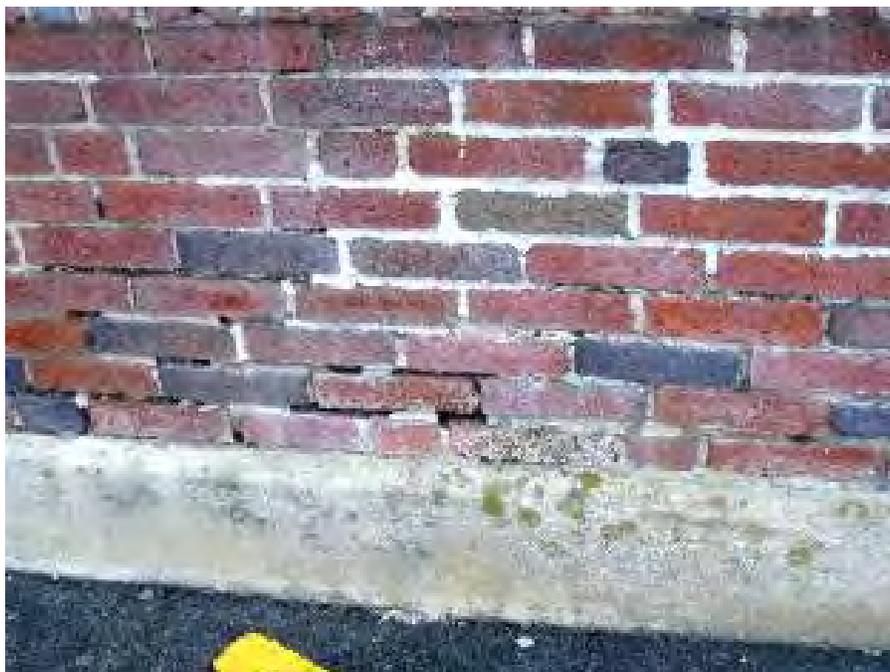
Picture 8

These conditions can undermine the integrity of the building envelope and provide a means of water entry by capillary action into the building through exterior walls, foundation concrete and masonry (Lstiburek & Brennan, 2001).

Missing/Damaged Mortar around Exterior Brick

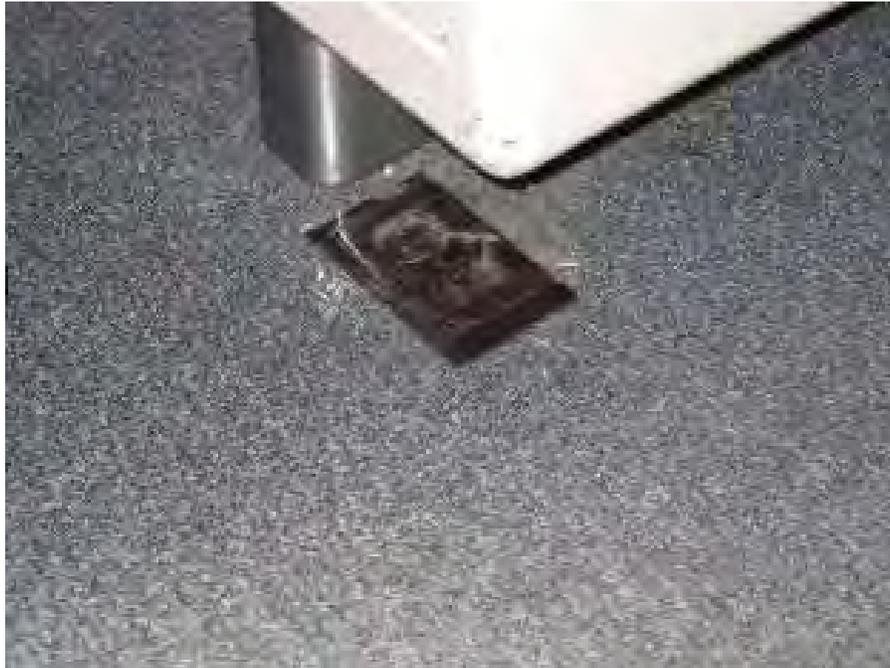
Picture 9

BEH staff noted musty odors emanating from the electrical outlets located on the floor of the main office. Tape appeared to have been placed over outlets not in use in order to prevent

the odors from entering the office (Picture 9). Since any moisture gaining entry to the building envelope, particularly under the slab, can contribute to the musty odors emanating from the floor-mounted electrical outlets, every attempt should be made to eliminate moisture from entering the building envelope. Likewise, any open utility holes within the MRC should be identified and properly sealed. Since the building was formerly used as a car dealership, the building may have originally contained floor drains or abandoned plumbing drains that exist in wall cavities. It would be prudent to examine the original floor plans (if available) to determine the presence and location of any existing floor drains, in that the drain is not adequately sealed.

Musty Odors Emanating From Electrical Outlet

13. Seal all open utility holes in basement in order to eliminate musty odors emanating into office from floor mounted electrical outlets.
14. Consider providing plants with drip pans and avoid over-watering. Examine drip pans periodically for mold growth. Disinfect with an appropriate antimicrobial where necessary.

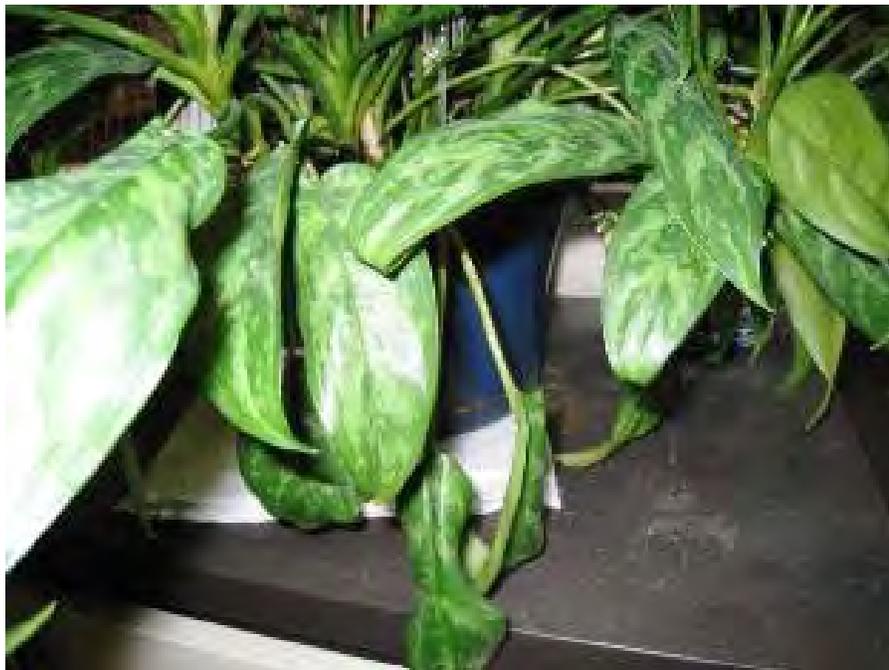
Picture 10

Numerous plants, some lacking drip pans, were observed in the office. Plants should be equipped with drip pans to prevent water pooling. In one instance, paper was placed beneath a plant to absorb excess water (Picture 10). Paper is a porous material that can grow mold if wetted repeatedly. Plants should be properly maintained and located away from the air stream of mechanical ventilation to prevent aerosolization of dirt, pollen or mold.

Plant Resting on Paper

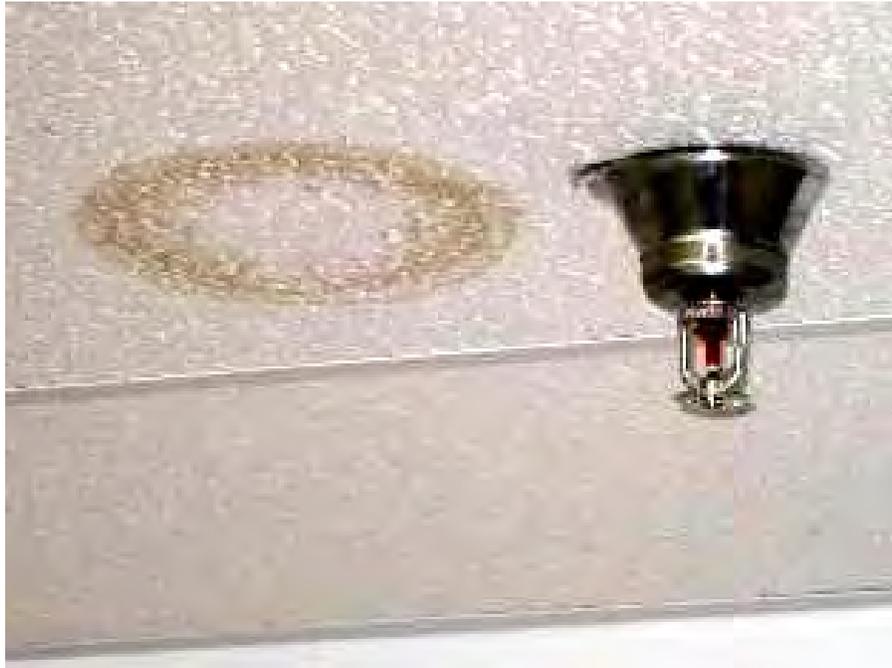
Picture 11

BEH staff found water-damaged ceiling tiles in a number of areas (Table 1/Picture 11), which can indicate leaks from the roof or plumbing system. Water-damaged ceiling tiles can provide a source of mold and should be replaced after a water leak is discovered and repaired.

Water Damaged Ceiling Tile

6. Ensure roof/plumbing leaks are repaired. Remove/replace water damaged ceiling tiles. Examine the areas above and around for mold growth. Disinfect areas of water leaks with an appropriate antimicrobial if necessary.
