# **INDOOR AIR QUALITY ASSESSMENT**

**Sherwood Middle School  
30 Sherwood Ave  
Shrewsbury, MA 01545**

Prepared by:  
Massachusetts Department of Public Health  
Bureau of Environmental Health  
Indoor Air Quality Program  
December 2009

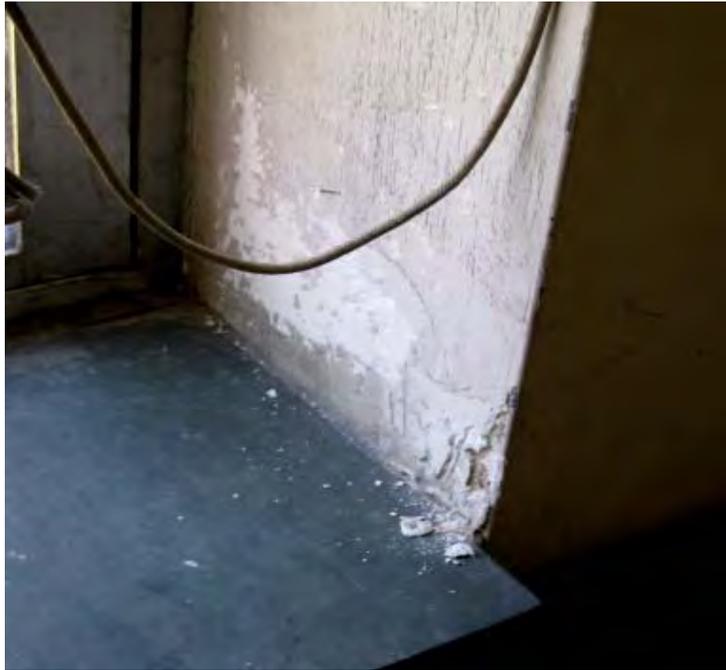
**Picture 1**

- Water damaged plaster around window frames (Pictures 1 and 2);
- Water damaged ceiling plaster and efflorescence (Pictures 3 through 5); and
- Water stained ceiling tiles (Picture 6).

**Water Damaged Plaster around Window Frames**

18. Consider replacement of window systems throughout the building to prevent water penetration and drafts through window frames.
19. Consider having exterior brick re-pointed and waterproofed to prevent water intrusion.

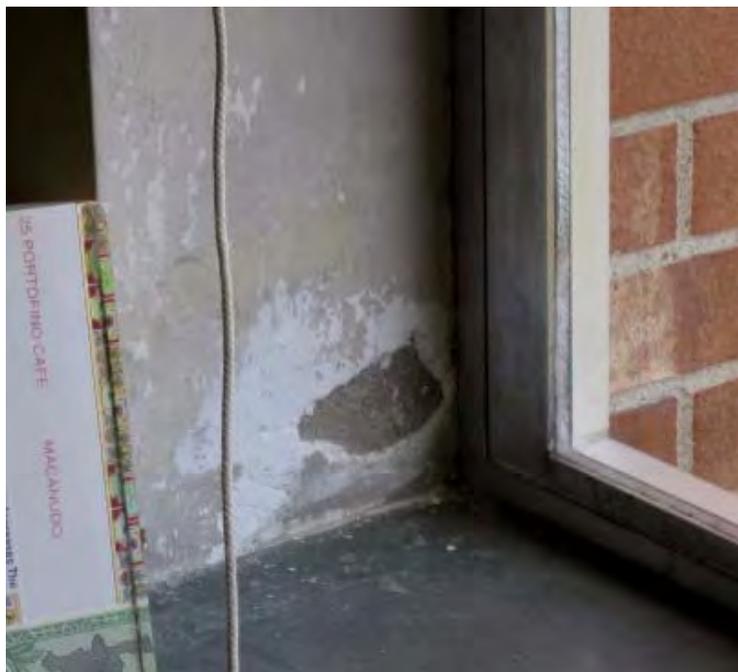
**Picture 2**

**Water Damaged Plaster around Window Frames**

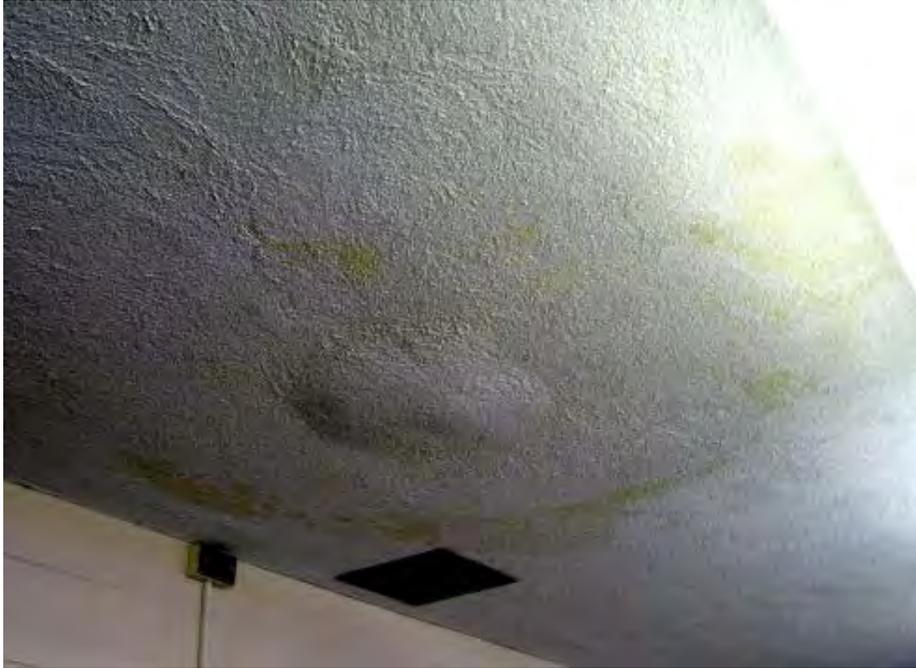
**Picture 3**

A chronic roof leak was reported in the main office where water damaged ceiling plaster was noted (Picture 3). Office staff reported that buckets are commonly placed beneath areas of known water leaks during rainstorms. Leaks were also reported in 1st floor classrooms 120/121, where again water damaged ceiling plaster was also noted. BEH staff examined the classroom above this area and found a clogged drain (Picture 7), which may be the source of previous water leaks.

**Water Stained Ceiling Plaster in Main Office, Note Bulge in Center**

10. Replace missing elbows to downspouts in a manner to direct rainwater away from the building.
11. Ensure drain pipe in classroom 208 is unclogged.
12. Inspect/repair roof above main office and make repairs as needed.

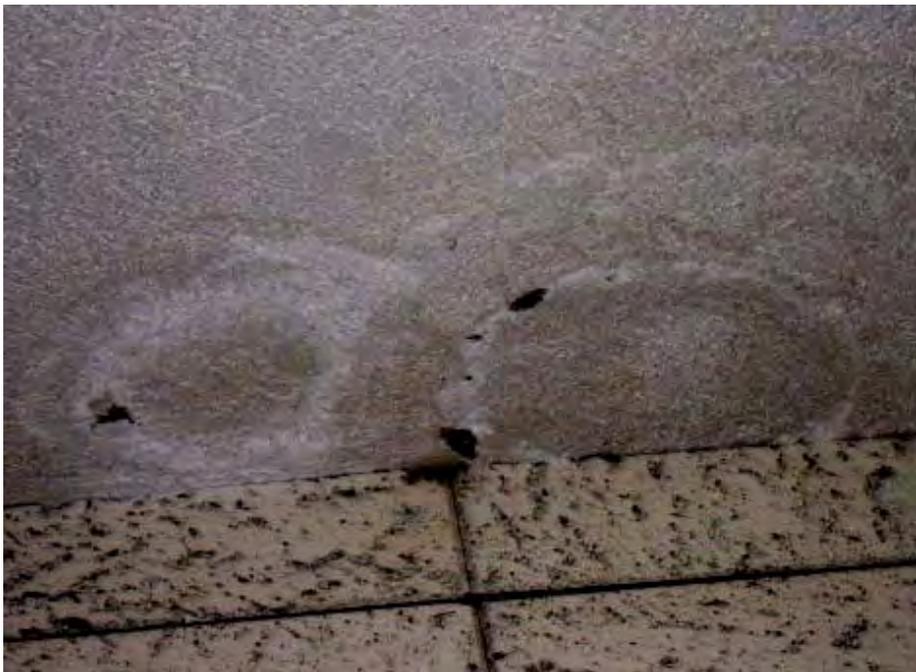
**Picture 4**

Efflorescence is a characteristic sign of water damage but it is not mold growth. As moisture penetrates and works its way through mortar, brick or plaster, water-soluble compounds dissolve, creating a solution. As the solution moves to the surface of the material, the water evaporates, leaving behind white, powdery mineral deposits.

**Water Damaged Ceiling Plaster and Efflorescence**

17. Scrape/clean efflorescence from masonry walls/ceilings and monitor for further water penetration. Clean, prepare, and re-paint concrete/plaster ceilings and walls in water damaged areas once leaks are repaired.

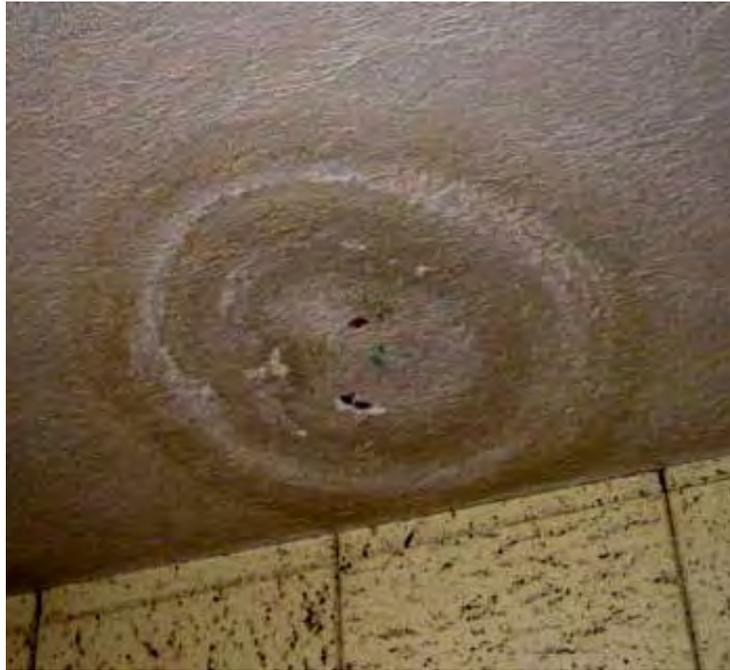
**Picture 5**

**Water Damaged Ceiling Plaster and Efflorescence**

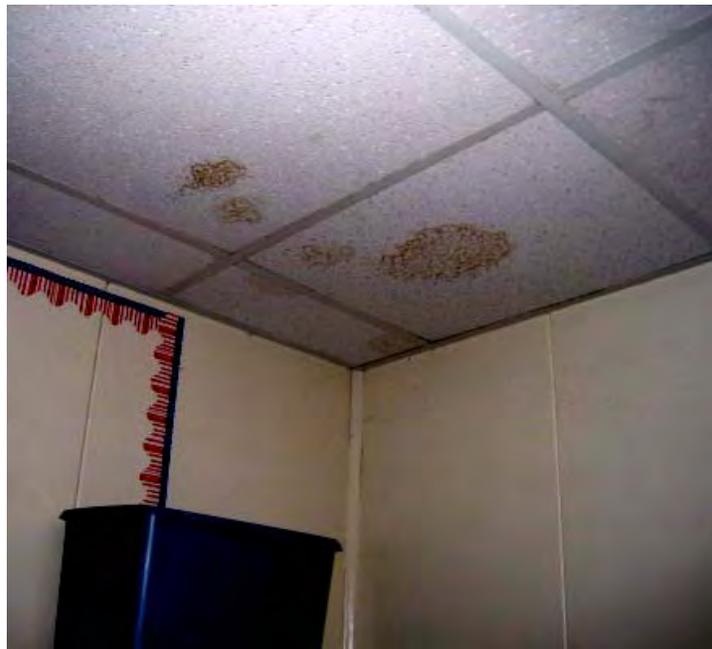
**Picture 6**

**Water Damaged Ceiling Tiles in Modular Classroom 109, Note Bucket to Catch Leaks  
(April 9, 2009)**

13. Remove/replace water damaged ceiling tiles. Examine the areas above and around for mold growth. Disinfect areas of water leaks with an appropriate antimicrobial.

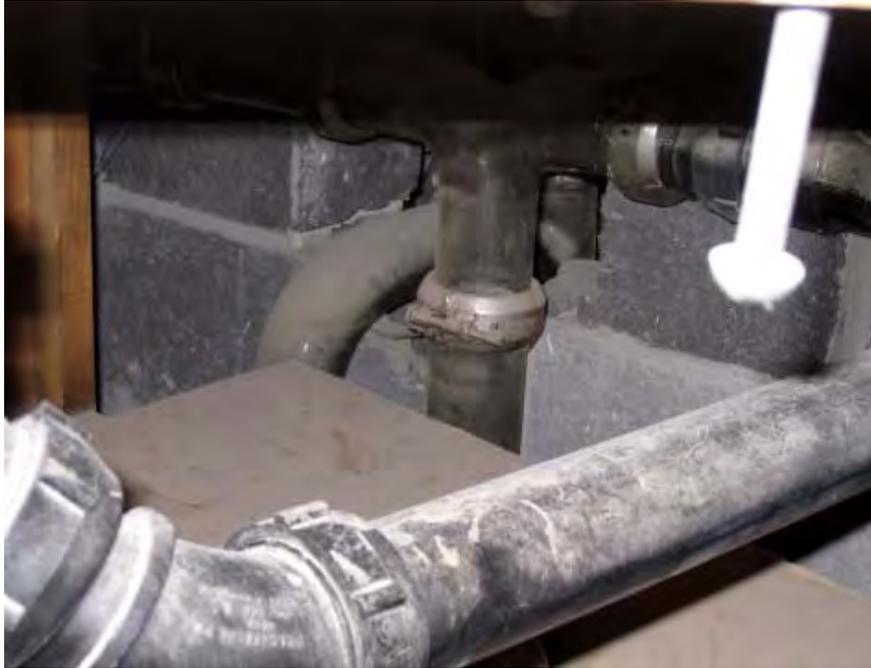
**Picture 7**

**Clogged Drain in Classroom 208, Directly above Classroom 121**

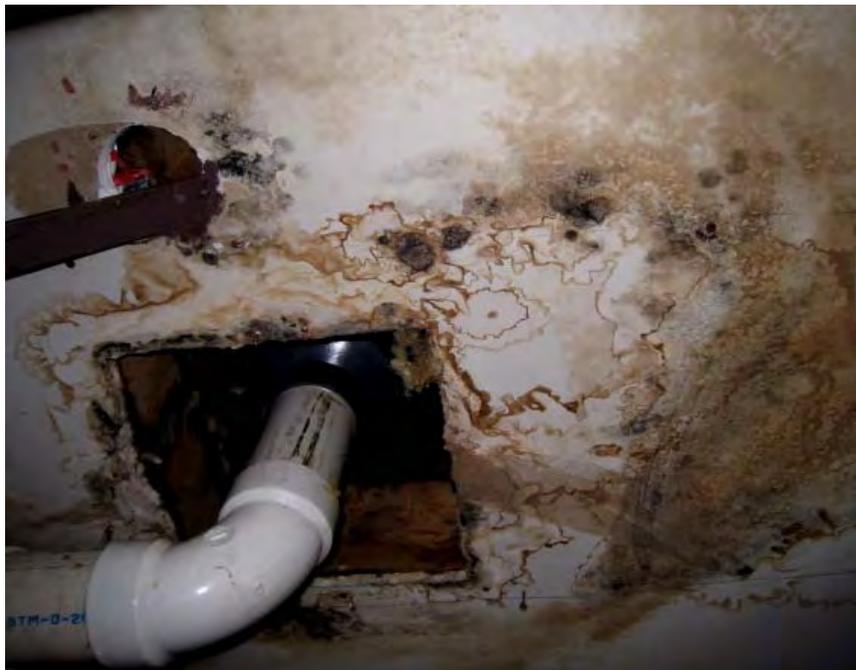
**Picture 8**

Active leaks were also reported in modular classroom 109. At the time of the April 9, 2009 visit, visible mold growth was observed on the gypsum wallboard (GW) ceiling above ceiling tiles in the corner of the classroom (Picture 8). SPBD staff reported that a roof drain above this modular classroom had frozen, causing damage to the integrity of the drainpipe, which caused the water leak and subsequently damaged the ceiling tiles. In order to prevent future pipe freezing, the SPBD installed heated coils in roof drains to melt ice (Picture 9). As mentioned, BEH staff visited the SMS on June 12, 2009, subsequent to the pipe heating system installation, which was after several days of rain. BEH staff found that the ceiling tile below the in this area was saturated (Pictures 10 and 11), indicating that the damaged drainpipe was unlikely to be the sole cause of water penetration. In subsequent

**Water Damaged/Mold Colonized Gypsum Wallboard Ceiling in Modular Classroom 109**

2. Remove water-damaged/mold-colonized gypsum wallboard in modular classroom 109. Consider replacing with a non-porous material. This measure will remove actively growing mold colonies that may be present.

6. Work with a roofing contractor to make repairs to chronic roof leaks in modular classroom wing. Replacing water damaged materials will remove mold growth; however, unless the source of moisture is repaired materials will continue to get wet and may lead to subsequent mold growth.

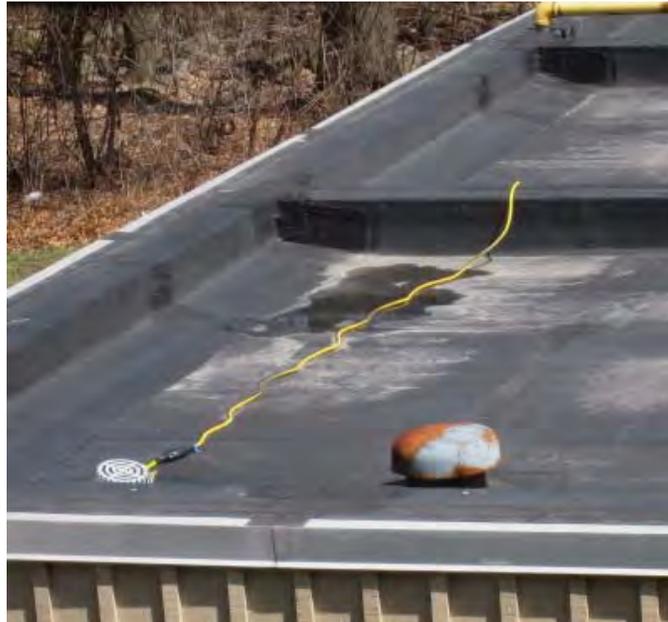
**Picture 9**

**Heated Electrical Coils to Melt Ice in Rooftop Drains of Modular Wing**

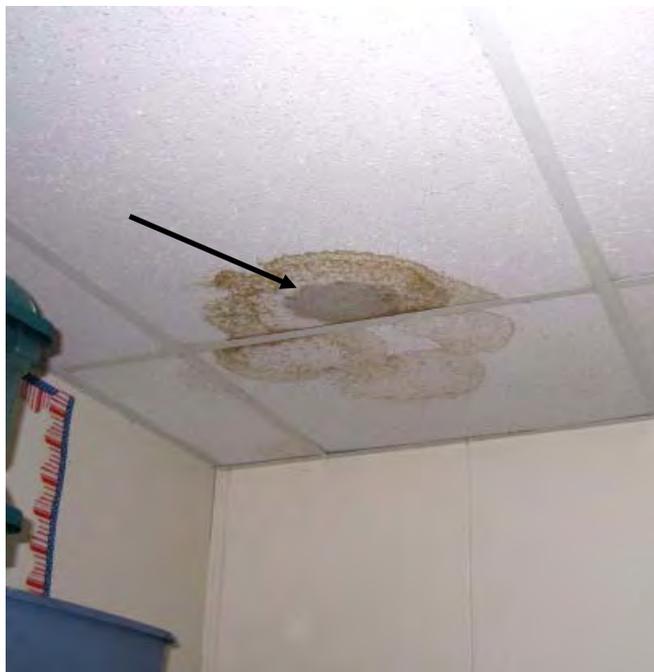
**Picture 10**

**Water Damaged Ceiling Tiles in Modular Classroom 109, Note Dark Circular Stain Indicating Tile was Saturated (June 12, 2009)**

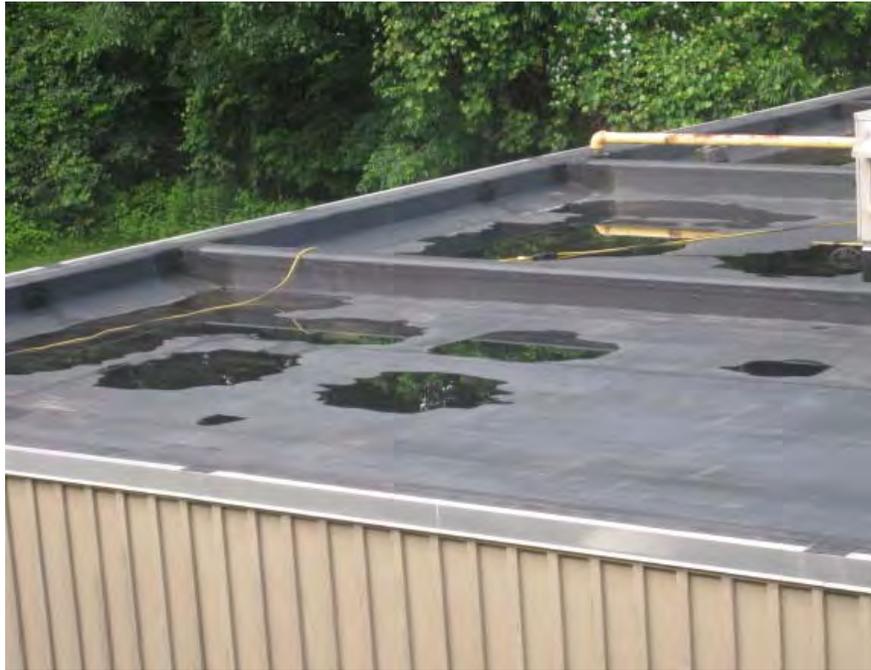
**Picture 11**

**Pooling Water on Roof of Modular Classroom Wing (June 12, 2009)**

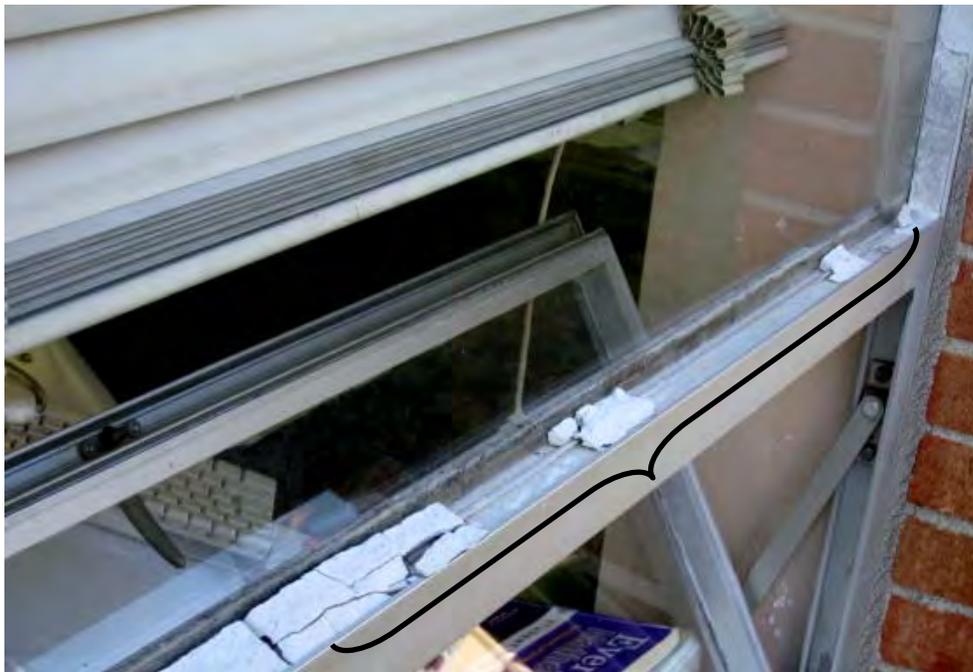
**Picture 12**

- Missing/damaged exterior window caulking (Pictures 12 through 14);
- Missing/damaged mortar and exterior brick (Picture 15);
- A clogged exterior drain at the rear of the building (Pictures 16 and 17);
- Missing elbow extensions on downspouts (Picture 18); and
- Spaces under exterior doors (Picture 19).

**Missing/Damaged Exterior Window Caulking**

15. Remove leaves and debris from exterior drain, examine for proper drainage. Make repairs as needed.
16. Seal windows to prevent water penetration and drafts.

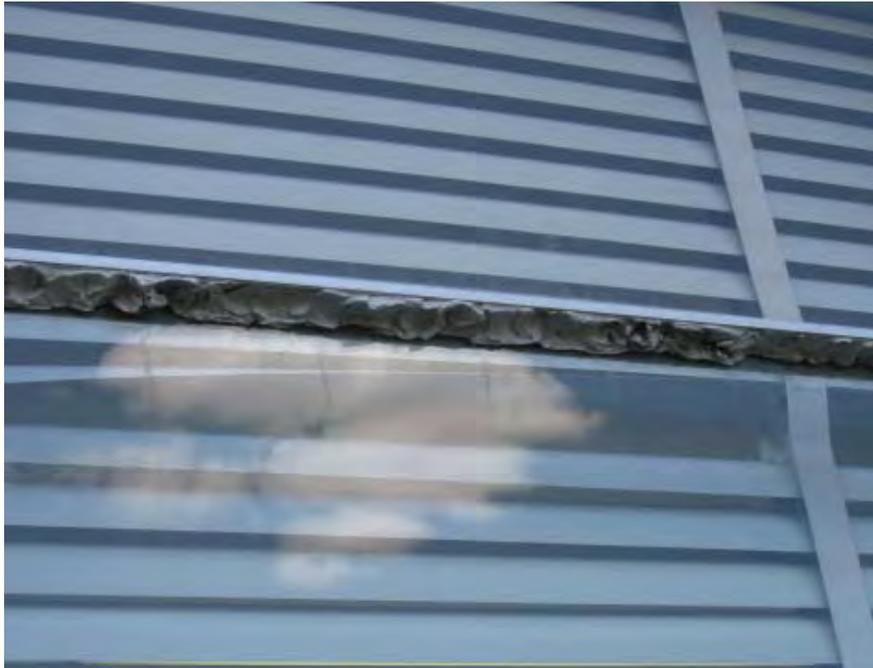
**Picture 13**

**Missing/Damaged Exterior Window Caulking**

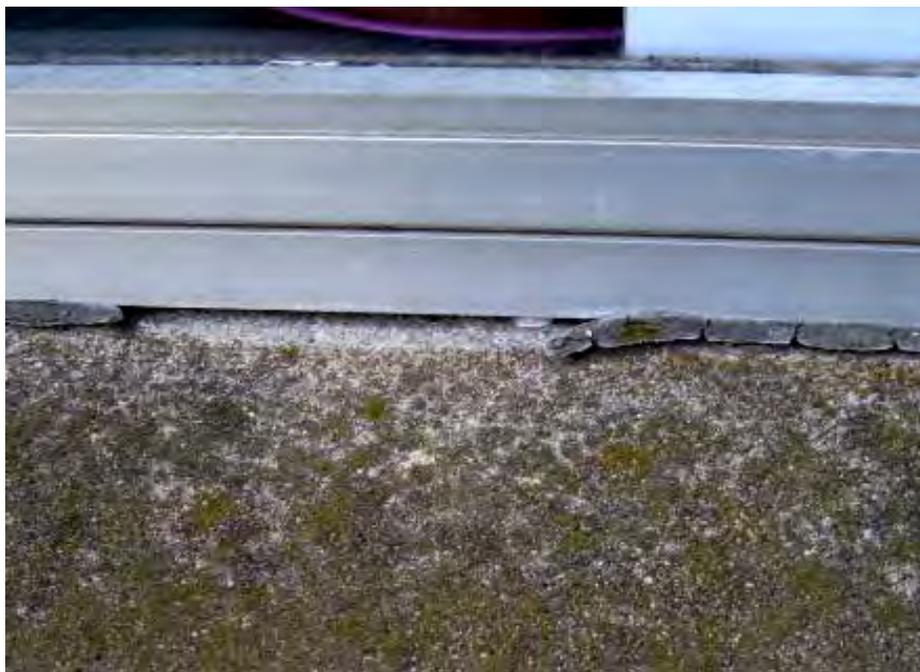
**Picture 14**

**Missing/Damaged Caulking around Window Frame**

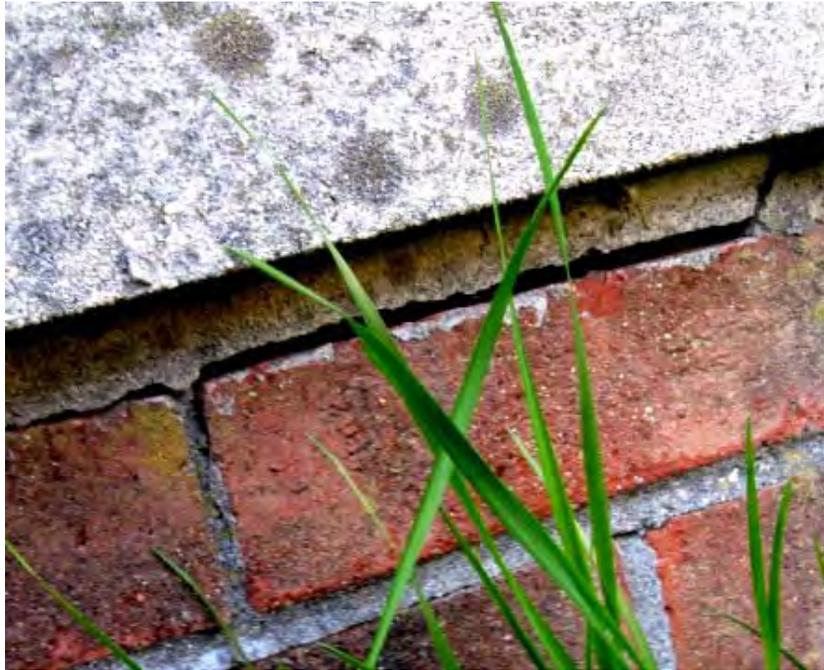
**Picture 15**

**Missing/Damaged Mortar around Exterior Brick**

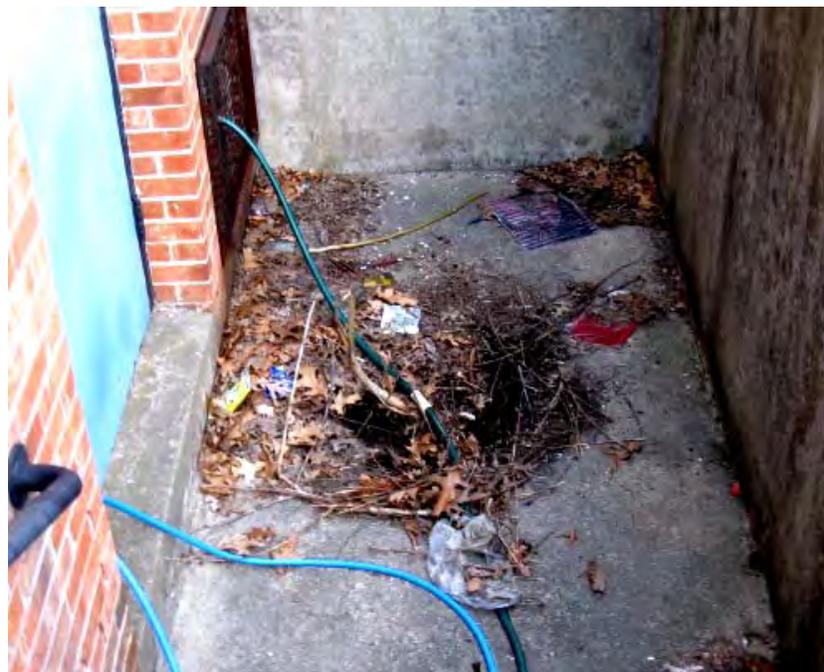
**Picture 16**

**Clogged Drain at Bottom of Exterior Stairwell**

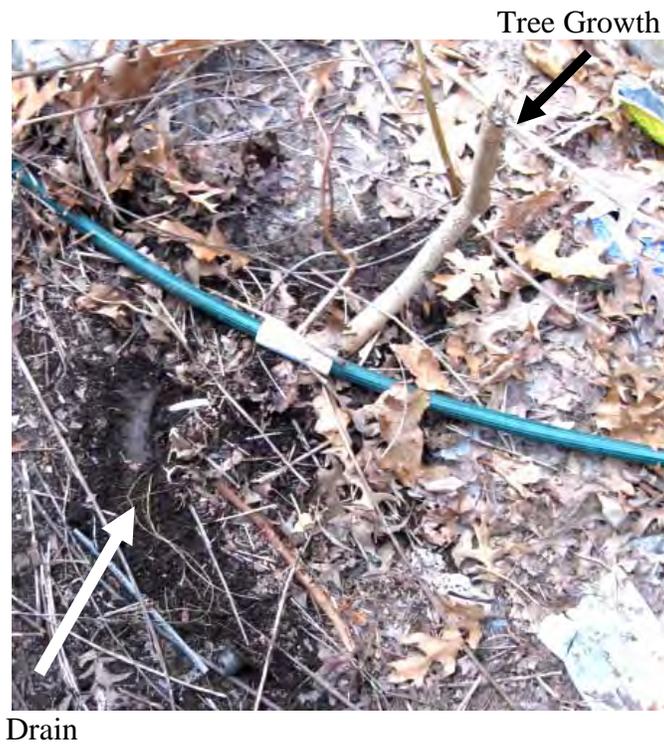
**Picture 17**

**Close-Up of Clogged Drain at Bottom of Exterior Stairwell,  
Note Tree Growing out of Dirt/Debris**

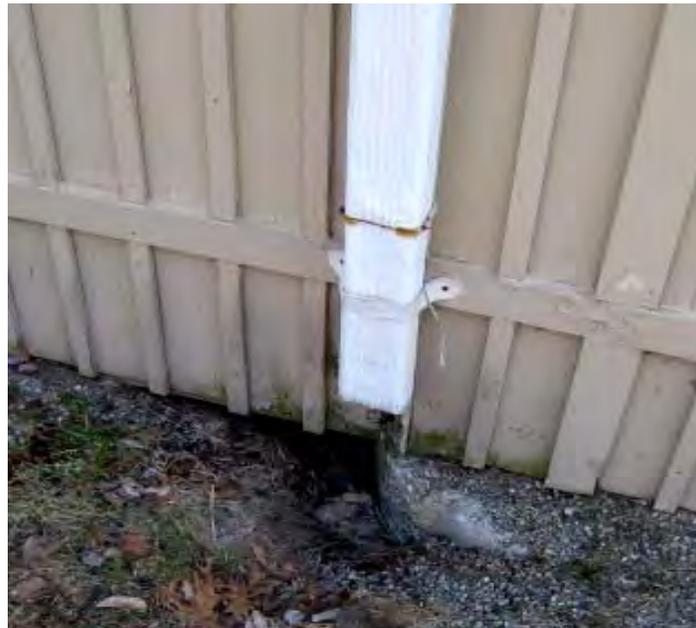
**Picture 18**

**Missing Elbow Extension on Downspout**

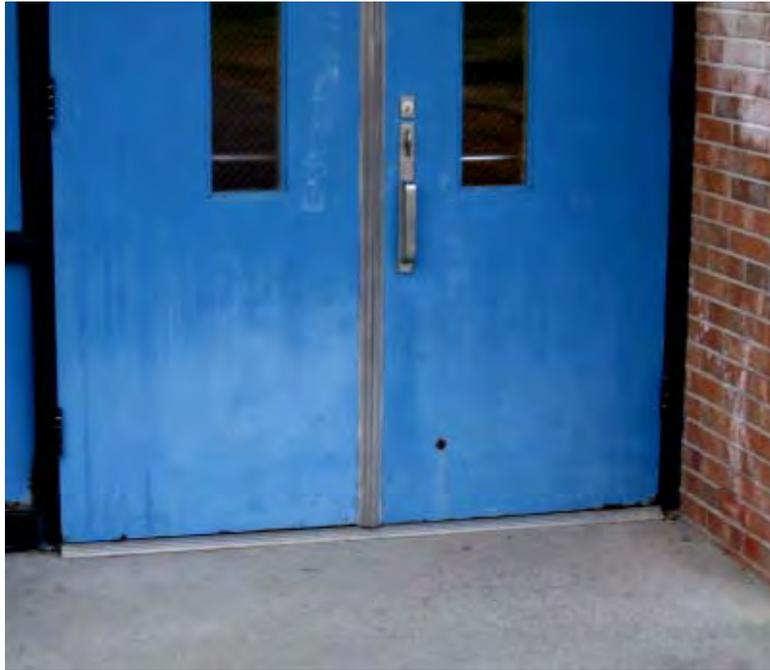
**Picture 19**

**Spaces under Exterior Doors**

7. Seal utility holes/breaches in exterior walls and install weather stripping around exterior doors to prevent pest entry, water penetration and drafts.

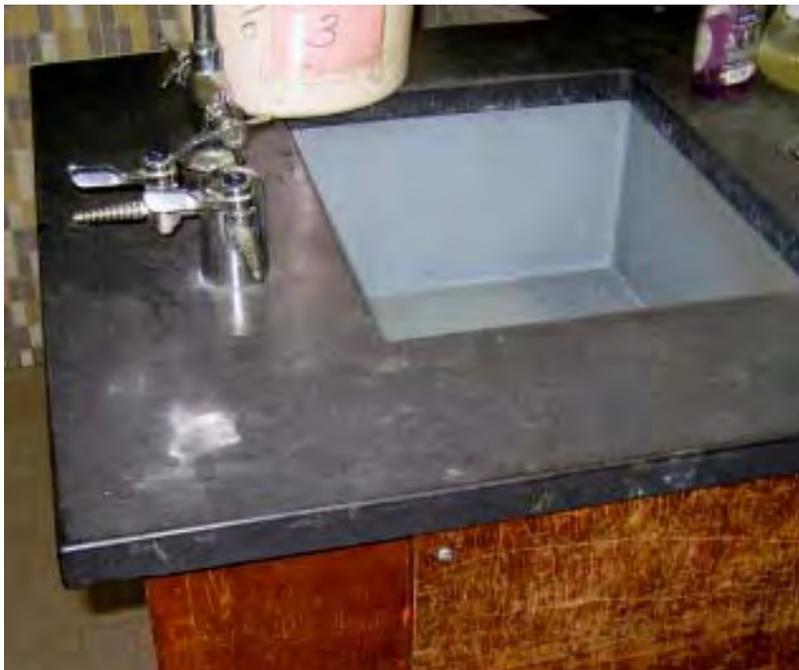
**Picture 20**

- Lab benches/classroom countertops (Pictures 20 and 21);
- Damaged (vinyl/linoleum) countertop material adjacent to univents (Picture 22);

- Lab benches in several areas (rooms 122, 123, 124, 207, 208, and 209) are made of Transite, which is a hard, fireproof composite material made of cement and asbestos. Transite is characterized as non-friable ACM. It is unclear if this excludes other similar looking lab benches and countertop material in other classrooms.
- No direct reference was listed for vinyl/linoleum material adjacent to univents.
- Wall tiles were determined to be non ACM.
- Wall plaster tested negative for ACM, with the exception of plaster in room 129 behind an outlet. It is unclear why this room was unique.

**Sink Countertops**

1. Continue to conduct required 6-month and 3-year AHERA inspections and document in accordance with current asbestos management plan.
2. Coordinate efforts between building occupants, maintenance staff, building officials, and the school's licensed asbestos inspection firm to confirm that building materials (i.e., lab benches/countertops, linoleum/vinyl surfaces adjacent to univents and wall plaster) do not have ACM. Where asbestos-containing materials are found and/or damaged, these materials should be removed, remediated or maintained in a manner consistent with Massachusetts asbestos remediation laws (MDLI, 1993).

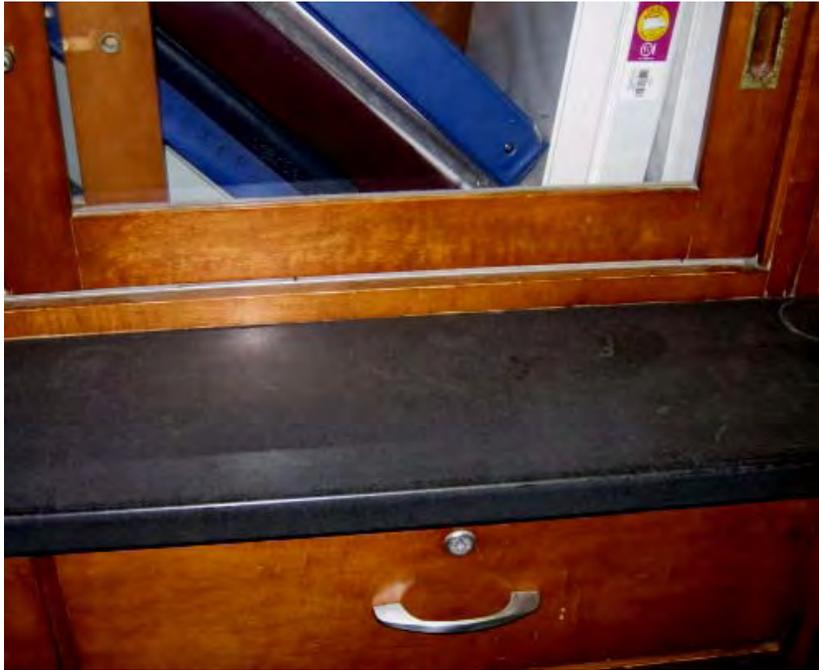
**Picture 21**

**Classroom Countertop**

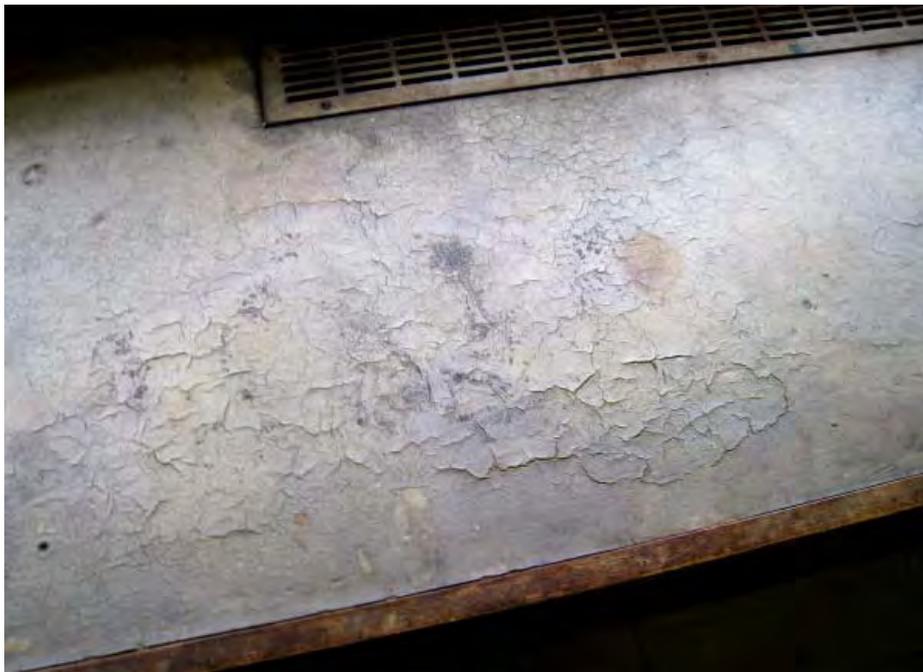
**Picture 22**

**Countertop Material Adjacent to Univent along Windows**

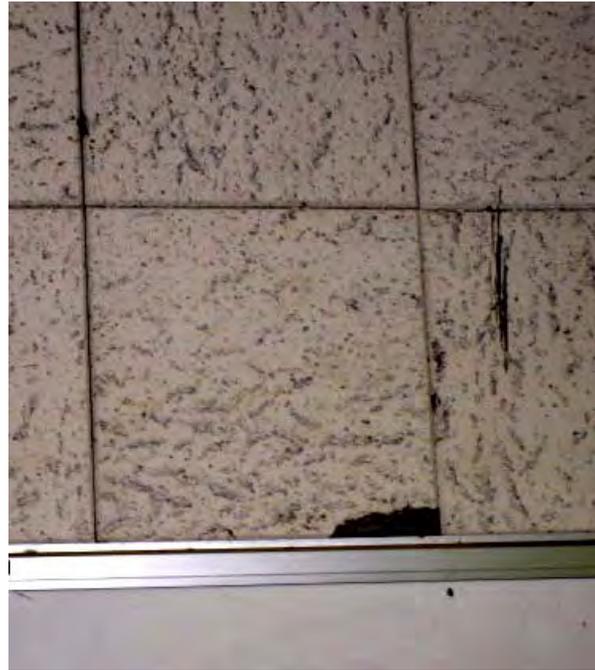
**Picture 23**

- Damaged acoustical wall tiles (Picture 23); and
- Damaged wall plaster along windows (Picture 24).

**Damaged Acoustical Wall Tile**

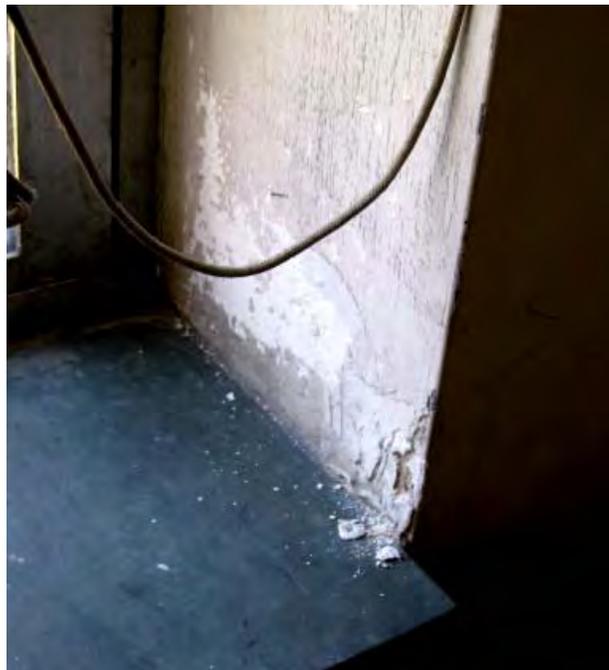
**Picture 24**

**Water Damaged Plaster around Window Frames**

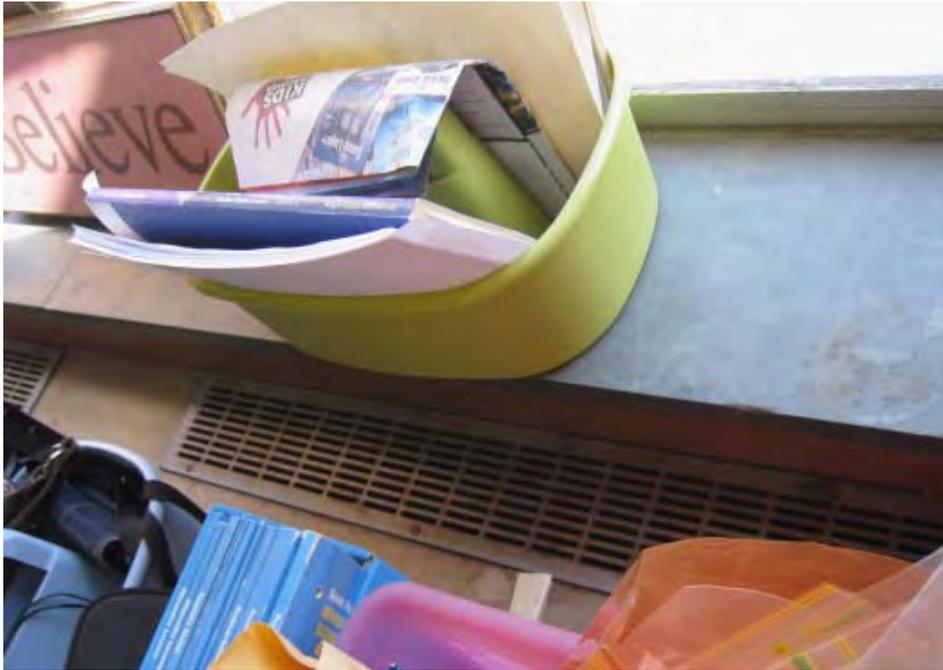
**Picture 25**

Other conditions that can affect indoor air quality were observed during the assessment. Occupants had complaints of dirt/dust accumulation in perimeter radiant heat vents along exterior walls and windowsills (Picture 25 and 26). Over time, dirt, dust and debris settle in these vents where they accumulate. When the heating system is activated and heat rises from these vents (or from pipes traversing the grates), it can create a source of airborne particulates and odors.

**Perimeter Radiant Heat Vents along Window Sill**

20. Remove and conduct thorough cleaning of perimeter wall-mounted radiator units and window vents (Pictures 23 and 24) using a high efficiency particulate arrestance (HEPA) filter equipped vacuum cleaner. Inspect periodically, clean as needed.

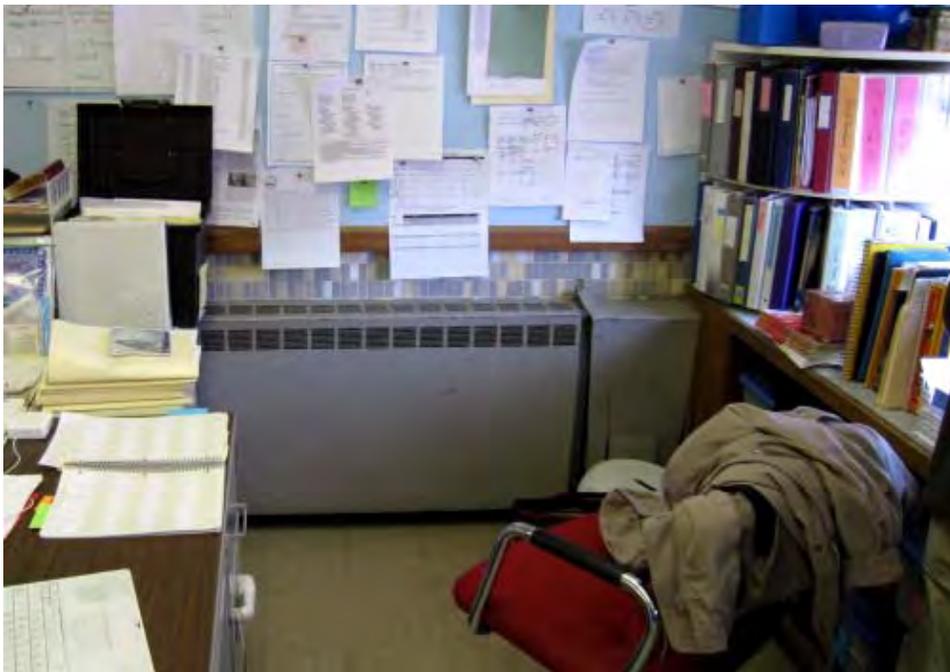
**Picture 26**

**Perimeter Radiant Heat Vents along Exterior Wall**

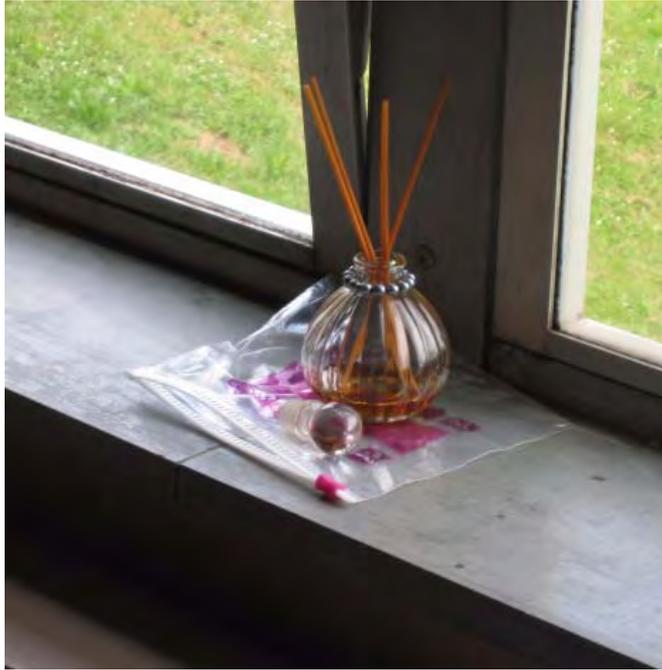
**Picture 27**

Scented oil was observed on the univent in classroom 137 (Picture 27). Air deodorizers contain chemicals that can be irritating to the eyes, nose and throat of sensitive

individuals. Furthermore, deodorizing agents do not remove materials causing odors, but rather mask odors that may be present in the area.

**Scented Oil on Windowsill near Univent in Classroom 137**

21. Refrain from scented oils, air fresheners and deodorizers to prevent exposure to VOCs.
22. For buildings in New England, periods of low relative humidity during the winter are often unavoidable. Therefore, scrupulous cleaning practices should be adopted to minimize common indoor air contaminants whose irritant effects can be enhanced when the relative humidity is low. To control for dusts, a high efficiency particulate arrestance (HEPA) filter equipped vacuum cleaner in conjunction with wet wiping of all surfaces is recommended. Drinking water during the day can help ease some symptoms associated with a dry environment (throat and sinus irritations).

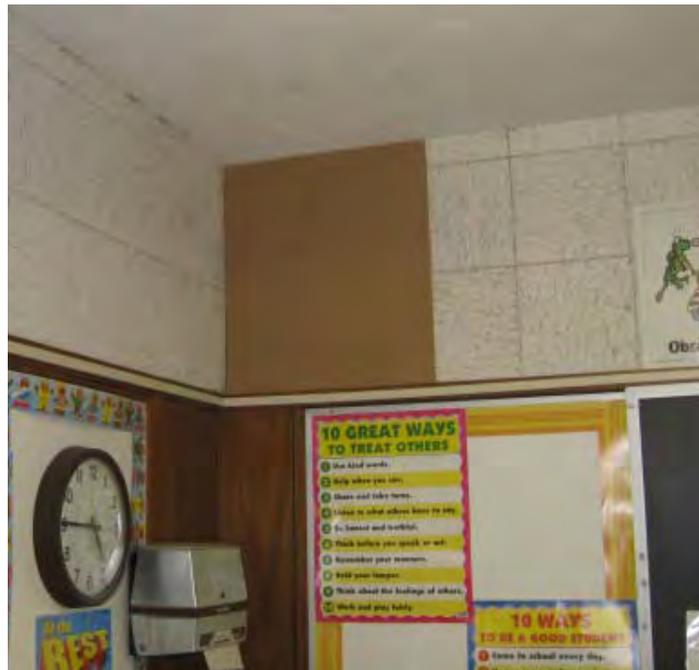
**Picture 28**

Several occupants questioned the presence of a plywood sheet covering a portion of the cinderblock wall in classroom 122 (Picture 28). BEH staff removed the panel to observe conditions of the wall and found that several of the cinderblocks had been removed to gain access to plumbing fixtures in the wall cavity (Picture 29).

**Plywood Panel on Wall in Classroom 122**

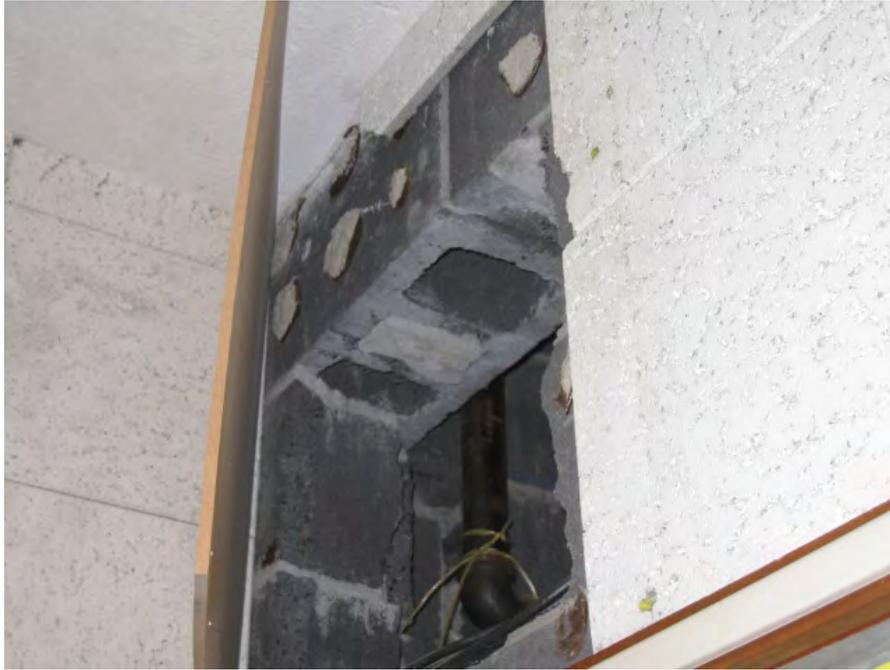
**Picture 29**

**Plumbing Fixture behind Plywood Panel on Wall in Classroom 122**

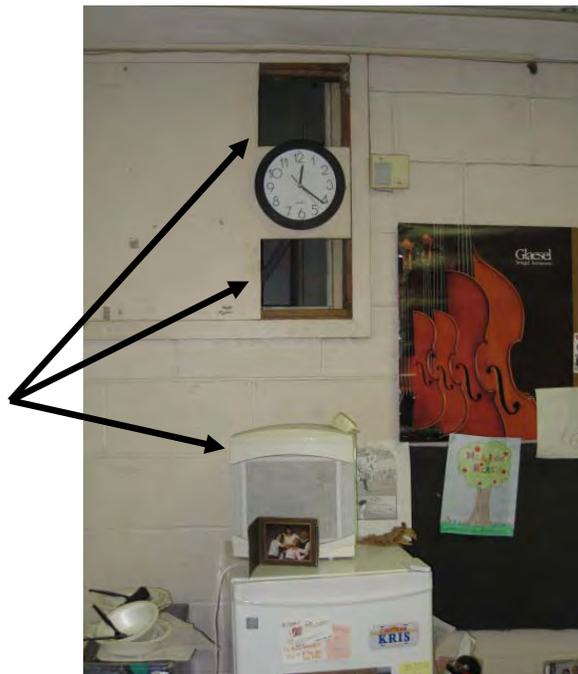
**Picture 30**

An occupant of the room that was created behind the stage had complaints of asthma exacerbation. BEH noted holes in a wall panel that opened into the wall cavity, which could serve as a pathway for dirt, dusts and odors into the stage room (Picture 30). Located in close proximity to these holes was a portable air purifier (Picture 30). Air purifiers have an internal fan that draws air into them. The close proximity of the air purifier to the openings in the wall can actually draw dirt, dust and odors from the wall cavity into the stage room, where the teacher's desk is located. In addition, an access panel was missing from the air handling unit (AHU) that supplies ventilation for this area (Picture 31). The lack of an access panel will render the AHU casing non-airtight and draw air from the basement space into the unit. As air bypasses filters, the opportunity exists for airborne dirt, dust, odors and particulates to be drawn into the HVAC system and be distributed to occupied areas. Aerosolized dust, particulates and odors can provide a source of eye, skin and respiratory irritation.

**Proximity of Air Purifier to Holes in Wall Panel in Stage Room**

23. Seal holes in wall panel in stage room.
24. Replace missing access panel for AHU in stage room to prevent filter bypass.
25. Consider adopting the US EPA (2000) document, “Tools for Schools”, as an instrument for maintaining a good indoor air quality environment in the building. This document is available at: <http://www.epa.gov/iaq/schools/index.html>.
26. Refer to resource manual and other related indoor air quality documents located on the MDPH’s website for further building-wide evaluations and advice on maintaining public buildings. These documents are available at: <http://www.mass.gov/dph/iaq>.

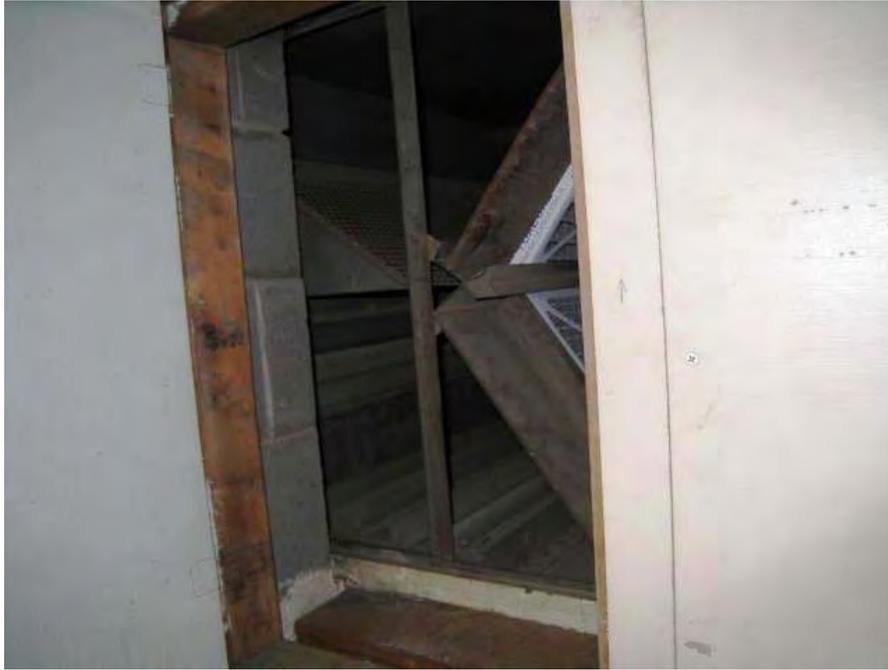
**Picture 31**

**Missing Panel on HVAC Unit in Stage Room Allowing for Filter Bypass**
