INDOOR AIR QUALITY ASSESSMENT

**Southwick Town Hall
454 College Highway
Southwick, Massachusetts**

Prepared by:
Massachusetts Department of Public Health
Bureau of Environmental Health
Indoor Air Quality Program
December 2009

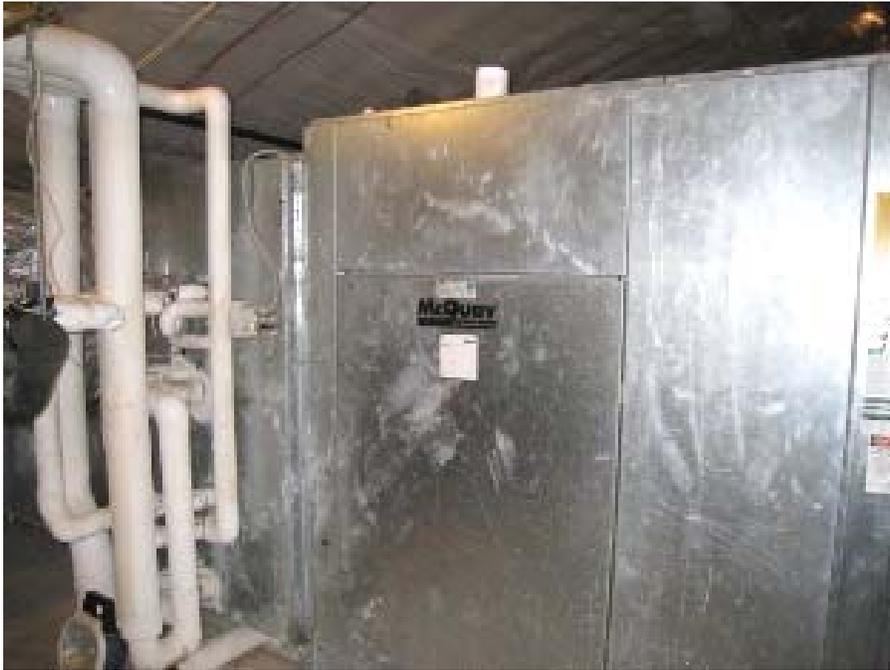
Picture 3

Ventilation is provided by two heating, ventilating, and air-conditioning (HVAC) systems. Fresh air is supplied to most of the building by an air handling unit (AHU) located in the attic (Picture 3). The primary AHU for the activities room is located in a tunnel on the ground floor (Pictures 4 and 5). The large AHU located in the attic also serves as a backup system for the activities room. Fresh air is distributed to offices and other areas by ceiling-mounted fresh air diffusers and returned to the respective units via ductwork. The AHUs are controlled by a computerized system. Each room contains a wall-mounted sensor that monitors temperatures (Picture 6). Filter changes reportedly occur twice yearly, as provided under a maintenance agreement. Ducts are cleaned every other year and are due for servicing in 2010.

AHU in Attic

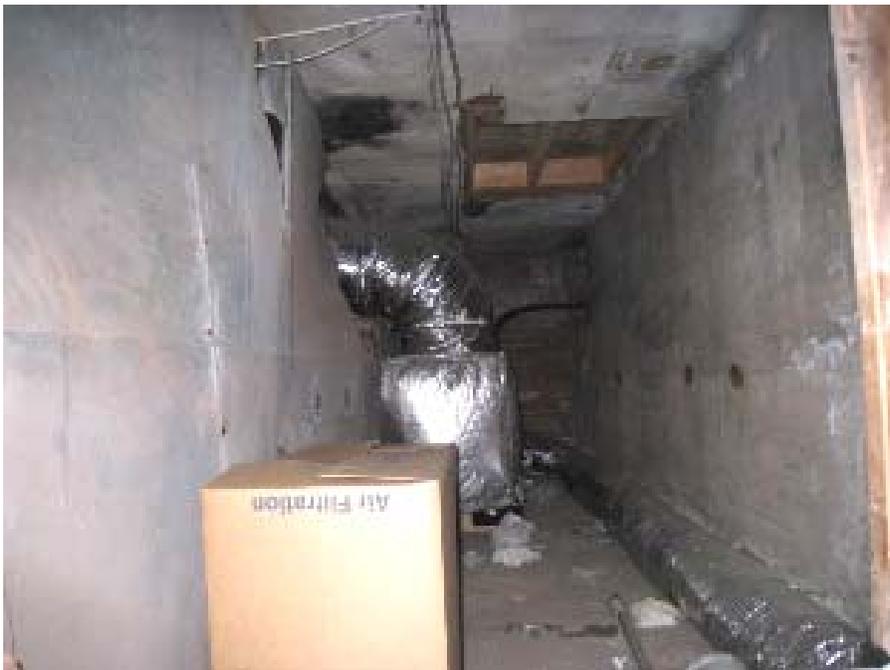
Picture 4

A cardboard box of filters was observed in the tunnel leading to the AHU on the ground floor. Additionally, a section of a separate tunnel had been removed to facilitate storage of cleaning supplies, some in cardboard boxes (Picture 18). Storage of cardboard or other porous materials in unconditioned spaces may become moistened and encourage the growth of mold.

**AHU Located in Tunnel
Note Cardboard Box Stored in Unconditioned Space**

4. Contact an HVAC engineering firm to examine the AHU in the tunnel to ensure structural integrity (e.g., no breaches in ductwork) as to not draw air from the tunnel into the ventilation system.

17. Eliminate storage of cardboard boxes from unconditioned spaces.
18. Consider removing wall-to-wall carpeting and other porous materials such as upholstered furniture from below grade areas.

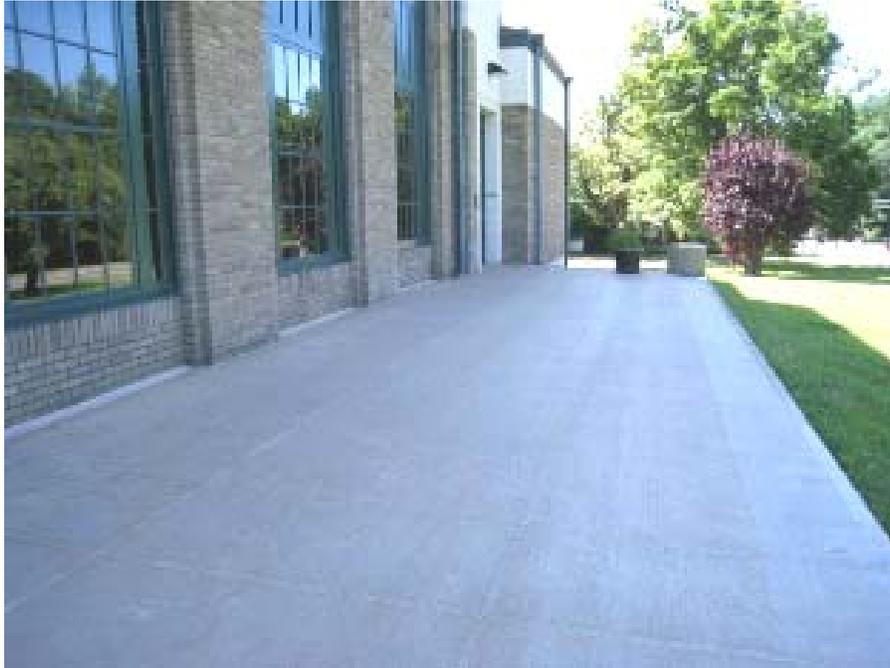
Picture 7

At the time of the assessment, a new concrete patio had recently been installed (Picture 7), in addition to a new drainage system below the patio. This system connects to a 10" conveyance line and drains into a storm drain at the southwest corner of the property. An

Newly Installed Concrete Patio

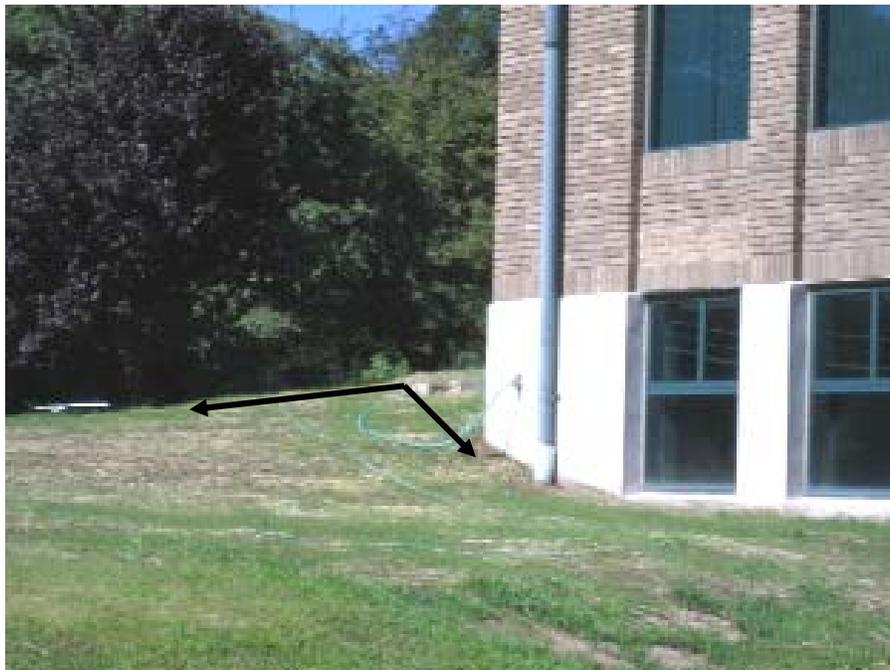
Picture 8

overflow pipe disperses additional groundwater at the top of the slope on the west side of the building (Picture 8). Of note in Picture 8, land sloped downward to the storm drain as well as toward the west side of the building, potentially allowing the overflow waters to saturate the soils closest to the building.

**Overflow Pipe to Drainage System below Patio
Note Slope of Ground toward Building**

7. Consider extending overflow pipe to drainage system further down the slope to decrease potential impact of moist soils adjacent to the building.
8. Repair cracks in foundation.

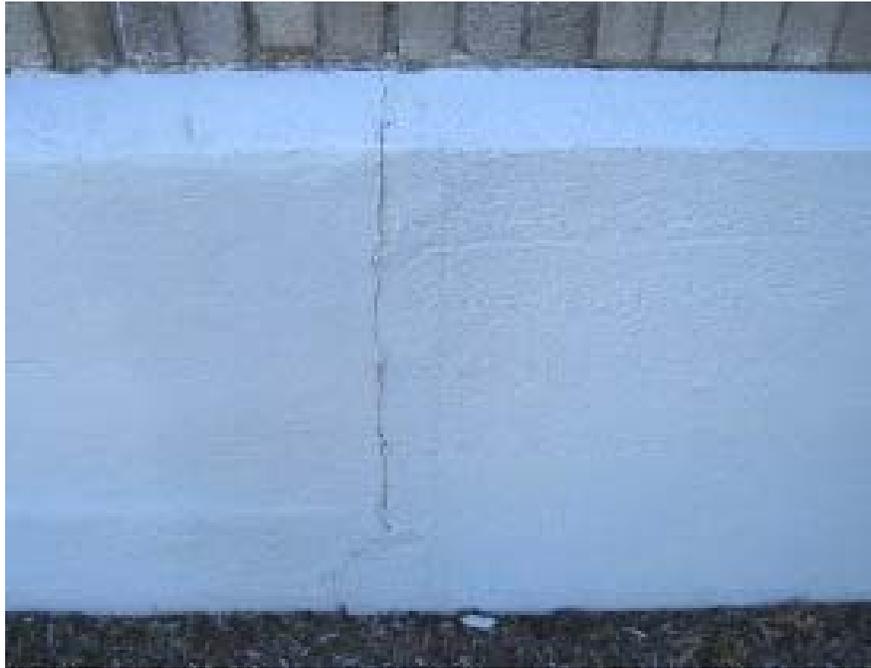
Picture 9

- Cracks were observed in the foundation (Picture 9).
- Weep holes in the exterior brick wall were plugged with soil/debris (Picture 10).
Weep holes allow for accumulated water to drain from a wall system (Dalzell, 1955).
When blocked, the drainage capacity of the wall system is compromised.

Crack in Foundation

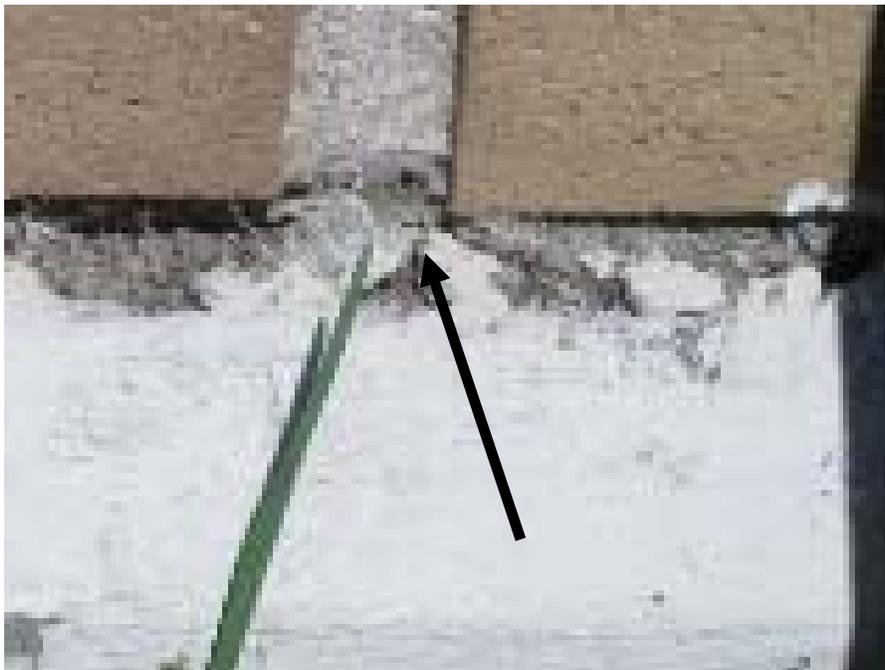
Picture 10

Weep Hole in Exterior Brick Blocked With Debris

9. Remove blockages from affected weep holes.

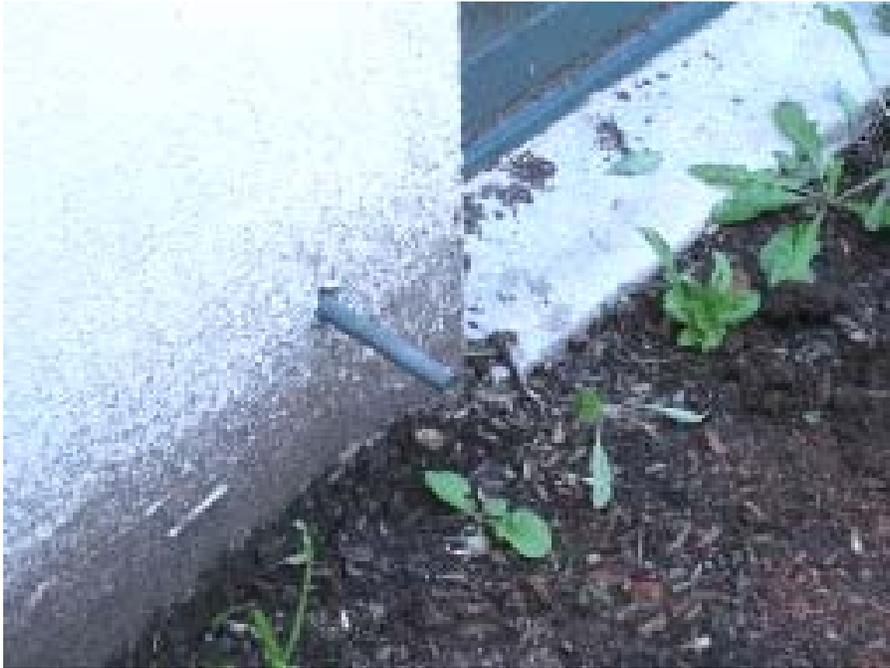
Picture 11

- Three dehumidifiers are used on the ground floor. These dehumidifiers empty water through tubing to the exterior of the building in close proximity to the foundation (Picture 11).

Drain Line from Dehumidifier

10. Consider either extending drainage lines for dehumidifiers further away from the building or manually emptying reservoirs. Clean reservoirs periodically in accordance with manufacturer's specifications.

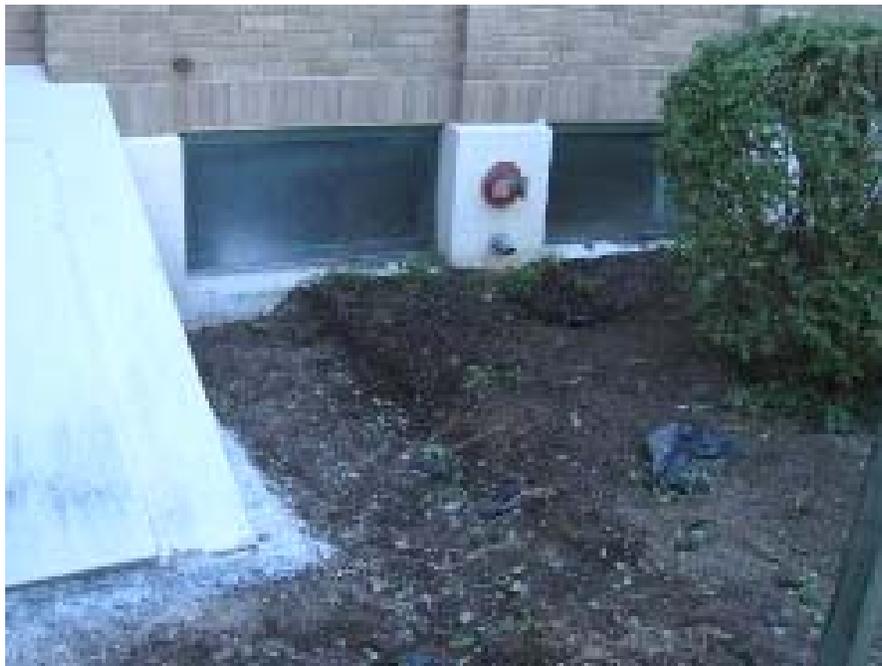
Picture 12

- A heavy layer of wood mulch was observed adjacent to the foundation (Picture 12).
One characteristic of wood mulch is its ability to retain water, which can hold moisture against the building envelope. In addition to causing erosion of soil adjacent to the building, moisture adjacent to a building can eventually penetrate the foundation.

Thick Accumulation of Mulch against Foundation

11. Consider reducing or eliminating mulch from areas adjacent to building.
12. Remove plants/weeds at juncture of building and ground surface.
13. Ensure shrubs are at least five feet away from building.

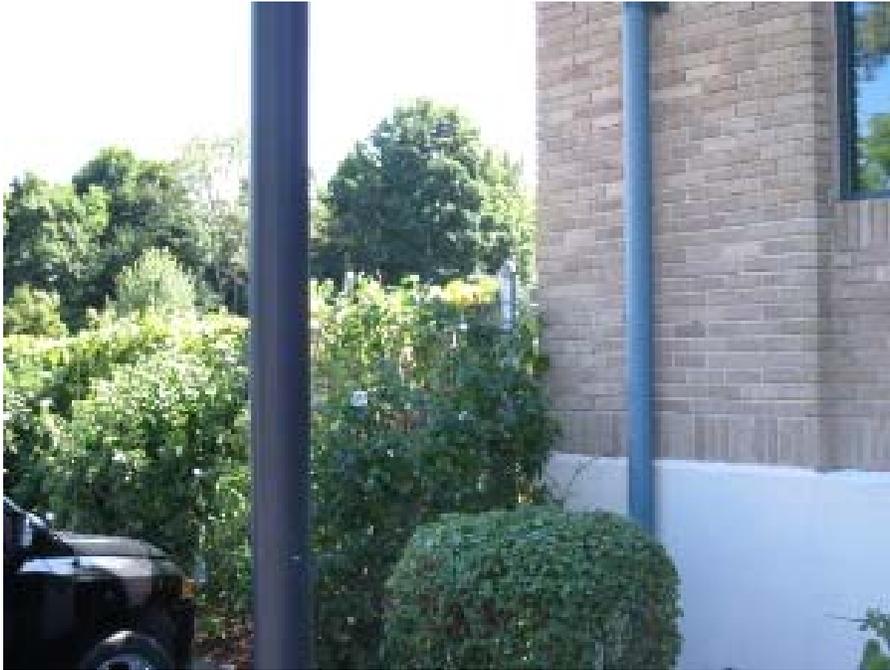
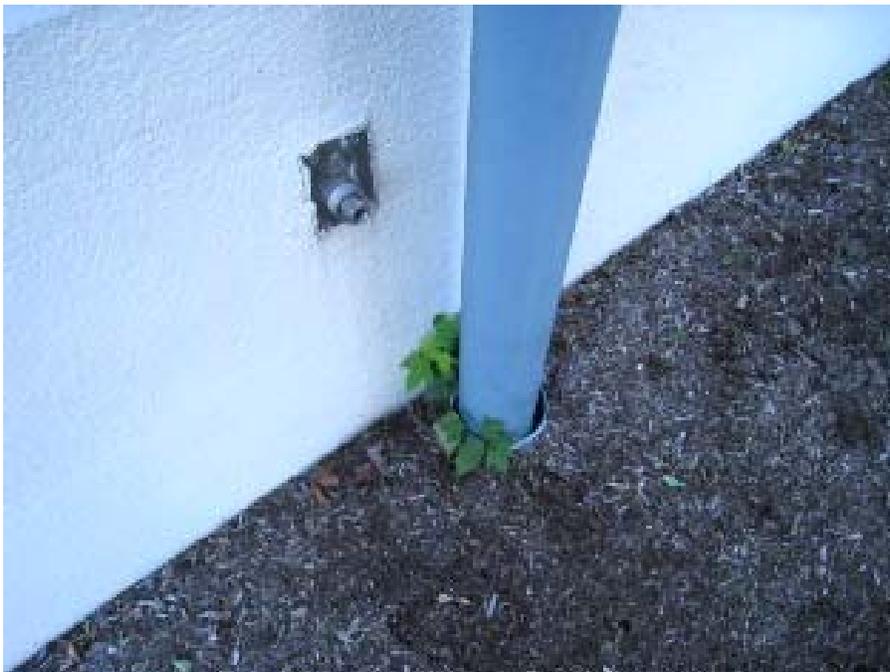
- Shrubs and plants were observed adjacent to the building (Pictures 13 and 14). Over time, the roots from these plants can compromise the building's foundation.

Shrubs and Plants in Close Proximity to Building

Plants Growing Adjacent to Building

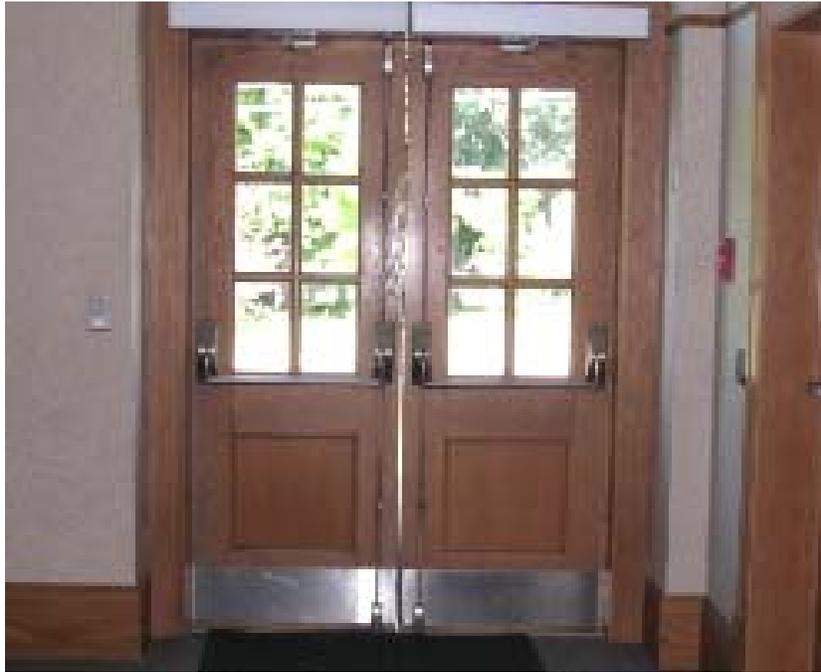
Picture 15

- Exterior doors exhibit gaps (Picture 15), allowing unconditioned air into the building.

Gaps between Exterior Doors

14. Seal exterior door gaps.
15. Test new bulkhead repair for water tightness and seal as necessary.
16. Ensure leaks are repaired and replace water damaged ceiling tiles.

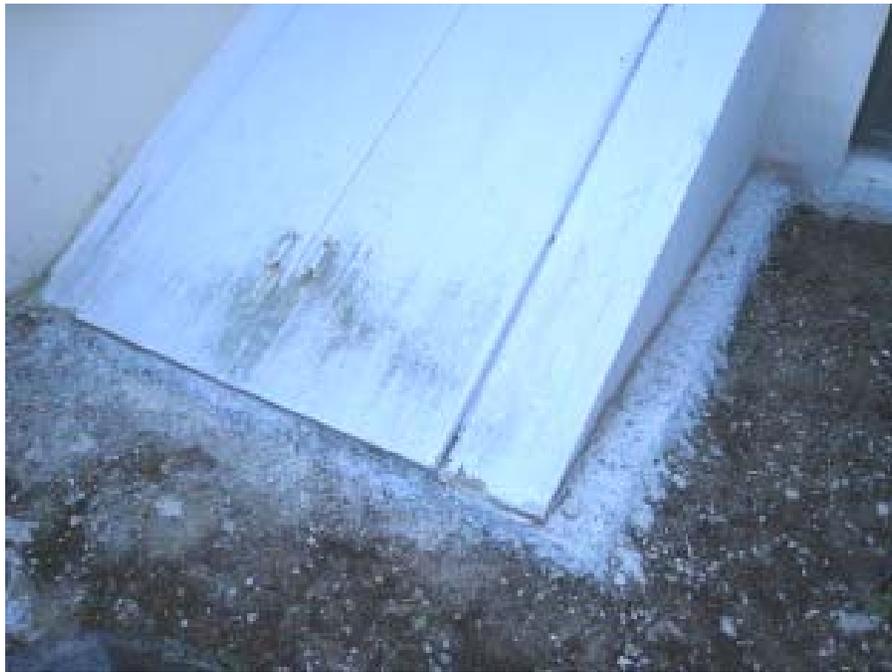
Picture 16

- Water had previously leaked into the building from the bulkhead, which had recently been repaired (Picture 16).

Newly Installed Concrete Pad around Bulkhead

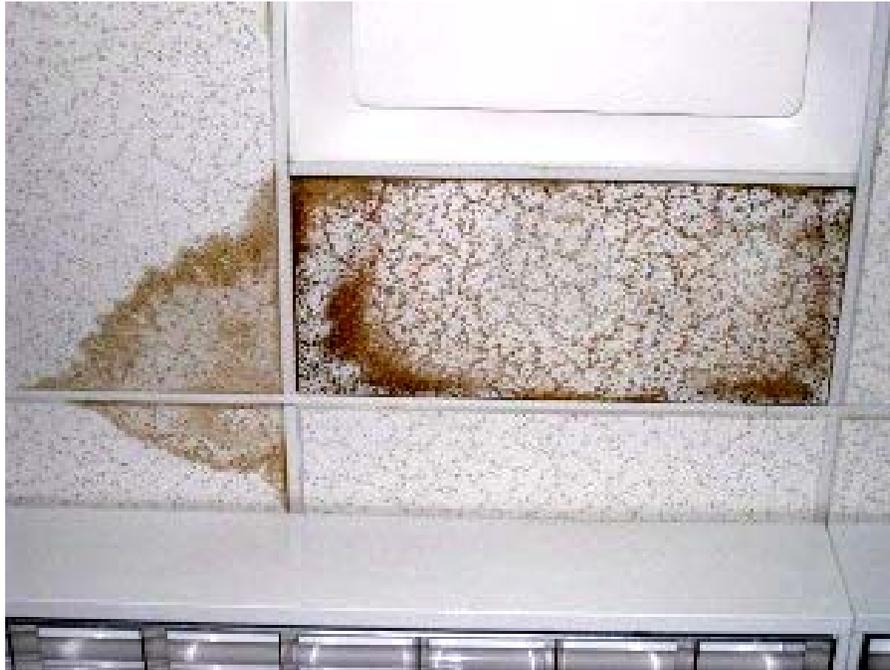
Picture 17

Several potential sources of water damage and/or mold growth were observed indoors at the STH. Water damaged ceiling tiles were observed in some areas (Table 1/Picture 17). Water-damaged ceiling tiles can indicate leaks from either the roof or plumbing system. Water damaged tiles can provide a medium for mold growth and should be replaced after a water leak is discovered and repaired. STH staff stated that they believed the water damage observed was located in areas that were damaged prior to the recent replacement of the gutter system, and that they likely did not represent active leaks. Historic water damage was visible on walls in some areas as well.

Water Damaged Ceiling Tiles

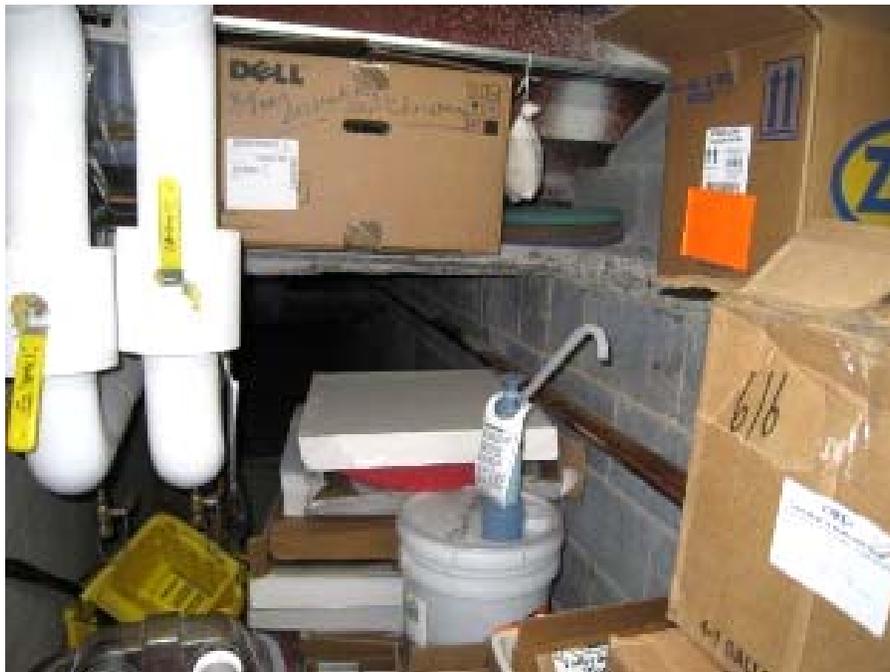
Picture 18

Cardboard Boxes and Filters Stored in Tunnel

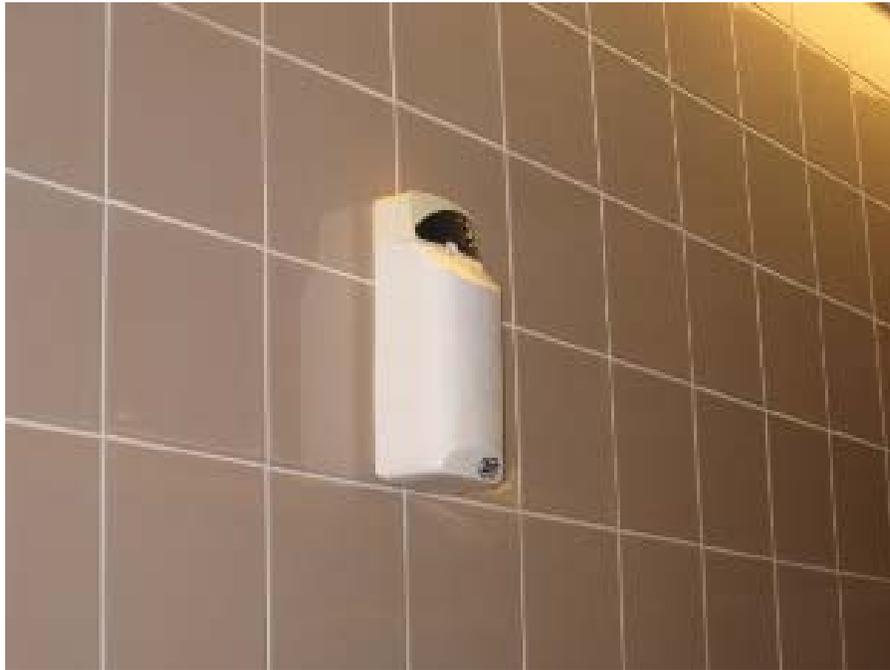
Picture 19

Deodorizing materials were observed in several areas (Picture 19). Air deodorizers contain chemicals that can be irritating to the eyes, nose and throat of sensitive individuals.

Many air fresheners contain 1,4-dichlorobenzene, a VOC which may cause reductions in lung function (NIH, 2006). Furthermore, deodorizing agents do not remove materials causing odors, but rather mask odors that may be present in the area.

Wall Mounted Air Deodorizer

21. Clean dry erase marker trays regularly to prevent the build-up of excessive debris and particulates.
22. Refrain from using strongly scented products (deodorizers) in the STH.

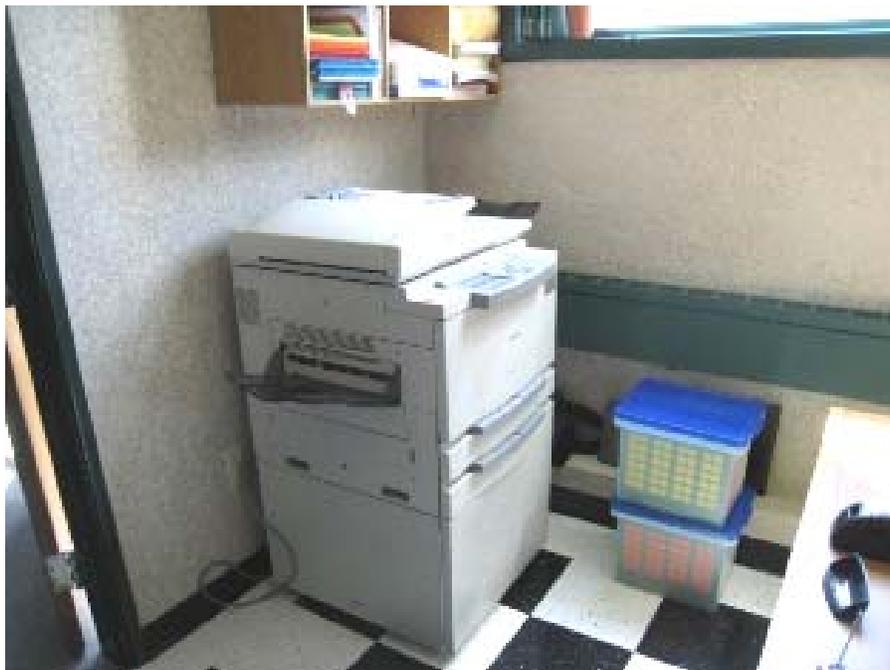
Picture 20

Photocopiers were observed in the STH. In particular, a large photocopier was observed in the Park & Recreation office (Picture 20). Photocopiers can produce VOCs and ozone, particularly if the equipment is older and in frequent use. VOCs and ozone are respiratory irritants (Schmidt Etkin, D., 1992). The office currently lacks mechanical air supply and exhaust, therefore, there is not an adequate means of removing these irritants from the interior of the office exists. Although the office has one window, utilizing a window for ventilation in the winter months is not practicable. Consideration might be given to moving the copier out of the office to an area with ventilation. It is recommended that local separate exhaust systems that do not recirculate into the general ventilation system be used (US DOE, unknown).

Photocopier in Room with No Mechanical Ventilation

23. Consider installing local exhaust ventilation for copier or moving copier out of Park & Recreation office into room with adequate exhaust.

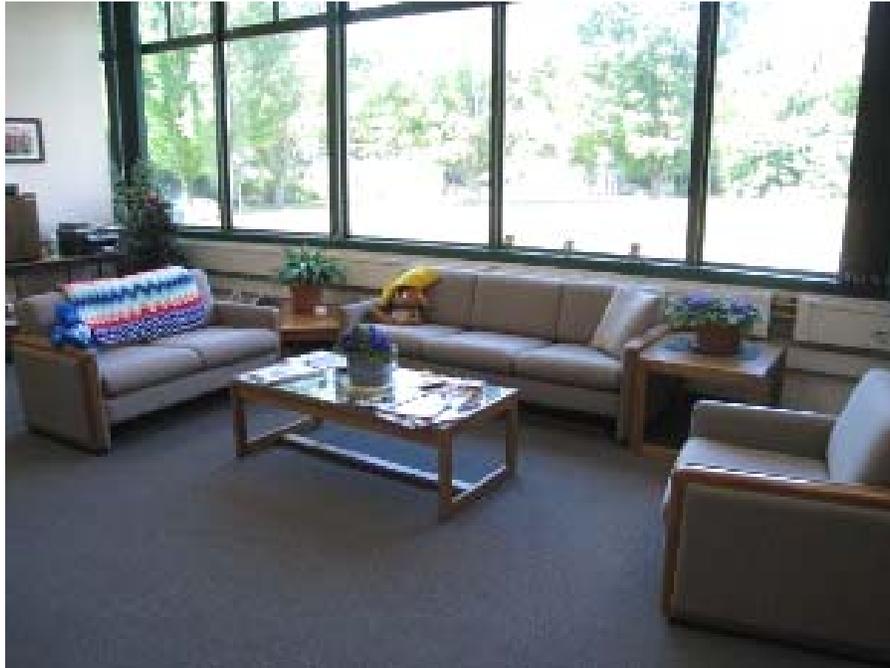
Picture 21

Other conditions that can affect indoor air quality were observed during the assessment. A number of rooms contained upholstered furniture (Picture 21). Upholstered furniture is covered with fabric that comes in contact with human skin. This type of contact can leave oils, perspiration, hair and skin cells. Dust mites feed upon human skin cells and excrete waste products that contain allergens. In addition, if relative humidity levels increase above 60

percent, dust mites tend to proliferate (US EPA, 1992). In order to remove dust mites and other pollutants, frequent vacuuming of upholstered furniture is recommended (Berry, M.A., 1994). It is also recommended that upholstered furniture be professionally cleaned on an annual basis. If an excessively dusty environment exists due to outdoor conditions or indoor activities (e.g., renovations), cleaning frequency should be increased (every six months) (IICRC, 2000).

Upholstered Furniture in Senior Center

24. In order to remove dust mites and other pollutants, vacuum upholstered furniture frequently (Berry, M.A., 1994). Professionally clean upholstered furniture on an annual basis.
25. Seal gaps created by ill-fitting ceiling tiles.
26. Seal open utility holes.
27. Ensure personal fans are periodically cleaned to remove dust accumulation.
28. Food items should be stored in containers with tight fitting covers.
29. Refer to resource manual and other related indoor air quality documents located on the MDPH's website for further building-wide evaluations and advice on maintaining public buildings. These documents are available at: http://mass.gov/dph/indoor_air.

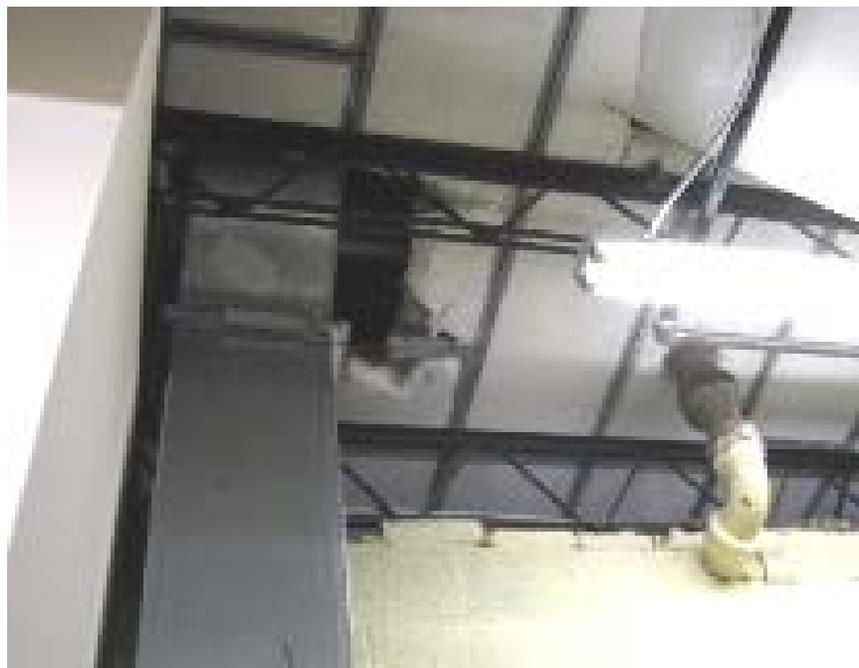
Picture 22

Ceiling tiles were found to be ajar in some rooms. In addition, some open penetrations through walls and ceilings were observed (Pictures 21 and 22). These conditions can allow odors, vapors, dusts and particulates to enter the occupied space. In addition, personal fans were noted in several areas. Personal fans often accumulate dust and debris. Dust can be a source for eye and respiratory irritation.

Open Penetrations of Utilities through Ceiling
