INDOOR AIR QUALITY ASSESSMENT

**600 Washington Street
Fifth Floor
Boston, Massachusetts**

Prepared by:
Massachusetts Department of Public Health
Bureau of Environmental Health
Indoor Air Quality Program
November 2010

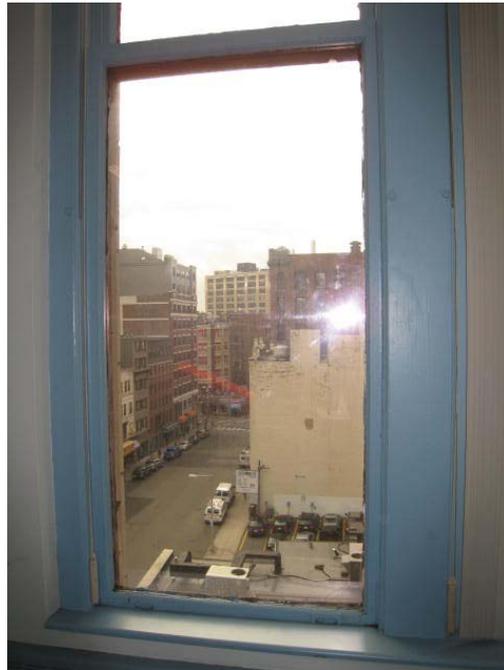
Picture 1

The fifth floor of 600 Washington Street contains private offices, open work areas (cubicles), conference rooms and storage areas. Windows in the building are weighted sash windows that were originally designed to be opened; but have been reportedly sealed for some time (Picture 1).

In subsequent e-mail correspondence with Ms. Ghiloni and David Greene, Northland Corp., Building Management, it was reported that windows could not be opened as they had reportedly been sealed shut. As an alternative, Northland intended to depressurize the fifth floor

Typical Sash Window on Fifth Floor

- a. Temporarily break the seal and open at least one window in each of the two work areas. Once windows are open, several fans should be stationed on the INSIDE/work area of the plastic barriers to direct air TOWARDS the open windows with an additional fan near the open window to direct airborne dust/particulates/odors *outside* the building. If HVAC system in work areas *cannot* be isolated from occupied areas, all HVAC supply vents should be sealed with plastic/tape to prevent pressurization of the work areas in relation to occupied areas.

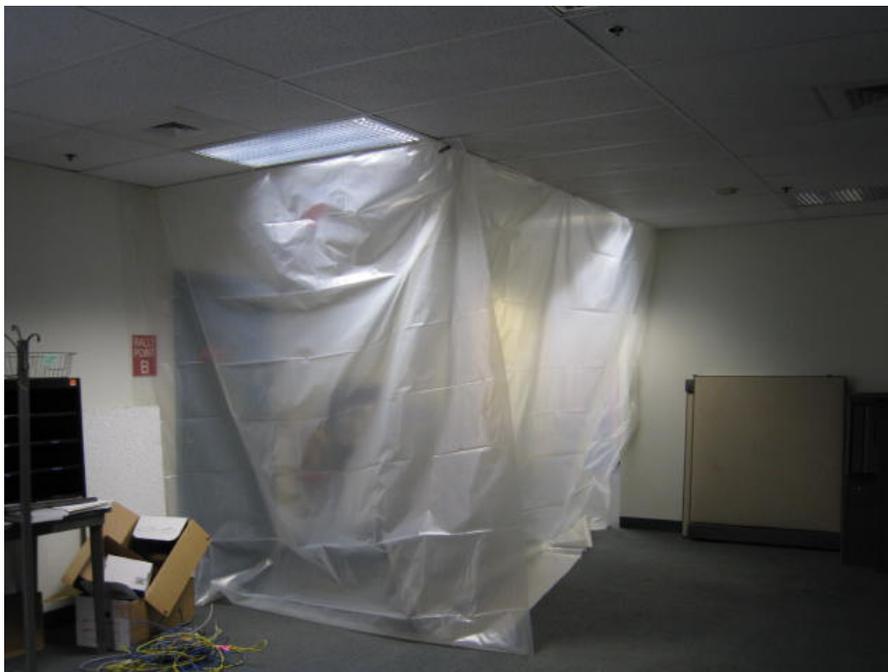
Picture 2

During the assessment, floor to ceiling plastic polyethylene barriers were being erected to separate occupied areas from the renovation zones (Pictures 2 and 3). BEH staff recommended sealing the barriers along all sides (i.e. ceiling, walls, floor) with tape on the inside and outside of the barrier to render as airtight as possible. BEH staff also recommended depressurizing the work areas by using fans to direct pollutants out of the building. This requires opening at least one window in each of the two work areas. In addition to establishing negative ventilation in the work areas, BEH staff recommended the deactivation of HVAC vents in work areas or, if not feasible, sealing the vents to prevent entrainment into the general ventilation system.

Area Sealed with Plastic Polyethylene Sheeting

3. Ensure polyethylene plastic barriers are sealed on all sides with duct tape. Seal these barriers on both renovation and occupied sides to create a dual barrier. Ensure integrity of barriers by monitoring for drafts around seams.

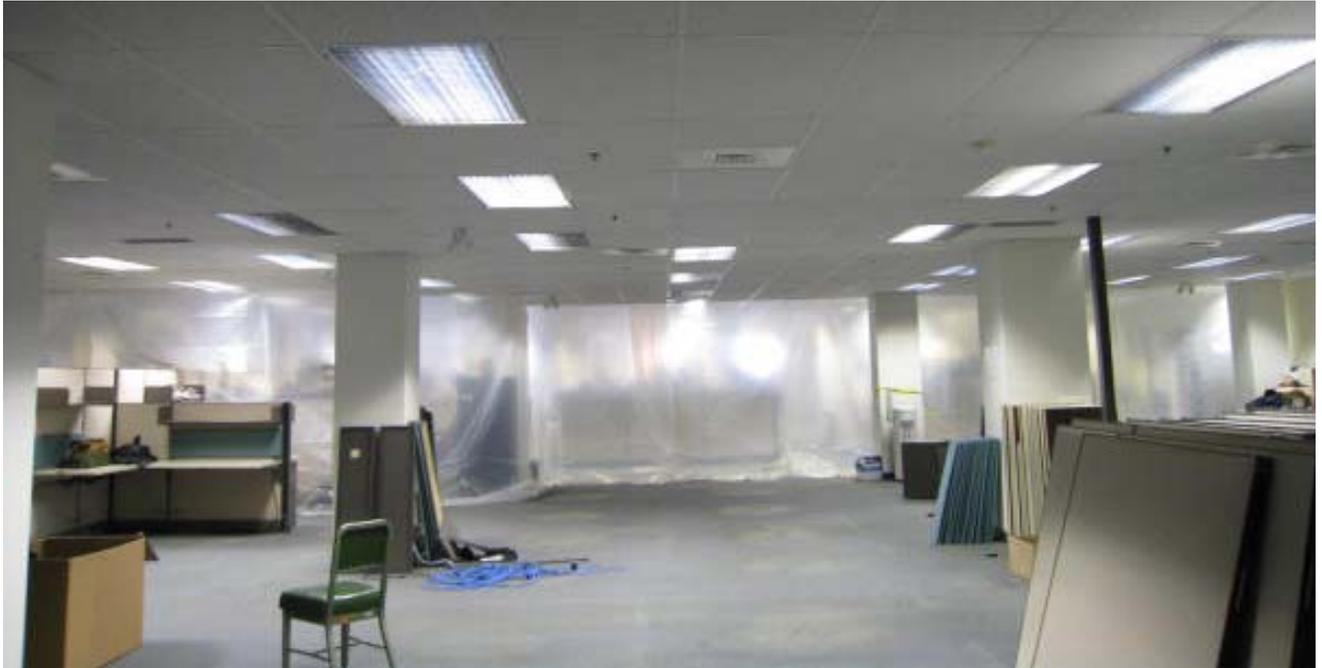
Picture 3

Area Sealed with Plastic Polyethylene Sheeting

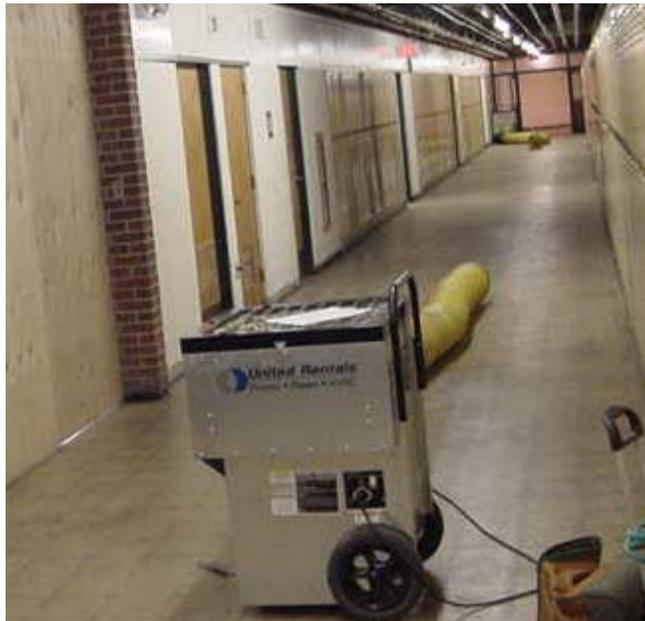
Example of Air Filtration Unit “Air Scrubber” Equipped with High Efficiency Particulate Arrestance (HEPA) Filters at Construction Site

- c. If dust/debris cannot be vented to the outdoors, employ air filtration units/“air scrubbers” equipped with high efficiency particulate arrestance (HEPA) filters inside the work areas (see Picture 4 for example).
