INDOOR AIR QUALITY ASSESSMENT

**Executive Office of Health and Human Services
Human Resources
600 Washington Street, 2nd Floor
Boston, Massachusetts**

Prepared by:
Massachusetts Department of Public Health
Bureau of Environmental Health
Indoor Air Quality Program
April 2010

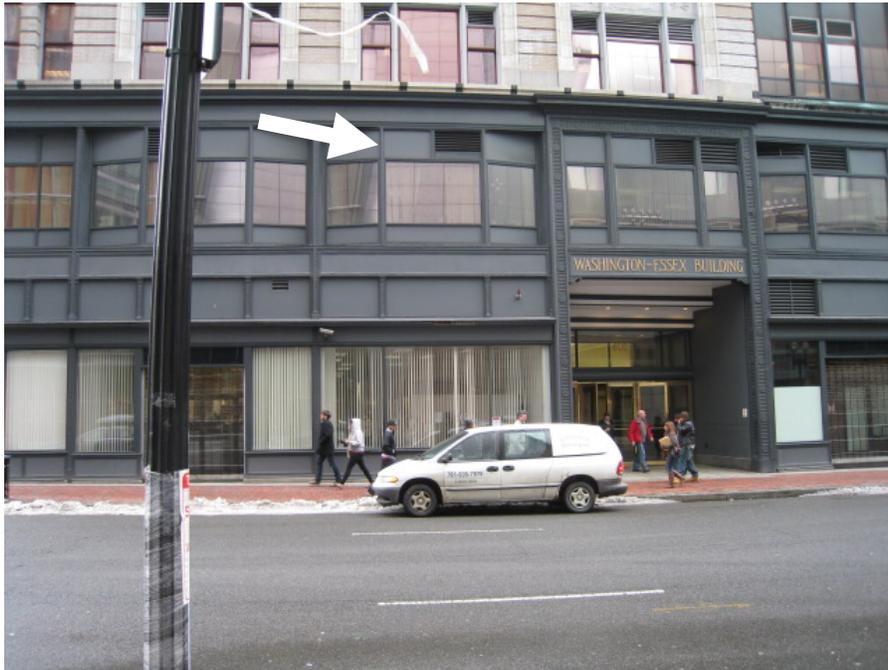
Building occupants expressed concerns about cigarette smoke odors that periodically are noticed in office space along the front of the building on the second floor. The fresh air intake for the second floor ventilation system is located on the front of the building (Picture 1). In an effort to alleviate this problem, the landlord has posted no smoking signs in the window directly below fresh air intakes (Picture 4). In addition to cigarette smoke, occupants also report odors thought to be the result of idling traffic. In order to address these concerns, the HVAC system should have more efficient filters to remove these odors from the air. Cigarette smoke and vehicle exhaust are irritants to the eyes, nose and respiratory system.

Fresh Air Intake, Note Car and Pedestrians

1. Relocate or remove one of the fresh air diffusers depicted in Picture 1 to reduce the excessive airflow into the cubicle/office area.
2. Install filters with increased efficiency in the HVAC system to reduce cigarette smoke and vehicle exhaust. If this measure does not reduce or eliminate cigarette smoke and/or vehicle exhaust odors in the occupied space, consideration should be given to moving the fresh air intake for this air-handling unit to another exterior wall not readily impacted by traffic or cigarette smokers.

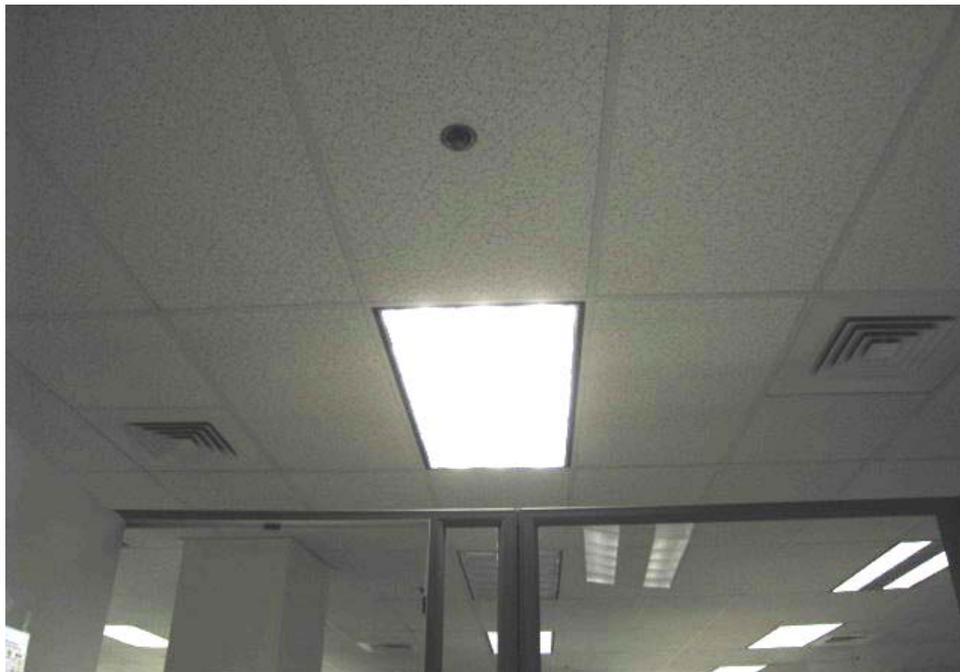
Picture 2

Of note is the location of fresh air diffusers that appear to be directing airflow into a single office/cubicle. Unlike all other office/cubicles on the floor, this particular location has two fresh air diffusers that are directing air into the cubicle instead of one fresh air diffuser (Picture 2). This additional airflow can make the cubicle/office occupant uncomfortable; they may experience irritating symptoms as a result of being in direct airflow, which likely aerosolize normally occurring pollutants in the cubicle (e.g., dust and dirt).

**Two Air Diffusers Directing Air into One Office Cubicle
(View From Inside Office/Cubicle)**

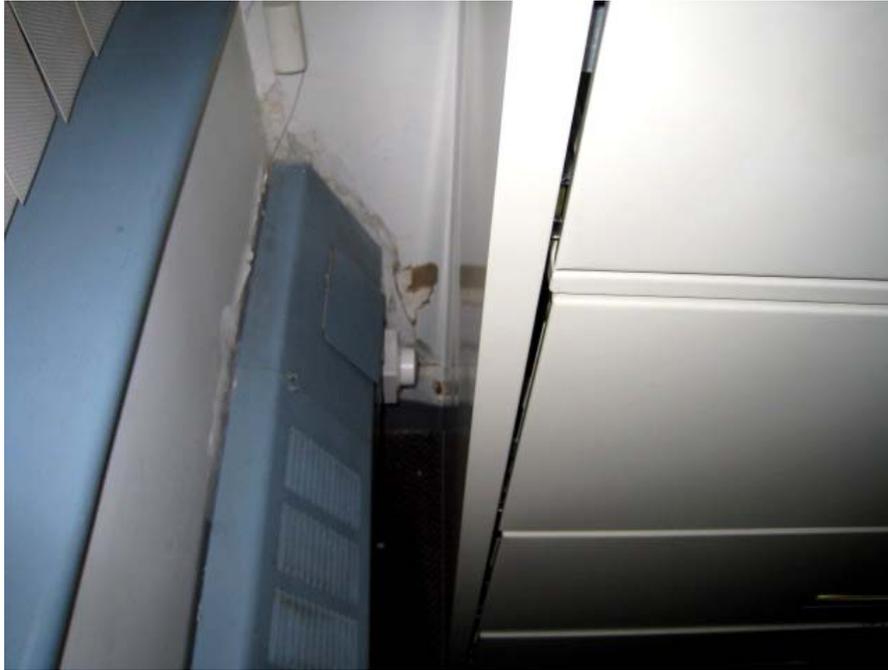
Picture 3

Heating Register in Office, Typical of Heating System on Second Floor

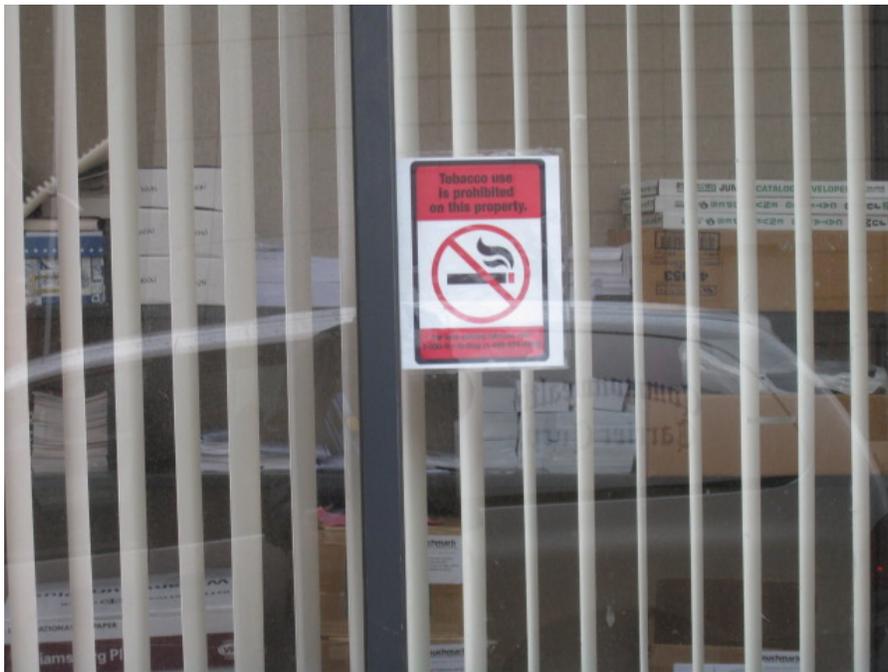
Picture 4

No Smoking Signs in the Window Directly Below Fresh Air Intake

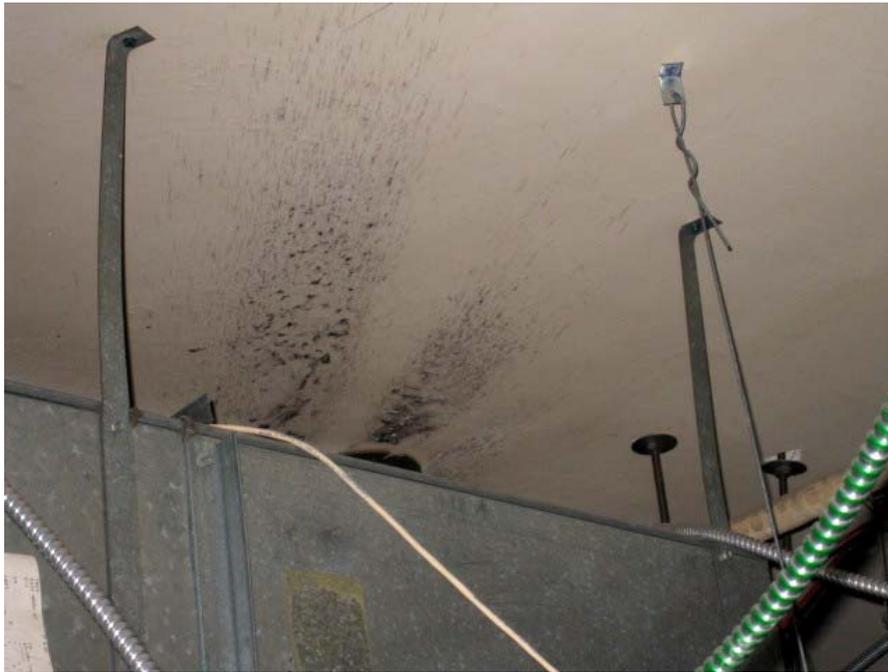
Picture 5

Also of note is noise from the ceiling mounted air-handling unit. An examination of the AHU found a dust pattern that would indicate a leak from the ductwork (Picture 5), which may account for the noise that was noticeable in workstations below this unit.

Dust Pattern on Ceiling above the Air Handling Unit Indicative of Air Leak

3. Examine each noisy air handling unit and ductwork for holes/spaces that may be causing excessive noise.
4. Consider balancing mechanical ventilation systems every 5 years, as recommended by ventilation industrial standards (SMACNA, 1994). Balancing the HVAC system is important and will likely bring the majority of carbon dioxide levels with comfort limits.
