INDOOR AIR QUALITY ASSESSMENT

**Massachusetts Rehabilitation Commission
59 Temple Place, 9th Floor
Boston, Massachusetts**

Prepared by:
Massachusetts Department of Public Health
Bureau of Environmental Health
Indoor Air Quality Program
August 2010

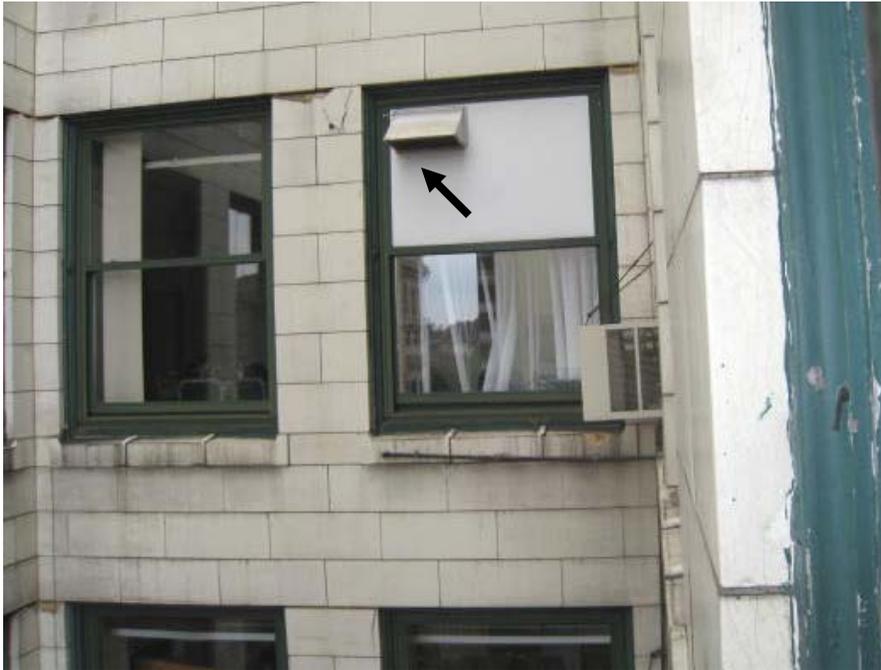
Picture 1

Fresh Air Intake

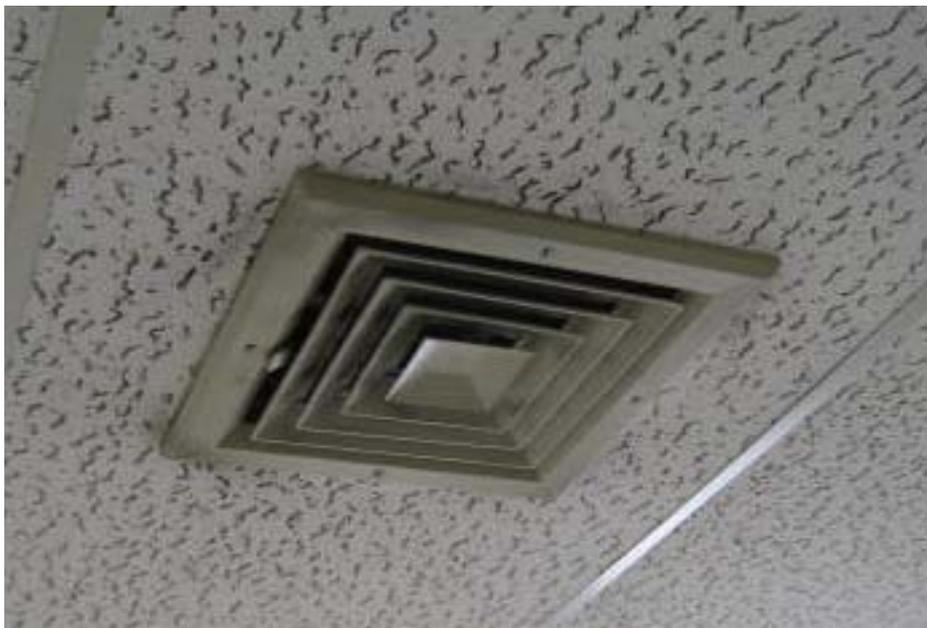
Picture 2

Conditioned air is supplied to occupied areas through ceiling and/or wall-mounted air diffusers (Pictures 2 and 3). Air is returned to the AHUs by use of a ceiling plenum system, which uses the space between the suspended ceiling and the 10th floor deck as a large, open duct. An opening connects the ceiling plenum to each mechanical room (Picture 4). Air is drawn into each AHU by an opening in the unit's cabinet, which in turn makes each mechanical room a part of the airflow/duct system.

Ceiling-Mounted Air Diffuser, Note Dust/Debris Accumulation on Vent and Surrounding Ceiling Tiles

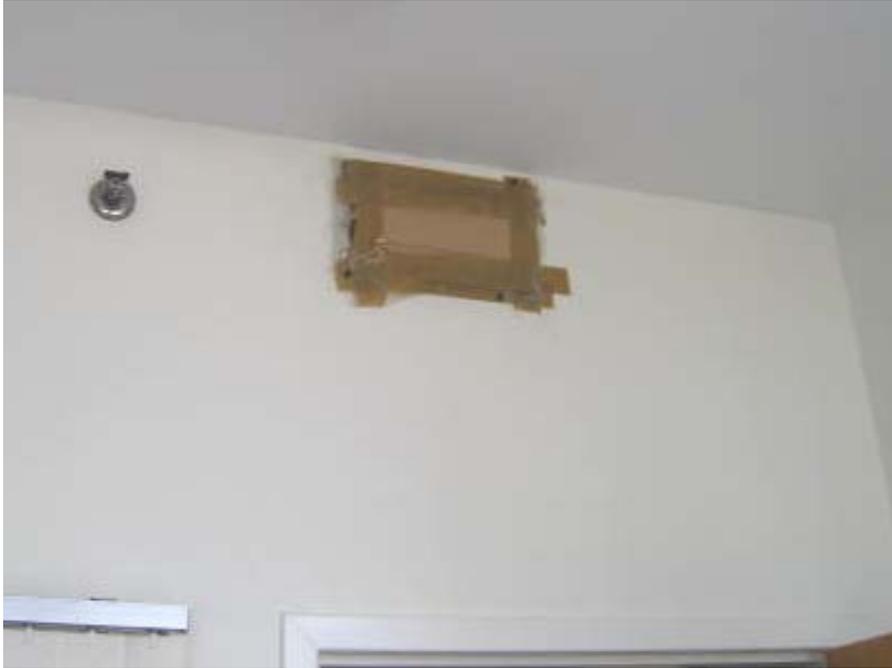
Picture 3

Occupants expressed complaints of uneven heating and cooling. Fresh air supply diffusers have fixed louvers, which cause air to be directed straight down into the space, frequently on building occupants. In some instances, vents were observed to be blocked with cardboard or paper (Picture 3). These types of alterations can affect the airflow and balance of the ventilation system, resulting in the creation of uneven heating/cooling conditions in other areas.

Wall-Mounted Supply Vent Blocked with Cardboard and Tape

1. Remove cardboard from fresh air supplies. Consideration should be given to installing wall mounted fresh air supply diffusers with movable louvers to direct airflow away from work stations in private offices.
2. Have the AHU coils/fins cleaned.
3. Remove all stored materials from mechanical rooms, clean and disinfect floors.
4. Seal all unnecessary openings (floors/walls/ceilings) in mechanical rooms.
5. A preventative maintenance program for all HVAC equipment should be developed and implemented, which should include changing filters for HVAC equipment (including window-mounted ACs) as per the manufacturer's instructions or more frequently if

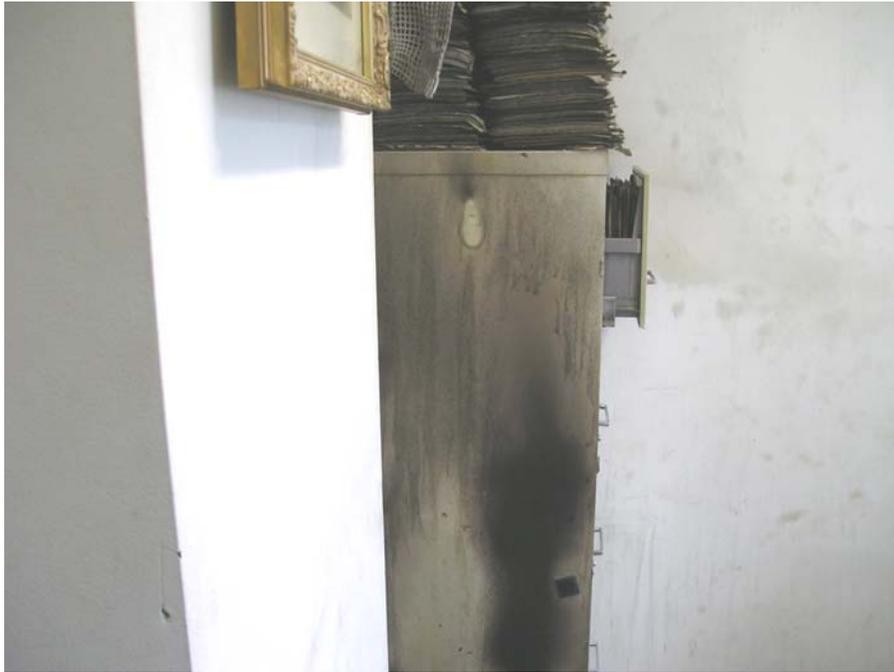
Picture 5

Water Damage to Filing Cabinet (Photo Taken by MRC Staff)

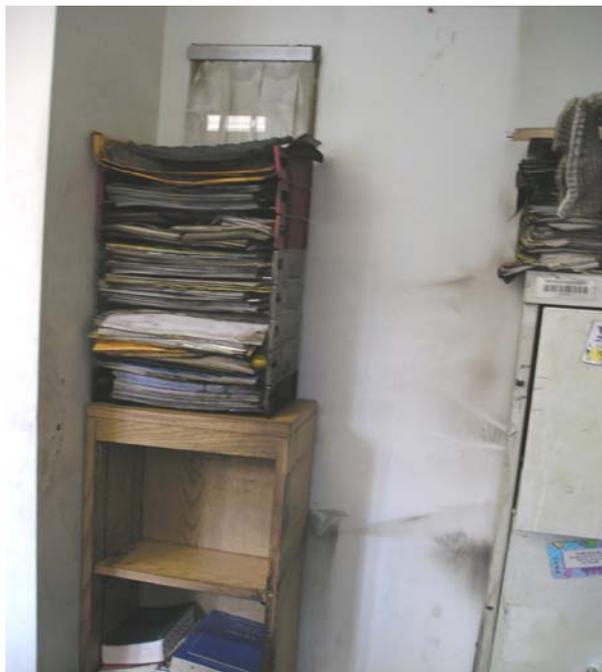
Picture 6

Fire Damage to Office (Photo Taken by MRC Staff)

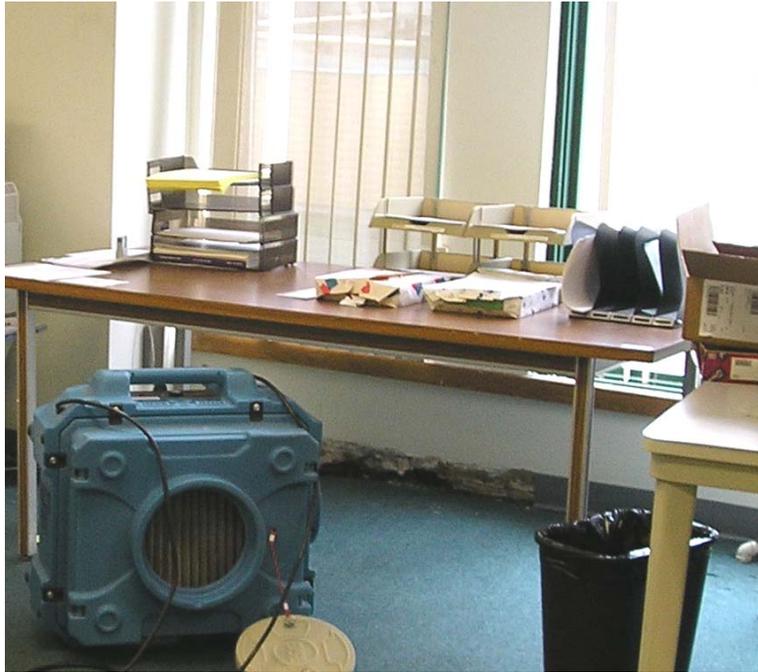
Picture 7

Water Damage to Gypsum Wallboard (below Table), Note Dehumidifier

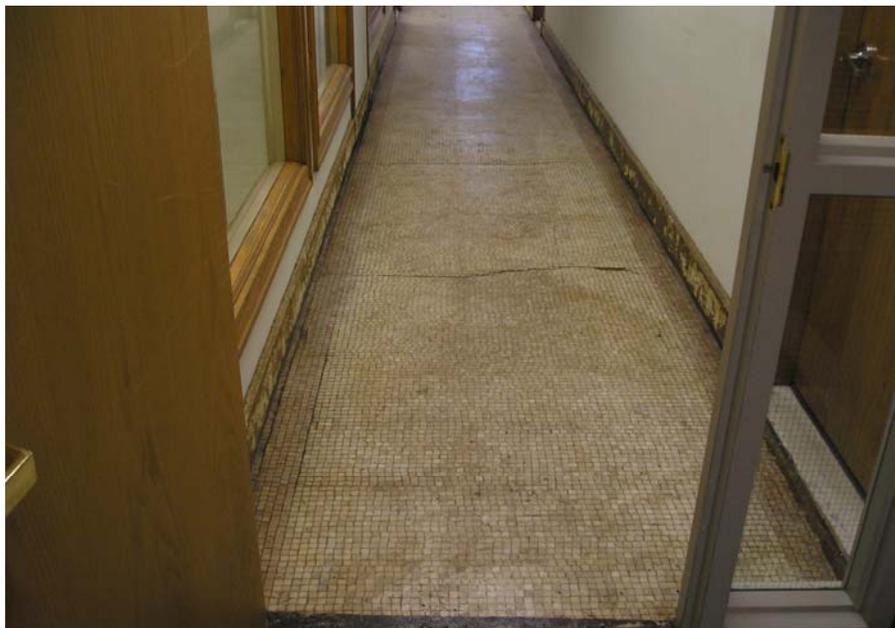
Picture 8

Water-Damaged Main Hallway outside MRC, Note Removed Gypsum Wallboard at Base of Walls

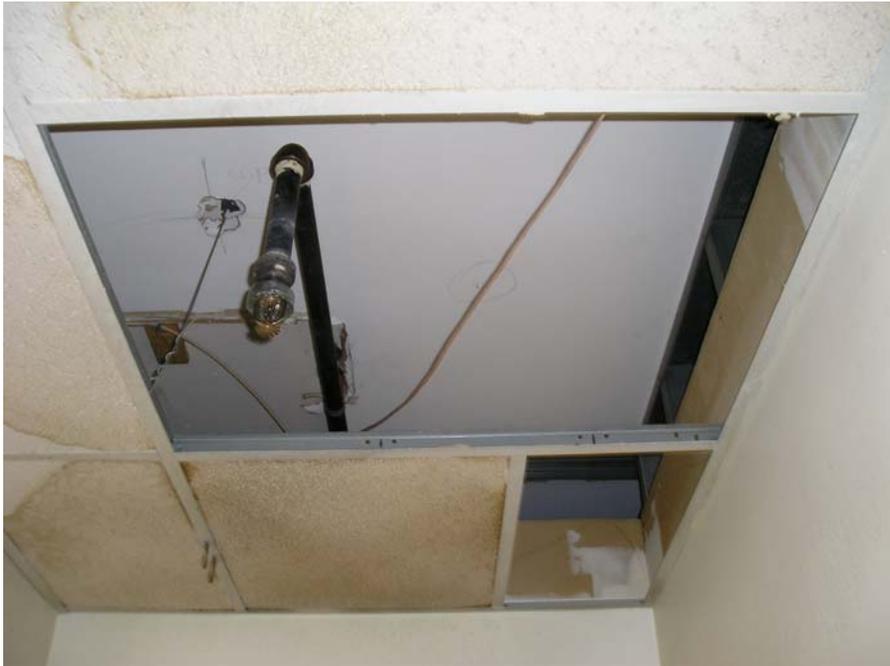
Picture 9

Ceiling Plenum above Fire, Note Lack of Soot Deposition Indicating Rapid Suppression of Fire

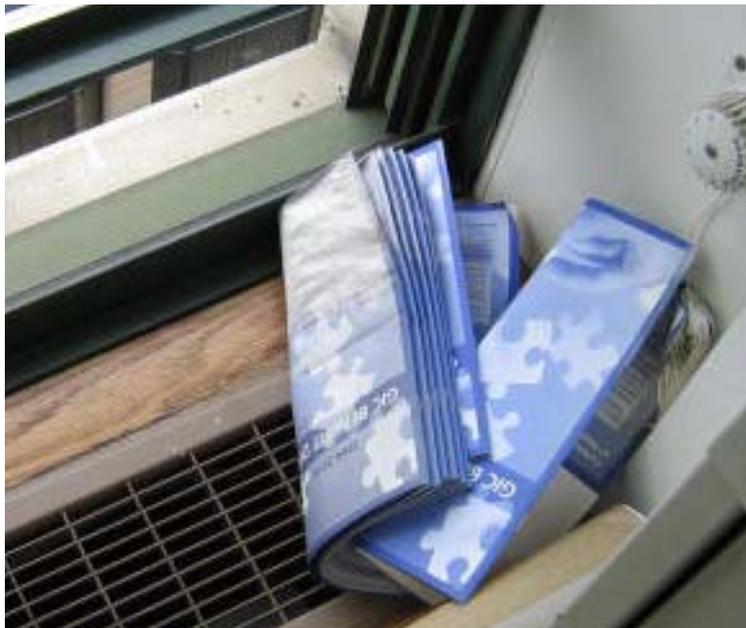
Picture 10

At the time of the IAQ assessment, a number of plants were observed in several areas. Plant soil and drip pans can serve as a source of mold growth. A number of these plants did not have drip pans, which can lead to water pooling and mold growth on windowsills. Wet paper materials colonized with mold were observed near an open window in office 19 (Picture 10).

Wet Paper Materials Colonized with Mold near open Window in Office 19

11. Discard water-damaged/mold-colonized paper materials in office 19.
 12. Consider reducing the number of plants in offices. Ensure plants have drip pans. Examine drip pans periodically for mold growth and disinfect with an appropriate antimicrobial where necessary.

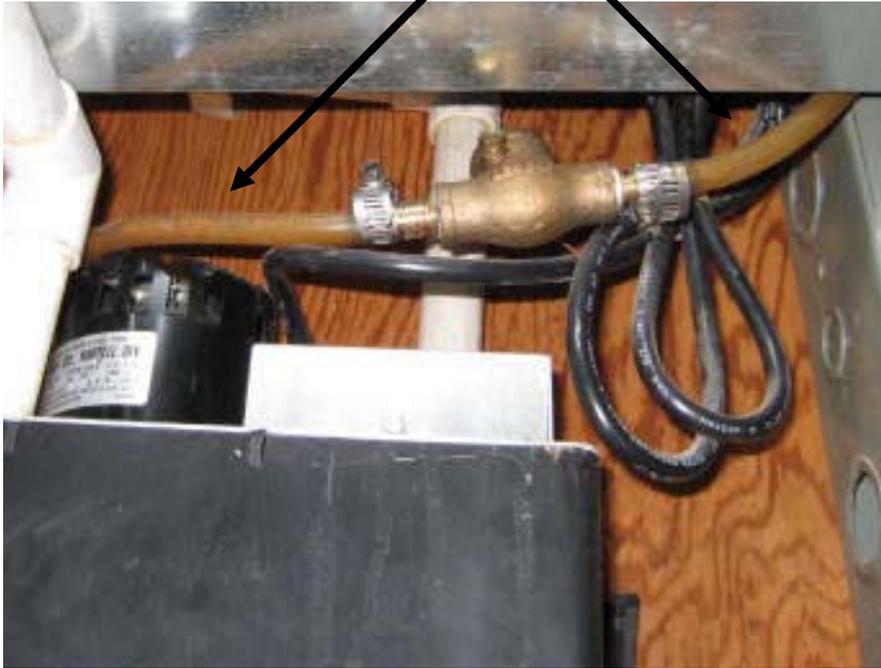
Picture 11

A visual inspection of AHUs was conducted to determine proper drainage and whether condensation was accumulating. Since the HVAC system provides air conditioning, each unit with cooling coils is attached to a PVC pipe system that drains condensate. Drainage for AHUs is provided by a clear plastic flexible hose. At the time of the assessment, the interior of the flexible hose was coated with a heavy deposition of scale and debris, which can provide a source of microbial growth and/or foul odors (Picture 11). As the AHU operates, negative pressure is created which can draw air from the drain system through these hoses and into the unit. This can be a means for microbial growth and/or odors to be drawn into the unit and be distributed by the HVAC system.

Flexible Tubing, Note Tubing Should be Clear in Color

7. Examine flexible hosing connecting the condensation drains to the AHUs for debris/mold growth during routine changing of filters. Replace or disinfect this tubing with an appropriate antimicrobial prior to the air-conditioning season on a routine basis.

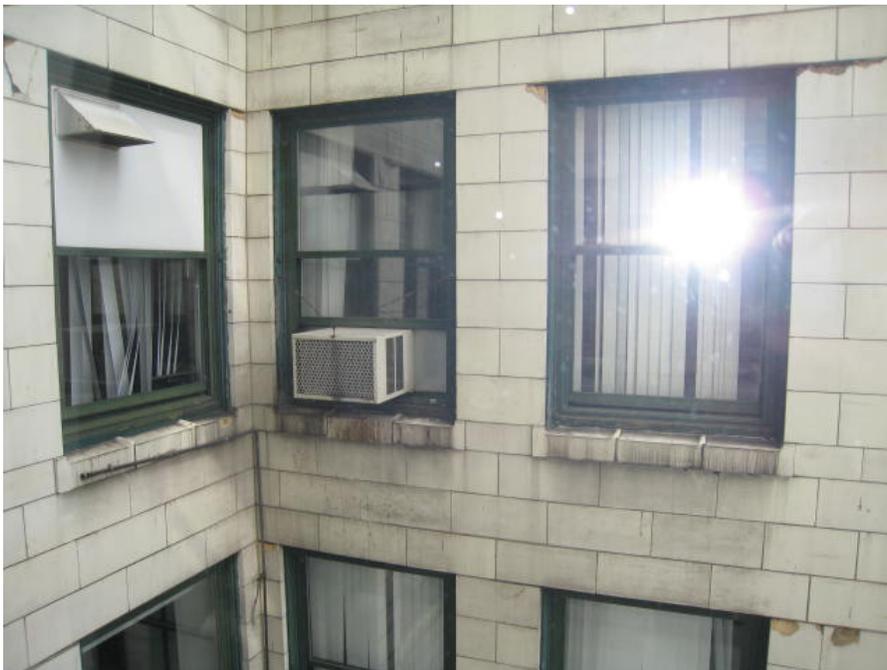
Picture 12

Examination of the interior of the building found no visible signs of bird infestation. However, evidence of pigeon roosting in the form of bird wastes and nesting materials was observed on top of/under window-mounted ACs (Picture 12). While the bird wastes are on the exterior of the building, ACs have the ability to introduce fresh air from outdoors. As air is drawn into the AC, bird waste particulate can be entrained (drawn into) the building. Bird wastes in a building raise three concerns: 1) diseases that may be caused by exposure to bird wastes, 2) the need for clean up of bird waste and 3) appropriate disinfection.

Bird Wastes on Air Conditioner and Window Ledges

14. Clean bird wastes and contaminated materials around ACs. Remove accumulated bird wastes from flat, non-porous surfaces and disinfect with an appropriate antimicrobial agent. Once disinfected, each treated area should be cleaned to ensure the removal of residual bird waste and cleaning materials.

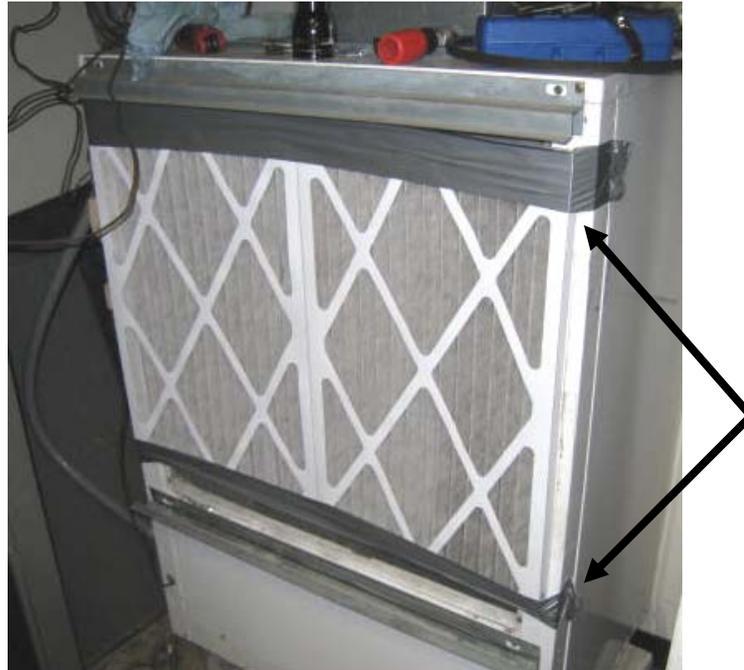
Picture 13

Several other conditions were noted during the assessment which can affect indoor air quality. The AHUs installed at the MRC are designed to have filters, however many of the filters were ill-fitting, held to the units with duct tape or missing altogether (Pictures 13 through 16). As air bypasses filters, the opportunity exists for airborne dirt, dust, odors and particulates

Filter Duct-Taped to AHU, Note Exposed Cooling Fins and Spaces around Filter at Bottom/Top

- needed, as well as the examination of all HVAC equipment periodically for maintenance and function.
6. Ensure filters for all ACs, AHUs fit flush in their racks with no spaces to prevent bypass of unfiltered air.

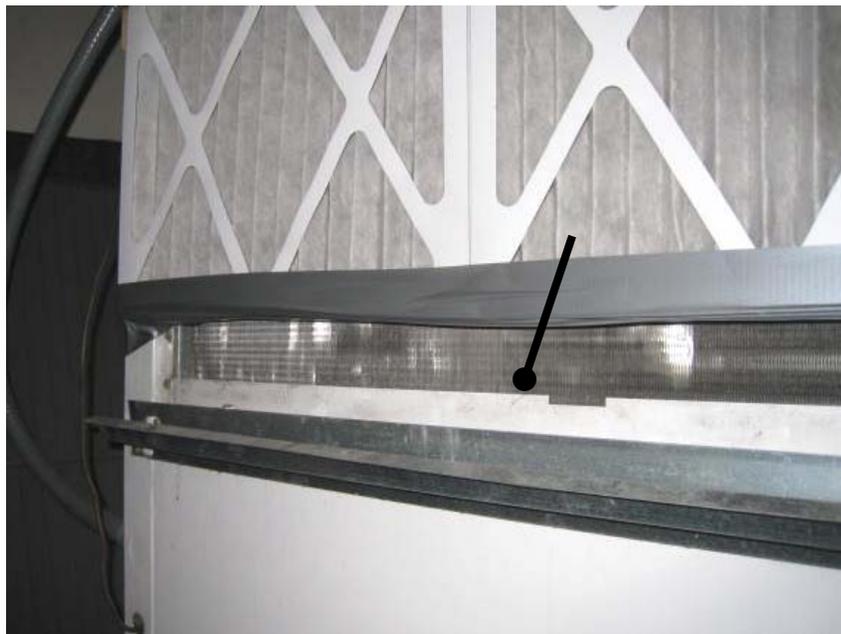
Picture 14

Close-Up of Filter Duct-Taped to AHU, Note Exposed Cooling Fins at Bottom

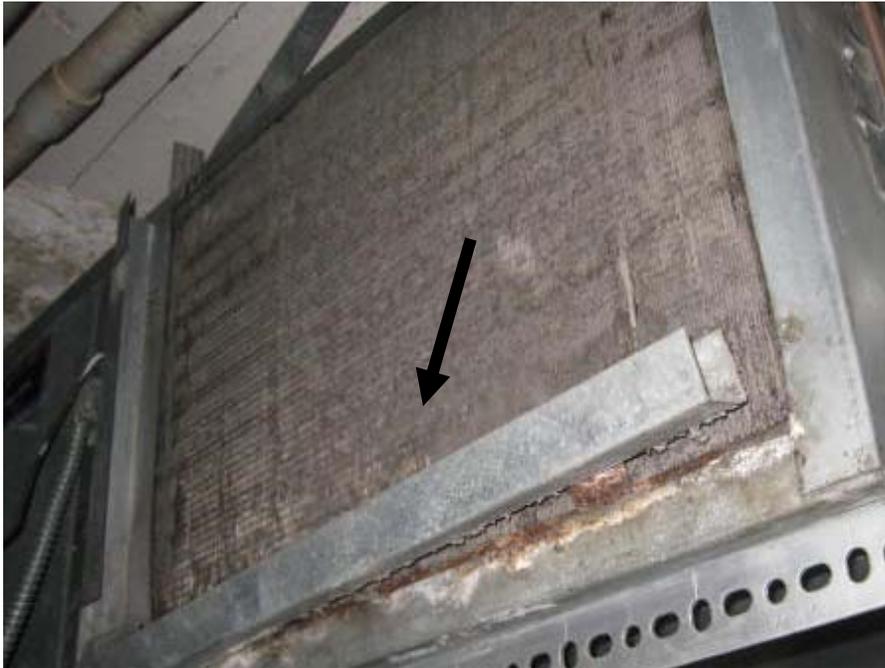
Picture 15

to be drawn into the HVAC system and be distributed to occupied areas. Aerosolized dust, particulates and odors can provide a source of eye, skin and respiratory irritation to certain individuals. In addition, accumulated debris in the cooling fins/coils from lack of proper filtration can decrease the efficiency of air conditioning, accelerate the degradation of HVAC equipment, and provide a source of mold growth when the fins/coils become moistened during hot, humid weather (Picture 15).

AHU Missing Filter, Note Empty Rack (Arrow) and Fins Occluded with Dust/Debris

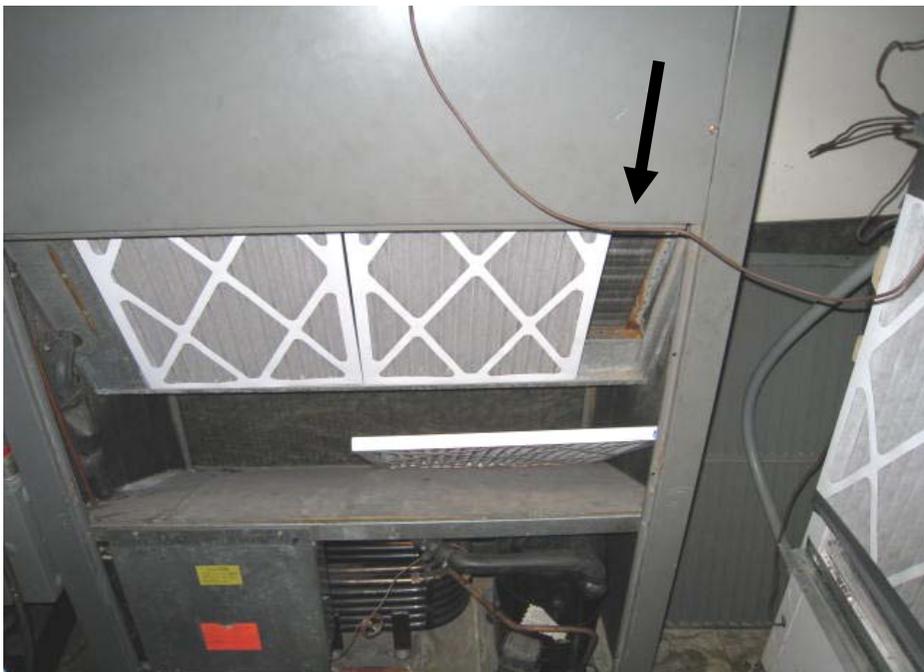
Picture 16

AHU with Undersized Filter, Note Space on Right for Filter Bypass

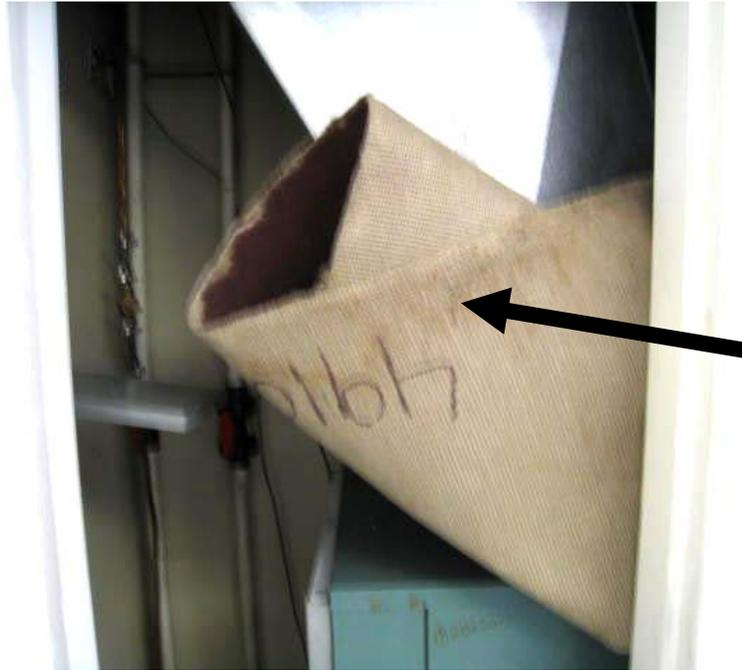
Picture 17

Pollutants from stored materials in the AHUs closets (e.g., water-damaged carpeting, paint cans and other debris) can be drawn into the AHUs and distributed into occupied spaces (Pictures 17 and 18). Open utility holes were also observed in mechanical room ceilings, walls and floors (Picture 19). These breaches can provide a pathway for odors, fumes, dusts and vapors to enter the mechanical room from adjacent rooms and floors.

Water-Damaged Carpet in AHU Closet, Note Stain

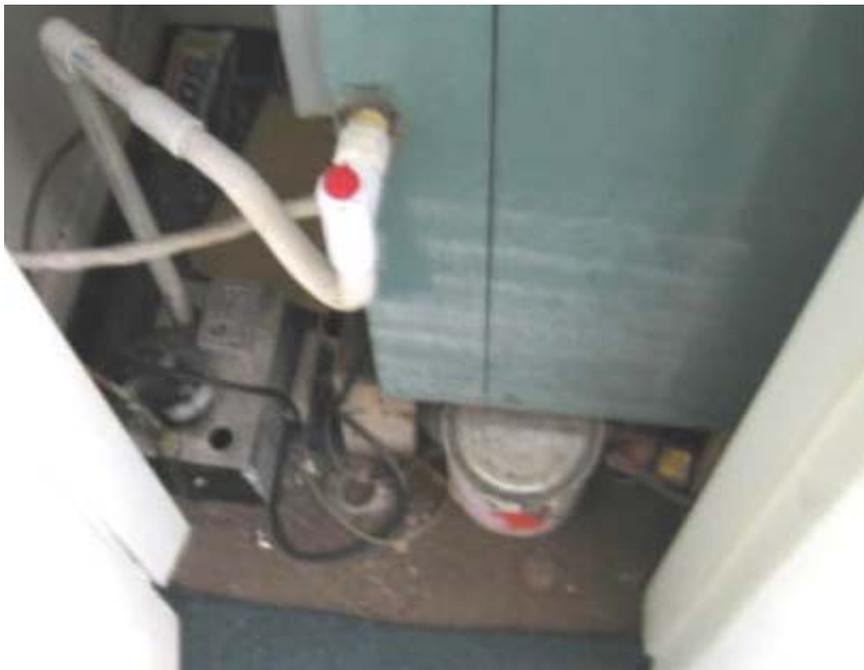
Picture 18

Paint Can Stored in Mechanical Room beneath AHU

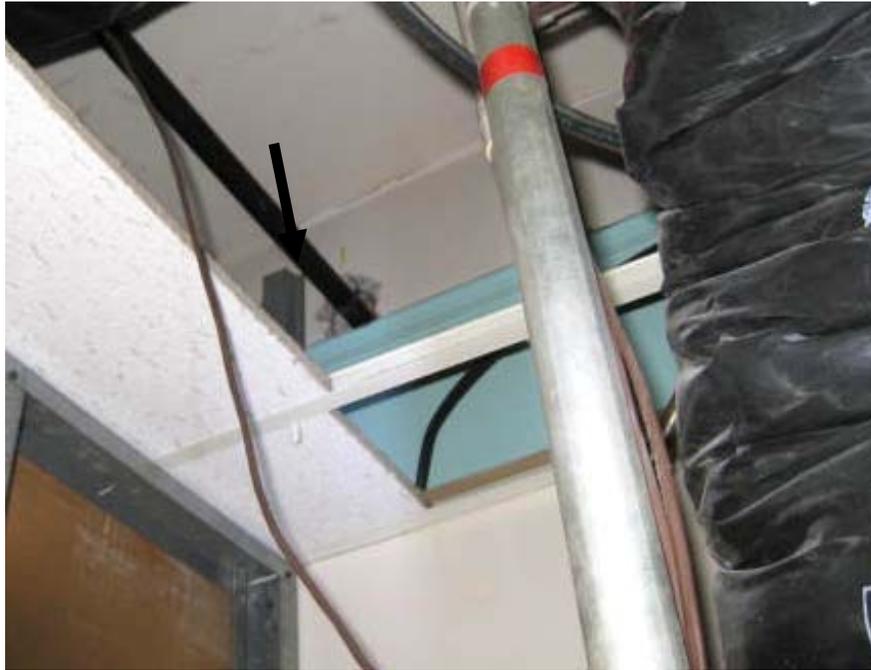
Picture 19

Holes in AHU Closet Wall

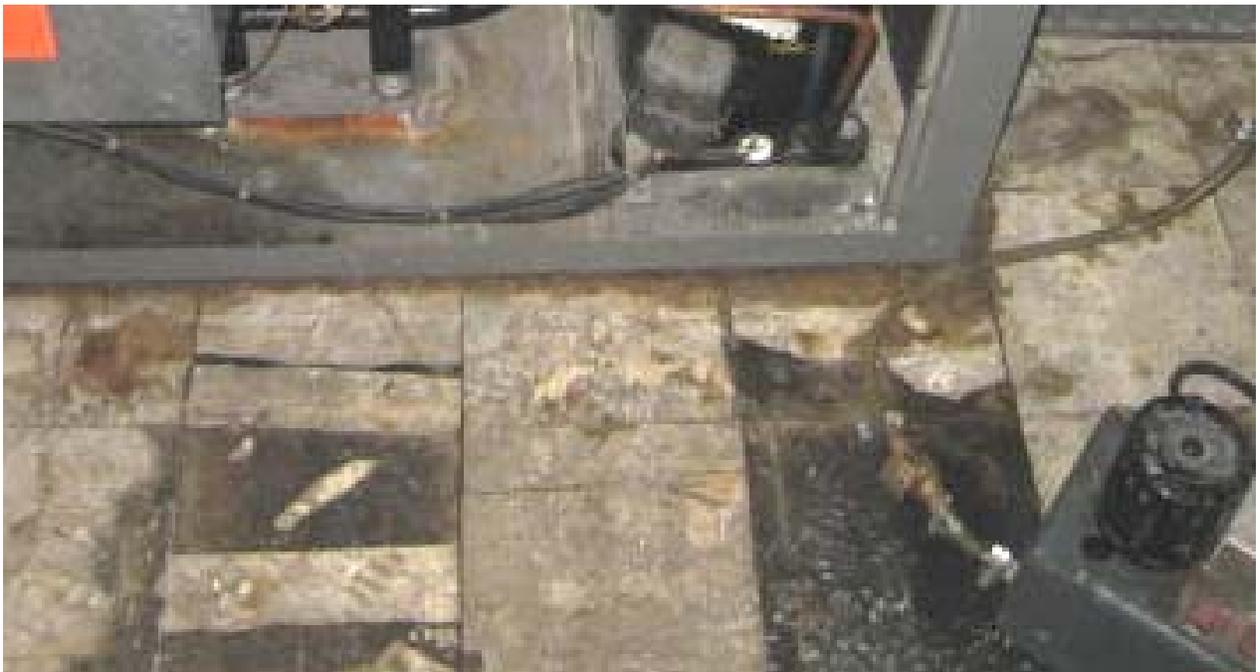
Picture 20

Of note are loose/damaged floor tiles in the main mechanical room (Picture 20). Other areas that were water-damaged due to by the sprinkler activation include carpeting installed over asbestos-containing floor tiles, mastic and paper backing (Vertex, 2010). Since floor tiles in the mechanical room are similar to those removed during the fire restoration, it can be assumed that this tile, mastic and paper backing likely contains asbestos. Damaged flooring materials containing asbestos must be remediated and disposed of in a manner consistent with Massachusetts asbestos disposal laws.

Water-Damaged/Cracked Floor Tile in Main AHU Closet

15. Ascertain whether floor tiles in the main mechanical room contains asbestos, remediate or remove in a manner consistent with Massachusetts asbestos remediation laws.
