INDOOR AIR QUALITY ASSESSMENT

**Suffolk County Sheriff's Department
151 Merrimac Street
Boston, Massachusetts**

**Prepared by:
Massachusetts Department of Public Health
Bureau of Environmental Health
Indoor Air Quality Program
August 2010**

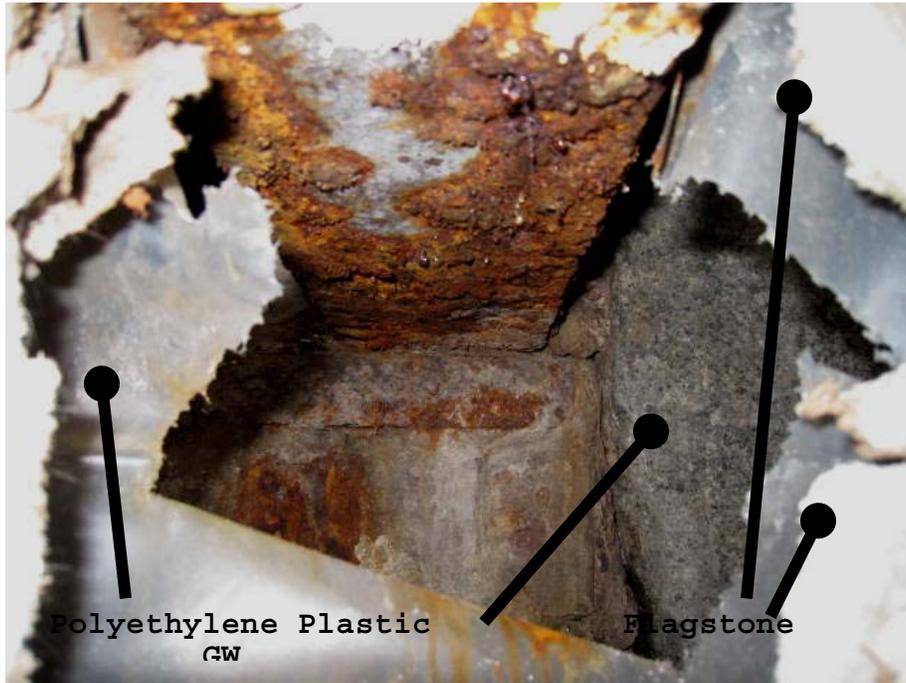
Picture 1

At the time of the BEH assessment, IAQ staff could not identify any dehumidifiers in use to control relative humidity in sub-grade areas. In addition, it does not appear that any of the recommendations made by Envirotest were acted upon in any substantive manner. Gypsum wallboard (GW, sheetrock) remained in place in Areas I, J, K, and L (Picture 1).

These areas are also unconditioned space that has GW and polyethylene plastic installed over the flagstone foundation wall¹ (Pictures 1 and 12). As moisture passes through the flagstone wall, GW absorbs water to become routinely moistened, particularly after rainstorms. As a result Areas I, J, K, L are routinely subjected to uncontrolled moisture exposure, making it unsuitable for storage of paper records. Any porous materials (paper documents and cardboard boxes) stored in this area would be susceptible to mold growth. The US Environmental Protection Agency (US EPA) and the American Conference of Governmental Industrial Hygienists (ACGIH) recommend that porous materials be dried with fans and heating within 24 to 48 hours of becoming wet (US EPA, 2001; ACGIH, 1989). If not dried within this time frame, mold growth may occur. Once mold has colonized porous materials, they are difficult to clean and should be removed/discarded.

GW and Polyethylene Plastic Installed over Flagstone Foundation

1. Due to the configuration of the foundation wall, Areas I, J, K, L should not be used for document storage due to its lack of ventilation and chronic dampness. At minimum, all recommendations made in the 2009 Envirotest report should be implemented.

2. It is not recommended that any material be put in place of GW unless measures to prevent water infiltration are implemented.
3. In order to prevent further water penetration into Areas I, J, K, L a building engineer should be consulted. Repairs most likely to prevent water penetration may include:

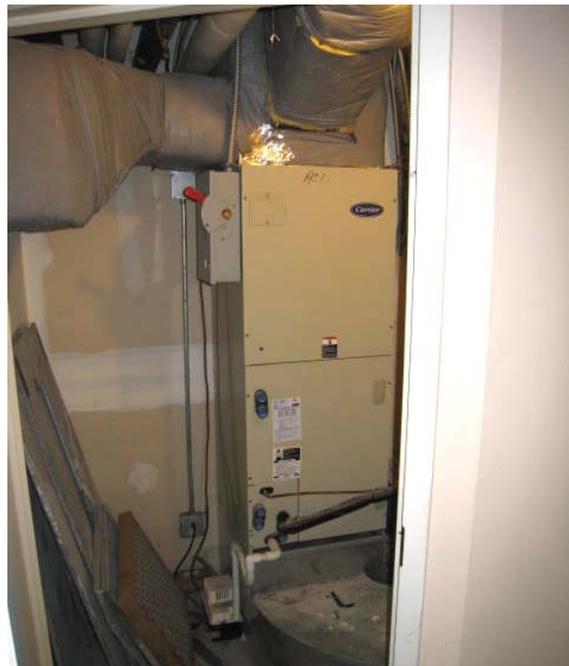
Picture 2

Return ventilation is provided by ceiling and/or wall-mounted return vents that are ducted back to AHUs (Pictures 2 and 3). This design uses the entire office space as a return air plenum. Private offices do not have return air vents, but appear to rely on return air being drawn through spaces beneath office doors. It appears that the AHUs do not have the capacity to exhaust air from the office. Without a means of exhaust ventilation, stale air and associated interior pollutants can accumulate inside the building and be continuously re-circulated, which can lead to air quality/comfort complaints.

North AHU Return Air Intake

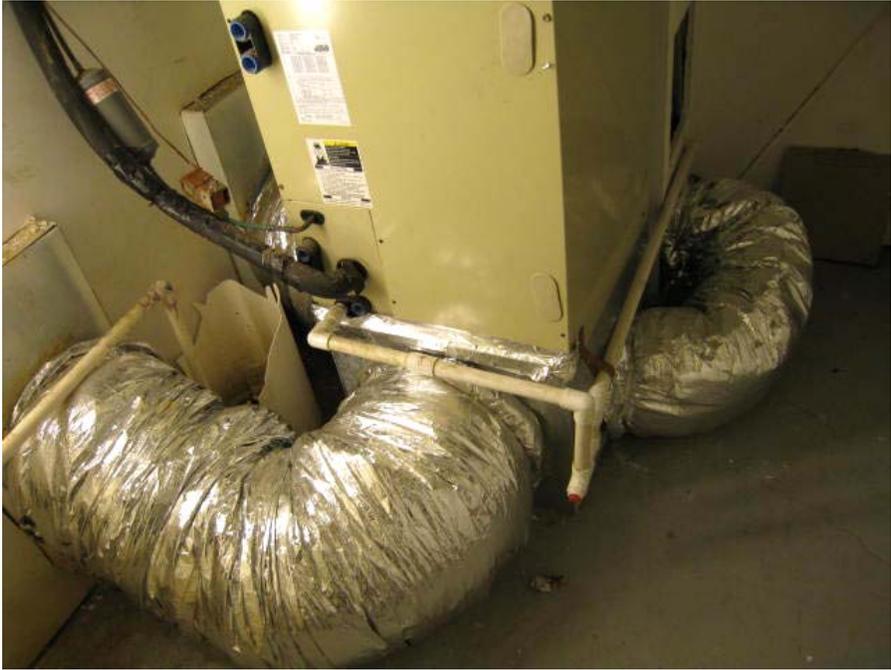
Picture 3

Area L AHU Return

9. Consideration should be given to reconfiguring the HVAC system to relocate the Area L AHU to a dry location.

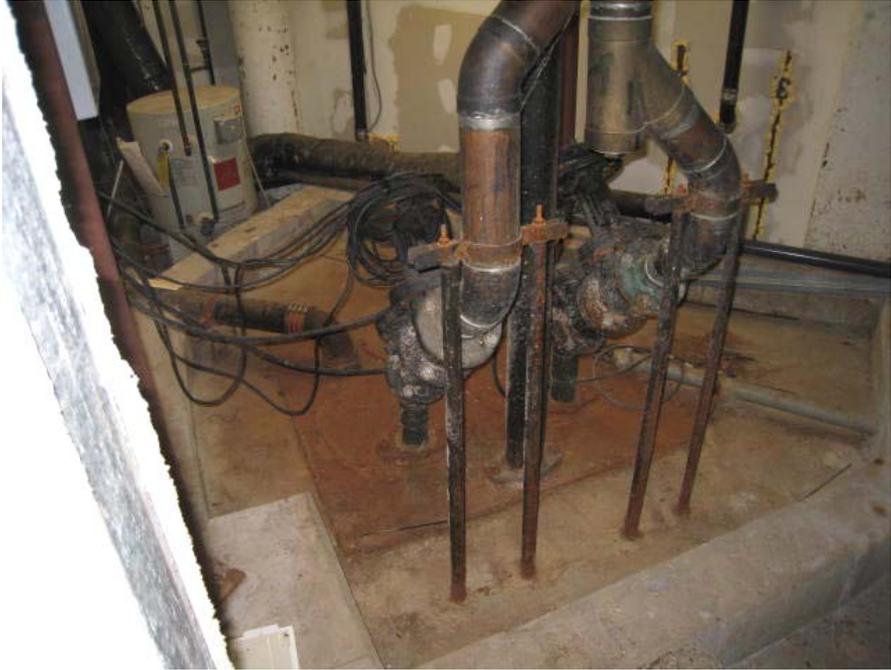
Picture 4

A number of moisture sources were identified. Immediately adjacent to the SCSD offices are three sewage receptacles with pumps (Pictures 4, 5 and 6) and an open pit with a sump pump (Picture 7). Another source of moisture is water penetration through the ceiling and exterior walls of the storage rooms (areas I, J, K, L on Map 2). These areas of the basement are not equipped with functioning exhaust ventilation. Moisture from these areas is likely drawn through the SCSD basement door when the AHUs are operating, since the office space becomes depressurized. With no operating exhaust components in the HVAC system, water vapor will tend to accumulate, which in turn can moisten building and office materials leading to musty odors and/or mold growth.

Pump in Pump Room

8. Consideration should be given to installing mechanical exhaust ventilation in the pump room area to draw odors and moisture away from the SCSD office space.

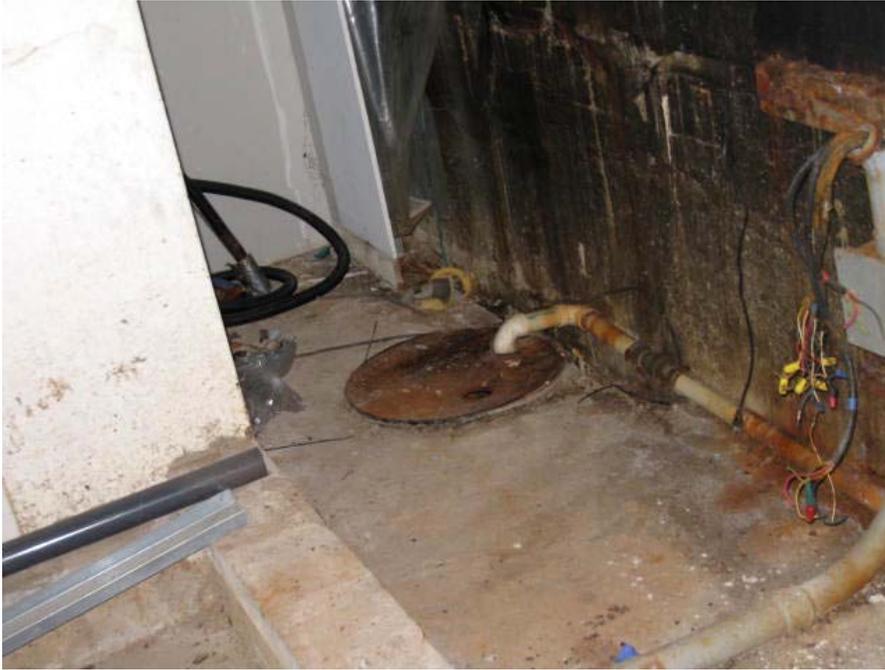
Picture 5

Pump outside Pump Room

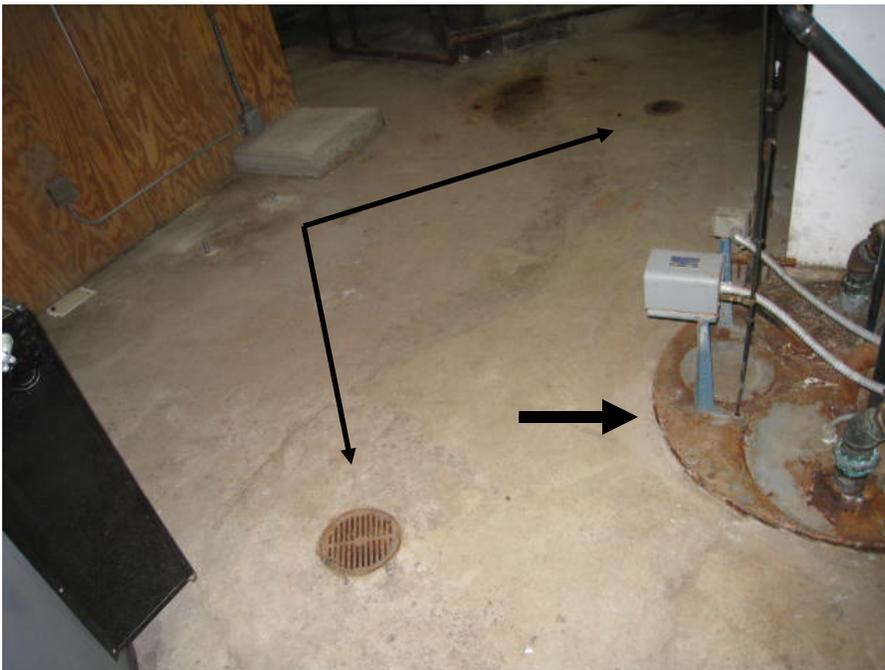
Picture 6

Pump outside Pump Room (Large Arrow) and Two Floor Drains

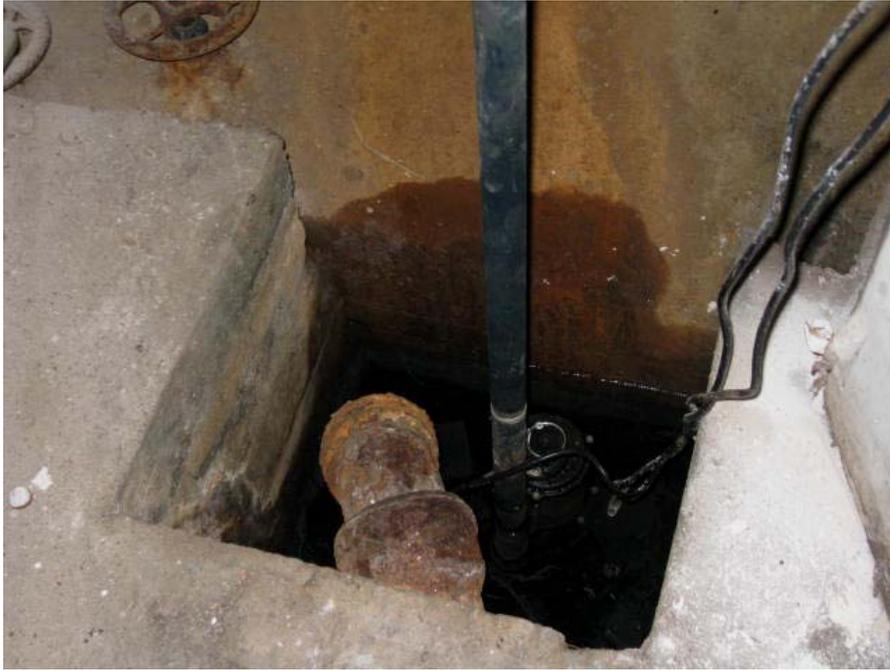
Picture 7

Open Pit with Sump Pump

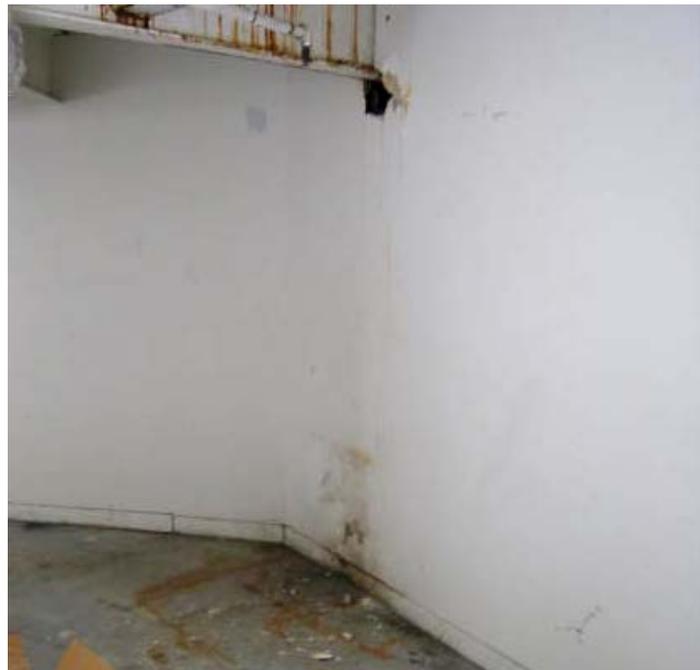
Picture 8

The basement offices had a distinct musty odor, which can be attributed to chronic water damage in Areas I, J, K, L (Map 2) that are used for records storage. These areas are below sidewalks that leak into the basement and had numerous signs of water penetration through ceilings and exterior walls (Pictures 8 through 11). The exterior wall behind gypsum wallboard (GW) appears to be flagstone (Picture 12), which is not watertight.

Water-Damaged Ceiling and Wall in Area I

- a. Waterproofing the exterior side of the foundation;
 - b. Sealing interior ceilings with an appropriate material; and
 - c. Sealing all spaces in the topside of the sidewalk, parking lot/building junction along the south exterior wall and the sidewalk/building junction.

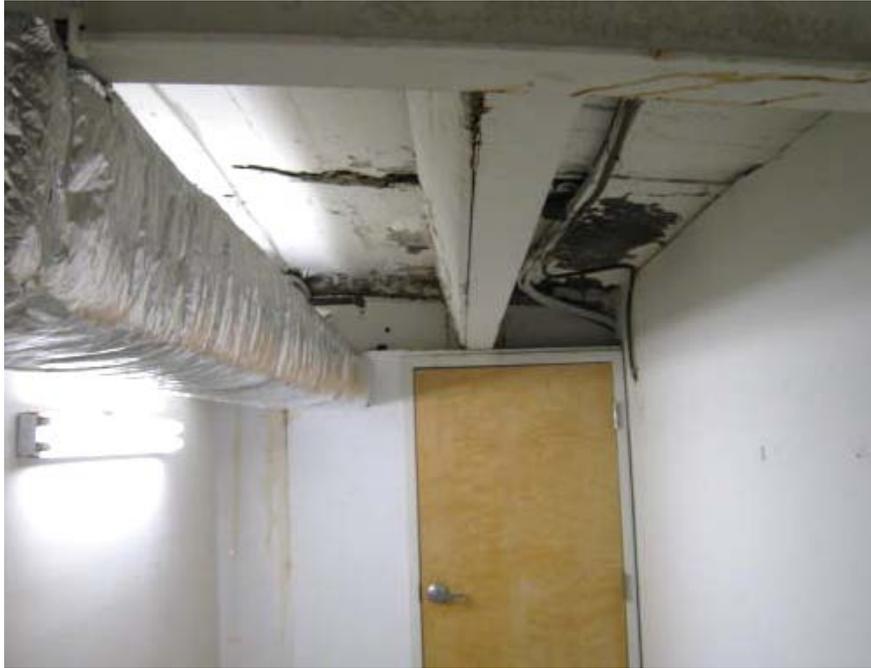
Picture 9

Water-Damaged Ceiling and Wall in Area I

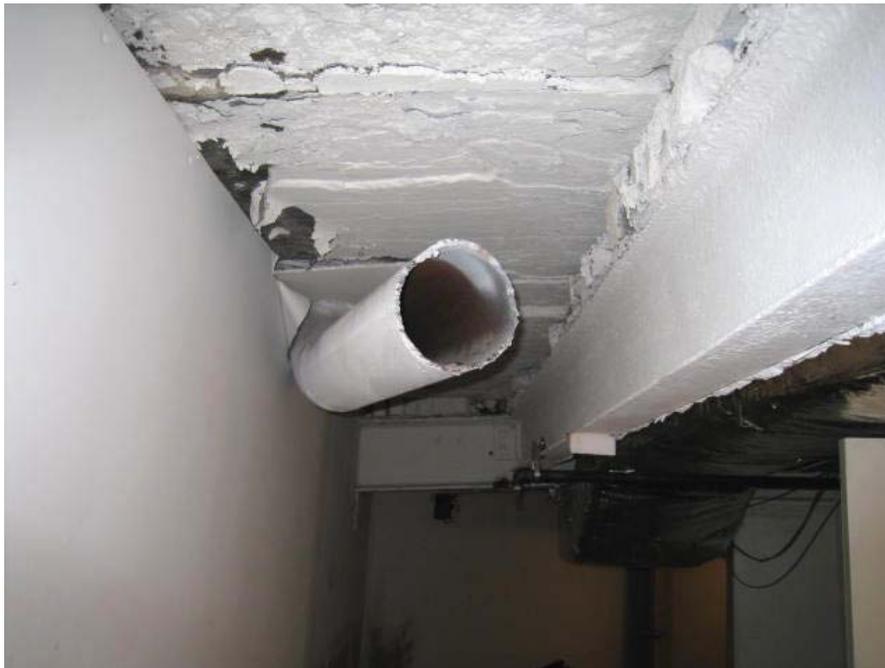
Picture 10

Water-Damaged Ceiling and GW in Area L

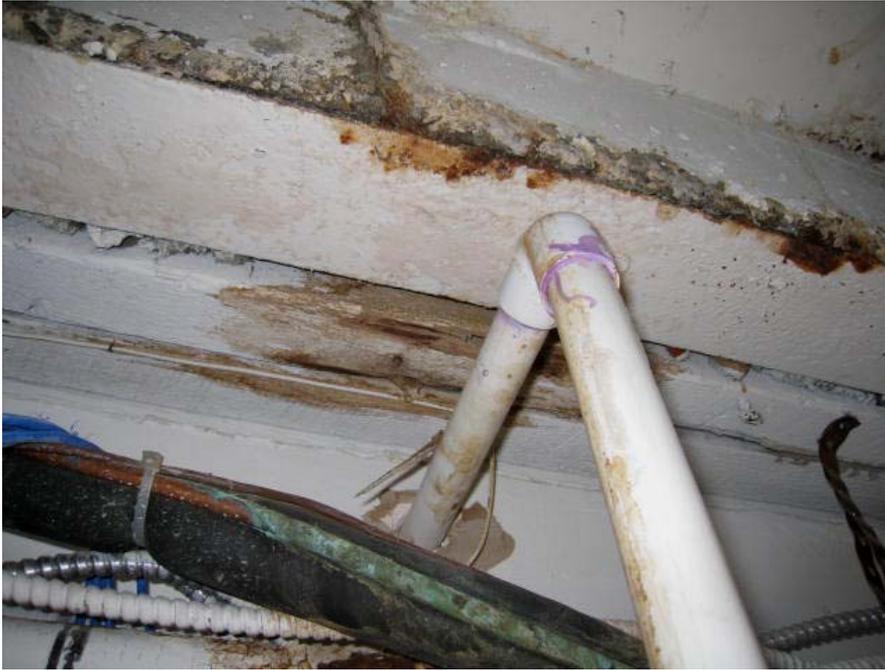
Picture 11

Water-Damaged Ceiling and GW in Area L

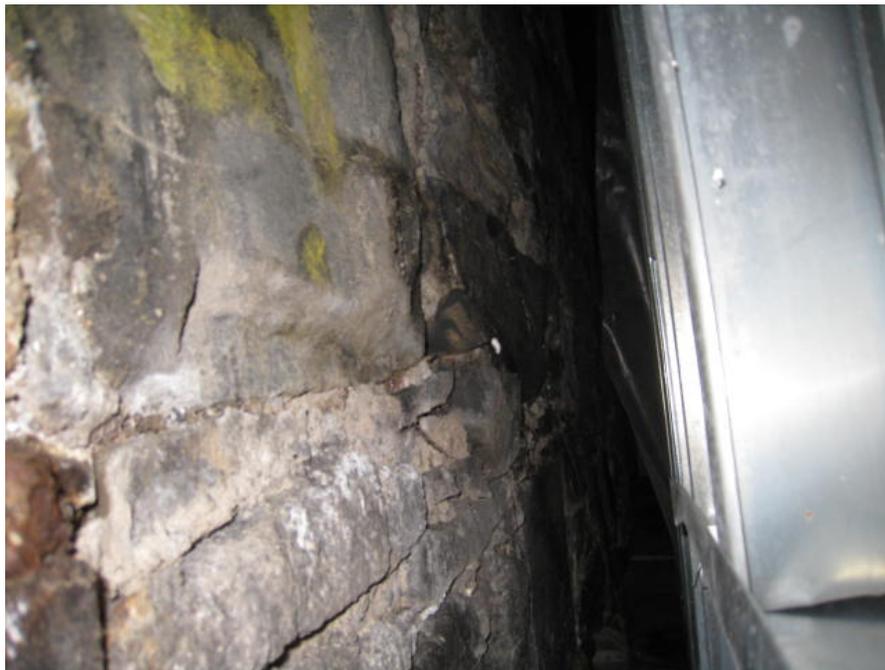
Picture 12

Flagstone Foundation with Minimal Concrete in Joints

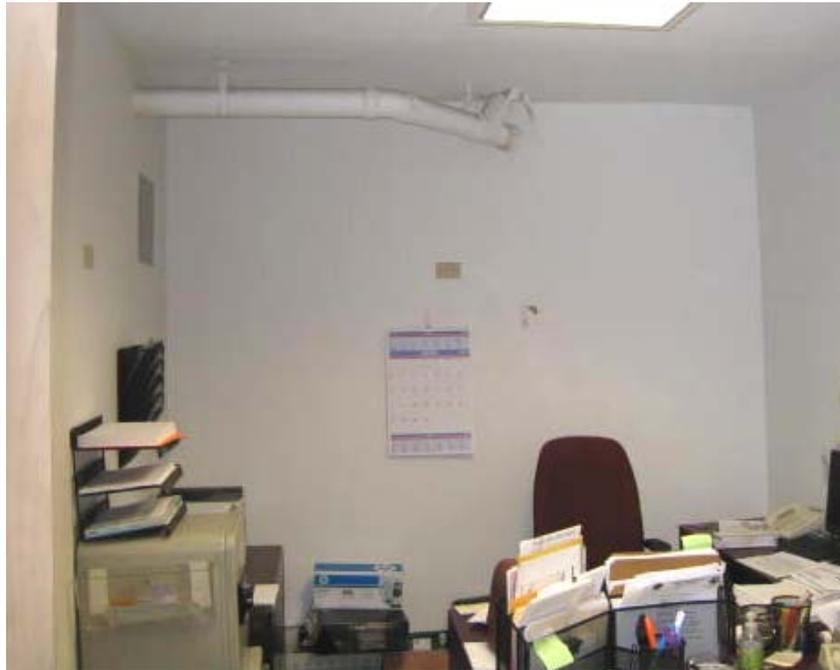
Picture 13

Building occupants reported that drainpipes leaked into office space and saturated building materials (Picture 13 and 14). It was also reported that wall-to-wall carpeting was replaced in this area; however wall coving and GW were not remediated. Since this drain system likely contained sewage, methods for cleaning heavy microbial contamination should have been employed (IICRC, 1999). In general, it is recommended that absorbent materials (GW, insulation, carpeting, fabrics, books, cardboard, etc.) be discarded once in contact with sewage (IICRC, 1999). Flooring and sub-flooring (such as wood and tile) should be evaluated, cleaned, disinfected, dried and sealed when appropriate (IICRC, 1999). The GW and plastic coving should have been removed and replaced.

Pipes (along ceiling) in Office Reported to Have Leaked Sewer Water

6. All GW in areas where sewage contamination occurred should be removed to a height of 1-foot above the flood-line.
7. Doors leading to unoccupied basement areas should be rendered airtight using weather-stripping and door sweeps.

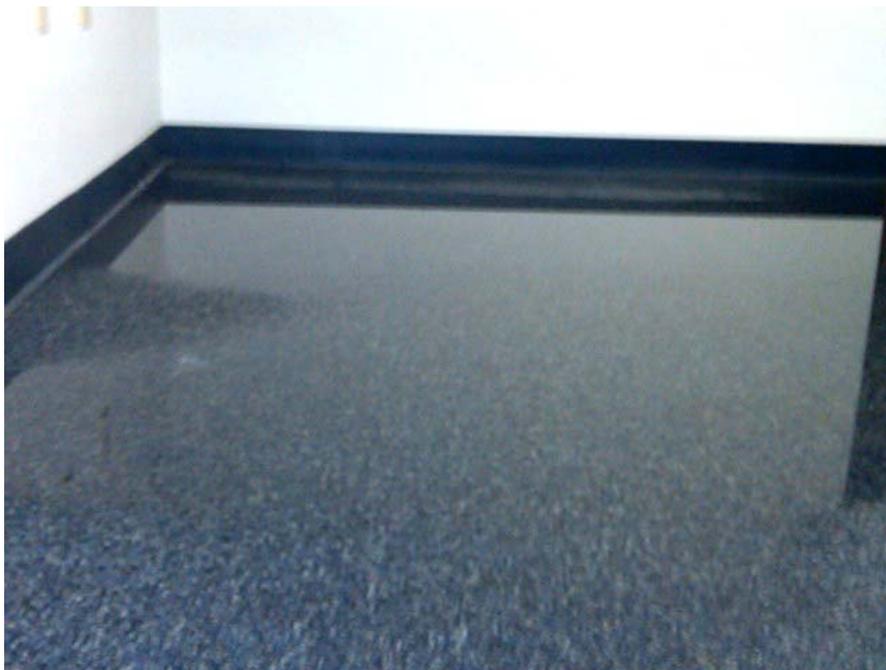
Picture 14

Wet Floor from Reported Sewer Leak

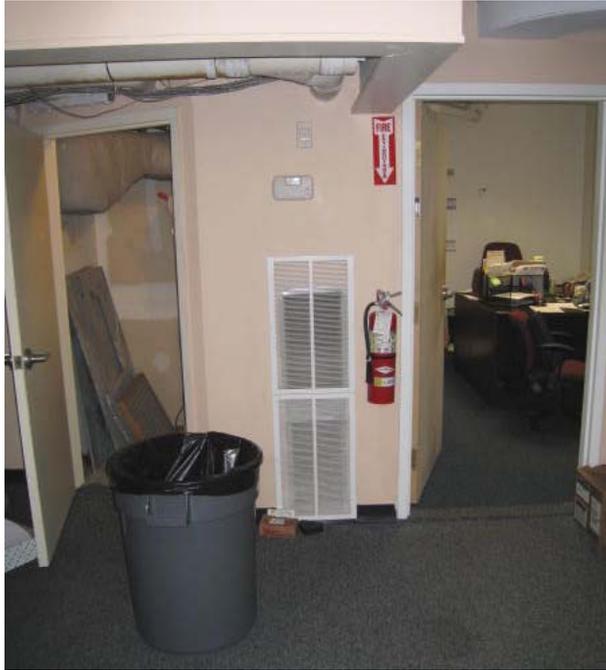
Picture 15

The AHUs had filters missing (Picture 15) or filters installed in a manner that allow air to bypass the filter (Picture 16). The AHU must have the appropriate equipment to make each filter fit flush in the rack. Without filters properly in place, spaces around filters can allow for unfiltered air to bypass the filters and be distributed by the AHUs.

North AHU Fresh Air Intake Missing Filter

10. Consideration should be given to installing an exhaust ventilation component to the HVAC system if one does not exist.
11. Ensure filters are properly installed in all AHUs. Change as per the manufacturer's instructions or more frequently if needed.

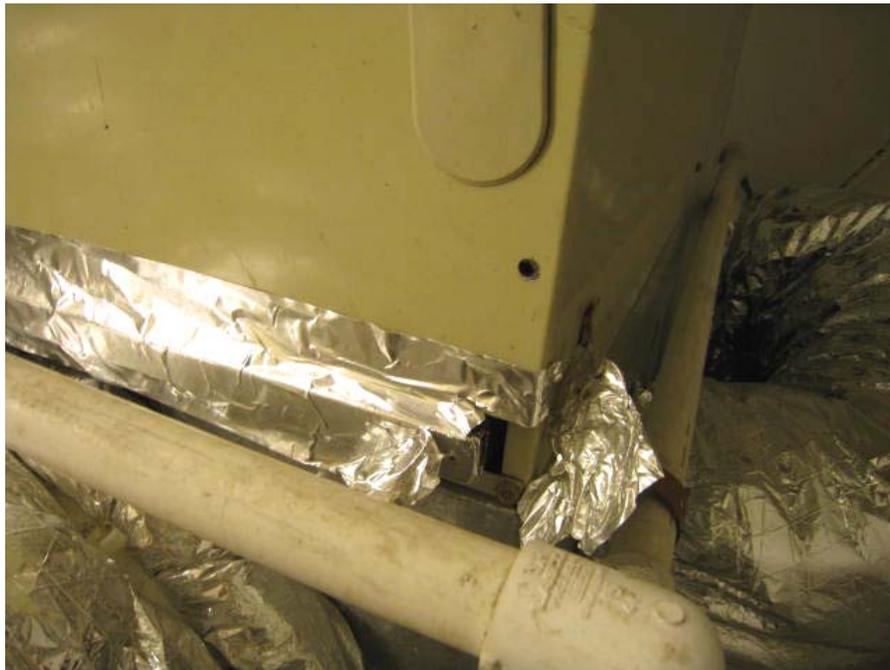
Picture 16

Hole in Tape Allowing AHU to Draw Air from Area L

4. All doors to Areas I, J, K, and L should be rendered airtight using weather-stripping and door sweeps.
5. Completely seal all seams to the AHU located in Area L to prevent dust/debris/odors from being entrained into the HVAC system.
