INDOOR AIR QUALITY ASSESSMENT

**Department of Children and Families
63 Fountain Street
Framingham, Massachusetts**

Prepared by:
Massachusetts Department of Public Health
Bureau of Environmental Health
Indoor Air Quality Program
April 2010

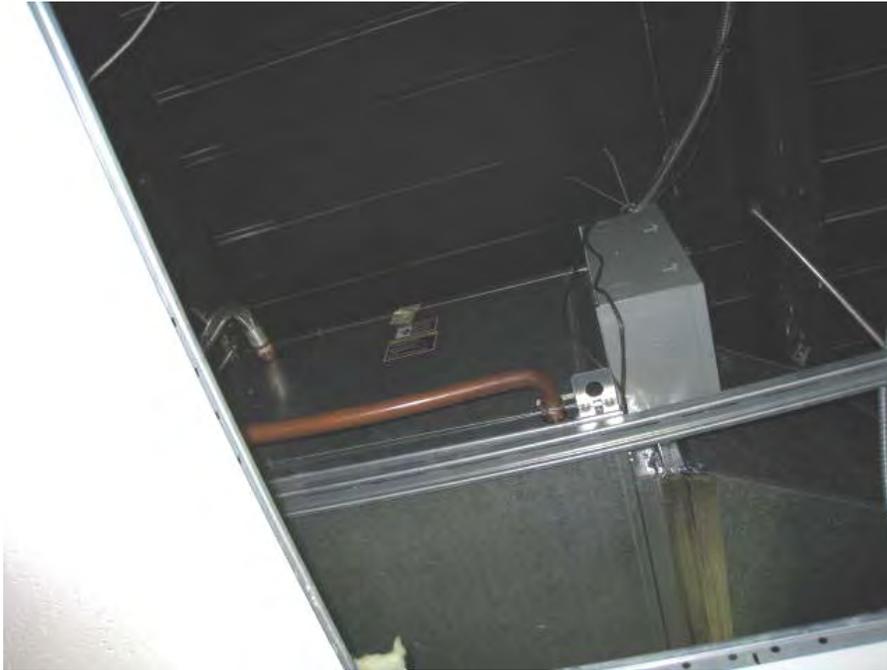
Picture 1

The ventilation system at the DCF consists of ceiling-mounted heat pumps located above the ceiling tile system (Picture 1). The system does not appear to be designed to provide either mechanical fresh air supply or exhaust ventilation but rather recycles existing air. Heated or cooled air is supplied to occupied areas via ceiling-mounted air diffusers (Pictures 2 and 3). Air is filtered and returned to the heat pumps by ducted ceiling-mounted return vents (Picture 4).

Heat Pump Located above Ceiling Tile System

1. Contact an HVAC engineering firm to evaluate the HVAC system for retrofitting fresh air intake and exhaust to increase air exchange and removal environmental pollutants from the building.
2. Work with an HVAC firm to the modify system in IT/Family Meeting Room to control comfort. Consider separate thermostats or units. Consider installing a spot-cooling AC unit in the IT room.

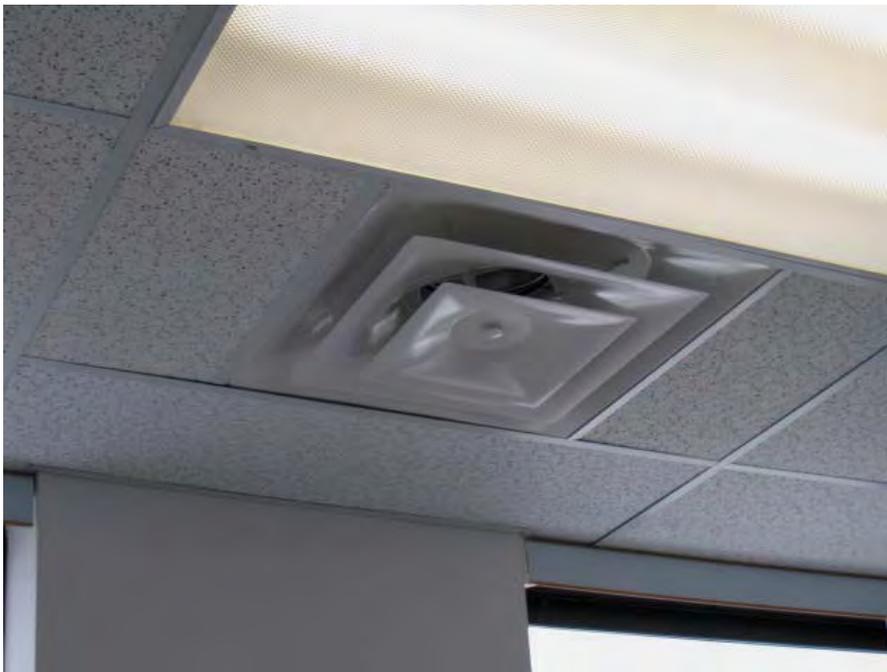
Picture 2

Ceiling-Mounted Supply Diffuser

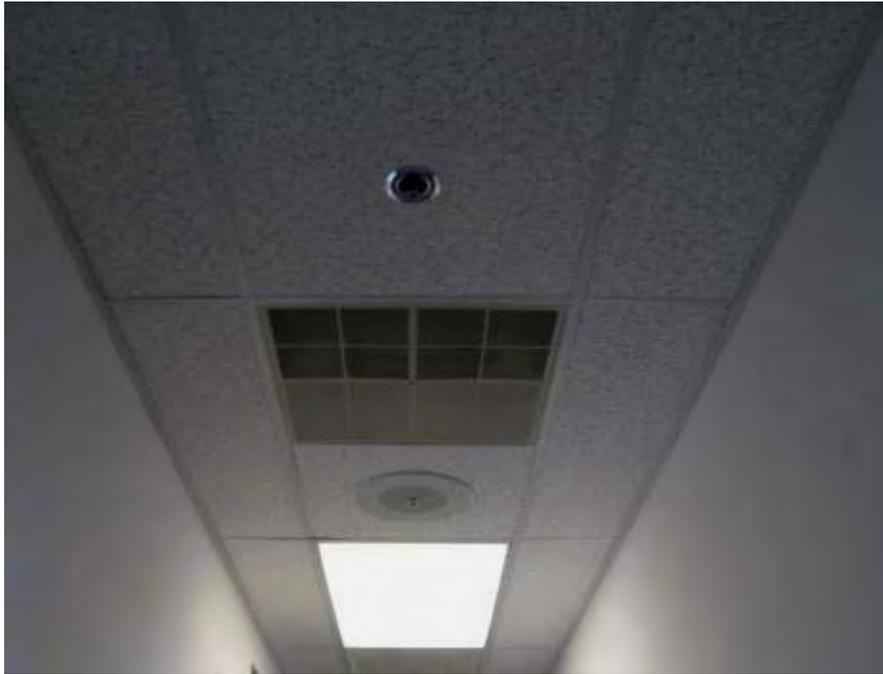
Picture 3

Ceiling-Mounted Supply Diffuser

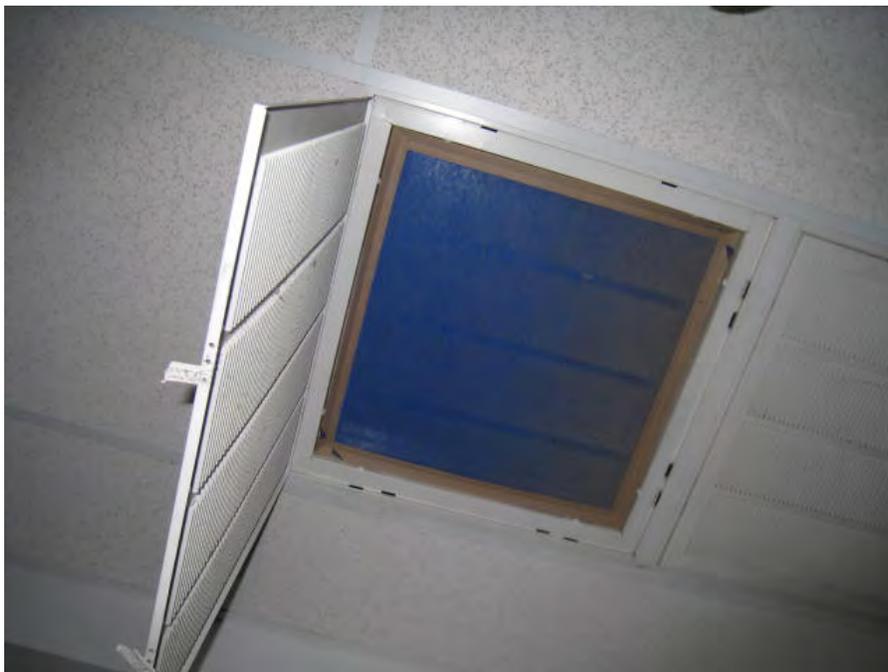
Picture 4

Other conditions that can affect indoor air quality were observed during the assessment. Air handling equipment (e.g., HVAC units, heat pumps) is normally equipped with filters that strain particulates from airflow. The filters in heat pumps at the DCF are installed within the return vent frame and provide minimal filtration (Picture 4). In order to decrease aerosolized particulates, disposable filters with an increased dust spot efficiency can be installed. The dust

Ceiling-Mounted Return Vent, Note Filter

4. Increase the dust-spot efficiency of HVAC filters. Prior to any increase of filtration, each piece of air handling equipment should be evaluated by a ventilation engineer as to whether it can maintain function with more efficient filters.

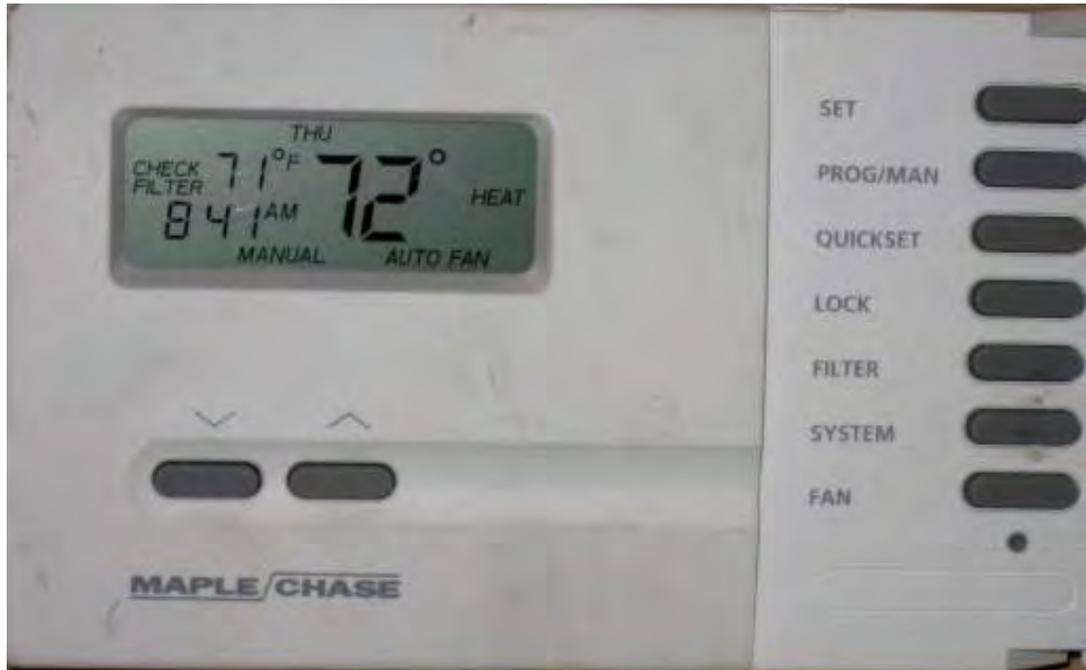
Picture 5

The system is controlled by digital wall-mounted thermostats (Picture 5). Thermostats have fan settings of “on” and “automatic”. At the time of the MDPH assessment, the thermostats were set to the “auto” setting. The “automatic” setting on the thermostat activates the HVAC system at a preset temperature. Once the preset temperature is reached, the HVAC system is deactivated, whereas the “on” setting provides *continuous* airflow/filtration, which is recommended by the MDPH. Some thermostats were older and did not appear to have an obvious fan-control (Picture 6). Without a mechanical means to provide air exchange, the only means to provide fresh air and remove pollutants from the indoor environment would be to open windows.

Digital Thermostat, Note Fan Button (Lower Left) and Display of Fan in “Auto” Position

1. Consider setting digital thermostats for the HVAC system in the fan “on” mode (as opposed to the fan “auto” setting) to supplement the use of windows and provide continuous air circulation and filtration.

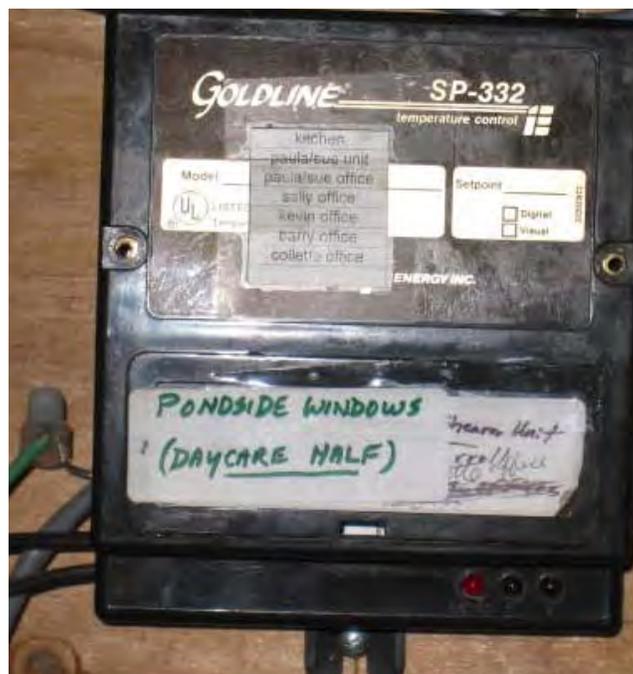
Picture 6

Older Model Non-Digital Thermostat

2. Consider replacing older model thermostats with digital thermostats.
3. Provide air exchange by using openable windows to control for comfort. Care should be taken to ensure windows are properly closed as needed to avoid the freezing of pipes and potential flooding.

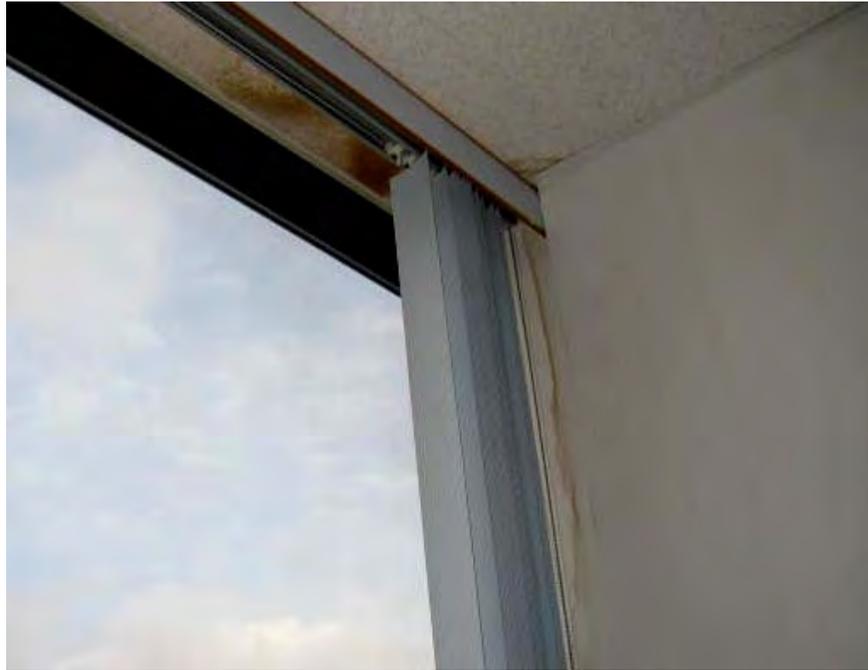
Picture 7

As mentioned previously, the DCF has experienced chronic leaks over the years. In an effort to stem leaks the rear portion of the roof was repaired, which has appeared to be successful. However, several areas continue to have periodic leaks along the roof/window junction (Pictures 7 and 8), which may be related to window “headers” rather than roof leaks. It was reported by Mr. Lopas that replacement windows were smaller than the original windows. To fit properly, a header is installed at the top of the window frame to take up space (Picture 9). It is likely that water is infiltrating through failed sealant around the header.

Water damaged ceiling tiles were observed in a number of areas, which indicate current/historic plumbing or other building envelope leaks (Table 1). Water damaged ceiling tiles can provide a source of mold and should be replaced after a water leak is discovered and repaired.

Water Damaged Ceiling Tiles along Top of Windows, Also Note Stain Down Side of Wall

8. Ensure all roof leaks are repaired, and replace water damaged ceiling tiles. Examine the area above and around water-damaged areas for mold growth. Disinfect areas with an appropriate antimicrobial as needed.

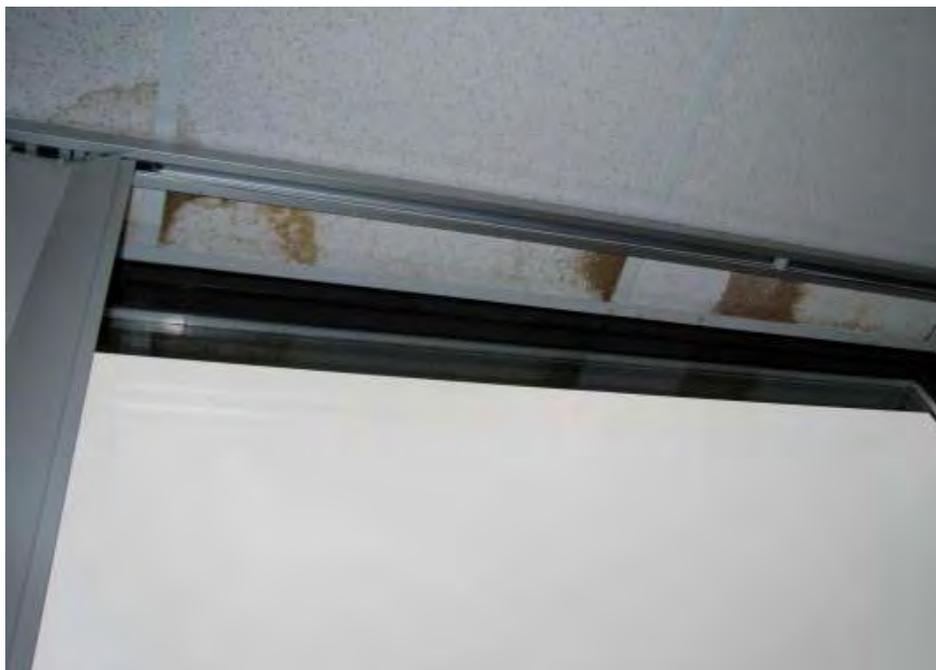
Picture 8

Water Damaged Ceiling Tiles along Top of Windows in Office

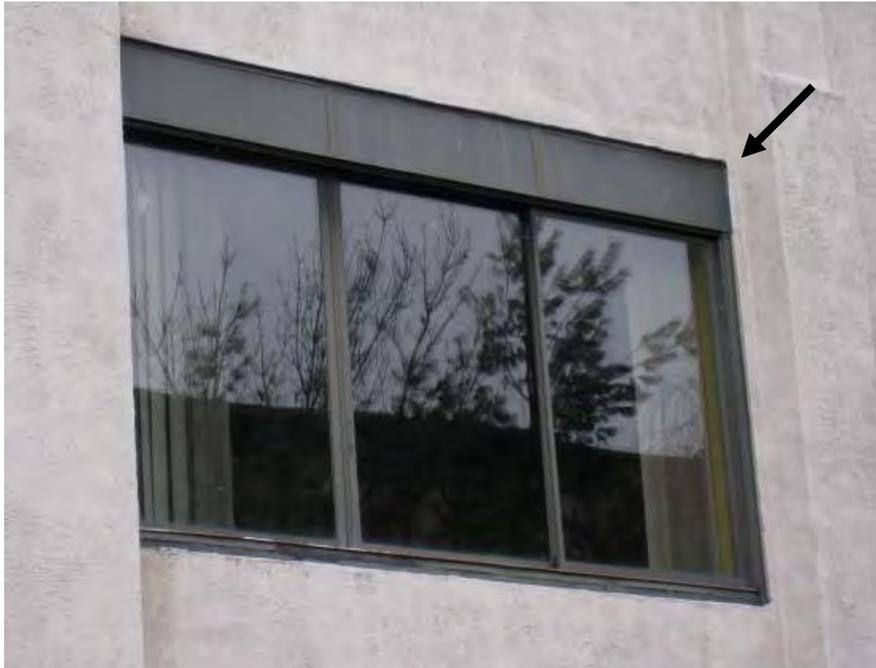
Picture 9

Window “Header”

9. Seal seams/spaces around window headers to prevent further moisture infiltration.
10. Discard plastic tubing connecting the condensation drains to the cooling units. Examine flexible hosing for mold growth during routine changing of filters. Replace or disinfect this tubing with an appropriate antimicrobial prior to the air-conditioning season on a routine basis.

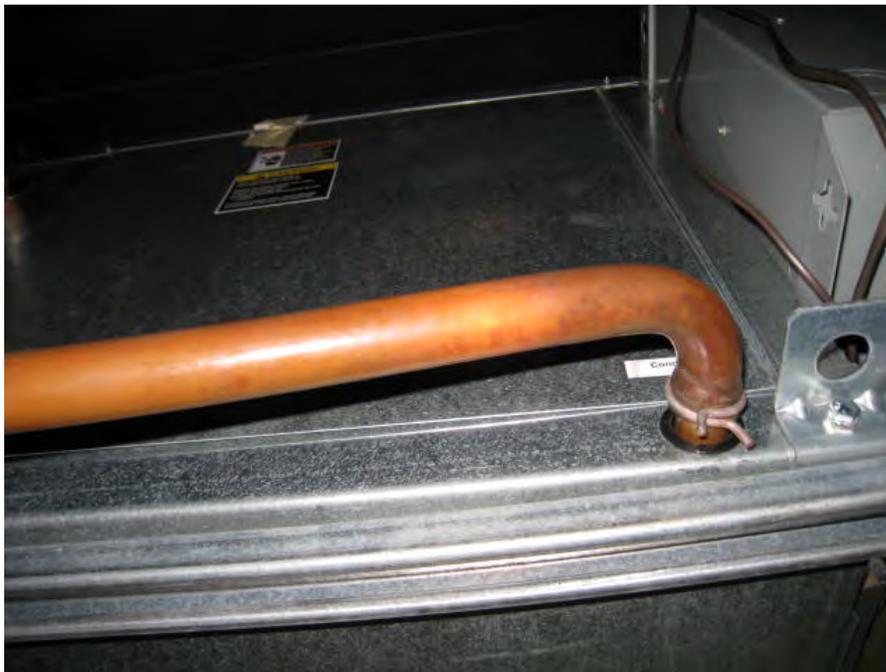
Picture 10

It appears that the interior of the flexible hose is coated with a heavy deposition of scale and debris, which can also provide a source of microbial growth and/or foul odors (Picture 10). As the heat pump operates, negative pressure is created which can draw air from the drain system through these hoses and into the unit. This can be a means for microbial growth and/or odors to be drawn into the unit and be distributed by the HVAC system. At the time of the assessment BEH staff recommended that the tubing be replaced. In subsequent correspondence with Mr. Kroening, it was reported that the tubing for this unit, as well as another, was replaced.

Clear Plastic Heat Pump Condensation Tube, Note Tube Should be Clear in Appearance

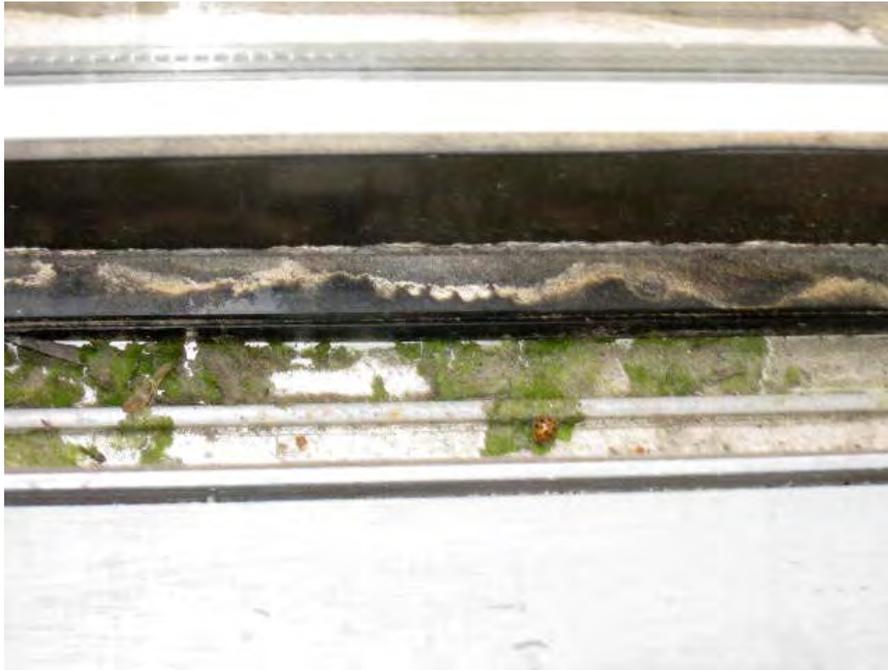
Picture 11

A green algae/mold growth was observed in the metal window tray in interview room 2 (Picture 11). Although metal is not a good mold growth medium, dirt, dust and debris that builds up in the trays can become moistened and provide a source for mold growth. In subsequent

Algae/Mold Growth in Window Tray

11. Clean window trays on a regular schedule.
12. Install weather-stripping/door sweeps beneath stairwell doors to prevent drafts and pest entry.
13. Refer to resource manual and other related indoor air quality documents located on the MDPH's website for further building-wide evaluations and advice on maintaining indoor environmental conditions in public buildings. These documents are available at:
<http://mass.gov/dph/iaq>.

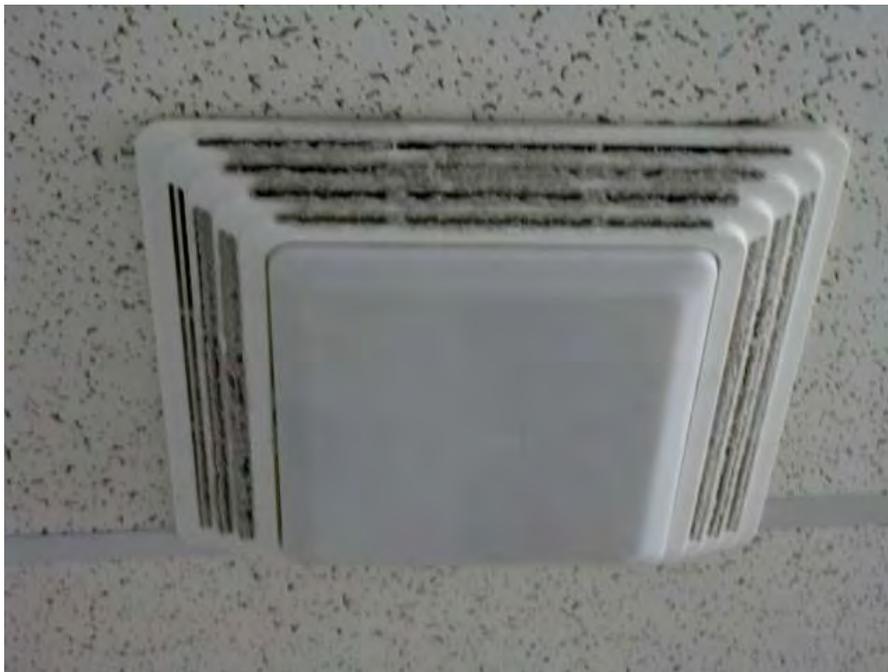
Picture 12

Restrooms are equipped with mechanical exhaust vents (Picture 12). The vents were not drawing air at the time of the assessment. BEH staff removed ceiling tiles to determine if the vents were properly vented and found that the ductwork was of extreme length and folding back upon itself (Picture 13). Further, it could not be determined if these vents were ducted to the exterior of the building. Exhaust ventilation is necessary in restrooms to remove excess moisture and to prevent odors from penetrating into adjacent areas.

Restroom Exhaust Vent

5. Change filters as per manufacturer’s instructions or more frequently if needed.
6. ***Ensure that restroom exhaust ventilation is operating and ducted to the outside of the building.***

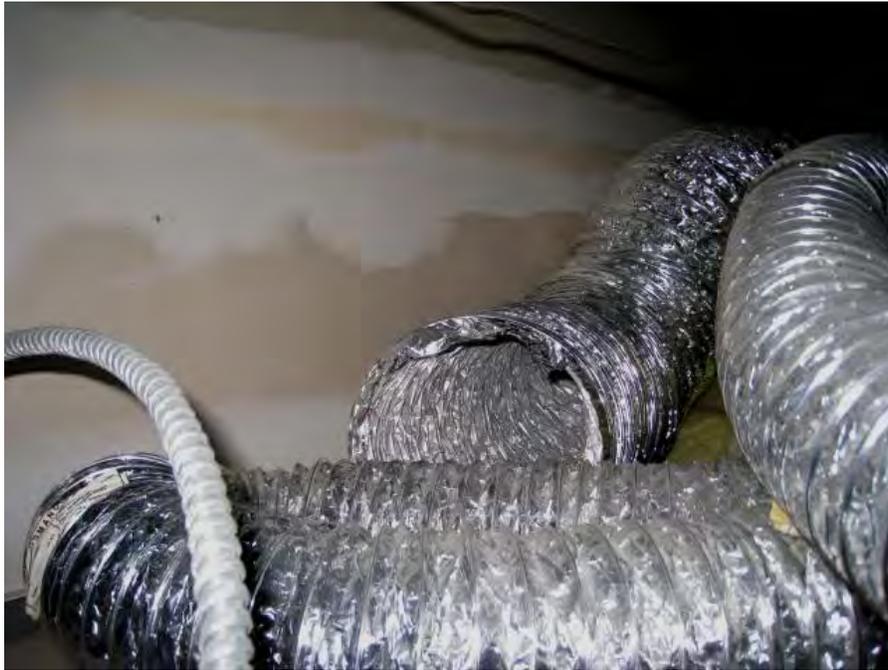
Picture 13

Flexible Ductwork for Restroom Exhaust Vent above Ceiling Plenum

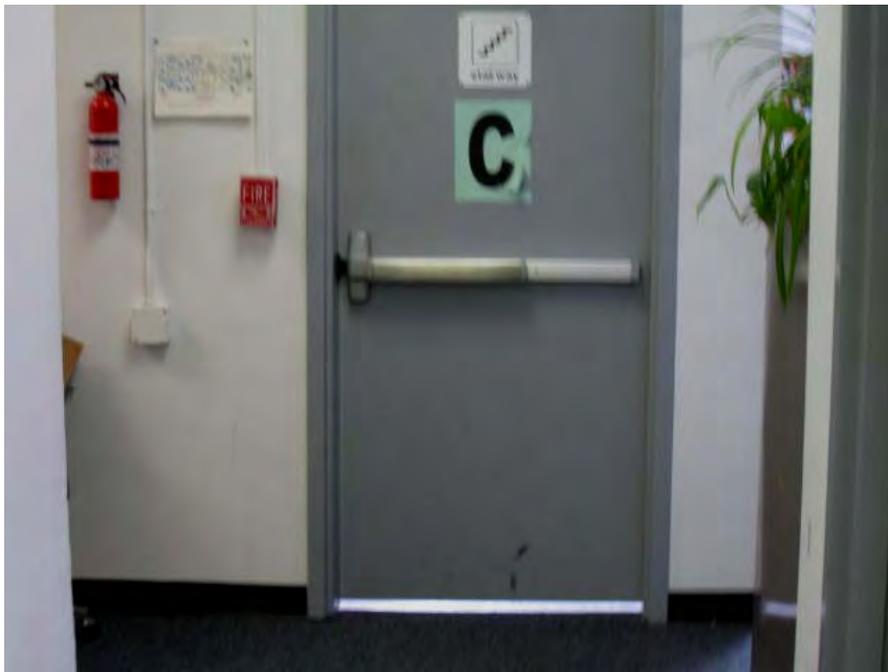
Picture 14

Finally, large spaces were observed beneath stairwell doors (Picture 14). Spaces beneath doors can serve as sources of drafts and serve as pathways for insects, rodents and other pests into the occupied space.

Spaces under Stairwell Door
